Midwest State's Regional Pooled Fund Research Program Fiscal Year 1996-1997 (Year 7) NDOR Research Project Number SPR-3(017)

DEVELOPMENT OF A 7.62-m LONG SPAN GUARDRAIL SYSTEM

MwRSF Research Report No. TRP-03-72-99 April 6, 1999

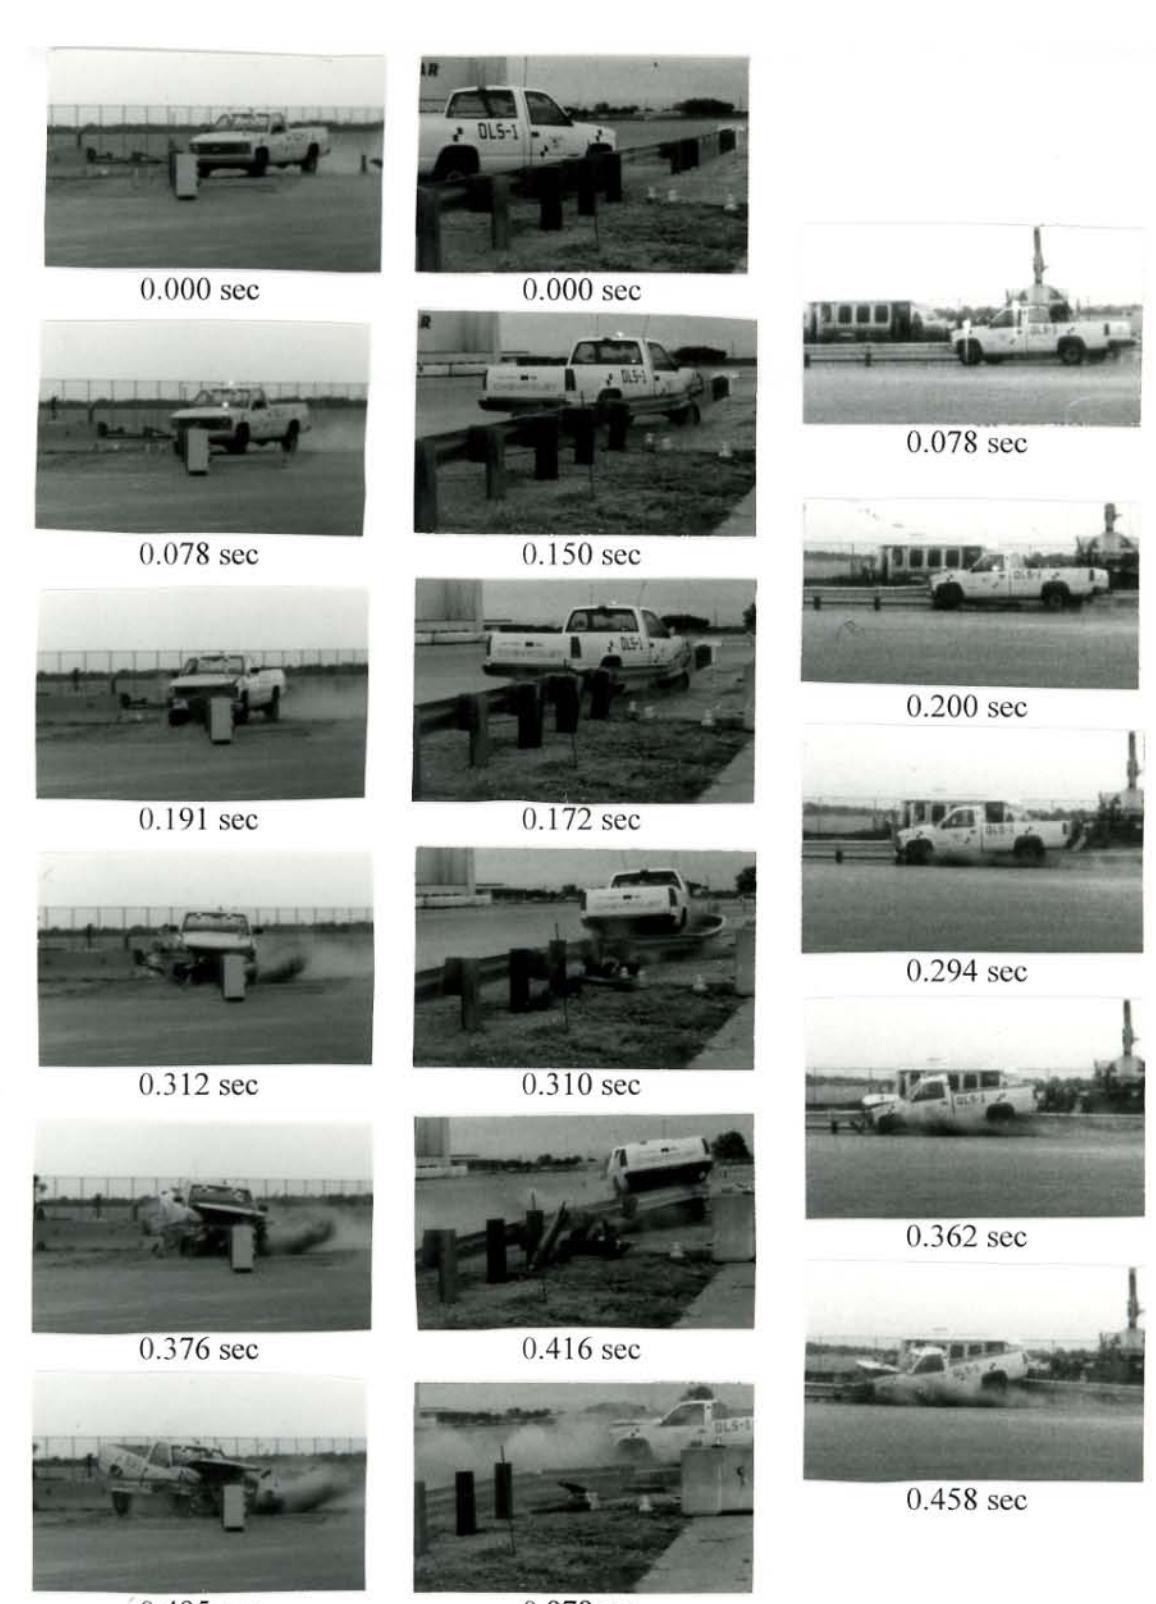
Figure 14. Additional Sequential Photographs, Test OLS-1 (Design No. 1)

Initial impact occurred between post nos. 4 and 5 or 2.44-m downstream from the center of post no. 5, as shown in Figure 16. At 0.062 sec after impact, the right-front corner of the vehicle was at the middle splice between post nos. 4 and 5. At 0.150 sec, the guardrail crushed the right-front side of the vehicle, while the right-front tire was deformed and protruded under the guardrail at 0.159 sec. The upstream portion of the guardrail began to move longitudinally at 0.164 sec after impact. At 0.170 sec, the BCT cable anchor failed. Subsequently, post nos. 4 through 6 fractured or split at 0.172 sec. At 0.197 sec after impact, the front end of the vehicle was at post no. 3. The vehicle impacted post no. 3 at 0.235 sec, resulting in post fracture. At 0.285 sec, the front end of the vehicle was at post no. 2, and the guardrail was positioned under the front of the vehicle. The vehicle became parallel to the guardrail at 0.316 sec after impact with a velocity of 57.5 km/hr. At 0.334 sec, the vehicle continued to be redirected when it yawed counter-clockwise (CCW) with the back corner of the vehicle contacting the guardrail. At 0.396 sec after impact, the vehicle's forward motion ceased, but the vehicle continued to rotate in a CCW motion. At 0.458 sec after impact, the rear end of the vehicle reached its maximum position above the ground. At 0.495 sec, the guardrail wrapped around the right-rear tire and moved up into the wheel well. At 0.878 sec, the vehicle was

back on the ground and positioned approximately perpendicular to the system. The vehicle's postimpact trajectory is shown in Figure 13. The vehicle came to rest behind post nos. 1 and 2, approximately 6.55-m downstream from impact and 1.27-m laterally behind a line projected parallel to the traffic-side face of the rail, as shown in Figure 13.

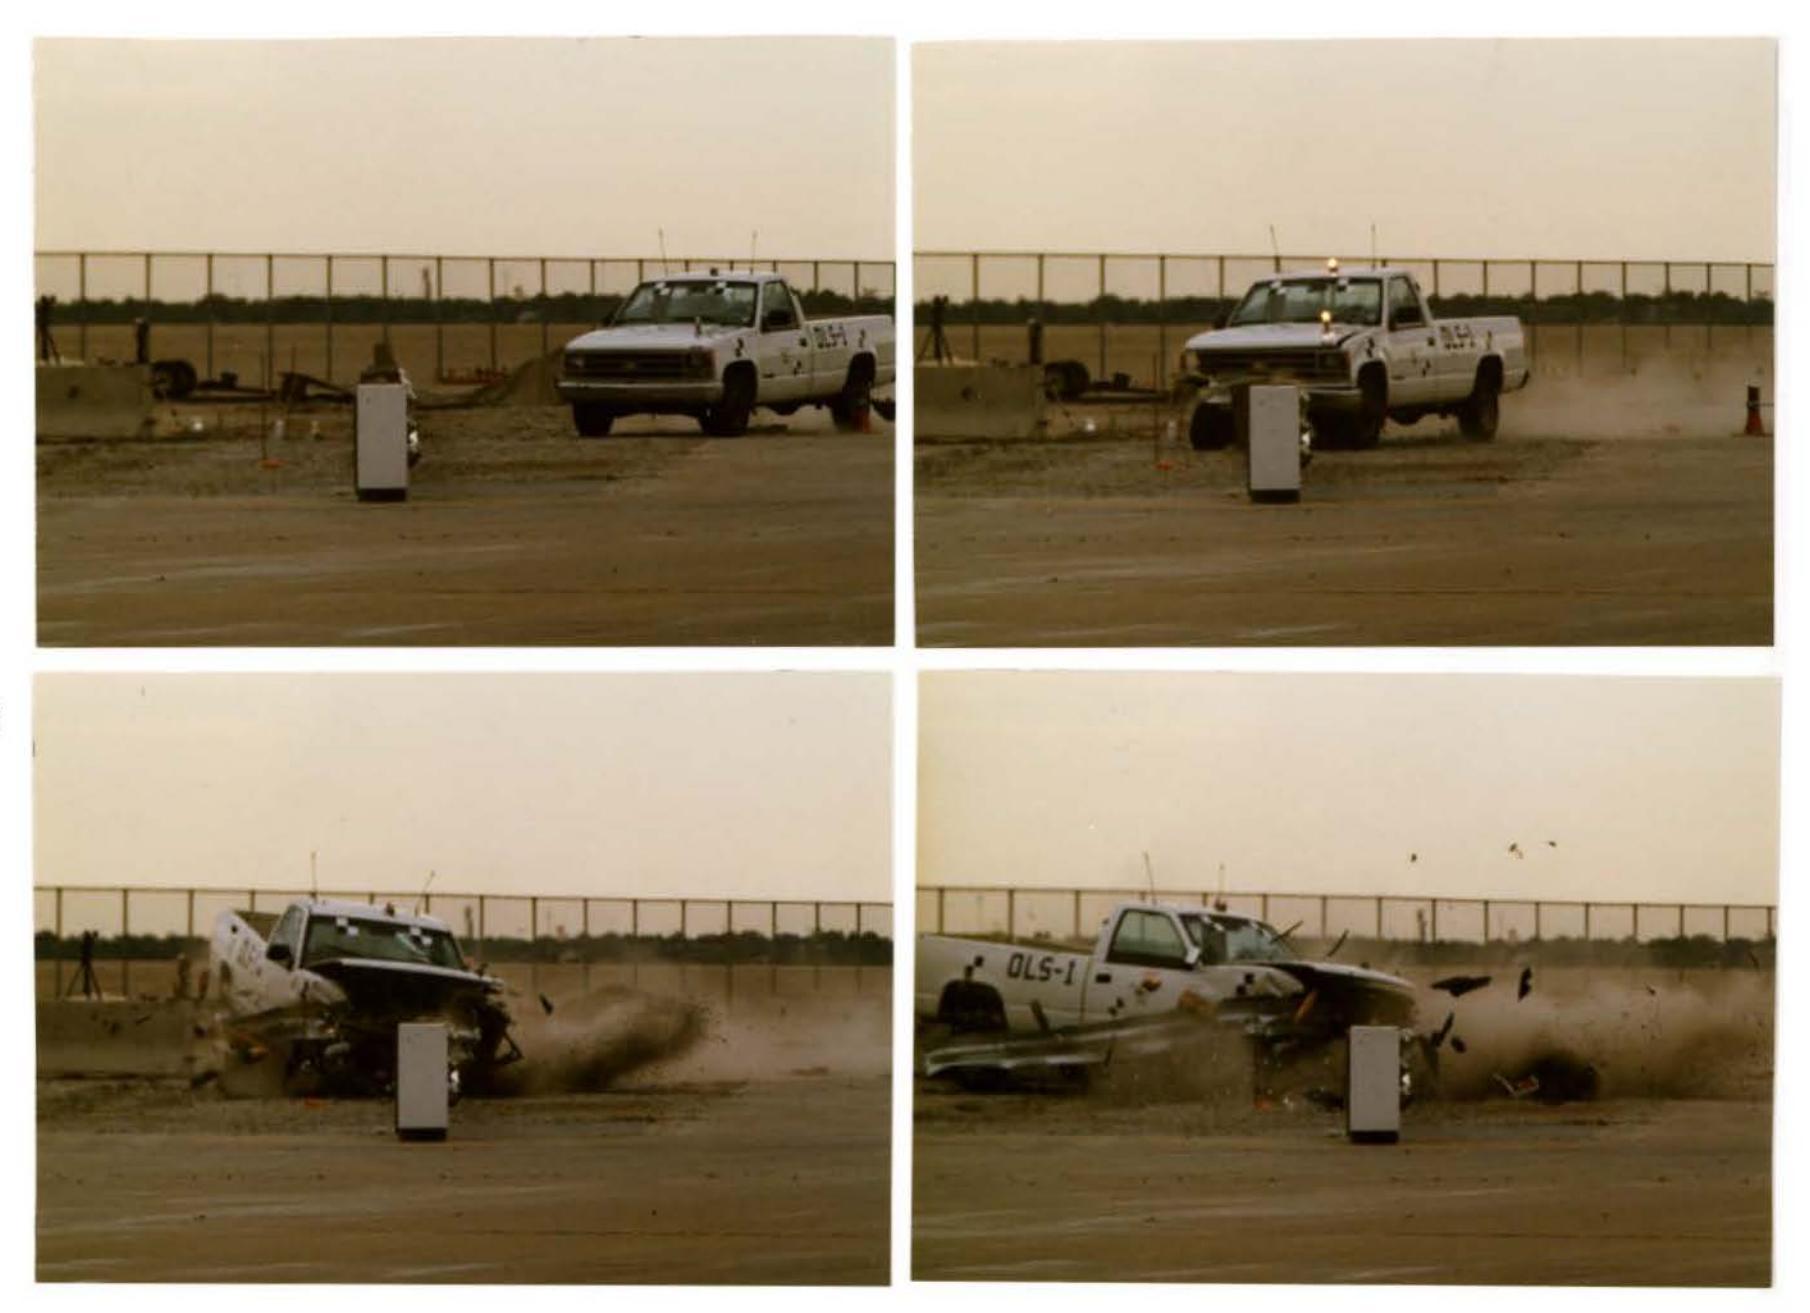
Figure 15. Documentary Photographs, Test OLS-1 (Design No. 1)

The 1,999-kg pickup truck impacted the long-span guardrail system (Design No. 1) at a speed of 101.3 km/hr and an angle of 25.4 degrees. A summary of the test results and the sequential photographs are shown in Figure 13. Additional sequential photographs are shown in Figure 14. Documentary photographs of the crash test are shown in Figure 15.

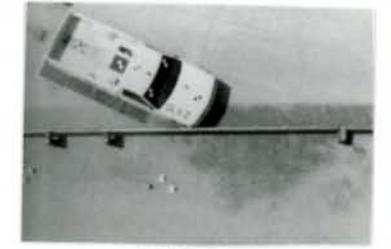
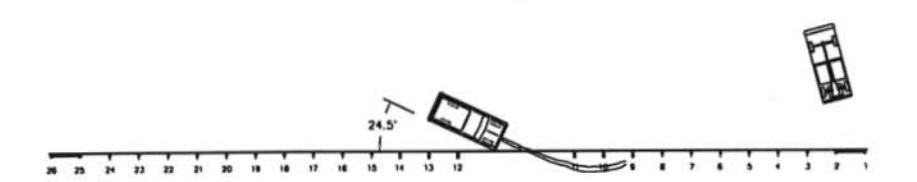
Figure 24. Summary of Test Results and Sequential Photographs, Test OLS-2 (Design No. 2)

Initial impact occurred between post nos. 11 and 12 or 2.44-m downstream from the center of post no. 12, as shown in Figure 30. At 0.024 sec after impact, the right-front corner of the bumper deformed. At 0.043 sec, the right-front corner of the vehicle was at the midpoint between post nos. 11 and 12. At 0.111 sec, the right-front corner of the vehicle crushed inward while post no. 11 fractured. At 0.126 sec after impact, the right-front tire protruded under the guardrail. At 0.182 sec, post nos. 10, 12, and 13 deflected, while the right-front corner of the vehicle was at the initial position of post no. 11. At 0.255 sec after impact, the right-front corner of the vehicle was at post no. 10 as the right-rear corner of the bumper contacted the guardrail. The vehicle became parallel to the guardrail at 0.263 sec after impact with a velocity of 73.2 km/hr. At 0.292 sec, the vehicle rolled counter-clockwise (CCW), allowing the left-front and left-rear tires to become airborne and the rear bumper to mount the top of the rail. At 0.302 sec, post no. 10 fractured. At 0.340 sec after impact, the right-front corner of the vehicle was at post no. 9, while the guardrail was positioned under the right-rear corner of the vehicle. At this time, the vehicle exited the guardrail at an angle of 16.7 degrees and a speed of 66.2 km/hr. At 0.428 sec, only the right-front corner of the vehicle was contacting the ground. At 0.450 sec, the right-front corner of the vehicle was at post no. 8, while the rear end of the vehicle yawed CCW into the guardrail. At 0.570 sec, the rear end of the vehicle yawed clockwise (CW) away from the guardrail. At 0.946 sec, the vehicle pitched and rolled across the front end and the right-front corner was airborne. The left-front corner of the vehicle was on the ground and the rear end rotated CW at 1.116 sec. At 1.260 sec, the entire vehicle rolled CW while airborne. At 1.444 sec after impact, the rear end of the vehicle contacted the ground on the left side as the vehicle continued its CW rotation. The vehicle's post-impact trajectory is shown in Figure 24. The vehicle came to rest 34.90 m downstream from impact and 10.73 m away from the traffic-side face of the rail, as shown in Figure 24.

The normalized longitudinal and lateral occupant impact velocities were determined to be 6.74 m/sec and 4.96 m/sec, respectively. The maximum 0.010-sec average occupant ridedown decelerations in the longitudinal and lateral directions were 6.35 g's and 8.27 g's, respectively. It is noted that the occupant impact velocities (OIV) and occupant ridedown decelerations (ORD) were within the suggested limits provided in NCHRP Report No. 350. The results of the occupant risk, determined from the accelerometer data, are summarized in Figure 24. Results are shown

٠	Vehicle Angle	
	Impact	24.5 degrees
	Exit	16.7 degrees
٠	Vehicle Snagging	Minor contact on spacer blocks
		Snagging on post no. 11
٠	Vehicle Pocketing	Minor
٠	Vehicle Stability	Vehicle rollover
٠	Occupant Ridedown Deceleration (10 msec	avg.)
	Longitudinal	6.35 < 20 G's
	Lateral (not required)	8.27
٠	Occupant Impact Velocity (Normalized)	
	Longitudinal	6.74 < 12 m/s
	Lateral (not required)	4.96
٠	Vehicle Damage	Extensive
	TAD ¹⁴	NA
	SAE ¹⁵	NA
٠	Vehicle Stopping Distance	34.90 m downstream
	 Reconcision of the state of the international state of the state of th	10.73 m traffic-side face
٠	Barrier Damage	Moderate
٠	Maximum Deflections	
	Permanent Set	956 mm
	Dynamic	1,342 mm

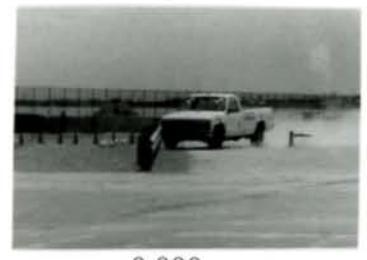
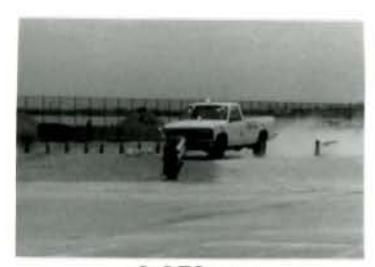
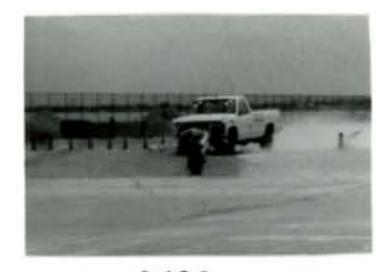
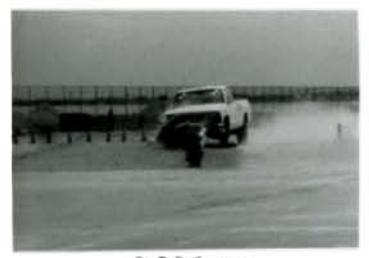
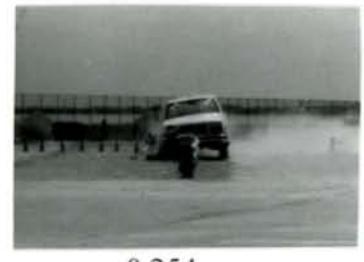
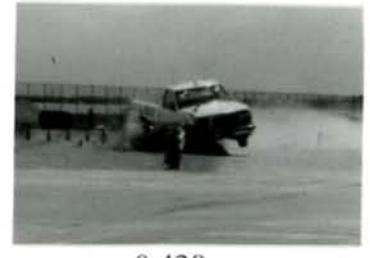
Figure 25. Additional Sequential Photographs, Test OLS-2 (Design No. 2)

The 1,997-kg pickup truck impacted the modified long-span guardrail system (Design No. 2) at a speed of 102.7 km/hr and an angle of 24.5 degrees. A summary of the test results and the sequential photographs are shown in Figure 24. Additional sequential photographs are shown in Figures 25 and 26. Documentary photographs of the crash test are shown in Figures 27 through 29.
