GUARDRAIL AND GUARDRAIL TERMINALS INSTALLED OVER CURBS - PHASE II

MIDWEST ROADSIDE SAFETY FACILITY

MwRSF Research Report No. TRP-03-105-00

November 5, 2001

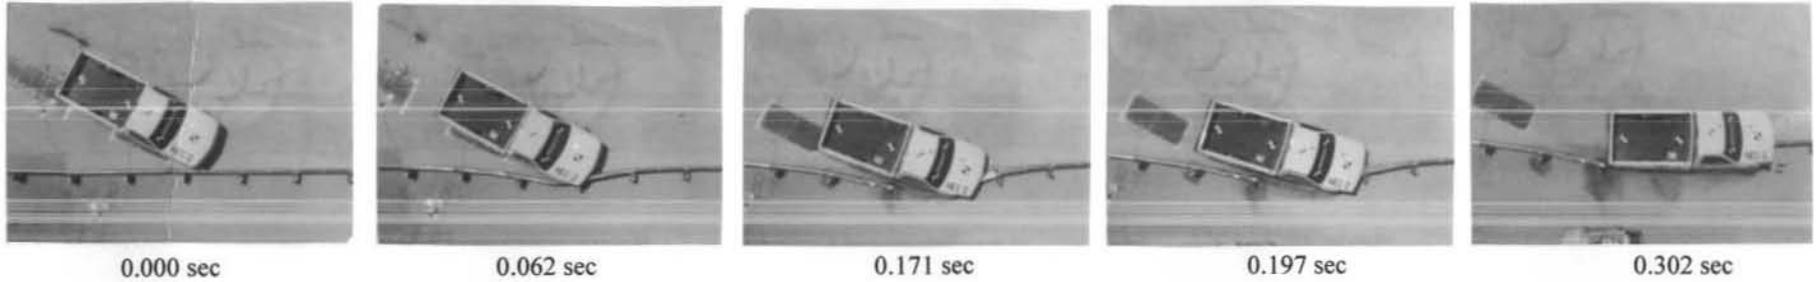
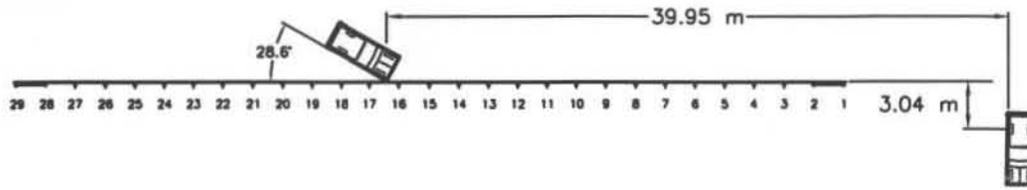
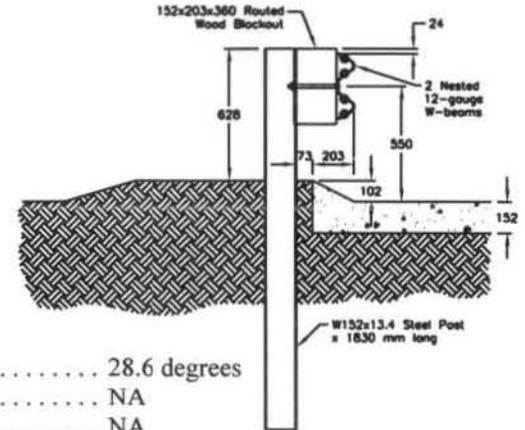
The analysis of the test results for test NEC-2 showed that the guardrail installed over a curb adequately contained and redirected the vehicle with controlled lateral displacements of the guardrail. Detached elements and debris from the test article did not penetrate or show potential for penetrating the occupant compartment. Deformations of, or intrusion into, the occupant compartment that could have caused serious injury did not occur. The vehicle remained upright during and after collision. Vehicle roll, pitch, and yaw angular displacements were noted, but they were deemed acceptable because they did not adversely influence occupant risk safety criteria nor cause rollover. The vehicle's trajectory did not intrude into adjacent traffic lanes. In addition, the vehicle's exit angle was less than 60 percent of the impact angle. Therefore, test NEC-2 conducted on the guardrail/curb combination was determined to be acceptable according to the NCHRP Report No. 350 criteria.

- Test Number NEC-2
- Date 7/24/00
- Appurtenance W-beam guardrail over curb system
- Total Length 53.34 m
- Steel Nested W-Beam
 - Thickness Two at 2.66 mm each
 - Top Mounting Height 706 mm
- Steel Posts
 - Post Nos. 3 - 27 W152x13.4 by 1,830-mm long
- Wood Posts
 - Post Nos. 1 - 2, 28 - 29 (BCT) . 140 mm x 190 mm by 1,080-mm long
- Routed Wood Spacer Blocks
 - Post Nos. 3 - 27 152 mm x 203 mm by 360-mm long
- Curb AASHTO 102 mm x 203 mm
 - Type "G" Curb
 - Curb Span Post no. 19 to post no. 9
 - Total Curb Length 19.05 m
- Soil Type Grading B - AASHTO M 147-65 (1990)
- Vehicle Model 1994 GMC 2500 ¾-Ton
 - Curb 2,017 kg
 - Test Inertial 2,033 kg
 - Gross Static 2,033 kg
- Vehicle Speed
 - Impact 100.3 km/hr
 - Exit NA

- Vehicle Angle
 - Impact 28.6 degrees
 - Exit NA
- Vehicle Snagging NA
- Vehicle Pocketing NA
- Vehicle Stability Satisfactory
- Occupant Ridedown Deceleration (10 msec avg.)
 - Longitudinal 6.72 < 20 G's
 - Lateral (not required) 5.75
- Occupant Impact Velocity
 - Longitudinal 6.09 < 12 m/s
 - Lateral (not required) 4.85
- Vehicle Damage Moderate
 - TAD¹⁴ 1-RFQ-4
 - SAE¹⁵ 1-RFEW5
- Vehicle Stopping Distance Behind the system
 - Left Rear Tire 42.04 m downstream
 - 3.11 m behind
- Barrier Damage Moderate
- Maximum Deflections
 - Permanent Set 721 mm
 - Dynamic 1,072 mm

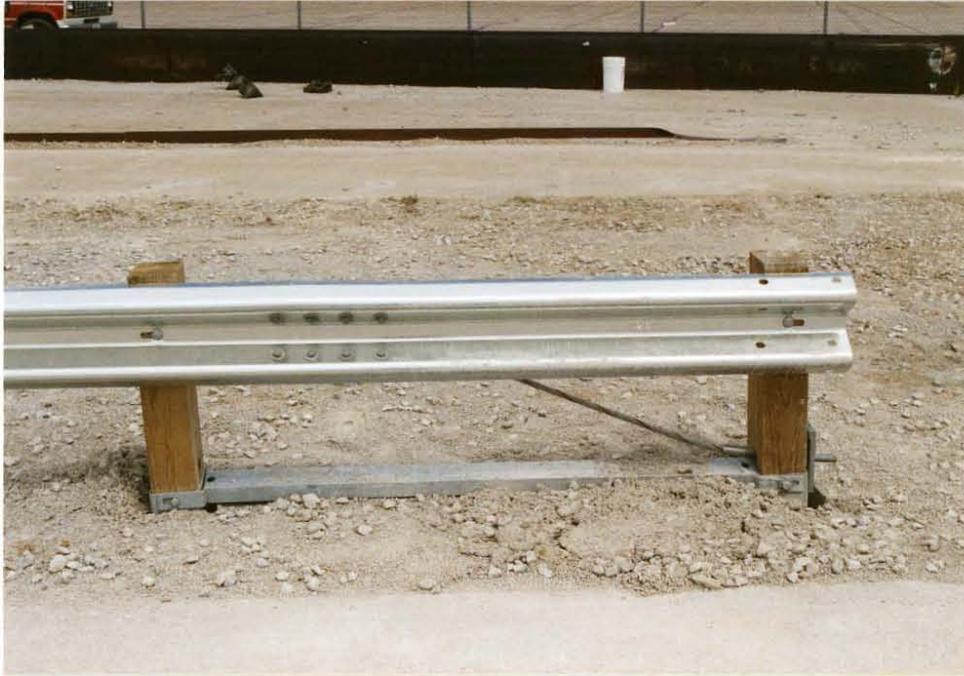
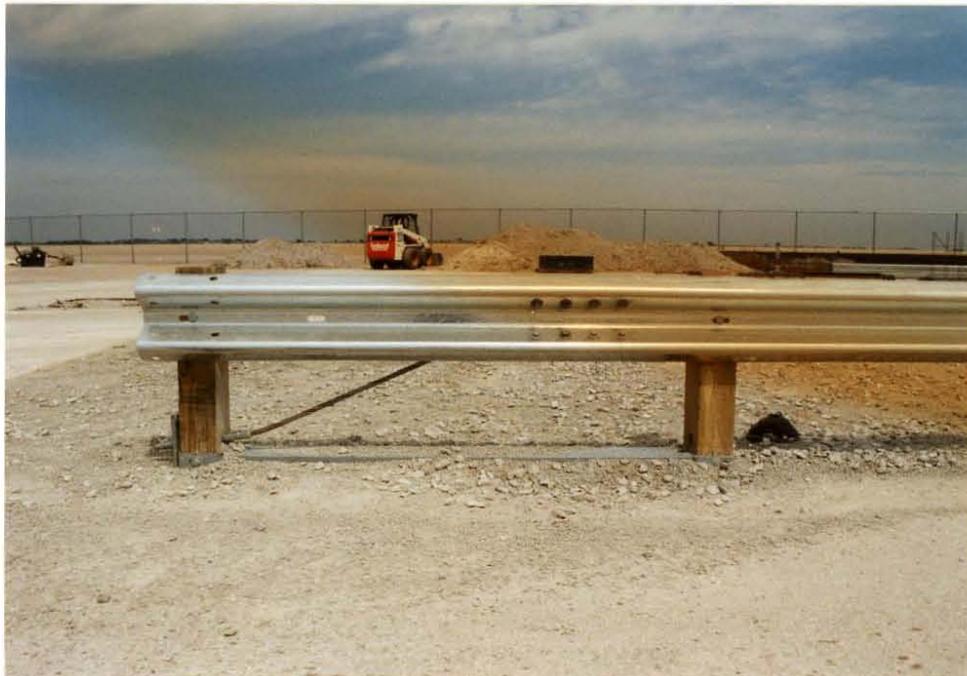
Figure 25. Permanent Set Deflections of End Anchorages, Test NEC-2

The permanent set of the guardrail and posts is shown in Figures 21 through 25. The cable anchor ends encountered slight permanent set deformations, as shown in Figure 25. The maximum lateral permanent set rail and post deflections were approximately 721 mm at the centerline of post no. 15 and 737 mm at post no. 16, respectively, as measured in the field. The maximum lateral dynamic rail and post deflections were approximately 1,072 mm at the centerline of post no. 15 and 802 mm at post no. 16, respectively, as determined from the high-speed film analysis.
