GUARDRAIL AND GUARDRAIL TERMINALS INSTALLED OVER CURBS

MIDWEST ROADSIDE SAFETY FACILITY

MwRSF Research Report No. TRP-03-83-99

March 21, 2000

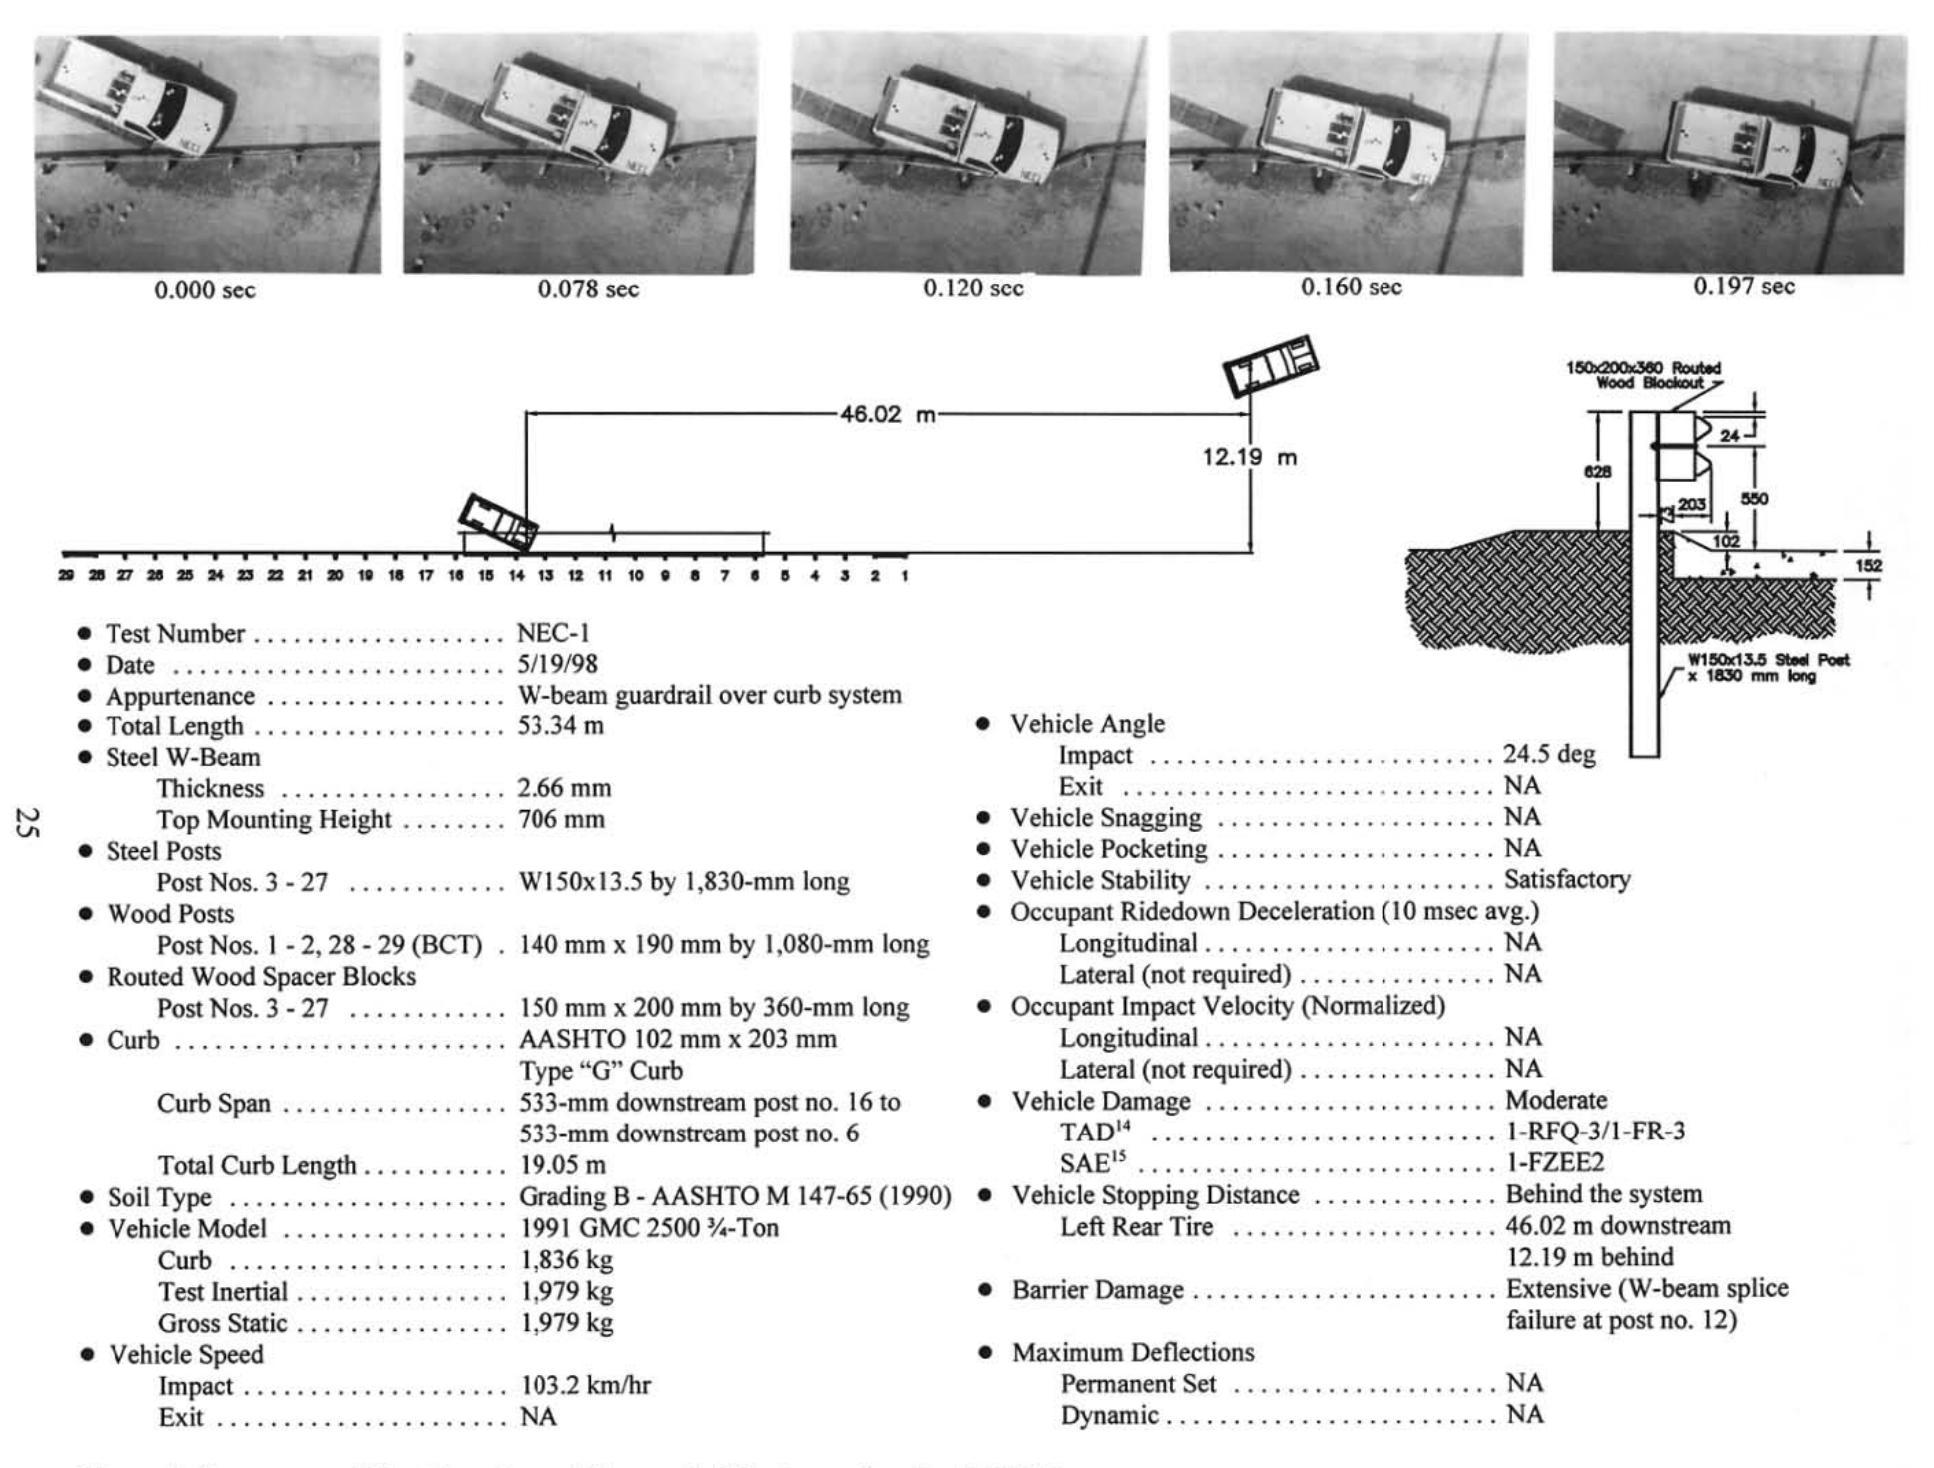
Figure 7. Summary of Test Results and Sequential Photographs, Test NEC-1

The 1,979-kg pickup truck impacted the guardrail over curb system at a speed of 103.2 km/hr and an angle of 24.5 degrees. A summary of the test results and the sequential photographs are shown in Figure 7. Additional sequential photographs are shown in Figure 8. Documentary photographs of the crash test are shown in Figures 9 and 10.

The analysis of the test results for test NEC-1 showed that the guardrail installed over a curb did not contain nor redirect the vehicle with controlled lateral displacements of the guardrail. Detached elements and debris from the test article did not penetrate or show potential for penetrating the occupant compartment. Deformations of, or intrusion into, the occupant compartment that could have caused serious injury did not occur. The vehicle remained upright during and after collision. The vehicle's trajectory did not intrude into adjacent traffic lanes, but the penetration of the vehicle through the system was unacceptable. Therefore, test NEC-1 conducted on the guardrail/curb combination was determined to be unacceptable according to the NCHRP Report No. 350 criteria.
