DEVELOPMENT OF THE GC-8000 BRIDGE RAILING AND TRANSITION

MwRSF Research Report No. TRP-03-161-06

May 2, 2006

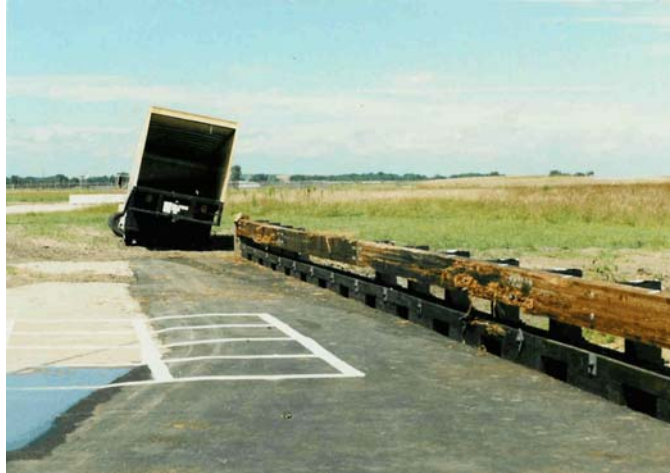
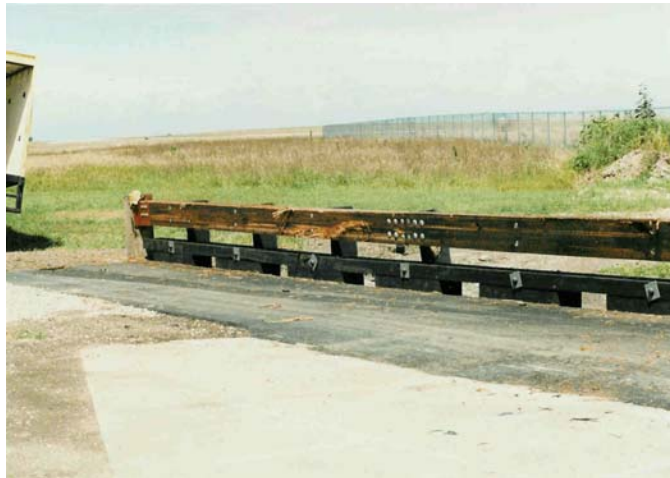
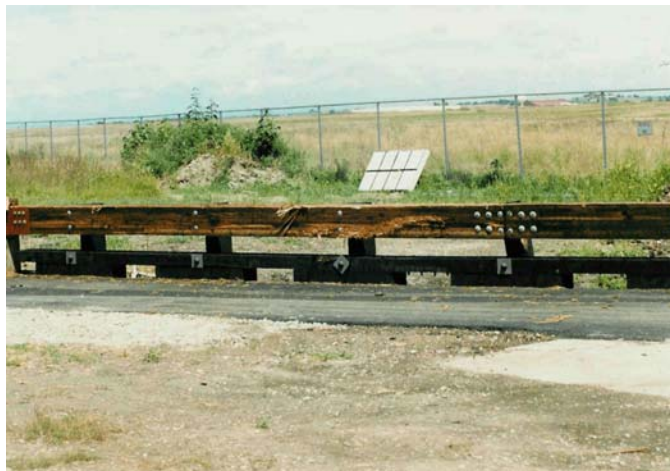
Figure 51. Rail Damage Downstream from Impact, Test FSCR-1

The moderate bridge railing damage is shown in Figures 51 through 59. Significant gouging and scrapes occurred to the glulam rail from the midspan between post nos. 3 and 4 to post no. 5. The curb rail received major gouges between post nos. 4 and 5. Minor scrapes were found on the glulam rail between post nos. 5 and 7. Major gouging and scrapes occurred to the top of the glulam rail from post nos. 7 through 12. Significant gouging and scrapes occurred to the glulam rail from the midspan between post nos. 12 and 13 to the midspan between post nos. 13 and 14, as shown in Figure 51. Minor scrapes were evident on the curb rail near post no. 13, as shown in Figure 51. The lower portion of the downstream end of glulam rail no. 1, located at post no. 4, was fractured on the lower part of the rail. Timber material was removed from the lower portion of the upstream end of glulam rail no. 2, also located at post no. 4. Three steel plate washers, located on the face of the curb rail at post nos. 4 through 6, were deformed due to wheel hub contact. At post nos. 4 and 5, the dome heads of several bolts on the rail face were deformed and/or severed due to vehicle gouging on the glulam rail, as shown in Figure 54.

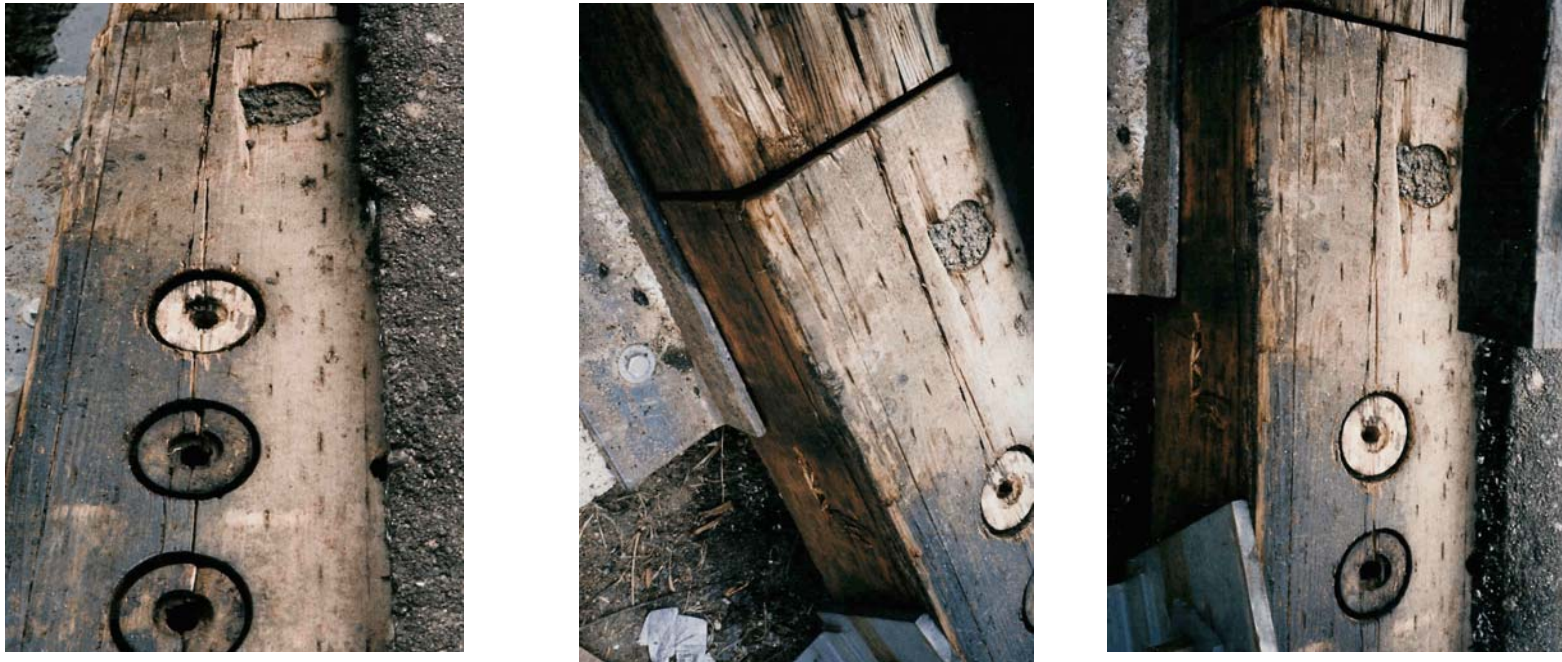
Figure 60. Deck Cracking on Upstream Side of Post No. 4, Test FSCR-1

The glulam timber bridge deck received some surface cracks near post no. 4, as shown in Figures 60 through 62. The crack width ranged between 1.6 mm ($\frac{1}{16}$ in.) and 3.2 mm ($\frac{1}{8}$ in.). The maximum lateral permanent set deflections for midspan rail and post locations were approximately 30 mm (1.2 in.) and 28 mm (1.1 in.), respectively, as measured in the field. The maximum lateral dynamic deflections for midspan rail and post locations were 145 mm (5.7 in.) and 165 mm (6.5 in.), respectively, as determined from high-speed analysis. The effective coefficient of friction was determined to be approximately 0.38.

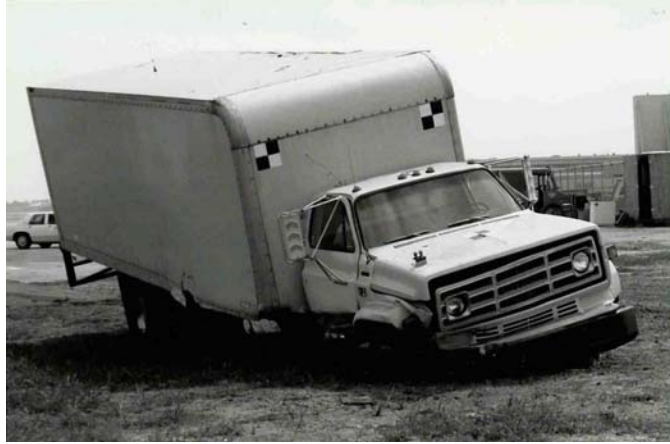
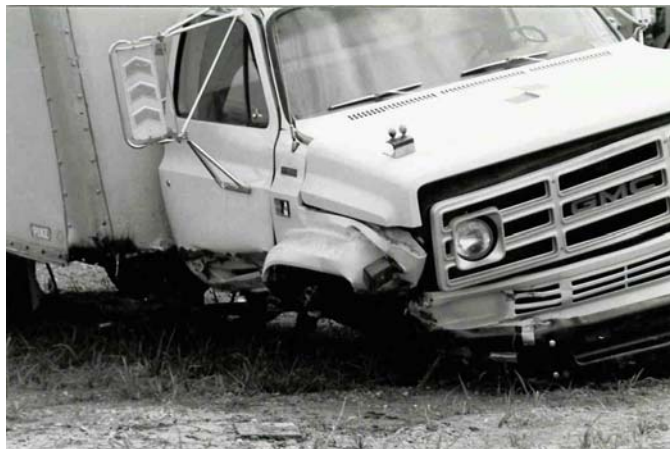
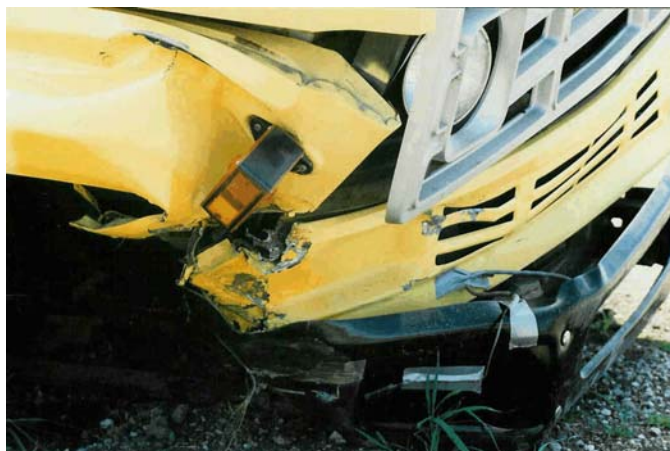
Figure 63. Vehicle Damage, Test FSCR-1

Exterior vehicle damage was moderate as shown in Figures 63 through 67. Vehicle damage occurred to several body locations, such as door and quarter panels, engine hood, front bumper, right-side wheels and rims, front axle, engine hood, truck box and support frame, side-mounted foot steps, and fuel tank. The right corner of the front bumper and the right-side door and quarter panels were crushed inward. The front axle, with attached tires and steel rims, became detached from the truck and came to rest under the left-side of the truck cab. The right-front and right-rear (outer dual) tires were deflated. The right-front steel rim, bolts, and nuts were worn and deformed. The right-side

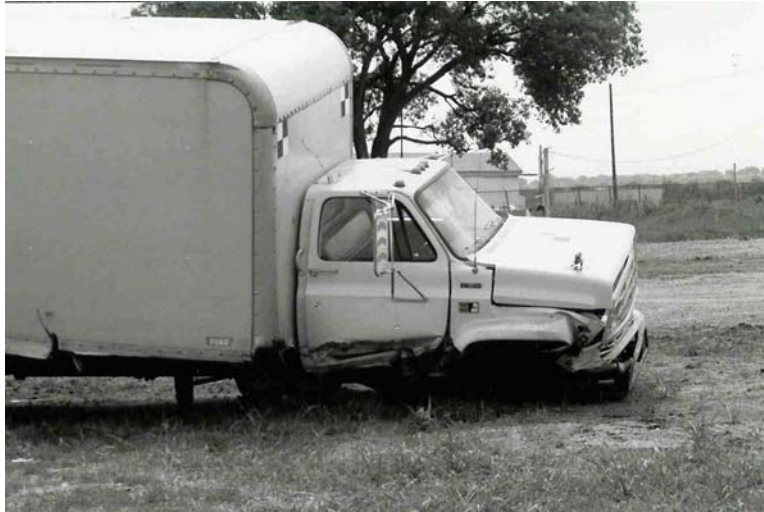
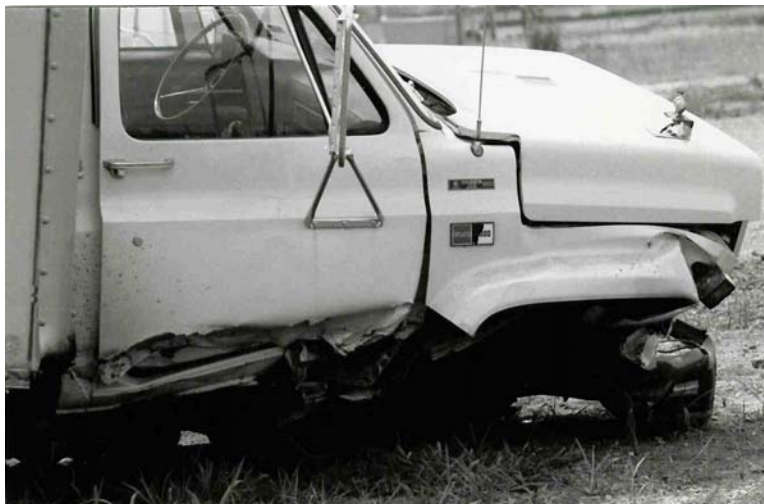
Figure 65. Vehicle Damage, Test FSCR-1

step and fuel tank were also removed. The truck box was shifted to the right of the longitudinal centerline of the truck cab and support frame. U-bolts, used to attach the box to the frame, were also deformed due to the box shift. The right-front lower corner of the box was deformed inward. Black creosote oil was found on the right-front lower corner of the box due to contact with the top and sides of the timber posts and spacer blocks located behind the glulam rail. The right-side vertical wall of the truck box collapsed outward due to the sandbag and steel plate ballast shifting. The floor support beam and corner frame on the lower right-side of the box was bent, deformed, and torn. It should be noted that some of the right-side vehicle damage occurred after the truck traveled parallel to the rail and impacted the downstream strong-post anchor, as shown in Figure 66.

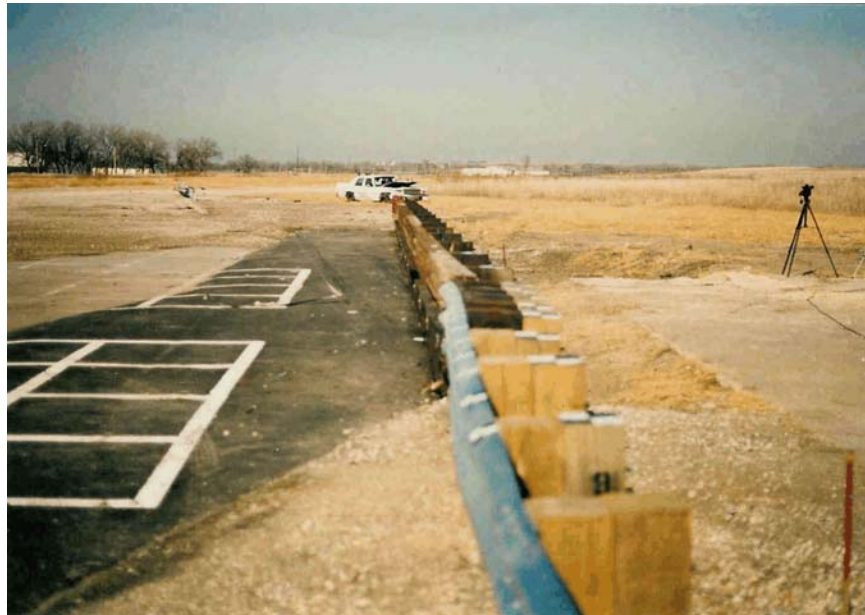
Figure 73. Impact Locations, Test FSCR-2

Impact occurred between guardrail post nos. 4A and 5A, approximately 2,924 mm (9 ft - 7 $\frac{1}{8}$ in.) upstream from bridge post no. 1, as shown in Figure 73. After initial impact with the transition, the right-front corner of the bumper and quarter panel crushed inward. At 0.039 sec, the right-front tire was near post no. 2A. Also at this same time, there was evidence of uplift of the vehicle's right-front corner, as well as the left-front corner of the engine hood opening. At 0.053 sec, the maximum dynamic lateral midspan deflection was measured between post nos. 1A and 2A. At 0.069 sec, the maximum dynamic lateral post deflection was measured at post no. 1A. At 0.079 sec, the vehicle's right-front corner was near the end of the transition or the beginning of the glulam bridge rail. At 0.157 sec, the vehicle was approximately parallel to the transition with a velocity of 78.9 km/h (49.0 mph). At 0.275 sec, the right-rear corner of the vehicle was near the end of the transition. At 0.295 sec, the vehicle exited the railing at a speed of approximately 71.8 km/h (44.6 mph) and at an angle of 3.7 degrees. The vehicle's trajectory and final position are shown in Figures 68 and 74. The vehicle came to rest approximately 57.9 m (190 ft) downstream from the impact point.

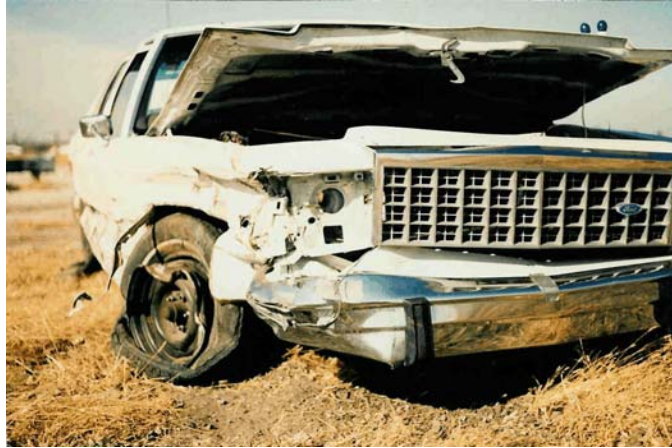
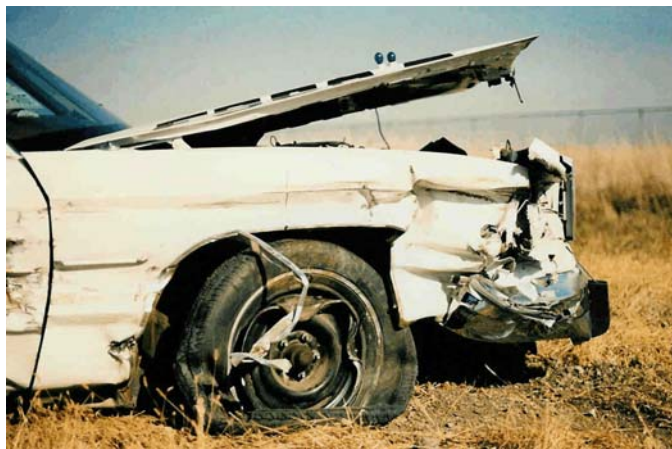
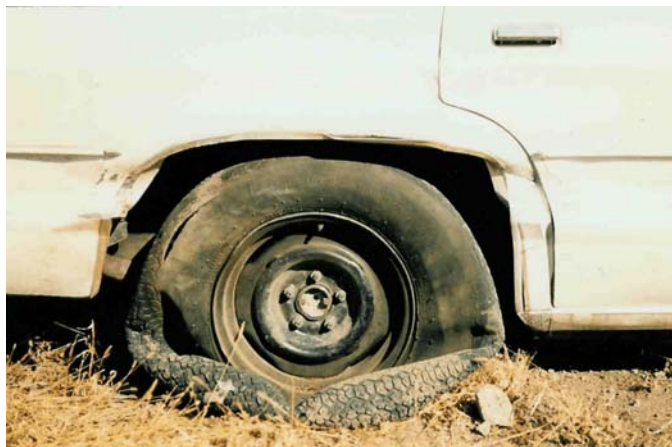
Figure 80. Vehicle Damage, Test FSCR-2

Exterior vehicle damage was moderate, as shown in Figures 80 through 82. Occupant compartment deformations to the right-front floorboard, as shown in Figure 83, were judged insufficient to cause serious injury to the vehicle occupants.

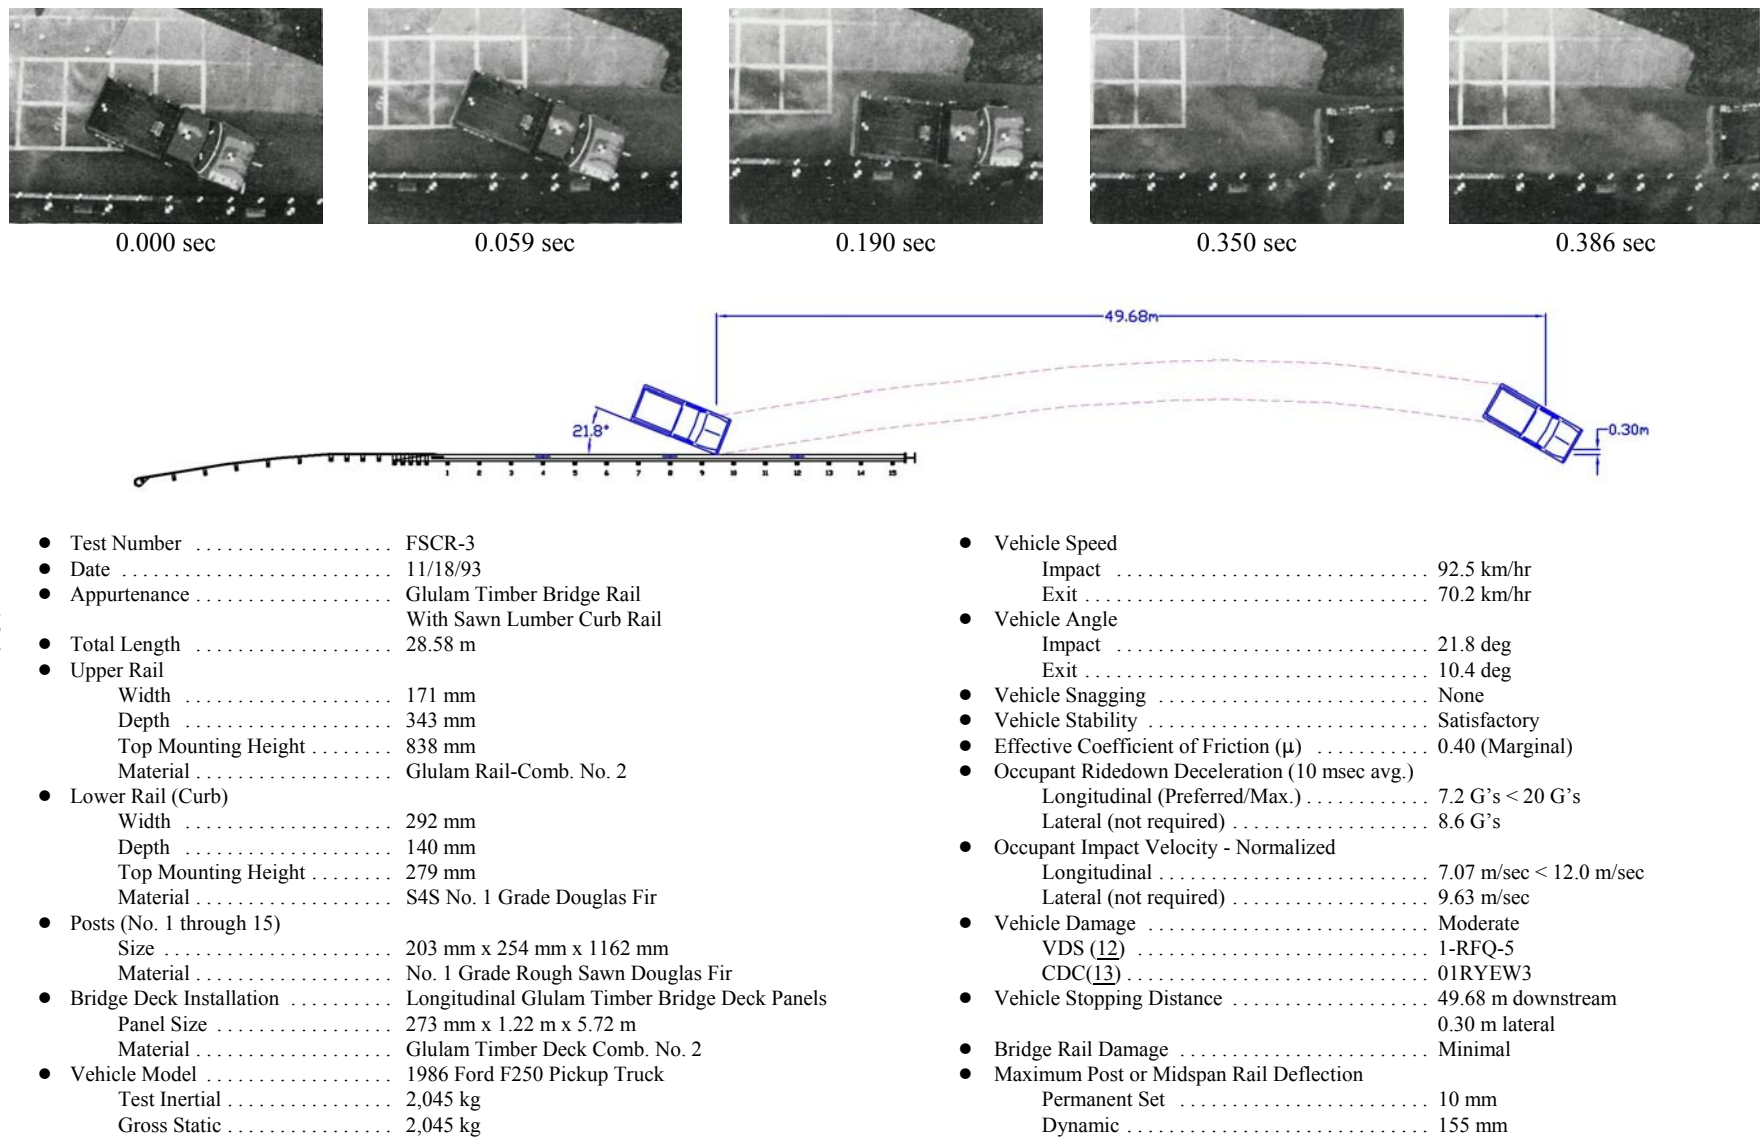
Figure 84. Summary of Test Results and Sequential Photographs, Test FSCR-3

The 2,045-kg (4,509-lb) pickup truck impacted the bridge railing at a speed of 92.5 km/h (57.5 mph) and at an angle of 21.8 degrees. A summary of the test results and the sequential photographs are shown in Figure 84. Additional sequential photographs are shown in Figure 85. Documentary photographs of the crash test are shown in Figures 86 through 88.

The longitudinal and lateral normalized occupant impact velocities were determined to be 7.07 m/s (23.2 ft/sec) and 9.63 m/s (31.6 ft/sec), respectively. The maximum 0.010-sec average occupant ridedown decelerations in the longitudinal and lateral directions were 7.2 g's and 8.6 g's, respectively. It is noted that the occupant impact velocities and occupant ridedown decelerations were within the suggested limits provided in NCHRP Report No. 350. The results of the occupant risk, determined from accelerometer data, are summarized in Figure 84. Results are shown graphically in Appendix H.

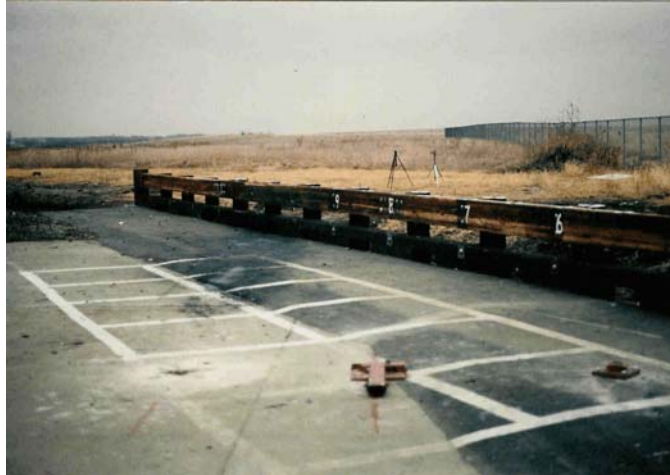
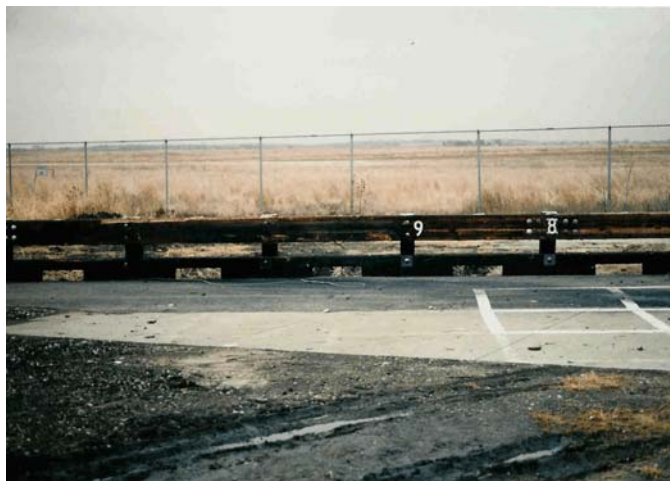
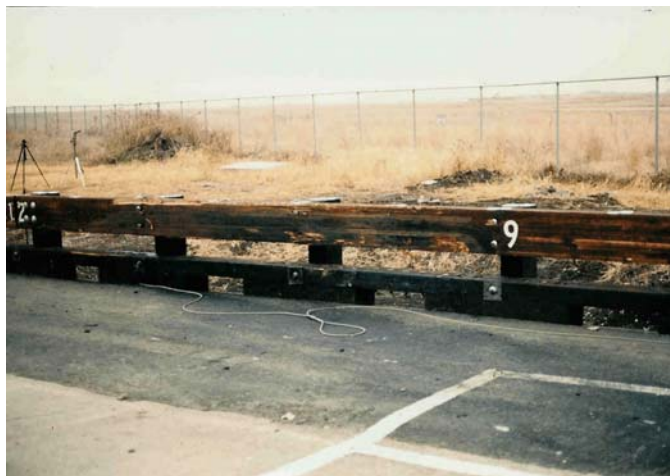
Figure 91. Bridge Rail Damage, Test FSCR-3

The minor bridge railing damage is shown in Figures 91 and 92. Scrapes and gouging approximately 3.96-m (13-ft) long occurred to the top-side and traffic-side faces of the glulam timber rail from the impact location to the downstream side of post no. 11. Minor scuff marks were also evident on the curb rail near post no. 10. No damage occurred to the timber bridge posts. One steel plate washer, located on the traffic-side face of the curb rail at post no. 10, was deformed due to wheel hub contact, as shown in Figure 92.

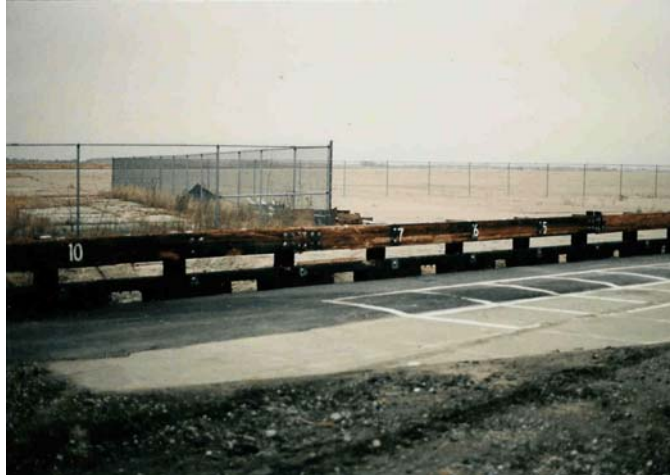
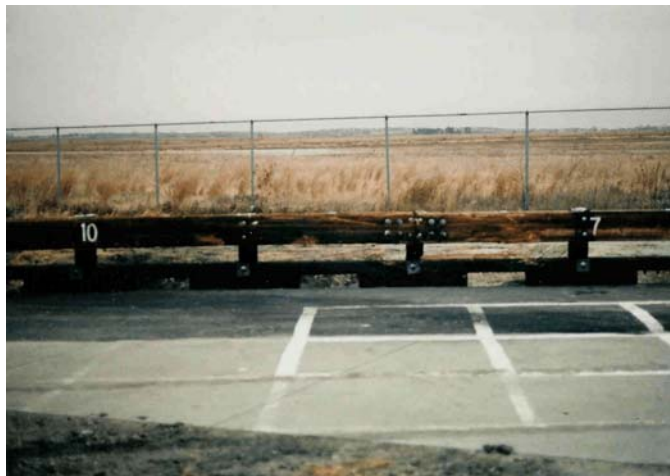
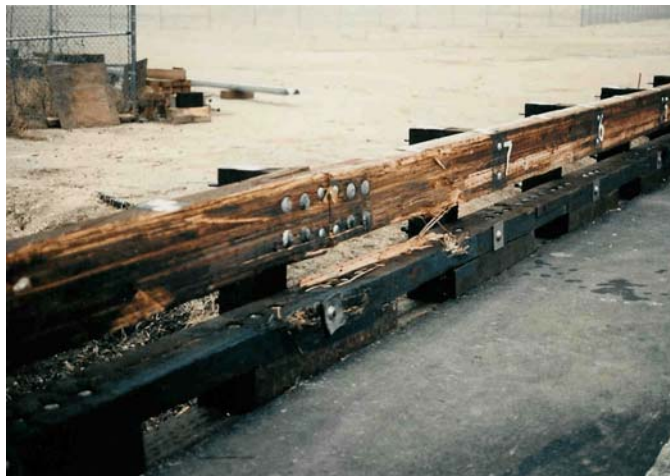
Figure 99. Bridge Rail Damage, Test FSCR-4

The minor bridge railing damage is shown in Figures 99 and 100. Scrapes and gouging occurred to the upper glulam timber and sawn lumber curb rails. Significant tire and rim contact with the curb rail occurred from the downstream side of post no. 7 to the downstream side of post no. 8. Longitudinal cracking occurred toward the bottom traffic-side face of the glulam rail at post no. 8. The downstream edge of the glulam rail splice located at post no. 8 was fractured. Flexural failure occurred in the tension region of the glulam rail (or the back side of the vertical saw-cut section) and near the downstream end of the steel splice plate, as shown in Figures 101 and 102.

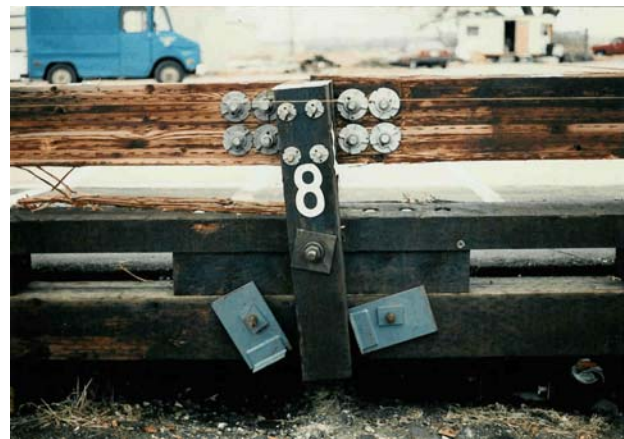
Figure 103. Damage at Post No. 8, Test FSCR-4

Permanent set in the curb rail was found at post nos. 7, 8, and 9. No physical damage occurred to the timber bridge posts or spacer blocks. However, rotation of post no. 8 occurred at the post to curb rail bolt attachment location, as shown in Figure 103. The high-strength bar, located transversely through the timber deck and on the upstream-side of post no. 8, pulled out of the high-strength nut and bearing plate located on the inside vertical deck surface, as shown in Figures 103 and 104. Note the residual of nut threads left on the end of the bar. One steel plate washer, located on the traffic-side face of the curb rail at post no. 8, was deformed due to wheel hub contact, as shown in Figure 105. Two steel plate washers, located on the back side of post nos. 8 and 9, were slightly deformed. Additional curb rail damage consisted of cracking along a vertical plane through the longitudinal centerline of the bolts, as shown in Figures 106 and 107. The glulam timber bridge deck received some surface cracks, as shown in Figures 107 and 108. The crack width ranged between 1.59 mm ($\frac{1}{16}$ in.) and 6.35 mm ($\frac{1}{4}$ in.).

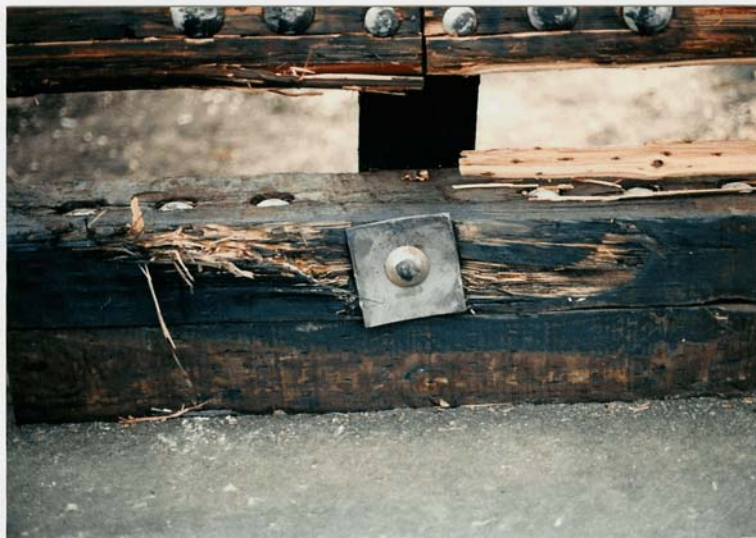
Figure 105. Plate washer deformation at Post No. 8, Test FSCR-4

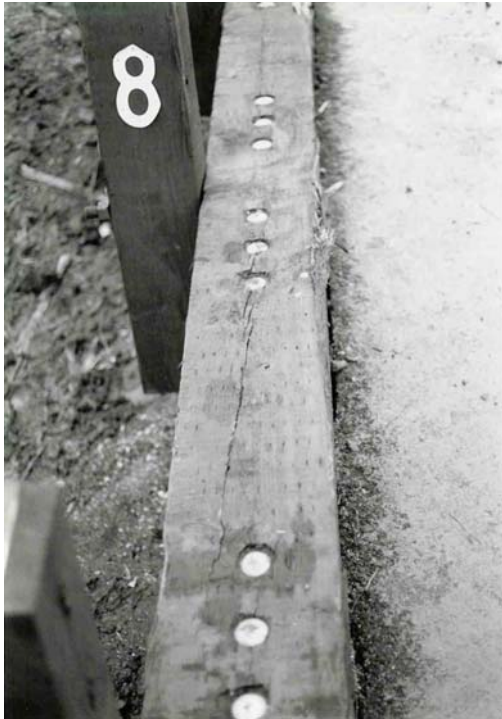
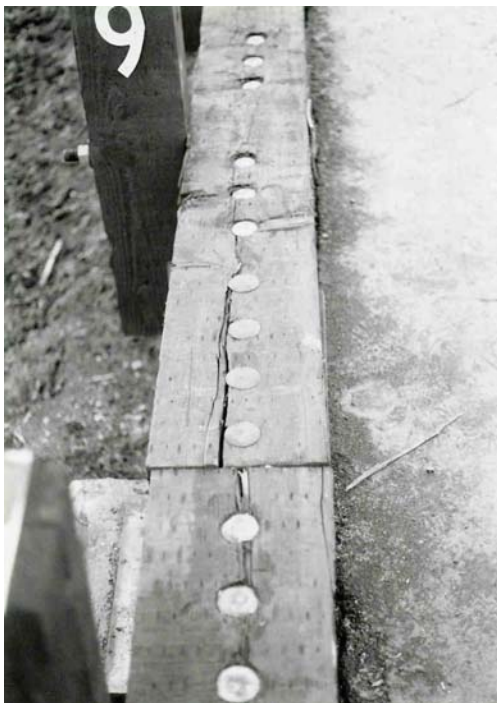
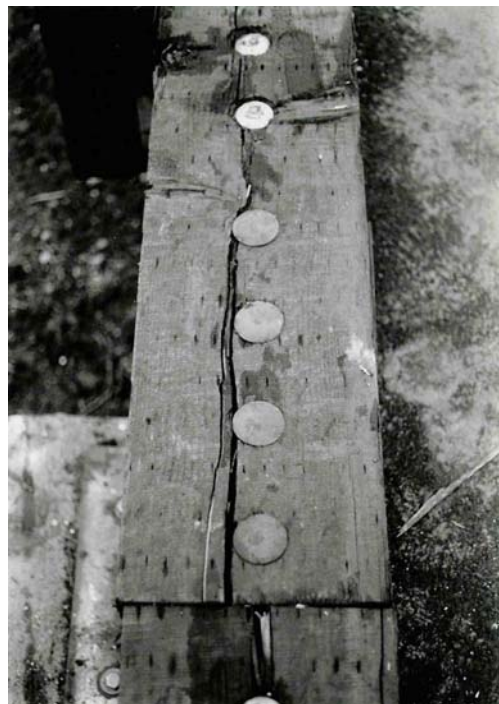
Figure 106. Curb Rail Damage Between Post Nos. 8 through 10, Test FSCR-4

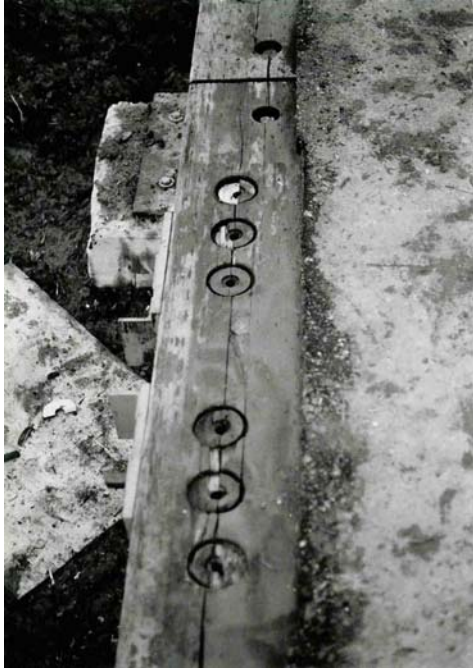
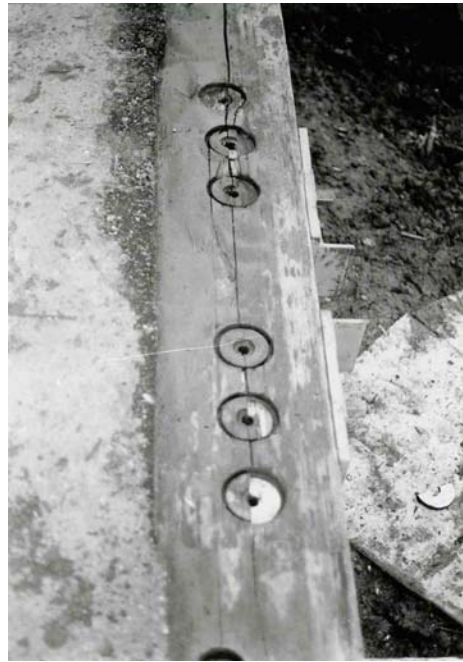
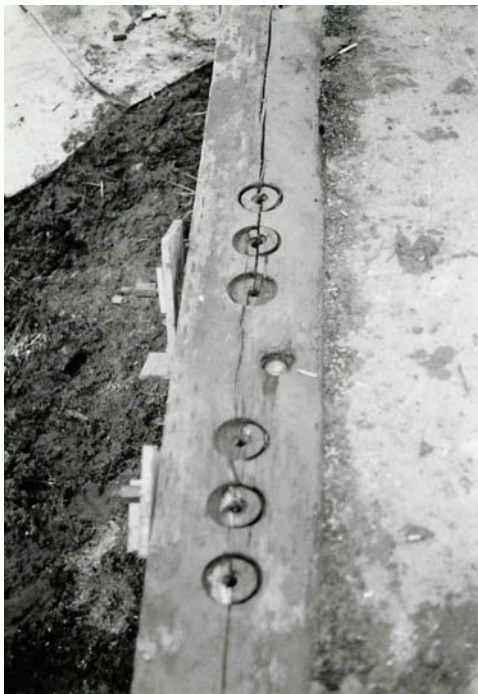
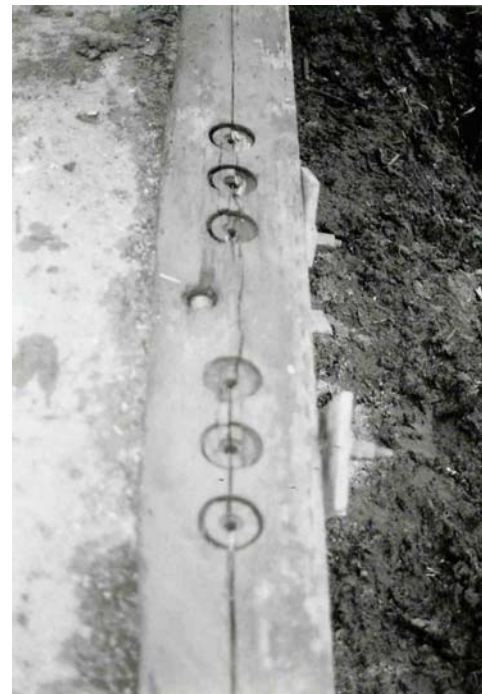
Figure 108. Deck Cracking at Post Nos. 7 and 8, Test FSCR-4
