FULL-SCALE VEHICULAR CRASH TESTING
of
EXPERIMENTAL SIGNS
on
BARRICADE STRUCTURES

TRANSPORTATION RESEARCH REPORT TRP-03-017-88

Civil Engineering Department
W348 Nebraska Hall
University of Nebraska-Lincoln
Lincoln, Nebraska 68588-0531
(402) 472-2371

June 1989

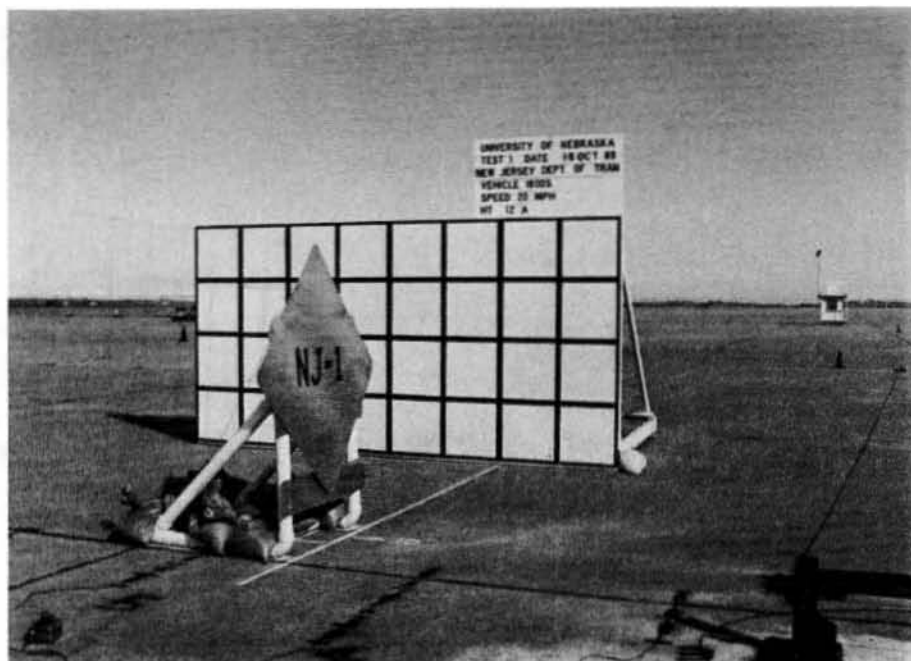
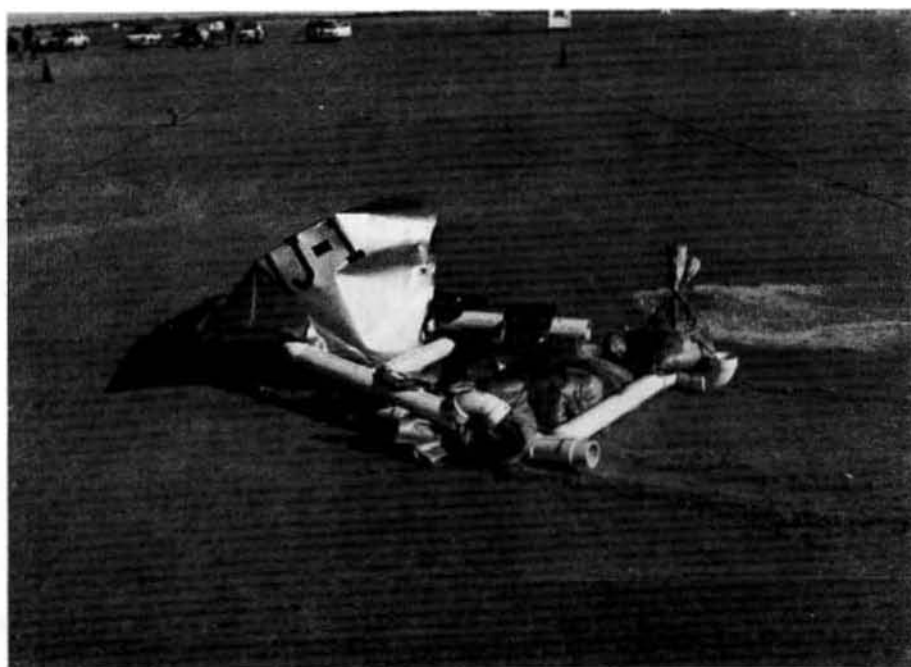
FIGURE 7. Photographs of Barricade Before and After Test No. 1

In test no. 1, the PVC shattered upon impact and the aluminum sign stayed in front of the vehicle. The vehicle rode up on some of the barricade debris and continued to push the rest of the debris until the vehicle came to a stop. The vehicle received no damage. It traveled 44-ft. past the point of impact with the barricade and veered 9-ft. to the right of its initial path. Photographs of the barricade and test vehicle, before and after impact, are shown in Figures 7, 8, and 9.

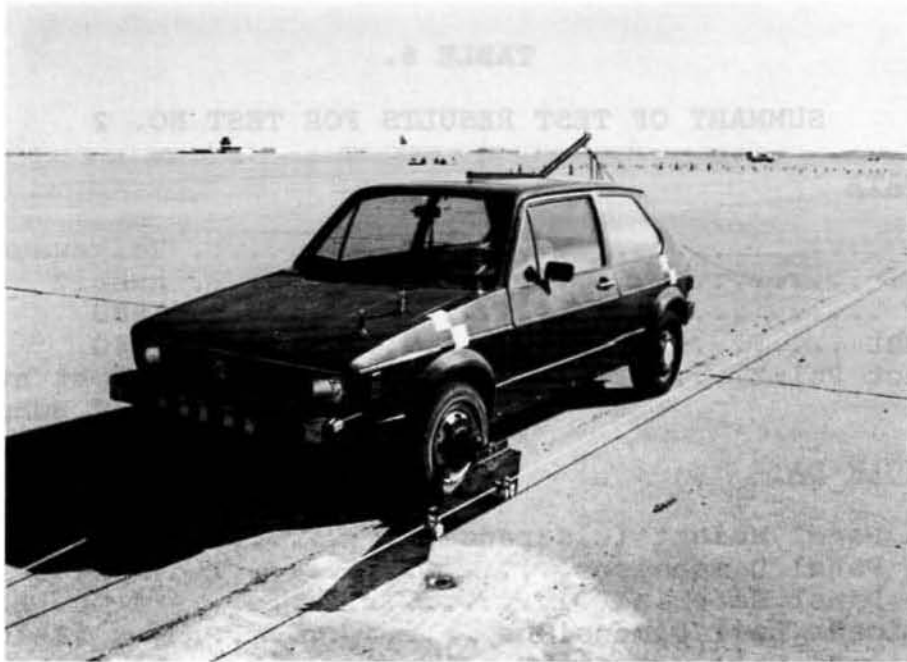
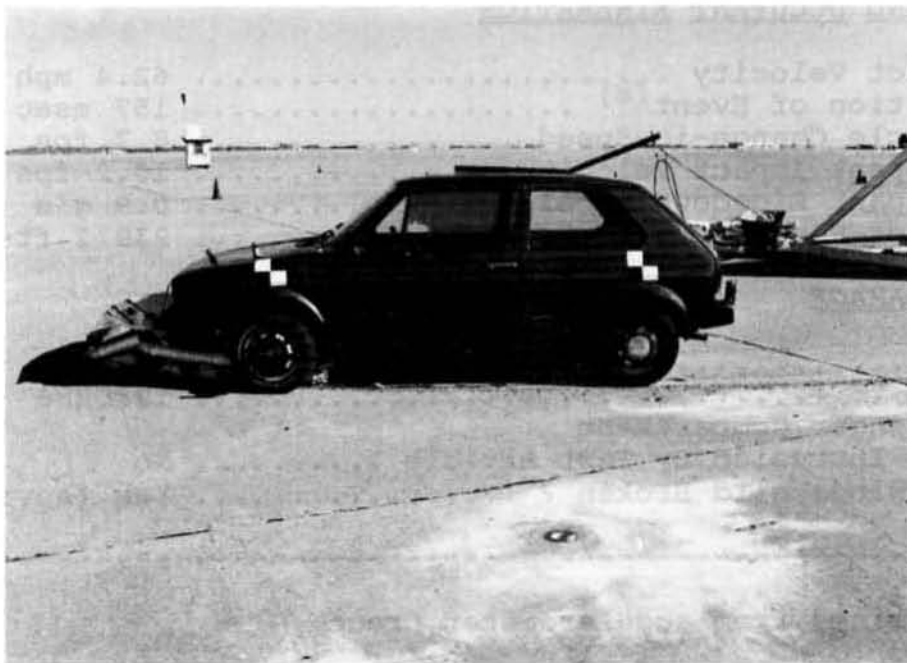
FIGURE 9. Photographs of Vehicle Before and After Test No. 1

TAD	FR-1
VDI	12FRMN1
Passenger Compartment	
Intrusion By Test Article	No
Was Windsheild Broken ?	No

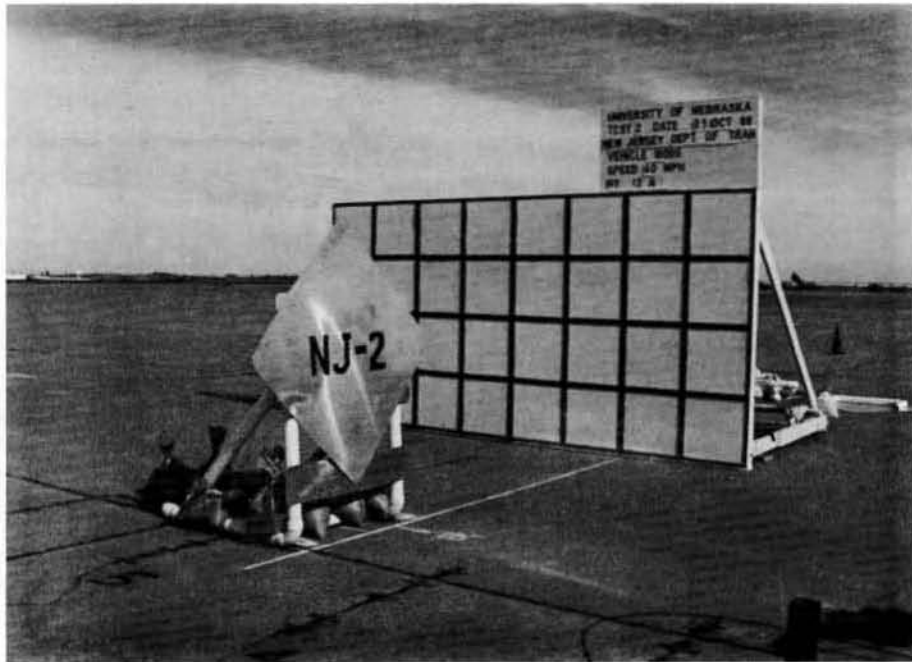
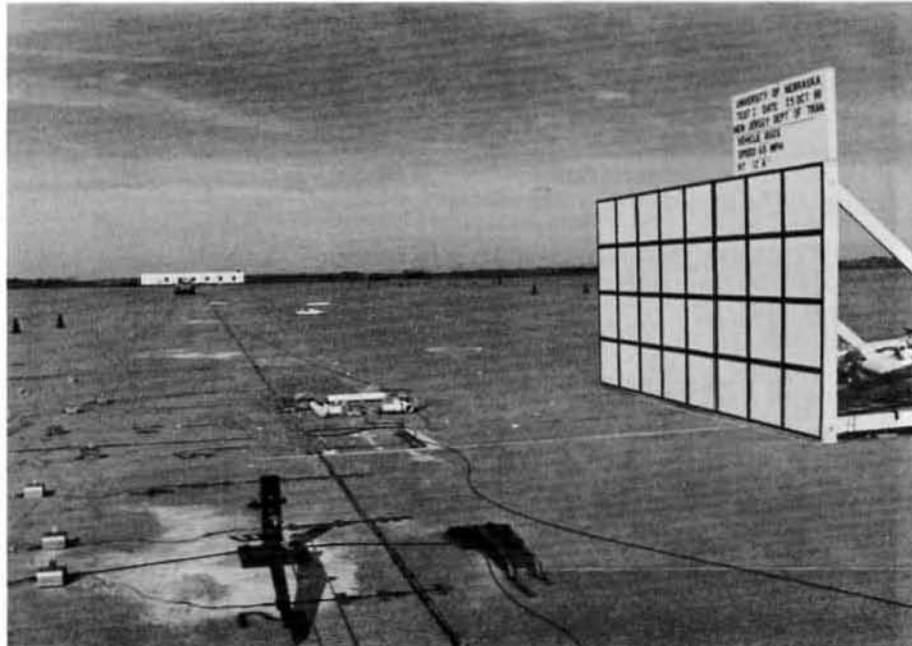
FIGURE 11. Photographs of Barricade Before and After Test No. 2

windshield as a result of the impact. The vehicle also received two dents in the hood where the vehicle and the two upright posts of the barricade contacted at impact. The vehicle traveled 279-ft. past the point of impact and veered 8-ft. to the left of its initial path before impact. Figures 11, 12, and 13 show photographs of the barricade and test vehicle before and after impact.

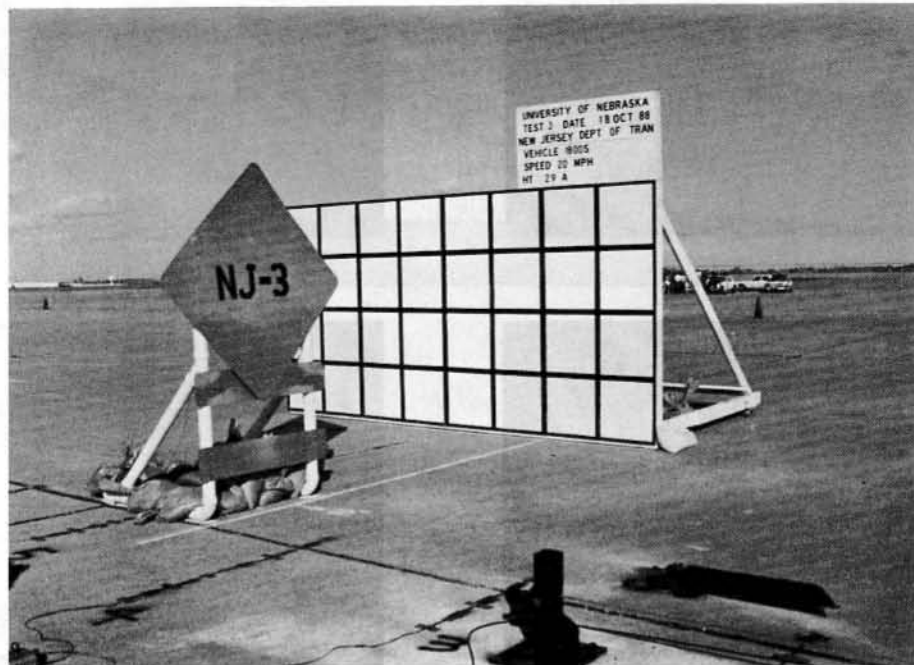
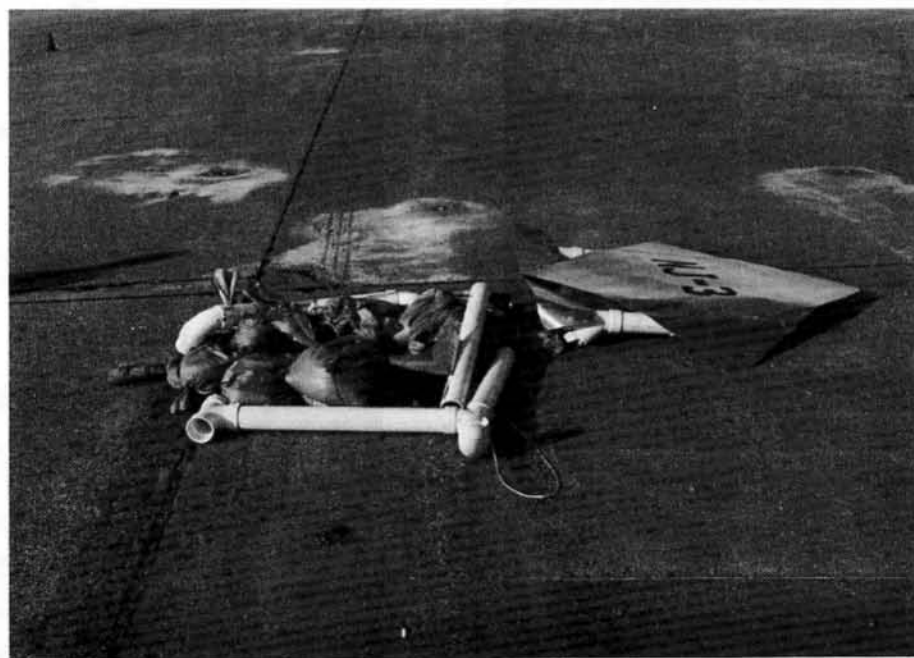
FIGURE 16. Photographs of Barricade Before and After Test No. 3

Test no. 3 was conducted at a target impact speed of 20 mph. At impact, the barricade collapsed and began to pile-up underneath the front end of the vehicle while the sign panel fell off to the passenger's side of the vehicle on the front right quarter panel. The vehicle proceeded to drag the barricade debris under its front end until it finally came to a stop 28-ft. beyond the point of impact. The test vehicle received no damage in this test. The duration of the event was not available since the accelerometer data cable broke during the test and the barricade debris stayed in contact with the vehicle until the vehicle stopped. The duration of the event is not evident without the accelerometer data since one does not know how much the barricade debris affected the braking of the vehicle. Figures 16, 17, and 18 show photographs of the test vehicle and barricade before and after impact.

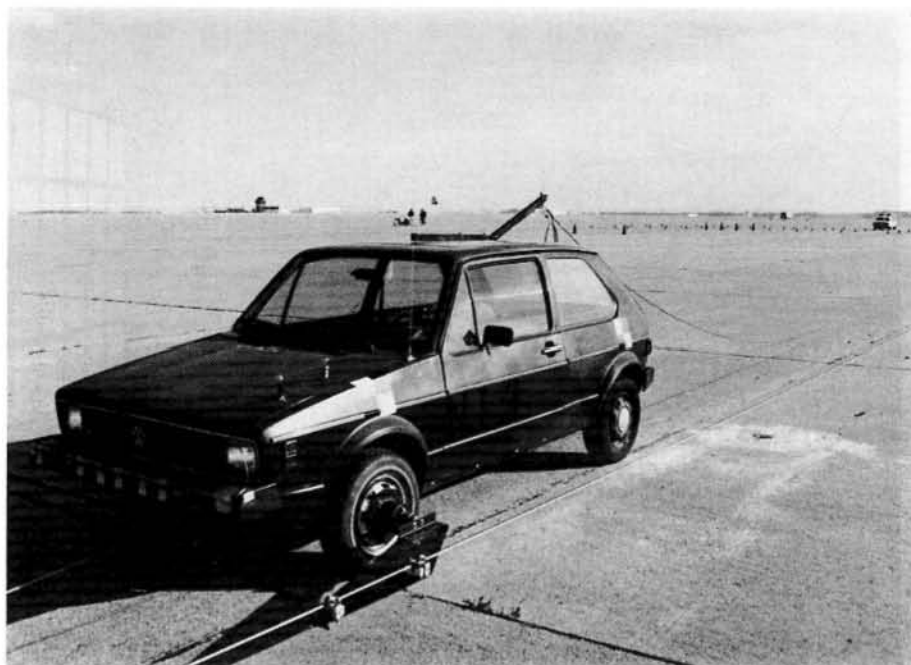
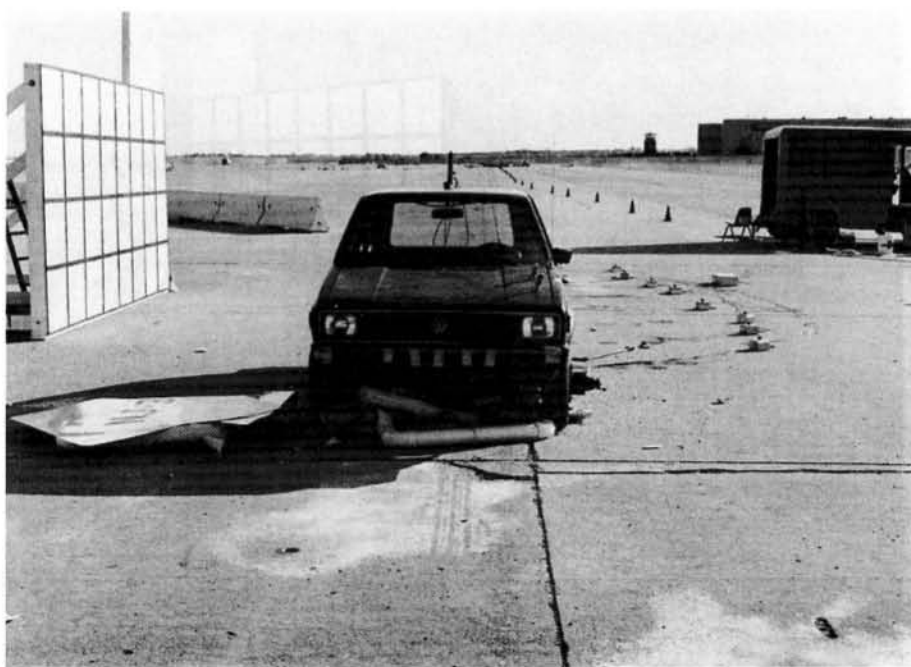
FIGURE 18. Photographs of Vehicle Before and After Test No. 3

TAD	FL-1
VDI	12FLMN1
Passenger Compartment	
Intrusion By Test Article	No
Was Windsheild Broken ?	No

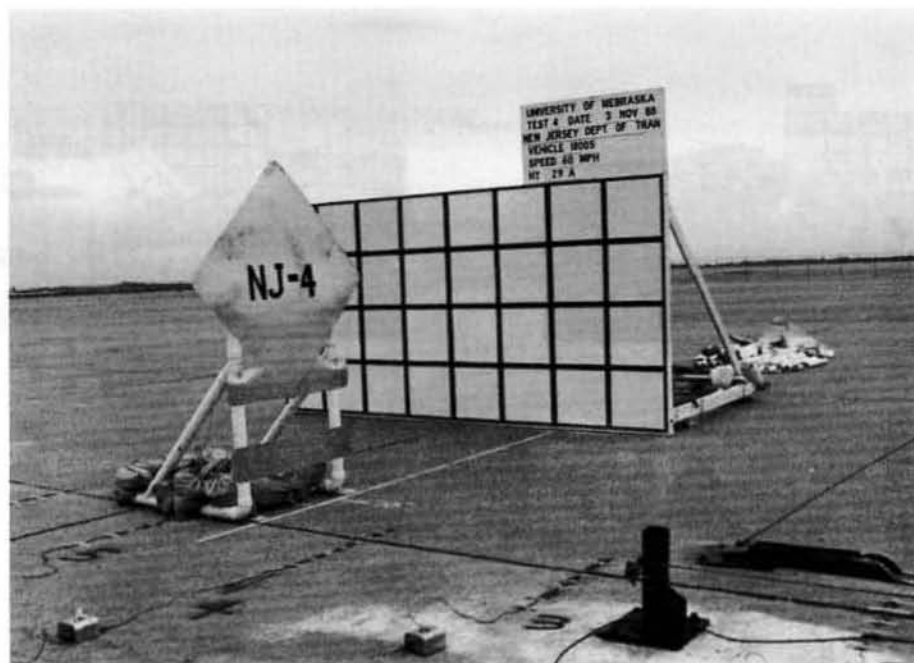
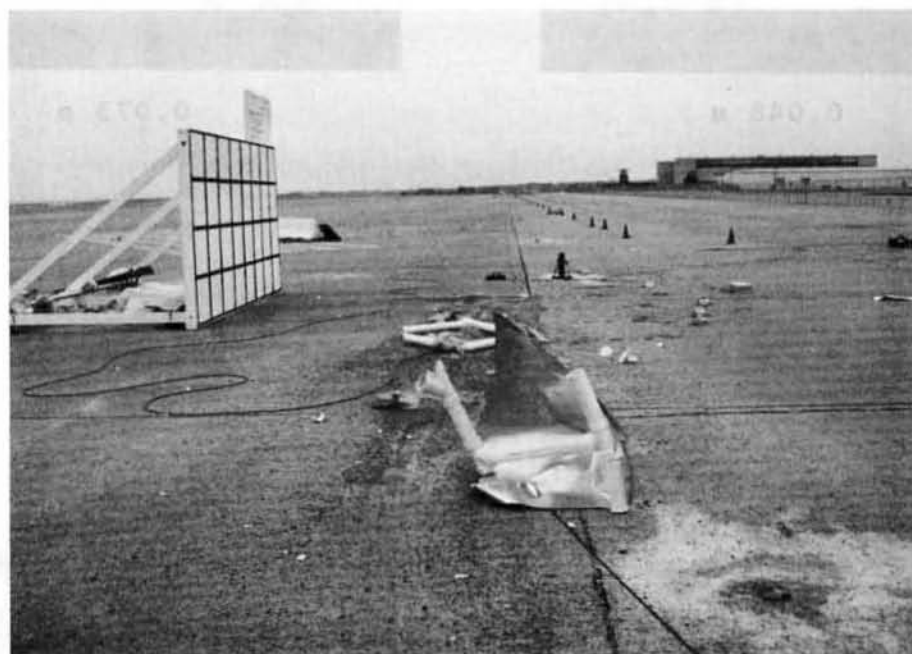
FIGURE 20. Photographs of Barricade Before and After Test No. 4

Test no. 4 was conducted at a target impact speed of 60 mph. Upon impact, the barricade collapsed and pieces of PVC pipe were projected out in front of the vehicle. The sign panel detached from the barricade, impacted the vehicle's windshield, and then proceeded to slide over the roof of the vehicle. The sign panel ended up 35-ft. beyond the point of impact, while the vehicle ended up 217-ft. beyond the point of impact and veered 44-ft. to the left of it's initial path. The only damage done to the vehicle was a small crack in the windshield (a ' bird's eye ' approximately the size of a half dollar) and two dents on the hood where the vehicle impacted the two upright posts of the barricade. Photographs of the barricade and vehicle, before and after impact, are shown in Figures 20, 21, and 22.

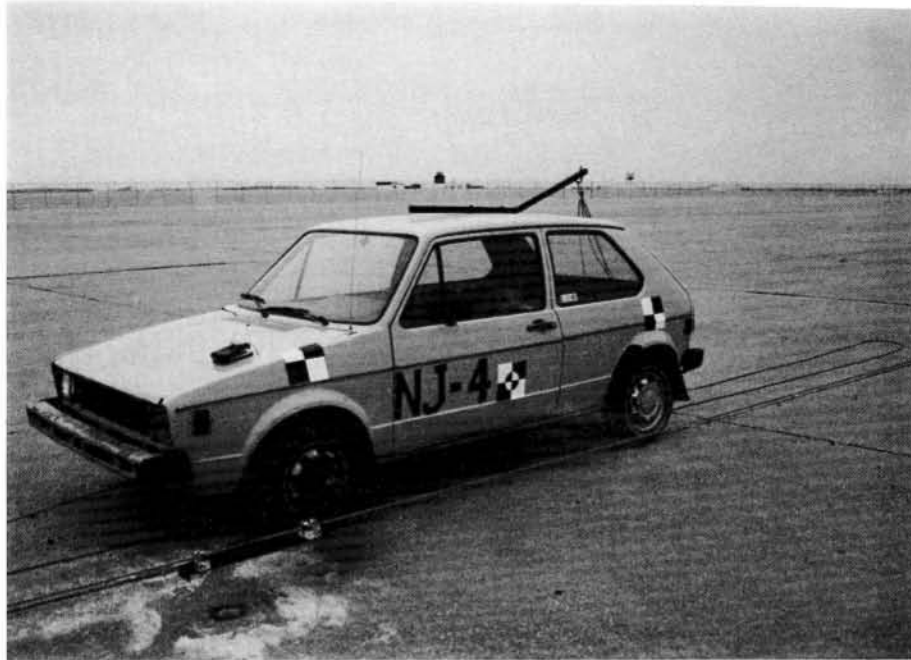
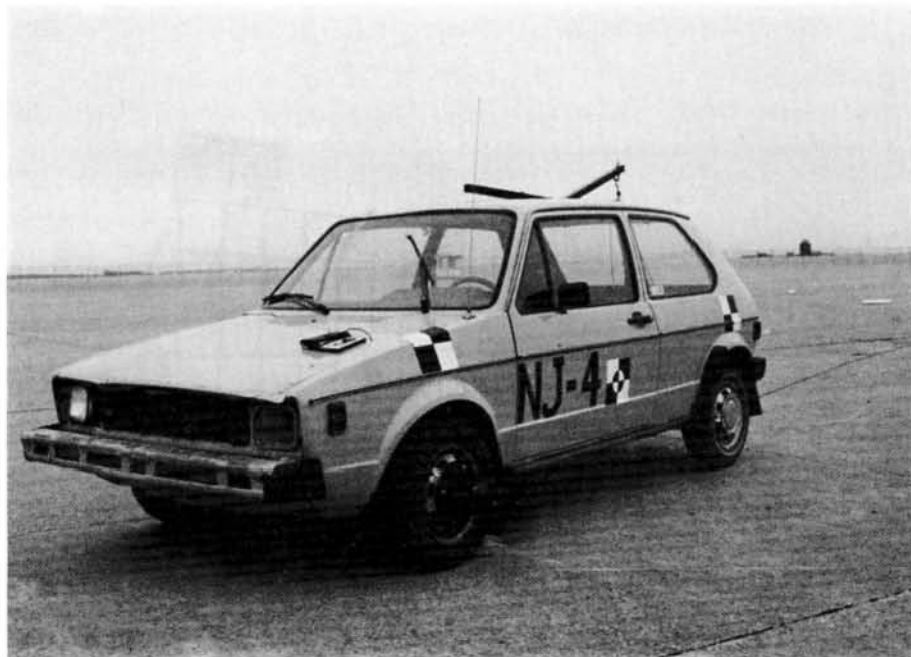
FIGURE 22. Photographs of Vehicle Before and After Test No. 4

TAD	FD-1
VDI	12FDHN6
Passenger Compartment	
Intrusion By Test Article	No
Was Windshield Broken ?	Yes

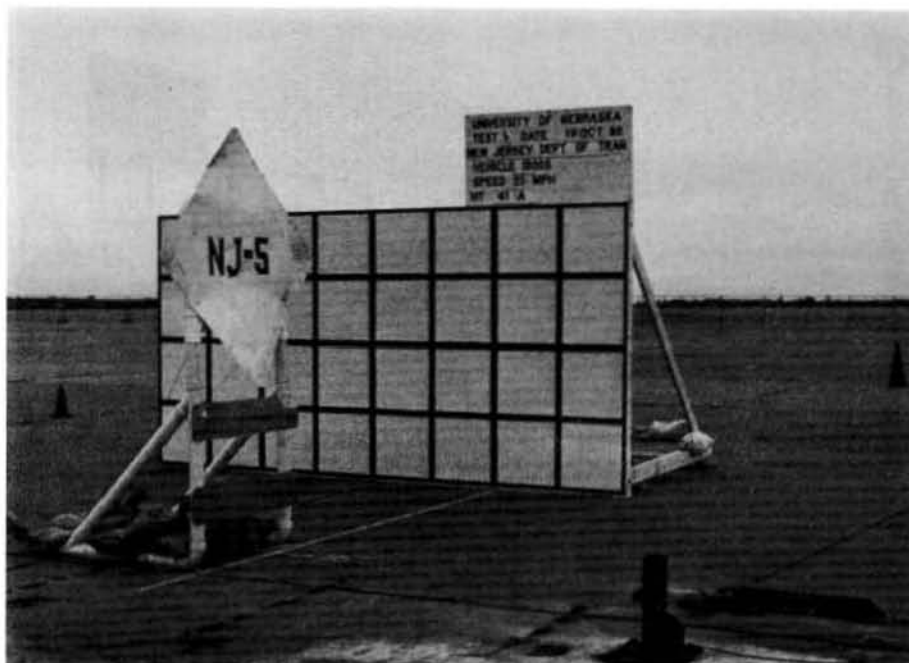
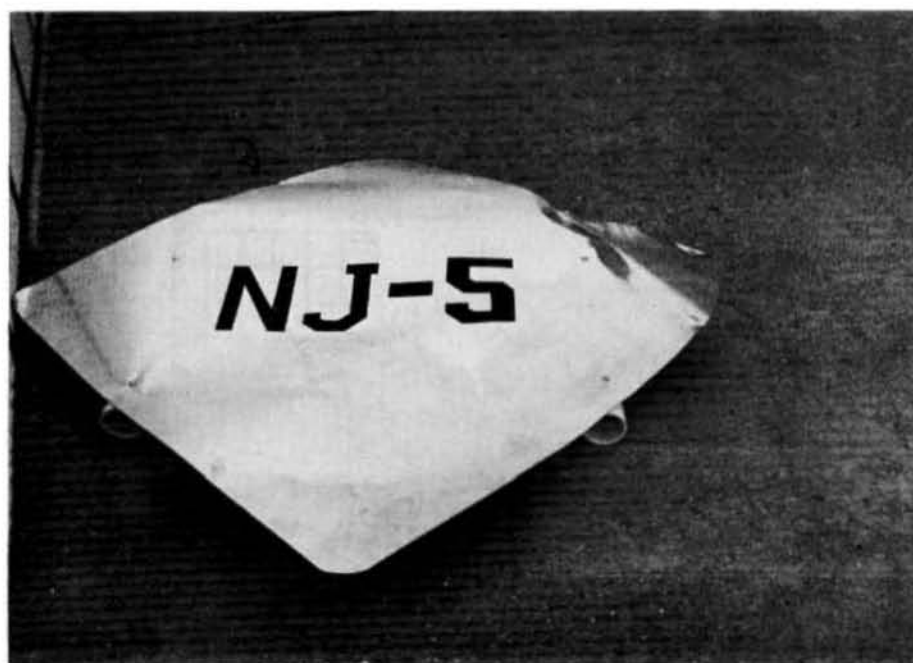
FIGURE 25. Photographs of Barricade Before and After Test No. 5

In test no. 5, which was conducted at a target impact speed of 20 mph, the barricade again collapsed and the barricade debris piled-up underneath the front end of the vehicle as in tests no. 1 and test no. 3. The barricade continued to push the debris until the vehicle came to a stop 33-ft beyond the point of impact. The pile-up of barricade debris caused a higher 'g' force than one might expect, as shown in Table 11. The sign panel detached from the barricade and was projected over the vehicle coming to a resting point which was 11-ft beyond the point of impact. The vehicle received no damage. Photographs of the test vehicle and barricade, before and after impact, are shown in Figures 25, 26, and 27.

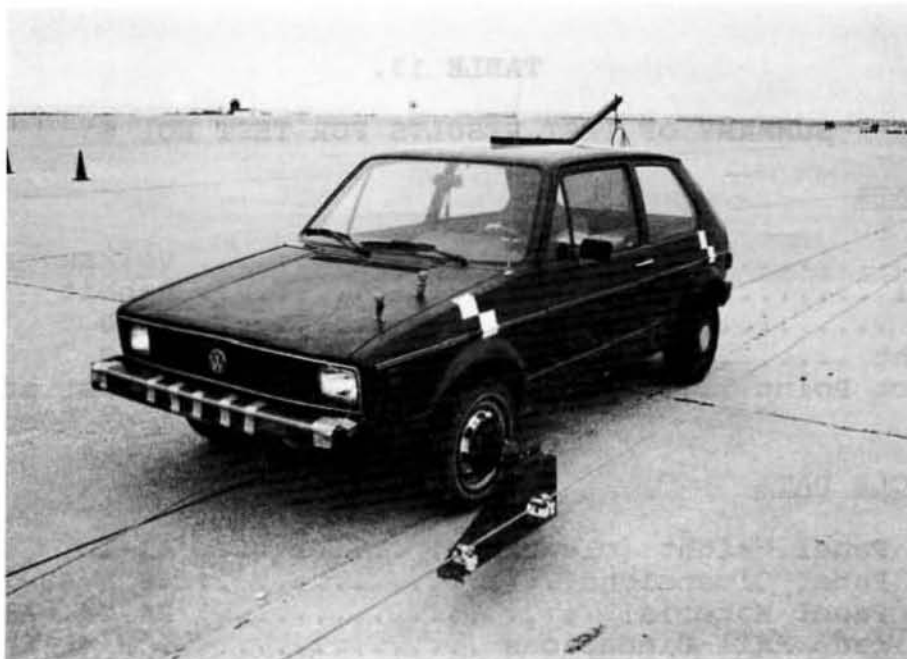
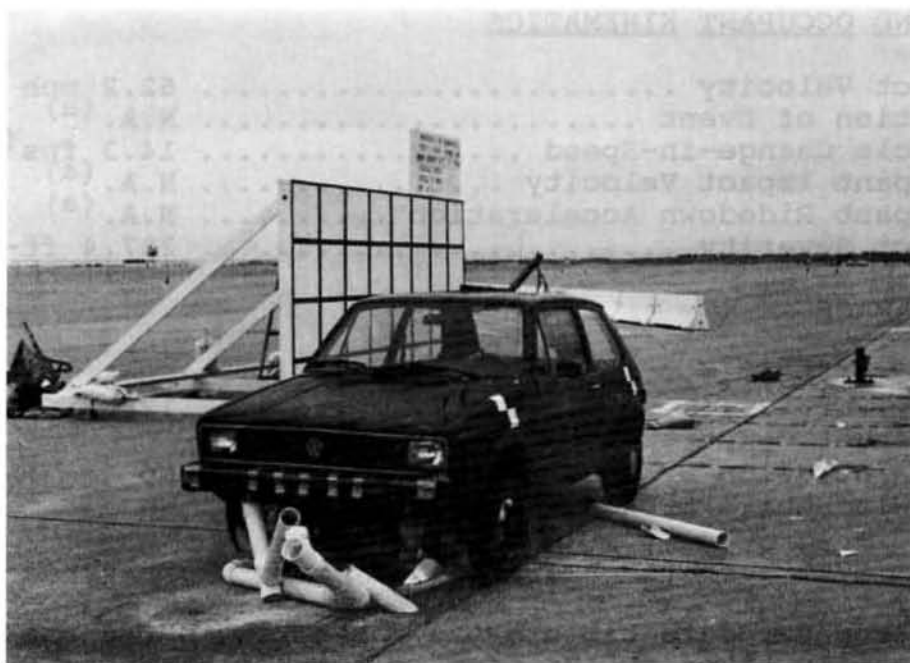
FIGURE 27. Photographs of Vehicle Before and After Test No. 5

TAD	FD-0
VDI	None
Passenger Compartment	
Intrusion By Test Article	No
Was Windsheild Broken ?	No

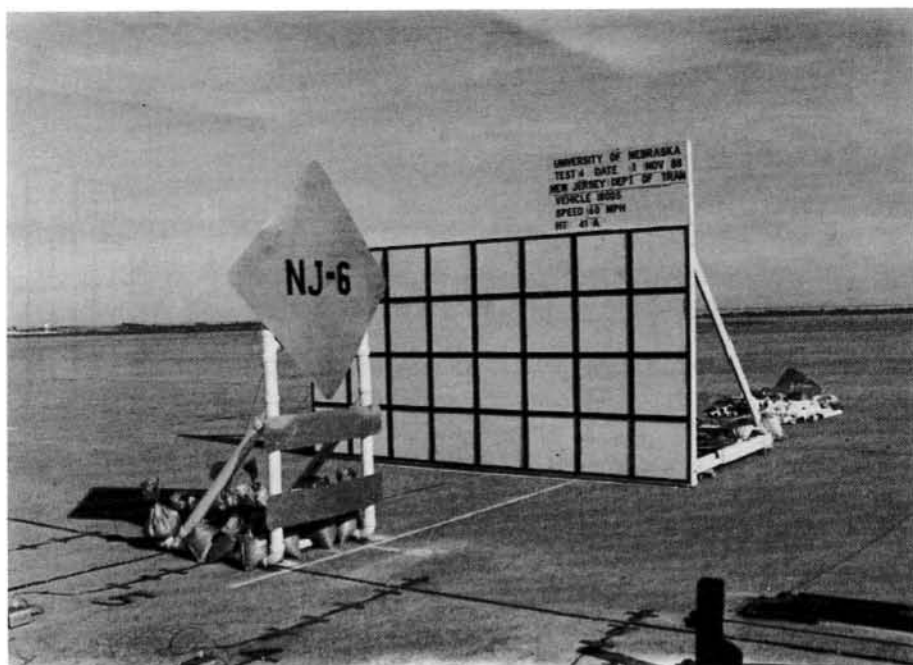
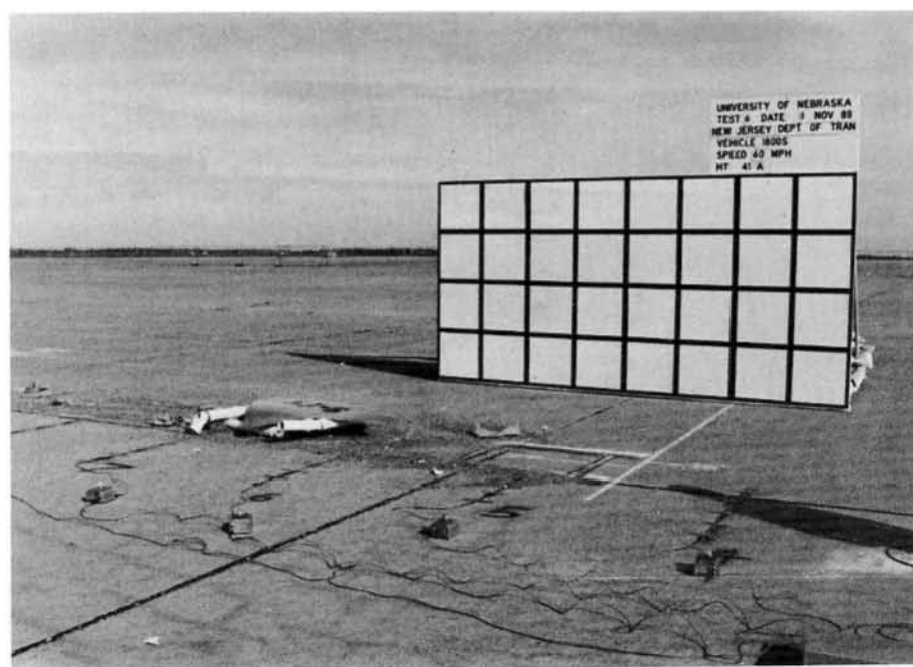
FIGURE 29. Photographs of Barricade Before and After Test No. 6

the barricade and was projected over the the vehicle landing 10-ft. beyond its initial position before impact. The vehicle traveled 285-ft. beyond the point of impact and received a small amount of damage to the two front corners of its hood as a result of the impact. The accelerometer data cable broke in this test so the high-speed film was used for analyzing purposes. It should be noted here that not enough data could be obtained from the high-speed film to get the time at which the occupant 24-in. flail space would have occurred; therefore, the occupant impact velocity and the occupant ridedown acceleration are not available for this test. However, looking at the vehicle's change-in-velocity plot in Appendix C, one can see that the curve starts to level out near the end of the plot; thus, one may assume that at the time the occupant reaches the 24-in. flail space, the change-in-velocity would be around the 15 fps range. Also, looking at the deceleration curve, one may assume that the maximum deceleration experienced by the occupant would not be much more than 2.5 g's. Figures 29, 30, and 31 show photographs of the barricade and test vehicle before and after impact.

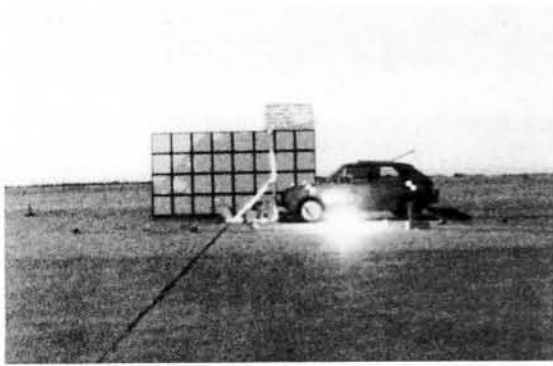
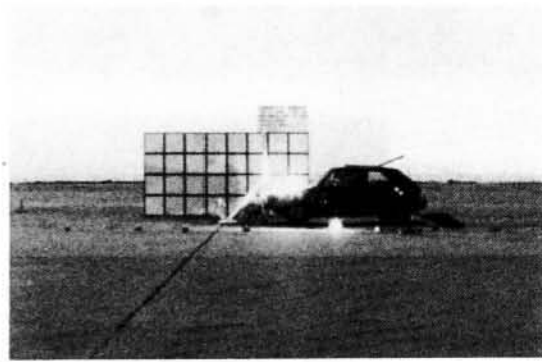
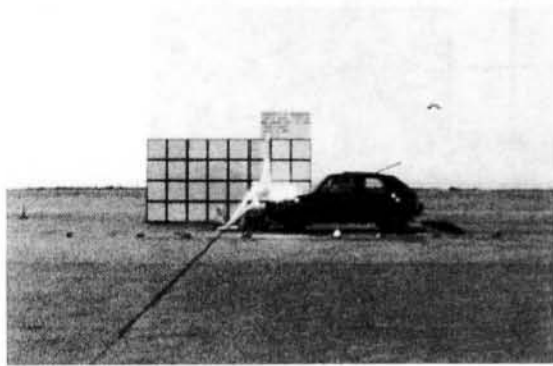
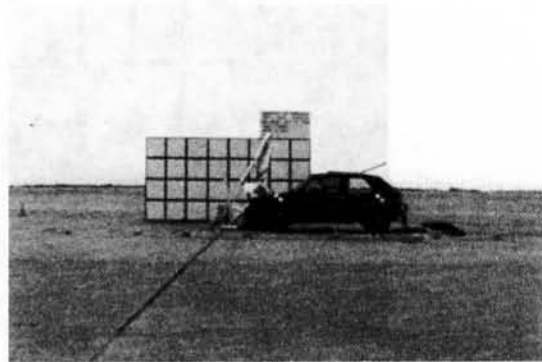
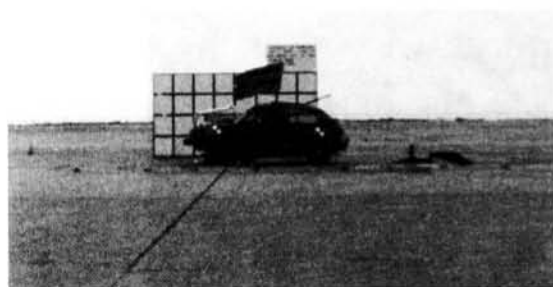
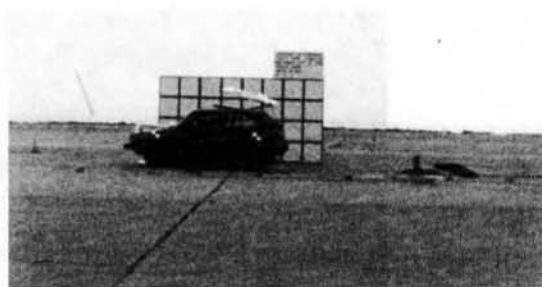
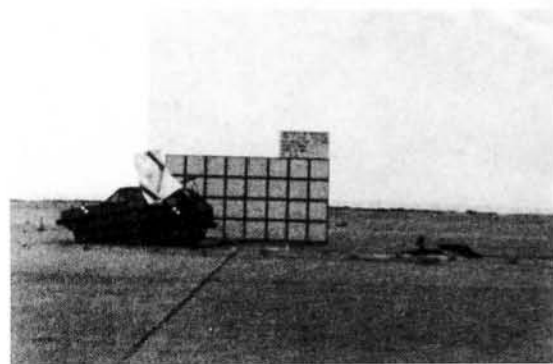
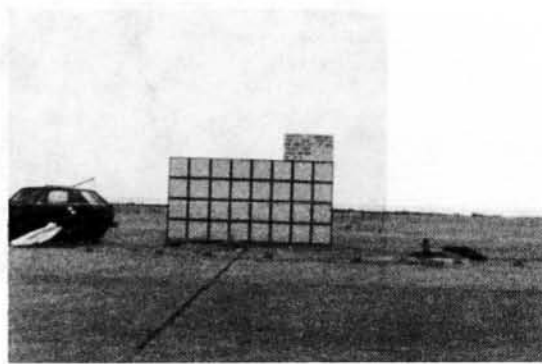
FIGURE 33. Sequential Photos of Test No. 7

Test no. 7 was conducted at a target impact speed of 20 mph. The upright post of the barricade on the driver's side was the only post impacted during this test. At impact, the barricade collapsed and the sign panel detached from the barricade. The sign then proceeded over the vehicle where it hit the coaxial cable support bar used to support the accelerometer data cable. After the sign hit the support bar, it was deflected left and landed 21-ft. beyond the point of impact. The vehicle traveled 45-ft. past the point of impact and veered 8-ft. to the right of its initial path. No damage was done to the vehicle. Figures 34, 35, and 36 show photographs of the barricade and the test

Time (sec)	Event
0.000	Impact
0.015	Lower vertical supports begin to fracture
0.027	Slanted supports are disengaged from barricade
0.069	Barricade collapses
0.267	Sign begins to fly over vehicle
0.490	Sign hits coaxial cable support bar and is deflected to the side
0.812	Sign slides off to the right hand side of the vehicle
1.344	Sign is on the concrete

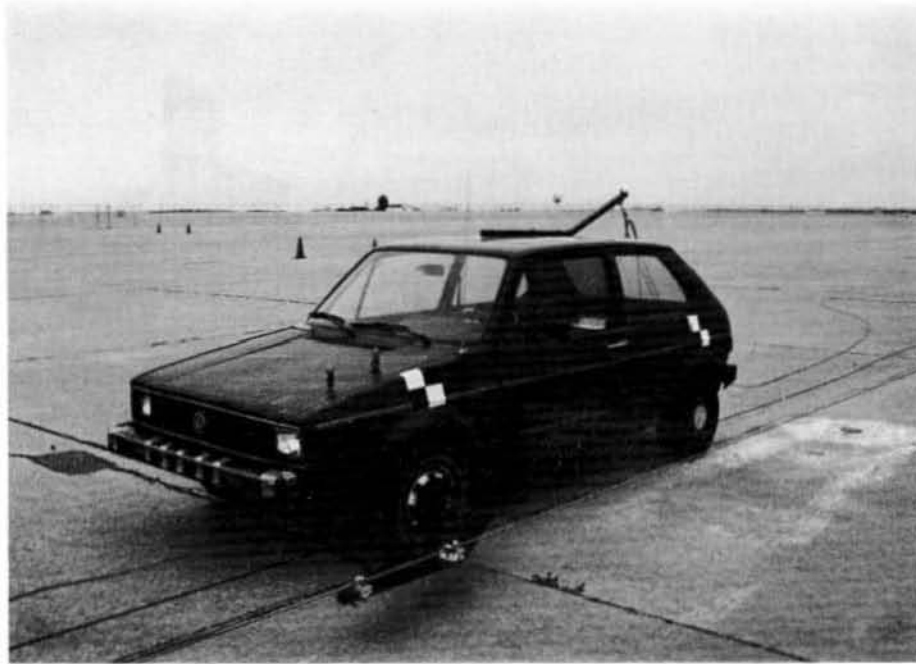
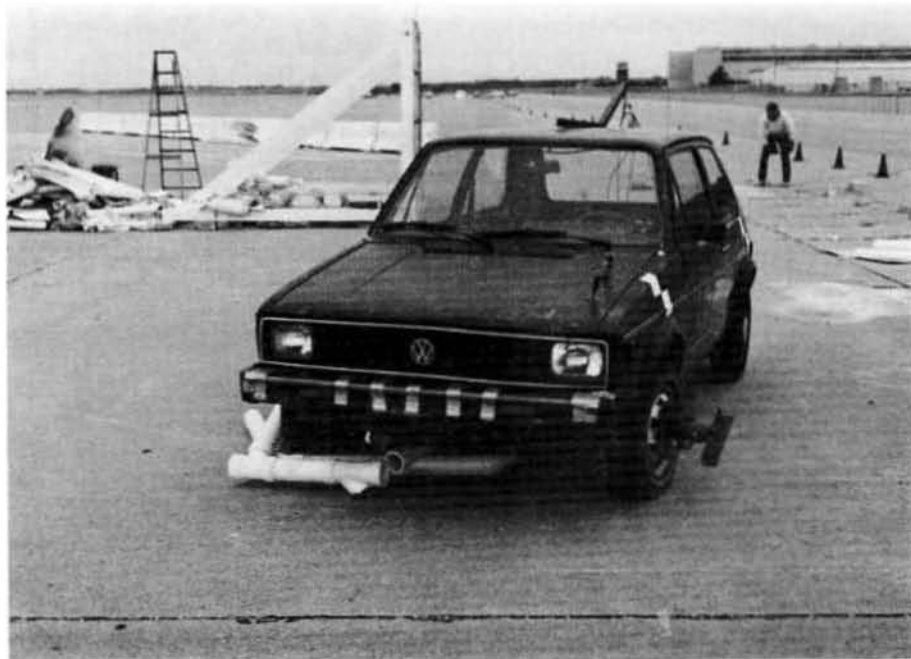
FIGURE 36. Photographs of Vehicle Before and After Test No. 7

TAD	FD-0
VDI	None
Passenger Compartment	
Intrusion By Test Article	No
Was Windshield Broken ?	No

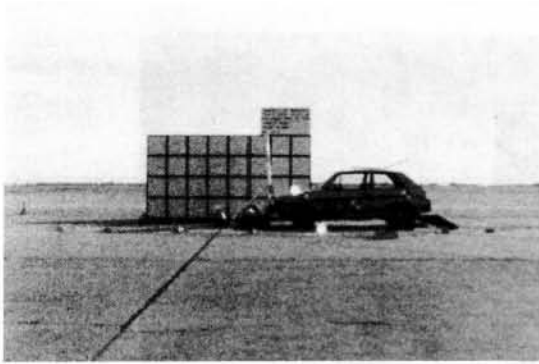
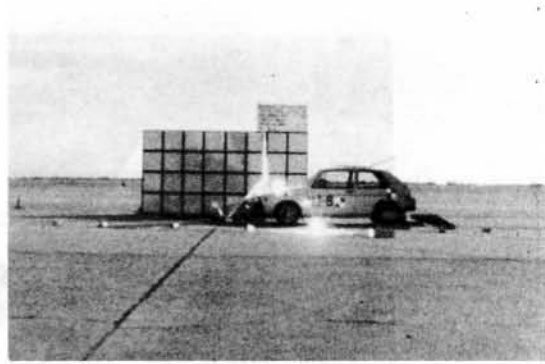
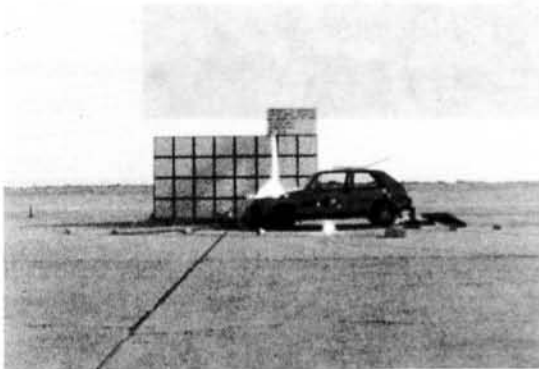
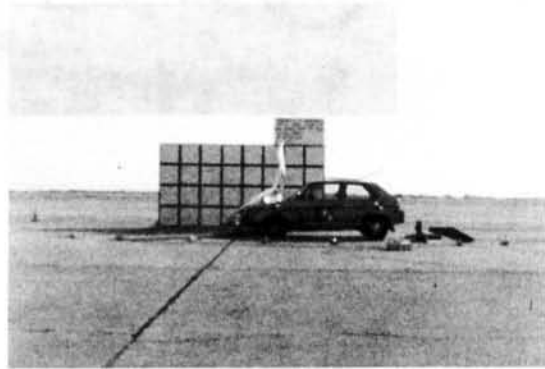
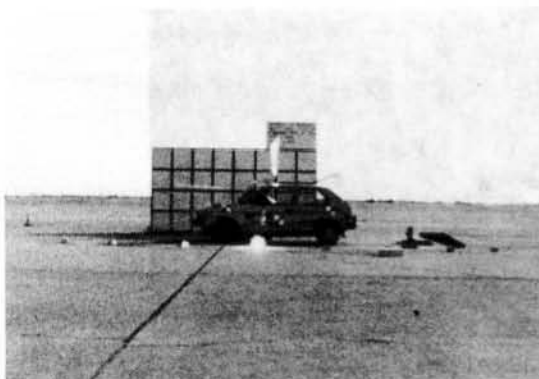
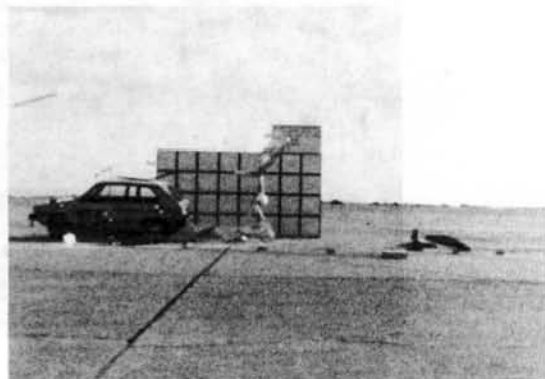
FIGURE 37. Sequential Photos of Test No. 8

In test no. 8, which was conducted at a target impact speed of 60 mph, again only the left upright post of the barricade was impacted. The barricade collapsed at impact and some pieces of PVC were projected. The sign panel did not detach , but just fell to the side after the post on the driver's side was impacted. The vehicle came to rest 405-ft. beyond the point of impact and did receive some minor damage. The damage was a broken windshield and a dent on the front center of the hood. Before and after photographs of the test vehicle and barricade are shown in Figures 38, 39, and 40 .

Time (sec)	Event
0.000	Impact
0.010	Lower vertical supports begin to fracture
0.023	Slanted barricade supports are fractured
0.071	Sign is directly above hood of vehicle
0.121	Sign is above roof of vehicle and debris is being projected
0.229	Vehicle is separated from the majority of barricade debris

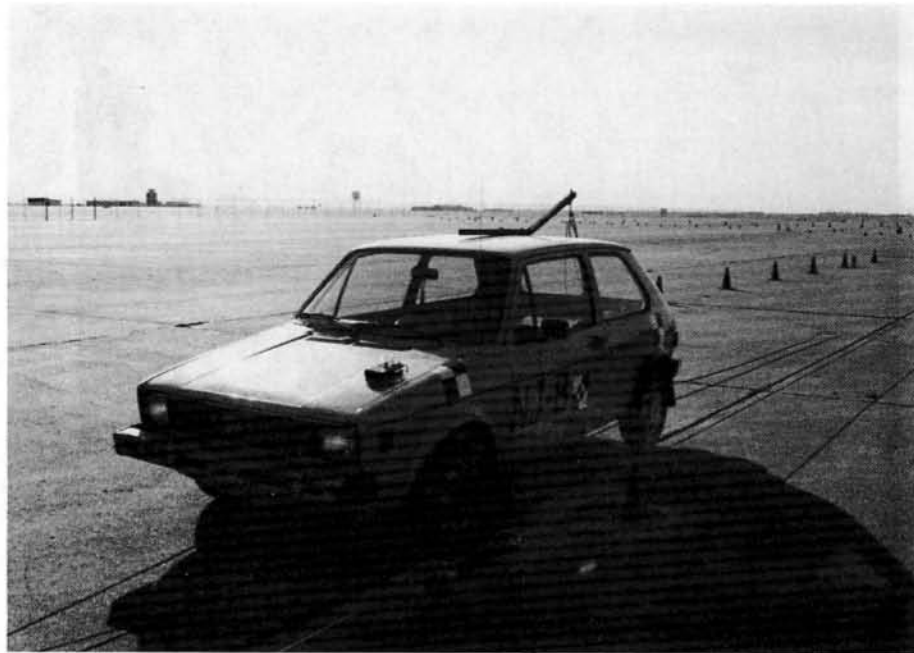
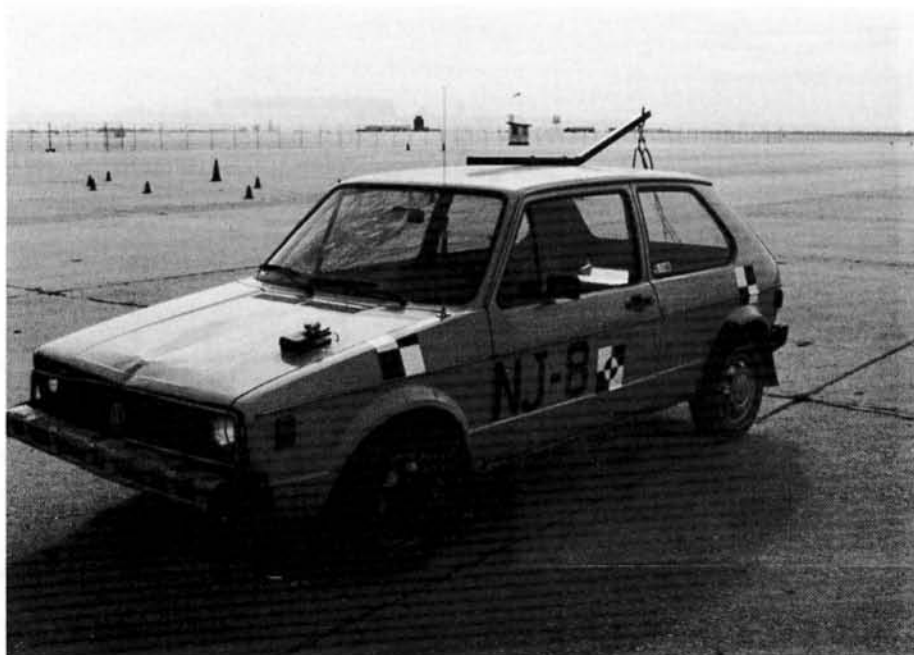
FIGURE 40. Photographs of Vehicle Before and After Test No. 8

TAD	FC-1
VDI	12FCHN6
Passenger Compartment	
Intrusion By Test Article	No
Was Windshield Broken ?	Yes (b)

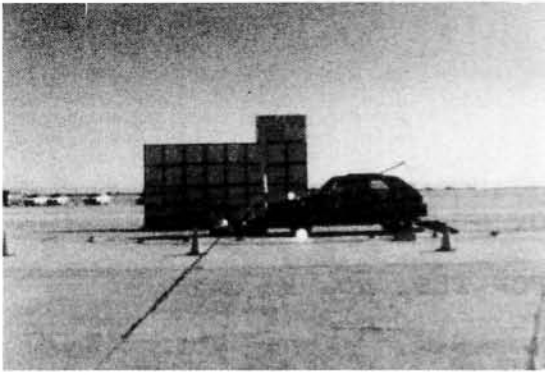
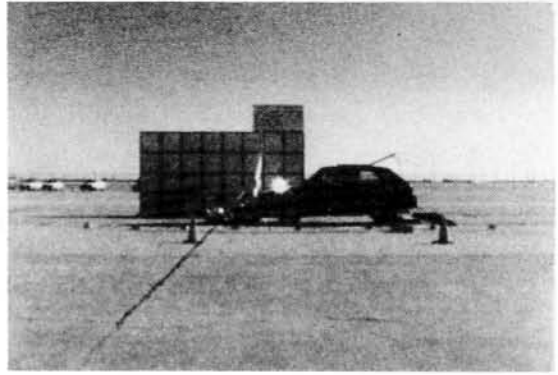
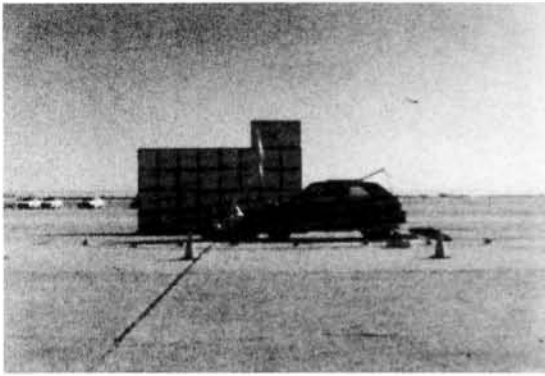
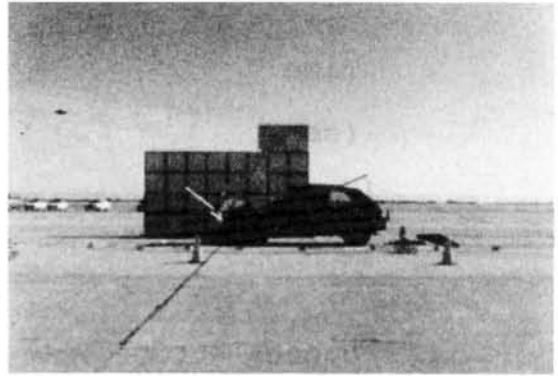
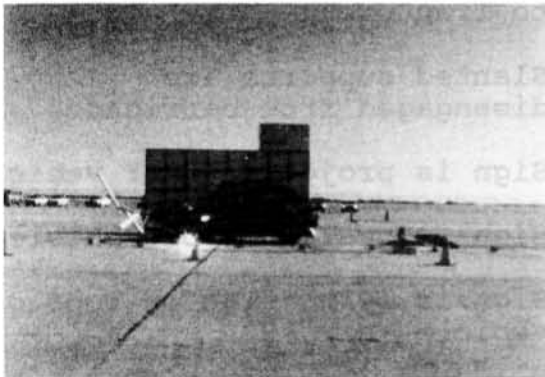
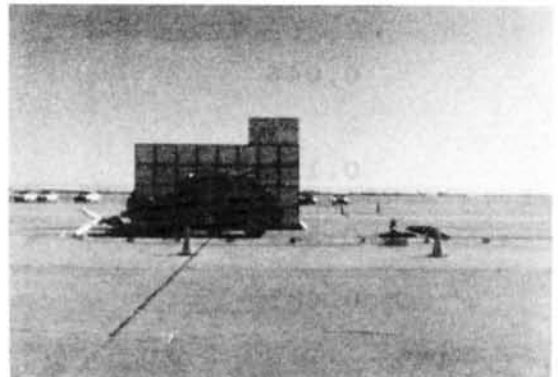
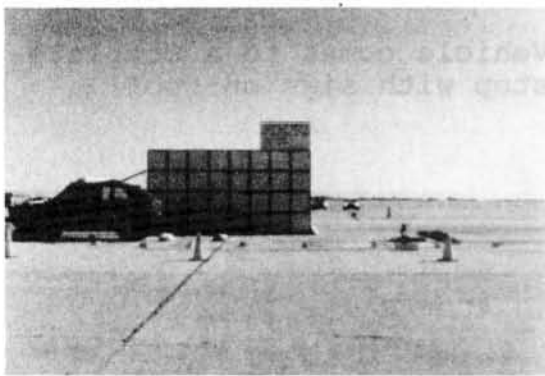
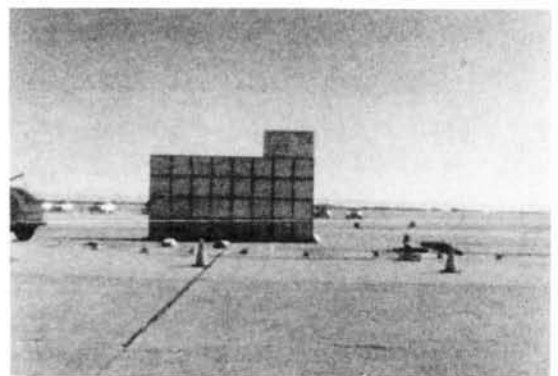
FIGURE 42. Sequential Photos of Test No. 9

Time (sec)	Event
<hr/>	
0.000	Impact
0.023	Lower vertical supports begin to fracture
0.046	Slanted supports are disengaged from barricade
0.131	Sign is projected over vehicle
0.379	Sign is over roof of vehicle
0.485	Sign is lying flat on roof of vehicle
0.625	Vehicle continues to proceed with sign on roof
1.229	Vehicle comes to a complete stop with sign on roof

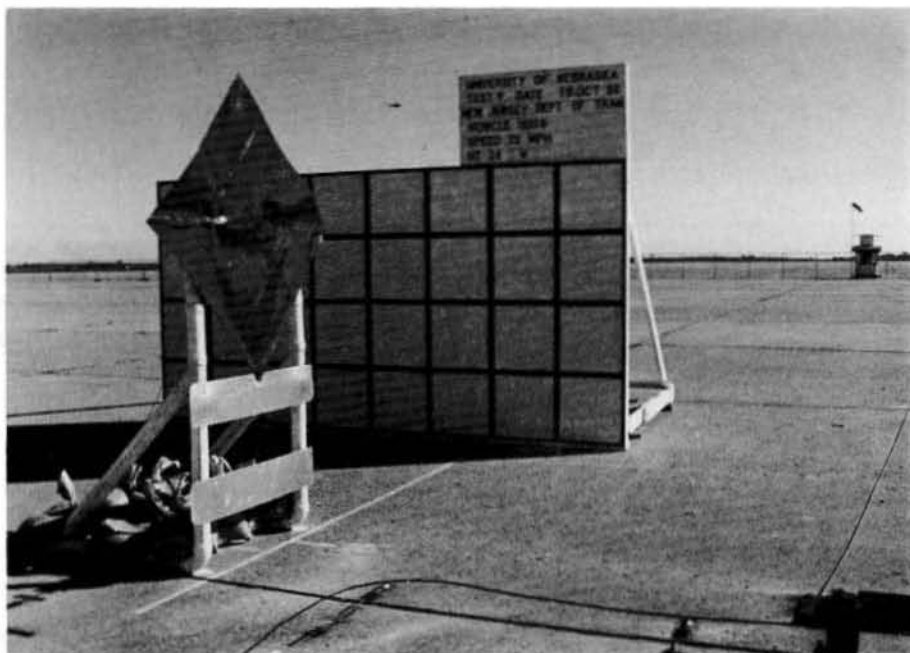
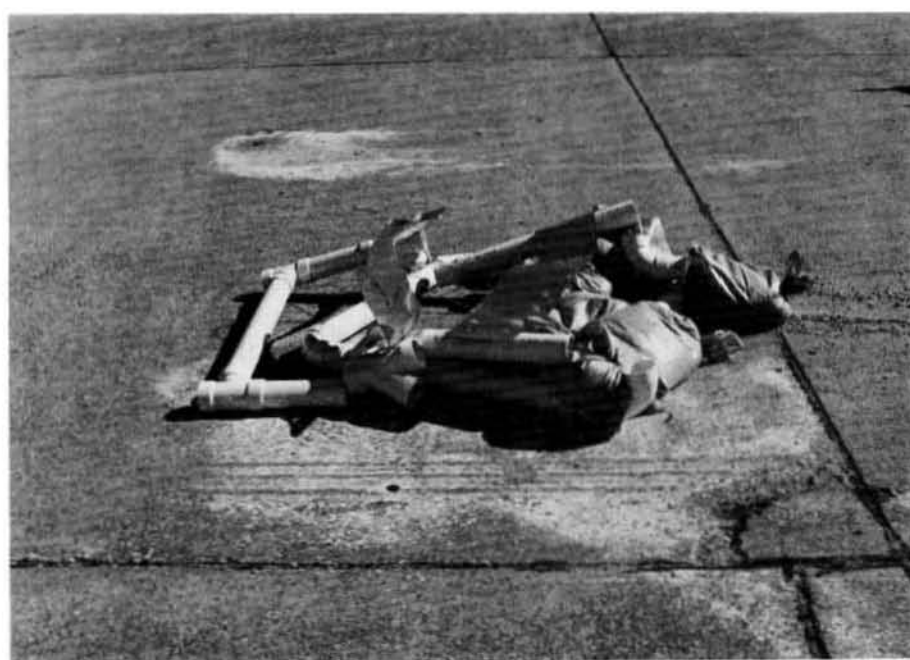
FIGURE 43. Photographs of Barricade Before and After Test No. 9

test vehicle, before and after the test, are shown in Figures 43, 44, and 45.
