FULL-SCALE VEHICULAR CRASH TESTING
of
EXPERIMENTAL SIGNS
on
BARRICADE STRUCTURES

TRANSPORTATION RESEARCH REPORT TRP-03-017-88

Civil Engineering Department
W348 Nebraska Hall
University of Nebraska-Lincoln
Lincoln, Nebraska 68588-0531
(402) 472-2371

June 1989

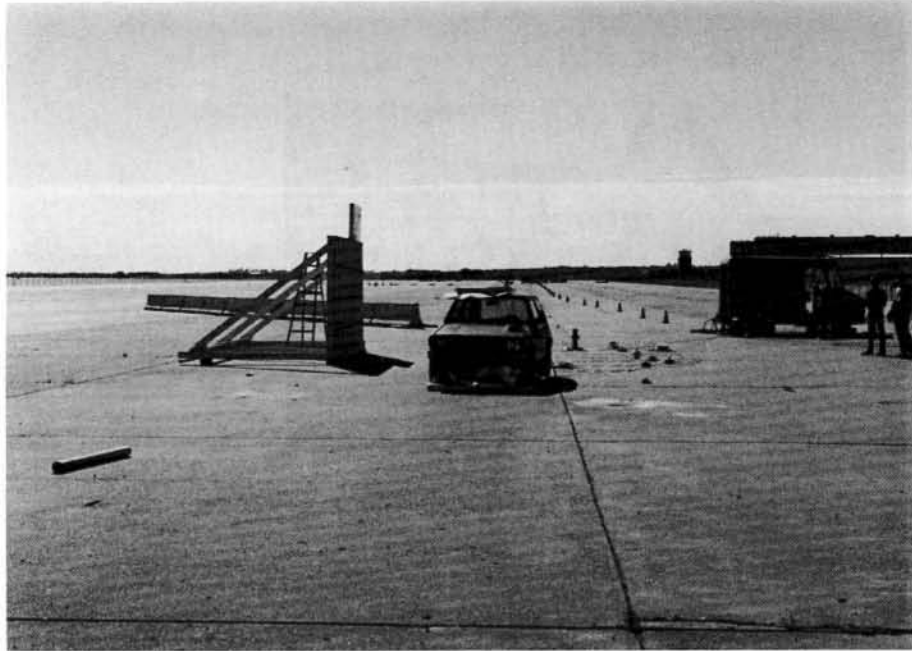
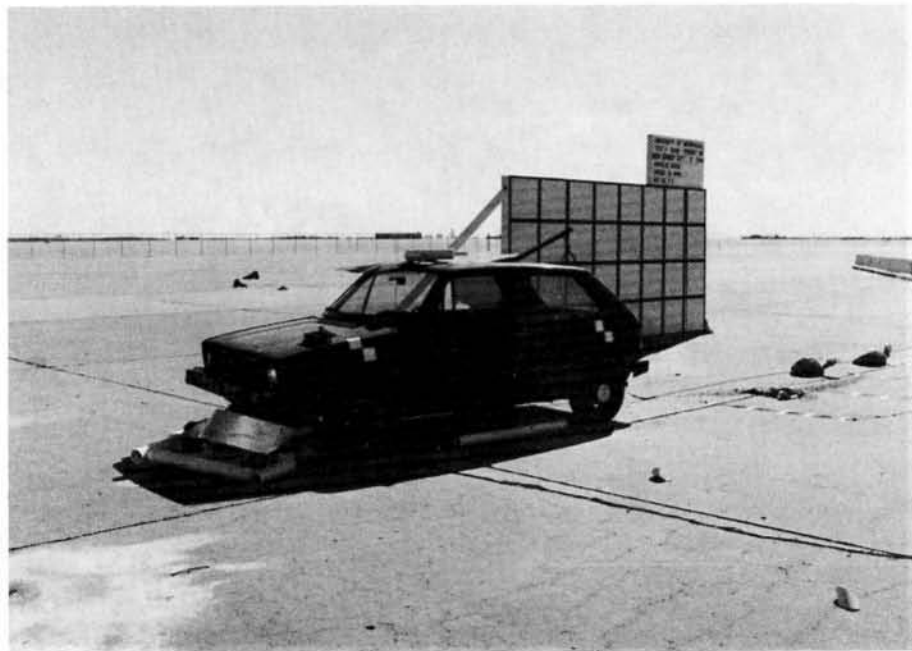
FIGURE 44. Photographs of Vehicle and Barricade After Test No. 9

test vehicle, before and after the test, are shown in Figures 43, 44, and 45.

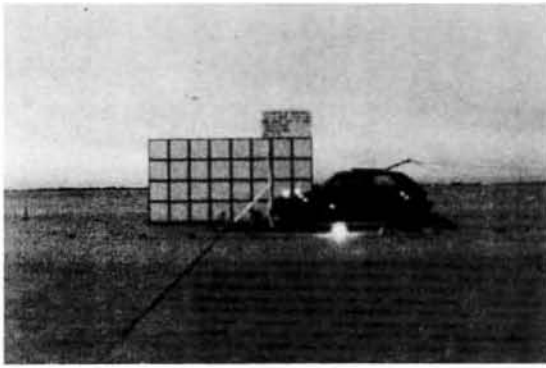
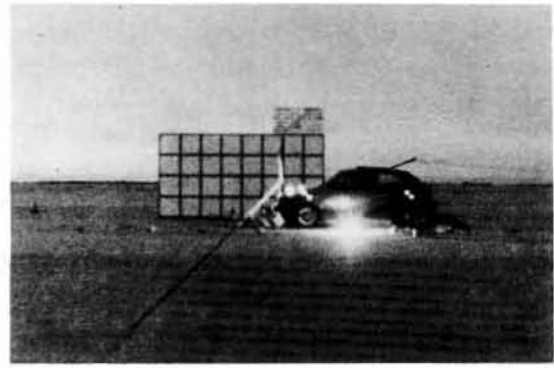
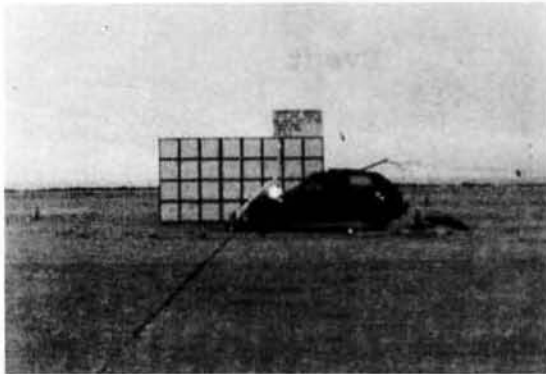
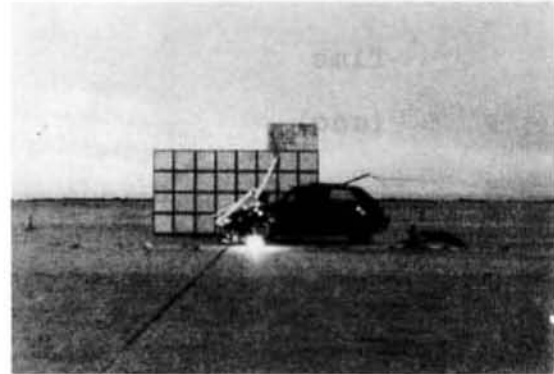
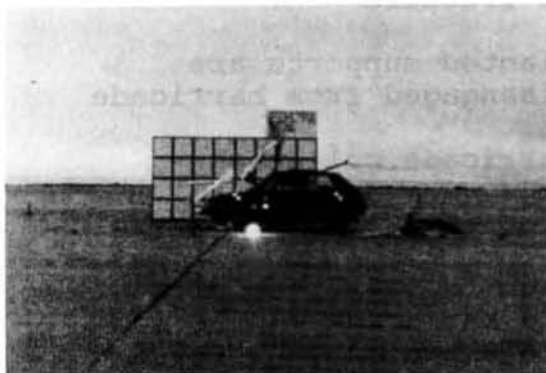
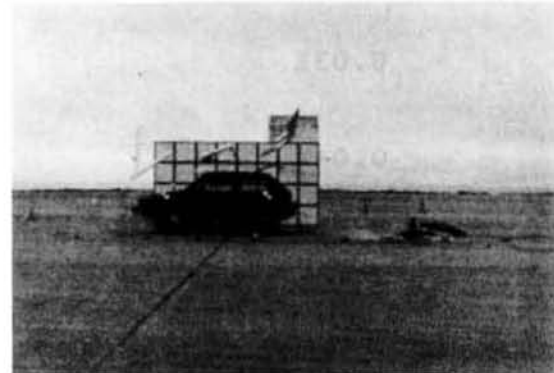
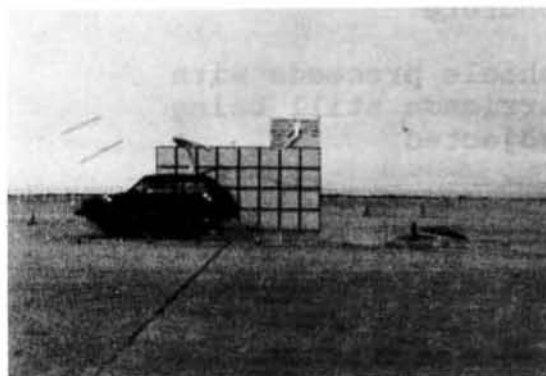
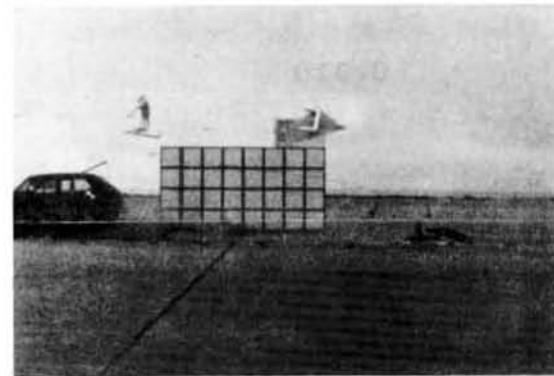
FIGURE 46. Sequential Photos of Test No. 10

0.000	Impact
0.006	Lower vertical supports begin to fracture
0.031	Slanted supports are disengaged from barricade
0.044	Barricade collapses
0.062	Sign is over roof of vehicle
0.131	Sign is over rear of vehicle and barricade debris is projected
0.190	Left wheels of vehicle are off concrete
0.310	Vehicle proceeds with barricade still being projected

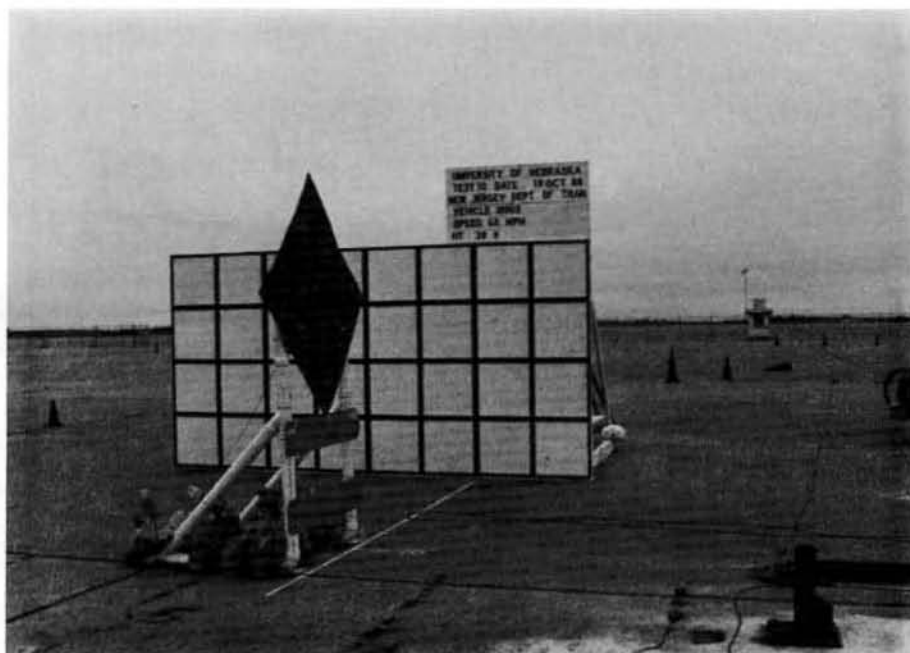
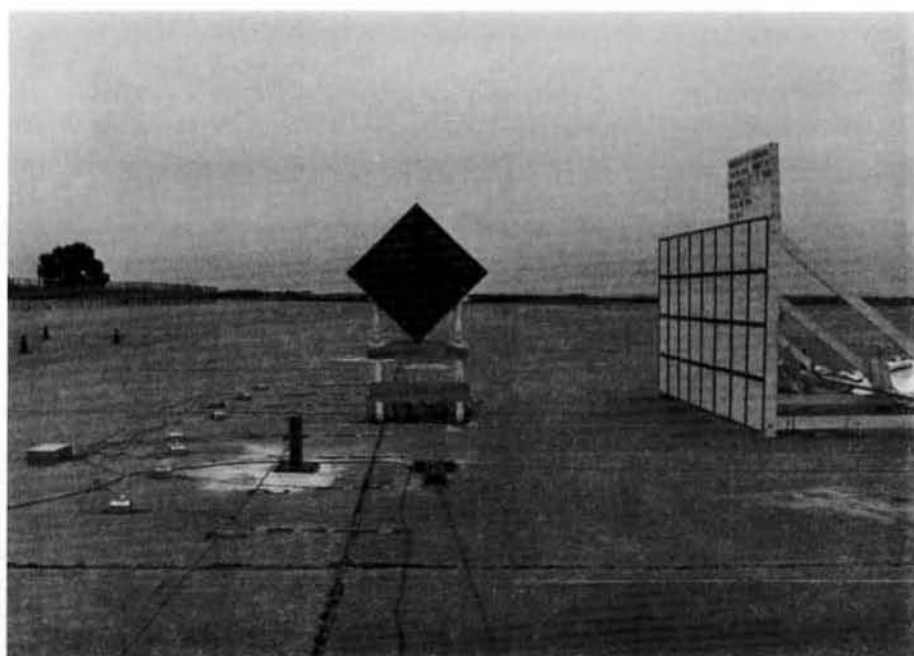
FIGURE 47. Photographs of Barricade Before Test No. 10

In test no. 10 the barricade was shattered upon impact and pieces of PVC pipe were projected from the barricade. The sign detached and was projected over the vehicle and landed 13-ft. in front of the initial position of the barricade. Figures 47 and 48 show photographs of the barricade before and after the test. In this test, the accelerometer data cable broke; therefore, all the analyses of this test were from the high-speed film. Accessing the damage to the test vehicle was impossible due to the test vehicle going through the fence which borders the test facility. The damage to the vehicle after going through the fence was far more extensive than what would be expected from the impact with the barricade; thus, the damage resulting from the impact could not be determined.

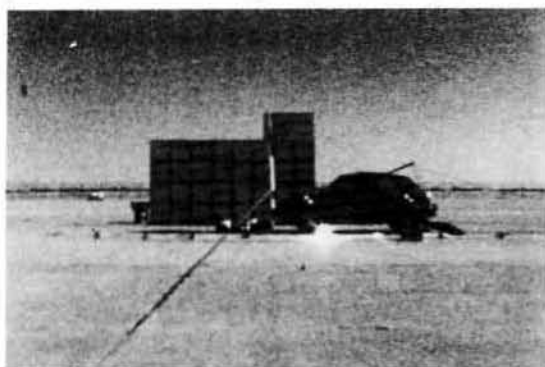
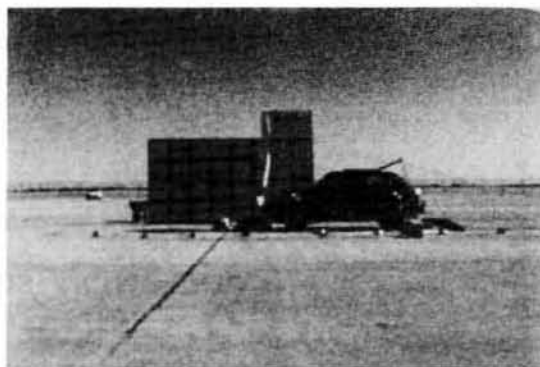
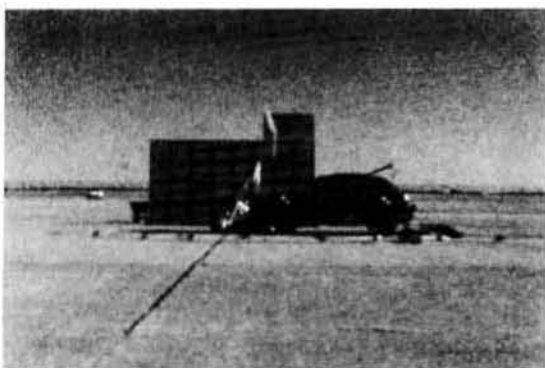
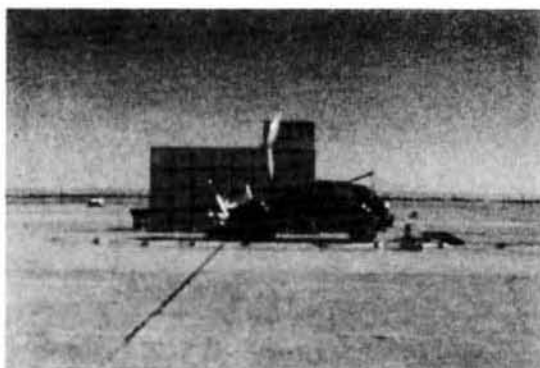
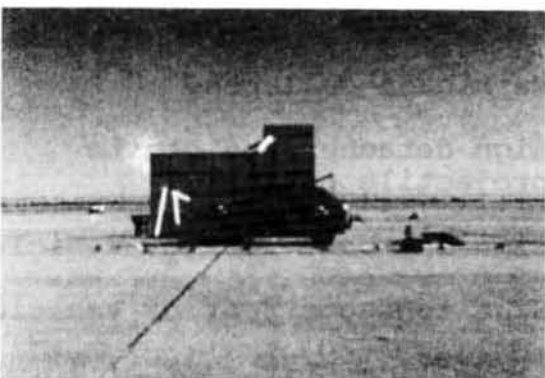
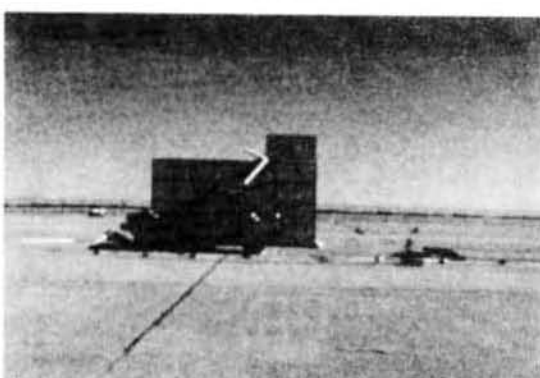
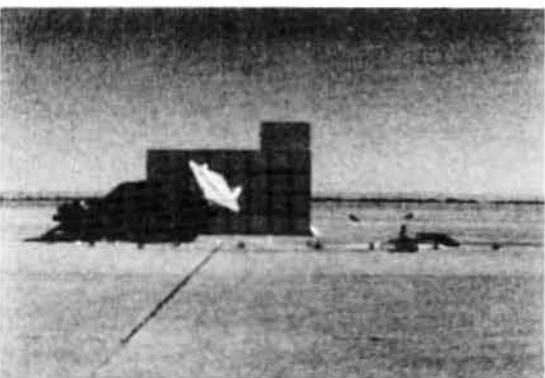
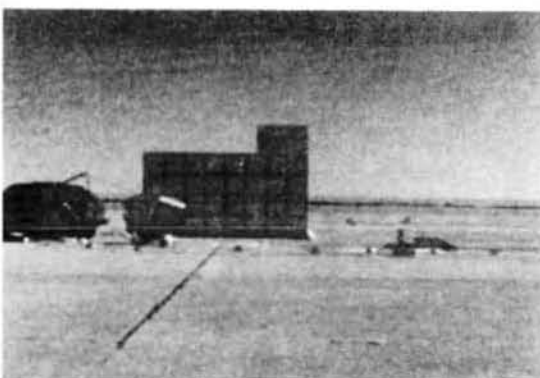
FIGURE 50. Sequential Photos of Test No. 11

Time (sec)	Event
0.000	Impact
0.031	Lower vertical supports begin to fracture
0.062	Barricade collapses
0.125	Sign detaches and starts projectile motion
0.262	Sign is above roof of vehicle
0.521	Sign contacts roof of vehicle
0.804	Sign slides off roof of vehicle
1.375	Sign is on concrete behind vehicle

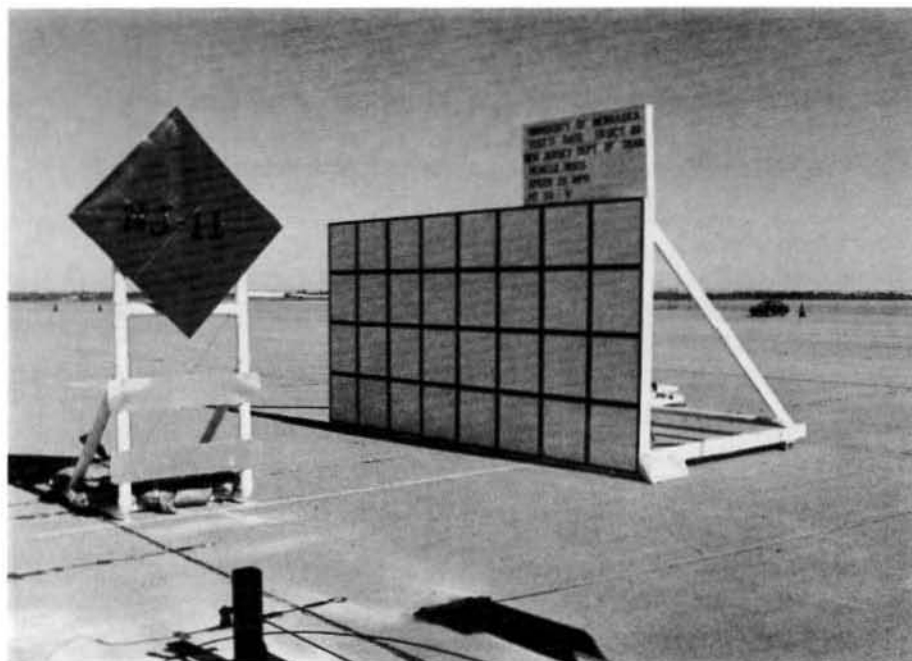
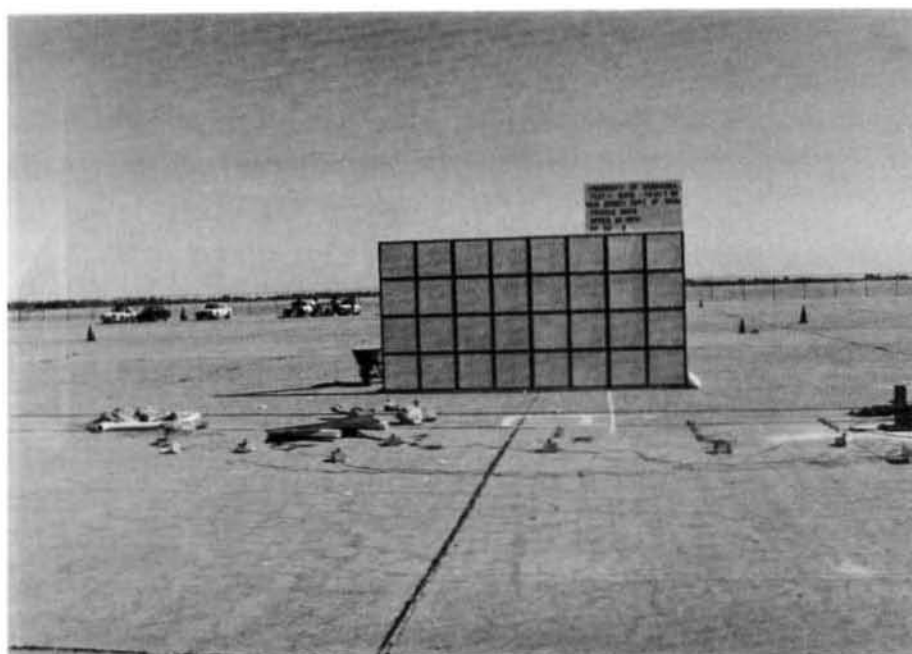
FIGURE 51. Photographs of Barricade Before and After Test No. 11

Test no. 11 was conducted at a target impact speed of 20 mph. At impact, the barricade collapsed with some of the debris from the barricade getting piled-up under the front end of the vehicle. The vehicle then proceeded to drag the debris until it came to a stop 66-ft. beyond the point of impact. The sign panel was projected over the vehicle and landed 5-ft. behind the initial position of the barricade. The vehicle did not receive any damage during the test. Figures 51, 52, and 53 show photographs of the test vehicle before and after impact.

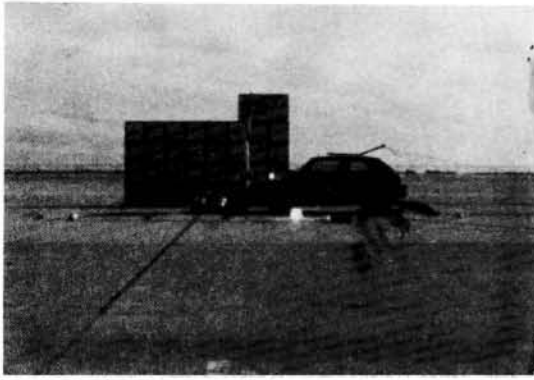
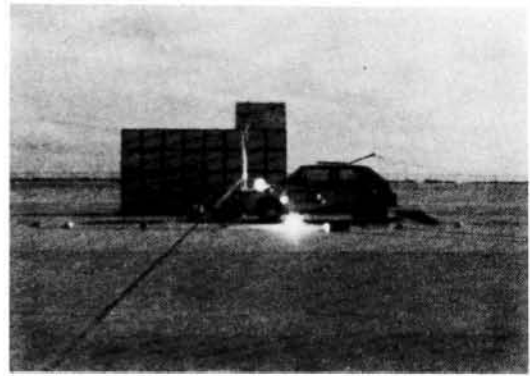
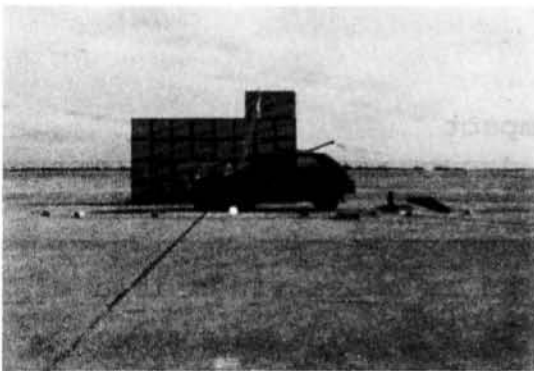
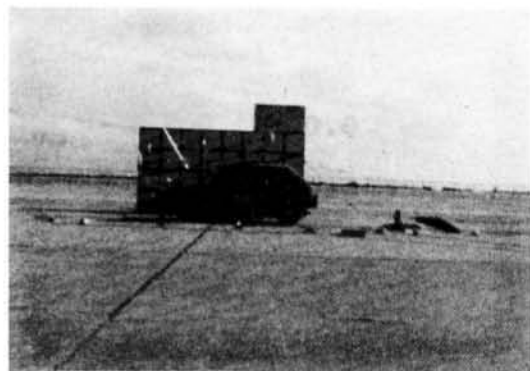
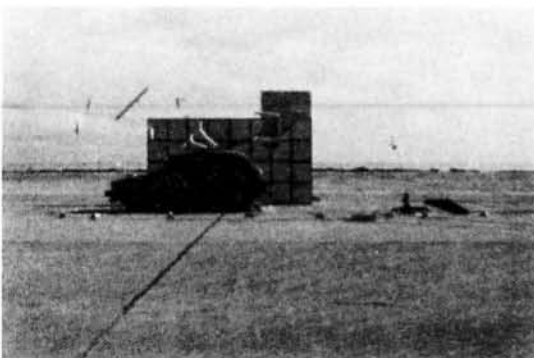
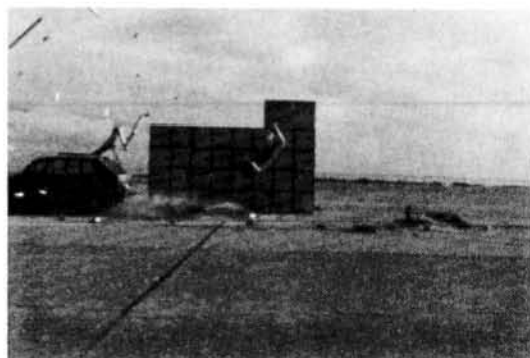
FIGURE 54. Sequential Photos of Test No. 12

Time (sec)	Event
<hr/>	
0.000	Impact
0.003	Lower vertical supports begin to fracture
0.018	Sign is above windshield of vehicle
0.031	Sign is above roof of vehicle and debris is being projected
0.050	Barricade debris is on roof of vehicle
0.096	Vehicle loses contact with all debris and sign is descending

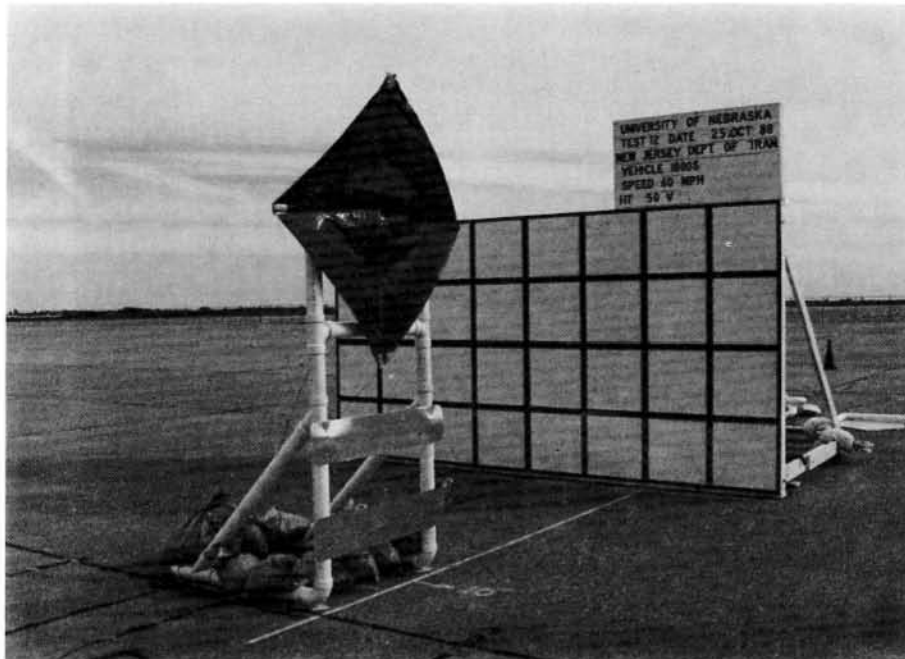
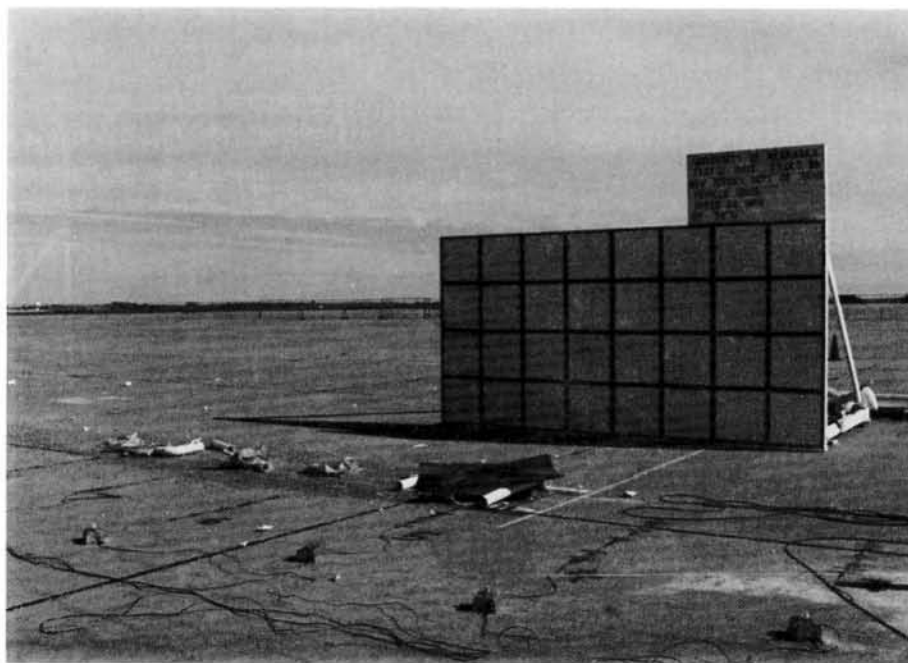
FIGURE 55. Photographs of Barricade Before and After Test No. 12

In test no. 12, which was conducted at a target impact speed of 60 mph, the barricade shattered upon impact and pieces of PVC pipe were projected from the barricade. Again the sign panel detached from the barricade and was projected over the vehicle landing right on the spot where the barricade was positioned before impact. The vehicle traveled 236-ft. beyond the point of impact and received only minor damage which consisted of two small dents on the front of the vehicle's hood. Figures 55, 56,

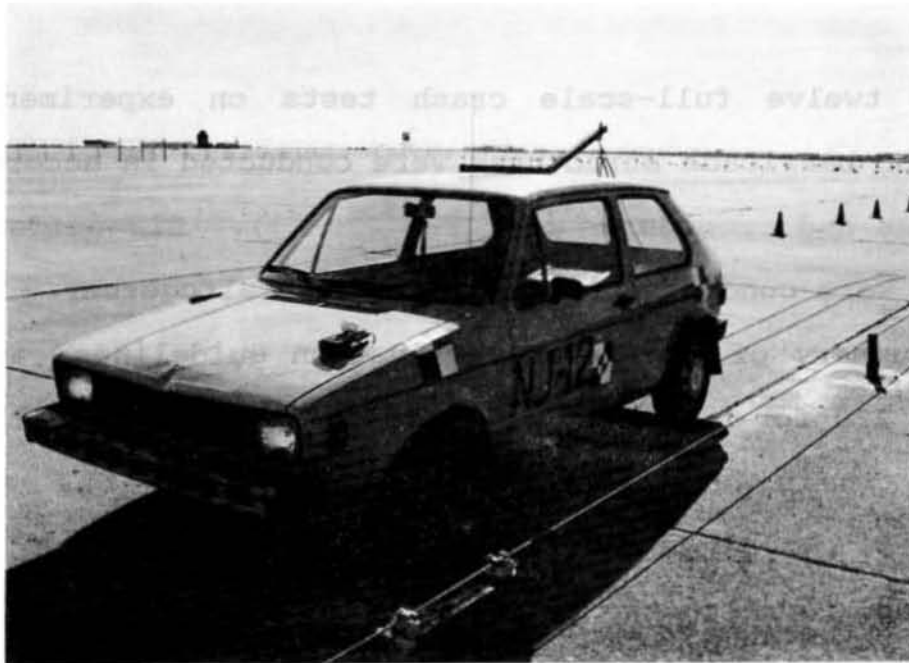
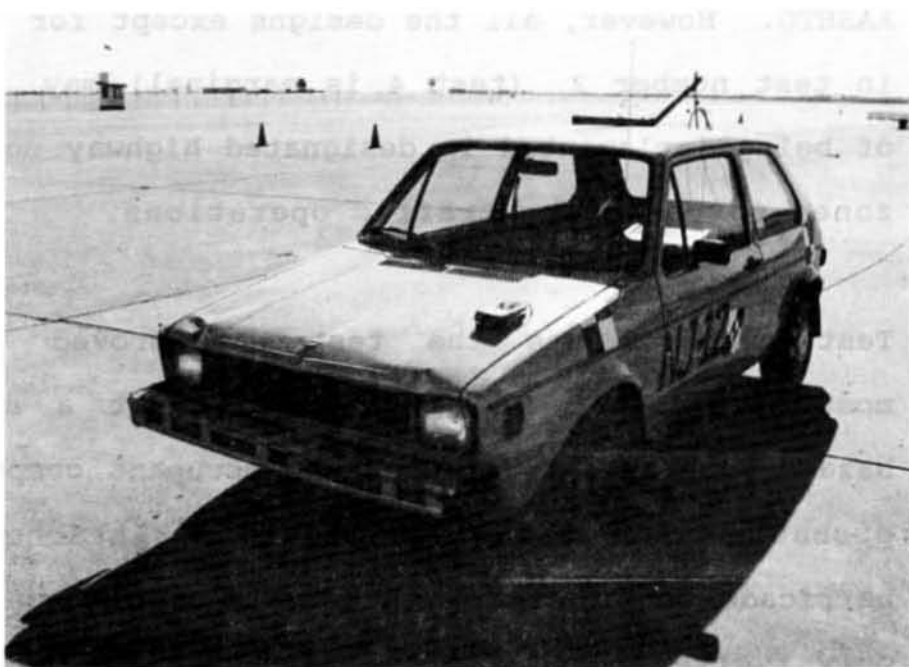
FIGURE 57. Photographs of Vehicle Before and After Test No. 12

TAD	FD-1
VDI	12FDMN1
Passenger Compartment	
Intrusion By Test Article	No
Was Windshield Broken ?	No
