CRASH TESTING OF SOUTH DAKOTA'S CABLE GUARDRAIL TO W-BEAM TRANSITION

MIDWEST ROADSIDE SAFETY FACILITY

SOUTH DAKOTA DEPARTMENT OF TRANSPORTATION

MwRSF Research Report No. TRP-03-80-98
December 4, 1998

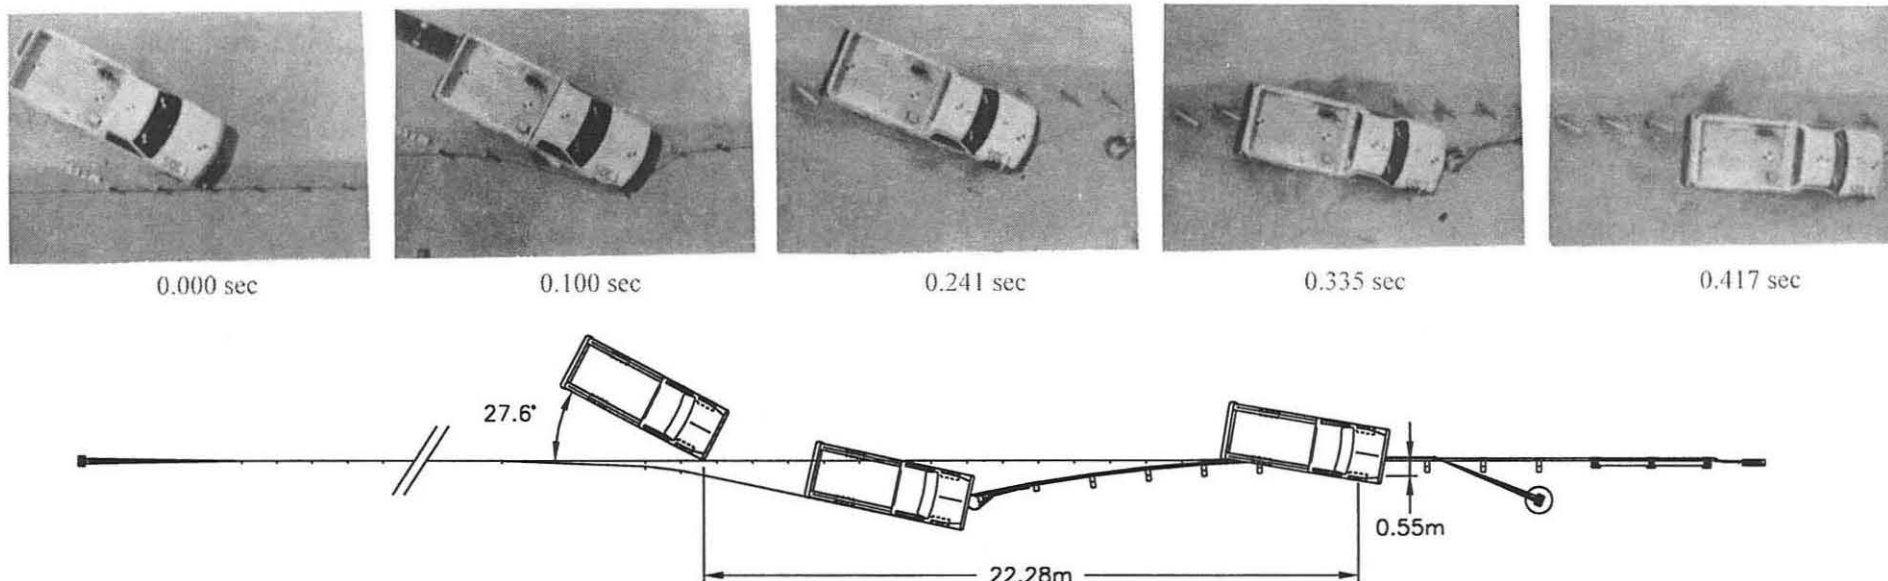
- Test Number SDC-1
- Date 8/11/98
- Appurtenance Cable Guardrail to W-Beam Transition
- Three-Strand Cable Guardrail
 - Diameter 19.0 mm
 - Specification 3 x 7 Wire Rope
 - Top Mounting Height 686 mm (center of upper cable)
- Steel Posts
 - Post Nos. 1C - 32C W76x8.5
- W-Beam Guardrail
 - Thickness 2.66 mm
 - Top Mounting Height 686 mm
- Wood Posts
 - Spacing 1,905 mm
 - Post Nos. 1W - 2W 140 mm x 190 mm x 1,080 mm
 - Post Nos. 3W - 11W 152 mm x 203 mm x 1,829 mm
- Wood Spacer Blocks
 - Post Nos. 3W - 11W 152 mm x 203 mm x 356 mm
- Soil Type Grading B - AASHTO M 147-65 (1990)
- Vehicle Model 1993 GMC 2500 (¾-ton) 2WD
 - Curb 2,173 kg
 - Test Inertial 2,013 kg
 - Gross Static 2,013 kg

- Vehicle Speed
 - Impact 101.9 km/hr
 - Exit NA
- Vehicle Angle
 - Impact 27.6 deg
 - Exit NA
- Vehicle Snagging Minor tire and undercarriage snagging on posts
- Vehicle Pocketing Minor
- Vehicle Stability Moderate roll angle but stable
- Occupant Ridedown Deceleration (10 msec avg.)
 - Longitudinal 12.21 G's < 20 G's
 - Lateral (not required) 7.36 G's
- Occupant Impact Velocity (Normalized)
 - Longitudinal 4.62 m/s < 12 m/s
 - Lateral (not required) 2.99 m/s
- Vehicle Damage Moderate
 - TAD¹³ 1-RFQ-3, 12-FC-3
 - SAE¹⁴ 01RFEW2, 12FCLN1
- Vehicle Stopping Distance 22.3 m downstream
0.55 m behind traffic-side face
- Barrier Damage Extensive
- Maximum Dynamic Deflection 2.4 m

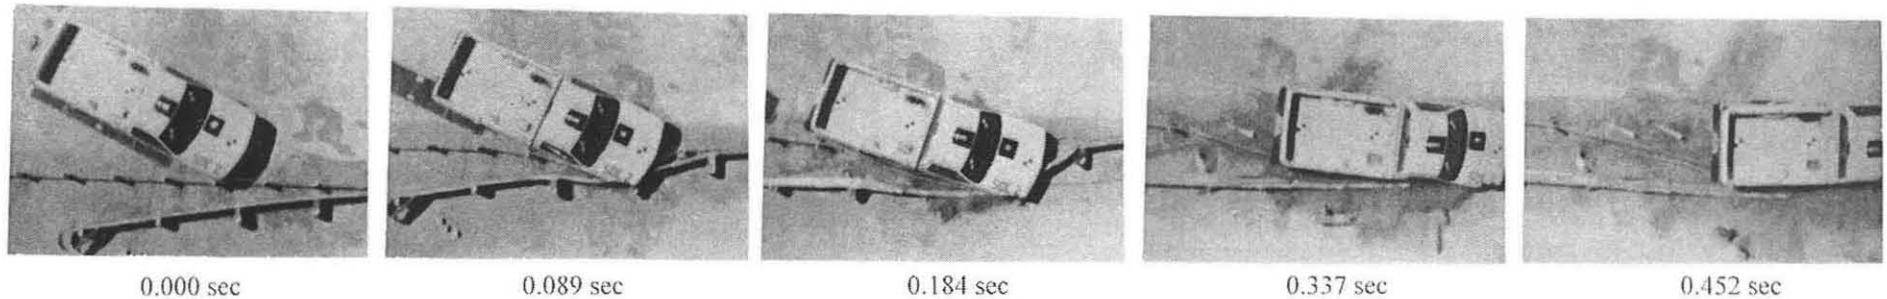
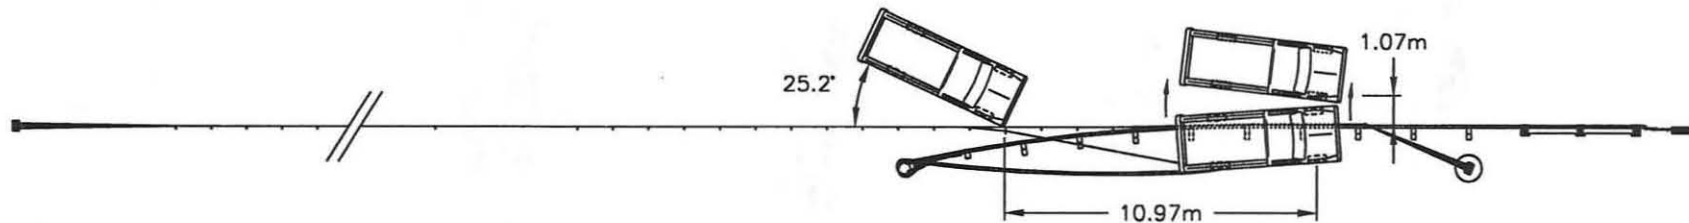
Figure 30. Summary of Test Results and Sequential Photographs, Test SDC-2

- Test Number SDC-2
- Date 8/18/98
- Appurtenance Cable Guardrail to W-Beam Transition
- Three-Strand Cable Guardrail
 - Diameter 19.0 mm
 - Specification 3 x 7 Wire Rope
 - Top Mounting Height 686 mm (center of upper cable)
- Steel Posts
 - Post Nos. 1C - 32C W76x8.5
- W-Beam Guardrail
 - Thickness 2.66 mm
 - Top Mounting Height 686 mm
- Wood Posts
 - Spacing 1,905 mm
 - Post Nos. 1W - 2W 140 mm x 190 mm x 1,080 mm
 - Post Nos. 3W - 11W 152 mm x 203 mm x 1,829 mm
- Wood Spacer Blocks
 - Post Nos. 3W - 11W 152 mm x 203 mm x 356 mm
- Soil Type Grading B - AASHTO M 147-65 (1990)
- Vehicle Model 1994 GMC 2500 (¾-ton) 2WD
 - Curb 2,045 kg
 - Test Inertial 2,023 kg
 - Gross Static 2,023 kg

- Vehicle Speed
 - Impact 101.8 km/hr
 - Exit NA
- Vehicle Angle
 - Impact 25.2 deg
 - Exit NA
- Vehicle Snagging Minor tire snagging on posts
- Vehicle Pocketing None
- Vehicle Stability Moderate roll angle but stable
- Occupant Ridedown Deceleration (10 msec avg.)
 - Longitudinal 9.25 G's < 20 G's
 - Lateral (not required) 5.97 G's/-7.44 G's
- Occupant Impact Velocity (Normalized)
 - Longitudinal 6.84 m/s < 12 m/s
 - Lateral (not required) 3.77 m/s
- Vehicle Damage Moderate
 - TAD¹³ 1-RFQ-4
 - SAE¹⁴ 01RFEW3
- Vehicle Stopping Distance 11.0 m downstream
1.07 m on traffic-side face
- Barrier Damage Extensive
- Maximum Dynamic Deflection Not visible

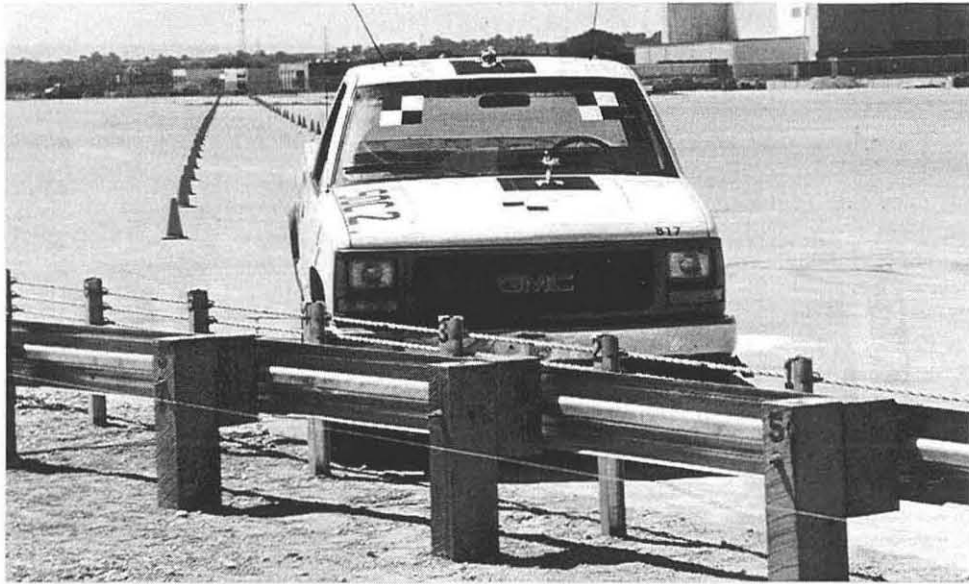
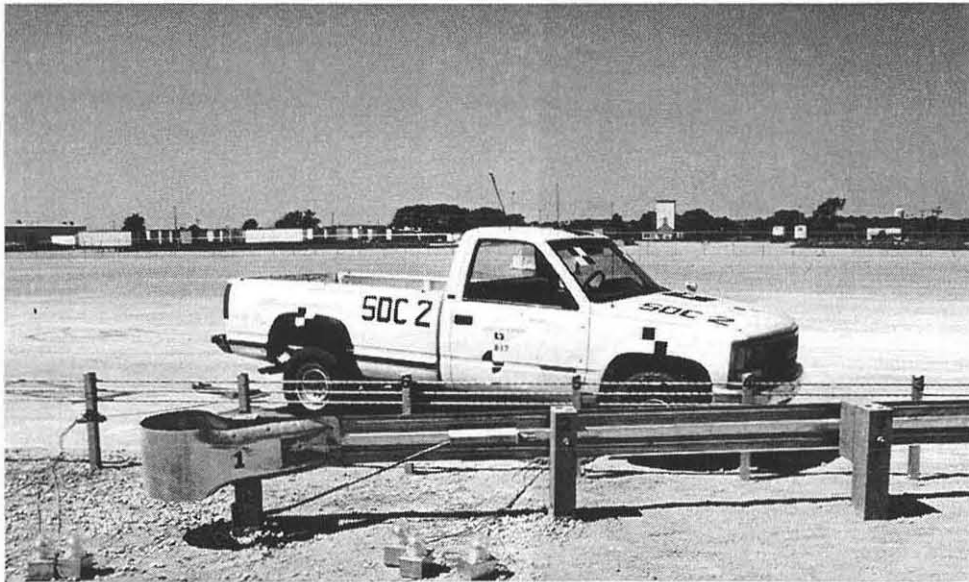
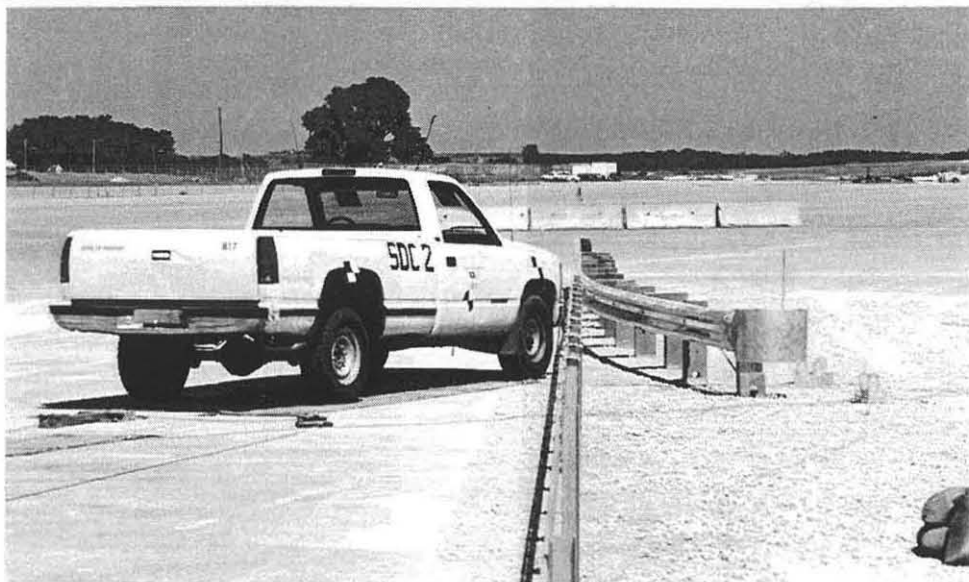
Figure 35. Impact Location, Test SDC-2

Initial impact occurred at the upstream edge of post no. 4C, as shown in Figure 35. At 0.042 sec after impact, the right-front corner of the vehicle impacted the W-beam rail at the midpoint between post nos. 3W and 4W. The right-front corner of the vehicle reached post no. 4W at 0.089 sec which subsequently fractured. At 0.091, one of the lower cables lost its tensile capacity when it pulled out at the anchorage located on the downstream end. At 0.145 sec after impact, post no. 5W fractured as the remaining lower cable lost its tensile capacity when it also pulled out at the anchorage located at the downstream end. As the vehicle continued to travel along the guardrail and penetrate laterally into the system, tensile loads increased in the W-beam rail located upstream from the original impact location. At 0.184 sec, this tensile loads caused post nos. 3W and 2W to fracture, in that order. In addition, the upper cable slipped over the top of the W-beam rail and was observed to be angled toward the ground at the downstream anchorage system. At 0.230 sec, the rear end of the vehicle contacted the cable, and at 0.246 sec, the left-front tire struck and drove over post no. 1C as the vehicle began to roll clockwise toward the rail. At 0.260 sec, the right-side midpoint of the vehicle contacted post no. 6W as the left-front tire became airborne. Subsequently, post no. 6W fractured about its weak axis at 0.267 sec after impact. At 0.311 sec, the upper cable released from

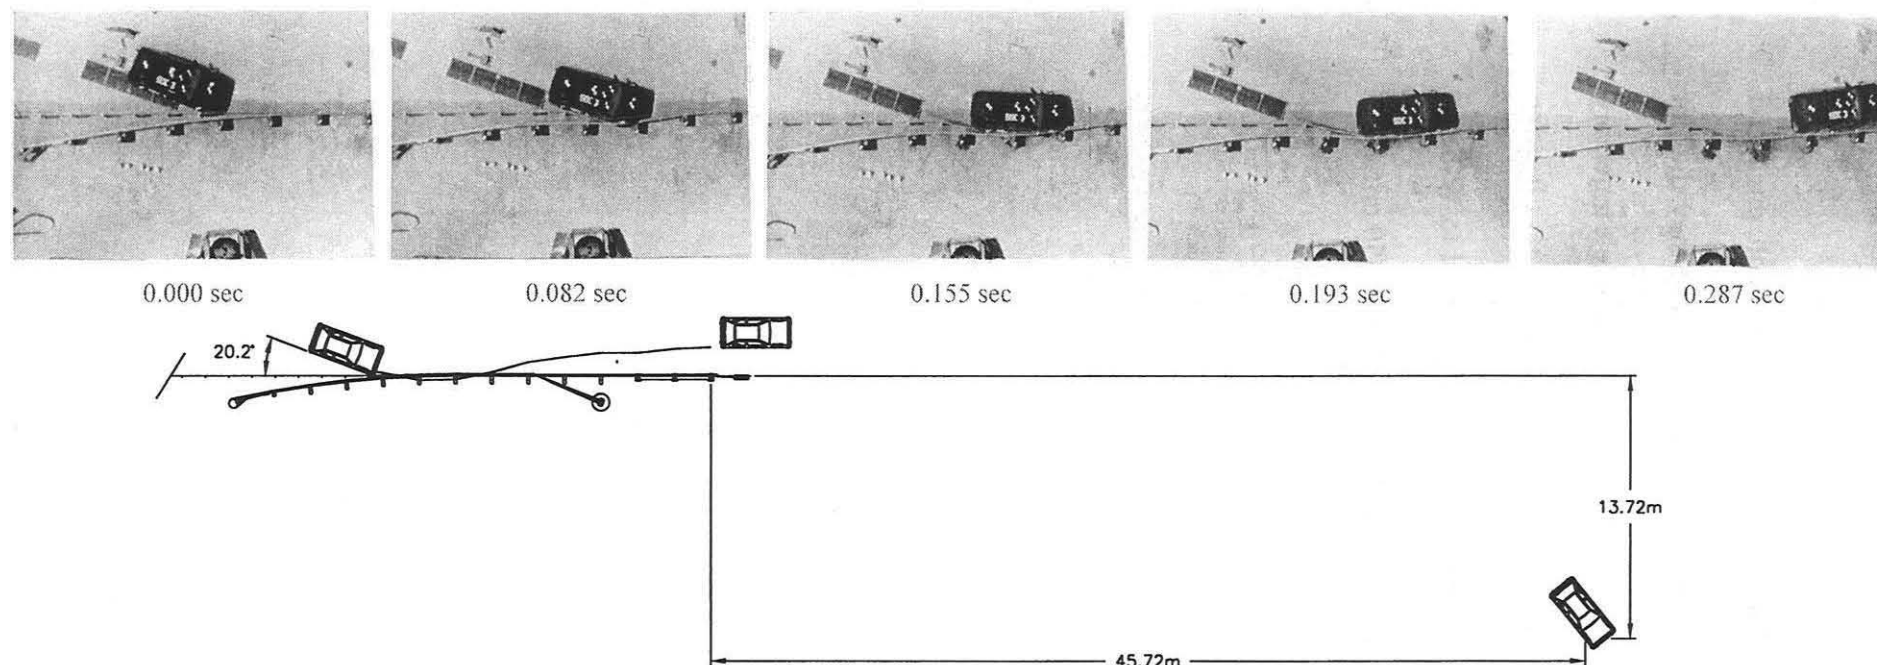
Figure 41. Summary of Test Results and Sequential Photographs, Test SDC-3

- Test Number SDC-3
- Date 8/31/98
- Appurtenance Cable Guardrail to W-Beam Transition
- Three-Strand Cable Guardrail
 - Diameter 19.0 mm
 - Specification 3 x 7 Wire Rope
 - Top Mounting Height 686 mm (center of upper cable)
- Steel Posts
 - Post Nos. 1C - 32C W76x8.5
- W-Beam Guardrail
 - Thickness 2.66 mm
 - Top Mounting Height 686 mm
- Wood Posts
 - Spacing 1,905 mm
 - Post Nos. 1W - 2W 140 mm x 190 mm x 1,080 mm
 - Post Nos. 3W - 11W 152 mm x 203 mm x 1,829 mm
- Wood Spacer Blocks
 - Post Nos. 3W - 11W 152 mm x 203 mm x 356 mm
- Soil Type Grading B - AASHTO M 147-65 (1990)
- Vehicle Model 1991 Geo Metro
 - Curb 753 kg
 - Test Inertial 802 kg
 - Gross Static 878 kg

- Vehicle Speed
 - Impact 99.6 km/hr
 - Exit 78.8 km/hr
- Vehicle Angle
 - Impact 20.2 deg
 - Exit 7.4 deg
- Vehicle Snagging Minor tire snagging on posts
- Vehicle Pocketing None
- Vehicle Stability Very Stable
- Occupant Ridedown Deceleration (10 msec avg.)
 - Longitudinal 2.83 G's/-3.24 G's < 20 G's
 - Lateral 16.64 G's < 20 G's
- Occupant Impact Velocity (Normalized)
 - Longitudinal 5.72 m/s < 12 m/s
 - Lateral 5.94 m/s < 12 m/s
- Vehicle Damage Moderate
 - TAD¹³ 1-RFQ-3
 - SAE¹⁴ 01RDAW2
- Vehicle Stopping Distance 45.7 m downstream
13.7 m behind traffic-side face
- Barrier Damage Moderate
- Maximum Dynamic Deflection 0.50 m
