# **Safety Performance Evaluation of the Steel Backed Wood Rail to Bridge Rail Transition**

Transportation Research Report TRP-03-49-95

**FHWA Contract No. DTFH71-90-C-00035**

September 1995

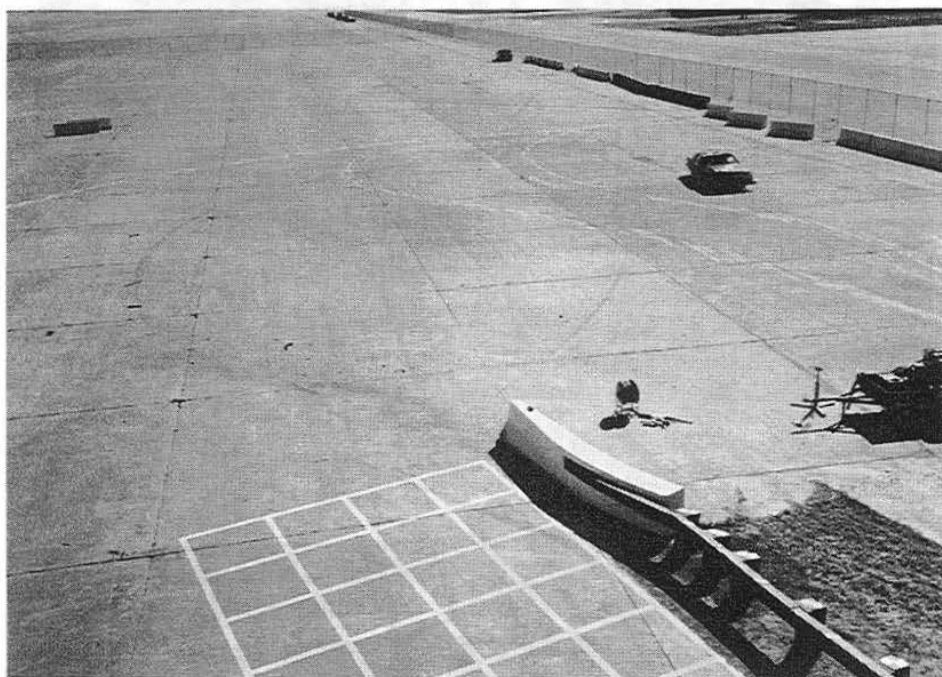
**Figure 6.** Vehicle Trajectory, Test SBT-1.

Upon impact with the steel backed wood rail, the right front corner of the vehicle began to crush inward. As the collision continued, the wood rail deflected considerably, with the maximum dynamic deflection of 13 in. (130 mm) occurring at post 1 at 130 ms. Immediately after this, at 133 ms, the vehicle impacted the end of the concrete abutment resulting in major damage to the vehicle. Approximately 167 ms after impact the buckling of the vehicle roof became very evident. At 204 ms after impact the vehicle became parallel to the system, and it exited the barrier at 439 ms at an angle of 17.5 degrees. The vehicle came to rest downstream and behind the rail as shown in Figure 5.

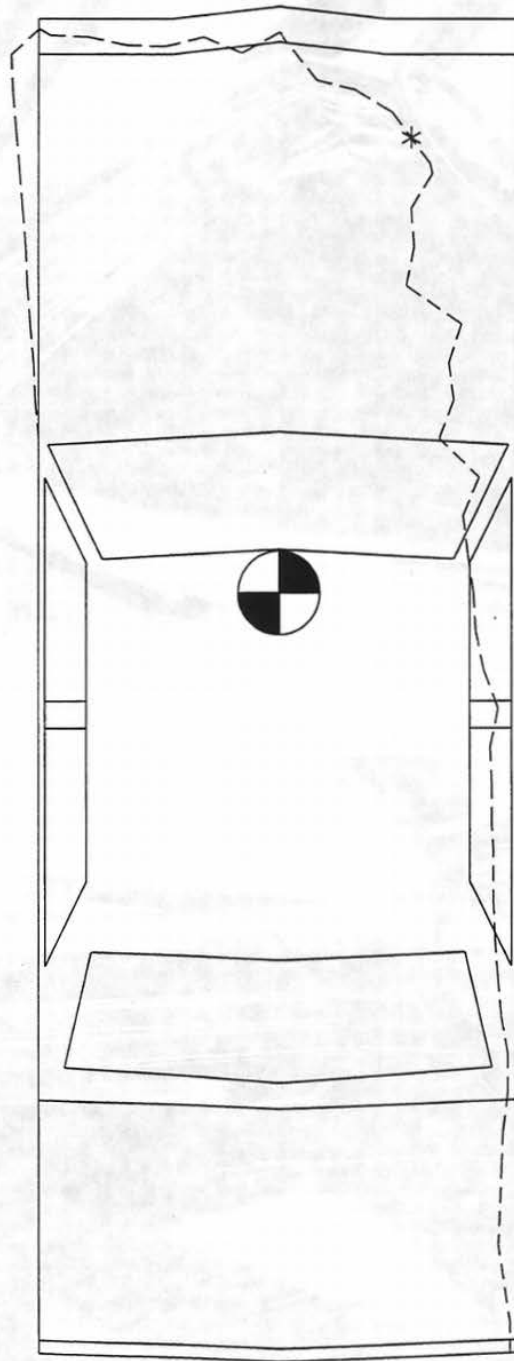
**Figure 9.** Crush Depth Diagram, Test SBT-1.

Damage to the vehicle, which can be seen in Figures 7 and 8, included major crushing and deformation of the right front corner of the vehicle, as well as buckling of the vehicle roof. The entire front half of the vehicle was bent slightly toward the drivers side. Interior compartment damage included buckling of the floorboard on the passenger side, as well as buckling of the dash. The maximum crush deformation of 17 in. (492 mm) is shown in Figure 9.

\*Maximum Crush=17in. (492mm)

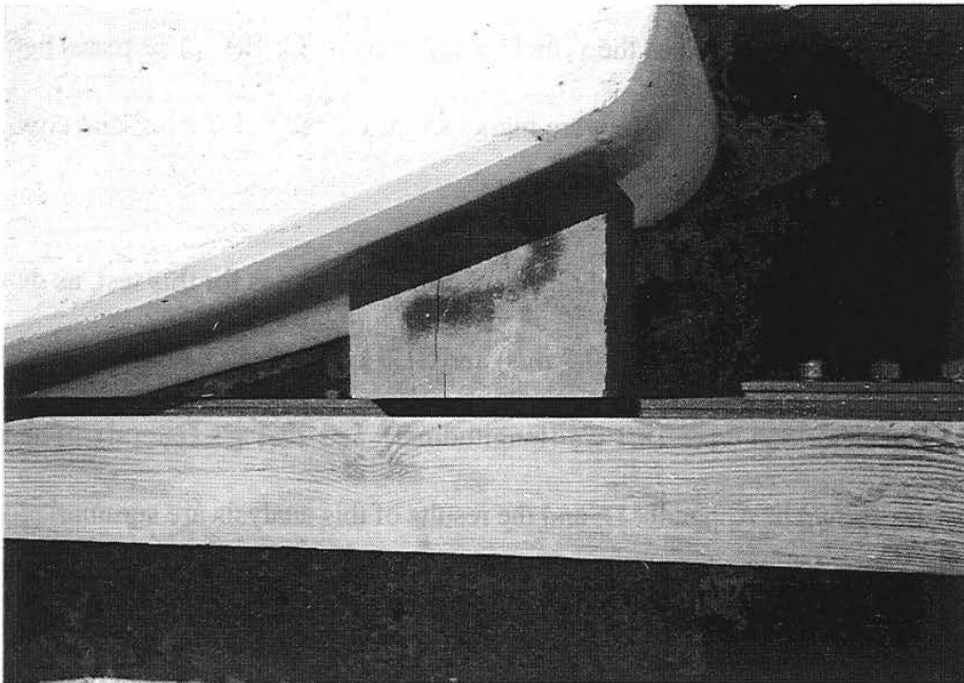
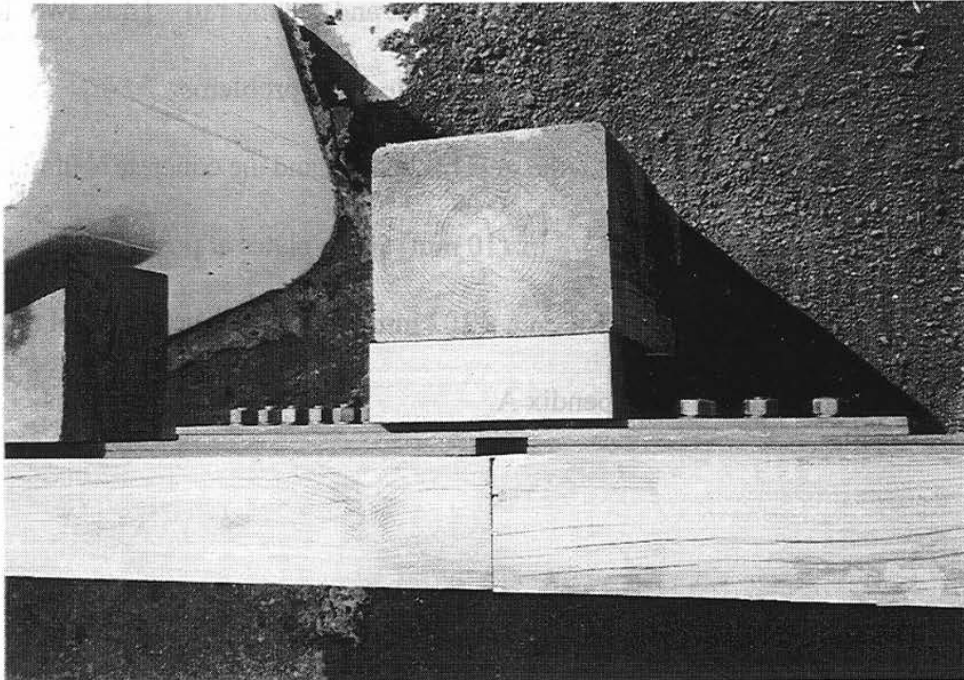
**Figure 13.** Design Modifications, Test SBT-2.

Two of the systems design flaws became apparent as a result of this test. The first was that the wood blockout between the wood rail and concrete abutment made the first rail section much too stiff, which resulted in the snagging problem at splice No. 1. The second observation was that the steel splice plates did not provide adequate strength for the splice between the first and second rail. Thus, two design changes were incorporated into the next design in an effort to alleviate these problems.

First, the angled wood blockout between the steel backed rail and the concrete abutment was replaced with a 6 in. diameter pipe. Secondly, the two 3/8 in. (10 mm) splice plates at post No. 1 were replaced with a 3 ft (0.91 m) length of 6 in. x 4 in. x 1/2 in. (152 mm x 102 mm x 13 mm) structural steel tube. The details of these design changes can be found in Appendix A.

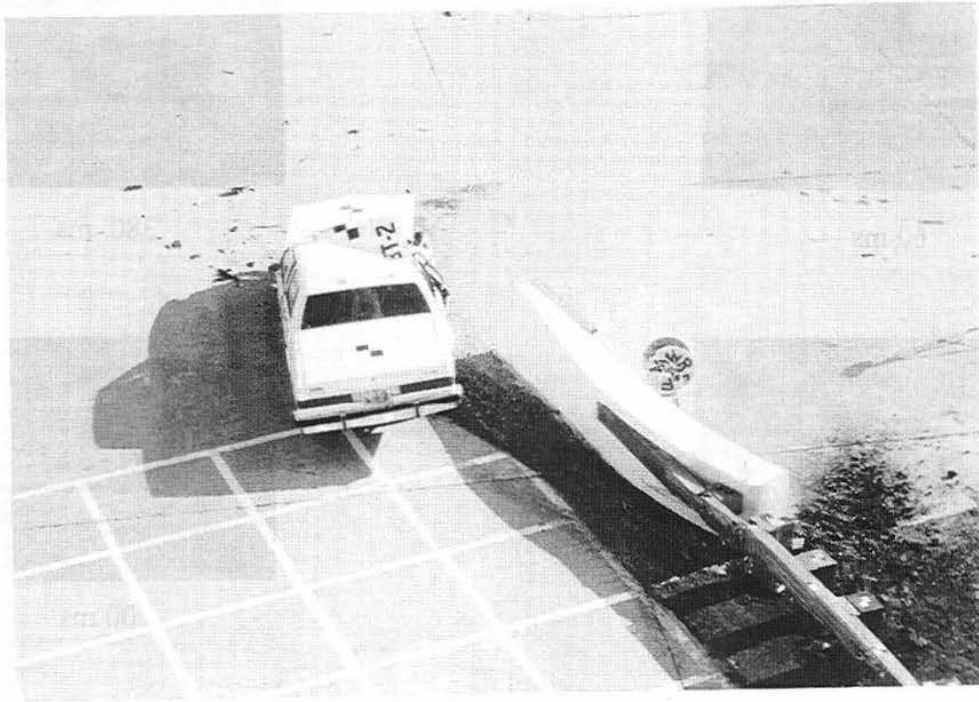
**Figure 17.** Vehicle Trajectory, Test SBT-2.

Upon impact with the wood rail, the right front corner of the test vehicle began to crush inward. Rail No. 2 began to deflect shortly after impact, but the wood spacer block between the concrete and rail prevented rail No. 1 from deflecting. As a result of this significant difference in stiffness, the splice between these two rails yielded, and 110 ms after impact the first rail speared into the vehicle. The vehicle never became parallel to the rail, and it exited at 450 ms at an angle of 17.3 degrees. The snagging at the first splice resulted in major vehicle and occupant compartment deformation, and the sedan was brought to a complete stop shortly after it exited the rail, as can be seen by its final resting position shown in Figure 17.

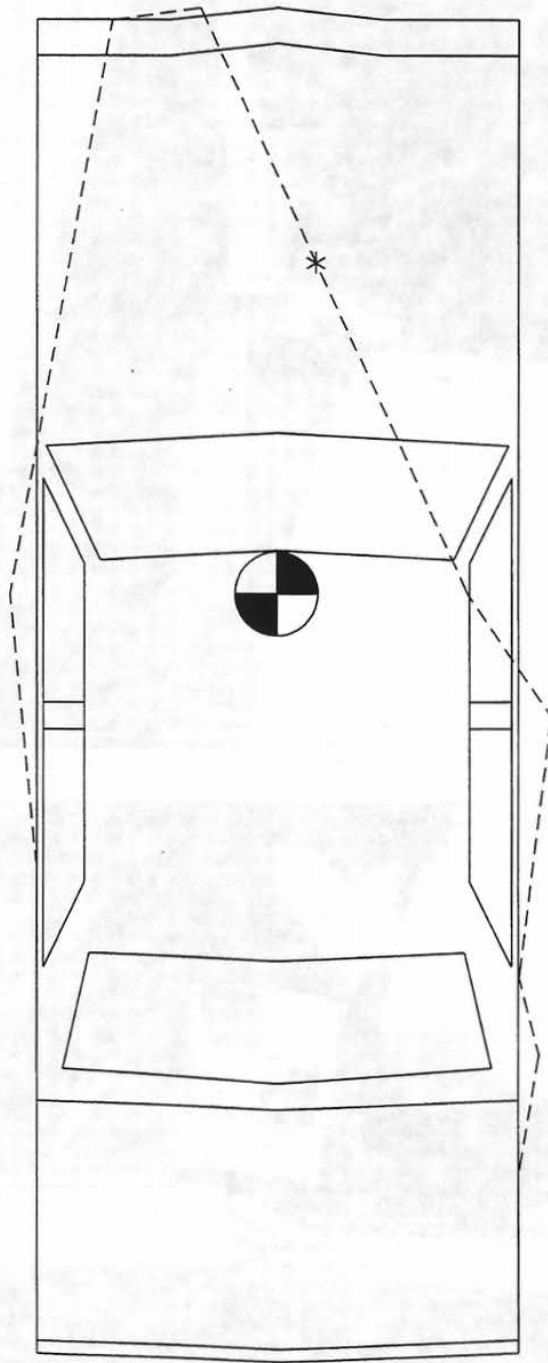
**Figure 20.** Crush depth diagram, Test SBT-2.

The damage to the vehicle was substantial, as can be seen in Figures 18 and 19. The entire front right portion of the vehicle was crushed and pushed back toward the occupant compartment considerably. The firewall and floorboard were pushed up and in on the passenger side, and a section of the wood rail penetrated the firewall on the extreme right hand side. The windshield was broken and the roof of the vehicle was buckled considerably. The maximum vehicle crush of 31.5 (800 mm) inches is shown schematically in Figure 20.

\*Maximum Crush=31.5in. (800mm)

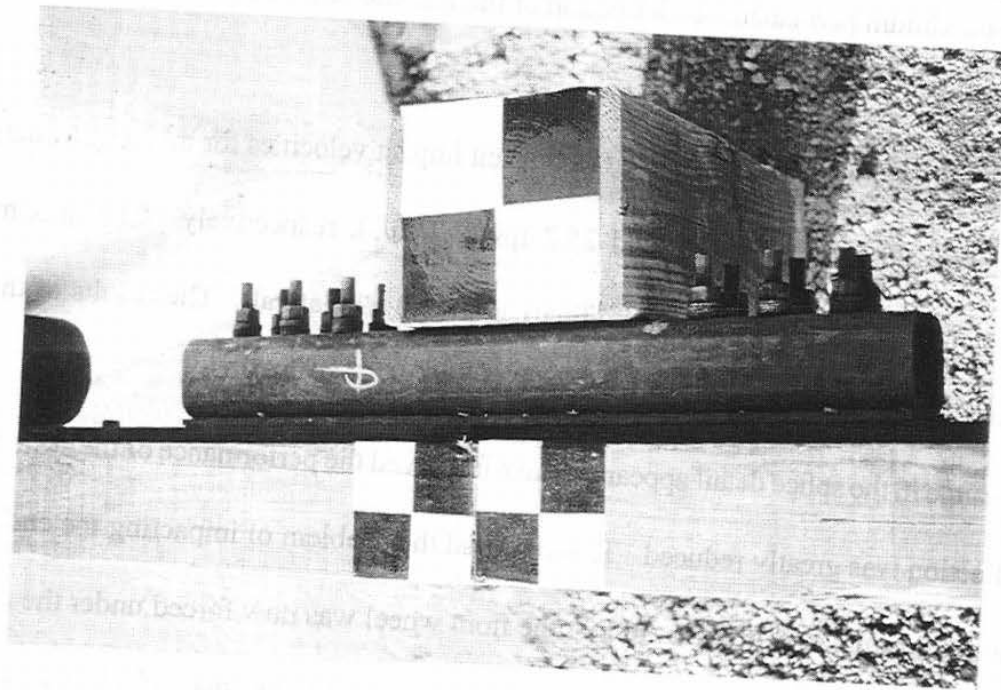
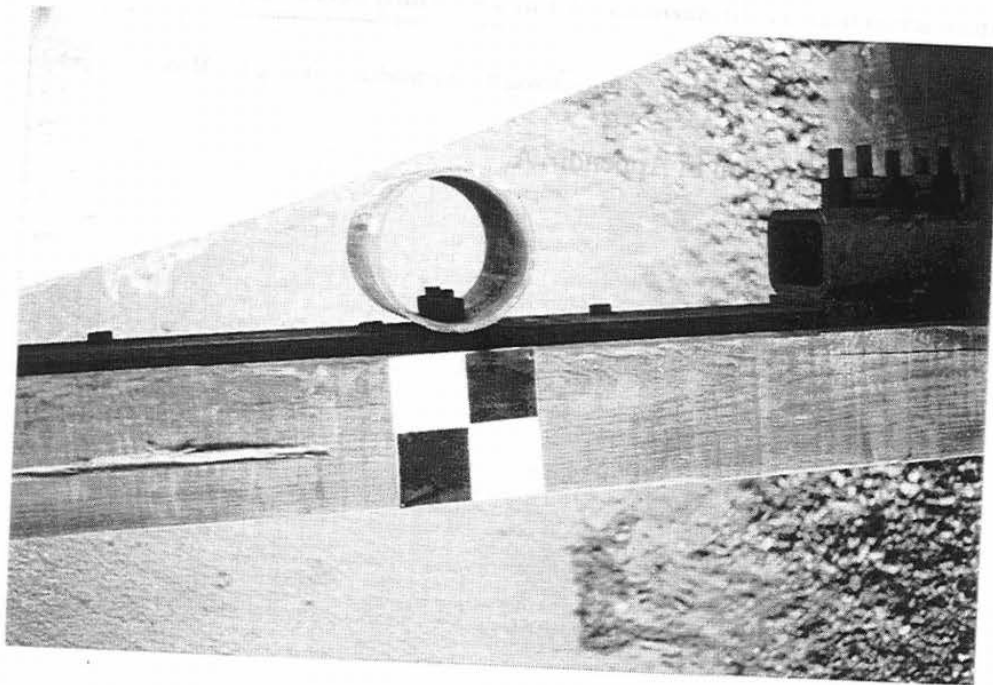
**Figure 23.** Design Modifications, Test SBT-3.

The change in the splice detail appears to have improved the performance of the system considerably, as the rail deflection was greatly reduced. This resolved the problem of impacting the end of the concrete abutment, but produced a new problem in that the front wheel was now forced under the rail and snagged on post Nos. 1 and 2. Tire marks on the posts indicated that a maximum snag of 5.5 in. (140 mm) occurred at post No. 2. In order to remedy this problem, a 4 in. (102 mm) deep blockout was added to post No. 1 and the 4 in. (102 mm) blockout at posts Nos. 2 and 3 were increased to a depth of 8 in. (203 mm). The details of these design changes can be seen in Appendix A.

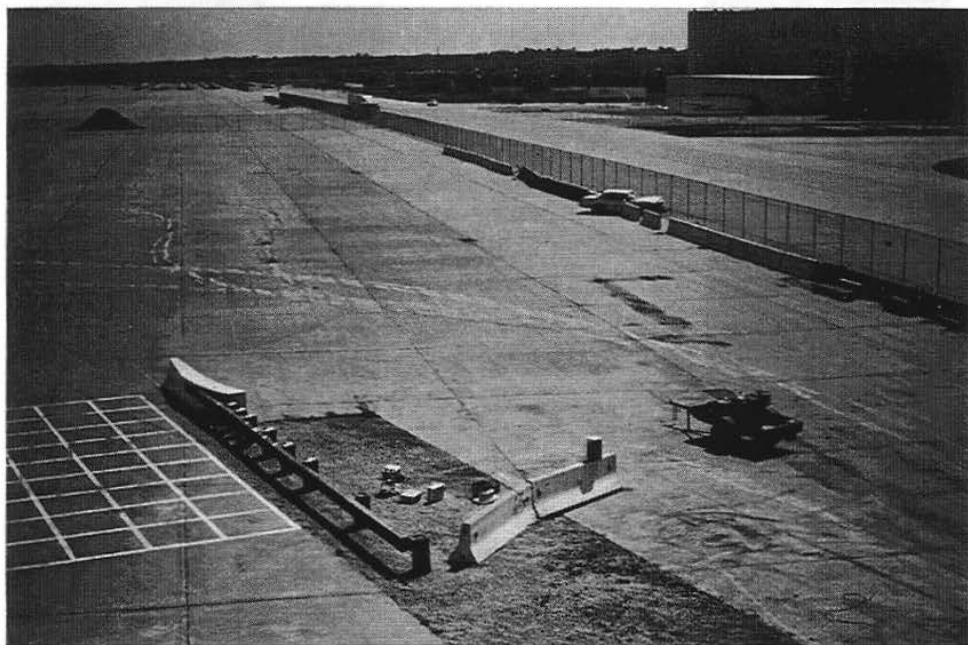
**Figure 27.** Vehicle Trajectory, Test SBT-3.

Upon impact with the wood rail, the right front corner of the test vehicle was crushed inward, and the wheel was forced under the rail and back to the post. This resulted in considerable tire snagging on posts Nos. 1 and 2, which pushed the wheel back against the firewall and resulted in deformation of the occupant compartment. The vehicle became parallel to the system at 212 ms, and exited at 343 ms and 5.8 degrees. The maximum dynamic deflection of this system was limited to 6.4 in. (163 mm) at post No. 3, and there was no problem with the vehicle impacting the end of the concrete abutment. The final resting position of the vehicle was downstream and behind the rail, as seen in Figure 27.

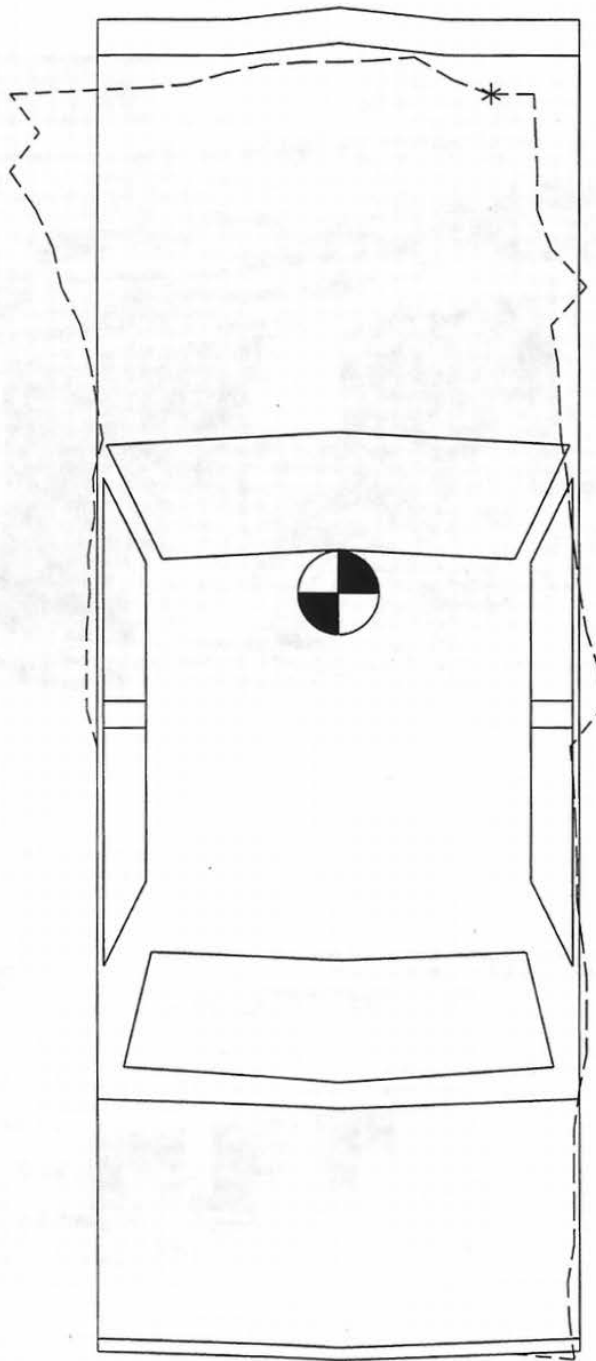
**Figure 30.** Crush Depth Diagram, Test SBT-3.

The vehicle damage, shown in Figures 28 and 29, consisted of the crushing of the front right corner of the vehicle, as well as scrapes and dents continuing down the side to the rear wheel well. The tire was torn off the front right wheel, and the rim was bent. Occupant compartment damage included buckling of the floor on the passenger side of the vehicle, as well as buckling of the dashboard. The maximum crush deformation of 13.75 in. (349 mm) is shown schematically in Figure 30.

\*Maximum Crush=13.75in. (349mm)

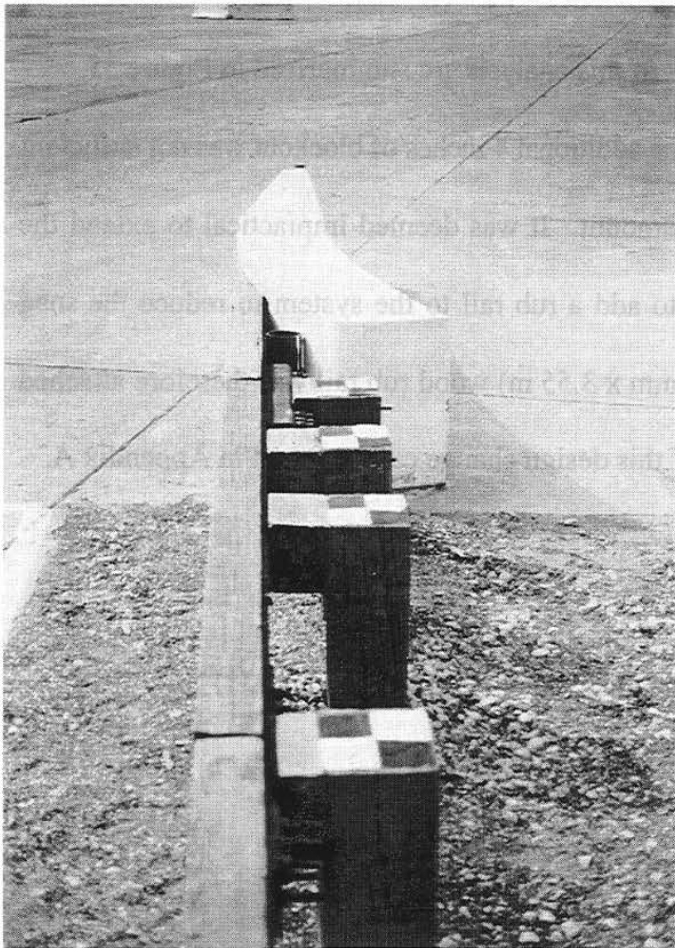
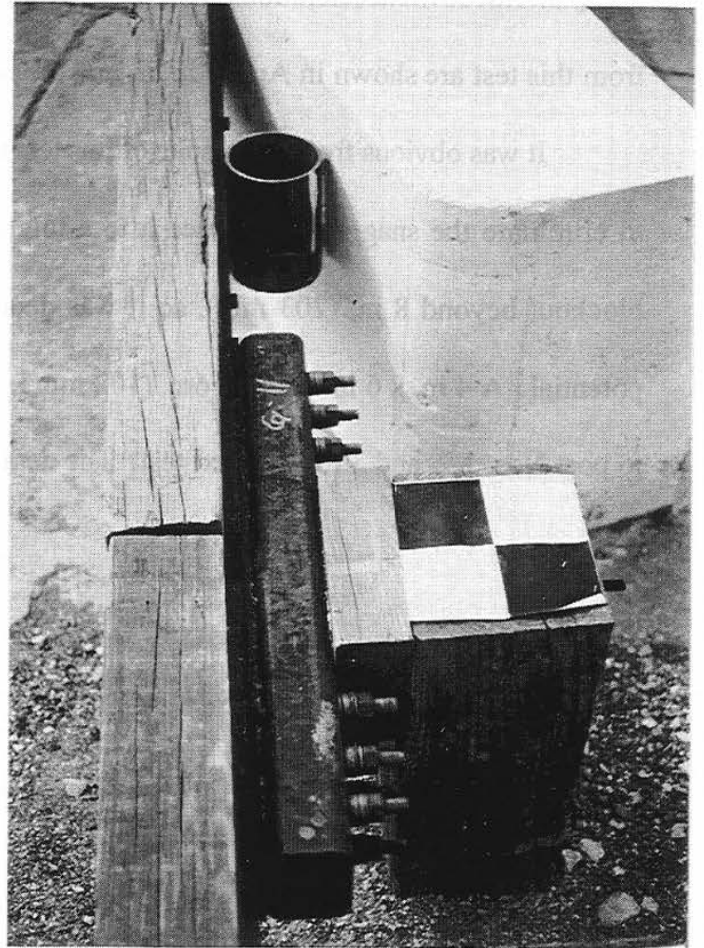
**Figure 33.** Design Modifications, Test SBT-4.

The design changes discussed in the previous section were incorporated into the system for this test. These changes can be seen in Figure 33, and the design details are presented in Appendix A. A 1984 Mercury Grand Marquis was directed into the Steel Backed Wood Rail to Bridge Rail Transition using a reverse tow and cable guidance system (4). The vehicle was released from the tow cable and guidance system and was free wheeling at impact. The speed of the vehicle at impact was 60.0 mph (96.5 km/h) and the angle of impact was 26.2 degrees. The impact point was located midway between the 3rd and 4th posts from the concrete bridge abutment as shown in Figure 34. A summary of the test results and sequential photographs are shown in Figure 35. Additional sequential photos are shown in Figure 36.

It was obvious from the results of this test that the additional 4 inches of blackout was not sufficient to eliminate the snagging or reduce it to a tolerable amount. It was deemed impractical to extend the blackout beyond 8 in. (203 mm), so it was decided to add a rub rail to the system to reduce the snag potential. A 4 in. x 6 in. x 11ft - 6in. (102 mm x 152 mm x 3.55 m) wood rub rail was therefore attached to post Nos. 1,2, and 3 for the next test. The details of this design change can be found in Appendix A.

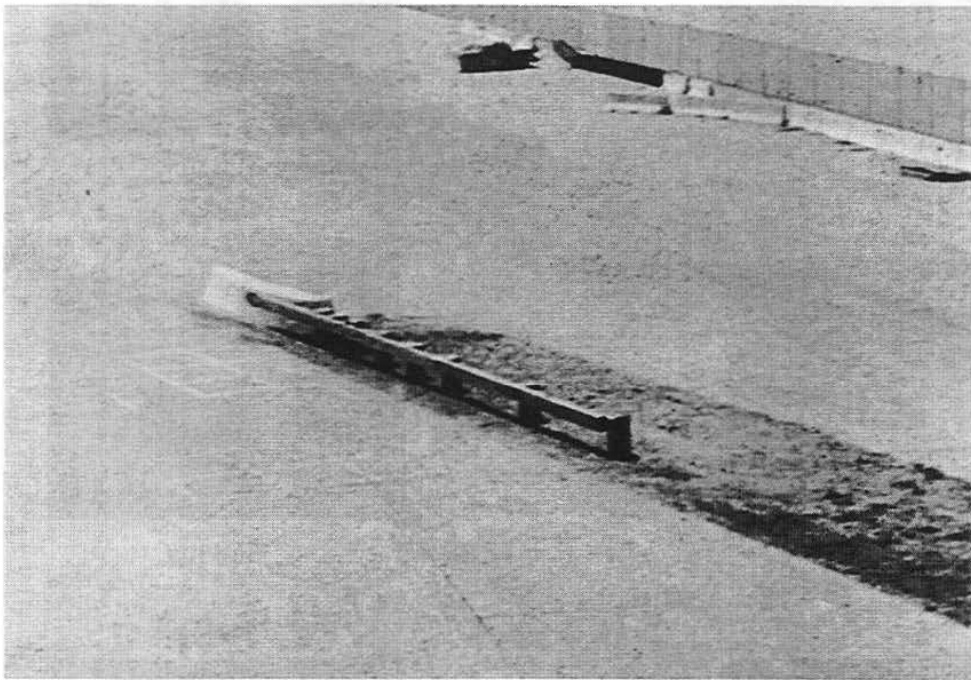
**Figure 37.** Vehicle Trajectory, Test SBT-4.

This test performed similar to Test SBT-3 in that as the right front corner of the vehicle was crushed upon impact, the wheel was forced under the rail and contacted the posts. This snagging occurred even though the first three posts had been moved back 4 in. (102 mm) with blockouts, and resulted in considerable occupant compartment deformation. After this snagging occurred, the vehicle became parallel to the system at 246 ms, and then exited the system at 357 ms and an angle of 4.0 degrees. The final resting position of the vehicle is shown in Figure 37.

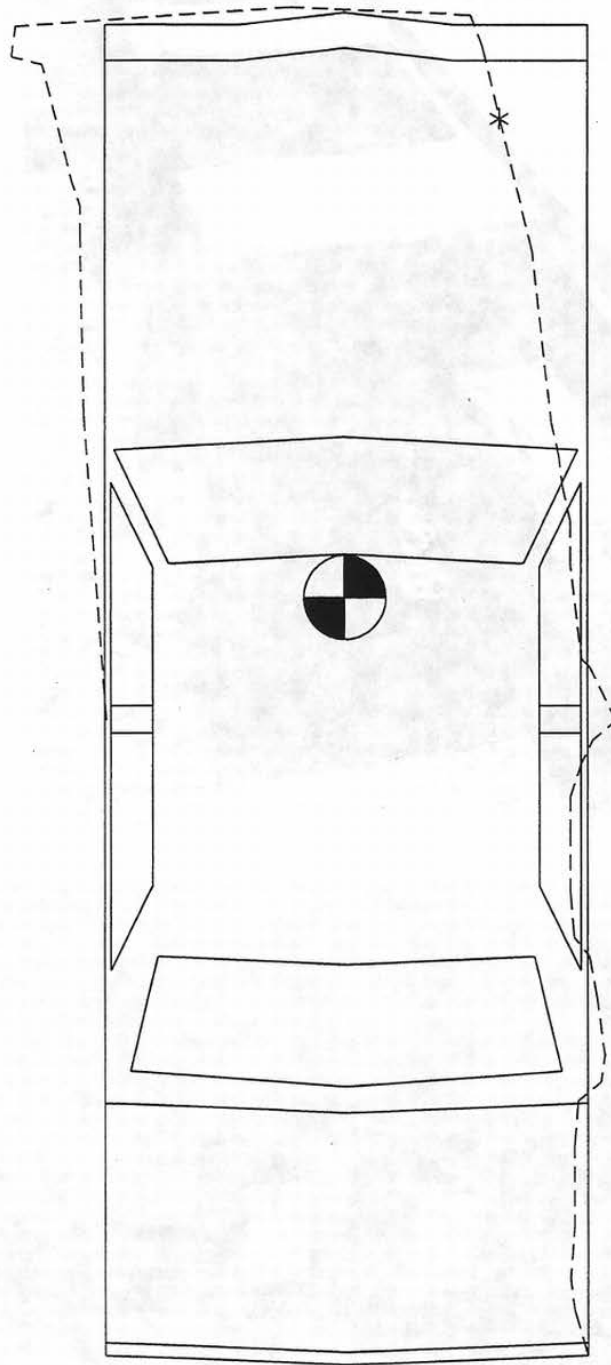
**Figure 40.** Crush Depth Diagram, Test SBT-4.

The damage to the vehicle, shown in Figures 38 and 39, consisted of deformation of the front right corner of the vehicle, which continued down the passenger side of the vehicle as scrapes and dents. The front left tire was removed from the rim, and the front bumper was pushed toward the drivers side considerably. The entire front end of the vehicle was pushed toward the passenger side and the roof was buckled. Interior compartment damage consisted of buckling of the floorboard on the passenger side and of the dash. The maximum crush deformation of 13.75 in. (349 mm) is shown schematically in Figure 40.

\*Maximum Crush=13.75in. (349mm)

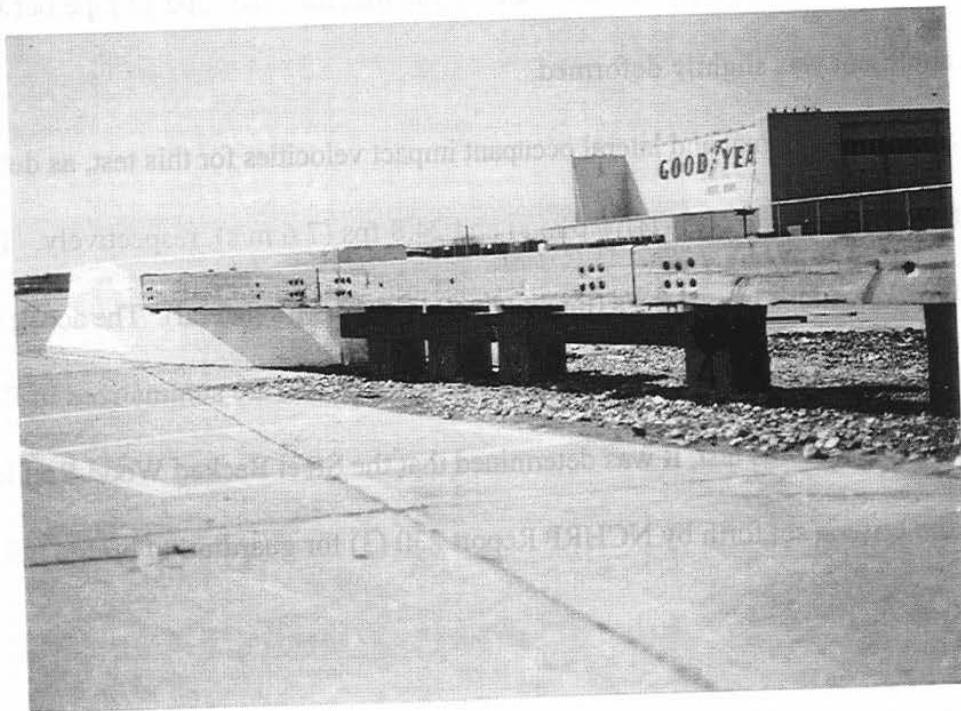
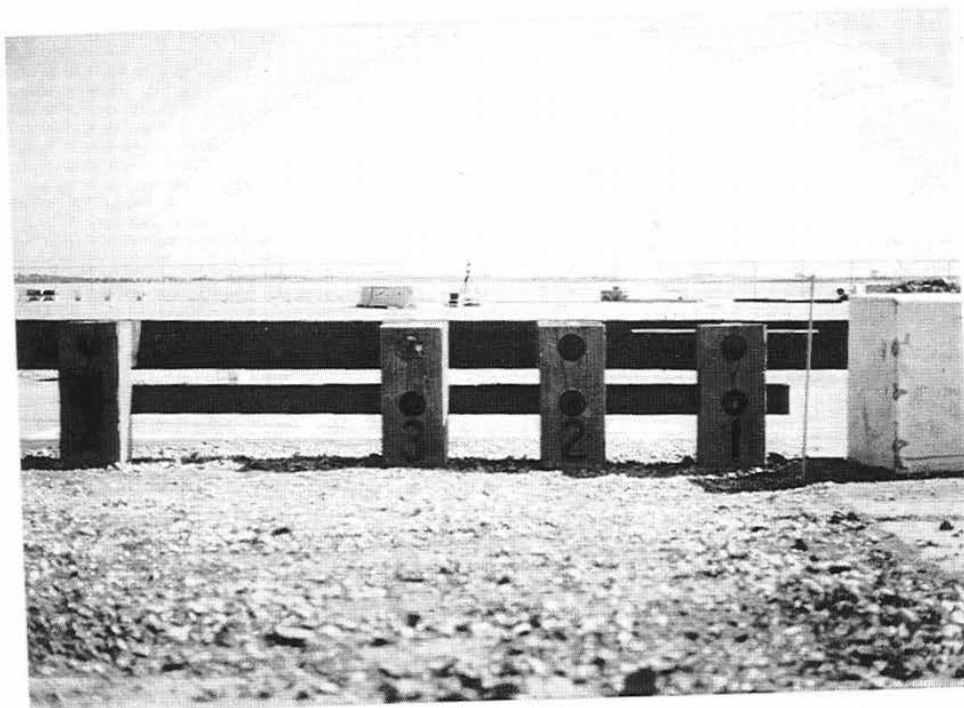
**Figure 43.** Design Modifications, Test SBT-5.

A rub rail was added to the previous system for this test, as shown in Figure 43 and Appendix A. The 1984 Ford LTD was directed into the Steel Backed Wood Rail to Bridge Rail Transition using a reverse tow and cable guidance system (4). The vehicle was released from the tow cable and guidance system and was free wheeling at impact. The speed of the vehicle at impact was 58.6 mph (94.3 km/h) and the angle of impact was 24.8 degrees. The impact point was located midway between the 3rd and 4th posts from the concrete bridge abutment as shown in Figure 44. A summary of the test results and sequential photographs are shown in Figure 45. Additional sequential photographs are shown in Figure 46.

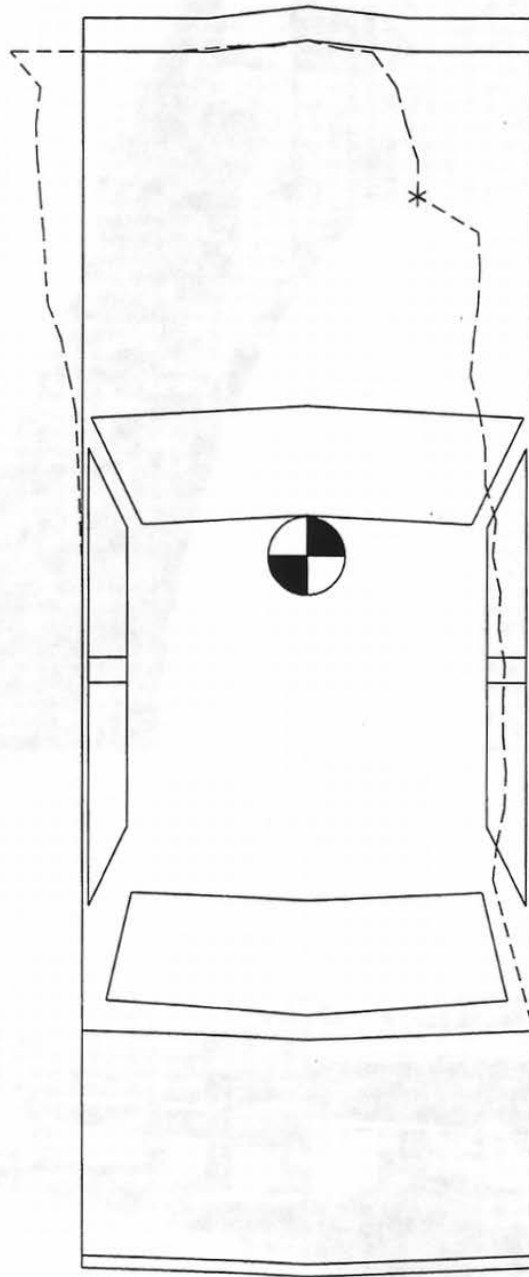
**Figure 50.** Crush Depth Diagram, Test SBT-5.

Damage to the vehicle, shown in Figures 48 and 49, included deformation of the front right corner, continuing along the length of the vehicle to the rear wheel well. There was no evidence of snagging, and the occupant compartment remained intact with the exception of minor deformation of the floorboard on the passenger side. The maximum crush deformation of 19.4 in. (492 mm) is shown schematically in Figure 50.

\*Maximum Crush=19.4in. (492mm)

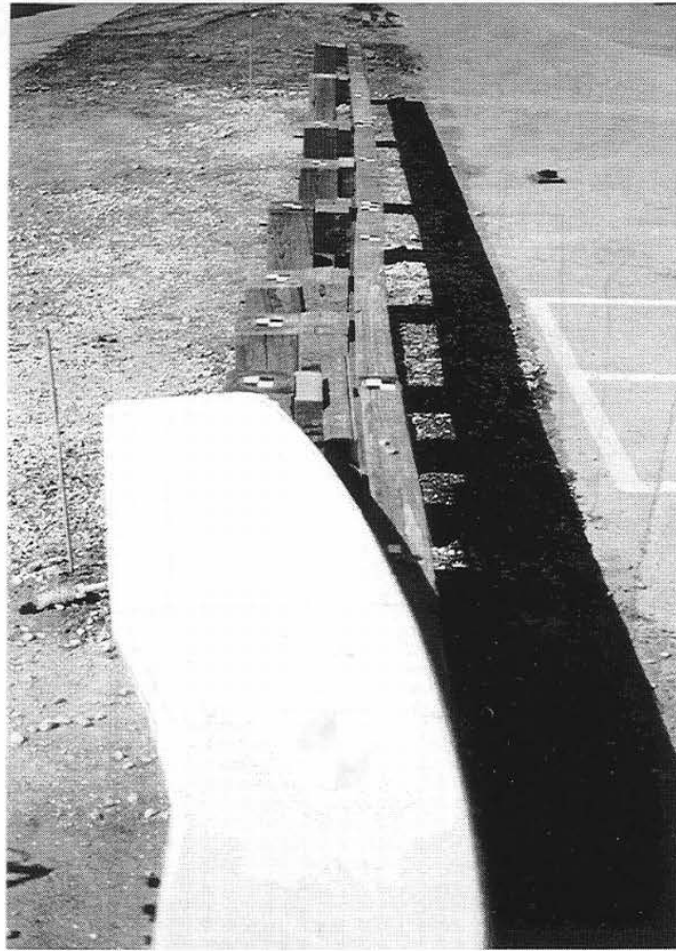
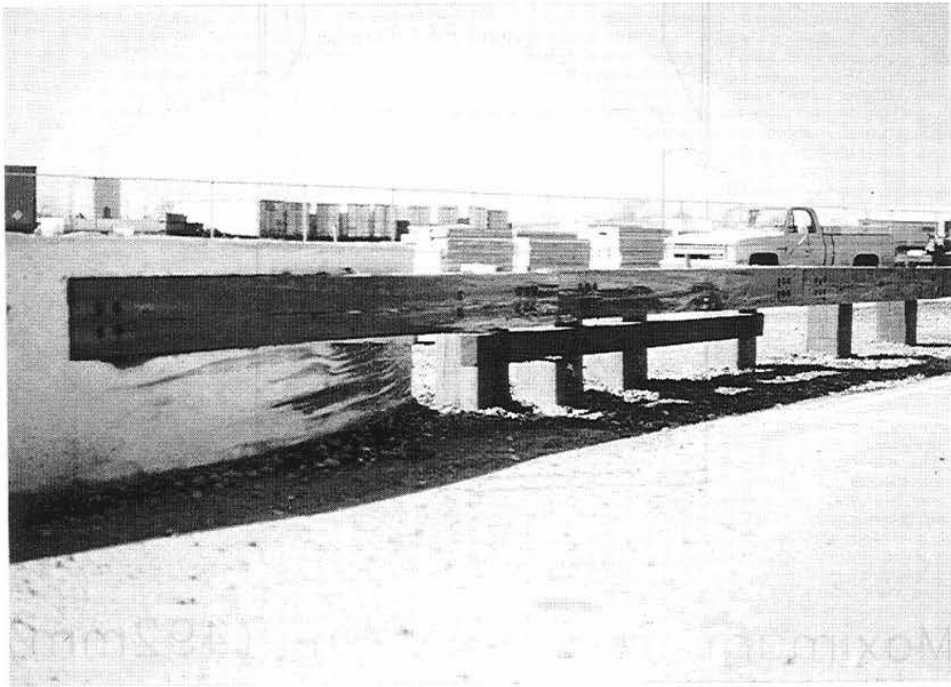
**Figure 51.** System Damage, Test SBT-5.

As can be seen in Figures 51 and 52, the wood rail sustained minor scraping and gouging along its face. The rub rail showed signs of tire contact starting 10.5 in. (267 mm) downstream of post No. 3 and continuing to the end of the rail. A 4 in. (102 mm) trench was dug by the vehicle starting and post No. 3 and continuing to post No. 1. Full tire contact was evident on the concrete abutment starting at its upstream
