**Safety Performance Evaluation of  
a Modified Perforated Tension Fuse Plate  
for Dual Support Breakaway Signs**

Project RES 2 (0099) P464  
TRANSPORTATION RESEARCH REPORT TRP-03-33-92

March 1993

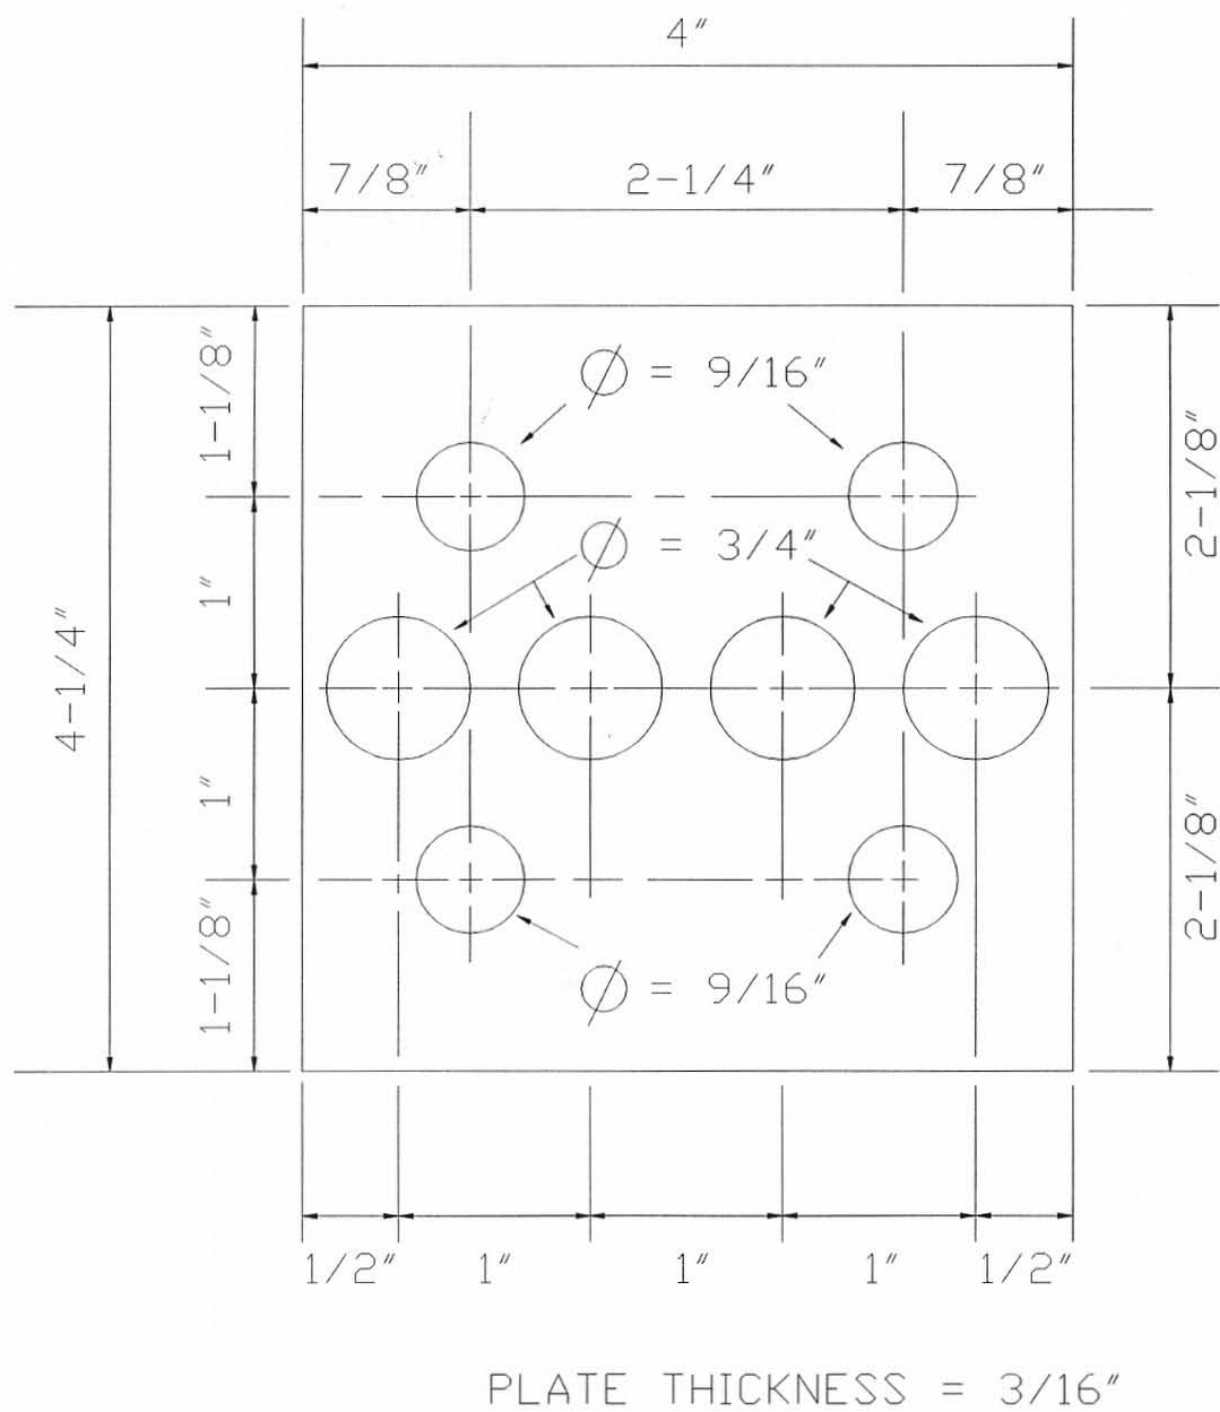
FIGURE 3. Details of the modified perforated tension fuse plate

Each support was mounted on the permanent lower slipbase assembly by four 5/8 in. diameter bolts torqued to 345 in.-lbs. These bolts were held in place by a bolt retainer made from 30 gauge galvanized sheet metal. The height of the permanent lower slipbase assembly was 4 in. A drawing of the fuse plate which was used in the safety evaluation is shown in Figure 3 and photographs of this plate on the installation are shown in Figure 4.

A number of static bend tests were performed on the existing design as shown in Appendix C. It was determined that a potential solution to this problem involves specifying a free machining steel to be used for the fuse plate. This type of steel contains inclusions which cause the dynamic strength of the plate to be reduced by approximately 50% in the direction perpendicular to rolling. When the perforation holes are drilled in a line parallel to the roll direction, the static strength of the plate remains the same, but the plate will fail in a dynamic loading situation such as a collision. A suggested material for this plate is AISI 8620 (Yield Strength = 65 ksi, Ultimate Tensile Strength = 89 ksi, % elongation at failure = 25%). The cost of this material is about 70% higher than that of the A36 material which is currently being used, but because of the relatively small size of the fuse plate, this would represent an increase of only approximately \$25 per system. If this material was to be used, the geometry of the fuse plate could remain the same except for those changes indicated in Table 3.

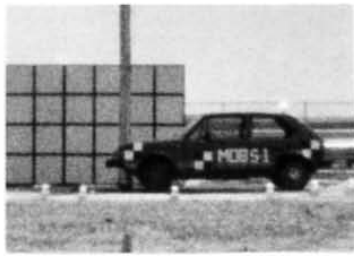
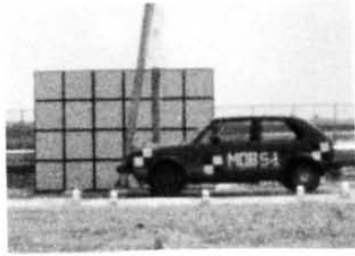
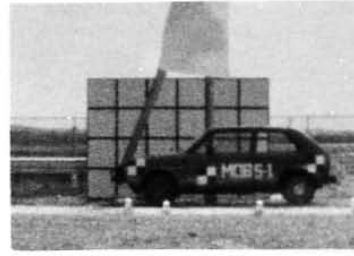
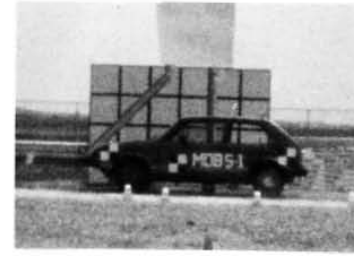
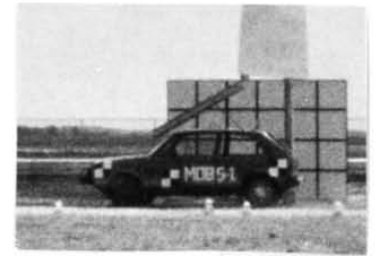
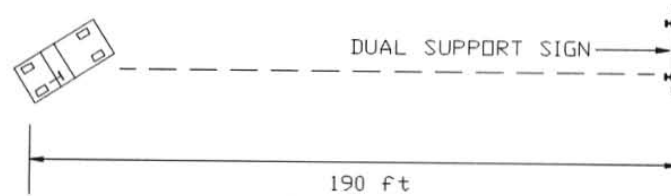
In Test MOBS-1, the 1979 Volkswagen Rabbit impacted the sign structure head on at a speed of 20.6 mph. A summary of the test results is shown in Figure 8. The target impact point was the center of the front bumper, but the actual impact was offset 5.5 in. toward the passenger side of the vehicle. A maximum crush depth of 9.75 in. was measured on the front bumper of the test vehicle. The damage to the test vehicle is shown in Figure 9. Damage to the sign support consisted only of destruction of the perforated tension fuse plate and the impacted support. Damage to the installation is shown in Figure 10.

velocity was 8.7 fps, well below the limit of 15 fps. The vehicle change in speed was determined to be 8.7 fps, which is below the required limit of 16 fps. The maximum ridedown acceleration of 1.0 g was well below the specified limit of 15 g's.

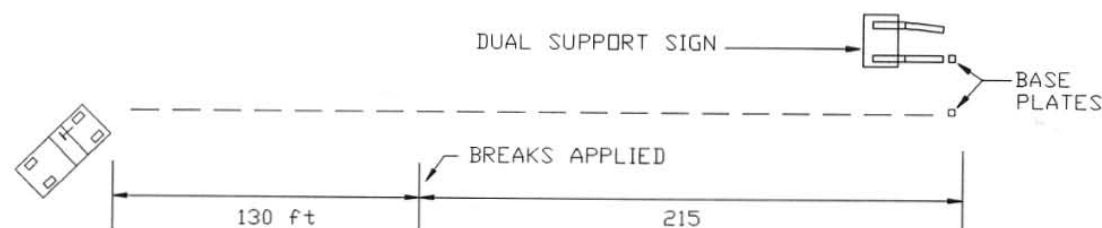
In Test MOBS-2, the 1979 Volkswagen Rabbit impacted the sign structure head on at a speed of 59.3 mph. A summary of the test results is shown in Figure 11. The target impact point was the center of the front bumper, but the actual impact occurred 6.25 in. from the center point toward the driver side of the vehicle. The damage to the test vehicle is shown in Figure 12, and damage to the test installation is shown in Figure 13. The impacted support and corresponding fuse plate were destroyed shortly after impact when the hinge mechanism activated. The other support was deformed as the sign system rotated around clockwise. One of the flanges from the stub of the non-impacted support was torn off as the support was rotated around. Damage to the sign was minimal, but one of the support beams was partially separated from the back of the sign.

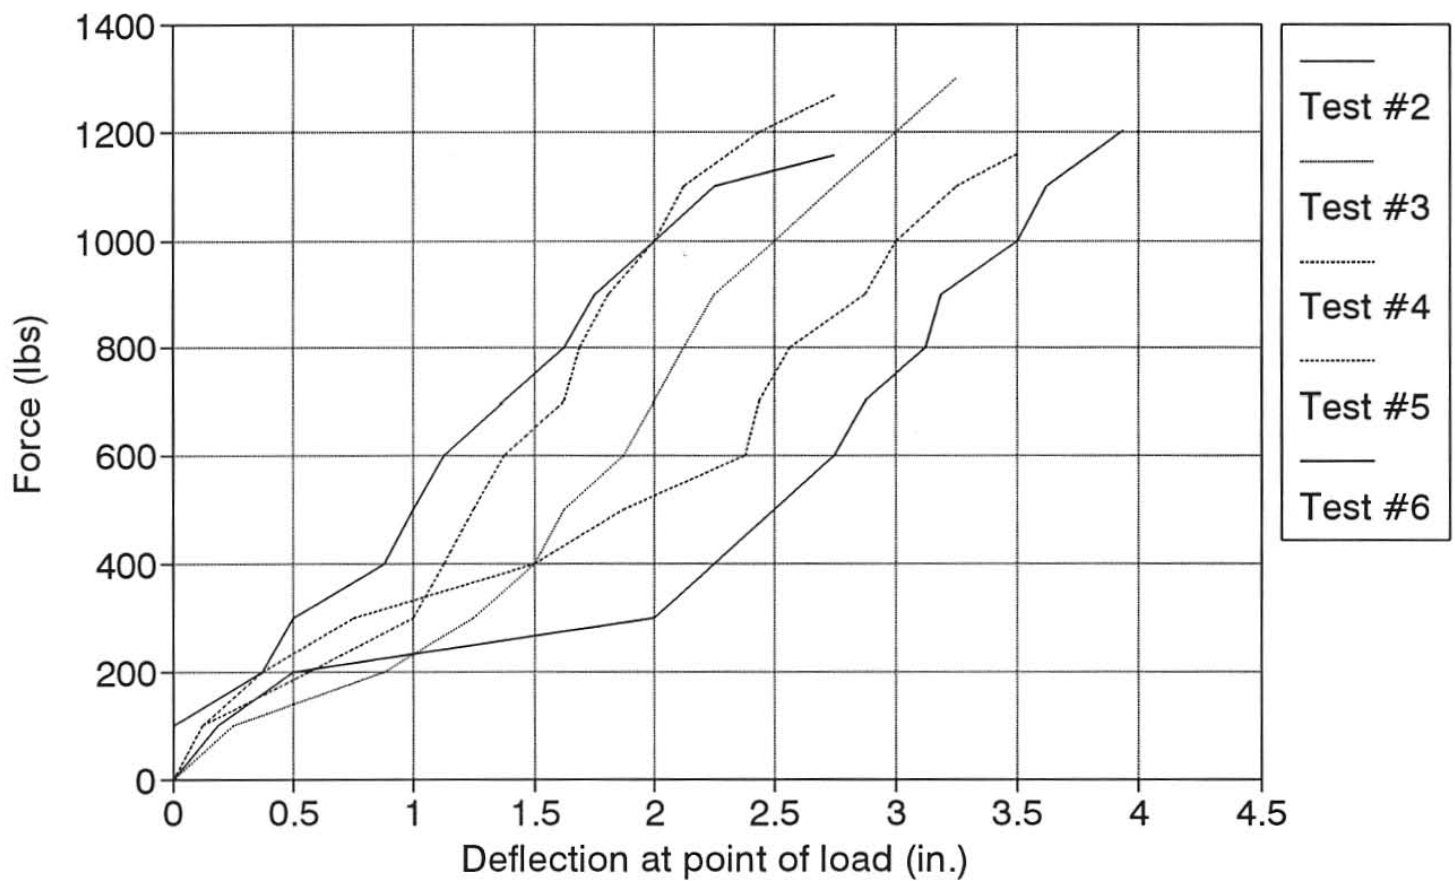
FIGURE C-1. Results of Static Bend Tests

In order to better understand the operation of the mechanical hinge, a series of static bend tests was conducted to obtain a set of force vs. deflection curves. In these tests the post was secured below the fuse plate and a load was applied 69 inches above the hinge. The load vs. deflection curves for these tests are presented Figure C-1.
