**Safety Performance Evaluation of a
Nested W-Beam with Half-Post Spacing
Over a Low-Fill Culvert**

Transportation Research Report No. TRP-03-36-92

March 1993

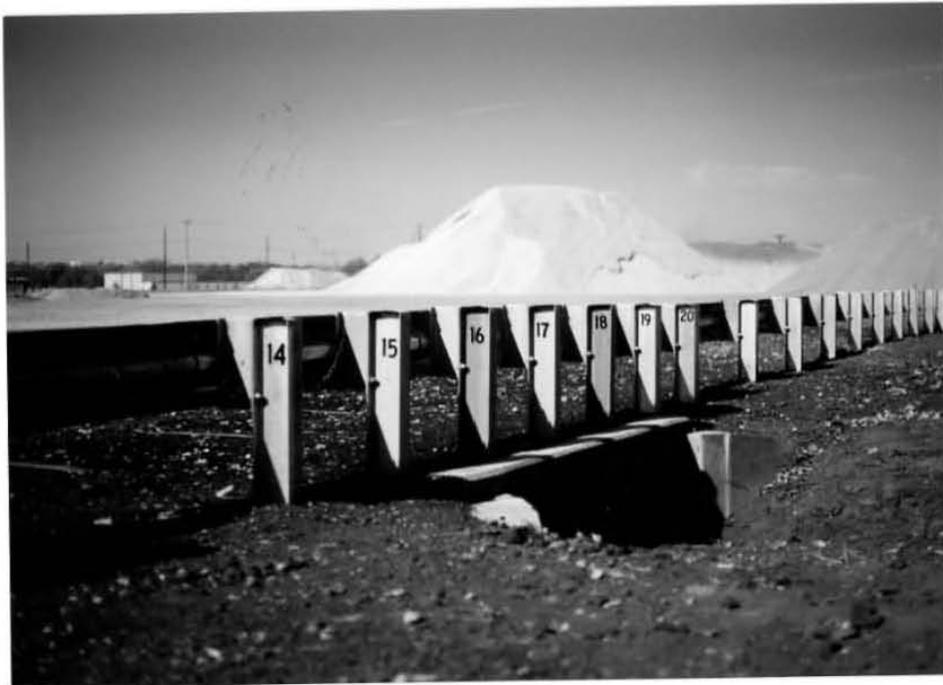
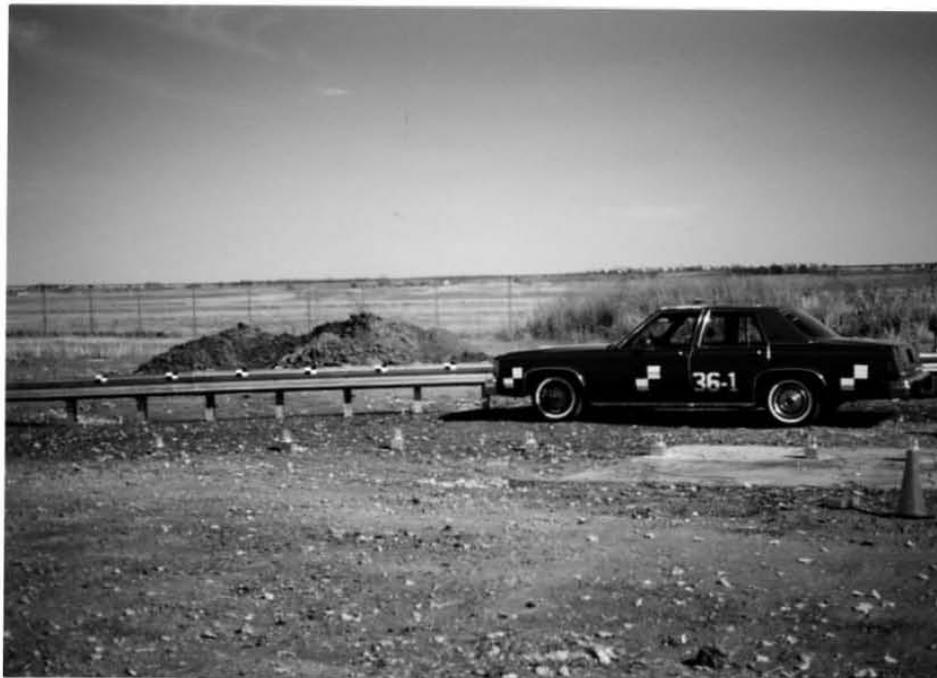
FIGURE 1. Photographs of the nested W-beam with half-post spacing over a low-fill culvert

Photographs of the test installation are shown in Figure 1, with design details shown in Figure 2. The test installation consisted of 12-gauge W-beam guardrail spanning a 10-ft wide concrete box culvert. The top of the box culvert was located 9 in. below grade. The strength of the concrete in the box culvert was tested to be 5130 psi at the time of the safety evaluation. The W6×9 steel posts were spaced at 6 ft 3 in. on center except over and adjacent to the low fill culvert where the spacing was reduced to 3 ft 1½ in. The shortened posts located over the culvert were bolted to the top slab of the culvert as shown in Figure 2. The posts over the culvert were installed adjacent to the concrete headwall on the end of the box culvert. The remainder of the posts were installed by augering holes and backfilling while tamping around the post. An 18 ft 6 in. length of nested guardrail was centered over the culvert. Both ends of the 169 ft long installation were anchored with a standard Breakaway Cable Terminal (BCT).

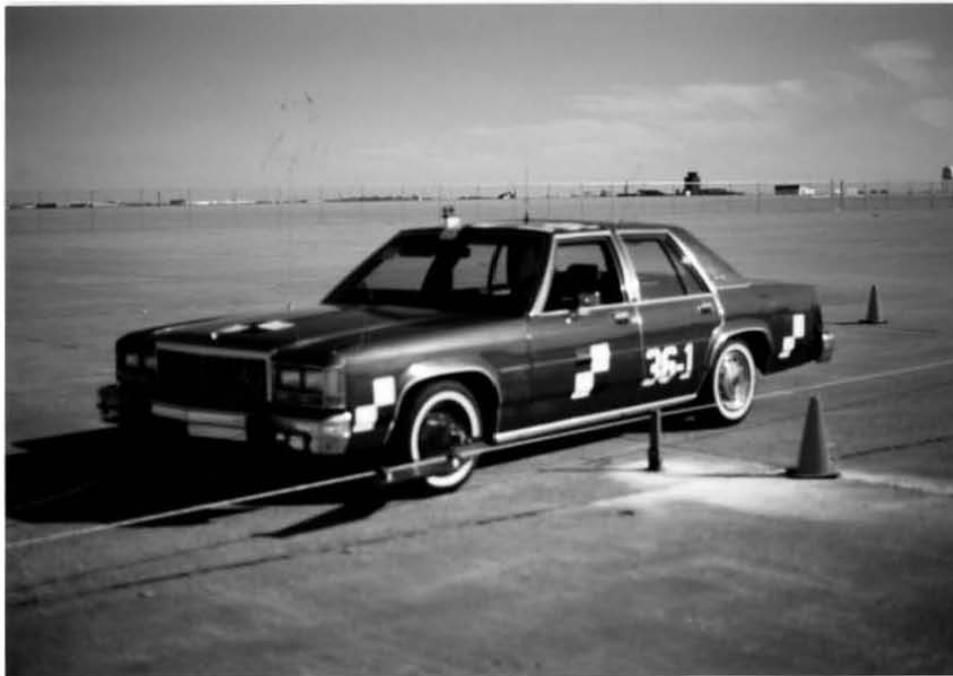
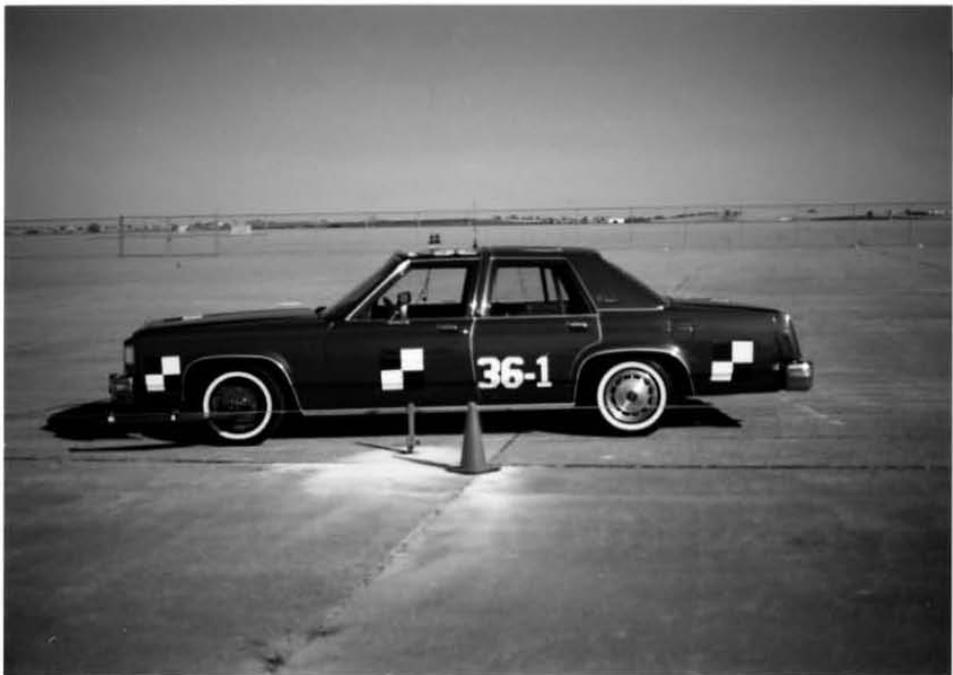
FIGURE 3. Test Vehicle

A 4500-lb 1985 Ford LTD, shown in Figure 3, was used as the test vehicle. Dimensions and axle weights of the test vehicle are shown in Figure 4. Black and white-checked targets were placed on the vehicle for high-speed film analysis. Two targets were located on the center of gravity, one on the top and one on the driver's side of the test vehicle. Additional targets were located for reference so that they could be viewed from all cameras. The front wheels were located for reference so that they could be viewed from all cameras. The front wheels of the test vehicle were aligned for camber, caster, and toe-in values of zero to ensure proper tracking of the vehicle along the guide cable. Two 5B flash bulbs, fired by a pressure tape switch on the front bumper, were mounted on the roof of the vehicle to establish the time of impact on the high-speed film.

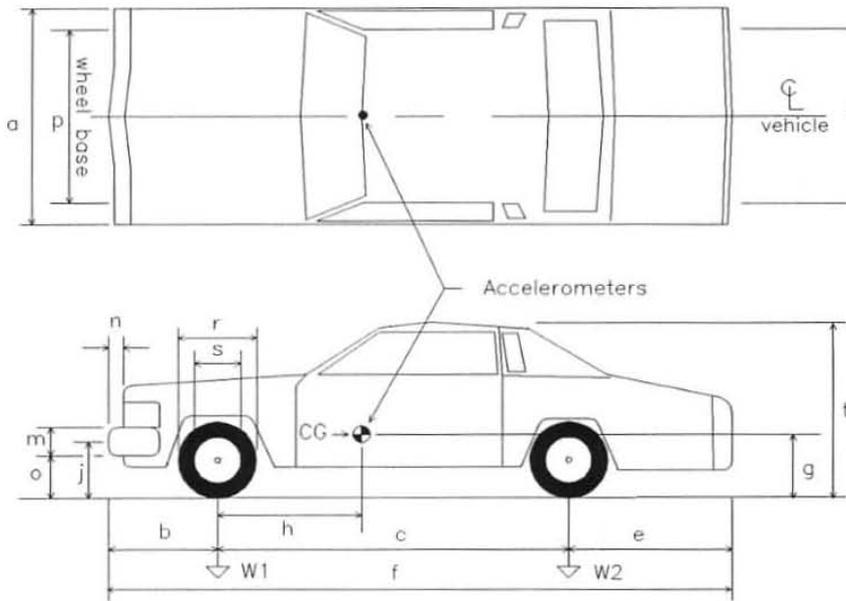
FIGURE 4. Test Vehicle Data Sheet

Damage prior to test: None

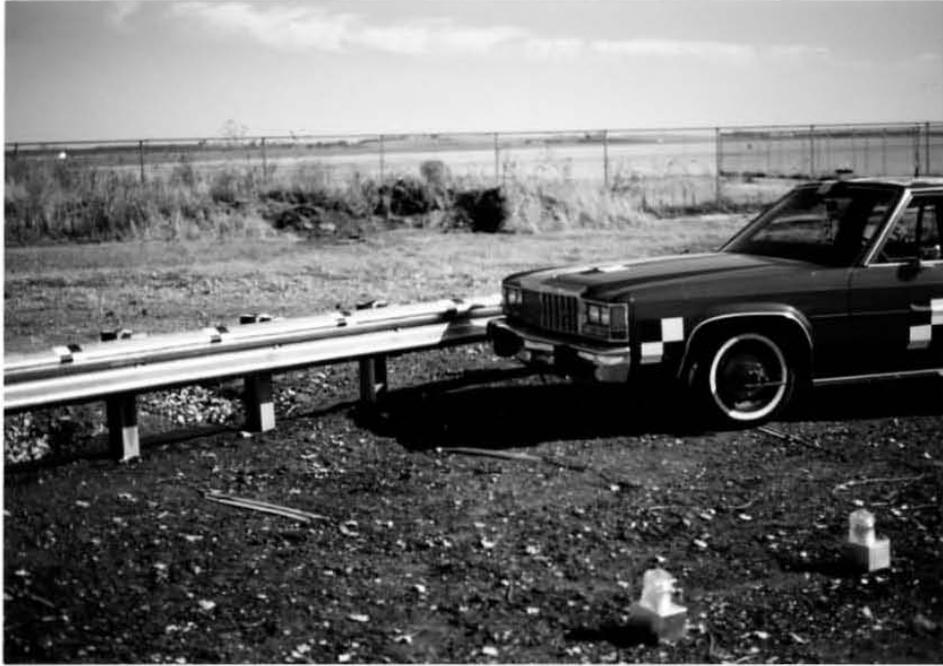
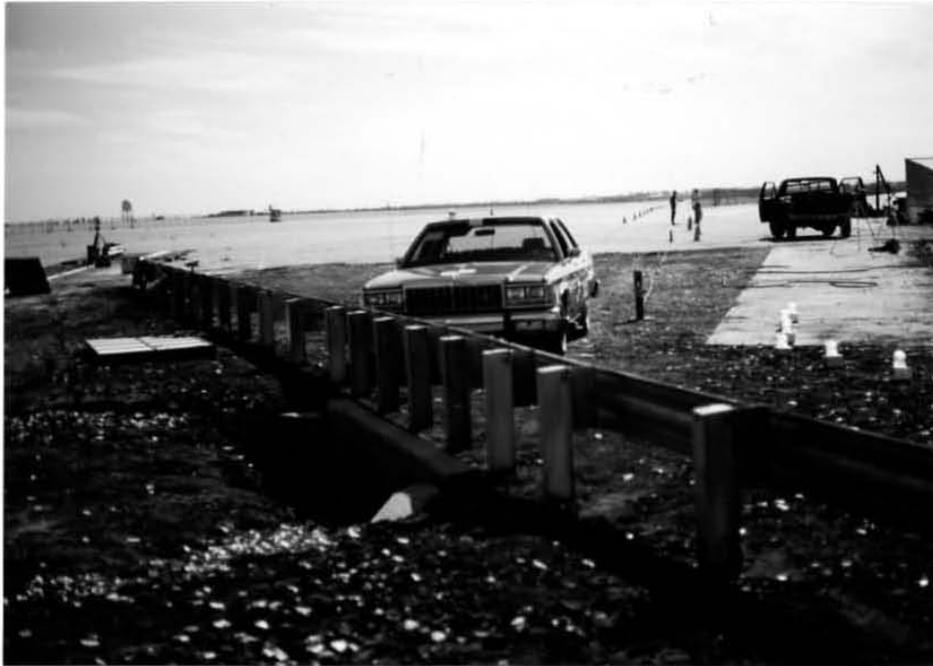
FIGURE 6. Vehicle Impact Location

The 1985 Ford LTD was directed into the W-beam guardrail system using a reverse tow and cable guidance system (3). The vehicle was released from the tow cable and guidance system and was free wheeling at impact. The speed and angle of the vehicle at impact were 61.0 mph and 28.2 degrees, respectively. The impact point, shown in Figure 6, was located 10 ft 9½ in. upstream from the center of the culvert. A summary of the test and sequential photographs are shown in Figure 7. Additional sequential photographs are shown in Figures 8 and 9.

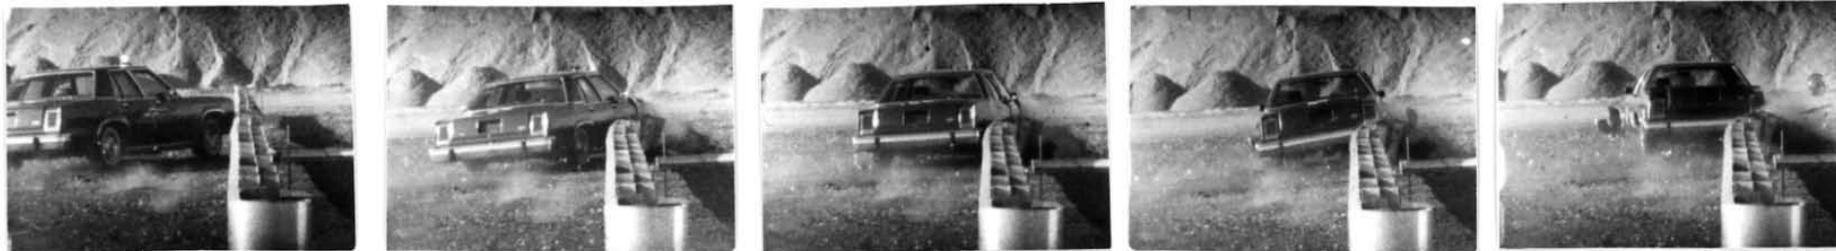
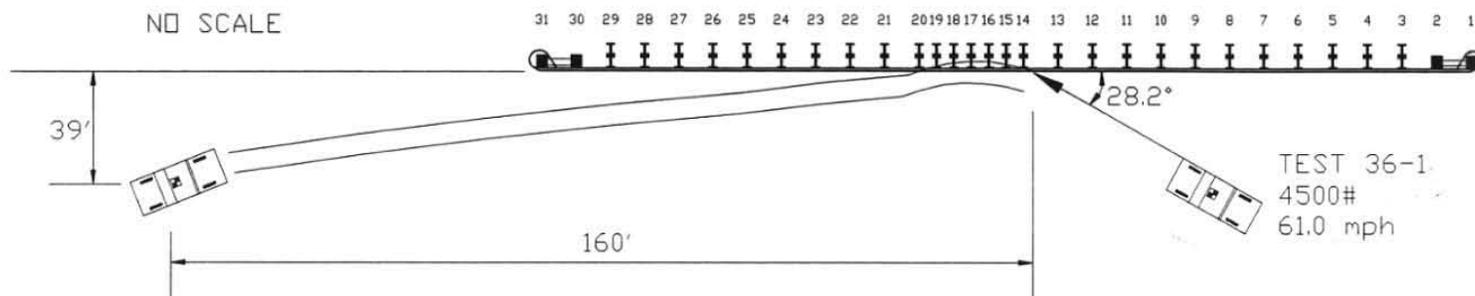
FIGURE 7. Test 36-1 Summary

Upon impact with the W-beam guardrail, the right front corner of the vehicle began to crush inward as the rail deflected. The right-front wheel then contacted Post No. 16 and was separated from the vehicle. The detached wheel then went under the rail and came to rest under the culvert. As the vehicle progressed along the rail, the first two posts bolted to the culvert (Post Nos. 16 and 17) were separated from the rail and bent over as shown in Figure 10. The test vehicle became parallel to the guardrail 202 ms after impact with a speed of 35.6 mph.

The vehicle exited the rail at an angle and speed of 7.7 degrees and 30.6 mph, respectively, 350 ms after impact. After exiting the rail the vehicle continued to travel downstream and to the left, coming to rest 160 ft downstream from impact and 39 ft to the left of a line parallel to the railing face. This vehicle trajectory is shown in Figures 7 and 10.

Impact Speed 61.0 mph
 Impact Angle 28.2 deg
 Exit Speed 30.6 mph
 Exit Angle 7.7 deg
 Vehicle Change in Speed 30.4 mph
 Normalized Occupant Impact Velocity
 Longitudinal 27.9 fps
 Lateral 13.5 fps
 Occupant Ridedown Deceleration
 Longitudinal 11.3 g's
 Lateral 18.7 g's
 Vehicle Damage
 TAD 1-RFQ-5, 1-RD-6
 VDI 01RDES2
 Maximum Permanent Set Deflection . . . 18 ⅝ in. @ Post No. 16

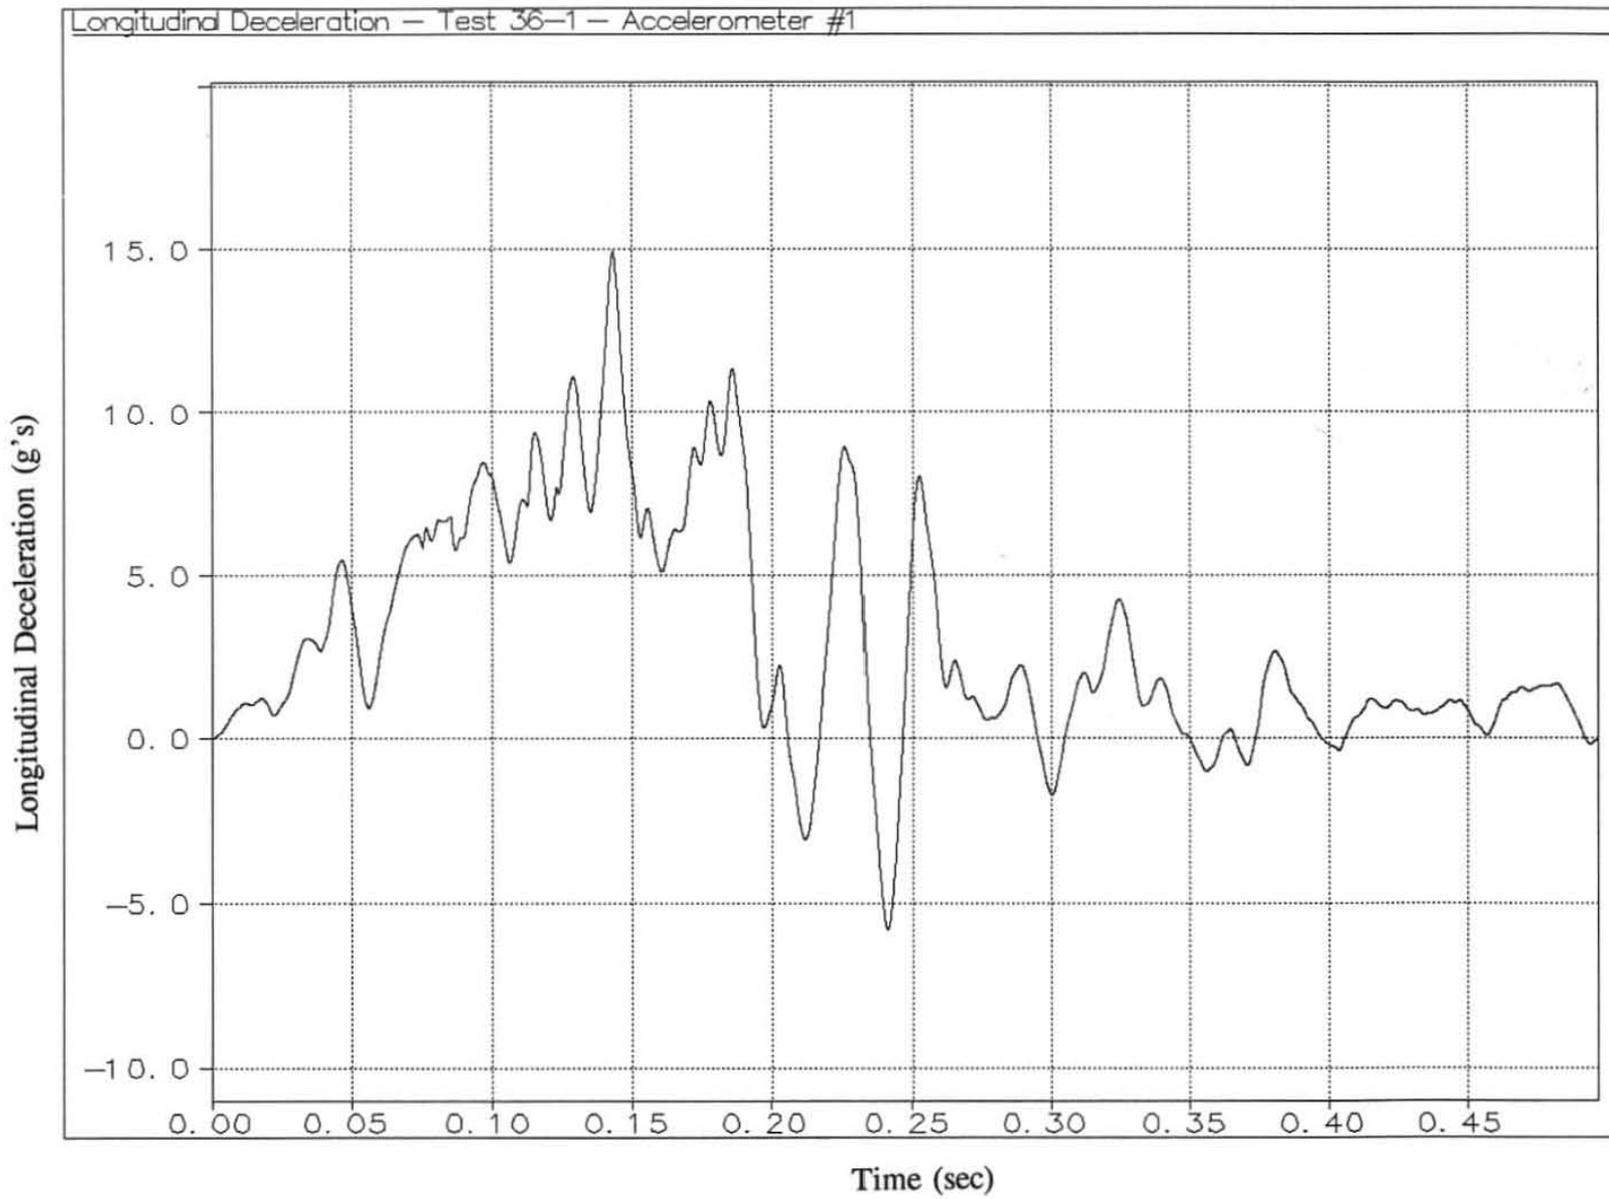
Figure A-1. Graph of Longitudinal Deceleration, Test 36-1

The test vehicle damage, shown in Figure 13, was extensive along the entire passenger side. The normalized longitudinal and lateral occupant impact velocities as determined from accelerometer data were 27.9 fps and 13.5 fps, respectively. The highest 10-ms average occupant ridedown decelerations were 11.3 g's (longitudinal) and 18.7 g's (lateral). The vehicle change in speed of 30.4 mph was greater than the value of 15 mph required by NCHRP 230 (2). However, many systems which have been approved for use by FHWA have been unable to pass this criteria (5,6), and the update to NCHRP Report 230 (4) does not contain this requirement. Accelerometer traces from this test are shown in Appendix A.
