Safety Performance Evaluation of the George Washington Memorial Parkway Bridge Rail

Transportation Research Report TRP-03-45-94

June, 1995

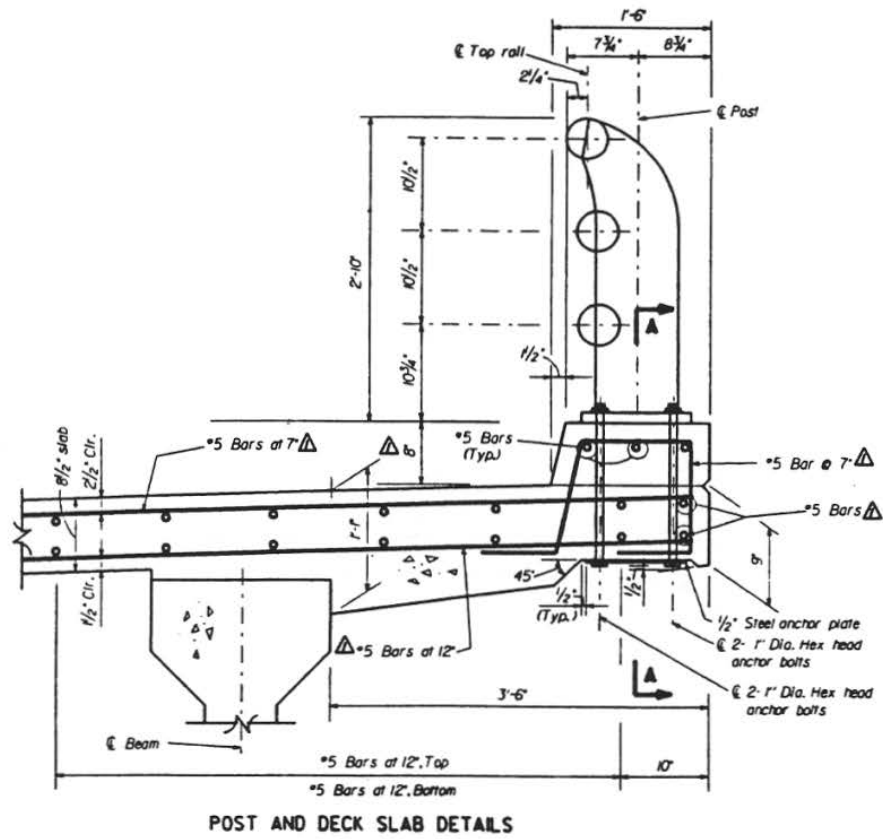
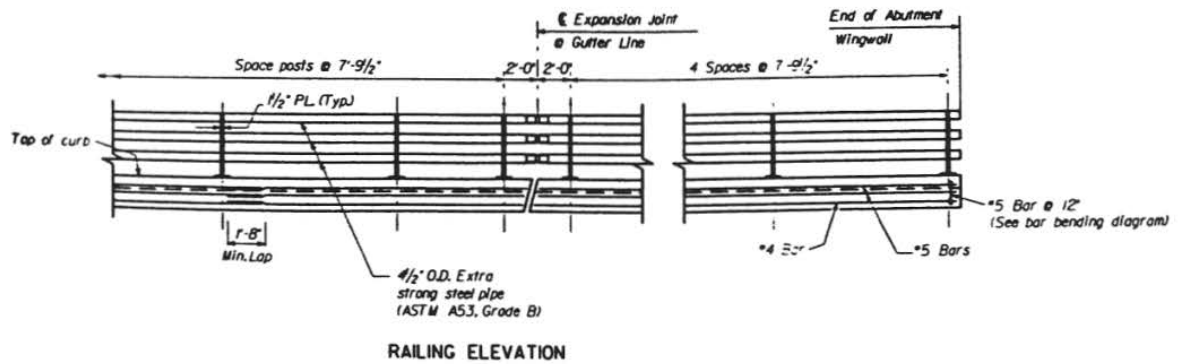
Figure 3. Design Details of the GWMPBR for Test GWMP-1.

As is evident in the vehicle damage shown in Figures 17 and 18, there was significant occupant compartment damage in the test vehicle. This damage was caused by the snagging of the vehicle on the system posts and, along with the excessive lateral ridedown decelerations, caused the system to fail this compliance test. In order to alleviate this snagging problem, the rail size was increased from 4.5 in. O.D. to 5.0 in. O.D. (114 mm to 127 mm), and it was moved further out from the post. The details of this change can be seen in Figures 3 and 4.

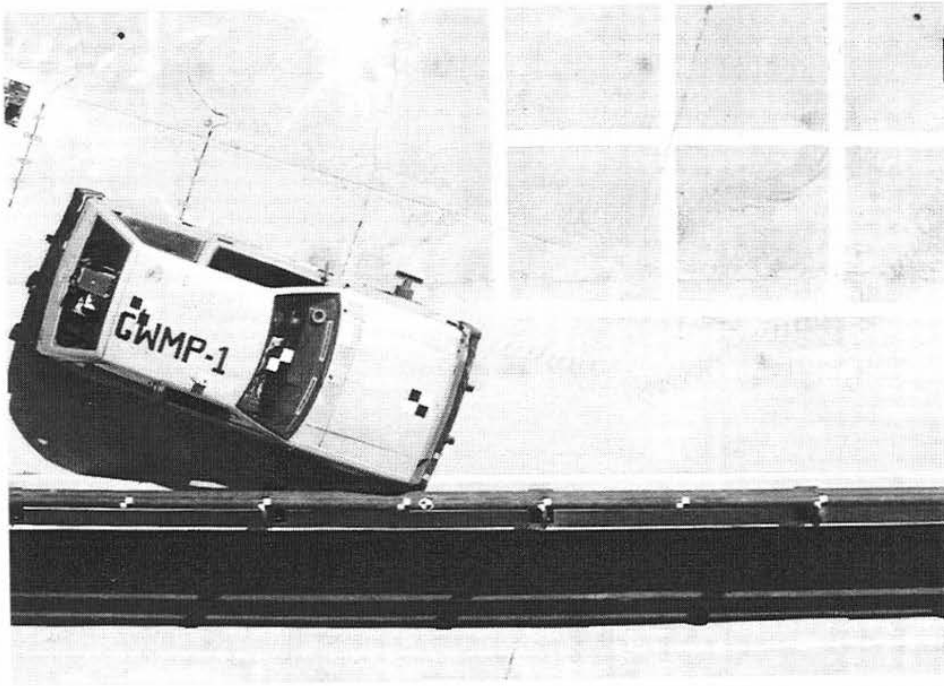
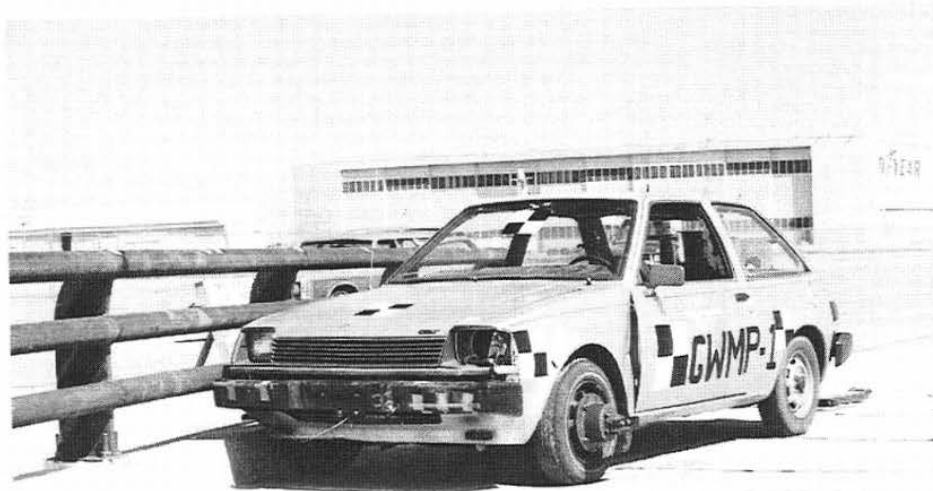
Figure 13. Impact Location, Test GWMP-1.

The 1984 Dodge Colt was directed into the George Washington Memorial Parkway Bridge Rail using a reverse tow and cable guidance system (5). The vehicle was released from the tow cable and guidance system and was free wheeling at impact. The speed of the vehicle at impact was 54.4 mph (87.5 km/h) and the angle of impact was 21.0 degrees. As shown in Figure 13, the impact point was located midway between the 3rd and 4th posts from the upstream end of the installation. A summary of the test results and sequential photographs are shown in Figure 14. Additional sequential photographs are shown in Figure 15.

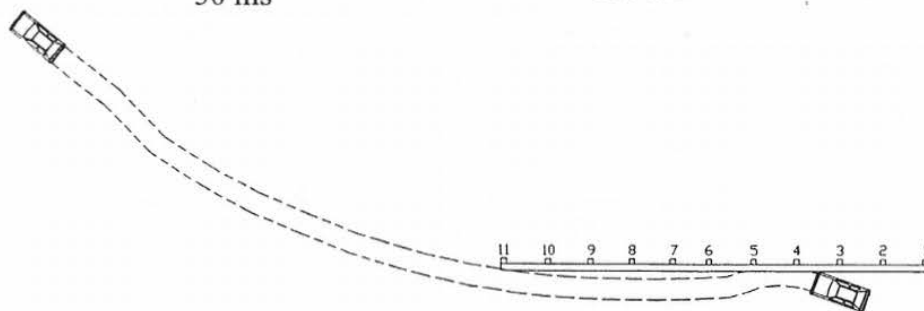
Figure 14. Summary of Test GWMP-1.

As a result of technical problems, the accelerometer data was not acquired for this test. It was therefore necessary to analyze the high-speed film to determine the values of the occupant risk criteria. The longitudinal and lateral occupant impact velocities as determined from this high speed film analysis were 24.6 and 8.2 fps, respectively. The maximum occupant ridedown decelerations were 12.0 g's (longitudinal) and 22.4 g's (lateral). The results of this analysis are summarized in Figure 14 and Table 1.

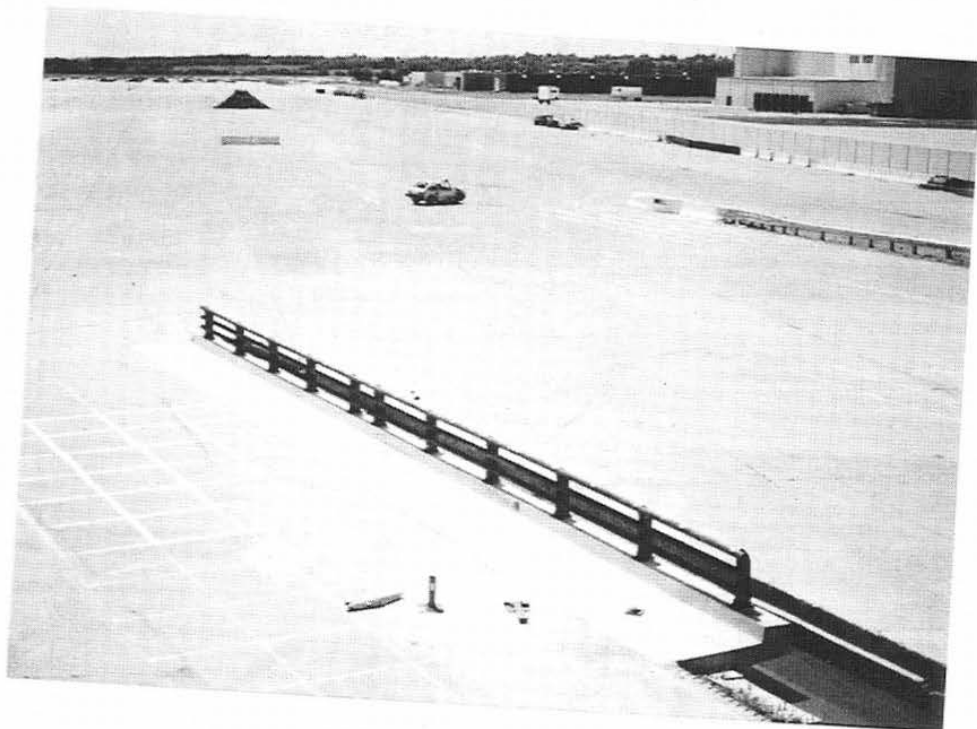
Figure 16. Vehicle Trajectory, Test GWMP-1.

Upon impact with the steel bridge rail, the right front quarter panel was crushed inward and the bumper was pulled to the right and pushed back causing the front end of the vehicle to bend toward the right side of its longitudinal centerline. 42 ms after impact the bumper began to contact post number 4 and was crushed into the front right tire. With the bumper pushing the tire into the firewall, the vehicle began to buckle at the door post. This caused the windshield frame and roof to buckle. At 116 ms the car lost contact with post number 4 and continued down the rail with no further snagging. There was no rolling motion detected throughout the collision, and the vehicle was redirected, coming to rest 170 ft. (51.8 m) downstream and 90 ft. (27.4 m) behind a line parallel to the rail face, as shown in Figure 16.

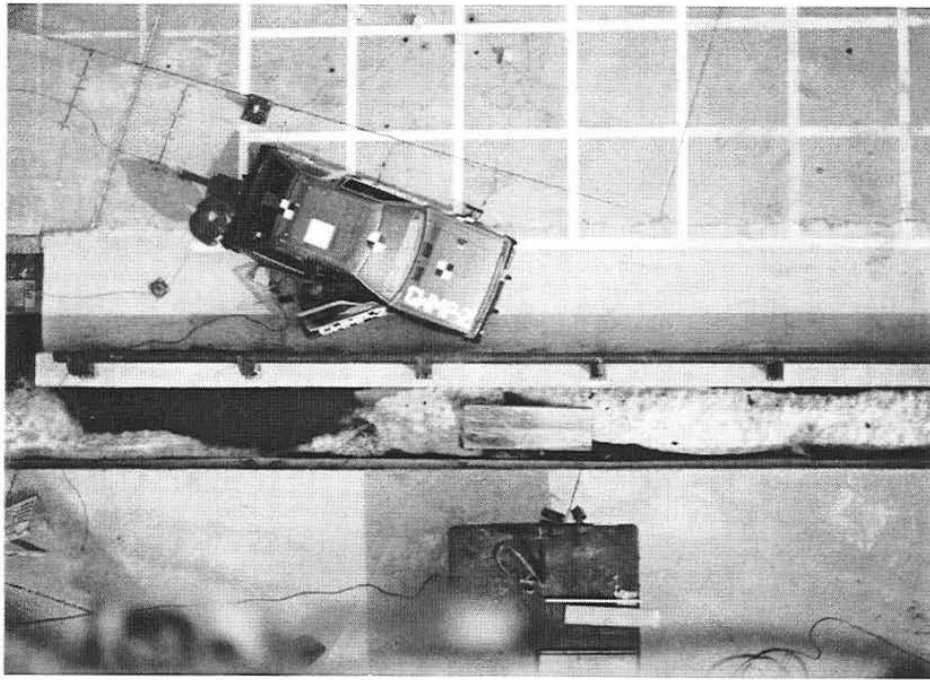
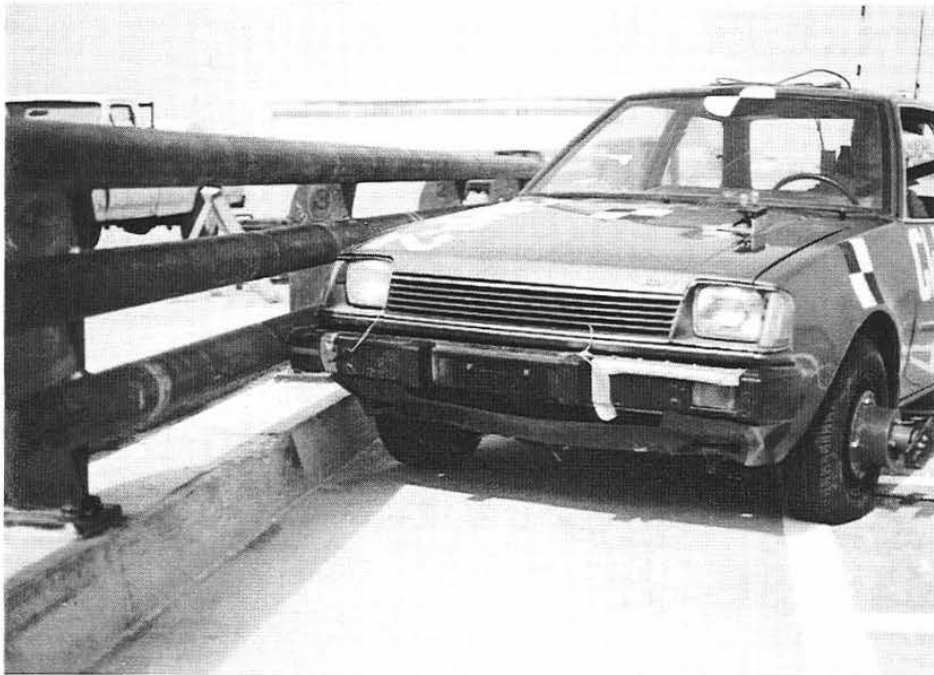
Figure 21. Impact Location, Test GWMP-2.

The 1984 Dodge Colt was directed into the George Washington Memorial Parkway Bridge Rail using a reverse tow and cable guidance system (5). The vehicle was released from the tow cable and guidance system and was free wheeling at impact. The speed of the vehicle at impact was 52.6 mph (84.65 km/h) and the angle of impact was 22.6 degrees. The impact point was located midway between the 3rd and 4th posts from the upstream end of the installation as shown in Figure 21. A summary of the test results and sequential photographs is shown in Figure 22.

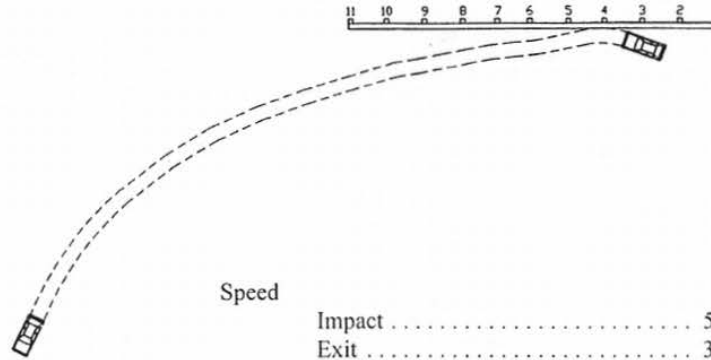
Figure 22. Summary of Test GWMP-2.

The longitudinal and lateral occupant impact velocities were 17.0 fps and 25.7 fps, respectively. The maximum occupant ridedown decelerations were 5.2 g's (longitudinal), and 9.6 g's (lateral). The results of this analysis are summarized in Figure 22 and Table 1. As can be seen, the only criteria which wasn't met in this test was the one which required that the vehicle move no more than 20 ft. (6.1 m) from the line of the traffic face of the railing. However, it was judged that failure of this criteria alone did not warrant failure of the entire test.

It was therefore determined that the overall performance of this test was acceptable according to the AASHTO (3) PL-1 guidelines.

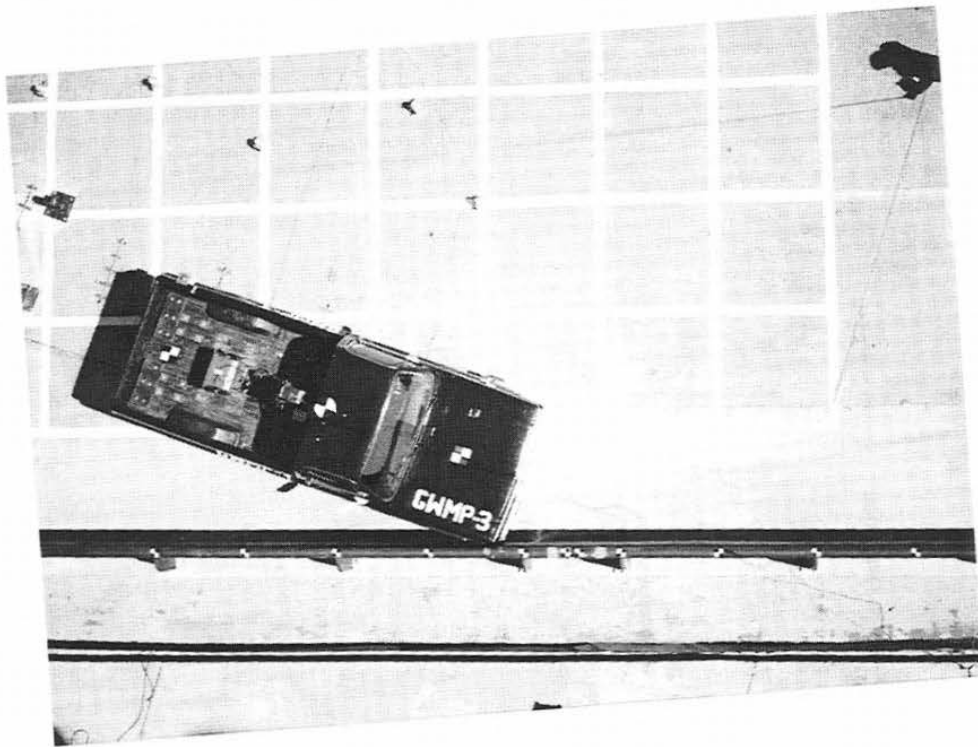
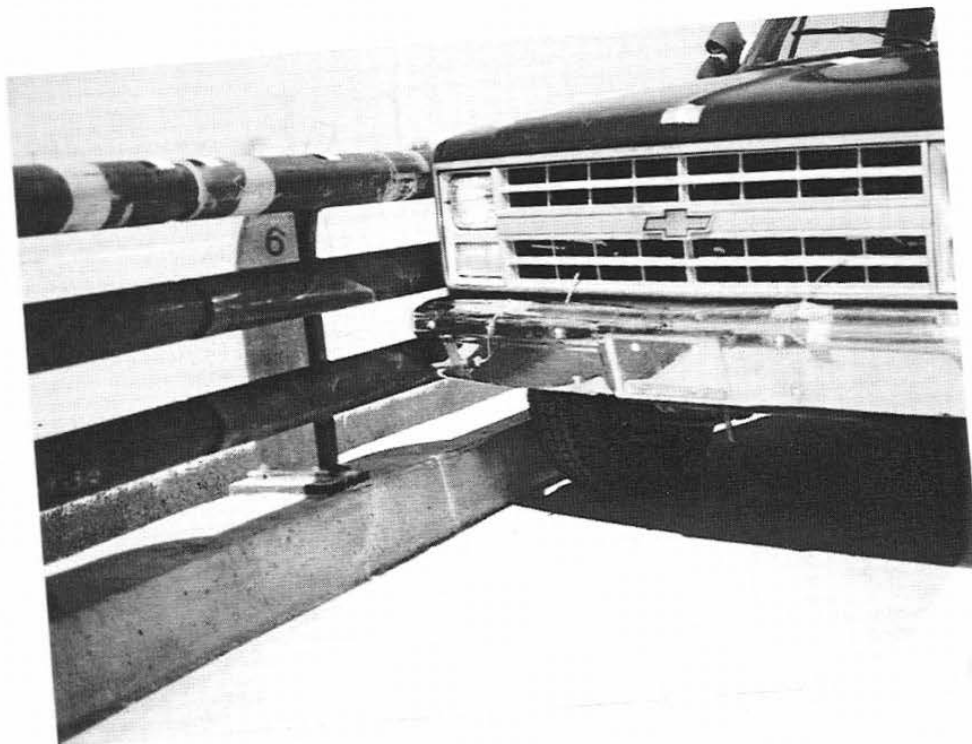
Figure 28. Impact Location, Test GWMP-3.

The 1985 Chevrolet 3/4 ton pickup was directed into the George Washington Memorial Parkway Bridge Rail using a reverse tow and cable guidance system (5). The vehicle was released from the tow cable and guidance system and was free wheeling at impact. The speed of the vehicle at impact was 46.6 mph (75.0 km/h) and the angle of impact was 22.7 degrees. The impact point was located 3 ft. - 3.5 in. (1.0 m) upstream of the expansion joint, just before post 6 from the upstream end of the installation as shown in Figure 28. A summary of the test results and sequential photographs is shown in Figure 29.

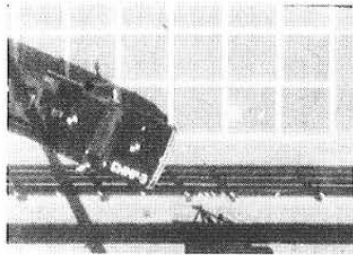
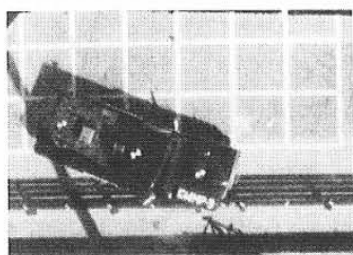
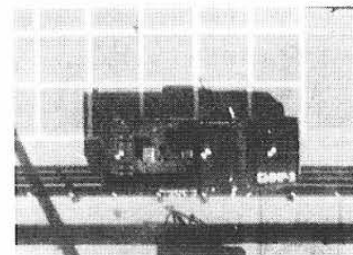
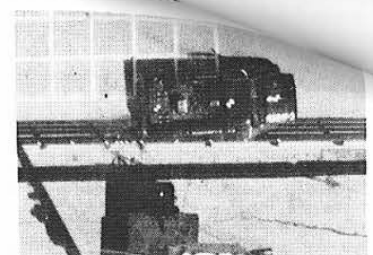
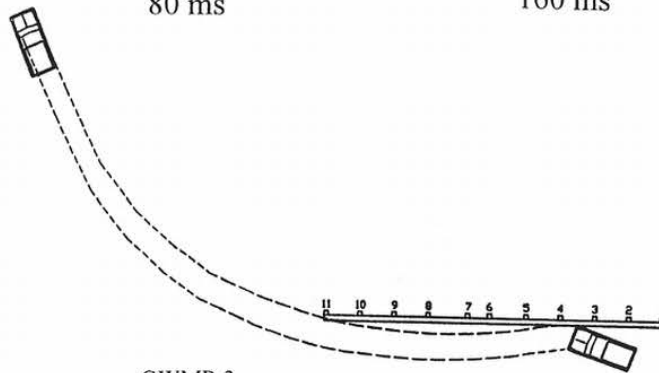
Figure 29. Summary of Test GWMP-3.

The longitudinal and lateral occupant impact velocities as determined from accelerometer data analysis were 9.6 fps (2.93 m/s) and 21.3 fps (6.49 m/s), respectively. The maximum occupant ridedown decelerations were 2.0 g's (longitudinal), and 8.0 g's (lateral). The results of this analysis are summarized in Figure 29 and Table 1.

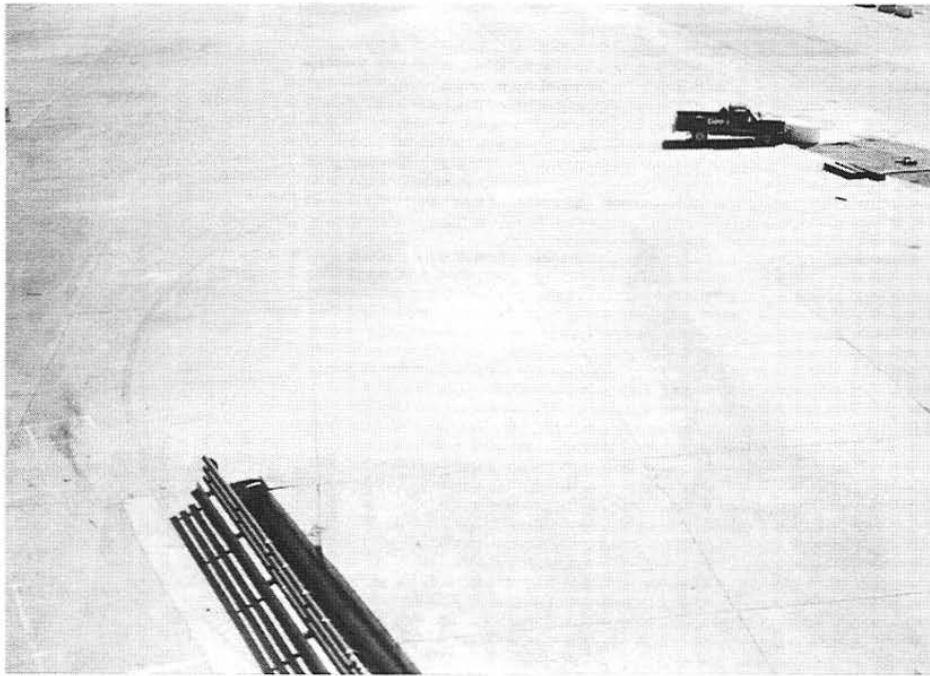
Figure 30. Vehicle Trajectory, Test GWMP-3.

The vehicle was smoothly redirected by the bridge railing, with a relatively small amount of damage to the vehicle. At 140 ms, tail slap occurred between the passenger side rear quarter panel of the vehicle and the rail. The tail slap caused cracking of the curb and deck at post 6. There was no snagging of the vehicle. There was a maximum permanent set deflection of 0.125 in. (0.32 cm) in the bridge rail. The vehicle came to rest 135 ft. (41.1 m) downstream and 110 ft. (33.5 m) to the back side of a line parallel with the front face of the bridge rail, as can be seen in Figure 30.

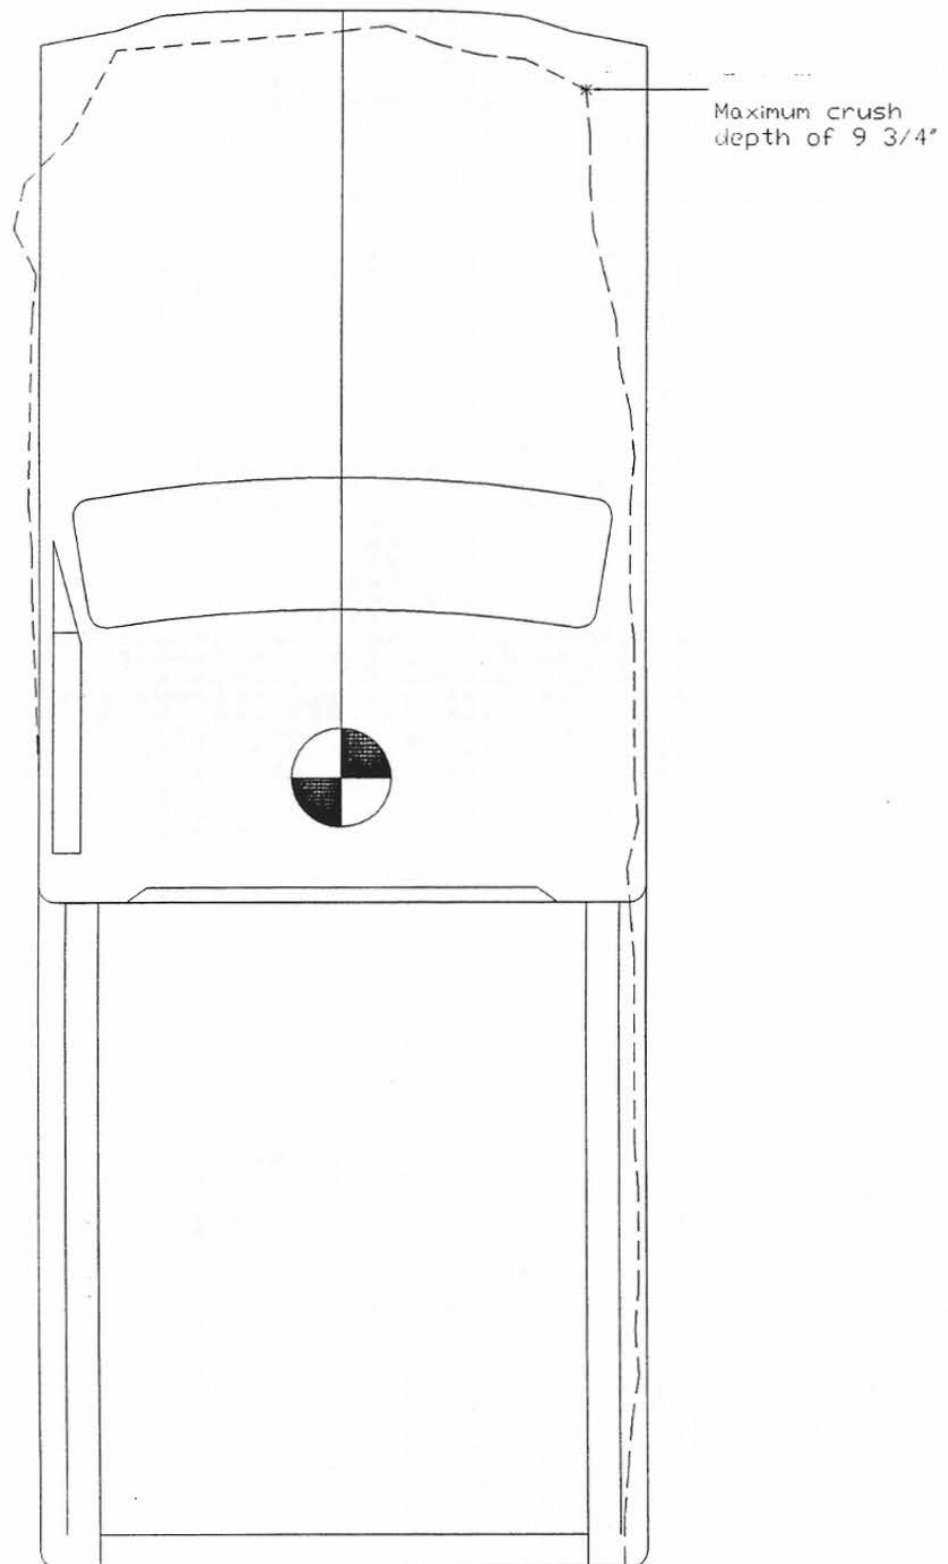
Figure 32. Vehicle Crush Measurements, Test GWMP-3.

The vehicle damage, shown in Figure 31, included the crushing of the right front corner of the vehicle, and scrapes and dents along the length of the passenger side. The right front tire was blown out and the rim was deformed. The maximum crush deformation of 9.75 in. (24.8 cm) is shown in Figure 32. All damage to the vehicle on the drivers side of the longitudinal centerline occurred after impact with the bridge rail. During the vehicle's run out, it struck an obstacle on the testing grounds, which resulted in damage to the left front corner of the vehicle..
