# **CRASH TESTING OF MICHIGAN'S TYPE B (W-BEAM) GUARDRAIL SYSTEM**

### **Michigan Department of Transportation**

MwRSF Research Report No. TRP-03-90-99

November 10, 1999

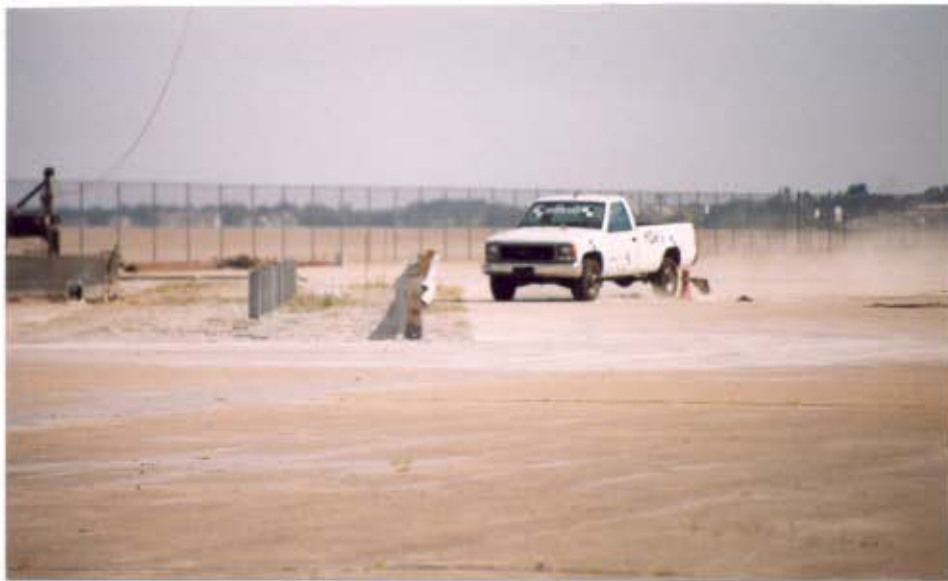
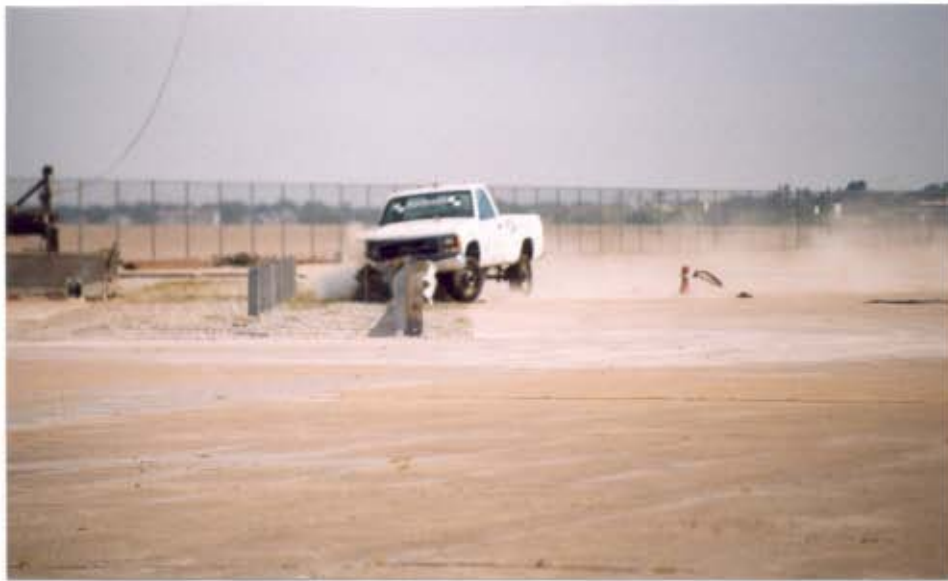
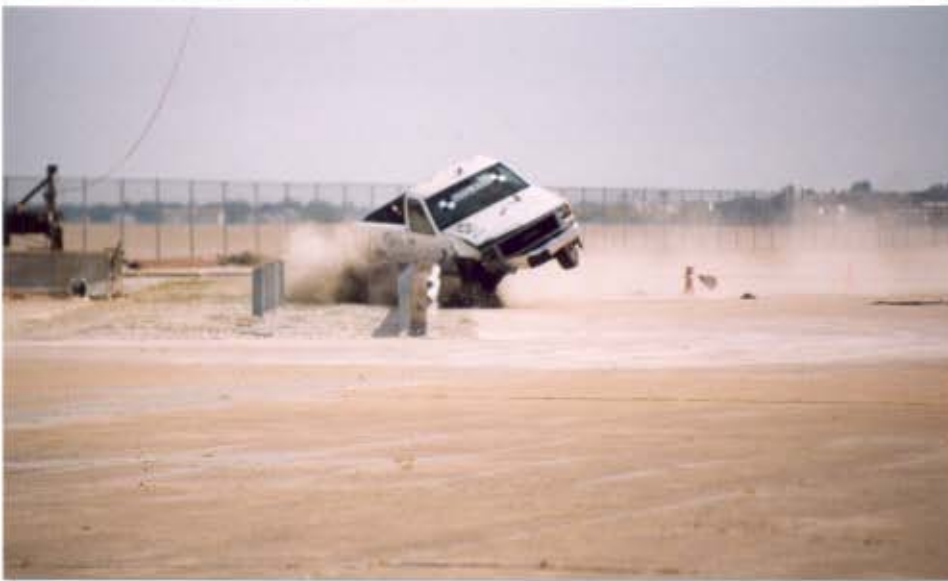
Figure 12. Documentary Photographs, Test MIW-1

The 2,007-kg pickup truck impacted the W-beam guardrail system at a speed of 99.8 km/hr and an angle of 25.8 degrees. A summary of the test results and the sequential photographs are shown in Figure 9. Additional sequential photographs are shown in Figures 10 through 11. Documentary photographs of the crash test are shown in Figures 12 through 14.

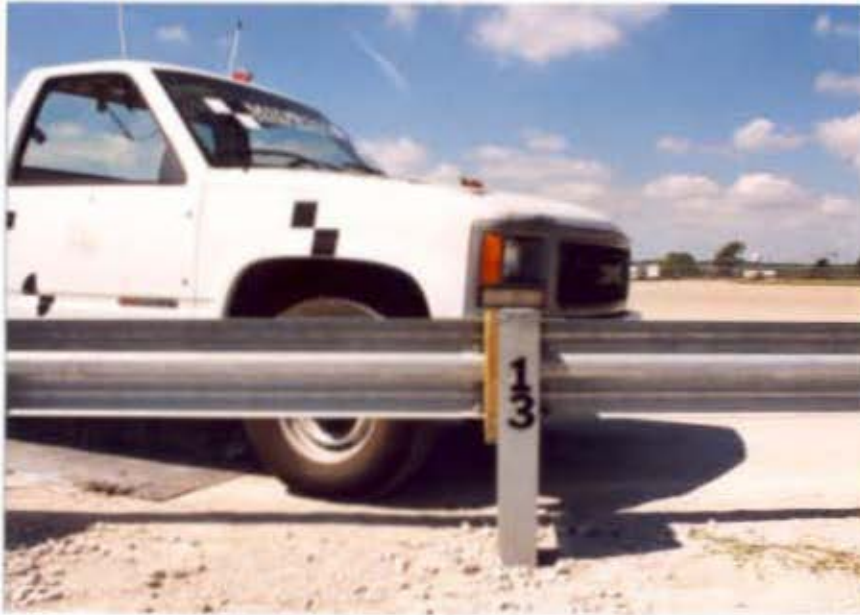
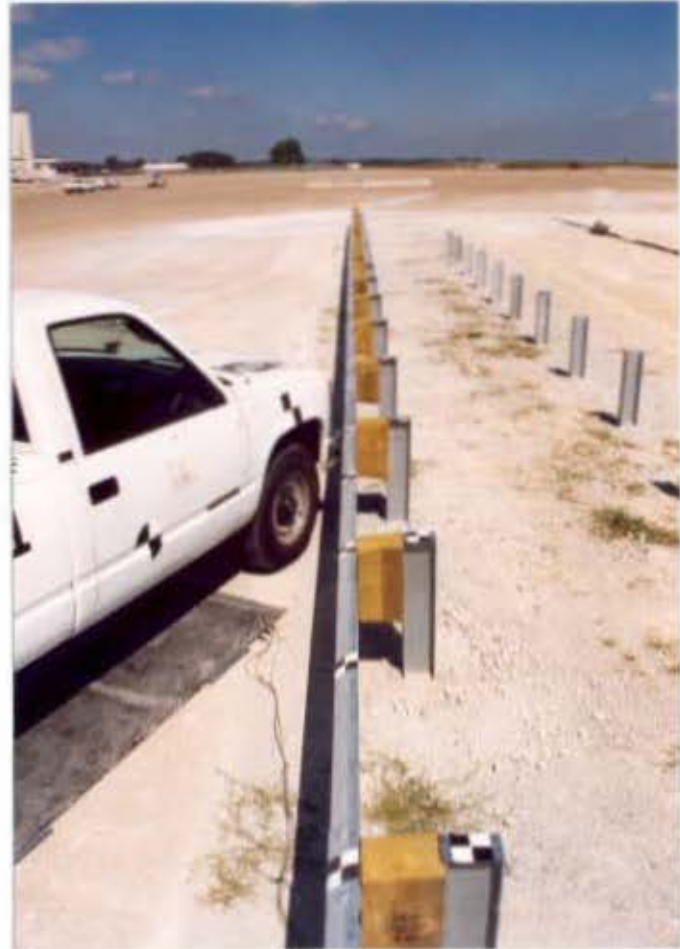
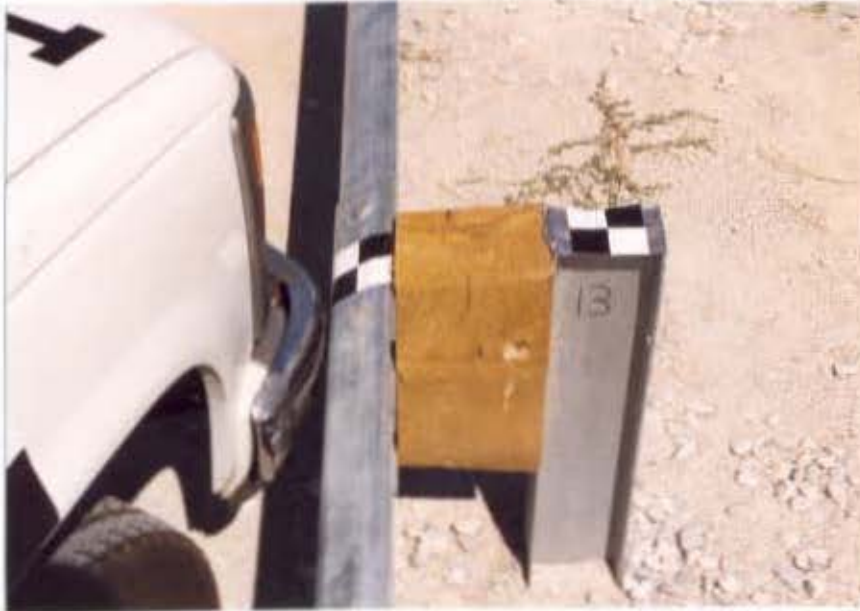
Figure 15. Impact Location, Test MIW-1

Initial impact occurred at the center of post no. 13, as shown in Figure 15. Upon impact with the guardrail, post no. 13 rotated backward. At 0.032 sec after impact, the right-front corner of the vehicle, which was at the midspan between post nos. 13 and 14, crushed inward except for the engine hood which protruded over the top of the guardrail. By this time, post no. 13 had moved backward and post no. 14 was twisted but without translating backward. At 0.057 sec, the right-front tire collapsed under the guardrail. At 0.060 sec, post nos. 13 and 14 had rotated backward about the same distance. At 0.072 sec, the right-front corner of the vehicle was at post no. 14, which continued to rotate backward. At this same time, post no. 15 began to show movement. At 0.123 sec, there was very little, if any, vehicle redirection with the right-front corner slightly past the midspan of post no. 14 and 15. During this same moment, a majority of the right-front fender was protruding over the guardrail. At 0.153 sec, the right-front corner of the vehicle was at post no. 15, and the test vehicle, with the right-side door frame cracked open, began to redirect. At this same time, post nos. 14 and 15 had rotated backward about the same distance, and post no. 16 continued to rotate. At 0.207 sec, the vehicle's right-front corner was positioned at the midspan between post nos. 15 and 16. In addition, the left-front tire was airborne with the rear-end yawed counter-clockwise (CCW)
