**FULL-SCALE 18,000 LB. VEHICLE CRASH TEST
ON THE
IOWA RETROFIT CONCRETE
BARRIER RAIL**

TRANSPORTATION RESEARCH REPORT TRP-03-19-90

January, 1990

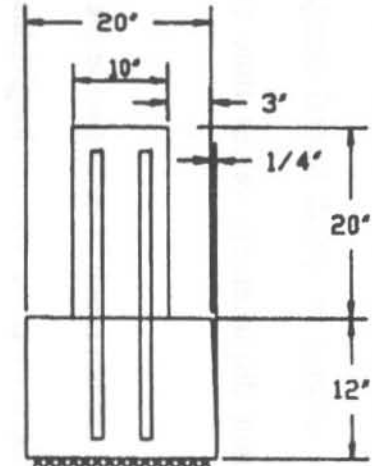
Figure 19. Test I4-1 summary and sequential photos.

Test No. I4-1
 Date. 8/23/89
 Installation Retrofit Concrete
 Barrier Rail
 Drawing No. BRF-0005(2)-38-00
 Length (ft) 100
Concrete Barrier
 Material Nebraska Class
 '47-B-PHE' Mix
 Member Rectangular Concrete
 Wall-Section
 Length 86
Dimensions
 Width (in) 10
 Height (in) 20
 Member Existing Concrete
 Curb-Section
 Length (ft) 86
Dimensions
 Width (in) 20
 Height (in) 12
 Member Concrete Endwalls
 Length (ft) 7 (each end)
Dimensions
 Width (in) 20
 Height (in) 32

Vehicle
 Model. 1983 7000 Series GMC
 Weight.
 Test Inertia (lb) 17,814
 Gross Static (lb) 17,814
Vehicle Speed
 Impact (mph) 44.8
 Exit (mph) 40.7
Vehicle Angle
 Impact (deg) 15.6
 Exit (deg) 6.0
Vehicle Snagging none
Vehicle Stability satisfactory
Occupant Impact Velocity
 Longitudinal (fps) NA
 Lateral (fps) 4.75
Occupant Ridedown Decelerations
 Longitudinal (g's) NA
 Lateral (g's) +2.5
Vehicle Damage
 TAD 1-RFQ-3
 VDI 0IRFES2
Vehicle Rebound Dist (ft) 22.2 AT 130
Bridge Rail Damage Minor concrete spalling
