PHASE II DEVELOPMENT OF A NON- PROPRIETARY, FOUR-CABLE, HIGH TENSION MEDIAN BARRIER

MIDWEST ROADSIDE SAFETY FACILITY

MwRSF Research Report No. TRP-03-253-12

March 21, 2012

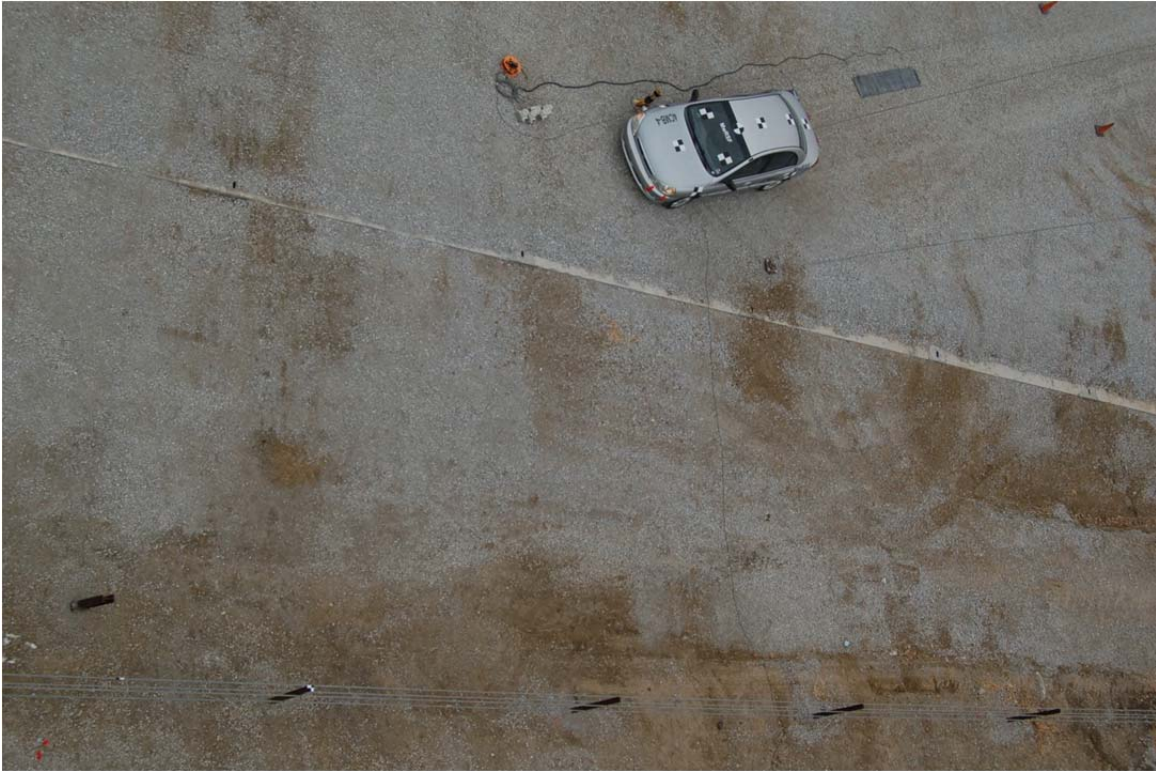
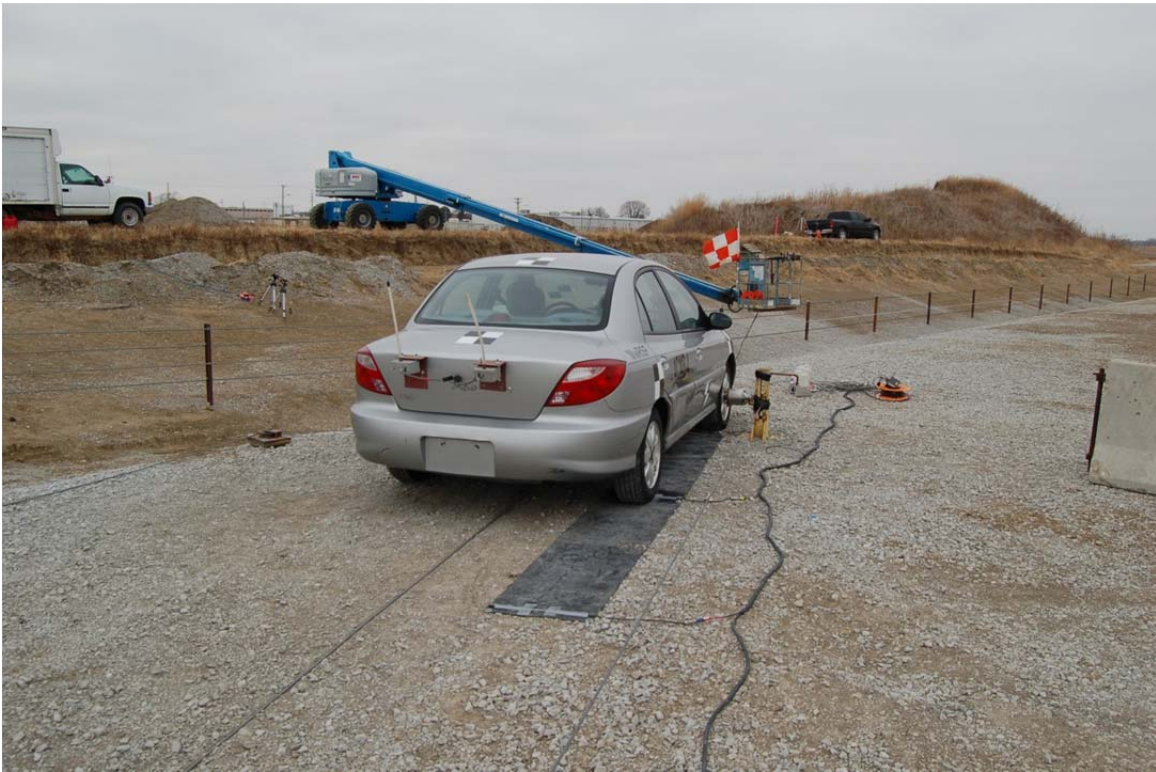
Figure 40. Impact Location, Test No. 4CMB-4

Initial vehicle impact was to occur 5 ft – 4 in. (1.6 m) downstream of post no. 16, as shown in Figure 40, which was selected using an analysis of the vehicle trajectory over the slope to maximize the potential for vehicle underride. The actual point of impact was 5 ft – 4in. (1.6 m) downstream of post no. 16. A sequential description of the impact events is contained in Table 5. The cables were numbered from 1 to 4, from the top to bottom, respectively. The vehicle came to rest parallel to the system captured in the cables 85 ft – 8 in. (26.1 m) downstream and 4 ft – 4 in. (1.3 m) to the left of the initial impact. The vehicle trajectory and final position are shown in Figures 36 and 41.

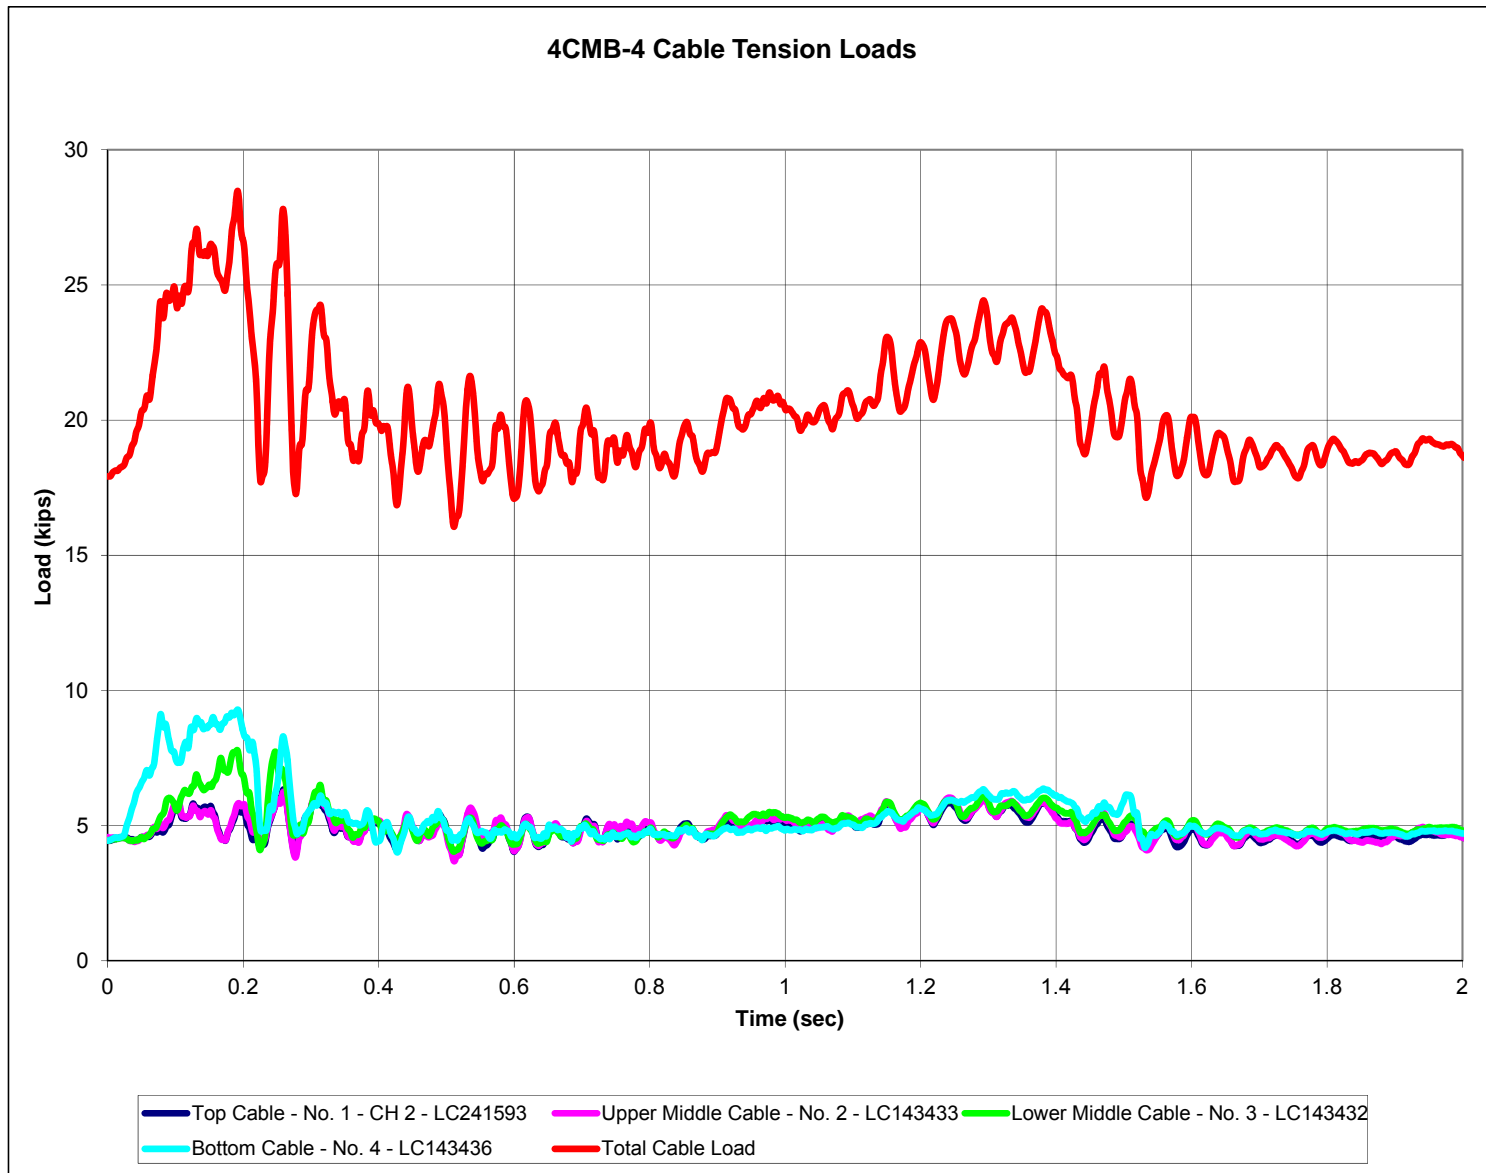
Figure 49. Cable Tension vs. Time, Test No. 4CMB-4

along with the total combined cable load imparted to the upstream end anchor, were determined and are shown graphically in Figure 49.

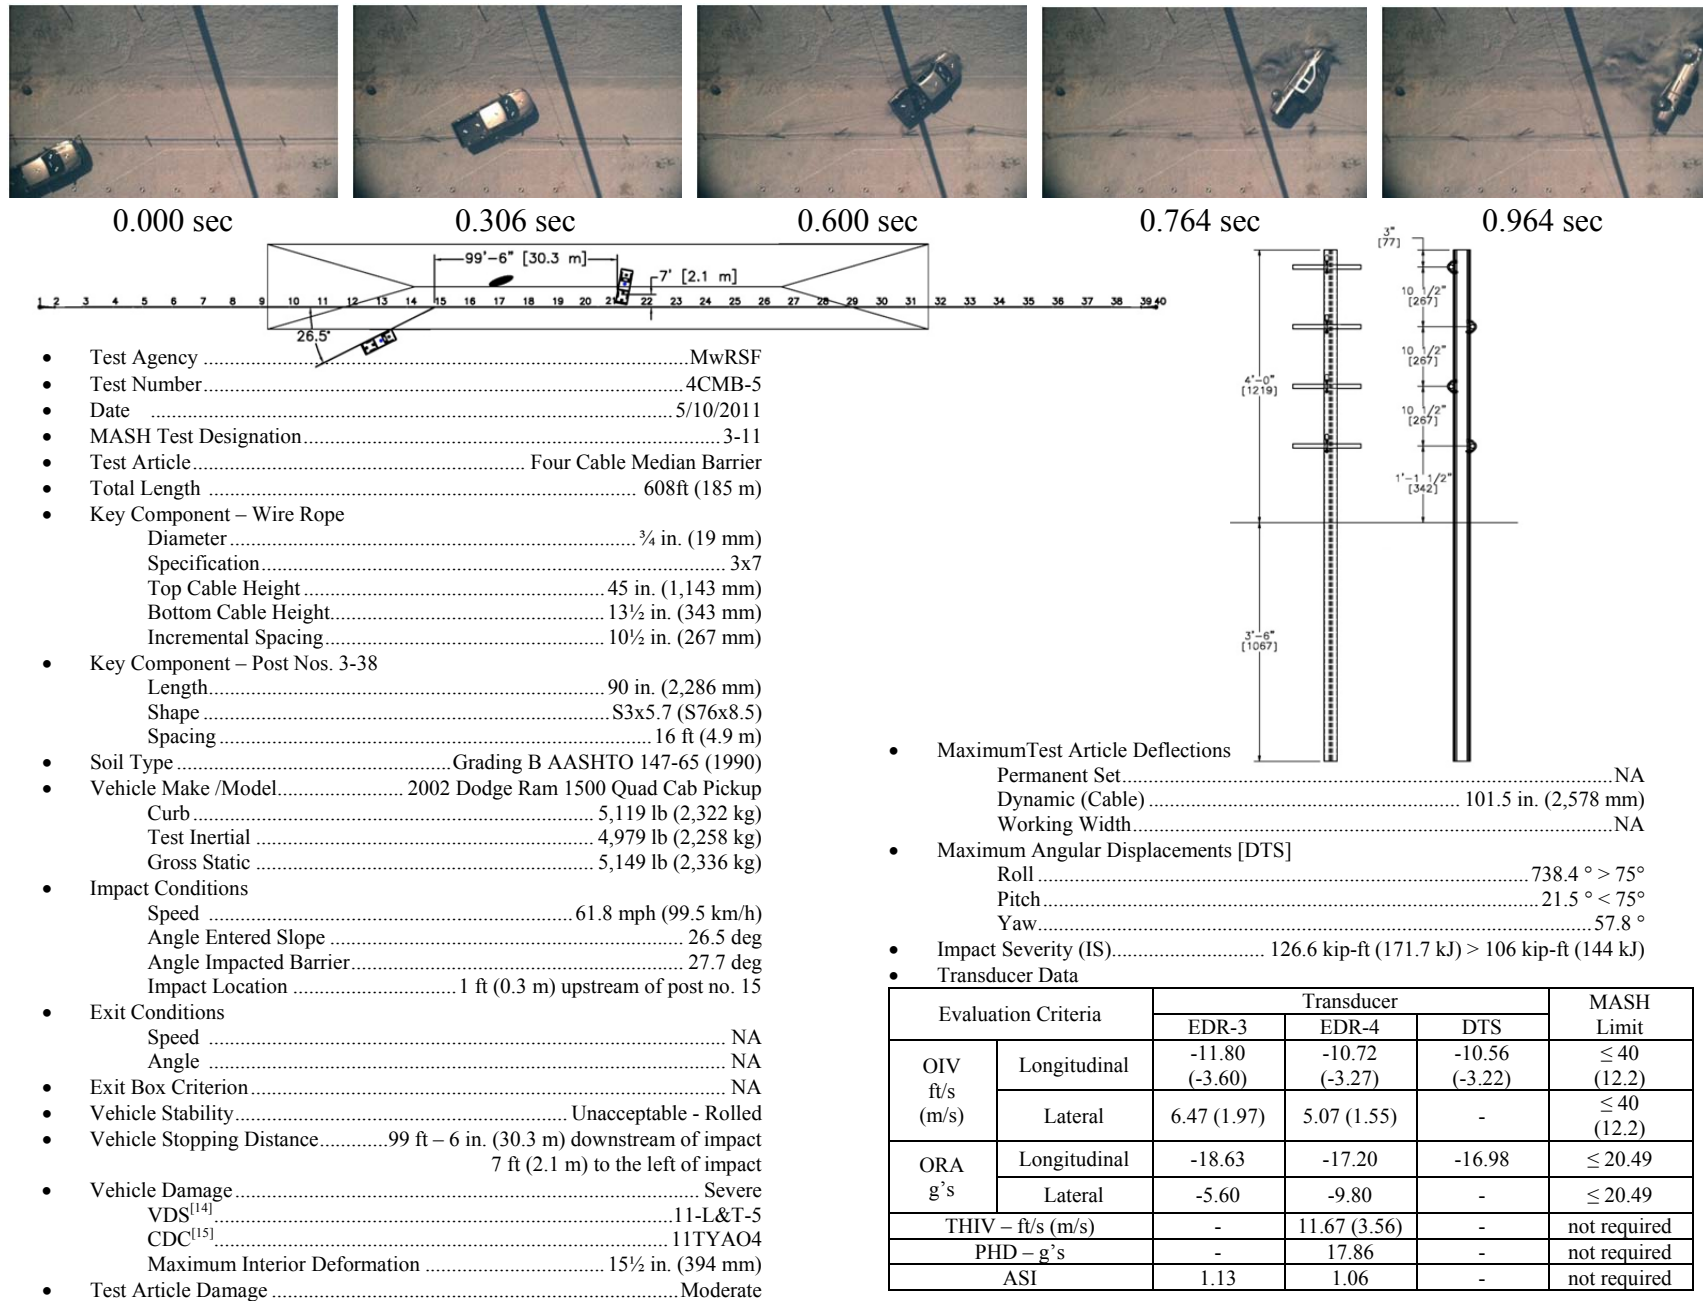
Figure 73. Summary of Test Results and Sequential Photographs, Test No. 4CMB-5

The 5,149-lb (2,336-kg) pickup truck impacted the four cable median barrier 12 ft (3.7 m) laterally down from the slope break point at a speed of 61.8 mph (99.5 km/h). The pickup truck entered the slope at an angle of 26.5 degrees and impacted the barrier at an angle of 27.7 degrees. A summary of the test results and sequential photographs are shown in Figure 73. Additional sequential photographs are shown in Figures 74 through 77.

Following the analysis of test no. 4CMB-5, the researchers concluded that the failure of the test was directly attributed to failure to capture the impacting vehicle and the subsequent override of the system. The failure of the system to capture the vehicle was caused by the vehicle impacting post no. 15 prior to engaging the top cable. Post no. 15 deflected laterally back as well as longitudinally downstream. Impacting the post was shown to be critical, as the motion of the post caused the cables to be pulled down and prevent them from capturing the vehicle bumper.

Based on the results of this test, there may be a need to utilize different, or modified, cable attachments at the various cable heights in the system. It may be necessary to modify the vertical release properties of the upper cable attachments such that they release under very low forces and deflections in order to prevent the cables from being pulled downward, as observed in test no. 4CMB-5. It was noted in this test that the location of the vehicle bumper in relation to the top cable was marginal with respect to the potential for vehicle capture, even prior to the pulldown of the cables by the post, as shown in Figure 87. These modifications, along with others will be considered as the research effort moves forward.

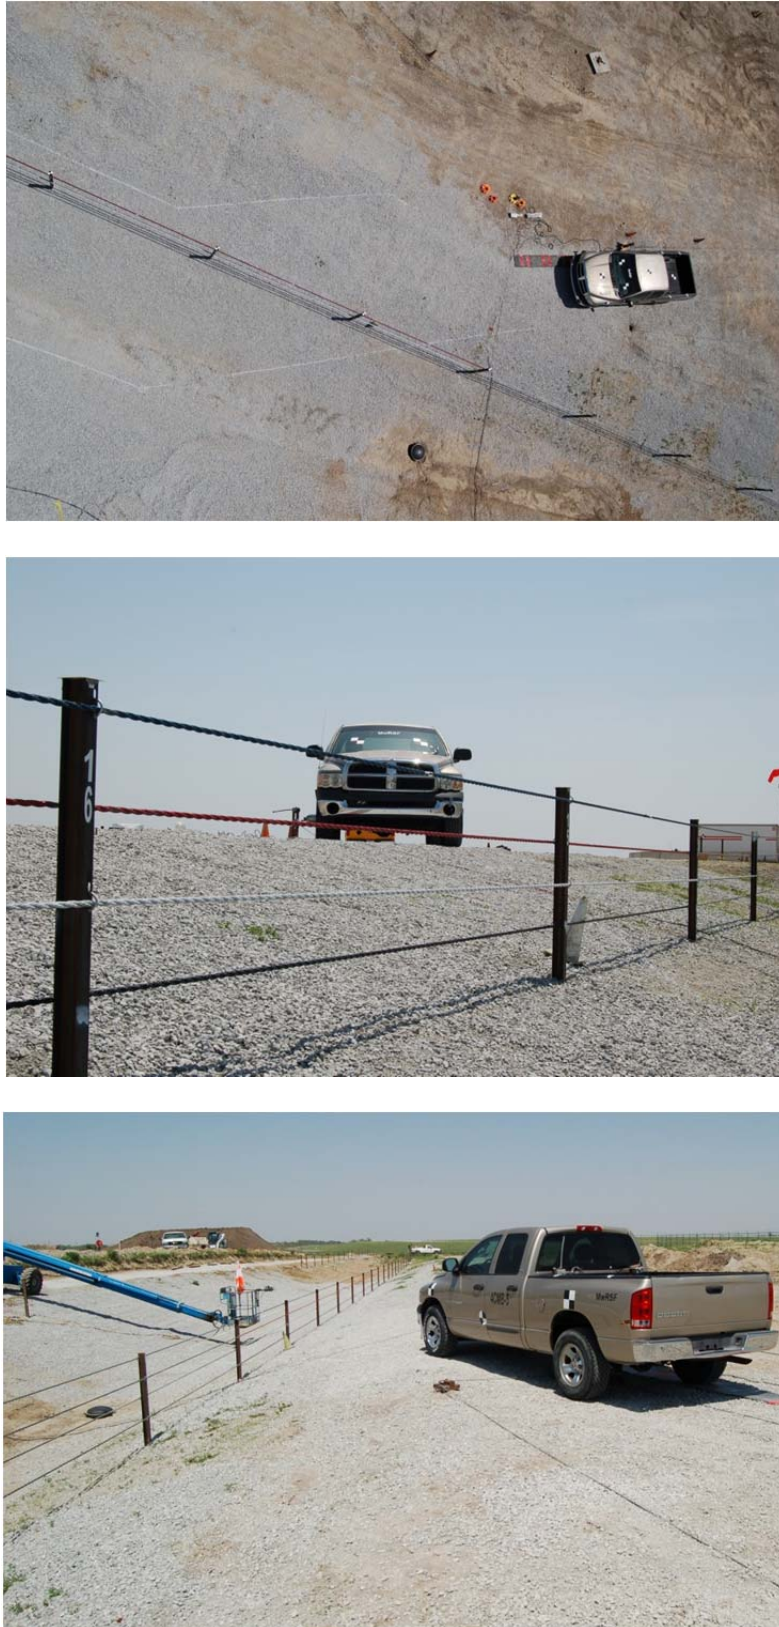
Figure 78. Impact Location, Test No. 4CMB-5

Initial vehicle impact was to occur 1 ft (0.3 m) upstream of post no. 15, as shown in Figure 78, which was selected using an analysis of the vehicle trajectory over the slope which would impact near a post causing the greatest potential to override the post and cables. The actual point of impact was 1 ft (0.3 m) upstream of post no. 15. A sequential description of the impact events is contained in Table 10. The cables were numbered from 1 to 4, from the top to bottom, respectively. The vehicle came to rest behind the barrier, 99 ft – 6 in. (30.3 m) downstream, straddling the bottom of the v-ditch with the rear of the pickup adjacent to the backside of the barrier. The vehicle trajectory and final position are shown in Figures 73 and 79.

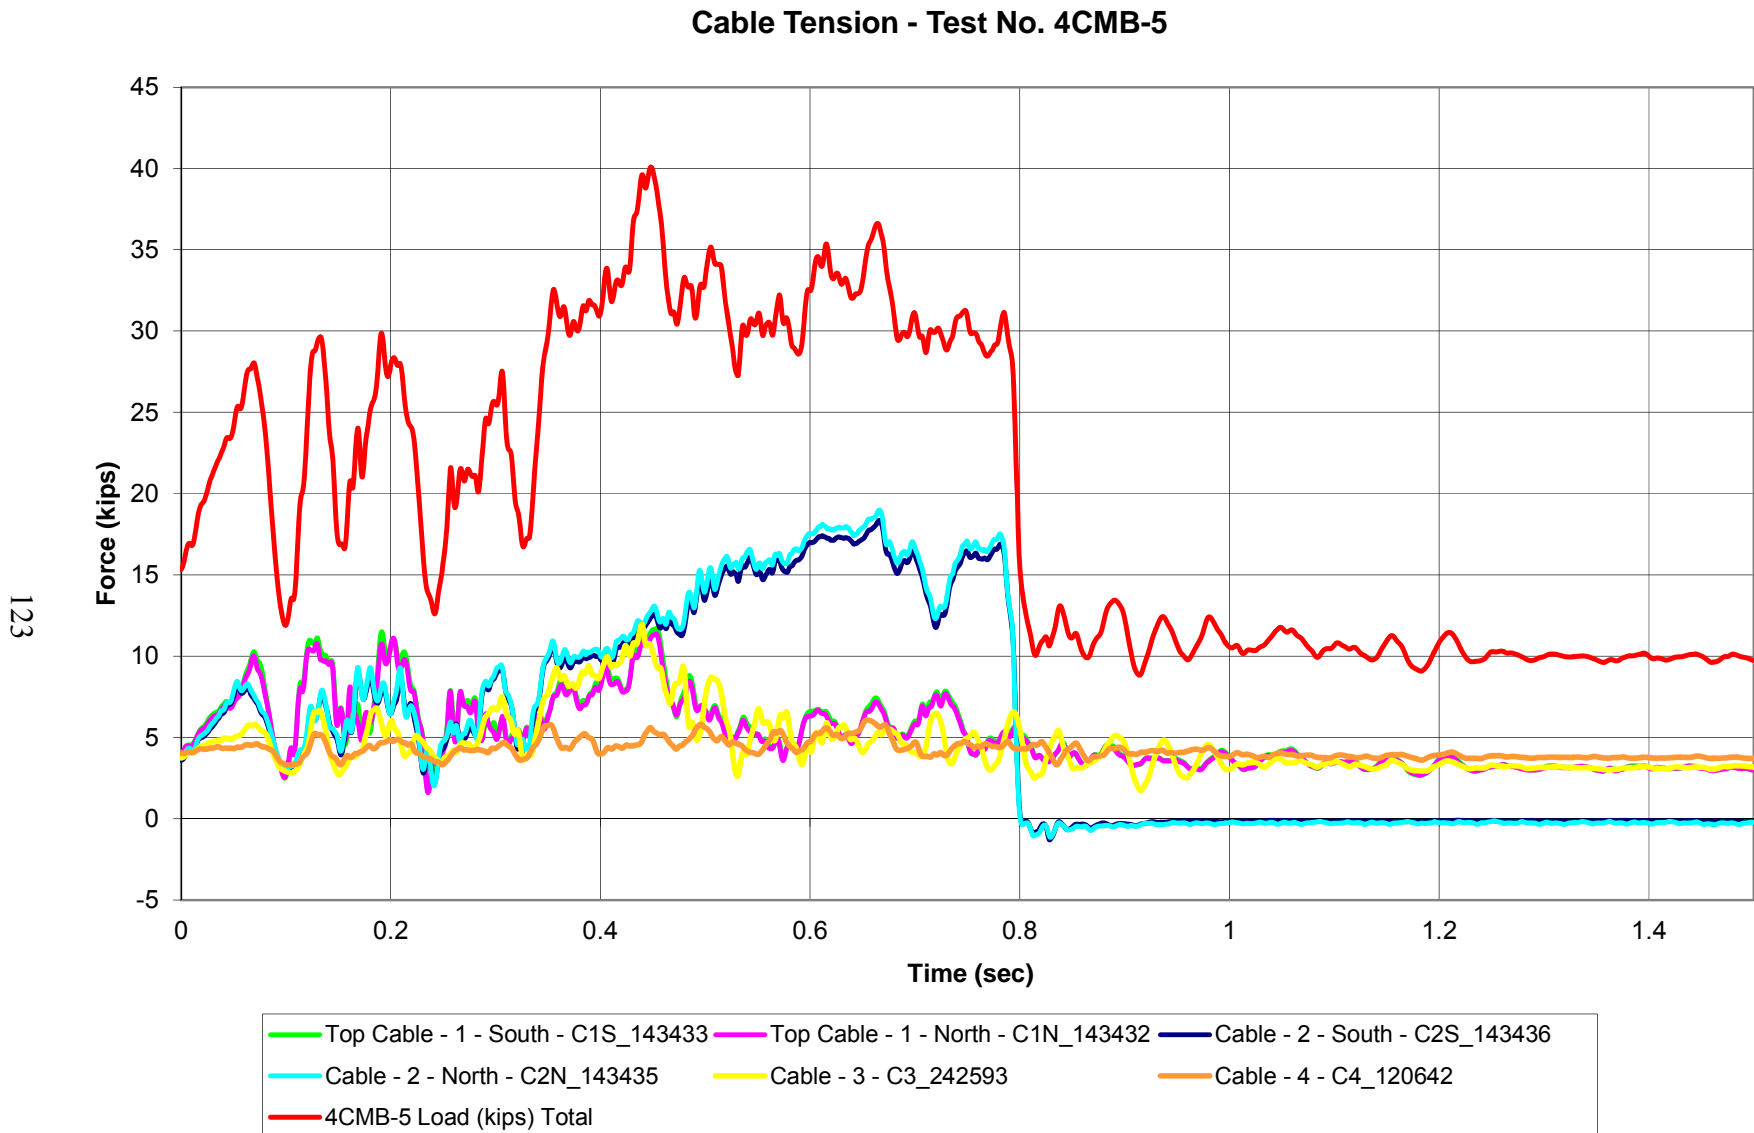
Figure 88. Cable Tension vs. Time, Test No. 4CMB-5

with respect to time. The load cell results are summarized in Table 14. The individual cable loads, along with the total combined cable load imparted to the upstream end anchor, were determined and are shown graphically in Figure 88.
