**SAFETY PERFORMANCE
EVALUATION OF MINNESOTA'S
ALUMINUM WORK ZONE SIGNS**

MwRSF Research Report No. TRP-03-107-01

January 29, 2002

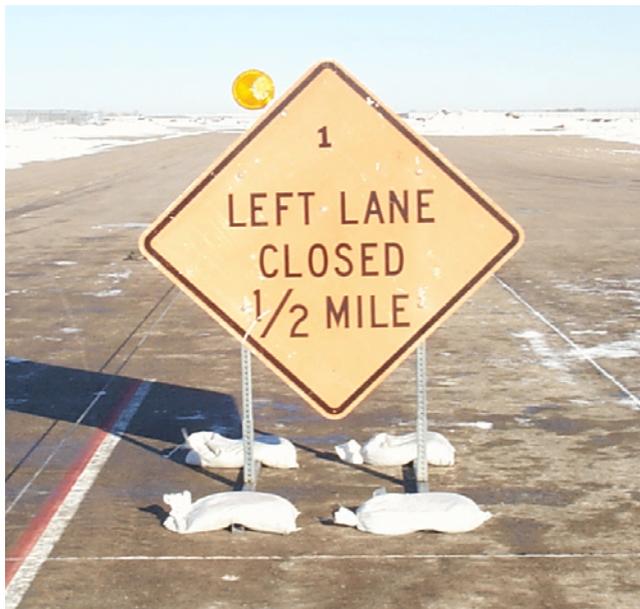
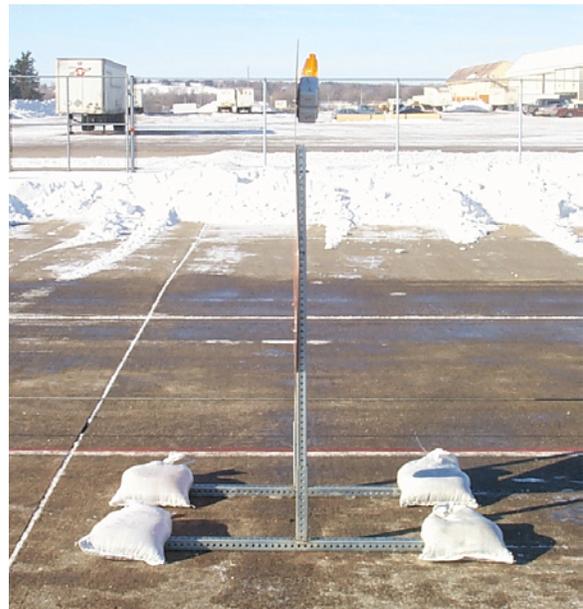
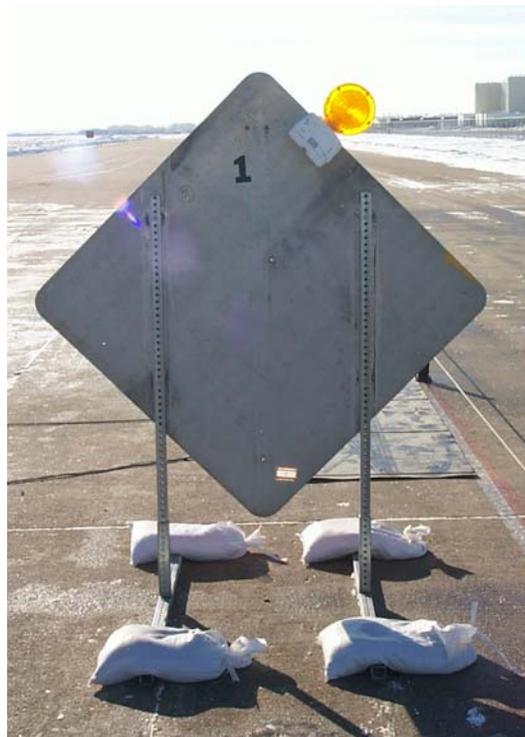
Figure 2. System No. 1 Sign, Test MNS-1

Damage to System Nos. 1 and 2 is shown in Figures 29 through 32. System No. 1 encountered moderate damage. The vertical upright tube on both legs was bent, and the weld fractured on three sides. Both legs were also disengaged from the masts. Both masts were deformed at bumper height. The mast on the left side was cracked. The light portion of the warning light broke off while the bottom box portion was still attached to the sign panel. The sign panel encountered slight deformations as well as scuff and scrape marks. The sandbags were torn open with the sand scattered along the path of the vehicle, starting at the initial position of the first sign support.

Following test MNS-1, a safety performance evaluation was conducted, and the work zone traffic control device, System No. 1 was determined to be unacceptable according to the NCHRP Report No. 350 criteria. It was deemed unacceptable due to the “spider web” cracking, indentation, and hole in the windshield, resulting in obstructed driver visibility and loss of structure of both glass layers. Deformations of, or intrusion into, the occupant compartment did occur as detached elements and debris from System No. 1 penetrated the left-central region of the windshield.

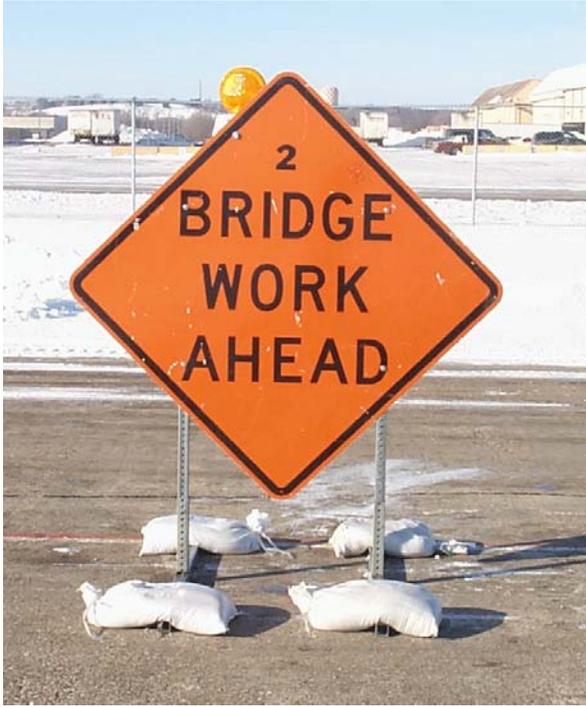
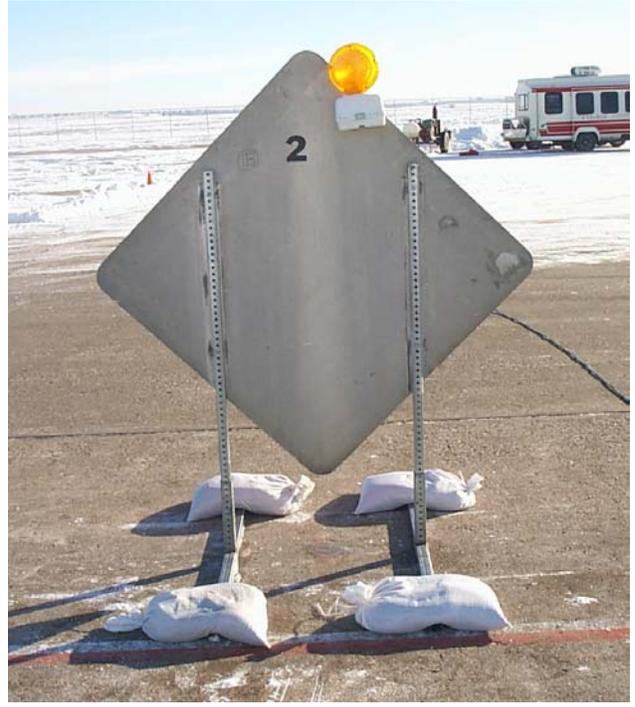
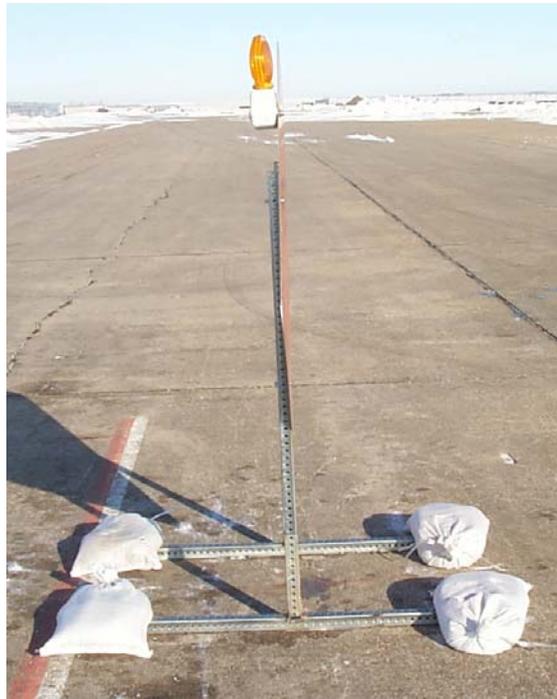
Figure 3. System No. 2 Sign, Test MNS-1

System No. 2 encountered moderate damage. Both legs disengaged from the masts but remained undamaged. Three out of the four sides of both masts were fractured at the bottom sign panel bolts. The impacted mast was also deformed at bumper height. The non-impacted mast also released from the bottom sign panel bolt. The sign panel encountered a 76-mm long tear due to the impacted-side bottom sign panel bolt slicing through the sign panel. The sign panel also encountered scuff and scrape marks as well as deformation to the top corner. The warning light remained intact and attached to the sign panel. Three of the sandbags were torn open with the sand scattered along the path of the vehicle, starting at the initial position of the second sign support. The other sandbag remained undamaged.

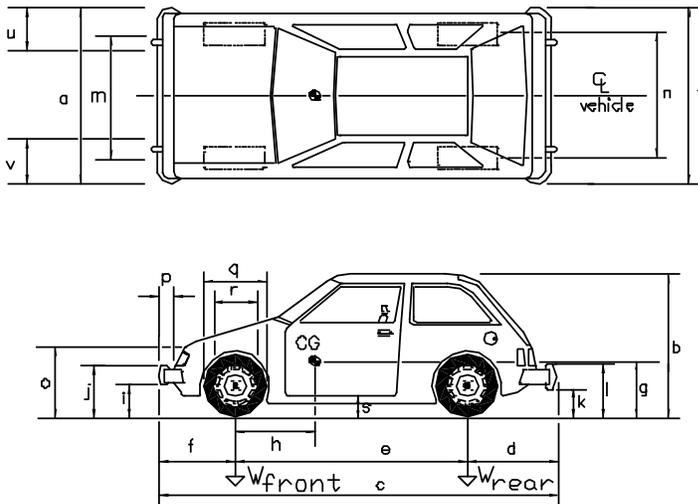
Figure 12. Vehicle Dimensions, Test MNS-1

Damage prior to test: minor cracked windshield

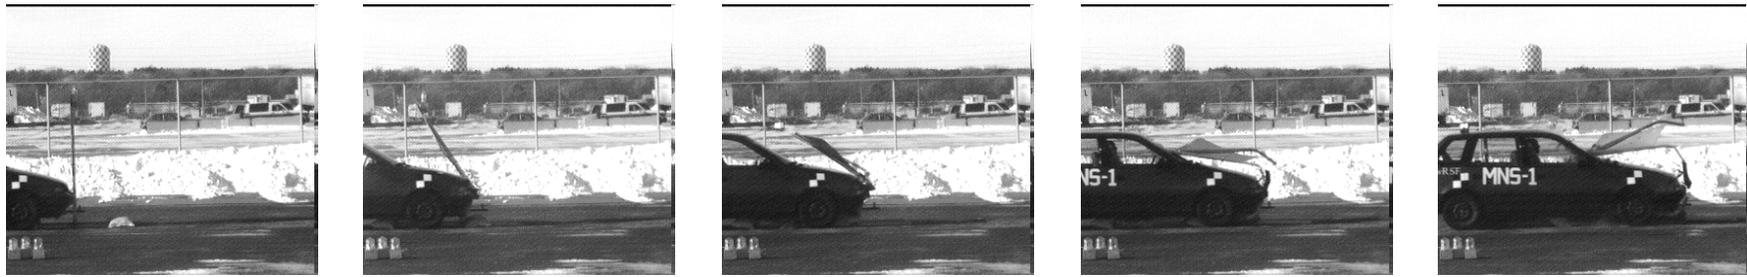
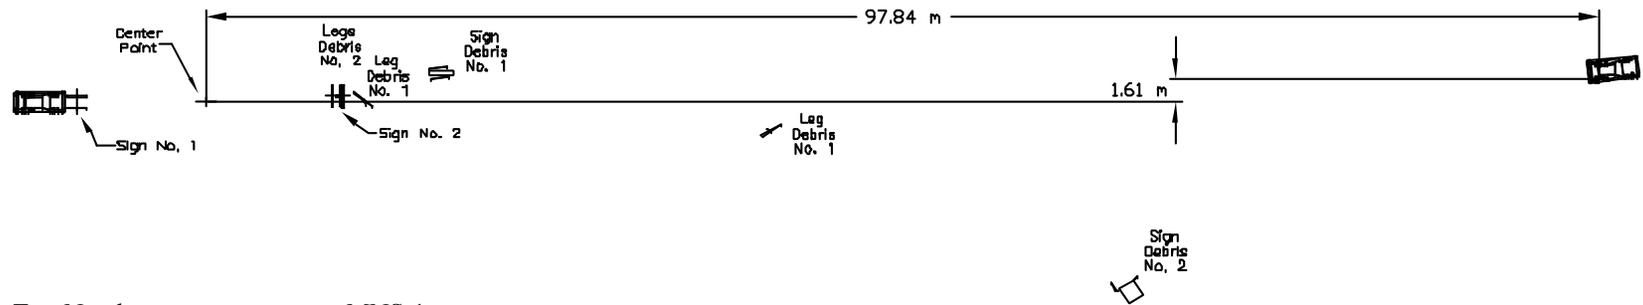
Figure 22. Summary of Test Results and Sequential Photographs, Test MNS-1, Impact No. 1

- TAD²³ 12-FC-1
 - SAE²⁴ 12-FDAW6
- Vehicle Stopping Distance 97.84 m downstream
1.61 m left
- Test Article Damage Moderate – Broke apart

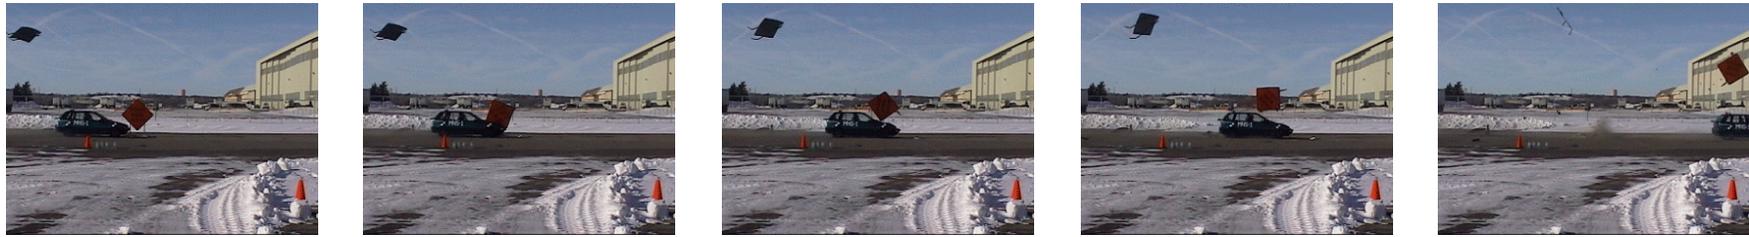
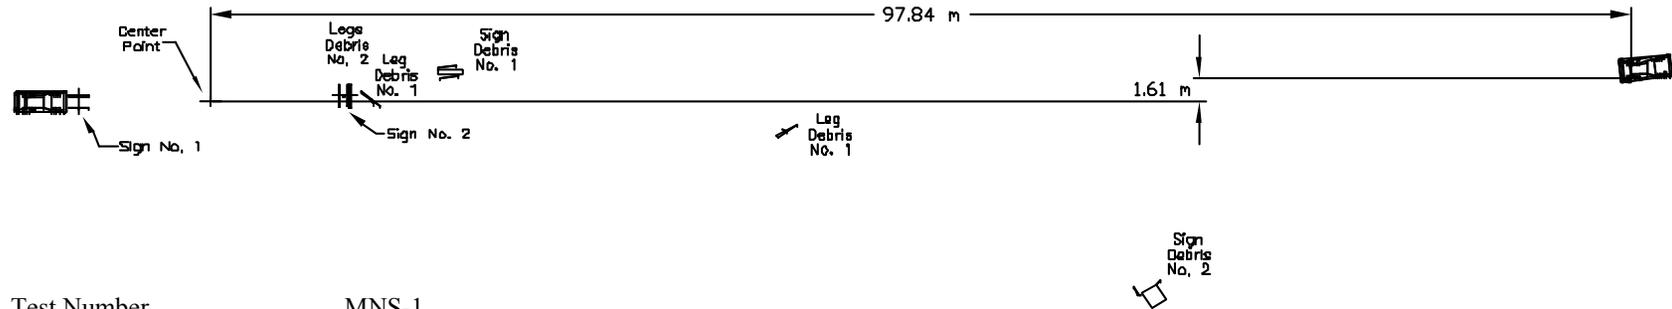
System No. 2 was determined to be acceptable according to the NCHRP Report No. 350 criteria. Detached elements and debris from System No. 2 did not penetrate nor show potential for

- Vehicle Angle
 - Impact 90 deg
 - Exit 90 deg
- Vehicle Stability Satisfactory
- Occupant Ridedown Deceleration (10 msec avg.)
 - Longitudinal NA
 - Lateral (not required) NA
- Occupant Impact Velocity (Normalized)
 - Longitudinal NA
 - Lateral (not required) NA
- Vehicle Damage Minimal
 - TAD²³ 12-FL-1
 - SAE²⁴ 12-FLEN5
- Vehicle Stopping Distance 97.84 m downstream
1.61 m left
- Test Article Damage Moderate – Broke apart

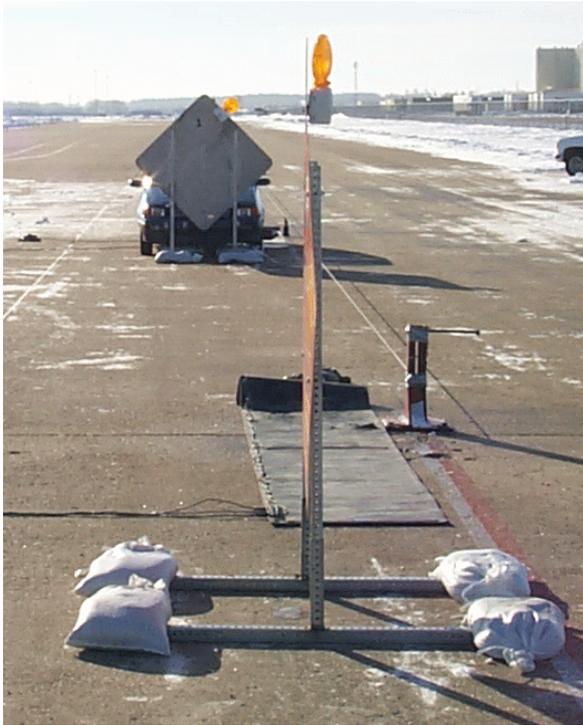
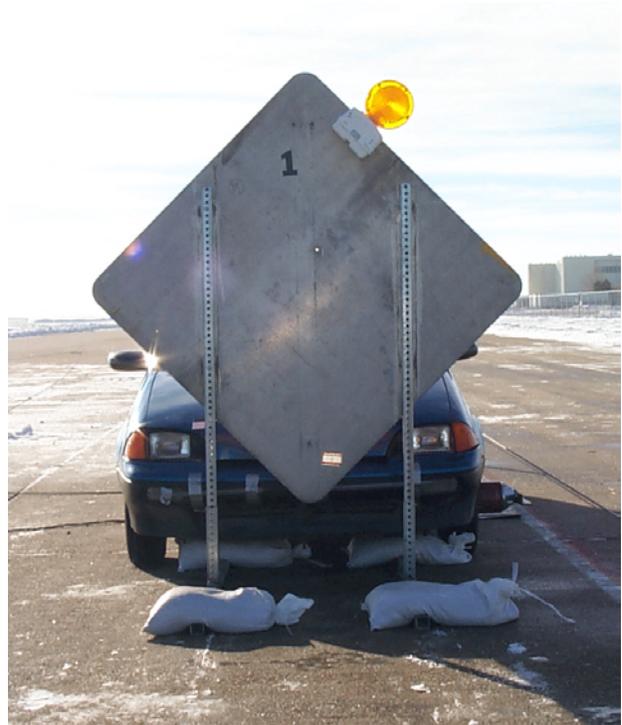
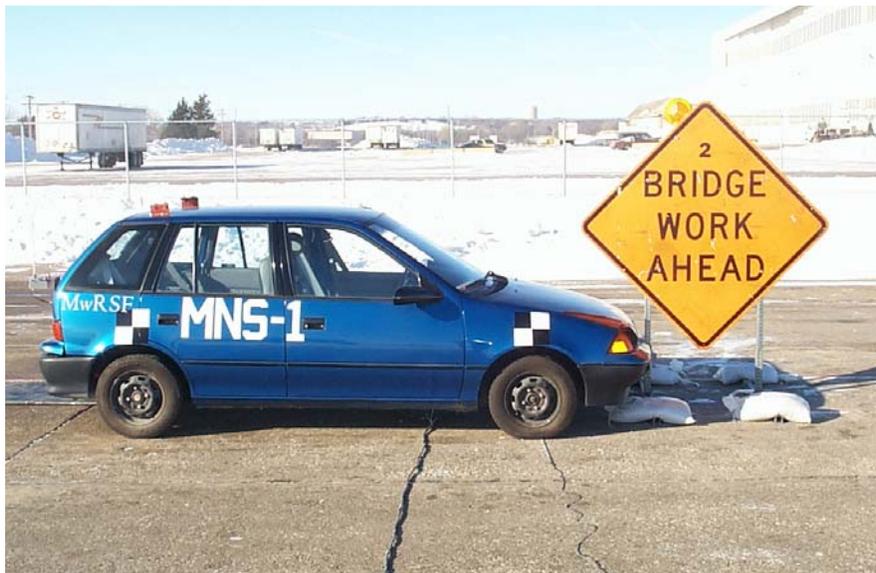
Figure 28. Impact Location, Test MNS-1

The test vehicle impacted System No. 1 with the centerline of the vehicle's bumper aligned with the centerline of the sign support, as shown in Figure 28. At 0.012 sec after impact, both masts deformed around the front of the vehicle as the sign panel rotated toward the vehicle and windshield. At this same time, the legs still attached to the masts moved along with the vehicle. At 0.022 sec, the vertical portion of the legs bent away from the vehicle. At 0.032 sec, the left mast fractured where it had been deformed by the front bumper, and the right mast disengaged from the vertical upright of the right leg. At this same time, the sign panel continued to rotate toward the vehicle. At 0.038 sec, the left mast disengaged from the vertical upright of the left leg. At 0.044 sec, the warning light impacted the windshield as the panel deformed. At this same time, part of the front bumper was ripped off by the deformed masts. At 0.056 sec, the sign panel impacted the windshield as the masts and sign panel continued to rotate toward the vehicle. At this same time, the legs were

Approximately 0.67 sec after impact with System No. 1, the vehicle impacted System No. 2 with the left-front quarter point of the vehicle aligned with the centerline of the sign support, as shown in Figure 28. At 0.035 sec after initial impact, the outside edge of the sign panel rotated into the vehicle as the left corner of the sign panel impacted the hood of the vehicle. At this same time, the non-impacted mast disengaged from the leg's vertical upright. At 0.104 sec, the sign panel rotated about its contact point with the hood of the vehicle. At 0.173 sec, the sign panel rotated above the vehicle to approximately 180 degrees counter-clockwise (CCW) from its initial position. At 0.449 sec, the sign panel continued to rotate CCW above the vehicle. One leg from the sign support was located 0.30-m downstream from the original position. The other leg from the sign support was located 0.46-m downstream from the original position. The sign panel with the masts and warning light still attached came to rest 55.78-m downstream and 13.41-m right of the initial position. Loose sand from the sandbags was scattered in a pattern bound by 0.0-m upstream, 1.52-m downstream, 0.76-m left, and 0.76-m right from the original position of the aluminum sign support.

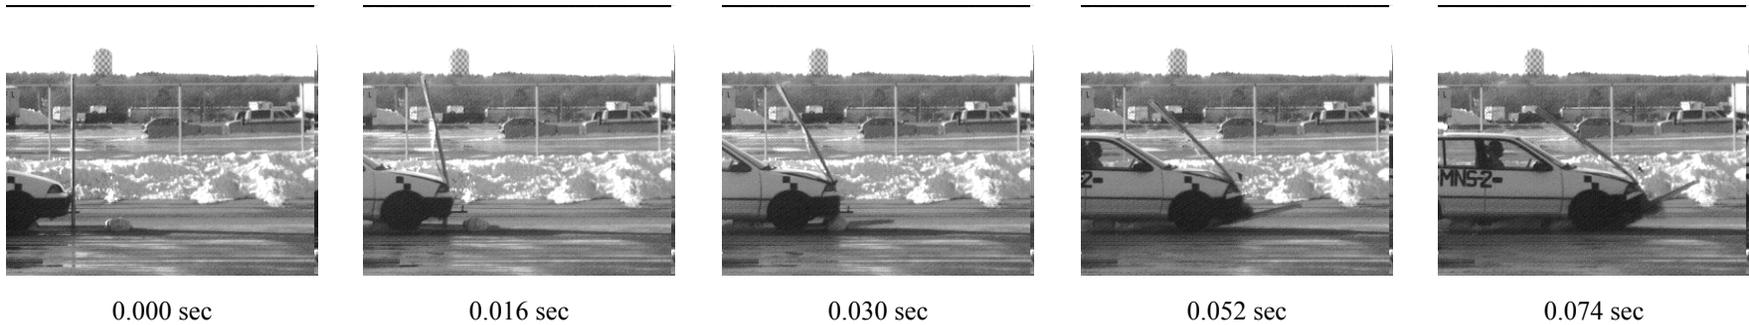
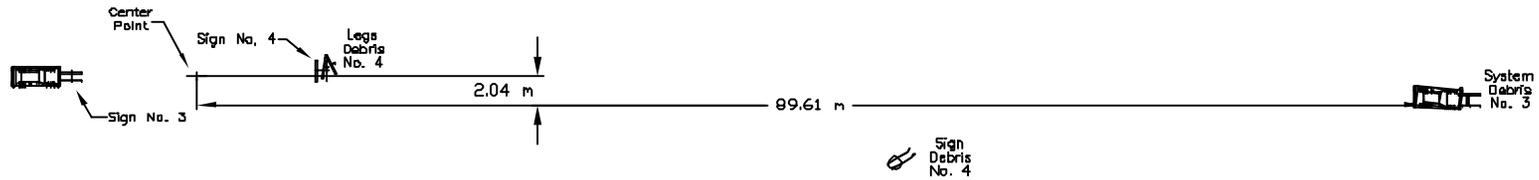
Figure 35. Summary of Test Results and Sequential Photographs, Test MNS-2, Impact No. 1

- TAD²³ 12-FC-1
 - SAE²⁴ 12-FDEW5
- Vehicle Stopping Distance 89.61 m downstream
2.04 m left
- Test Article Damage Moderate – Remained intact

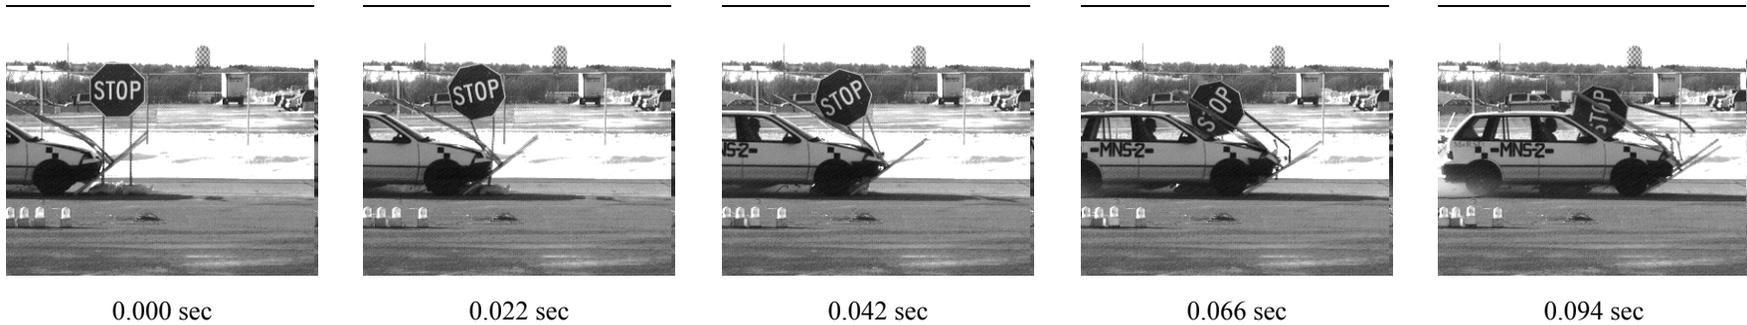
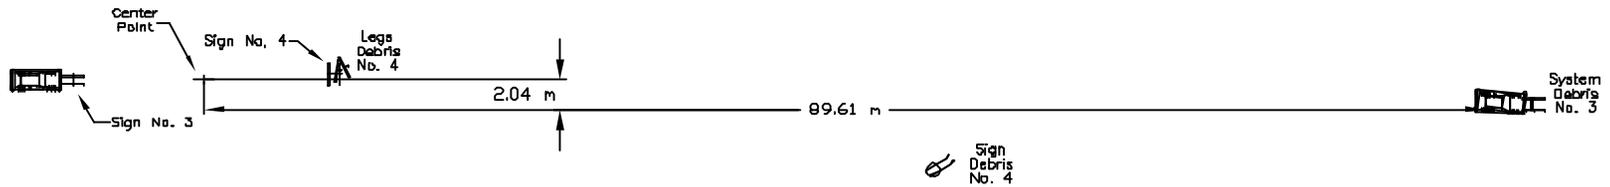
System No. 4 was determined to be unacceptable according to the NCHRP Report No. 350 criteria. It was deemed unacceptable due to the “spider web” cracking, indentation, and hole in the windshield, resulting in obstructed drive visibility and loss of structure of both glass layers. Deformation of, or intrusion into, the occupant compartment did occur as detached elements and debris from System No. 4 penetrated the left region of the windshield. The vehicle’s trajectory did not intrude into adjacent traffic lanes.

It should be noted that the impact speed for System No. 4 was measured to be approximately 92.0 km/hr or 8.0 km/hr less than the 100 km/hr target speed. However, it is believed that the performance of the system was not significantly effected and a higher impact speed would not have resulted in any less severe vehicle damage.

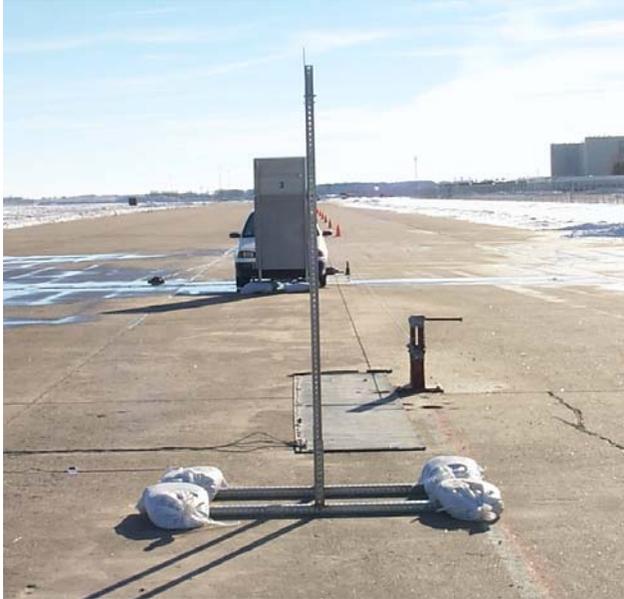
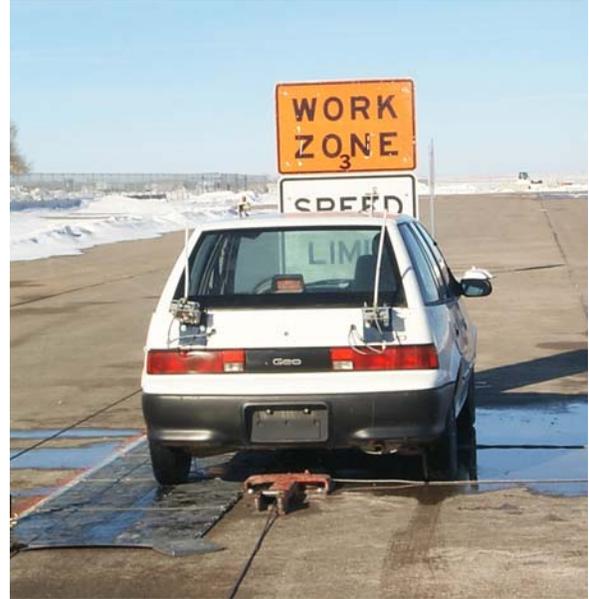
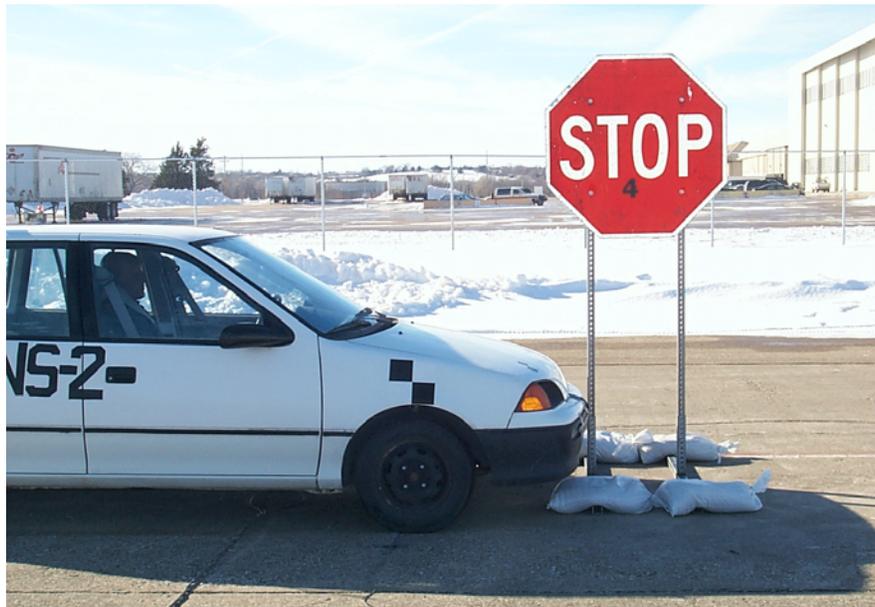
Figure 41. Impact Locations, Test MNS-2

The test vehicle impacted System No. 3 with the right-front quarter point of the vehicle's bumper aligned with the centerline of the sign support, as shown in Figure 41. At 0.010 sec after initial impact, both masts deformed around the front of the vehicle. At this same time, the bottom half of the sign panel bowed out away from the vehicle. At 0.016 sec, the legs slid along with the vehicle as the masts continued to deform around the front of the vehicle. At 0.026 sec, the hood deformed upward as the masts continued to deform. At this same time, the bottom half of the sign panel bowed and deformed away from the masts. At 0.030 sec, the legs raised up off the ground due to the deformation of the masts about the front of the vehicle. At this same time, the hood and masts continued to deform toward the vehicle. At 0.052 sec, the non-impacted ends of the legs rose into the air and to the height of the bumper. At 0.074 sec, the system rotated into the vehicle as it moved along with the vehicle. At this same time, the masts and panel were near the same angle as the windshield and the hood remained slightly deformed. At 0.110 sec, the system continued to rotate

Approximately 0.73 sec after impact with System No. 3, the vehicle impacted System No. 4 with the left-front quarter point of the vehicle aligned with the centerline of the sign support, as shown in Figure 41. At 0.012 sec after initial impact, the impacted mast deformed and moved toward the other mast. At this same time, the sign panel began to rotate slightly CCW toward the vehicle. At 0.022 sec, the impacted mast contacted the other mast as the sign panel rotated CCW and downward into the vehicle. At 0.028 sec, both masts were in contact with and deformed about the front of the vehicle. At this same time, the impacted mast disengaged from the impacted leg. At 0.042 sec, the non-impacted mast disengaged from the corresponding leg as the sign panel and masts continued to rotate CCW toward the vehicle. At 0.066 sec, the sign panel impacted the windshield. At this same time, the deformed masts rotated away from the vehicle. At 0.094 sec, the sign panel and masts rotated CCW about the windshield contact point. At this same time, the masts lost contact with the front of the vehicle. At 0.146 sec, the sign panel and masts lost contact with the windshield, rotated CCW, and ascended into the air. One leg from the sign support was located 0.30-m downstream and 0.30-m right from the original position. The other leg from the sign support was located 0.46-m downstream and 0.30-m right from the original position. The sign panel with the masts still attached came to rest 41.76-m downstream and 6.71-m right of the initial position.

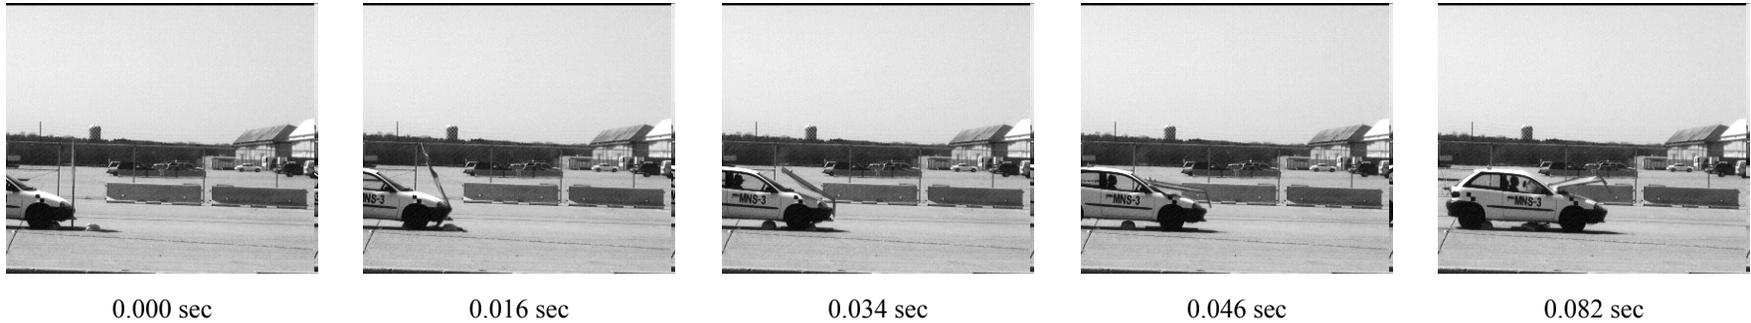
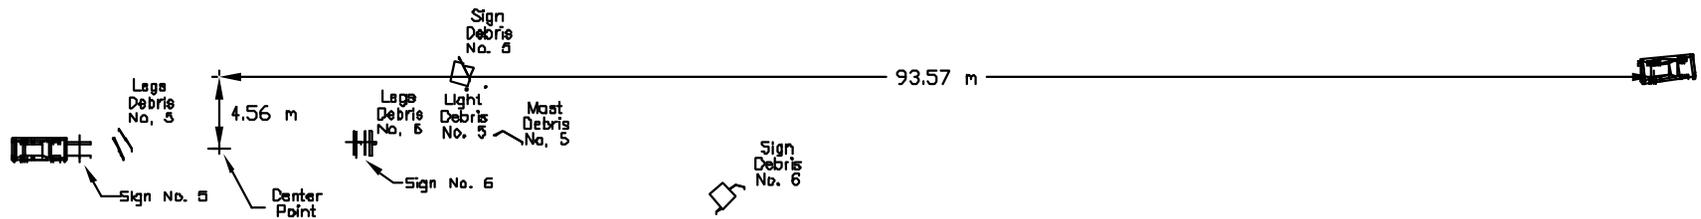
Figure 47. Summary of Test Results and Sequential Photographs, Test MNS-3, Impact No. 1

Following test MNS-3, a safety performance evaluation was conducted, and the work zone traffic control device, System No. 5, was determined to be unacceptable according to the NCHRP Report No. 350 criteria. It was deemed unacceptable due to the “spider web” cracking, indentation, and holes in the windshield, resulting in obstructed driver visibility and loss of structure of both glass layers. Deformations of, or intrusion into, the occupant compartment did occur as detached elements and debris from System No. 5 penetrated the left- and right-quarter point regions of the windshield.

- TAD²³ 12-FC-1
 - SAE²⁴ 12-FDAW7
- Vehicle Stopping Distance 93.57 m downstream
4.65 m left
- Test Article Damage Moderate – Broke apart

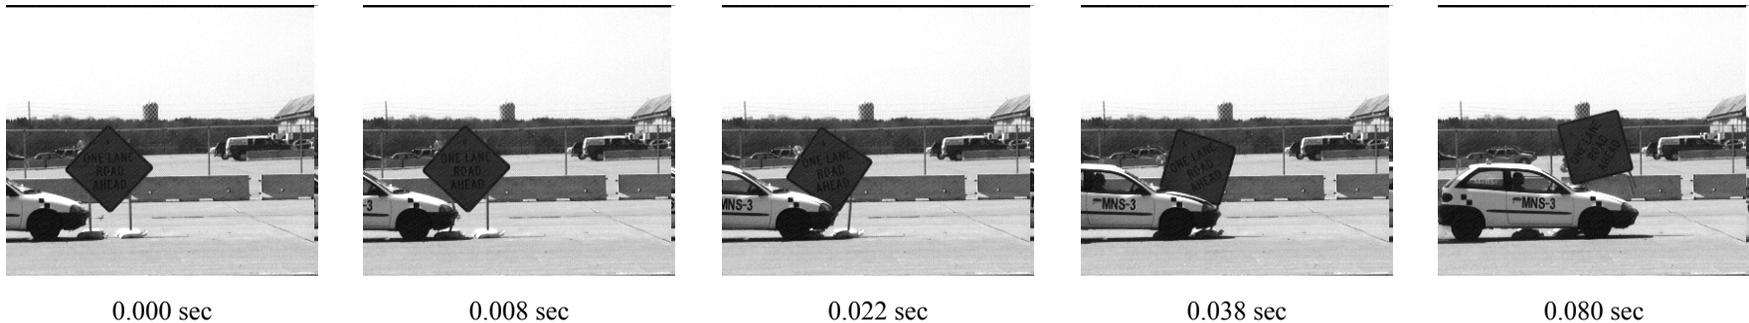
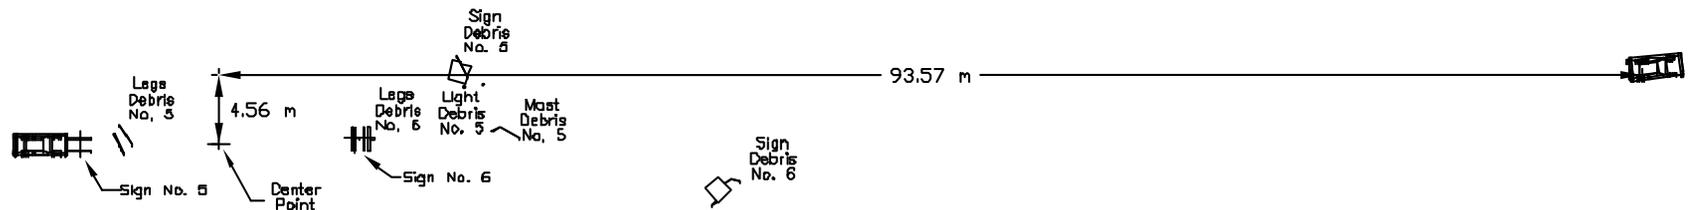
System No. 6 was determined to be unacceptable according to the NCHRP Report No. 350 criteria. It was deemed unacceptable due to the “spider web” cracking, indentation, and hole in the windshield, resulting in obstructed driver visibility and loss of structure of both glass layers. Deformations of, or intrusion into, the occupant compartment did occur as detached elements and debris from System No. 6 penetrated the left-side windshield. The vehicle’s trajectory did not intrude into adjacent traffic lanes.

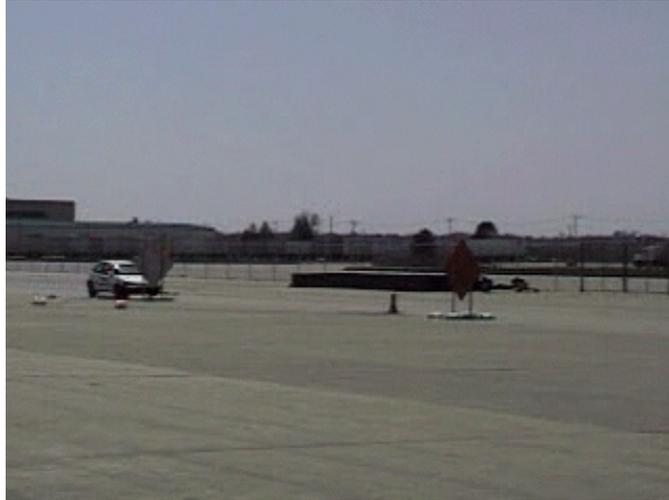
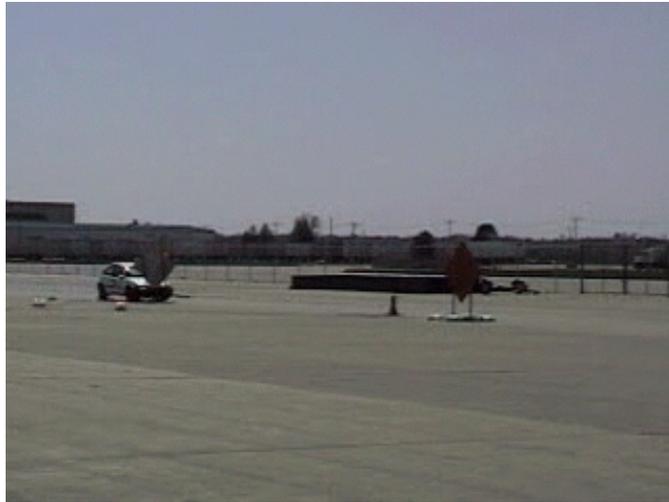
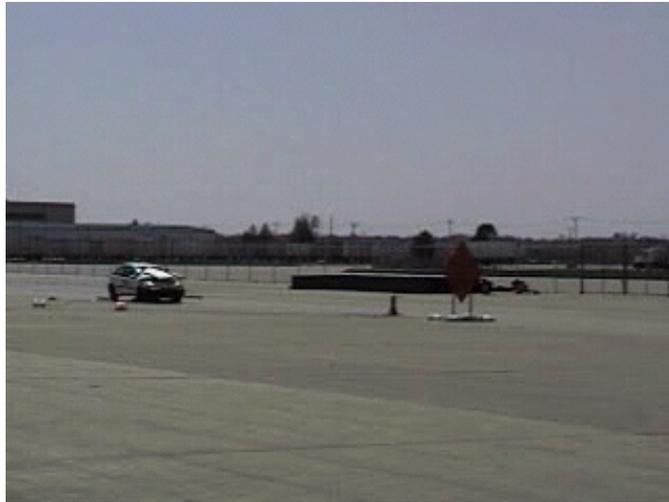
Figure 50. Documentary Photographs, Test MNS-3

The 898-kg small car impacted System No. 5, an aluminum sign support with a diamond-shaped aluminum panel oriented head-on to the vehicle, at a speed of 105.9 km/hr and at an angle of 0 degrees. The small car then impacted System No. 6, an aluminum sign support with a diamond-shaped aluminum panel oriented end-on to the vehicle, at a speed of 100.1 km/hr and at an angle of 90 degrees. A summary of the test results and the sequential photographs are shown in Figures 47 and 48. Additional sequential photographs are shown in Figure 49. Documentary photographs of the crash tests are shown in Figures 50 through 52.

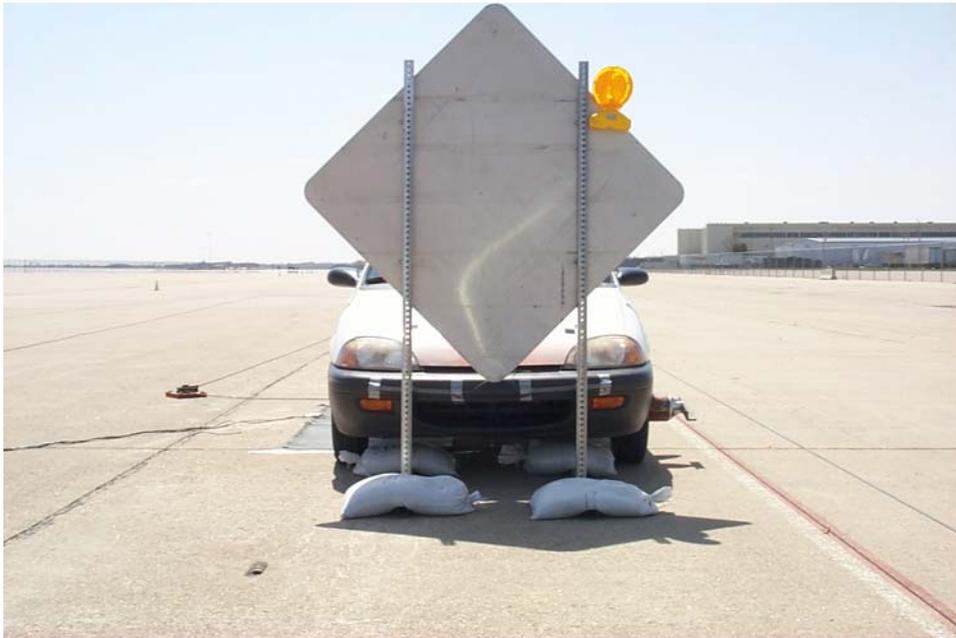
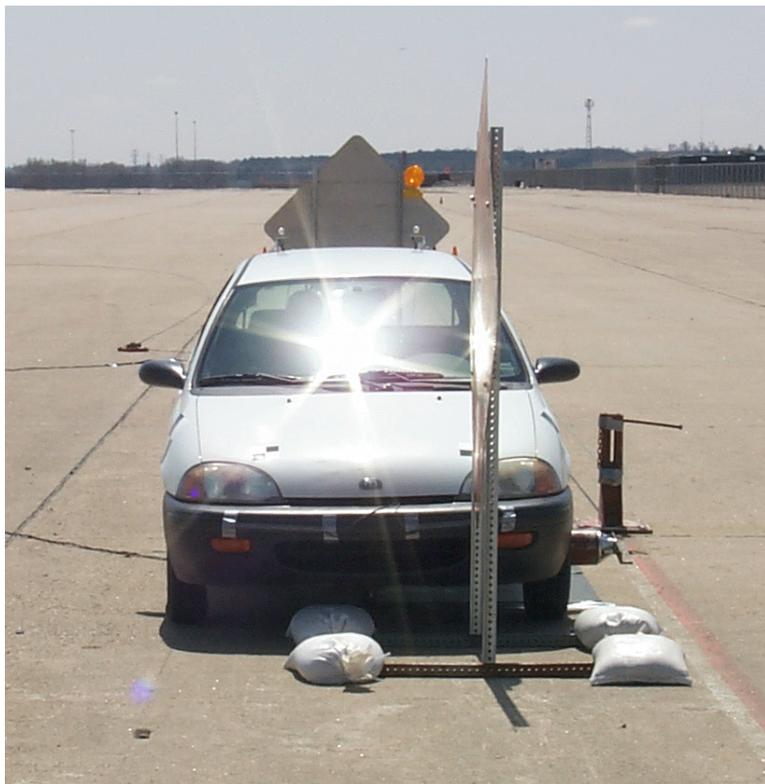
Figure 53. Impact Location, Test MNS-3

The test vehicle impacted System No. 5 with the centerline of the vehicle's bumper aligned with the centerline of the sign support, as shown in Figure 53. At 0.004 sec after initial impact, both masts deformed around the front of the vehicle. At this same time, the legs' vertical uprights bent away from the vehicle. At 0.010 sec, the masts deformed significantly with the top of the masts and the sign panel rotating toward the vehicle. At this same time, the sign panel deformed slightly outward toward the vehicle. At 0.016 sec, both masts were bent to approximately 90 degree angles at the bumper height. At this same time, the system slid along with the vehicle as the masts began to disengage from the legs' vertical uprights. At 0.024 sec, the masts disengaged from the legs' vertical uprights as the legs continue to travel forward in front of the vehicle. At this same time, the top of the sign panel and masts continued to rotate into the vehicle. At 0.034 sec, the sign panel and masts rotated to approximately the same angle as the windshield. At this same time, the lower portion of the masts which had been deformed by the bumper were positioned perpendicular to the

Approximately 0.69 sec after impact with System No. 5, the vehicle impacted System No. 6 with the left-front quarter point of the vehicle aligned with the centerline of the sign support, as shown in Figure 53. At 0.008 sec after initial impact, the impacted mast deformed around the front of the vehicle. At 0.016 sec, the impacted mast continued to deform around the front of the vehicle as the sign panel rotated CCW toward the vehicle. At 0.022 sec, the impacted mast disengaged from the leg's vertical upright tube. At this same time the bottom of the sign panel was in contact with
