# DEVELOPMENT OF AN ECONOMICAL GUARDRAIL SYSTEM FOR USE ON WIRE- FACED, MSE WALLS

Publication No. FHWA-CFL/TD-12-009

FEBRUARY 2012

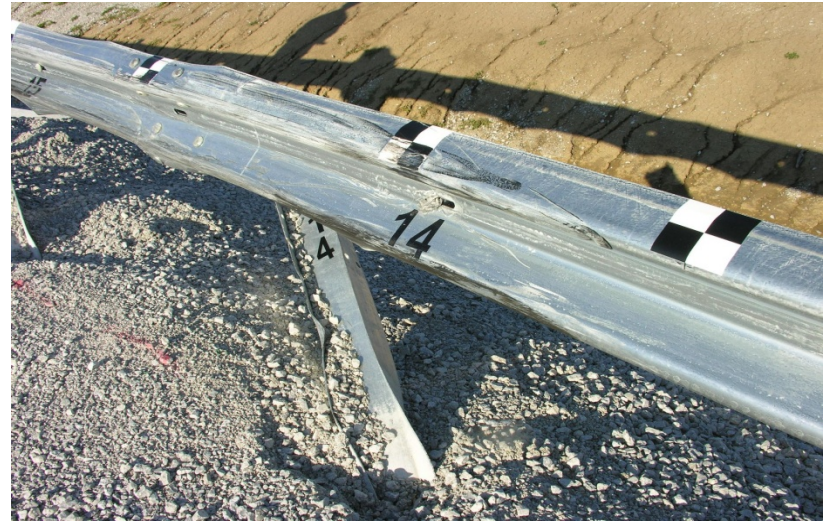
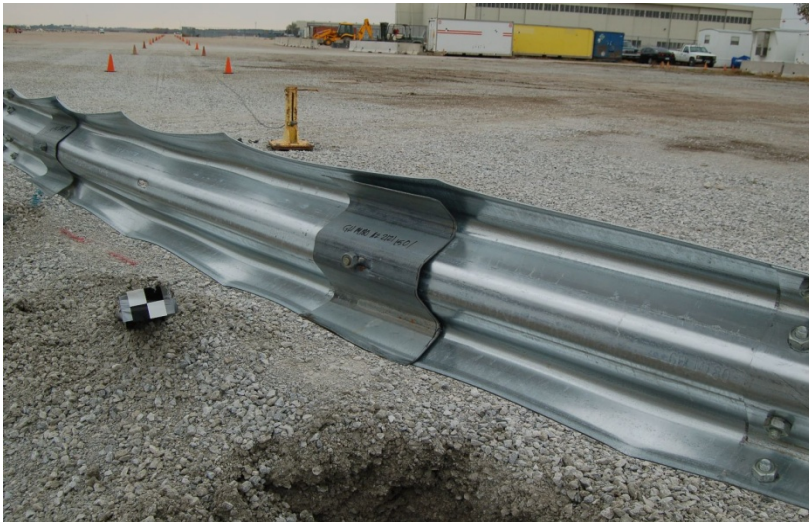
Figure 63. Photo. System Damage, Test No. MGSGW-1.

c. Rail at Post No. 14 Upstream Quarter View

b. Rail at Post No. Back View

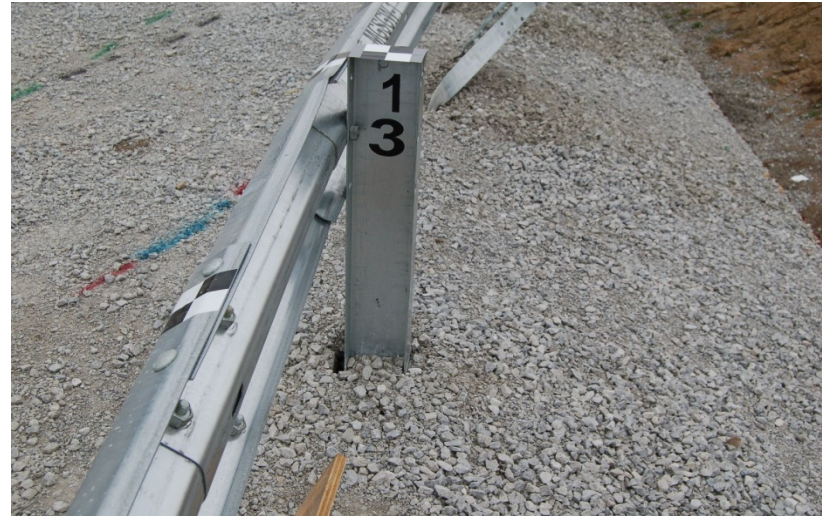
**Figure 64. Photo. Post Nos. 13 and 14 Damage, Test No. MGSGW-1.**

c. Post No. 13, Upstream View

b. Post No. 14, Front Side

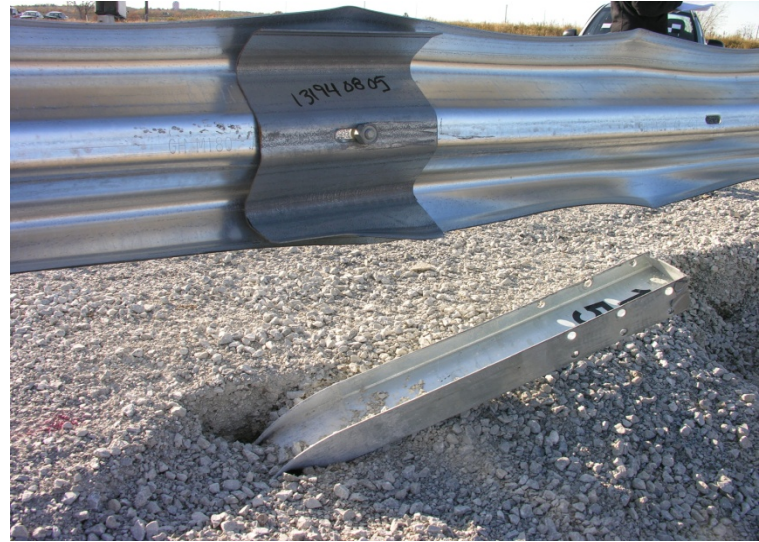
**Figure 65. Photo. Post Nos. 15 and 16 Damage, Test No. MGSGW-1.**

c. Post No. 15, Rear View

b. Post No. 16, Downstream View

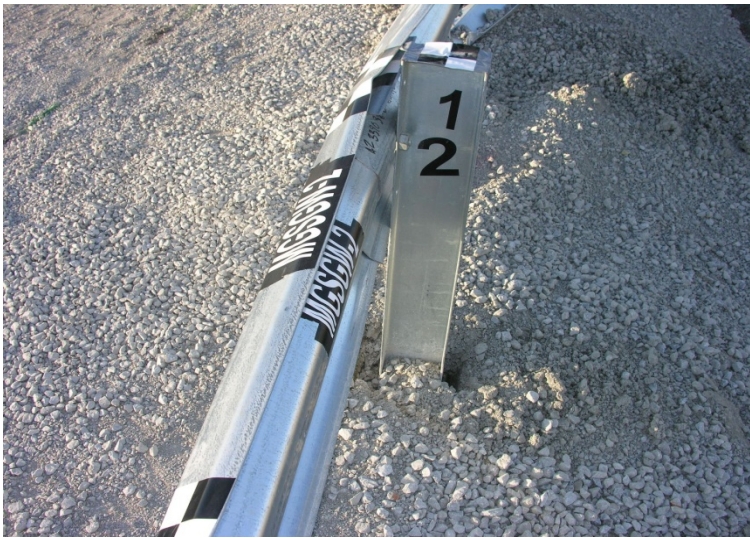
b. Post No. 12 Upstream View

**Figure 81. Photo. Post Nos. 11 and 12 Damage, Test No. MGSGW-2.**

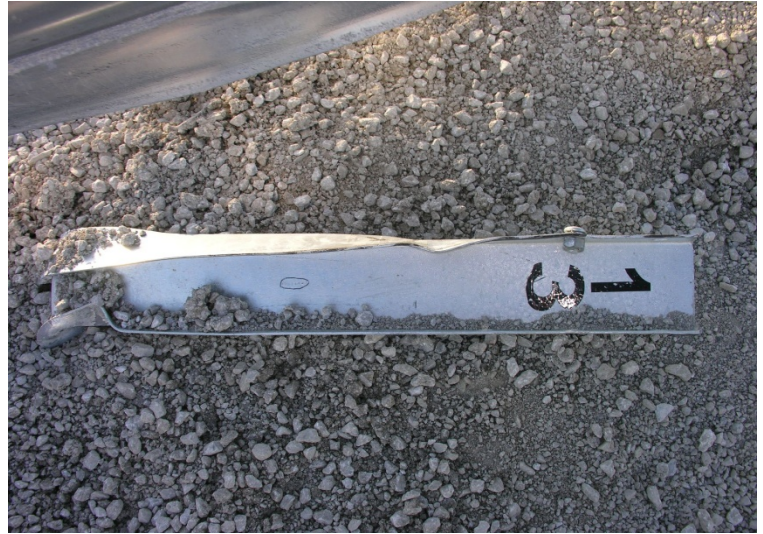
**Figure 82. Photo. Post Nos. 13 and 14 Damage, Test No. MGSGW-2.**

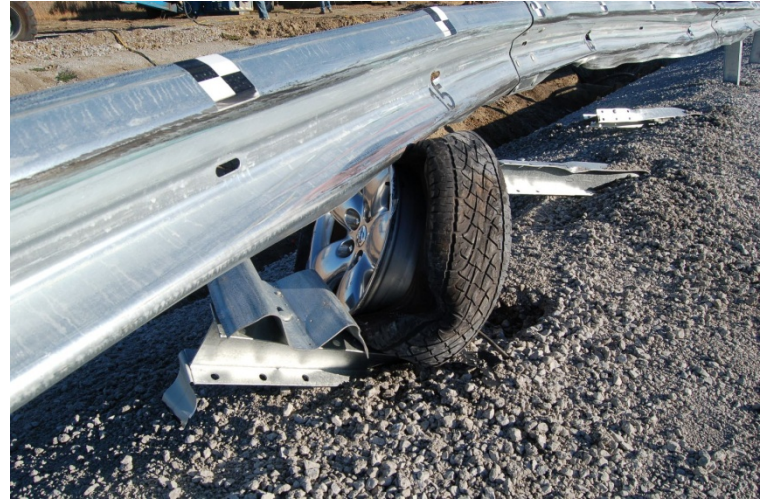
**Figure 83. Photo. Post Nos. 15 and 16 Damage, Test No. MGSGW-2.**
