*Midwest States Regional Pooled Fund Research Program  
Fiscal Year 2011 (Year 21)  
Research Project Number TPF-5(193) Supplemental #31  
NDOR Sponsoring Agency Code RFP-11-MGS-1*

# **MIDWEST GUARDRAIL SYSTEM (MGS) WITH SOUTHERN YELLOW PINE POSTS**

MwRSF Research Report No. TRP-03-272-13

September 4, 2013

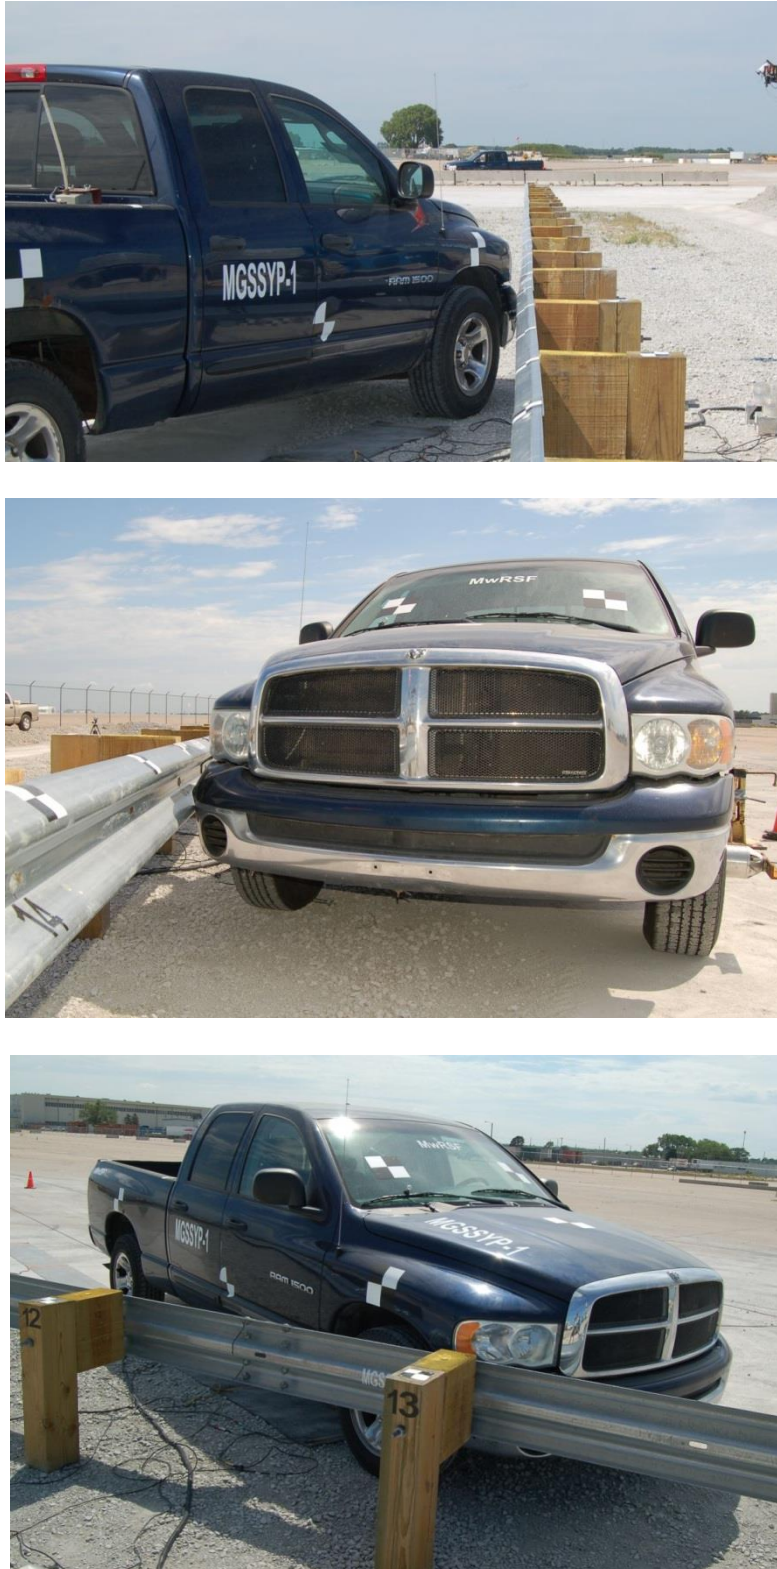
Figure 35. Impact Location, Test No. MGSSYP-1

Initial vehicle impact was to occur 12 ft (3.7 m) upstream of the center line of post no. 15, as shown in Figure 35, which was selected using the CIP plots found in Section 2.3 of MASH to maximize pocketing and the propensity of wheel snag. The actual point of impact was 12 ft – 6 in. (3.8 m) upstream of post no. 15. A sequential description of the impact event is

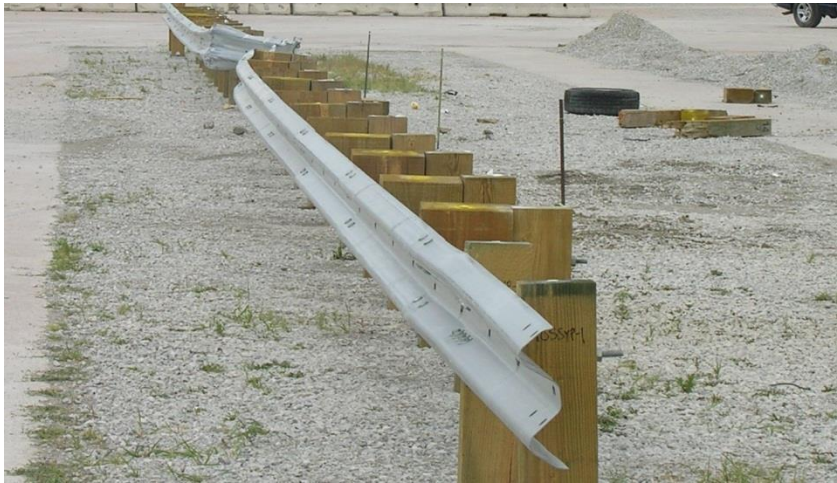
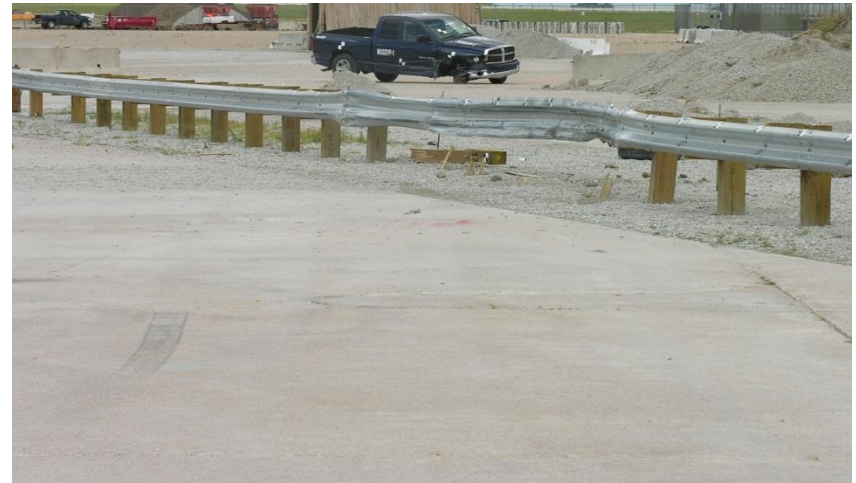
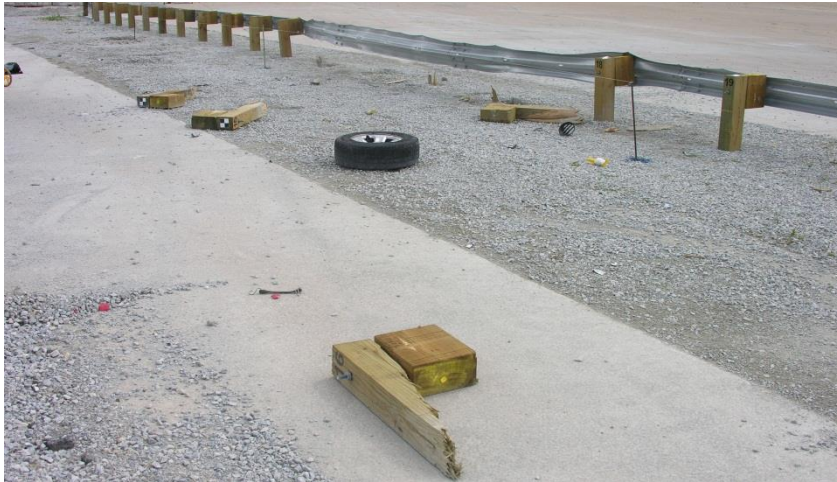
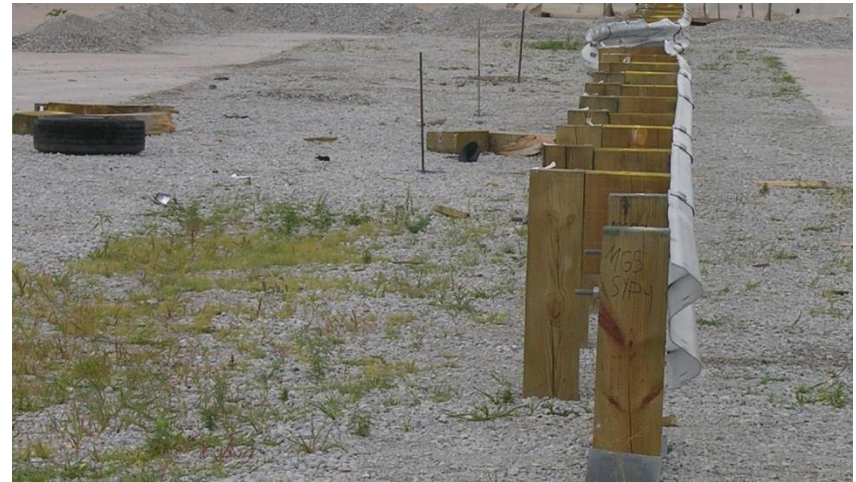
Figure 37. System Damage, Test No. MGSSYP-1

Damage to the barrier was moderate, as shown in Figures 37 through 38 . Barrier damage consisted of deformed guardrail, fractured posts, and contact marks on the front face of the W-beam guardrail. The length of vehicle contact along the barrier was approximately 34 ft – 4 in. (10.5 m) which spanned from 4 in. (102 mm) upstream of the centerline of post no. 13 and extended to 33 in. (838 mm) downstream of post no. 18.

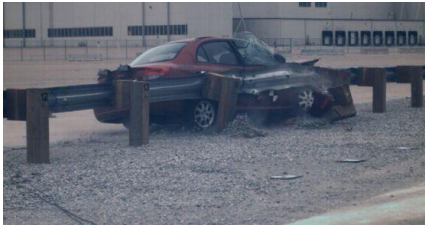
0.136 sec

0.120	The surrogate occupant's head impacted right-front window and shattered it.
0.136	Post no. 15 fractured near groundline.
0.150	The right side of front bumper detached from vehicle.

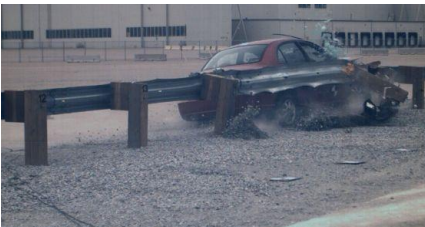
0.222 sec

0.194	The right-front tire impacted post no. 16, causing it to split vertically and fracture near groundline.
0.222	The blockout of post no. 16 detached from post no. 16

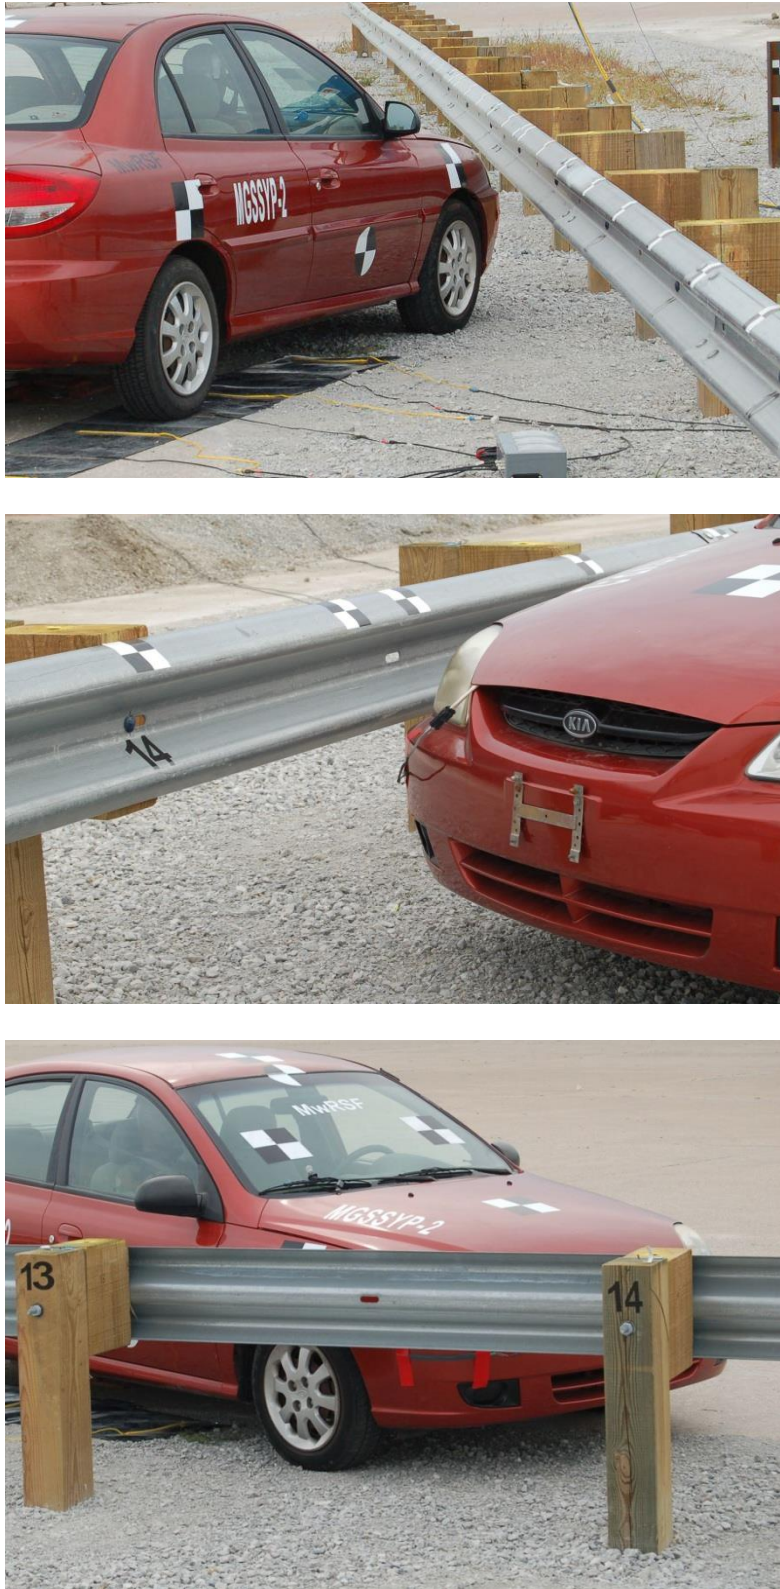
Figure 52. Impact Location, Test No. MGSSYP-2

Initial vehicle impact was to occur 8 ft – 7 in. (2.6 m) upstream of the center line of post no. 15, as shown in Figure 52, which was selected using the CIP plots found in Section 2.3 of MASH to maximize pocketing and the propensity of wheel snag. The actual point of impact was 8 ft – 4 in. (2.5 m) upstream of post no. 15. A sequential description of the impact events is contained in Table 10. The vehicle came to a rest 168 ft – 2 in. (51.3 m) downstream of the impact location and 17 ft – 11 in. (5.5 m) laterally in front of the barrier system, and its trajectory

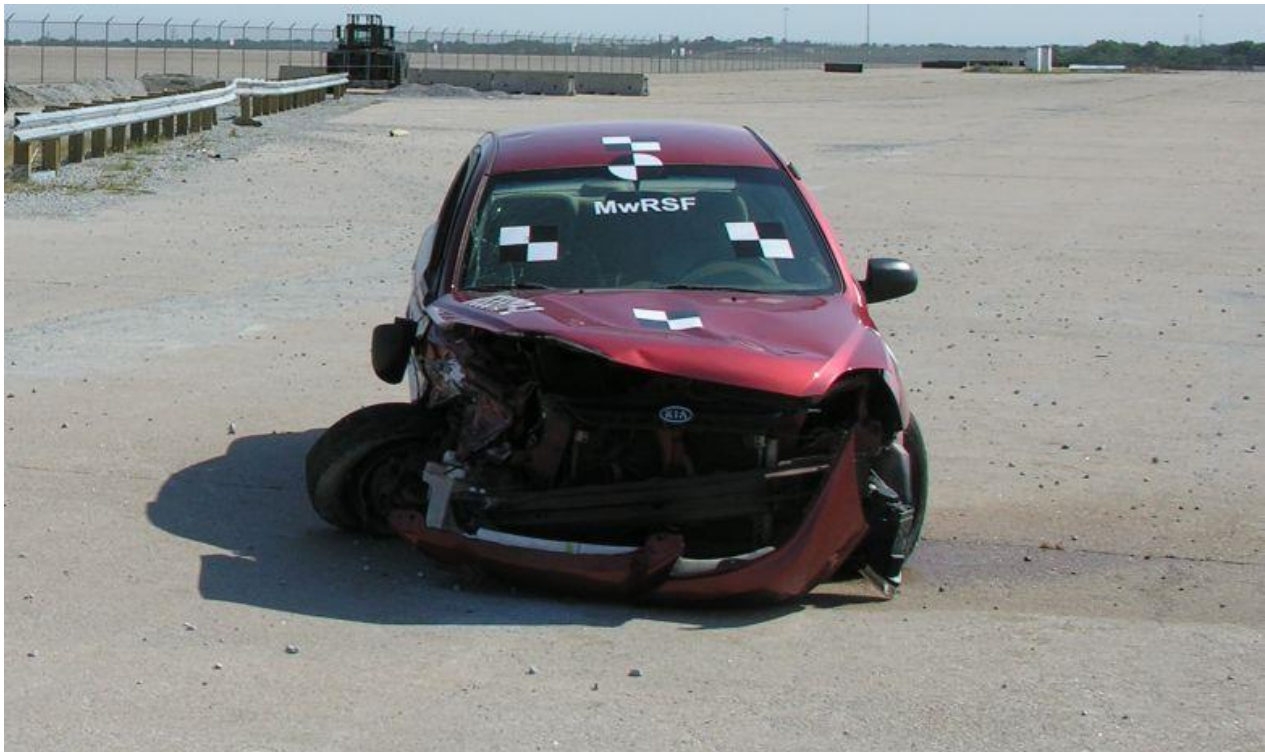
Figure 53. Vehicle Final Position and Trajectory Marks, Test No. MGSSYP-2

did not violate the bounds of the exit box. The vehicle trajectory and final position are shown in Figure 53.

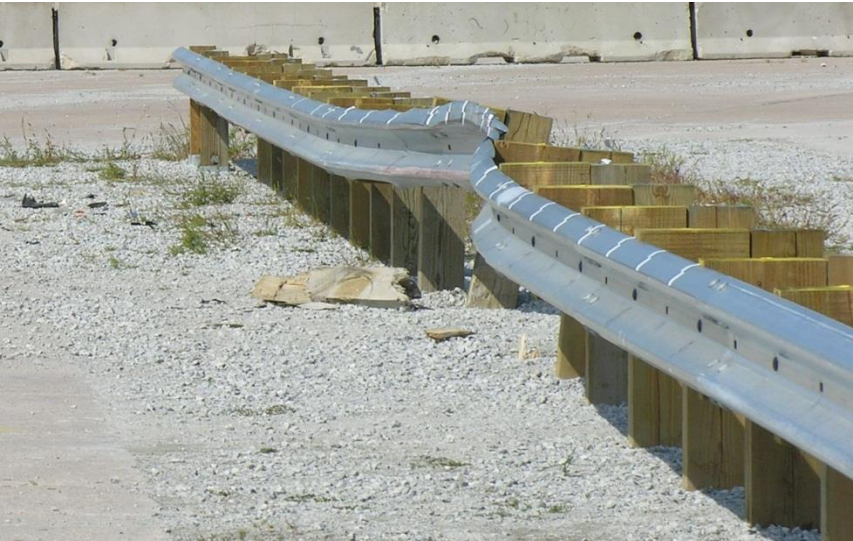
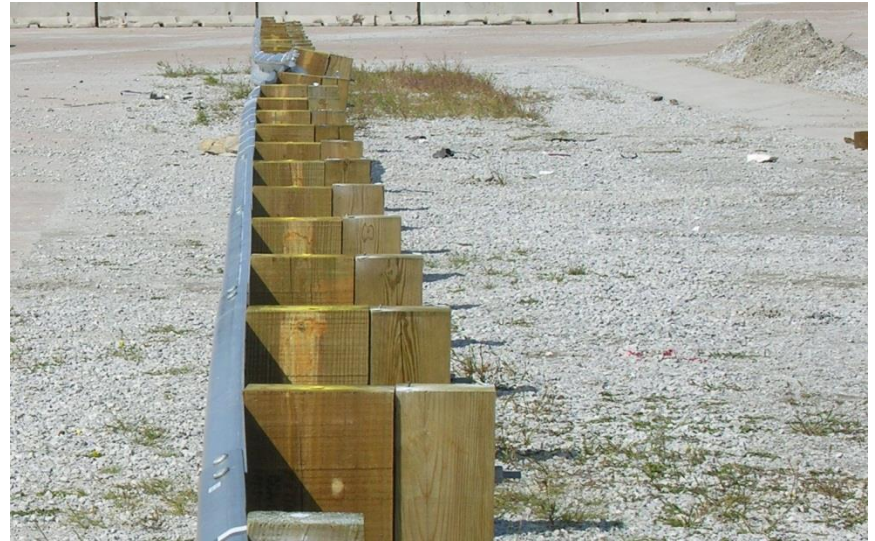
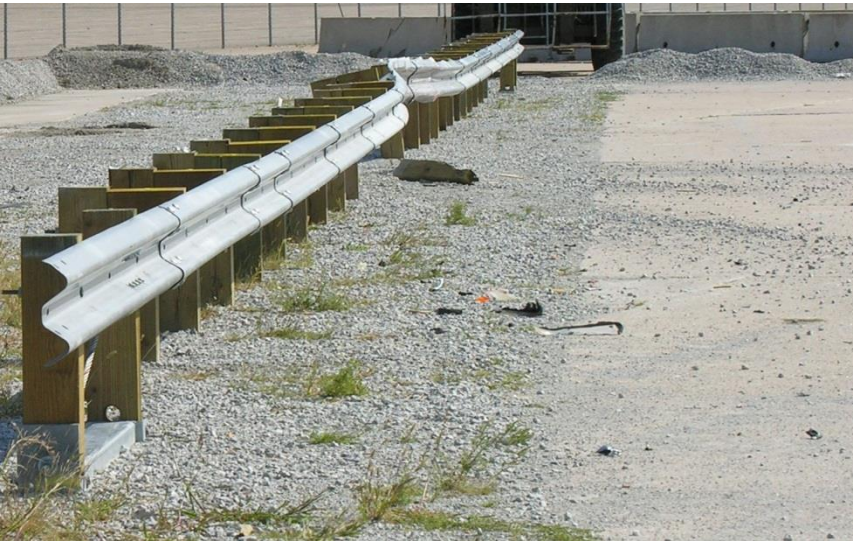
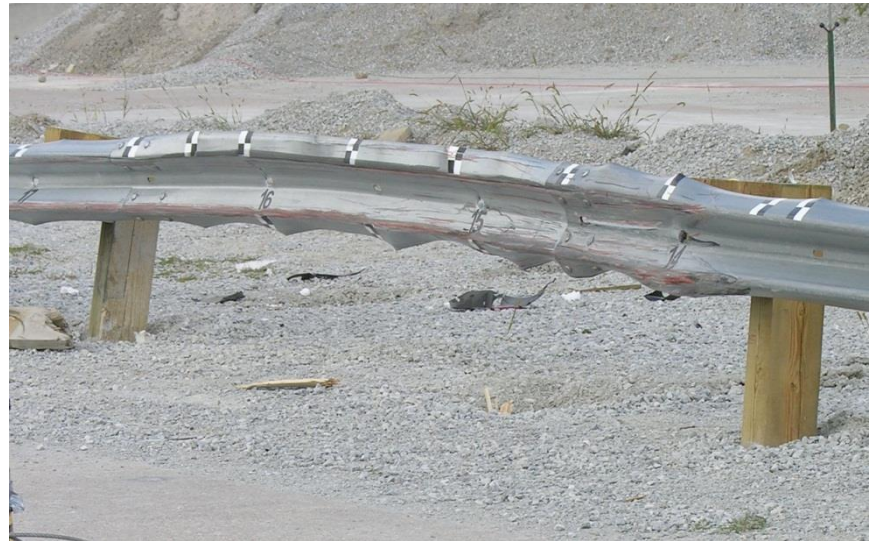
Figure 54. System Damage, Test No. MGSSYP-2

Damage to the barrier was moderate, as shown in Figures 54 through 56. Barrier damage consisted of deformed guardrail, rotated and fractured posts, and contact marks on the guardrail and posts. The length of vehicle contact along the barrier was approximately 23 ft – 1 in. (7.0 m) which spanned from 2 ft – 6½ in. (775 mm) upstream of post no. 14 to 1 ft – 9½ in. (546 mm) downstream of post no. 17.

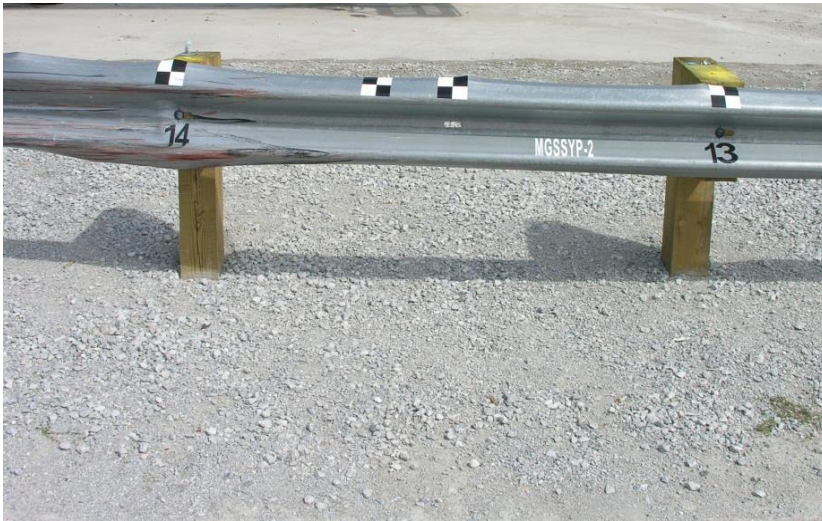
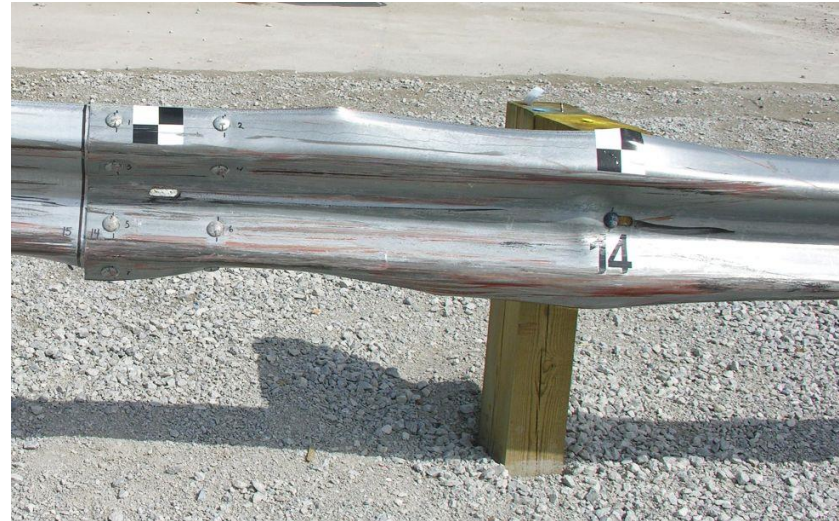
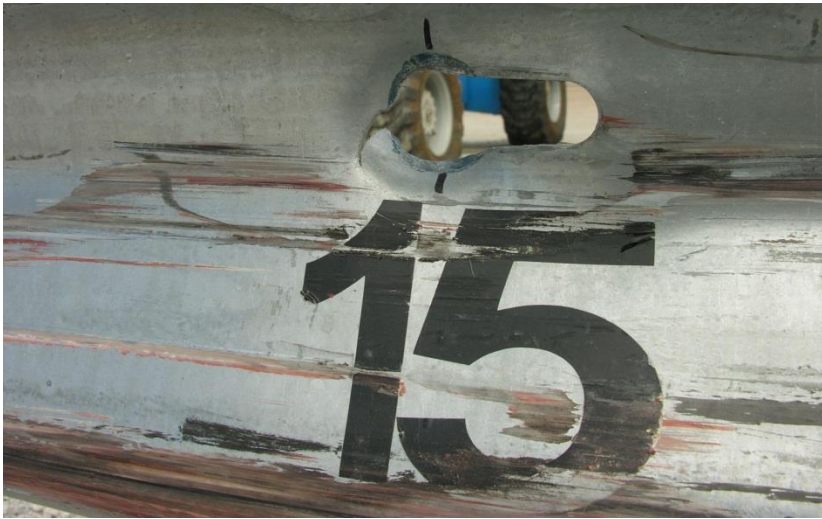
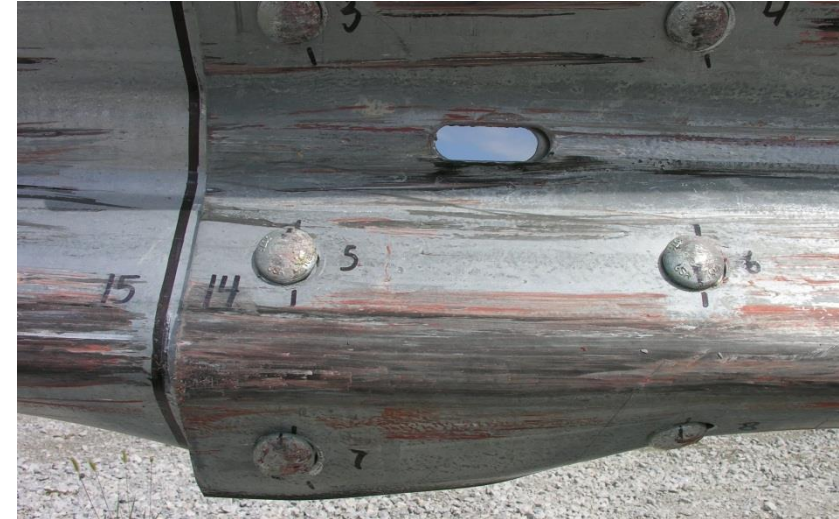
Figure 55. Rail Damage Between Post Nos. 13 and 15, Test No. MGSSYP-2

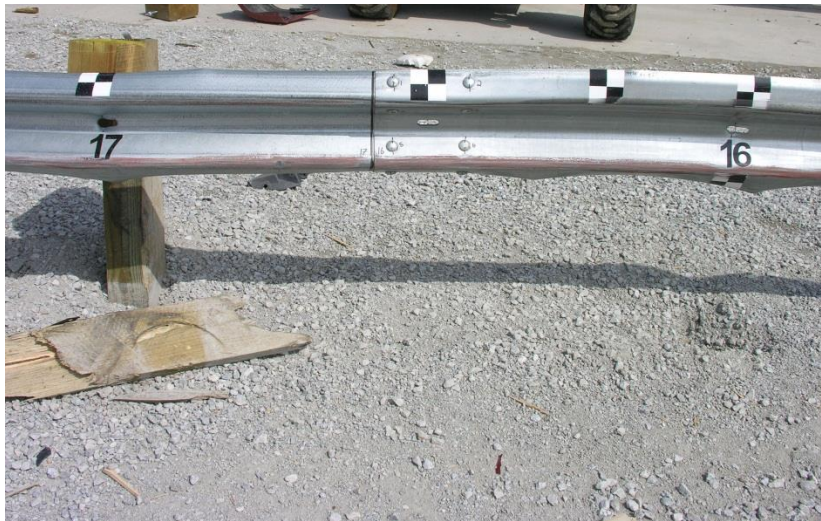
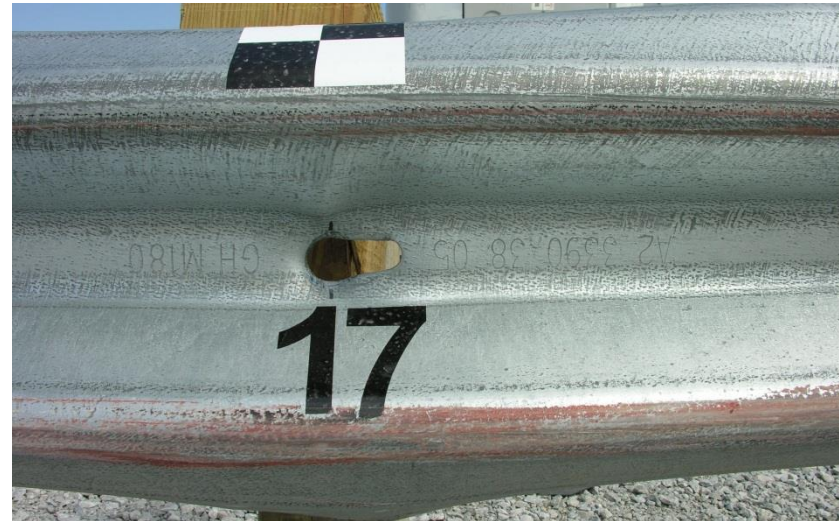
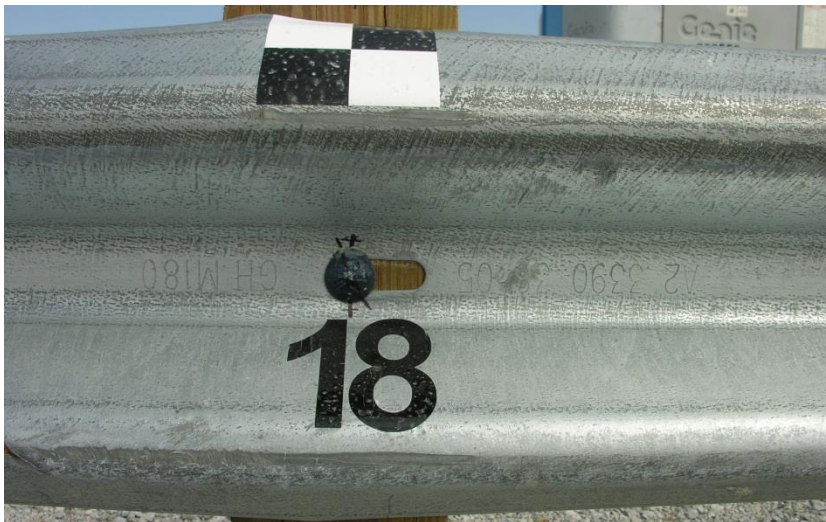
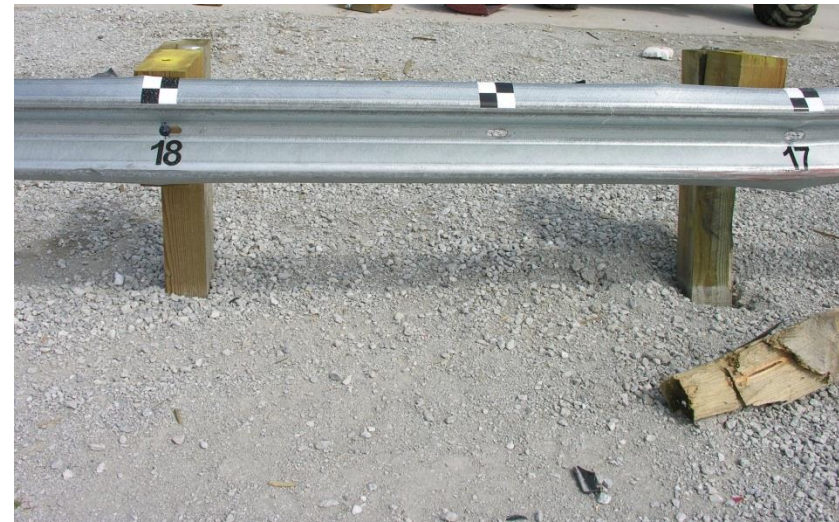
Figure 56. Rail Damage Between Post Nos. 16 and 18, Test No. MGSSYP-2

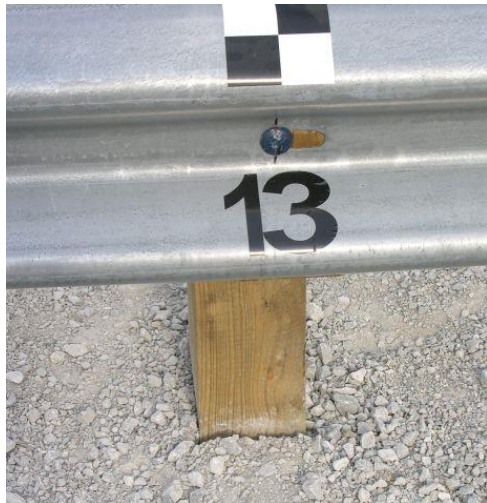
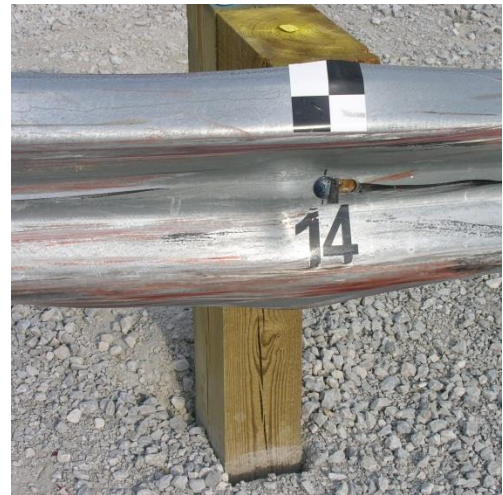
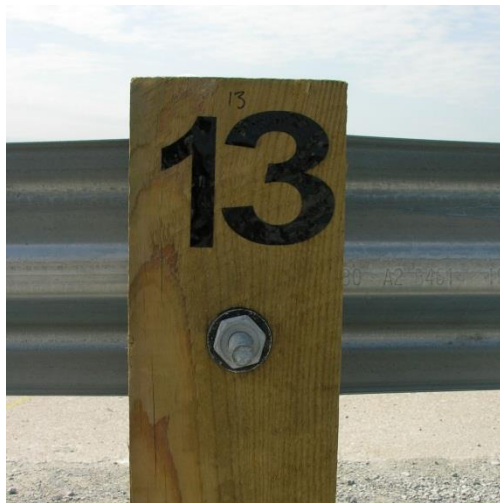
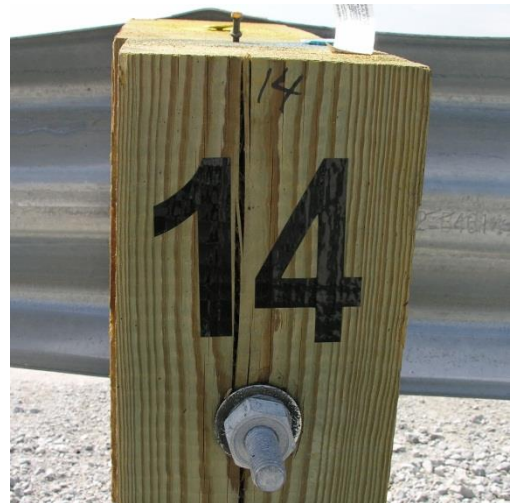
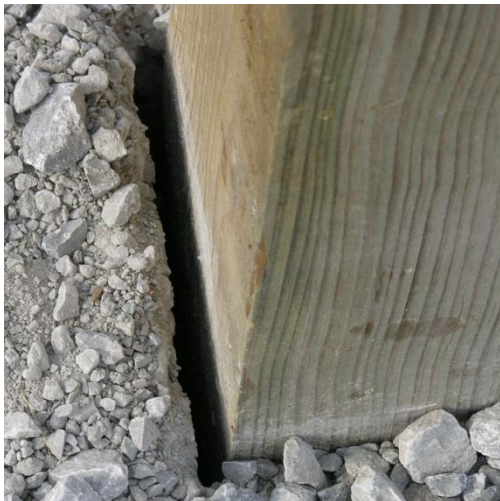
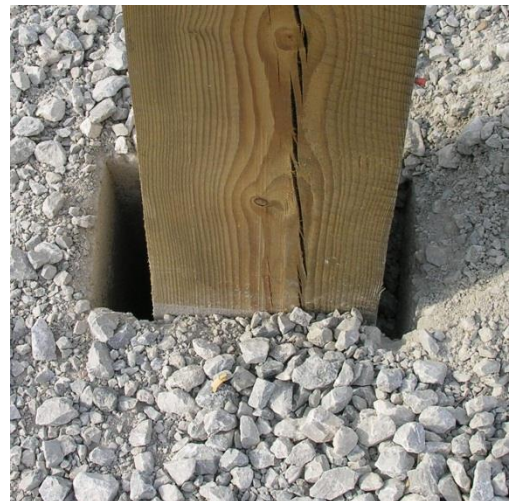
Figure 57. Post Nos. 13 and 14 Damage, Test No. MGSSYP-2

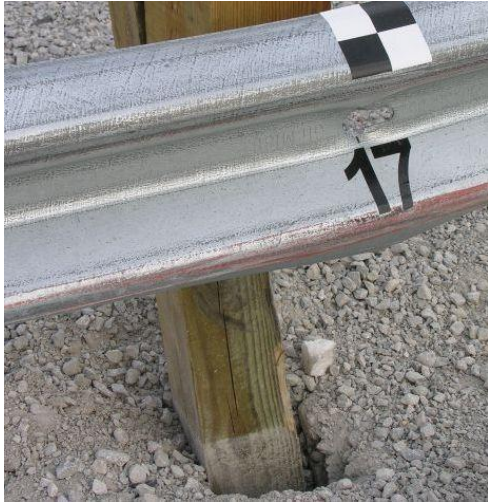
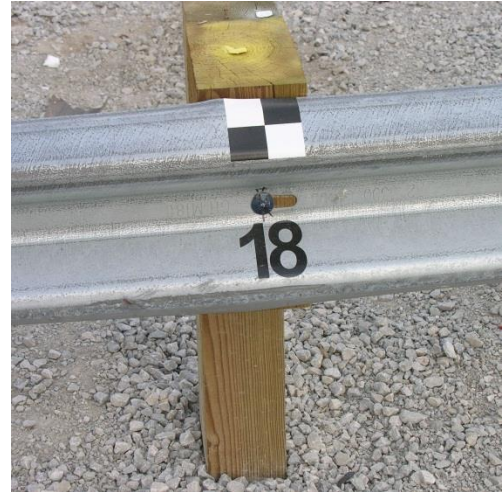
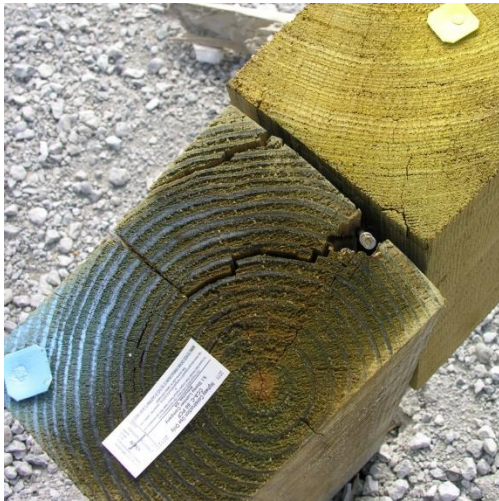
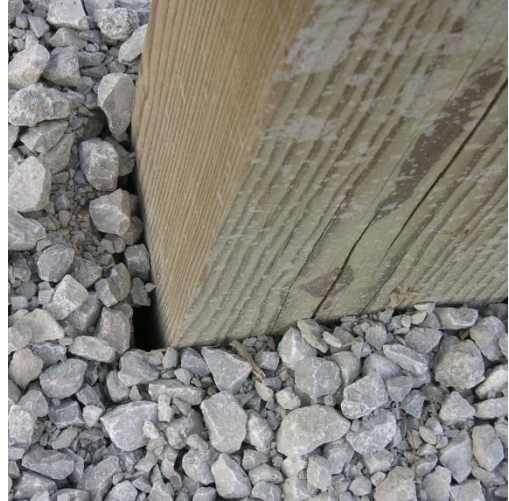
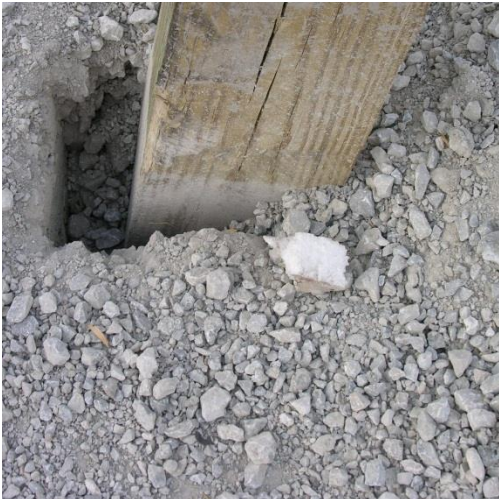
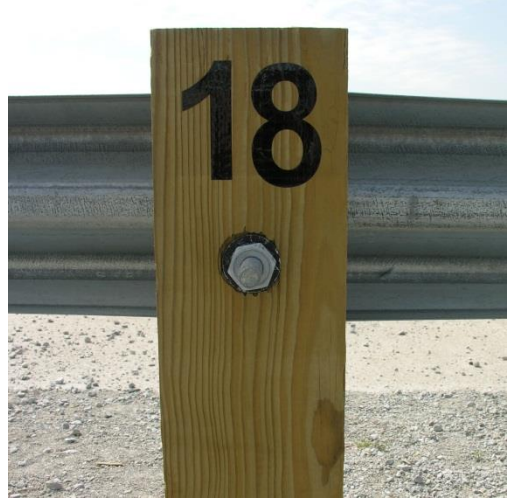
Figure 59. Post Nos. 17 and 18 Damage, Test No. MGSSYP-2

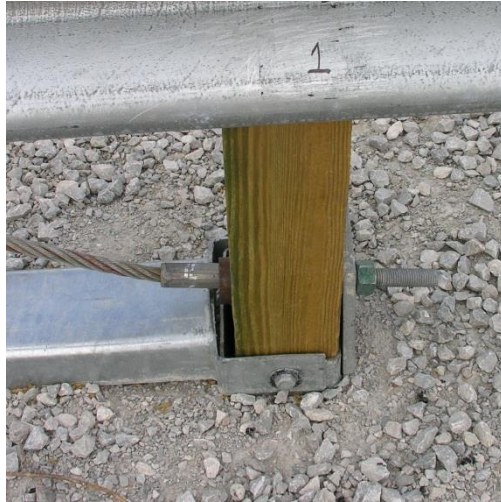
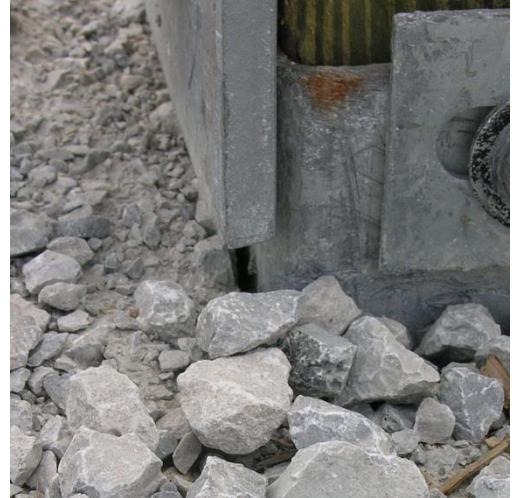
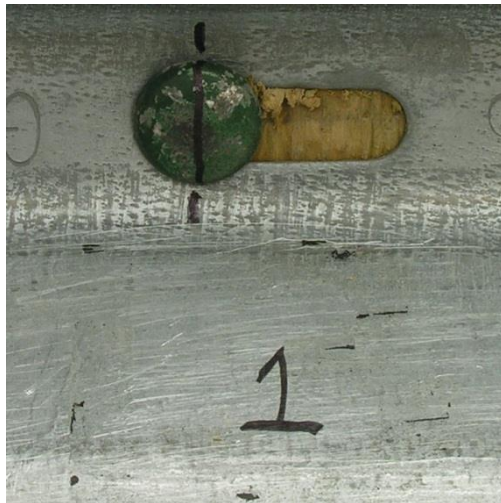
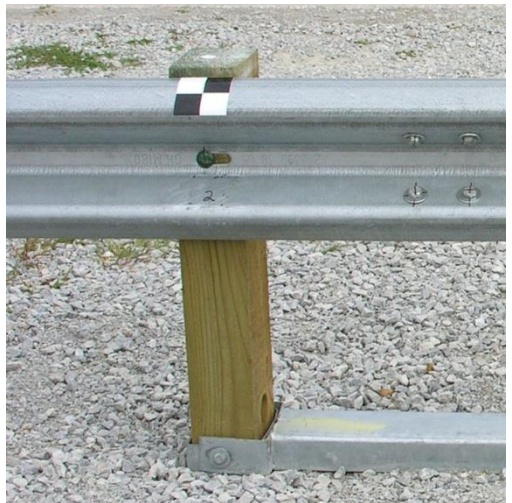
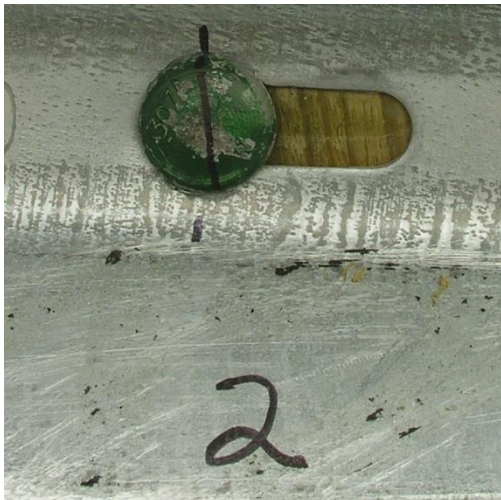
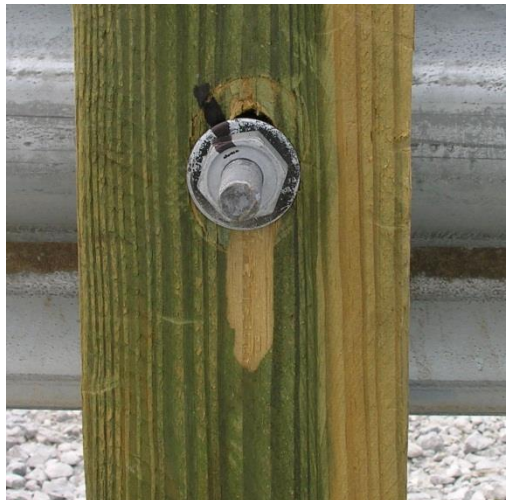
Figure 60. Upstream Anchor Damage, Test No. MGSSYP-2

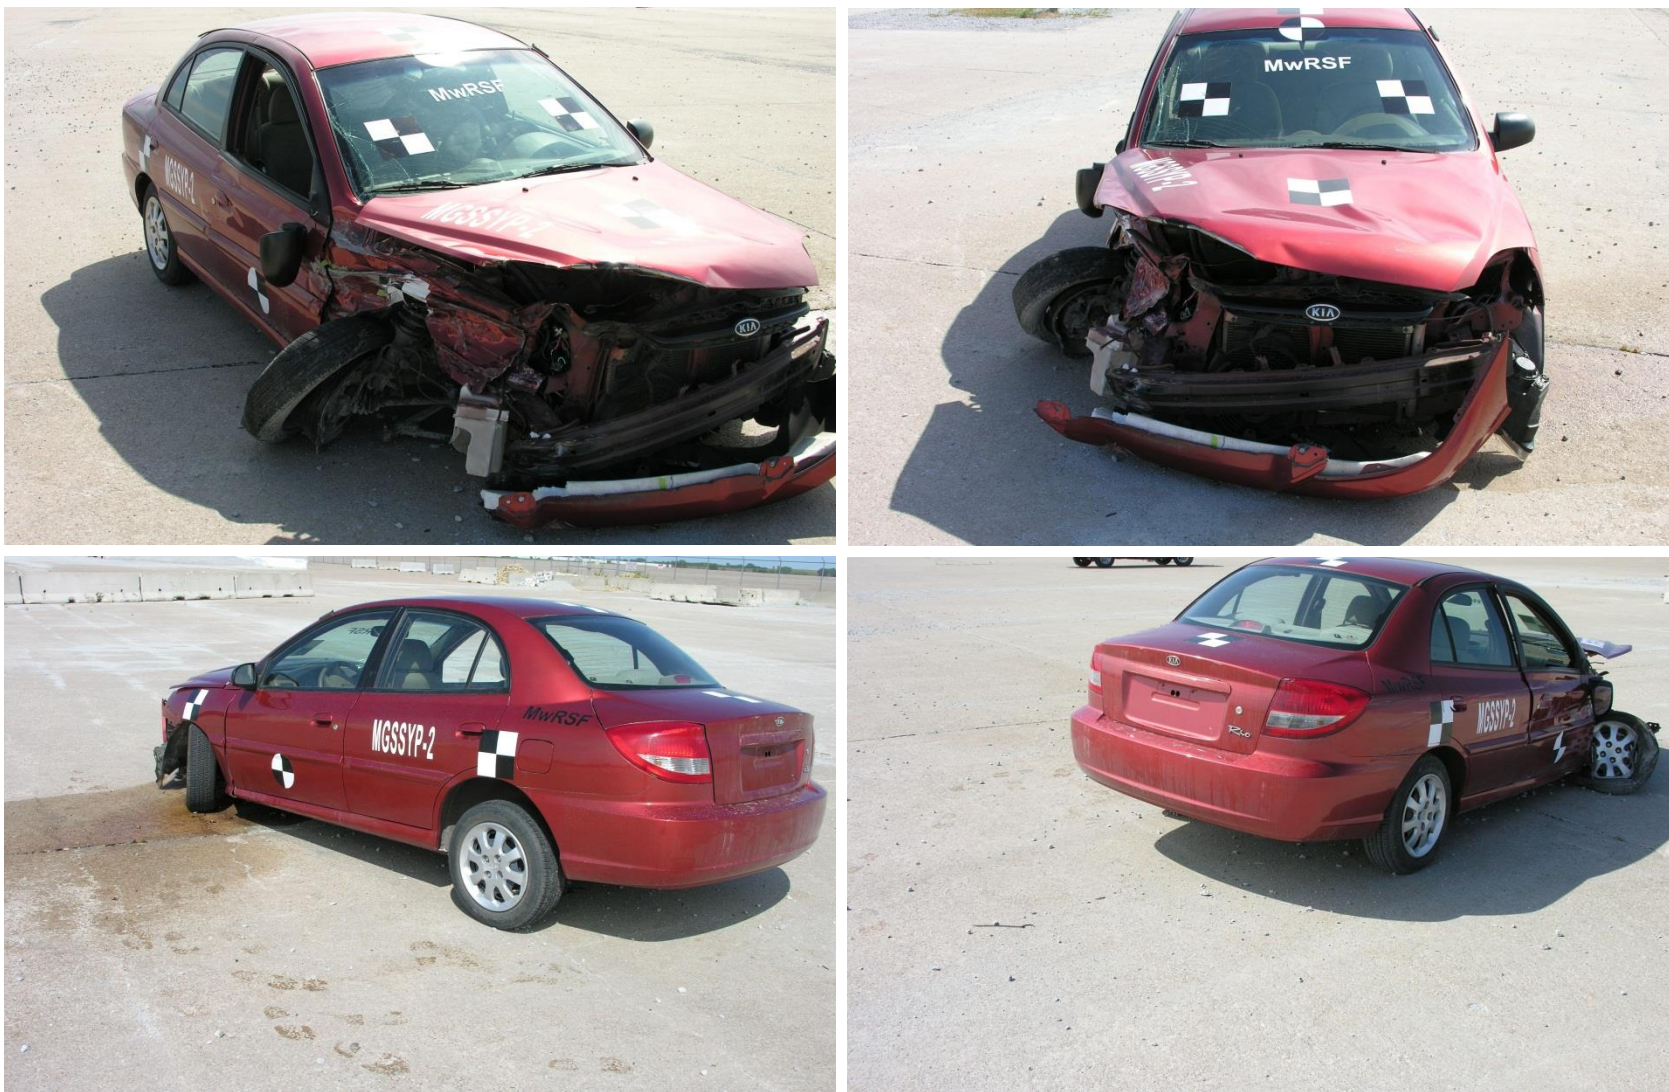
Figure 61. Vehicle Damage, Test No. MGSSYP-2

The damage to the vehicle was moderate, as shown in Figures 61 and 62. The maximum occupant compartment deformations are listed in Table 12 along with the deformation limits established in MASH for various areas of the occupant compartment. Note that none of the MASH established deformation limits were violated. Complete occupant compartment and vehicle deformations and the corresponding locations are provided in Appendix D.
