DYNAMIC EVALUATION OF MGS STIFFNESS TRANSITION WITH CURB

MIDWEST ROADSIDE SAFETY FACILITY

MwRSF Research Report No. TRP-03-291-14

June 30, 2014

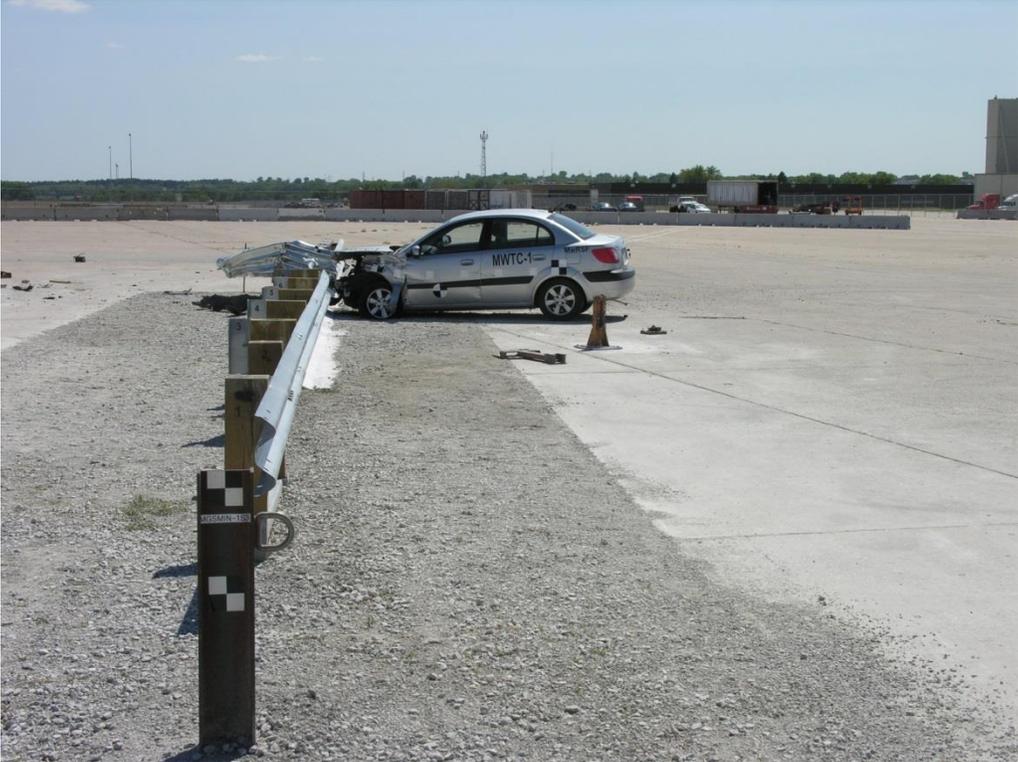
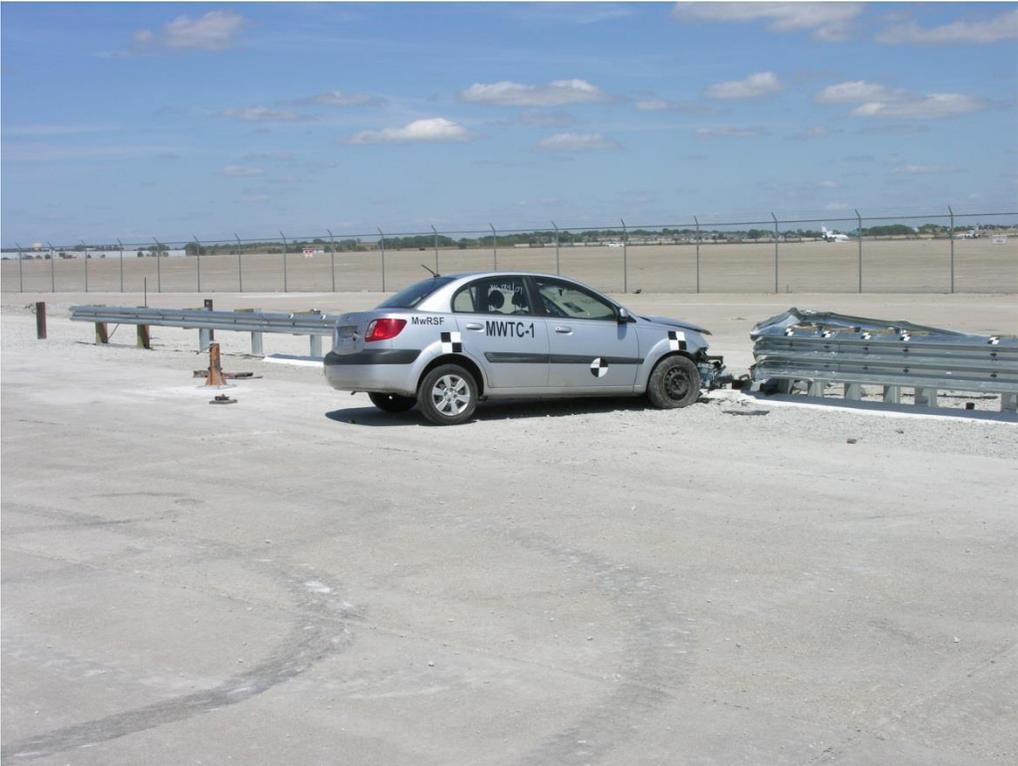
Figure 48. Impact Location, Test No. MWTC-1

Initial vehicle impact was to occur 18¾ in. (476 mm) downstream of post no. 7, as shown in Figure 48, which was selected based on previous testing [1-2]. The actual point of impact was 4 in. (102 mm) upstream of the target impact location. A sequential description of the impact events is contained in Table 4. The vehicle came to rest in front of post no. 11 and was facing the barrier. This location was 15.8 ft (4.8 m) downstream of impact and 4.3 ft (1.3 m) laterally in front of the system. The vehicle trajectory and final position are shown in Figures 45 and 49.

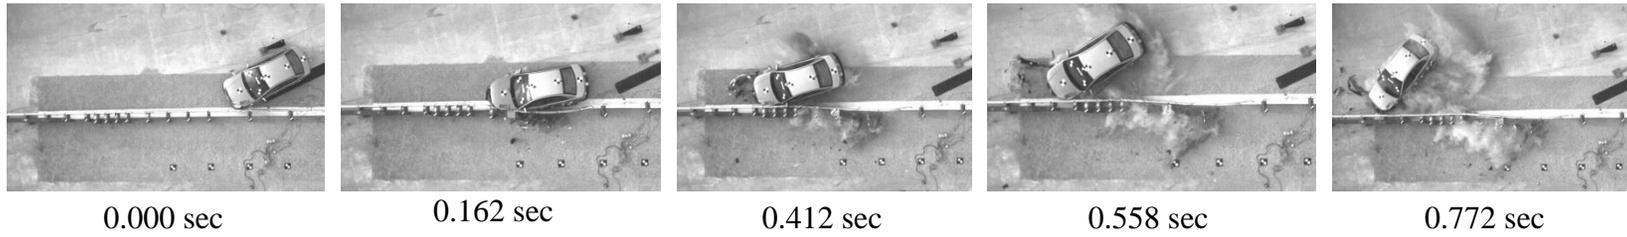
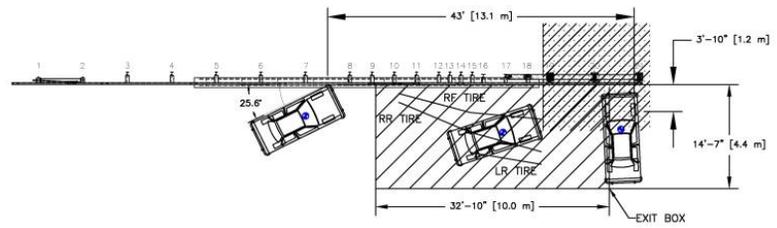
Figure 84. Summary of Test Results and Sequential Photographs, Test No. MWTC-2

- Vehicle Stopping Distance.....43.0 ft (13.1 m) downstream of impact
..... 3.8 ft (1.2 m) laterally in front of system
- Vehicle Damage..... Moderate
VDS^[7]..... 11-LFQ5
CDC^[8]..... 11-LFEW2
Maximum Interior Deformation..... 1 in. (25 mm)
- Test Article Damage Moderate
- Maximum Test Article Deflections
 - Permanent Set..... 16.1 in. (409 mm)
 - Dynamic 16.4 in. (417 mm)
 - Working Width 32.5 in. (826 mm)
- Maximum Angular Displacements
 - Roll -13.7° < 75°
 - Pitch..... -8.6° < 75°
 - Yaw -70.7°
- Transducer Data

Evaluation Criteria		Transducer			MASH Limit
		DTS	DTS SLICE	EDR-3	
OIV ft/s (m/s)	Longitudinal	-22.23 (6.78)	-23.04 (-7.02)	-24.21 (-7.38)	≤ 40 (12.2)
	Lateral	22.53 (6.87)	24.14 (7.36)	21.19 (6.46)	≤ 40 (12.2)
ORA g's	Longitudinal	-15.65	-16.58	-11.72	≤ 20.49
	Lateral	13.45	12.45	10.88	≤ 20.49
THIV – ft/s (m/s)		31.66 (9.65)	31.79 (9.69)	NA	not required
PHD – g's		15.69	18.84	NA	not required
ASI		1.32	1.40	1.27	not required

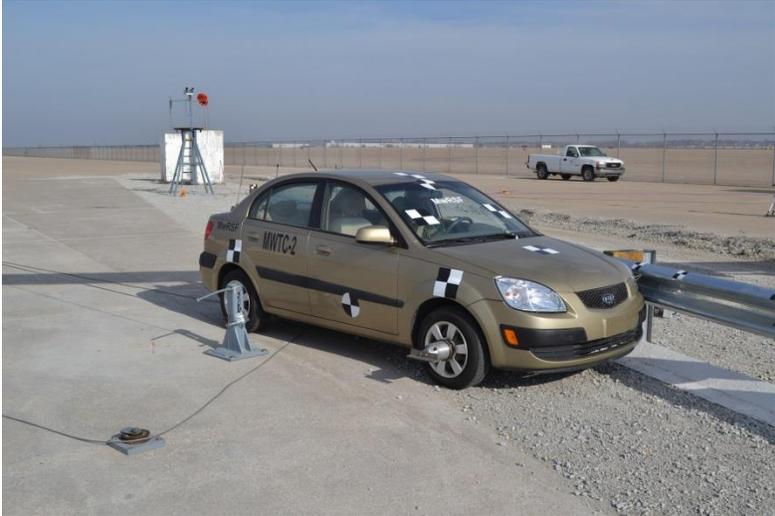
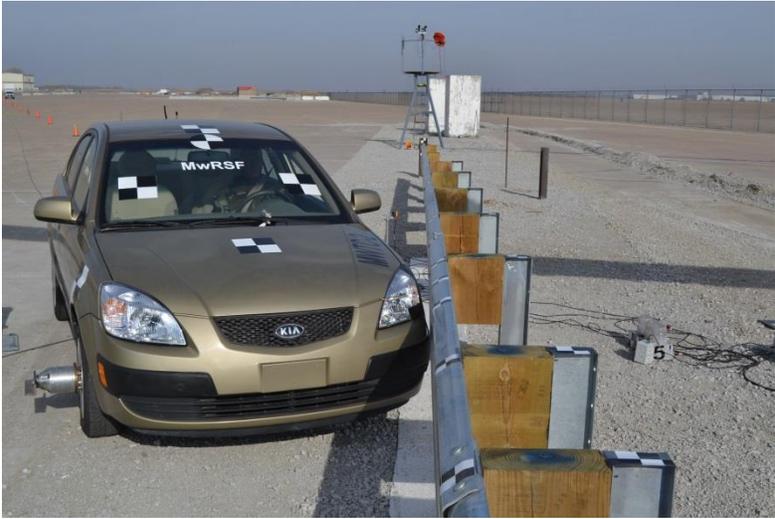
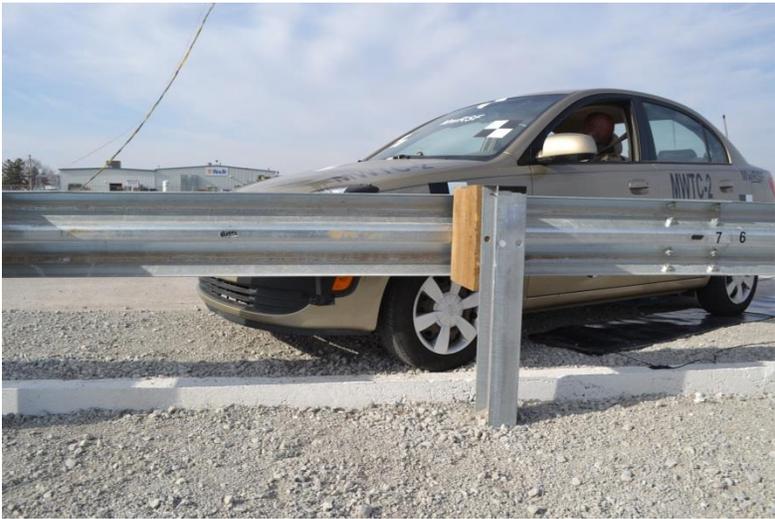
Figure 87. Impact Location, Test No. MWTC-2

Initial vehicle impact was to occur 18¾ in. (476 mm) downstream of post no. 7, as shown in Figure 87. The actual point of impact was 11¼ in. (286 mm) downstream of post no. 7. A sequential description of the impact events is contained in Table 8. The vehicle came to rest 43.0 ft (13.1 m) downstream of impact and 3.8 ft (1.2 m) laterally in front of the system. The vehicle trajectory and final position are shown in Figures 84 and 88.

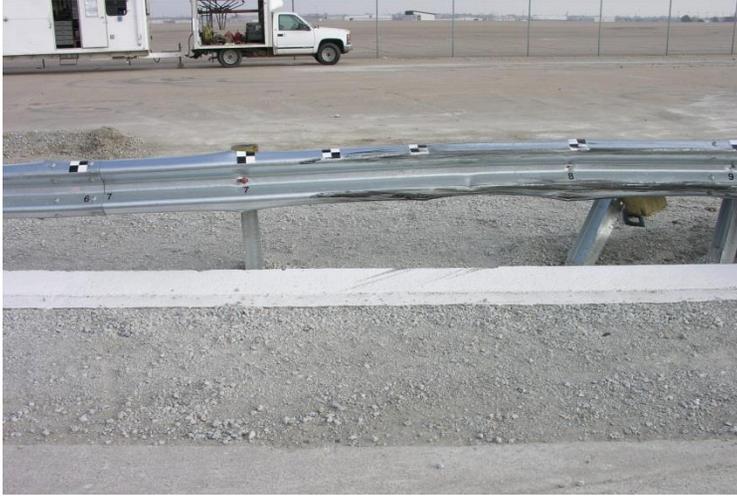
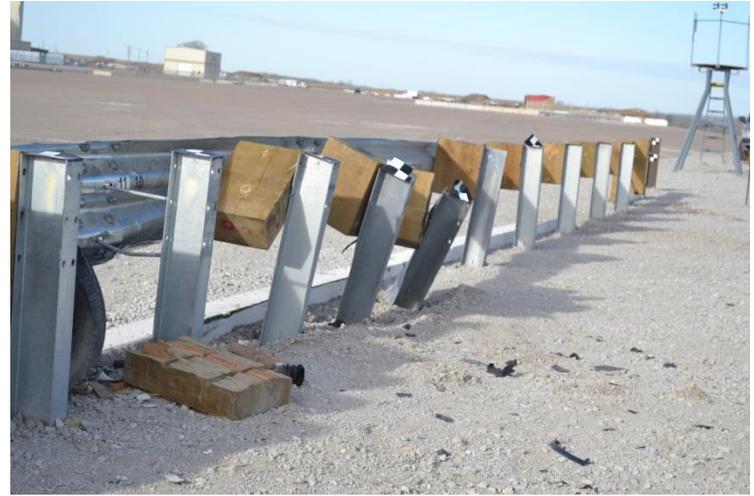
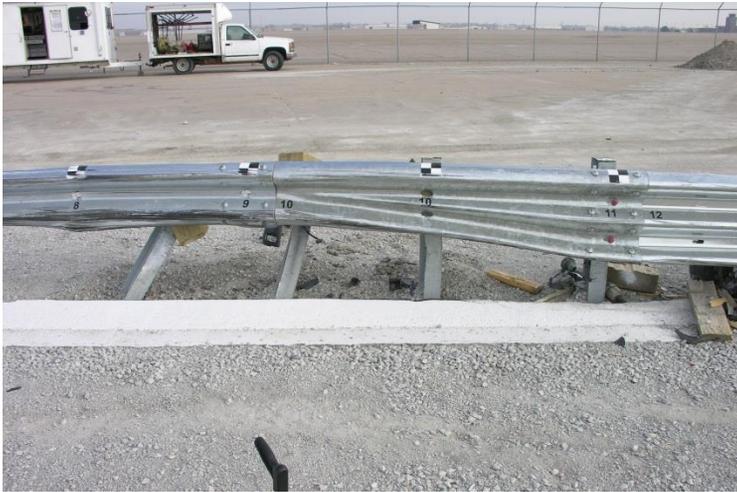
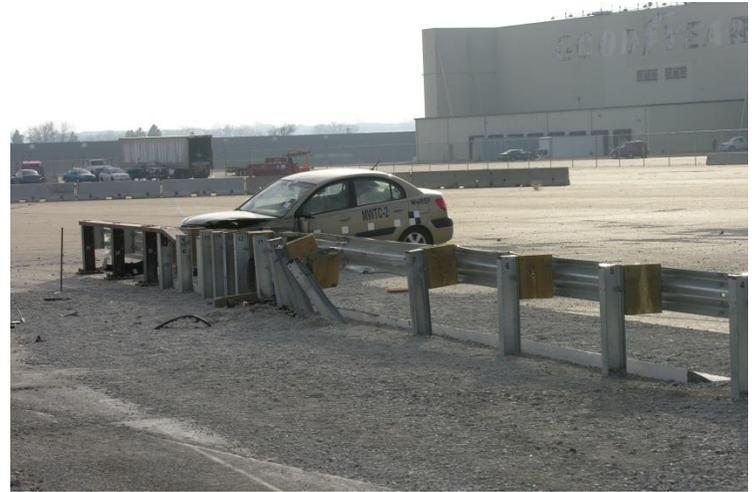
Figure 89. Impact Region Damage, Test No. MWTC-2

0.230	The blockout at post no. 11 fractured.
0.240	The vehicle's right-rear tire was airborne.
0.242	Vehicle's front bumper even with post no. 13, and vehicle nearly parallel with system.

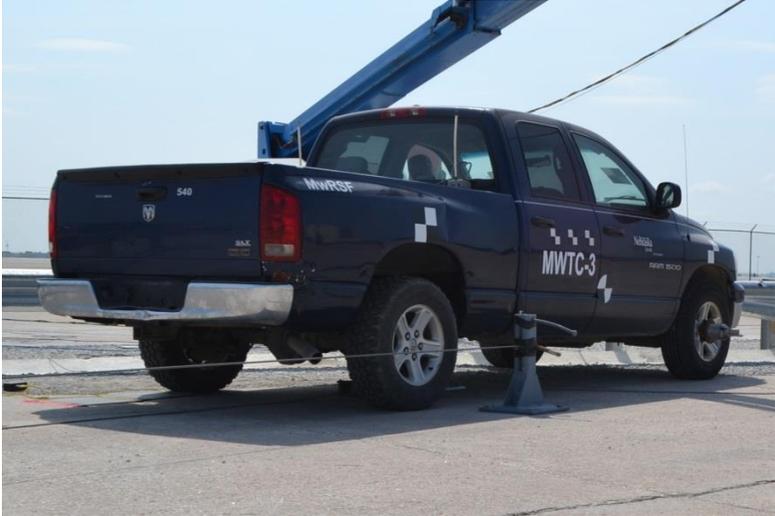
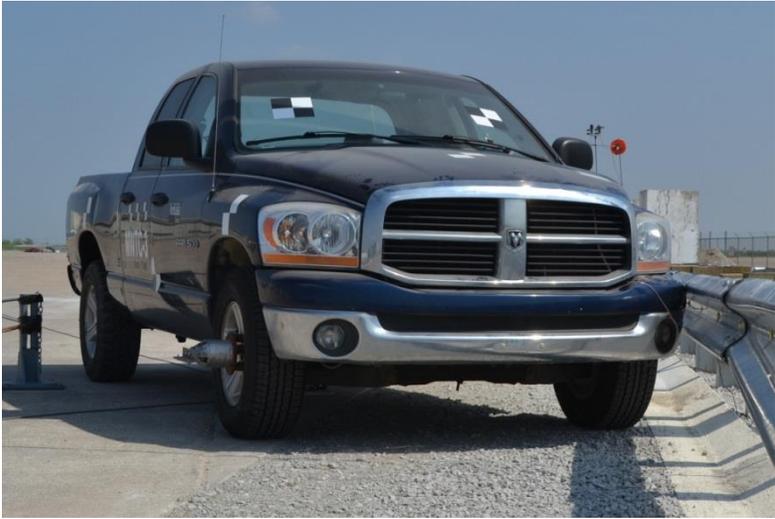
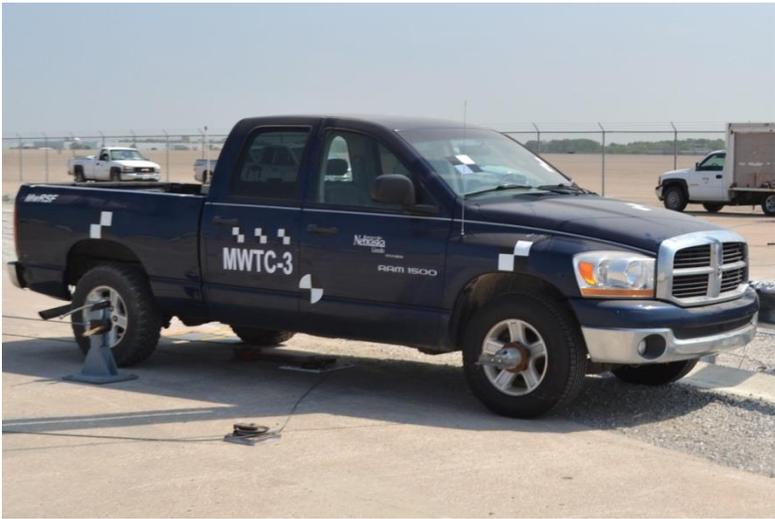
Figure 96. Impact Location, Test No. MWTC-3

Initial vehicle impact was to occur 75 in. (1,905 mm) upstream of post no. 9, as shown in Figure 96, which was selected based on previous testing [1-2]. Initial vehicle impact occurred at the targeted impact point. A sequential description of the impact events is contained in Table 12. The vehicle came to rest 101 ft (30.8 m) downstream of impact and 6.4 ft (2.0 m) laterally behind the system. The vehicle trajectory and final position are shown in Figures 93 and 97.
