MASH TEST NOS. 3-17 AND 3-11 ON A NON-PROPRIETARY CABLE MEDIAN BARRIER

MIDWEST ROADSIDE SAFETY FACILITY

MwRSF Research Report No. TRP-03-303-15

November 3, 2015

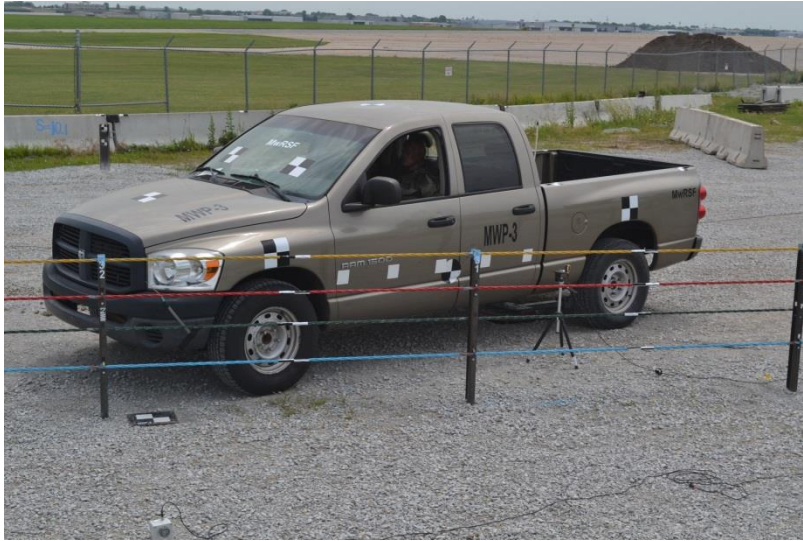
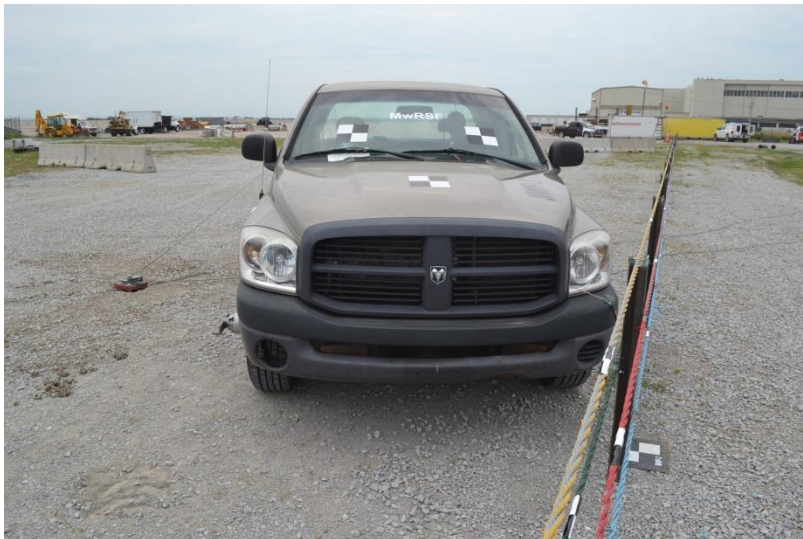
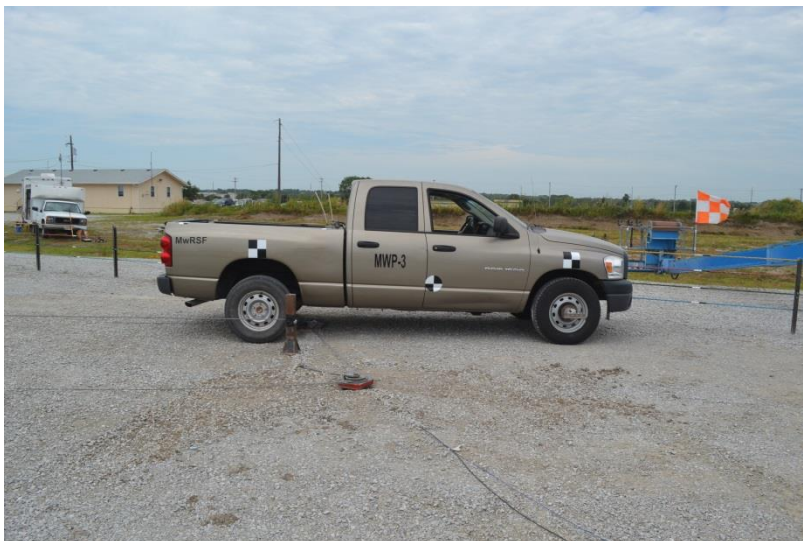
Figure 5. Test Vehicle, Test No. MWP-3

Note any damage prior to test: shallow dent along bottom of passenger front door. Dent in front bumper

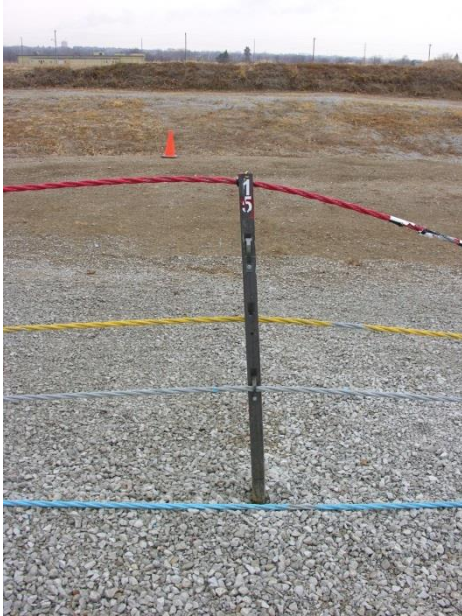
Post No. 15

Figure 46. System Damage, Post Nos. 15 through 17, Test No. MWP-1

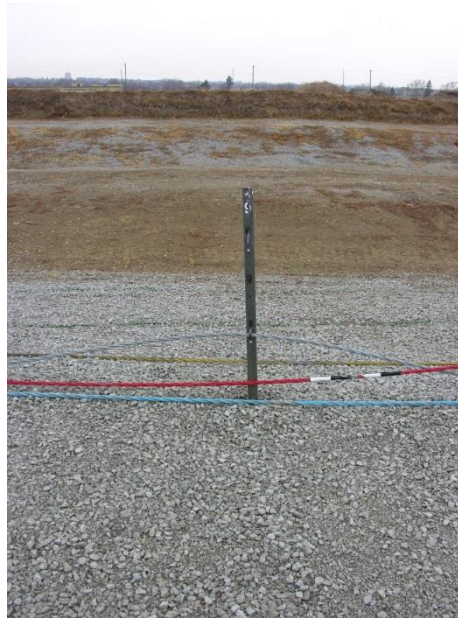
Post No. 19

Figure 47. System Damage, Post Nos. 18 through 20, Test No. MWP-1

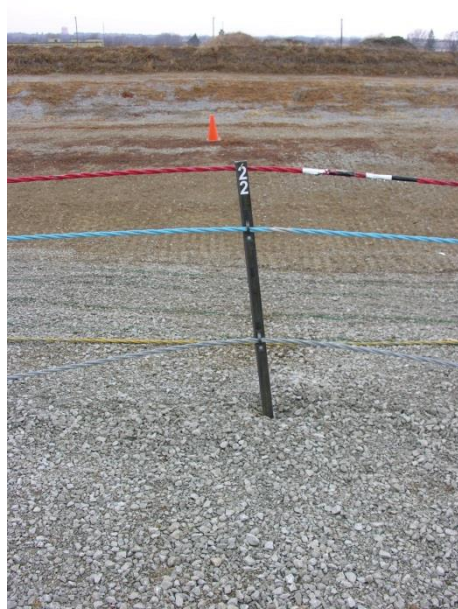
Post No. 22

Figure 48. System Damage, Post Nos. 21 through 23, Test No. MWP-1

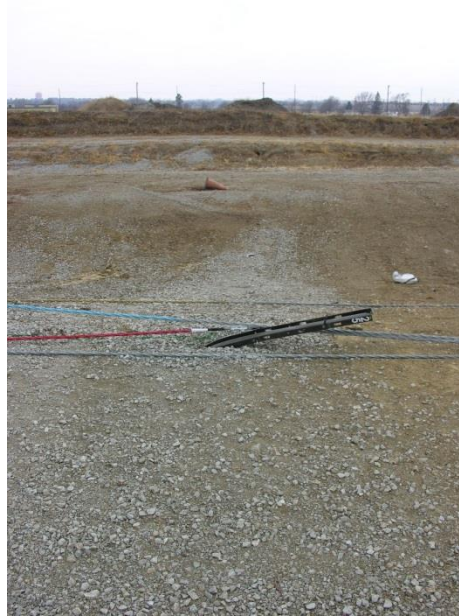
Post No. 25

Figure 49. System Damage, Post Nos. 24 through 26, Test No. MWP-1

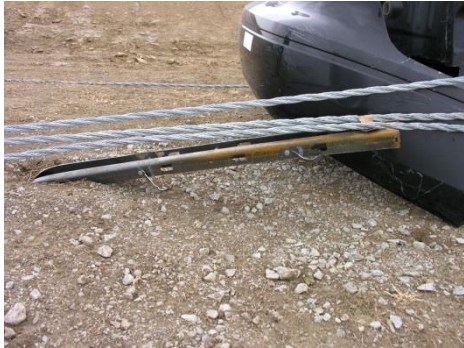
Post No. 27

Figure 50. System Damage, Post Nos. 27 through 29, Test No. MWP-1

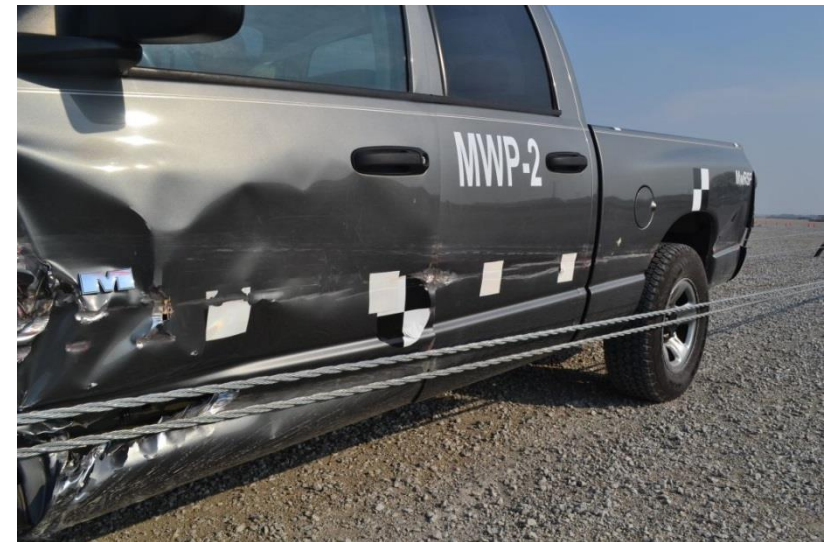
Figure 68. Vehicle Damage, Test No. MWP-2

The damage to the vehicle was moderate, as shown in Figure 68. The maximum occupant compartment deformations are listed in Table 11 along with the deformation limits established in MASH for various areas of the occupant compartment. Note that none of the MASH-established deformation limits were violated. Complete occupant compartment and vehicle deformations are provided in Appendix D.

- Vehicle Damage..... Moderate
 - VDS [14] 11-LFQ-3
 - CDC [15]..... 11-LFEN-5
 - Maximum Interior Deformation 3/4 in. (19 mm)

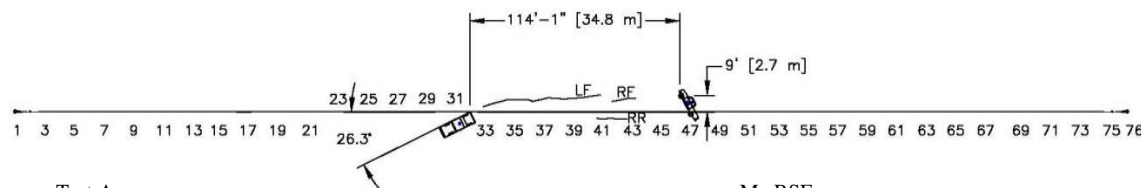
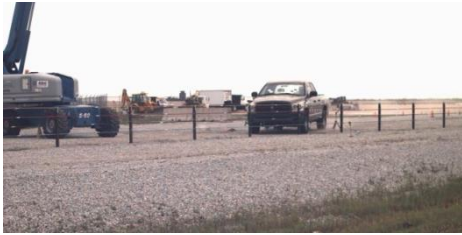
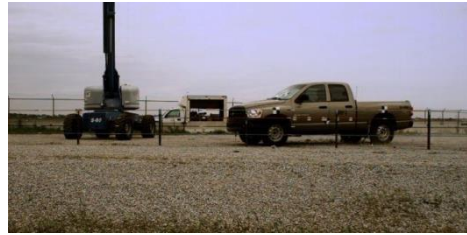
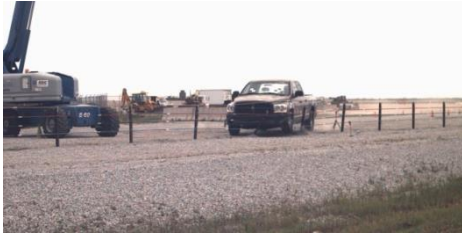
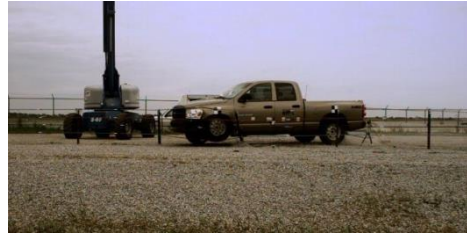
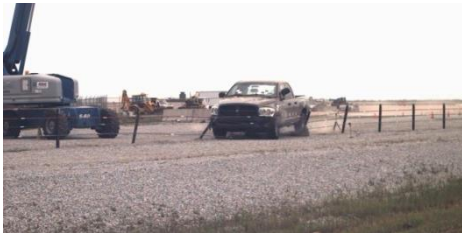
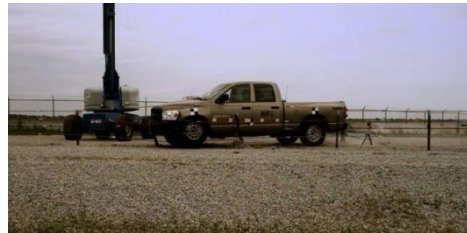
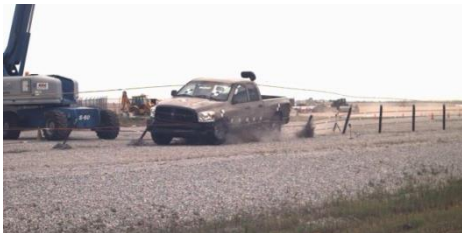
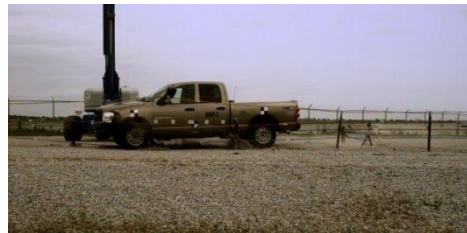
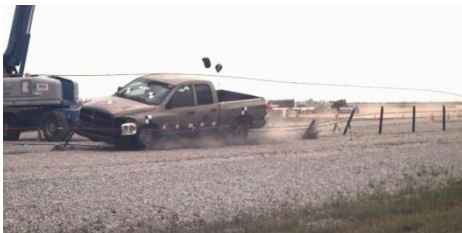
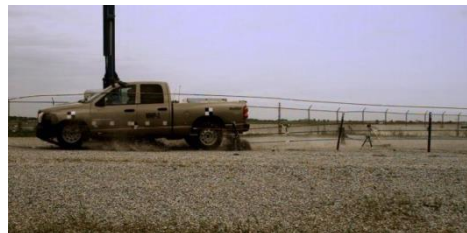
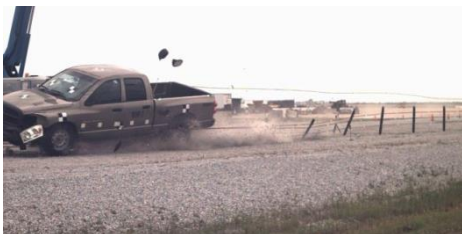
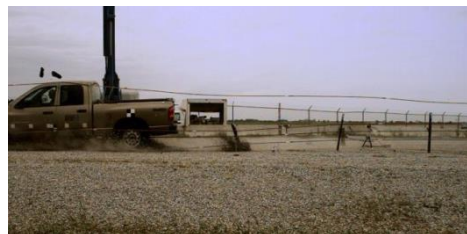
Figure 94. Summary of Test Results and Sequential Photographs, Test No. MWP-3

- Exit Conditions
 - Speed NA
 - Angle NA
- Exit Box Criterion NA
- Vehicle Stability..... Unsatisfactory
- Vehicle Stopping Distance 114 ft 1 in. (34.8 m)
- Vehicle Damage Extensive

- Test Article Damage Moderate
- Maximum Test Article Deflections
 - Permanent SetNA
 - Dynamic..... 80.7 in. (2,250 mm)
 - Working Width..... 100.7 in. (2,558 mm)
- Transducer Data

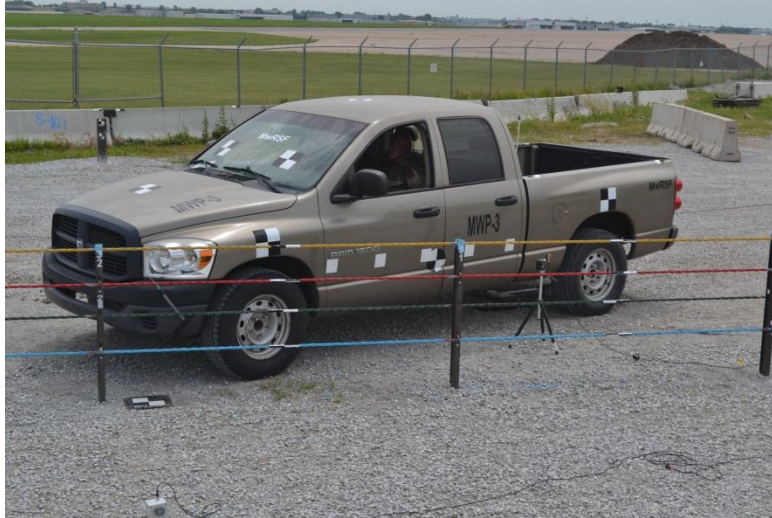
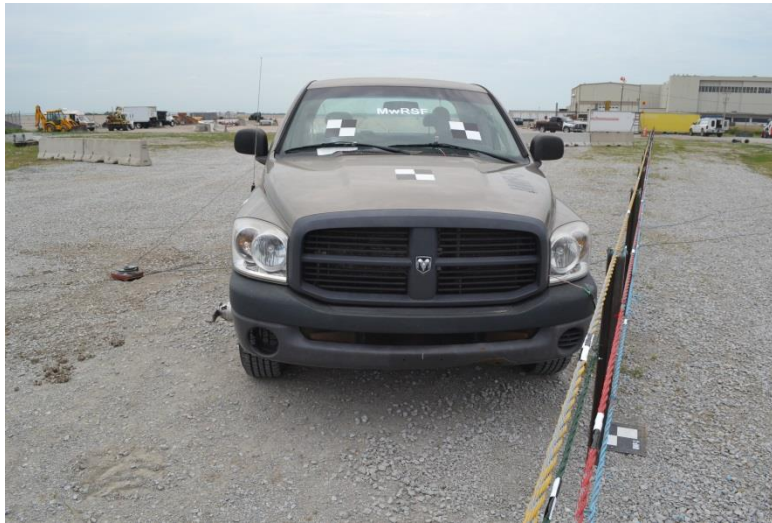
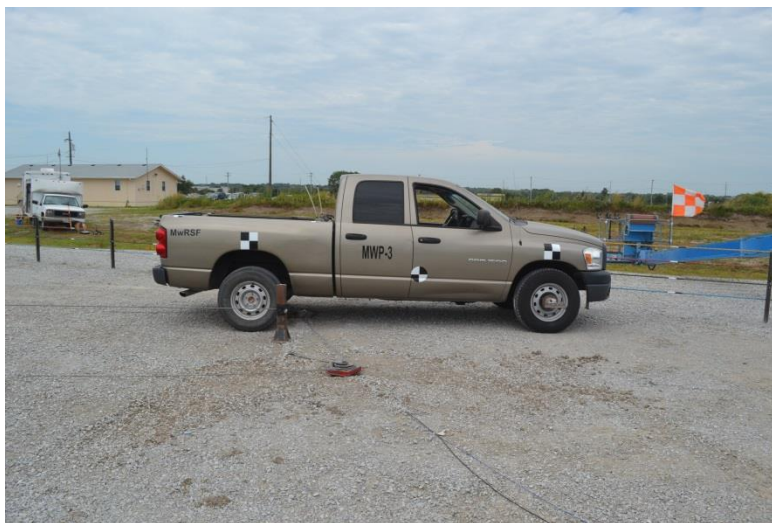
Figure 101. Impact Location, Test No. MWP-3

Initial vehicle impact was to occur 12 in. (305 mm) upstream from post no. 32, as shown in Figure 101, which was selected according to MASH. The actual point of impact was approximately 8 in. (203 mm) upstream from post no. 32. A sequential description of the impact events is contained in Table 15. The vehicle came to rest on its right side in line with the system 114 ft – 1 in. (34.8 m) downstream from the point of impact, with the system cables underneath it. The vehicle trajectory and final position are shown in Figures 94 and 102.
