PHASE III DEMONSTRATION OF PONDEROSA PINE ROUND POSTS AS ALTERNATIVE TO RECTANGULAR SYP POSTS IN G4(2W) GUARDRAIL SYSTEMS

MwRSF Research Report No. TRP-03-329-15

May 17, 2016

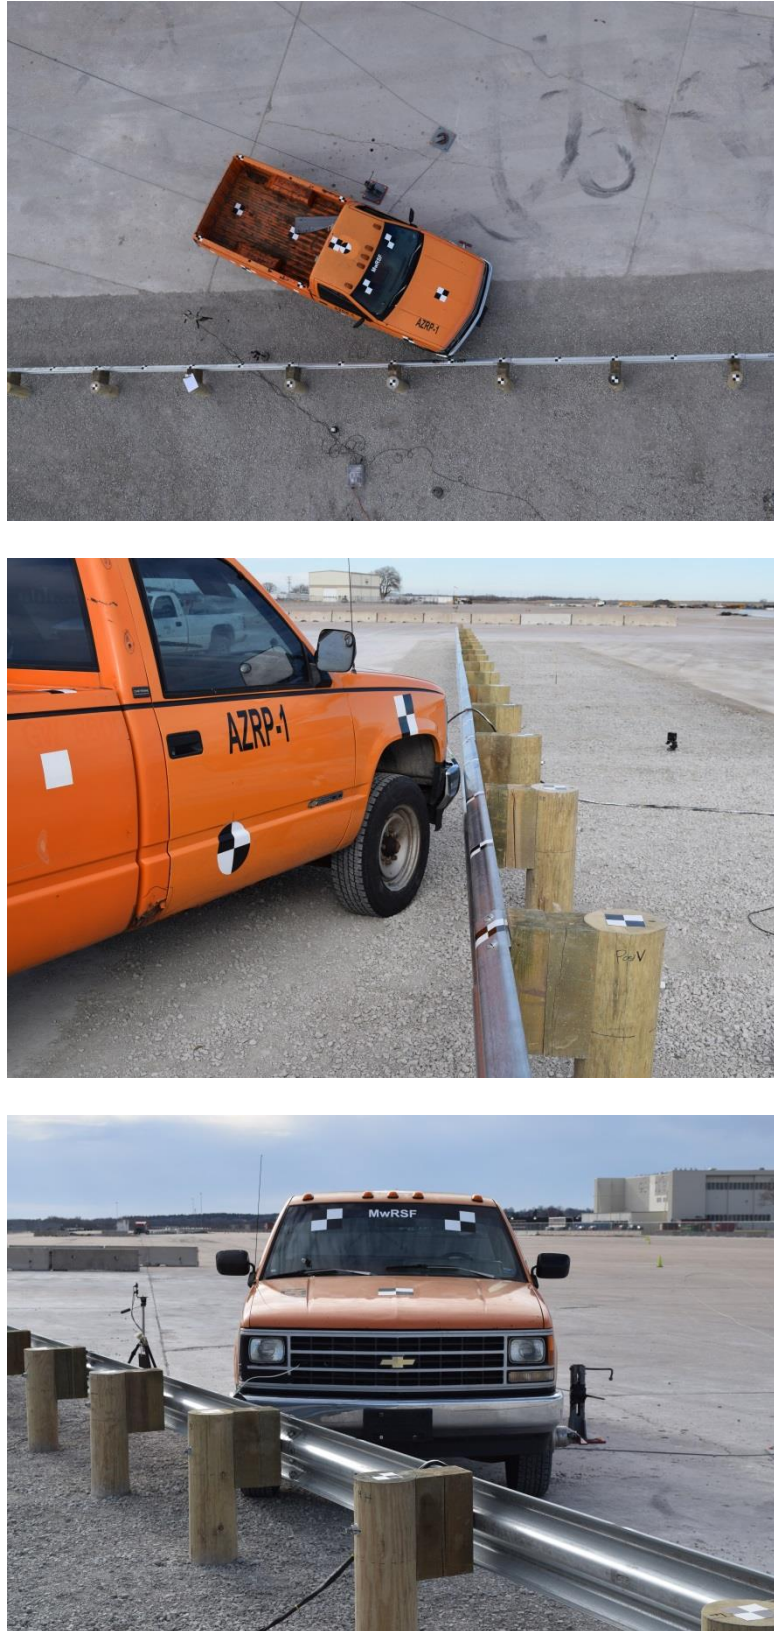
Figure 28. Impact Location, Test No. AZRP-1

Initial vehicle impact was to occur 185 in. (4,699 mm) upstream from post no. 15, as shown in Figure 28, which was selected using the CIP plots found in Section 3.4 of NCHRP Report No. 350 to maximize pocketing and the probability of wheel snag. The actual point of impact was 182¼ in. (4,629 mm) upstream from post no. 15 or 2¾ in. downstream from the

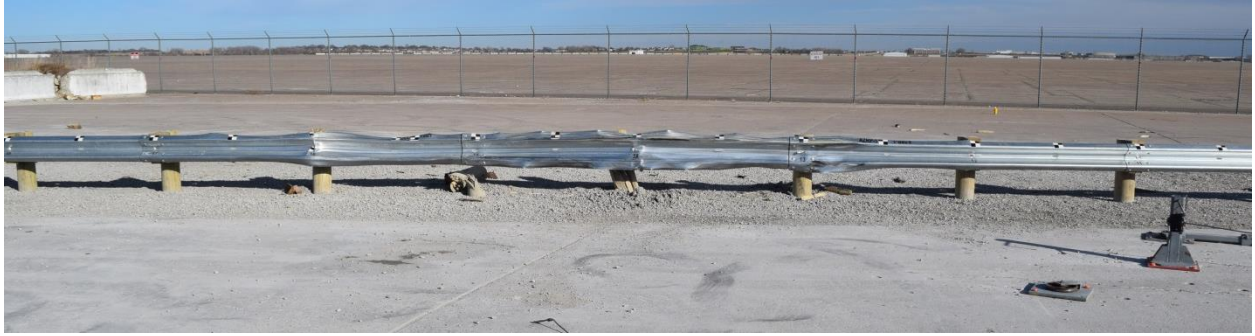
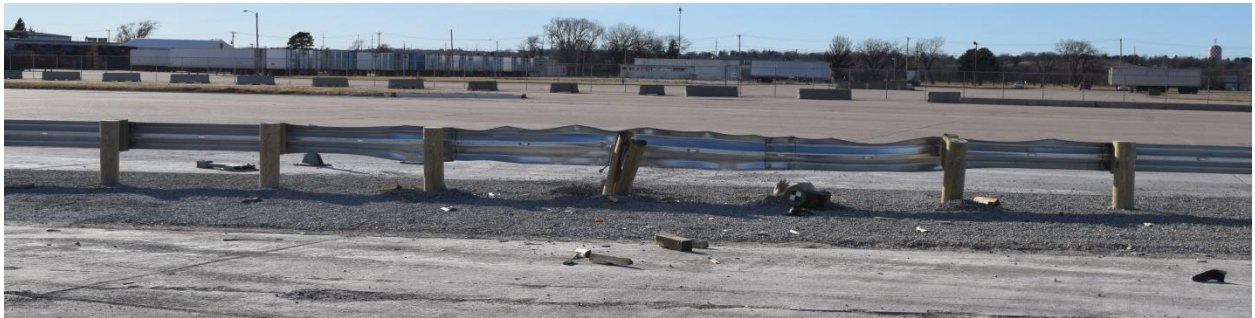
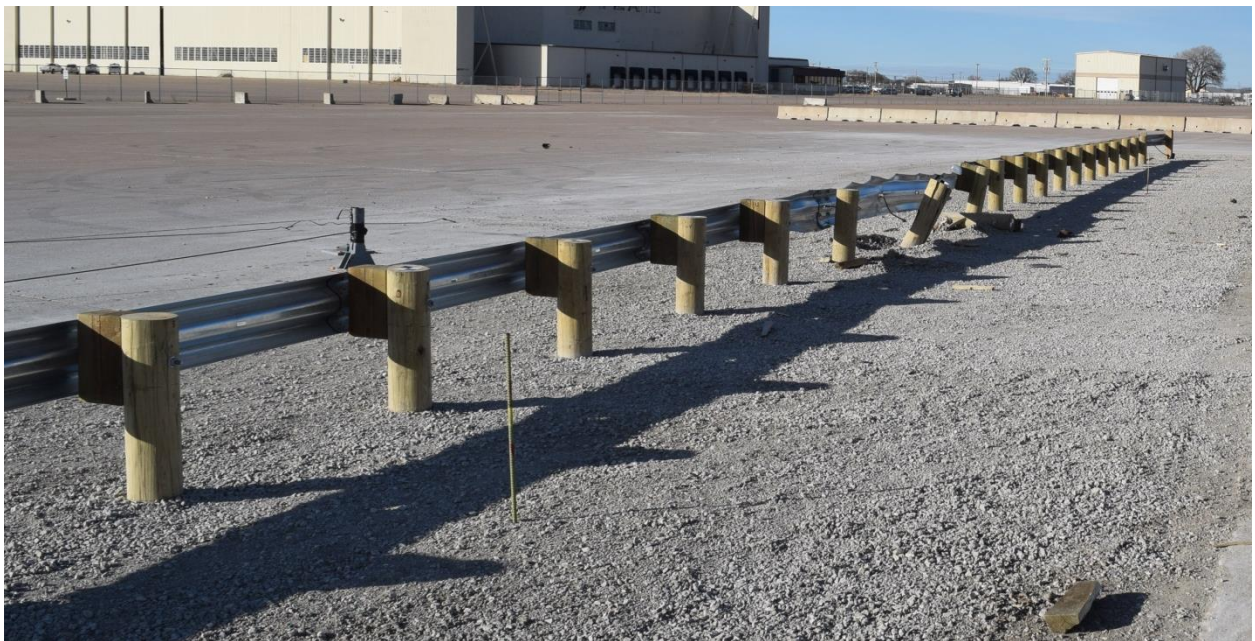
Figure 31. System Damage, Test No. AZRP-1

Damage to the barrier was moderate, as shown in Figures 30 through 39. Barrier damage consisted of rail deformation, disengagement of the W-beam rail from the posts, fractured wood posts, split wood blockouts, and displaced posts in soil. The length of vehicle contact along the barrier was approximately 27 ft – 8½ in. (8.4 m), which spanned from 32¼ in. (819 mm)

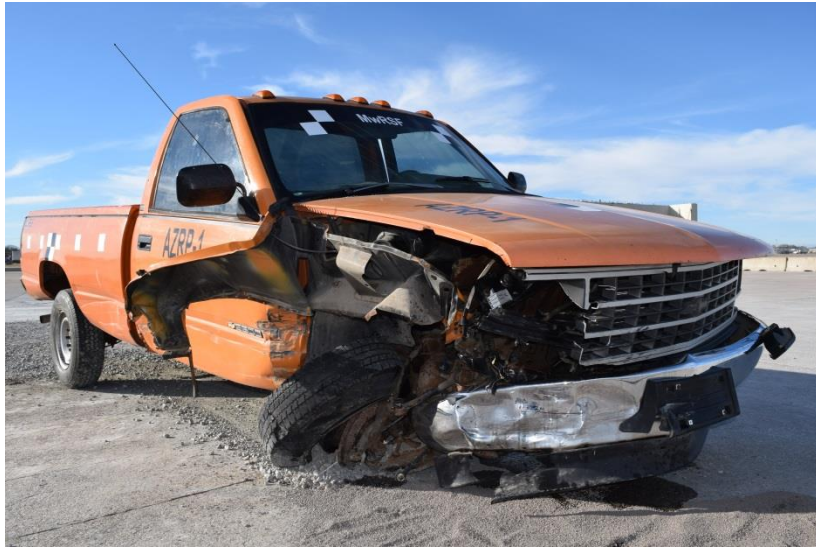
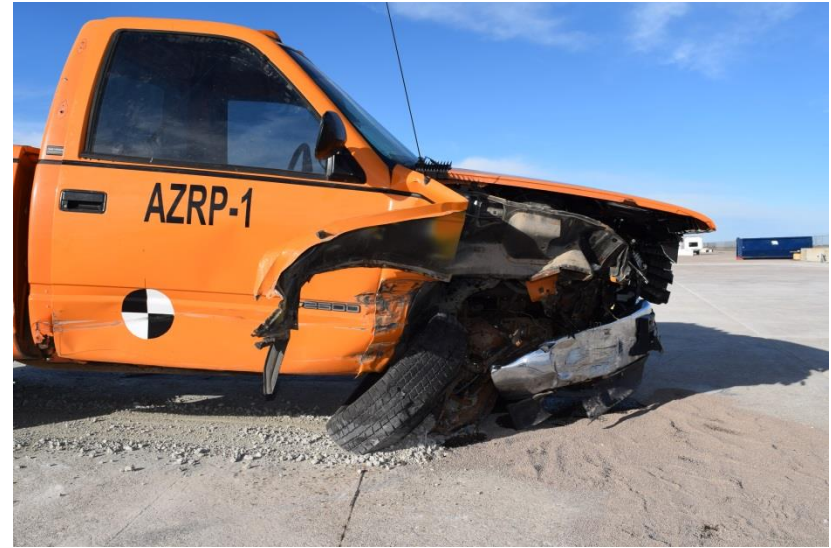
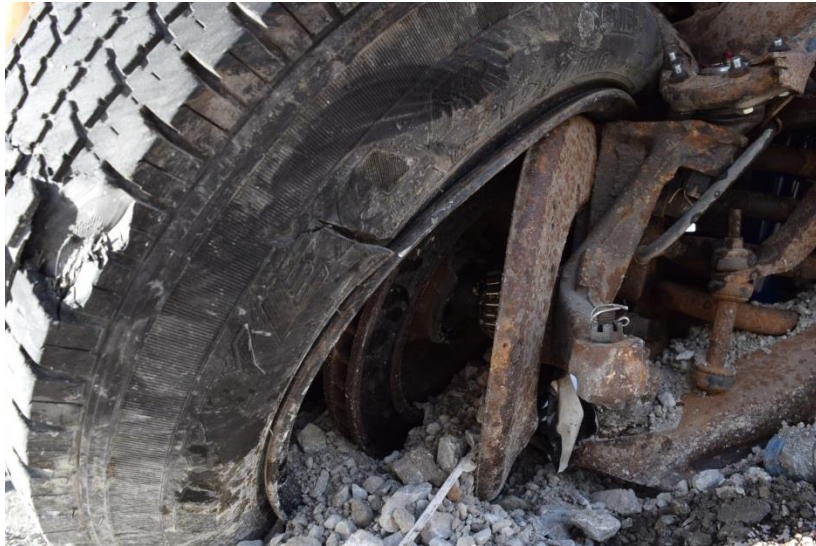
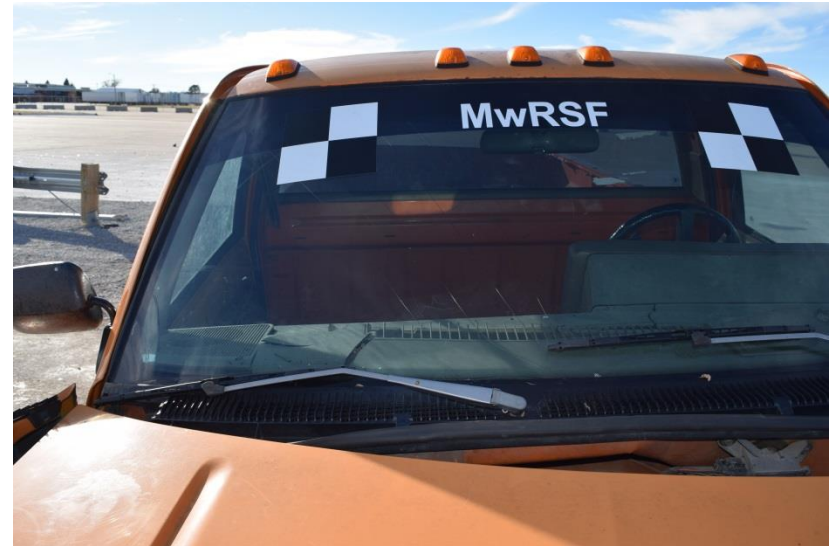
Figure 41. Vehicle Damage, Test No. AZRP-1

The damage to the vehicle was moderate, as shown in Figures 40 through 44. The maximum occupant compartment deformations are listed in Table 7. During vehicle preparation, the seat frame for the 2000P vehicle was removed and erroneously not placed back in the truck. Previous testing with the 2000P vehicles early in the implementation of NCHRP Report No. 350 found that the seat frame was critical to developing the proper rigidity of the truck floorpan. MwRSF normally has two control points to account for any occupant compartment deformations. However, due to floorboard deformation and movement, both control points encountered movement. Therefore, two sets of data are reported below. Even though both control points encountered minor movement, all deformations were below the previously-recognized NCHRP Report No. 350 deformation limits. Complete occupant compartment and vehicle deformations and the corresponding locations are provided in Appendix D.

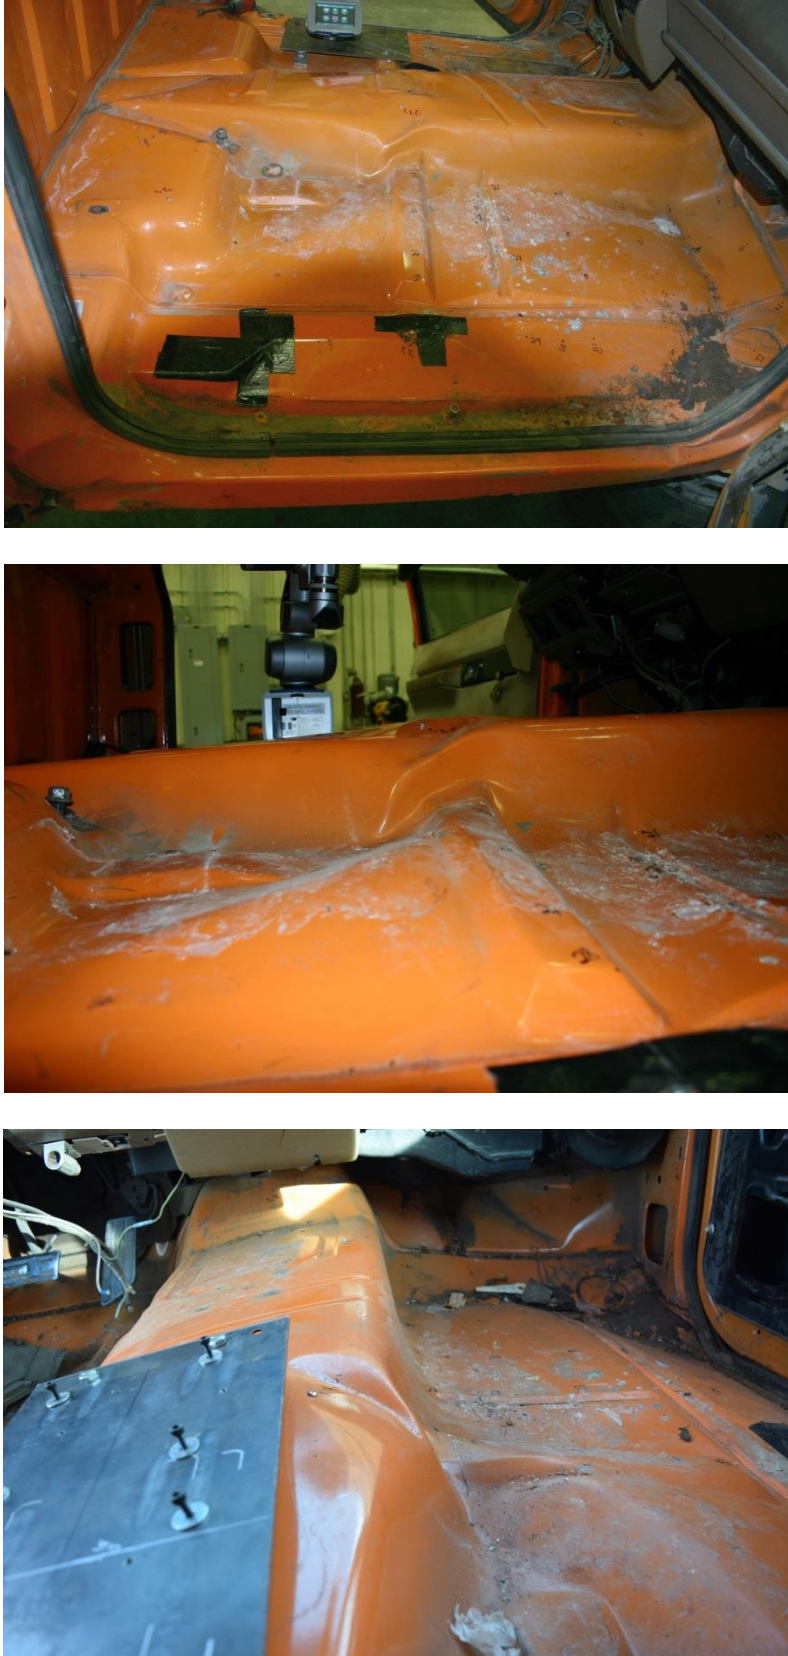
Due to the floorpan deformation near the mounting plate of the accelerometer units, as shown in Figures 42 and 43, a video analysis procedure, similar to that used in the past to evaluate full-scale crash tests, was used in order to address the invalid ORAs. The longitudinal

Figure 42. Vehicle Right-Side Floorboard Deformation, Test No. AZRP-1

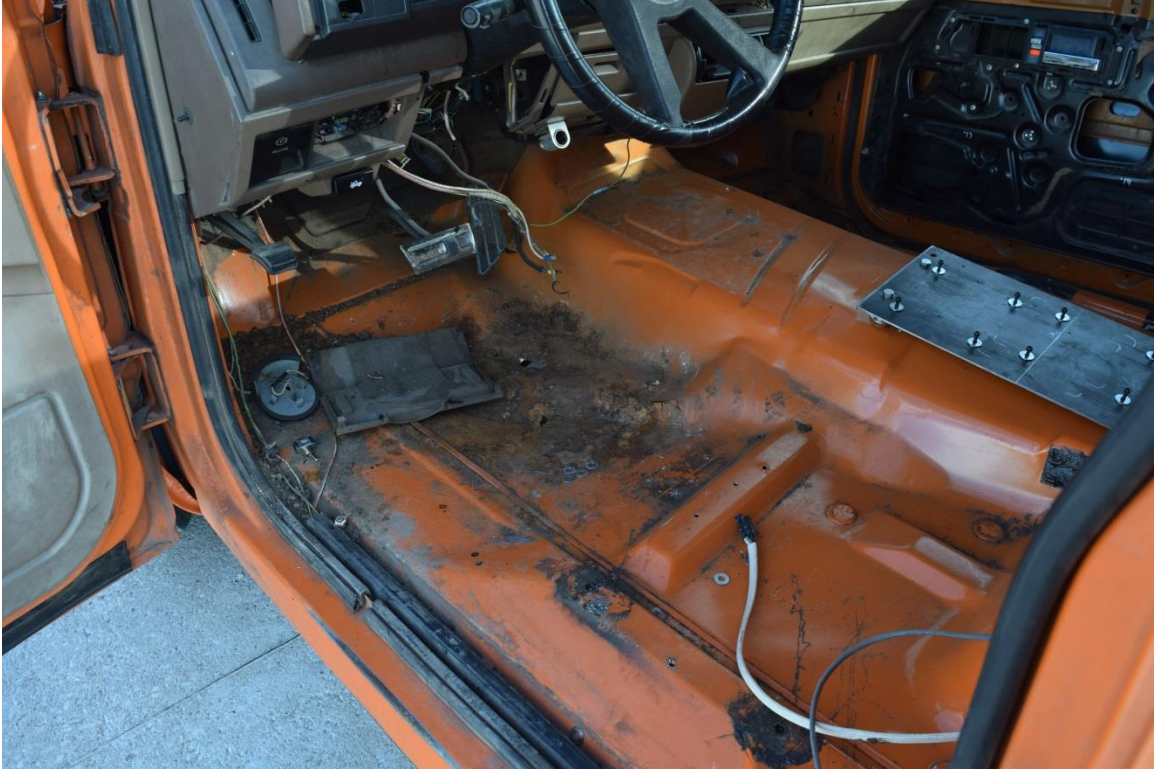
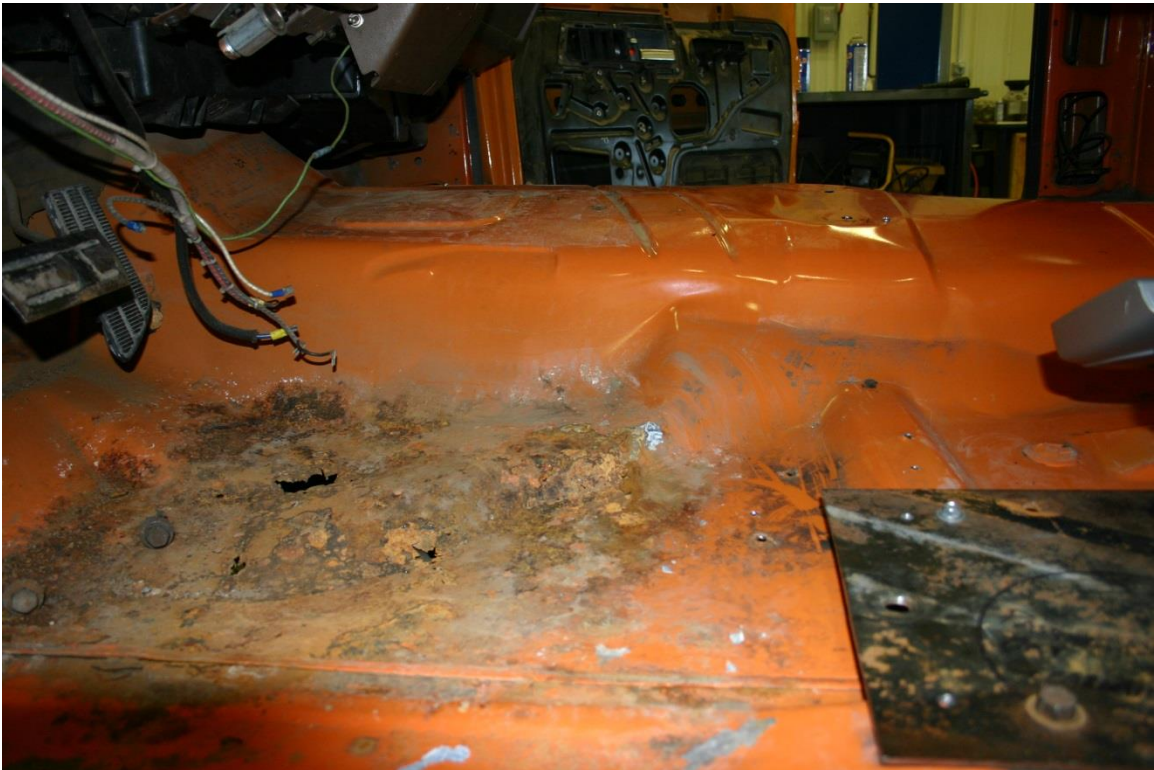
Figure 43. Vehicle Left-Side Floorboard Deformation, Test No. AZRP-1

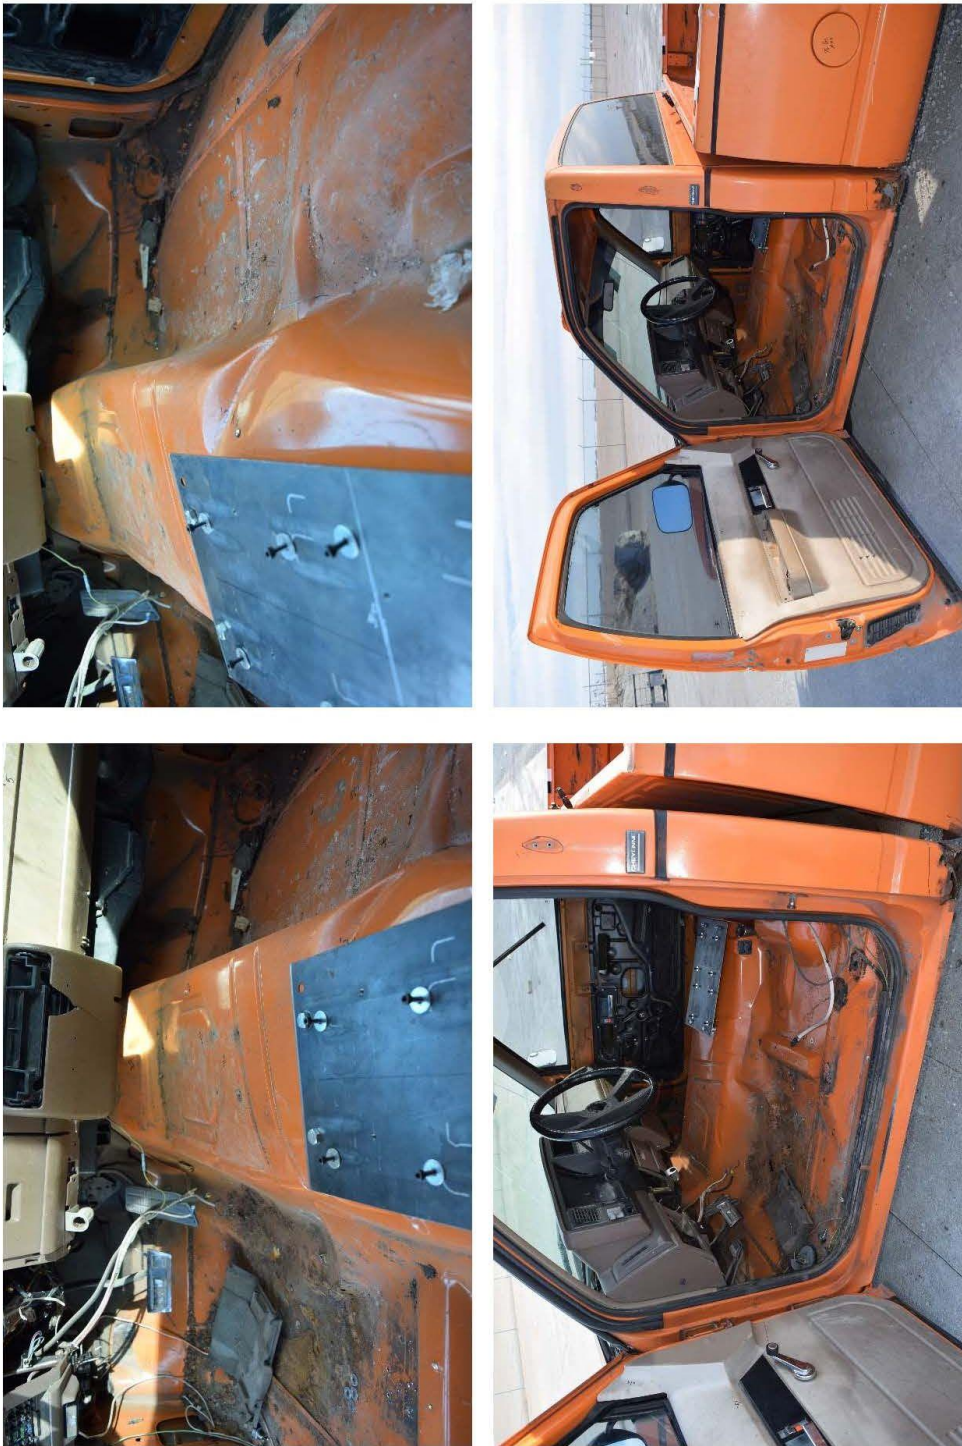
In test no. AZRP-1, MwRSF recorded Occupant Ridedown Acceleration (ORA) values in the lateral direction that exceeded the 20 g limit imposed in NCHRP Report No. 350. Review of the test vehicle found two critical issues.

Figure 1. Floorboard Deformation Due to Omission of Seat Frame, Test No. AZRP-1

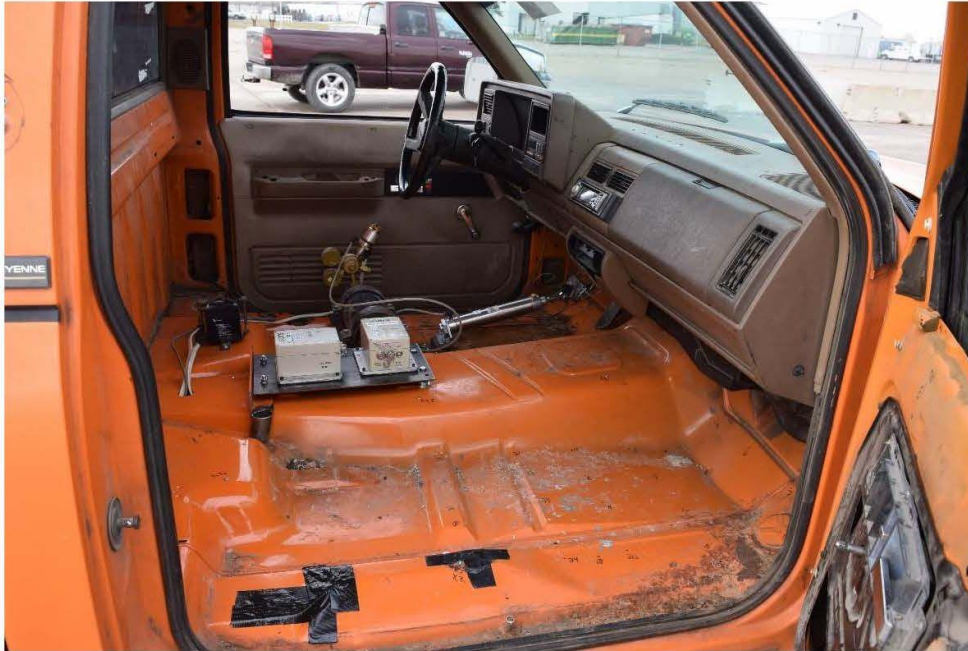
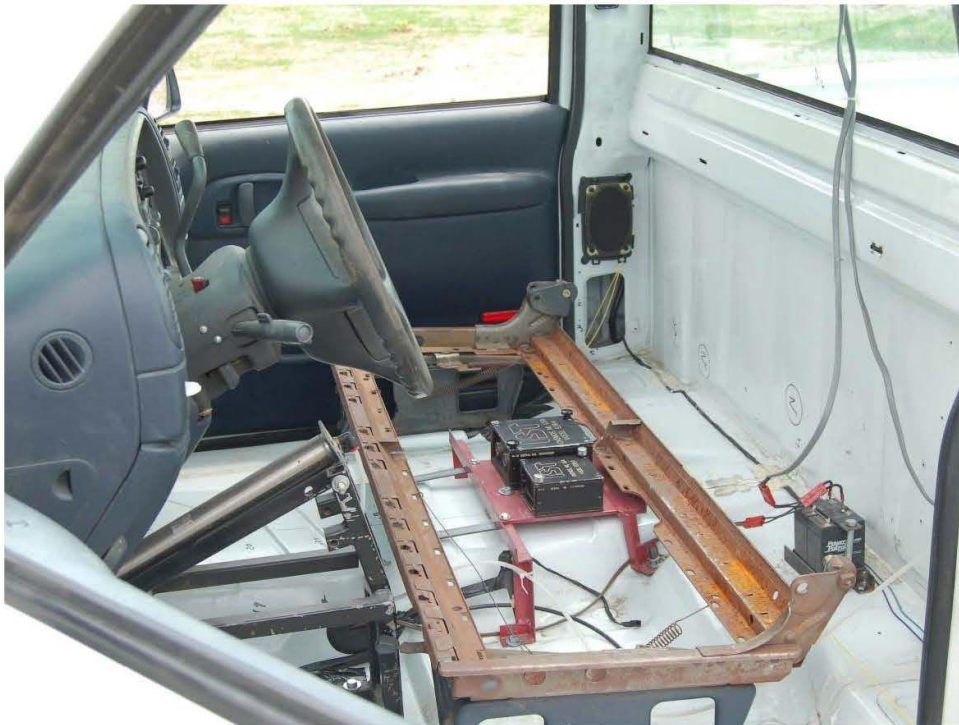
Figure 2. Standard 2000P Accelerometer Mounting with Seat Frame in Place versus Setup for Test No. AZRP-1
