*Midwest States Regional Pooled Fund Research Program  
Fiscal Year 2013 (Year 23)  
Research Project Number TPF-5(193) Supplement #56  
NDOR Sponsoring Agency Code RFP-13-MGS-3*

# **INCREASED SPAN LENGTH FOR THE MGS LONG-SPAN GUARDRAIL SYSTEM PART II: FULL-SCALE CRASH TESTING**

MwRSF Research Report No. TRP-03-339-17

April 7, 2017

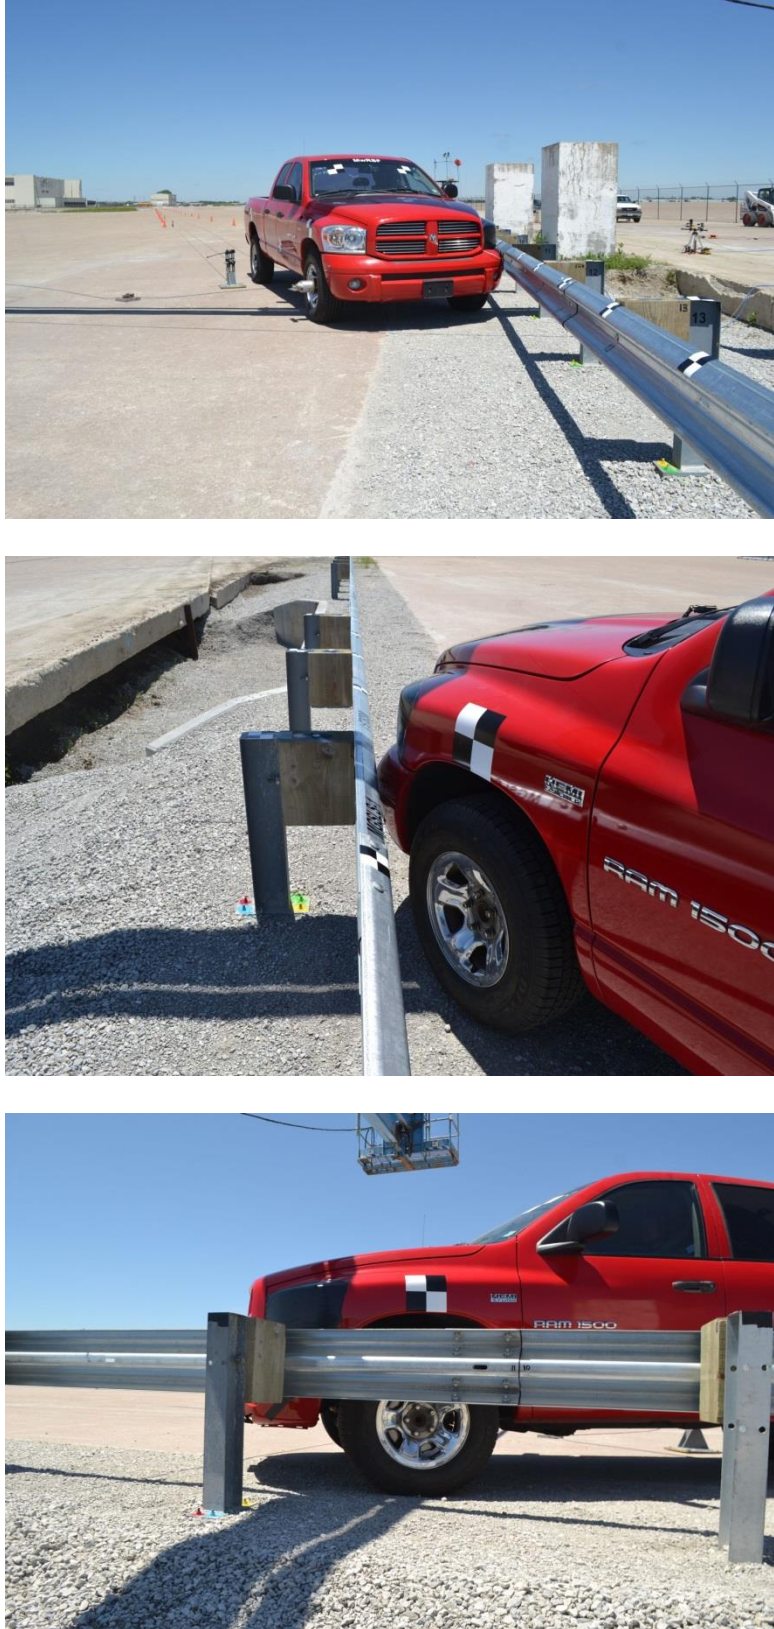
Figure 46. Impact Location, Test No. MGSLS-1

Initial vehicle impact was to occur at the centerline of post no. 11, as shown in Figure 46, which was selected using LS-DYNA analysis to evaluate the potential for vehicle instability by maximizing the interaction of the front wheel of the pickup truck with the wing wall of the culvert [3-4]. The actual point of impact was 1¾ in. (44 mm) downstream from post no. 11. A sequential description of the impact events is contained in Table 4. The vehicle came to rest 30 ft – 10 in. (9.4 m) behind the system and 177 ft – 6 in. (54.1 m) downstream from the point of impact. The vehicle trajectory and final position are shown in Figures 42 and 47.

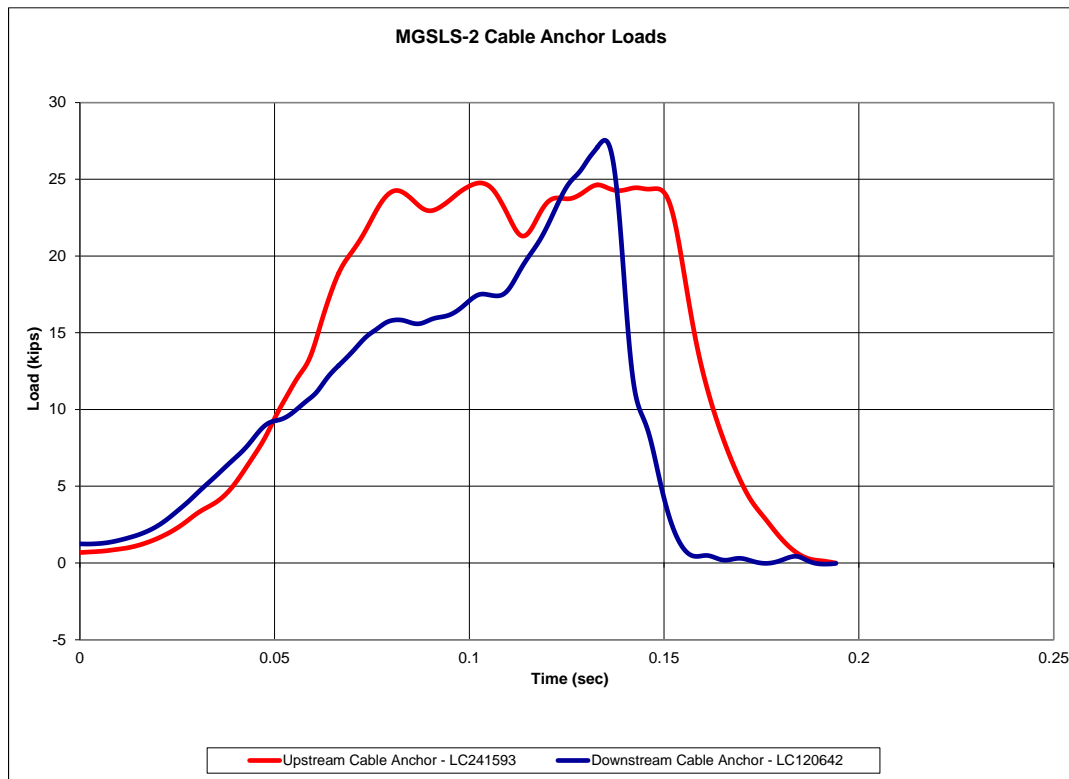
Figure 59. Cable Anchor Loads, Test No. MGSL-2

The pertinent data from the load cells and string potentiometers was extracted from the bulk signal and analyzed using the transducer's calibration factor. The recorded data and analyzed results are detailed in Appendix G. Summarized results from the load cells and string potentiometers can be seen in Figures 59 through 61. The string potentiometers located at the upstream and downstream anchorages registered maximum displacements of 1.85 in. and 21.29 in. (47 mm and 541 mm), respectively. The load cells from the upstream and downstream anchorages registered maximum loads of 24.8 kips and 27.5 kips (110.3 kN and 122.3 kN), respectively. The exact moment of impact could not be determined from the transducer data, as impact may have occurred a few milliseconds prior to a measurable signal increase in the data.

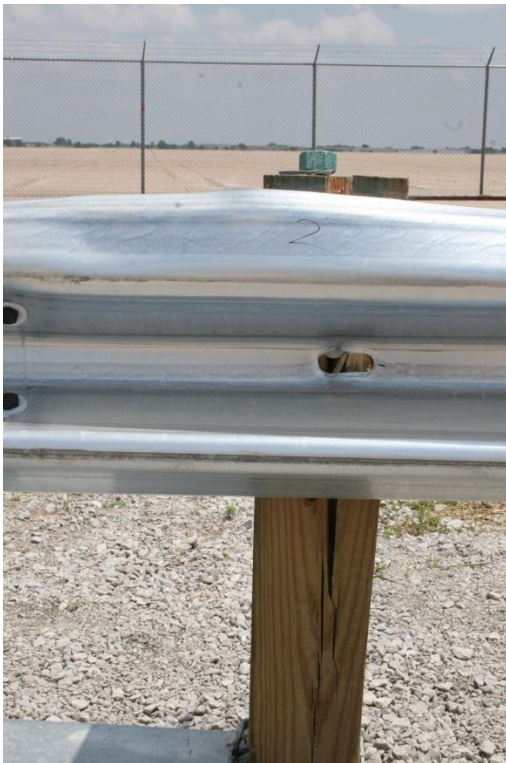
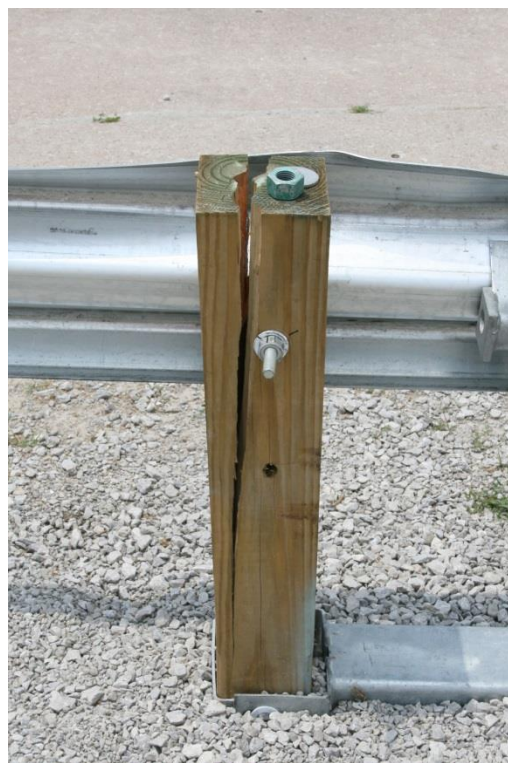
Figure 68. System Damage, Test No. MGSLS-2

Damage to the barrier system was severe, as shown in Figures 68 through 79. Barrier damage consisted of rail deformation and tearing, disengagement of W-beam rail away from posts, bending of steel posts, fracture of wood posts, and damage to the concrete culvert. The length of vehicle contact along the barrier was approximately 80 ft (24.4 m), which began 239<sup>7</sup>/<sub>8</sub> in. (6.1 m) upstream from post no. 13 and extended through the end of the barrier system.

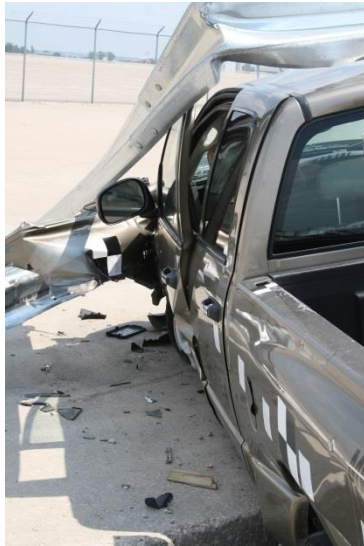
Figure 81. Vehicle Damage, Test No. MGSLS-2

The damage to the vehicle was moderate, as shown in Figures 81 through 85. The maximum occupant compartment deformations are listed in Table 9 along with the deformation limits established in MASH for various areas of the occupant compartment. Note that none of the MASH-established deformation limits were violated. Complete occupant compartment and vehicle deformations and the corresponding locations are provided in Appendix D.

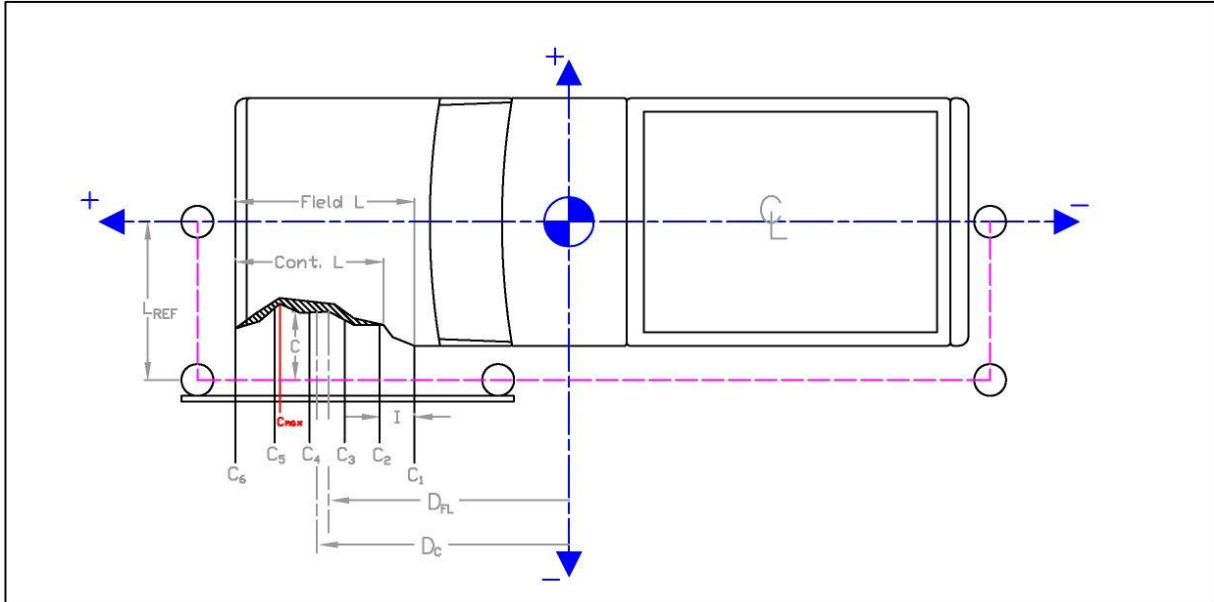
Figure D-5. Exterior Vehicle Crush (NASS) - Front, Test No. MGSL5-1
