# **MASH TEST NO. 3-10 OF A NON-PROPRIETARY, HIGH-TENSION CABLE MEDIAN BARRIER FOR USE IN 6H:1V V-DITCH (TEST NO. MWP-8)**

MwRSF Research Report No. TRP-03-331-17

May 10, 2017

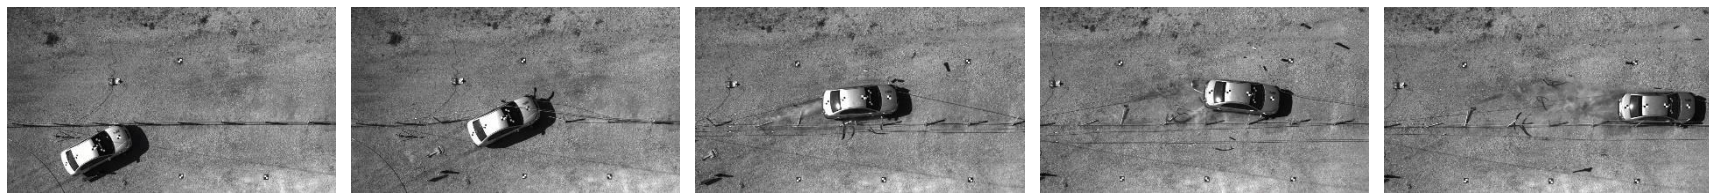
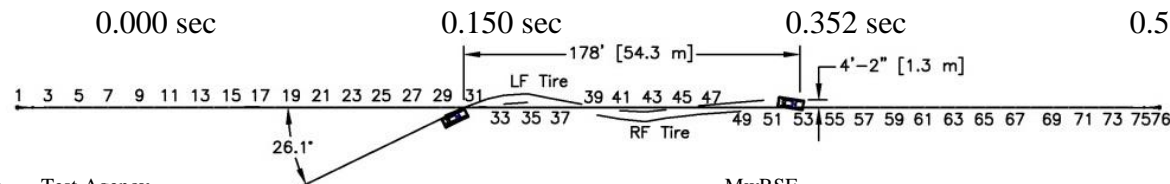
Figure 38. Summary of Test Results and Sequential Photographs, Test No. MWP-8

The analysis of the test results for test no. MWP-8 showed that the high-tension, four-cable median barrier adequately contained and redirected the 1100C vehicle with controlled lateral displacements of the barrier. The test vehicle did not penetrate or ride over the barrier, and remained upright during and after the collision. Vehicle roll, pitch, and yaw angular displacements, as shown in Appendix E, were deemed acceptable because they did not adversely influence occupant risk safety criteria nor cause rollover. After impact, the vehicle was captured and retained within the system, so there was no exit information. As the vehicle overrode the system posts, the posts tore the floorpan in two locations. The tears indicated that the free end of a post penetrated into the occupant compartment. Additional analysis and discussion of the floorpan tearing will be provided in the following chapter. Therefore, test no. MWP-8, conducted on the four-cable median barrier, was determined to be unacceptable according to the MASH safety performance criteria for test designation no. 3-10.

- Test Article Damage ..... Moderate
- Maximum Test Article Deflections
  - Permanent Set .....39¾ in. (1,010 mm)
  - Dynamic .....93.3 in. (2,370 mm)
  - Working Width.....94.7 in. (2,405 mm)
- Transducer Data

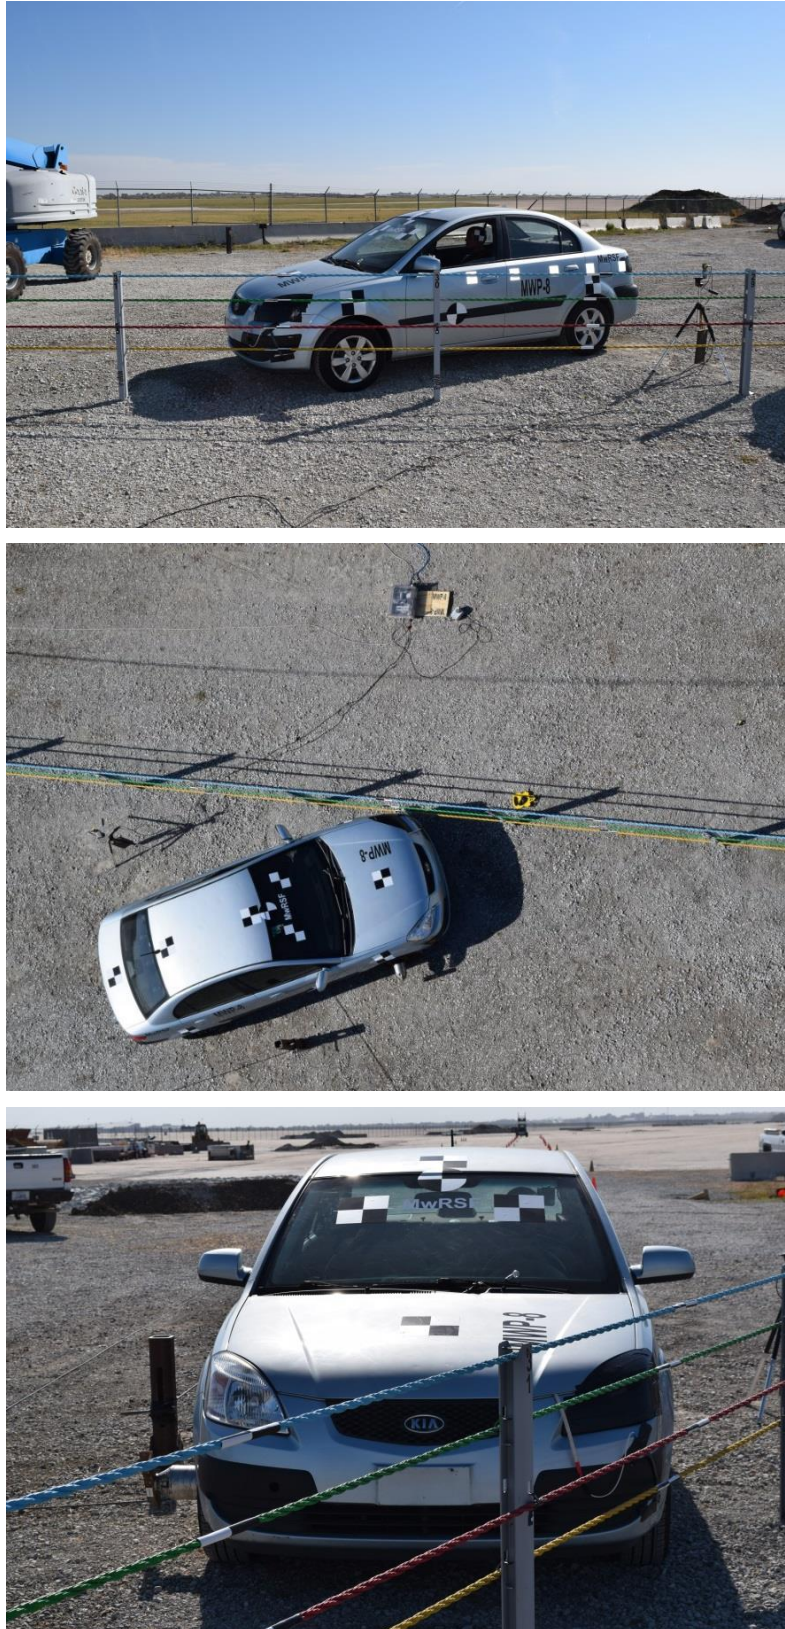
Figure 43. Impact Location, Test No. MWP-8

Initial vehicle impact was to occur at a midspan location, or 4 ft (1.2 m) upstream of post no. 31, as shown in Figure 43, which was selected using Table 2-2D of MASH. The actual point of impact was 3 ft – 4½ in. (1.0 m) upstream of post no. 31. A sequential description of the impact events is contained in Table 4. The vehicle came to rest approximately 154 ft (46.9 m) downstream from the point of impact, or between post nos. 52 and 53 and in contact with the cables. The right side of the vehicle was held in the air by cable nos. 2 and 3, which were underneath the vehicle. Cable nos. 1 and 4 were located on the non-impact side of the vehicle. The vehicle trajectory and final position are shown in Figures 38 and 44.

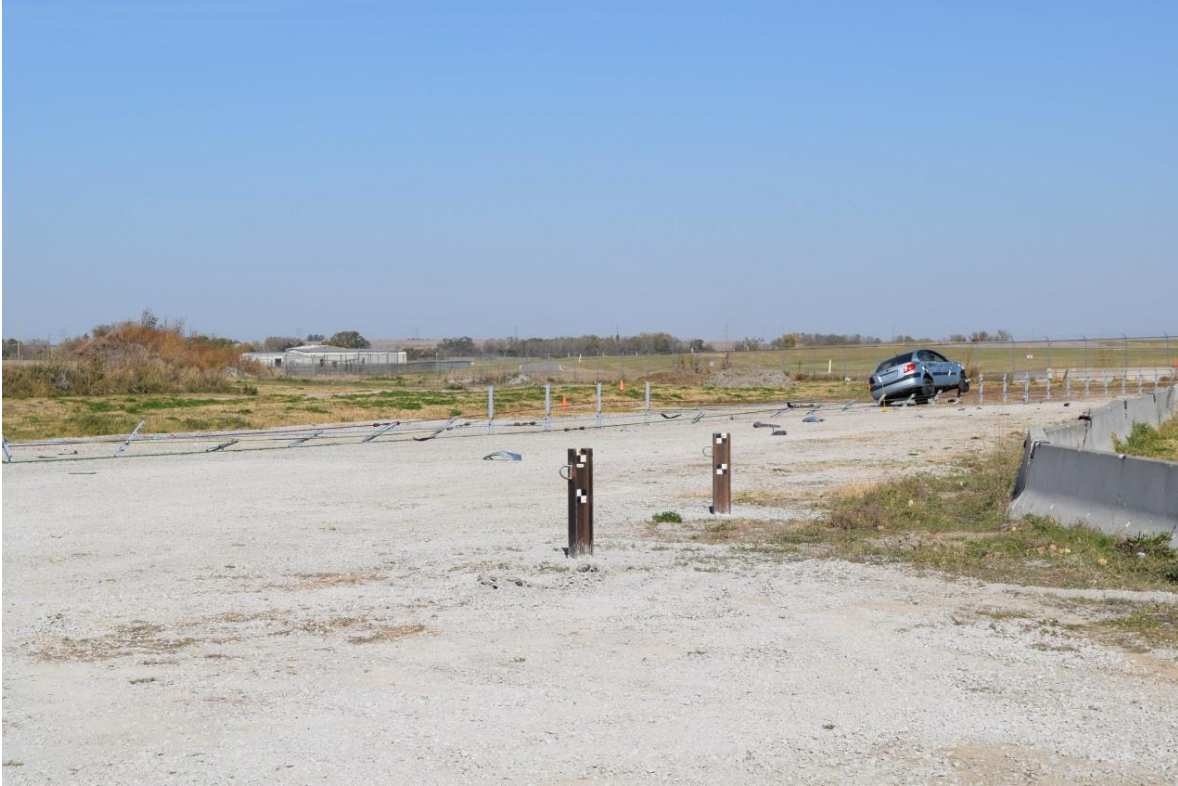
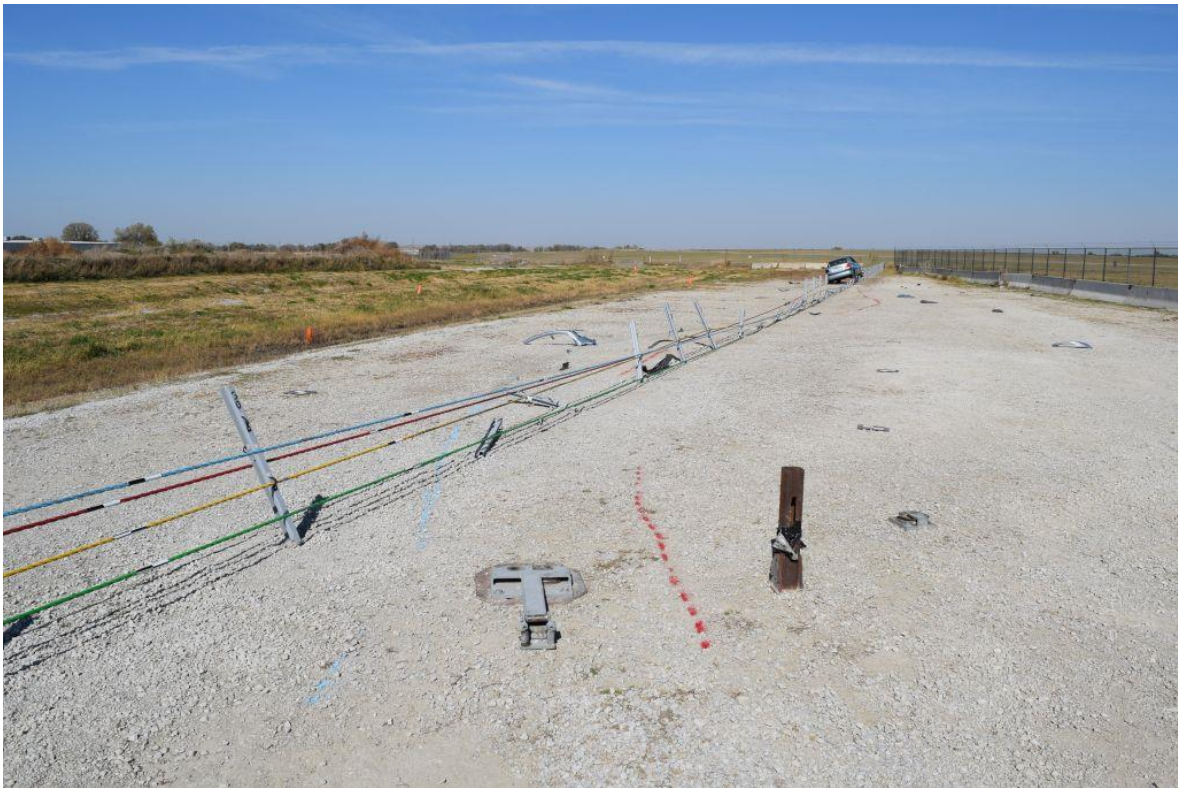
Figure 44. Vehicle Final Position and Trajectory Marks, Test No. MWP-8

passed over the top of the vehicle and as the vehicle was exiting the system, cable no. 4 impacted the right side of the vehicle and caused it to be redirected back toward the barrier system. The vehicle then impacted the system at post no. 45 and overrode post nos. 45 through 53. The vehicle did not exit the system and rested on top of post nos. 52 and 53 at the conclusion of the test.

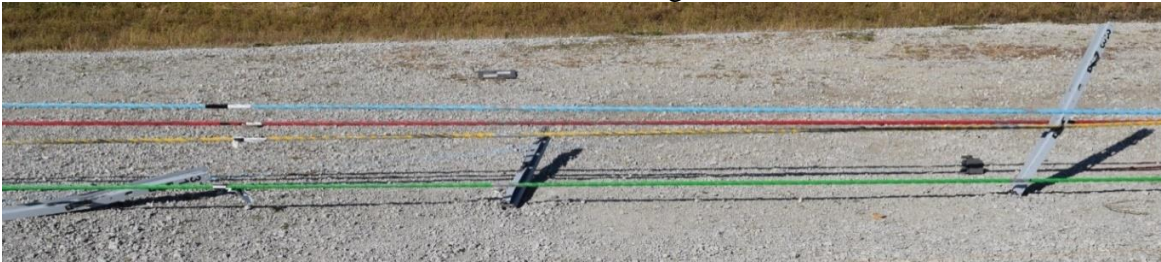
Post Nos. 31 through 33

Damage to the barrier was moderate, as shown in Figures 45 through 73. Barrier damage consisted of bent posts, disengaged cables, and deformed brackets. At its final resting position, the vehicle was still in contact with the cables. Cable nos. 2 and 3 were underneath the vehicle while cable nos. 1 and 4 were on the non-impact side of the vehicle. The length of vehicle contact along the barrier was approximately 181 ft (55.2 m), which spanned from 3 ft – 4½ in. (1 m) upstream of post no. 31 to post no 53. Table 5 summarizes the release mechanisms of each cable from the posts.

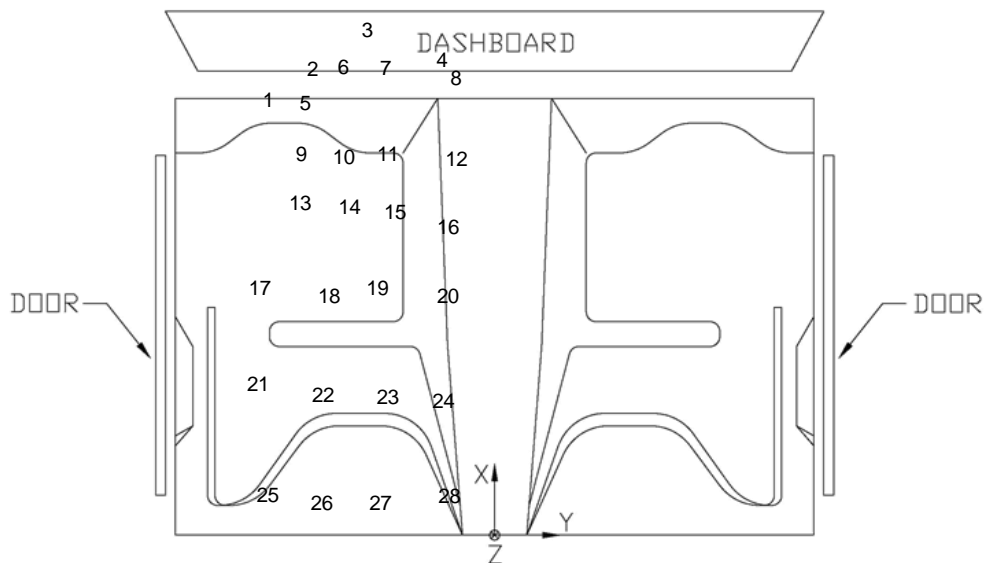
Figure D-1. Floorpan Deformation Data – Set 1, Test No. MWP-8

Two tears were found in the floorpan of the vehicle. One was a 3-in. (76-mm) long tear in the right-front floorpan and the other was a 7-in. (178-mm) long tear underneath the right-front seat, as shown in Figures 76 and 77. Although the occupant compartment deformations are within the bounds set by MASH, the occupant compartment penetration was unacceptable. The floorpan tearing was caused by the free edge of a post as the vehicle overrode the post.
