EVALUATION OF FLOORPAN TEARING AND CABLE SPICES FOR CABLE BARRIER SYSTEMS

MIDWEST ROADSIDE SAFETY FACILITY

MwRSF Research Report No. TRP-03-324-17

May 16, 2017

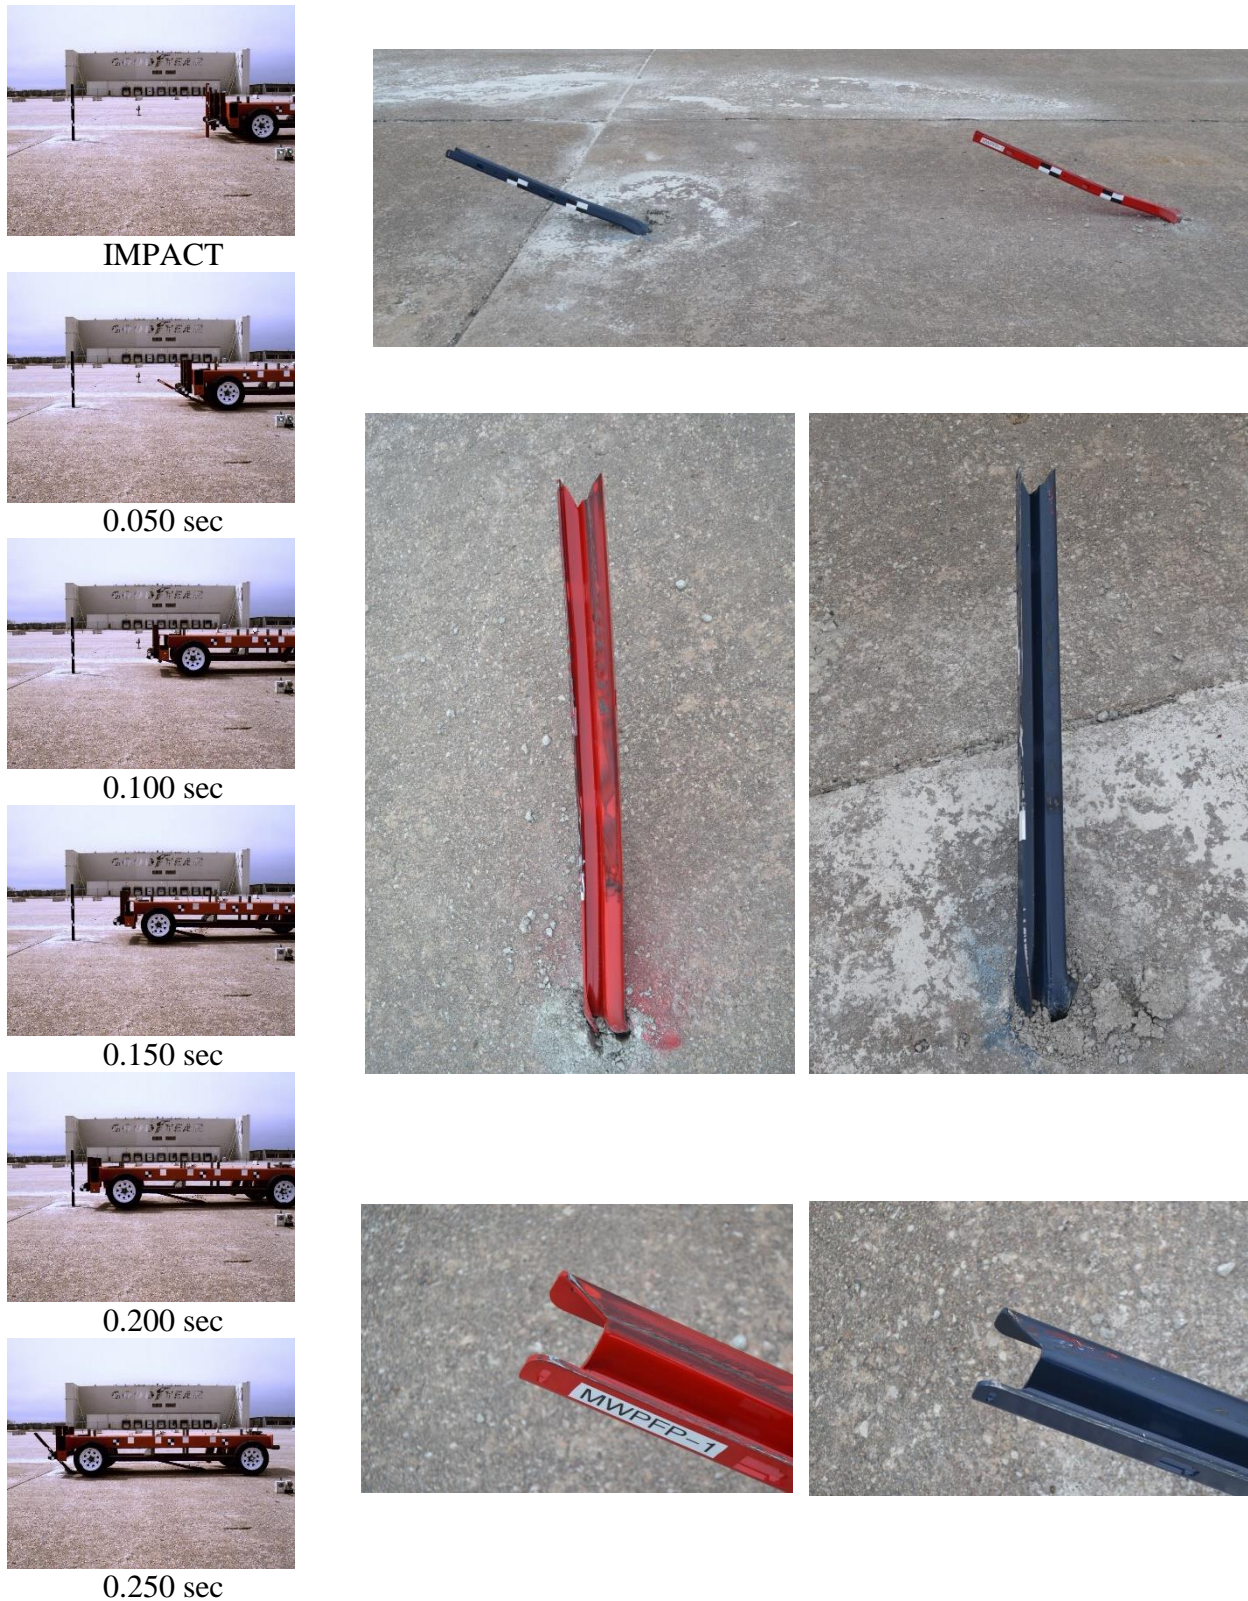
Figure 24. Time-Sequential and Post Damage Photographs, Test No. MWFPF-1

Unfortunately, the crossbeams located at the front and mid-span of the simulated floorpan had not been installed for test no. MWPFP-1. Thus, the front edge of the sheet steel was exposed to contact, and the posts snagged on the simulated floorpan. The simulated floorpan was torn from the front of the undercarriage frame, as shown in Figure 25. This result allowed a broader area of the simulated floorpan to deform and reduced the severity of the localized gouging and tearing. Therefore, modifications to the test setup were required to accurately replicate the floorpan of a Kia Rio. Subsequently, crossbeams were added to eliminate this problem for subsequent tests and to simulate undercarriage support members.

Force vs. deflection and energy vs. deflection curves were created from the accelerometer data. Additionally, the high-speed video was analyzed to determine the times when the bogie overrode each post, the posts contacted the simulated floorpan, and the posts lost contact with the bogie vehicle. Results from the data and video analysis are shown in Figure 30. The recorded impact loads were lower for the bogie impact with the second post. This finding was likely due to a combination of a reduced impact velocity and a higher impact point on the second post. The reduced impact velocity resulted from the energy absorbed by the impact with the first post, while the higher impact point was caused by the bogie pitching upward as it overrode the first post.

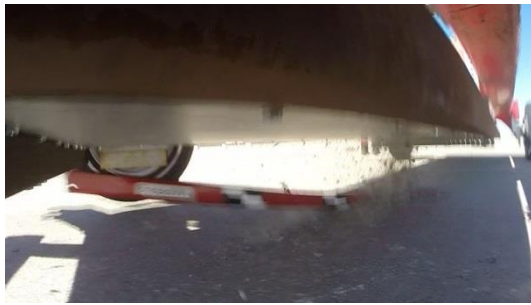
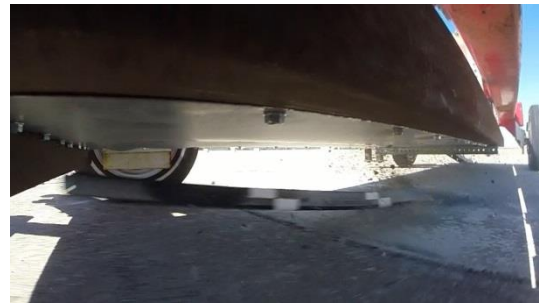
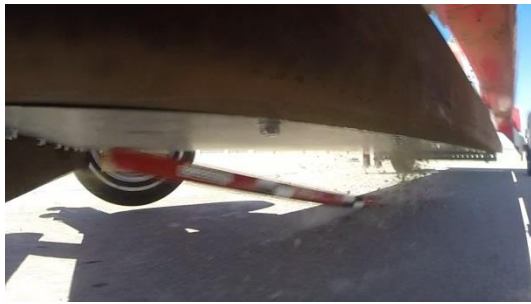
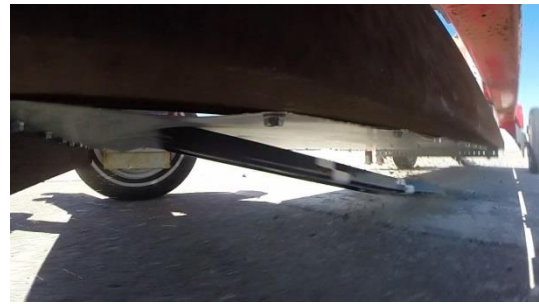
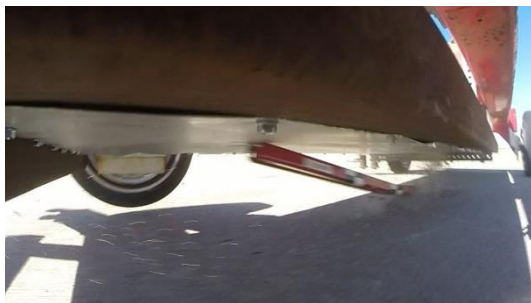
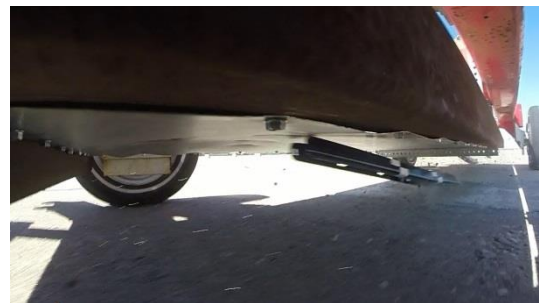
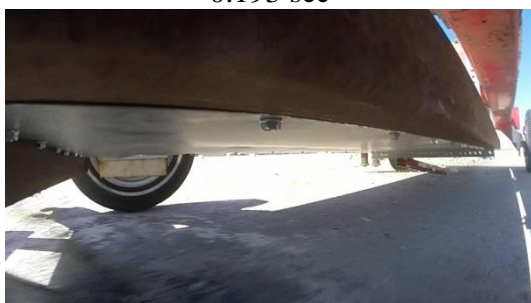
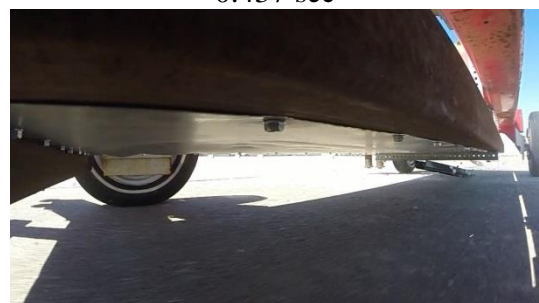
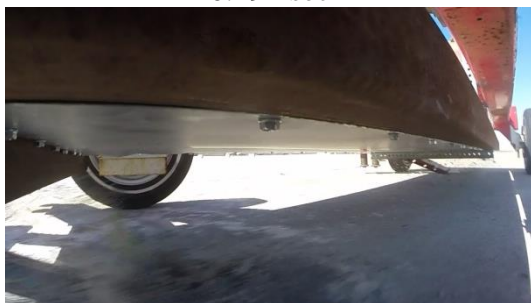
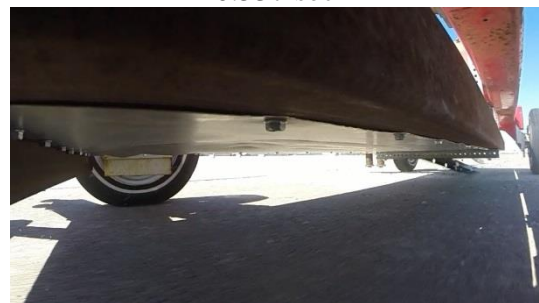
Figure 27. Time-Sequential Photographs Underneath Bogie, Test No. MWFPF-2

Test no. MWPFP-2 was conducted on MWPs installed in 8-in. (203-mm) diameter concrete sleeves with a 0-degree orientation angle, thus creating an impact about the post's weak-axis of bending. During the test, the bogie impacted the first post with a speed of 25.8 mph (41.5 km/h). Upon impact, a plastic hinge formed in the post near the groundline, and the post bent over until the bogie overrode it. As the crossbeams passed over the post, elastic restoration caused the top of the post to rebound upward and contact the simulated floorpan. The first post impacted the front and rear bays of the simulated floorpans 0.158 seconds and 0.298 seconds after impact, respectively. The bogie impacted the second post at 0.224 seconds and caused similar deformation and spring-back characteristics as observed in the first post. The second post impacted the front and rear bays of the simulated floorpans at 0.396 seconds and 0.540 seconds, respectively. The elastic spring-back of the posts and the contact with the simulated floorpan were captured via digital video taken underneath the bogie vehicle, as shown in Figure 27.

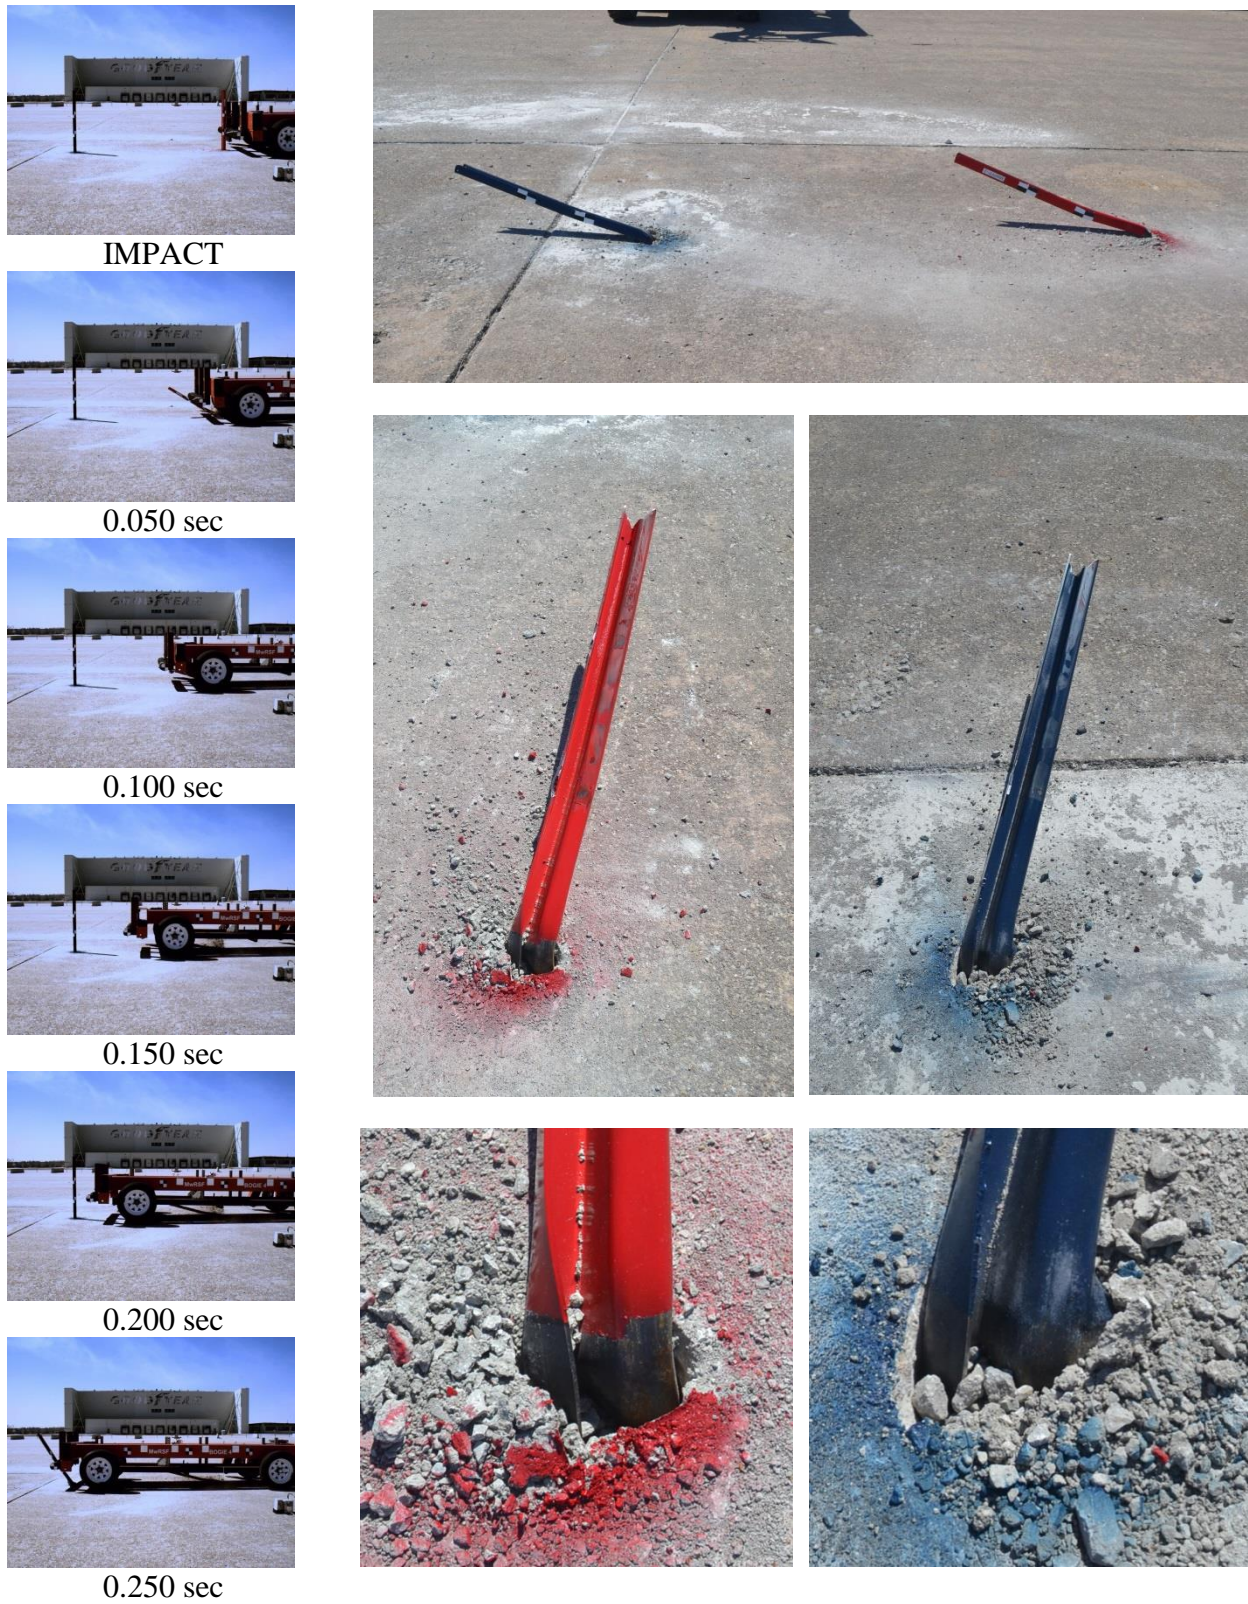
Figure 28. Time-Sequential and Post Damage Photographs, Test No. MWFPF-2

The posts were bent plastically near the groundline, and contact marks were found on the top half of the post along the free edge and impact side face of the post, as shown in Figure 28. Damage to the simulated floorpan included creasing and tearing due to contact from the top corners of both posts, as shown in Figure 29. Two tears were found in both the front and rear bays of the simulated floorpan. These tears corresponded to the location of initial contact between the free edges of the posts and the floorpan as the posts passed the crossbeams and rebounded upward. The largest tear was 5 in. (127 mm) long and had a maximum width of ½ in. (13 mm). Creases in the simulated floorpan were found extending from the tears toward the rear of the bogie. Approximately 3 in. (76 mm) to the right of the tears and creases caused by the free edges, additional creases caused by the continuous edges of the posts were present on the floorpan. All tears and creases observed on the simulated floorpan were measured and are summarized in Table 5.

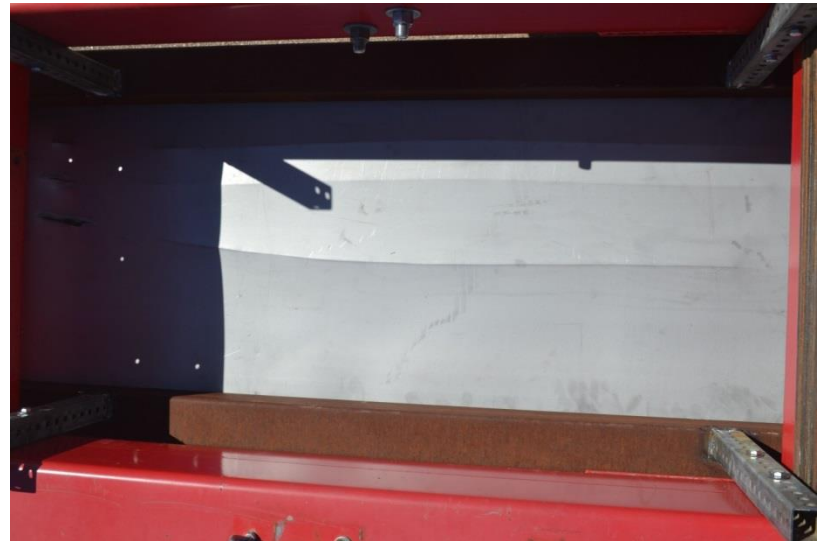
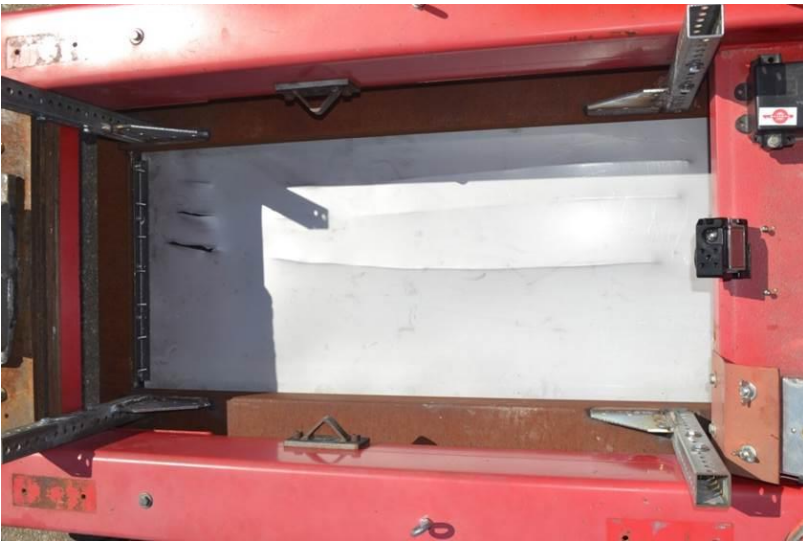
Figure 29. Simulated Floorpan Damage, Test No. MWFPF-2

Test no. MWFPF-2 provided very similar results as compared to full-scale crash testing. The elastic response of the overridden posts applied a vertical contact force to the simulated floorpan. Tears observed in the simulated floorpan were all caused by the free edges of the posts and were similar in length and opening width to those found in the test vehicles of test nos. MWP-6 and MWP-7. Additionally, creases running the length of the simulated floorpan were formed from contact with both edges the posts. Therefore, the bogie testing setup was thought to accurately replicate the floorpan damage observed in full-scale test nos. MWP-6 and MWP-7. The same test setup was utilized in the remaining bogie tests to evaluate various tearing mitigation methods.

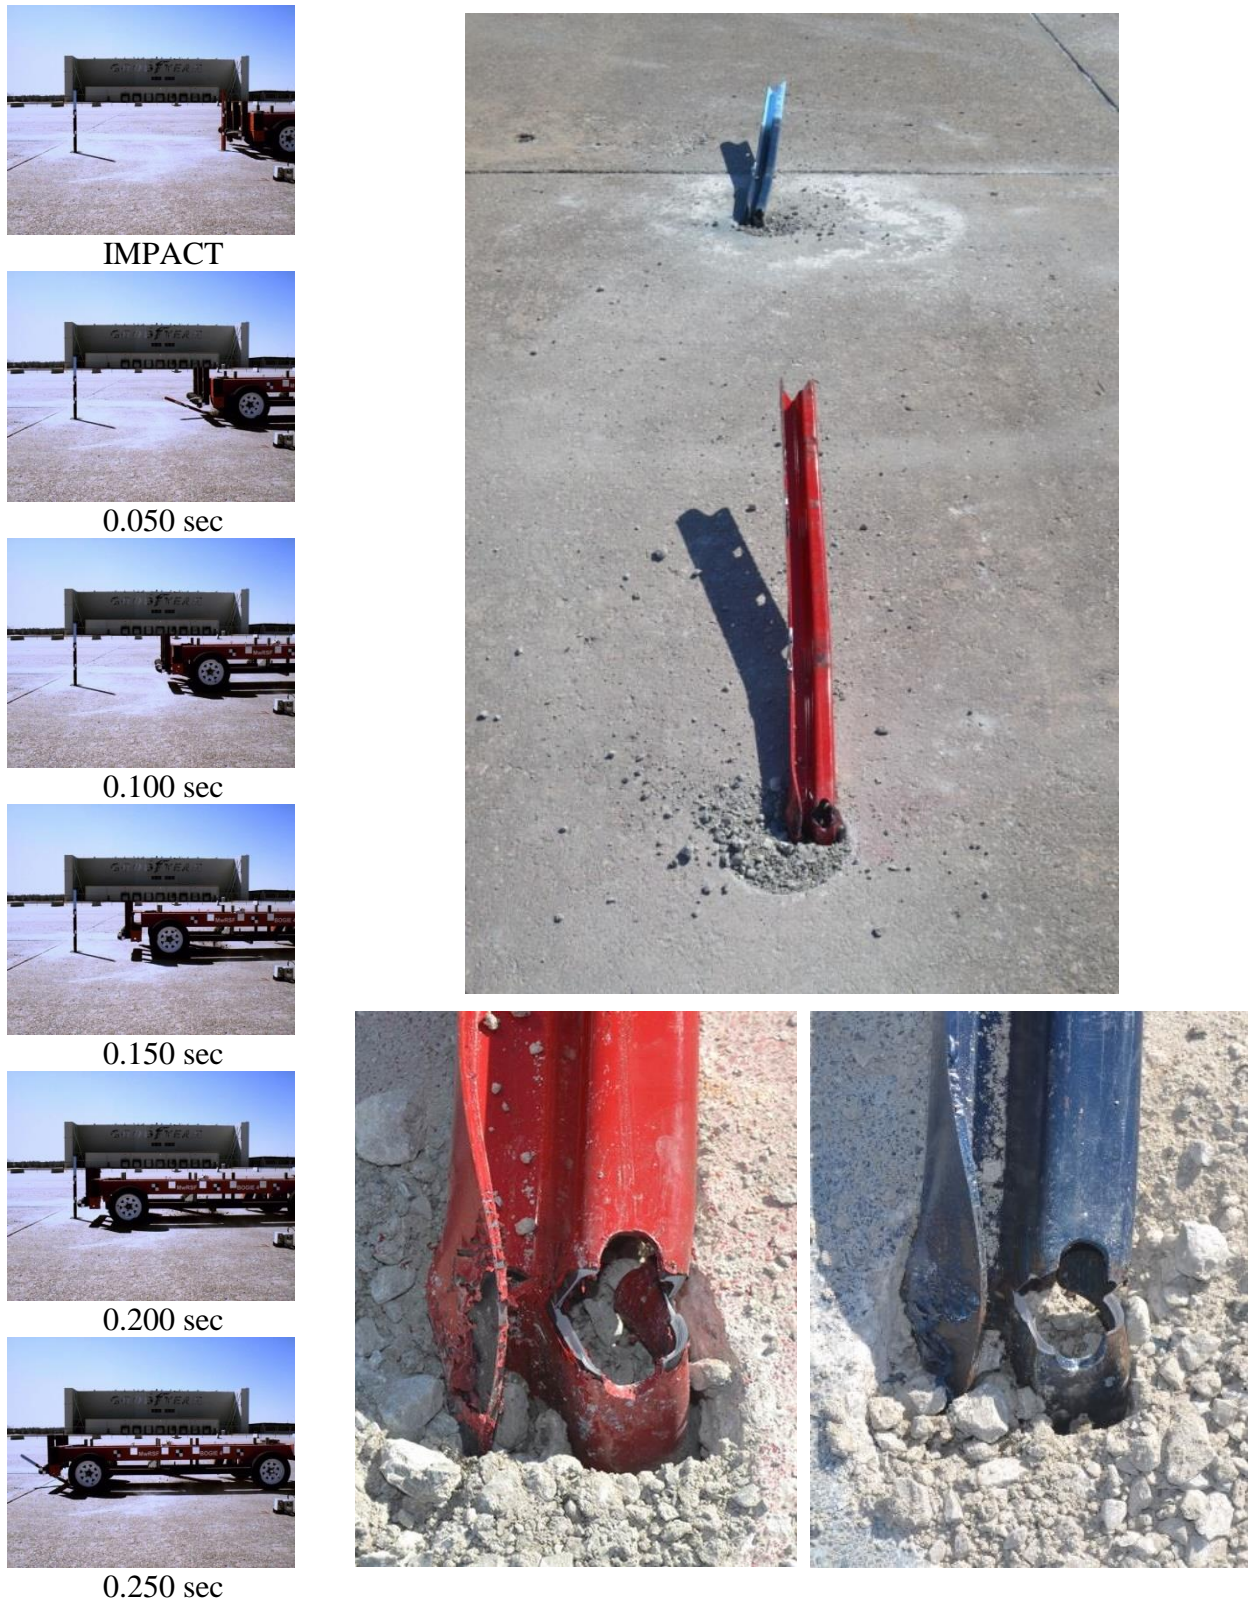
Figure 32. Time-Sequential and Post Damage Photographs, Test No. MWFPF-3

The posts were bent plastically near the groundline, and tearing was found in both posts, as shown in Figure 32. The tears initiated from the weakening holes on the impact side of the posts and extended into the webs and adjacent flanges. Contact marks were found on the top half of the post along the free edge and impact side face of the post. Damage to the simulated floorpan included scrapes and creases but no tearing. Four creases were found in both the front and rear bays of the simulated floorpan, as shown in Figure 33. The creases resulting from contact with the free edges of the posts extended nearly the entire length of the bogie vehicle, while the creases resulting from contact with the continuous edges of the posts were limited in length. All creases observed on the simulated floorpan were measured and are summarized in Table 6.

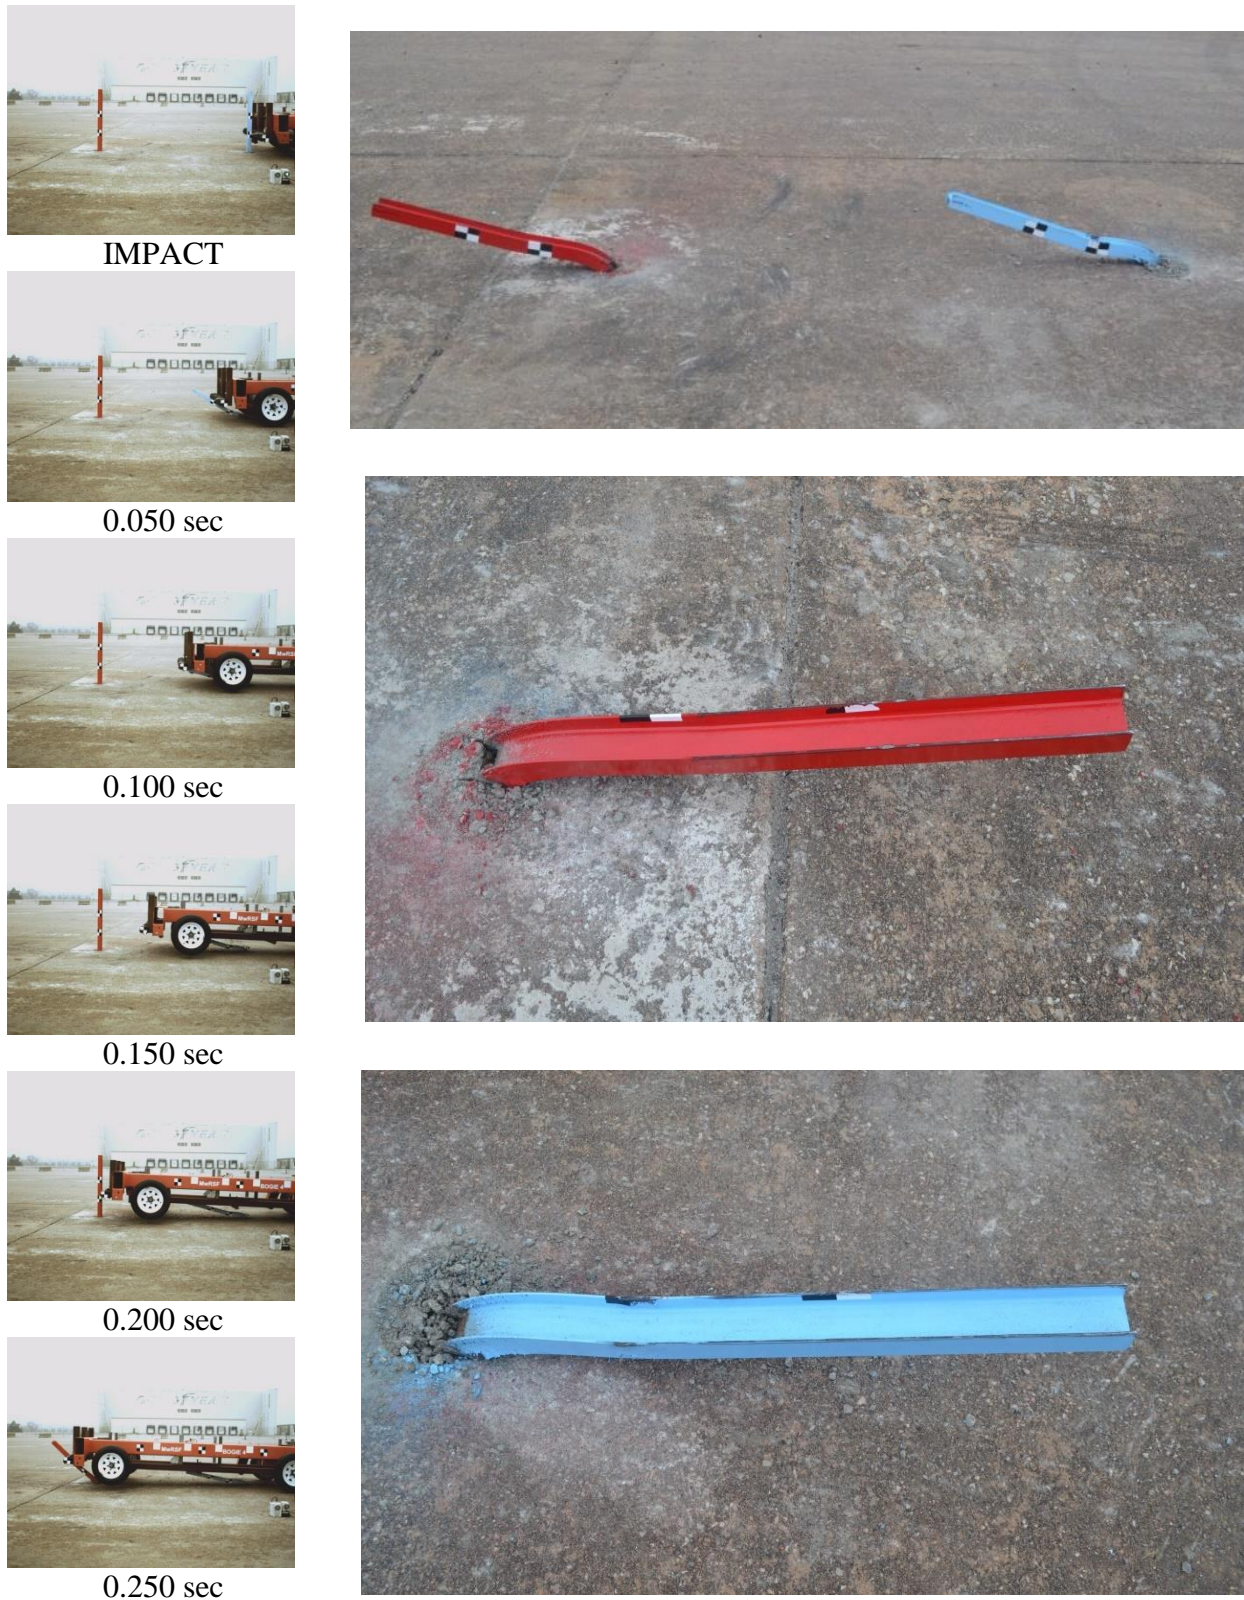
Figure 35. Time-Sequential and Post Damage Photographs, Test No. MWFPF-4

The posts were bent plastically near the groundline, and contact marks were present on both edges of the posts, as shown in Figure 35. Damage to the simulated floorpan included tearing and creasing due to contact with the top corners of both posts, as shown in Figure 36. Four tears were found in both the front and rear bays of the simulated floorpan. These tears corresponded to the location of initial contact between the free edges of the posts and the floorpan as the posts passed the crossbeams and rebounded upward. The largest tear was 6³/₄ in. (171 mm) long and had a maximum width of ⁵/₁₆ in. (8 mm). Creases in the simulated floorpan were found following all four tears and extending toward the rear of the bogie. All of the tears and creases observed on the simulated floorpan were measured and summarized in Table 7.

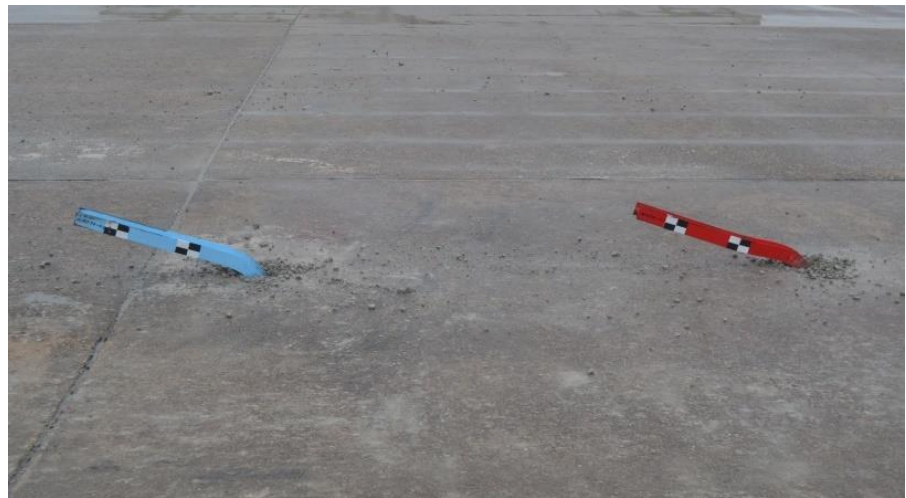
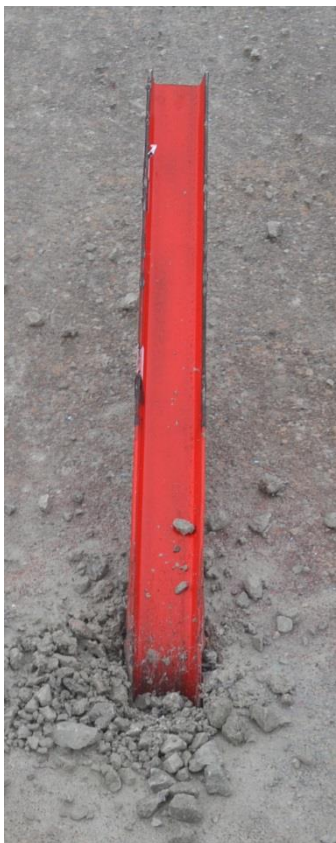
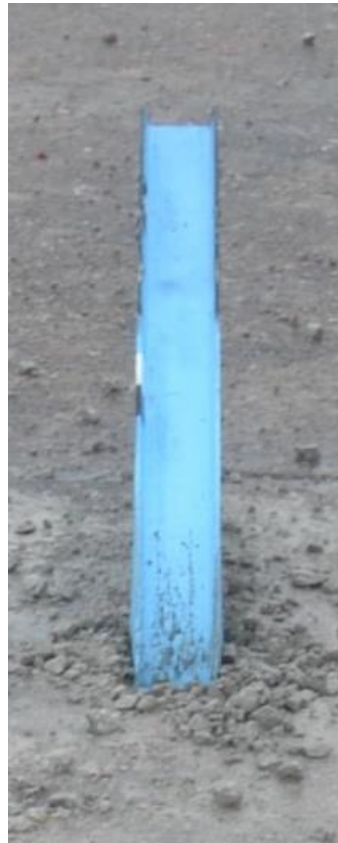
Figure 38. Time-Sequential and Post Damage Photographs, Test No. MWFPF-5

The posts were bent plastically near the groundline, and contact marks were present on both edges of the posts, as shown in Figure 38. Damage to the simulated floorpan included tearing and creasing due to contact with the top corners of both posts, as shown in Figure 39. Four tears were found in both the front and rear bays of the simulated floorpan corresponding to the location of initial contact between the posts and the floorpan as the posts passed the crossbeams and rebounded upward. The largest of these initial tears was 6½ in. (165 mm) long and had a maximum width of ¼ in. (6 mm). Continued contact with one of the posts resulted in two additional tears in the front bay measuring 16 in. (406 mm) and 13 in. (330 mm) in length. The shorter height of the posts appeared to cause higher restoration forces, which led to these additional tears. Creases were also found in the simulated floorpan extending from the initial tears toward the rear of the bogie. All of the tears and creases observed on the simulated floorpan were measured and are summarized in Table 8.

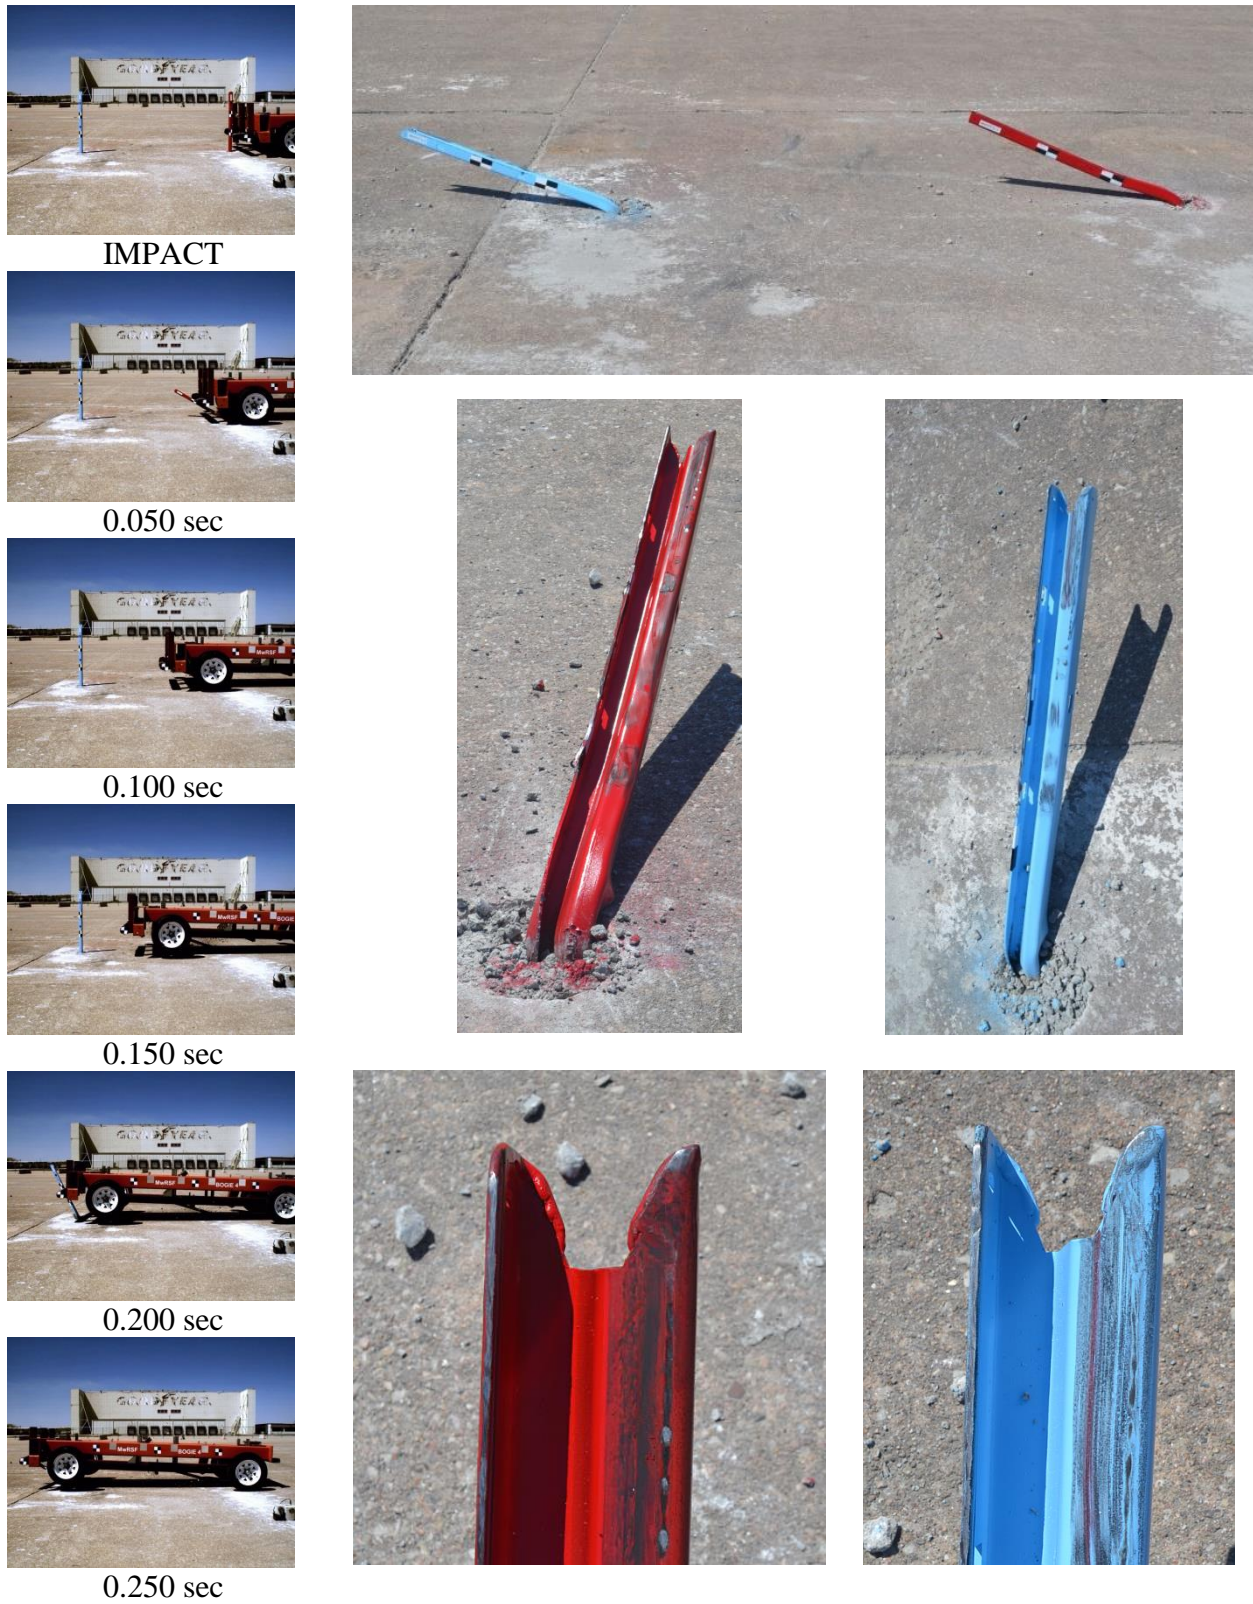
Figure 42. Time-Sequential and Post Damage Photographs, Test No. MWFPF-6

The posts were bent plastically near the groundline, and contact marks were found on the top half of the post along the free edge and impact side face of the post, as shown in Figure 42. Damage to the simulated floorpan included creasing and tearing due to contact from the top corners of both posts, as shown in Figure 43. Two tears were found in both the front and rear bays of the simulated floorpan. These tears corresponded to the location of initial contact between the free edges of the posts and the floorpan as the posts passed the crossbeams and rebounded upward. The largest tear was 12¾ in. (324 mm) long and had a maximum width of ½ in. (13 mm). Creases in the simulated floorpan were found extending from the tears toward the rear of the bogie. Additional creases caused by the continuous edges of the posts were present in the floorpan, approximately 3 in. (76 mm) to the right of the tears and creases caused by the free edges of the post. All tears and creases observed on the simulated floorpan were measured and are summarized in Table 9.

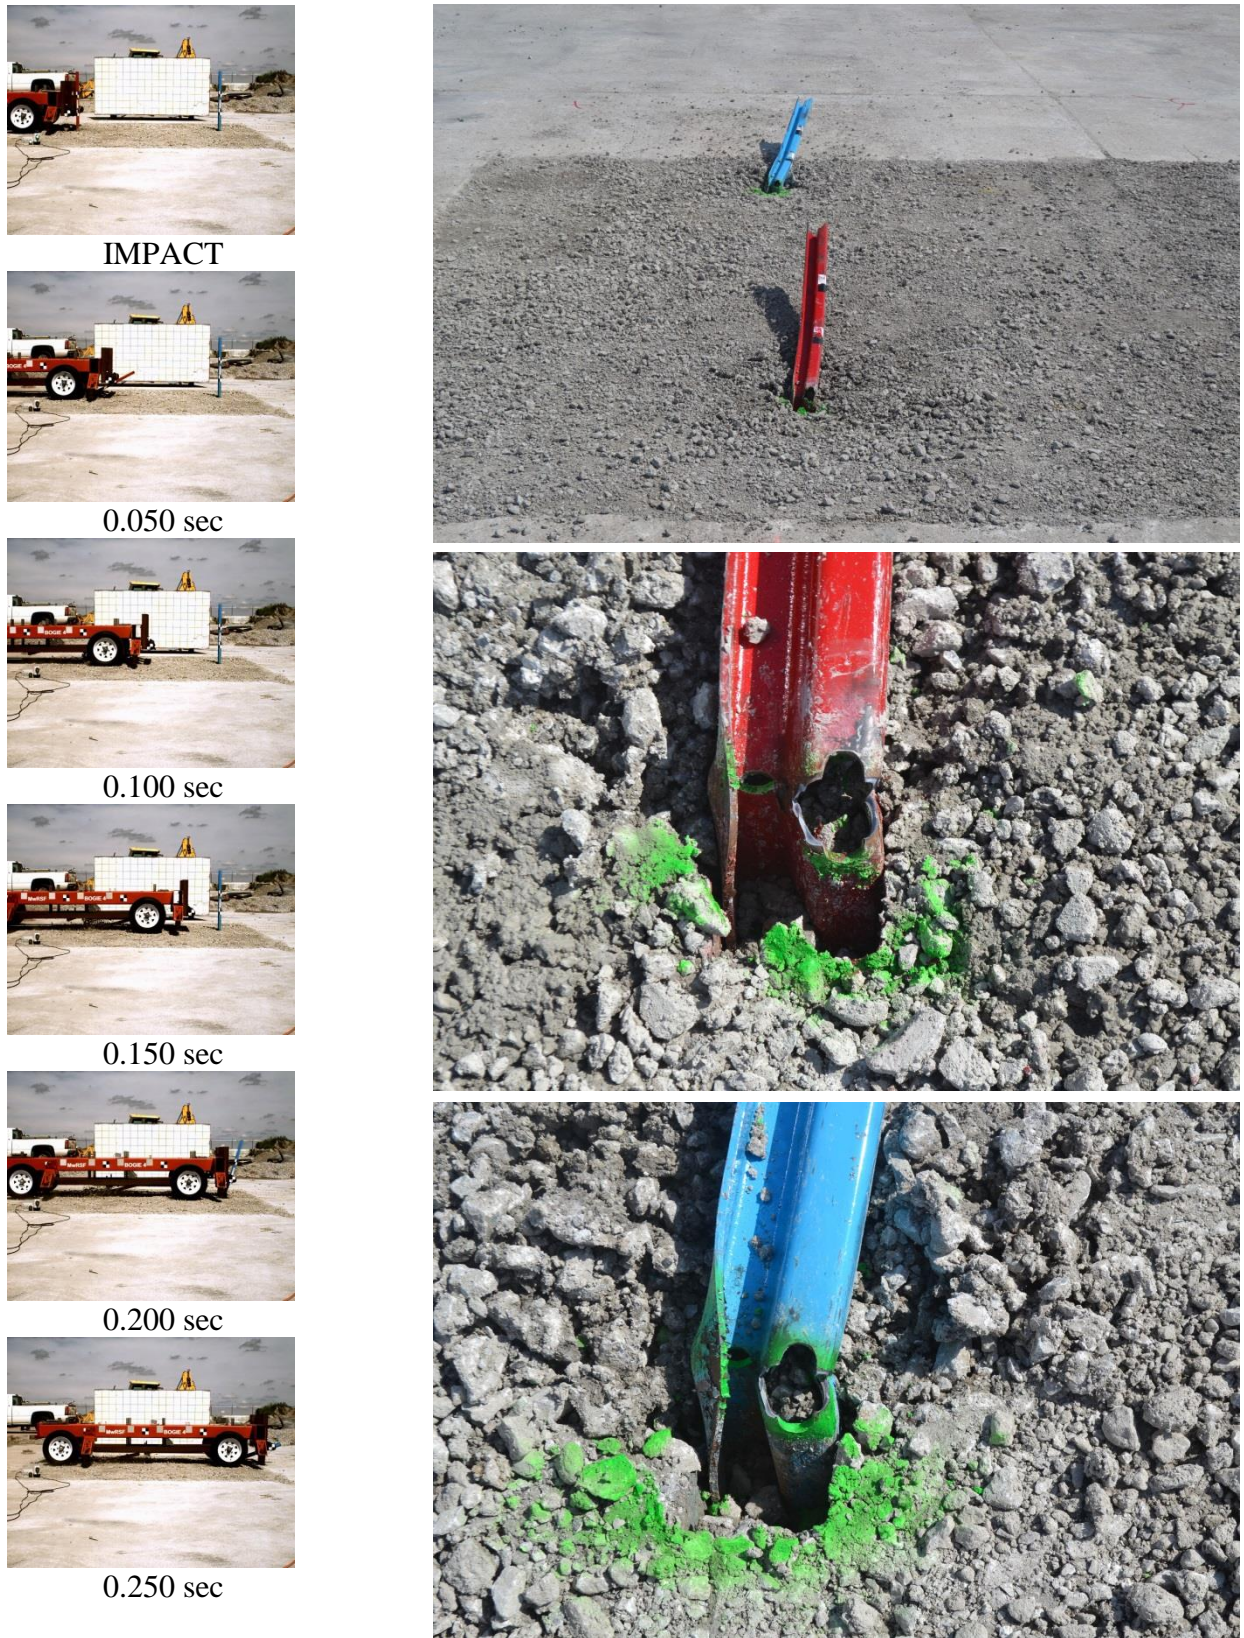
Figure 45. Time-Sequential and Post Damage Photographs, Test No. MWFPF-7

The posts were bent plastically near the groundline, and tearing was present in both posts, as shown in Figure 45. The tears initiated from the weakening holes on the impact side of the posts and extended into the webs and adjacent flanges. The posts displaced approximately 1 in. (25 mm) through the soil at the groundline. Contact marks were found on the top half of the post along the free edge and impact side face of the post. Damage to the simulated floorpan included scrapes and creases, but no tearing. Four creases were found in both the front and rear bays of the simulated floorpan, as shown in Figure 46. The two creases in each bay resulted from contact with the free edges of the posts and extended nearly the entire length of the bogie vehicle. The creases resulting from contact with the continuous edges of the posts were limited to less than 6 in. (152 mm). All creases observed on the simulated floorpan were measured and summarized in Table 10.

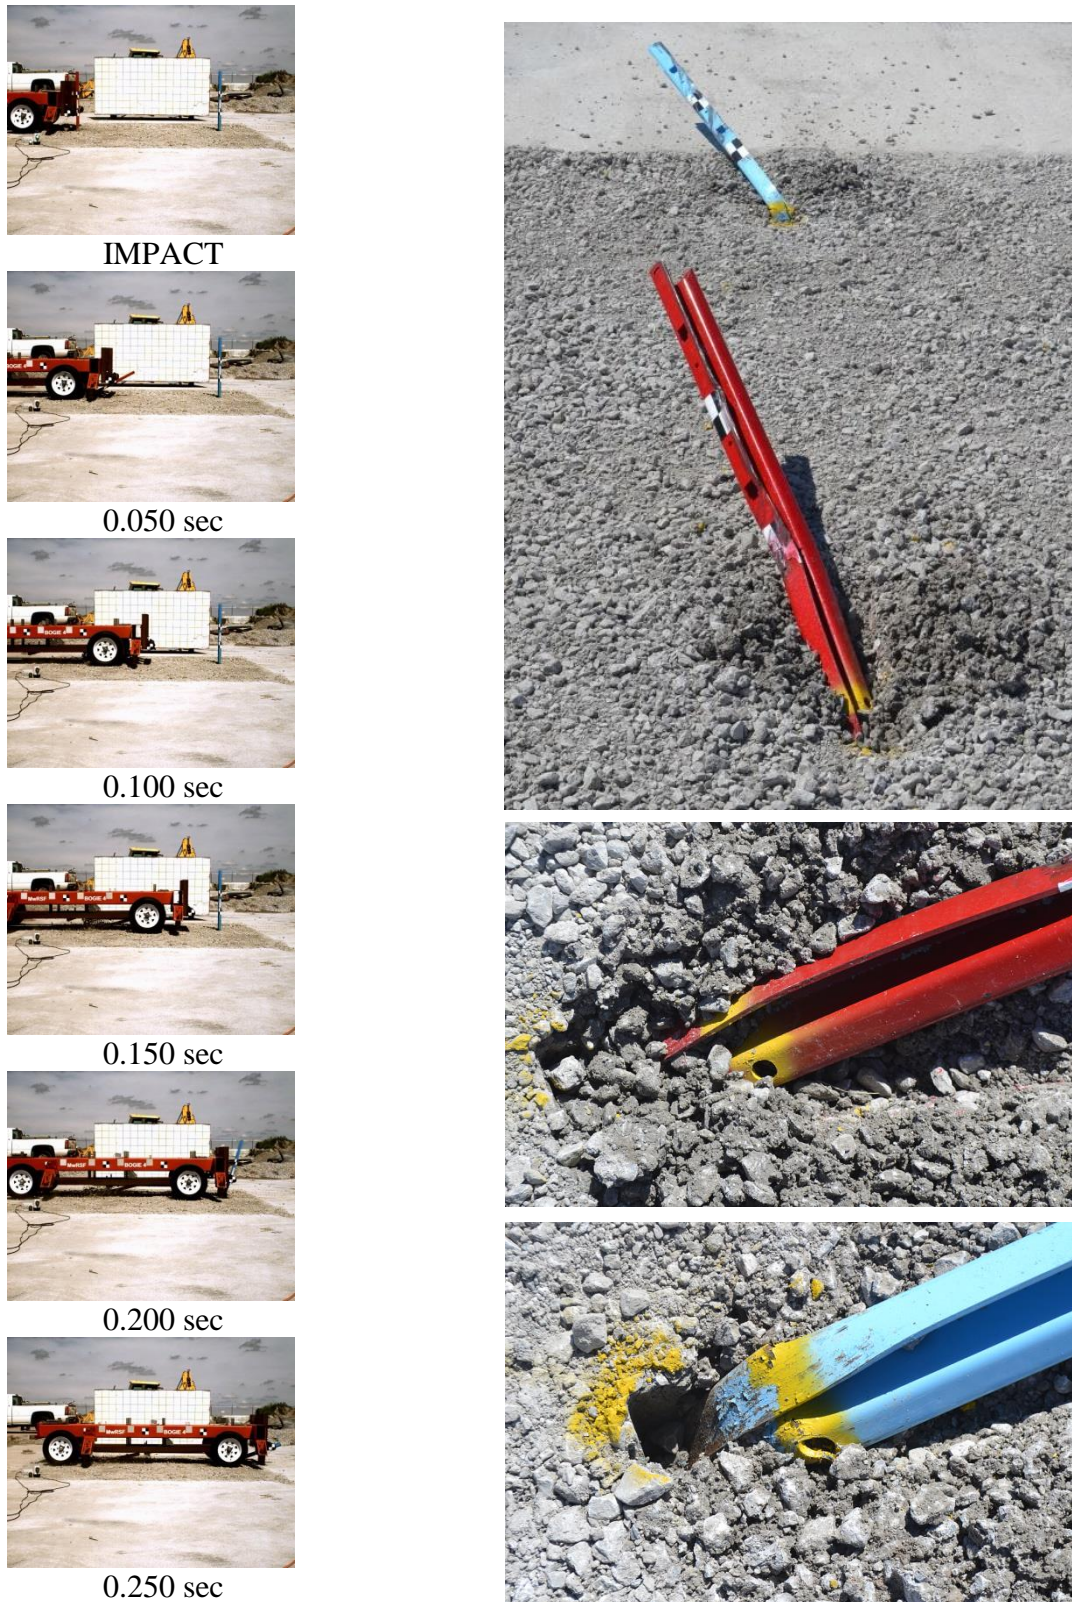
Figure 48. Time-Sequential and Post Damage Photographs, Test No. MWFPF-8

The posts were bent plastically near groundline, and contact marks were found along the top half of the post, as shown in Figure 48. No tearing was observed in the post around the weakening holes. The posts displaced 2 to 3 in. (51 to 76 mm) through the soil at the groundline. Damage to the simulated floorpan included tears and creases, as shown in Figure 49. Tears were found in the front and rear bays corresponding to contact from the free edge of the first post. Each bay had an initial tear near the crossbeam, the largest of which was 10¾ in. (273 mm) long with a maximum opening width of ⅝ in. (16 mm). Creasing followed these tears and eventually led to secondary tears measuring 25 in. (635 mm) and 18½ in. (470 mm). The free edge of the second post left a prominent crease along the front bay of the simulated floorpan and a short crease on the rear bay before sliding to the side of the bogie and losing contact with the floorpan. Due to the orientation angle of the post, the continuous edges left only minor creases in the floorpan. All tears and creases observed on the simulated floorpan were measured and are summarized in Table 11.

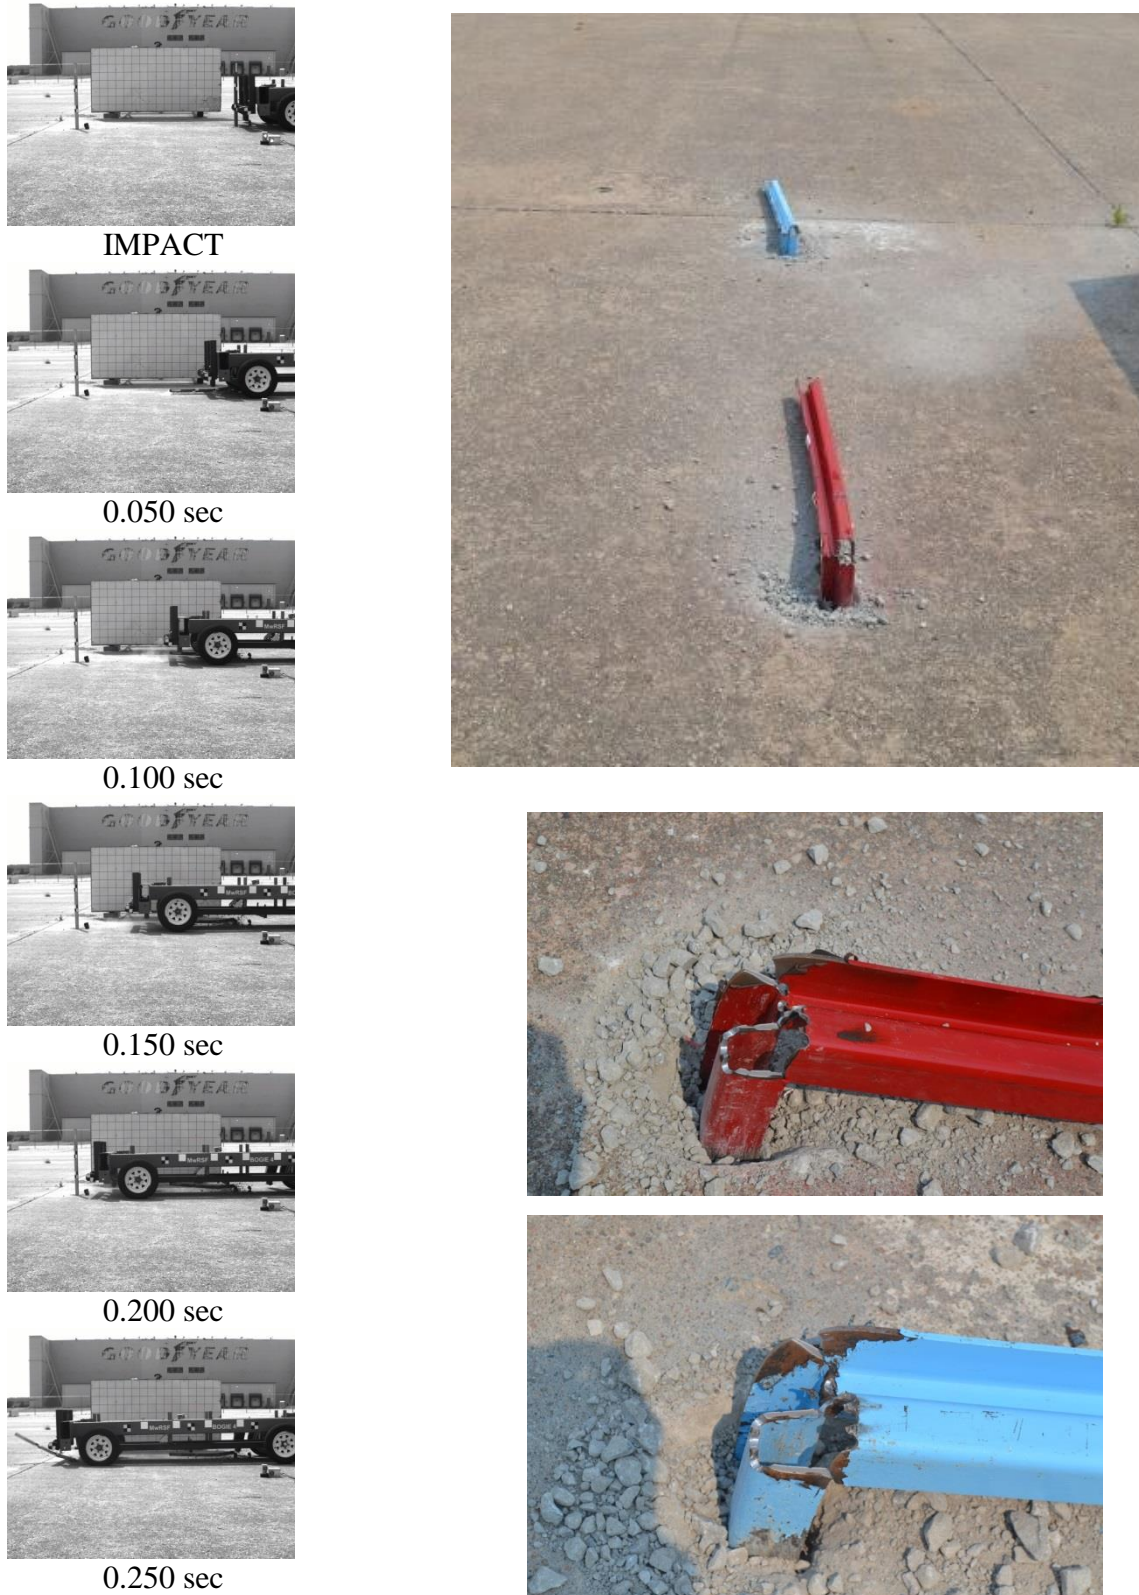
Figure 52. Time-Sequential and Post Damage Photographs, Test No. MWFPF-11

The posts were completely bent over, and tearing was present in both posts, as shown in Figure 52. The tears initiated from the weakening holes on the impact side of the posts and extended into the webs and adjacent flanges. Additional tears occurred in the free edges of the posts leaving only the backside face of the posts to hold the posts together. After the tears formed in the posts, the angular momentum of the top of the posts rotated backward and then impacted the ground causing the bottom of the posts to pull out of the ground vertically a few inches. The simulated floorpan was undamaged as the posts never contacted the undercarriage of the bogie vehicle.
