EVALUATION OF FLOORPAN TEARING AND CABLE SPICES FOR CABLE BARRIER SYSTEMS

MIDWEST ROADSIDE SAFETY FACILITY

MwRSF Research Report No. TRP-03-324-17

May 16, 2017

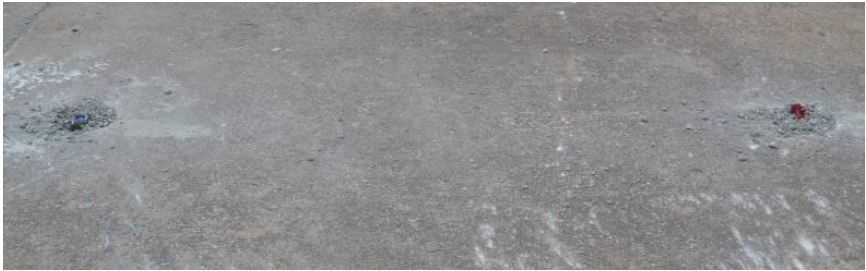
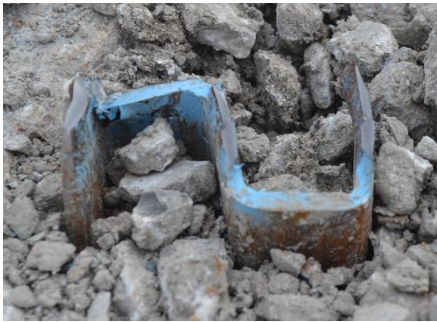
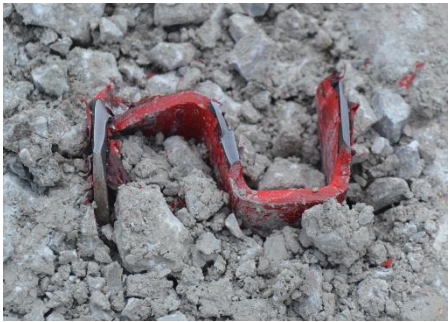
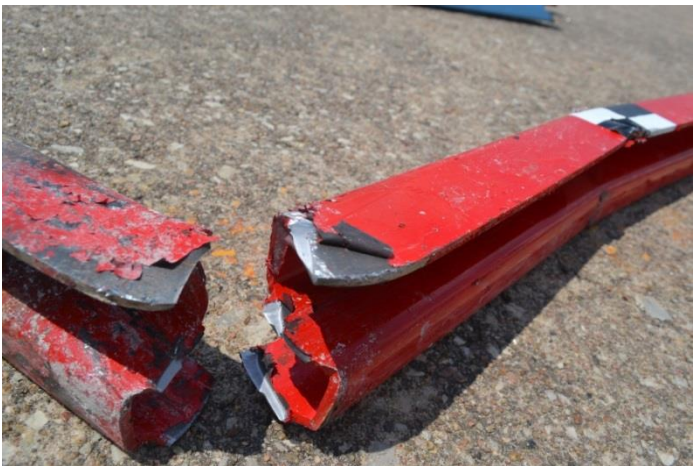
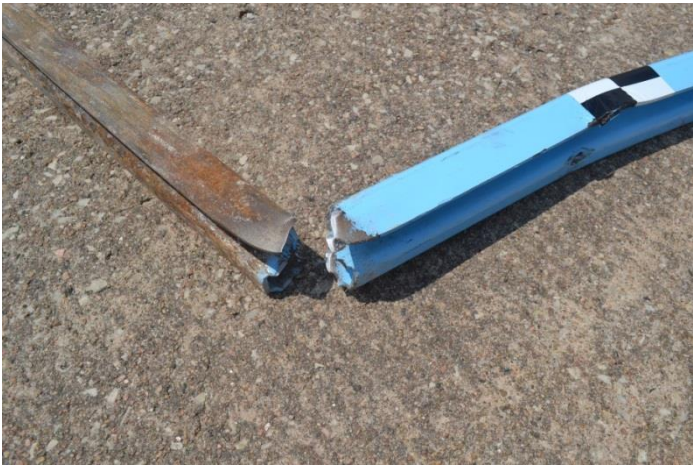
Figure 55. Time-Sequential and Post Damage Photographs, Test No. MWFPF-12

Both posts had ruptured at the groundline, as shown in Figure 55. Tearing was initiated around the weakening slots on the impact side of the posts and continued through the entire cross section. The simulated floorpan was undamaged as the posts never contacted the undercarriage of the bogie vehicle.

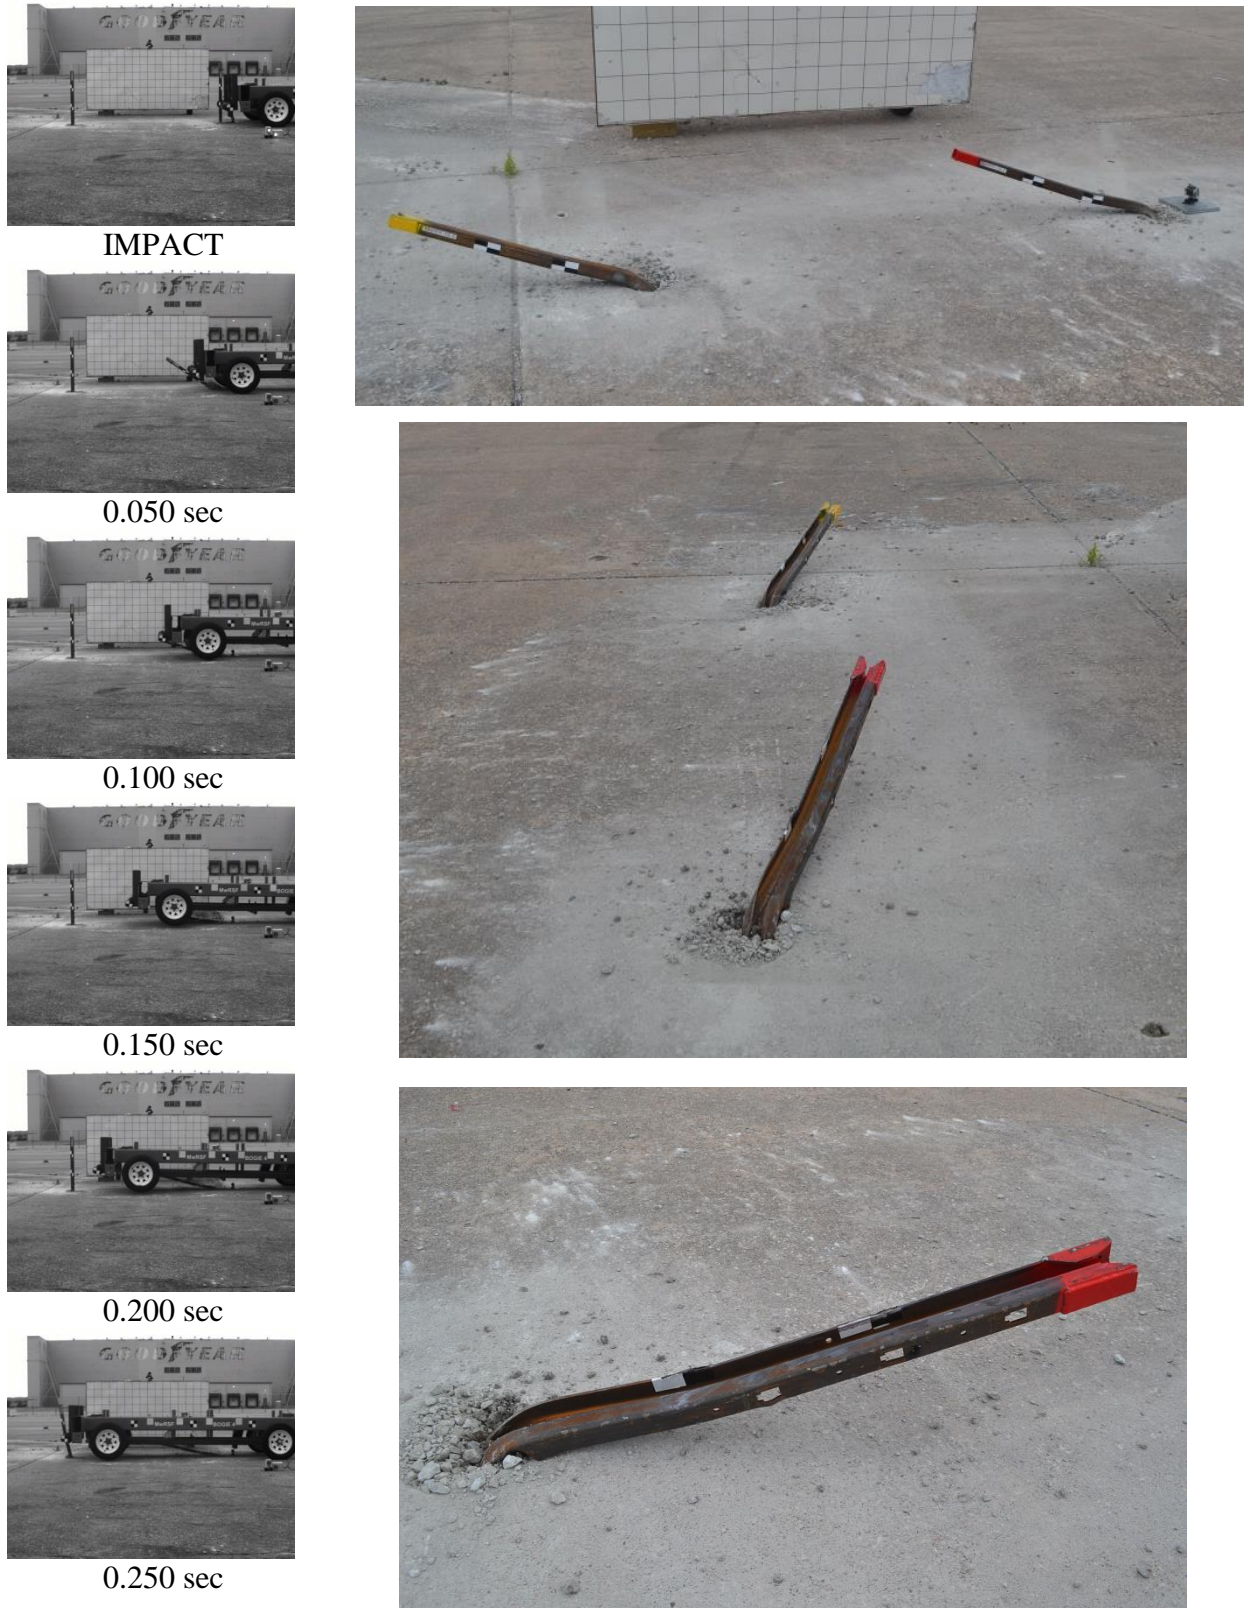
Figure 58. Time-Sequential and Post Damage Photographs, Test No. MWFPF-13

The posts were bent plastically near the groundline, and contact marks were found along the impact side of the posts, as shown in Figure 58. Damage to the simulated floorpan included tearing and creasing due to contact from the top corners of both posts, as shown in Figure 59. Two tears were found in both the front and rear bays of the simulated floorpan. These tears corresponded to the location of initial contact between the continuous edges of the posts and the floorpan as the posts passed the crossbeams and rebounded upward. The largest tear was 3 in. (76 mm) long and had a maximum width of ¼ in. (6 mm). Creases in the simulated floorpan were found along the entire length of the simulated floorpan. All tears and creases observed on the simulated floorpan were measured and are summarized in Table 12.

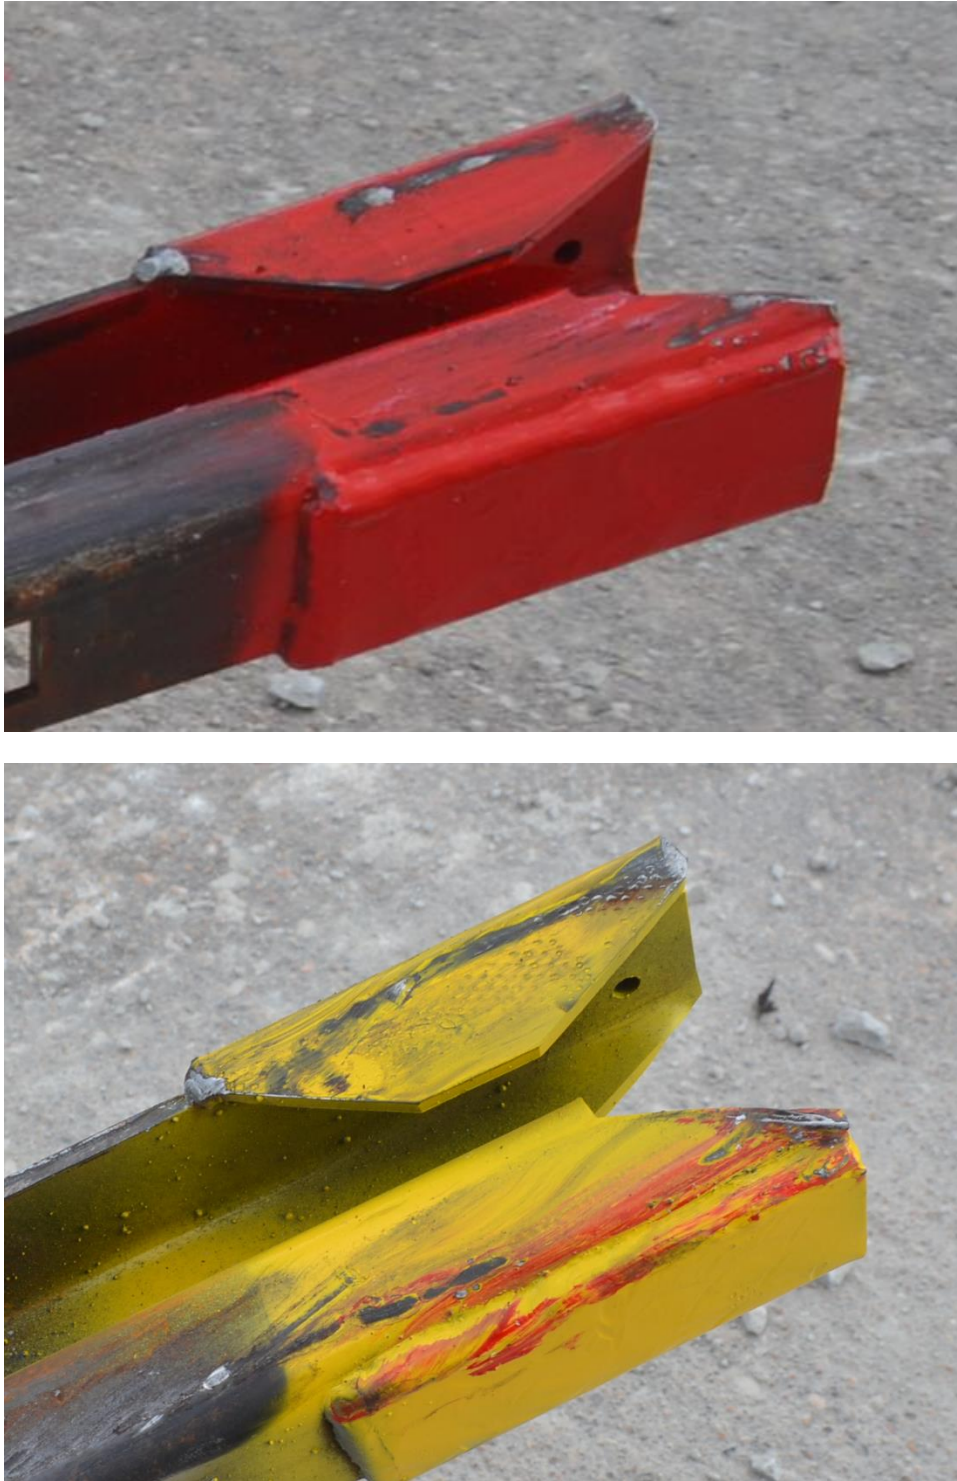
Figure 60. Post Damage, Test No. MWFPF-13

Figure 60, the lack of a radius at this location resulted in a sharp corner exposed to contact with an impacting vehicle. Further, these sharp corners were responsible for all four tears observed in the simulated floorpan. The protected free-edge sides of the posts caused only creasing in the simulated floorpan. Thus, the steel plate edge protector may have actually prevented tearing if the posts had been fabricated correctly.

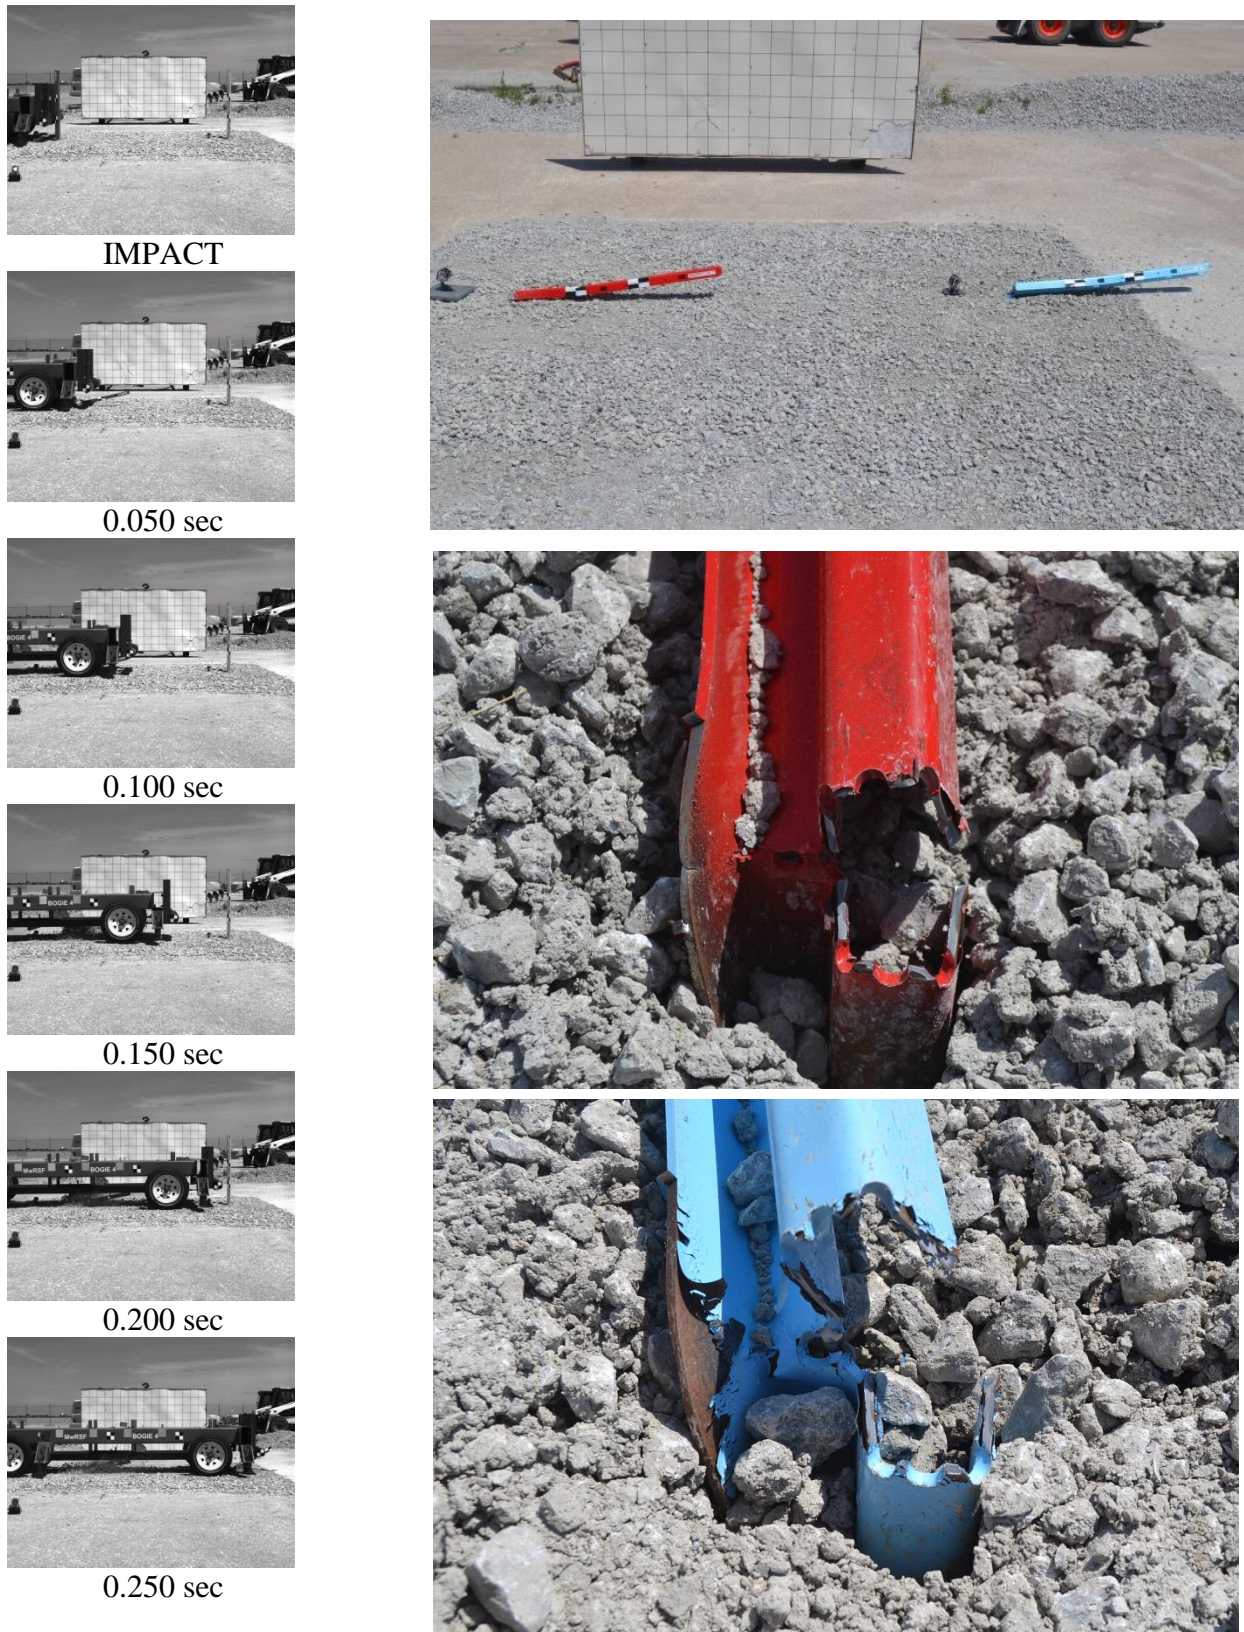
Figure 62. Time-Sequential and Post Damage Photographs, Test No. MWFPF-14

The posts were completely bent over, and tearing was present in both posts, as shown in Figure 62. The tears initiated from the weakening holes on the impact side of the posts and extended through the adjacent flanges and the webs. Only the opposite-side flanges and the backside faces of the posts were still intact and held the posts together. The posts displaced approximately 1½ in. (38 mm) through the soil at the groundline. The simulated floorpan was undamaged as the posts never contacted the undercarriage of the bogie vehicle.

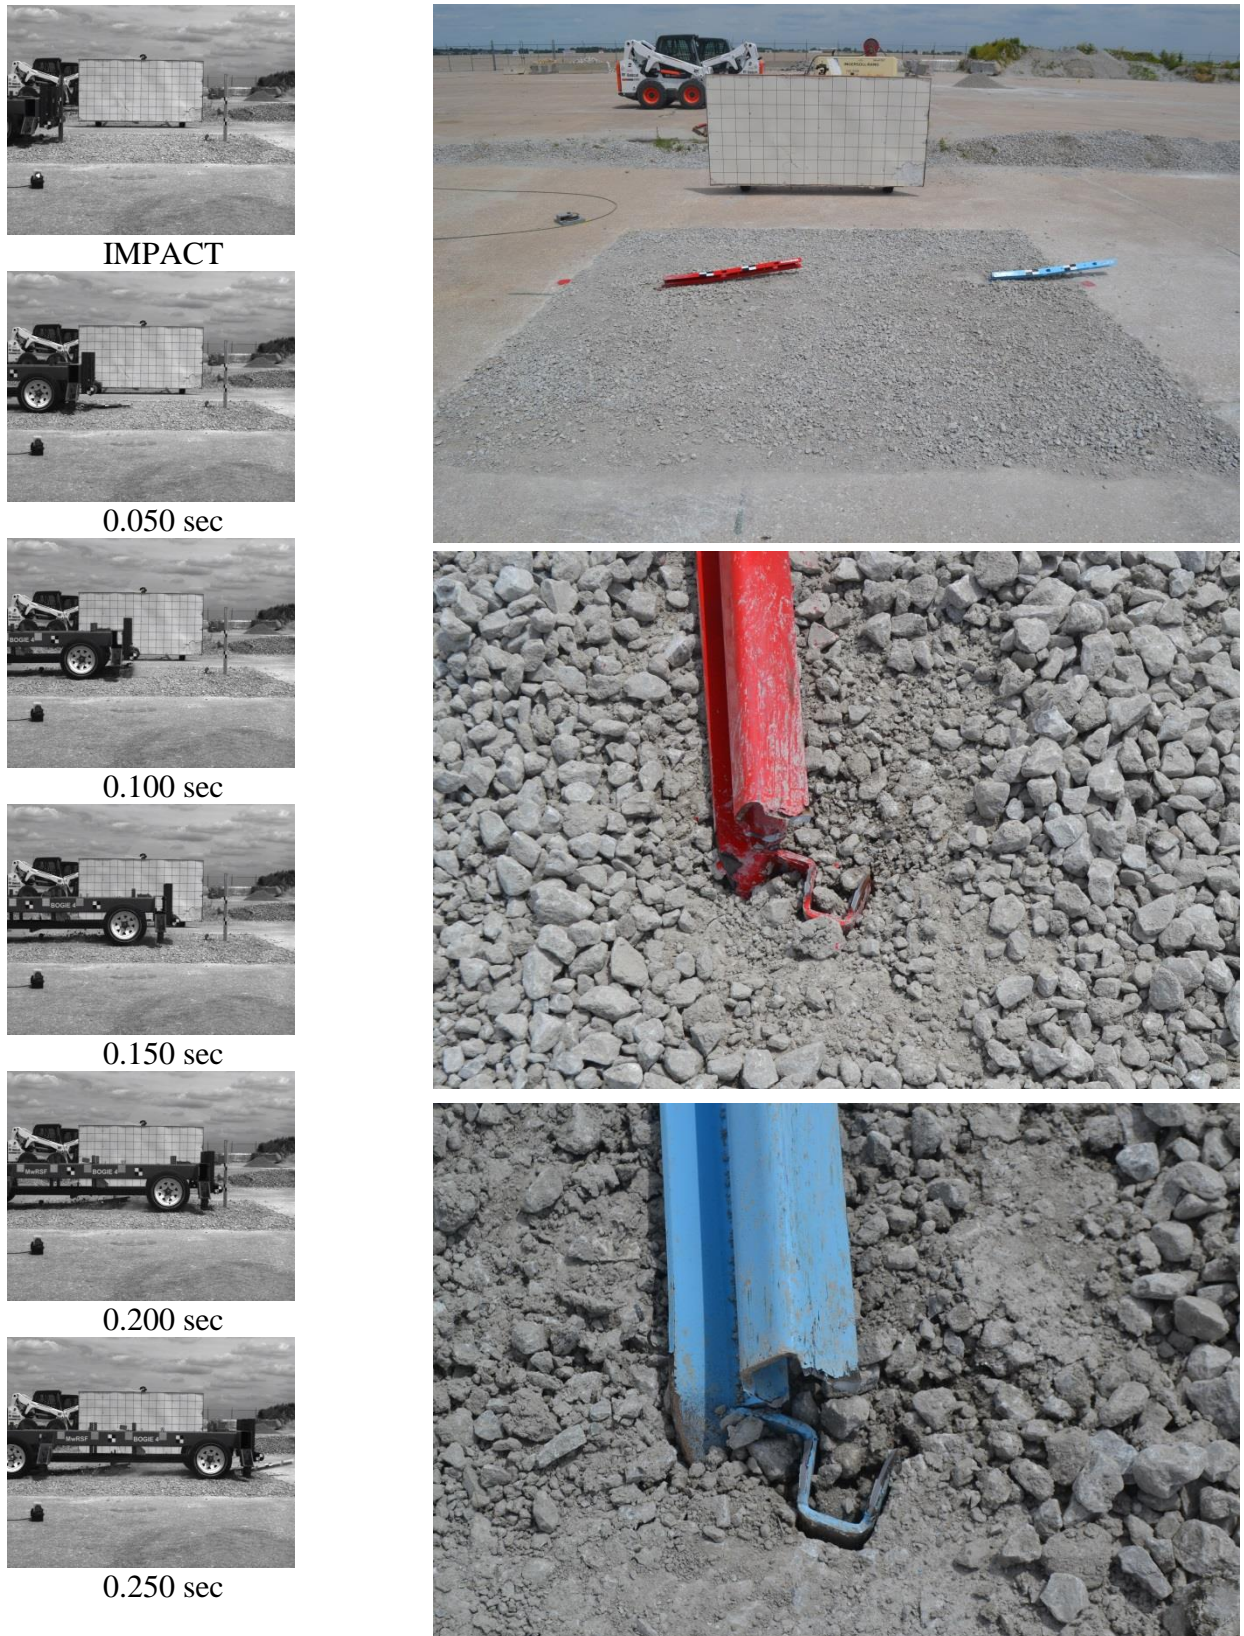
Figure 64. Time-Sequential and Post Damage Photographs, Test No. MWFPF-15

The posts were completely bent over, and tearing was present in both posts, as shown in Figure 64. The tears initiated from the weakening slots on the impact side of the posts and extended through the adjacent flanges and the webs. Only the opposite-side flanges of the posts were still intact and held the posts together. The posts displaced approximately $\frac{1}{2}$ in. (13 mm) through the soil at groundline. The simulated floorpan was undamaged as the posts never contacted the undercarriage of the bogie vehicle.

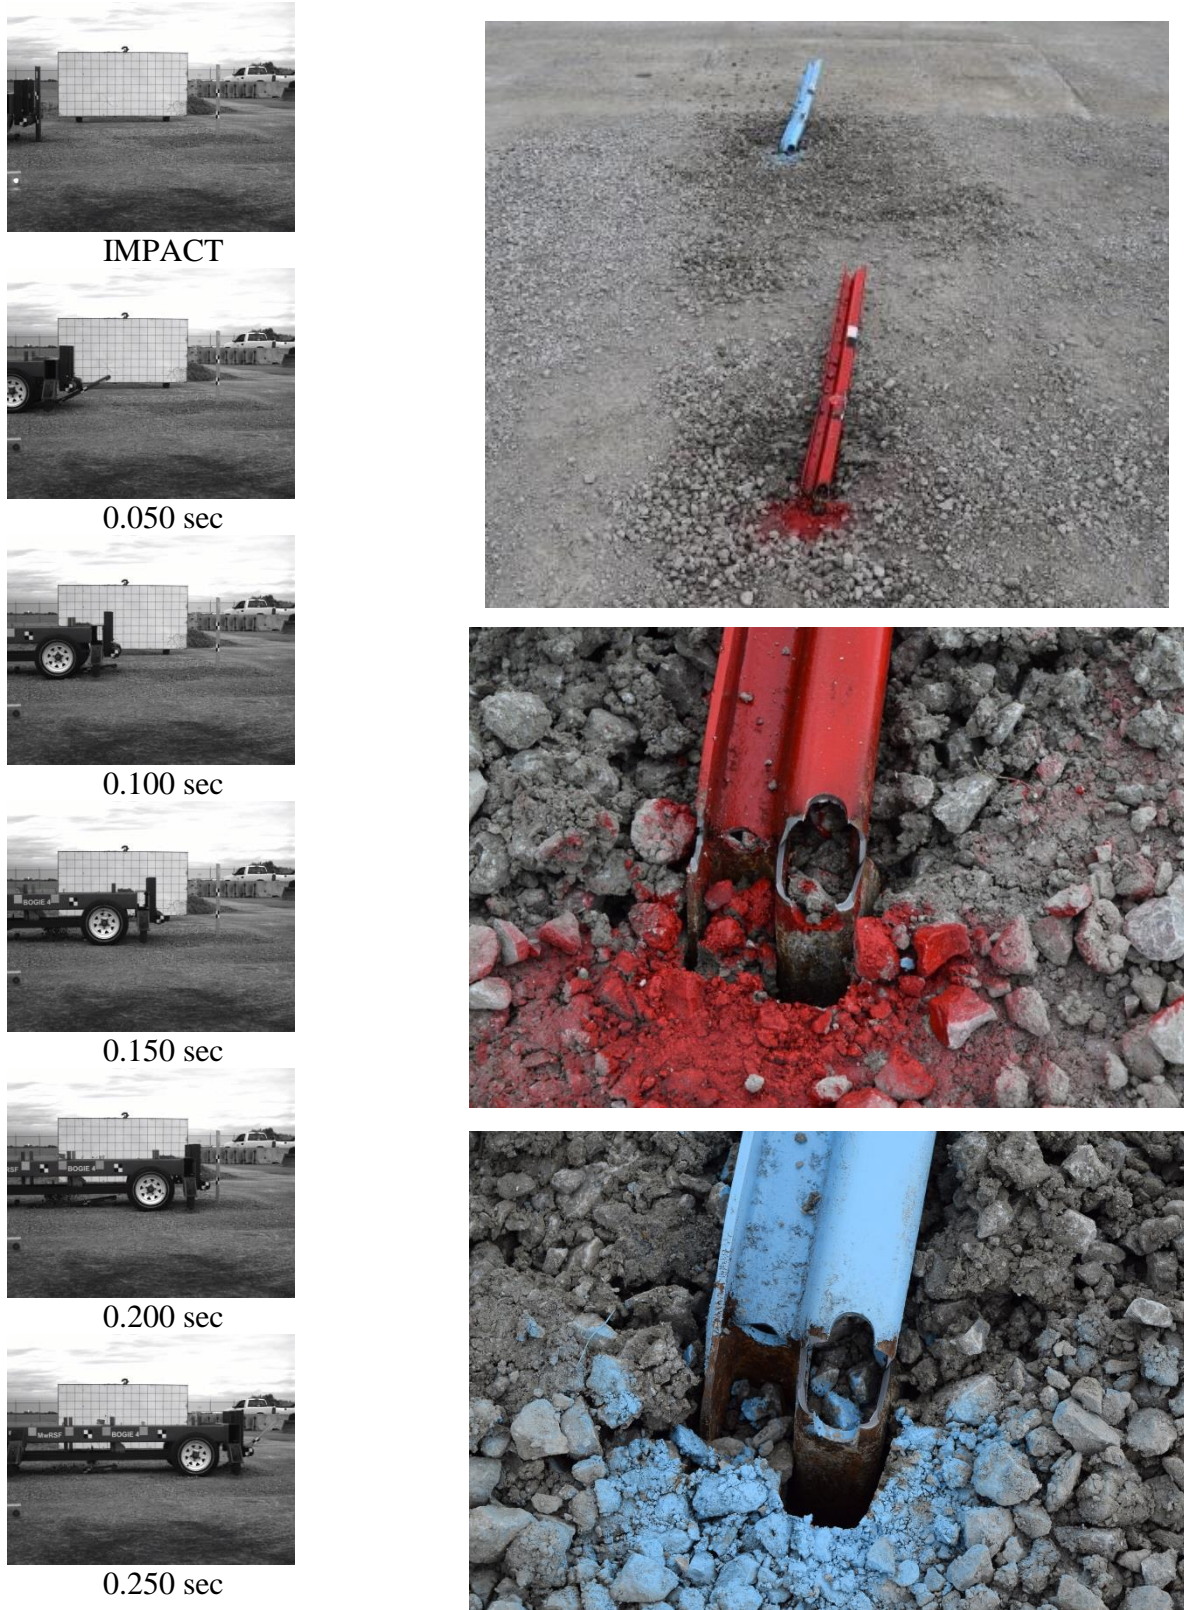
Figure 66. Time-Sequential and Post Damage Photographs, Test No. MWFPF-18

The posts were bent plastically near the groundline, and tearing was present in both posts, as shown in Figure 66. The tears initiated from the weakening holes on the impact side of the posts and extended into the webs and adjacent flanges. Additional tearing was found on the opposite side flange of the first post. The posts displaced approximately $1\frac{1}{2}$ in. (38 mm) through the soil at the groundline. Damage to the simulated floorpan included scrapes and creases, but no tearing. Two creases were found in both the front and rear bays of the simulated floorpan, as shown in Figure 67. Only one of the creases extended past the region of initial contact. All creases observed on the simulated floorpan were measured and are summarized in Table 13.

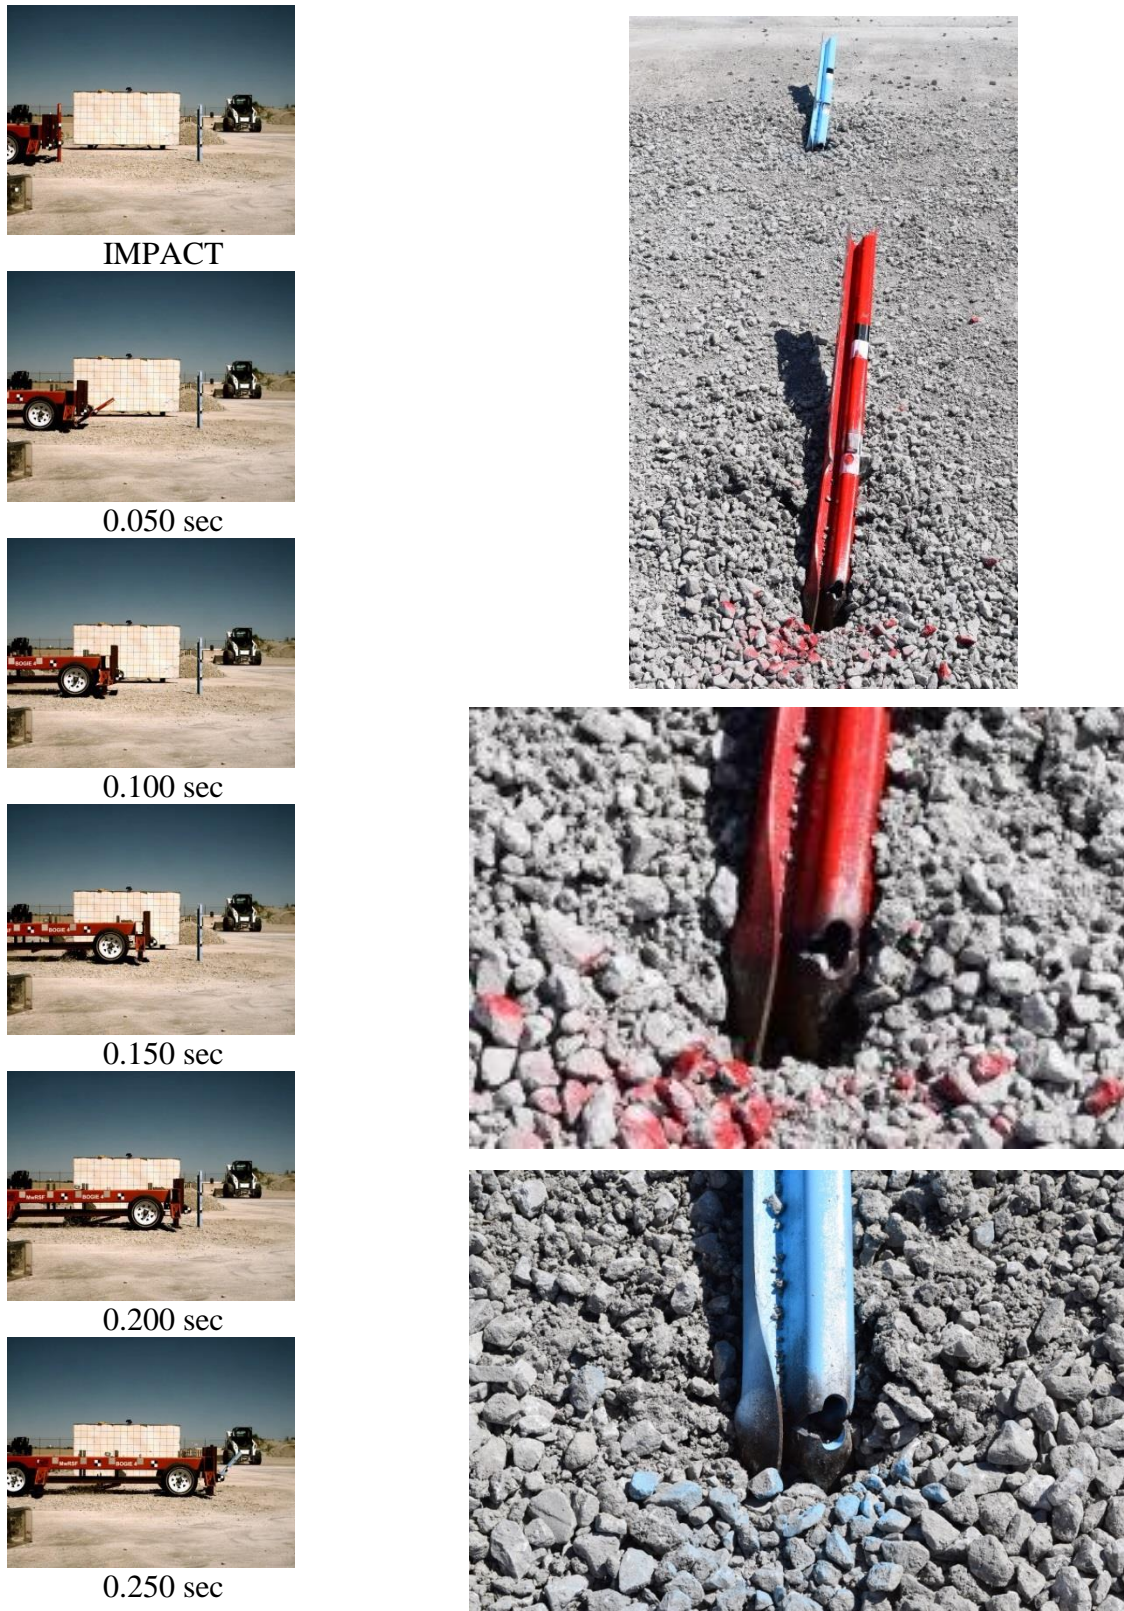
Figure 69. Time-Sequential and Post Damage Photographs, Test No. MWFPF-21

The posts were bent plastically near the groundline, and tearing was present in both posts, as shown in Figure 69. The tears initiated from the weakening holes on the impact side of the posts and extended into the webs and adjacent flanges. The posts displaced approximately 1½ in. (38 mm) through the soil at the groundline. Damage to the simulated floorpan included scrapes and creases, but no tearing. Three creases were found in both the front and rear bays of the simulated floorpan, as shown in Figure 70. Creases resulting from contact with free edges extended along the length of the simulated floorpan. Creases formed from contact with continuous edges were limited to only the area of initial contact. All creases observed on the simulated floorpan were measured and are summarized in Table 14.

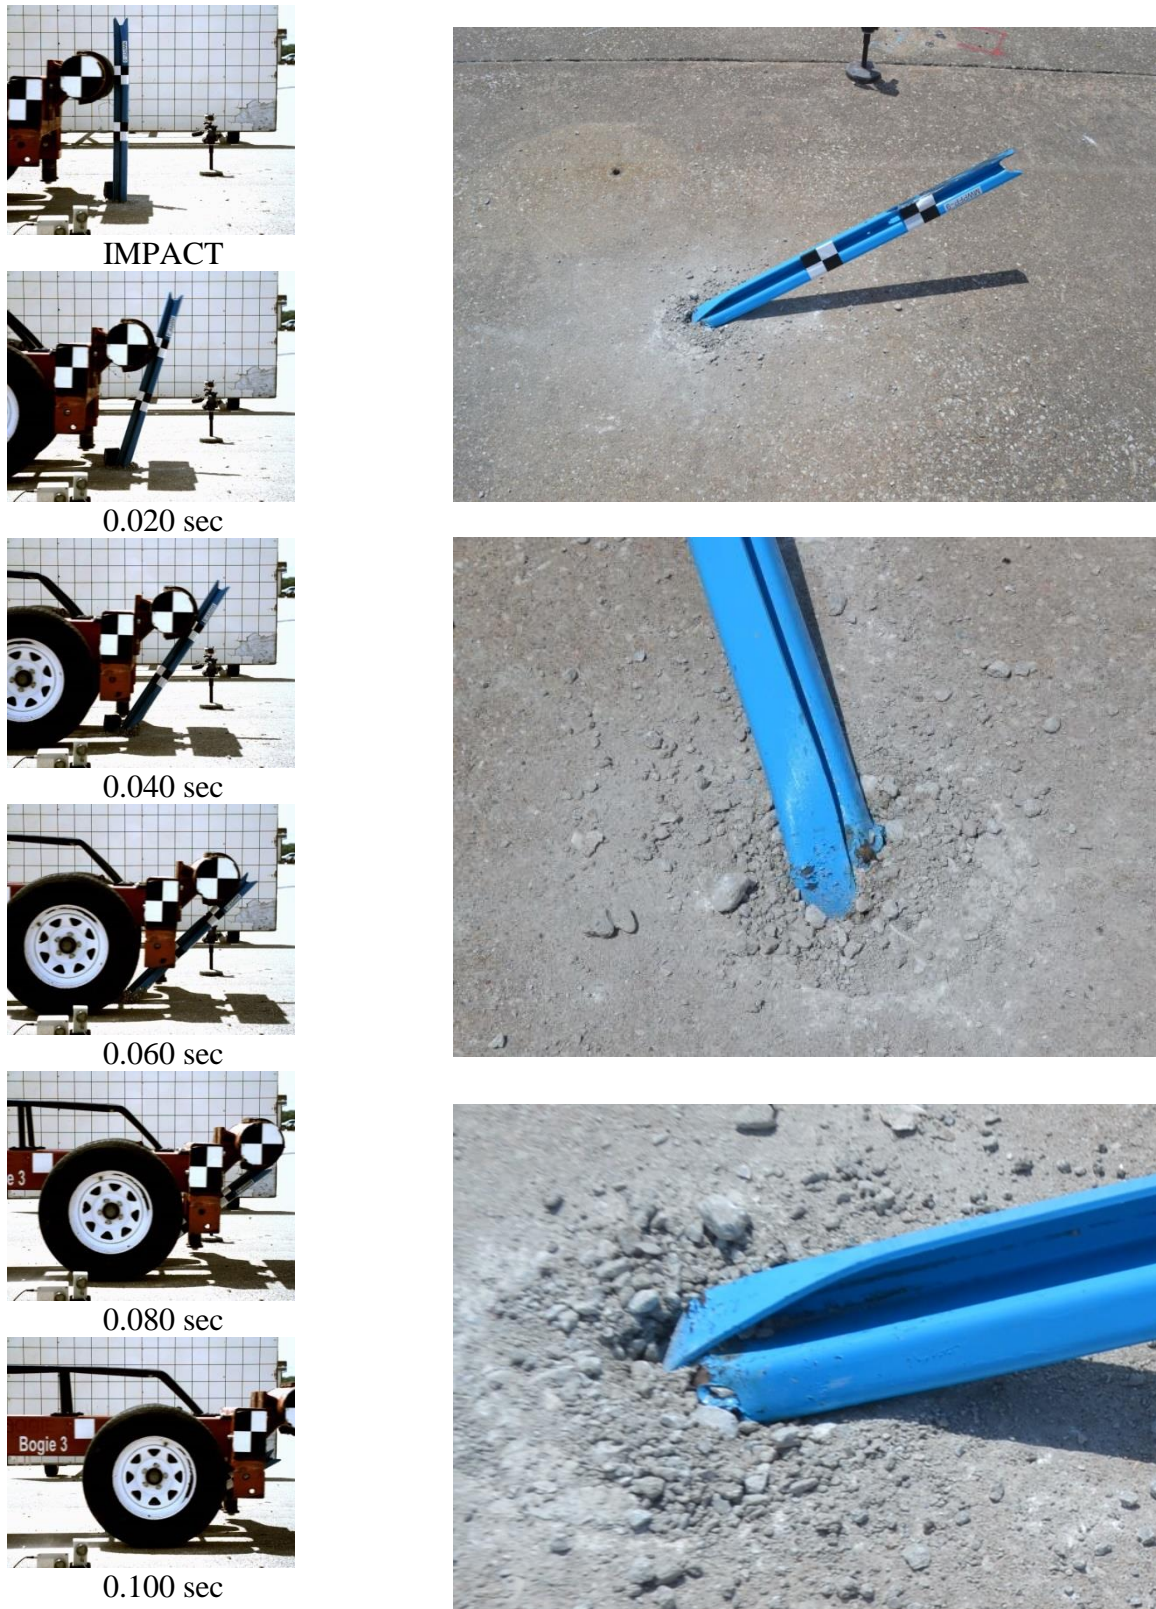
Figure 80. Time-Sequential and Post-Impact Photographs, Test No. MWPFP-9

Sequential and post damage photographs are shown in Figure 80. Contact marks were present along the top portion of the impact-side flange. A plastic hinge was observed around the weakening holes near groundline, and the post flanges collapsed inward toward the web. The weakening holes were deformed, but the post did not tear.

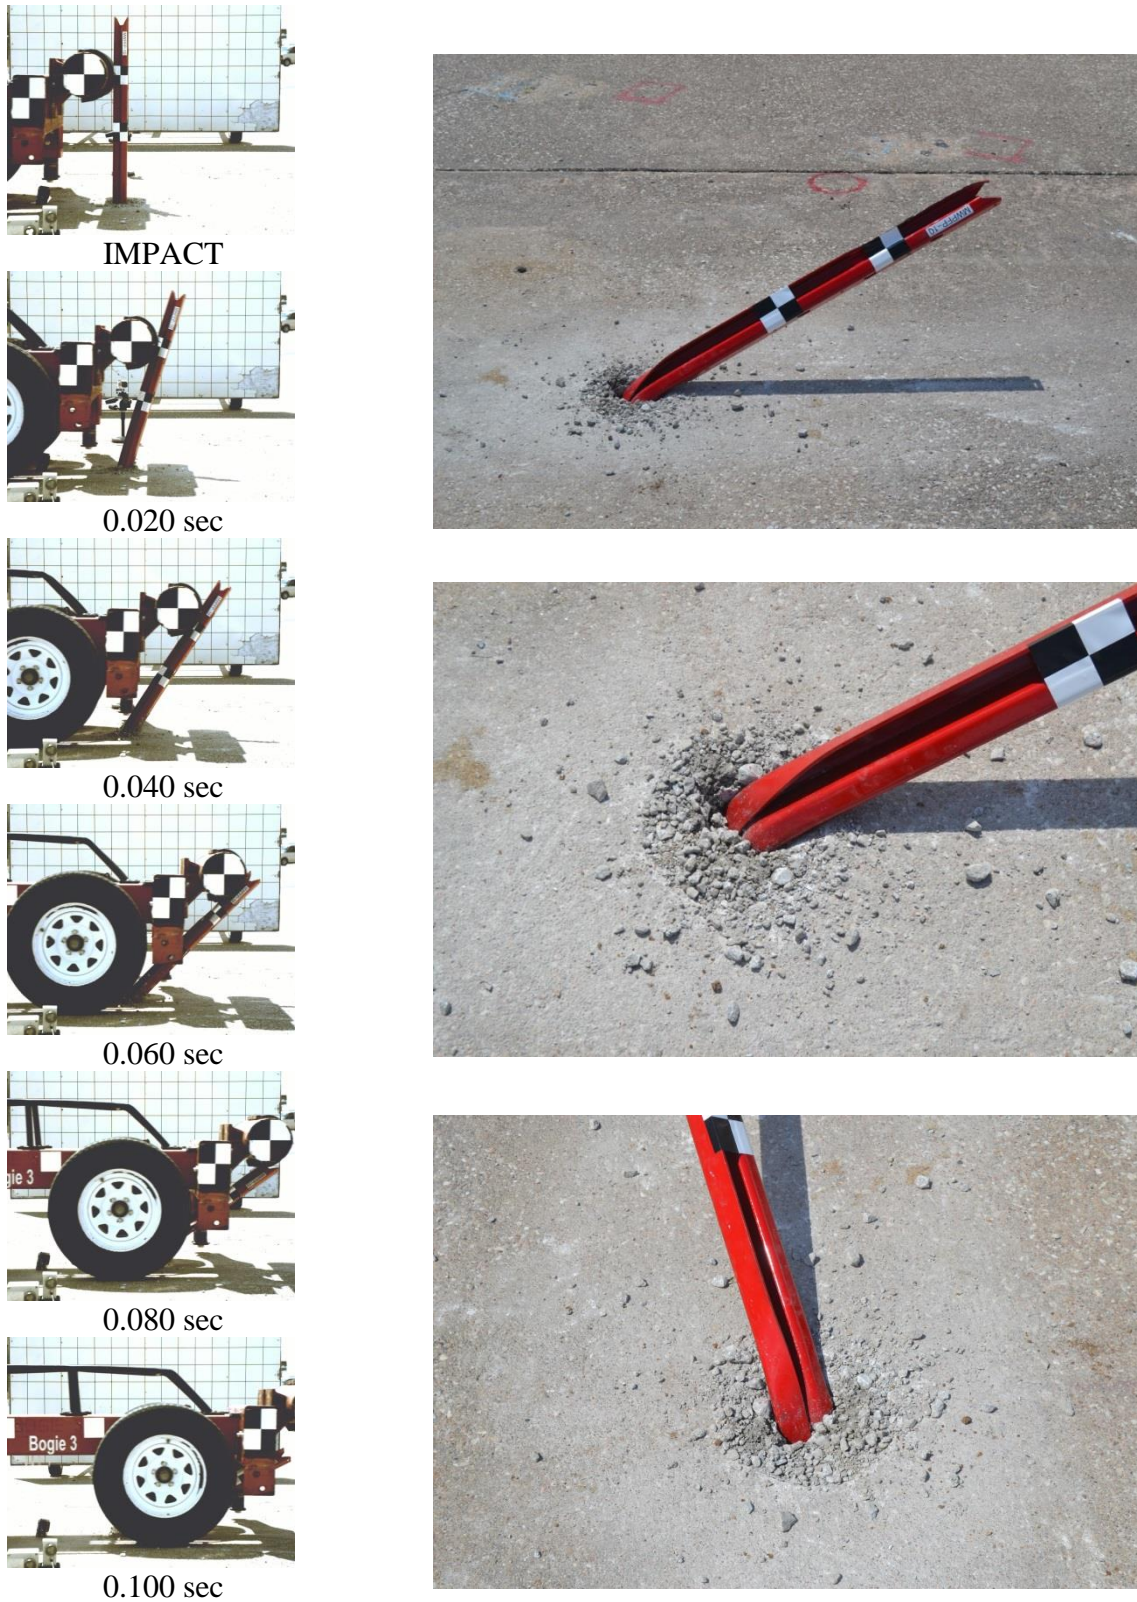
Figure 82. Time-Sequential and Post-Impact Photographs, Test No. MWPFP-10

Sequential and post damage photographs are shown in Figure 82. Contact marks were present along the top portion of the impact-side flange. A plastic hinge had formed in the post near the groundline, and the post flanges collapsed inward toward the web, but the post did not tear.

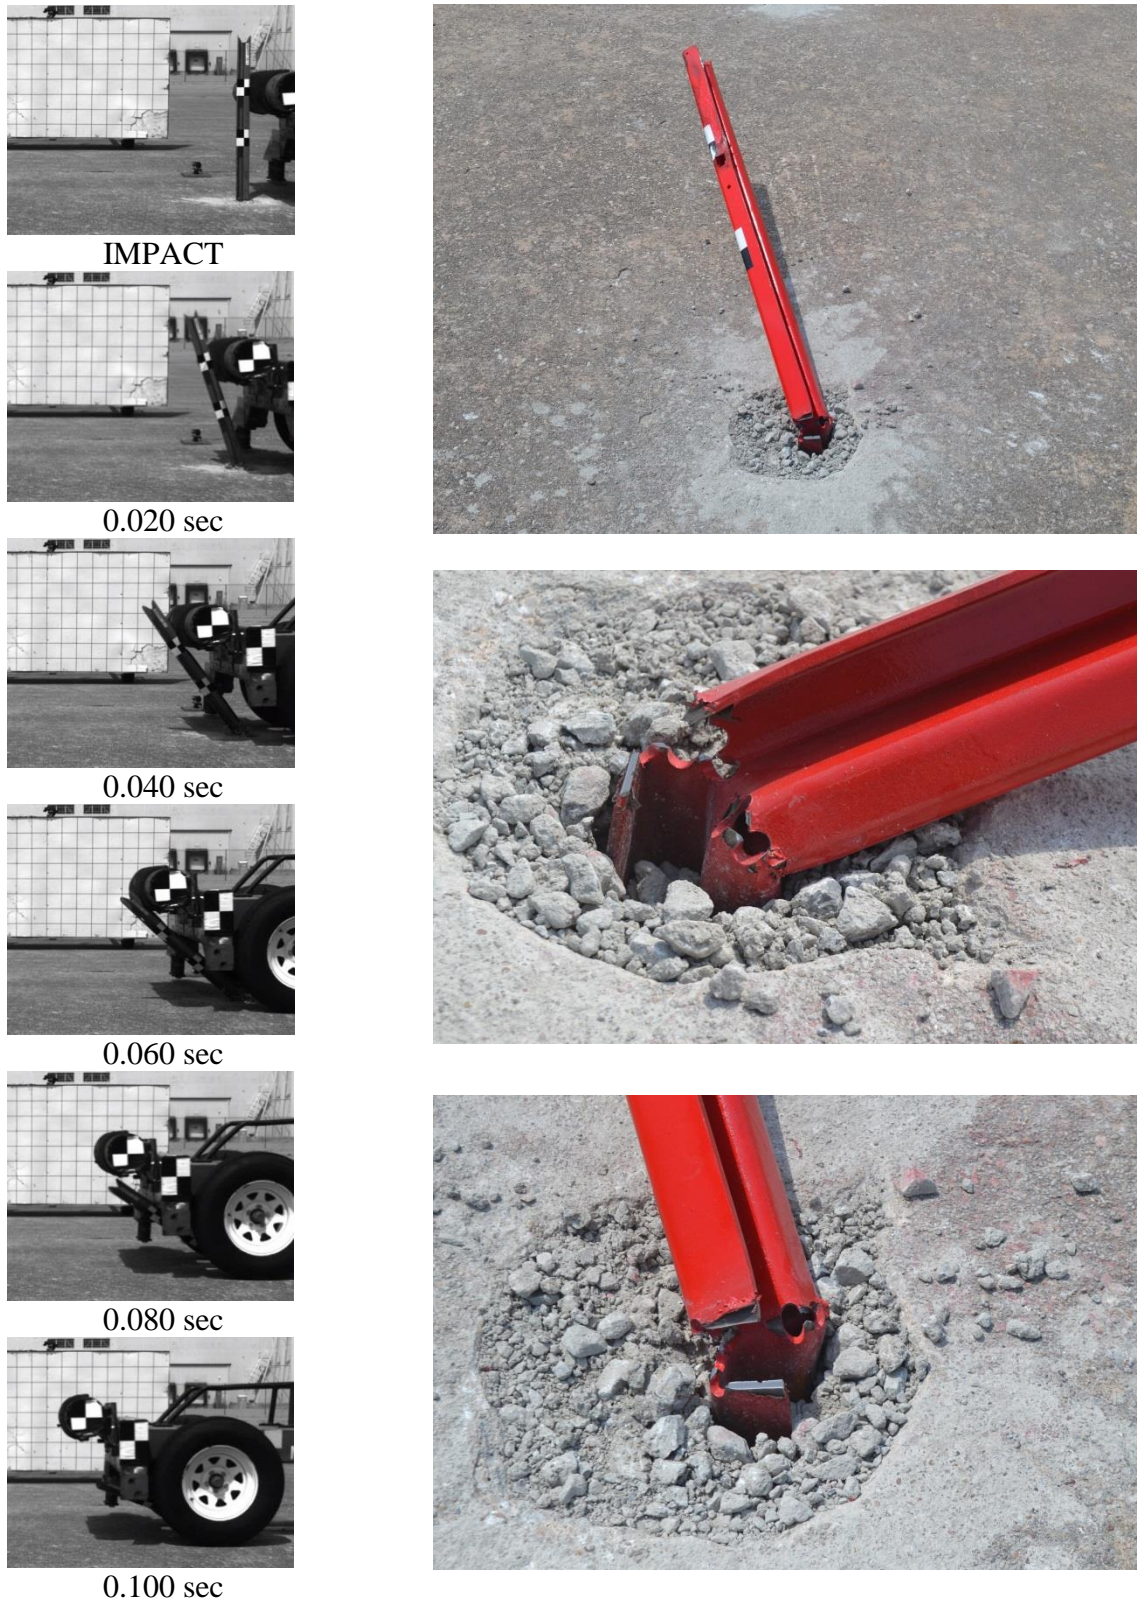
Figure 84. Time-Sequential and Post-Impact Photographs, Test No. MWPFP-16 Post 1

Sequential and post damage photographs are shown in Figure 84. Contact marks were present along the top portion of the impact-side flange. The post was bent and tore near the groundline. The front flange was completely torn, and the tear extended through the adjacent weakening holes. A second tear occurred between the weakening holes on the backside of the post.

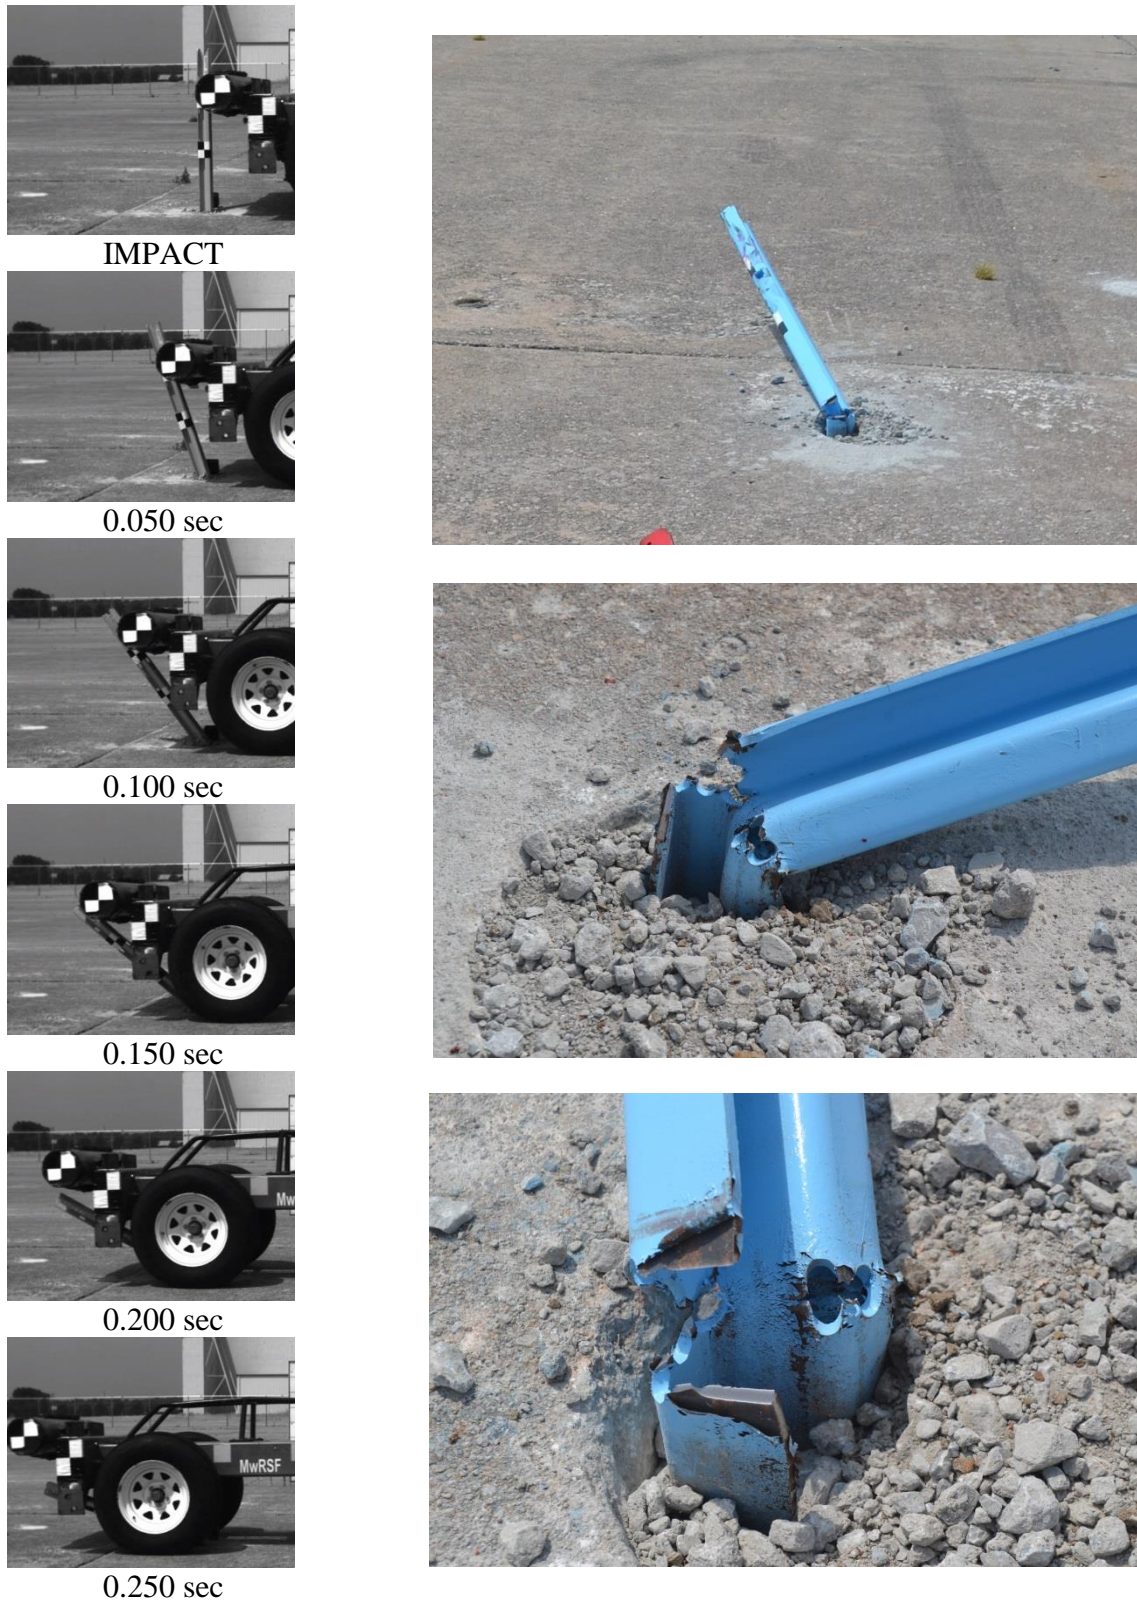
Figure 86. Time-Sequential and Post-Impact Photographs, Test No. MWPFP-16 Post 2

Sequential and post damage photographs are shown in Figure 86. Contact marks were present along the top portion of the impact-side flange. The post was bent and tore near the groundline. The front flange was completely torn, and the tear extended through the adjacent weakening holes. A second tear occurred between the weakening holes on the backside of the post.
