EVALUATION OF FLOORPAN TEARING AND CABLE SPICES FOR CABLE BARRIER SYSTEMS

MIDWEST ROADSIDE SAFETY FACILITY

MwRSF Research Report No. TRP-03-324-17

May 16, 2017

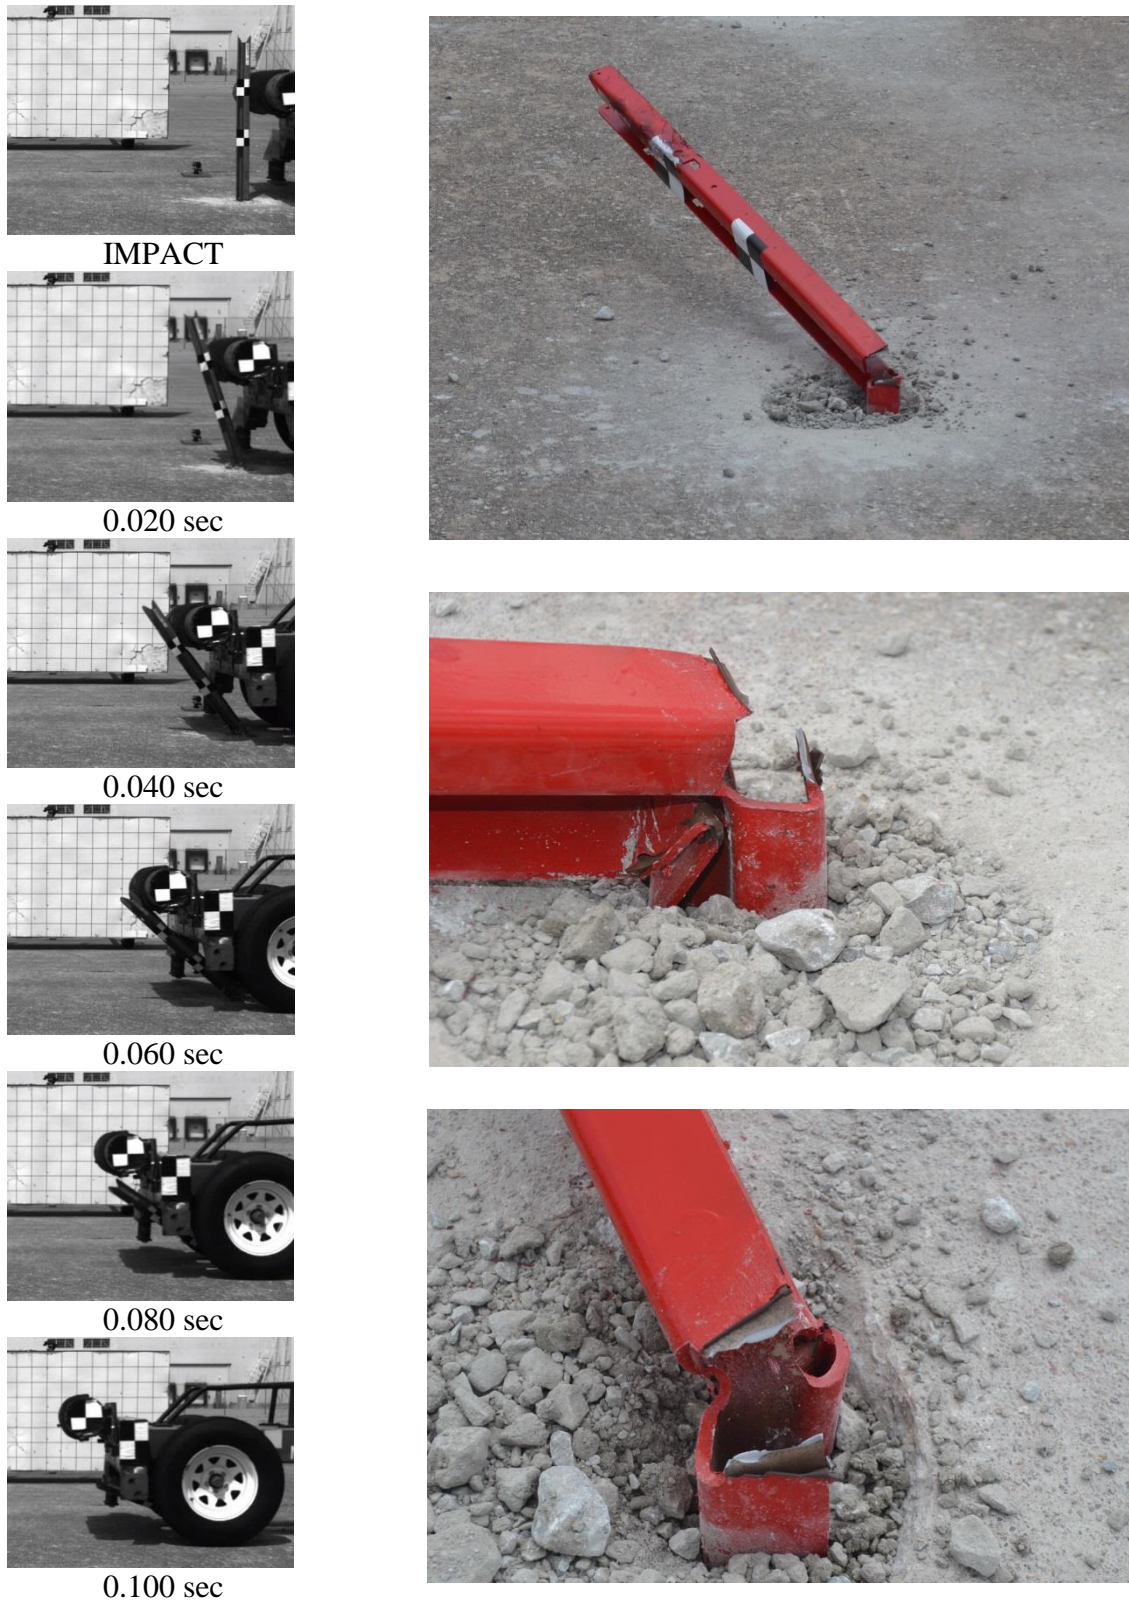
Figure 88. Time-Sequential and Post-Impact Photographs, Test No. MWPFP-17 Post 1

Sequential and post damage photographs are shown in Figure 88. Contact marks were present along the top portion of the impact-side flange. The post was bent near the groundline, and the front flange tore completely adjacent to the slot. The back flange buckled inward at the location of the plastic hinge. The slot adjacent to the back flange was deformed, but no additional tearing was observed.

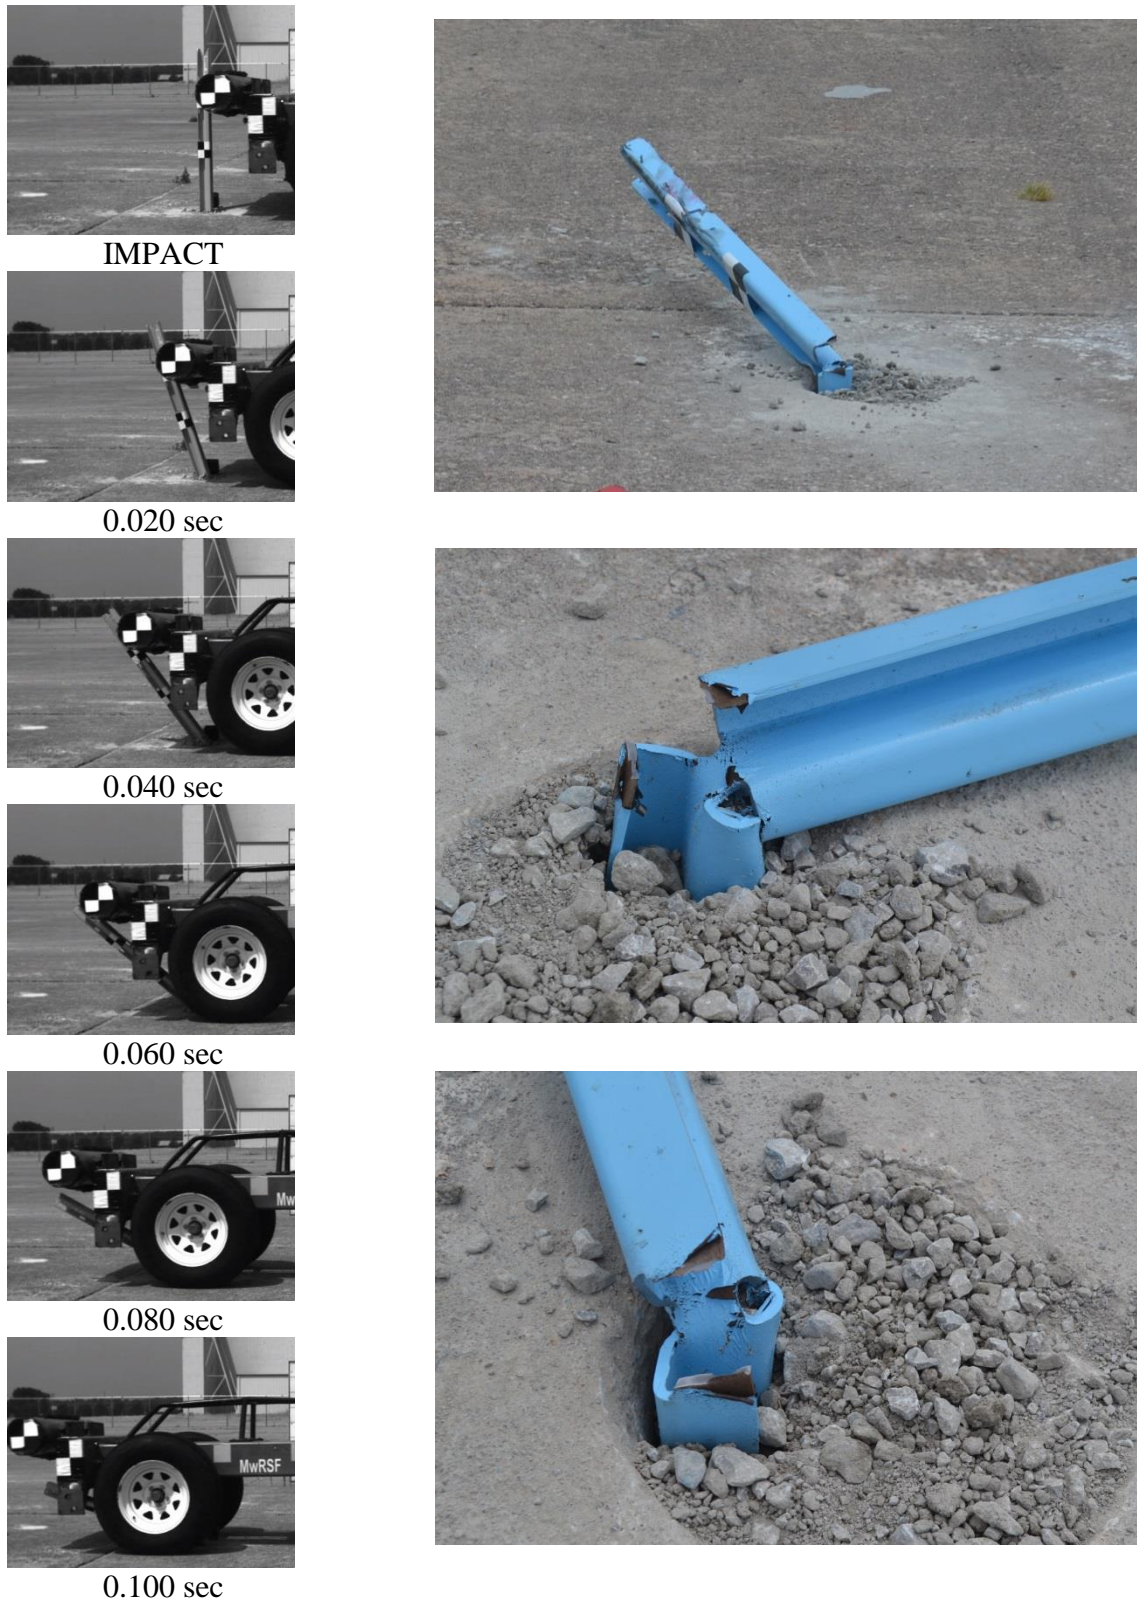
Figure 90. Time-Sequential and Post-Impact Photographs, Test No. MWPFP-17 Post 2

Sequential and post damage photographs are shown in Figure 90. Contact marks were present along the top portion of the impact-side flange. The post was bent near the groundline, and the front flange tore completely adjacent to the slot. The back flange buckled inward at the location of the plastic hinge. The slot adjacent to the back flange was deformed, but no additional tearing was observed.

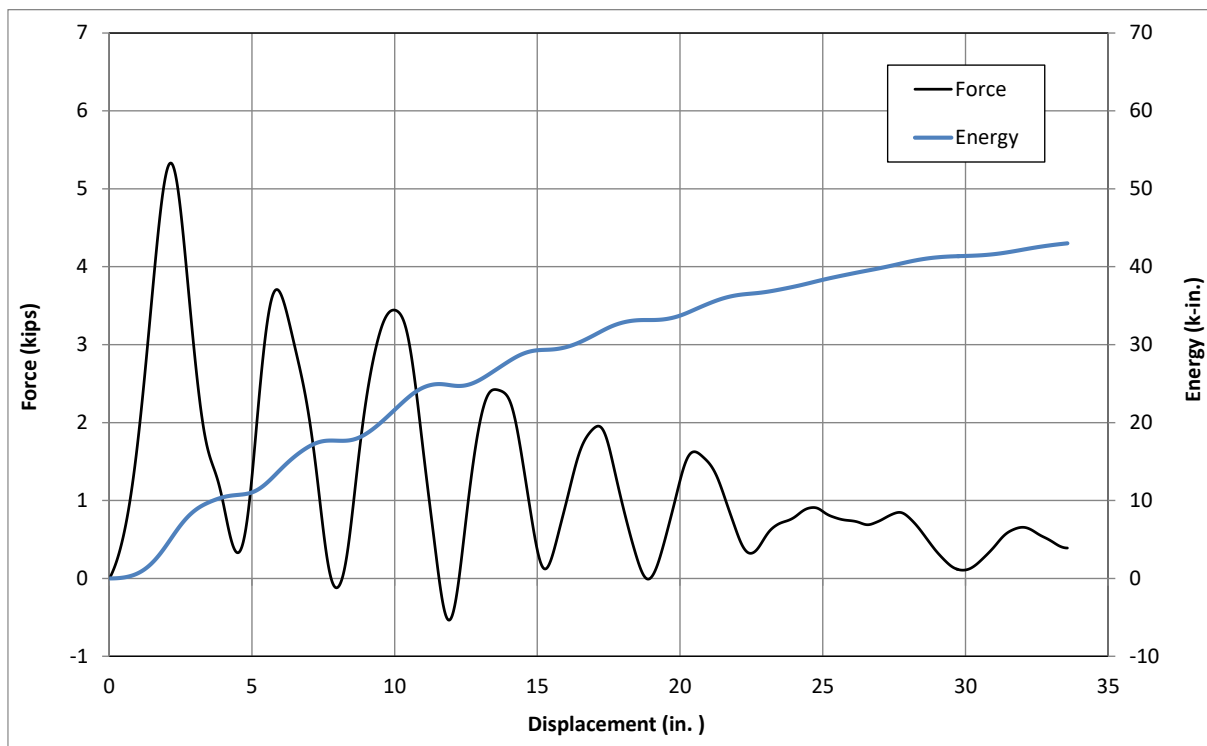
Figure 93. Force vs. Deflection and Energy vs. Deflection, Test No. MWPFP-20

Force vs. deflection and energy vs. deflection curves created from the accelerometer data are shown in Figure 93. The forces quickly rose to a peak force of 5.33 kips (23.72 kN) over the first few inches of deflection. The forces oscillated while decreasing through the rest of the impact event. The post provided an average resistive force of 1.69 kips (7.16 kN) and absorbed 33.7 kip-in. (3.8 kJ) of energy through 20 in. (508 mm) of deflection.

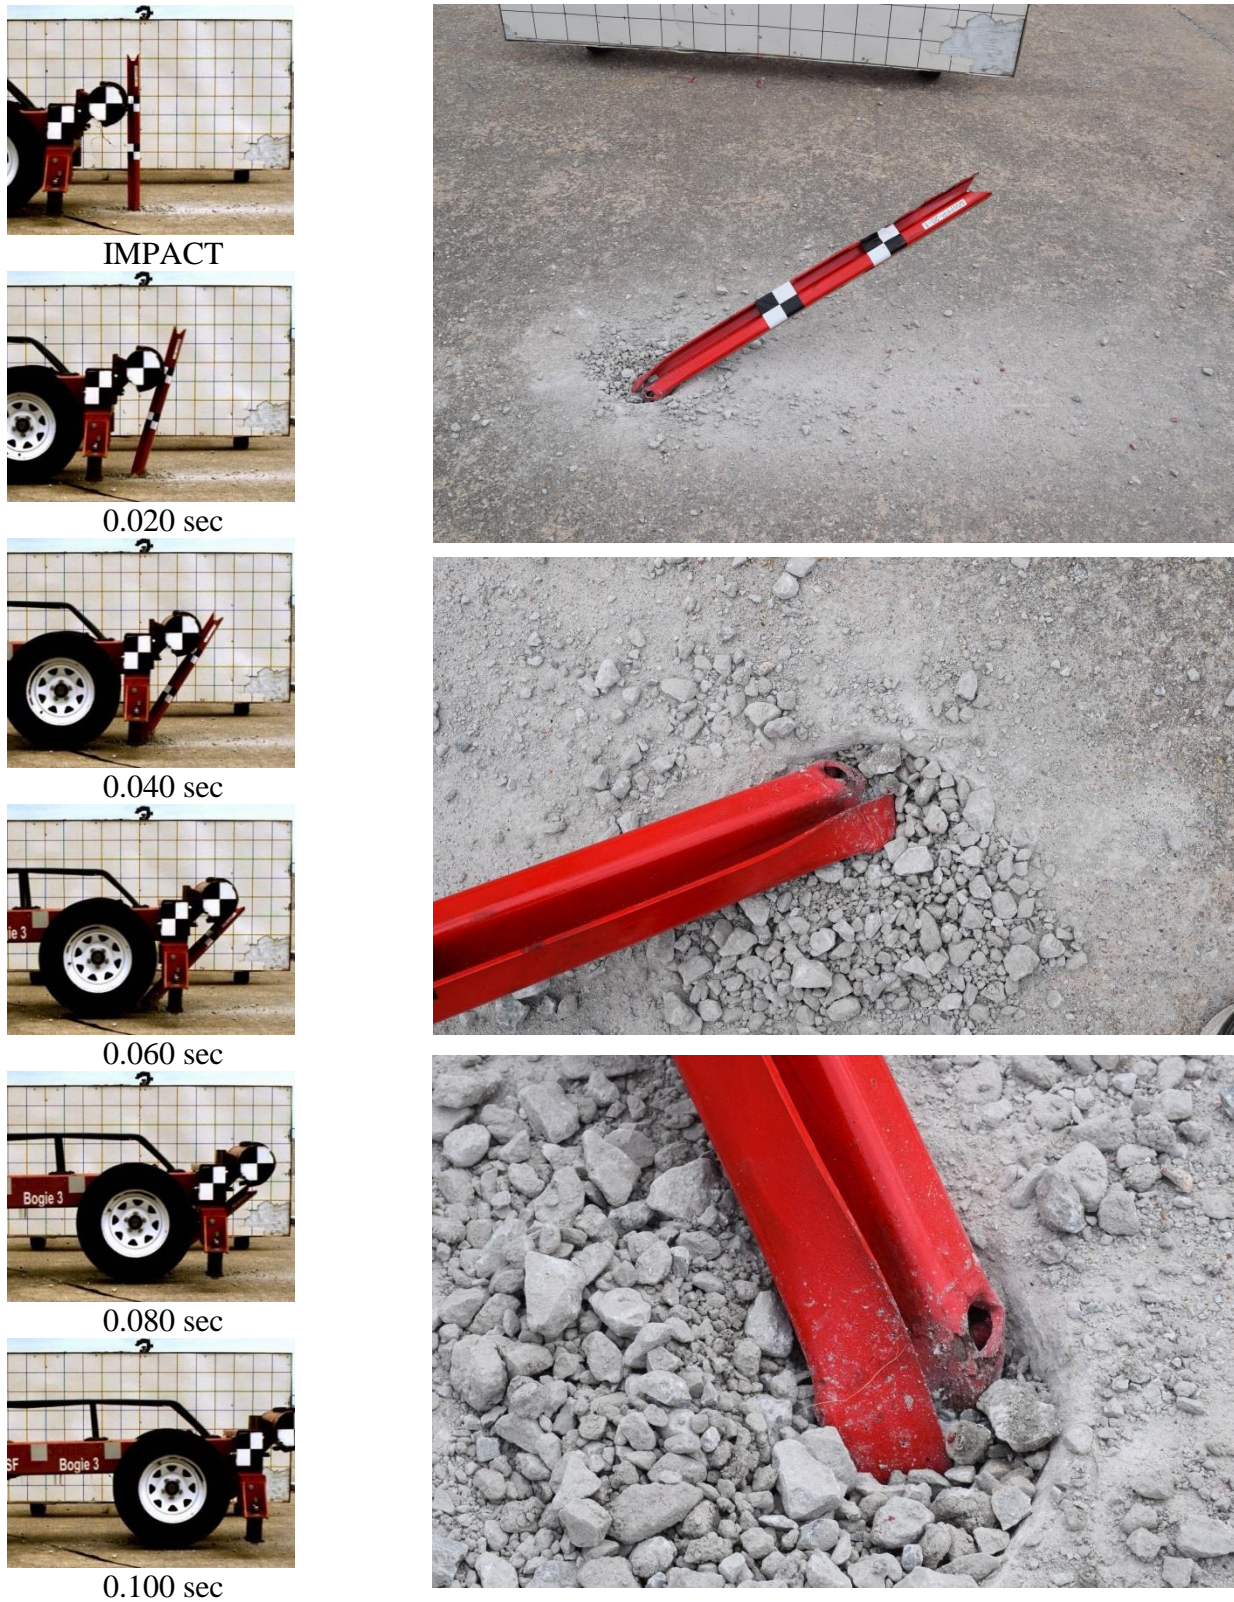
Figure 94. Time-Sequential and Post-Impact Photographs, Test No. MWPFP-20

Sequential and post damage photographs are shown in Figure 94. Contact marks were present along the top portion of the impact-side flange. A plastic hinge was observed around the weakening holes near the groundline, and the post flanges collapsed inward toward the web. The weakening holes were deformed, but did not tear.

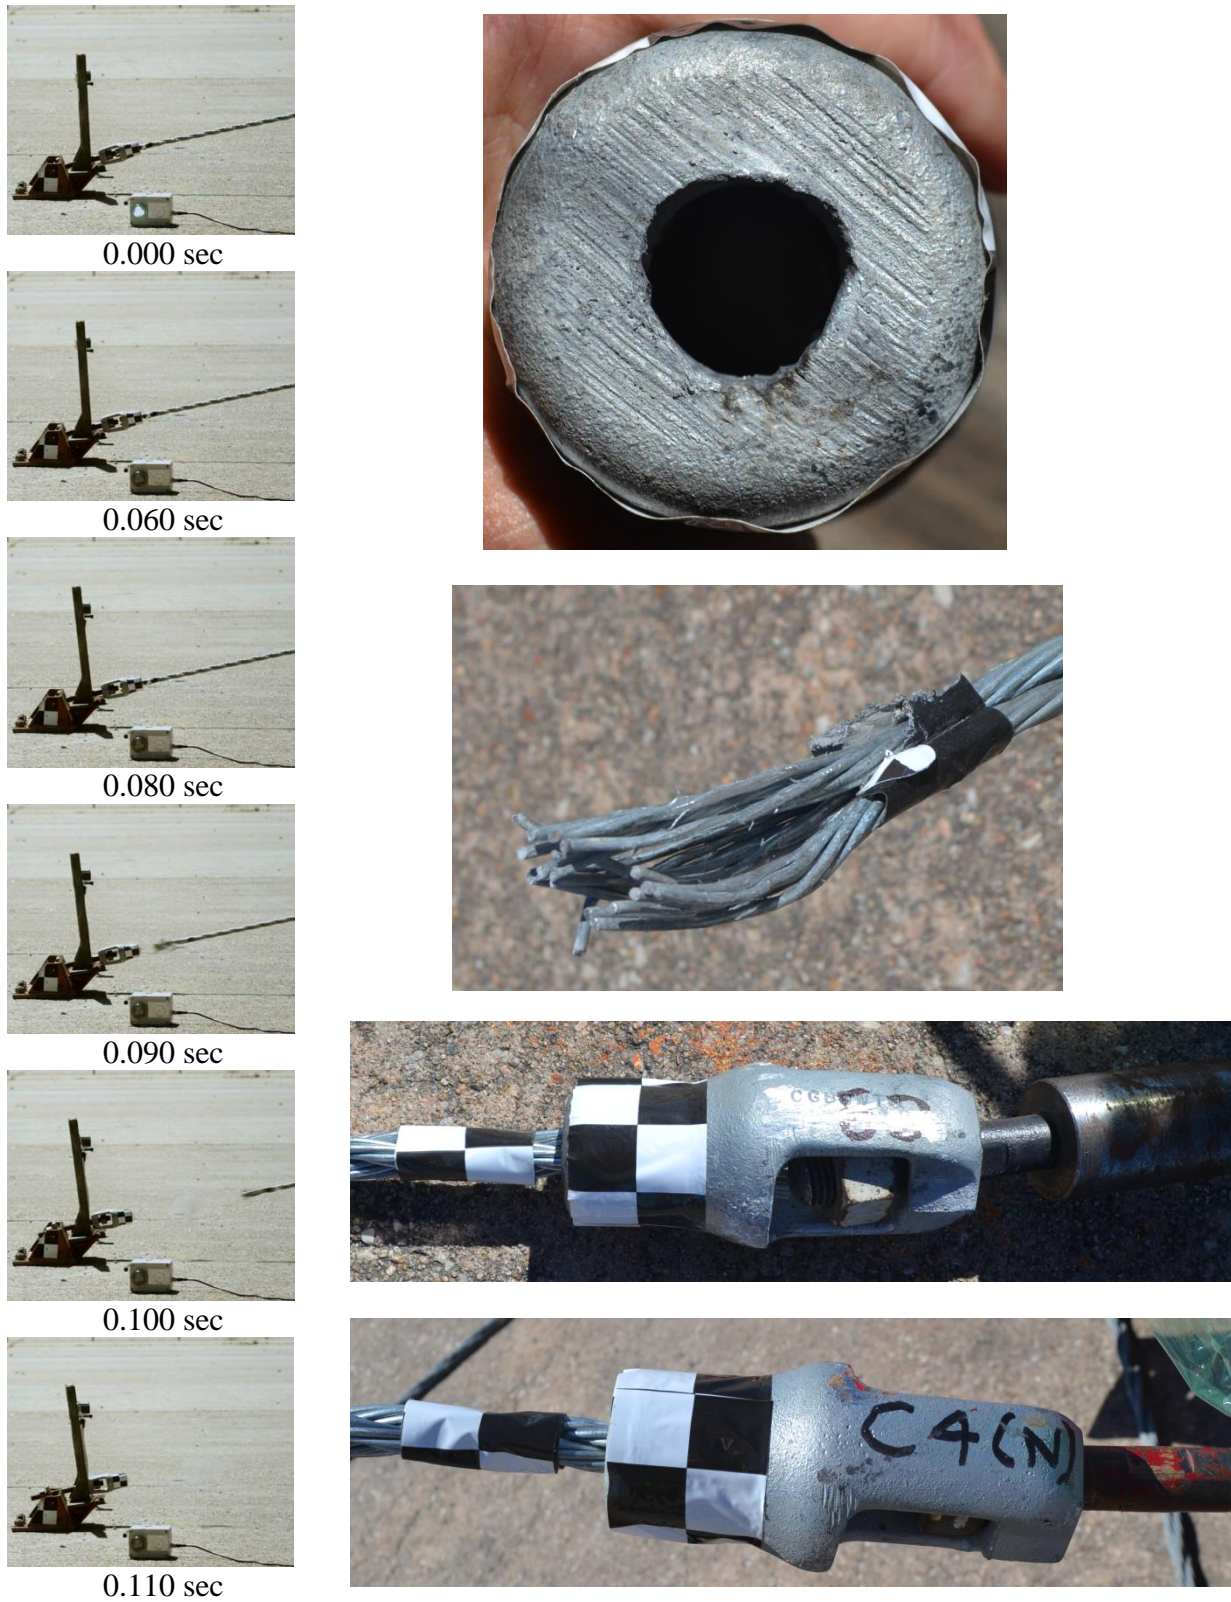
Figure 106. Time-Sequential and Post-Test Photographs, Test No. BBNC-1

Test no. BBNC-1 was conducted with the newer Bennett cable couplers, model no. CGBBWTH, located on both ends of the cable and on both sides of the turnbuckle splice. During the test, the cable was loaded to a maximum tension of 33.28 kips (148.10 kN), after which, the cable and wedge pulled through the coupler linking the cable to the anchor bracket. Sequential photographs and system damage photographs are shown in Figure 106.

The inside of the failed coupler contained striations, formed from the wire rope as it pulled through the opening, but the coupler was otherwise undamaged. The upstream end of the cable that pulled through the coupler was deformed and frayed, and the wedge was no longer entwined within the wire strands. The cable ends pulled $\frac{5}{8}$ in. (16 mm) out of the other three couplers.

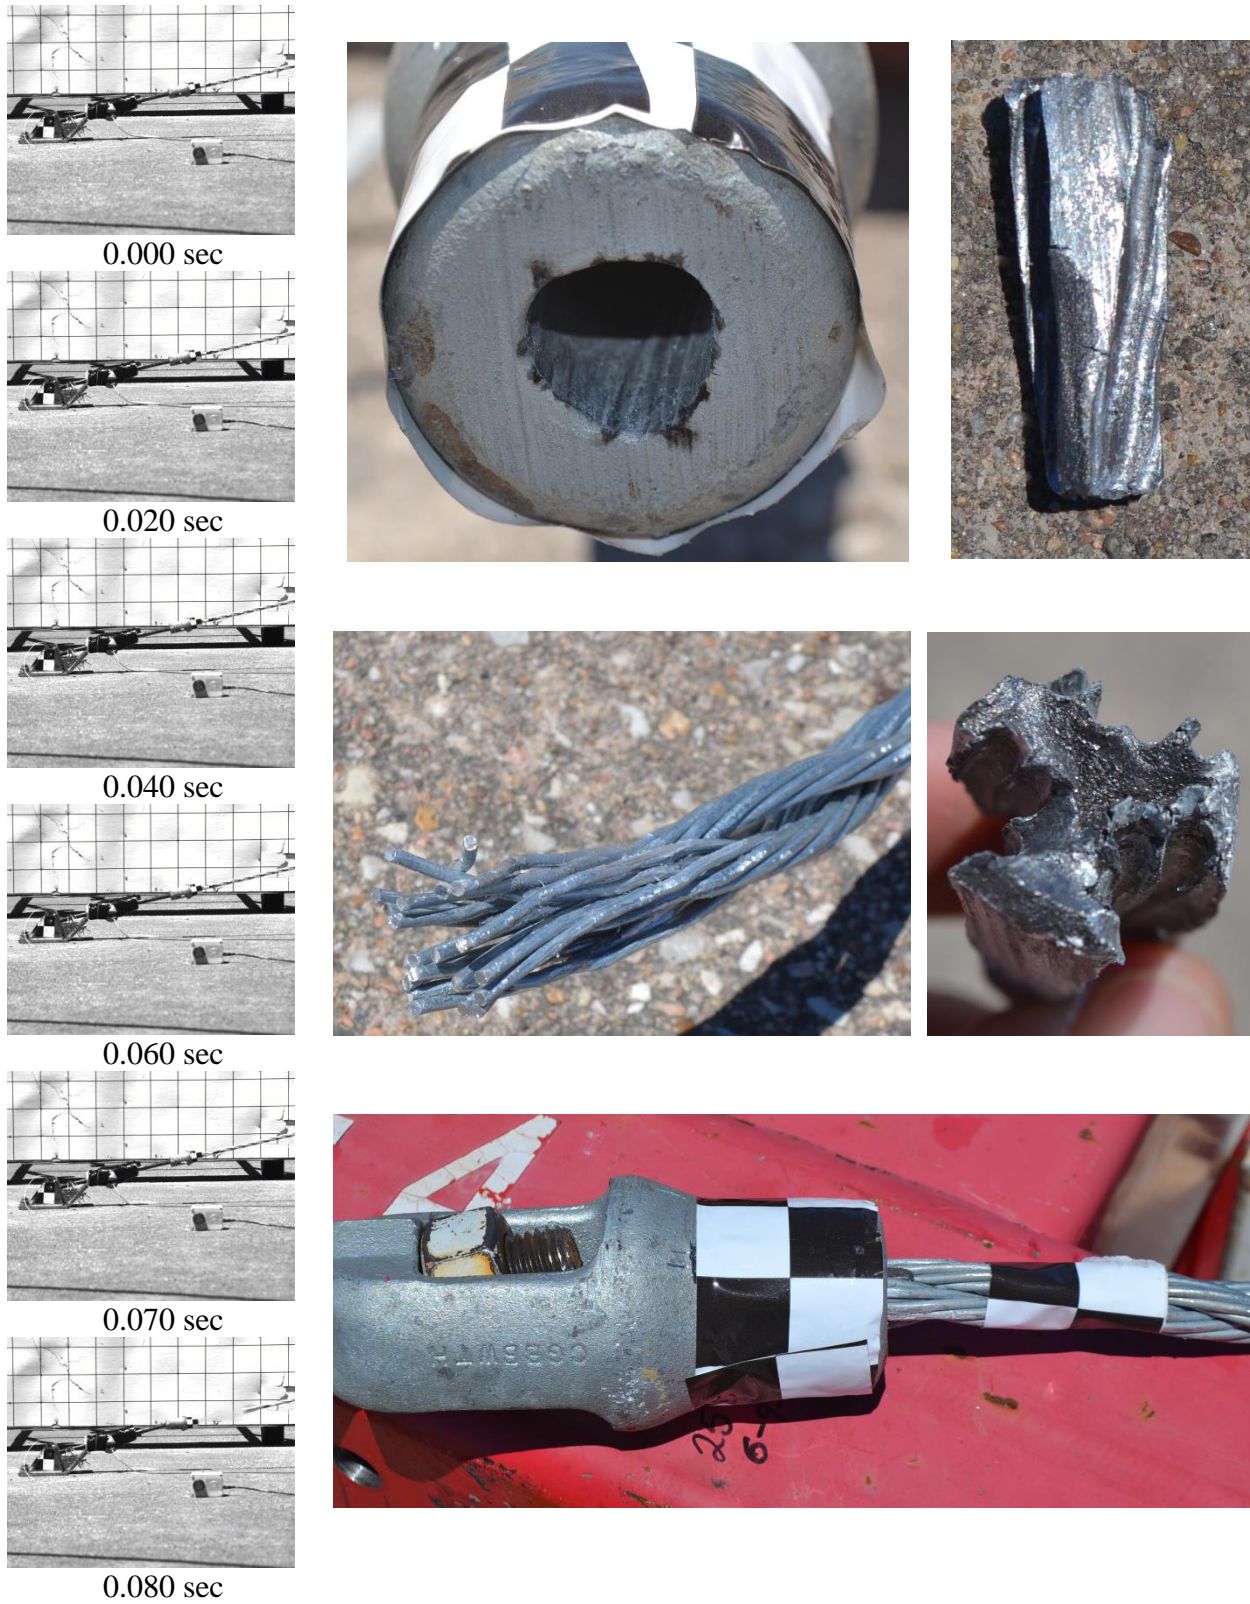
Figure 107. Time-Sequential and Post-Test Photographs, Test No. BBNC-2

Test no. BBNC-2 was conducted with the newer Bennett cable couplers, model no. CGBBWTH, located on both ends of the cable. During the test, the cable was loaded to a maximum tension of 32.43 kips (144.26 kN), after which, the cable and wedge pulled through the coupler linking the cable to the anchor bracket. Sequential photographs and system damage photographs are shown in Figure 107.

The inside of the failed coupler had striations formed from the wire rope as it pulled through the opening, but the coupler was otherwise undamaged. The upstream end of the cable that pulled through the coupler was deformed and frayed, and the wedge was no longer entwined within the wire strands. The wedge was deformed and contained more pronounced striations than the coupler. The cable end attached to the bogie vehicle pulled $1\frac{1}{8}$ in. (29 mm) out of the coupler, and the wedge pulled $\frac{1}{4}$ in. (6 mm) out of the coupler.

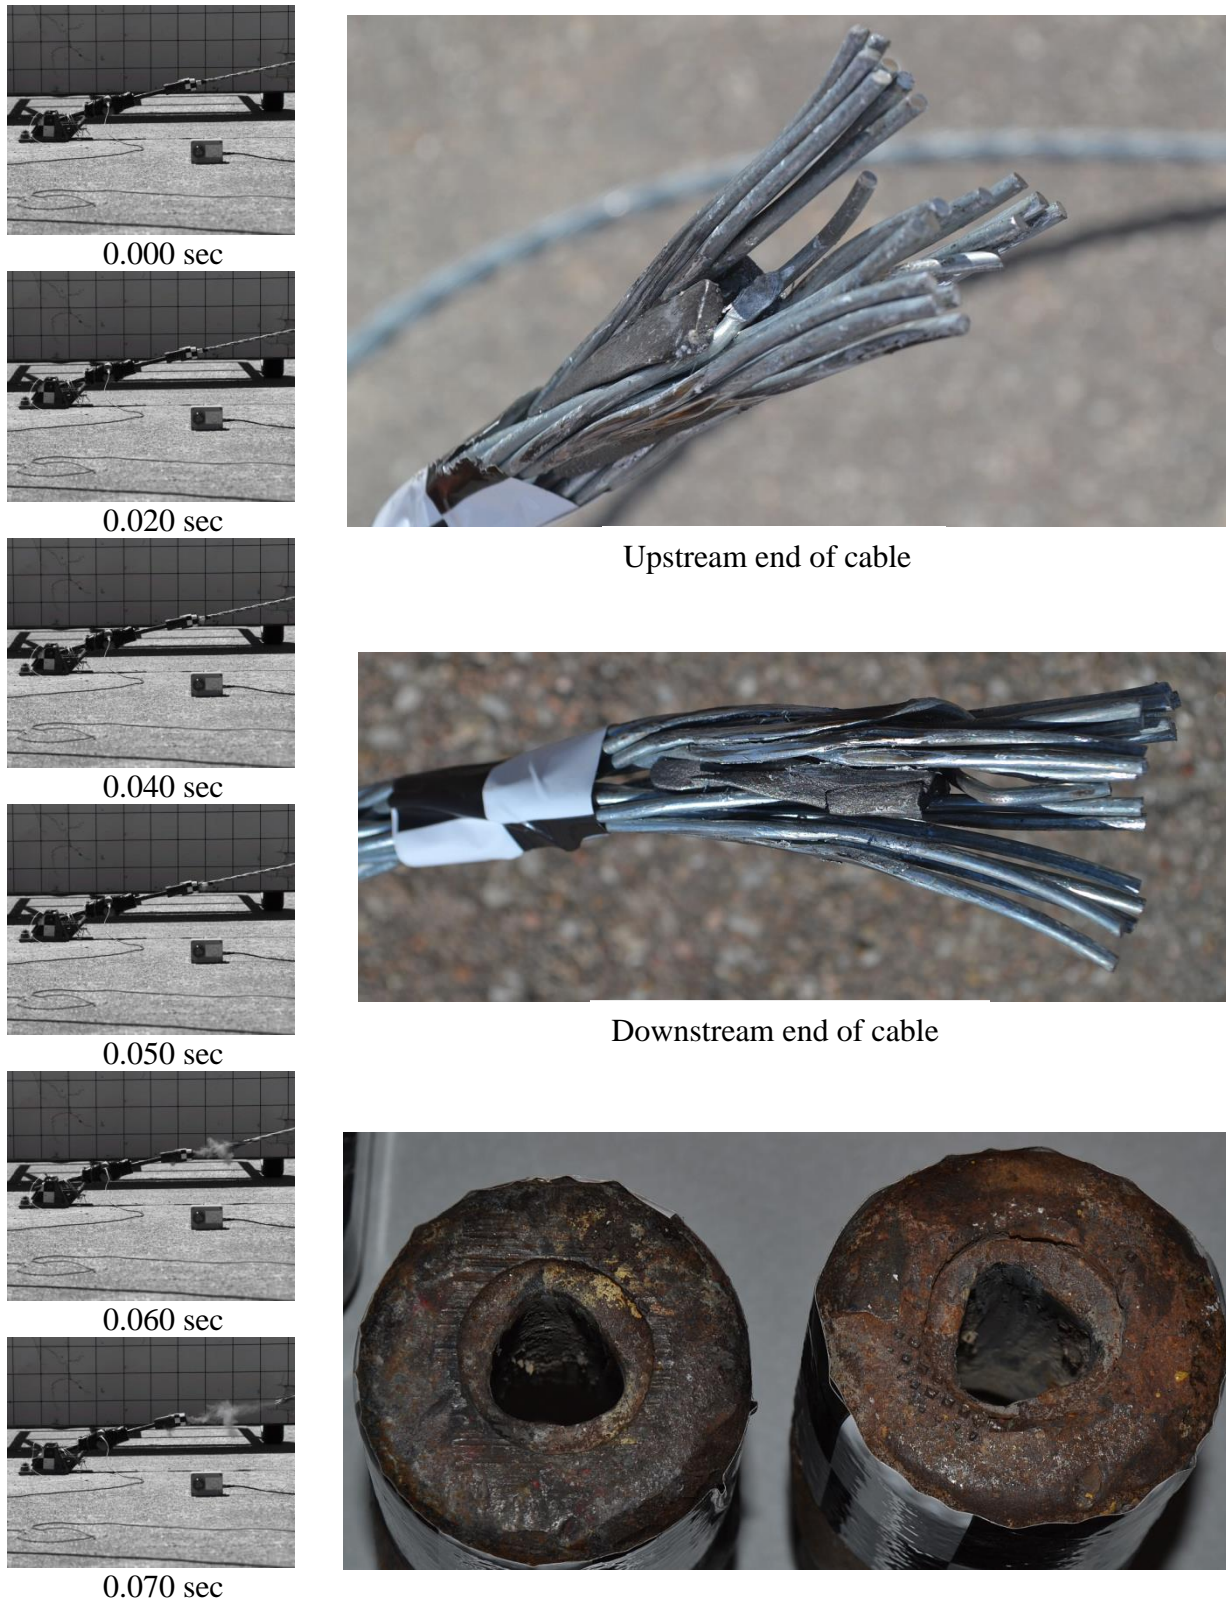
Figure 108. Time-Sequential and Post-Test Photographs, Test No. BBNC-3

Test no. BBNC-3 was conducted with the Bennett cable couplers currently utilized in full-scale crash testing of the cable barrier located on both ends of the cable, model no. CGBBHT. During the test, the cable was loaded to a maximum tension of 30.17 kips (134.20 kN), after which, the cable and wedge pulled through both couplers simultaneously. Sequential photographs and system damage photographs are shown in Figure 108.

The inside of the couplers contained striations formed from the wire rope as it pulled through the opening, but the couplers were otherwise undamaged. The cable ends were deformed and frayed, but unlike the previous tests, the wedges were still entwined within the wire strands at both ends. The wedges were crushed and plastically deformed around the individual wires of the cable.
