INCREASED SPAN LENGTH FOR THE MGS LONG-SPAN GUARDRAIL SYSTEM PART III: FAILURE ANALYSIS

MIDWEST ROADSIDE SAFETY FACILITY

MwRSF Research Report No. TRP-03-362-17

September 29, 2017

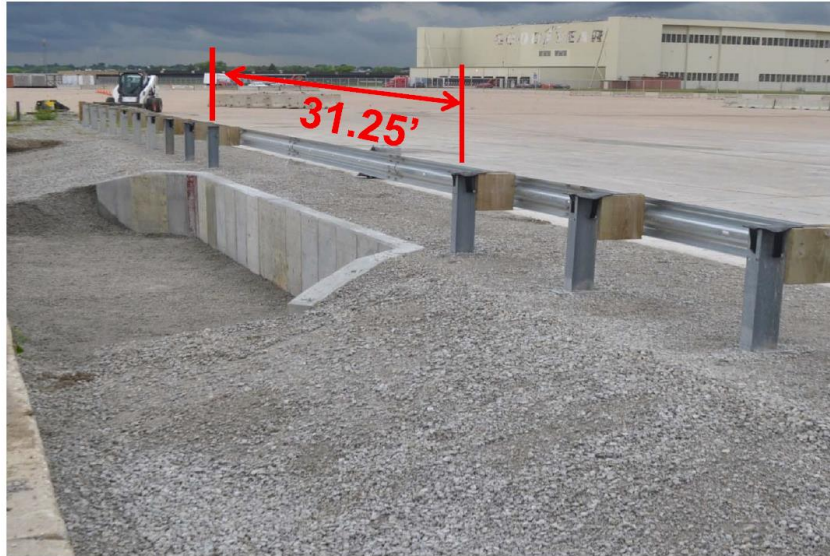
Figure 1. MGS Long-Span Guardrail, 31.25-ft (9.5-m) Unsupported Span

In a previous study conducted by Midwest Roadside Safety Facility (MwRSF) [14], two full-scale crash tests were performed on the MGS long-span guardrail with a span length of 31.25 ft (9.5 m), as shown in Figure 1. Both crash tests utilized pickup trucks weighing approximately 5,000 lb (2,268 kg) as per *Manual for Assessing Safety Hardware* (MASH) [15] test designation no. 3-11. The target impact conditions for the test were a speed of 62 mph (100 km/h) and an angle of 25 degrees. The first test was conducted to evaluate the potential for vehicle instability by selecting a critical impact point (CIP) that maximized vehicle extension over the culvert and the potential for interaction of the front wheel of the pickup truck with the wing wall of the culvert. The second test was designed to evaluate the structural capacity of the system. These tests utilized Universal Breakaway Steel Posts (UBSPs) adjacent to the long span in lieu of the CRT wood posts previously tested [16].

The current report is based on the results and findings of the second full-scale crash test mentioned above. In test no. MGSLS-2, the CIP was selected near the downstream end of the unsupported span in order to evaluate the structural capacity of the system. After impacting the barrier system, the downstream anchor failed and caused the vehicle to penetrate the barrier system. Due to the failure of test no. MGSLS-2, further testing and design refinements are necessary on the MGS long-span guardrail for lengths over the 25 ft (7.6 m) span length.

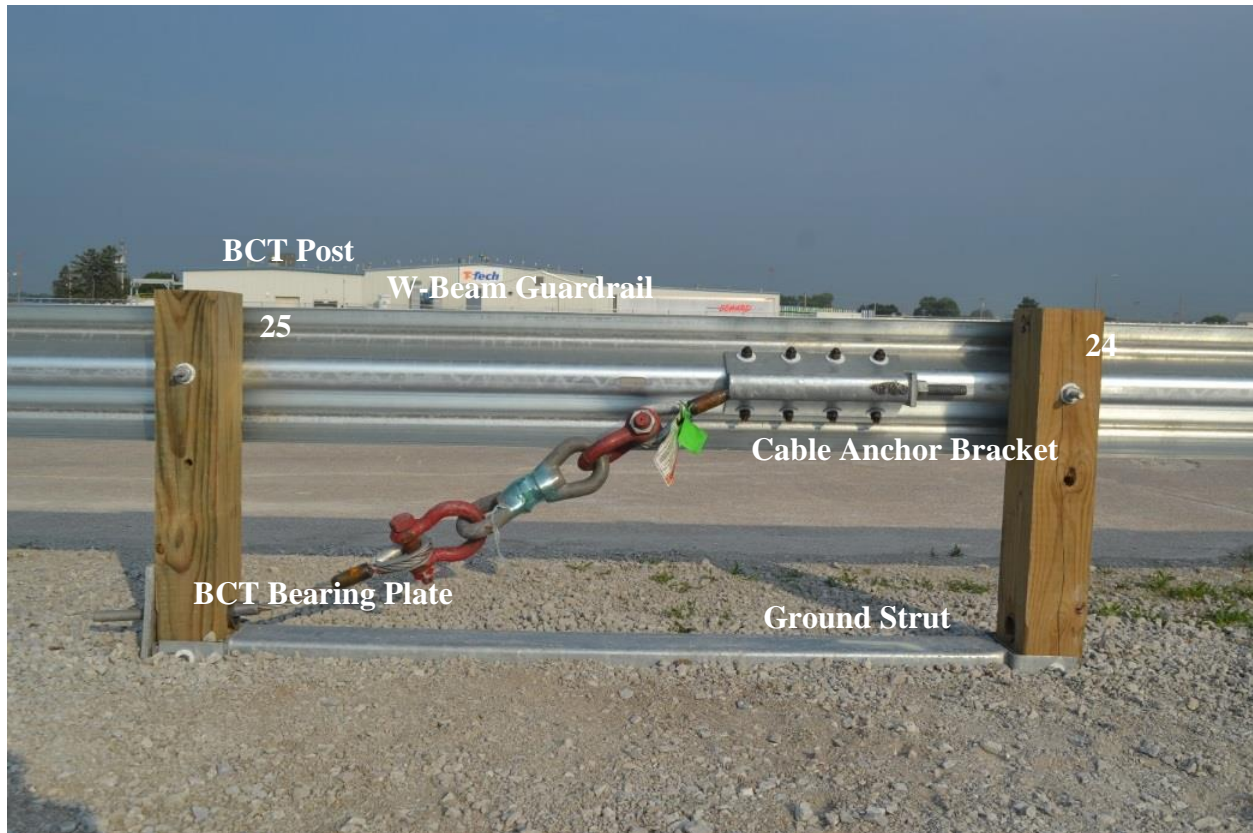
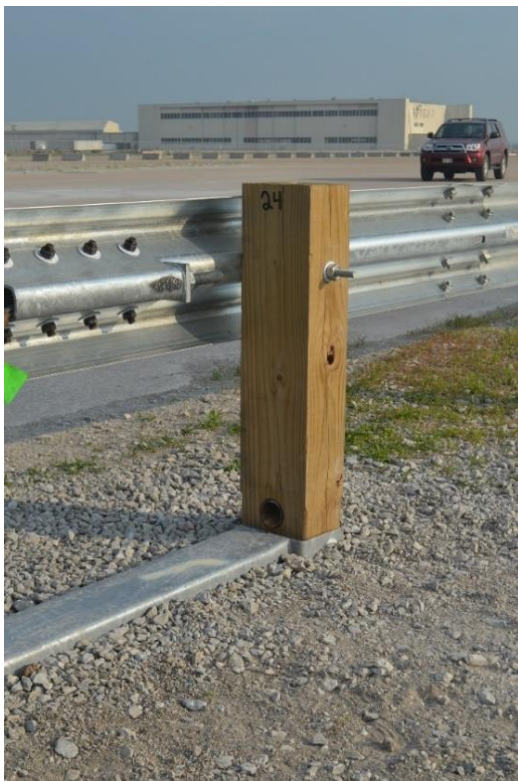
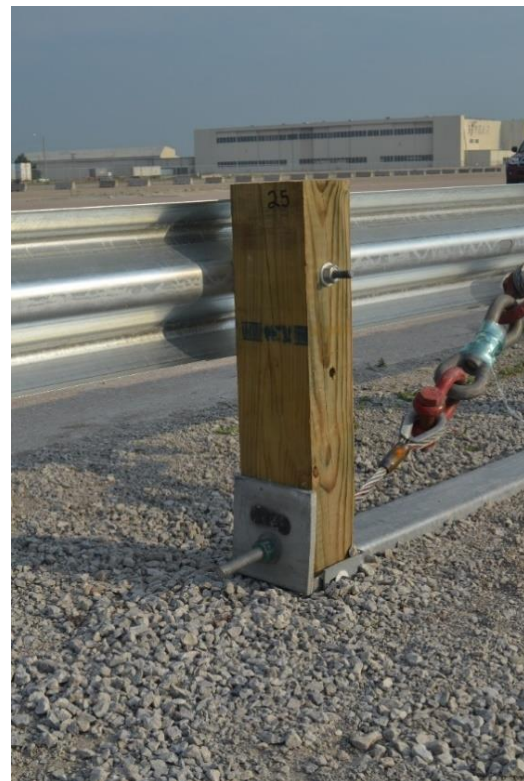
Figure 3. Long-Span End-Anchorage System, Test No. MGSLS-2

The MGS long-span end-anchorage system consists of the following components, as shown in Figure 3.

1. Two MGS BCT posts
2. Soil foundation tubes
3. Cable anchor assembly
4. Guardrail
5. C-channel ground line strut
6. Load cell assembly

The MGS BCT posts were installed in steel soil foundation tubes, which were embedded to a depth of 70 in. (1778 mm). A BCT cable assembly was attached to the post by inserting a swaged end of the cable into the BCT hole and through a bearing plate, and attached to the guardrail using a cable anchor bracket. The guardrail was attached to the BCT posts with a top mounting height of 31 in. (787 mm). A bent plate, C-shape, ground line strut was used to connect the two soil foundation tubes [20]. For test no. MGSLS-2, anchor cable on each end of the system was spliced with a 50-kip load cell assembly. The load cell had been spliced into the anchor cable in a variety of past guardrail tests with no adverse effect on anchor capacity, and the incorporation of the load cell provided valuable anchor load data.

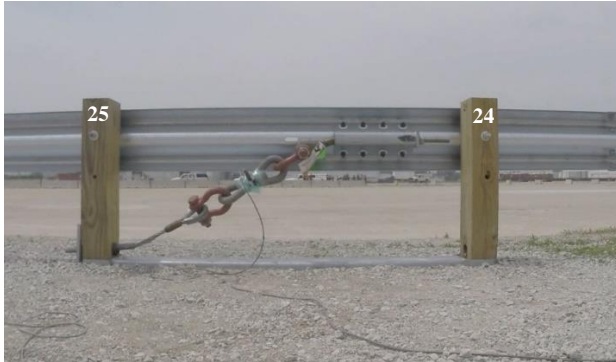
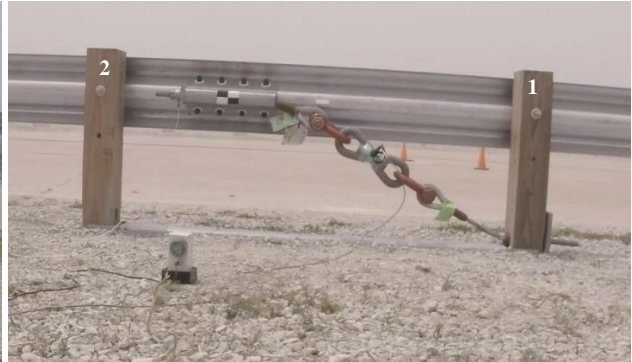
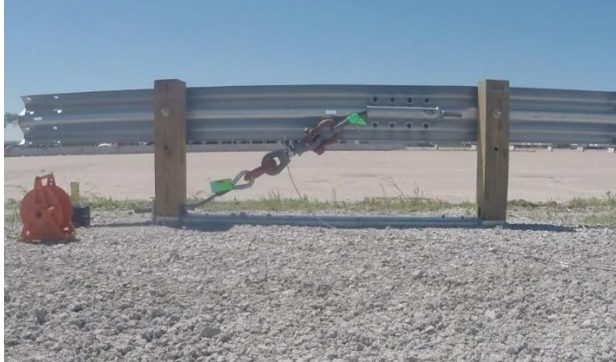
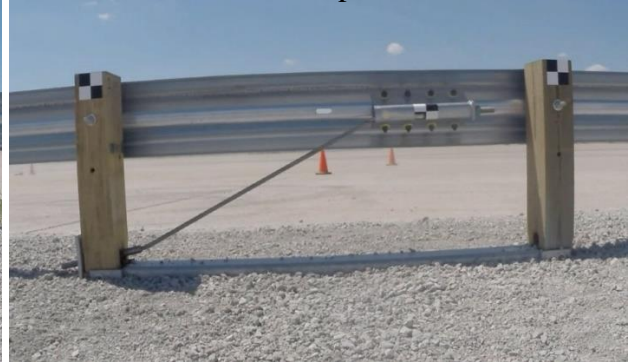
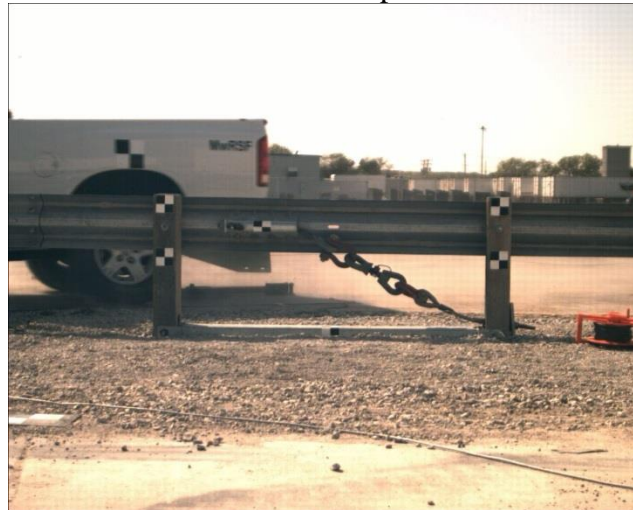
Figure 10. End Anchorage Sequential View Comparison of MGS Tests

Analysis of the anchor failure began with a comparison the load and deflection of the downstream end anchorage in test no. MGSLS-2 with other available data from tests of similar end anchorages. Figures 11 through 18 show a sequential comparison between the loading and deflection of the downstream end anchorage in test no. MGSLS-2 and other similar anchorages under full-scale testing impacts with 2270P vehicles, including the upstream end anchorages from test nos. MGSLS-2, MGSMP-1, and MGSMIN-1 and the downstream end anchorage from MGSLS-1. Review of the sequential images found that all of the anchorages displayed similar deflection behavior in terms of deflection downstream due to the tensile loading of the W-beam rail. The vertical splitting of post no. 24 in test no. MGSLS-2 was not a singular event as test nos. MGSLS-2 and MGSMP-1 demonstrated similar behavior on the upstream anchors, but did not fail. Motion of the cable end plate was also reviewed for all of the tests and no abnormal deflection or rotation of the cable end plate was noted in test no. MGSLS-2 prior to the anchorage failure as compared to the other tests.

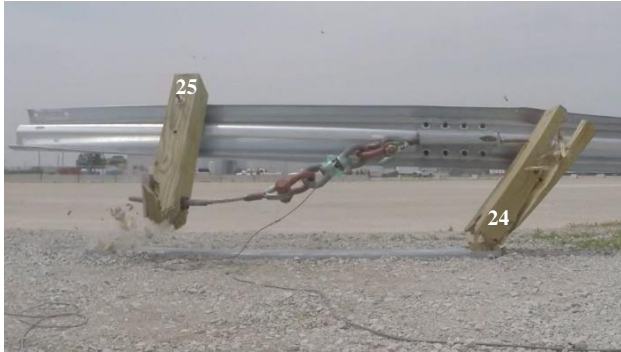
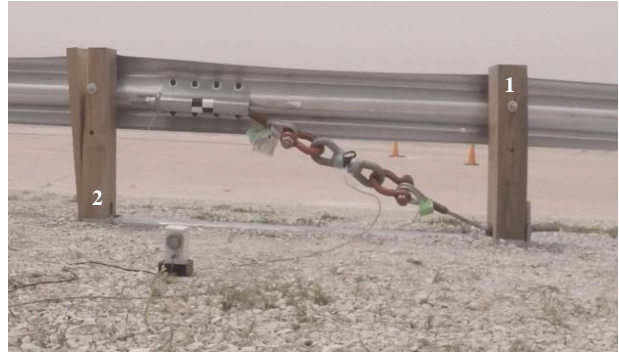
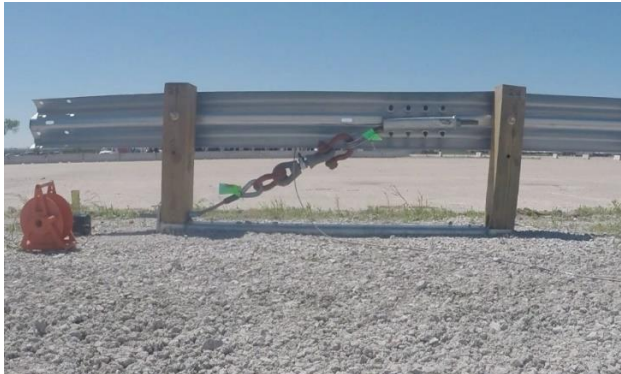
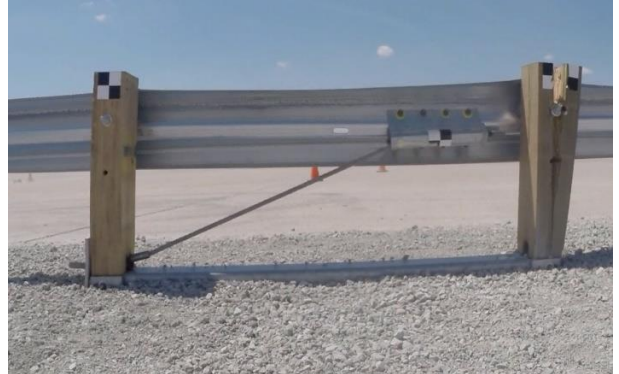
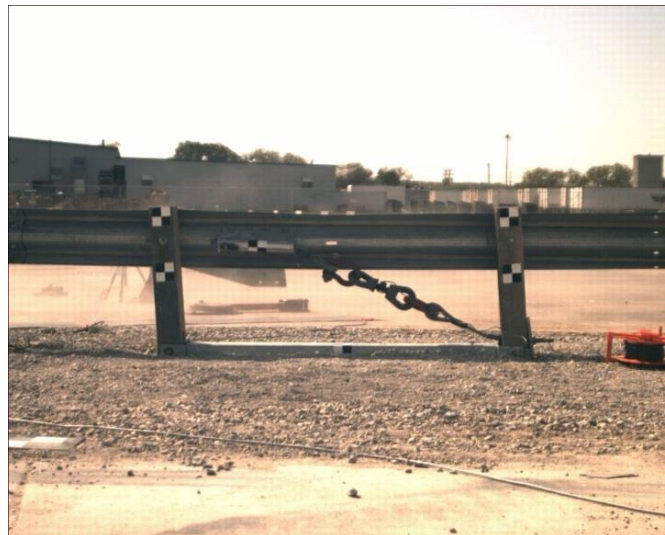
Figure 17. End Anchorage Sequential View Comparison of MGS Tests

Failure of an instrumented end anchorage assembly had not been observed in any full-scale crash tests prior to test no. MGSLS-2. However, dynamic component testing of end anchorages was conducted as part of the development of trailing end anchor requirements for the MGS [19]. As part of this research, the same end anchorage used in test no. MGSLS-2 was subjected to a dynamic pull test using the MwRSF heavy bogie vehicle, as shown in Figure 22. In test no. DSAP-2, the end anchorage was loaded until the final BCT post fractured at the base and released the anchor cable, as shown in Figure 23. This was a very similar failure mode to that observed in test no. MGSLS-2. Anchor cable load versus deflection of the foundation tube is shown in Figure 24. The end anchorage in test no. DSAP-2 developed a peak load of 34.6 kips (153.9 kN) at approximately 0.9 in. (23 mm) of deflection prior to failure the final BCT post and release of the anchor cable. The loads observed in test no. DSAP-2 were 25.8% higher than those observed in test no. MGSLS-2 and indicated that the end anchorage that failed during test no. MGSLS-2 had the potential to develop significantly higher end anchor loads prior to failure.

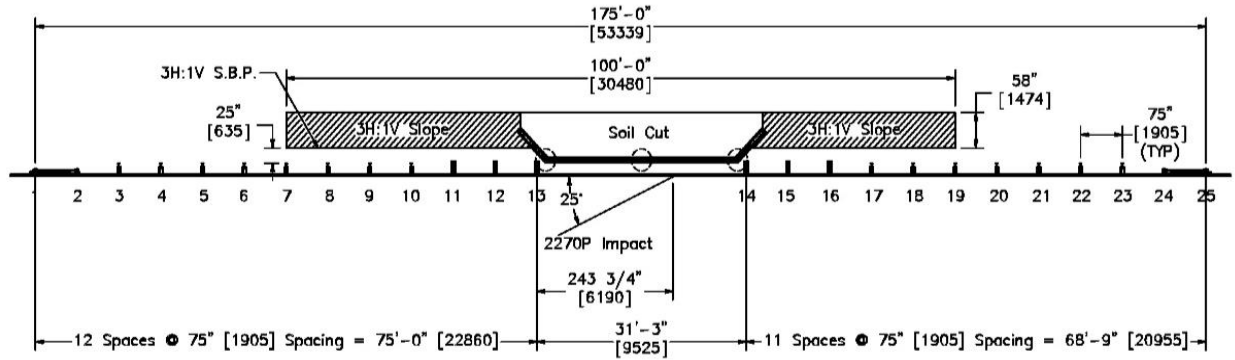
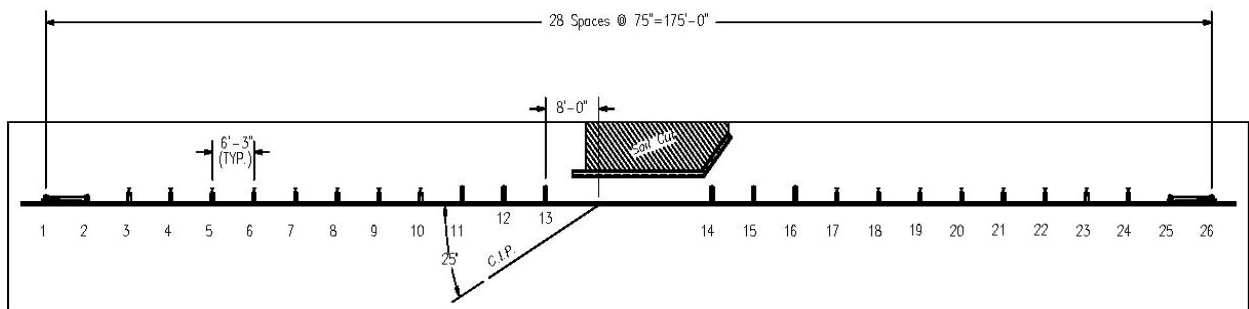
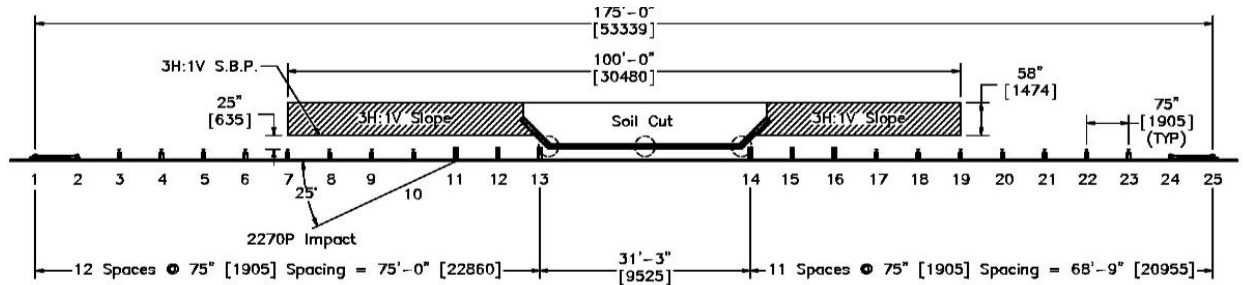
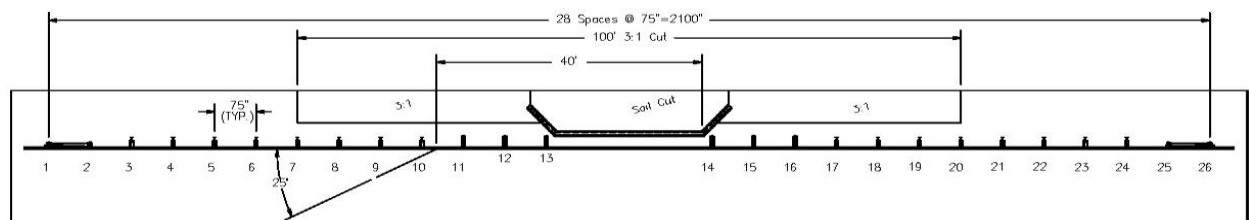
Figure 27. Impact Point for Test Nos. MGSLS-2, LSC-1, MGSLS-1, and LSC-2

Differences between the vehicle impact point of test no. MGSLS-2 and other comparable tests were reviewed to determine if the vehicle impact point may have contributed to the failure of the downstream end anchorage. The impact point for test no. MGSLS-2 was compared with other similar tests with respect to its proximity to the first post downstream of impact, its proximity to the first rail splice downstream of impact, and the distance to the downstream end anchorage. It was believed that the position of the vehicle impact relative to these critical points may have affected the barrier performance and altered the loading of the end anchorage. Impact points for test no. MGSLS-2 and several comparable tests are shown in Figure 27 and Figure 28. The impact points relative to the first post downstream of impact and the first splice downstream of impact to for test no. MGSLS-2 and comparable tests are shown in Figure 29 and Figure 30, respectively. Finally, the position of the impact points for each test relative to the location of the downstream end anchorage is shown in Figure 31.

Review of the data found that the impact point for test no. MGSLS-2 fell into the mid-range with respect to distance to the first post downstream of impact, which suggested that the impact point with respect to the first impacted post likely had little effect on loading of the end anchorage. However, rail pocketing caused by the impact location relative to a post may have increased anchor loads, as noted previously. Similarly, the distance from the impact point to the first splice downstream for test no. MGSLS-2 fell into the mid-range of the comparable systems. It was noted that in test no. MGSLS-2 the impact was closer to the downstream end anchorage than in previous long span guardrail tests and was closer to the end of the guardrail system than all comparable tests except test nos. WIDA-1 and MGSMIN-1. Test no. LSC-1 was impacted farther from the first post downstream of the unsupported span than test no. MGSLS-2, but no concerns with anchor failure were associated with the former test. Test no. WIDA-1 evaluated an impact near the end of the redirective length of the MGS with a trailing end terminal. In this test, the end anchor failed, but it did not release until the 2270P vehicle had nearly reached the end of the barrier system, and high lateral and longitudinal loads were imparted on the trailing end anchorage. Thus, the failure mode was not similar to the failure under longitudinal loading observed in test no. MGSLS-2. Test no. MGSMIN-1 evaluated a 75-ft (22.9-m) long MGS and impacted 56 ft-3 in. (17.1 m) from the end anchorage. However, the 2270P vehicle was safely redirected and no failure of the end anchorage occurred as a result of the impact closer to the downstream end anchorage. Thus, while the impact point for test no. MGSLS-2 was different as compared to previous tests of the MGS and MGS long span, no evidence was found that suggested the impact point directly contributed to the anchor failure.

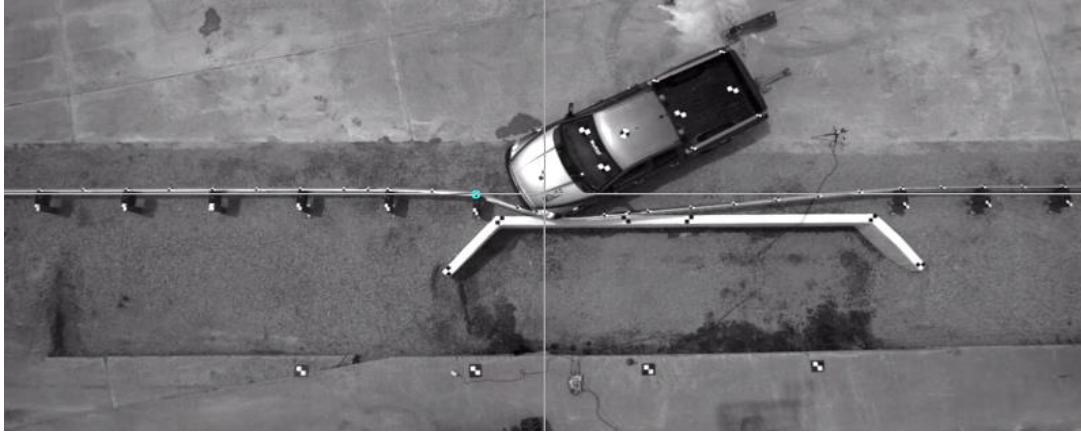
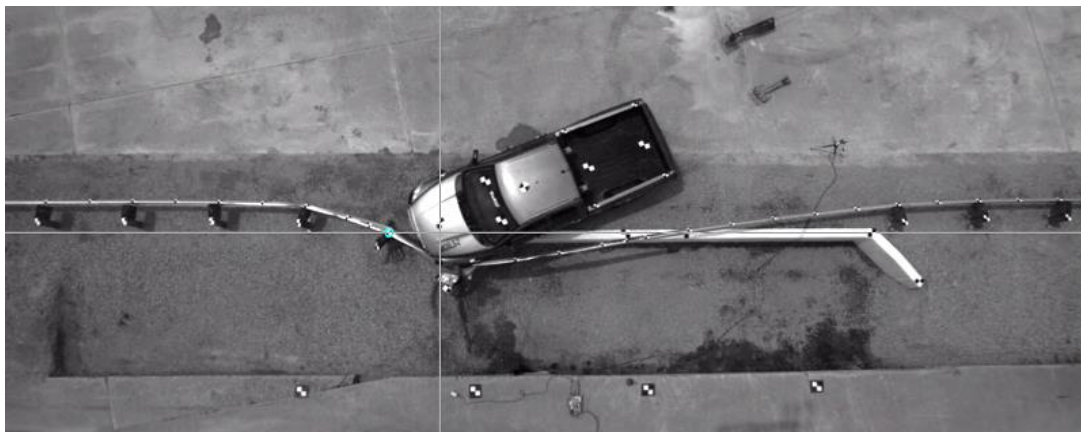
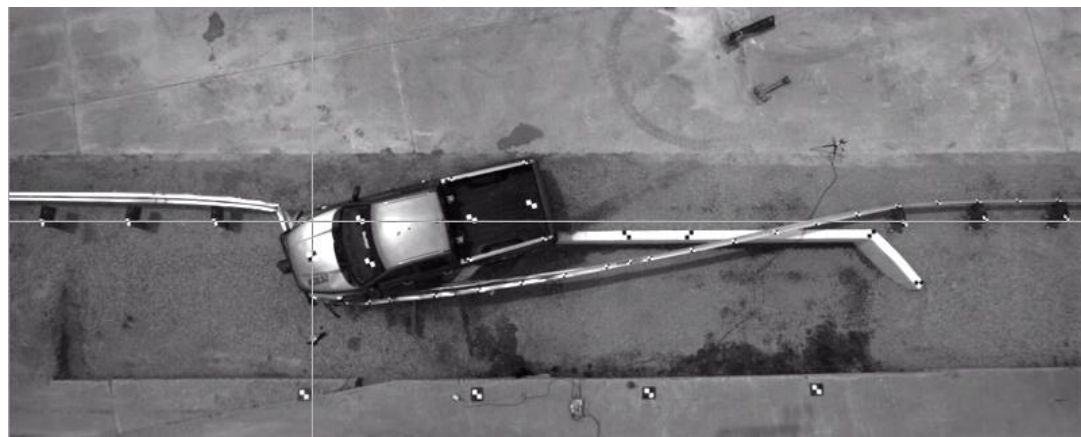
Figure 32. Longitudinal Distance of Fractured Post Relative to 2270P Bumper Corner, Test no. MGSLS-2

The comparison of post fracture and disengagement in test nos. MGSLS-2 vs LSC-1 is shown in Table 2. Review of the data found that the UBSPs in test no. MGSLS-2 broke away when the truck was significantly closer to the post as compared to test no. LSC-1. Comparison of post breakaway was most relevant for the first breakaway post downstream of the unsupported span in each test, as anchor failure occurred in test no. MGSLS-2 prior to breakaway of the second and third posts downstream of the unsupported span. The first breakaway post downstream of the unsupported span in test no. MGSLS-2 disengaged when the truck was 18.7 in. (475 mm) closer as compared to the disengagement of the same post in test no. LSC-1. This may indicate that the UBSP provided additional support to the guardrail prior to fracture and may have led to increased barrier stiffness and rail pocketing. Another factor in the delayed disengagement of the UBSP post

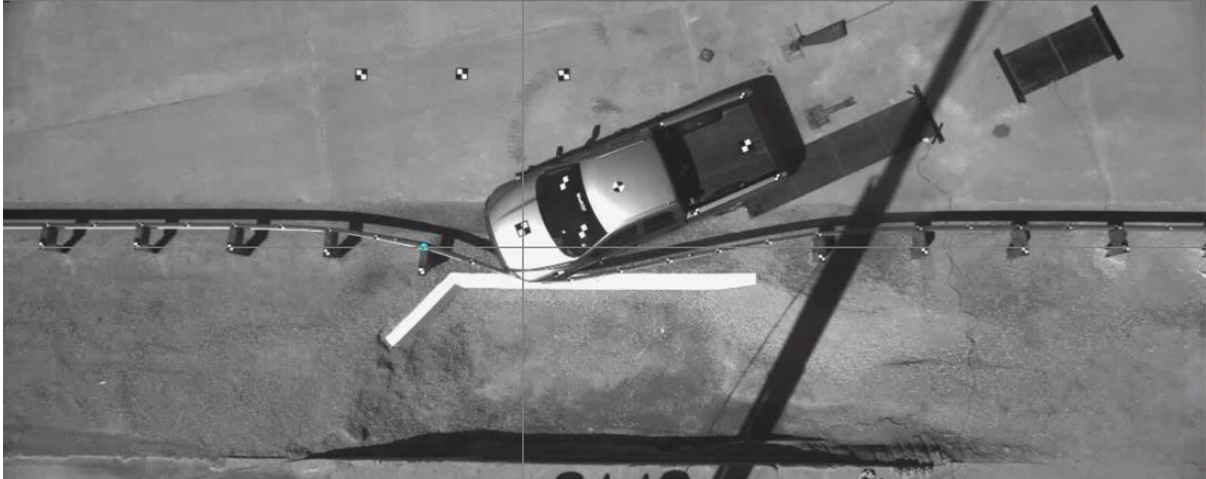
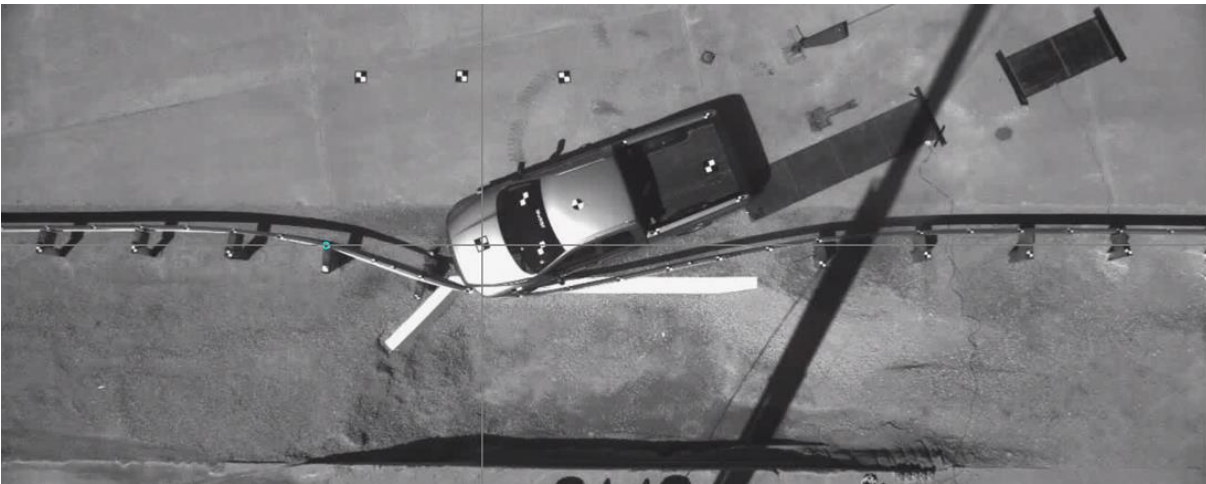
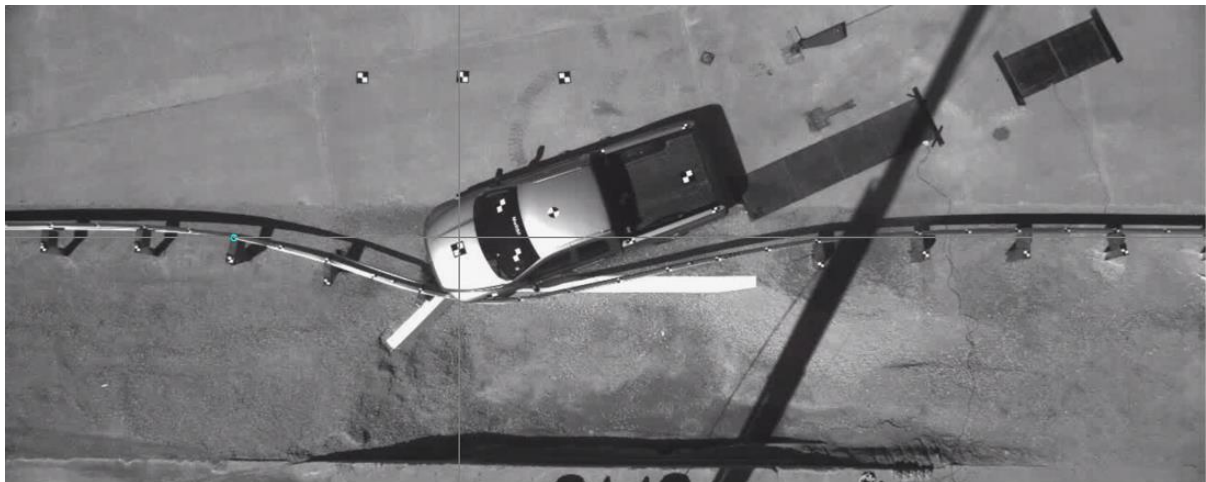
Figure 33. Longitudinal Distance of Fractured Post Relative to 2270P Bumper Corner, Test no. LSC-1

may have been that some of the CRT posts in test no. LSC-1 fractured at the second weakening hole in the CRT post below grade, as well as splitting vertically. The UBSP only has a fracture mechanism at ground line and is made of steel. Thus, it cannot replicate a failure of the post below grade or the vertical splitting observed in test no. LSC-1.

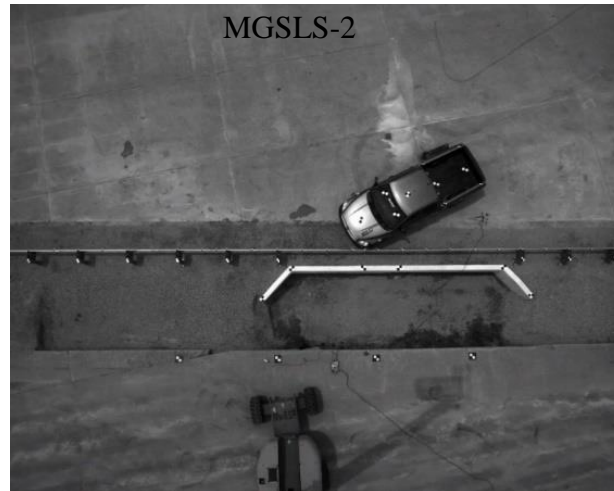
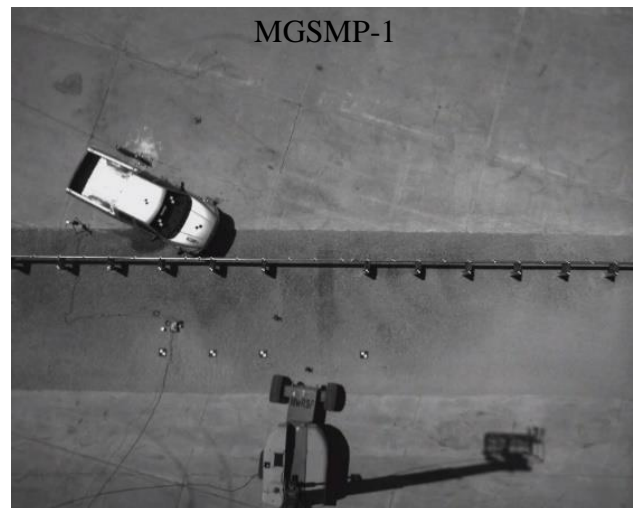
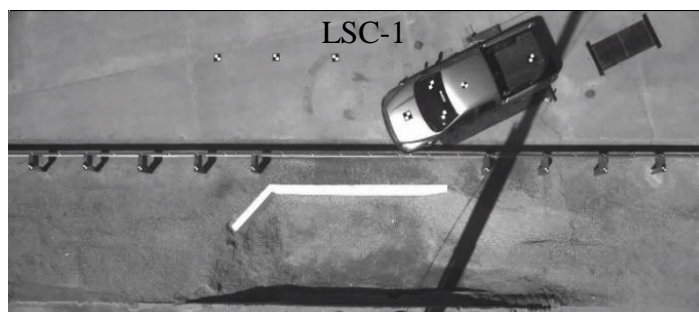
Figure 34. Overhead View at Time = 0.000 sec, Test Nos. MGSLS-2, MGSMP-1, and LSC-1

The maximum pocketing angle for test no. MGSLS-2, as well as comparable test nos. MGSLS-1 and MGSMP-1, were calculated from analysis of overhead video. Sequential images of the overhead video from 0.000 sec to 0.140 sec for test nos. MGSLS-2, LSC-1, and MGSMP-1 are shown in Figures 34 through 37, and the calculated pocketing angles are shown in Figure 38. Note that the calculated pocketing angles shown for test no. MGSLS-2 are only relevant up to the point of the downstream end anchor failure at approximately 140 msec after impact. Review of the data found that test no. MGSLS-2 initially had slightly higher pocketing angles than test nos. LSC-1 and MGSMP-1. By 0.040 sec after impact, test no. MGSMP-1 showed a sharp increase in pocketing angle due to the vehicle approaching the first standard line post downstream of the unsupported span created by the omission of a single post. Test no. MGSLS-2 showed a similar increase in pocketing angle as the vehicle approached the first UBSP downstream of the unsupported span. The pocketing angle for test no. MGSLS-2 continued to increase until anchor failure at approximately 0.140 sec after impact. Test no. MGSLS-2 displayed pocketing angles

that were generally greater than those of test no. LSC-1. This was consistent with the earlier disengagement of the CRT posts in test no. LSC-1 noted previously, and may potentially indicate that rail loading was affected by use of the UBSPs. However, anchor load data was not available from test no. LSC-1. The pocketing angles observed for all three tests were less than or very near

the threshold of 23 degrees that has previously been deemed acceptable. Additionally, the maximum pocketing angles for test nos. MGSLS-2 and MGSMP-1 were very similar prior to anchor failure, but the end anchor in test no. MGSMP-1 did not fail. The pocketing analysis also noted that some kinking of the rail was observed at the first post downstream of the unsupported span in test no. MGSLS-2 which was not observed in test nos. MGSMP-1 and LSC-1. This may indicate that the UBSF provided additional stiffness prior to fracture and potentially affected rail loading as compared the other tested systems. However, the kinking observed was not sufficient to believe to be a direct cause of the failure of the end anchorage.

Thus, the analysis indicated that the rail pocketing observed in test no. MGSLS-2 was more than observed in previous testing of the MGS long-span guardrail and may have affected rail loading, but the magnitude did not appear to be large enough to indicate a serious concern that would lead the researchers to suspect it as the cause of the downstream end anchorage failure. Additionally, while pocketing of the guardrail was similar to previous testing rail loading may have been affected based on the kinking of the rail prior to anchor failure.

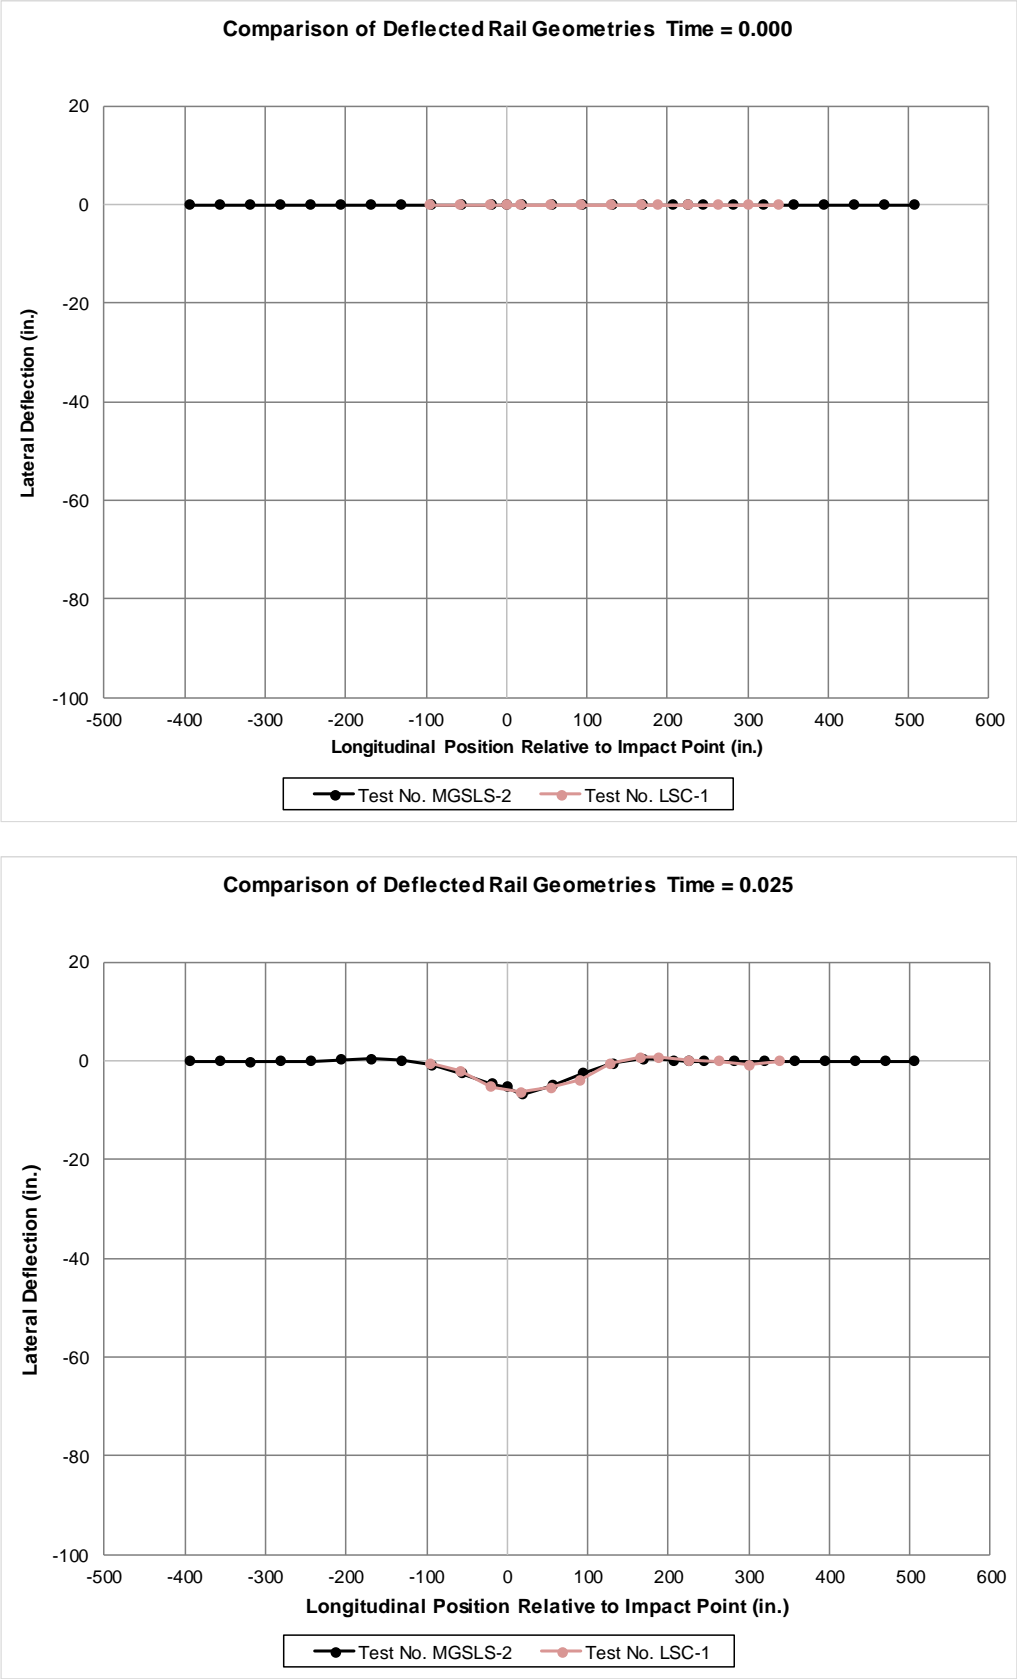
Figure 39. Comparison of Deflected Rail Geometries

with the original unsupported span length. The dynamic rail deflection at various time intervals for test nos. MGSLS-2 and LSC-1 is shown in Figures 39 through 42. Test no. MGSLS-2 displayed higher rail deflections at each time interval as compared to test no. LSC-1. The increased deflection was consistent with the effect of the increased unsupported span length in test no. MGSLS-2 and correlated well with the increased pocketing angles noted previously for test no. MGSLS-2. When combined with increased rail pocketing, the increased rail deflection observed would suggest that the loading of the downstream end anchorage in test no. MGSLS-2 may have been affected by modifications to the barrier as compared to the long-span guardrail evaluated in test no. LSC-1. However, the increased rail deflection and pocketing were not believed to be sufficient to precipitate the failure of the downstream anchorage.

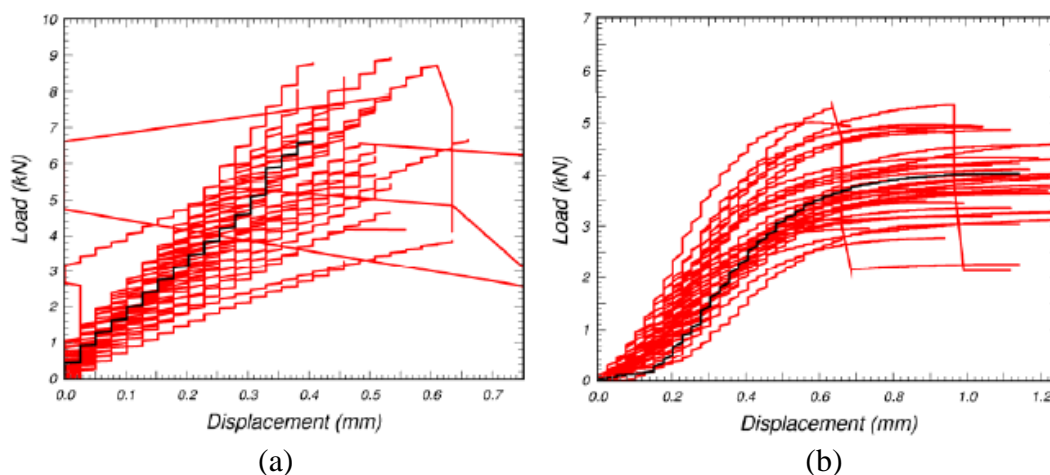
Figure 44. Southern Yellow Pine (a) Tension Parallel and (b) Compression Perpendicular

Another potential factor that could have affected the failure of the downstream end anchorage in test no. MGSLS-2 was the inherent variability of the southern yellow pine (SYP) BCT posts used in the anchorage. The strength of SYP can vary for several reasons, including natural variations in density, the presence of latewood and earlywood growth rings, and defects such as knots, checks, and shakes. Moisture content and other factors may play a role as well. Figure 44 shows the variability in tension and compression of SYP clear wood at 12% moisture content. The plots show that even clear wood has strengths that vary 50% or more from the median.
