SAFETY PERFORMANCE EVALUATION OF MINNESOTA'S ALUMINUM TYPE III BARRICADES

MwRSF Research Report No. TRP-03-101-00

October 19, 2000

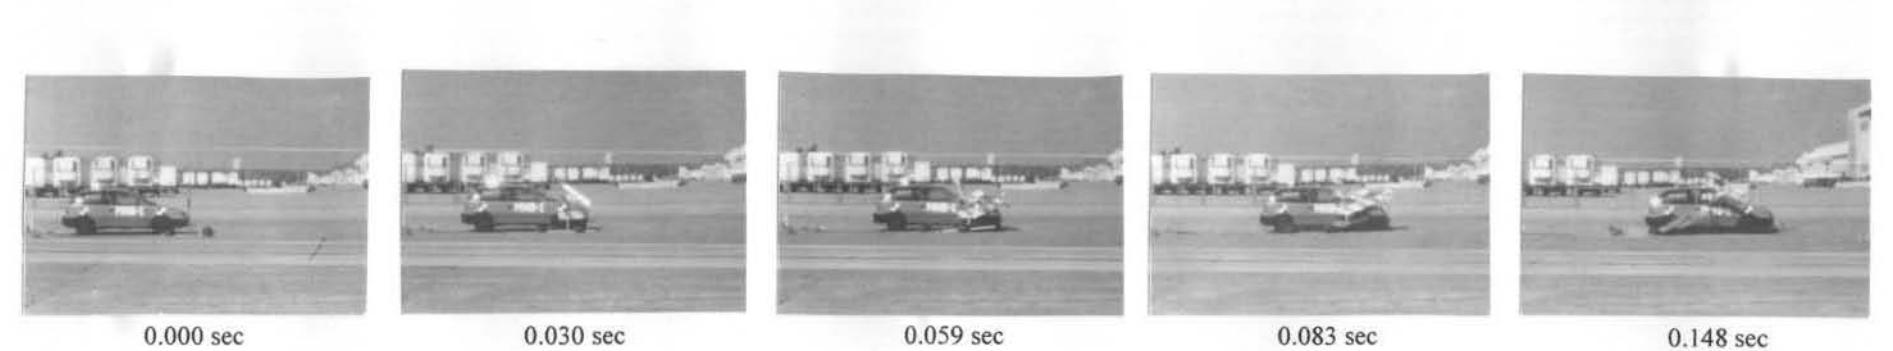
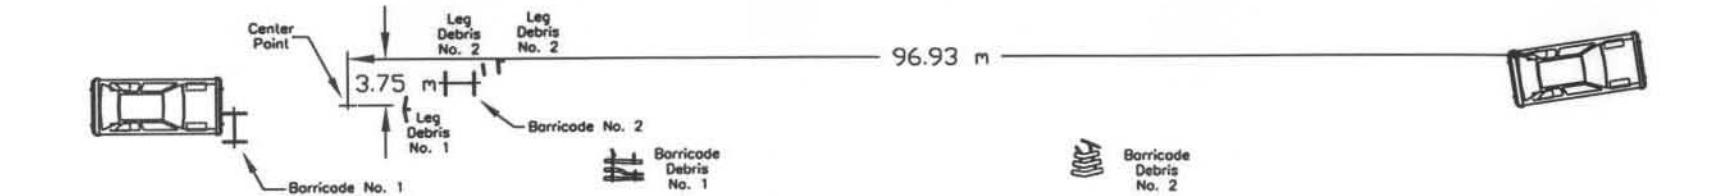
Figure 16. Summary of Test Results and Sequential Photographs, Test MNB-1, Impact No. 1

The 893-kg small car impacted System No. 1, an aluminum type III barricade oriented headon to the vehicle (perpendicular to the vehicle's path), at a speed of 105.1 km/hr and an angle of 0 degrees. The small car then impacted System No. 2, an aluminum type III barricade oriented end-on to the vehicle (parallel to the vehicle's path), at a speed of 99.3 km/hr and an angle of 90 degrees. A summary of the test results and the sequential photographs are shown in Figures 16 and 17. Documentary photographs of the crash tests are shown in Figures 18 through 19.

The test vehicle impacted System No. 1 with the right-front quarter point of the vehicle's bumper aligned with the centerline of the barricade, as shown in Figure 20. At 0.008 sec after initial impact, the contact point on the left mast deformed around the front of the vehicle. At this same time, the system wrapped around the right side of the vehicle. At 0.030 sec, the mast continued to deform around the top of the lower panel. At 0.040 sec, the leg of the left mast disengaged from the rest of the barricade as the top of the barricade rotated counter-clockwise (CCW) toward the vehicle. At 0.059 sec, the barricade system slid along the hood as the barricade panels deformed. At 0.083 sec, the barricade system was still in contact with the vehicle as it traveled downstream. At 0.148 sec, the barricade system slid along the vehicle's windshield. At this same time, the disengaged left leg was airborne in front of the vehicle. At 0.234 sec, the barricade system rested across the vehicle's windshield and roof as it traveled with the vehicle. At 0.344 sec, the barricade system moved toward the rear of the vehicle along the vehicle's roof. The leg that disengaged from the barricade was located 13.72-m downstream and 4.09-m right from the original position. The

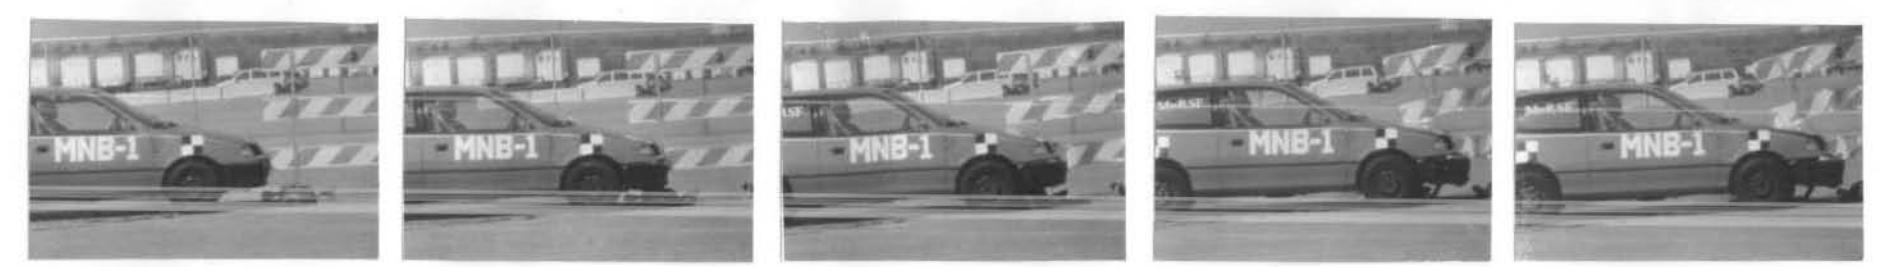
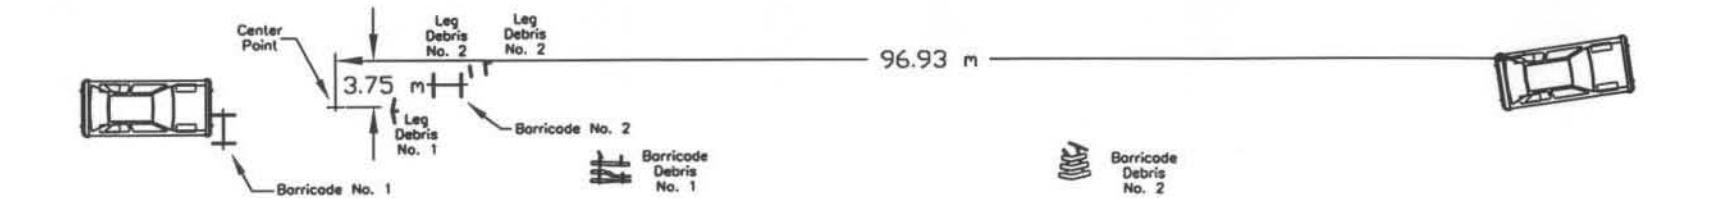
Figure 17. Summary of Test Results and Sequential Photographs, Test MNB-1, Impact No. 2

Approximately 0.64 sec after impact with System No. 1, the vehicle impacted System No. 2 with the left-front quarter point of the vehicle aligned with the centerline of the barricade, as shown in Figure 20. At 0.010 sec after initial impact, the outside edge of the barricade's bottom panel crushed toward the mast closest to the vehicle. At 0.014 sec, the impacted mast deformed about the front of the vehicle. At 0.024 sec, the panels deformed toward the non-impacted mast. At this same time, the mast closest to the vehicle disengaged from the leg's vertical upright. At 0.030 sec, the barricade system traveled with the vehicle as the panels continued to deform. At 0.038 sec, the bottom of the detached mast was pulled along the ground. At 0.042 sec, the hood became slightly ajar. At 0.049 sec, the impacted mast and the panels continued to deform as the hood opened further. The piece of the detached leg without the vertical upright was located 1.83-m downstream and 1.22m left from the original position. The other piece of the detached leg with the vertical upright was located 3.05-m downstream and 1.52-m left from the original position. The remainder of the barricade system came to rest 51.21-m downstream and 6.71-m right of the initial position. Loose sand from the sandbags was scattered in a pattern bound by 0.0-m upstream, 7.62-m downstream, 0.61-m left, and 1.52-m right from the original position of the barricade. The vehicle subsequently came to rest 96.93-m downstream from the longitudinal midpoint of the two impact points and 3.75m left from the centerline of the vehicle's original path. The final positions of the vehicle and the sign support are shown in Figures 16, 17, and 21.

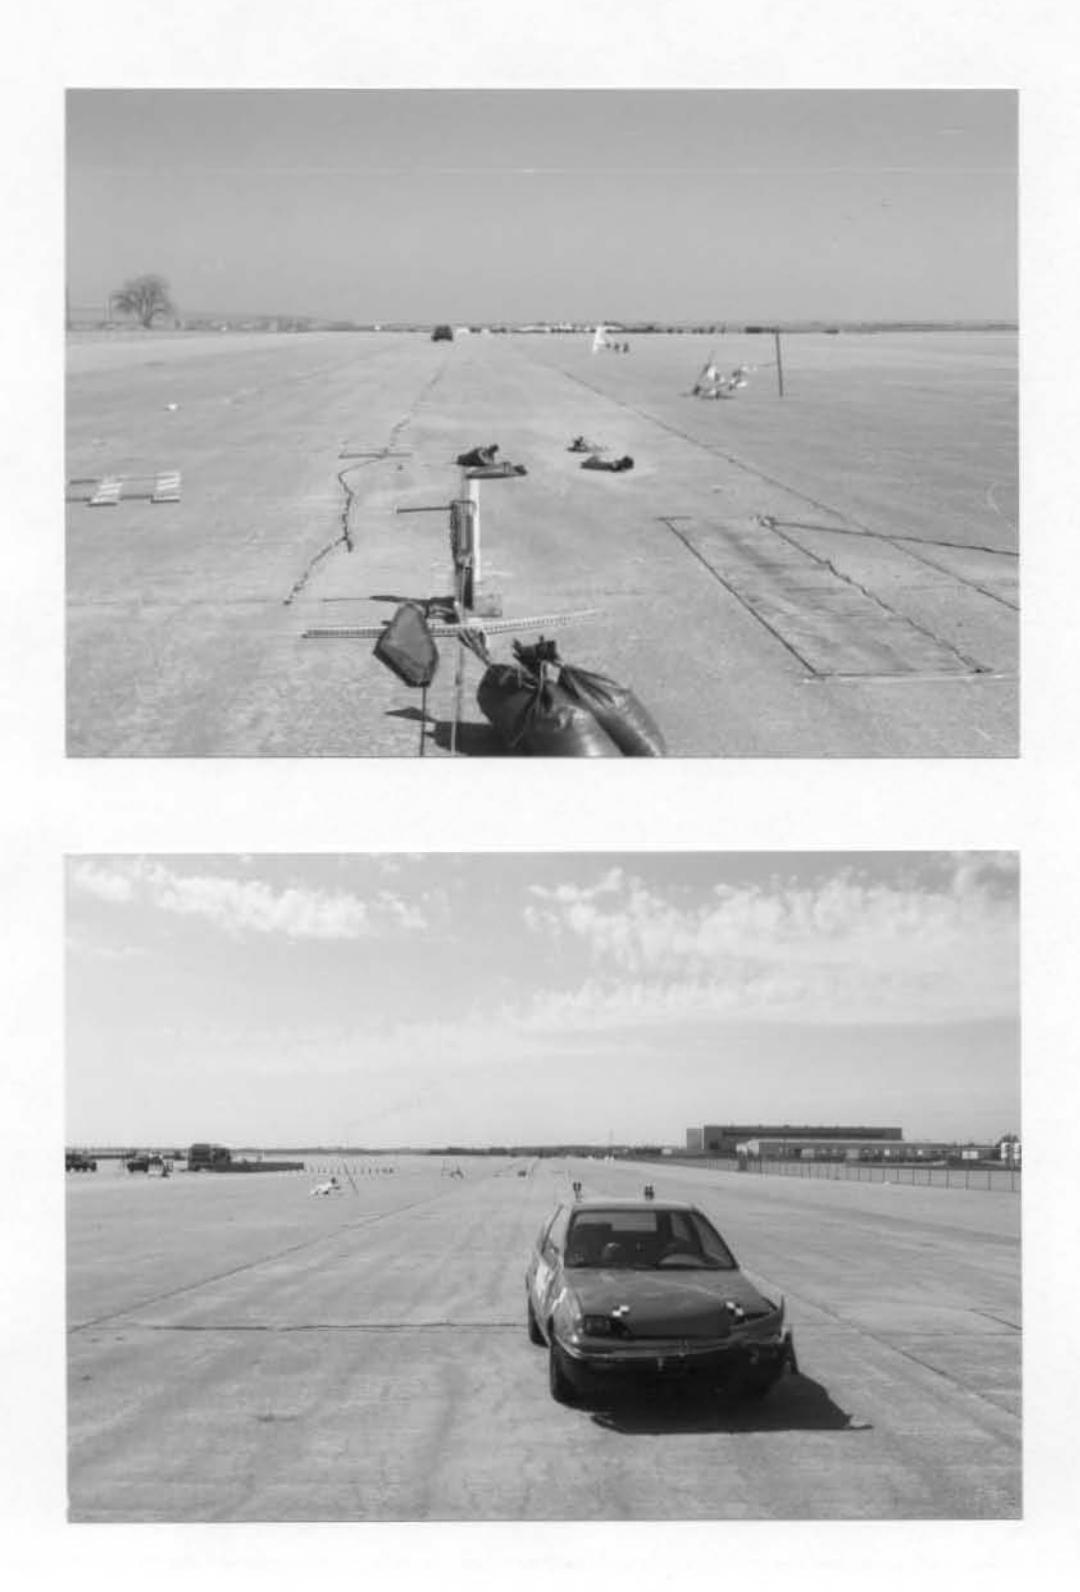
Figure 21. Overall Damage and Final Positions, Test MNB-1

Damage to System Nos. 1 and 2 is shown in Figures 21 through 25. System No. 1 encountered moderate damage. The leg on the left side was bent and disengaged from the mast. The left mast fractured above the lower panel. The vertical mast on the right side was deformed. All three of the barricade panels encountered deformations as well as scuff and scrape marks. The sandbags were torn open with the sand scattered along the path of the vehicle, starting at the initial position of the barricade.

System No. 2 encountered moderate damage. The leg closest to the vehicle disengaged and fractured at the vertical upright portion of the leg. The mast closest to the vehicle was bent to an approximate angle of 60 degrees and at a location below the bottom panel. All three of the barricade panels buckled from the side closest to the vehicle to the side furthest from the vehicle. All components of the barricade encountered scuff and scrape marks. Two of the sandbags were torn open with the sand scattered along the path of the vehicle to approximately 7.62-m downstream from the initial position of the second barricade. The other two sandbags remained undamaged.

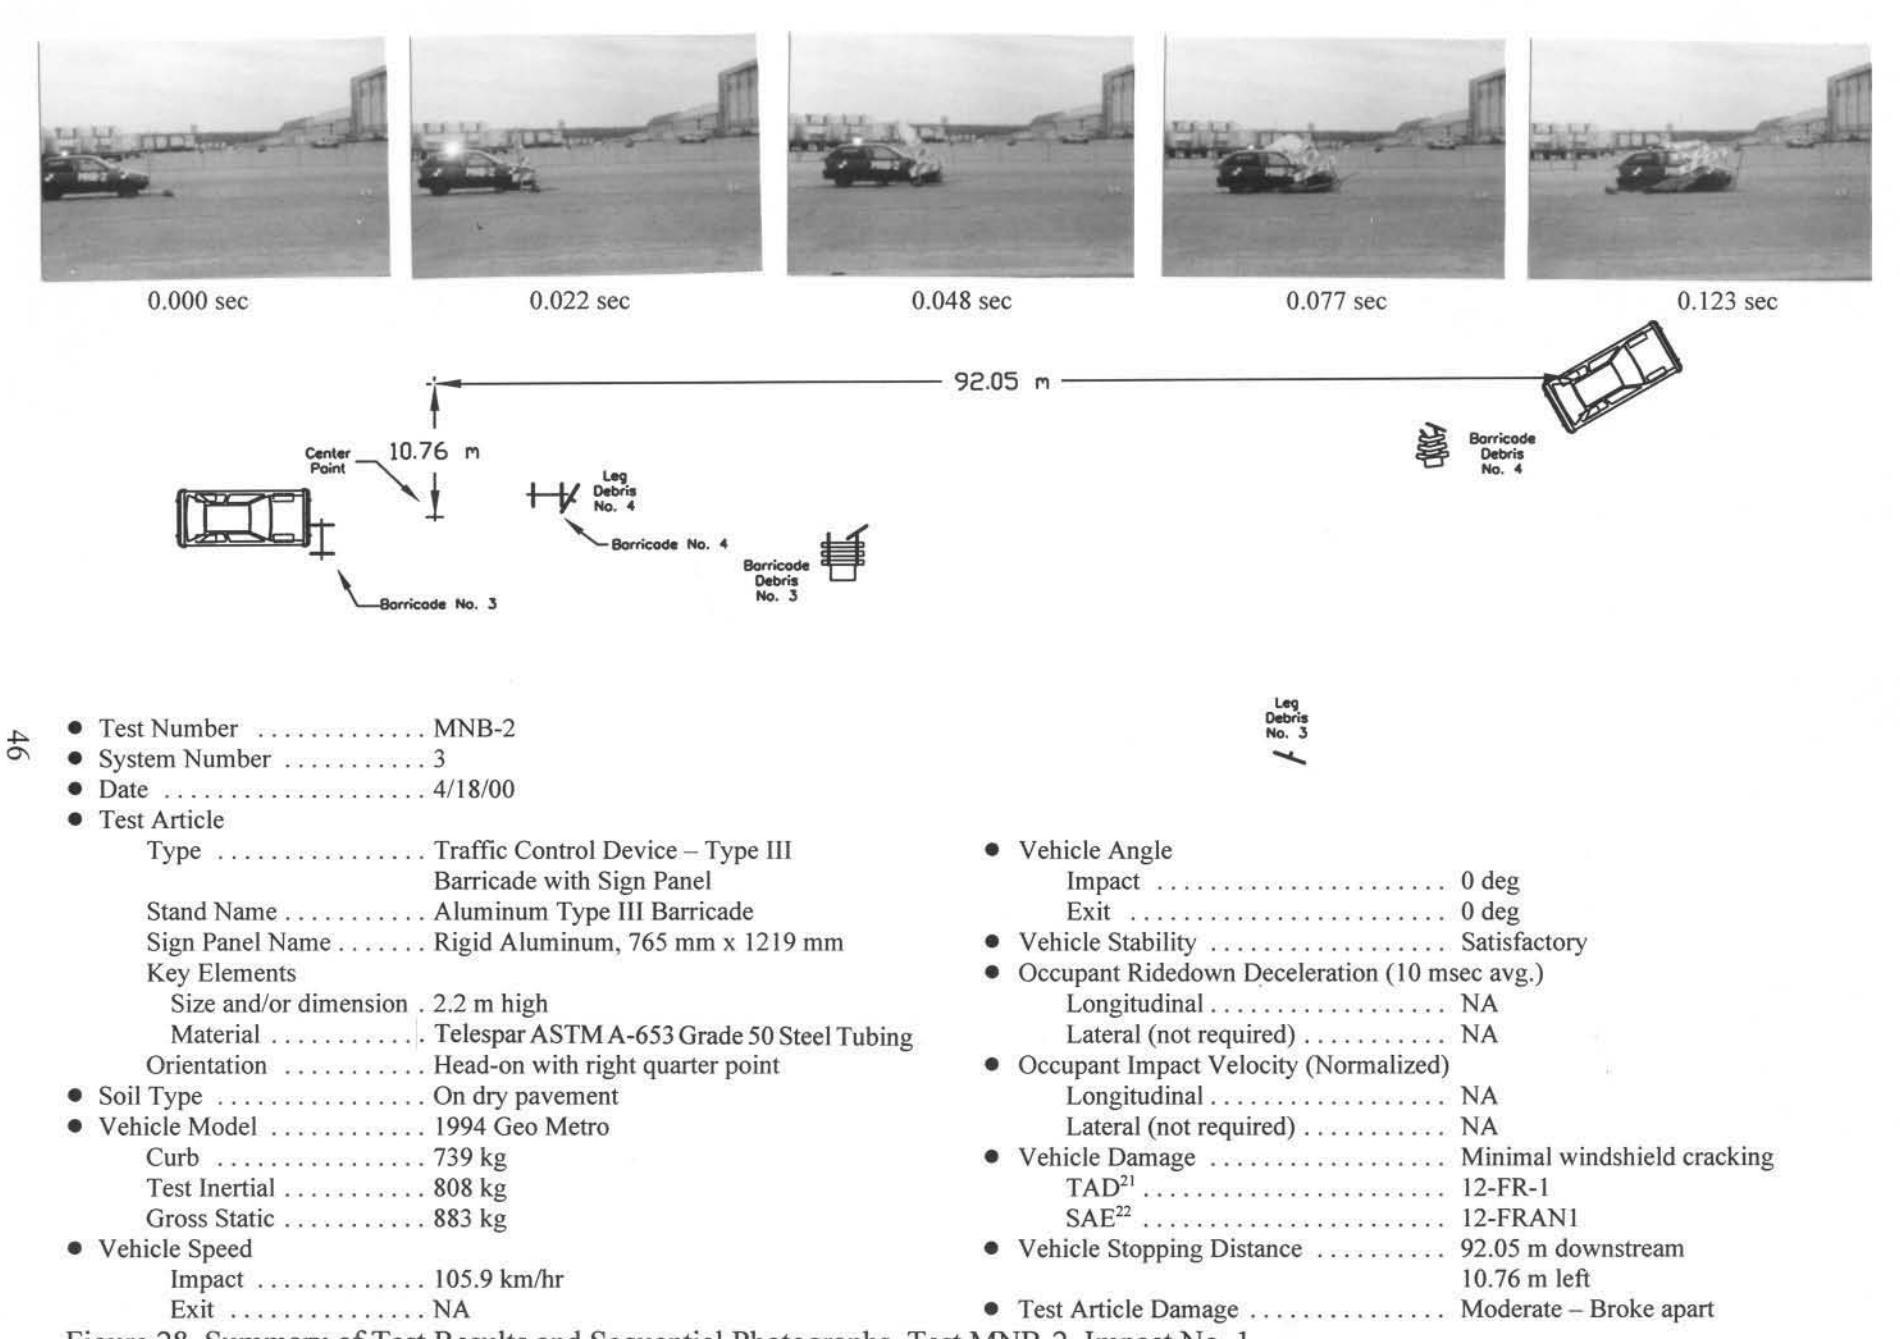
Figure 28. Summary of Test Results and Sequential Photographs, Test MNB-2, Impact No. 1

The 883-kg small car impacted System No. 3, an aluminum type III barricade oriented headon to the vehicle, at a speed of 105.9 km/hr and an angle of 0 degrees. The small car then impacted System No. 4, an aluminum type III barricade oriented end-on to the vehicle, at a speed of 97.4 km/hr and an angle of 90 degrees. A summary of the test results and the sequential photographs are shown in Figures 28 and 29. Documentary photographs of the crash tests are shown in Figures 30 through 31.

The test vehicle impacted System No. 3 with the right-front quarter point of the vehicle's bumper aligned with the centerline of the barricade, as shown in Figure 32. At 0.012 sec after initial impact, the contact point on the left mast deformed around the front of the vehicle. At 0.022 sec, the system wrapped around the right side of the vehicle as the top of the system rotated CCW toward the vehicle. At 0.048 sec, the left leg was airborne as the top of the system and sign panel continued to rotate CCW toward the vehicle. At 0.077 sec, the sign panel contacted the right windshield frame of the vehicle. At 0.097 sec, the barricade system continued to rotate CCW toward the vehicle. At 0.123 sec, the left mast disengaged from the rest of the barricade system. At this same time, the system continued to wrap around the right-front corner of the vehicle. At 0.160 sec, the barricade system slid along the windshield and roof. At this same time, the disengaged left leg was airborne in front of the vehicle. At 0.253 sec, the barricade system was airborne above the center of the vehicle with only the sign panel still in contact with the vehicle. At 0.412 sec, the barricade system was approximately perpendicular to the vehicle's roof. The disengaged leg was located

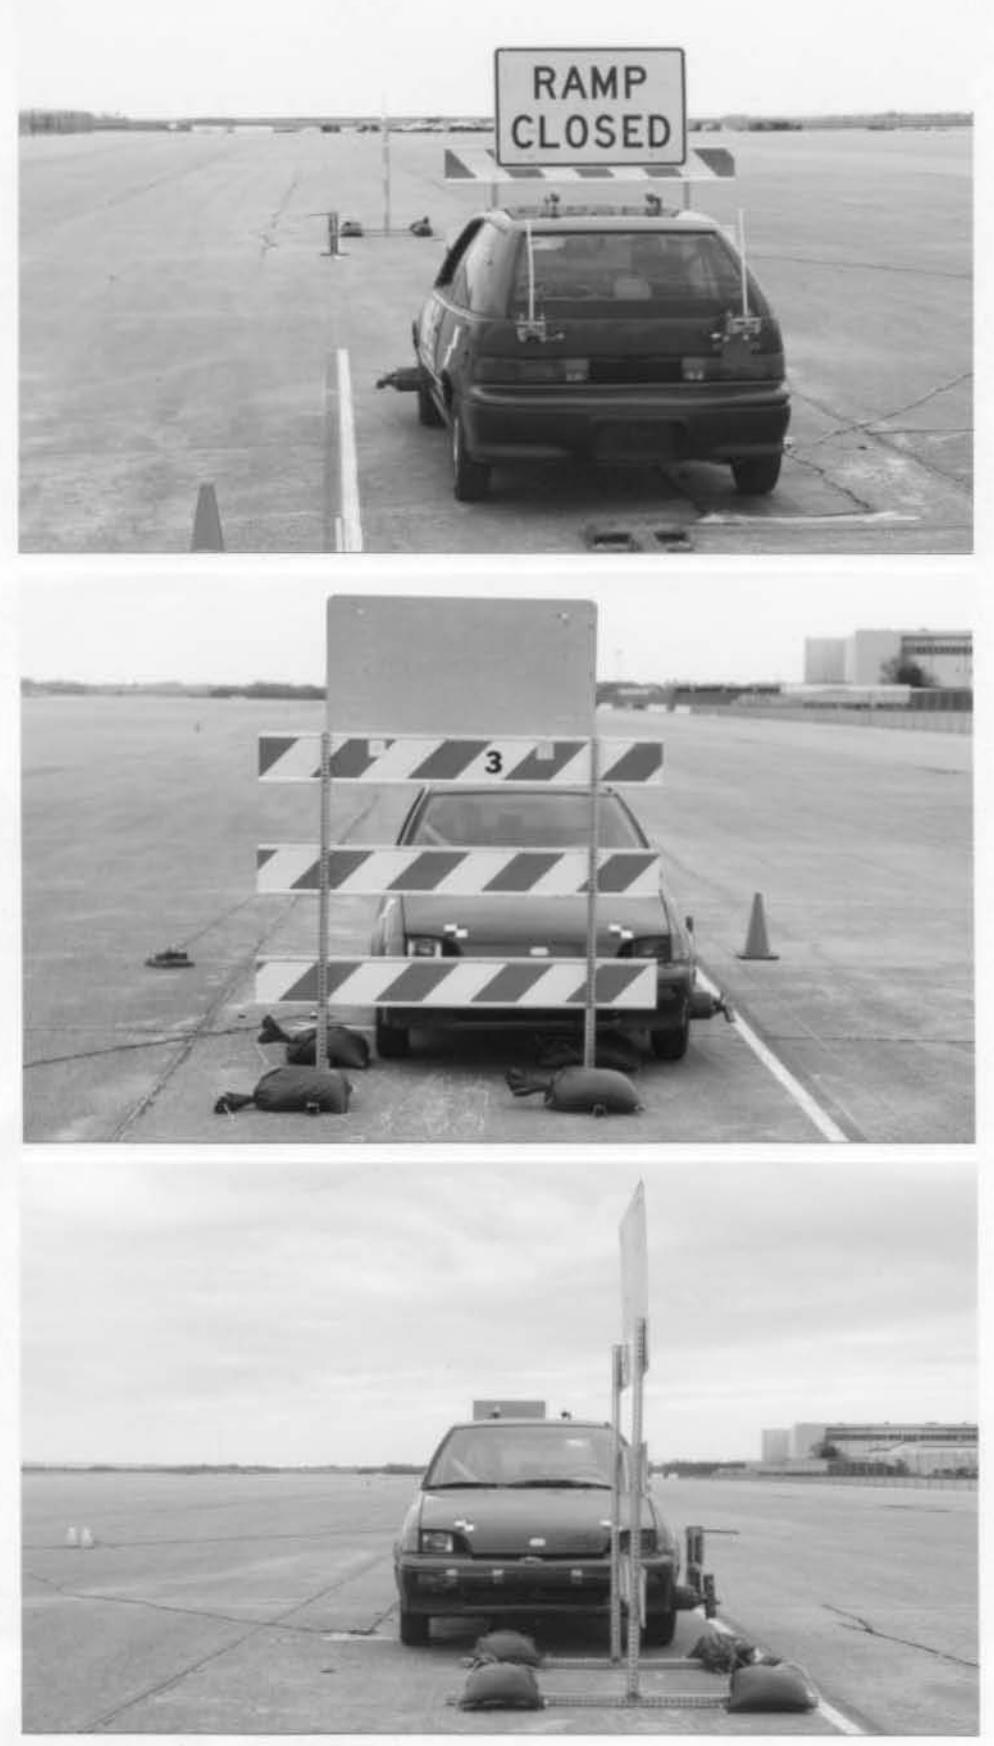
Figure 32. Impact Locations, Test MNB-2

Approximately 0.65 sec after impact with System No. 3, the vehicle impacted System No. 4 with the left-front quarter point of the vehicle aligned with the centerline of the barricade, as shown in Figure 32. At 0.012 sec after initial impact, the outside edge of the barricade's bottom panel crushed toward the mast closest to the vehicle. At 0.018 sec, the front of the vehicle impacted the mast closest to the vehicle. At 0.022 sec, the impacted mast deformed about the front of the vehicle and the hood became slightly ajar. At 0.032 sec, the barricade system rotated CCW toward the vehicle as the impacted mast slid toward the non-impacted mast, thus deforming the barricade panels. At 0.048 sec, the mast deformed to approximately a 90 degree angle and at a location below the bottom panel. At this same time, the barricade panels continued to deform. At 0.075 sec, the impacted mast contacted the other mast. At this same time, the sign panel deformed, and the top of the barricade system continued to rotate CCW toward the vehicle. At 0.085 sec, the end of the top panel impacted the windshield as the mast laid across the hood. At 0.214 sec, the sign panel impacted the seam between the windshield and roof as the rest of the system rotated into the air. At 0.293 sec, the barricade system rebounded off of the vehicle and was airborne above the vehicle. The disengaged leg was located 1.83-m downstream and 0.30-m right from the original position. The remainder of the barricade system came to rest 71.63-m downstream and 3.35-m left of the initial position. Loose sand from the sandbags was scattered in a pattern bounded by 0.0-m upstream, 15.24-m downstream, 1.68-m left, and 2.13-m right from the original position of the

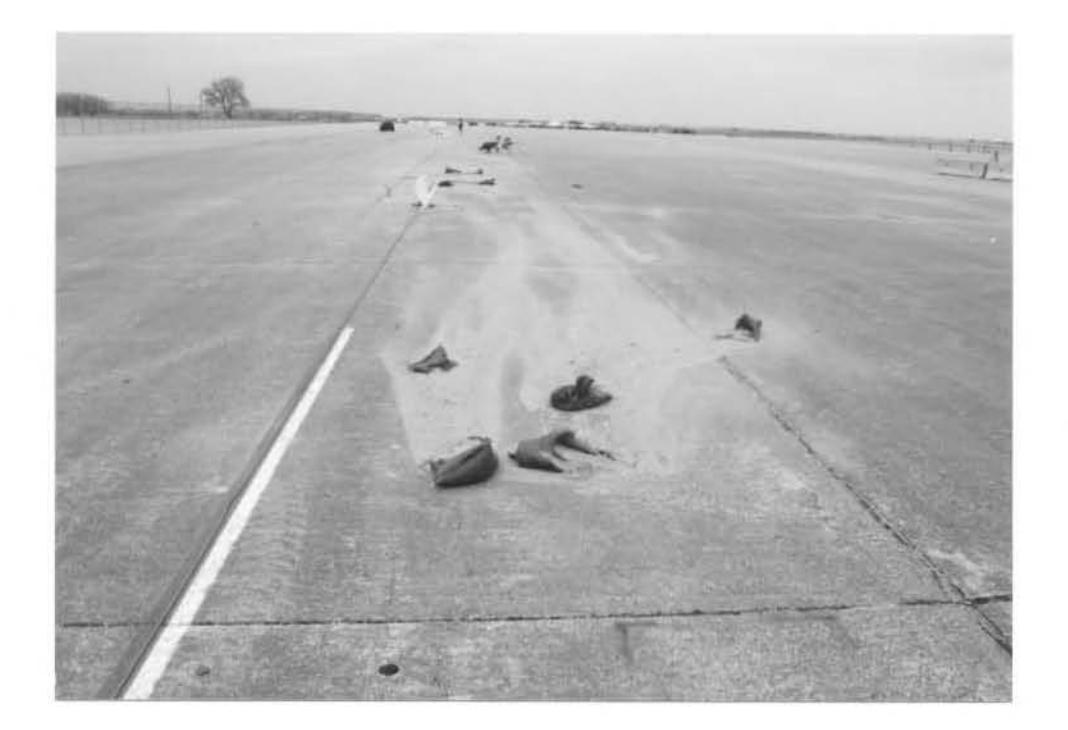
Figure 33. Overall Damage and Final Positions, Test MNB-2

Damage to System Nos. 3 and 4 is shown in Figures 33 through 36. System No. 3 encountered moderate damage. The left-side leg was slightly deformed and disengaged from the mast. The left-side mast fractured above the bottom panel. The vertical mast on both sides deformed with the one on the left encountering more severe deformations. All three of the barricade panels as well as the sign panel encountered deformations and scuff and scrape marks. The sandbags were torn open with the sand scattered along the path of the vehicle.

System No. 4 encountered moderate damage. The leg closest to the vehicle disengaged and was slightly deformed. The mast closest to the vehicle was bent to an approximate angle of 45 degrees and at a location below the bottom panel. The mast on the non-impact side was also deformed. All three of the barricade panels buckled from the side closest to the vehicle to the side furthest from the vehicle. The sign panel was also deformed. Three of the sandbags were torn open with the sand scattered along the path of the vehicle. The other sandbag remained undamaged.
