Guardrail Testing Program II

Final Report

Midwest Roadside Safety Facility
Civil Engineering Department
University of Nebraska-Lincoln
1901 'Y' Street, Bldg. 'C'
Lincoln, Nebraska 68588-0601

Transportation Research Report TRP-03-52-95

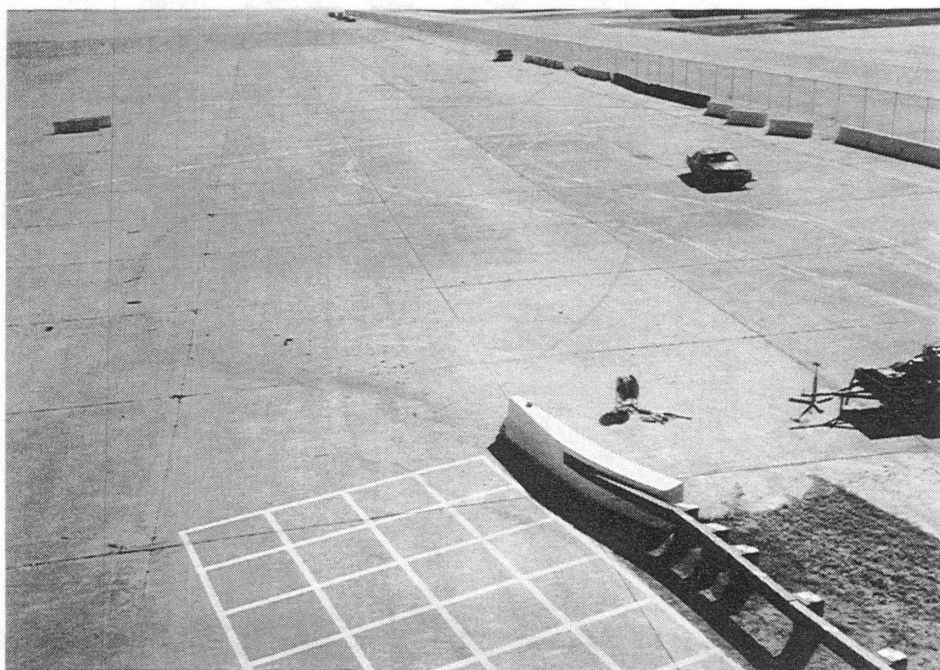
Figure 5. Vehicle Trajectory, Test SBT-1.

Upon impact with the steel-backed wood rail, the right-front corner of the vehicle began to crush inward. As the collision continued, the wood rail deflected considerably, with the maximum dynamic deflection of 13 in (130 mm) occurring at post no. 1 at 130 ms. At 133 ms, the vehicle impacted the end of the concrete abutment, resulting in major damage to the vehicle. Approximately 167 ms after impact, the buckling of the vehicle roof became very evident. At 204 ms after impact, the vehicle became parallel to the system, and at 439 ms it exited the barrier at an angle of 17.5 degrees. The vehicle came to rest downstream and behind the rail, as shown in figure 5.

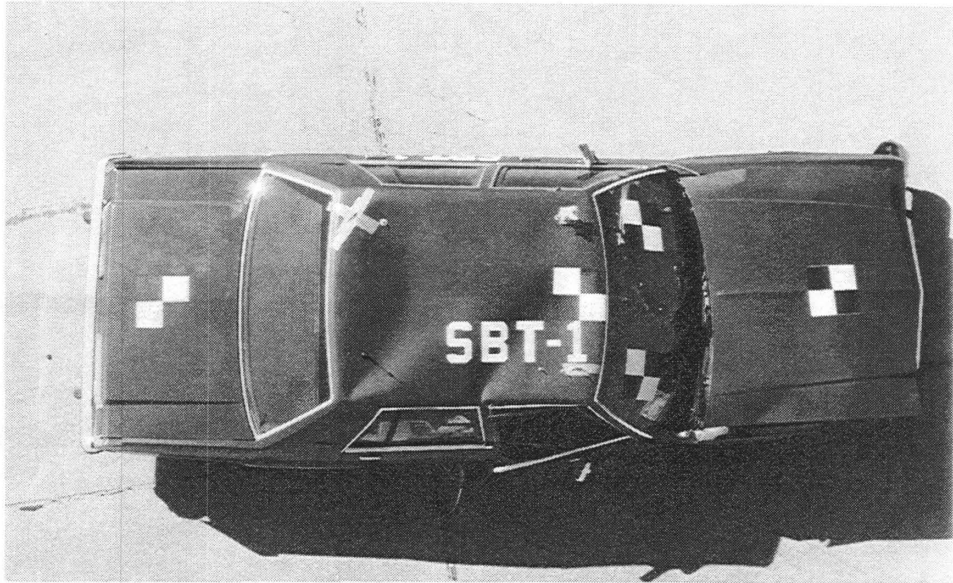
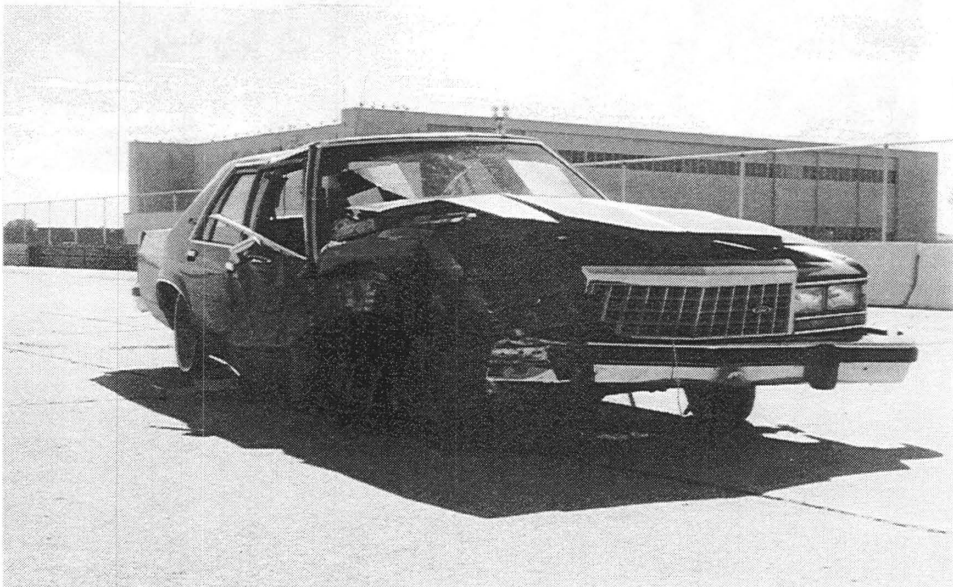
Figure 6. Vehicle Damage, Test SBT-1.

Damage to the vehicle, which can be seen in figure 6, included major crushing and deformation of the right-front corner of the vehicle, as well as buckling of the vehicle roof. The entire front half of the vehicle was bent slightly toward the driver's side. Interior occupant compartment damage included buckling of the floorboard on the passenger's side, as well as buckling of the dash. The maximum crush deformation of 17 in (492 mm) is shown in figure 7.

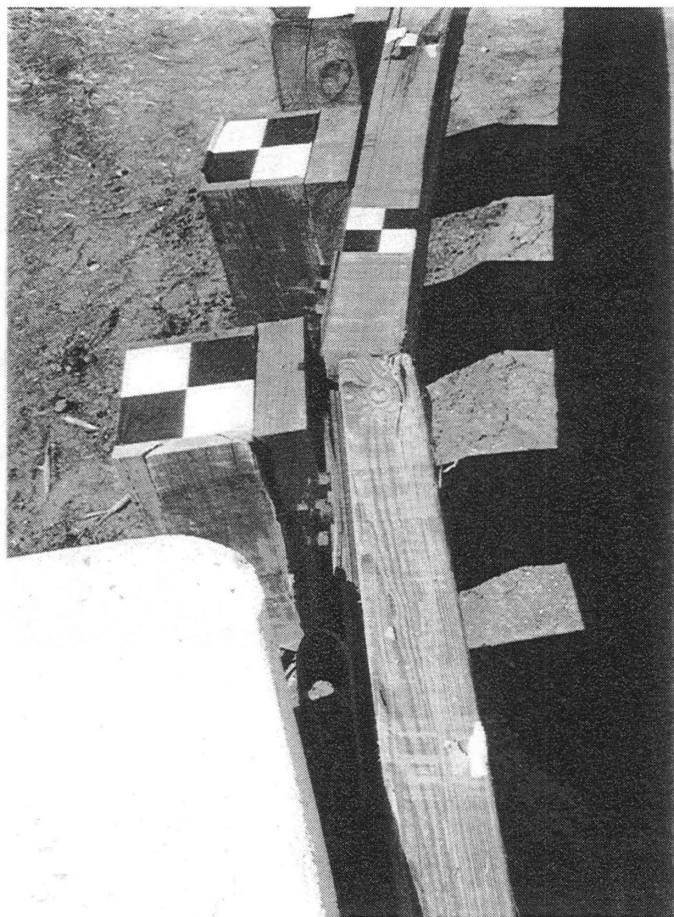
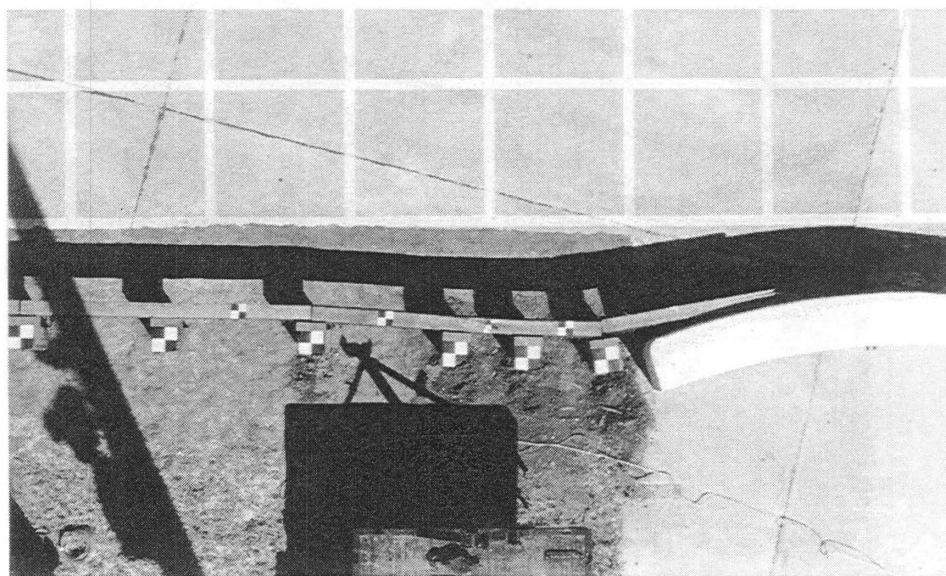
Figure 8. System Damage, Test SBT-1.

The damage to the system, shown in figures 8 and 9, consisted of a maximum permanent set deformation of 11.25 in (286 mm) at post no. 1. A flexural failure occurred in the first timber rail section, approximately 4.5 ft (1.37 m) from the downstream end of the rail. The 8-in (203-mm) inside diameter (I.D.) pipe located between the first rail and the concrete abutment was completely flattened. There was evidence of vehicle snagging at the splice between rails no. 1 and 2, as sheet metal from the vehicle was embedded in the end of rail no. 1. There were continuous scrape marks along the face of the rail from the point of impact to exit, as well as impact markings on the concrete abutment.

The impact with the end of the concrete abutment caused excessive occupant compartment deformation, which resulted in the failure of this test. It was determined that the stiffness of the steel-backed wood rail was inadequate as it deflected considerably, allowing the

vehicle to impact the end of the concrete abutment. The system was redesigned by Eastern Federal Lands Highway Division engineers for the next test by increasing the length of posts no. 1, 2, and 3 from 7 ft (2.13 m) to 8 ft (2.44 m). The 8-in (203-mm) I.D. pipe spacer between the rail and concrete abutment was replaced with an angled block of wood to restrict the deflection of the first rail. The splice between the first and second rails was stiffened by adding a second $\frac{3}{8}$ -in (10-mm) backup plate. The bolts at this splice were moved closer to the post and increased in number from 8 to 12. The details of these design changes are presented in the plan drawings in appendix A.

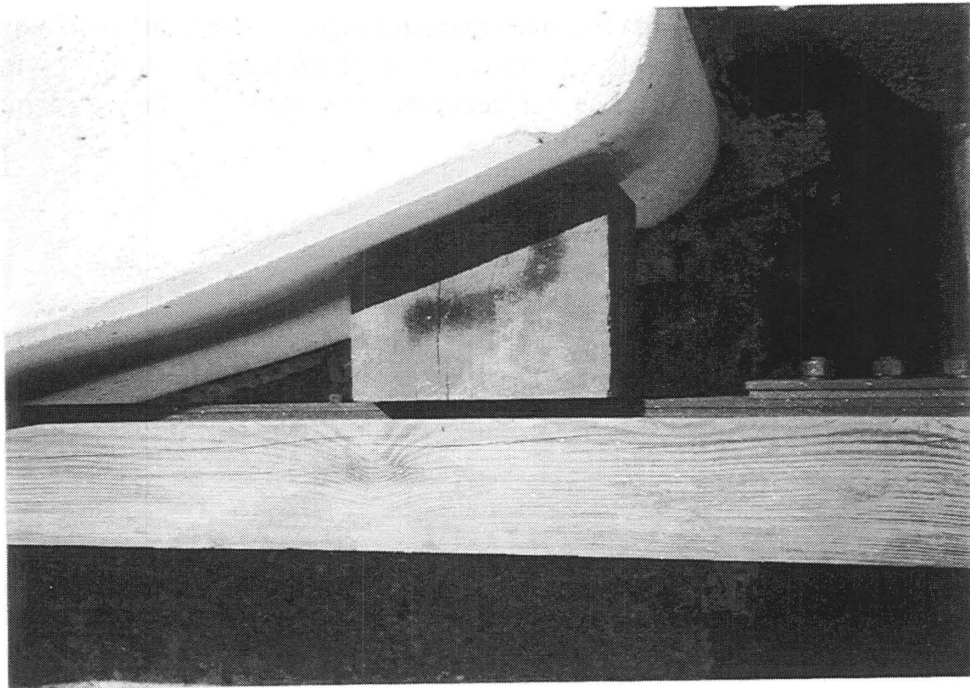
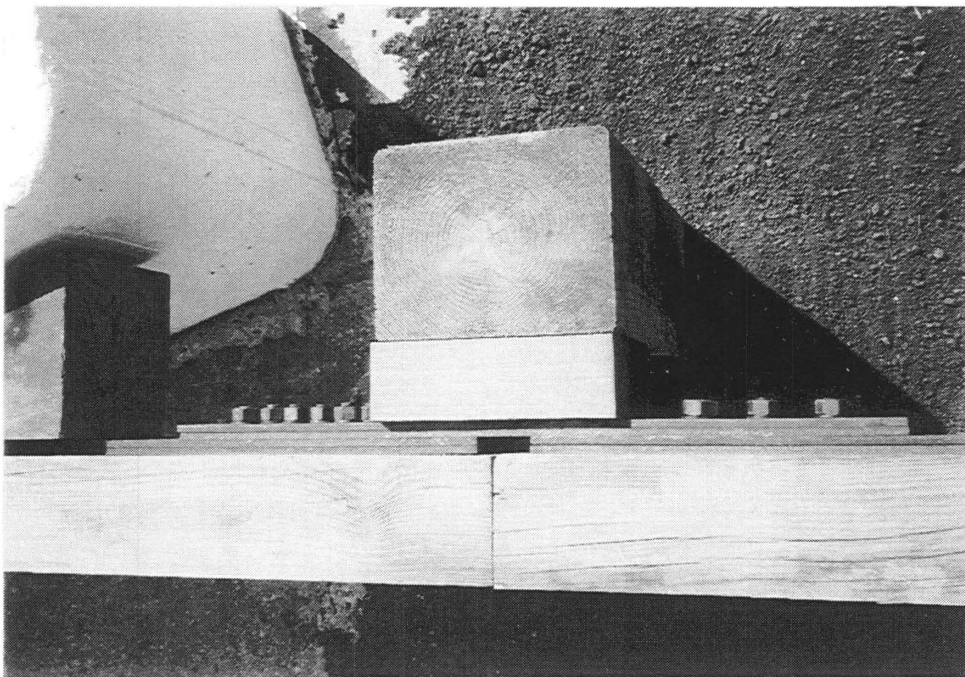
Figure 10. Design Modifications, Test SBT-2.

For this test, the system was modified as described in the previous section. These modifications are shown in figure 10, and details can be found in the plan drawings in appendix A. The 1984 Buick LeSabre impacted the system at 61.1 mi/h (98.3 km/h) and 26.5 degrees. The impact point was located midway between the third and fourth posts from the concrete bridge abutment, as shown in figure 11. A summary of the test results and sequential photographs are shown in figure 12. Additional sequential photos are presented in figure 13.

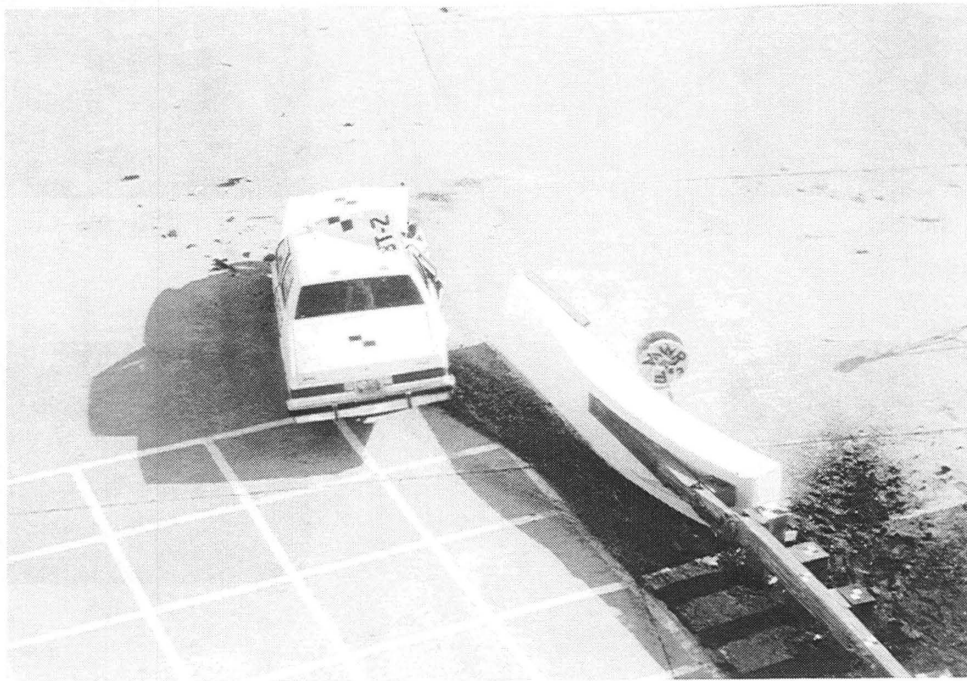
Figure 14. Vehicle Trajectory, Test SBT-2.

Upon impact with the wood rail, the right-front corner of the test vehicle began to crush inward. Rail no. 2 began to deflect shortly after impact, but the wood spacer block between the concrete and rail prevented rail no. 1 from deflecting. As a result of this significant difference in stiffness, the splice between these two rails yielded, and 110 ms after impact the first rail speared into the vehicle. The vehicle never became parallel to the rail, and it exited at 450 ms as its center of mass was traveling at an angle of 17.3 degrees to the barrier. The snagging at the first splice resulted in major vehicle and occupant compartment deformation, and the sedan was brought to a complete stop shortly after it exited the rail, as can be seen by its final resting position shown in figure 14.

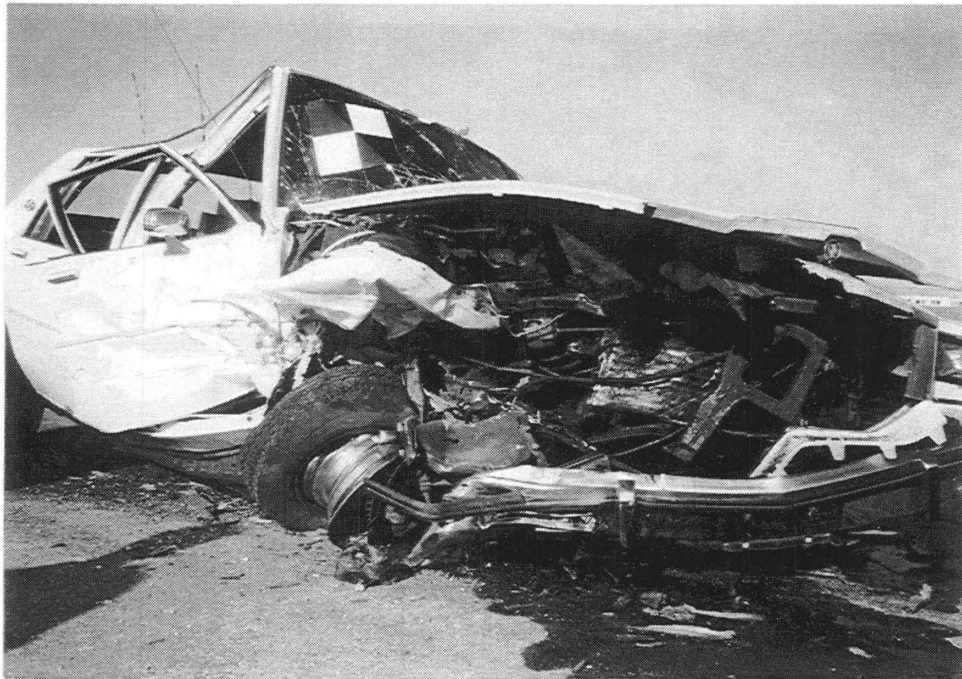
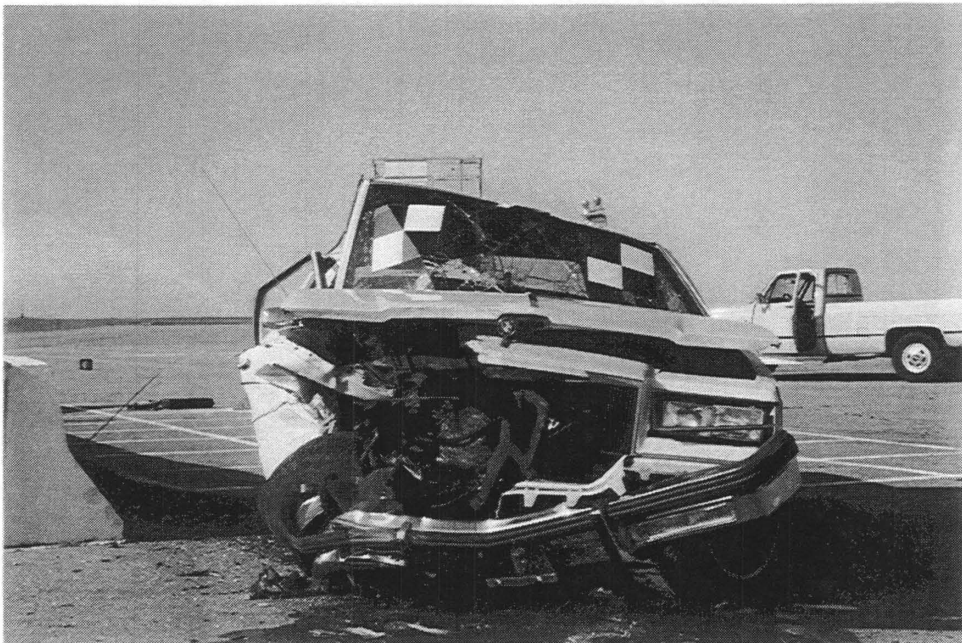
Figure 15. Vehicle Damage, Test SBT-2.

The damage to the vehicle was substantial, as shown in figure 15. The entire right-front portion of the vehicle was crushed and pushed back toward the occupant compartment. The firewall and floorboard were pushed backwards and up on the passenger's side, and a section of the wood rail penetrated the firewall on the extreme right-hand side. The windshield was broken and the roof of the vehicle was buckled considerably. The maximum vehicle crush of 31.5 in (800 mm) is shown schematically in figure 16.

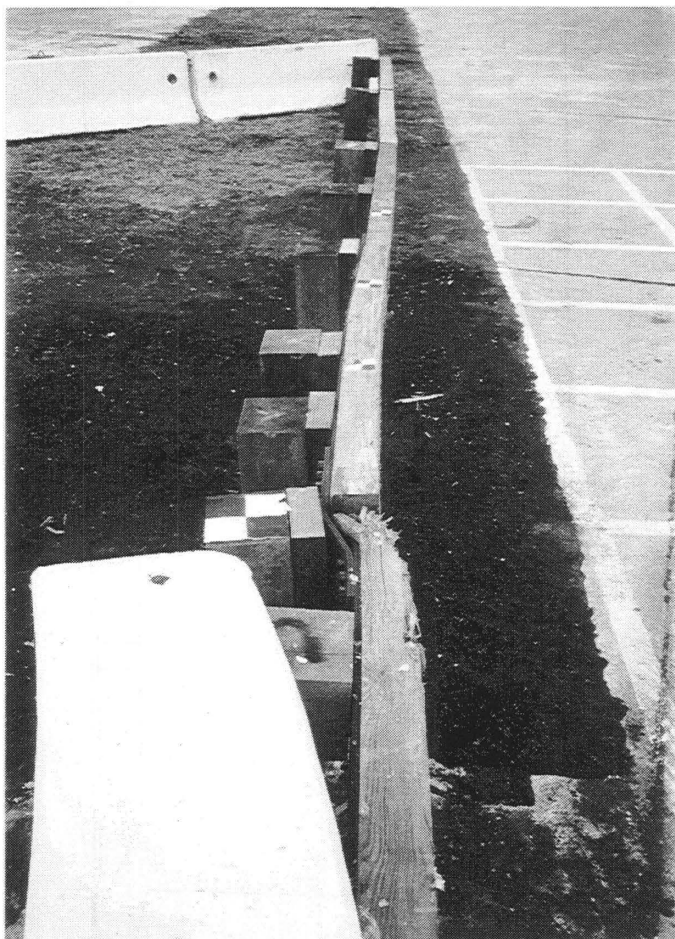
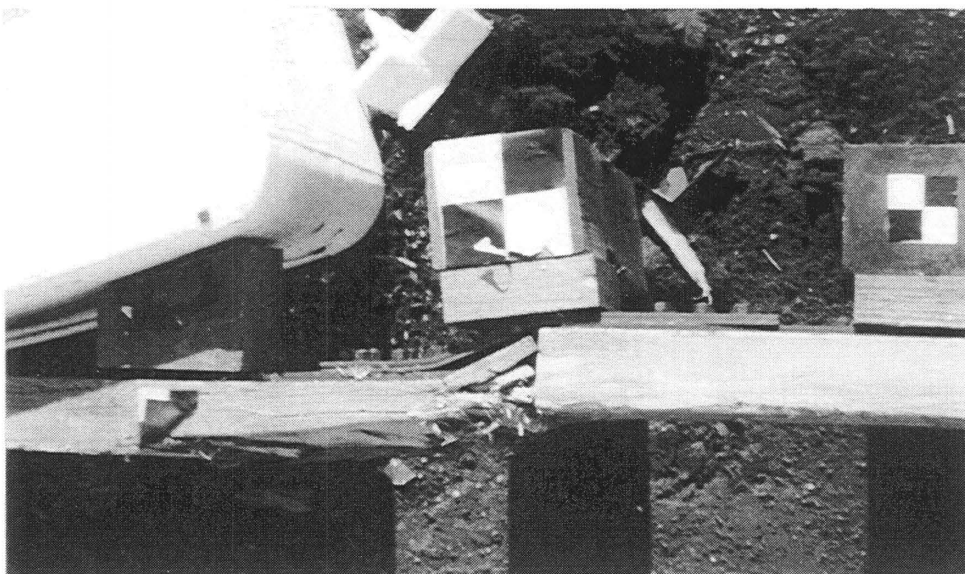
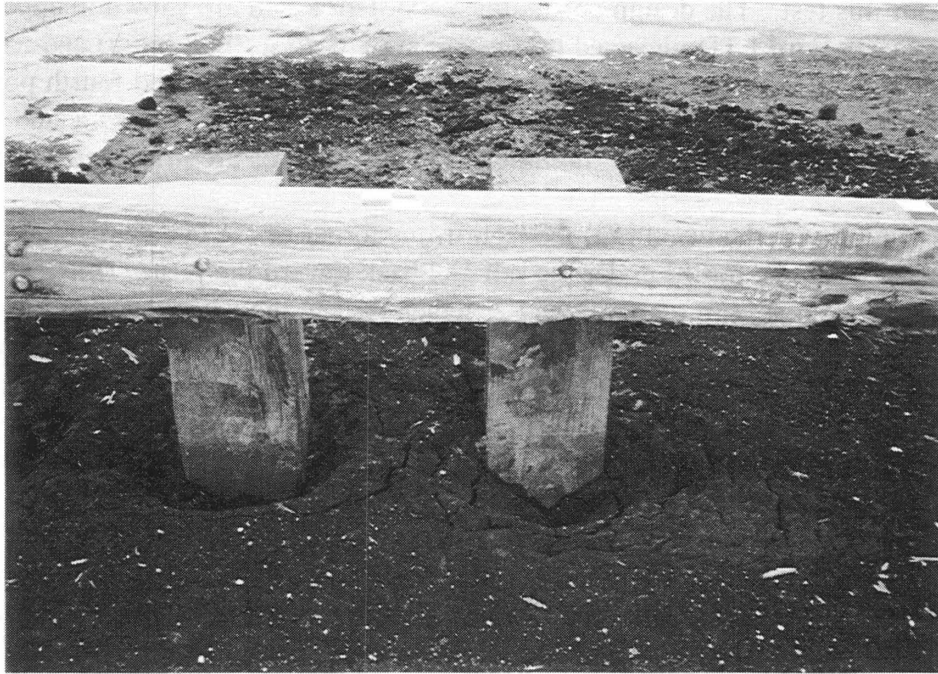
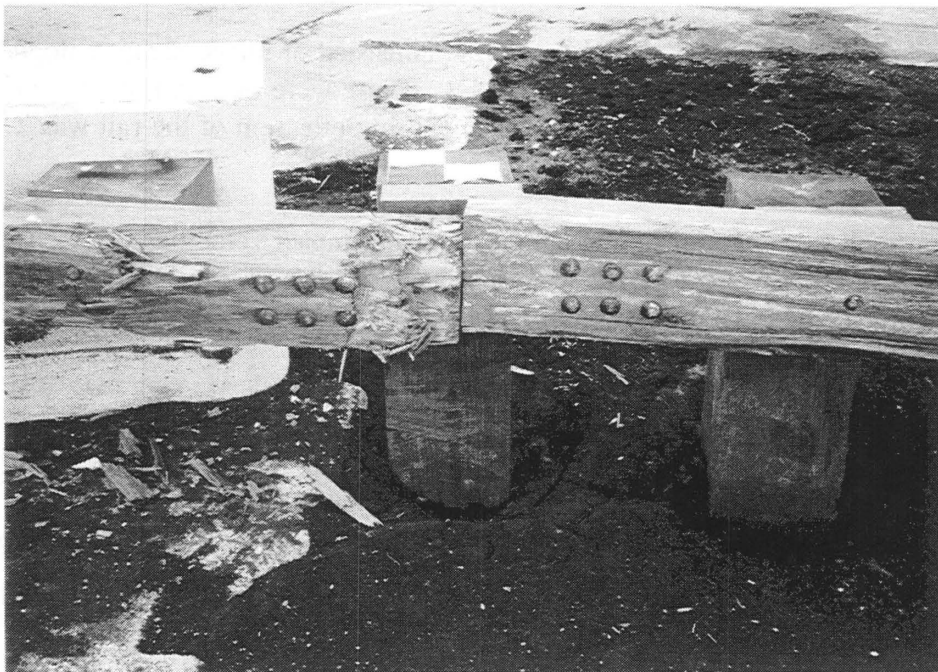
Figure 17. System Damage, Test SBT-2.

Damage to the steel-backed wood rail was considerable, as can be seen in figure 17. The upstream end of rail no. 1 was damaged as the vehicle snagged on it, and the splice plates between rails no. 1 and no. 2 were bent significantly. There were marks along the face of the rail and concrete abutment throughout the length of contact.

Two of the system's design flaws became apparent as a result of this test. The first was that the wood blockout between the wood rail and concrete abutment made the first rail section much too stiff, resulting in the snagging problem at splice no. 1. The second observation was that the steel splice plates did not provide adequate strength for the splice between the first and second rail. Thus, two design changes were incorporated by FHWA engineers into the next design in an effort to alleviate these problems.

First, the angled wood blockout between the steel-backed rail and the concrete abutment was replaced with a 6-in (152-mm) diameter pipe. Second, the two $\frac{3}{8}$ -in (10-mm) splice plates at post no. 1 were replaced with a 3-ft (0.91-m) length of 6-in by 4-in by $\frac{1}{2}$ -in (152-mm by 102-mm by 13-mm) structural steel tube. The details of these design changes can be found in appendix A.

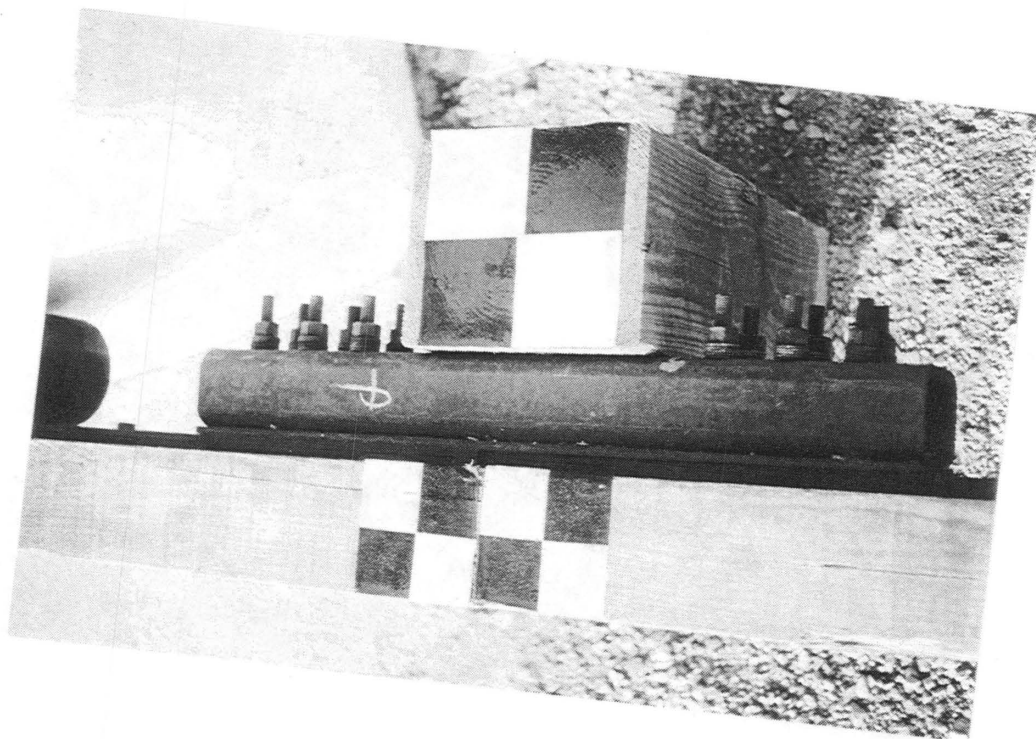
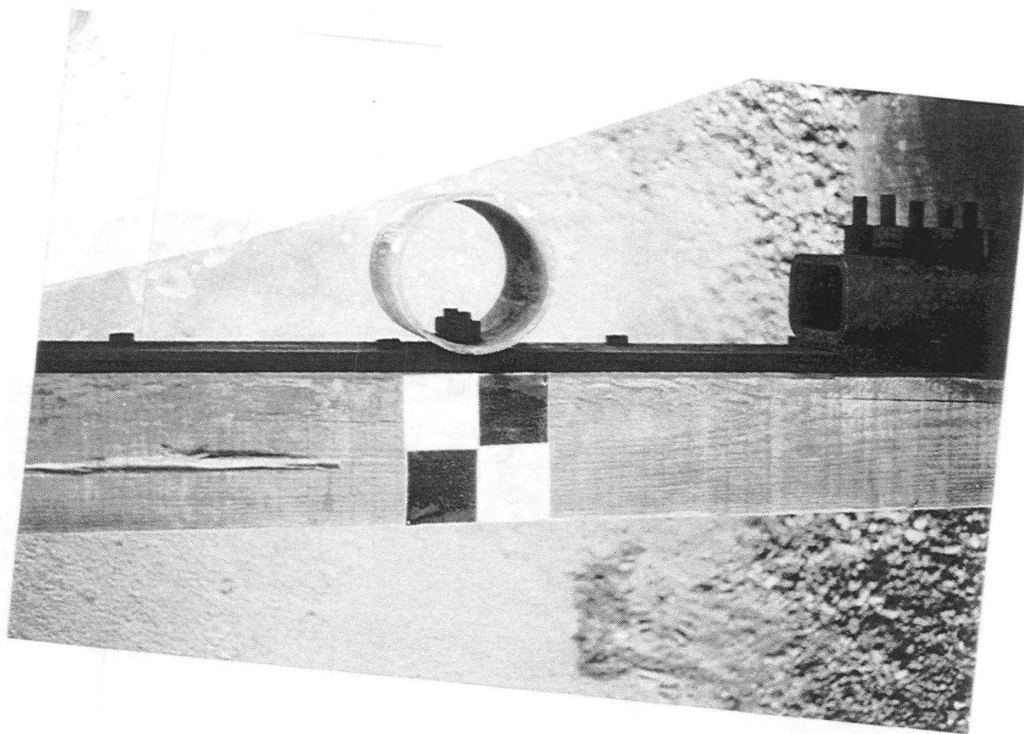
Figure 18. Design Modifications, Test SBT-3.

The design changes discussed in the previous section are shown in figure 18, and were implemented for this test. The design details for the system tested are shown in appendix A. For this test, a 1985 Ford LTD impacted the system at 62.0 mi/h (99.8 km/h) and 25.8 degrees. The impact point was located midway between the third and fourth posts from the concrete bridge abutment, as shown in figure 19. A summary of the test results and sequential photographs are shown in figure 20. Additional sequential photos are presented in figure 21.

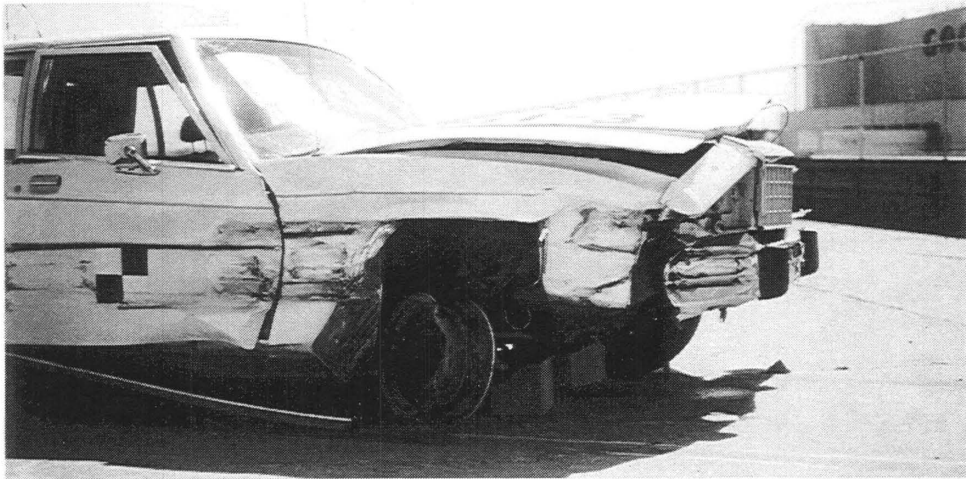
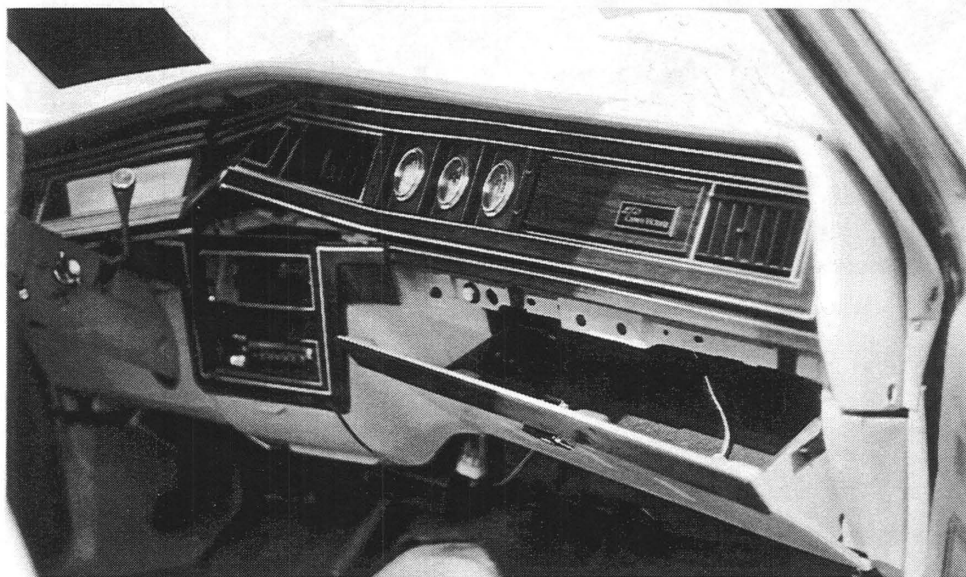
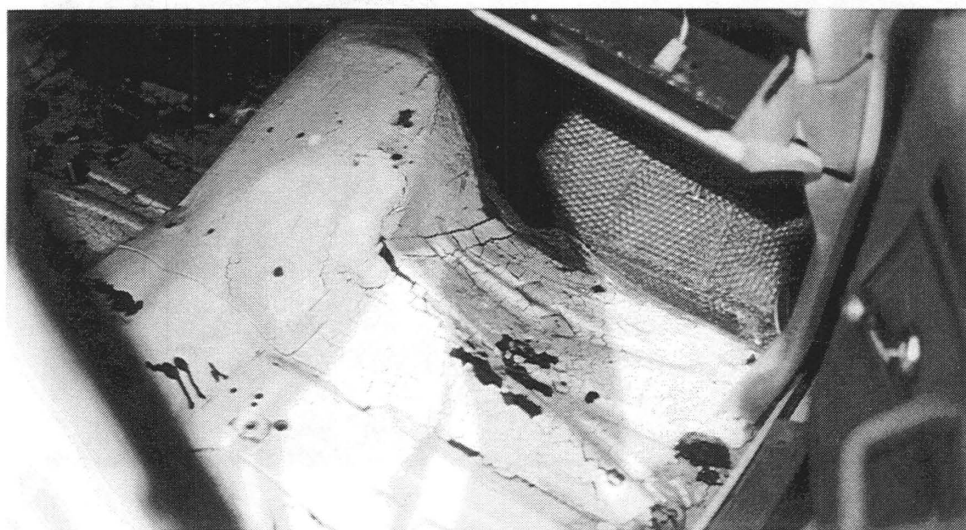
Figure 23. Vehicle Damage, Test SBT-3.

The vehicle damage, shown in figure 23, consisted of the crushing of the right-front corner of the vehicle, as well as scrapes and dents continuing down the side to the rear wheel assembly. The tire was torn off the right-front wheel, and the rim was bent. Occupant compartment damage included buckling of the floor on the passenger's side of the vehicle, as well as buckling of the dashboard. The maximum crush deformation of 13.75 in (349 mm) is shown schematically in figure 24.

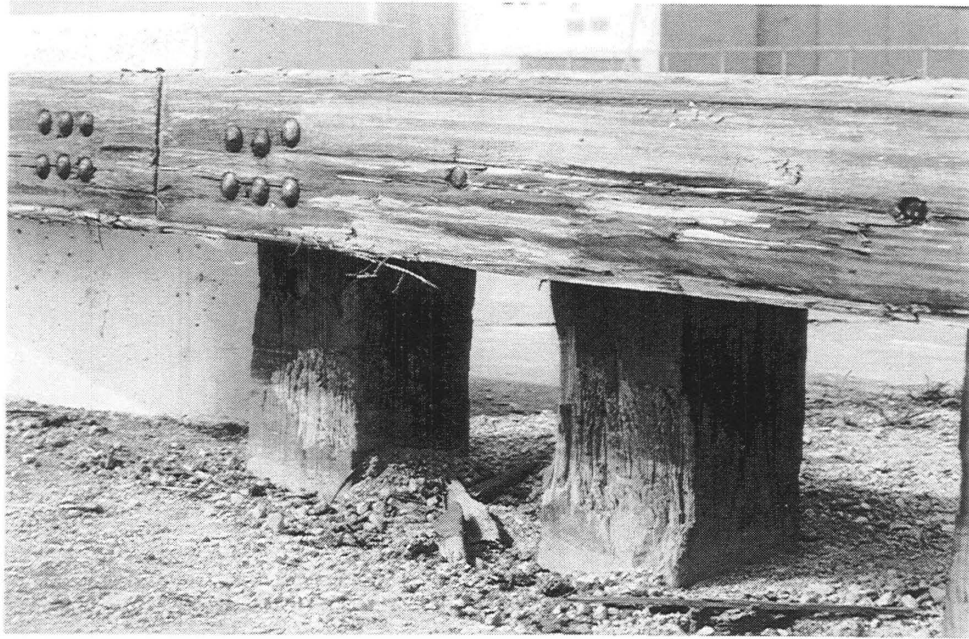
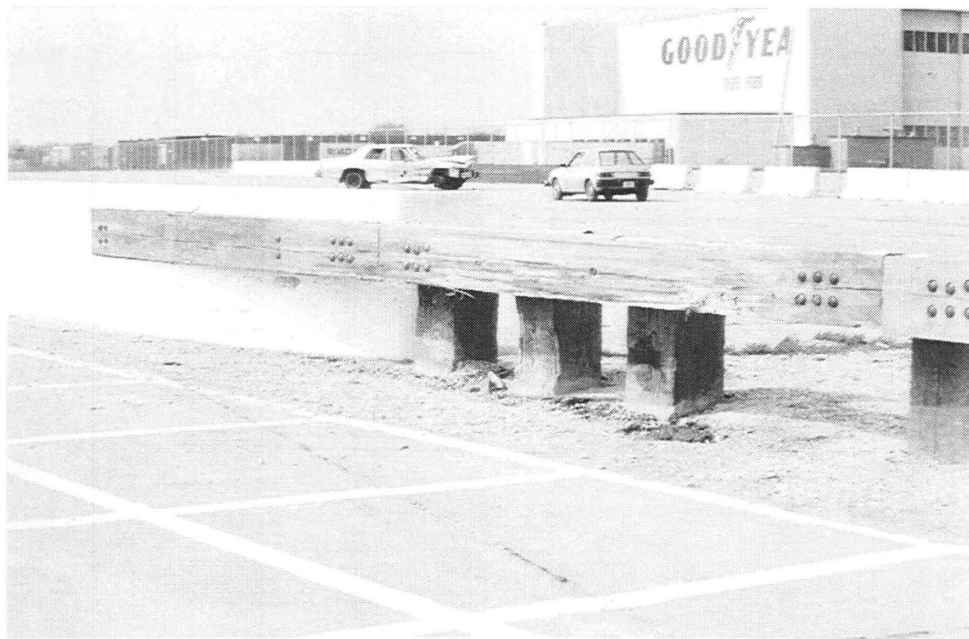
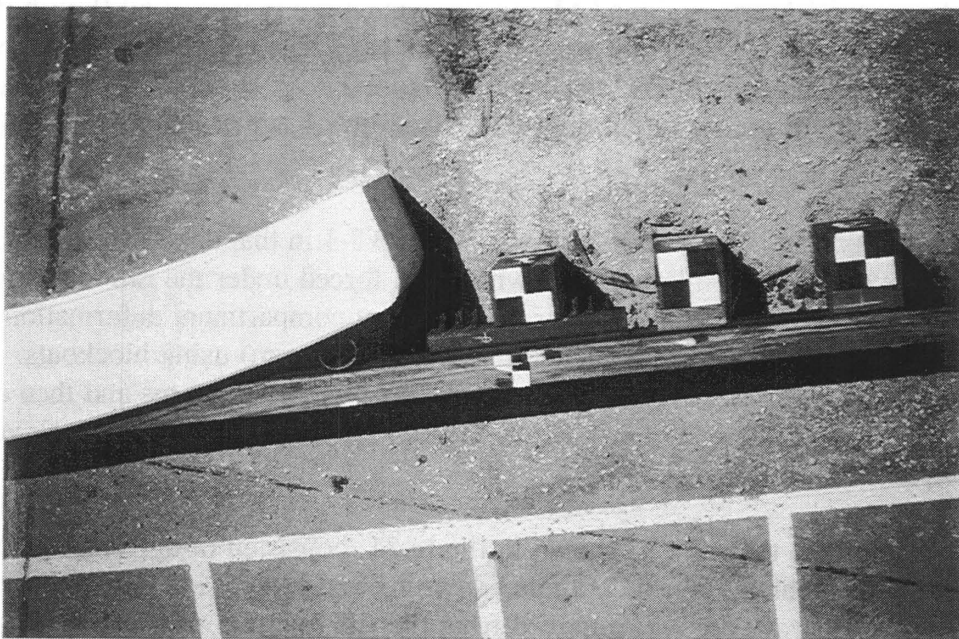
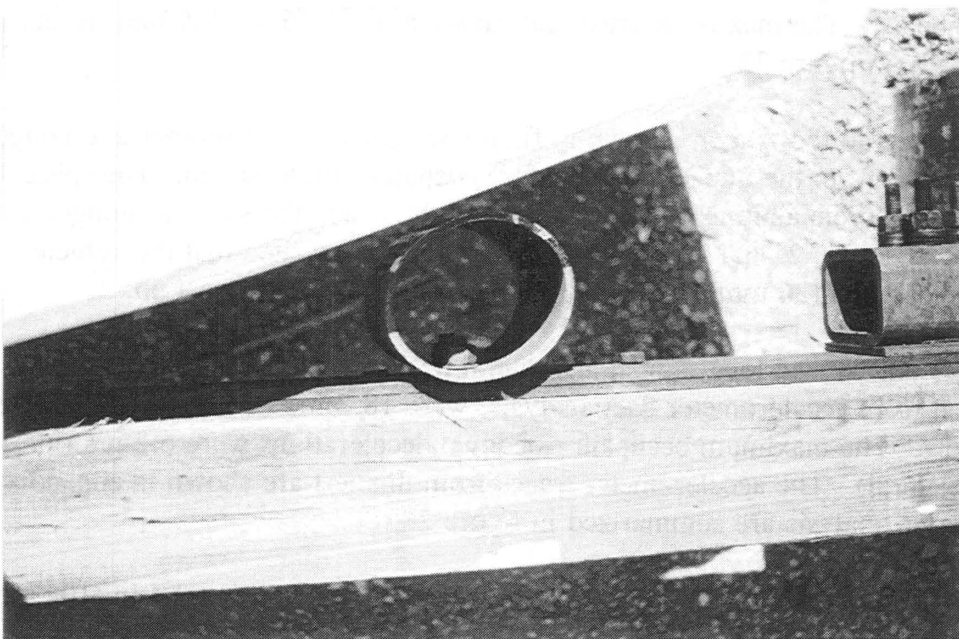
Figure 25. System Damage, Test SBT-3.

Damage to the system, shown in figure 25, consisted of minor scrapes along the face of the rail and significant gouges in posts no. 1 and 2. There were only minor tire marks evident on the concrete abutment. The maximum permanent set deflection of the rail was 2.5 in (64 mm), which occurred at post no. 2.

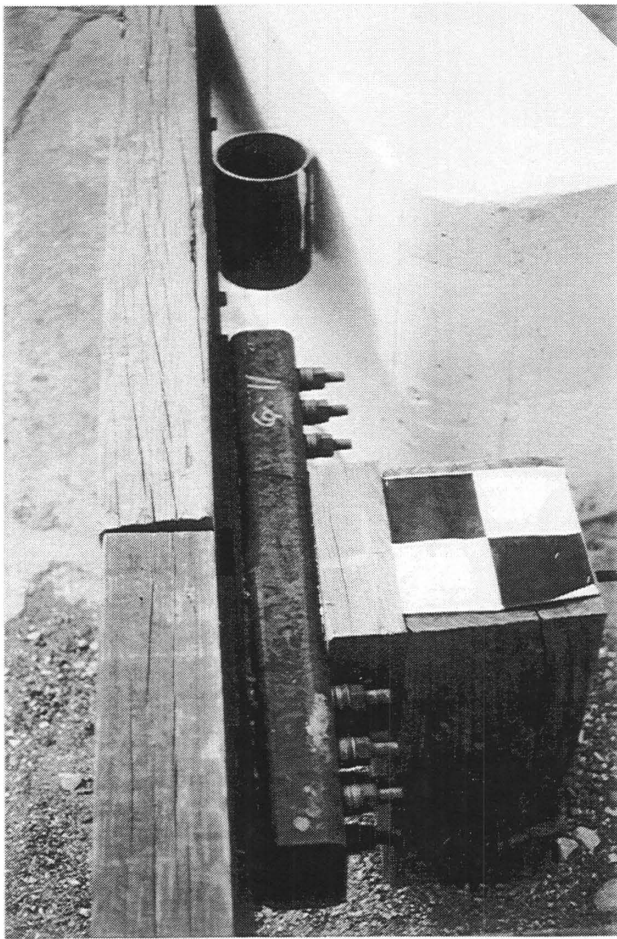
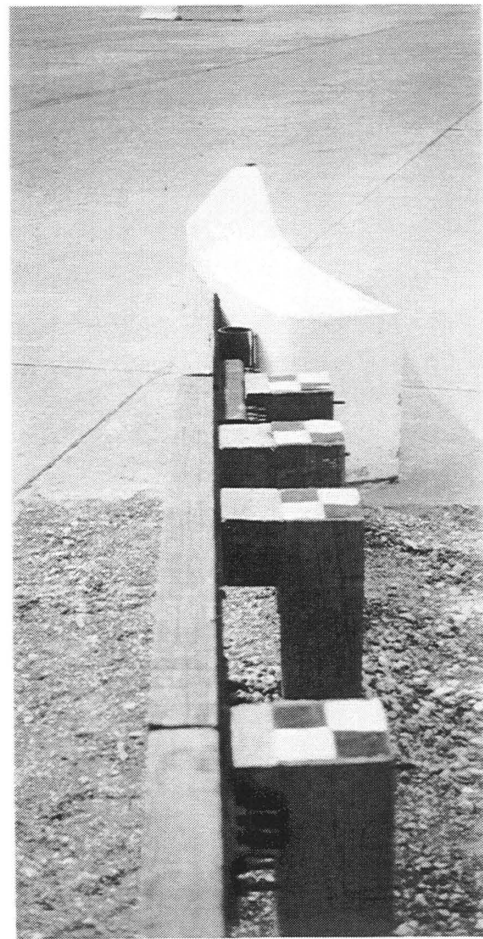
Figure 26. Design Modifications, Test SBT-4.

The results of this test were similar to Test SBT-3 in that as the right-front corner of the vehicle was crushed upon impact, the wheel was forced under the rail and contacted the posts. This snagging resulted in considerable occupant compartment deformation, even though the first three posts had been offset an additional 4 in (102 mm) using blockouts. After this snagging occurred, the vehicle became parallel to the system at 246 ms and then exited the system at 357 ms and an angle of 4.0 degrees. The final resting position of the vehicle is shown in figure 30.

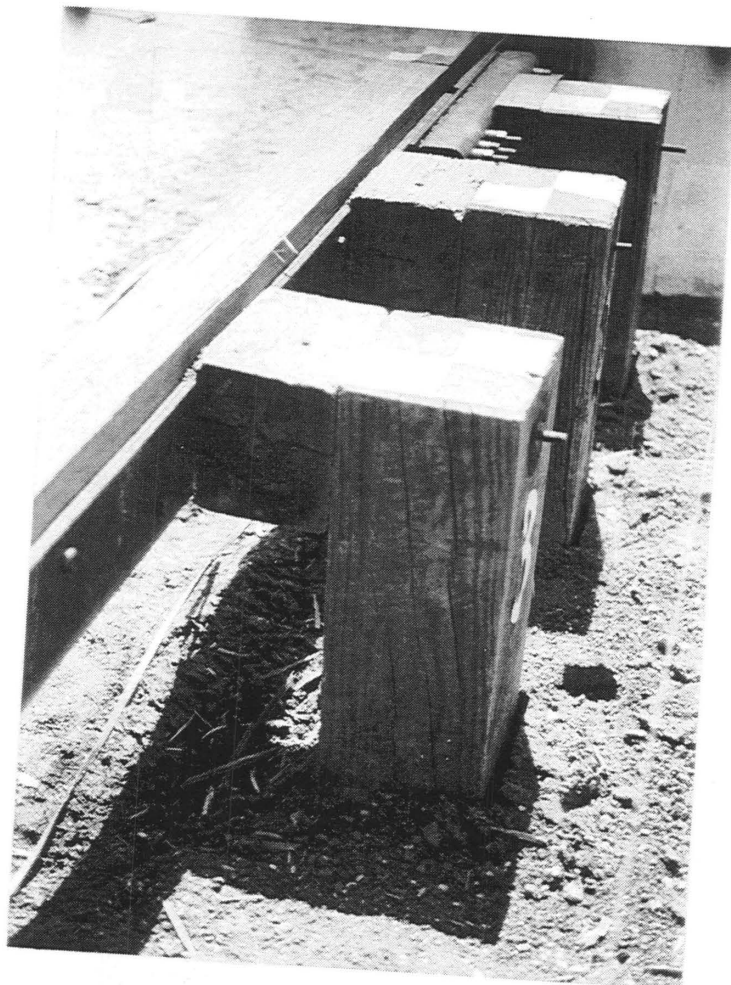
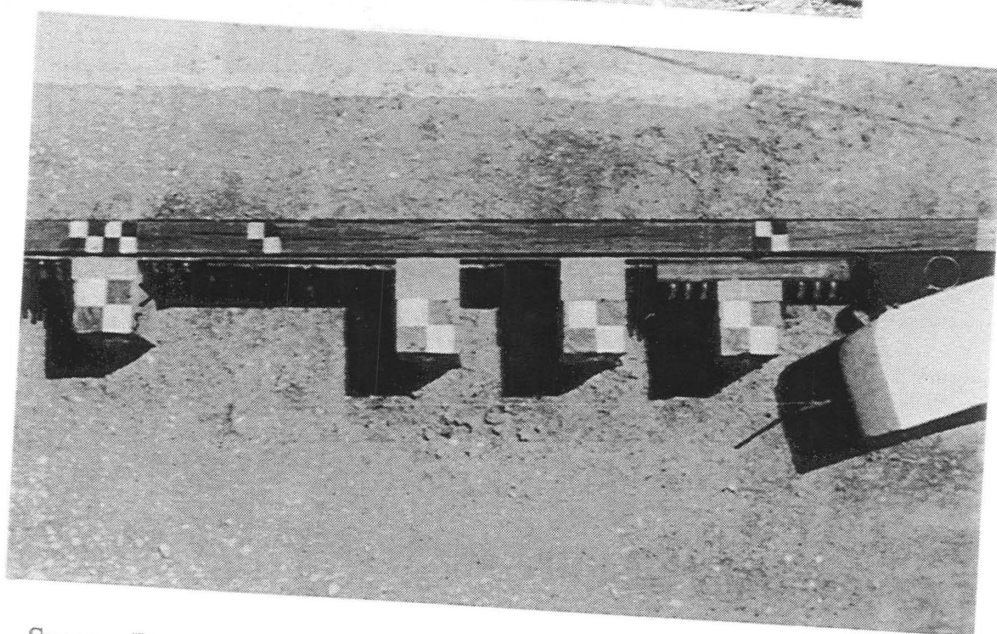
Figure 33. System Damage, Test SBT-4.

Damage to the system, shown in figure 33, consisted of scrapes and gouges along the face of the rail from the impact point to the midspan of the first rail. The spacer pipe between the rail and concrete abutment was deformed slightly, and the soil was gouged considerably in front of posts no. 1, 2, and 3. Markings on the posts indicated that the vehicle snagged approximately 1 in (26 mm) on post no. 1 and 3 in (76 mm) on post no. 2.

It was obvious from the results of this test that the additional 4 in (102 mm) of blockout was not sufficient to eliminate the snagging or reduce it to a tolerable amount. It was deemed impractical to extend the blockout beyond 8 in (203 mm), so it was decided to add a rub rail to the system to reduce the snag potential. A 4-in by 6-in by 11-ft 6-in (102-mm by 152-mm by

3.55-m) wood rub rail was attached to posts no. 1, 2, and 3 for the next test. The details of this design change can be found in appendix A.

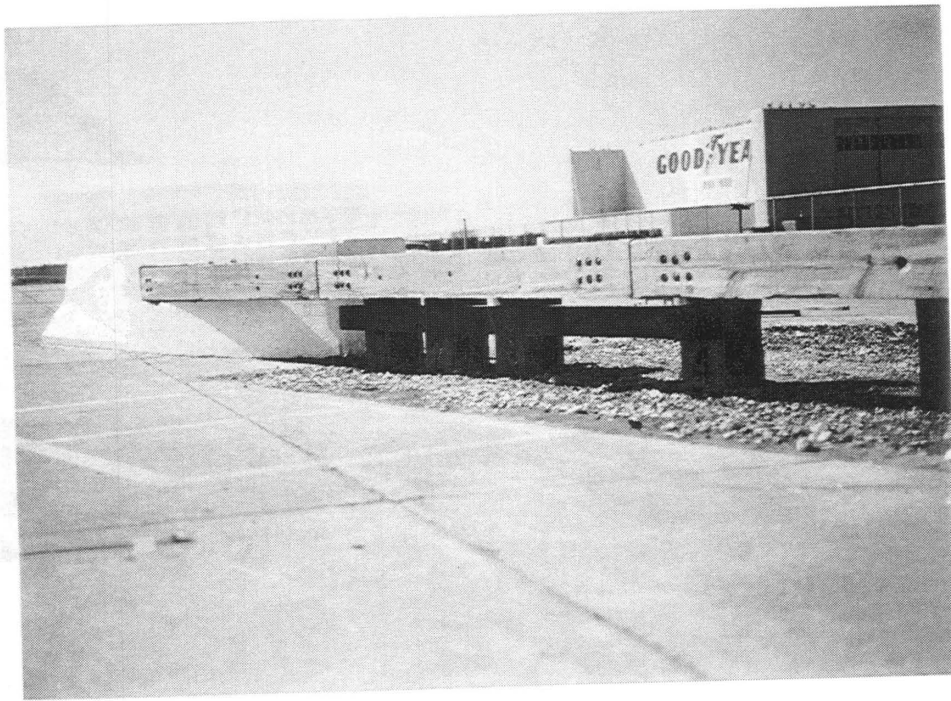
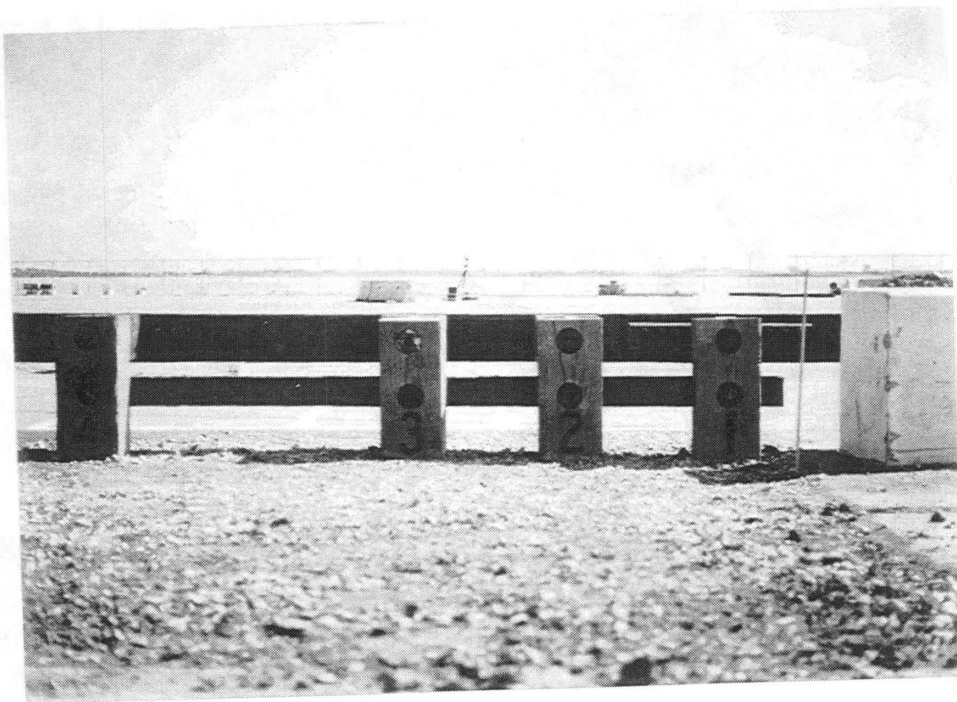
Figure 34. Design Modifications, Test SBT-5.

To eliminate the wheel snagging observed in the previous test, a rub rail was added to the system, as shown in figure 34 and appendix A. The 1984 Ford LTD impacted the system at 58.6 mi/h (94.3 km/h) and 24.8 degrees. The impact point was located midway between the third and fourth posts from the concrete bridge abutment, as shown in figure 35. A summary of the test results and sequential photographs are shown in figure 36. Additional sequential photographs are shown in figure 37.

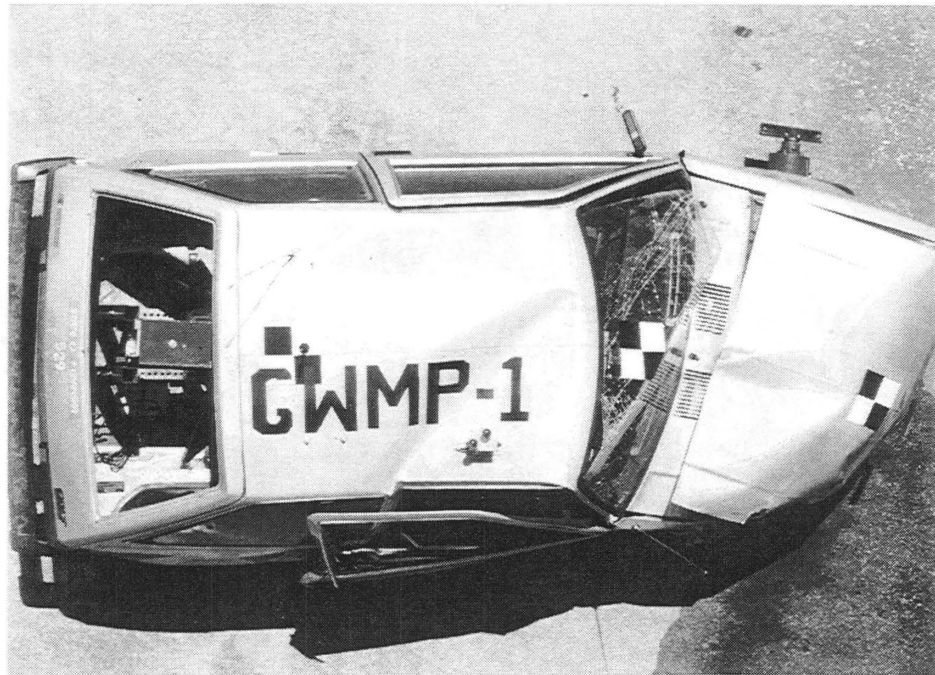
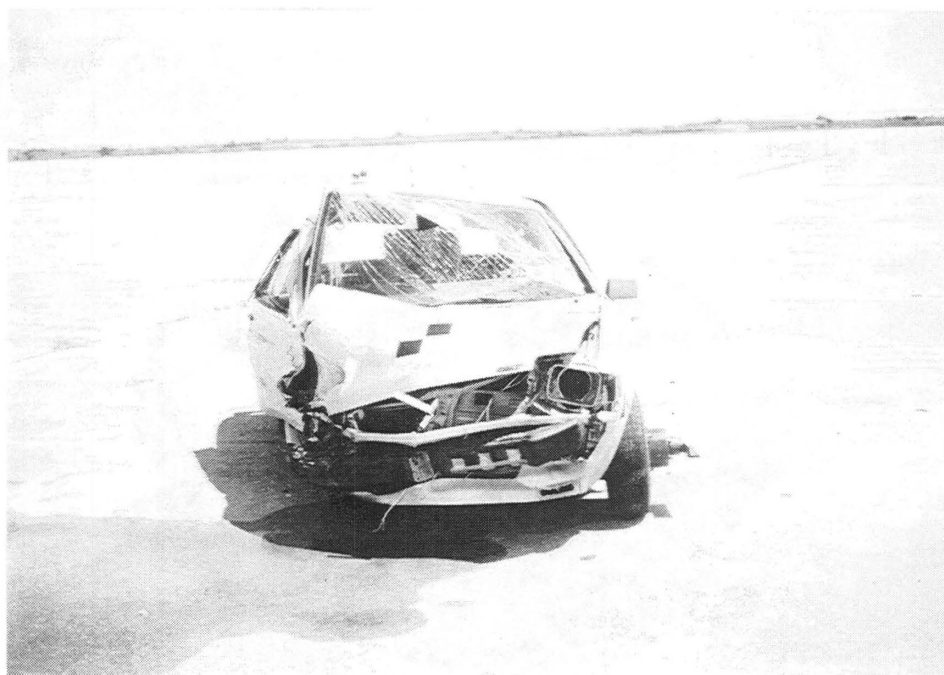
Figure 48. Vehicle Damage, Test GWMP-1.

The vehicle damage, shown in figure 48, included the crushing of the right-front corner of the vehicle, twisting of the car to the right of its longitudinal centerline, and buckling of the hood, roof, windshield frame, firewall, passenger compartment floor, and the passenger side door. The right-front tire was deflated, and the rim was deformed. The maximum crush deformation of 21 in (53.3 cm) is shown in figure 49.

As evident in the vehicle damage, shown in figure 48, there was significant occupant compartment damage to the test vehicle. This damage was caused by the snagging of the vehicle on posts no. 4 and 5. This occupant compartment deformation, accompanied by excessive lateral ridedown decelerations, caused the system to fail this compliance test. To alleviate this snagging problem, the rail size was increased from 4.5 in O.D. to 5.0 in O.D. (114 mm to 127 mm), and it was moved further out from the post, effectively moving the face of the rail 1 in (26 mm) further from the post. The design details of this change can be seen in appendix A.
