Guardrail Testing Program II

Final Report

Midwest Roadside Safety Facility
Civil Engineering Department
University of Nebraska-Lincoln
1901 'Y' Street, Bldg. 'C'
Lincoln, Nebraska 68588-0601

Transportation Research Report TRP-03-52-95

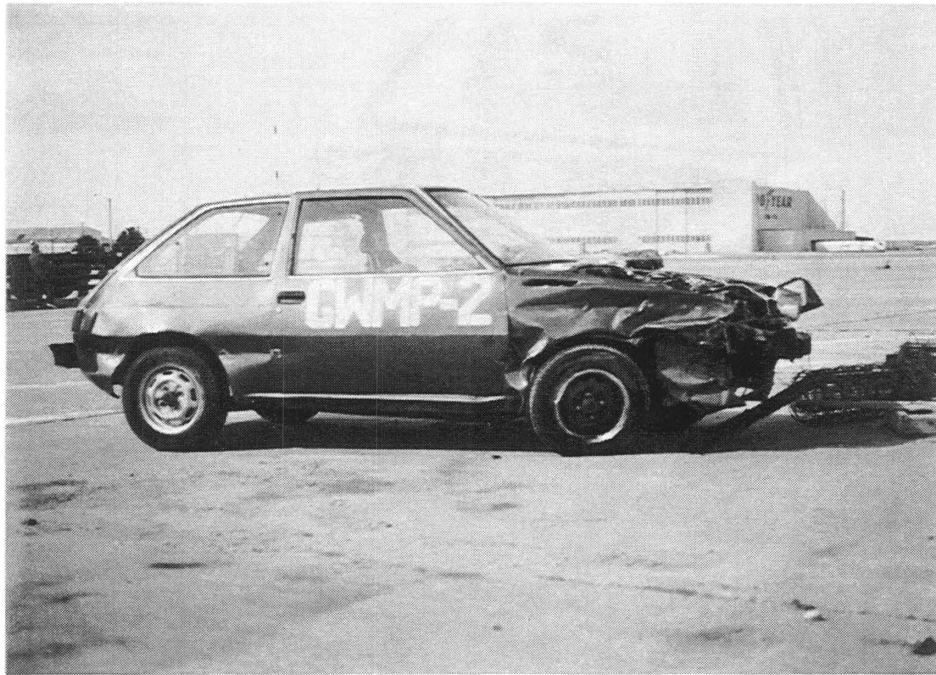
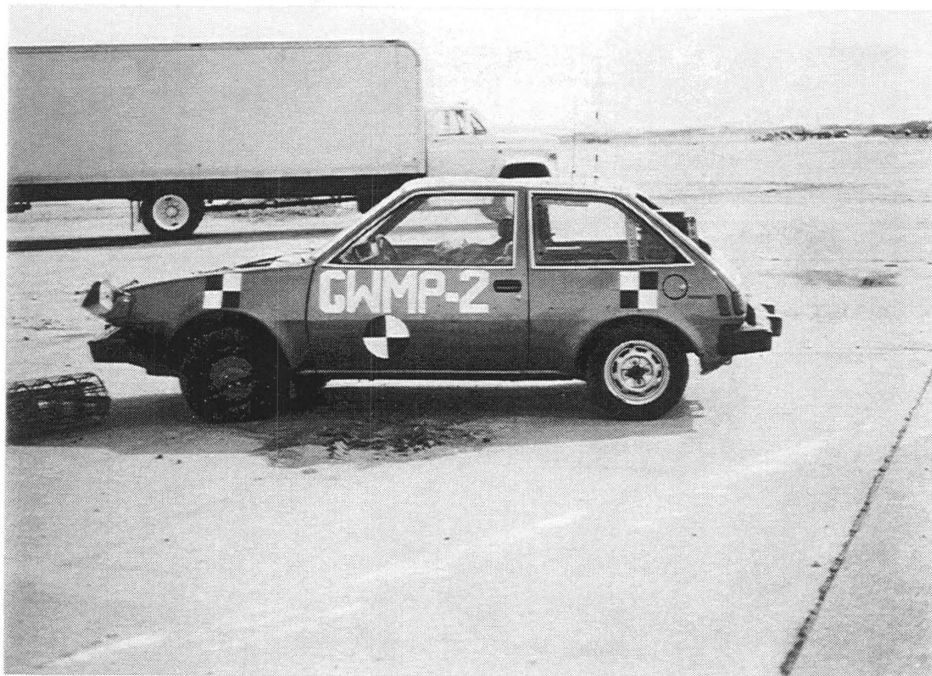
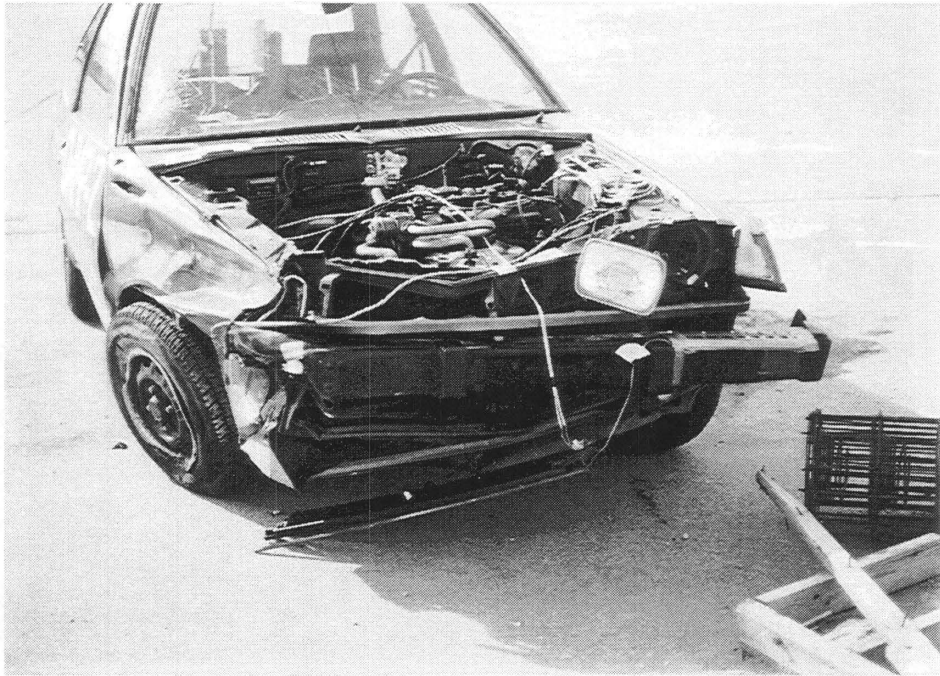
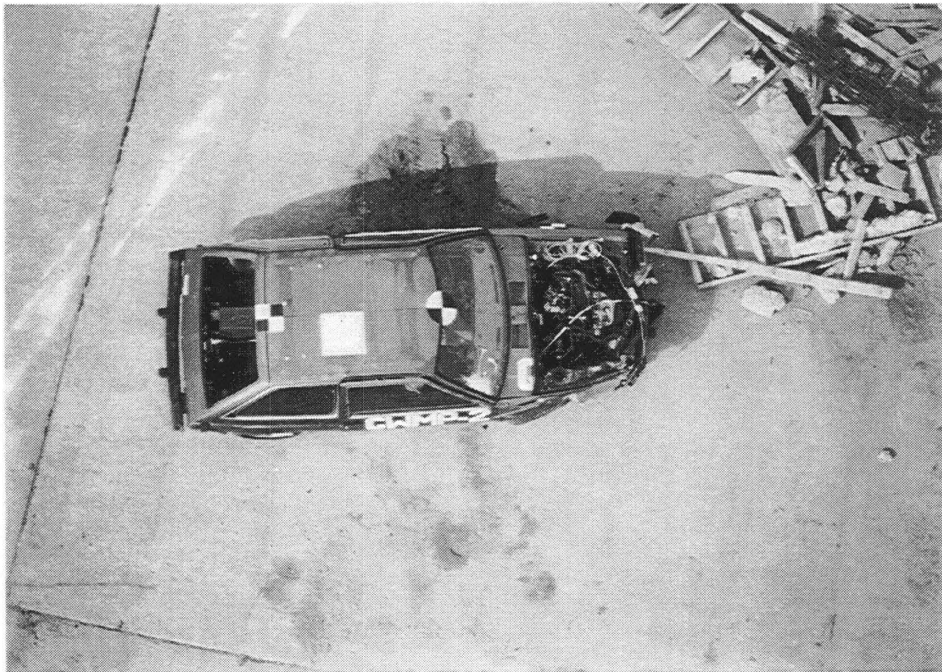
Figure 54. Vehicle Damage, Test GWMP-2.

The vehicle damage, shown in figure 54, included crushing of the right-front corner of the vehicle, minor scrapes and dents along the length of the passenger side, and separation of the hood. The windshield was not penetrated but did sustain localized cracking in the lower right corner. The right-front tire was blown out, and the rim was bent outward at the top. The occupant compartment floor sustained minor buckling in the front passenger side floor area. The maximum crush deformation of 12 in (30.5 cm) is shown in figure 55.

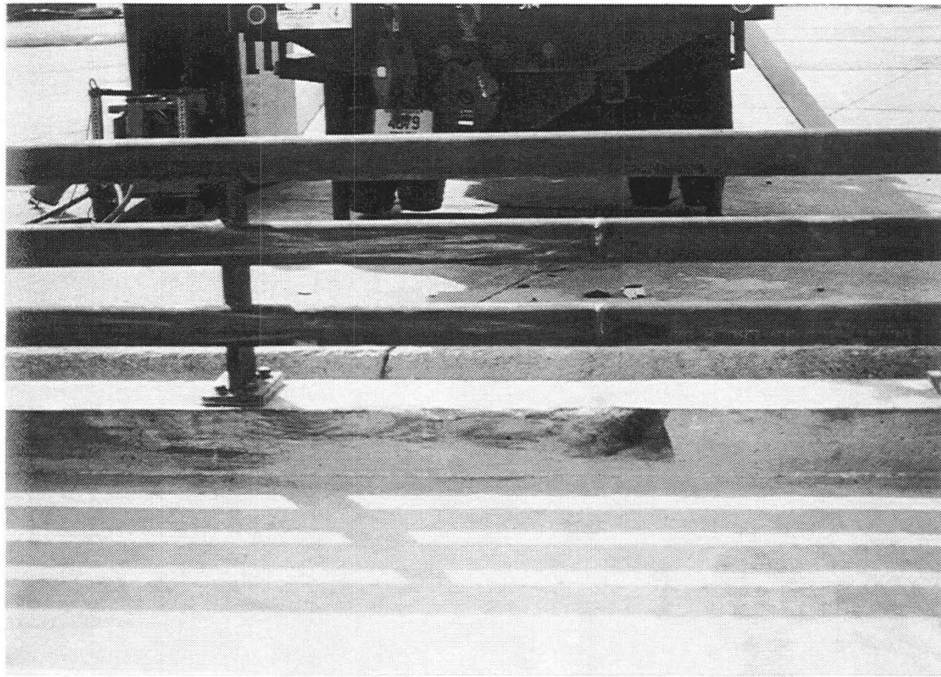
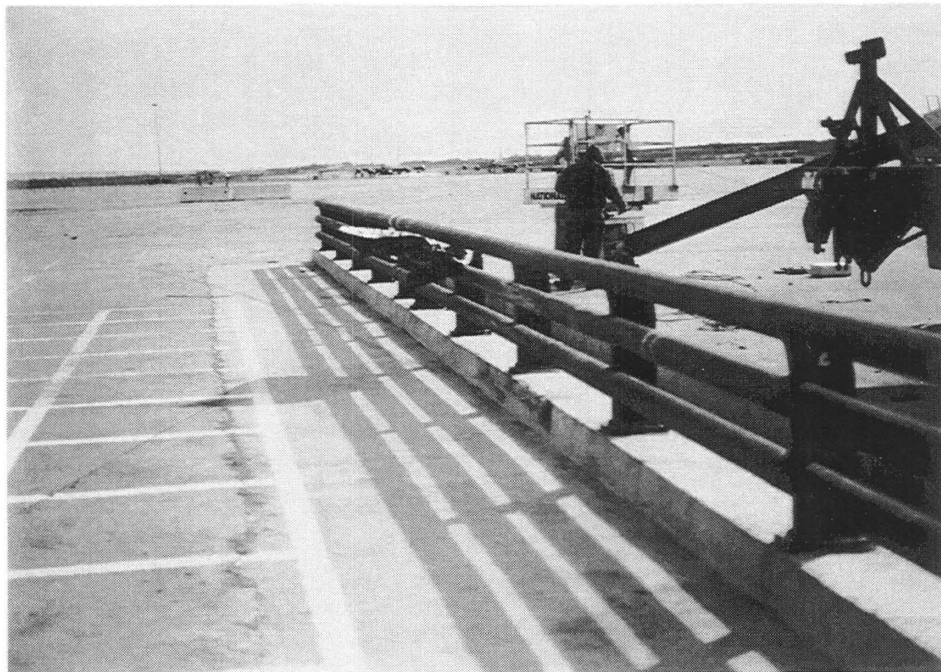
Figure 56. Bridge Rail Damage, Test GWMP-2.

As shown in figure 56, the bridge rail and curb sustained minor scrapes in the area where the impact occurred. Contact with the middle and lower rail began at the midspan between posts no. 4 and 5, and continued to the midspan between posts no. 3 and 4.

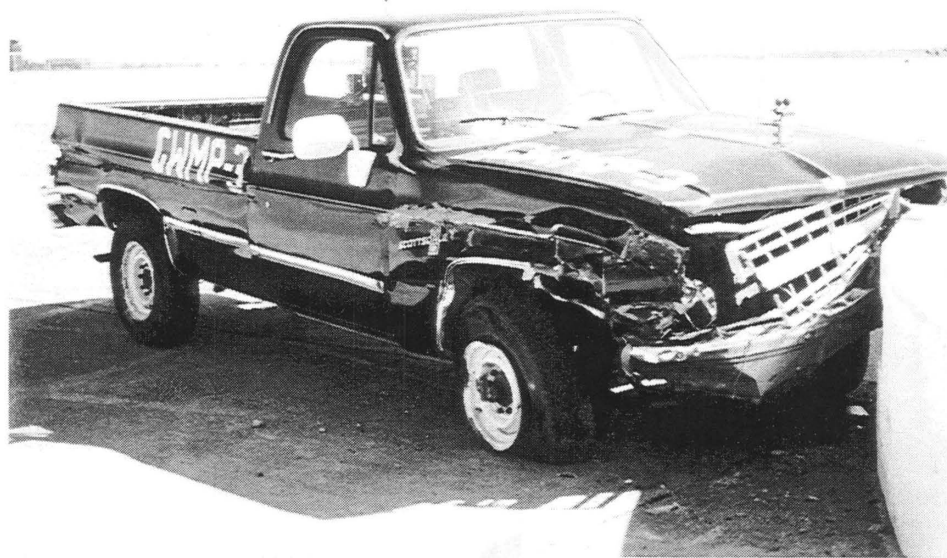
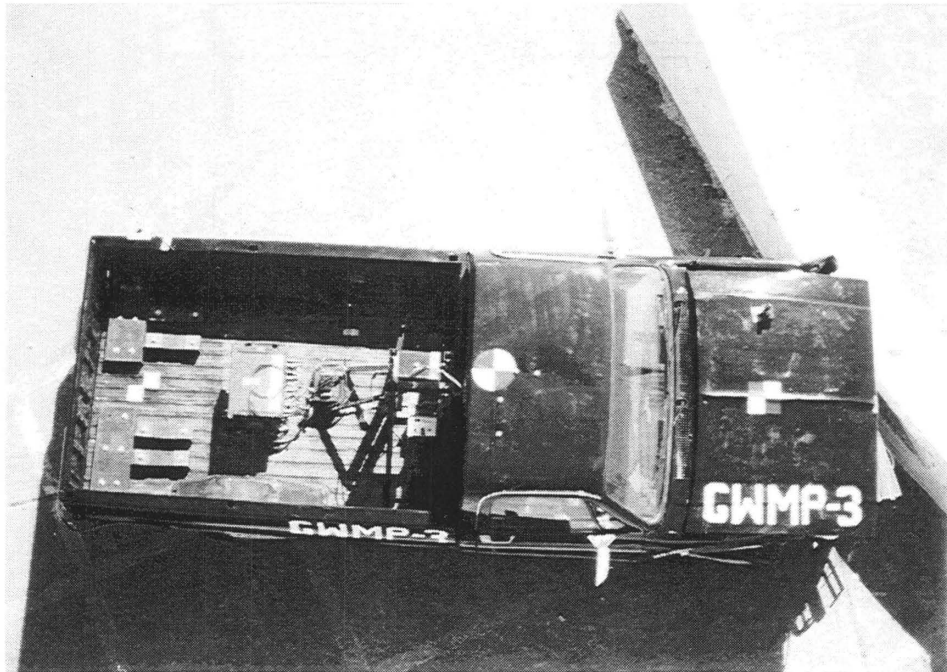
Figure 60. Vehicle Damage, Test GWMP-3.

The vehicle damage, shown in figure 60, included the crushing of the right-front corner of the vehicle and scrapes and dents along the length of the passenger side. The right-front tire was blown out, and the rim was deformed. The maximum crush deformation of 9.75 in (24.8 cm) is shown in figure 61. All damage to the vehicle on the driver's side of the longitudinal centerline occurred after impact with the bridge rail. Near the end of the vehicle's trajectory, the vehicle struck an obstacle on the testing grounds, resulting in damage to the left-front corner of the vehicle.

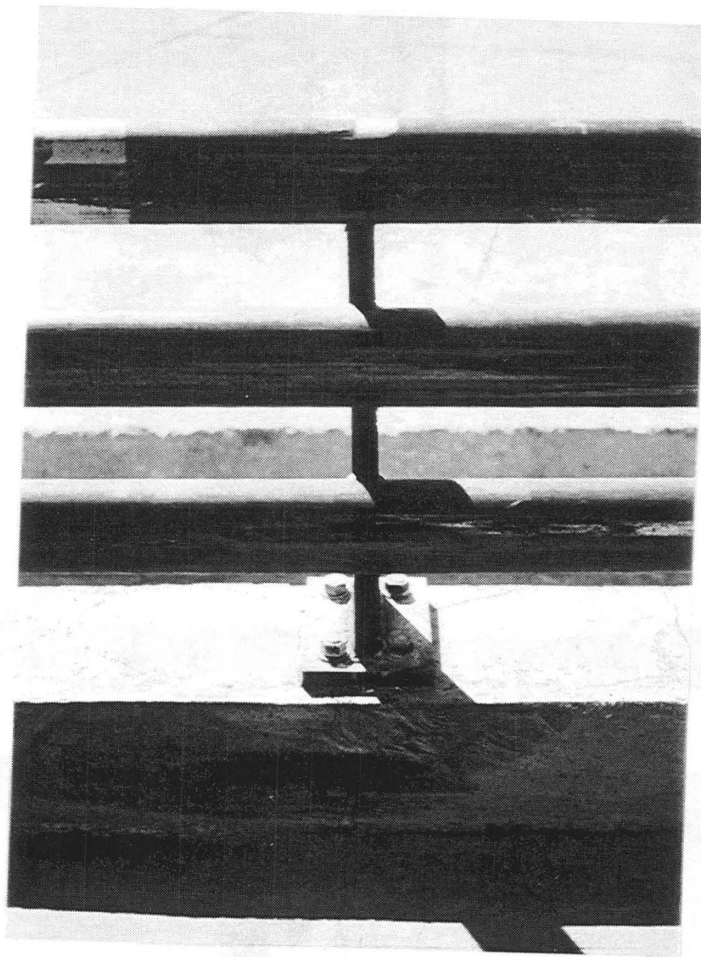
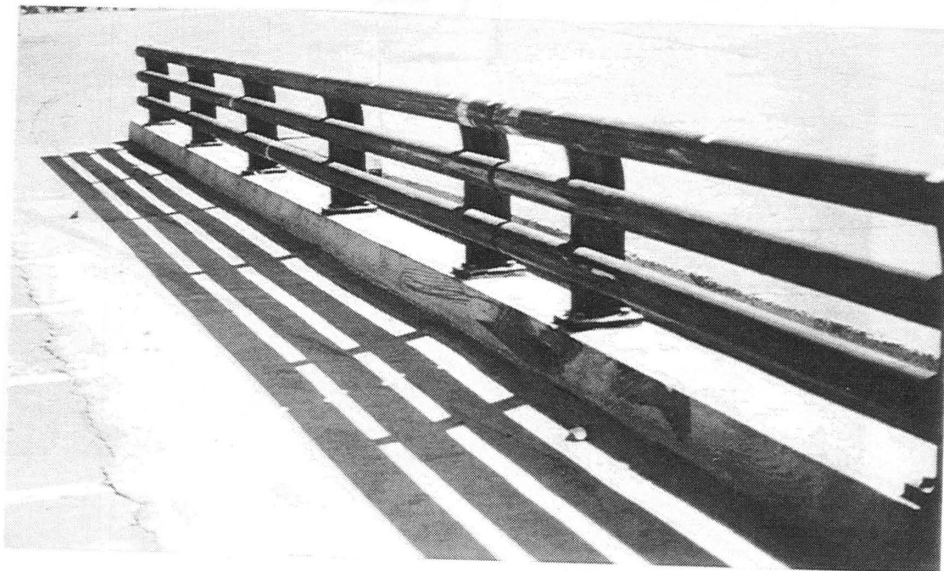
Figure 62. Bridge Rail Damage, Test GWMP-3.

The bridge rail sustained only minor cosmetic damage on each of the three rails, as shown in figure 62. Contact with each of the rails began 3 ft-5 in (1.04 m) upstream of the expansion joint. The vehicle remained in contact with the rail for 8 ft (2.44 m) on the bottom rail, 8 ft-6 in (2.59 m) on the middle rail, and 8 ft-2 in (2.49 m) on the top rail.

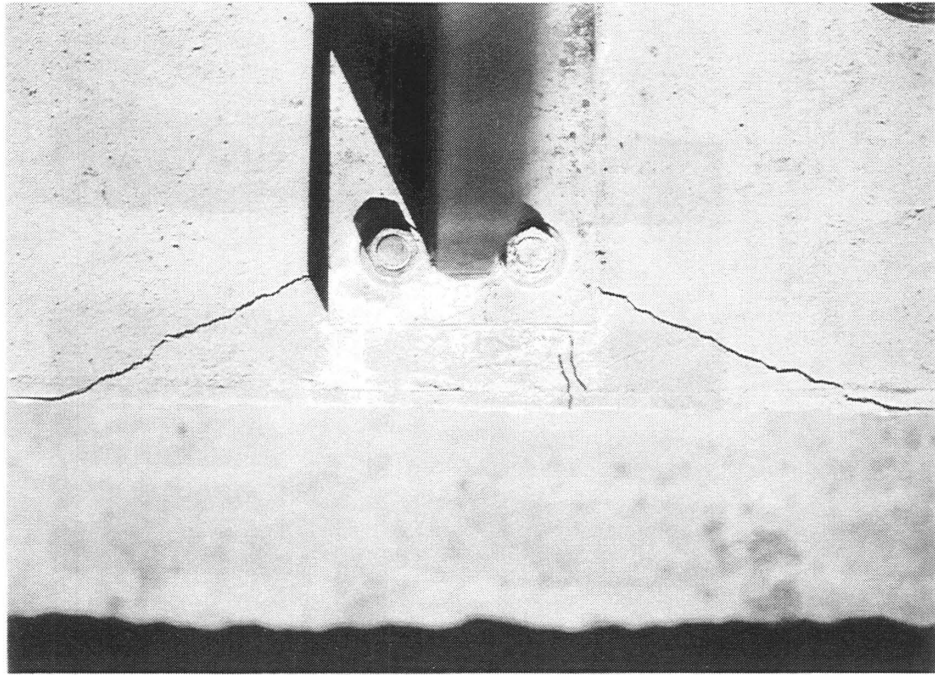
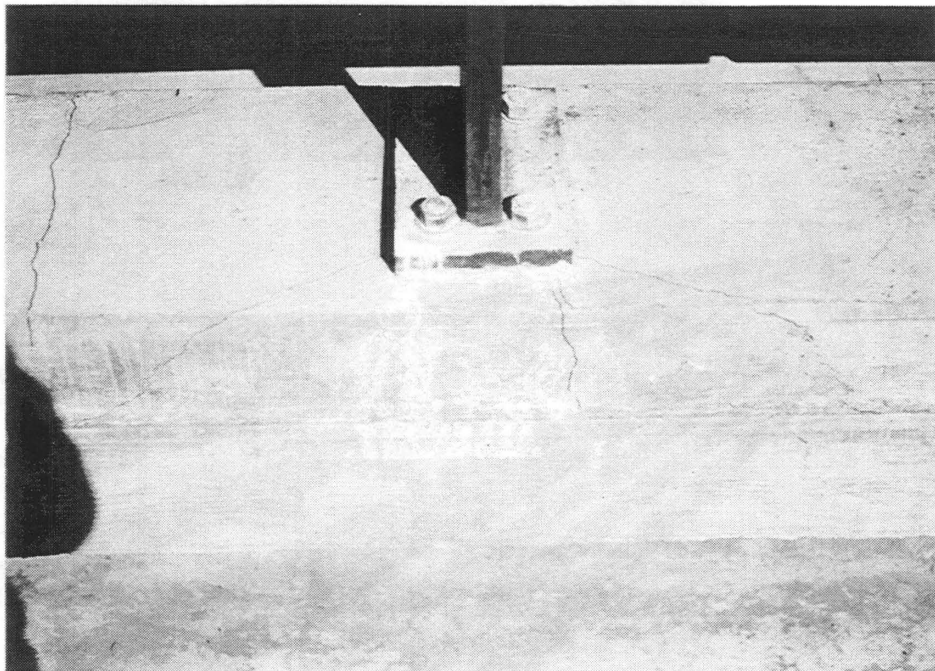
Figure 63. Curb Damage, Test GWMP-3.

Cracking occurred in the curb and bridge deck at post no. 6. On top of the curb, two cracks propagated outward from each of the rear post bolts, as shown in figure 63. The length of cracks upstream and downstream of post no. 6 were 10 in (25.4 cm) and 11 in (27.9 cm), respectively.

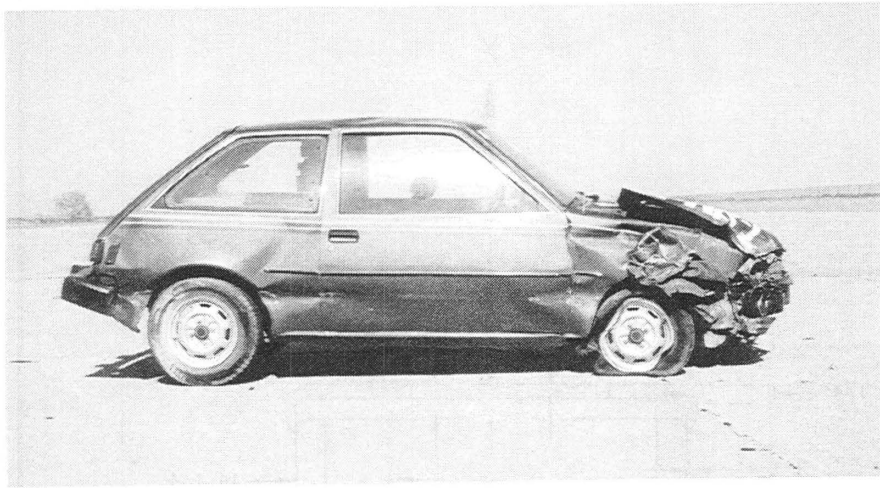
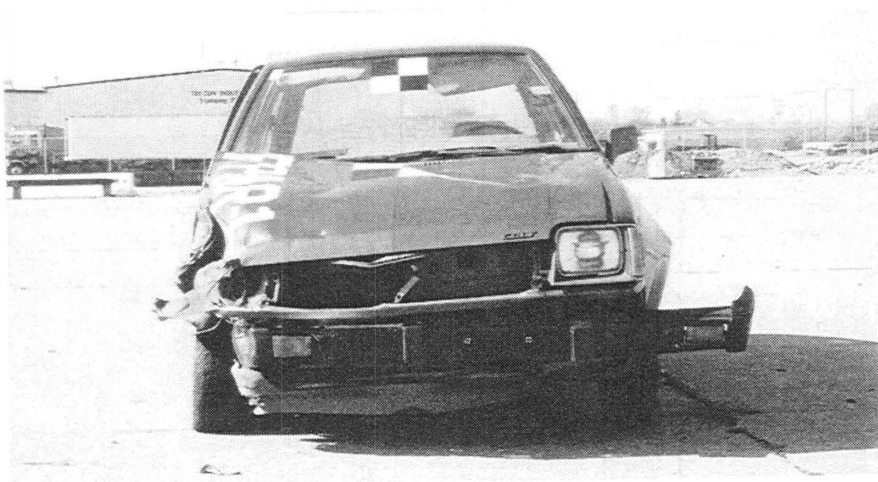
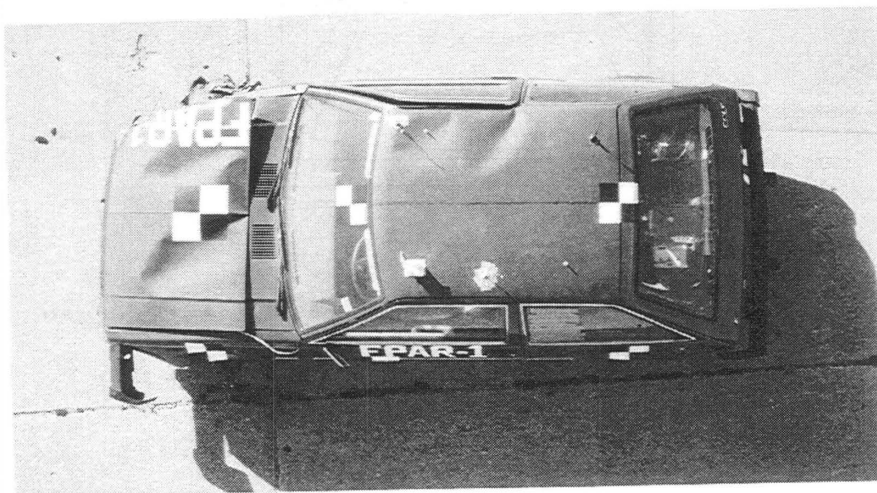
Figure 72. Vehicle Damage, Test FPAR-1.

The vehicle damage, shown in figure 72, included the crushing of the right-front corner of the vehicle and minor scrapes and dents along the length of the passenger side. The right-front tire was blown out, and the rim was bent. The maximum crush deformation of 11.25 in (28.6 cm) is shown in figure 73.

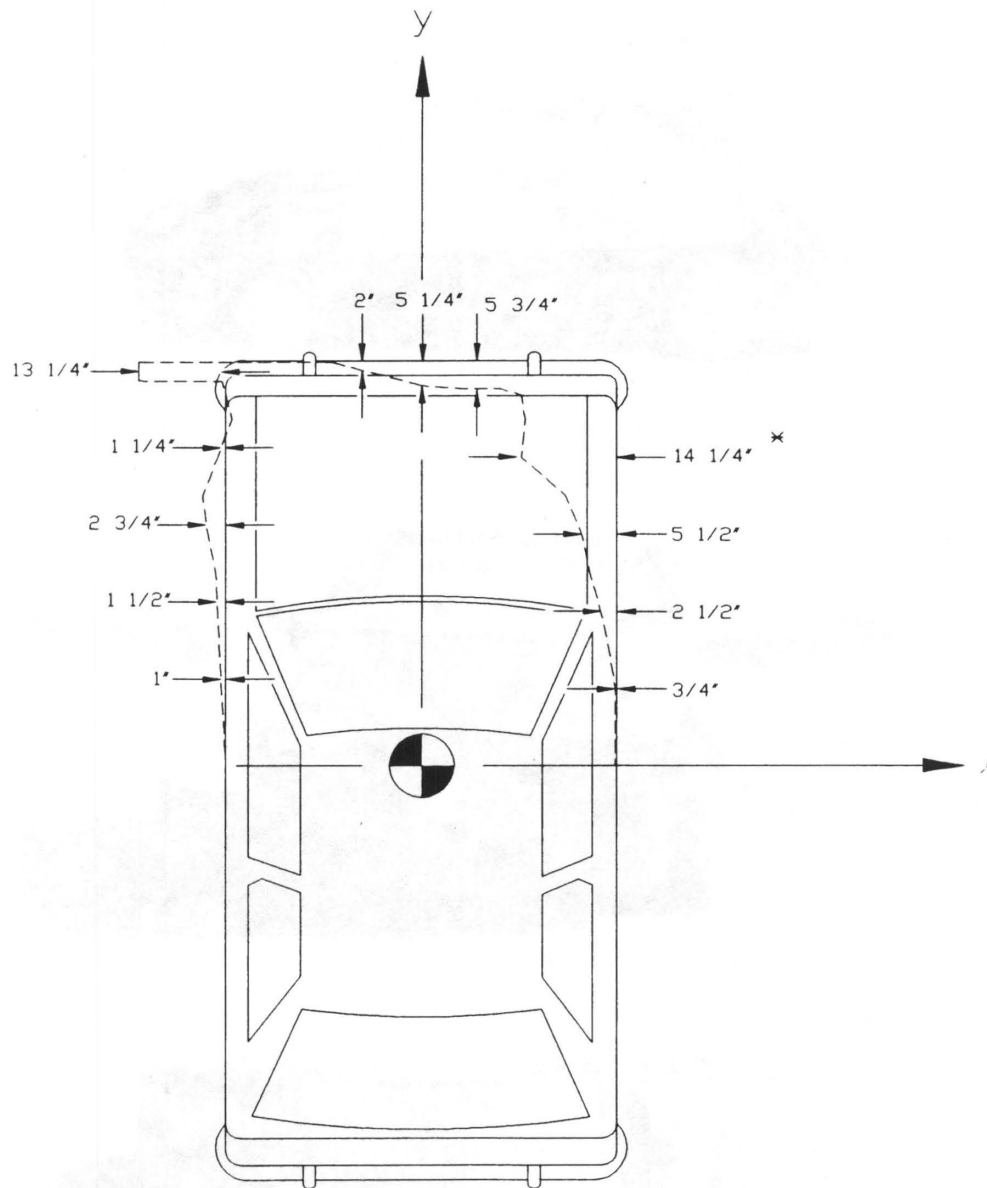
Figure 73. Crush Depth Diagram, Test FPAR-1.

* -Maximum static crush distance of 14 1/4" occurred at (15 3/4", 54")

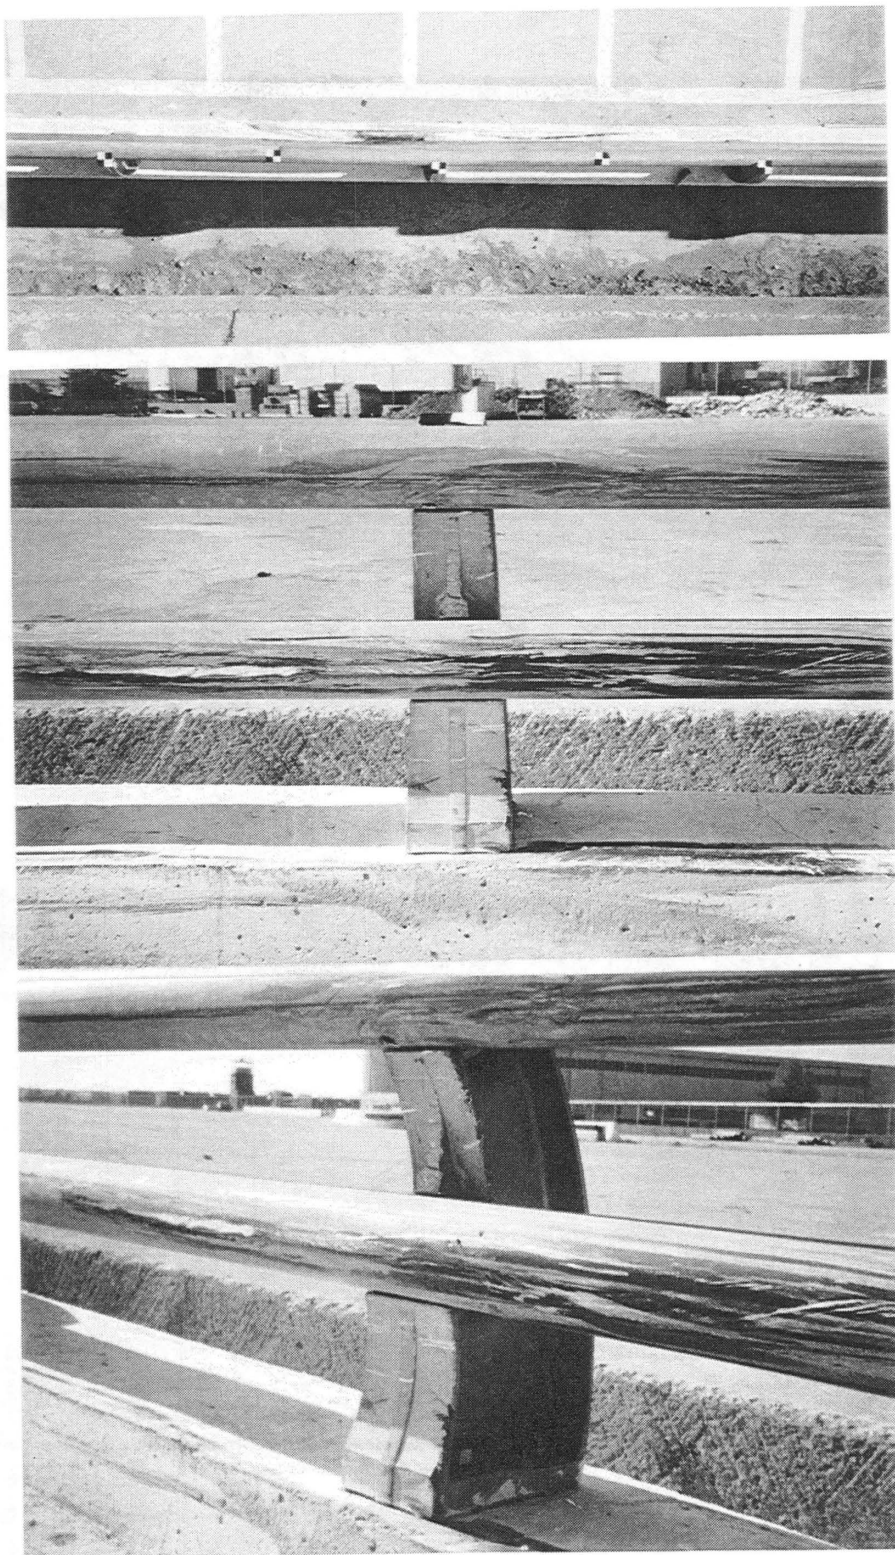
Figure 74. Bridge Rail Damage, Test FPAR-1.

The damage to the bridge rail was minor, with superficial scrapes on the curb and rail, as shown in figure 74. The maximum permanent set deflection of 1 in (2.54 cm) occurred approximately 2 ft (0.61 m) downstream from impact on the lower rail. There was evidence of minor tire and hub contact between the curb and the lower rail on the first post downstream from impact (post no. 4). There was also evidence of crushed vehicle body contact between

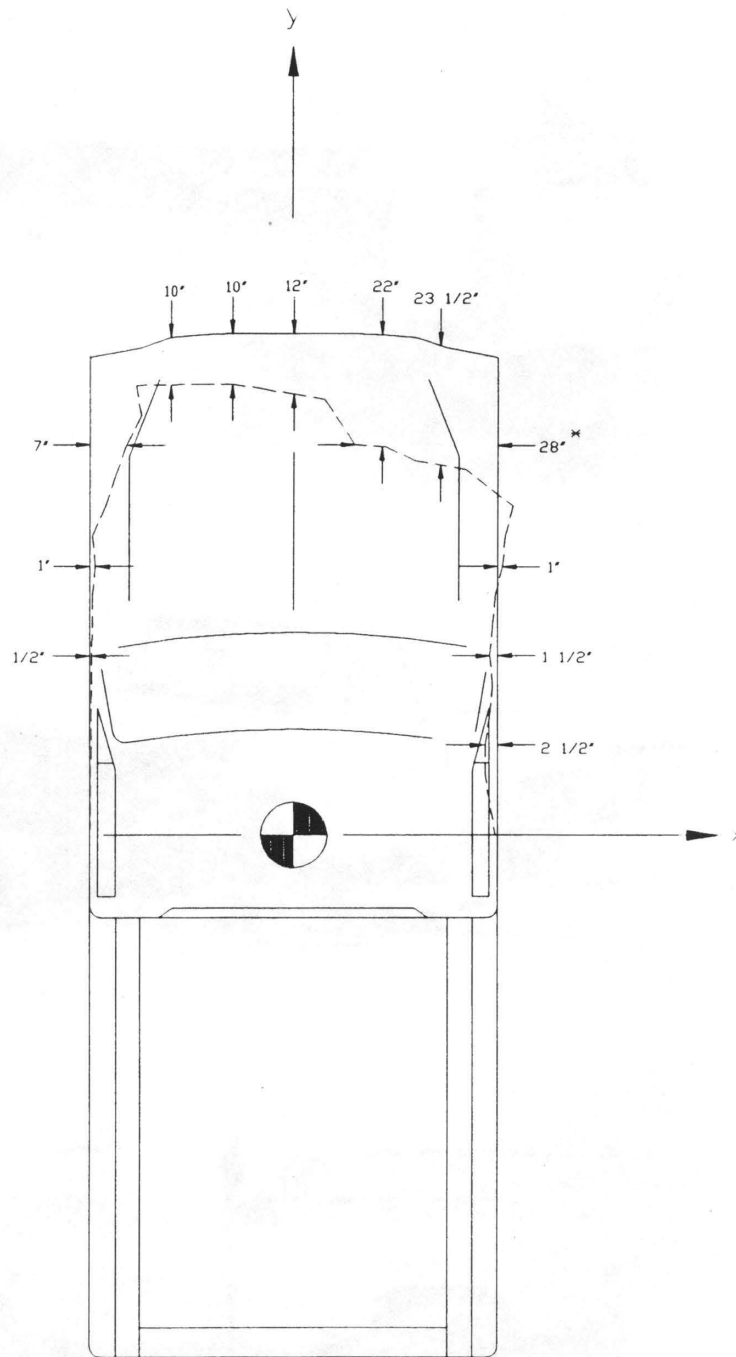
Figure 80. Crush Depth Diagram, Test FPAR-2.

* -Maximum static crush distance of 28" occurred at (40°, 78').

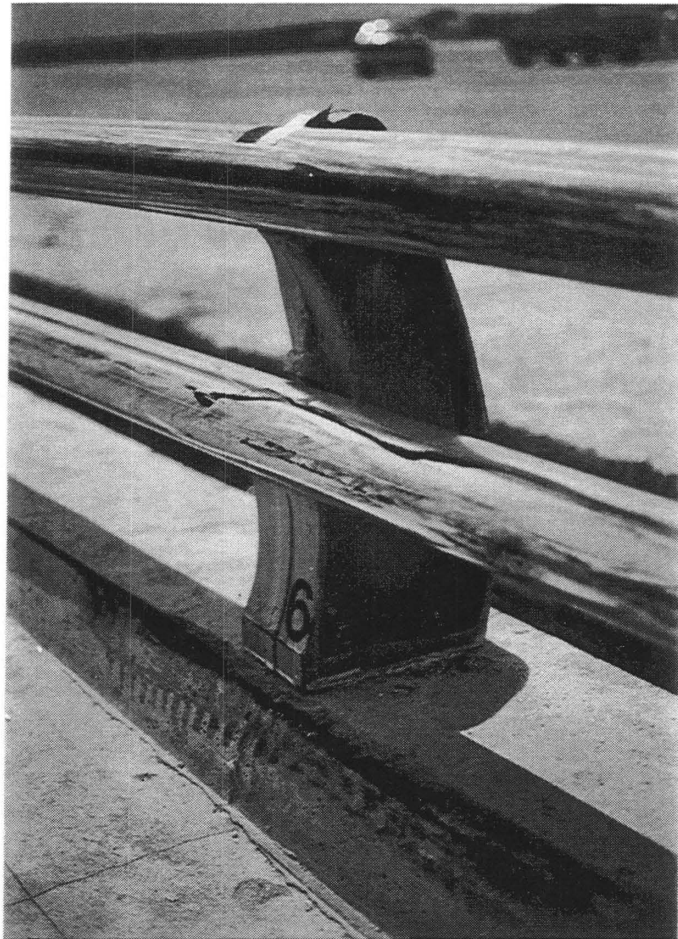
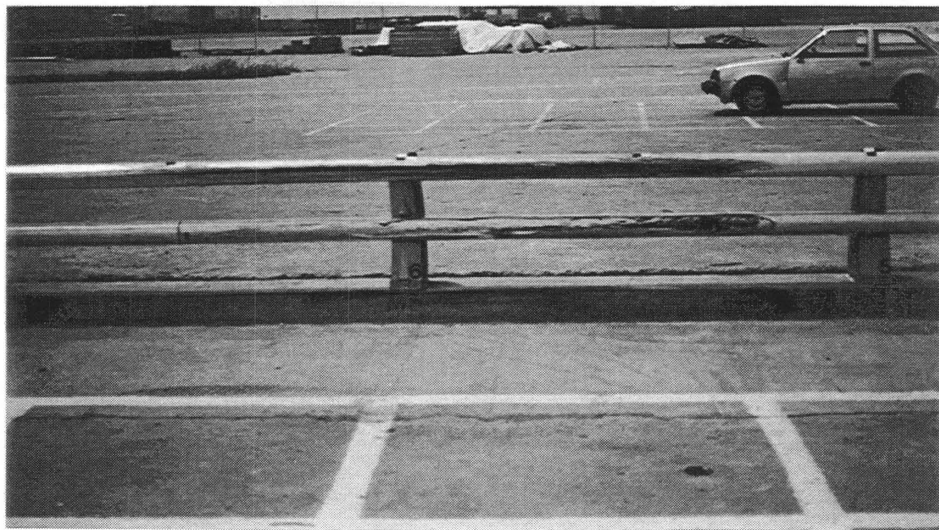
Figure 85. Bridge Rail Damage, Test FPAR-3.

The vehicle was smoothly redirected by the bridge railing, with a relatively small amount of damage to the rail and vehicle. There was no snagging of the vehicle or any evidence of cracking in the deck or curb. The maximum permanent set deflection of 1.9 in (4.8 cm) occurred midspan of posts no. 5 and 6. The damage to the bridge rail is shown in figure 85, and the vehicle trajectory is shown in figure 86.

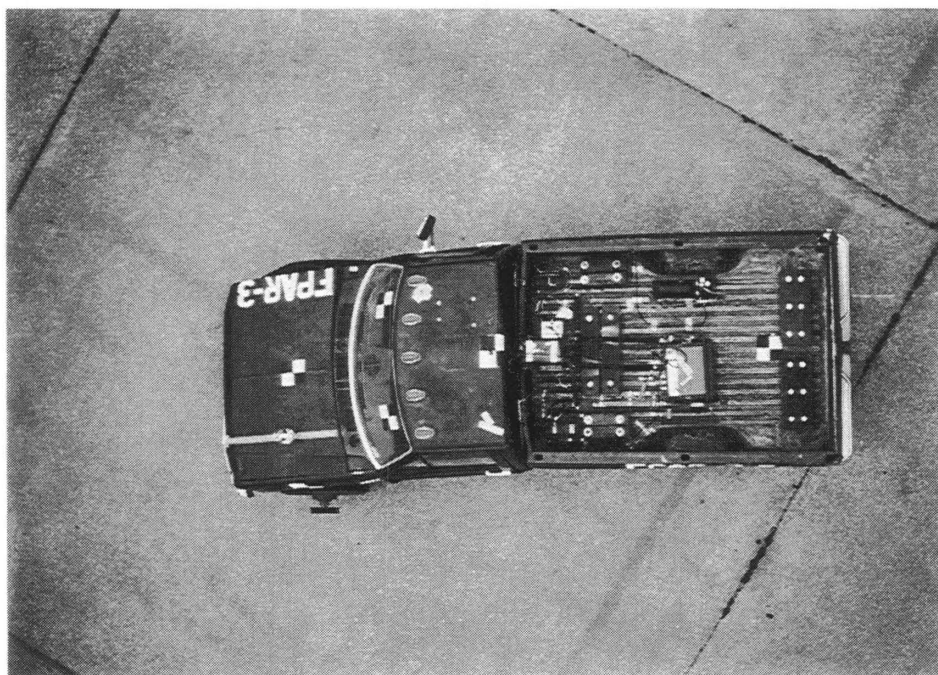
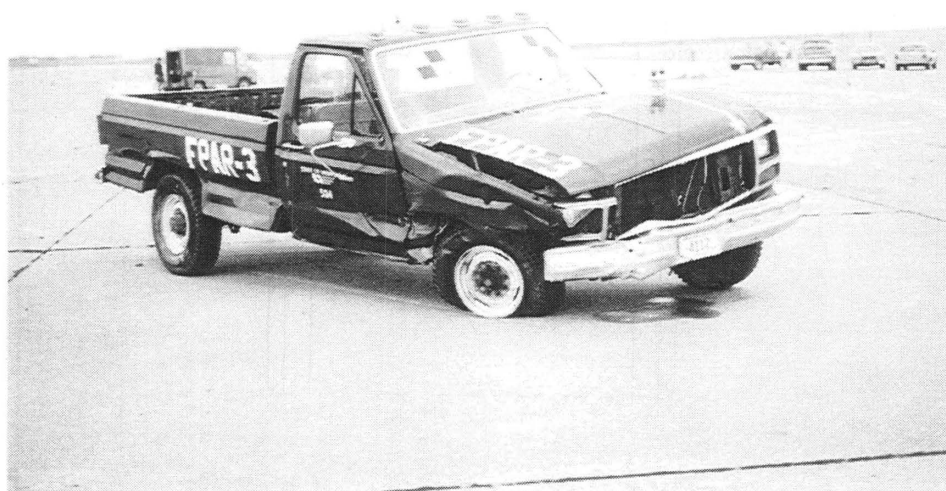
Figure 87. Vehicle Damage, Test FPAR-3.

The vehicle damage, shown in figure 87, included the crushing of the right-front corner of the vehicle and scrapes and dents along the length of the passenger side. The right-front tire was blown out, and the rim was bent. The maximum crush deformation of 10.75 in (27.3 cm) is shown in figure 88.

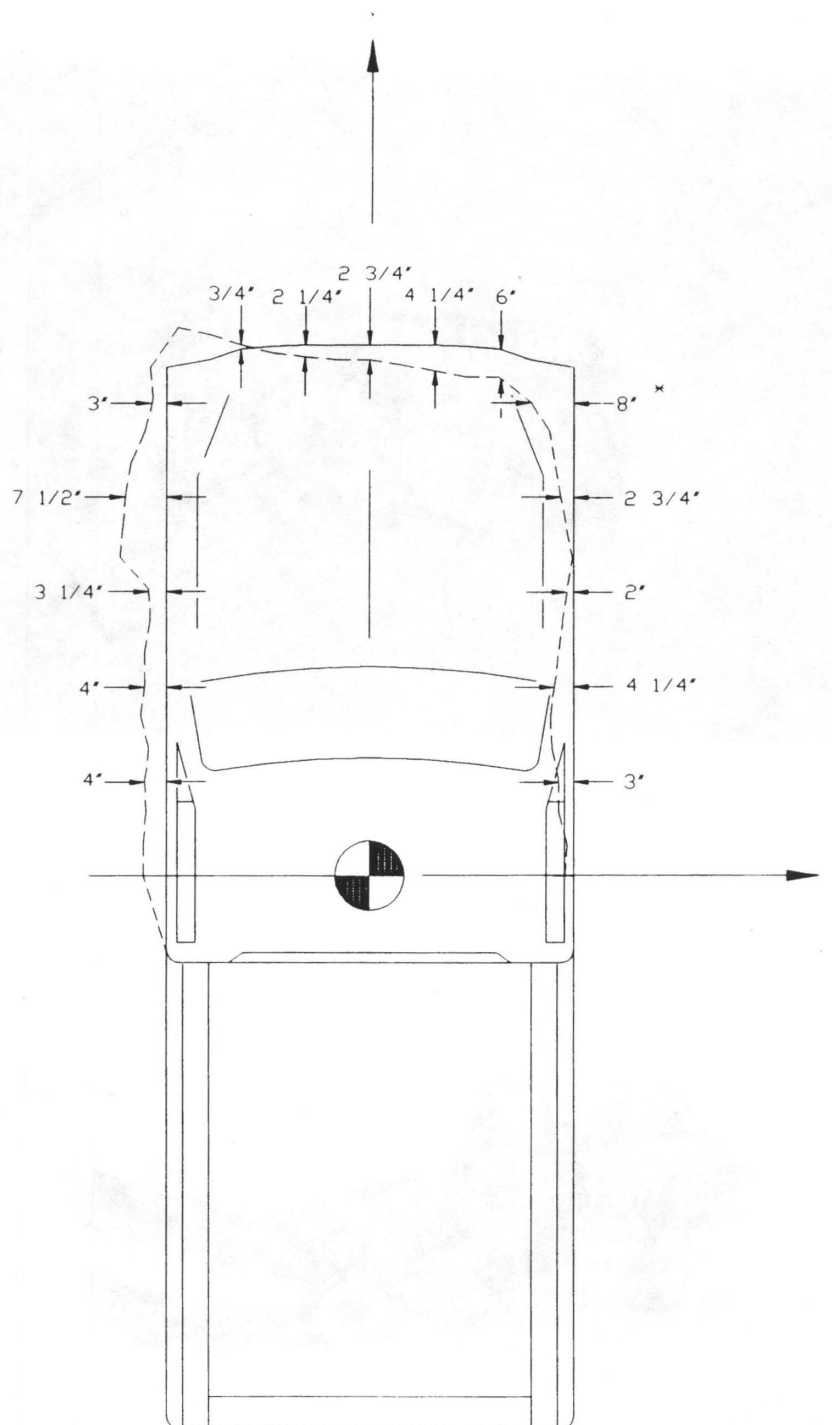
Figure 88. Crush Depth Diagram, Test FPAR-3.

* Maximum static crush distance of $8"$ occurs at $Q = 9\ 1/4"$.

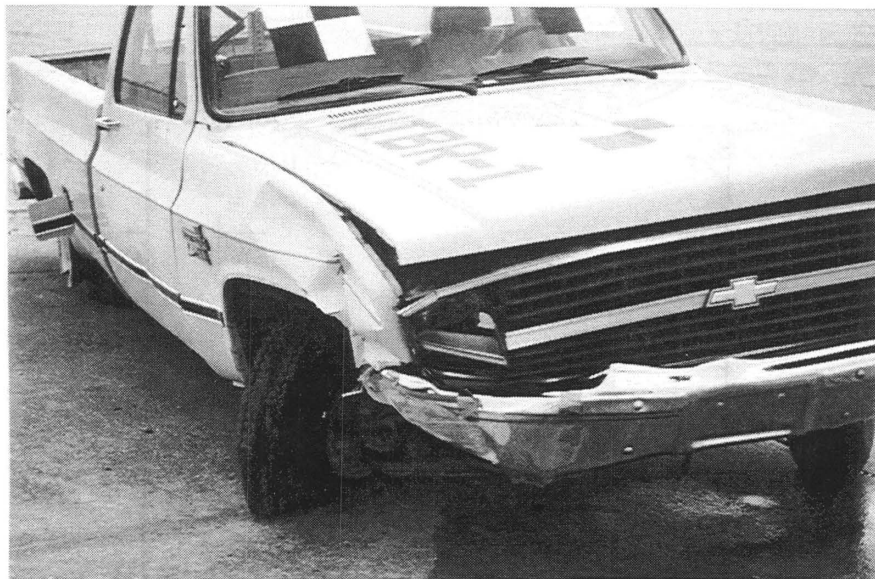
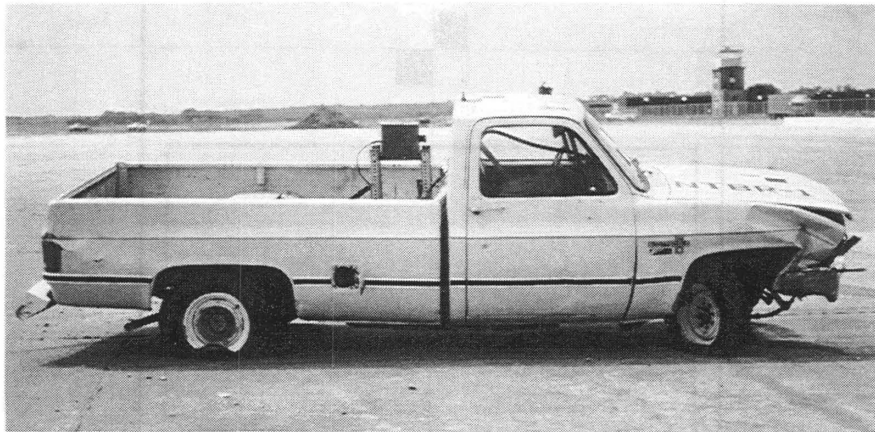
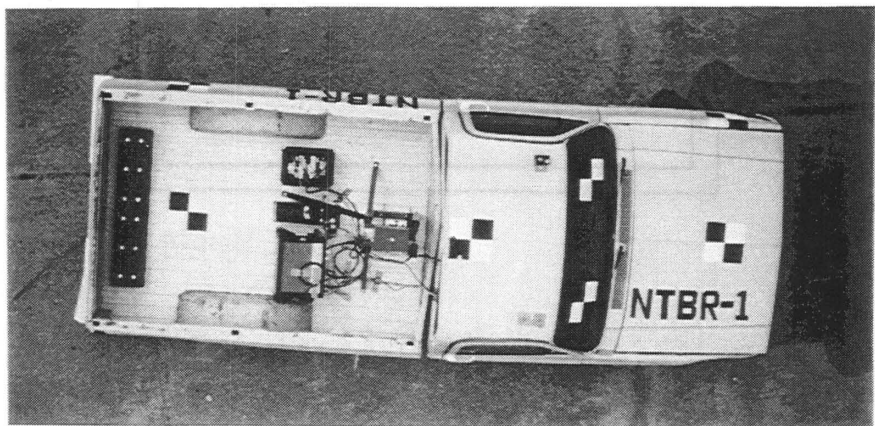
Figure 95. Vehicle Damage, Test NTBR-1.

Test vehicle damage was relatively minor and was largely limited to the right-front quarter panel and front bumper, as shown in figure 95. Both right-side tires were blown out, and the rims were damaged during the impact. The right-rear bumper also received minor damage. There was no intrusion or deformation of the occupant compartment. Vehicle crush measurements are shown in figure 96. The bridge rail received superficial damage, as shown in figure 97. Heavy tire marks and deep scrapes on the rail indicating large contact forces were found over a 13-ft-11-in (4.2-m) length of the bridge rail. Lighter tire marks and small scrapes were observed over a 13-ft (4-m) length of the rail. Evidence of impact with the curb was limited to 4 ft-8 in (1.4 m) of tire marks.

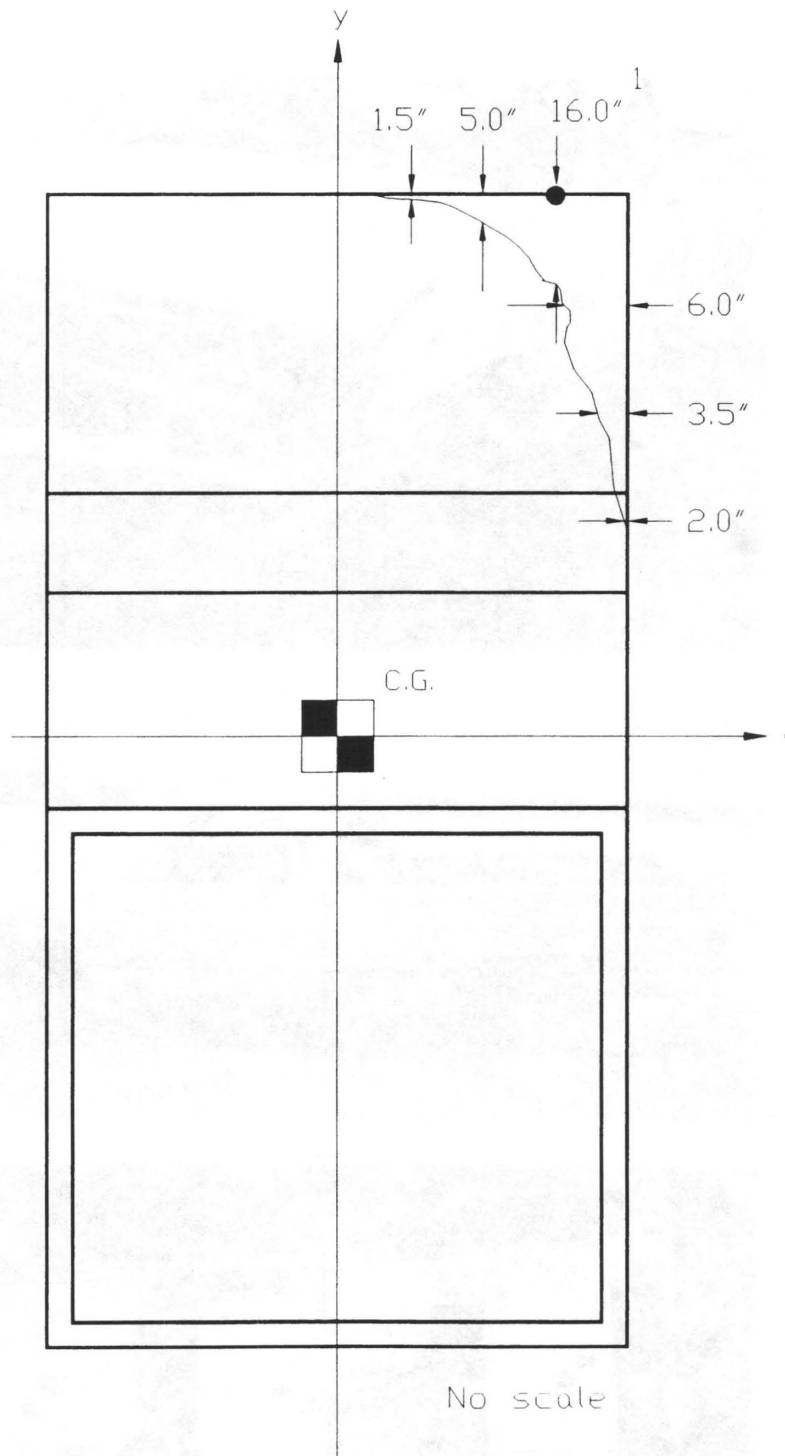
Figure 96. Crush Depth Diagram, Test NTBR-1.

Maximum static crush distance of 16" occurred
4.40" marked by the point

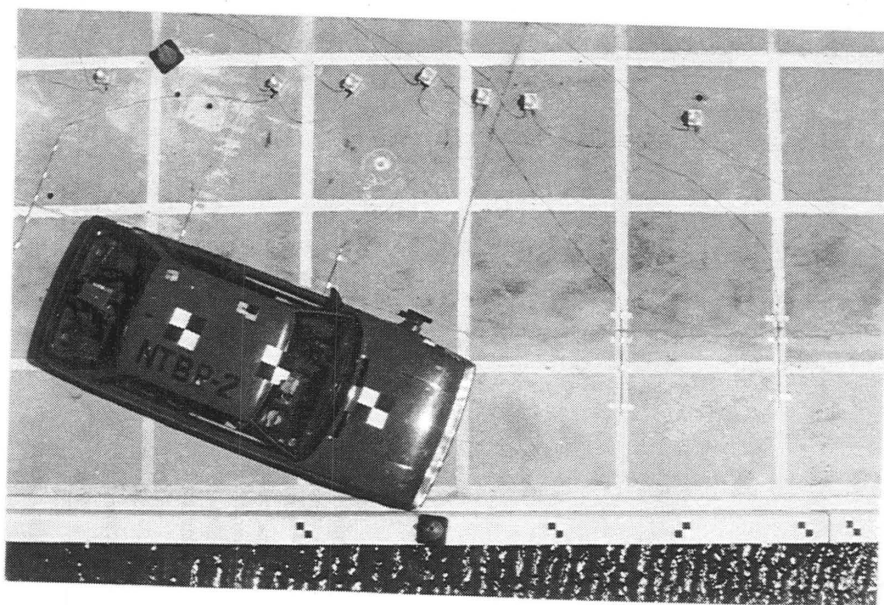
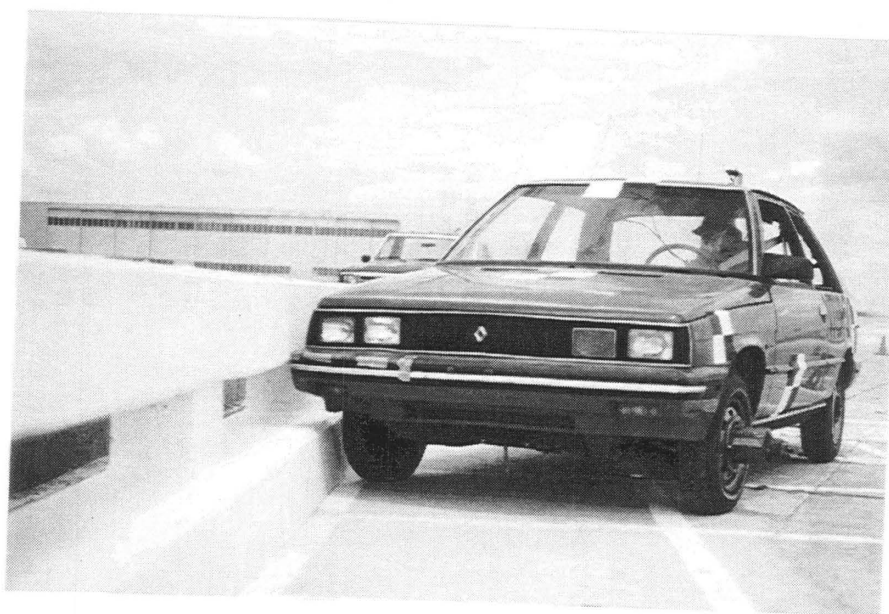
Figure 98. Vehicle Impact Location, Test NTBR-2.

The 1984 Renault Encore impacted the bridge rail at 51.5 mi/h (82.9 km/h) and 19.5 degrees. The impact point, shown in figure 98, was located at midspan between posts no. 4 and 5. A summary of the test results and sequential photographs are shown in figure 99. Additional sequential photographs are shown in figure 100.

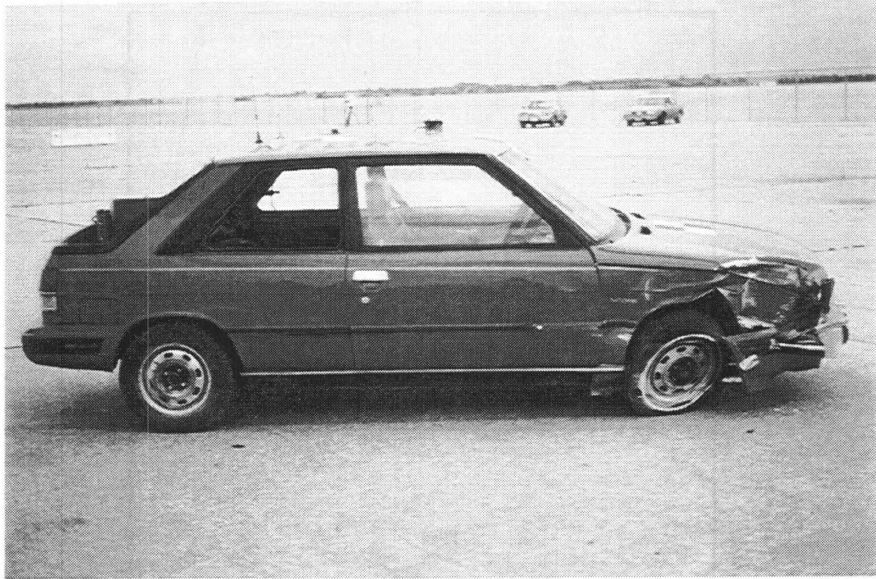
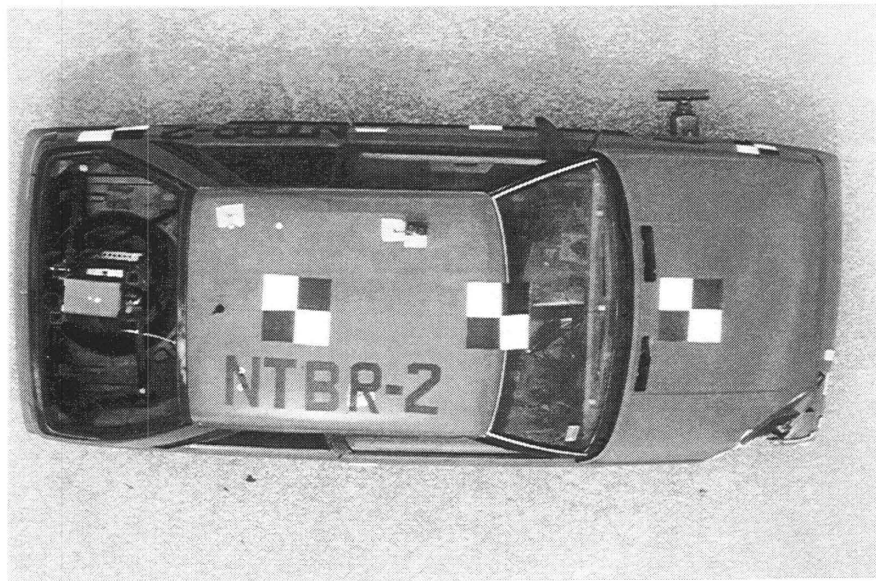
Figure 102. Vehicle Damage, Test NTBR-2.

Test vehicle damage was relatively minor and was largely limited to the right-front quarter panel and wheel, and front bumper, as shown in figure 102. There was slight buckling of the right-front floorboard and roof. The vehicle remained upright both during and after the test, and there was no intrusion of the occupant compartment. Vehicle crush measurements are shown in figure 103.

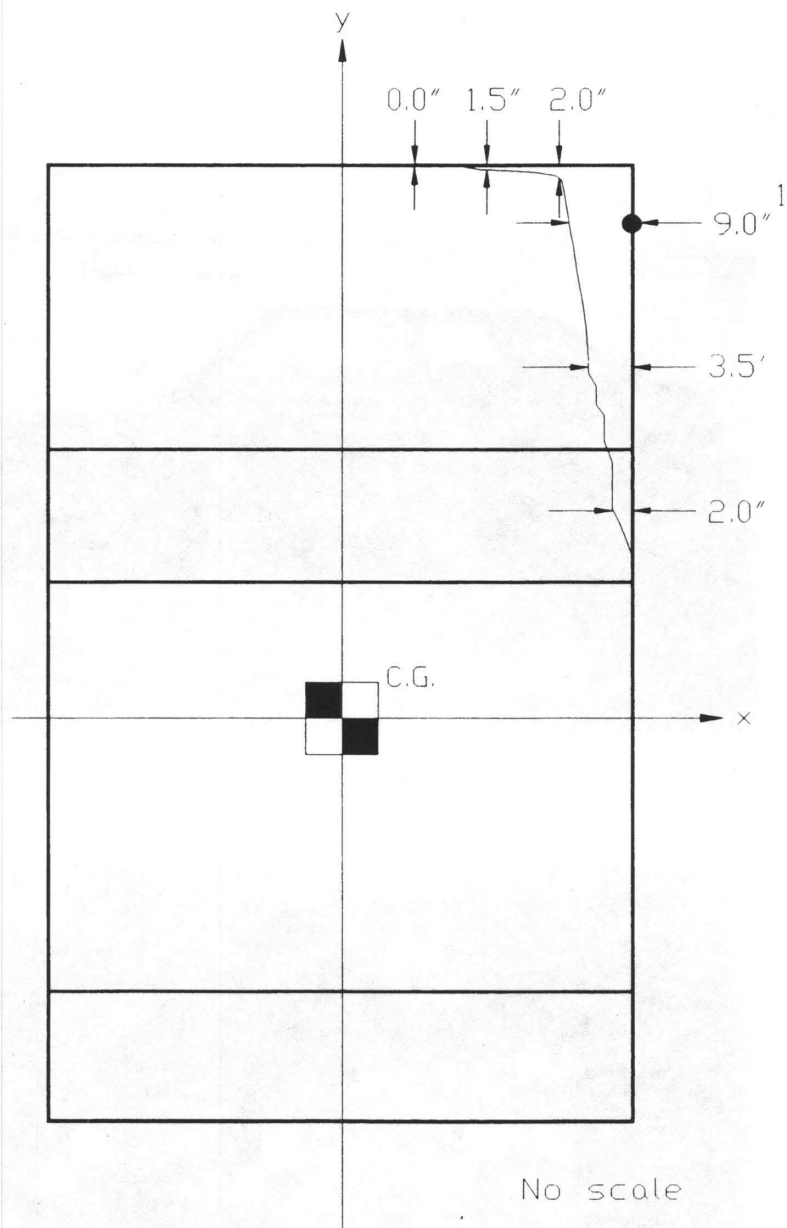
Figure 103. Crush Depth Diagram, Test NTBR-2.

Maximum static crush distance of 9" occurs at (24", 60") marked by the point
