Guardrail Testing Program II

Final Report

Midwest Roadside Safety Facility
Civil Engineering Department
University of Nebraska-Lincoln
1901 'Y' Street, Bldg. 'C'
Lincoln, Nebraska 68588-0601

Transportation Research Report TRP-03-52-95

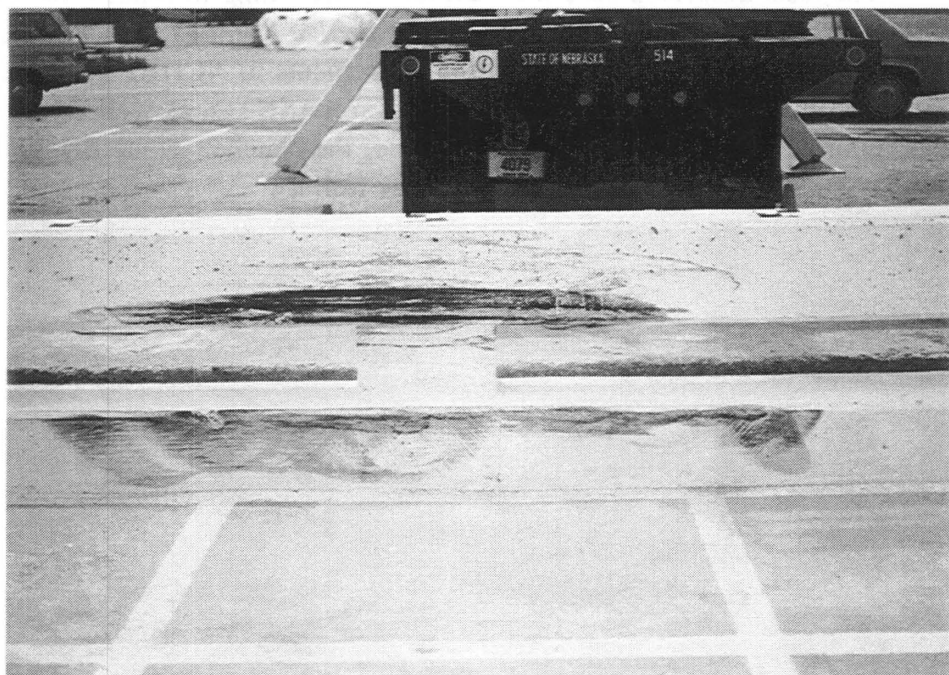
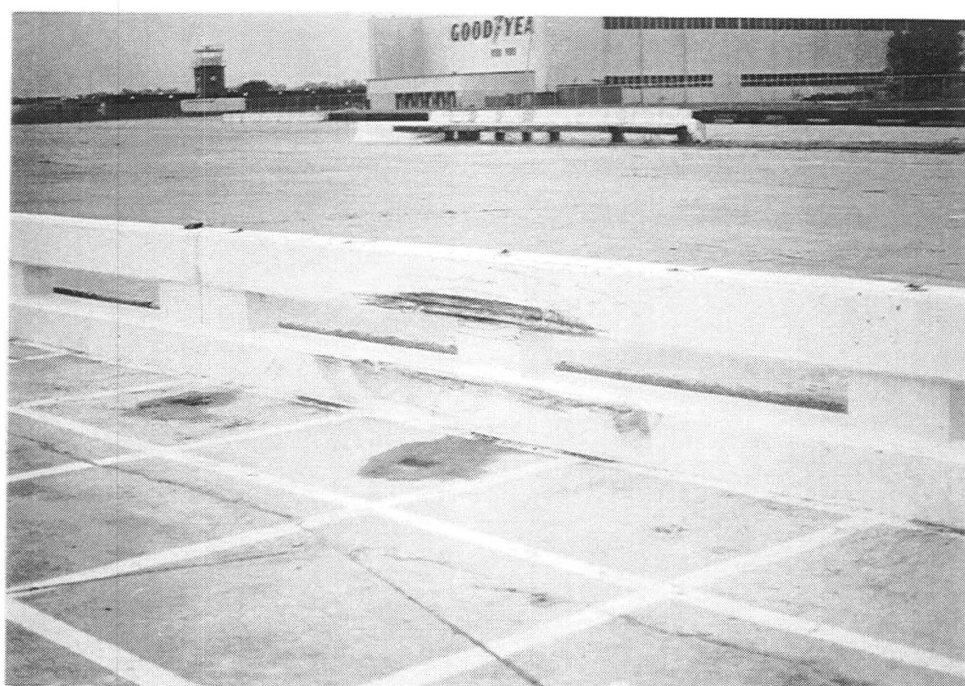
Figure 104. Bridge Rail Damage, Test NTBR-2.

Bridge rail damage is shown in figure 104. Tire marks and minor concrete spalling accounted for the majority of the damage. The length of the markings on the rail were approximately 7.5 ft (2.3 m), caused by the scraping of the bumper and the fender. The length of the markings on the curb were 8.5 ft (2.6 m), caused by the rubbing of the right-front tire, which blew out at impact.

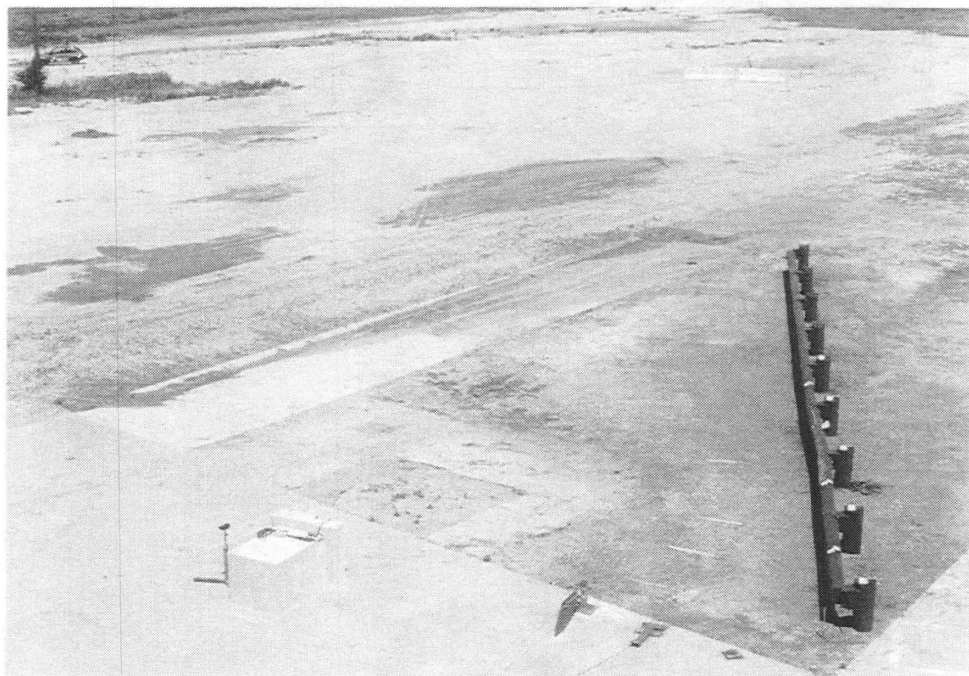
Figure 109. Vehicle Trajectory, Test SBLR-1.

Upon impact with the log rail, the front bumper slipped under the rail, and the right-front corner of the vehicle began to crush inward. The vehicle slid along the log rail and reached post no. 3 at 64 ms after impact. The vehicle reached post no. 4 approximately 216 ms after impact and became parallel to the rail at approximately 352 ms. The vehicle exited the rail at an angle of 2 degrees approximately 503 ms after impact. After exiting the rail, the vehicle continued to travel downstream and to the left, coming to a rest 240 ft (73 m) downstream from impact and 153 ft (46.5 m) to the left of a line parallel to the railing face. This vehicle trajectory is shown in figure 109.

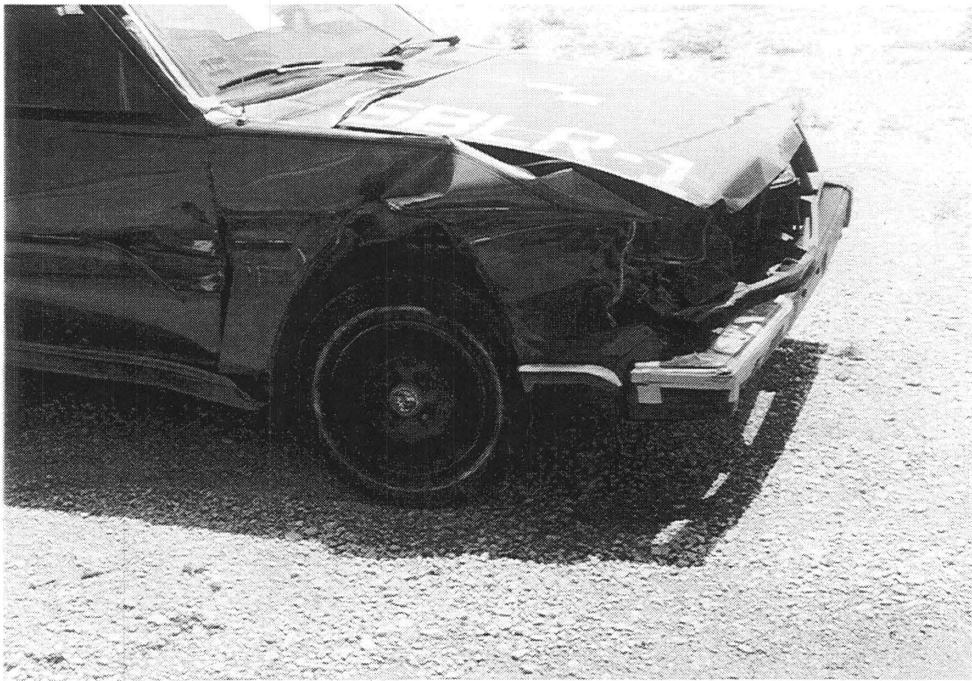
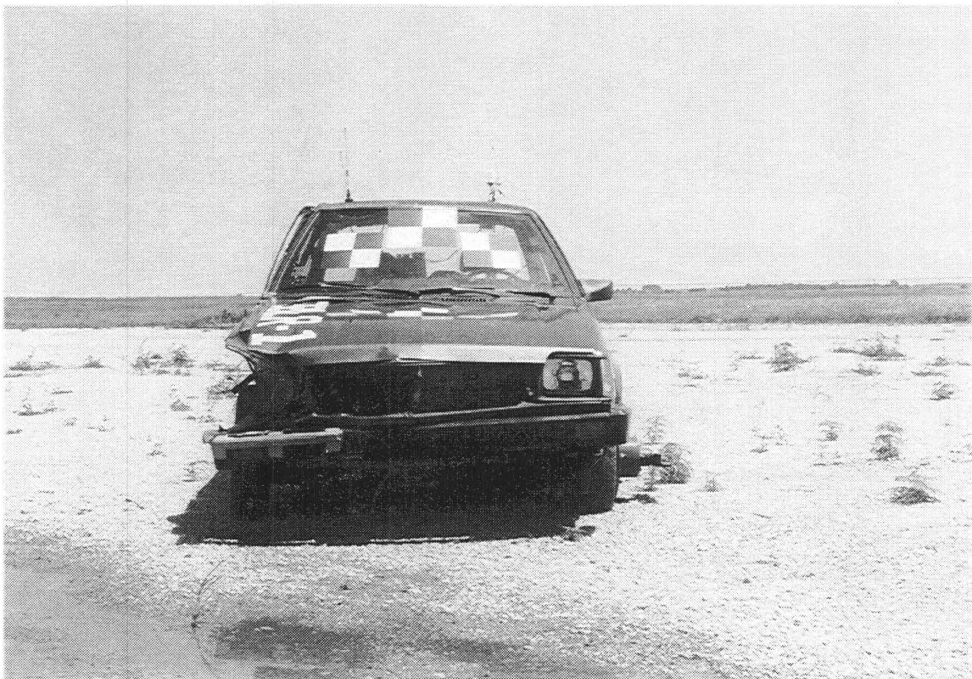
Figure 110. Vehicle Damage, Test SBLR-1.

Test vehicle damage was relatively minor and was largely limited to the right-front quarter panel and passenger door, as shown in figure 110. There was no intrusion or deformation of the occupant compartment. Vehicle crush measurements are shown in figure 111.

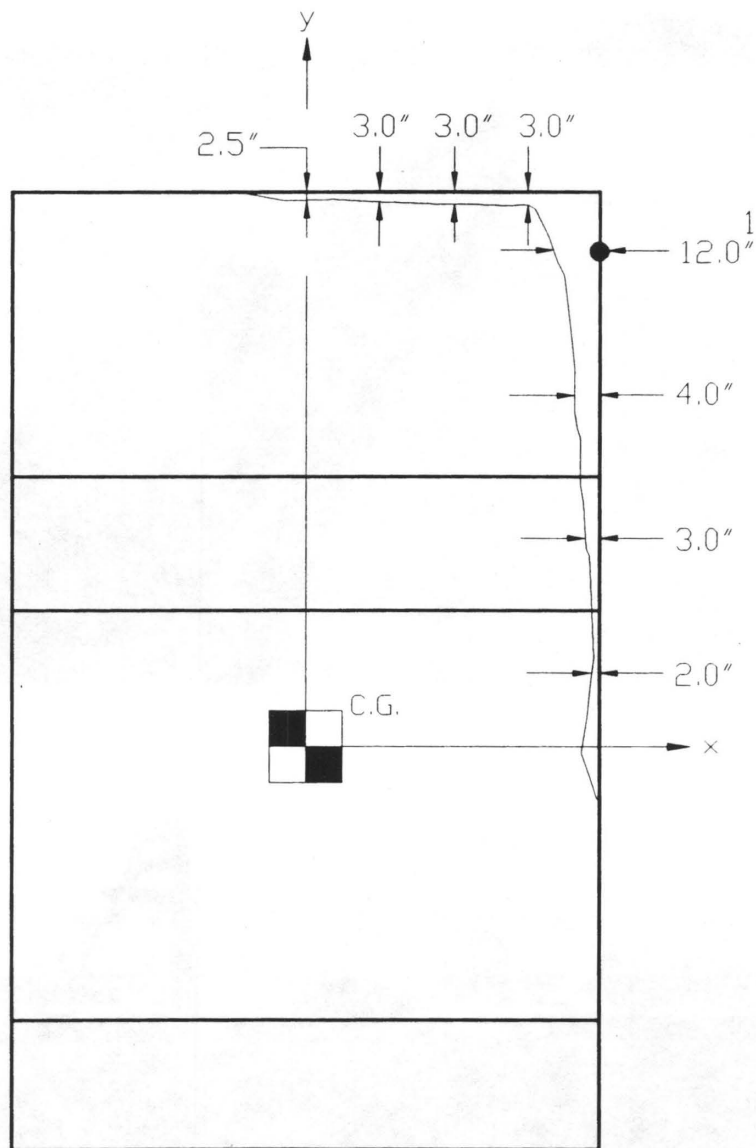
1 Maximum static crush distance of 12" occurred at (24", 54") marked by the point.

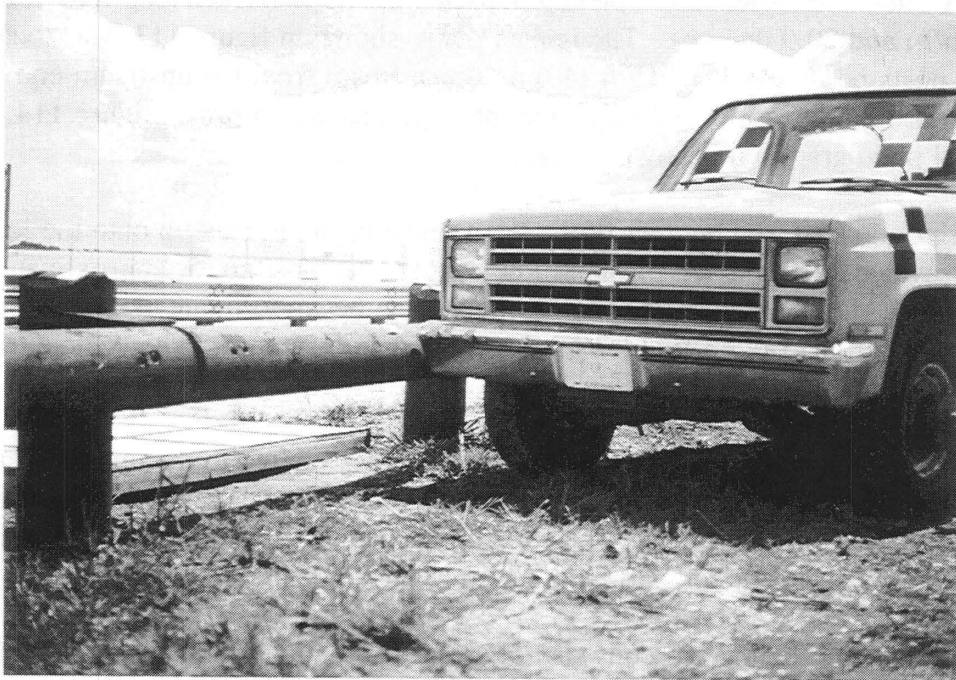
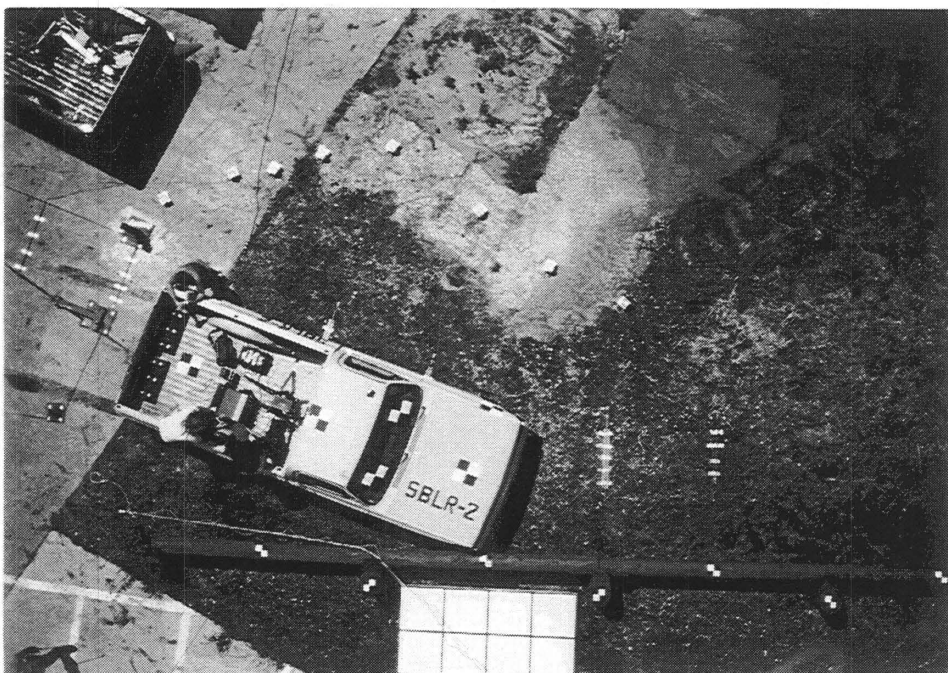
Figure 113. Vehicle Impact Location, Test SBLR-2.

A 1986 Chevrolet $\frac{3}{4}$ -ton pickup impacted the Steel-Backed Log Rail at 46.1 mi/h (74.2 km/h) and 20.9 degrees. The impact point, shown in figure 113, was located midspan between posts no. 2 and 3, or 15 ft (4.6 m) downstream from the upstream end of the rail. A summary of the test results and sequential photographs are shown in figure 114. Additional sequential photographs are shown in figure 115.

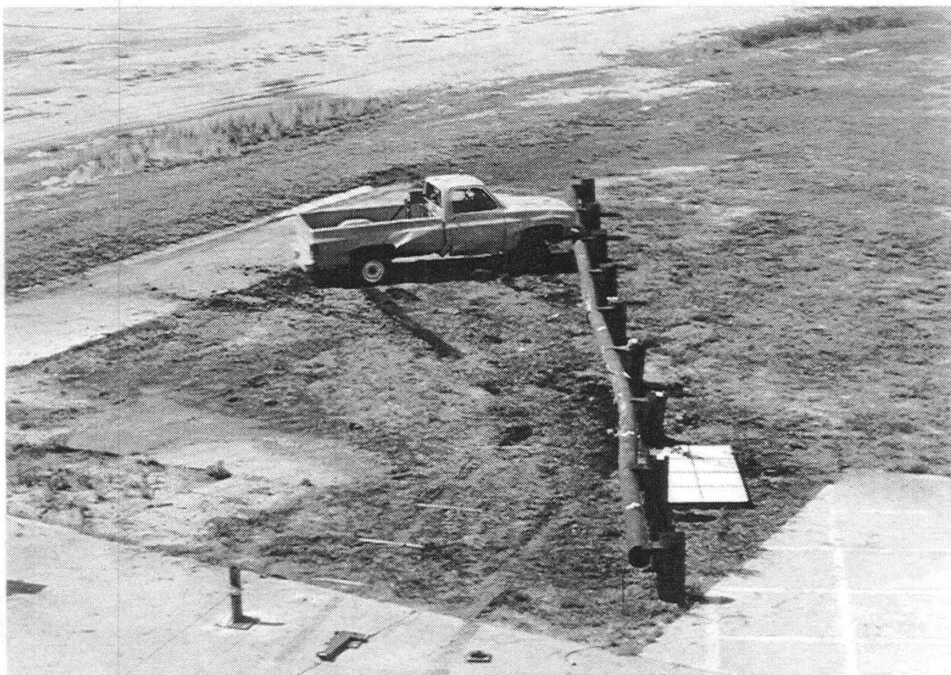
Figure 116. Vehicle Trajectory, Test SBLR-2.

Upon impact, the bumper of the test vehicle began to ride up onto the log rail. The vehicle traveled along the top of the rail until it reached post no. 5, approximately 448 ms after impact. After impacting post no. 5, the vehicle began to rotate clockwise, coming to rest perpendicular to the rail 45 ft (13.7 m) downstream from impact. The vehicle trajectory is shown in figure 116.

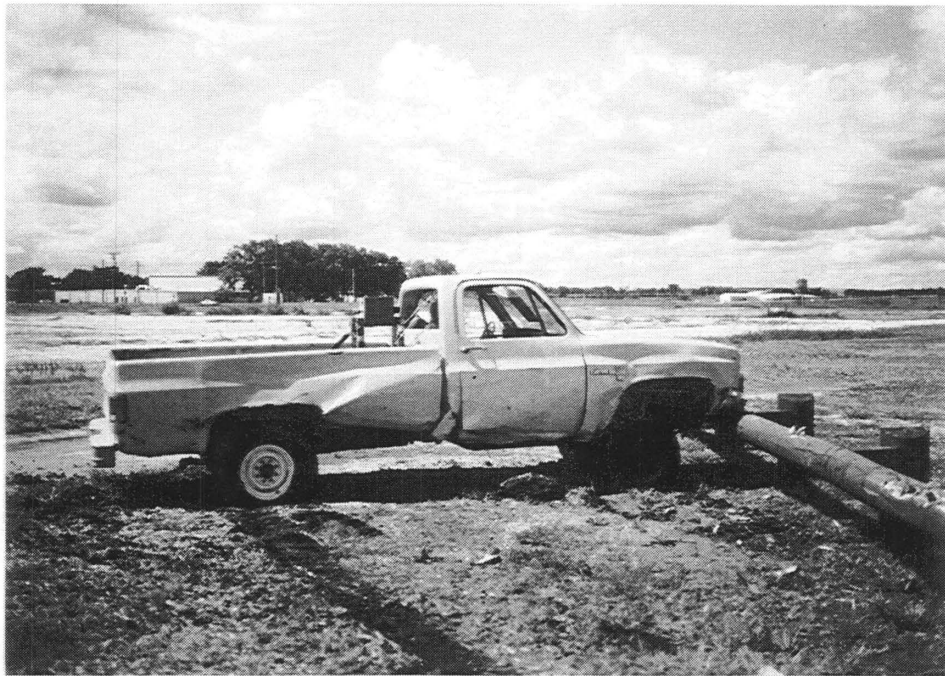
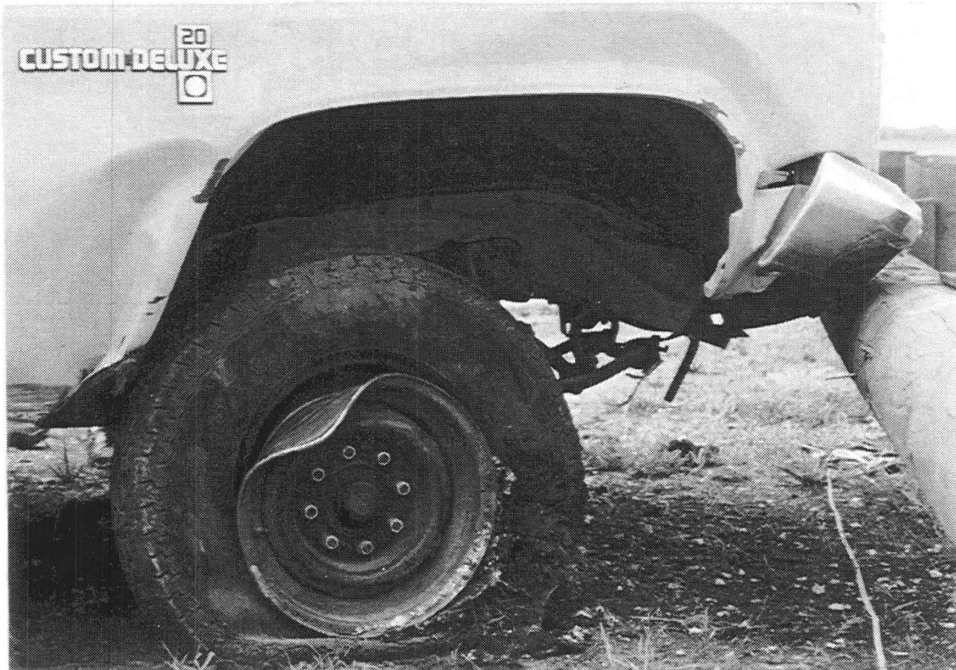
Figure 117. Vehicle Damage, Test SBLR-2.

Test vehicle damage, shown in figure 117, was limited to the undercarriage on the right-front corner and along the right side. Vehicle crush measurements are shown in figure 118. The vehicle remained upright both during and after the test, and there was no intrusion of the occupant compartment.

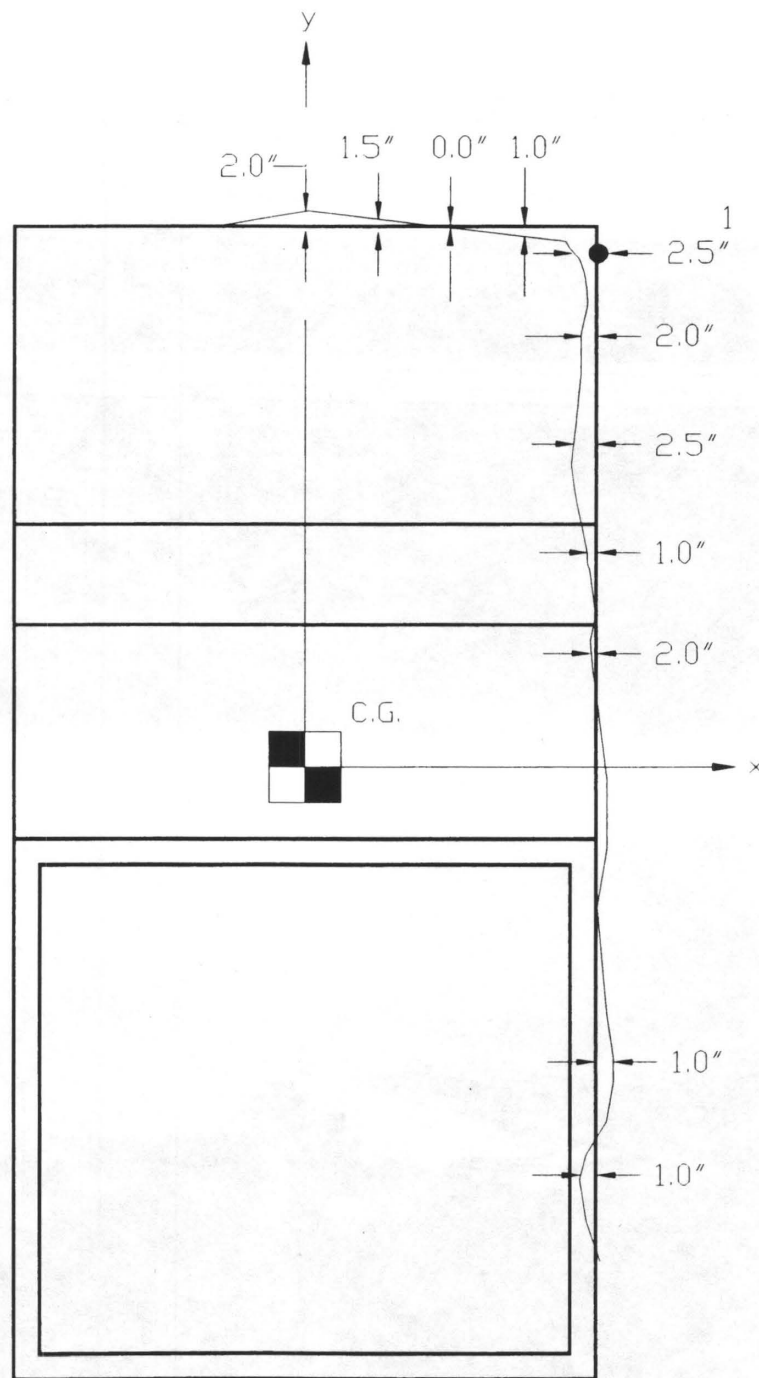
1 Maximum static crush distance of 2.5" occurred at (36",96") marked by the point.
