*Hawaii Department of Transportation  
Research Project Number 67167*

# **CRASH TESTING AND EVALUATION OF THE HDOT 34-IN. TALL AESTHETIC CONCRETE BRIDGE RAIL: MASH TEST DESIGNATION NOS. 3-10 AND 3-11**

MwRSF Research Report No. TRP-03-420-19

October 21, 2019

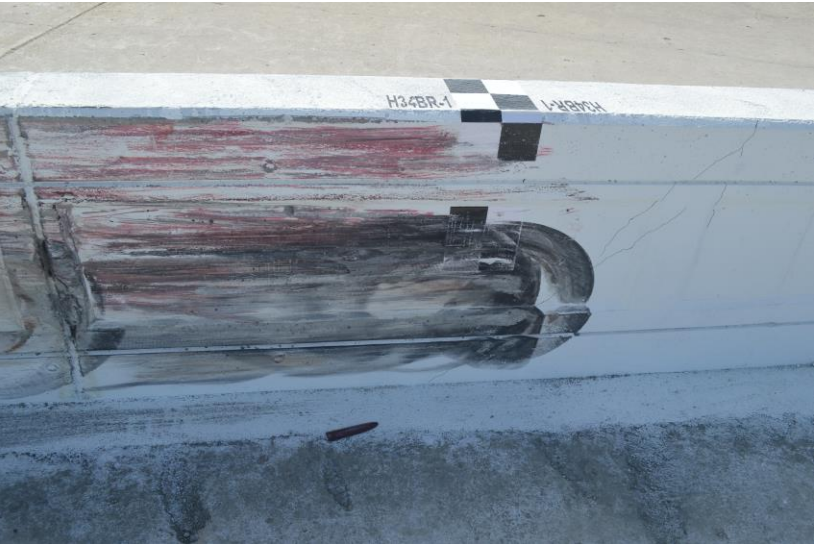
Figure 37. Traffic-Side System Damage, Test No. H34BR-1

Damage to the barrier was minor, as shown in Figures 35 through 39. Barrier damage consisted of minor cracking, spalling, and contact marks on the parapet and minor cracking and spalling at the expansion joint between barrier nos. 3 and 4. The locations for all of the listed damage were measured from the expansion joint between barrier nos. 3 and 4 as a reference point. The length of vehicle contact along the barrier was approximately 11 ft – 3 in. which spanned from 4 ft – 9 in. upstream from the expansion joint to 6 ft – 6 in. downstream from the expansion joint.

A 45-in. long and 1½-in. tall spall on the aesthetic asperity was observed 51 in. upstream from the expansion joint. Spalling measuring 4 in. long and 2½ in. wide was found 45 in. upstream from the expansion joint and 14 in. above the ground. Spalling measuring 11 in. long and ½ in. wide was found 34 in. upstream from the expansion joint and 23 in. above the ground. Spalling measuring 5½ in. long and 2½ in. wide was found 33 in. upstream from the expansion joint and 15 in. above the ground. Spalling measuring 61½ in. long was found 32 in. upstream from the expansion joint to 29½ in. downstream of the expansion joint and 32 in. above the ground. Spalling measuring 5 in. long, 10 in. wide, and ½ in. deep was found 3 in. upstream from the expansion joint and 14 in. above the ground. Spalling measuring 6 in. long was found 2 in. upstream from the expansion joint and 24 in. above the ground. A ½-in. diameter by ½-in. deep hole was observed 53 in. upstream from the expansion joint and 17½ in. above the ground. A 1-in. diameter by ½-in. deep hole was observed 24 in. upstream from the expansion joint and 23½ in. above the ground. Grout was disengaged over a 12½ in. height at the expansion joint was observed located 9½ in. above the ground.

Minor cracking of the barrier was also observed in several locations. A 19½-in. diagonal crack that started 18½ in. above the ground and ended 33½ in. above the ground was found 70½ in. upstream from the expansion joint. An 18½-in. diagonal crack that started 11 in. above the ground and ended 18½ in. above the ground was found 60 in. upstream from the expansion joint. A third smaller crack was noted on the top of the barrier starting near the middle of the expansion joint between barrier nos. 3 and 4 and extending diagonally approximately 8 in. downstream and toward the back of the barrier.

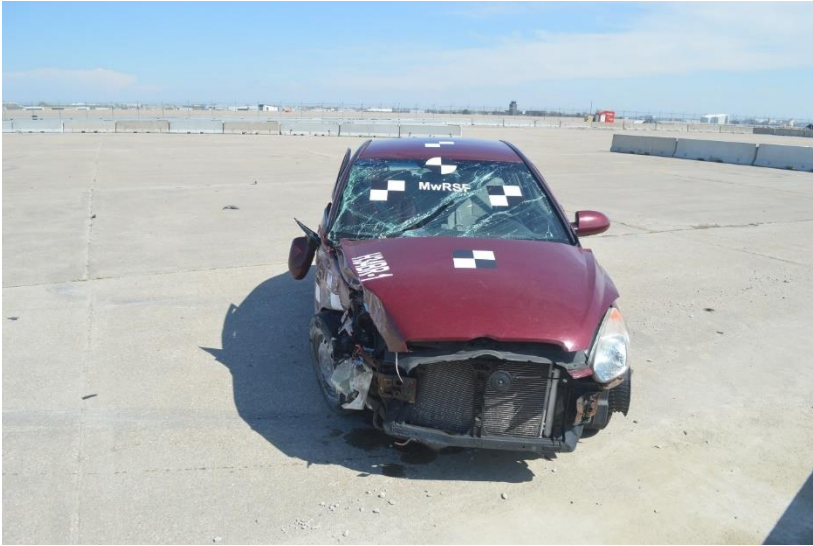
Figure 42. Vehicle Damage, Test No. H34BR-1

The damage to the vehicle was moderate, as shown in Figures 41 through 45. The maximum occupant compartment intrusions are listed in Table 5 along with the intrusion limits established in MASH 2016 for various areas of the occupant compartment. MASH 2016 defines intrusion or deformation as the occupant compartment being deformed and reduced in size with no observed penetration. Note that none of the established MASH 2016 intrusion limits were violated. The lateral B-Pillar and side door above and below the seat deformed slightly outward, which is not considered crush toward the occupant, is denoted as negative numbers in Table 5, and is not evaluated by MASH 2016 criteria. Complete occupant compartment and vehicle intrusions and the corresponding locations are provided in Appendix C.

The majority of the damage was concentrated on the right-front fender and right-front wheel of the vehicle where the impact had occurred. A small section of the seam where the floor pan and toe pan connected near the left-front corner of the right-side floor pan split due to floor pan deformation. The split seam was not due to intrusion of the barrier or a component of the vehicle. The vehicle's engine hood partially disengaged, but it remained attached to the vehicle's body. The front bumper and bumper cover disengaged from the vehicle. Kinks were found on the bottom support of the radiator, and the right radiator support was bent toward the engine compartment. A 23 $\frac{1}{8}$ -in. dent on the right side of the hood crushed 5 in. inward and toward the engine compartment. The right-front fender was crushed and had contact marks with the most significant occurring near the front of the wheel well. A 38 $\frac{1}{2}$ -in. long x 7 $\frac{1}{8}$ -in. wide x 1 $\frac{1}{2}$ -in. deep dent was found on the right-front door. The right-rear door was dented and scraped just ahead of the rear quarter panel.

It should be noted that the passenger side window fractured, and a large tear was visible in the vehicle windshield. Review of the high-speed video revealed that the side window damage was due to crush of the side of the vehicle door and not due to direct contact with the test article. Similarly, the video data showed that the tearing of the windshield was formed due to crushing of the right front corner of the windshield which propagated a shear crack through the glass and the liner. Neither of these items were in violation of the MASH 2016 criteria as none of the damage occurred due to contact with the test article or debris, nor was there the potential for the barrier to intrude into the occupant compartment.

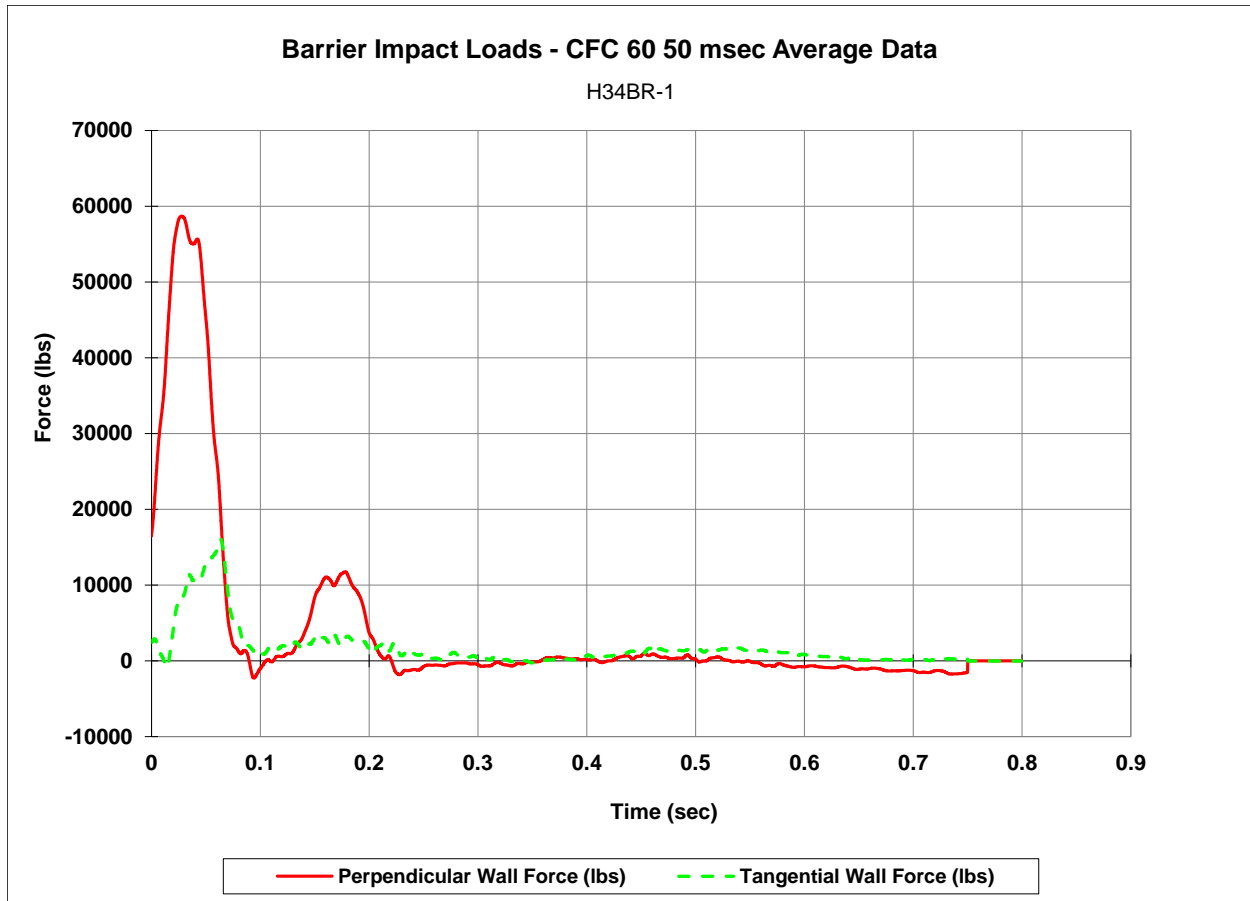
Figure 46. Perpendicular and Tangential Forces Imparted to the Barrier System (SLICE-2), Test No. H34BR-1

The longitudinal and lateral vehicle accelerations, as measured at the vehicle's c.g., were also processed using a SAE CFC-60 filter and a 50-msec moving average. The 50-msec moving average vehicle accelerations were then combined with the uncoupled yaw angle versus time data in order to estimate the vehicular loading applied to the barrier system. From the data analysis, the perpendicular impact forces were determined for the bridge rail, as shown in Figure 46. The maximum perpendicular (i.e., lateral) load imparted to the barrier was 58.8 kips determined by the SLICE-2 (primary) unit.

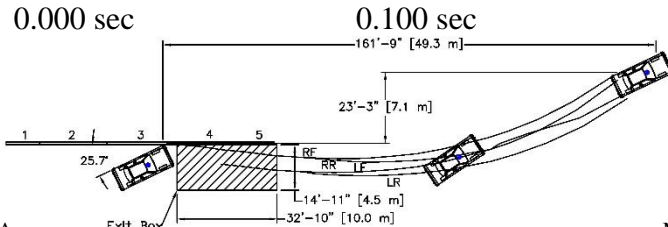
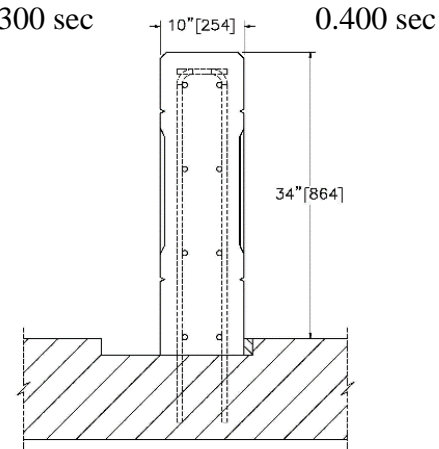
Figure 47. Summary of Test Results and Sequential Photographs, Test No. H34BR-1

The analysis of the test results for test no. H34BR-1 showed that the system adequately contained and redirected the 1100C vehicle with controlled lateral displacements of the barrier. A summary of the test results and sequential photographs are shown in Figure 47. Detached elements, fragments, or other debris from the test article did not penetrate or show potential for penetrating the occupant compartment, or present an undue hazard to other traffic, pedestrians, or work-zone personnel. Deformations of, or intrusions into, the occupant compartment that could have caused serious injury did not occur. The passenger side window shattered due to crush of the side of the vehicle door and not due to direct contact with the test article. The test vehicle did not penetrate nor ride over the barrier and remained upright during and after the collision. Vehicle roll, pitch, and yaw angular displacements, as shown in Appendix D, were deemed acceptable, because they did not adversely influence occupant risk nor cause rollover. After impact, the vehicle exited the barrier at an angle of 6.9 degrees, and its trajectory did not violate the bounds of the exit box. Therefore, test no. H34BR-1 was determined to be acceptable according to the MASH 2016 safety performance criteria for test designation no. 3-10.

- Vehicle Damage..... Moderate
  - VDS [11] ..... 1-RFQ-4
  - CDC [12]..... 01-RRER-5
  - Maximum Interior Deformation ..... 3.1 in.

- Test Article Damage ..... Minimal
- Maximum Test Article Deflections
  - Permanent Set ..... 0.2 in.
  - Dynamic..... 0.3 in.
  - Working Width..... 10.3 in.
- Transducer Data

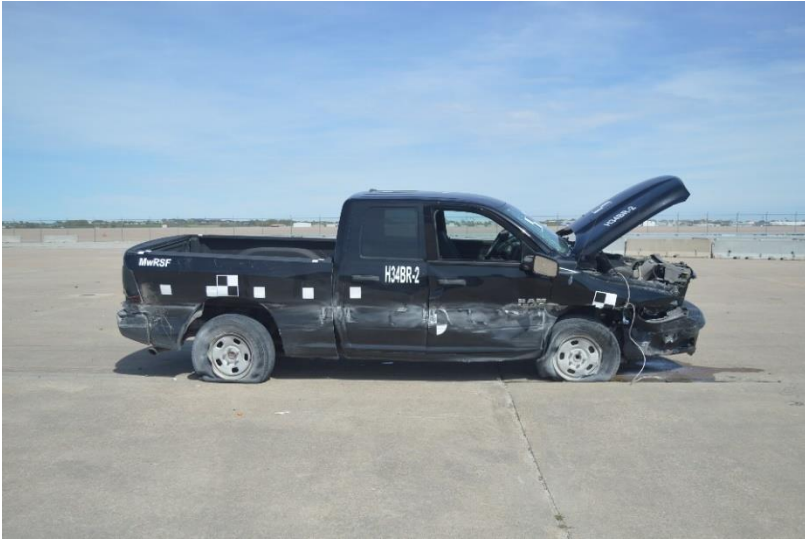
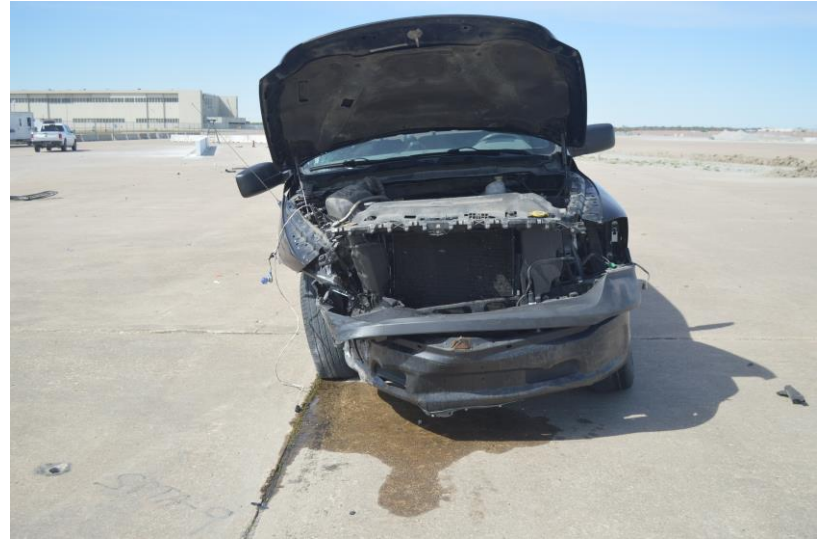
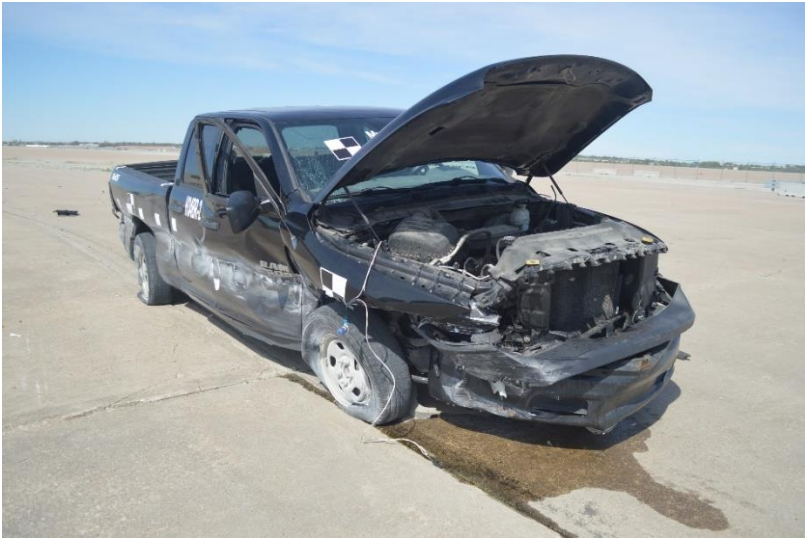
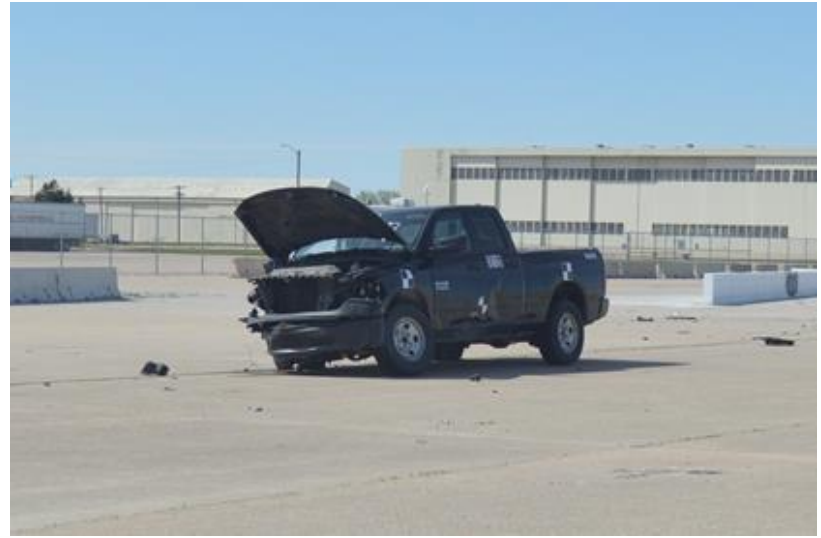
Figure 60. Vehicle Damage, Test No. H34BR-2

The damage to the vehicle was moderate, as shown in Figures 60 through 64. The maximum occupant compartment intrusions are listed in Table 9 along with the intrusion limits established in MASH 2016 for various areas of the occupant compartment. MASH 2016 defines intrusion or deformation as the occupant compartment being deformed and reduced in size with no observed penetration. Note that none of the established MASH 2016 intrusion limits were violated. The lateral A- and B-pillars and the side door above the seat deformed slightly outward, which is not considered crush toward the occupant, is denoted as negative numbers in Table 9, and is not evaluated by MASH 2016 criteria. Complete occupant compartment and vehicle intrusions and the corresponding locations are provided in Appendix C.

The majority of the damage was concentrated on the right-front corner and right side of the vehicle where the impact had occurred. The right side of the bumper was crushed inward and backward. The right-front fender was crushed inward toward the centerline of the vehicle and engine compartment. The right-front steel rim was deformed and crushed, and the right-front tire was torn and deformed. The right upper control arm was fractured. The grille was disengaged away

from the vehicle. The left-side headlight was disengaged away from the vehicle and right-side headlight and fog light were shattered. The right side of the radiator was pushed backward. A 16 $\frac{1}{2}$ -in. long x 21-in. wide x 2 $\frac{1}{2}$ -in. deep dent and scraping were observed on the entire right side. The right-front door was ajar, and creases were found in the door's sheet metal. The right-rear steel rim was crushed, and the tire was torn. The right side of the rear bumper was dented and scuffed. It should be noted that the window on the right-front side was shattered. It should be noted that the passenger side window was fractured. Review of the high-speed video revealed that the side window damage was due to crush of the side of the vehicle door and not due to direct contact with the test article. Thus, the side window damage was not in violation of the MASH criteria as it did not occur due to contact with the test article or debris. The bottom-right side of the windshield had a hairline crack, and no cracks were found on the left side of the windshield. The left-front fender was dented at the top and back. Minor scrapes and dents were found at the left-front and left-rear doors. The roof and remaining window glass remained undamaged.

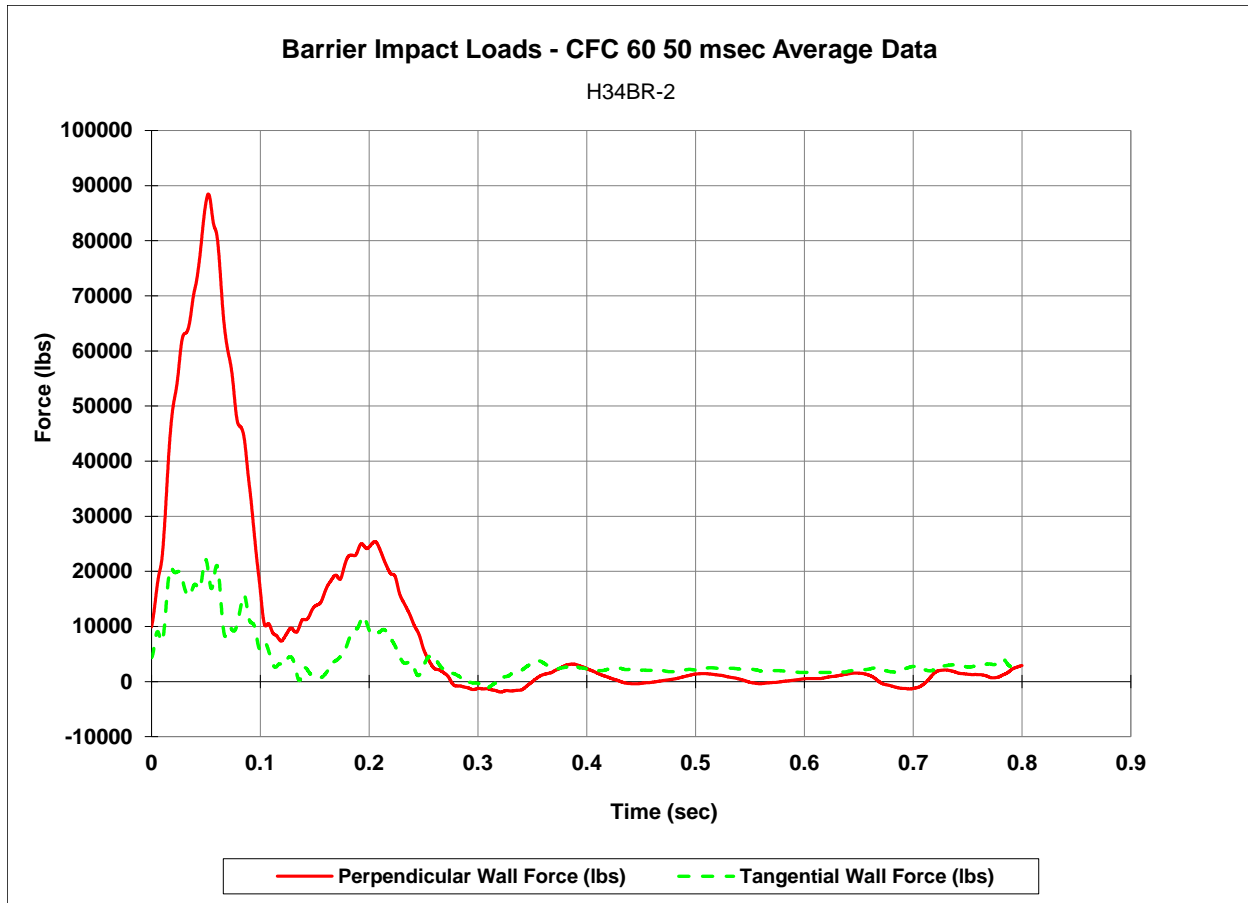
Figure 65. Perpendicular and Tangential Forces Imparted to the Barrier System (SLICE-2), Test No. H34BR-2

The longitudinal and lateral vehicle accelerations, as measured at the vehicle's c.g., were also processed using a SAE CFC-60 filter and a 50-msec moving average. The 50-msec moving average vehicle accelerations were then combined with the uncoupled yaw angle versus time data in order to estimate the vehicular loading applied to the barrier system. From the data analysis, the perpendicular impact forces were determined for the bridge rail, as shown in Figure 65. The maximum perpendicular (i.e., lateral) load imparted to the barrier was 88.6 kips determined by the SLICE-2 (primary) unit.

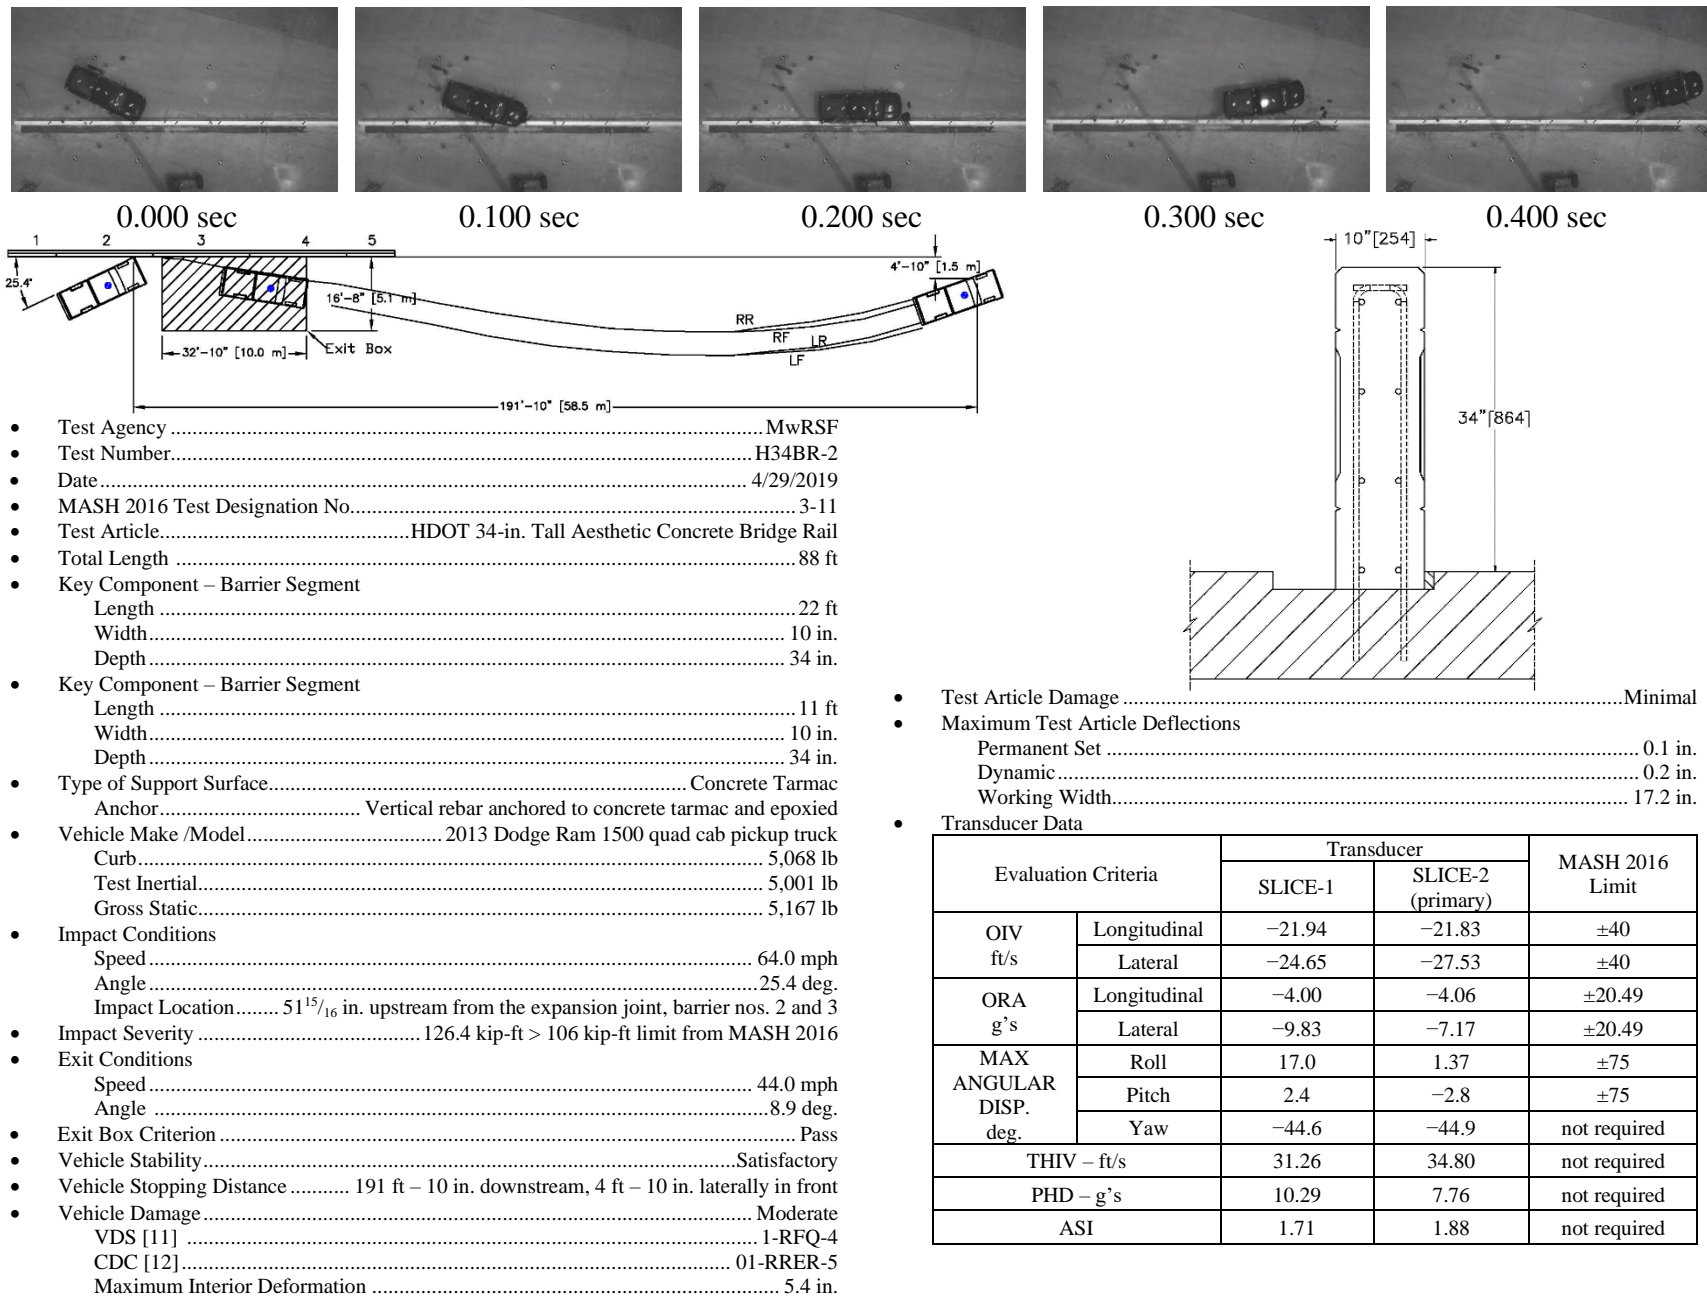
Figure 66. Summary of Test Results and Sequential Photographs, Test No. H34BR-2

The analysis of the test results for test no. H34BR-2 showed that the system adequately contained and redirected the 2270P vehicle with controlled lateral displacements of the barrier. A summary of the test results and sequential photographs are shown in Figure 66. Detached elements, fragments, or other debris from the test article did not penetrate or show potential for penetrating the occupant compartment, or present an undue hazard to other traffic, pedestrians, or work-zone personnel. Deformations of, or intrusions into, the occupant compartment that could have caused serious injury did not occur. The test vehicle did not penetrate nor ride over the barrier and remained upright during and after the collision. Vehicle roll, pitch, and yaw angular displacements, as shown in Appendix E, were deemed acceptable, because they did not adversely influence occupant risk nor cause rollover. After impact, the vehicle exited the barrier at an angle of 8.9 degrees, and its trajectory did not violate the bounds of the exit box. Therefore, test no. H34BR-2 was determined to be acceptable according to the MASH 2016 safety performance criteria for test designation no. 3-11.
