*Hawaii Department of Transportation
Research Contract No. 68212
Research Project No. STP-1500(092) – Phase II*

MASH TL-3 EVALUATION OF TRANSITION TO HAWAII MODIFIED DELAWARE RETROFIT THRIE-BEAM BRIDGE RAIL

MwRSF Research Report No. TRP-03-449-22

August 22, 2022

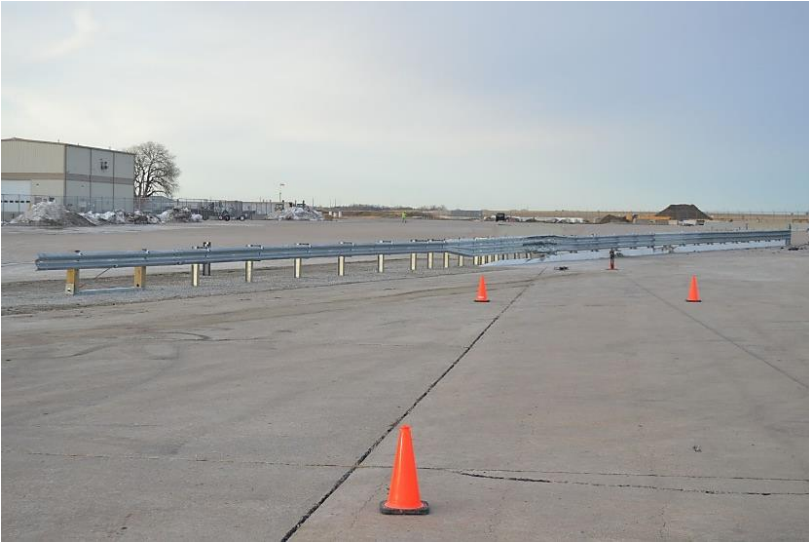
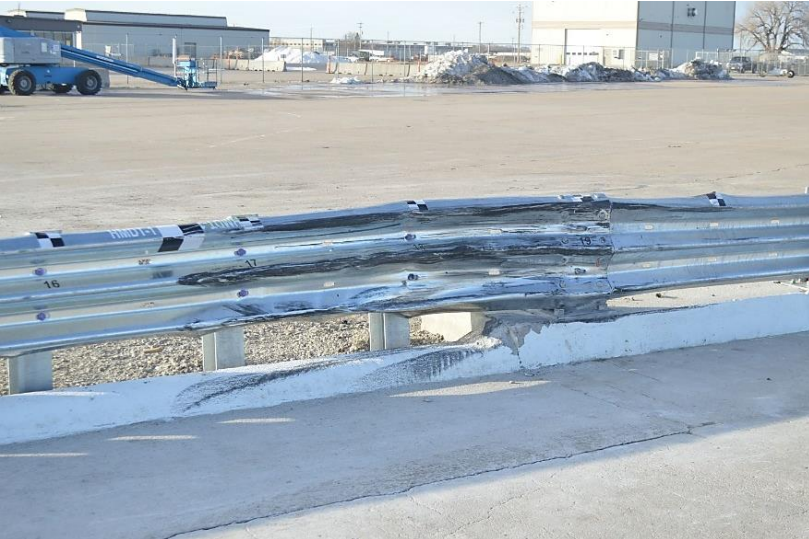
Figure 68. System Damage, Test No. HMDT-1

Damage to the barrier was moderate, as shown in Figures 68 through 70. Note that some pre-existing damage to the bridge rail was present from a previous test, test no. HMBDR-1, which has been previously reported [2]. The pre-existing damage included spalling of the concrete sidewalk between post nos. 24 and 26, missing post no. 25, and contact marks on the thrie-beam rail and sidewalk at post no. 24.

Barrier damage from test no. HMDT-1 consisted of deflected posts, flattening, contact marks and kinks on the thrie-beam rail, and minor concrete spalling and contact marks on the front face of the concrete curb and sidewalk. The length of vehicle contact along the barrier was approximately 19 ft – 3 in., which started 20 in. downstream from post no. 16 and extended to 63½ in. downstream from post no. 20. The bottom rail corrugation sustained various degrees of flattening starting from post no. 17 and continued 78¾ in. downstream. Multiple kinks were observed on the top and bottom corrugation of the thrie-beam rail from post no. 16 to post no. 20.

Post nos. 3 through 19 were slightly twisted counterclockwise except for posts nos. 15 and 18, and posts nos. 15 through 19 rotated backward. Post nos. 17, 18, and 19 experienced local buckling on the flange on the traffic side face. The upper rail connection bolt at post no. 19 sheared off during the impact event. Posts nos. 1 through 15 had minor soil gaps measuring less than 1 in. in front of the posts, while post nos. 16 through 18 had larger soil gaps between 1½ in. and 4½ in. in front of the posts. No movement was observed in the upstream anchorage system.

Tire contact marks were visible on the traffic side and top of the curb starting upstream from post no. 17, which extended for the length of 73½ in. downstream. The tire contact marks on the concrete sidewalk began from its upstream end and extended 55¾ in. downstream. Minor concrete spalling, measuring 5 in. x 7 in. x 3½ in. deep and 9 in. x 7 in. x 2¼ in. deep, was found on the top and front edge of the transition curb and sidewalk, respectively, at the joint between the transition curb and concrete sidewalk.

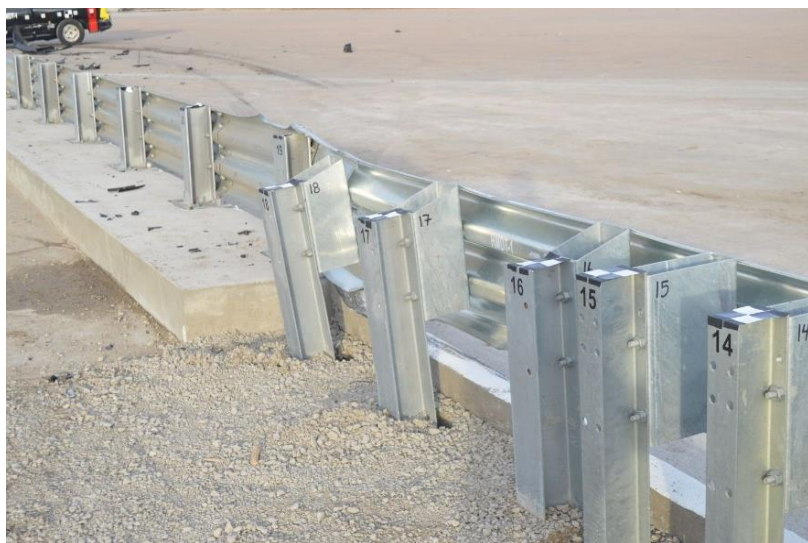
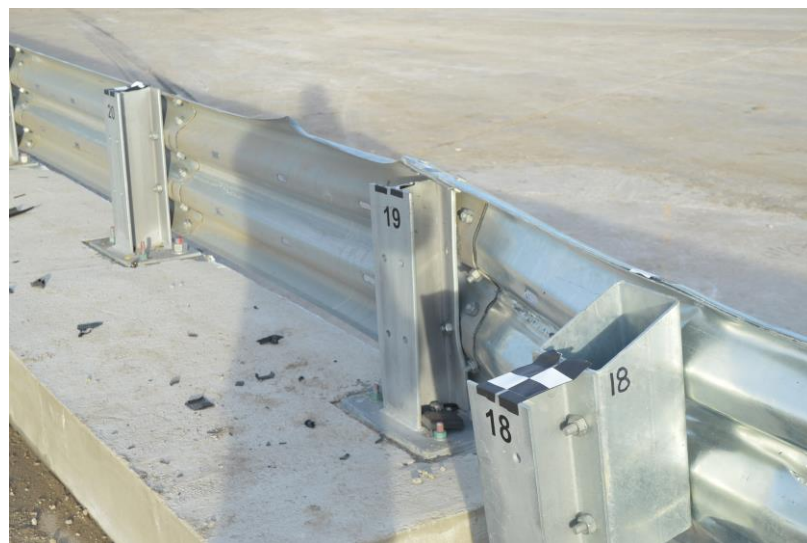
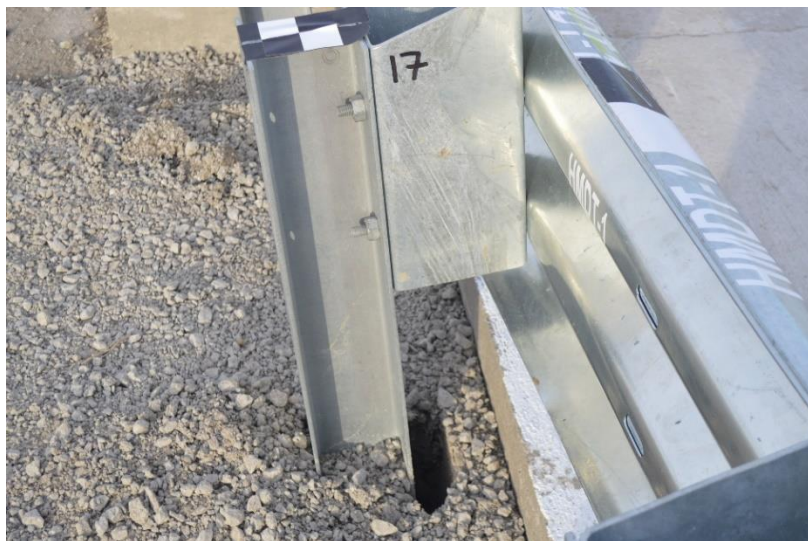
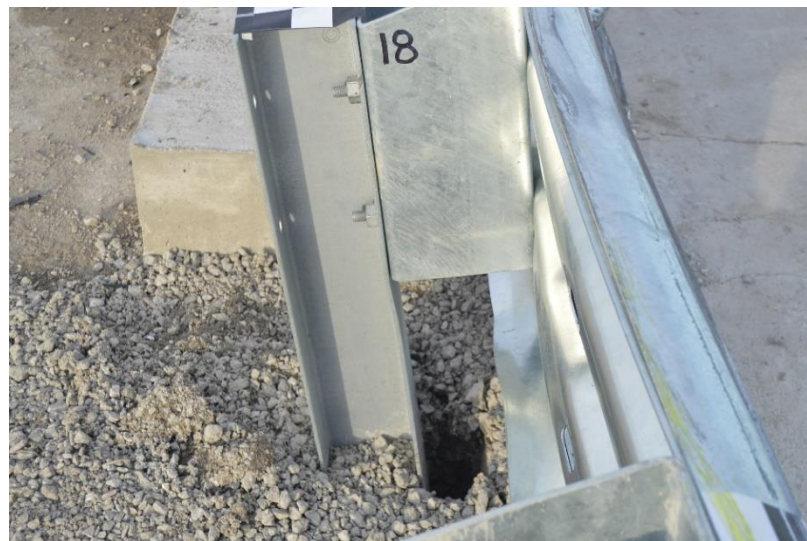
Figure 70. Soil Gap and Post Nos. 14 through 19 Damage, Test No. HMDT-1

The maximum lateral permanent set of the barrier system was 9.4 in., which occurred in the thrie-beam rail between post nos. 17 and 18, as measured in the field. The maximum lateral dynamic barrier deflection was 11.4 in. at the rail at post no. 18, as determined from high-speed digital video analysis. The working width of the system was found to be 28.9 in., also determined from high-speed digital video analysis. A schematic of the permanent set deflection, dynamic deflection, and working width is shown in Figure 71.

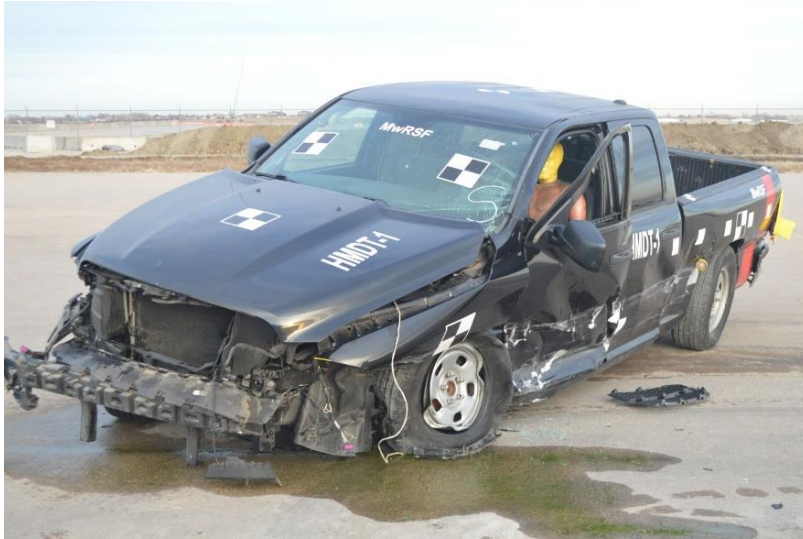
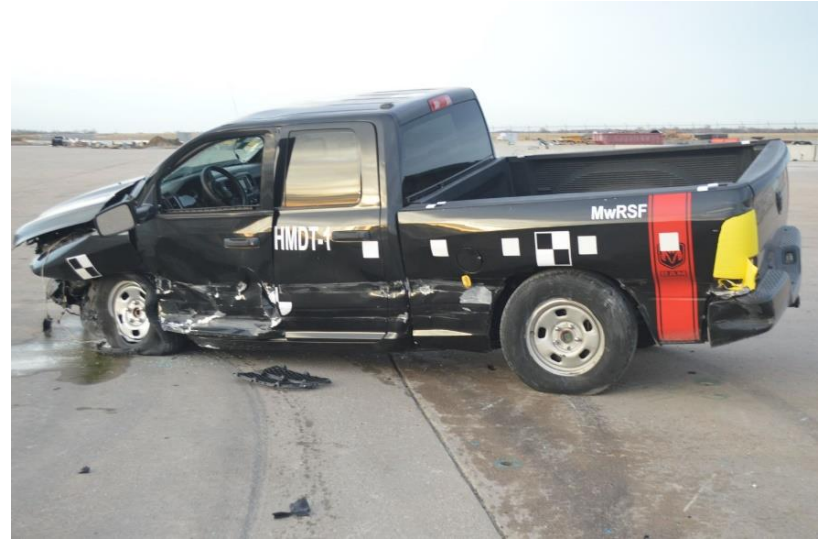
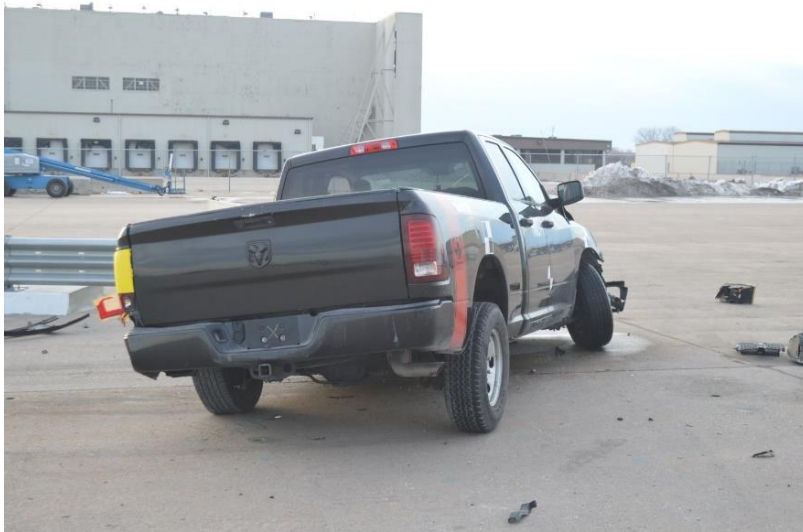
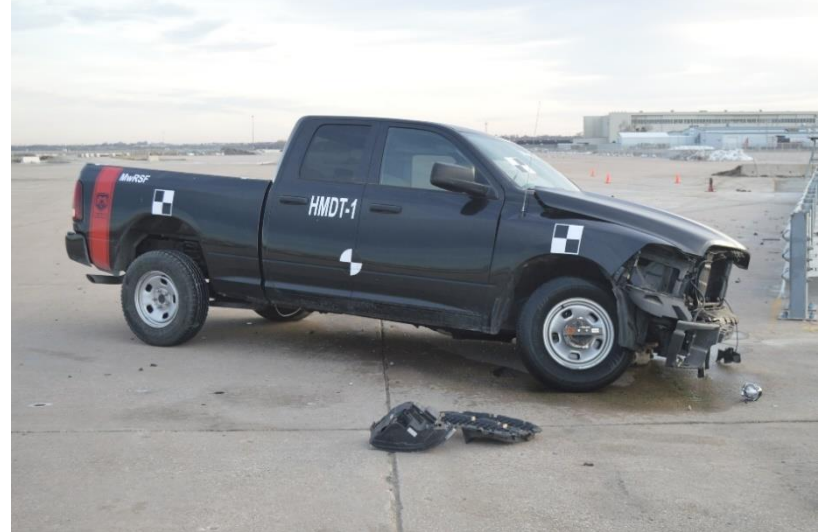
Figure 72. Vehicle Damage, Test No. HMDT-1

The damage to the vehicle was moderate, as shown in Figures 72 through 74. Concentrated damage occurred to the left-front corner and left side of the vehicle where the impact had occurred, with additional damage to the front of the vehicle and undercarriage.

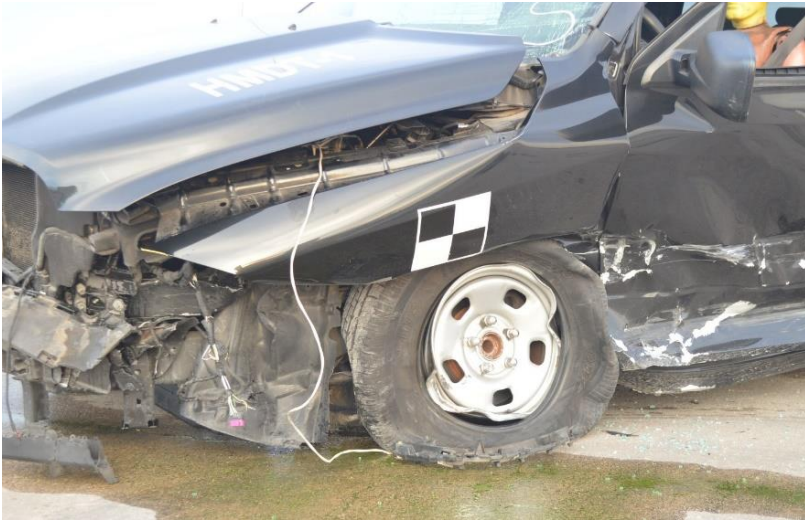
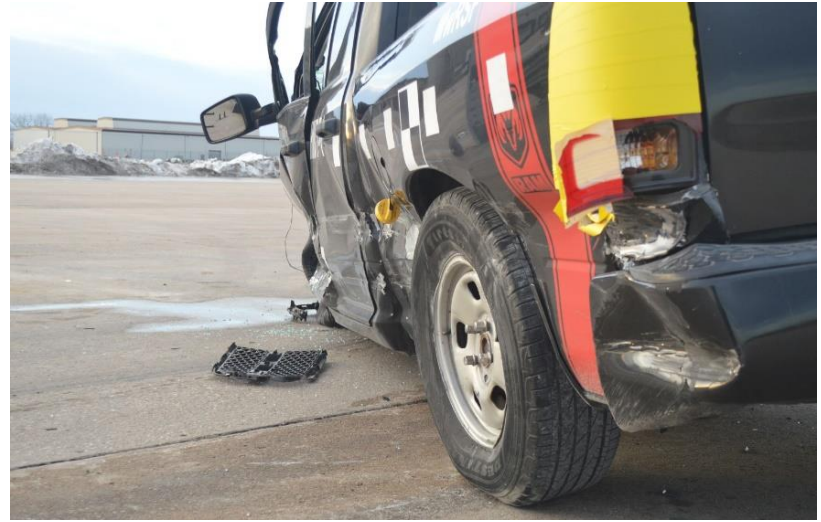
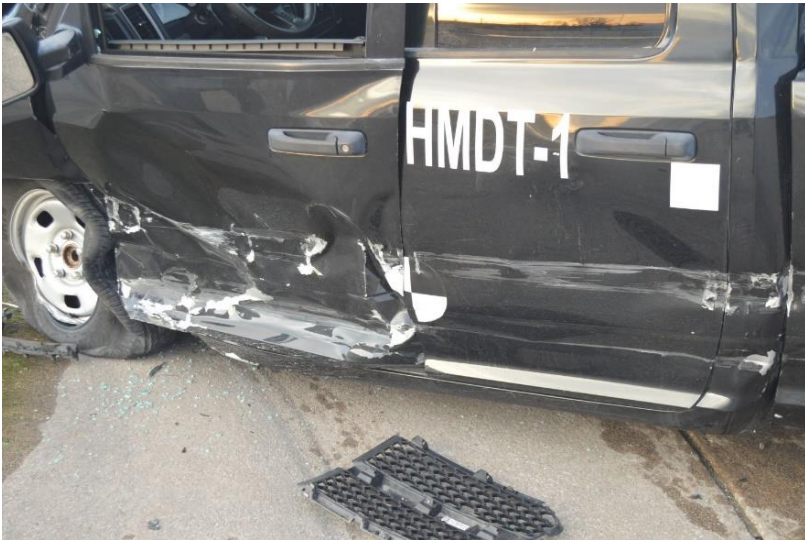
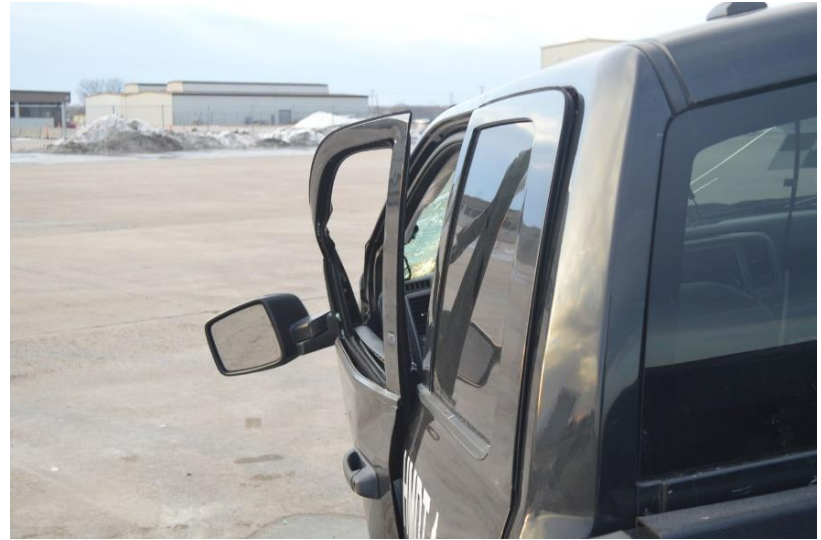
Figure 73. Vehicle Damage, Test No. HMDT-1

The front of the longitudinal frame rails was bent into an S-shape. Kinks and buckles were observed on the left side of all cross members. The front engine and transmission cross members were scraped and bent backward on the right side at the control arm joint. The middle cross member was bent downward, twisted, and backward on the left side at the control arm joint. The front windshield was intact with cracks on the left side, and the left-front window was shattered.

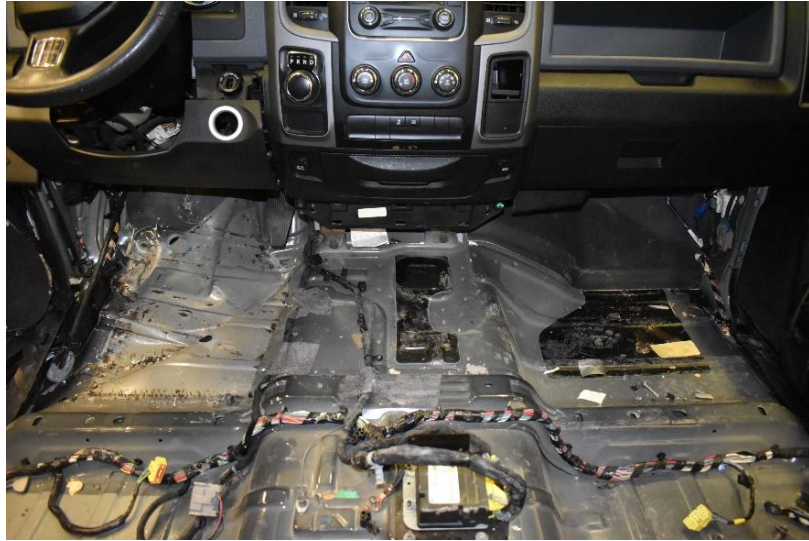
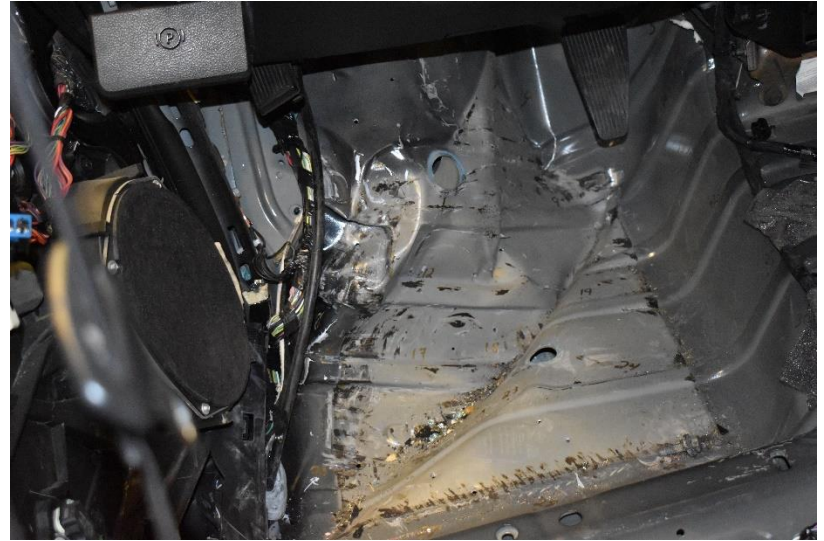
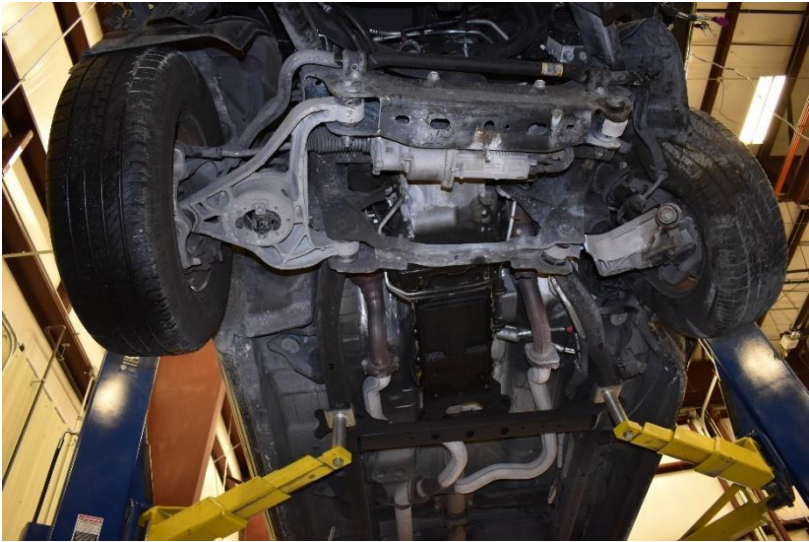
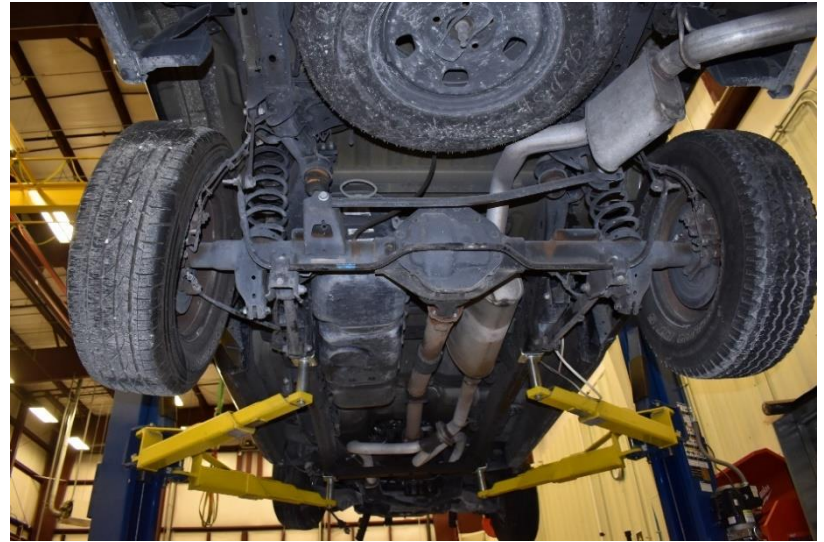
Figure 74. Interior and Undercarriage Damage, Test No. HMDT-1

The maximum occupant compartment intrusions are listed in Table 9, along with the intrusion limits established in MASH 2016 for various areas of the occupant compartment. Complete occupant compartment and vehicle deformations and the corresponding locations are provided in Appendix E. MASH 2016 defines intrusion or deformation as the occupant compartment being deformed and reduced in size with no observed penetration. Outward deformations, which are denoted as negative numbers in Appendix E, are not considered crush toward the occupant and are not evaluated by MASH 2016 criteria. Note that the maximum wheel well and toe pan intrusion of 10.5 in. exceeded the MASH 2016 limit of 9 in. There were no penetrations into the occupant compartment, but the measurement of the occupant compartment intrusion limits exceeded MASH criteria for occupant compartment deformation limits and resulted in the failure of test no. HMDT-1 to meet MASH 2016 criteria.

The analysis of the results for test no. HMDT-1 showed that the system contained and redirected the 2270P vehicle with controlled lateral displacements of the barrier. However, deformations of, or intrusions into, the wheel well and toe pan area of 10.5 in. exceeded the deformation limits of 9 in., as defined in MASH 2016. A summary of the test results and sequential photographs are shown in Figure 75. Detached elements, fragments, or other debris from the test article did not penetrate or show potential for penetrating the occupant compartment, or present an undue hazard to other traffic, pedestrians, or work-zone personnel. The test vehicle did not penetrate nor ride over the barrier and remained upright during and after the collision. Vehicle roll, pitch, and yaw angular displacements, as shown in Appendix F, were deemed acceptable, because they did not adversely influence occupant risk nor cause a rollover. After impact, the vehicle exited the barrier at an angle of 8.6 degrees, and its trajectory did not violate the bounds of the exit box. Therefore, test no. HMDT-1 was determined to be unacceptable according to the MASH 2016 safety performance criteria for test designation no. 3-21 due to the excessive wheel well and toe pan intrusion.

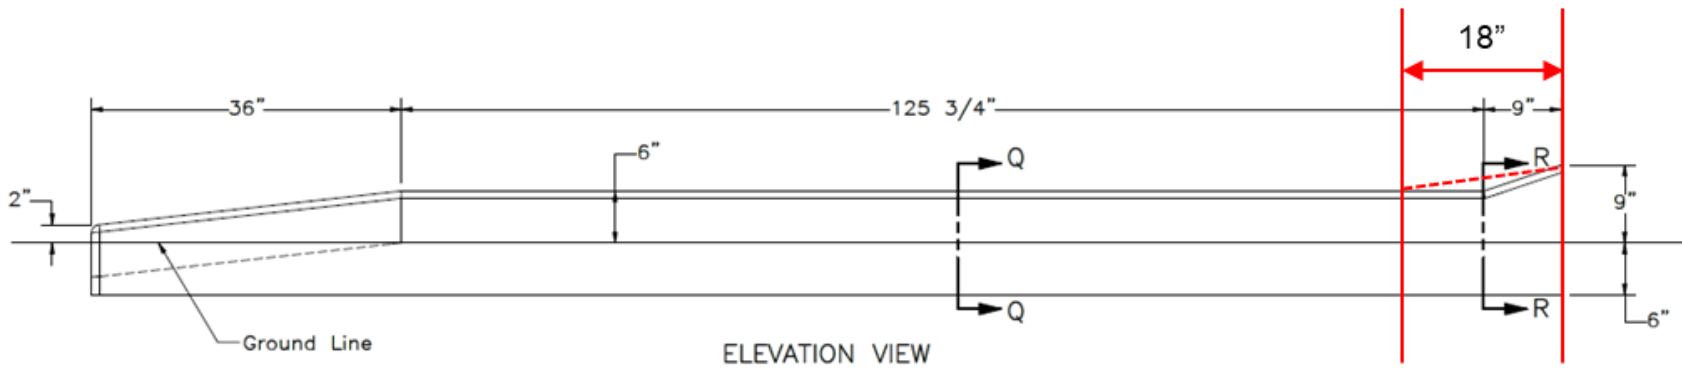
Figure 76. Curb Modification

As previously described, test no. HMDT-1 did not pass the MASH 2016 safety performance criteria for test designation no. 3-21 due to the excessive deformation of the wheel well and toe pan. Potential causes of failure and modifications to mitigate the concerns were investigated and discussed with HDOT prior to moving forward with crash testing of a modified AGT design.

Several design modifications were proposed to mitigate the vehicle snag and excessive wheel well and toe pan deformations. First, a flatter vertical slope for the curb may reduce abrupt wheel climb by reducing the slope from 3H:1V to 6H:1V, as shown in Figure 76. Second, reducing the post spacing adjacent to the bridge rail from 37½ in. to 18¾ in. and adding a W6x15 post between posts nos. 17 and 18 could increase the stiffness of the transition and reduce the potential for pocketing, as shown in Figure 77.

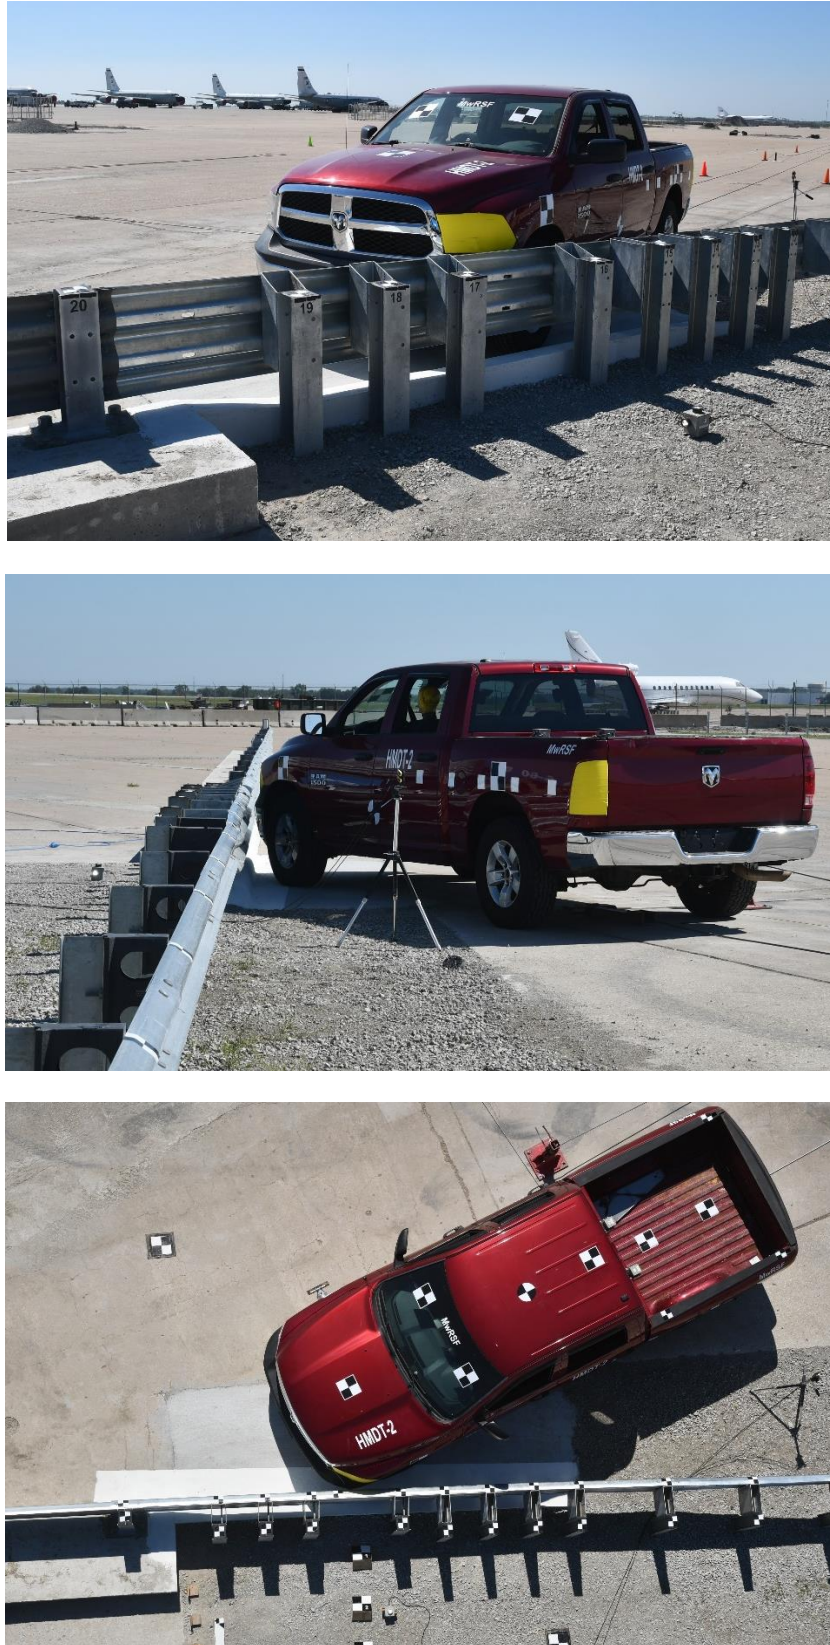
Figure 117. Impact Location, Test No. HMDT-2

Initial vehicle impact was to occur 11 in. upstream from post no. 17, as shown in Figure 117, which was selected using the CIP plots found in Figure 2-17 of MASH 2016 to maximize pocketing and the probability of wheel snag. The 4,981-lb crew cab pickup truck impacted the modified HDOT AGT at a speed of 62.5 mph and at an angle of 24.8 degrees. The actual point of impact was 18.5 in. upstream from post no. 17, or 7.5 in. upstream from the targeted impact location. The vehicle came to rest 203 ft downstream and 77.7 ft laterally behind the impact face of the system after the brakes were applied. The measured I.S. of test no. HMDT-2 was 114.4 kip-ft, which exceeded the 105.6 kip-ft minimum limit, as defined in MASH 2016 for test designation no. 3-21.

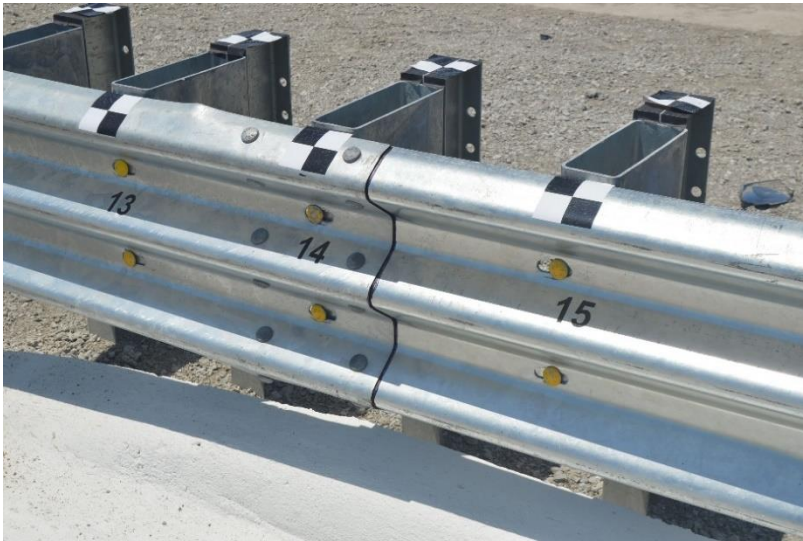
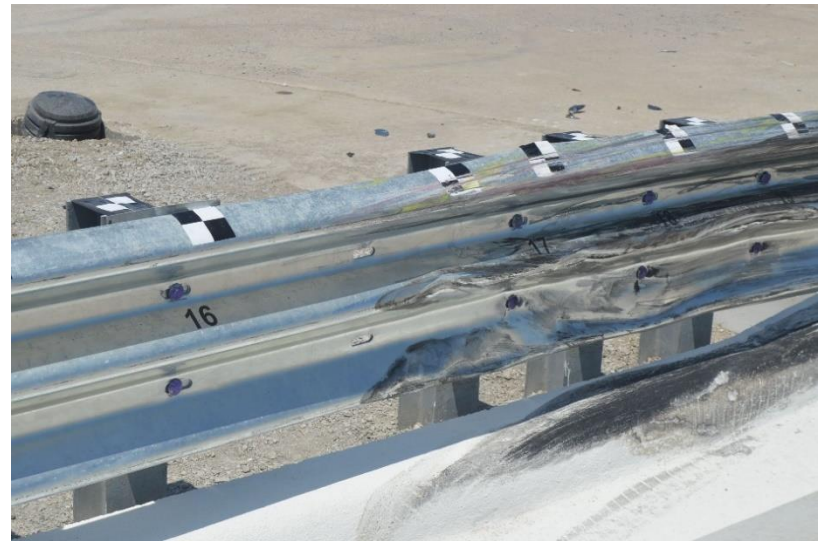
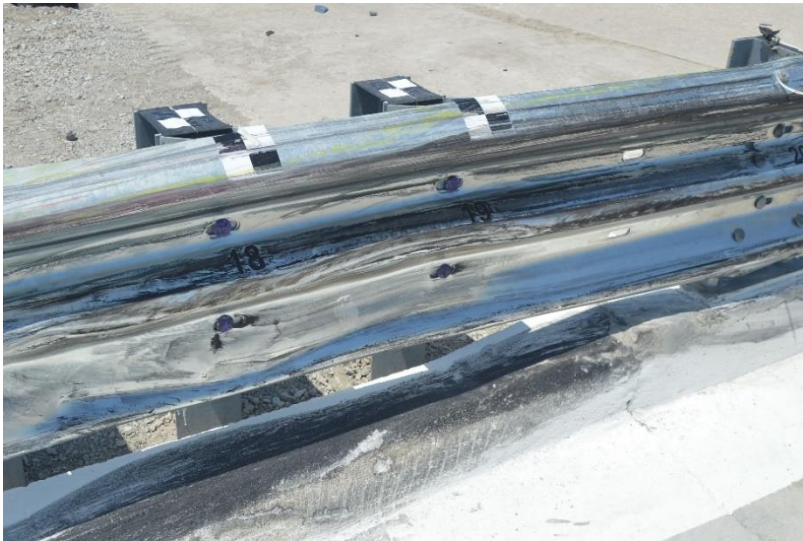
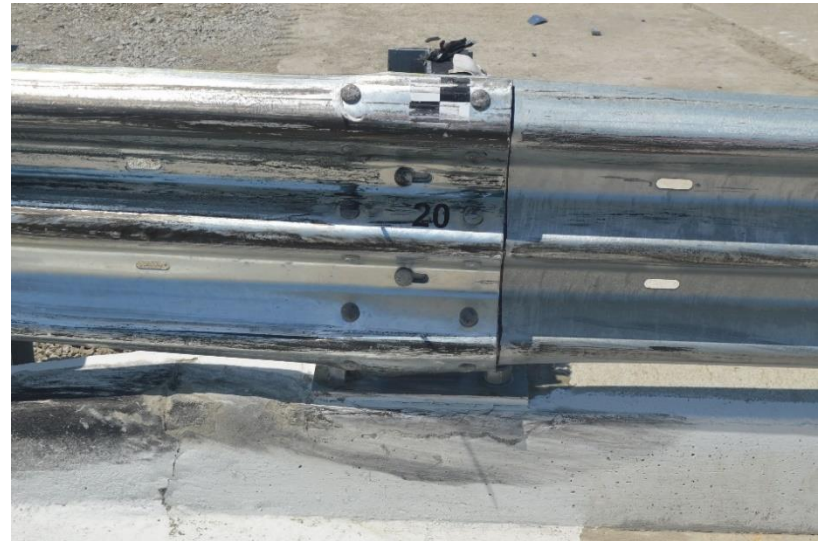
Figure 124. Thrie-Beam Rail Damage, Test No. HMDT-2

Damage to the barrier was moderate, as shown in Figures 123 through 125. Barrier damage consisted of contact marks, kinks, flattening, and deformation on the thrie-beam rail, contact marks on the front face of the curb, and minor spalling of the concrete sidewalk. The length of vehicle contact along the thrie-beam rail was approximately 176½ in., which spanned from 7¾ in. downstream from post no. 16 to approximately 3¼ in. upstream from post no. 21. There was minor gouging along the top and front face of the curb, starting 17¼ in. upstream from the baseplate edge at post no. 20 and extending 11¼ in. downstream.

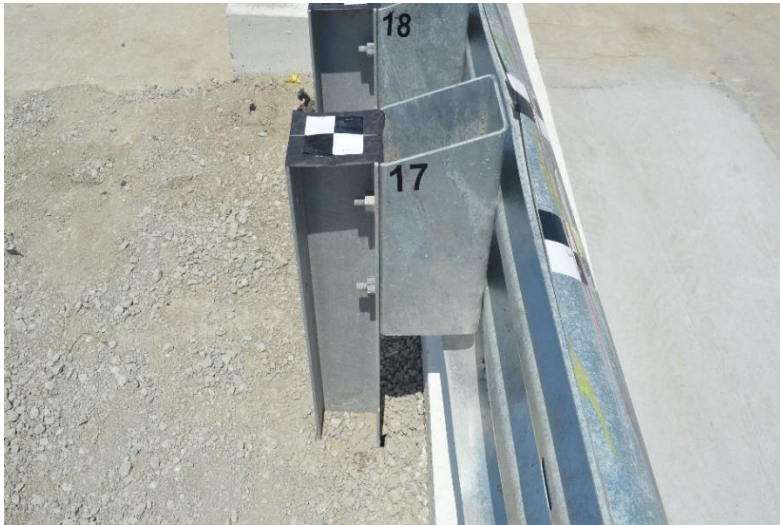
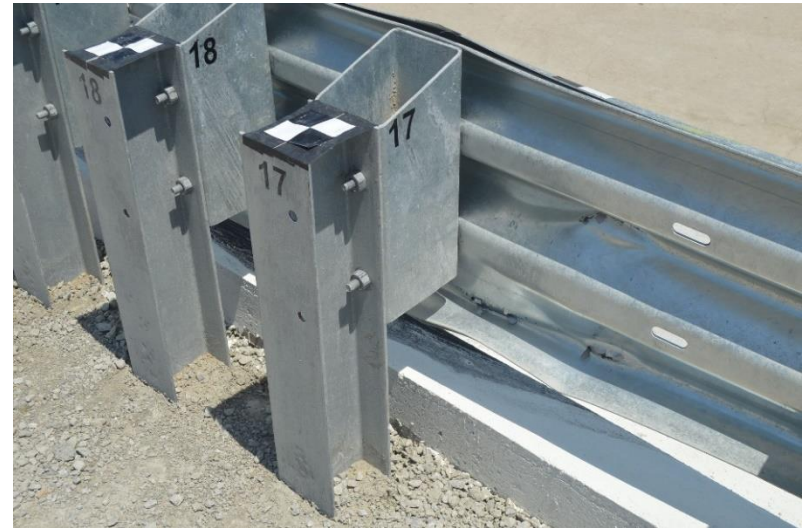
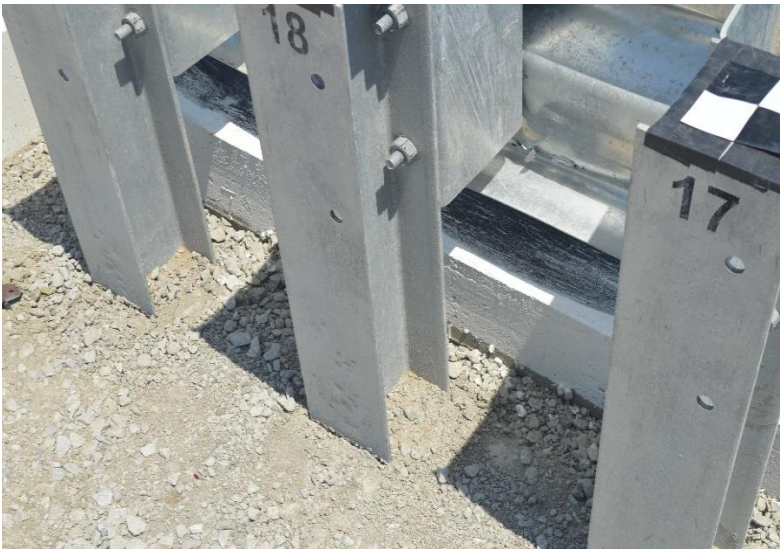
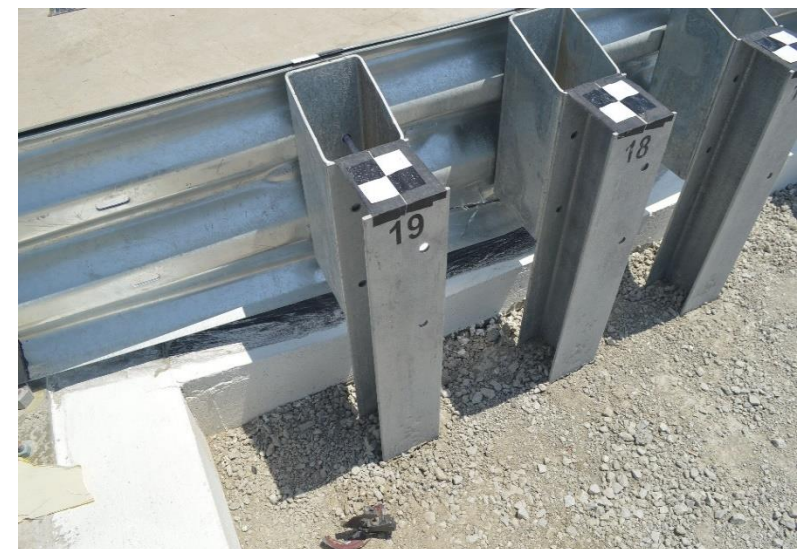
Figure 125. Soil Gap and Post Damage, Test No. HMDT-2

Post nos. 17, 18, and 19 rotated slightly backward. No other post damage or deflection was observed. Posts nos. 15, 16, and 17 through 19 had minor soil gaps measuring less than ¾ in. in front of and behind the posts. No movement was observed in the upstream anchorage system.

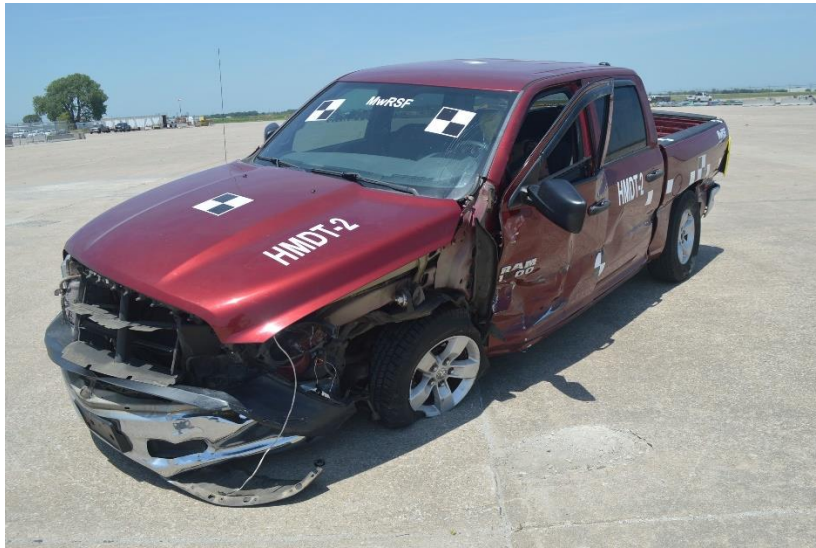
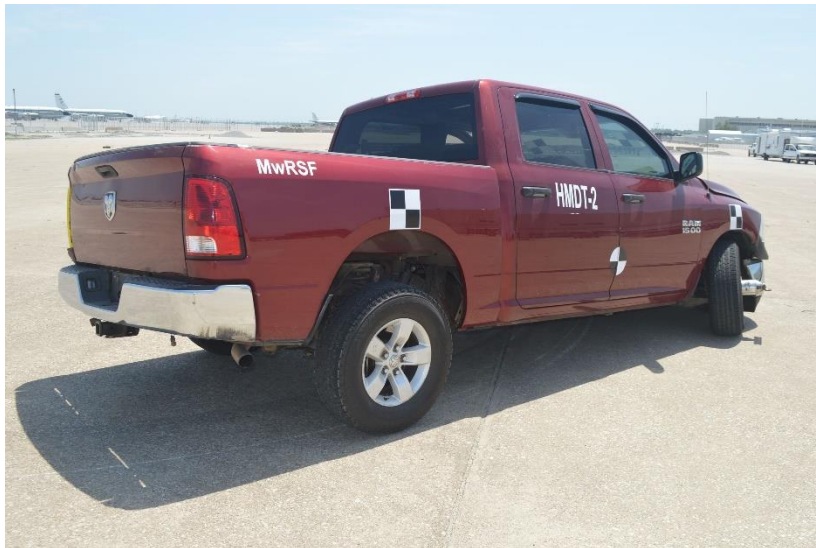
Figure 127. Vehicle Damage, Test No. HMDT-2

The damage to the vehicle was moderate, as shown in Figures 127 through 129. Majority of the damage was concentrated on the left-front corner and left side of the vehicle where the impact had occurred. The left-front quarter panel was disengaged, and the left-front wheel was pushed backward and inward toward the engine compartment. The left side of the front bumper, left-front headlight, and grille were disengaged. The left-front door was scraped, crushed, and bent outward. The full length of both left-side doors were dented and scraped. The left-front window was shattered. The left-rear quarter panel was scraped and crushed. The left-rear fender and bumper were dented inward.

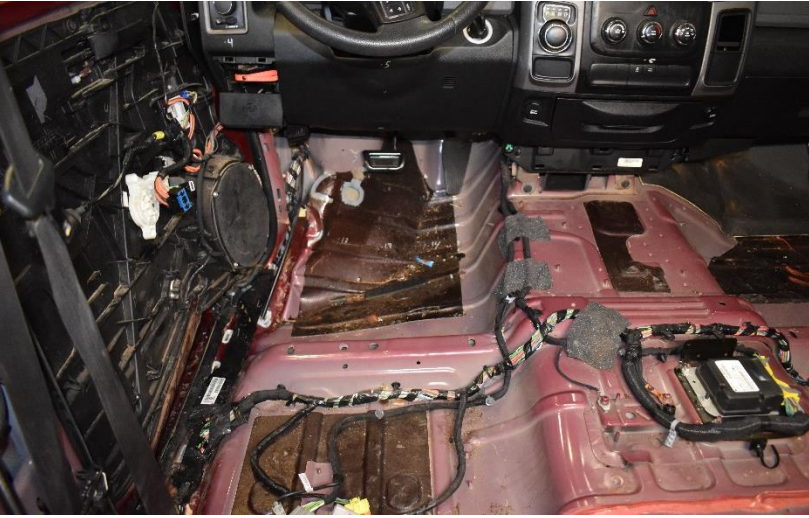
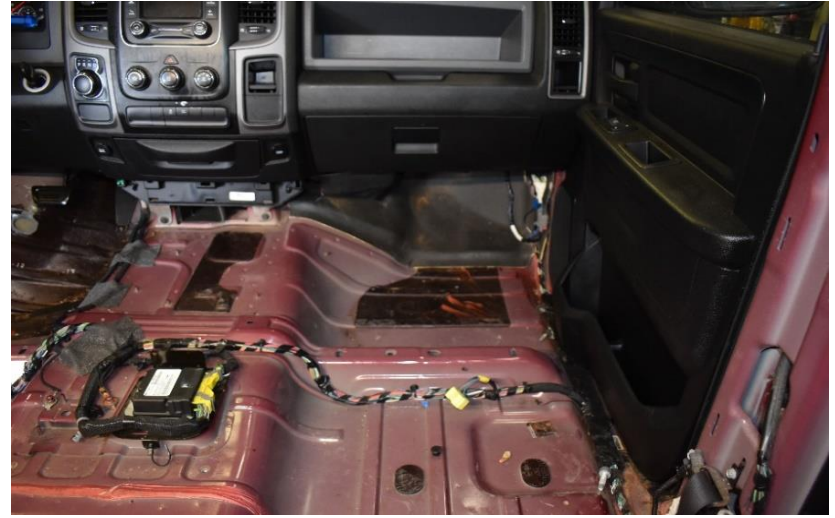
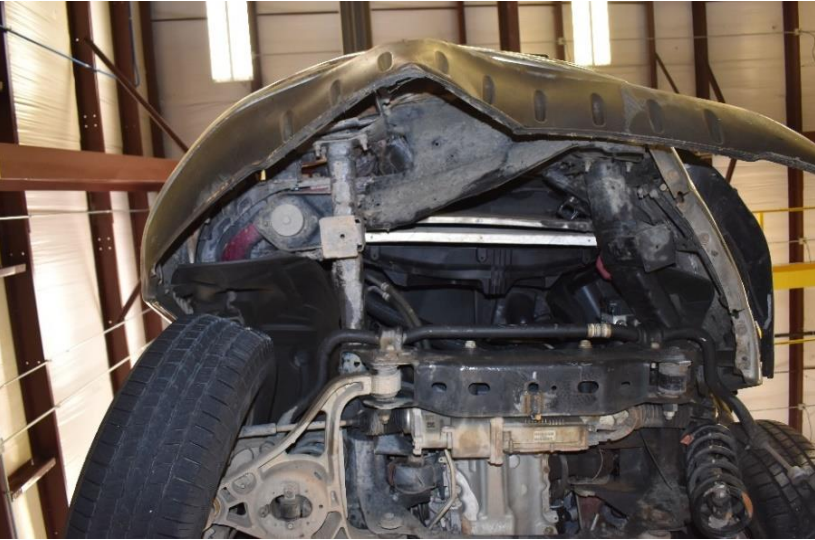
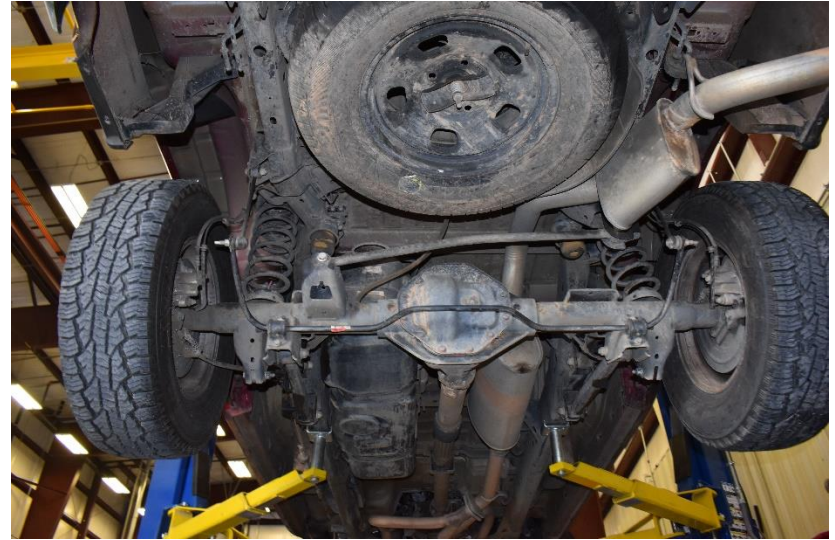
Figure 129. Interior and Undercarriage Damage, Test No. HMDT-2

Undercarriage damage was moderate. The left-front tire was torn, the left shock rod was bent, and the left shock was detached from the lower control arm. The left side end link of the sway bar was detached at the control arm. The upper ball joint of the left control arm fractured, and the left upper control arm was bent rearward. The left inner tie rod was disengaged from the steering rack. The secondary engine cross member buckled downward. The left side of the leading cross member was bent rearward and scraped along the leading edge. The second box mount was bent on both the right and left sides. There was no damage to the oil pan, floor pan, transmission pan, or gas tank.

Windshield damage was minimal, and some cracks on the windshield propagated from the lower-left corner to the upper left side. There was a small tear in the windshield caused by deformations to the vehicle's front-left side, quarter panel, and lower A-frame, not due to direct contact with the system.

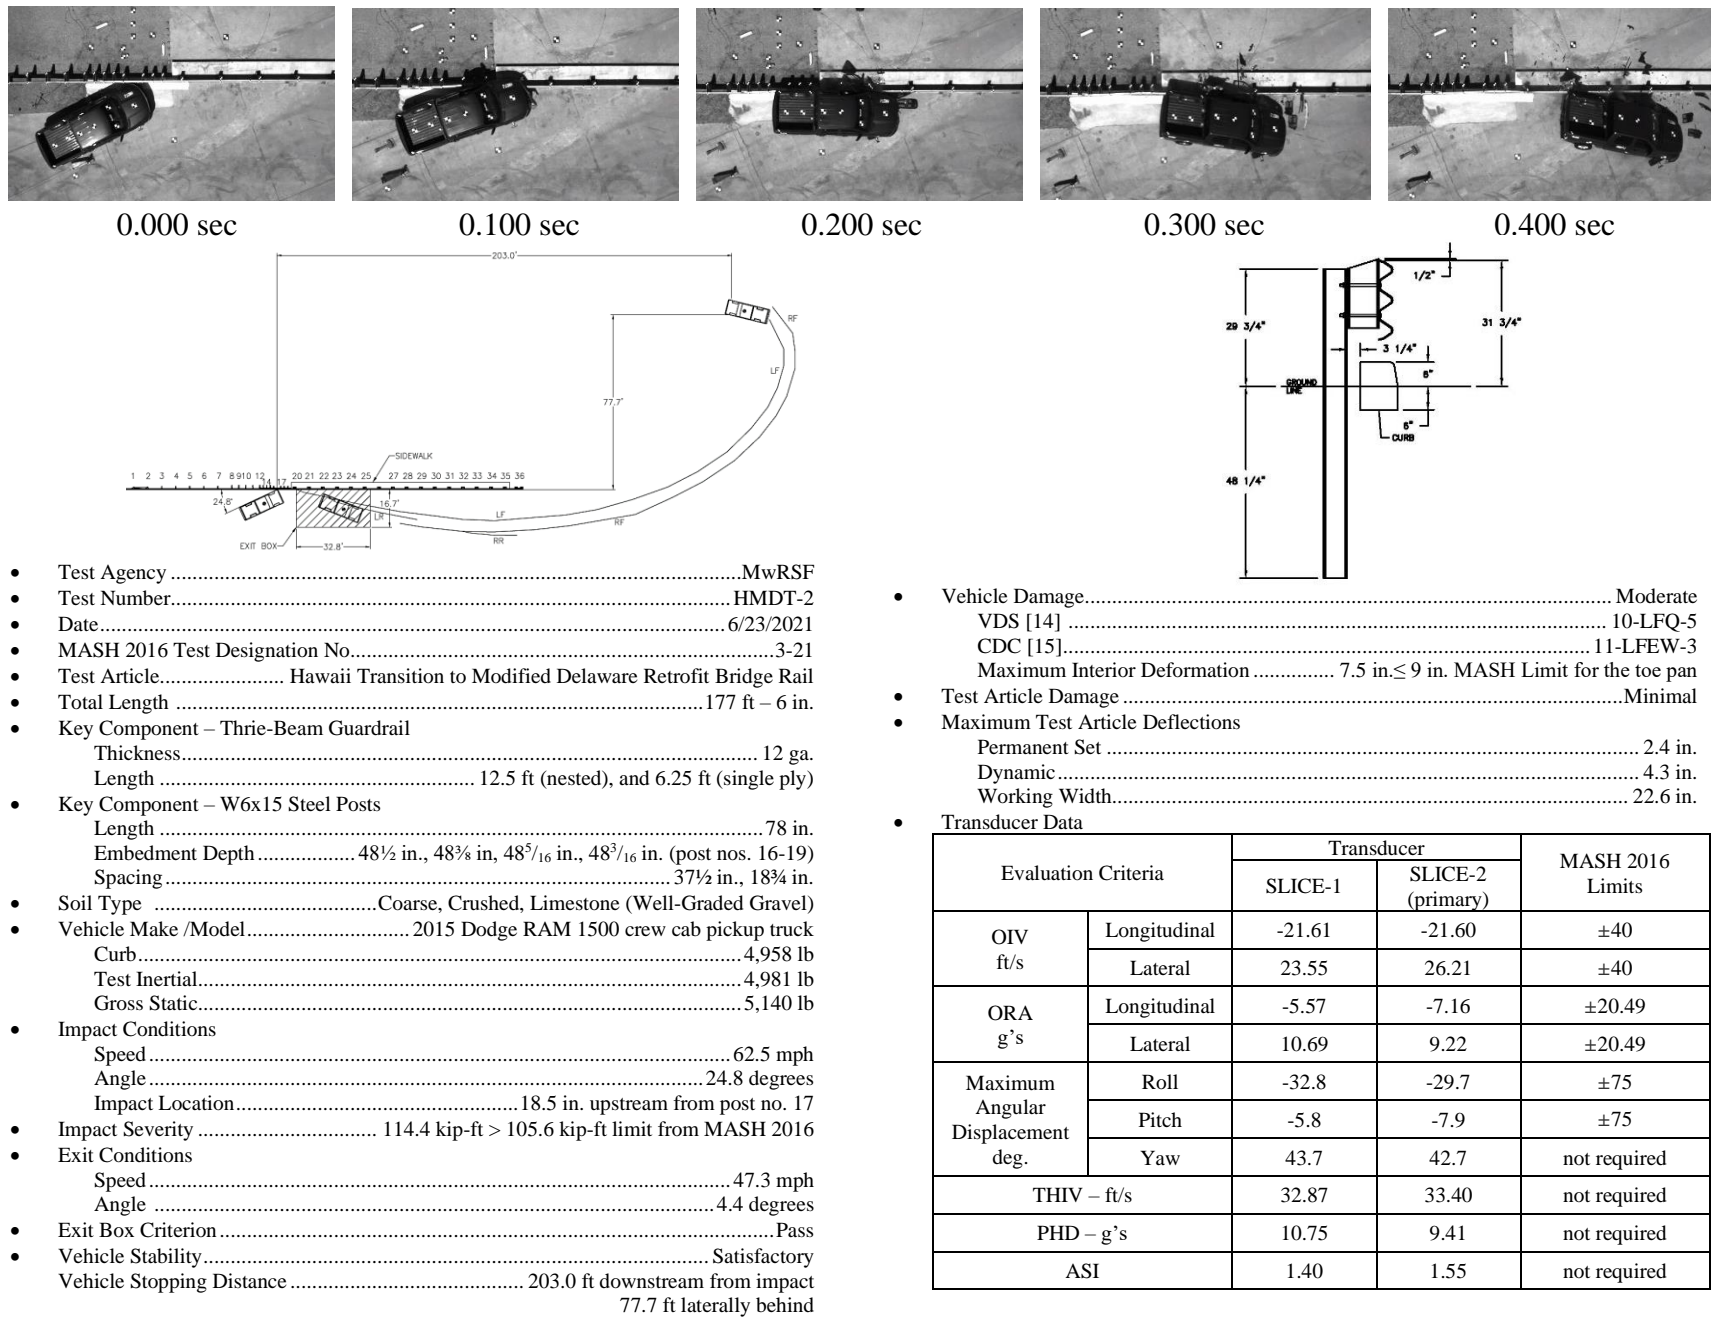
Figure 130. Summary of Test Results and Sequential Photographs, Test No. HMDT-2

The analysis of the results for test no. HMDT-2 showed that the system adequately contained and redirected the 2270P vehicle with controlled lateral displacements of the barrier. A summary of the test results and sequential photographs are shown in Figure 130. Detached elements, fragments, or other debris from the test article did not penetrate or show potential for penetrating the occupant compartment, or present an undue hazard to other traffic, pedestrians, or work-zone personnel. Deformations of, or intrusions into, the occupant compartment that could have caused serious injury did not occur. The test vehicle did not penetrate nor ride over the barrier and remained upright during and after the collision. Vehicle roll, pitch, and yaw angular displacements, as shown in Appendix H, were deemed acceptable, because they did not adversely influence occupant risk nor cause rollover. After impact, the vehicle exited the barrier at an angle of 4.4 degrees, and its trajectory did not violate the bounds of the exit box. Therefore, test no. HMDT-2 was determined to be acceptable according to the MASH 2016 safety performance criteria for test designation no. 3-21.

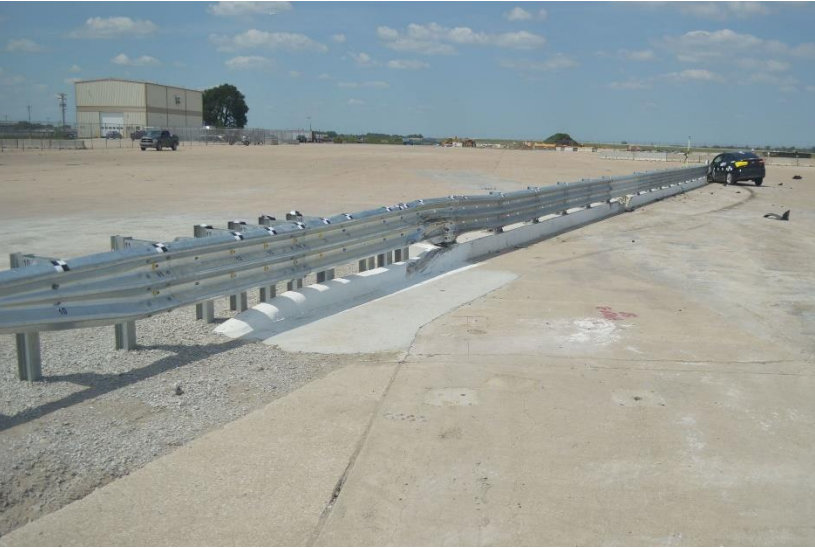
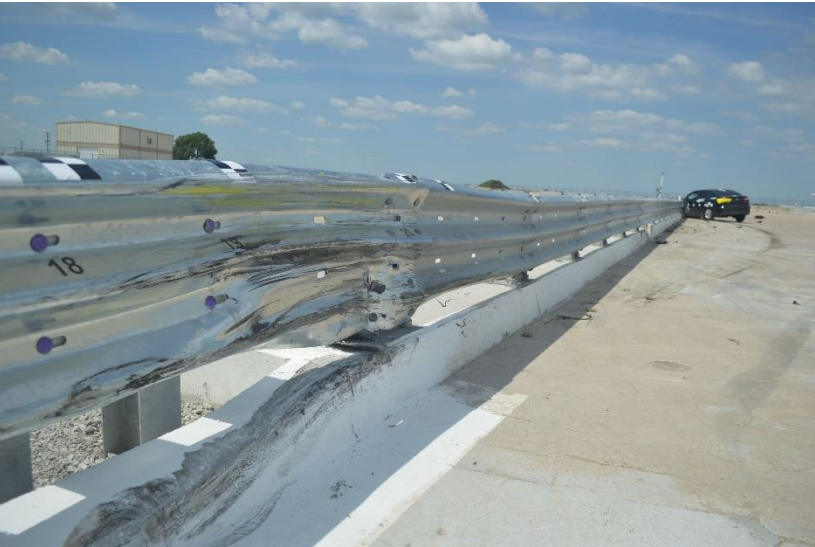
Figure 137. System Damage, Test No. HMDT-3

Damage to the barrier was minimal, as shown in Figures 137 through 139. Barrier damage consisted of contact marks on the curb and thrie-beam rail, concrete spalling, and deformation of the thrie-beam rail. The length of vehicle contact was approximately 113 in., which spanned from 7 in. upstream from post no. 18 and to 25¼ in. upstream from post no. 21.

A 67-in. long contact mark on the concrete curb and sidewalk started 12½ in. downstream from post no. 17. A 24-in. long gouge was found along the top and front face of the curb, starting 15 in. downstream from post no. 17. A 7½-in. long minor crack was found on the top face of the curb and extended toward the back of the curb between post nos. 19 and 20. The bottom corrugation of the thrie-beam rail was flattened, starting 2½ in. downstream from post no. 19 and extending 33 in. downstream. Kinks were found on the top and bottom edges of the thrie-beam rail along the length of contact. At post no. 18, there was a 4-in. long kink on the rail bottom corrugation and a 2-in. long kink on the rail top corrugation, starting from 4¼ in. upstream from post no. 21. The upstream, bottom two splice bolts at the splice located at post no. 20 fractured, and the downstream, bottom end of the upstream thrie beam was disengaged from the splice and bent backward.

Post nos. 10 and 11 rotated counterclockwise. Post deflection was minor and limited to post nos. 17 through 19. Post no. 20 bent backward. Posts nos. 17 and 19 had minor soil gaps measuring less than ½ in. between the curb and soil. No movement was observed in the upstream anchorage system.
