*Hawaii Department of Transportation
Research Contract No. 68212
Research Project No. STP-1500(092) – Phase II*

MASH TL-3 EVALUATION OF TRANSITION TO HAWAII MODIFIED DELAWARE RETROFIT THRIE-BEAM BRIDGE RAIL

MwRSF Research Report No. TRP-03-449-22

August 22, 2022

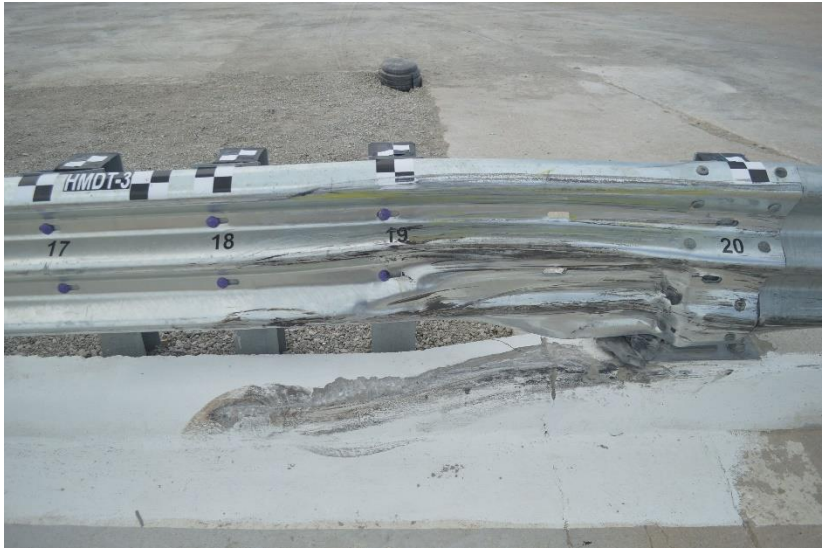
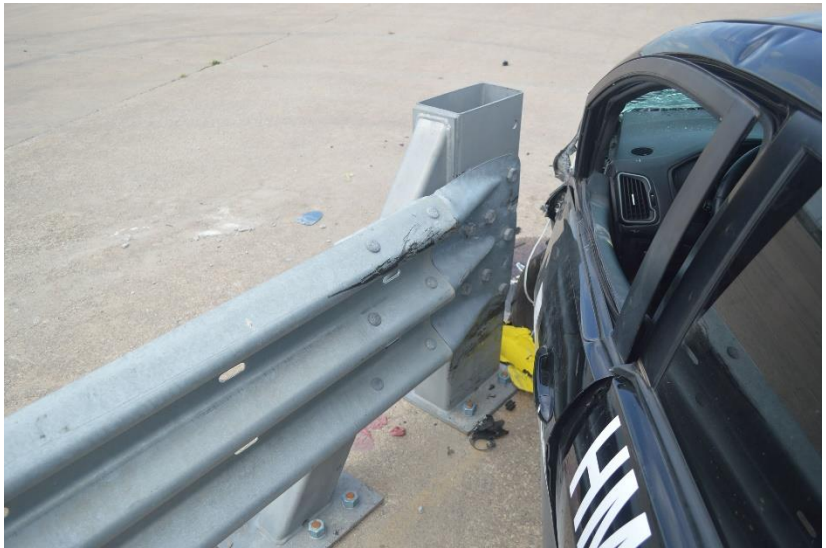
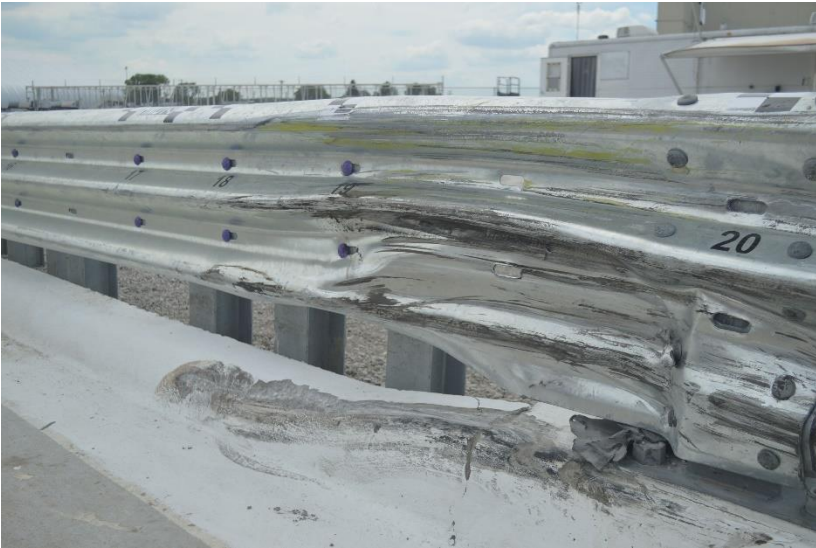
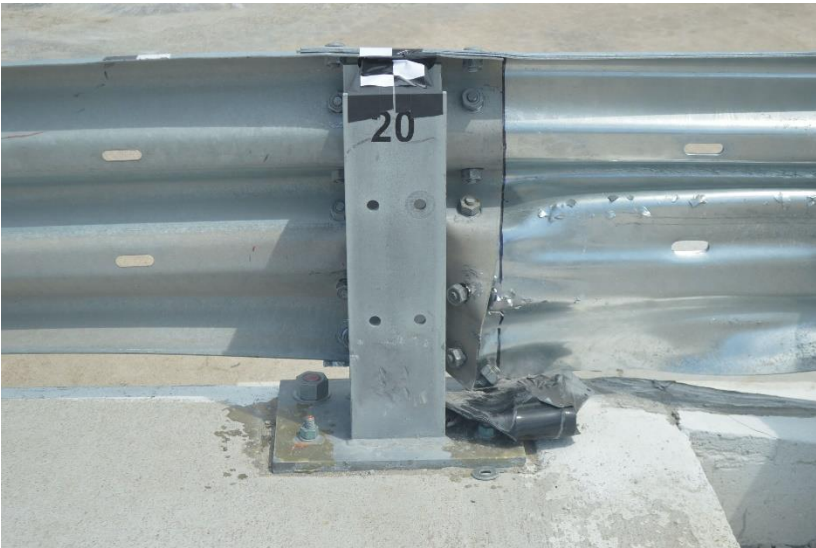
Figure 138. Thrie-Beam Rail Damage, Test No. HMDT-3

A 67-in. long contact mark on the concrete curb and sidewalk started 12½ in. downstream from post no. 17. A 24-in. long gouge was found along the top and front face of the curb, starting 15 in. downstream from post no. 17. A 7½-in. long minor crack was found on the top face of the curb and extended toward the back of the curb between post nos. 19 and 20. The bottom corrugation of the thrie-beam rail was flattened, starting 2½ in. downstream from post no. 19 and extending 33 in. downstream. Kinks were found on the top and bottom edges of the thrie-beam rail along the length of contact. At post no. 18, there was a 4-in. long kink on the rail bottom corrugation and a 2-in. long kink on the rail top corrugation, starting from 4¼ in. upstream from post no. 21. The upstream, bottom two splice bolts at the splice located at post no. 20 fractured, and the downstream, bottom end of the upstream thrie beam was disengaged from the splice and bent backward.

As previously described, test no. HMDT-3 did not pass the MASH 2016 safety performance criteria for test designation no. 3-20 due to the excessive side front panel deformation and vehicle component penetration of the occupant compartment. During the test, the bottom rail corrugation of the nested thrie beam AGT rails were flattened and formed a sharp kink adjacent to the first bridge rail post (i.e., post no. 20), as shown previously in Figures 137 through 139. These localized rail deformations resulted in the front wheel snagging on the bridge rail post and being pushed toward the occupant compartment. Thus, the AGT rail segments adjacent to the bridge rail post needed to be reinforced against localized deformations (flattening and kinking) to mitigate wheel snag and the corresponding occupant compartment deformation.

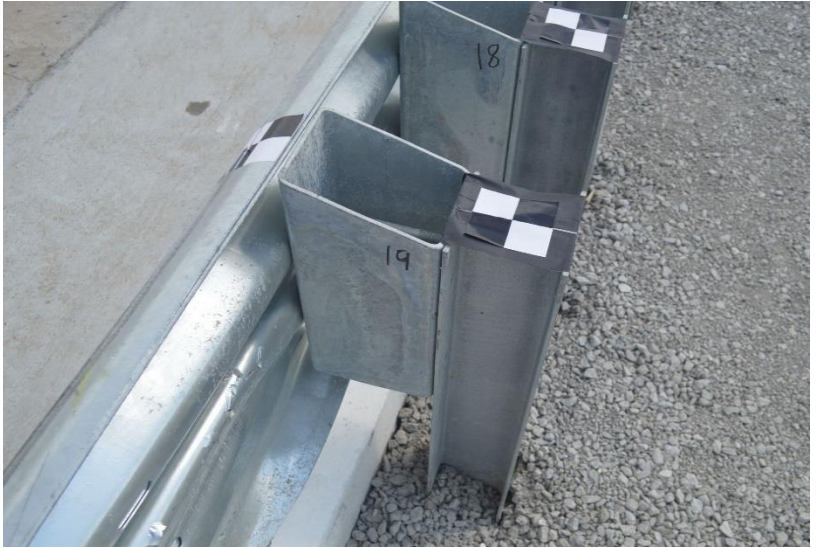
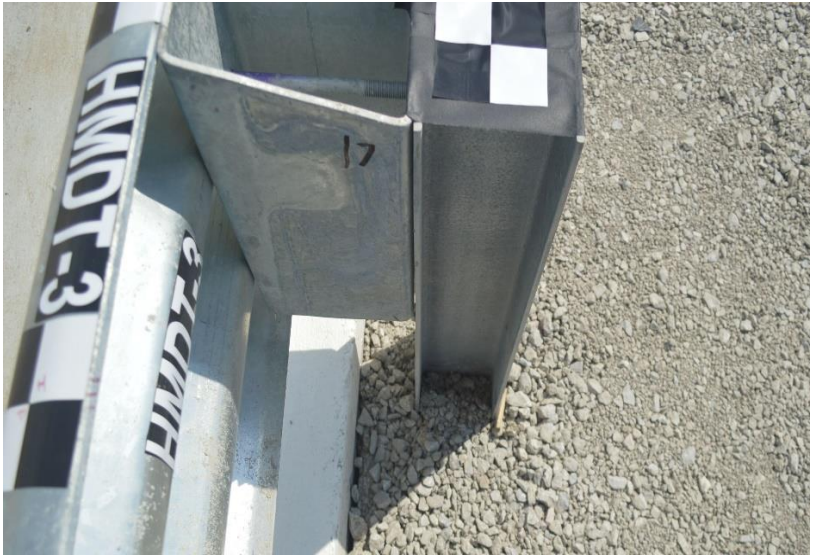
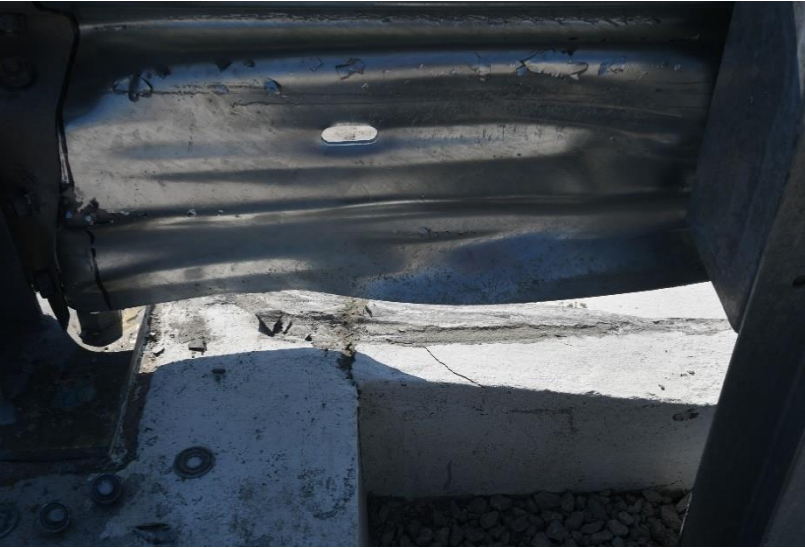
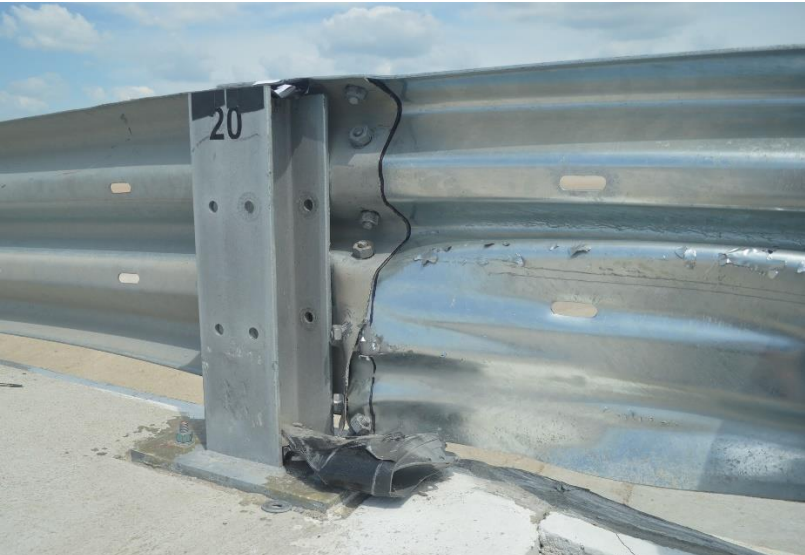
Figure 139. Curb and Post Damage, Test No. HMDT-3

Post nos. 10 and 11 rotated counterclockwise. Post deflection was minor and limited to post nos. 17 through 19. Post no. 20 bent backward. Posts nos. 17 and 19 had minor soil gaps measuring less than ½ in. between the curb and soil. No movement was observed in the upstream anchorage system.

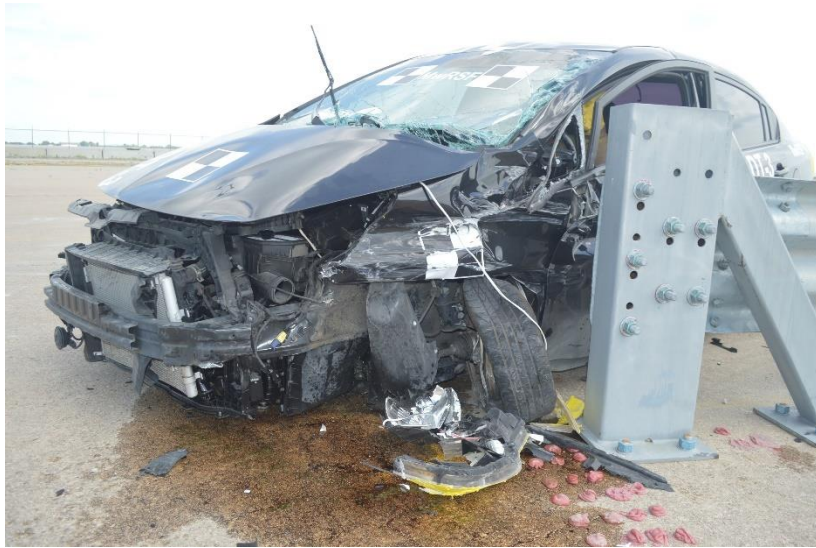
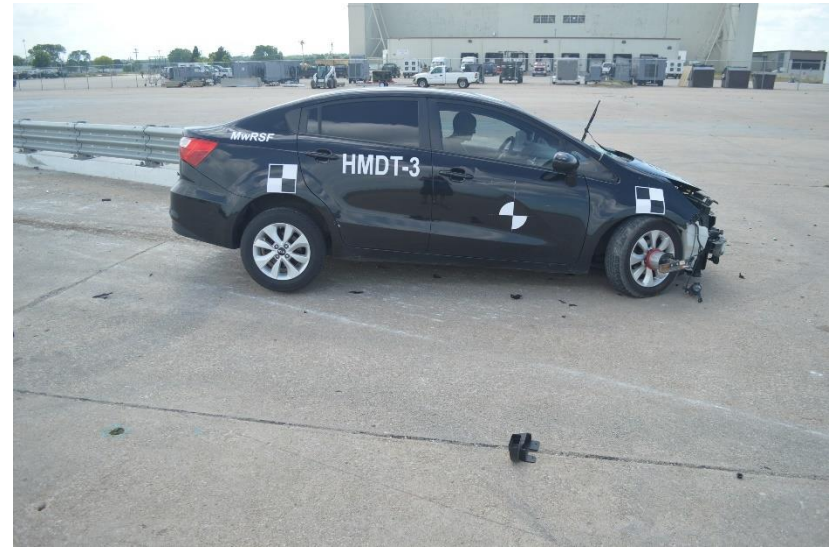
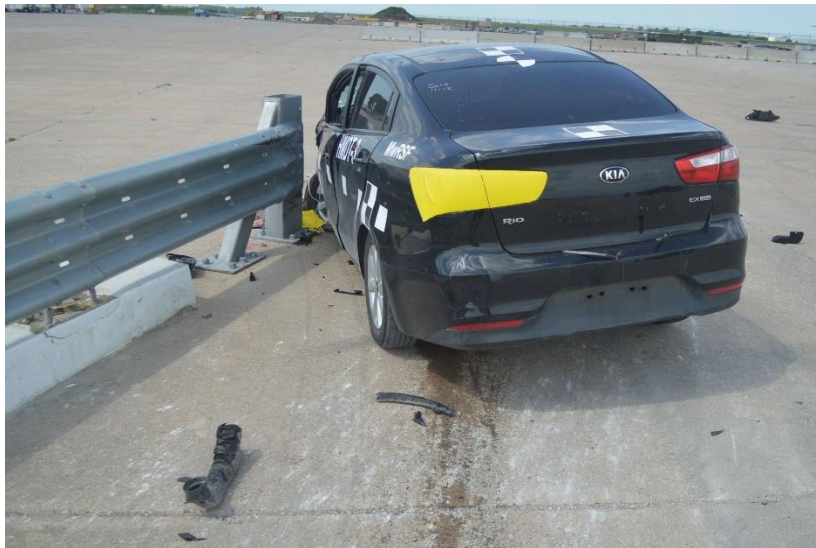
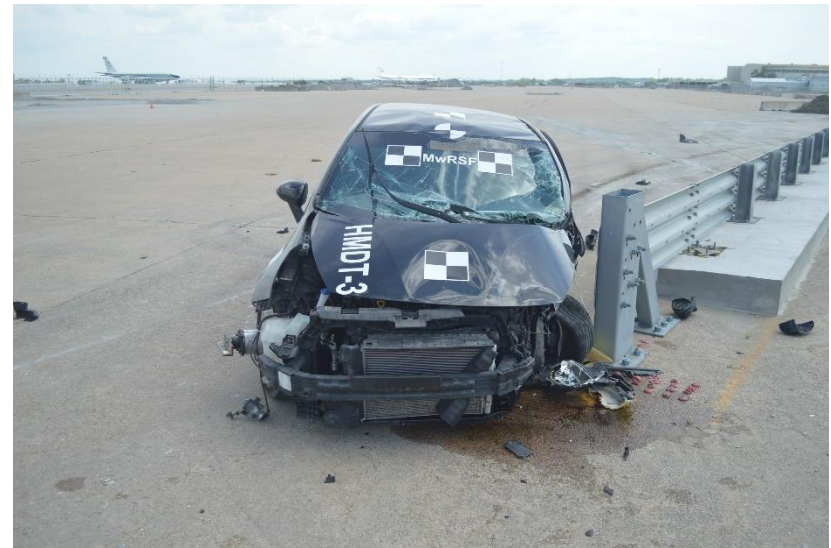
Figure 141. Vehicle Damage, Test No. HMDT-3

The damage to the vehicle was moderate, as shown in Figures 141 through 143. Majority of the damage was concentrated on the left-front corner and left side of the vehicle. The front bumper was disengaged. The hood was slightly rotated toward the left side, and the front center was dented. Both headlights disengaged. The front side of the left fender was scraped, dented, and crushed inward along the entire length. At the rear side, the left front fender was separated from the A-pillar. The scrapes from the fender continued along the half of the left-front door. The left-front door was shifted backward and bent, leading to a gap between the frame and the door at both the top and bottom of the door. The left-front and left-rear doors were dented at their intersection at the center of the panel. The left-rear door had a dent in the center of the panel. The front half of the roof was dented in several places, including a dent that started at the frame above the left-front door and continued to the center of the roof.

The windshield was cracked across its entire width, with extensive cracking located at the lower left-side corner. The right and left windshield wipers penetrated the windshield. The left-front window was shattered. The left side mirror was disengaged. The left-front tire was deflated and partially separated from the rim with punctures and a tear in the sidewall. The outer side of the front-left wheel rim was bent outward. The front-left wheel was crushed backward and inward, creating an opening in the toe pan and tearing an opening in the undercarriage body panel seams.

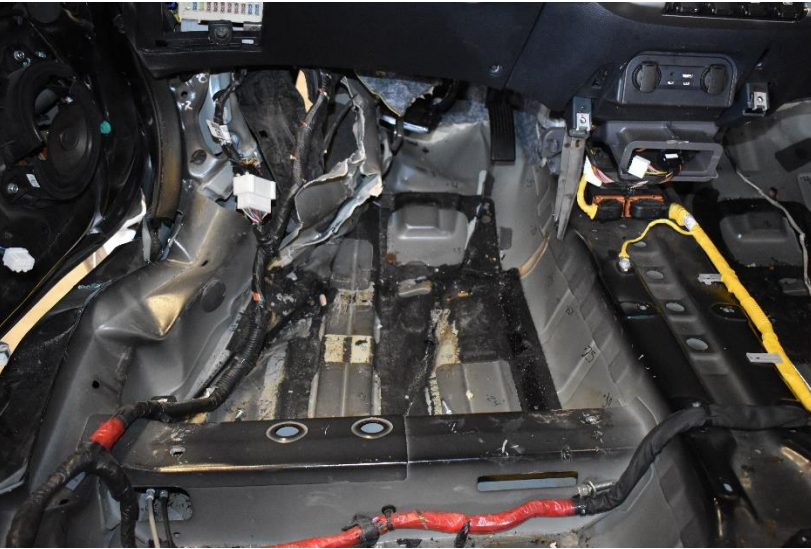
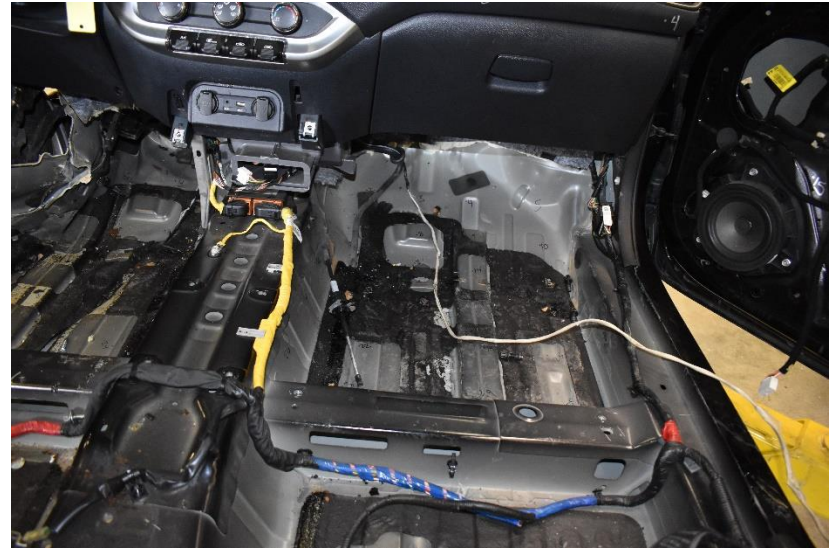
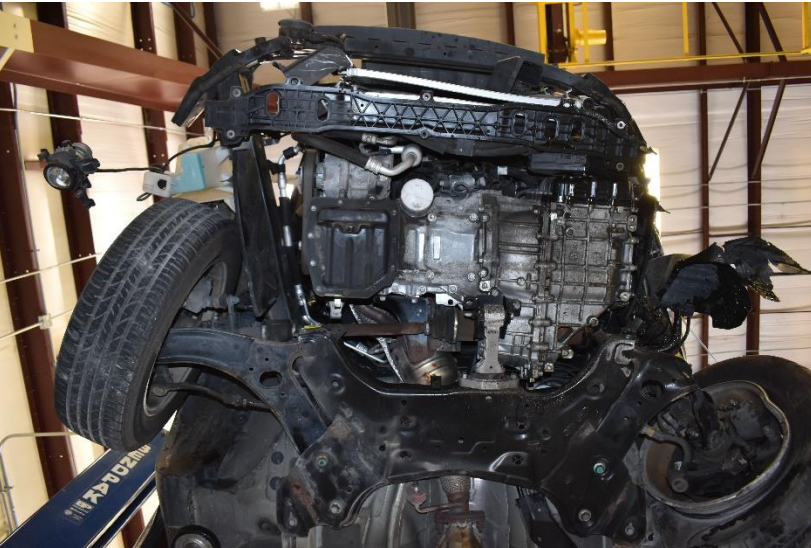
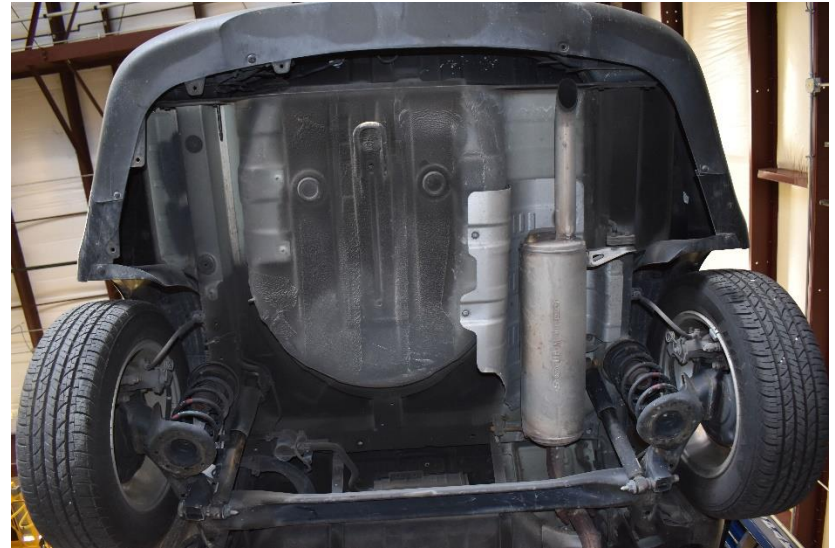
Figure 143. Interior and Undercarriage Damage, Test No. HMDT-3

Undercarriage damage was moderate. The left side of the front sway bar was bent backward, and the entire assembly was shifted to the right. The left steering knuckle was broken at the lower ball joint. The left-side control arm was disconnected from the steering knuckle, bent rearward and twisted. The outer tie rod of the left steering control arm was bent approximately 90 degrees rearward. There was no damage to the shocks, springs, and rear suspension. The engine and transmission cross members were scraped on the bottom left side. The engine and transmission mounts were stressed but not visibly damaged. The floor pan was dented and creased. The left side of the floor pan was bent upward.

The maximum occupant compartment intrusions are listed in Table 17, along with the intrusion limits established in MASH 2016 for various areas of the occupant compartment. Note that the damage to the vehicle was so severe that post-test vehicle crush measurements were not possible. Instead, the maximum deformation was measured through comparative crush using an undamaged vehicle of the same body style. The maximum intrusion was measured at the side front panel in front of the A-pillar and was 13³/₈ in., which exceeded the MASH 2016 limit of 12 in., as shown in Figure 144. Additionally, the left-front wheel penetrated the toe pan area. These penetration and exceedance of the occupant compartment intrusion limits resulted in the failure of test no. HMDT-3 to meet the MASH 2016 criteria.

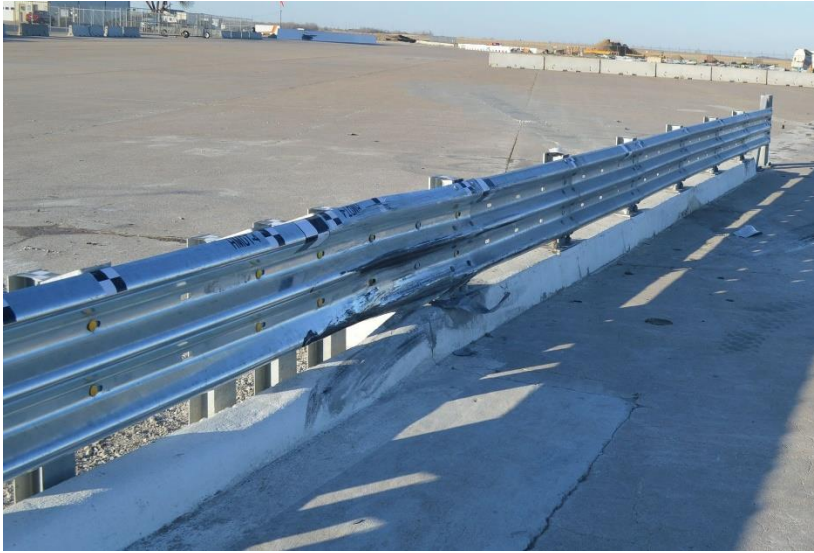
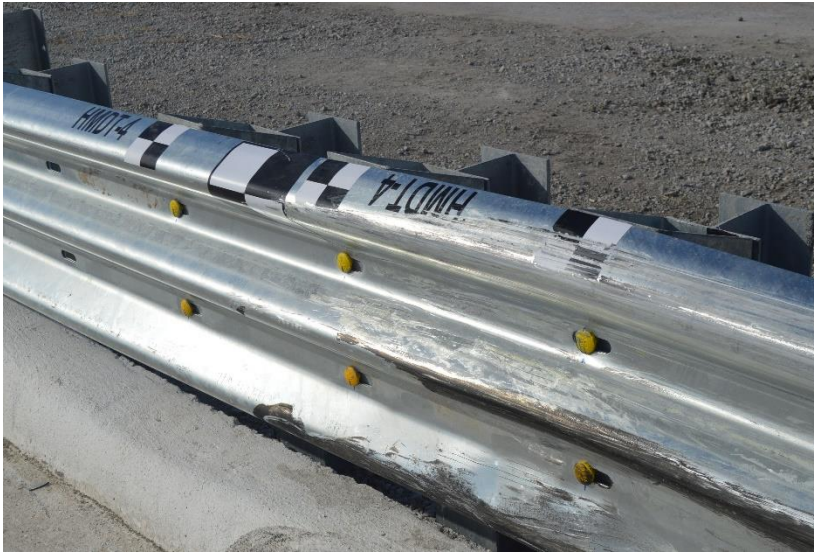
Figure 190. System Damage, Test No. HMDT-4

Damage to the barrier was minimal, as shown in Figures 190 and 191. Barrier damage consisted of contact marks on and kinking of the thrie-beam sections, contact marks on the front face of the curb, and minor spalling of the concrete. The total length of vehicle contact along the system was approximately 215 in., which began 3 in. downstream from the center line of post no. 17.

A contact mark was found on the concrete curb starting 3 in. downstream from post no. 17 and extending to the concrete sidewalk. A minor gouge was found along the top and front face of the curb, starting 4 in. upstream from post no. 18 and extending 12 in. downstream. A crack on the interface of the concrete curb and sidewalk had occurred in the previous test, test no. HMDT-3. Minor spalling of the concrete was found around that crack.

Post no. 17 had a soil gap of 1/16 in. on the back of the post, and post no. 19 had soil gaps of ¾ and ¼ in. in front and back of the post, respectively. Post nos. 18 and 19 had a soil heave on the back side and measured 11 in. diameter and 1½ in. high. No post damage or movement occurred to the upstream anchorage system.

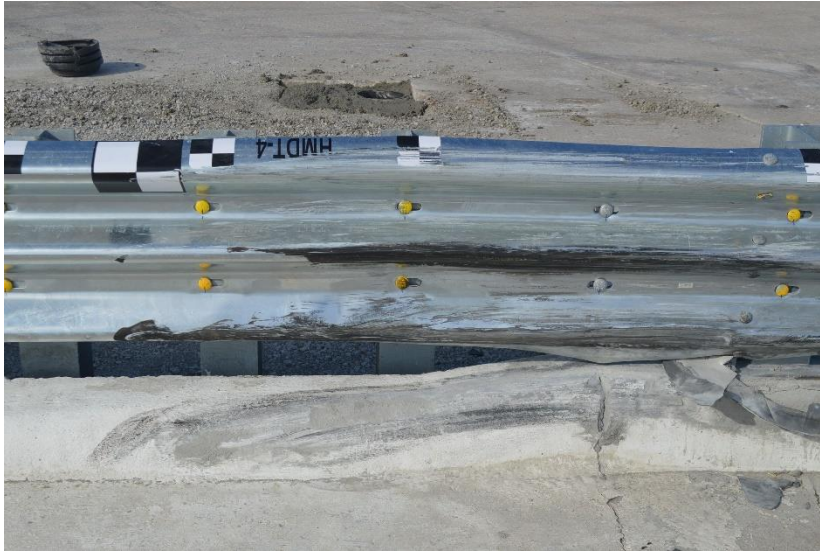
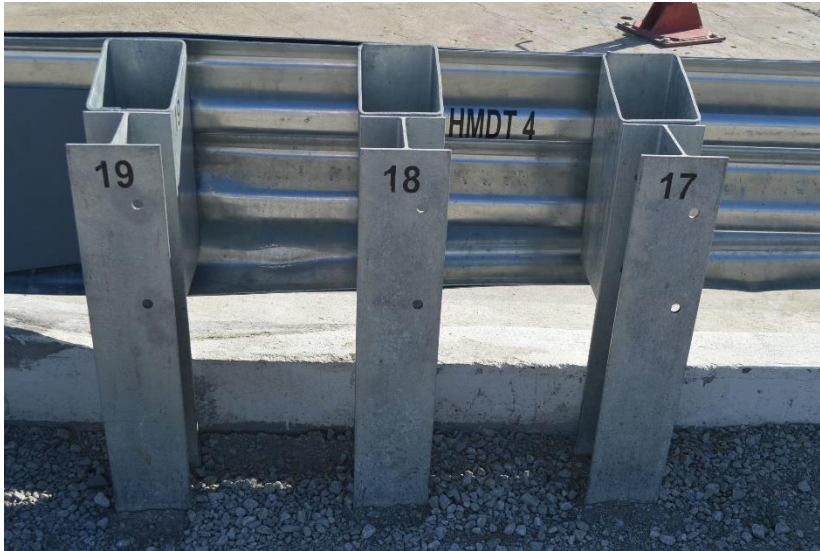
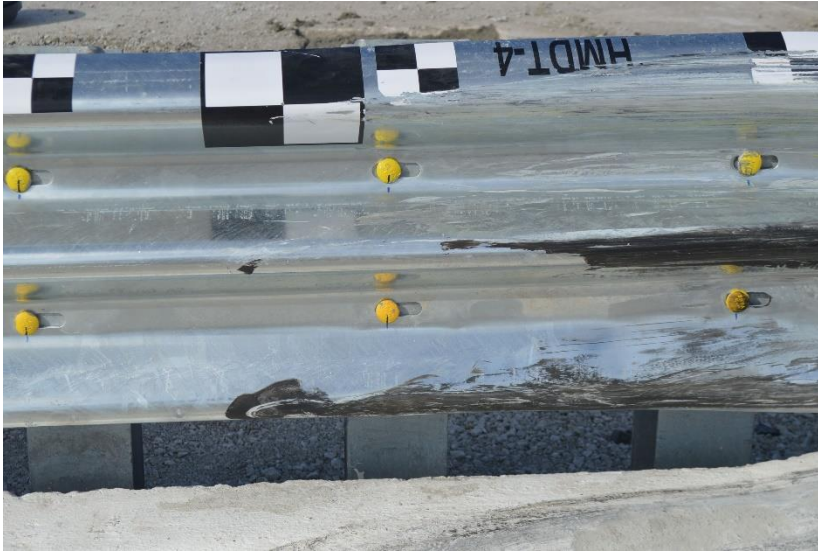
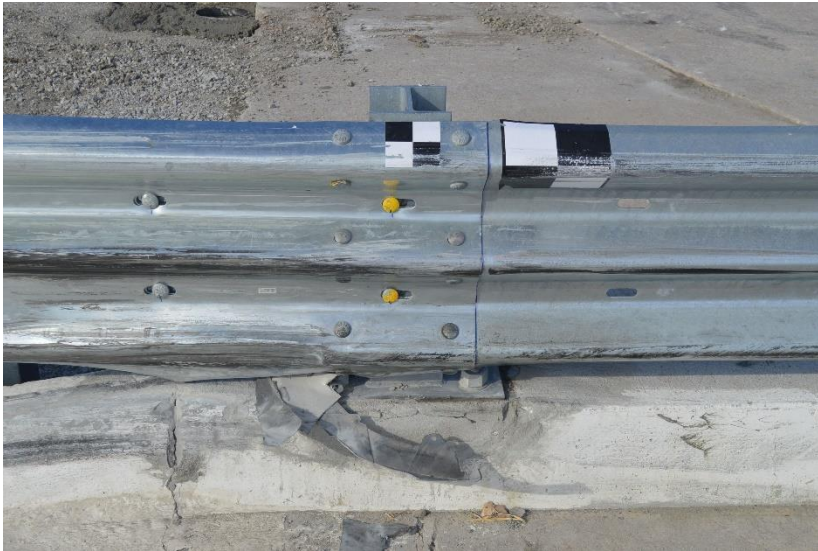
Figure 191. Thrie-Beam Rail Damage, Test No. HMDT-4

Contact marks on the thrie-beam rail began 8 in. downstream from the centerline of post no. 17, continued 124½ in. downstream to the bridge rail, and extended 57½ in. downstream from post no. 20. The thrie-beam rail slightly bent inward for a length of 90 in., starting 17 in. upstream from post no. 17. Multiple kinks were found on the top and bottom of the thrie-beam rail around post nos. 18 and 19. The bottom corrugation of the thrie-beam rail was flattened, beginning 13 in. downstream from post no. 19 and continued to the upstream edge of post no. 20. Dents were found on the bottom corrugation of the thrie-beam rail, starting 12 in. upstream from post no. 19 for a length of 16 in. and starting 23½ in. upstream from post no. 20 for a length of 16¾ in.

The maximum lateral permanent set of the barrier system was 1.3 in., which occurred at the rail between post nos. 19 and 20, as measured in the field. The maximum lateral dynamic barrier deflection was 3.2 in., which occurred at post no. 19, as determined from high-speed digital video analysis. The working width of the system was found to be 21.6 in., also determined from high-speed digital video analysis. A schematic of the permanent set deflection, dynamic deflection, and working width is shown in Figure 192.

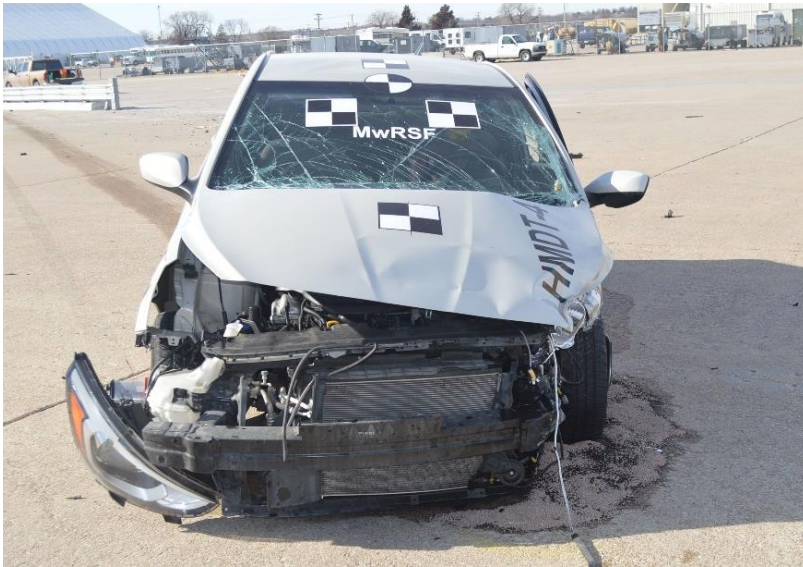
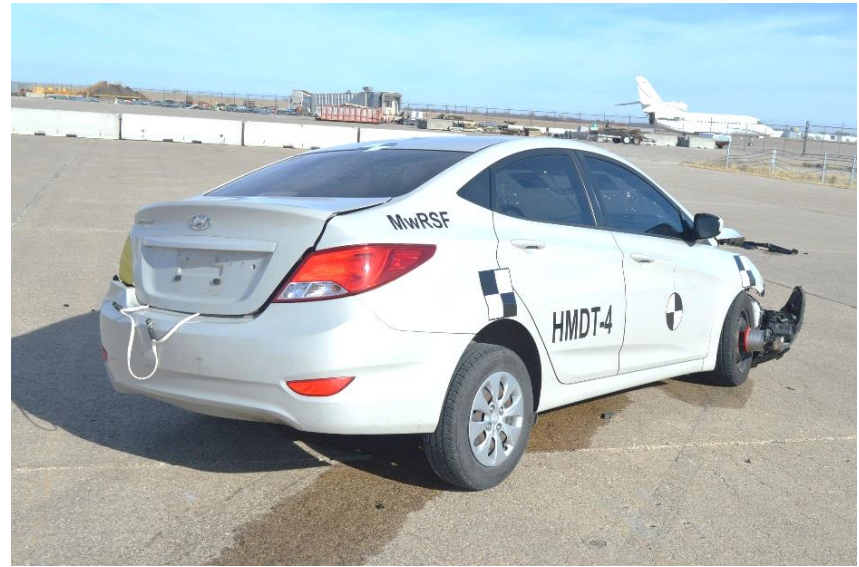
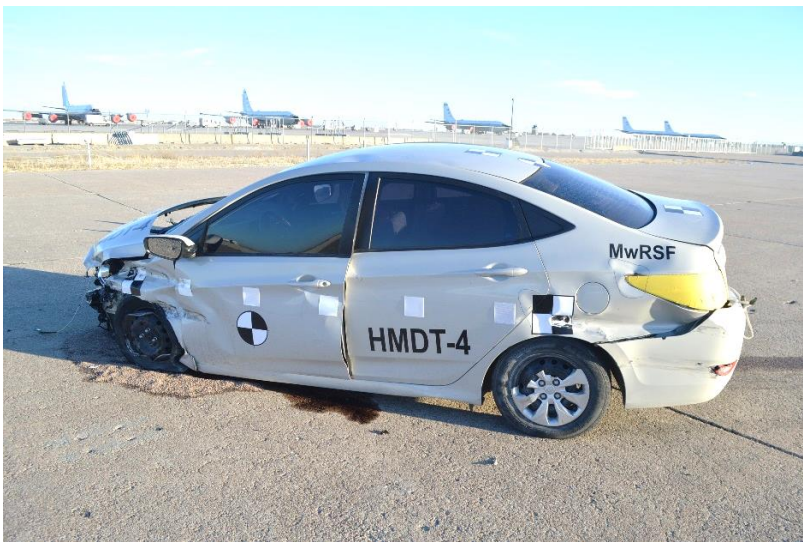
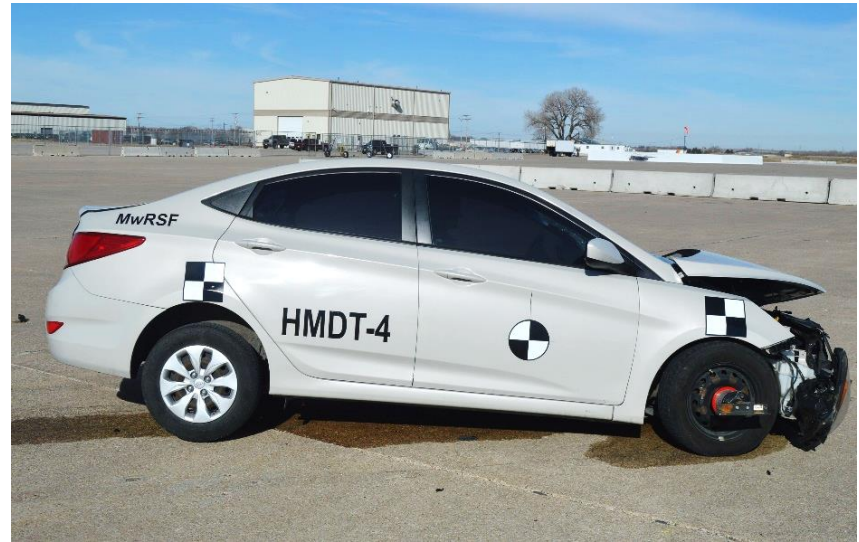
Figure 193. Vehicle Damage, Test No. HMDT-4

The damage to the vehicle was moderate, as shown in Figures 193 through 195. Majority of the damage was concentrated on the left-front corner and left side of the vehicle where the impact had occurred. The front bumper was disengaged. The hood was slightly warped inward and bent upward. The right-side headlights disengaged from the housing. The vehicle was scraped and crushed inward along the entire left side. The left-front door was shifted slightly backward and bent, leading to a gap between the frame and the door at the top and back side. The left-front door was also dented at the back and the center of the panel. The left-rear fender was displaced inward and bent inward on the back side. The rear bumper was scraped on the left-side. The left-front corner of the roof was dented. The windshield was cracked across the whole surface, with more severe cracking near the bottom and left side corner.

The left-front tire was deflated and partially separated from the rim. The outer side of the left-front wheel rim was bent outward at several places. The left-rear wheel cover fractured and disengaged, but there was no visible damage on the rim. The lower control arm of the left suspension was twisted inward. The left frame rail was bent inward. No other damage to the vehicle's undercarriage was observed.

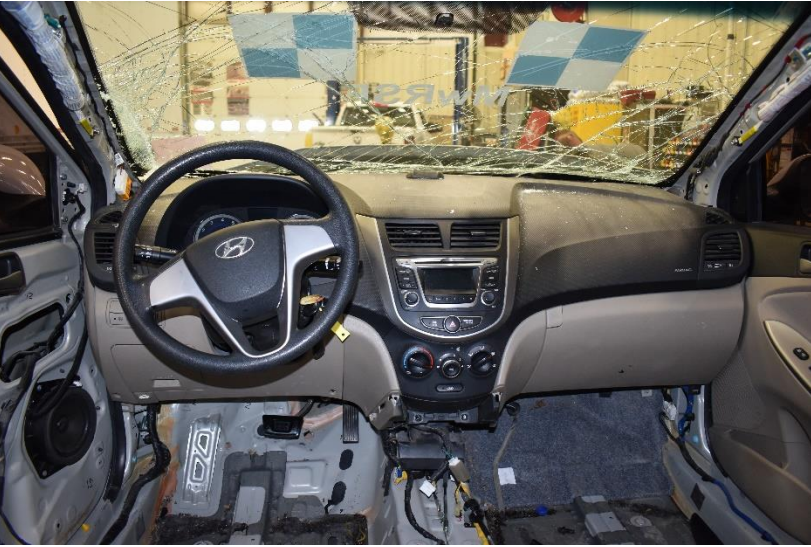
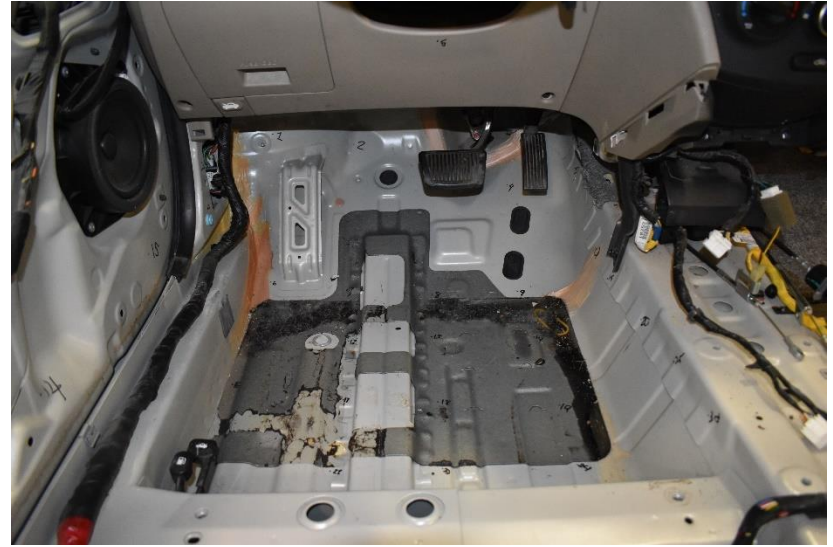
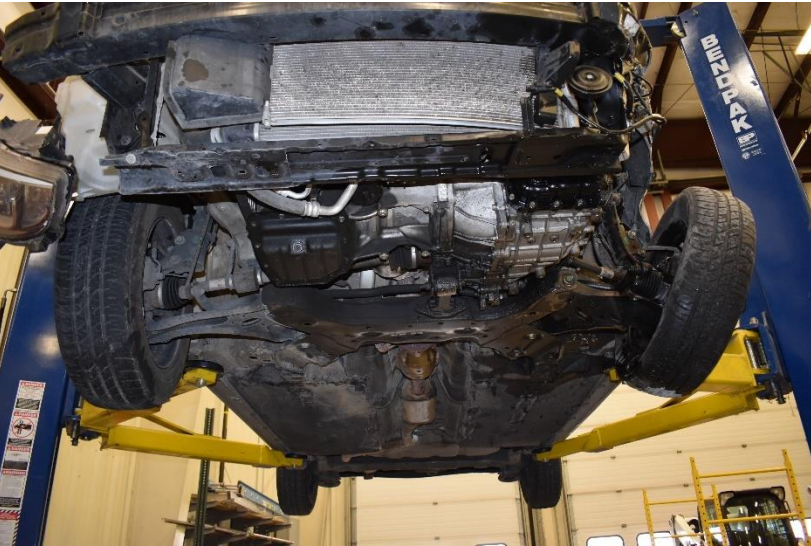
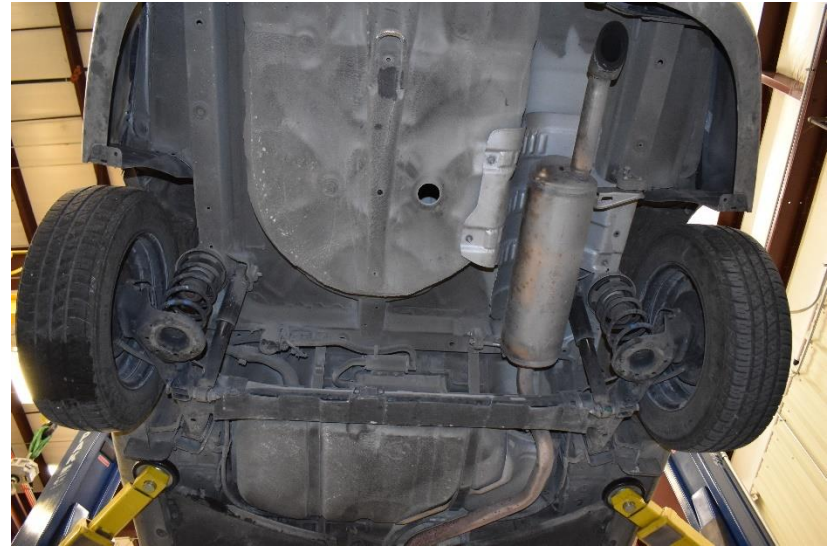
Figure 195. Interior and Undercarriage Damage, Test No. HMDT-4

The maximum occupant compartment intrusions are listed in Table 21, along with the intrusion limits established in MASH 2016 for various areas of the occupant compartment. Complete occupant compartment and vehicle deformations and the corresponding locations are provided in Appendix E. MASH 2016 defines intrusion or deformation as the occupant compartment being deformed and reduced in size with no observed penetration. There were no penetrations into the occupant compartment, and none of the established MASH 2016 deformation limits were violated. Outward deformations, which are denoted as negative numbers in Appendix E, are not considered crush toward the occupant, and are not evaluated by MASH 2016 criteria.

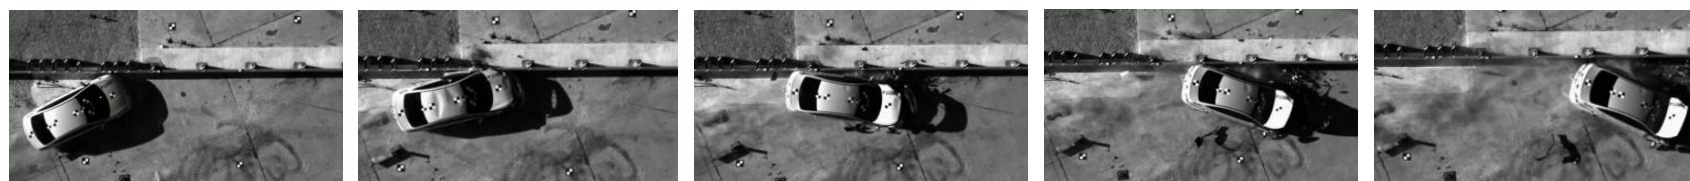
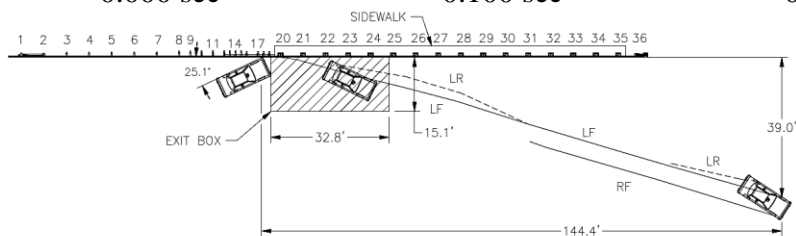
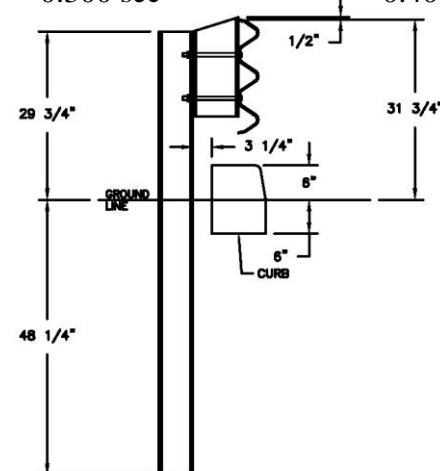
Figure 196. Summary of Test Results and Sequential Photographs, Test No. HMDT-4

The analysis of the results for test no. HMDT-4 showed that the system adequately contained and redirected the 1100C vehicle with controlled lateral displacements of the barrier. A summary of the test results and sequential photographs are shown in Figure 196. Detached elements, fragments, or other debris from the test article did not penetrate or show potential for penetrating the occupant compartment, or present an undue hazard to other traffic, pedestrians, or work-zone personnel. Deformations of, or intrusions into, the occupant compartment that could have caused serious injury did not occur. The test vehicle did not penetrate nor ride over the barrier and remained upright during and after the collision. Vehicle roll, pitch, and yaw angular displacements, as shown in Appendix K, were deemed acceptable, because they did not adversely influence occupant risk nor cause rollover. After impact, the vehicle exited the barrier at an angle of 10.2 degrees, and its trajectory did not violate the bounds of the exit box. Therefore, test no. HMDT-4 was determined to be acceptable according to the MASH 2016 safety performance criteria for test designation no. 3-20.

- Test Article Damage Minimal
- Maximum Test Article Deflections
 - Permanent Set 1.3 in.
 - Dynamic 3.2 in.
 - Working Width 21.6 in.
- Transducer Data
