*Hawaii Department of Transportation
Research Project Number 67167*

CRASH TESTING AND EVALUATION OF THE HAWAII THREE BEAM APPROACH GUARDRAIL TRANSITION: MASH TEST NOS. 3-20 AND 3-21

MIDWEST ROADSIDE SAFETY FACILITY

MwRSF Research Report No. TRP-03-425-20

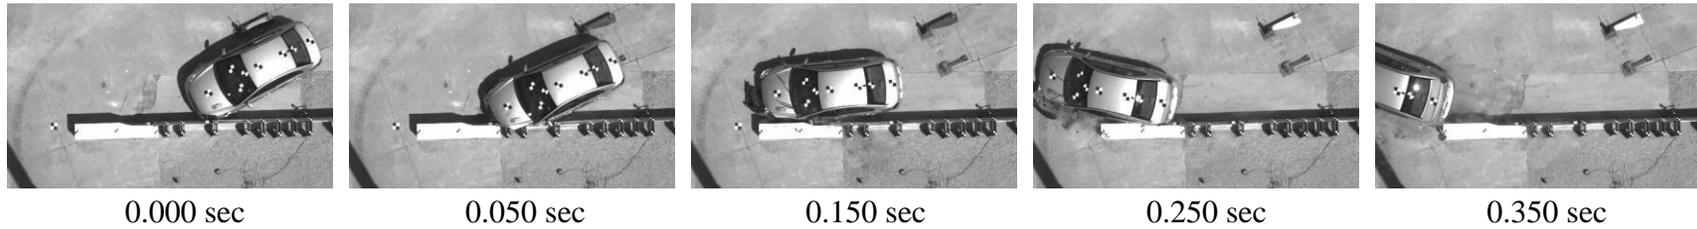
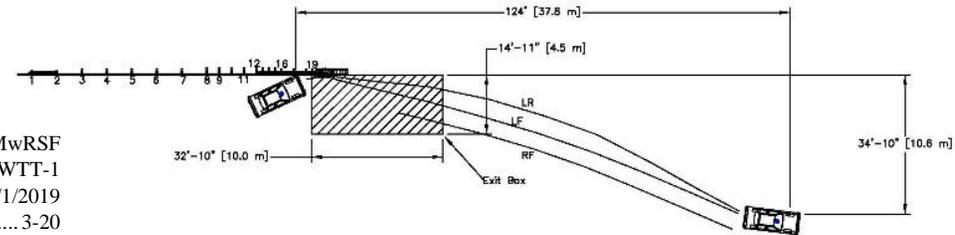
Figure 67. Summary of Test Results and Sequential Photographs, Test No. HWTT-1

The analysis of the test results for test no. HWTT-1 showed that the system adequately contained and redirected the 1100C vehicle with controlled lateral displacements of the barrier. A summary of the test results and sequential photographs are shown in Figure 67. Detached elements, fragments, or other debris from the test article did not penetrate or show potential for penetrating the occupant compartment, or present an undue hazard to other traffic, pedestrians, or work-zone personnel. Deformations of, or intrusions into, the occupant compartment that could have caused serious injury did not occur. The test vehicle did not penetrate nor override the barrier and remained upright during and after the collision. Vehicle roll, pitch, and yaw angular displacements, as shown in Appendix E, were deemed acceptable as they did not adversely influence occupant risk nor cause rollover. After impact, the vehicle exited the barrier at an angle of 12.8 deg., and its trajectory did not violate the bounds of the exit box. Shattering of the side window was due to impact with the dummy's head and not a barrier component. Further, the dummy's head did not contact any barrier component as it extended out the side window. Deformations and tearing of the windshield were caused by vehicle deformations as the windshield was never in contact with the barrier. Thus, there was no potential for the test article to penetrate into the vehicle, and there was no perceived risk to the occupant. Therefore, test no. HWTT-1 was determined to be acceptable according to the MASH 2016 safety performance criteria for test designation no. 3-20.

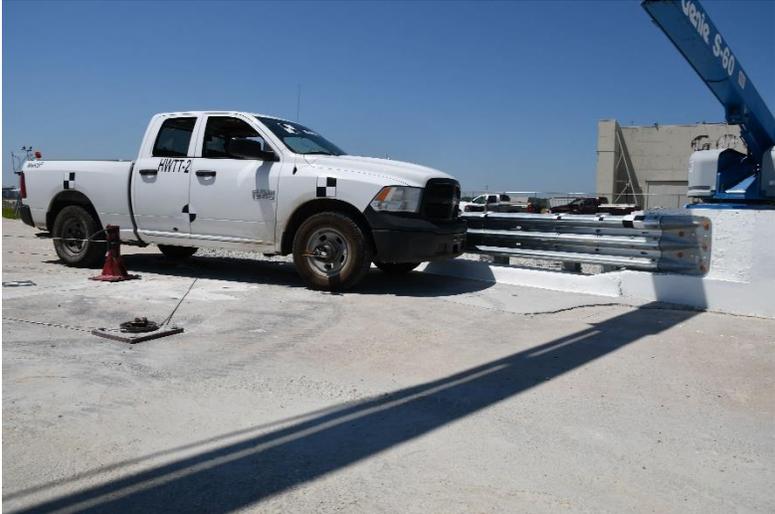
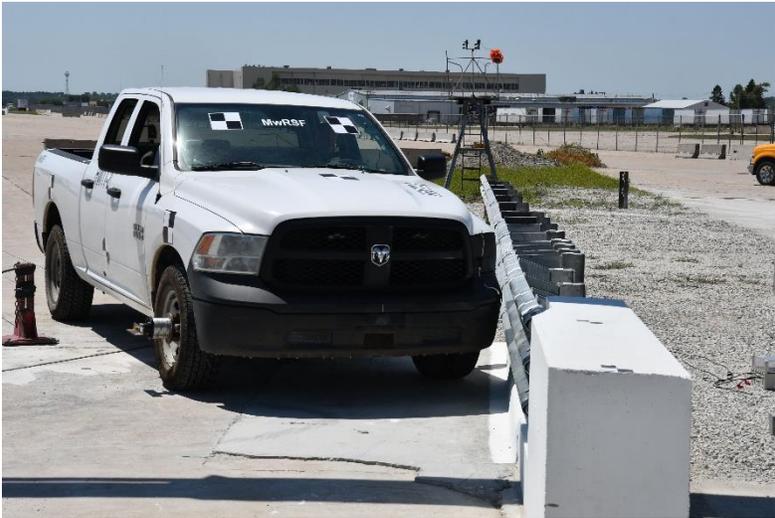
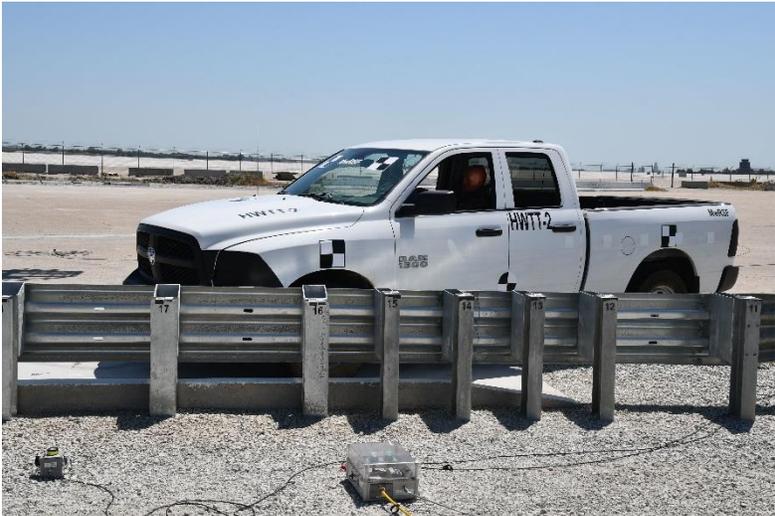
Figure 68. Impact Location, Test No. HWTT-2

Initial vehicle impact was to occur 84 in. upstream from the upstream end of the concrete end post, as shown in Figure 68, which was selected using the CIP plot found in Figure 2-17 of MASH 2016 to maximize the probability of pocketing and vehicle snag on the concrete parapet. The 5,000-lb pickup truck impacted the modified HDOT AGT at a speed of 63.0 mph and at an angle of 25.2 deg. The actual point of impact was 5.7 in. upstream from the targeted impact location. The vehicle was captured and redirected by the modified HDOT AGT with minor deflections to the system. The front-left tire rode up on top of the curb but did not snag on the concrete end post. The vehicle remained stable throughout the impact event. During the redirection of the vehicle, the dummy's head contacted the side window, thus causing the window to shatter. However, the head did not strike any component of the barrier. All measured accelerations resulted in occupant risk values (OIV and ORA) within the MASH allowed limits. After exiting the system, the vehicle continued traveling downstream before the remote brakes were applied and the vehicle came to a stop 165 ft – 8in. downstream from impact and 6 ft – 6 in. behind the system.

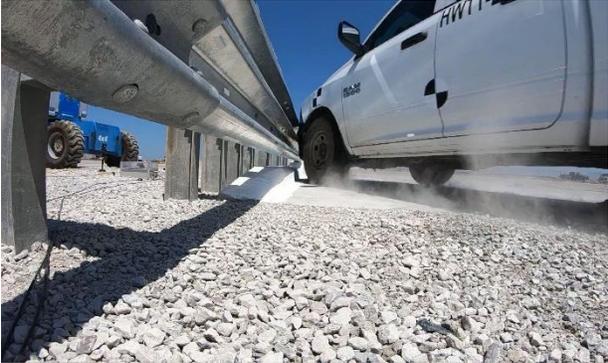
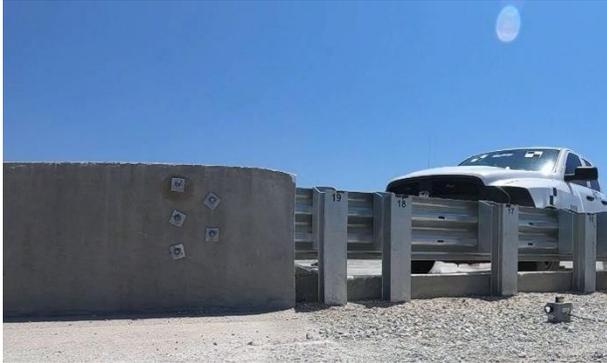
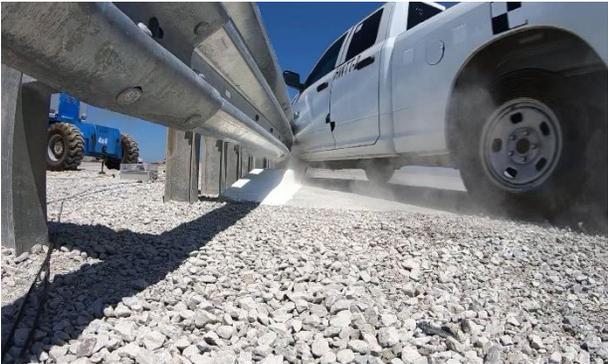
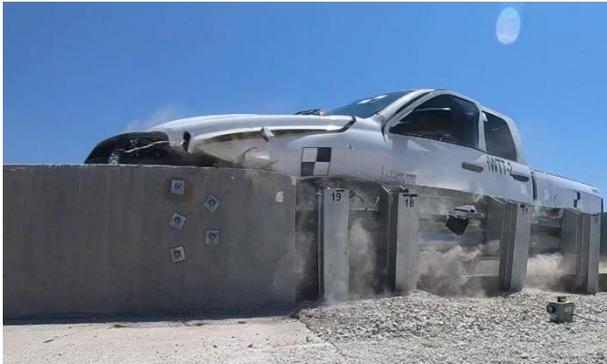
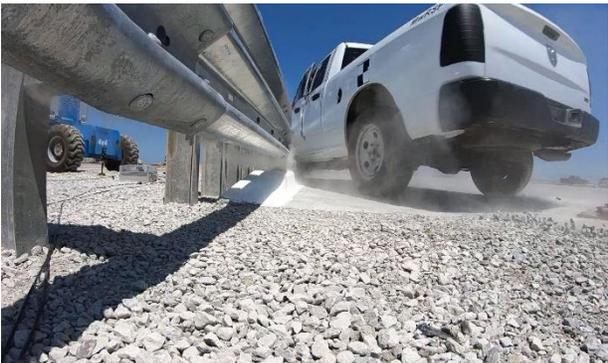
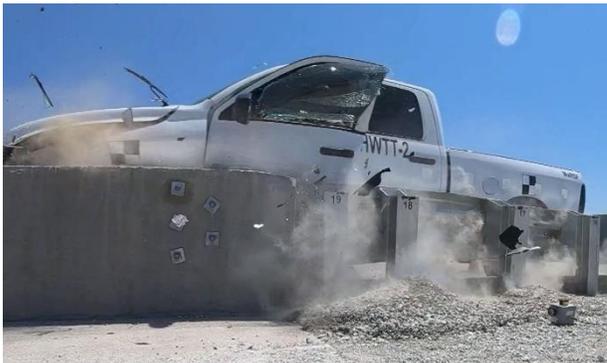
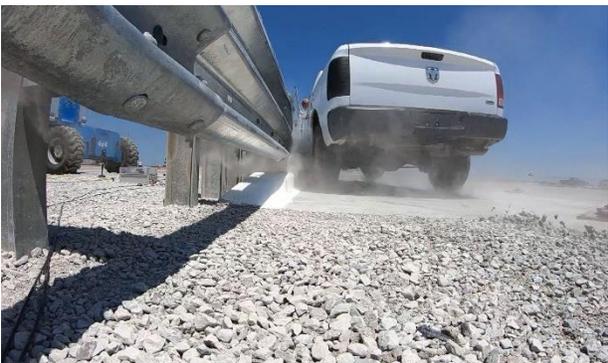
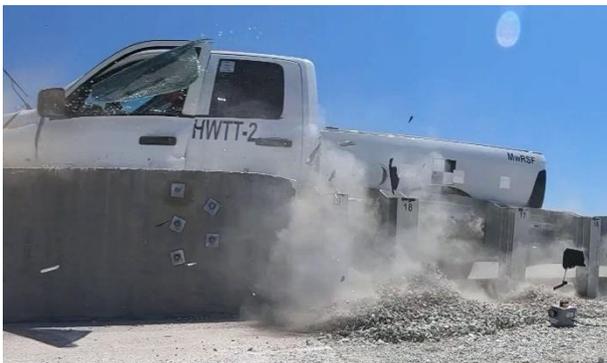
Figure 71. Documentary Photographs, Test No. HWTT-2

A detailed description of the sequential impact events is contained in Table 8. Sequential photographs are shown in Figures 69 and 70. Documentary photographs of the crash test are shown in Figure 71. The vehicle trajectory and final position are shown in Figure 72.

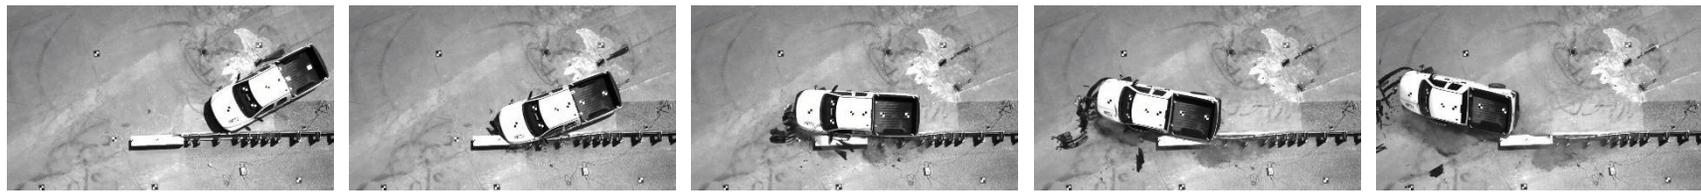
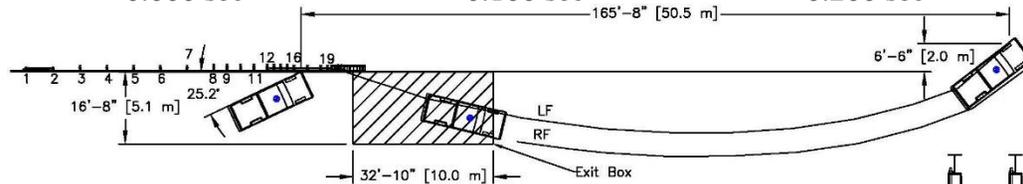
Figure 80. Summary of Test Results and Sequential Photographs, Test No. HWTT-2

The analysis of the test results for test no. HWTT-2 showed that the system adequately contained and redirected the 2270P vehicle with controlled lateral displacements of the barrier. A summary of the test results and sequential photographs are shown in Figure 80. Detached elements, fragments, or other debris from the test article did not penetrate or show potential for penetrating the occupant compartment, or present an undue hazard to other traffic, pedestrians, or work-zone personnel. Deformations of, or intrusions into, the occupant compartment that could have caused serious injury did not occur. The test vehicle did not penetrate nor ride over the barrier and remained upright during and after the collision. Vehicle roll, pitch, and yaw angular displacements, as shown in Appendix F, were deemed acceptable, because they did not adversely influence occupant risk nor cause rollover. Shattering of the side window was due to impact with the dummy's head and not a barrier component. Further, the dummy's head did not contact any barrier component as it extended out the side window. After impact, the vehicle exited the barrier at an angle of 11.1 deg., and its trajectory did not violate the bounds of the exit box. Therefore, test no. HWTT-2 was determined to be acceptable according to the MASH 2016 safety performance criteria for test designation no. 3-21.

- Impact Conditions
 - Speed 63.0 mph
 - Angle 25.2 deg.
 - Impact Location..... 89.7 in. upstream from concrete parapet
- Impact Severity 120.6 kip-ft > 106 kip-ft limit from MASH 2016

- Exit Conditions
 - Speed 41.0 mph
 - Angle 11.1 deg.
- Exit Box Criterion Pass
- Vehicle Stability..... Satisfactory
- Vehicle Stopping Distance 165 ft 8 in. downstream and 6 ft 6 in. behind

- Vehicle Damage..... Moderate
 - VDS [19] 10-LFQ-5
 - CDC [20]..... 11-LFEW-4
 - Maximum Interior Deformation 6.5 in.
- Test Article Damage Moderate
- Maximum Test Article Deflections
 - Permanent Set 6.2 in.
 - Dynamic 9.0 in.
 - Working Width..... 23.0 in.
- Transducer Data
