Hawaii Department of Transportation Research Project Number 68212 Research Project No. STP-1500(092)R – Phase III

CRASH TESTING AND EVALUATION OF THE HDOT 34-IN. TALL, AESTHETIC CONCRETE BRIDGE RAIL WITH PEDESTRIAN HANDRAIL AND SIDEWALK: MASH TEST DESIGNATION NOS. 3-10 AND 3-11

MwRSF Research Report No. TRP-03-456-22

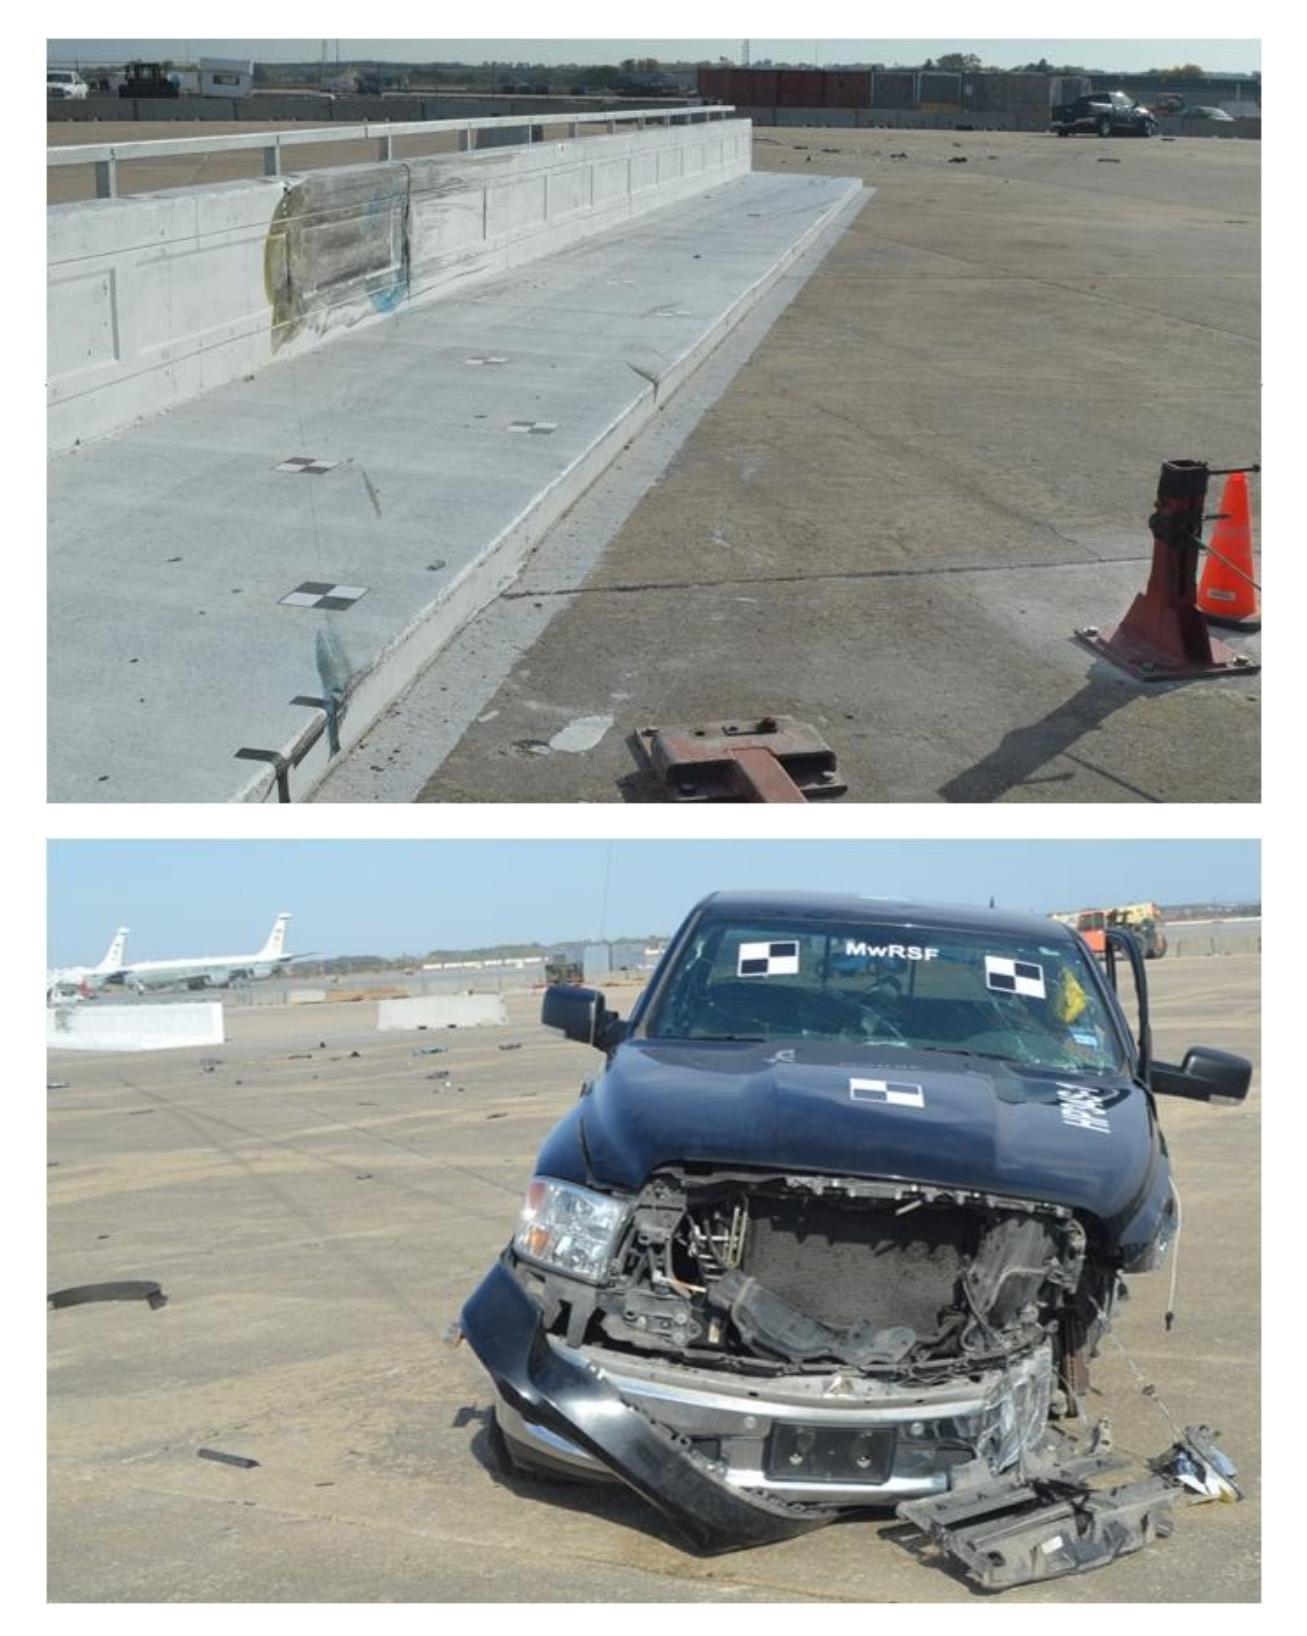
Figure 42. Vehicle Final Position and Trajectory Marks, Test No. HP34S-1

The 2270P pickup truck interaction with the curb did not exceed 2.0 g's within a 50-ms period around the time of impact; therefore, event start time, t=0, occurred at the time of impact with the bridge rail. A detailed description of the sequential impact events is contained in Table 4. Sequential photographs are shown in Figures 36 and 37. Documentary photographs of the crash test are shown in Figures 38 through 41. The vehicle trajectory and final position are shown in Figure 42.

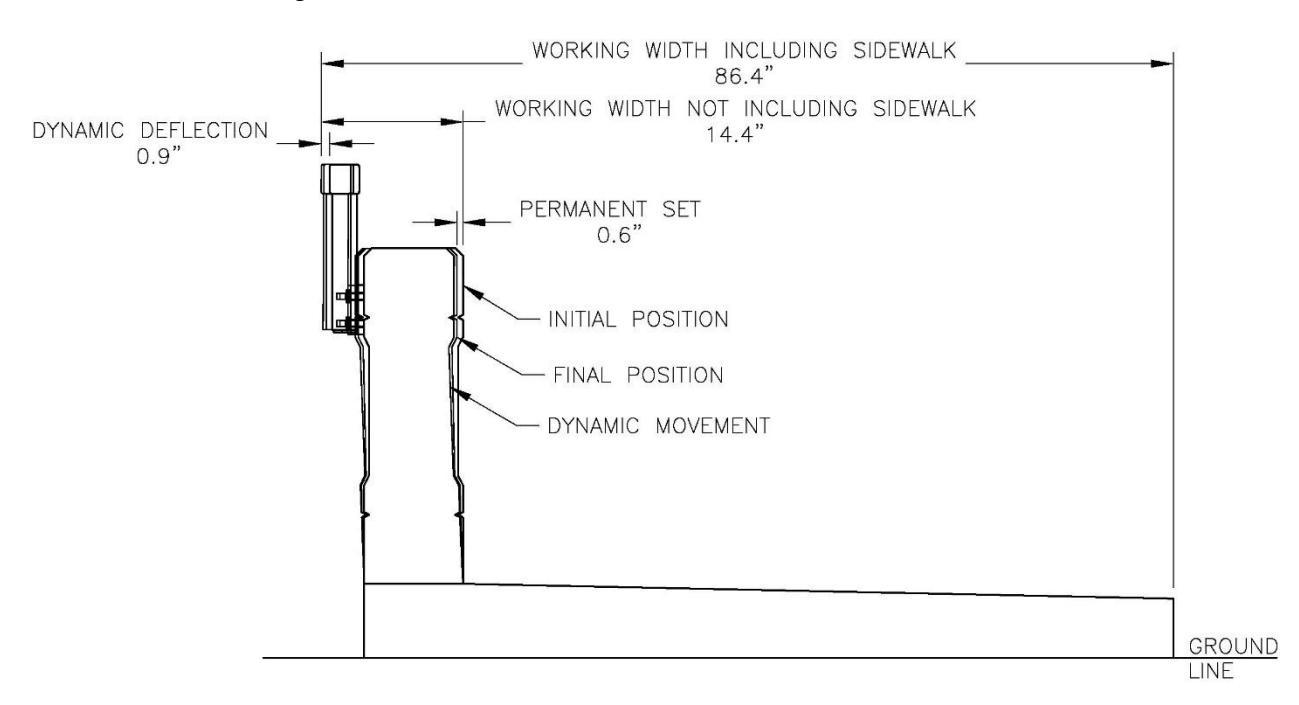
Figure 49. Permanent Set, Dynamic Deflection, and Working Width, Test No. HP34S-1

Figure 48. System Damage at Post No. 8, Test No. HP34S-1
The maximum lateral permanent set of the barrier system was 0.6 in. at the downstream end of barrier segment no. 2, as measured in the field. The maximum lateral dynamic barrier deflection, including tipping of the barrier along the top surface, was 0.9 in. at the downstream end of barrier segment no. 2, as determined from high-speed digital video analysis. The working width of the system was found to be 14.4 in. measured from the front face of the barrier and 86.4 in. measured from the front face of the sidewalk, respectively, also determined from high-speed digital video analysis. A schematic of the permanent set deflection, dynamic deflection, and working width is shown in Figure 49.

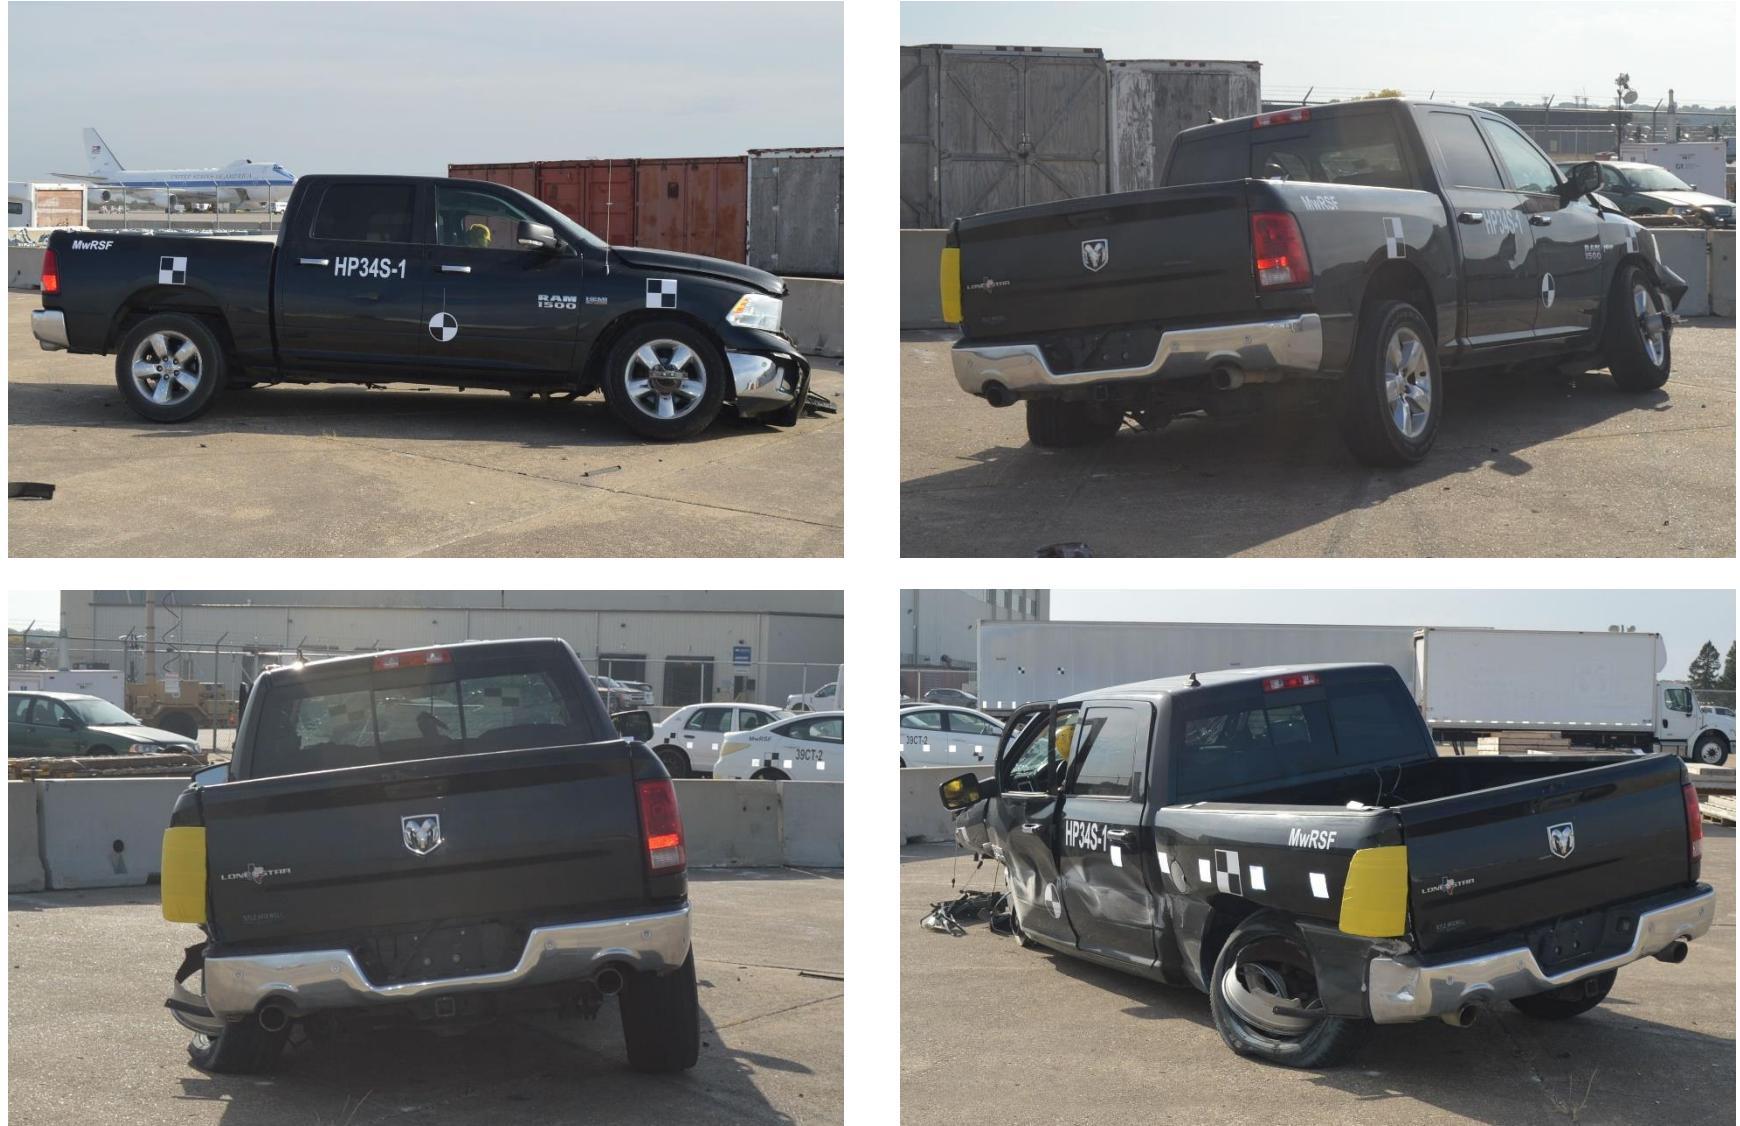
Figure 51. Vehicle Damage, Test No. HP34S-1

The damage to the vehicle was moderate, as shown in Figures 50 through 53. The maximum occupant compartment intrusions are listed in Table 5, along with the intrusion limits established in MASH 2016 for various areas of the occupant compartment. Complete occupant compartment and vehicle deformations and the corresponding locations are provided in Appendix C. MASH 2016 defines intrusion or deformation as the occupant compartment being deformed and reduced in size with no observed penetration. There were no penetrations into the occupant compartment, and none of the established MASH 2016 deformation limits were violated. Outward deformations, which are denoted as negative numbers in Appendix C, are not considered crush toward the occupant and are not evaluated by MASH 2016 criteria.

Majority of the damage was concentrated on the left-front corner and left side of the vehicle where the impact had occurred. The left side of the front bumper was crushed inward and backward. The left-front fender was crushed inward toward the centerline of the vehicle and engine compartment. The left-front wheel was disengaged from the vehicle, the tire was punctured and deflated, and the rim was fractured along three of the five spokes extending from the hub. The leftrear wheel rim was fractured and separated into multiple pieces. The tire remained engaged with the fractured pieces of the rim. The left-front and left-rear fenders, both left-side door panels, and the left-rear bumper were crushed inward and scraped. The grille and left headlight were disengaged from the vehicle. Both left-side doors, the truck bed, and the left side of the rear bumper were crushed inward. The right-front fender was displaced rearward, causing difficulty in opening the right-front door. The bottom of the right-front tire was angled away from the vehicle. The leftfront side window shattered, and the windshield was cracked across its entire length. The left-front side window damage was not due to contact with the test article.

The left-front lower control arm was fractured and disengaged from the vehicle. The leftfront shock and suspension spring were disengaged from the left-front lower control arm and displaced backwards. The Panhard bar was bent upward, and the left-front control arm was bent but remained engaged with the steering linkage. The anti-roll bar was bent into a "U"-shape and disengaged. The rear bearing joint of the right-front lower control arm was fractured, and the rightfront spring and suspension were displaced forward. The lateral engine cradle support beam was bent downward into a "U"-shape. The left-front frame horn was crushed inward. The gas tank was scraped and the oil pan was displaced slightly left and backward.

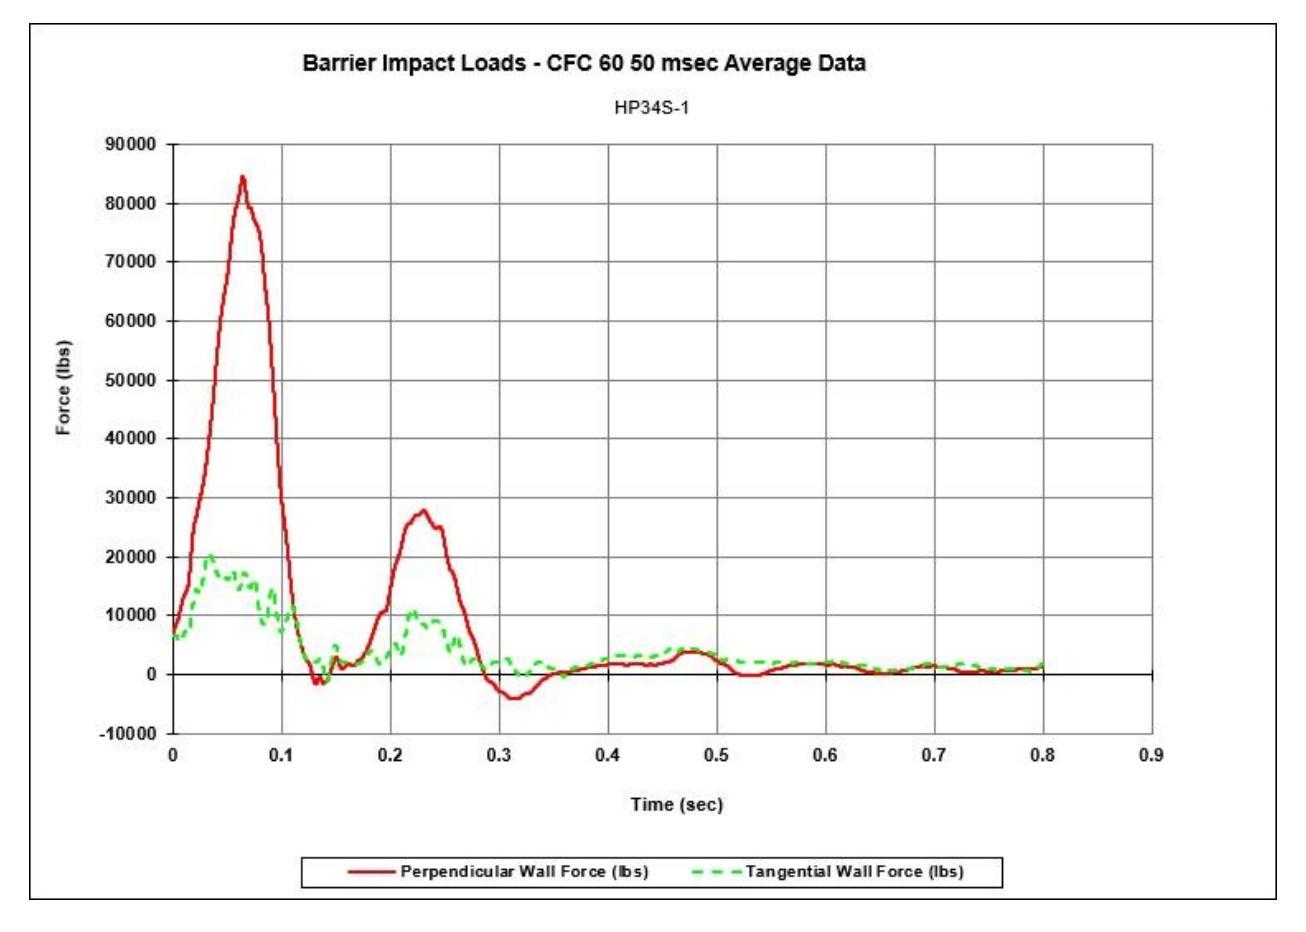
Figure 54. Perpendicular and Tangential Forces Imparted to the Barrier System (SLICE-2), Test No. HP34S-1

The longitudinal and lateral vehicle accelerations, as measured at the vehicle's c.g., were also processed using a SAE CFC-60 filter and a 50-msec moving average. The 50-msec moving average vehicle accelerations were then combined with the uncoupled yaw angle versus time data in order to estimate the vehicular loading applied to the barrier system. From the data analysis, the perpendicular impact forces were determined for the bridge rail, as shown in Figure 54. The maximum perpendicular (i.e., lateral) load imparted to the barrier was 84.5 kips determined by the SLICE-2 (primary) unit.

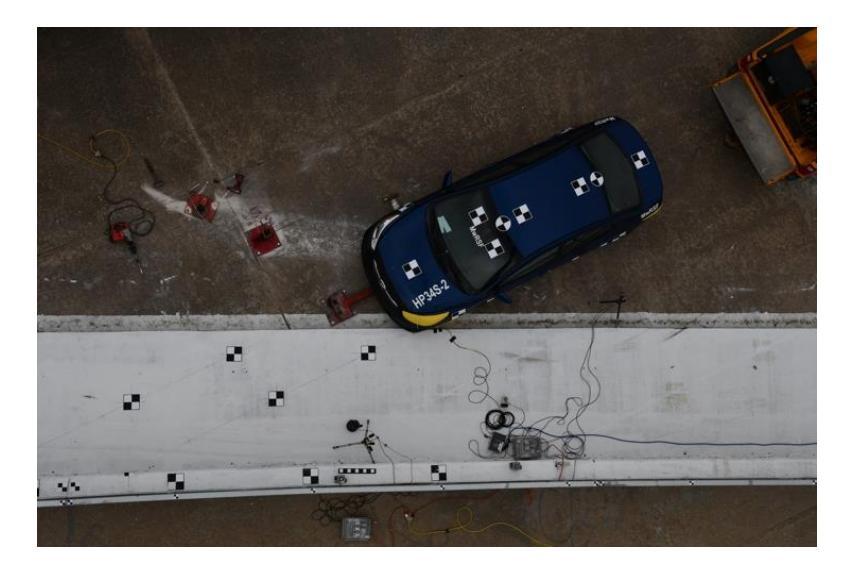
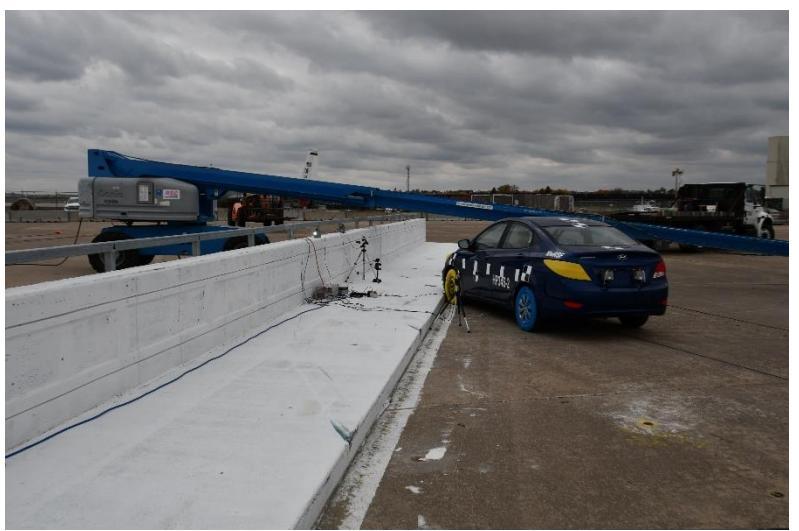
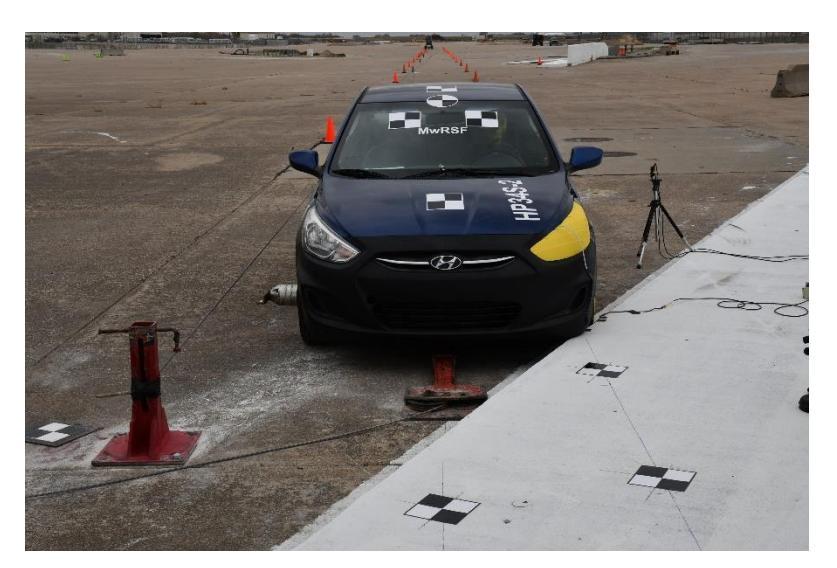
Figure 56. Impact Location, Test No. HP34S-2

Initial vehicle impact was to occur 43 in. upstream from the upstream face of post no. 11, as shown in Figure 56, which was selected using video analysis from previous tests with sidewalks to maximize the probability of wheel snag and vehicle interaction with the pedestrian handrail. The 2,413-lb small car impacted the sidewalk at a speed of 62.0 mph and at an angle of 25.0 degrees and impacted the barrier at a speed of 60.2 mph and an angle of 22.8 degrees. The actual point of impact was 2.43 in. downstream from the targeted impact point. After brakes were applied, the vehicle came to rest 183.8 ft downstream from impact and 11.0 ft laterally from the front of the sidewalk, as measured to the center of the right-front wheel.

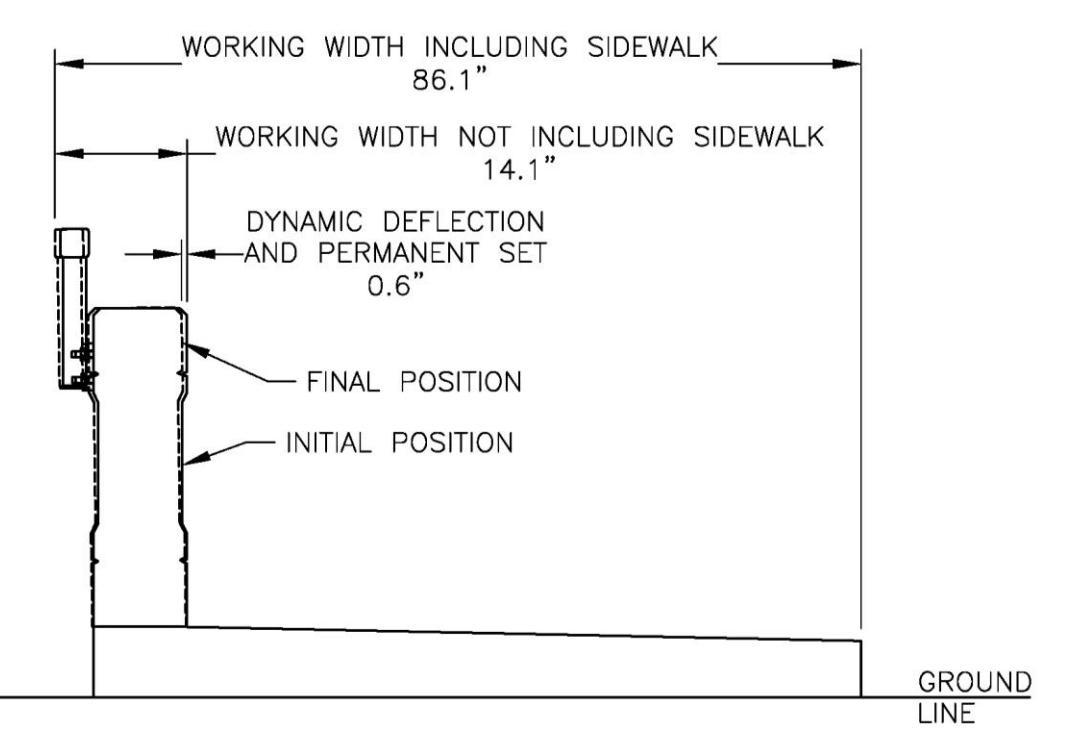
Figure 67. Permanent Set, Dynamic Deflection, and Working Width, Test No. HP34S-2

The maximum lateral permanent set of the barrier system was 0.6 in. at the downstream end of barrier segment no. 3, as measured in the field. The maximum lateral dynamic barrier deflection measurement, including tipping of the barrier along the top surface, was 0.6 in as determined from high-speed digital video analysis. The working width of the system was found to be 14.1 in. measured from the front face of the barrier and 86.1 in. measured from the front face of the sidewalk, respectively, also determined from high-speed digital video analysis. A schematic of the permanent set deflection, dynamic deflection, and working width is shown in Figure 67.

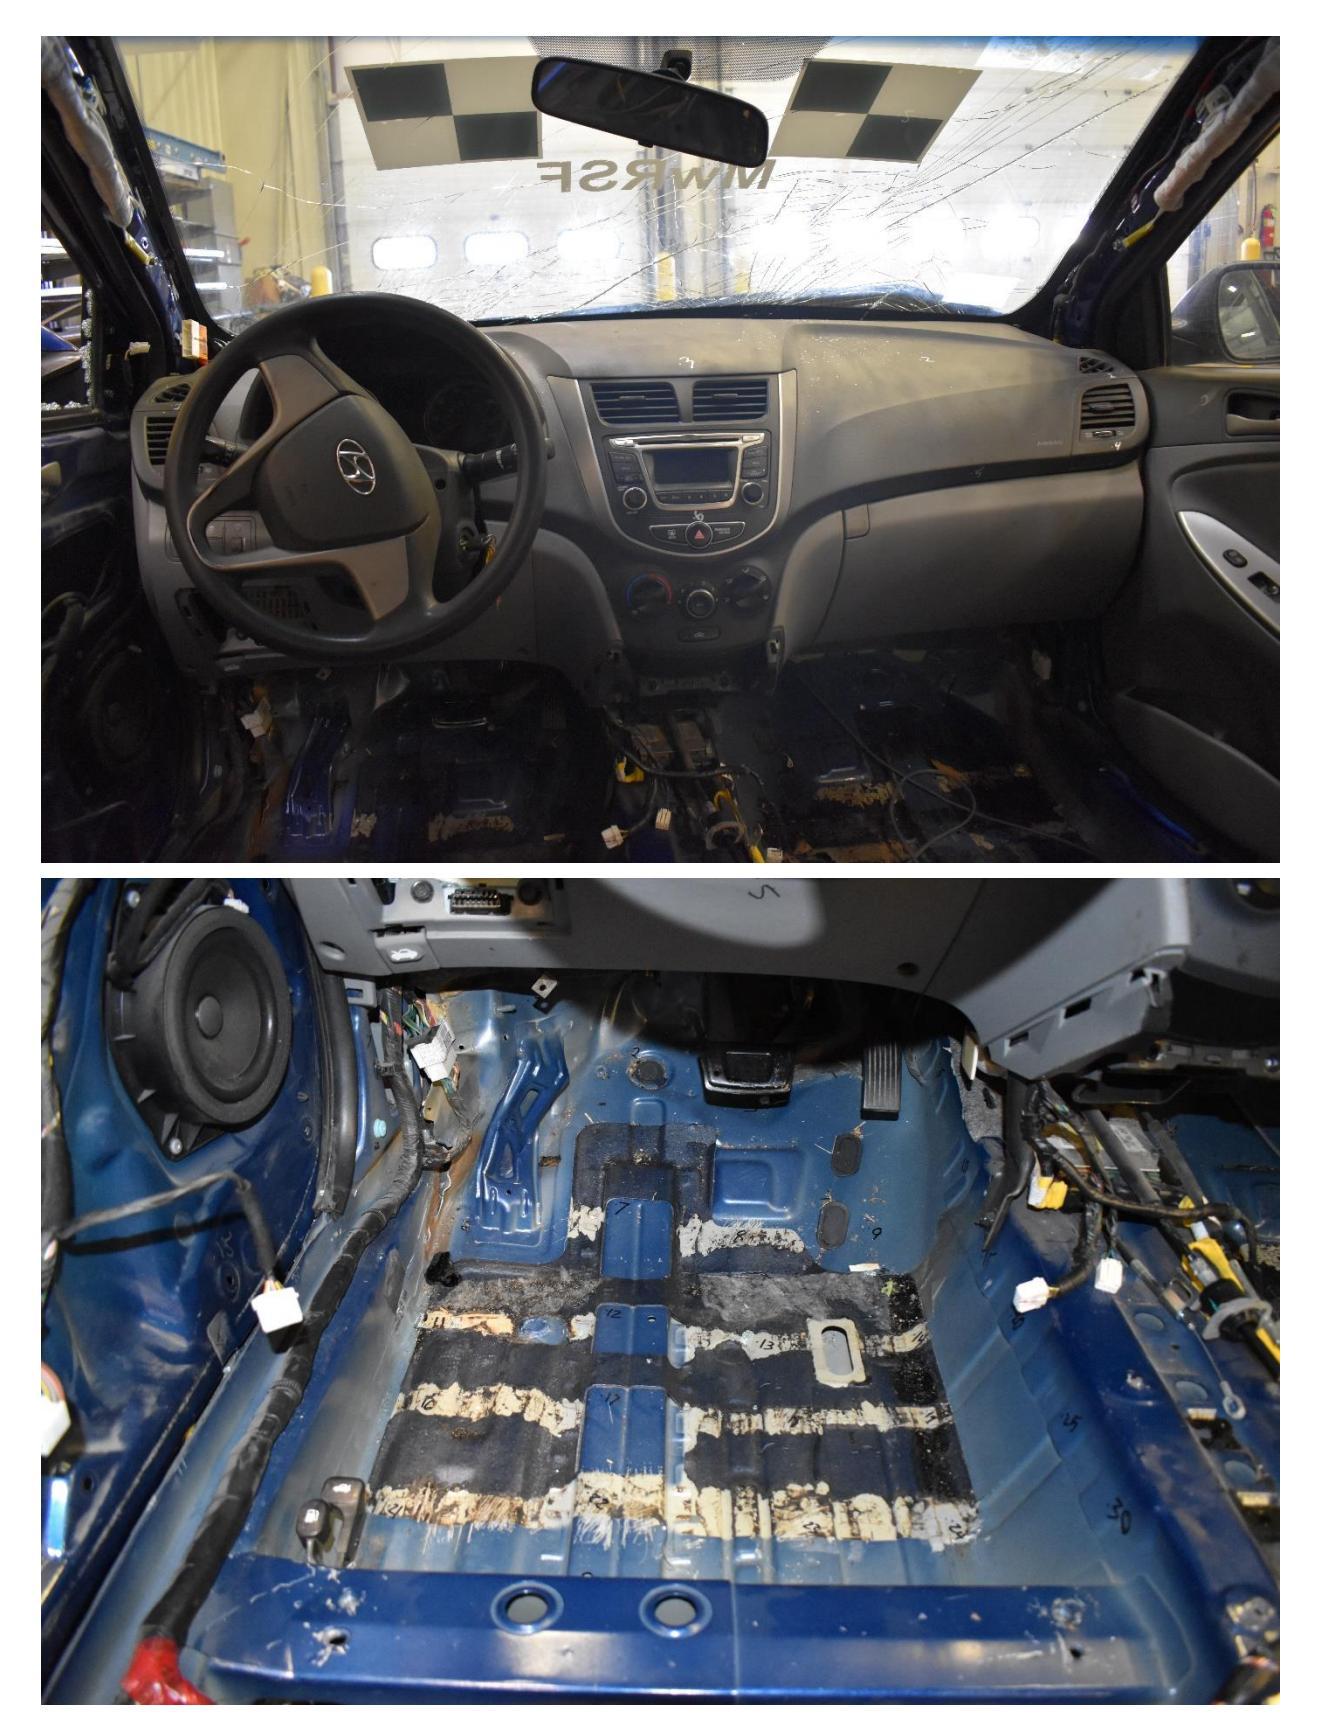
Figure 72. Occupant Compartment Damage, Test No. HP34S-2

The damage to the vehicle was moderate, as shown in Figures 68 through 73. The maximum occupant compartment intrusions are listed in Table 10, along with the intrusion limits established in MASH 2016 for various areas of the occupant compartment. Complete occupant compartment and vehicle deformations and the corresponding locations are provided in Appendix C. MASH 2016 defines intrusion or deformation as the occupant compartment being deformed and reduced in size with no observed penetration. There were no penetrations into the occupant compartment, and none of the established MASH 2016 deformation limits were violated. Outward deformations, which are denoted as negative numbers in Appendix C, are not considered crush toward the occupant and are not evaluated by MASH 2016 criteria.

fender. The entire left fender and the front of the left-front door were crushed inward. There were multiple dents on the left quarter panel above the wheel well, and the area above the rear bumper connection was crushed inward. Both left-side wheel rims were deformed. The trunk hatch was bent to the left during impact causing the trunk to become wedged shut. The right-side fender was bent outward during impact. The left-front side window shattered, and the windshield was cracked across its entire length. The left-front side window damage was not due to contact with the test article.

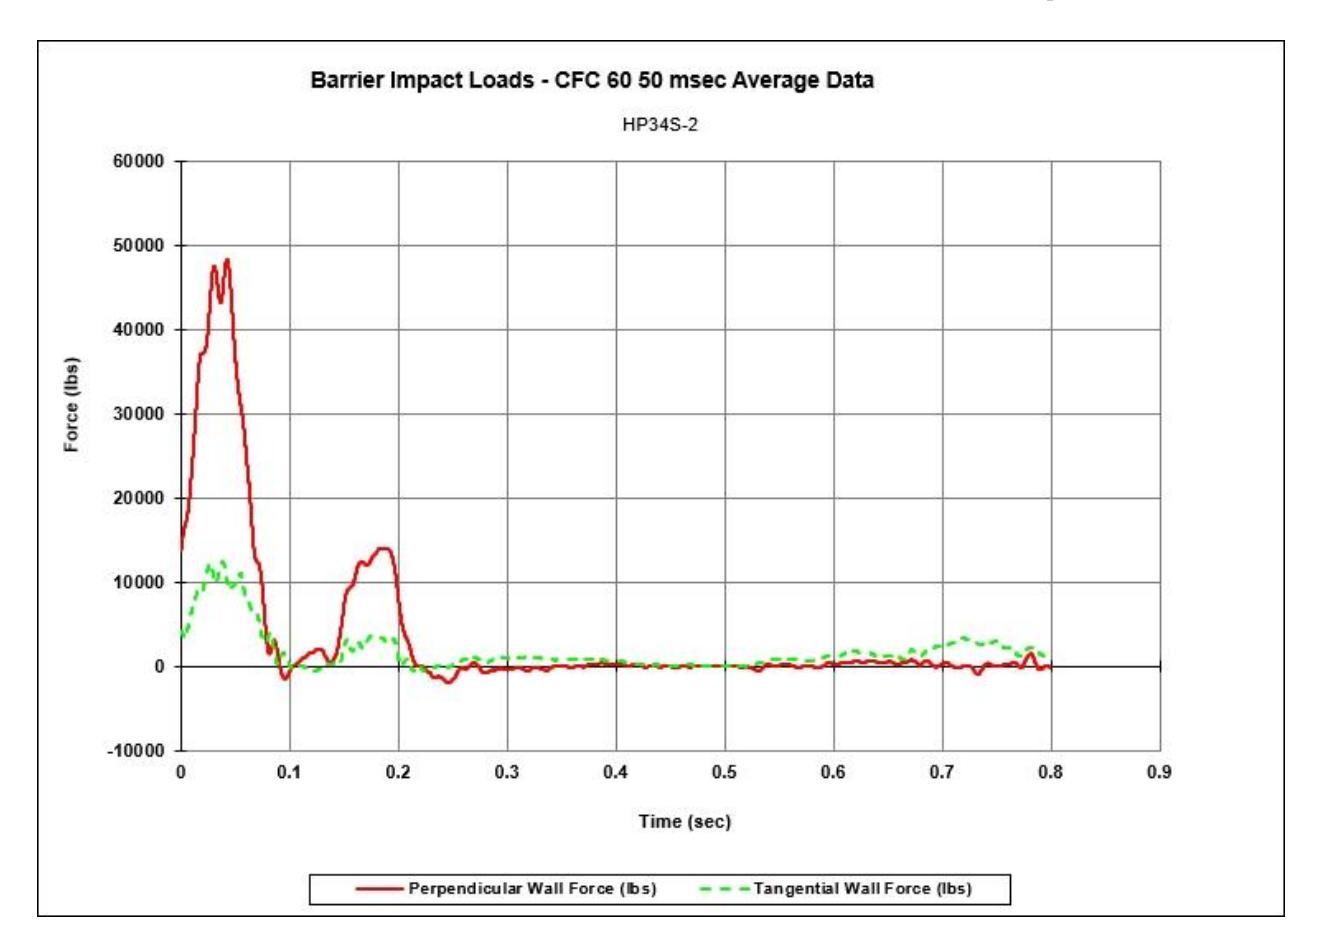
Figure 74. Perpendicular and Tangential Forces Imparted to the Barrier System (SLICE-1), Test No. HP34S-2

The longitudinal and lateral vehicle accelerations, as measured at the vehicle's c.g., were also processed using a SAE CFC-60 filter and a 50-msec moving average. The 50-msec moving average vehicle accelerations were then combined with the uncoupled yaw angle versus time data in order to estimate the vehicular loading applied to the barrier system. From the data analysis, the perpendicular impact forces were determined for the bridge rail, as shown in Figure 74. The maximum perpendicular (i.e., lateral) load imparted to the barrier was 48.4 kips determined by the SLICE-1 (primary) unit.
