Research Project Number TPF-5(193) Supplement #132

MASH 2016 EVALUATION OF THE MODIFIED THRIE BEAM SYSTEM

MwRSF Research Report No. TRP-03-417-20

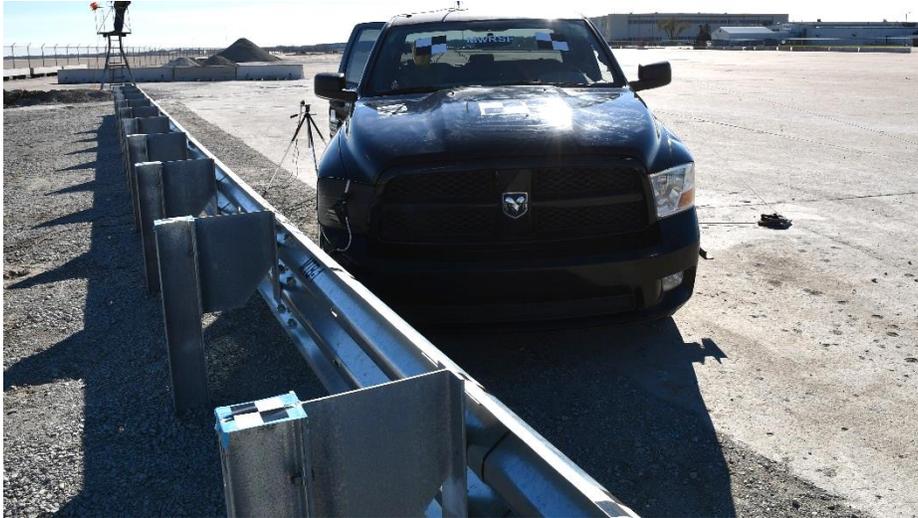
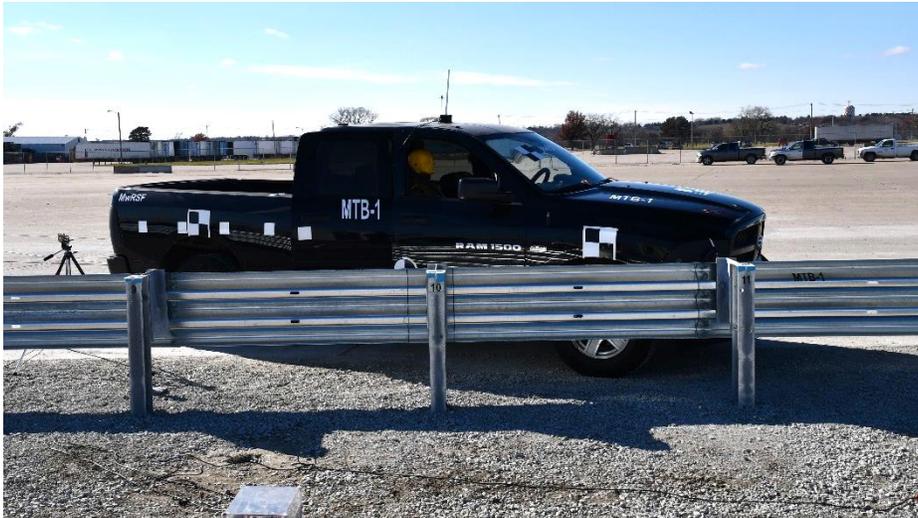
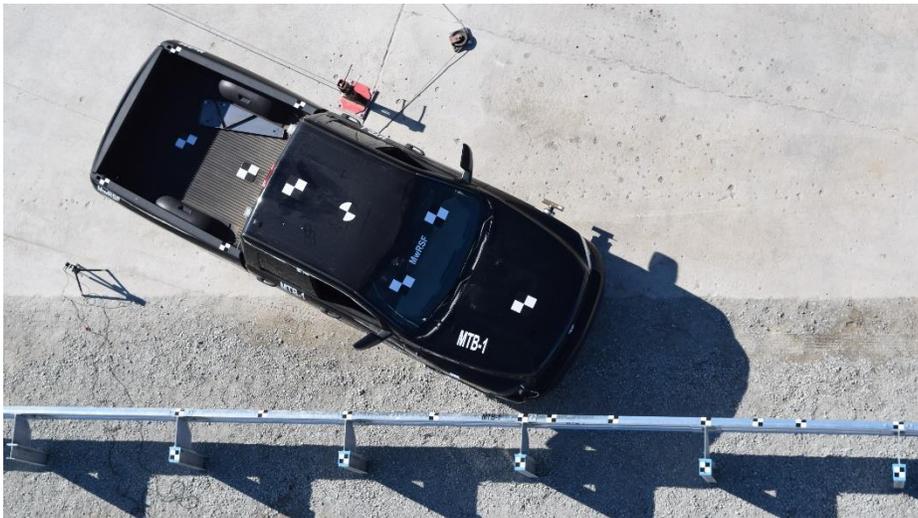
Figure 26. Impact Location, Test No. MTB-1

Test no. MTB-1 was conducted under the MASH TL-3 guidelines for test designation no. 3-11. Test designation no. 3-11 is an impact of the 2270P vehicle at 62 mph and 25 degrees on the system. The critical impact point for this test was selected to maximize vehicle snag on the system posts and splice loading. Initial vehicle impact was to occur 11 ft – 6 in. upstream from post no. 13, as shown in Figure 26, which was selected using the critical impact point plots found in Section 2.3 of MASH 2016. The 5,003-lb quad cab pickup truck impacted the modified thrie beam guardrail at a speed of 62.9 mph and an angle of 25.4 deg. The actual point of impact was 0.3 in. downstream from the target location. During the test, the pickup truck was captured and redirected by the thrie beam system. During the redirection of the vehicle, torsional collapse of some of the W-section blockouts was observed. The torsional collapse of the blockouts did not compromise the overall test result, but it allowed increased wheel snag on the posts and disengagement of the vehicle’s right-front wheel. Additionally, the collapse of the blockouts allowed the lower portion of the thrie beam guardrail to contact the flange and web of the blockout and post flanges at post no. 13. The contact at post no. 13 was sufficient to cause a small tear downstream from the thrie beam splice at that post. However, this tear did not adversely affect the barrier system performance. The stability and trajectory of the vehicle were acceptable. Prior to coming to a stop, the test vehicle impacted portable barriers used to shield other areas of the test facility downstream from the barrier. This contact was well after vehicle exit and resulted in minor damage to the front of

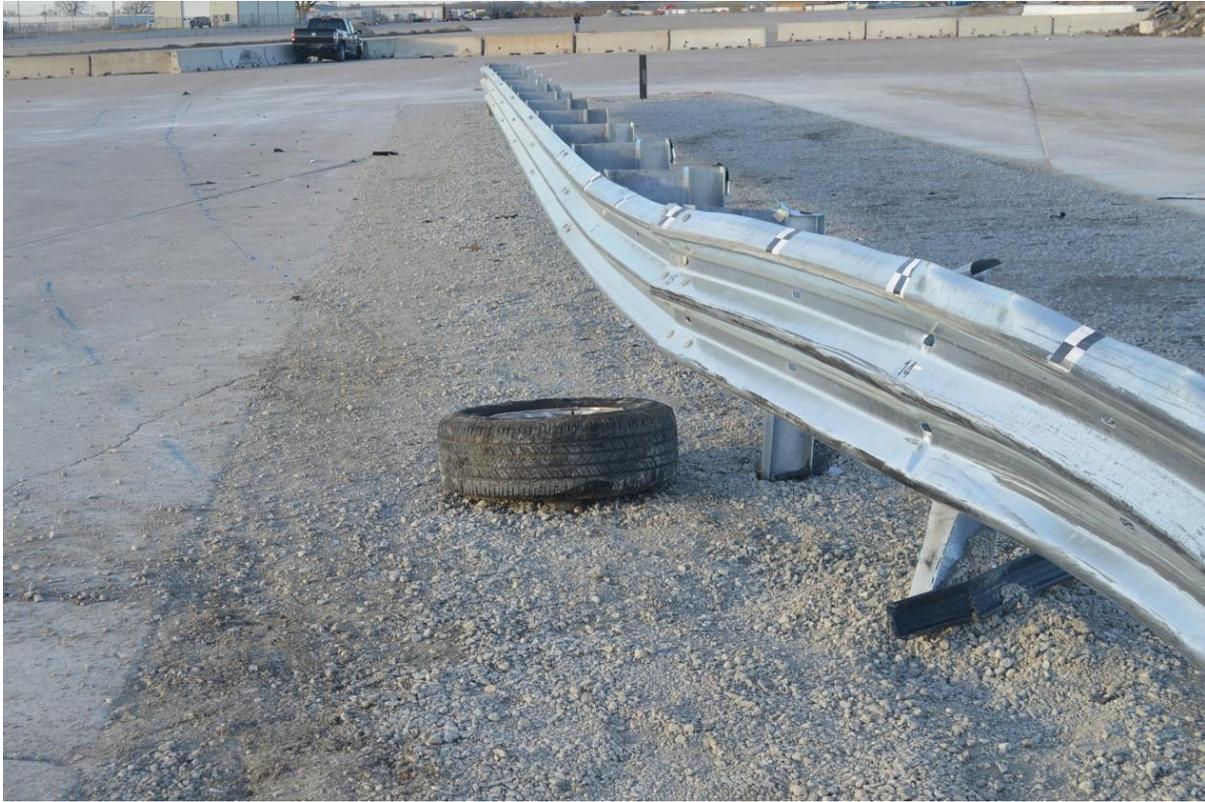
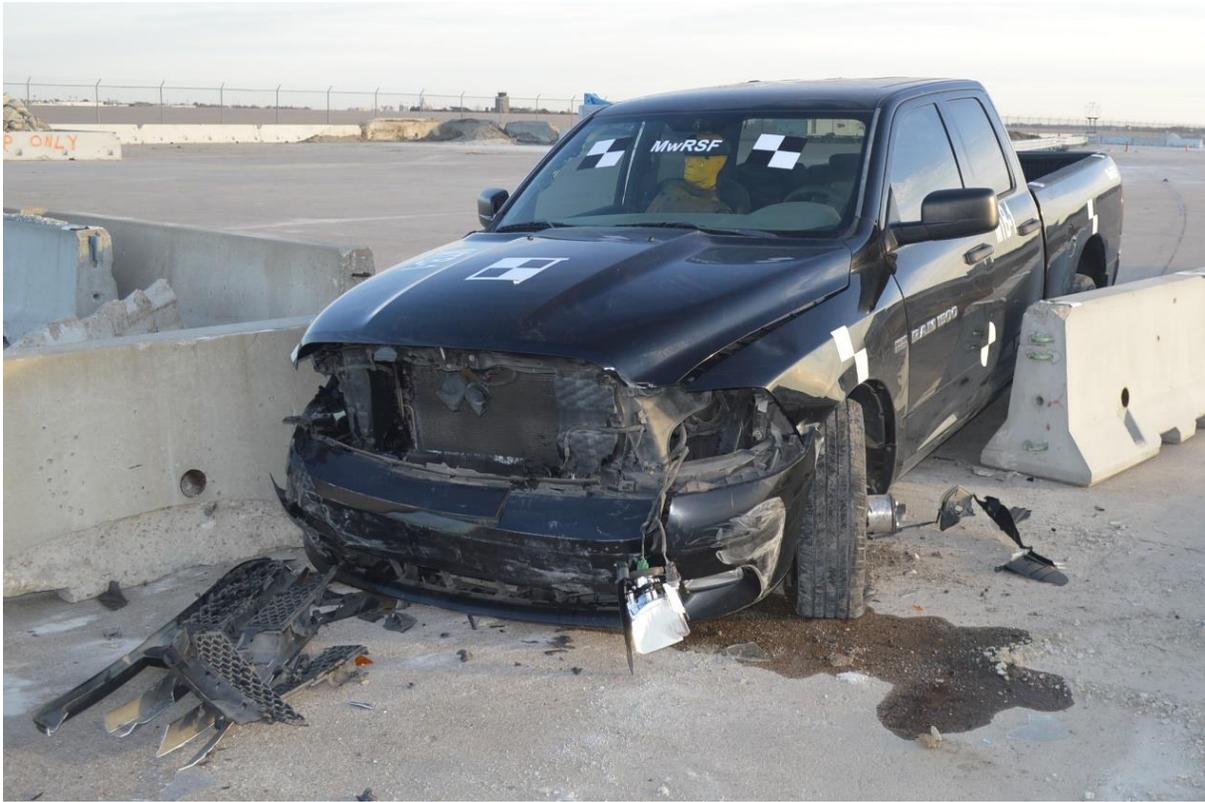
Figure 30. Vehicle Final Position and Trajectory Marks, Test No. MTB-1

the test vehicle. The vehicle came to rest 282 ft – 3 in. downstream from the impact point and 14 ft – 7 in. laterally in front of the barrier after brakes were applied.
