PHASE I MASH TESTING OF A THRIE BEAM BULLNOSE WITH BREAKAWAY STEEL POSTS (TEST NOS. MSPBN-1, -2, AND -3)

MIDWEST ROADSIDE SAFETY FACILITY

MwRSF Research Report No. TRP-03-389-20

August 27, 2020

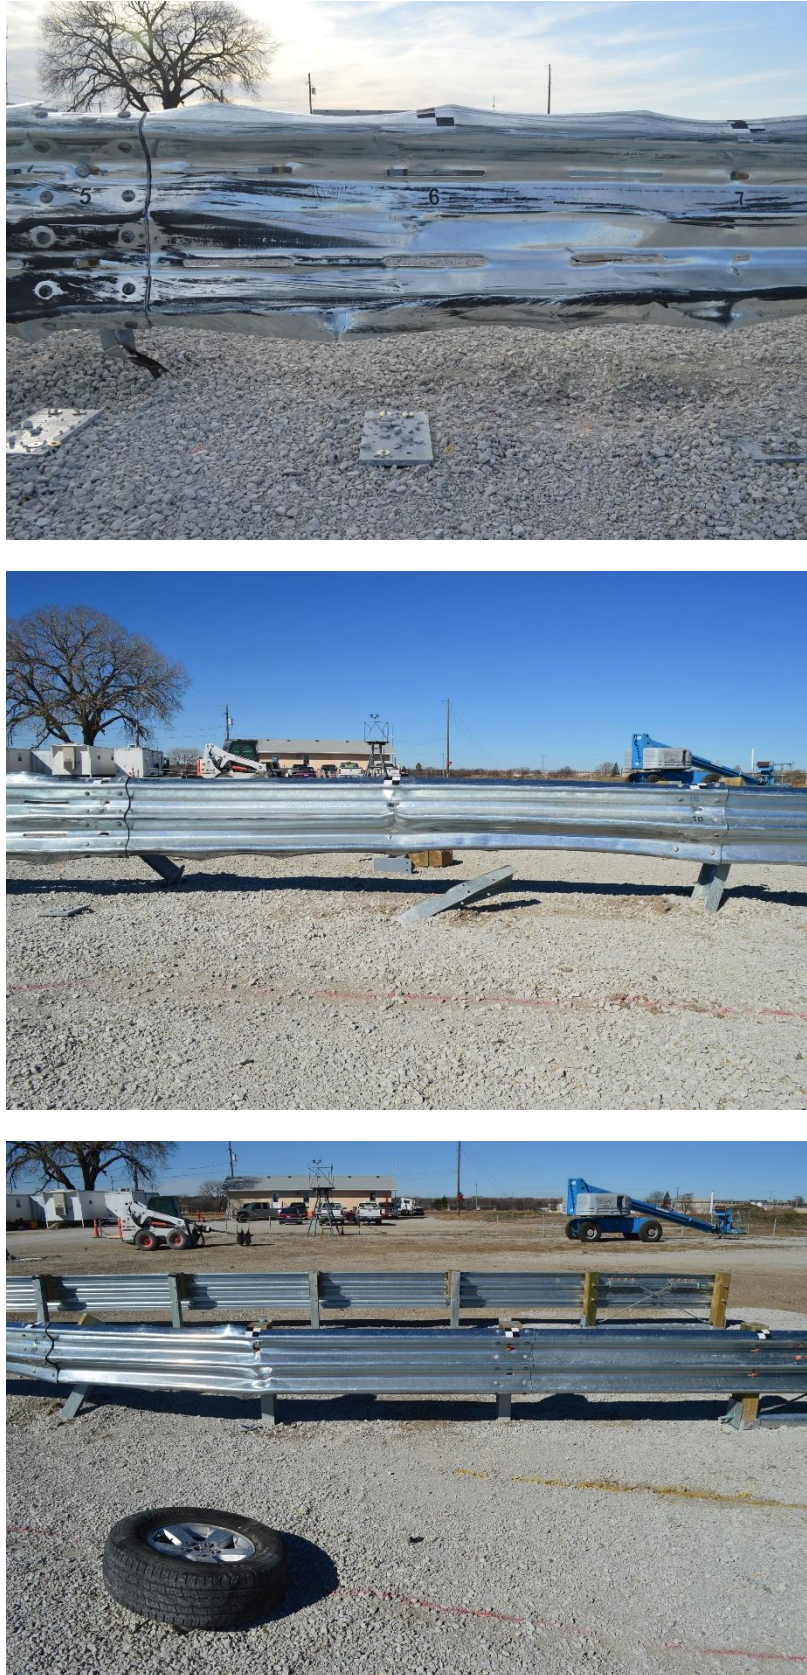
Figure 58. Post Nos. A1 through A5 Damage, Test No. MSPBN-1

The foundation tube of post no. A1 was crushed in on the upstream side. Post no. A2 fractured on the upstream side of the post at the foundation tube bolt. The post base bolts of post nos. A5 through A8 fractured at the ground line. Post nos. A6 and A7 were detached from the rail. Post no. A9 was bent backward and downstream, the blockout disengaged from the post and the rail, the guardrail bolt fractured, and there were dents on the front and back upstream flanges 17 in. (432 mm) and 20½ in. (521 mm) from the top of the post, respectively. The back upstream flange of post no. B9 was dented 18½ in. (470 mm) from the bottom by post no. A7, which flew backward.

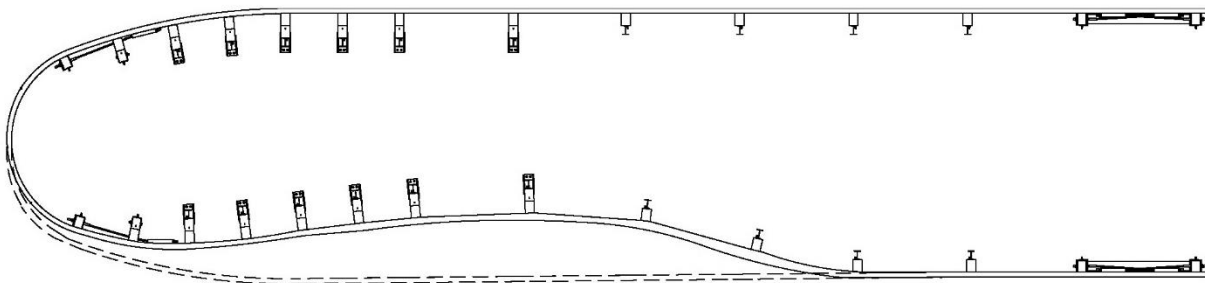
Figure 66. System Deformation After Impact, Test No. MSPBN-1

The maximum lateral dynamic barrier deflection was 46.2 in. (1,173 mm) at the rail at post no. A6, as determined from high-speed digital video analysis. The vehicle was successfully redirected during the impact event. The system working width was 177.25 in. (4,502 mm) based on the width of the bullnose system. Note that working width for redirective impacts is defined based on the maximum of the lateral dynamic deflection of the system, the lateral extension of the vehicle, and the barrier width as measured from the front face of the barrier during a vehicle impact. However, the bullnose system is sufficiently wide to allow for lateral deflection and vehicle extension internal to the barrier width. Thus, the working width is defined based on the overall width of the system. The system deformation is shown in Figure 66.

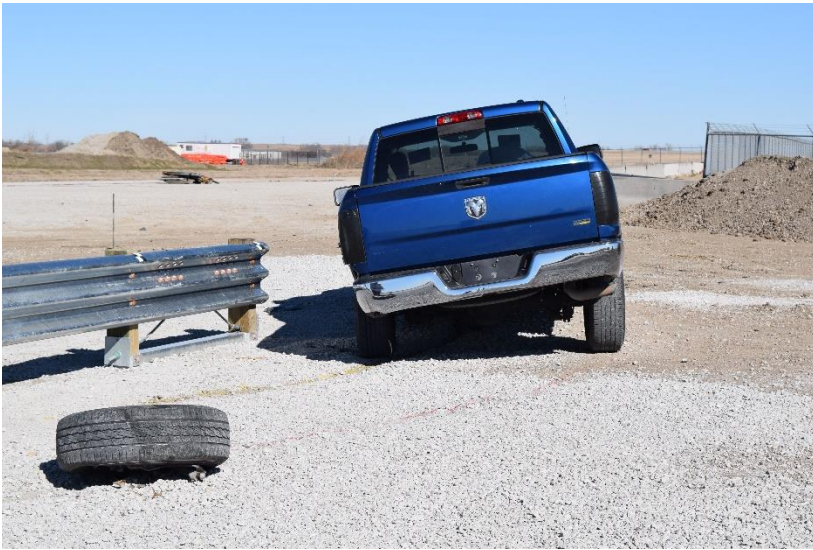
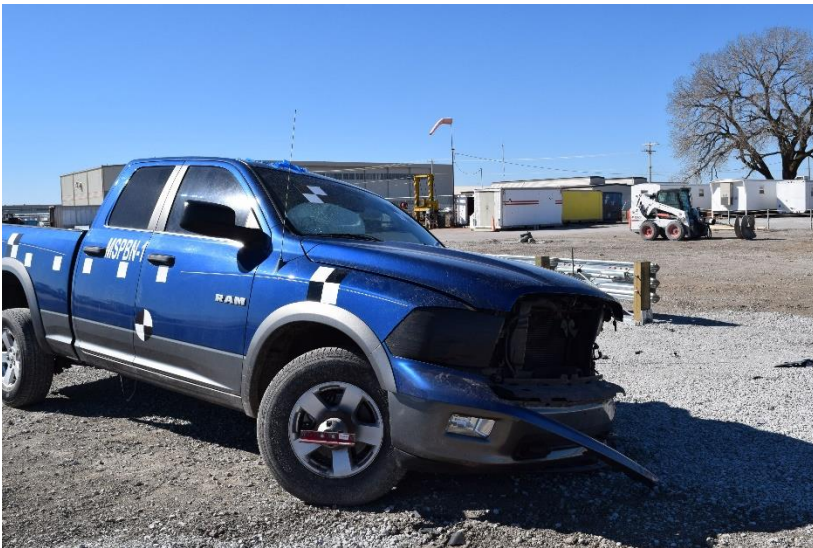
Figure 67. Vehicle Damage, Test No. MSPBN-1

The majority of the damage was concentrated on the on the left-front corner and left-front side of the vehicle where the impact occurred. The entire grille assembly was disengaged from the front of the vehicle. A 21-in. x 6-in. (533-mm x 152-mm) section on the left side of the front facia above the front bumper was detached. The remainder of the front facia was only attached by a small section on the right side of the vehicle. The left headlight and left-front fog light were disengaged. The left side of the front bumper was dented and crushed inward. The left fender was bent up and inward, and the rear section was separated. The left-front wheel, brake assembly, and tie rod were disengaged. The inner wheel well plastic was dented and kinked, and the top portion was separated from the vehicle. The front of the left-front door had a series of dents and scrapes at the middle of the door. The left-rear corner of the cab and the front edge of the right quarter panel were dented and scraped. Dents and scraping were located on the left quarter panel just below the taillight. A 27-in. (686-mm) diameter spider web crack was found in the windshield due to right-side airbag activation.

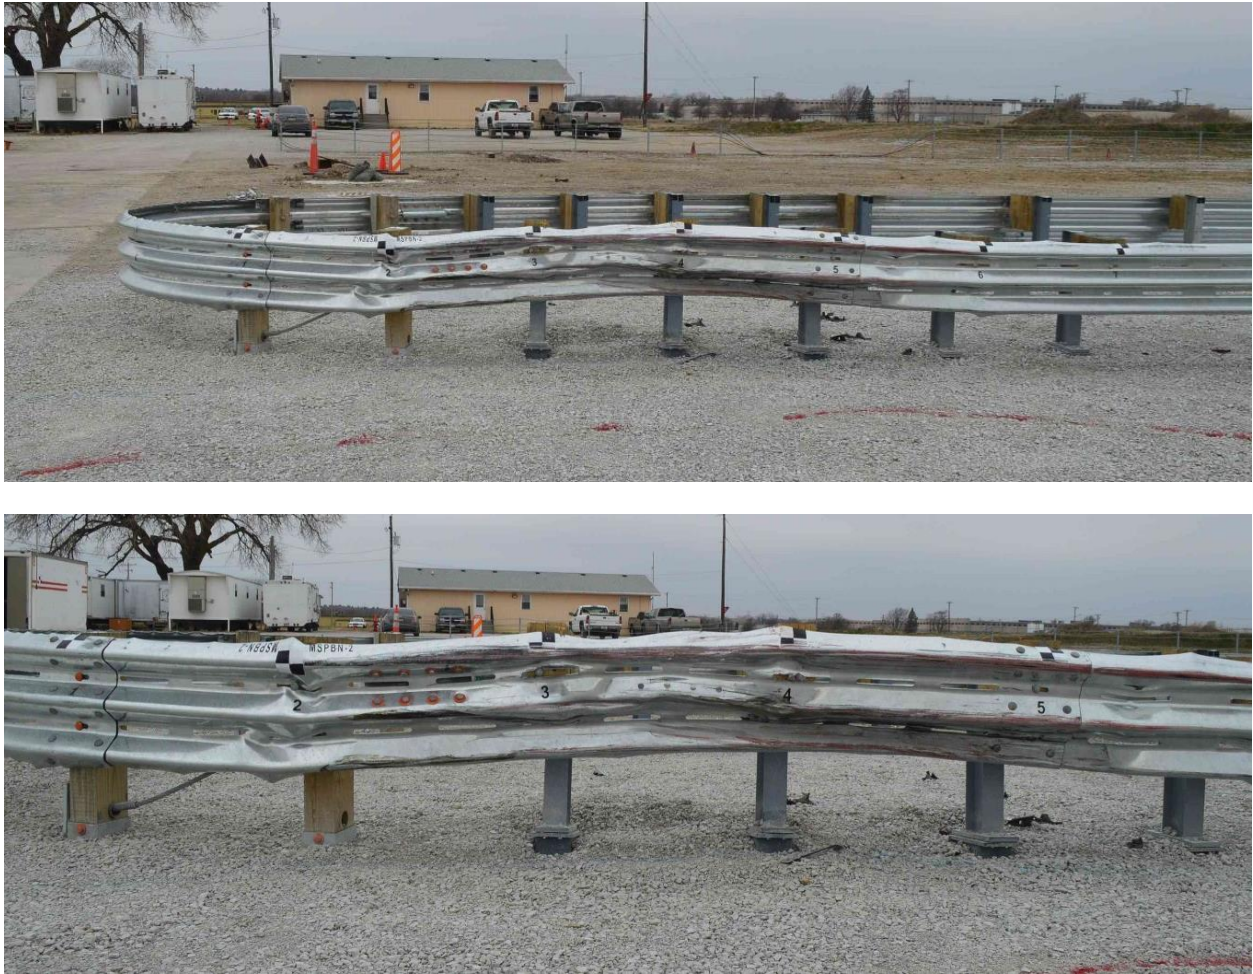
Figure 79. Post nos. A1 through A5 Damage, Test No. MSPBN-2

No movement or damage was seen for post no. A1. The top downstream corner of the block out for post no. A2 had a chip measuring $\frac{3}{4}$ in. (19 mm) deep, $1\frac{3}{4}$ in. (44 mm) wide and 2 in. (51 mm) tall. Post no. A3 rotated backward, the top downstream corner of the block out was chipped, and the post bolt partially pulled through the slot in the thrie-beam. Tire marks were found on the front flange of post no. A4, 3 in. (76 mm) from the bottom and in front of the base plate. Post no. A4 also rotated backward during the impact. Post no. A5 experienced a backward rotation, and tire marks were found on the front of the base.

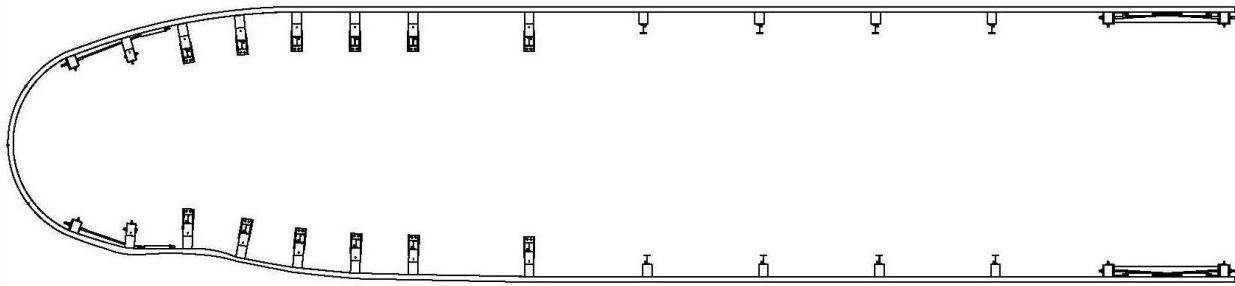
Figure 83. System Deformation After Impact, Test No. MSPBN-2

The maximum lateral dynamic barrier deflection was 13.7 in. (349 mm) at the rail at post no. A4, as determined from high-speed digital video analysis. As the vehicle was successfully redirected during the impact event and the rail experienced slight outward deformation around the nose, the system working width was 177.25 in. (4,502 mm) based on the width of the bullnose system. Note that working width for redirective impacts is defined based on the maximum of the lateral dynamic deflection of the system, the lateral extension of the vehicle, and the barrier width as measured from the front face of the barrier during a vehicle impact. However, the bullnose system is sufficiently wide to allow for lateral deflection and vehicle extension internal to the barrier width. Thus, the working width is defined based on the overall width of the system. The system deformation is shown in Figure 83.

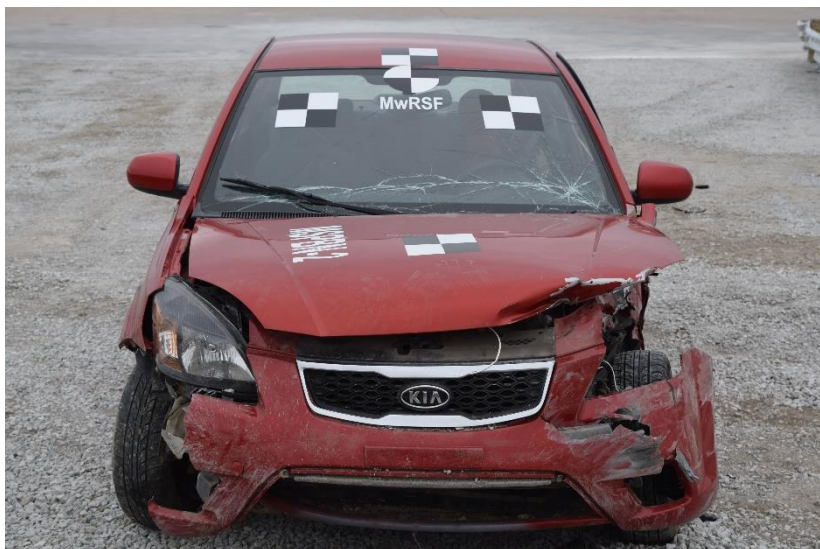
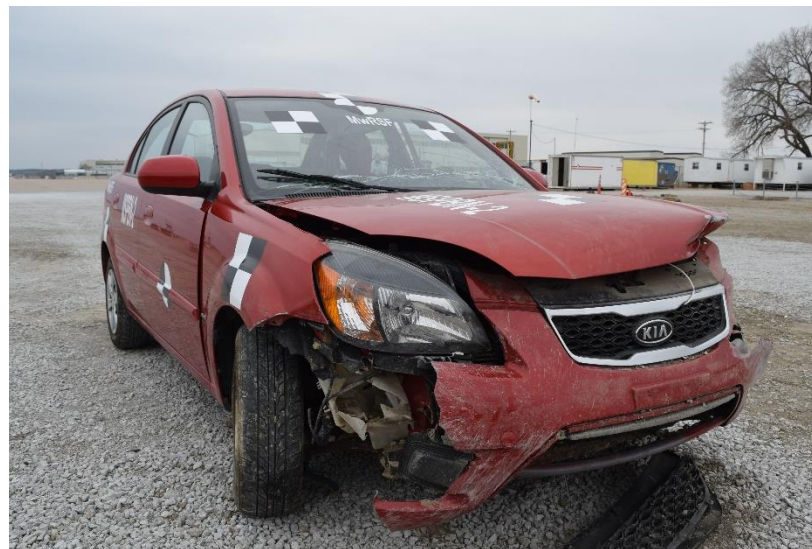
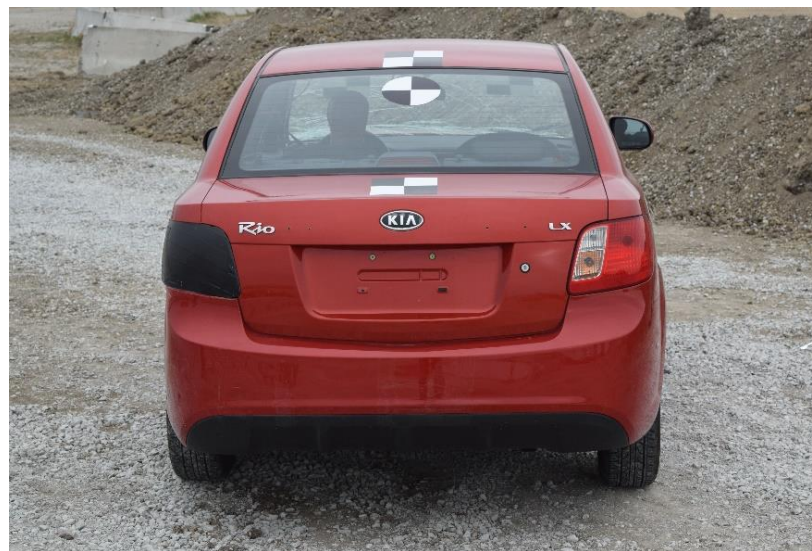
Figure 84. Vehicle Damage, Test No. MSPBN-2

The majority of the damage was concentrated on the left-front corner and left-front side of the vehicle where the impact occurred. A crease developed along the length of the vehicle on the left side along with multiple contact marks and small dents. The vehicle's fuel door on the vehicle disengaged and the fuel door hinge cracked just above the mounting bolt. An 8½-in. (216-mm) diameter dent was found 2 in. (51 mm) from the left-front door and 10 in. (254 mm) from the bottom of the window. An 11-in. x 4-in. (279-mm x 102-mm) dent formed on the rear section of the left-front door. Contact marks and multiple tears were located along the entire front of the fascia. The damage on the right side of the vehicle was mostly due to the impact with earth berm. The lower right corner of the grille assembly and the left headlight detached. A 13-in. (330-mm) tall crack extended the entire length of the windshield. A 3½-in. (89-mm) gap was found between the front right fender and the front of the hood that decreased to 1¾ in. (44 mm) at the rear of the hood. The right-front tire came into contact with the rear of the front wheel well.

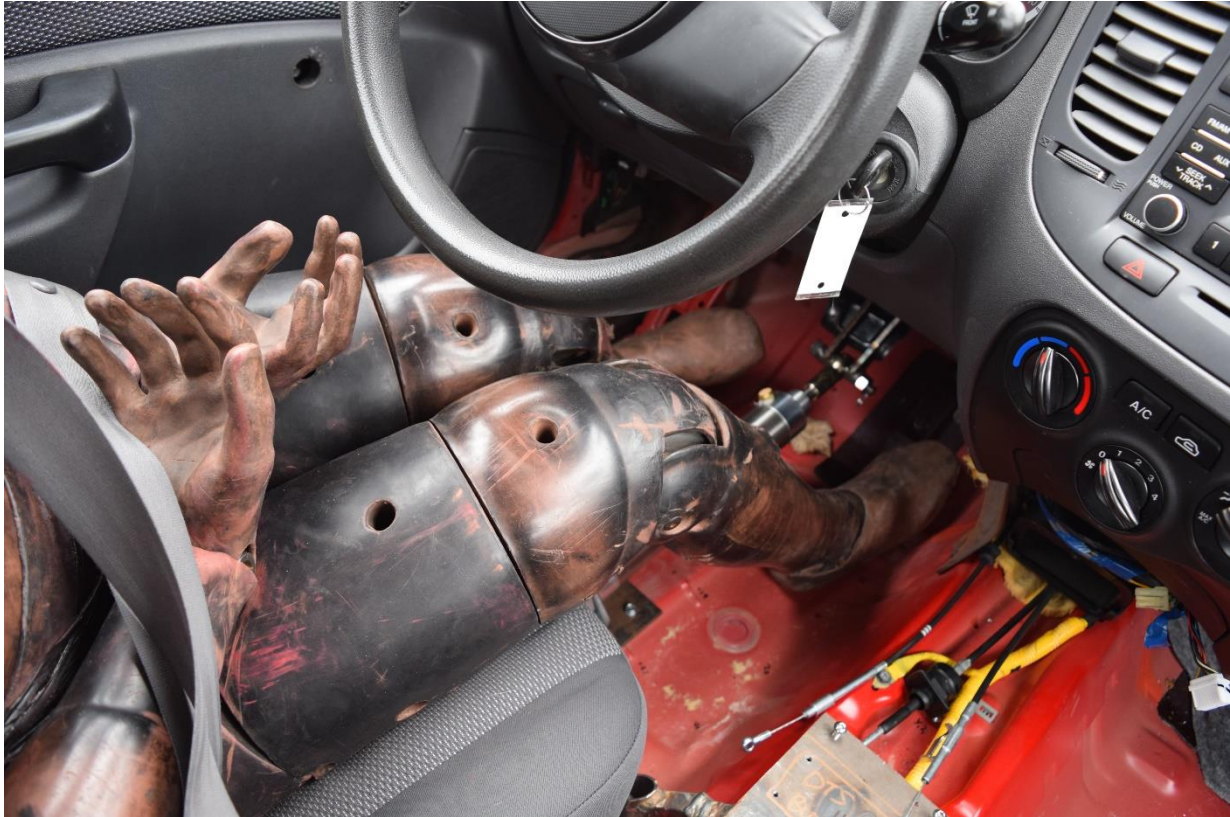
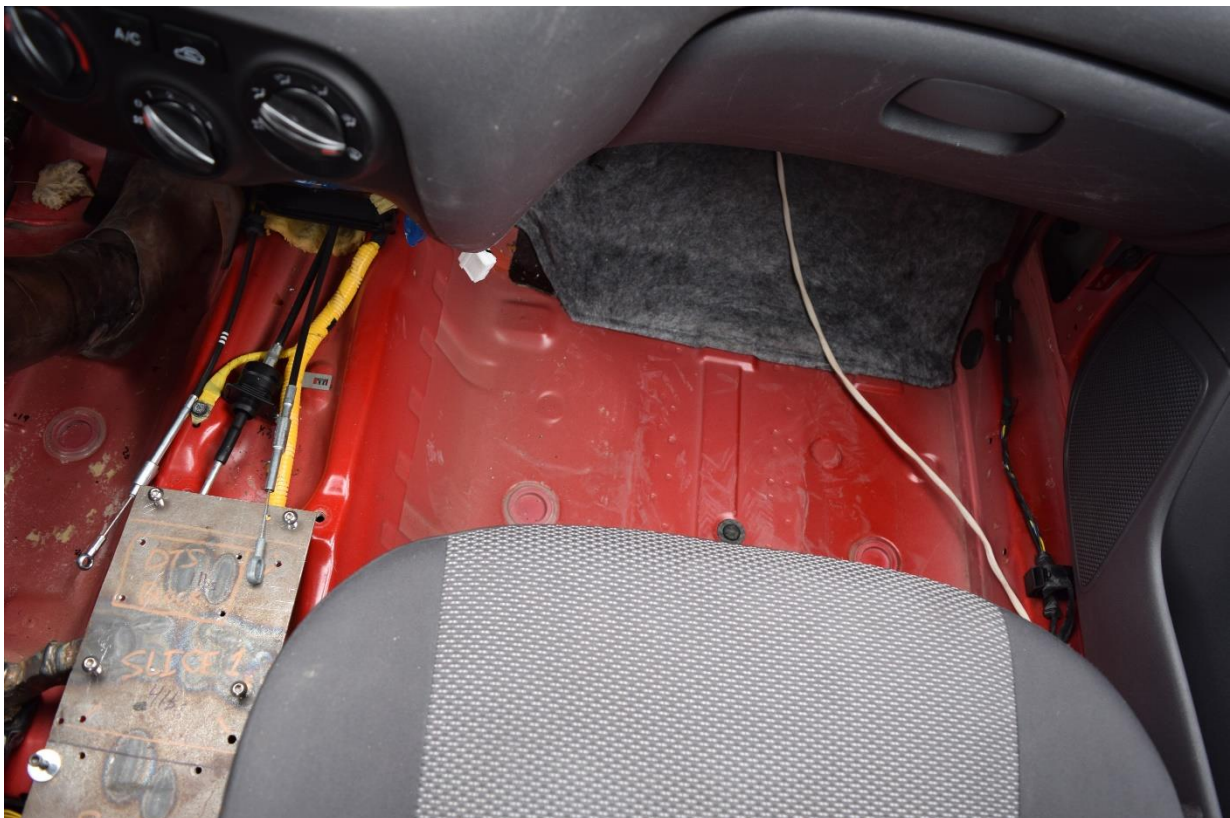
Figure 86. Floorboard Damage, Test No. MSPBN-2

The damage to the vehicle was moderate, as shown in Figures 84 through 87. The maximum occupant compartment intrusions are listed in Table 10 along with the intrusion limits established in MASH 2016 for various areas of the occupant compartment. As noted previously, a secondary impact with an earth berm downstream from the impact with the three-beam bullnose may have contributed to the observed vehicle damage and intrusions. Note that none of the established MASH 2016 deformation limits were violated. Complete occupant compartment and vehicle intrusions and the corresponding locations are provided in Appendix D.

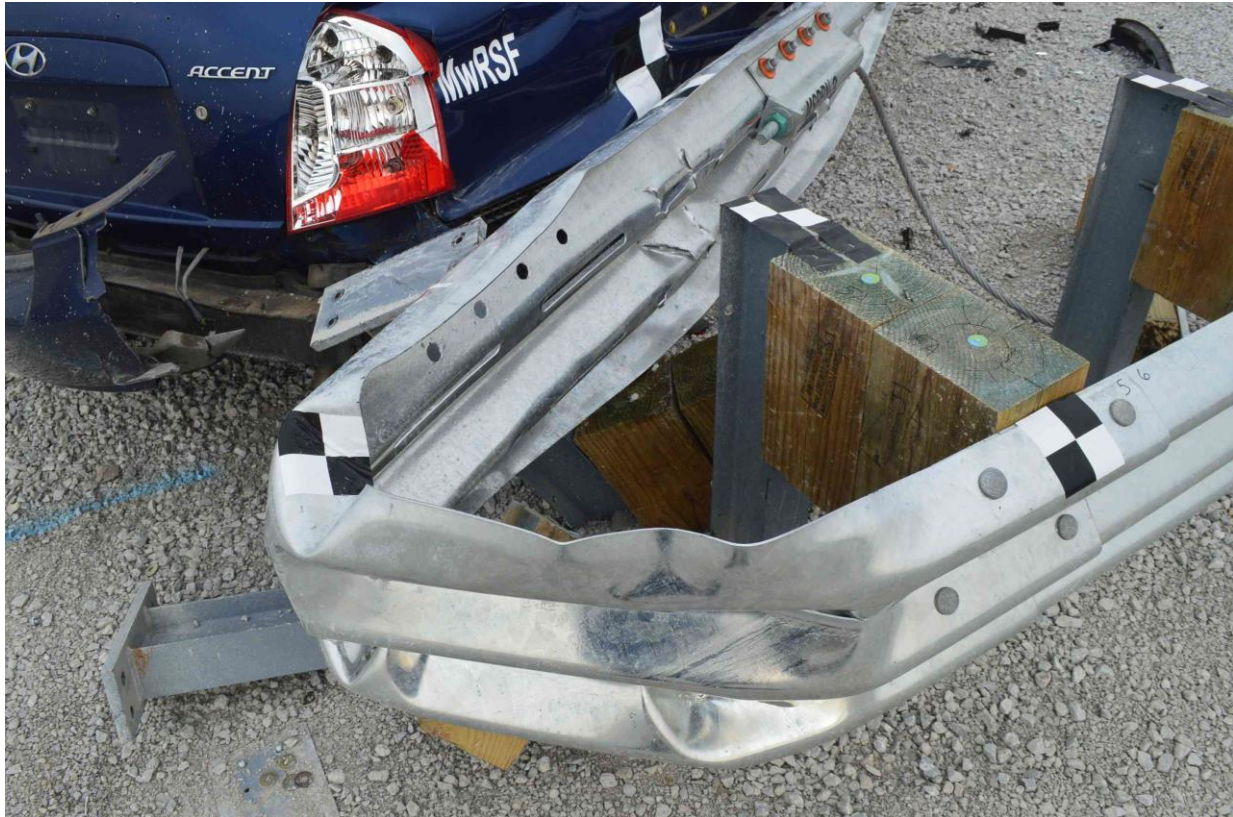
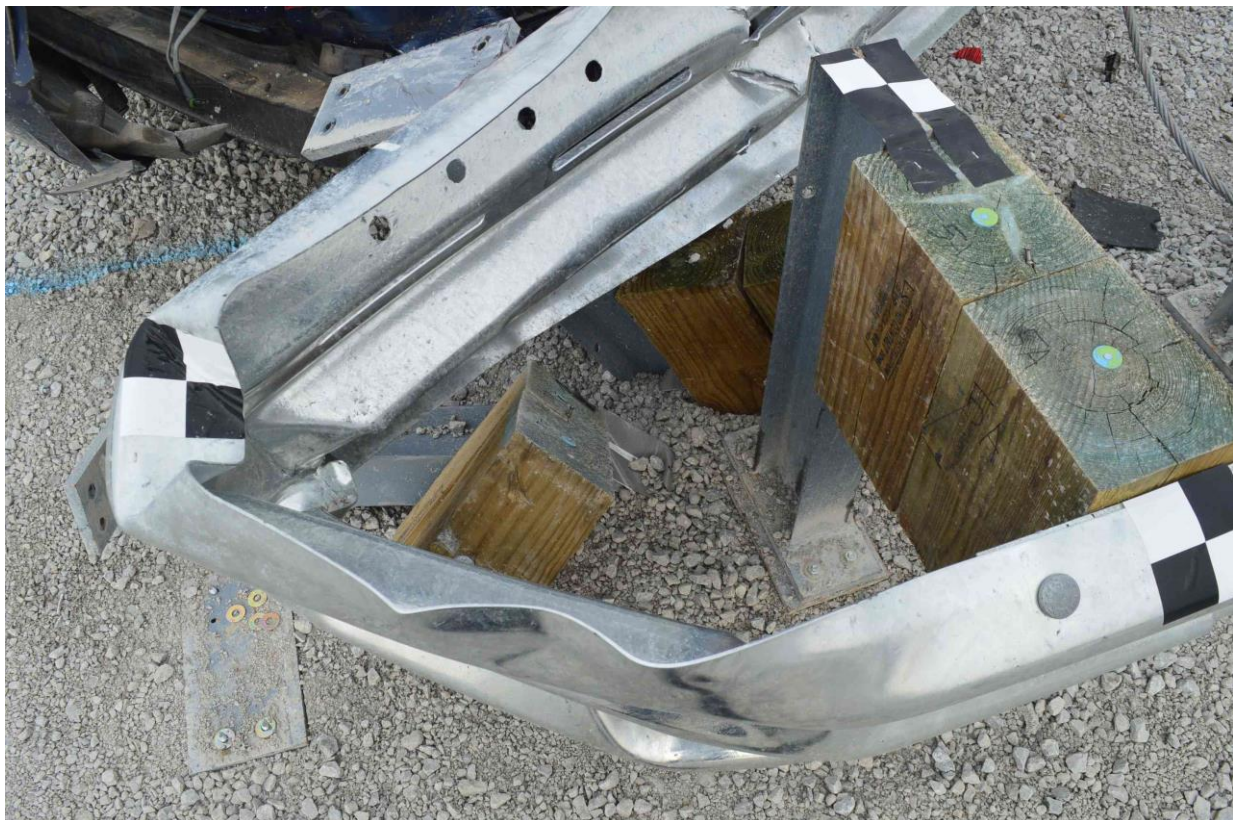
Figure 96. Post Nos. A3, A4, and A5 Damage, Test No. MSPBN-3

The timber post damage included crushing, splits, dents, and fractures at the foundation tube. Post nos. 1A, 2A, and 2B fractured at the ground line through the BCT hole and disengaged at the base. Post no. 1A was crushed along a horizontal line on the front face and split on the upstream side. Post no. 2A had a 1-in. (25-mm) long x ½-in. (13-mm) wide dent that was ⅛ in. (3 mm) deep on the front-upstream corner 11-in. (280-mm) from top of the post. The rail was detached from post no. 2A. Post no. 1B fractured diagonally from upstream to downstream on the front face of post 9-in. (229-mm) above the foundation tube. Post no. 1B also fractured diagonally on upstream face 10-in. (254-mm) from the foundation tube.

Steel post damage included fracture of bolts, twisting, rotation, and detachment from the post bases. All base bolts on post nos. 3B through 7B fractured at the ground line. Post no. 3B detached from the rail and the post twisted in counter-clockwise direction. Contact marks were found on the lower base plate from the upstream to downstream corner and 5 in. (127 mm) from the back edge. The top of post nos. 5B, 9B, 10B, and 11B twisted counter-clockwise. The blockouts attached to post nos. 6B, 8B, and 9B split on the upstream face. All base bolts on post nos. 3A and 4A fractured at the ground line. The rail detached from post nos. 3A and 4A. Crushing measuring 2½ in. (64 mm) long x 1½ in. (38 mm) wide and ¼ in. (6 mm) deep was found on the front and downstream corner of the blockout on post no. 3A. The blockout of post no. 4A disengaged from the post, but the rail remained attached.

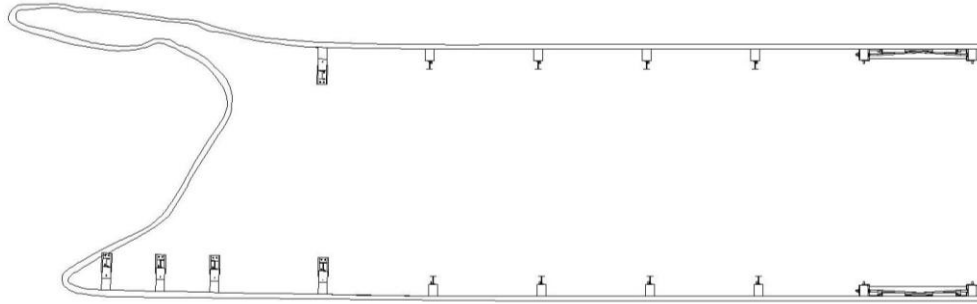
Figure 98. System Deformation After Impact, Test No. MSPBN-3

The maximum lateral dynamic barrier deflection was 72.0 in. (1,829 mm) at the impact point as determined from high-speed digital video analysis. The vehicle was contained within the bullnose system after the impact, which resulted in a working width in both the longitudinal and lateral directions. This working width envelope contained a 23 ft – 7 in. (7.2 m) longitudinal working width and a 16 ft – 11 in. (5.2 m) lateral working width. The system deformation is shown in Figure 98.

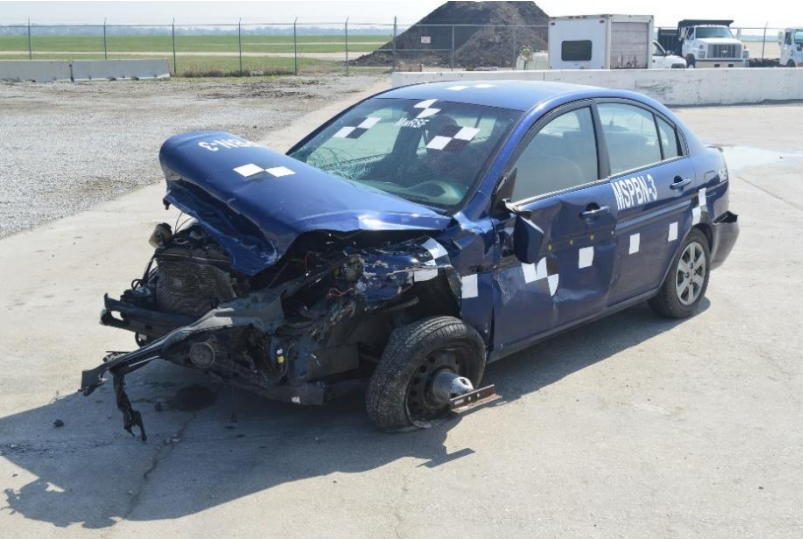
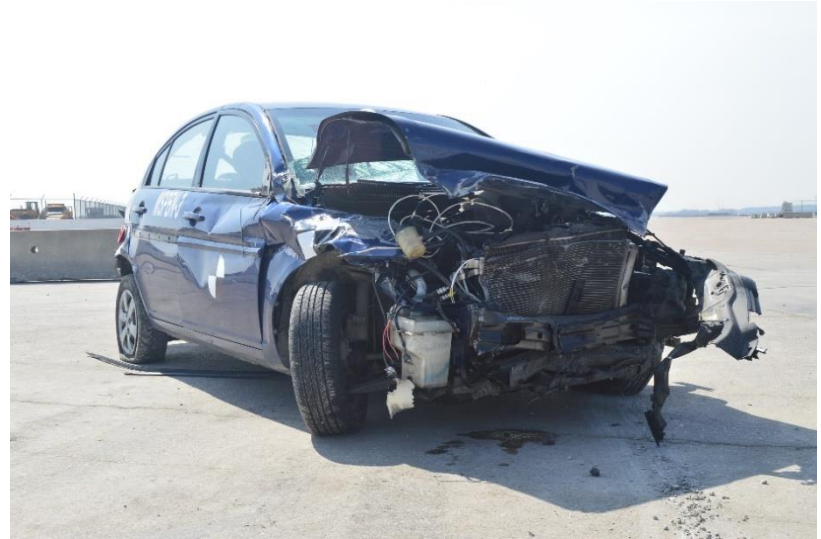
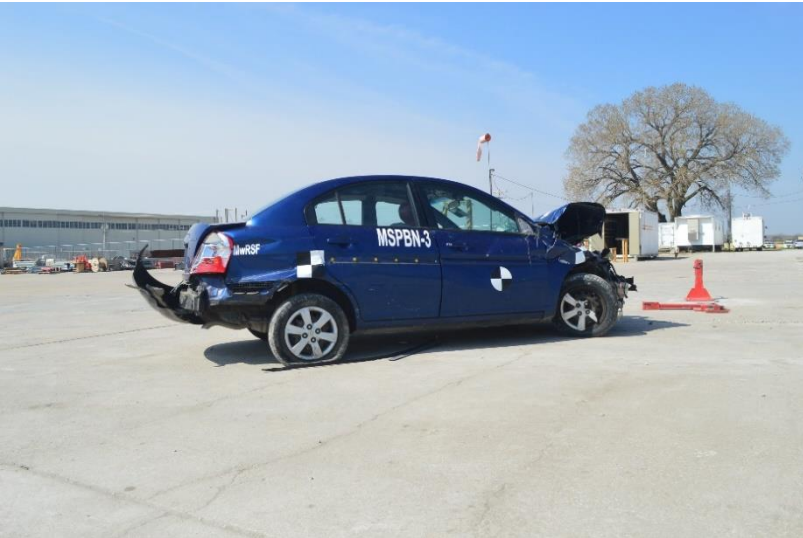
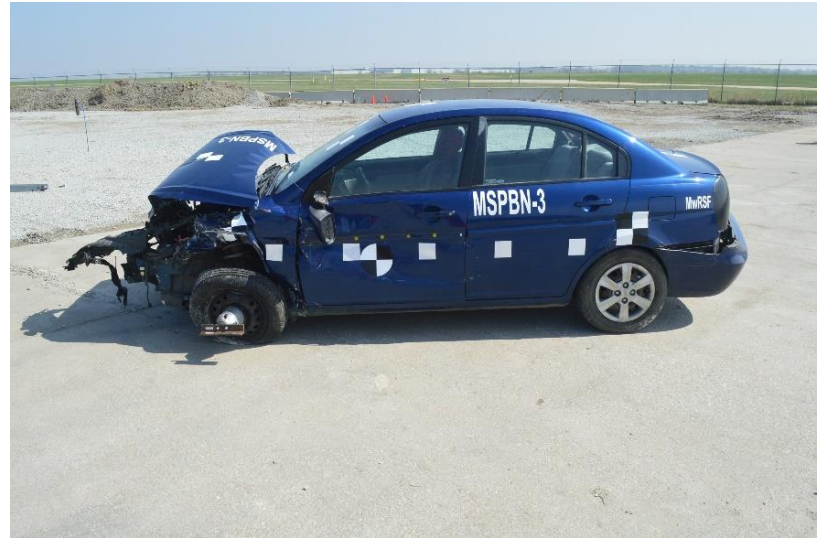
Figure 99. Vehicle Damage, Test No. MSPBN-3

The majority of the damage was concentrated on the front side of the vehicle where the impact had occurred. Both headlights, fog lights, and side mirrors, as well as the front grille and

front bumper cover disengaged from the vehicle. The radiator on the front side showed bending and detached from its mounts. The grille disengaged from the vehicle. The hood bucked upward approximately 5 in. (127 mm) on the left side and 13 in. (330 mm) on the right side. A 40-in. (1,016-mm) wide by 7-in. (178-mm) long dent that was 5 in. (127 mm) deep was found in the front of the hood. The AC condenser had a 10-in. (254-mm) diameter by 1-in. (25-mm) deep dent. A 2½-in. (64-mm) gap was found between the A-pillar and the right-front fender. A 31-in. (787-mm) long crease developed at the right-front door and the bottom of the window. The right side of rear bumper cover was disengaged from the vehicle, but the left-side rear bumper remained attached. Numerous dents were found on the right-rear door. The right-rear fender was crushed, and the right-rear tire deflated and contained a 1-in. (25-mm) tear. An 11-in. (279-mm) wide x 33-in. (838-mm) long x 1-in. (25-mm) deep dent was found starting 2½ in. (64 mm) from the rear of the left-front door and 6 in. (152 mm) from the bottom of the door. A ½-in. (13-mm) gap was found at the top corner of left-front door. A 14-in. (356-mm) long x 3-in. (76-mm) wide x ½-in. (13-mm) deep dent was observed on the left-rear quarter panel. The fenders on the left-front side and right-front side were crushed. The buckling of the left-front fender started 9½ in. (241 mm) from the rear of the fender and folded back over whole width. Many scrapes, contact marks could be observed. The left-front tire was deflated but still partially attached to the wheel. Dents, measuring 3 in. (76 mm) and 4½ in. (114 mm) long, were found on outer wheel rim. Both the left-front and right-front doors would not open after the test. The hood contacted the bottom-right side of windshield during impact, causing a 29-in. (737-mm) by 12-in. (305-mm) spider web crack that was found on the bottom right side of the windshield, with additional cracks extending on top of the windshield. A 4-in. (102-mm) long longitudinal tear was found 5 in. (127 mm) from the bottom of the windshield and 1 in. (25 mm) from the right side of the windshield. A 5-in. (127 mm) long vertical tear was found 5 in. (127 mm) from the bottom of the windshield and 5 in. (127 mm) from the right side of the windshield. Note that the windshield damage was likely due to contact with the hood not due to contact with the bullnose system. The side windows remained undamaged.

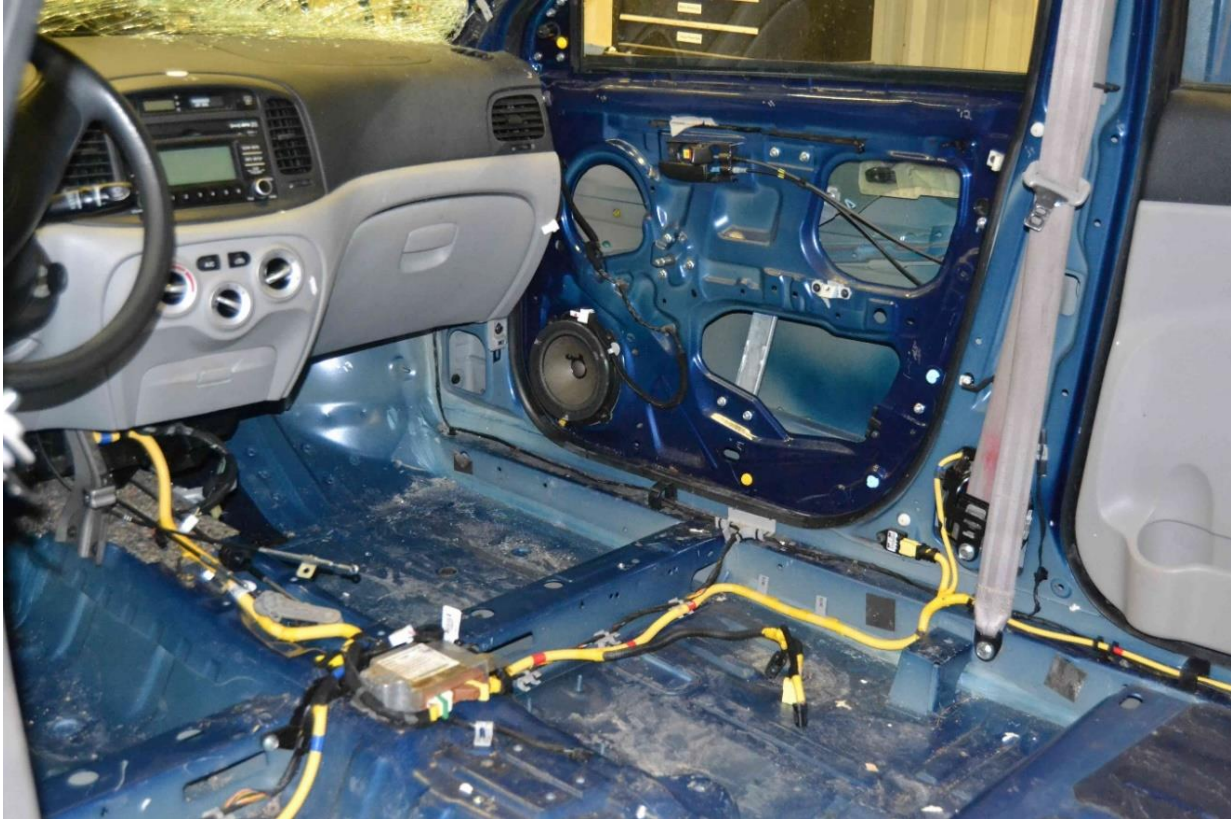
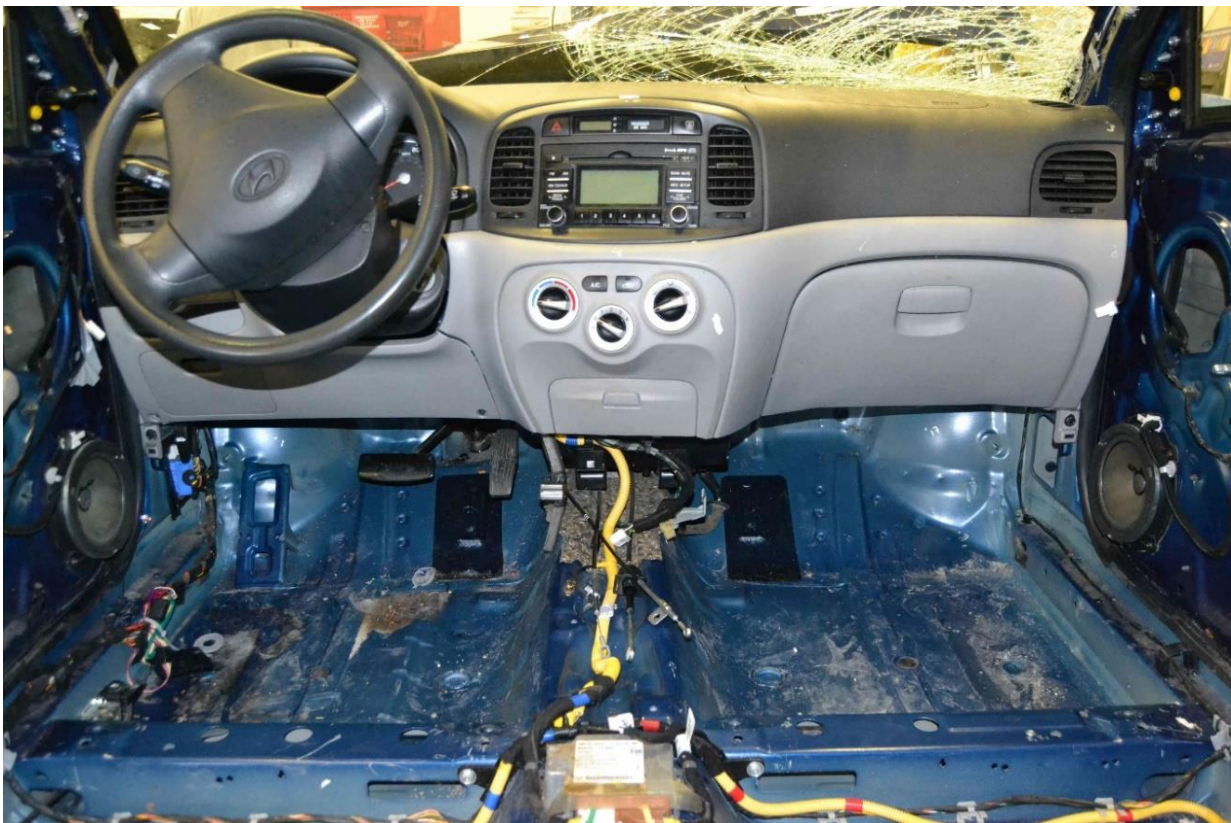
Figure 101. Floorboard Damage, Test No. MSPBN-3

The damage to the vehicle was moderate, as shown in Figures 99 through 103. The maximum occupant compartment intrusions are listed in Table 15 along with the intrusion limits established in MASH 2016 for various areas of the occupant compartment. Note that none of the established MASH 2016 deformation limits were violated. Complete occupant compartment and vehicle intrusions and the corresponding locations are provided in Appendix D.
