*Midwest Pooled Fund Research Program  
Fiscal Years 2017-2019 (Years 27 through 29)  
Research Project Number TPF-5 (193) Supplement #106  
NDOT Sponsoring Agency Code RFPF-17-MGS-2*

## **EVALUATION OF THE MGS PLACED 6 IN. BEHIND A 6-IN. TALL AASHTO TYPE-B CURB TO MASH TL-3**

MWRSF Research Report No. TRP-03-390-20

August 27, 2020

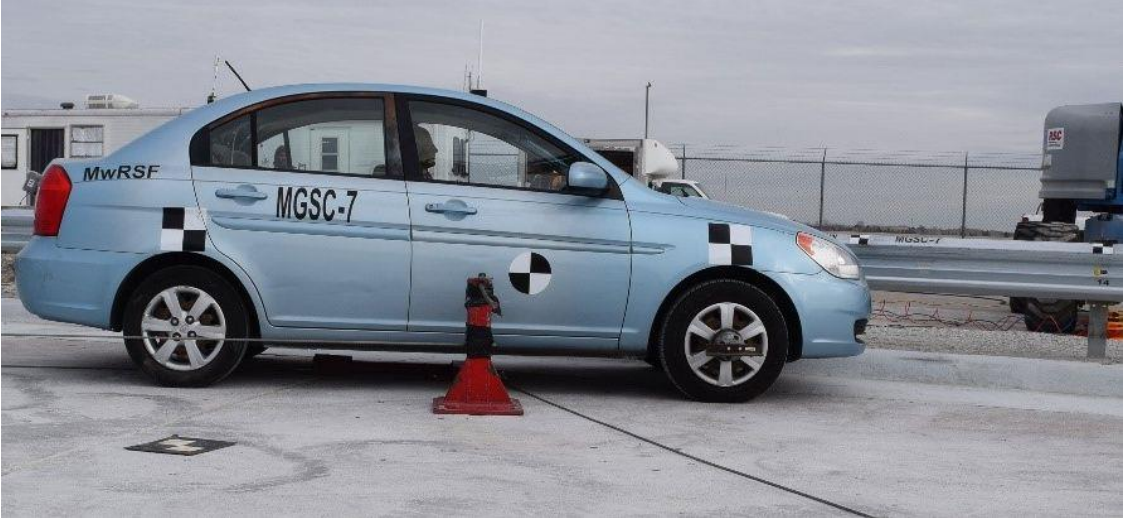
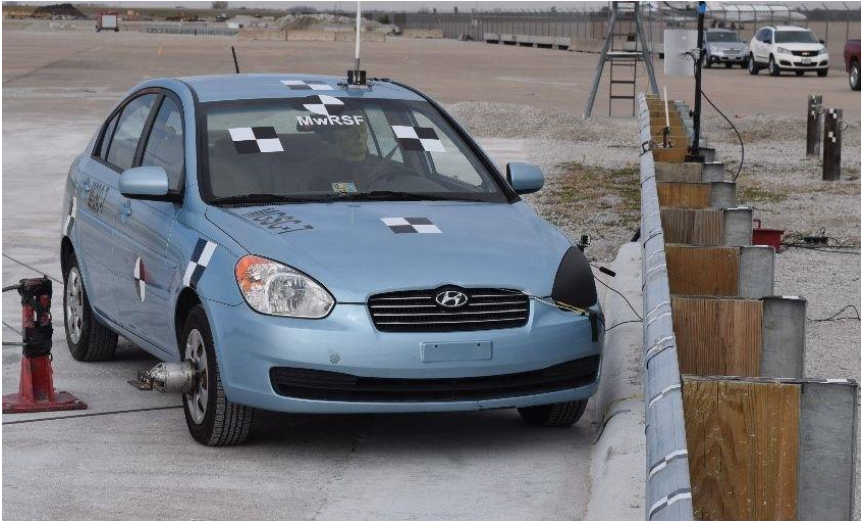
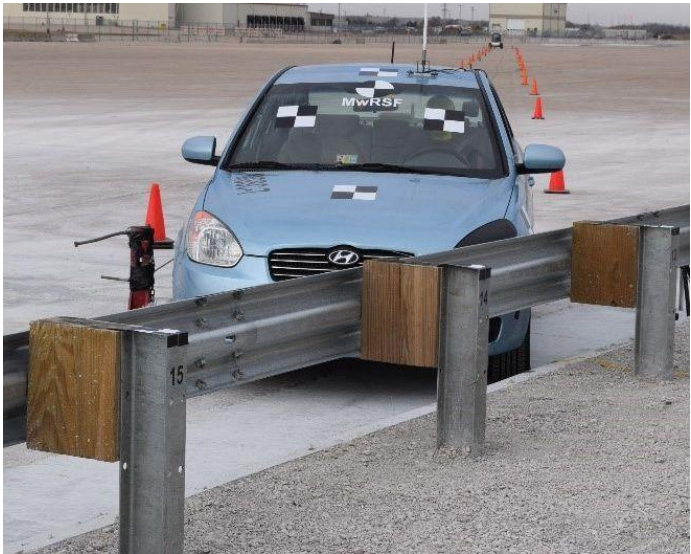
Figure 41. Impact Location, Test No. MGSC-7

The critical impact point for test no. MGSC-7 was selected using the CIP plots found in Section 2.3 of MASH. The critical impact point was determined to be 89 in. upstream from the splice located between post nos. 14 and 15, as shown in Figure 41.

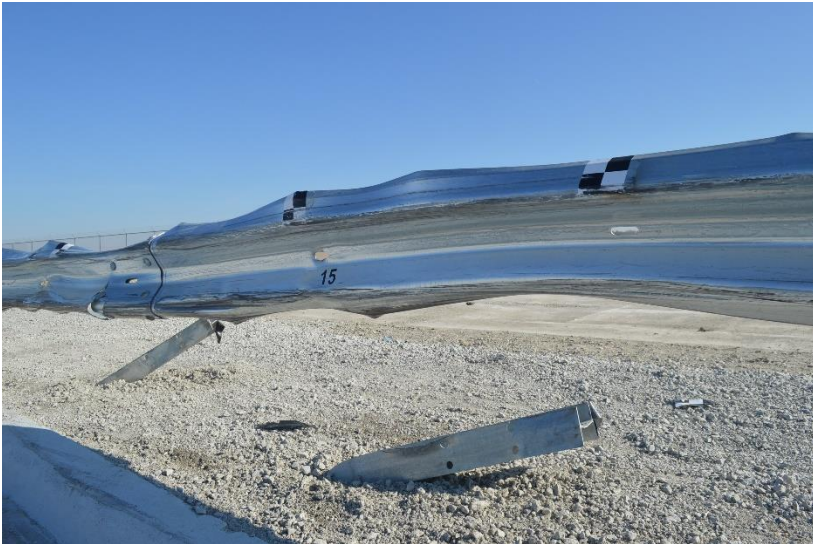
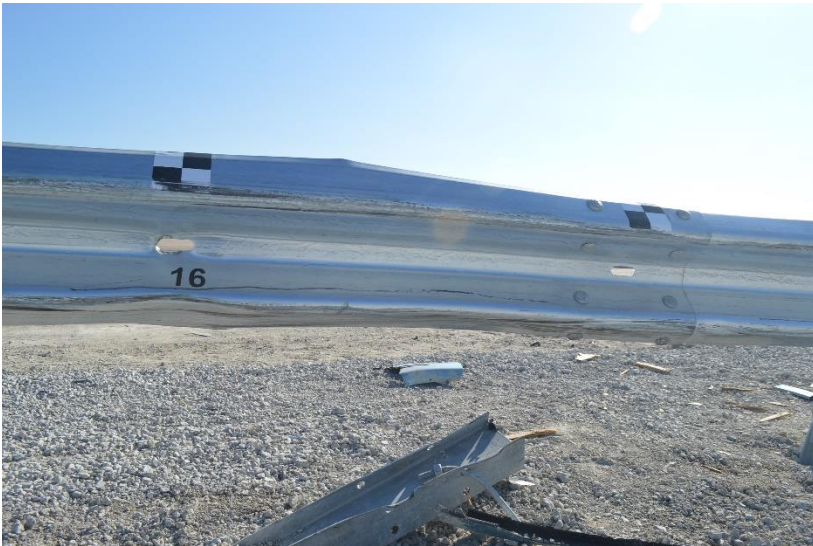
Figure 50. Guardrail Damage, Post Nos. 13 through 15, Test No. MGSC-7

Damage to the W-beam guardrail with curb system was moderate, as shown in Figures 49 through 57. Damage consisted of contact marks on various MGS components, as well as bending, kinking, tearing, and twisting of the posts and guardrail. The length of vehicle contact along the barrier was approximately 25 ft – 7 in., which spanned from 12 in. downstream from post no. 13 to 19 in. downstream from post no. 17.

The W-beam guardrail was laterally displaced between post nos. 13 and 17 and was disengaged from post nos. 14 through 17. Rail kinking and flattening was observed at multiple locations along the rail between post nos. 13 and 17. The bottom of the rail was bent upward from post no. 14 to post no. 17. The rail was partially torn at the splice location between post nos. 14 and 15. The tear extended from the bottom edge of the rail, through the lower-upstream bolt holes, and stopped near the middle of the W-beam valley.

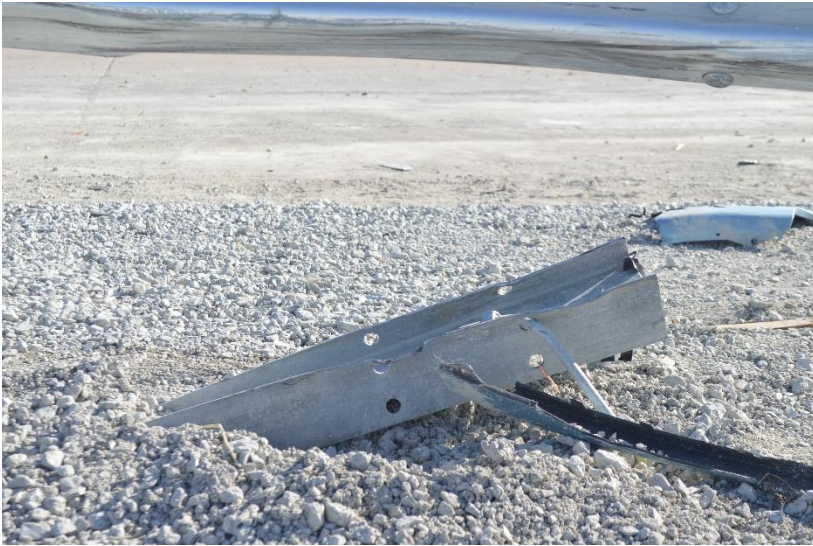
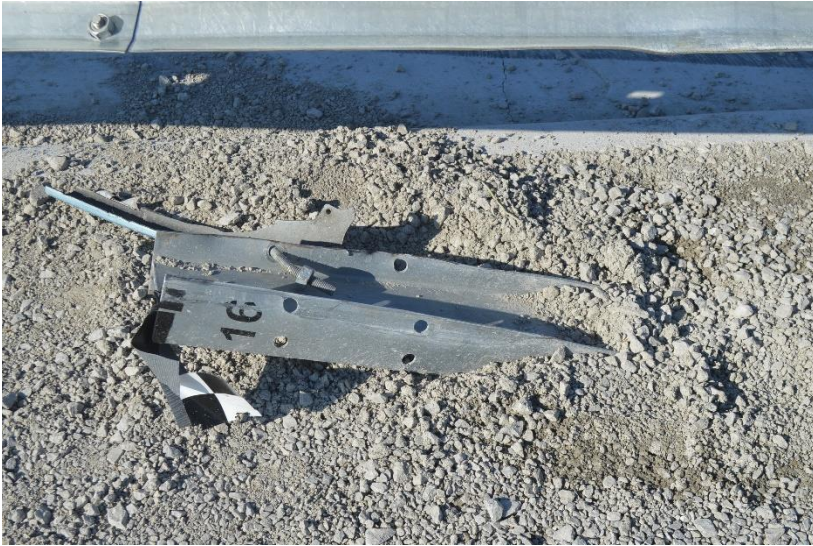
Figure 54. Post Nos. 14 and 15 Damage, Test No. MGSC-7

Post nos. 14 through 16 were bent back and downstream at ground line. Post no. 17 was bent slightly downstream and twisted to face downstream. Soil heaves and craters formed at the bases of post nos. 14 through 17. Contact marks were found on the upstream edge of post nos. 14 through 17. Post nos. 3 through 14, 16, and 17 were twisted to face downstream. Post nos. 1, 2, and 19 through 29 did not deflect and were not damaged.

Blockouts disengaged from post nos. 14 through 17. The attachment bolt of post no. 15 tore out of the upstream flange web. The blockout of post no. 18 was slightly rotated such that the top of blockout angled upstream. Minor blockout splitting was observed on post nos. 3 through 5, 7, 8, and 12. Curb damage consisted of contact marks which spanned from post nos. 13 to 15.

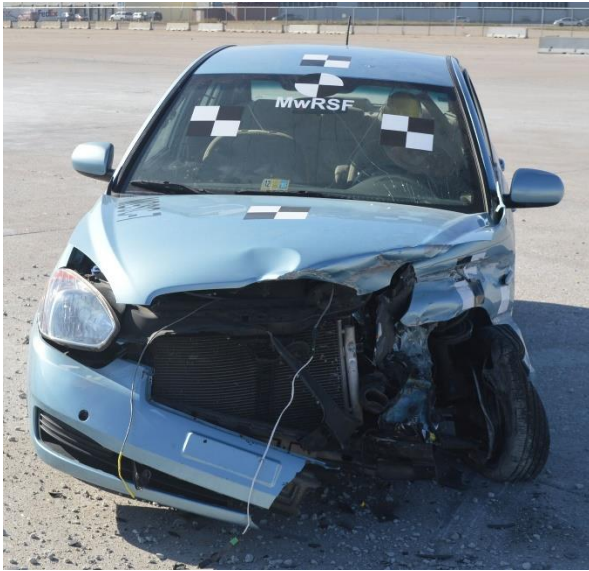
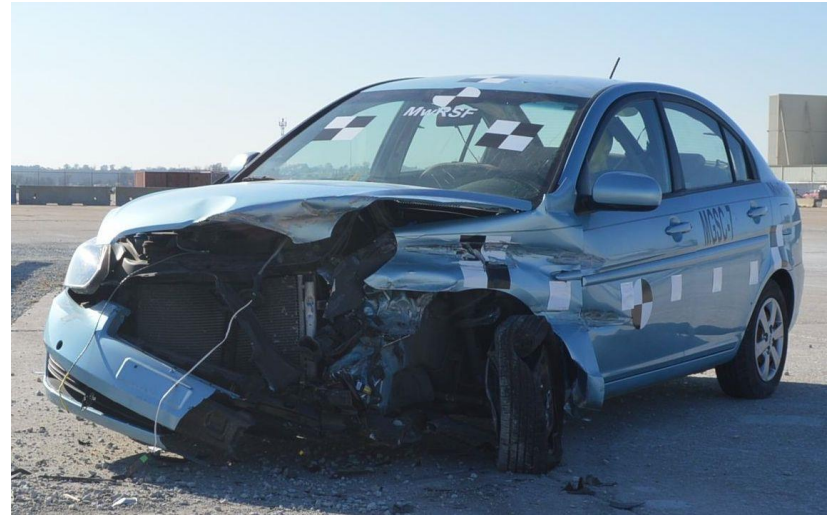
Figure 59. Vehicle Damage, Test No. MGSC-7

The majority of the damage was concentrated at the left-front corner and front end of the vehicle where the impact had occurred. The left-side of the bumper cover was ripped and detached starting 8 in. left of bumper center. The left-front bumper corner was crushed inward and down. The left-side of the radiator core support was displaced. The left-front hood was folded under and pushed in. The left-front fender was bent inward 10 in., and the bottom of the fender protruded outward 5 in. The left-front frame rail was split and crushed backward. The left-front tire was torn, and the wheel rim was bent at three locations. The left-front door was dented near the front and the latch was damaged. The windshield was cracked at the bottom left-front corner, but the roof and remaining window glass were undamaged.

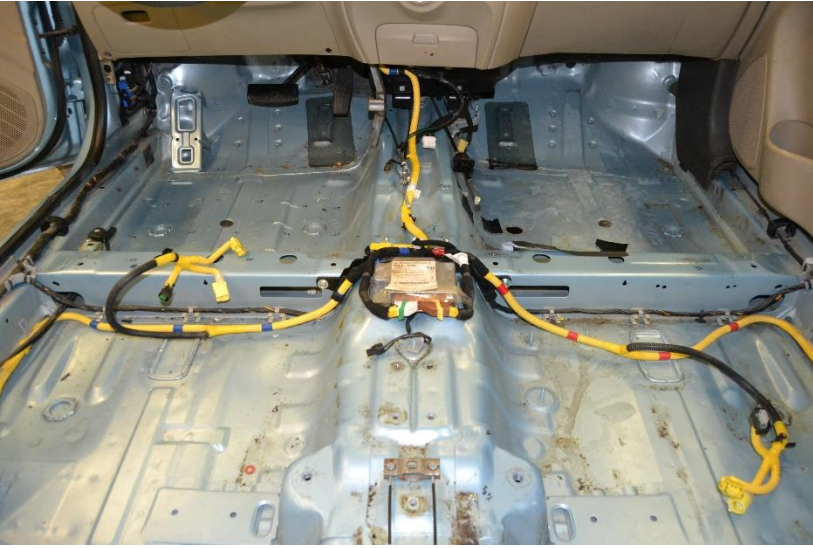
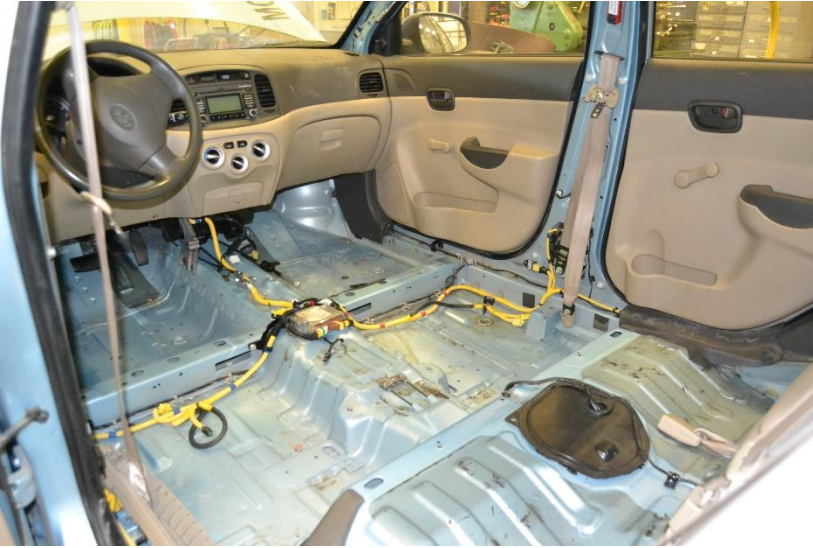
Figure 61. Occupant Compartment Damage, Test No. MGSC-7

The damage to the vehicle was moderate, as shown in Figures 59 through 62. The maximum occupant compartment deformations are listed in Table 6 along with the deformation limits established in MASH 2016 for various areas of the occupant compartment. Note that none of the established MASH 2016 deformation limits were violated. Complete occupant compartment and vehicle deformations and the corresponding locations are provided in Appendix D.

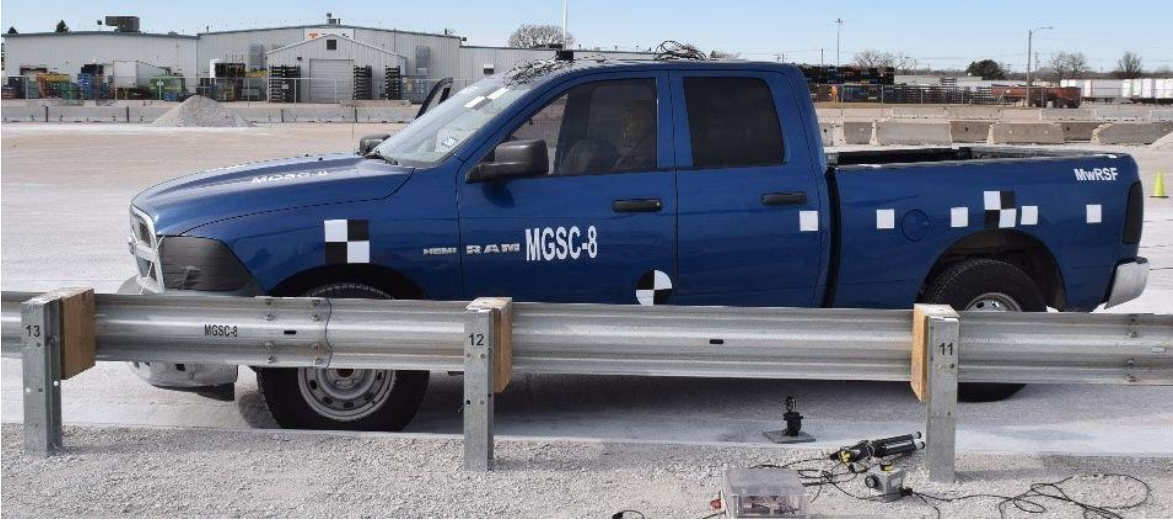
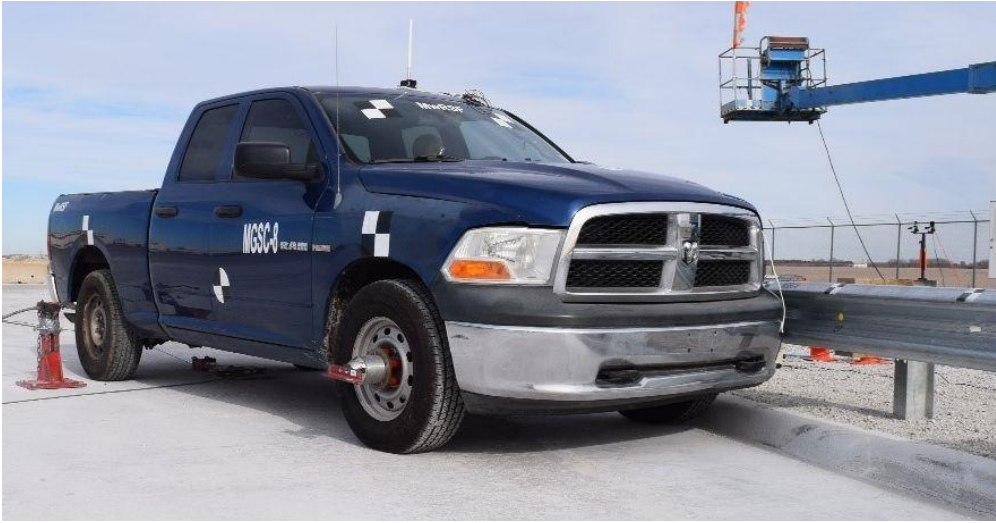
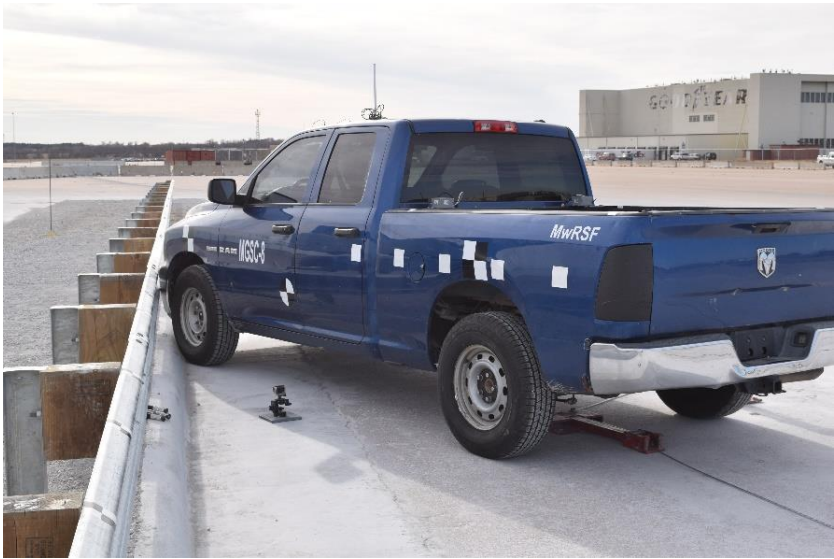
Figure 64. Impact Location, Test No. MGSC-8

The test installation for test no. MGSC-8 was nearly identical to that from test no. MGSC-7, except the rail height was lowered 1 in. to its nominal 31-in. top mounting height. The critical impact point for test no. MGSC-8 was selected using the CIP plots found in Section 2.3 of MASH. The critical impact point was determined to be 138 in. upstream from the splice located between post nos. 14 and 15, as shown in Figure 64.

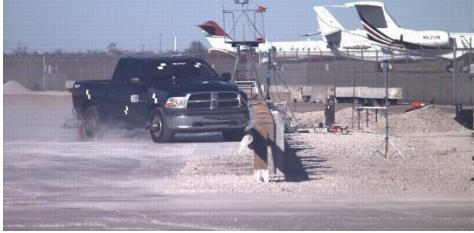
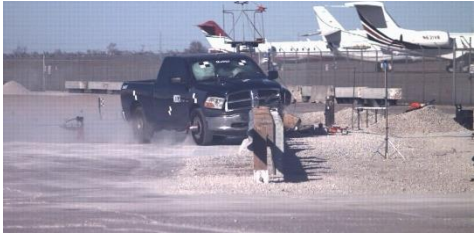
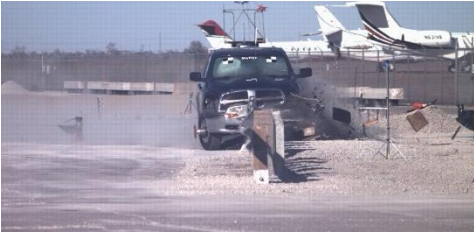
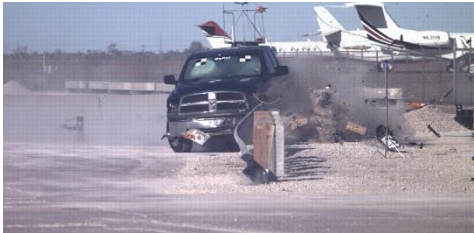
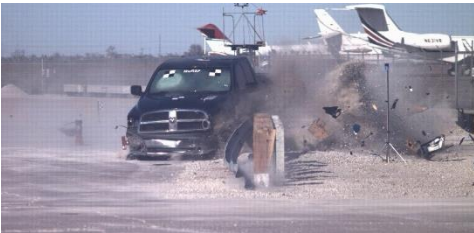
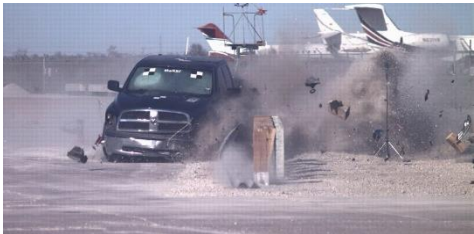
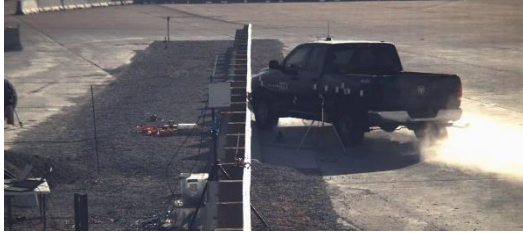
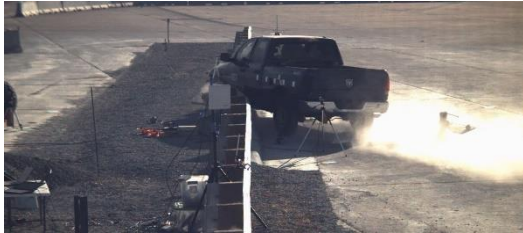
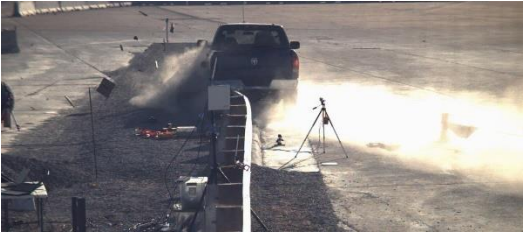
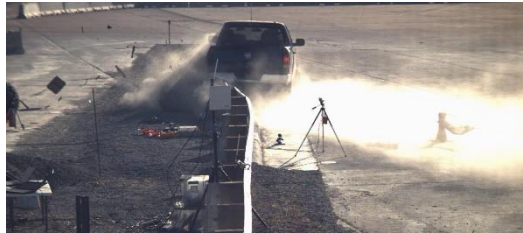
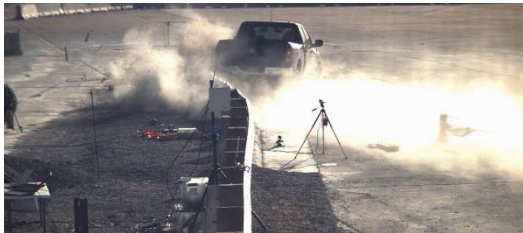
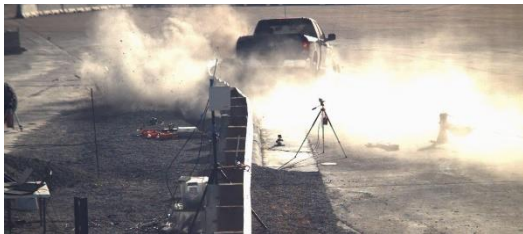
Figure 65. Sequential Photographs, Test No. MGSC-8

0.026	Vehicle's left fender contacted rail.
0.044	Vehicle's left-front tire became airborne. Vehicle's front airbags deployed.
0.046	Post no. 13 deflected upstream. Vehicle rolled away from barrier. Vehicle's windshield cracked from airbag deployment.

1.806	Post no. 26 deflected backward.
1.824	Vehicle's left-front tire overrode rail.
1.986	Vehicle's front bumper contacted blockout no. 27.
2.024	Post no. 27 deflected backward.

2.302	Vehicle's front bumper contacted post no. 28.
2.324	Post no. 28 deflected downstream.
2.464	Vehicle's right-front tire overrode rail.
3.500	Vehicle came to rest on top of downstream anchorage.

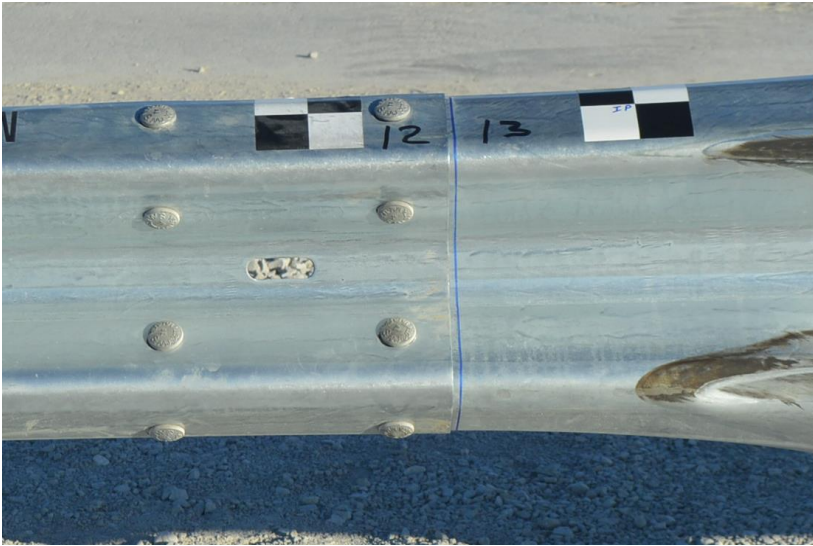
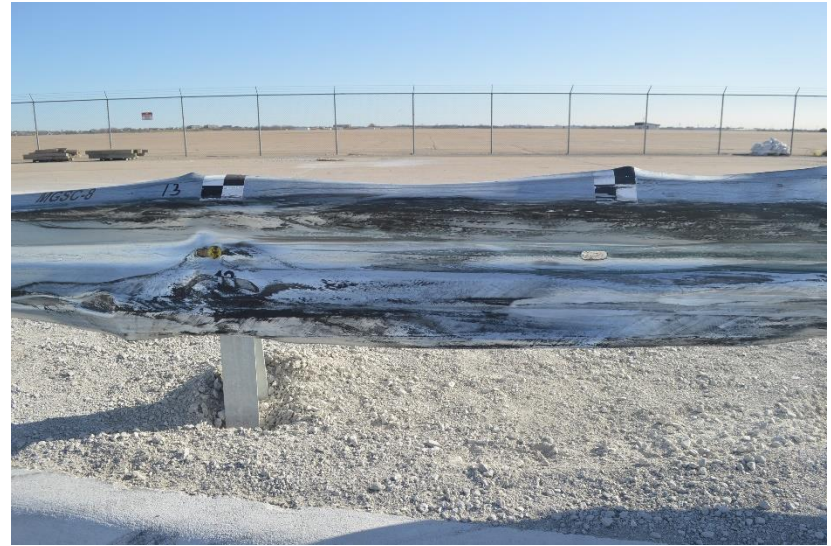
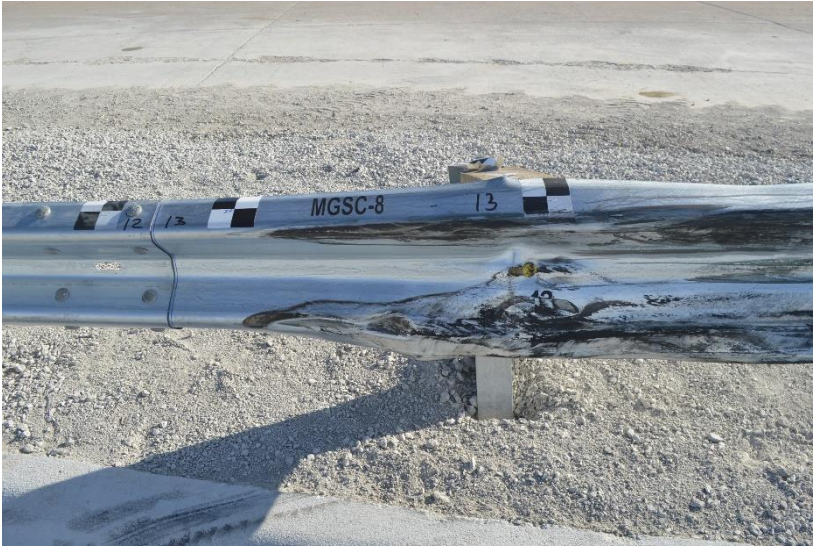
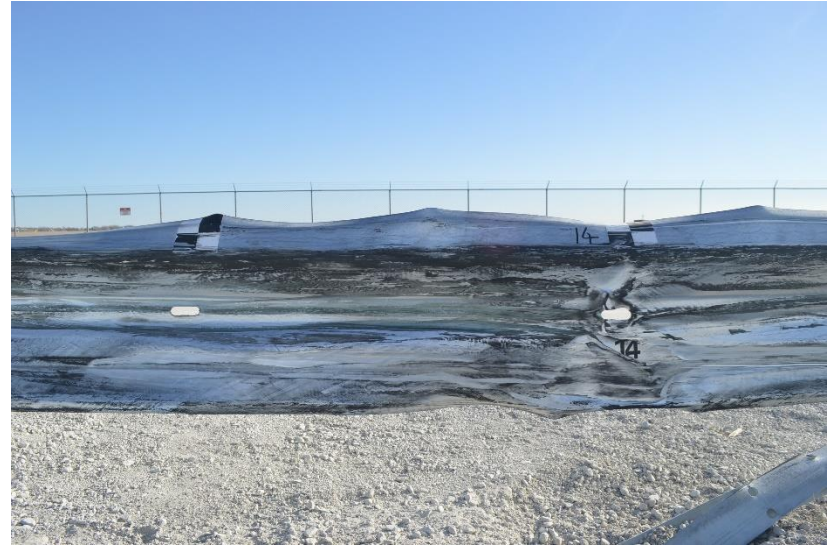
Figure 71. System Damage, Test No. MGSC-8

Damage to the barrier was moderate, as shown in Figures 71 through 79. Damage to the barrier spanned from post no. 12 through the downstream anchorage of the test installation. The initial contact region spanned from 50 in. downstream from post no. 12 to 5 in. downstream from post no. 18, and the secondary impact was between post nos. 26 and 29.

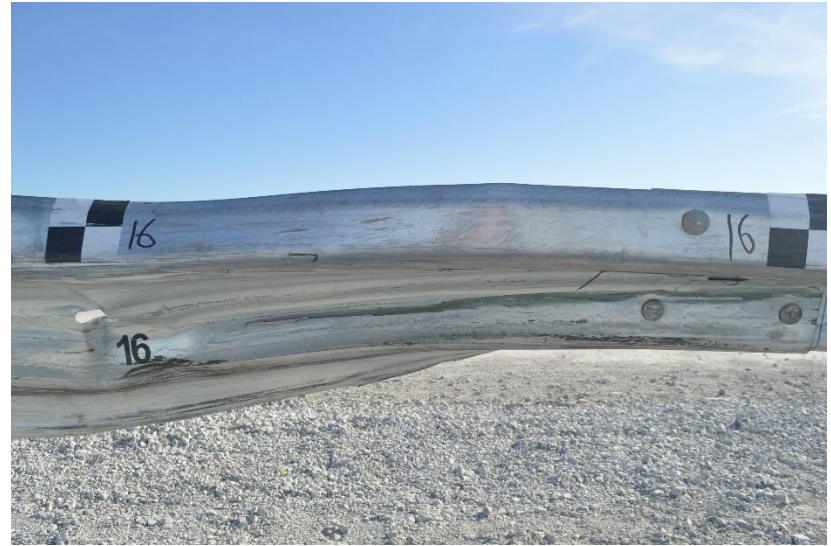
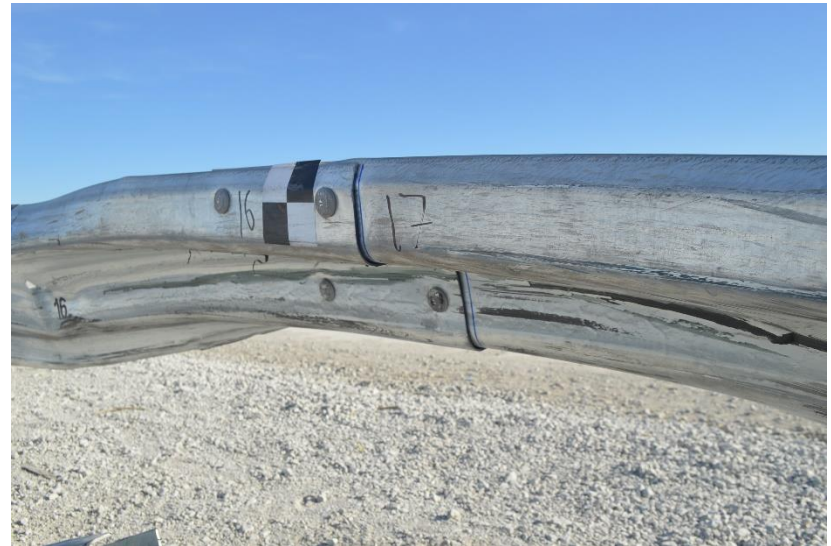
Figure 72. System Damage, Guardrail at Post Nos. 12 through 14, Test No. MGSC-8

Curb damage consisted of intermittent tire marks between post nos. 12 and 14. A 68-in. long tire mark was found on the top face of the curb 33 in. downstream from post no. 18. Gouges measuring 7 in., 8 in., and 23 in. were observed near post nos. 13 and 14.

Guardrail damage and deformations were observed along the entire length of the test installation. The rail between post nos. 1 and 2 was slightly bent toward the back side of the system due to tension at the anchorage cable connection. Bolt-slot deformation occurred at post nos. 1, 3, 5 through 7, 12, and 13, and bolt pullout occurred at post nos. 2, 4, 8 through 11, and 14 through 29. A small kink in the W-beam guardrail was observed at post no. 12. Various kinking, flattening, and bending of the guardrail was found continuously between post nos. 13 and 18. The rail was folded under along its bottom edge at the center of post no. 13 and 74½ in. downstream from post no. 13. The rail was flattened beginning 3¾ in. downstream from post no. 13 spanning to the center of post no. 16. Kinking occurred at many locations at the top and bottom edges of the rail between post nos. 13 and 19. The rail buckled 6¼ in., ¾ in. downstream from post no. 17. Additional flattening occurred along the base of the rail 1½ in. downstream from post no. 17 for a length of 41 in. The rail was bent 5¼ in. upstream and 5¼ in. downstream from post no. 18. The rail buckled 4¼ in and 5⅛ in. downstream from post no. 18. Several additional kinks were found along the rail from post no. 22 to the end of the system.

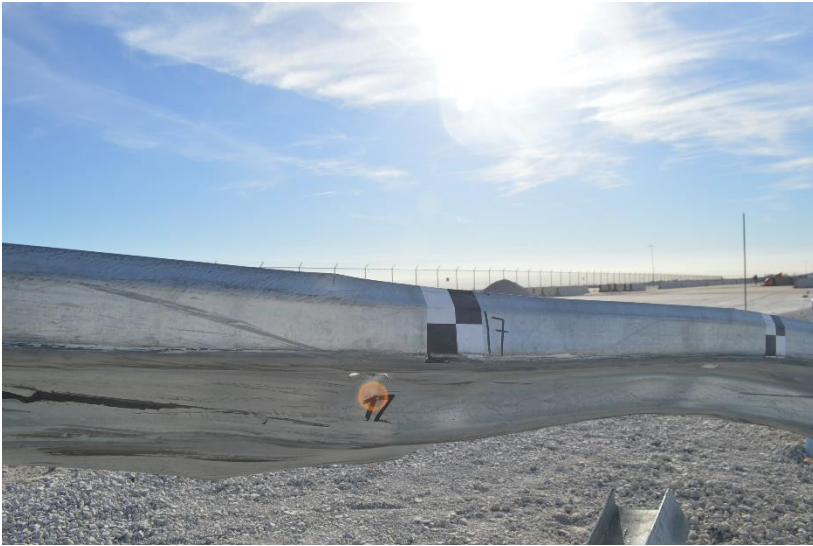
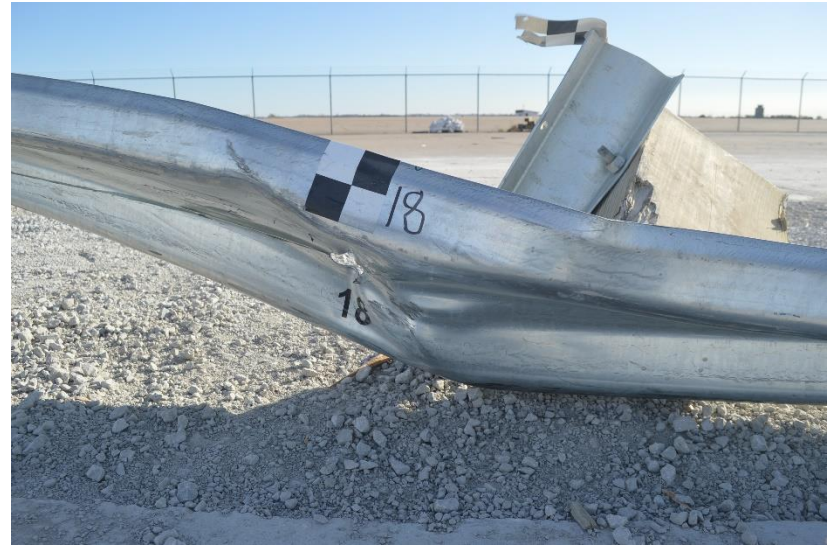
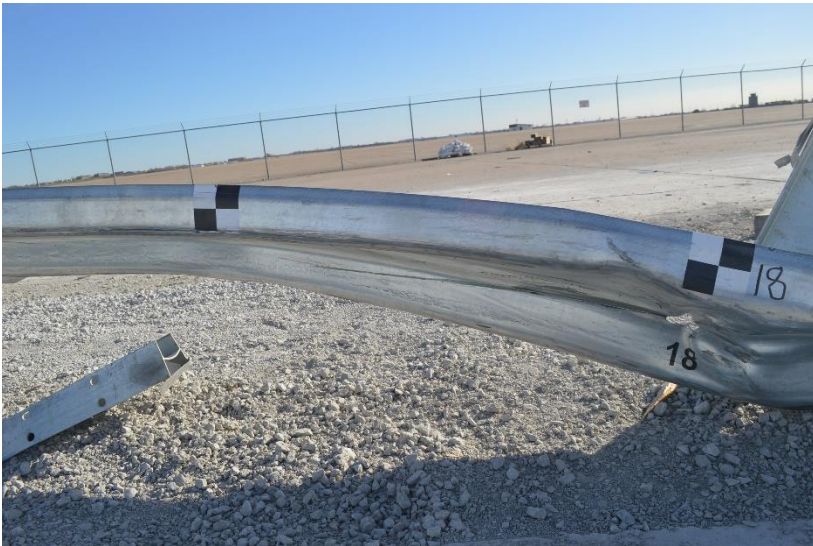
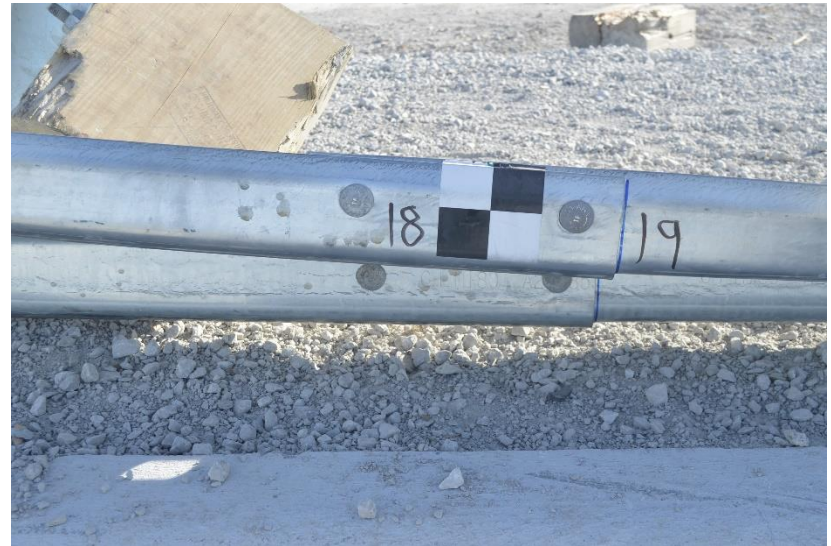
Figure 73. System Damage, Guardrail at Post Nos. 14 through 17, Test No. MGSC-8

The maximum lateral permanent set of the barrier system was 26¾ in., which occurred on the guardrail located at post no. 15, as measured in the field. The maximum lateral dynamic barrier deflection was 39.4 in. measured on the guardrail at post no. 16, as determined from high-speed digital video analysis. The working width of the system was found to be 48.5 in., also determined from high-speed digital video analysis. A schematic of the permanent set deflection, dynamic deflection, and working width is shown in Figure 80.

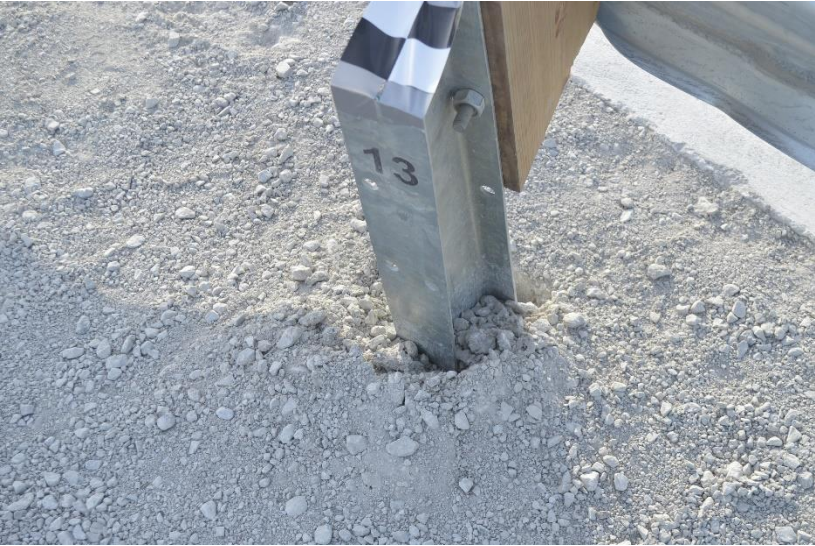
Figure 77. System Damage, Post Nos. 12 through 15, Test No. MGSC-8

The most significant post displacements and deformations spanned from post no. 13 to post no. 18. Soil gaps formed at the bases of post nos. 6 through 8, 10, 12, and 22. Soil heaves and craters formed at the bases of post nos. 14 through 19, and additional soil heaves were found at post nos. 26 and 27. Post no. 13 was bent backward and twisted downstream. Blockouts disengaged from post nos. 14 through 17. Each post in this range was bent backward and downstream in addition to being twisted to face upstream. Post no. 18 was bent backward and downstream while being twisted to face downstream. The blockouts of post nos. 18 through 23 had rotated about the attachment bolt. Post nos. 26 and 17 were bent backward and downstream, and post no. 28, which was a BCT post within the downstream anchorage, fractured off at ground level.

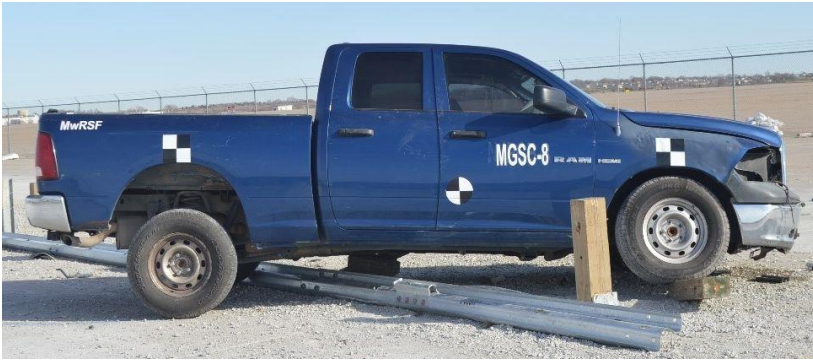
Figure 81. Vehicle Damage, Test No. MGSC-8

The damage to the vehicle was moderate, as shown in Figures 81 through 85. The maximum occupant compartment deformations are listed in Table 11 along with the deformation limits established in MASH 2016 for various areas of the occupant compartment. Note that none of the established MASH 2016 deformation limits were violated. Complete occupant compartment and vehicle deformations and the corresponding locations are provided in Appendix D.

The majority of the damage was concentrated at the left-front corner of the vehicle where impact occurred. The left-front bumper was deformed inward toward the engine, and the grille was partially fractured and disengaged from the vehicle. Both front headlights were disengaged. The left-front fender was bent and torn, and the left-front tire sidewall was torn. The wheel rim was bent at several locations. Several minor dents were found on both the left-front and left-rear vehicle doors. Scrapes extended from the left-front fender to the rear bumper along the left side of the vehicle. The left-rear bumper was dented inward. The windshield was cracked at mid-height on the right side due to contact from the vehicle airbag. Additional cracks in the windshield extended outward from the bottom left corner of the windshield. The roof and remaining windows were undamaged.
