*Midwest Pooled Fund Research Program
Fiscal Years 2017-2020 (Year 28)
Research Project Number TPF-5(193) Supplement #123
NDOT Sponsoring Agency Code RFP-18-BULLNOSE*

MASH TESTING OF BULLNOSE WITH BREAKAWAY STEEL POSTS (TEST NOS. MSPBN-4 THROUGH MSPBN-8)

MwRSF Research Report No. TRP-03-418-20

September 1, 2020

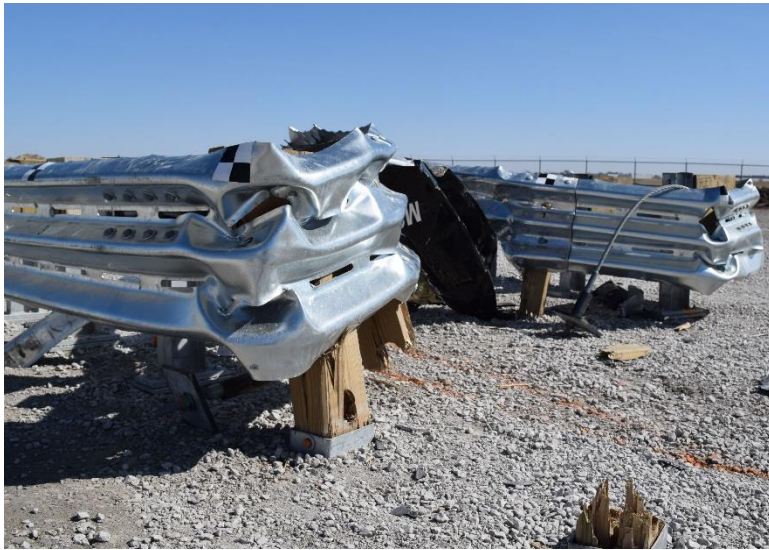
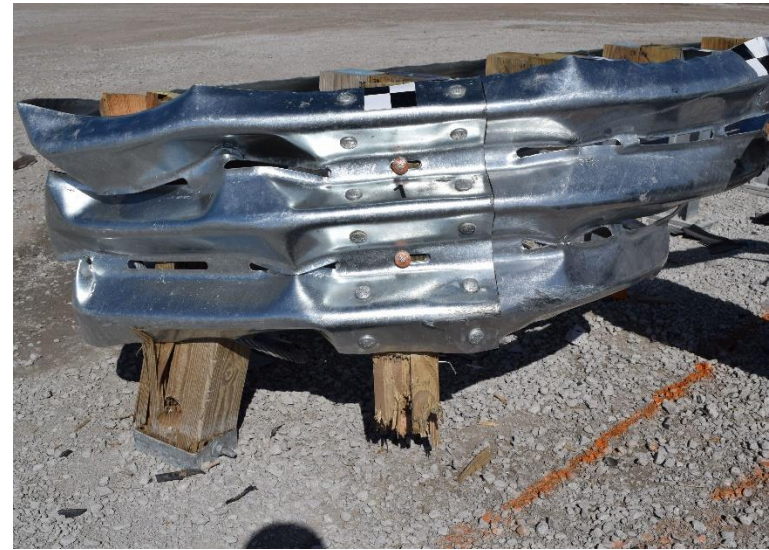
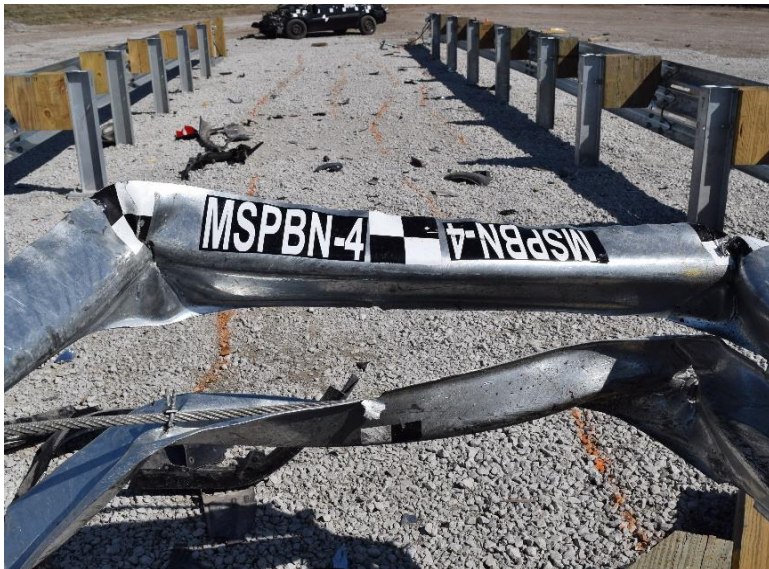
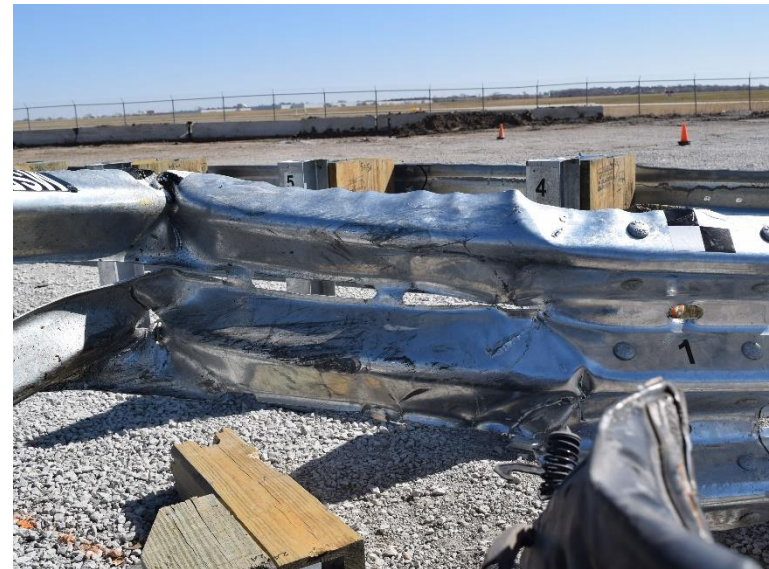
Figure 64. Close Up of Damage to Impact Area, Test No. MSPBN-4

The thrie-beam nose section of the barrier and the adjacent rail sections on Side A and Side B were deformed backward and into the interior of the barrier as the vehicle entered the system. Rail tearing occurred at several locations in the nose of the system. The slot tabs connecting the top and middle rail corrugations located 75 in. (1,905 mm) upstream from post no. A1 were fractured. The slot tabs located 20 in. (508 mm) and 75 in. (1,905 mm) upstream from post no. A1 along the bottom corrugation were fractured, and a 65-in. (1,651-mm) long rupture of the bottom rail corrugation occurred 20 in. (508 mm) upstream from post no. A1. A tear was found 11½ in. (292 mm) upstream from post no. A1 along the bottom corrugation of the rail. Tearing also occurred 57 in. (1,448 mm) upstream from post no. A1 along the middle corrugation of the rail. A 58-in. (1,473-mm) long tear occurred 27½ in. (699 mm) upstream from post no. B1 along the bottom corrugation of the rail. The anchorage cables in the top two corrugations of the thrie-beam nose remained intact after impact.

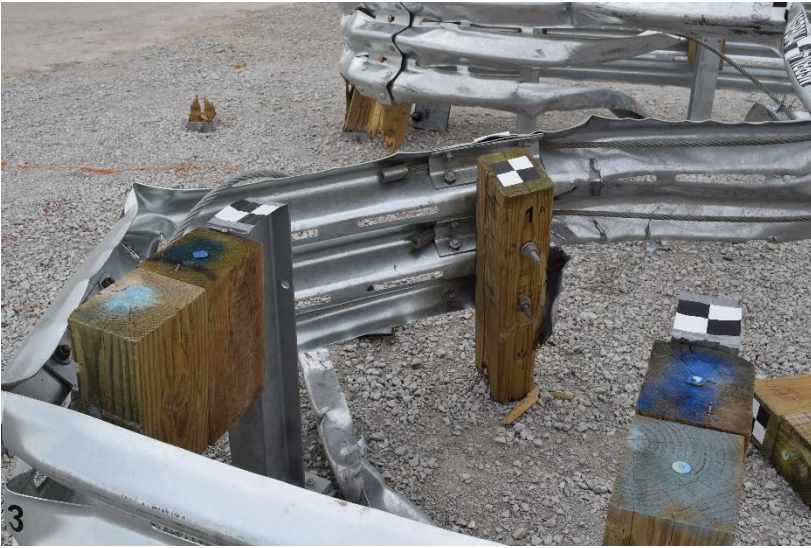
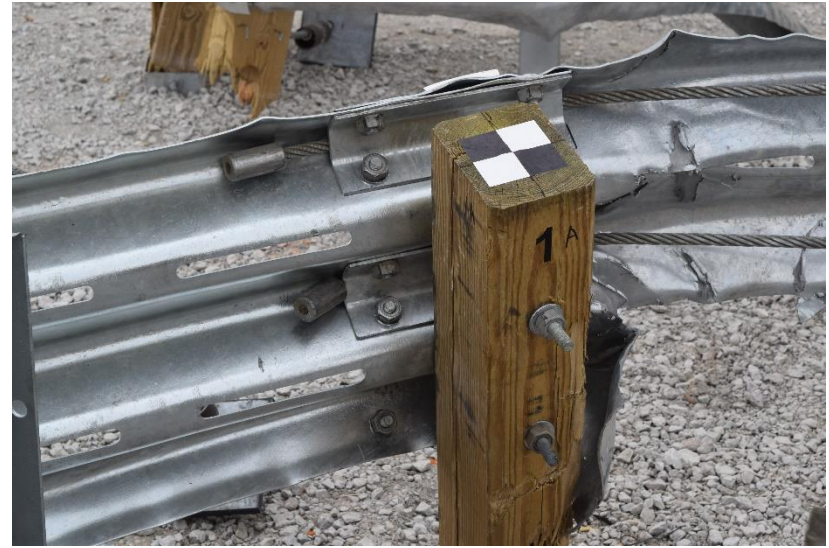
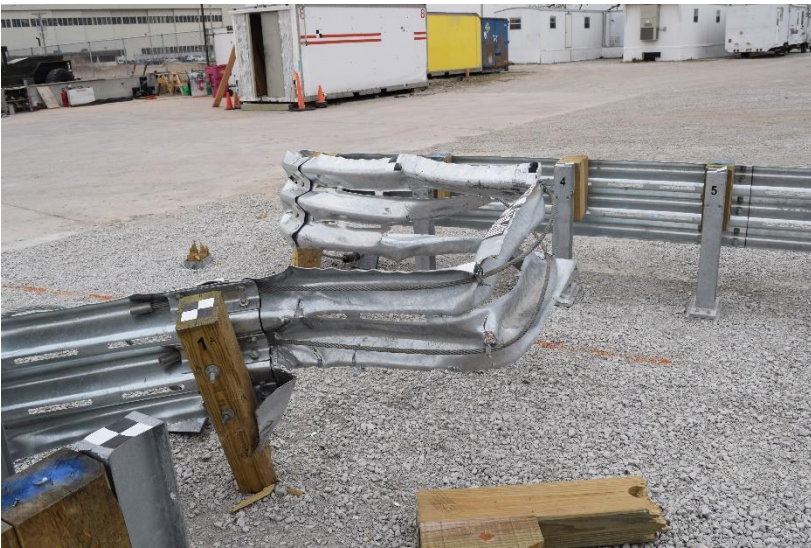
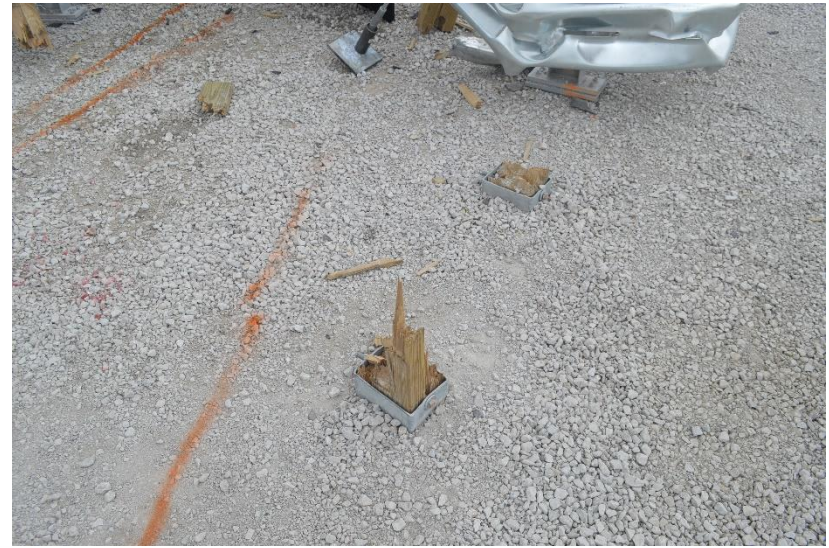
Figure 65. Damage to Post Nos. A1 and A2, Test No. MSPBN-4

Several of the breakaway posts in the bullnose were damaged and/or disengaged during the impact. On Side A of the system, post no. A1 was fractured through the BCT hole at the base of the post, and post no. A2 was fractured at its base and was also detached from the railing with the post bolt pulling away from the guardrail. The blockout of post no. A3 rotated downstream, and the bolt connecting post no. A4 pulled out of the rail. The UBSP posts on Side A of the system were undamaged. On Side B of the system, post no. B1 was fractured at its base, and post no. B2 was partially fractured at its base. The blockout attached to post no. B4 was rotated upstream. The UBSP posts on Side B of the system were undamaged. The BCT anchor cables were disengaged from post no. 1 on both sides of the system.

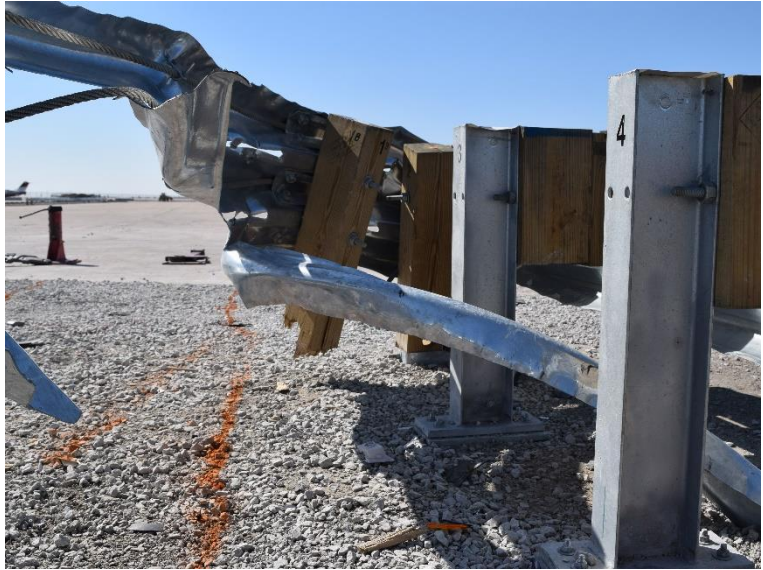
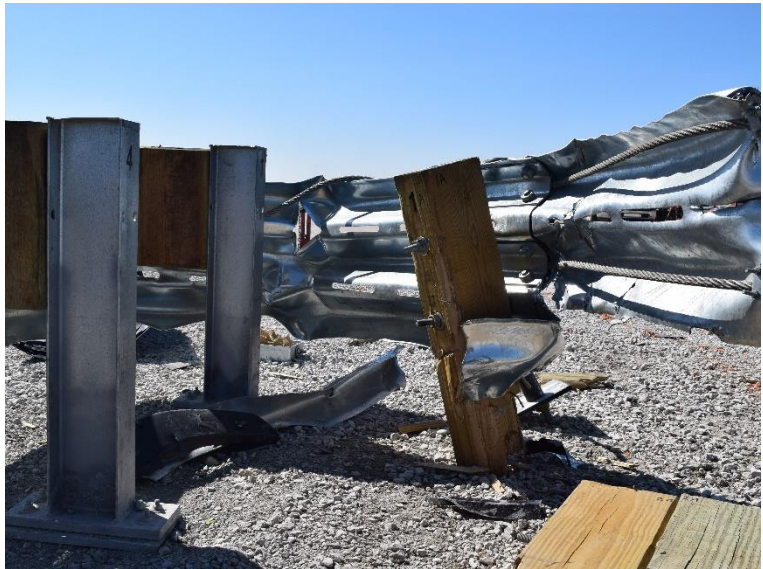
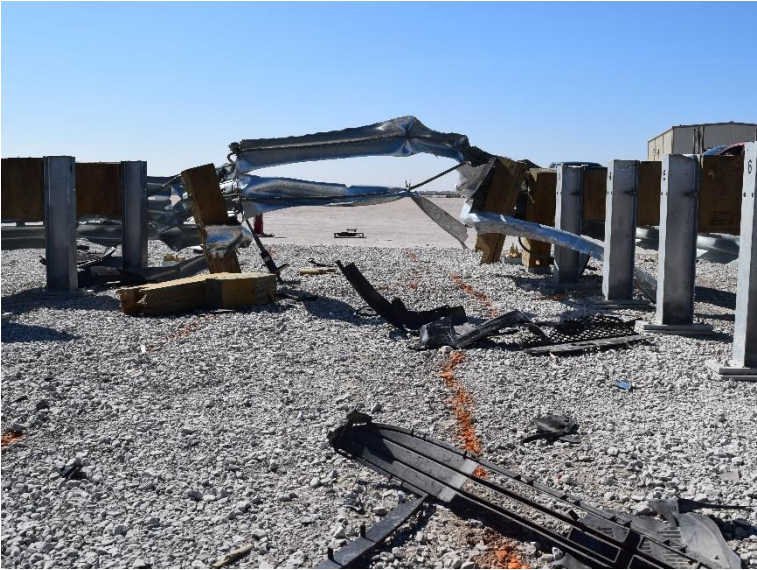
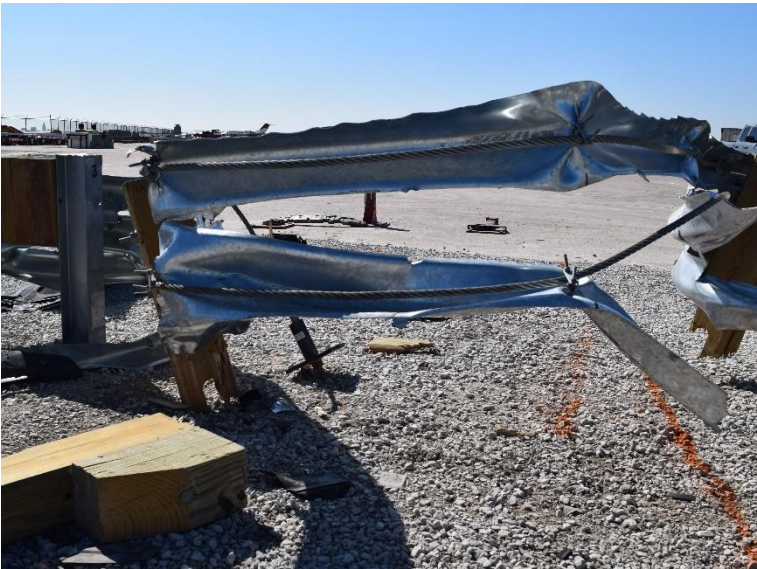
Figure 67. Damage to Impact Location, Test No. MSPBN-4

Rail section no. 2 on Side A of the system was kinked, deformed, and bent inward toward the interior of the system at post no. A3. A second large kink and bend in the rail was observed at post no. A2. Additional deformations and kinks were observed on rail section no. 2 on Side A beginning at the upstream end of the rail section and extending to post no. A4. The bolt connecting post no. A6 to the rail pulled through the rail, leaving a tear 1¼ in. (32 mm) long by ¼ in. (6 mm) high.

Rail section no. 2 on Side B of the system was kinked, deformed, and bent inward toward the interior of the system a post no. B2. A second large kink and bend in the rail was observed at post no. B2. Additional deformations and kinks were observed on rail section no. 2 on Side B beginning at the upstream end of the rail section and extending slightly downstream of post no. B2.

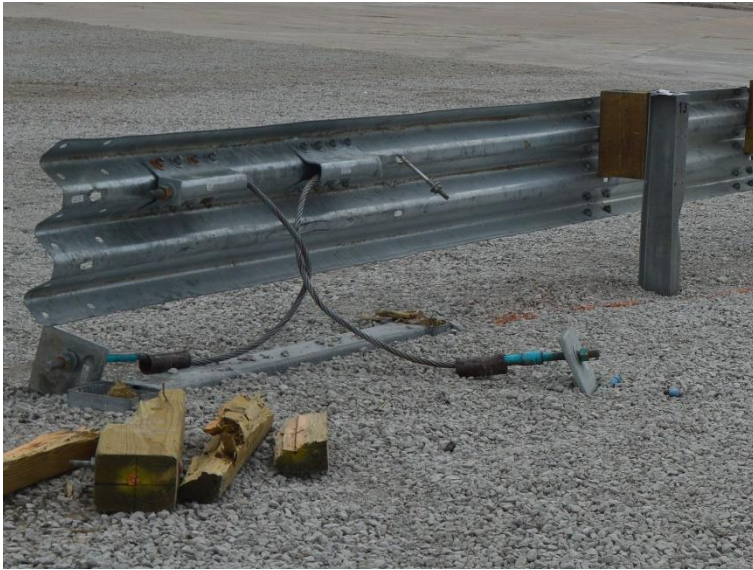
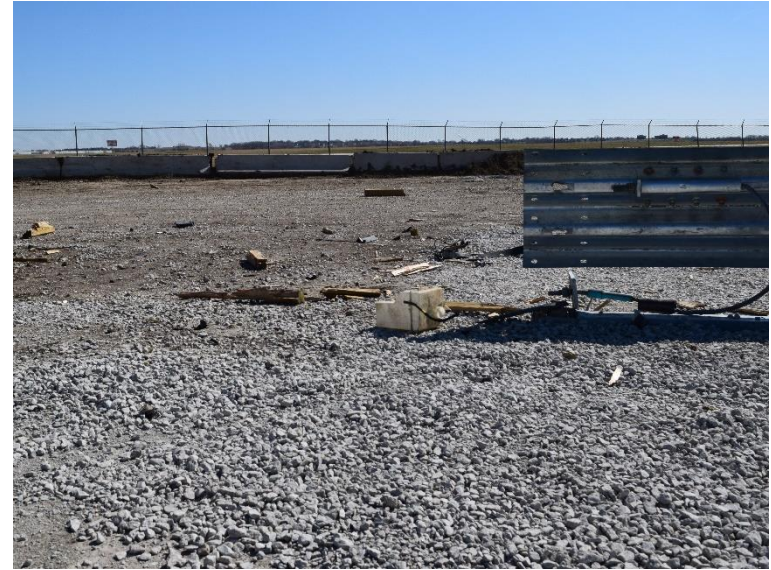
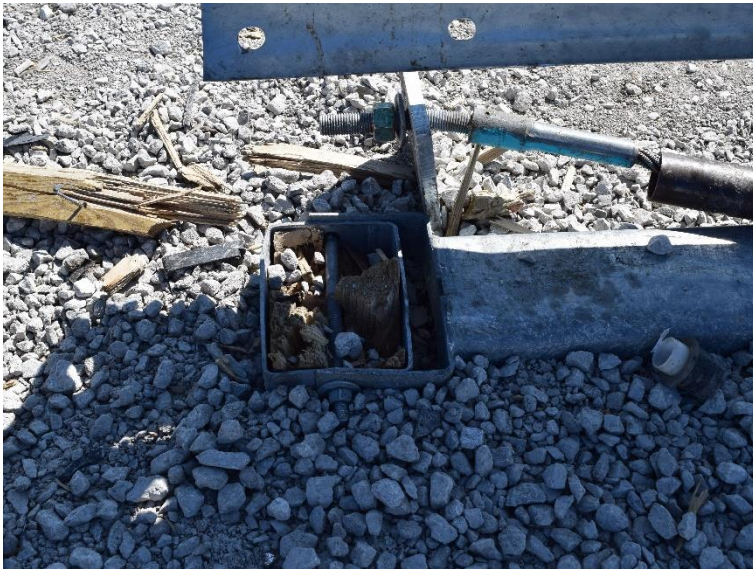
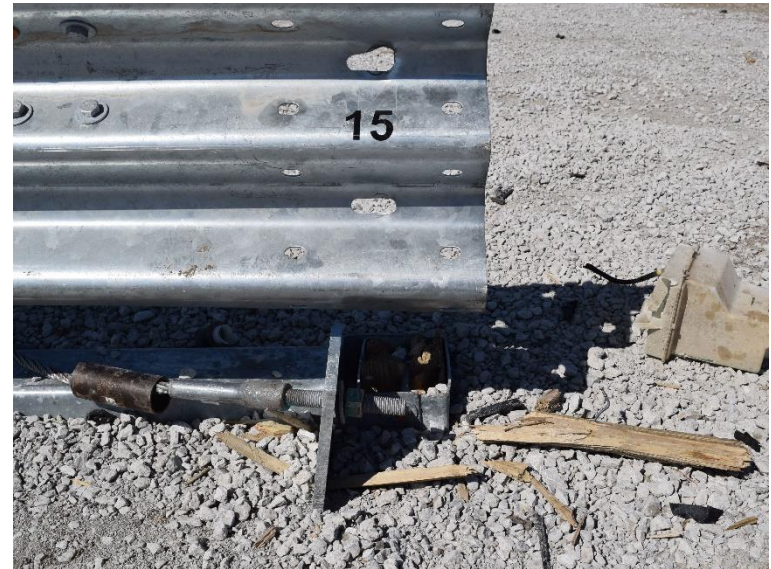
Figure 68. Damage to Post Nos. A14 and A15, Test No. MSPBN-4

The downstream section of the A side of the system experienced significant damage. The test vehicle struck post nos. A13, A14, and A15. Post no. A13 had a 7-in. (178-mm) tall by 1-in. (25-mm) deep dent along the upstream back flange starting 17½ in. (445 mm) from the top of the post. Both post nos. A14 and A15 were fractured off at their bases. A 22¾-in. (578-mm) long by

1½-in. (38-mm) high contact mark was observed on the back side of the rail 11½ in. (292 mm) downstream from post no. A14.

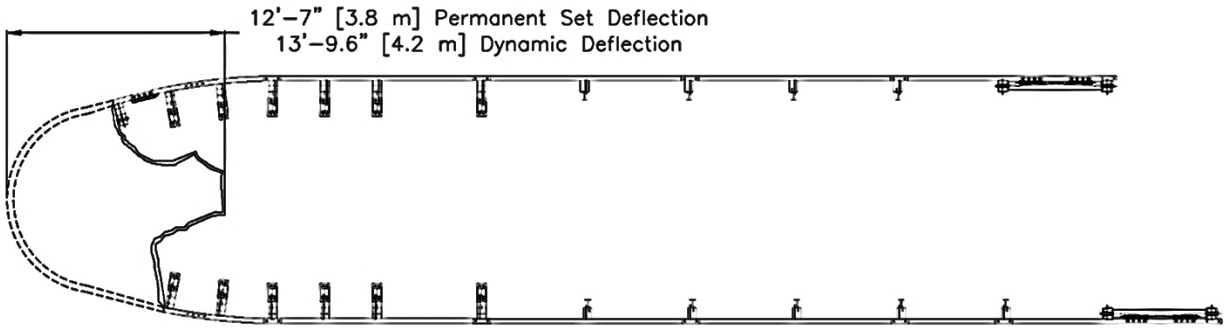
Figure 69. System Deformation, Test No. MSPBN-4

The maximum longitudinal permanent set of the barrier system was 12 ft – 7 in. (3.8 m) at the midspan of the nose rail section, as measured in the field. The maximum lateral permanent set deflection was internal to the bullnose system and is not shown. A maximum longitudinal dynamic barrier deflection of 13 ft – 9.6 in. (4.2 m) was noted at the quarter point of the nose on Side A, as determined from high-speed digital video analysis. The maximum lateral dynamic barrier deflection was internal to the bullnose system and is not shown. Working widths for the system were not shown because the system did not capture the impacting vehicle. A schematic of the permanent set deflection is shown in Figure 69.

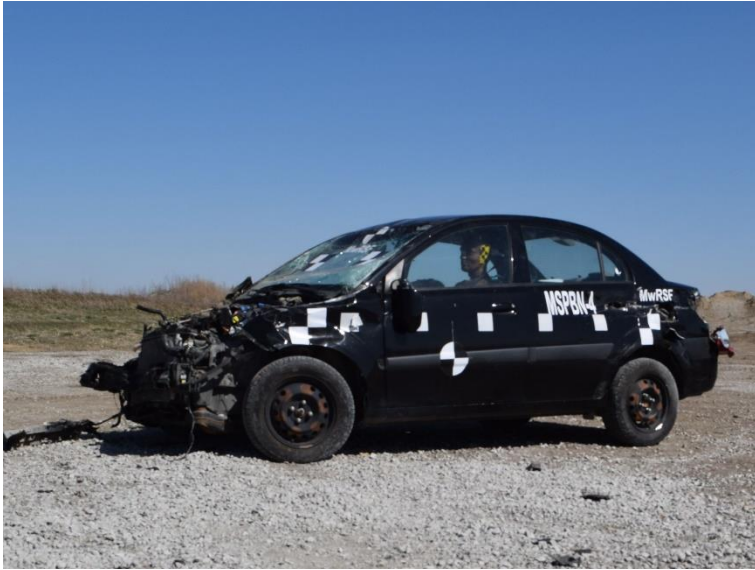
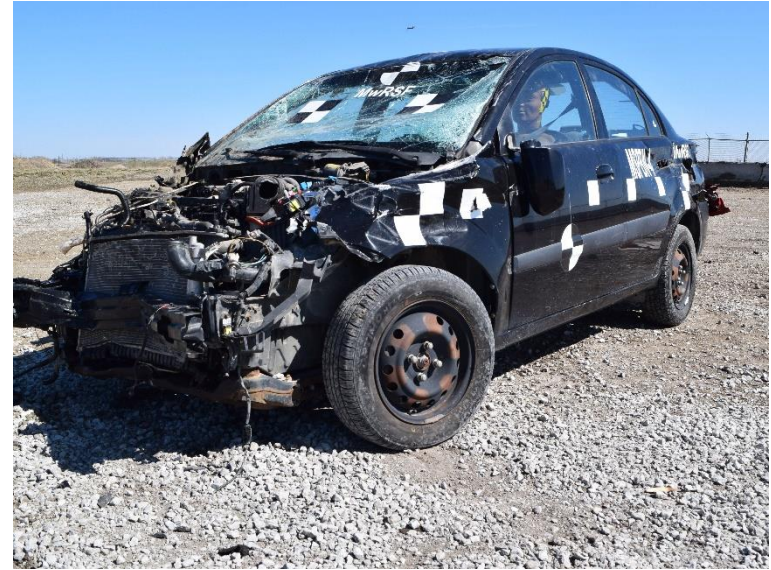
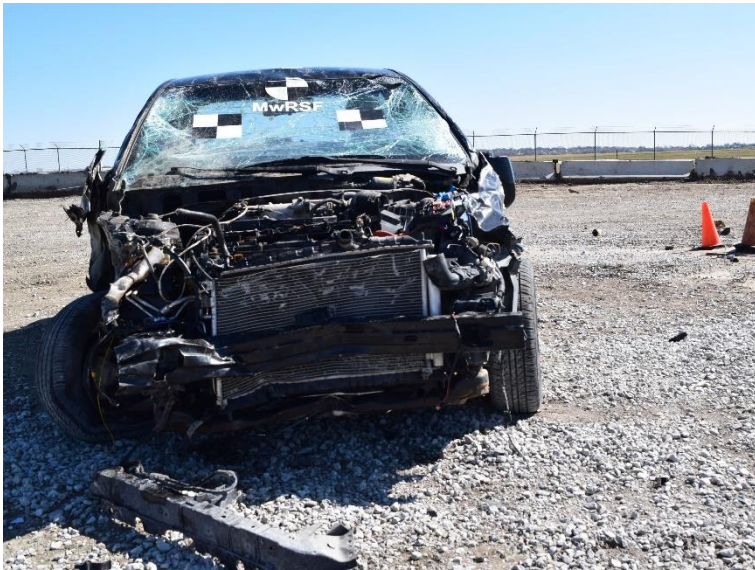
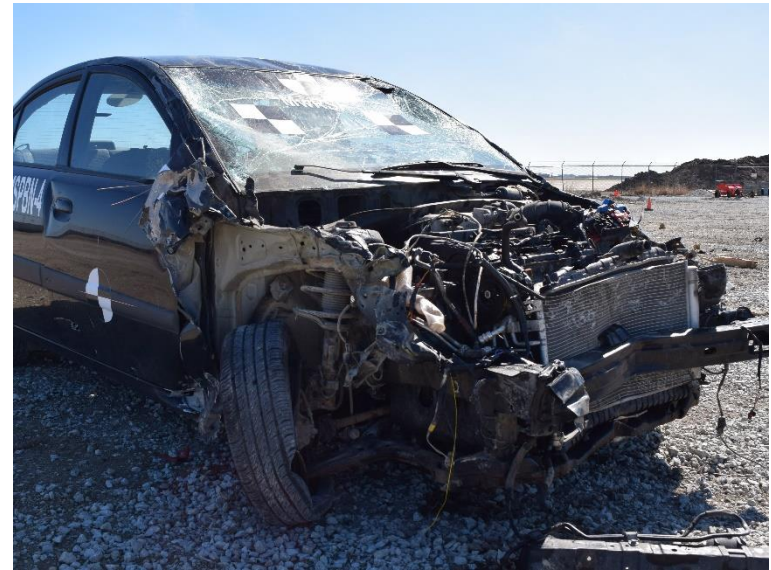
Figure 70. Vehicle Damage, Test No. MSPBN-4

The majority of the damage was concentrated on the front of the vehicle where the impact had occurred. The front grille and hood were disengaged from the vehicle. The right-front fender was peeled back, and the front portion of the left fender was crushed and pushed back. The center of the bumper was crushed inward toward the engine. The windshield was shattered and crushed inward due to contact with the thrie-beam and the vehicle hood as the vehicle underrode the rail. Additionally, a 6-in. (152-mm) long hole was torn in the upper left corner of the windshield. The right-front door was dented near the handle. The left-rear door and left-rear side panel had a large dent 56 in. (1,422 mm) long by 7 in. (178 mm) wide. The left-rear taillight was disengaged from its housing.

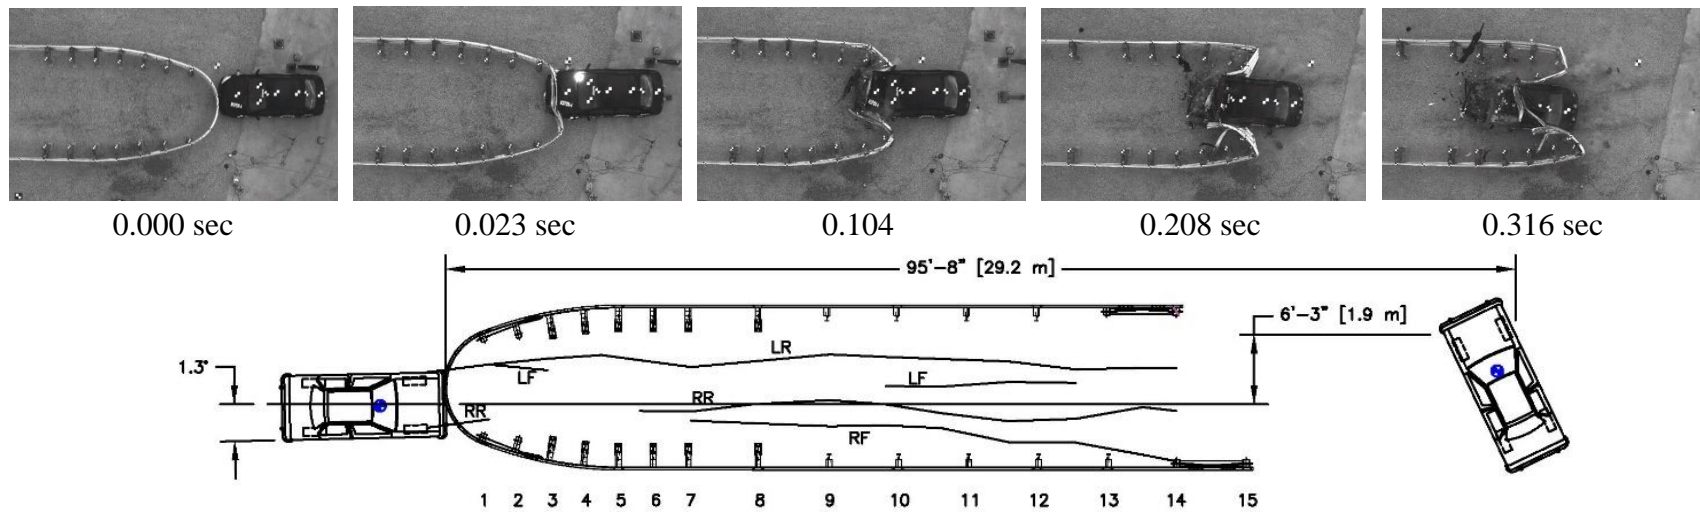
The analysis of the results for test no. MSPBN-4 showed that the system did not adequately capture and contain the 1100C vehicle with controlled longitudinal displacements of the barrier. The test vehicle penetrated the system by underriding the thrie-beam but remained upright during and after the collision. Vehicle roll, pitch, and yaw angular displacements, as shown in Appendix E, were deemed acceptable, because they did not adversely influence occupant risk nor cause rollover. Contact with the vehicle hood and thrie-beam rail elements caused excessive windshield deformation and created a tear in the upper left corner for the windshield. Therefore, test no. MSPBN-4 was determined to be unacceptable according to the MASH 2016 safety performance criteria for test designation no. 3-30. A summary of the results of test no. MSPBN-4 is shown in Figure 74.

- Vehicle Capture and Containment..... Failed due to Underride
- Vehicle Stopping Distance 95 ft – 8 in. (29.2 m) downstream

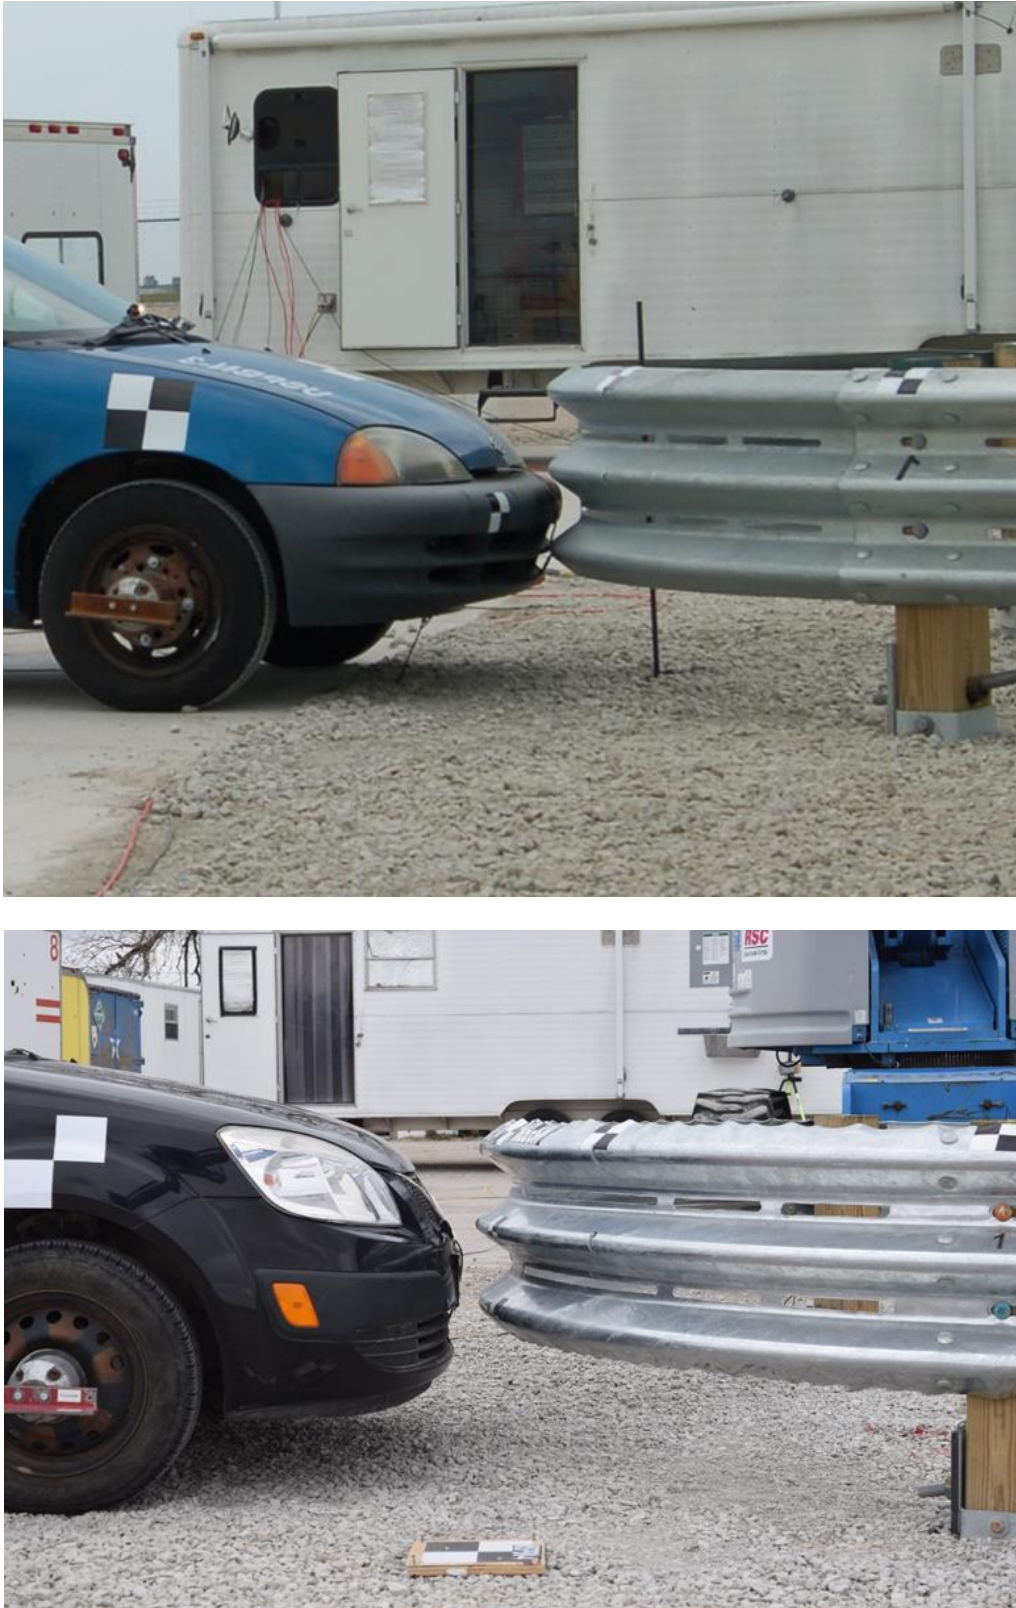
Figure 75. Vehicle Geometry and Barrier Alignment Comparison, Test Nos. USPBN-3 (top) and MSPBN-4 (bottom)

2. The 1100C front-end geometry and structure appears to be significantly different than that for the 820C vehicle tested previously in test no. MSPBN-3. These geometric differences may have altered the vehicle engagement and interlock with the nose rail and changed the nose rail slot tab tearing and corrugation separation. Differences in the front-end geometry of the 820C vehicle used in test designation no. MSPBN-3 and the 1100C vehicle used in test designation no. MSPBN-4 are shown in Figure 75. The center of the bumper was in a similar location for both tests, but the 1100C vehicle has a more vertical profile, which may have contributed to the more rapid slot tab tearing and rail opening as well the vertical motion of the upper two corrugations of the thrie beam up and over the front of the vehicle. Additionally, it was noted that the behavior of the vehicle's engine hood was different as the vehicle hood remained latched and in place in test no. MSPBN-3, while the hood was opened, pushed back, and disengaged in test no. MSPBN-4.

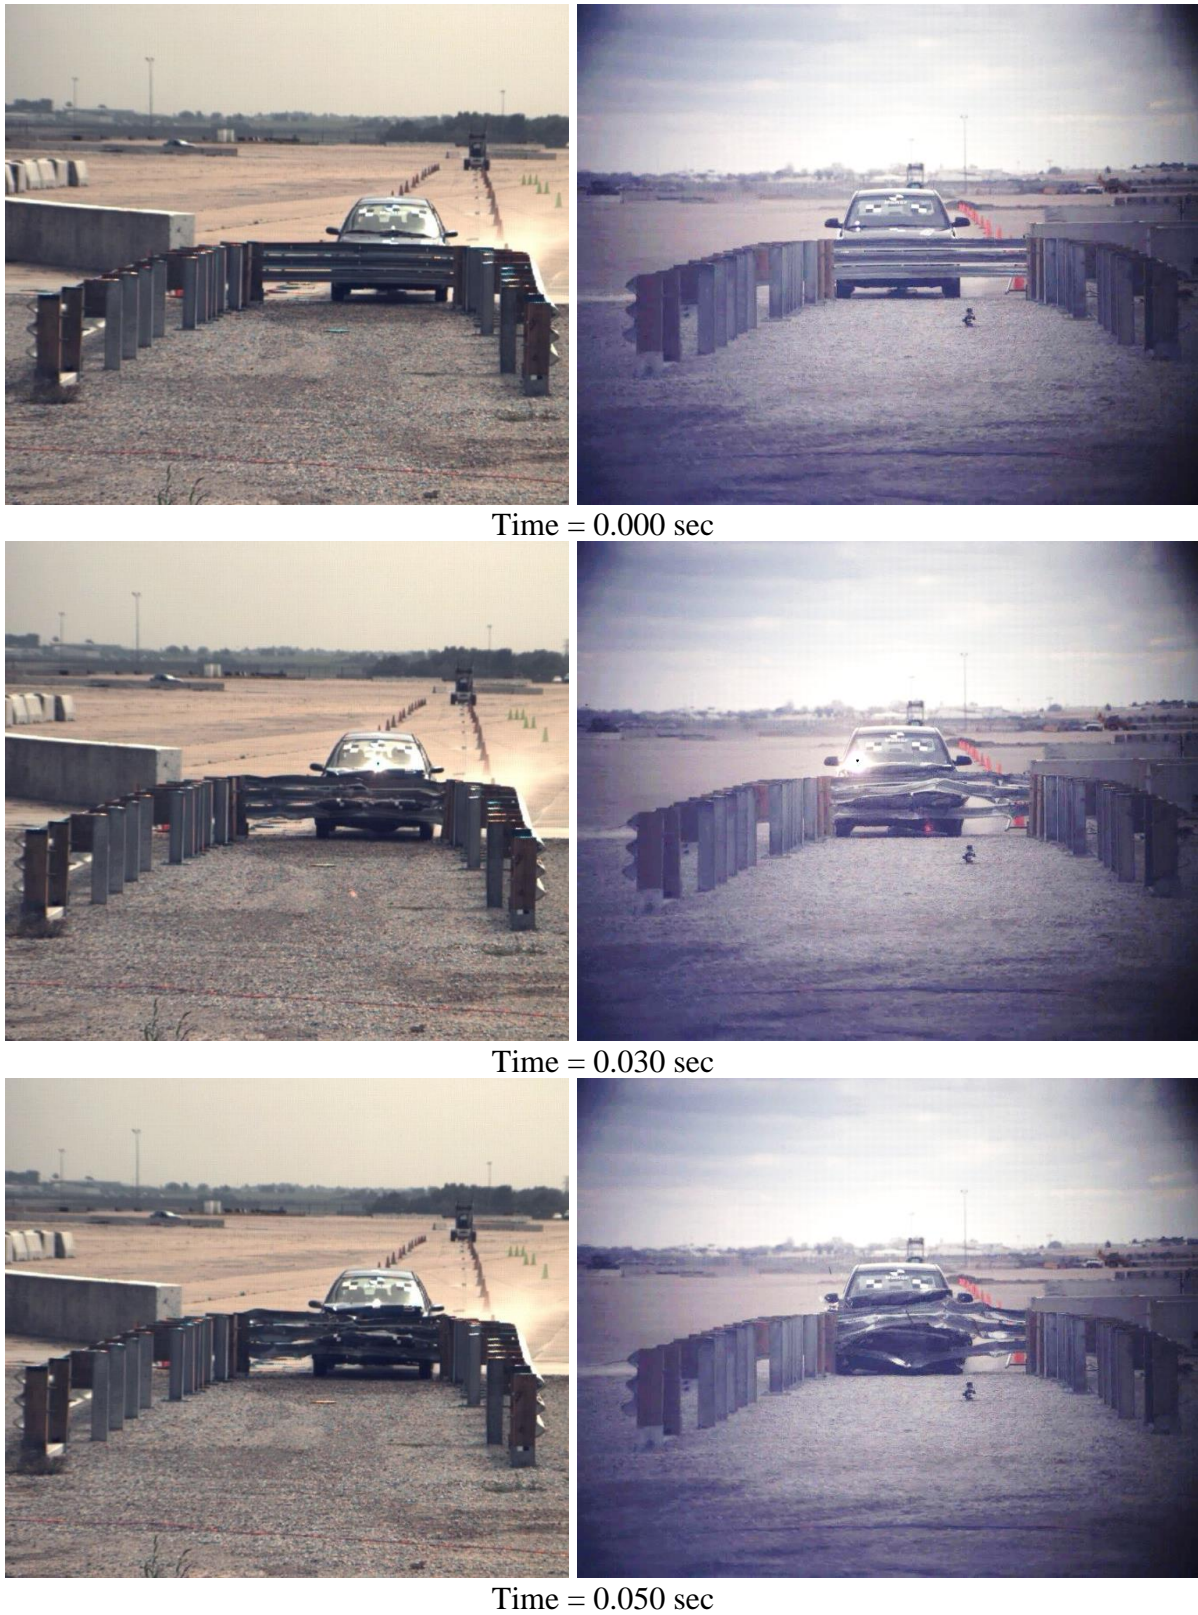
Figure 76. Time Sequential Comparison, Test Nos. USPBN-3 (left) and MSPBN-4 (right)

3. The previous two factors led to more rapid rupture of the thrie-beam slot tabs in the nose section, opening of the thrie beam between the middle and lower rail corrugations, upward movement of the upper two rail corrugations, and rupture of the lower rail corrugation, which allowed the vehicle to penetrate the system. Sequential views comparing the 820C vehicle from test no. MSPBN-3 and the 1100C vehicle in test no. MSPBN-4 are shown in Figure 76 and Figure 77. The two tests displayed differences in the rail tearing, rail corrugation separation, and capture of the front of the small car. The bullnose systems in these tests were identical. Note that fracture of the lowest rail corrugation was noted in the previous 820C testing as well, but it occurred later in the impact event, and the upper two rail corrugations were more effective in capturing the vehicle.

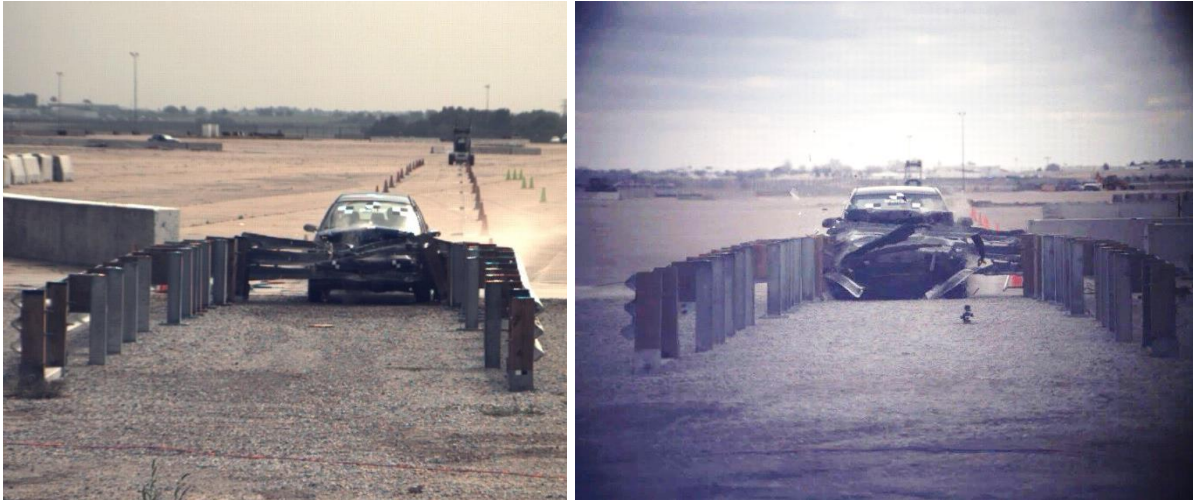
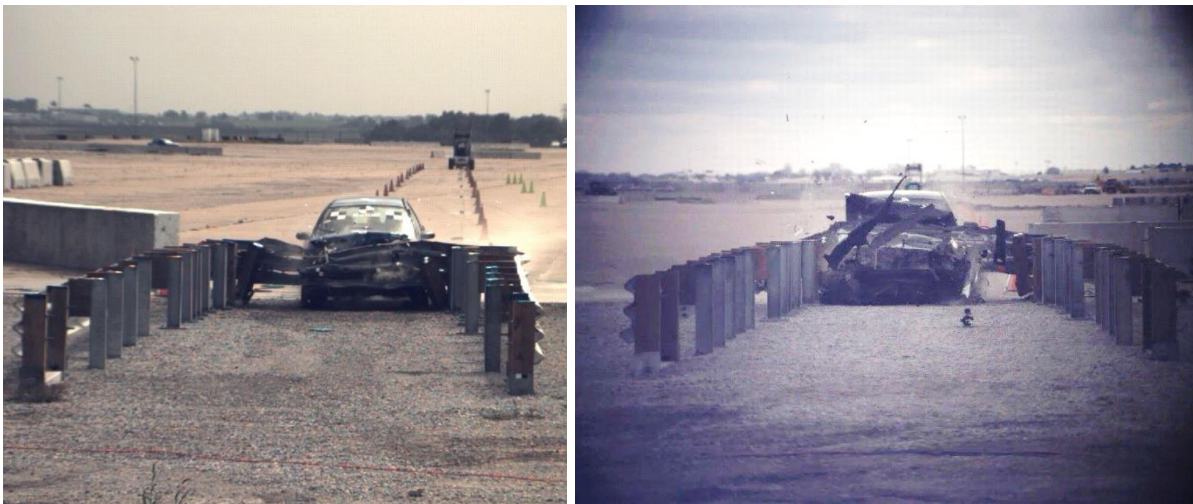
Figure 77. Time Sequential Comparison, Test Nos. USPNB-3 (left) MSPBN-4 (right)

It should be noted that the opening and separation of the lower corrugation from the upper two corrugations in test no. MSPBN-4 led to some concern that capture of the front end of the 1100C vehicle may not be optimal, even with the addition of a third nose cable. In test no. MSPBN-4, the lower corrugation was riding below the apex or middle of the vehicle's bumper prior to rupturing. The addition of the third nose cable would prevent loss of tension across the front of the vehicle, but the position of that capture element may not be as positive as observed in previous 820C testing. However, this was believed to be the best option moving forward. If the addition of the third nose cable was unsuccessful, additional research using LS-DYNA would likely be required to develop modifications necessary to improve the capture of the 1100C vehicle.

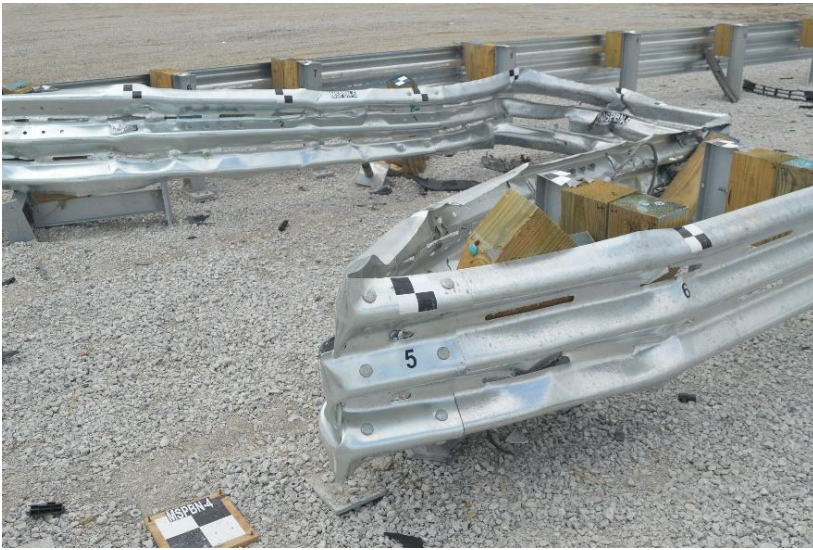
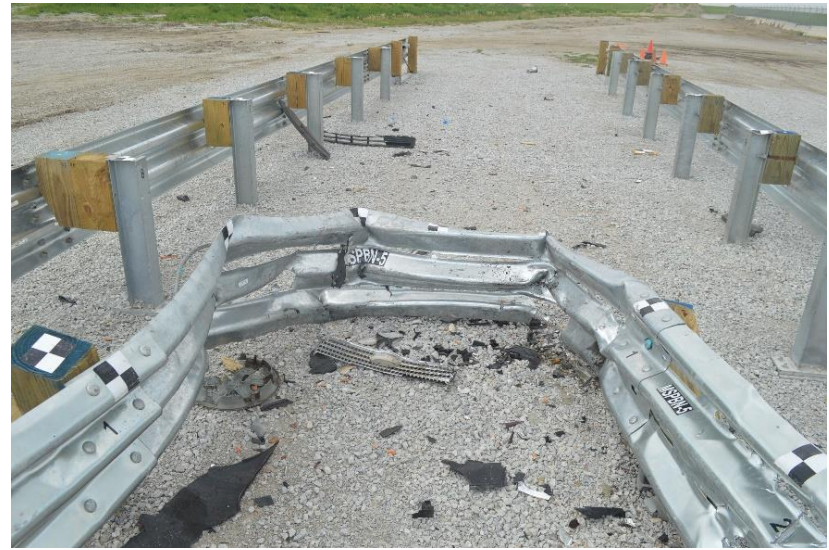
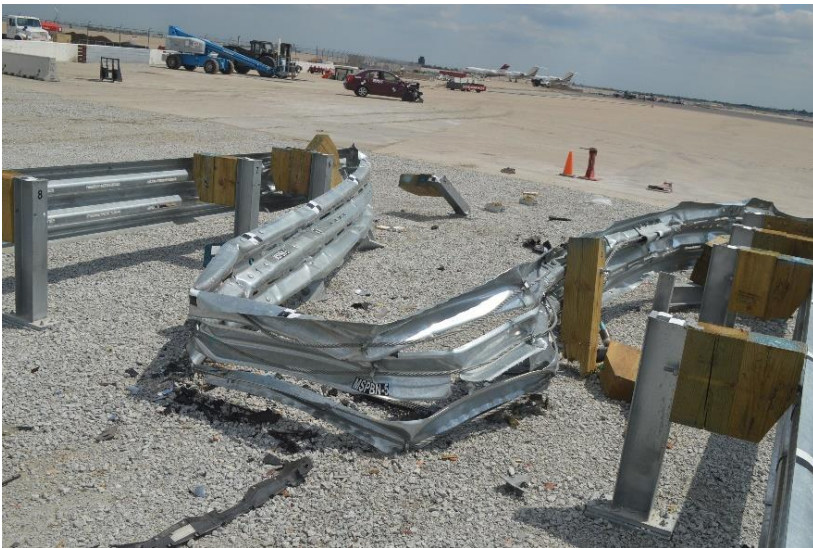
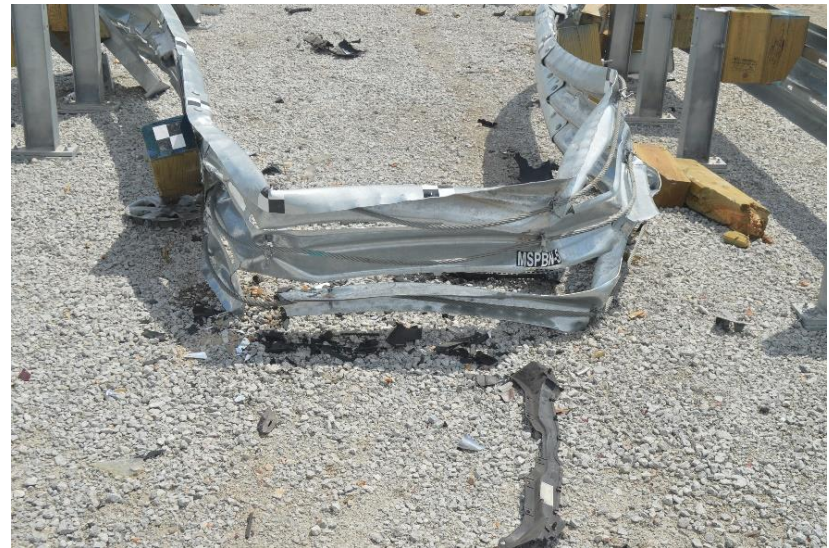
Figure 124. Close-Up of Impacted Area, Test No. MSPBN-5

Damage to the barrier was extensive, as shown in Figures 123 through 130. Barrier damage primarily consisted of contact marks, deformation, bending, and tearing of the thrie-beam rail segments and disengagement of the breakaway posts. Damage occurred to both sides A and B of the barrier and was contained from the nose section of bullnose downstream to posts nos. A6 and B5, respectively.

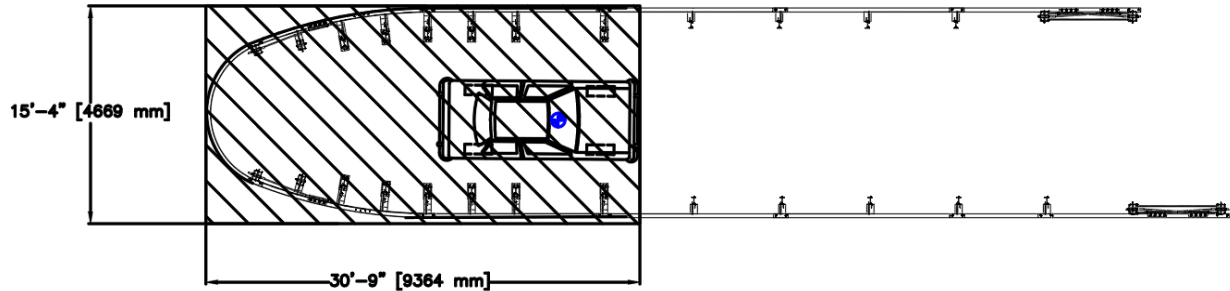
Figure 131. Working Width, Test No. MSPBN-5

The maximum longitudinal permanent set of the barrier system was 30 ft – 2¼ in. (9.2 m) in the rail at the centerline of the nose, as measured in the field. The maximum lateral permanent set deflection was internal to the bullnose system and is not shown. The maximum longitudinal dynamic barrier deflection was 30 ft – 4.3 in. (9.3 m) at the centerline target as determined from high-speed digital video analysis. The maximum lateral dynamic barrier deflection was internal to the bullnose system and is not shown. The longitudinal working width of the system was found to be 30 ft – 9.0 in. (9.4 m), and the lateral working width was found to be 15 ft – 4 in. (4.7 m), also determined from high-speed digital video analysis. A schematic of the working width is shown in Figure 131.

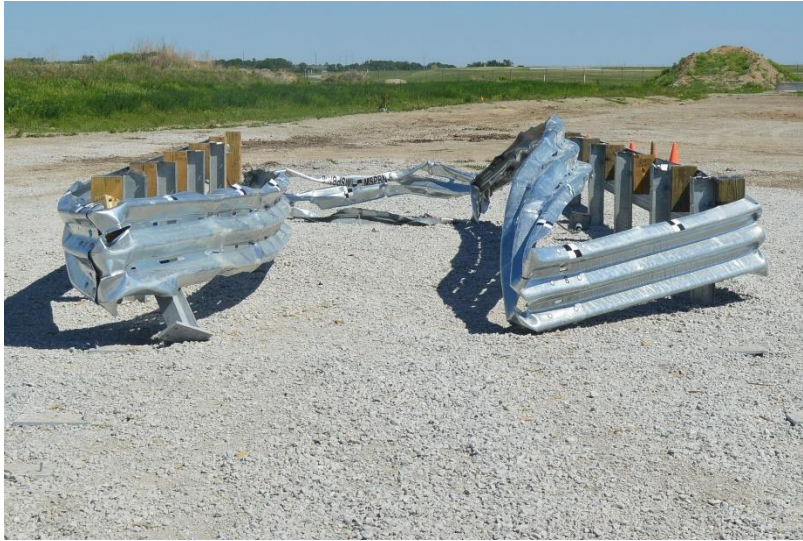
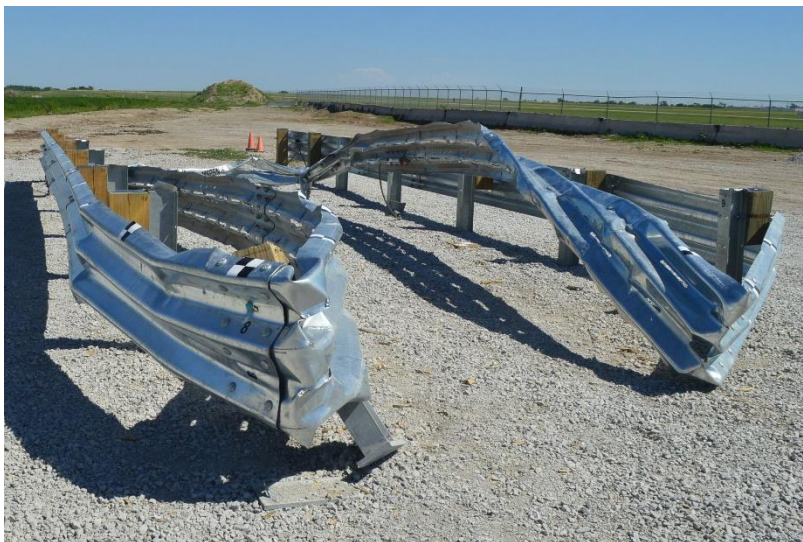
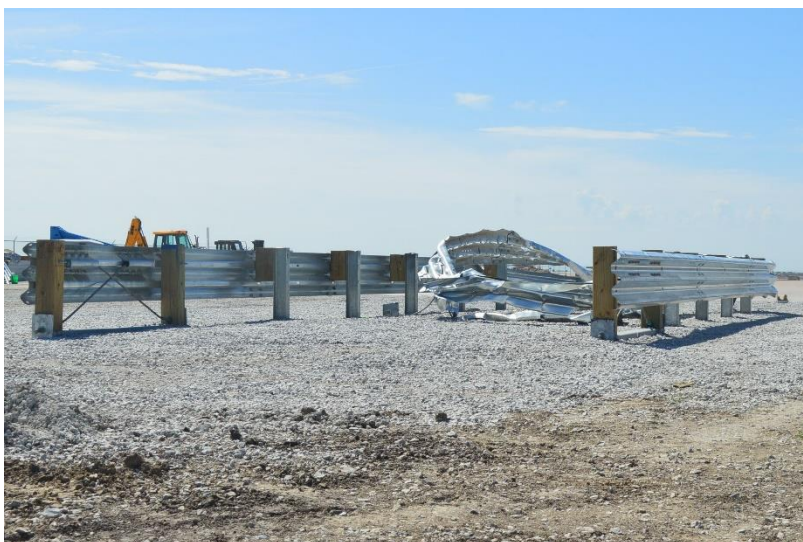
Figure 143. Overview of System Damage with Vehicle Present, Test No. MSPBN-6

Damage to the barrier was extensive, as shown in Figures 143 through 154. Barrier damage primarily consisted of contact marks, deformation, bending, and tearing of the thrie-beam rail segments and disengagement of the breakaway posts. Damage occurred to both sides A and B of the barrier and was contained from the nose section of bullnose downstream to posts nos. A9 and B9 on each side of the system. Post nos. A1 through A8 and B1 through B8 were fractured or disengaged from their bases.

The thrie-beam nose section of the barrier and the adjacent rail sections on Side A and Side B were deformed backward and into the interior of the barrier as the vehicle entered the system. Rail tearing occurred at several locations in the nose of the system. The slot tabs on the bottom valley of the nose section were fractured, except for the two 2-in. (51-mm) wide slot tabs adjacent to post no. B1 and the first 2-in. (51-mm) wide slot tab adjacent to post no. A1. The 1-in. (25-mm) wide slot tab on the top valley of the nose section 60¼ in. (1,530 mm) upstream of post no. B1 was fractured as well. The middle corrugation of the nose-section thrie beam was completely fractured approximately 9 in. (229 mm) upstream from post no. A1. Several additional partial rail tears were noted on the nose section of the bullnose system. The nose cables were all intact following the impact event.
