*Midwest Pooled Fund Research Program
Fiscal Years 2017-2020 (Year 28)
Research Project Number TPF-5(193) Supplement #123
NDOT Sponsoring Agency Code RFP-18-BULLNOSE*

MASH TESTING OF BULLNOSE WITH BREAKAWAY STEEL POSTS (TEST NOS. MSPBN-4 THROUGH MSPBN-8)

MwRSF Research Report No. TRP-03-418-20

September 1, 2020

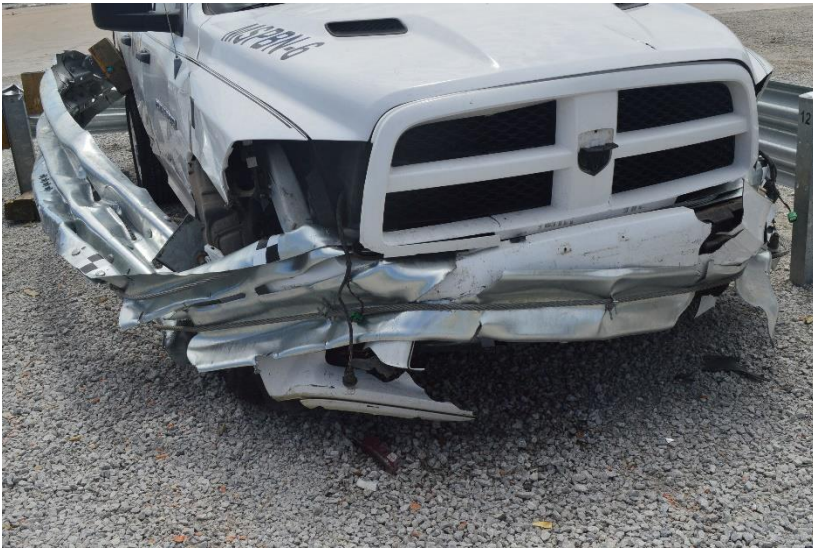
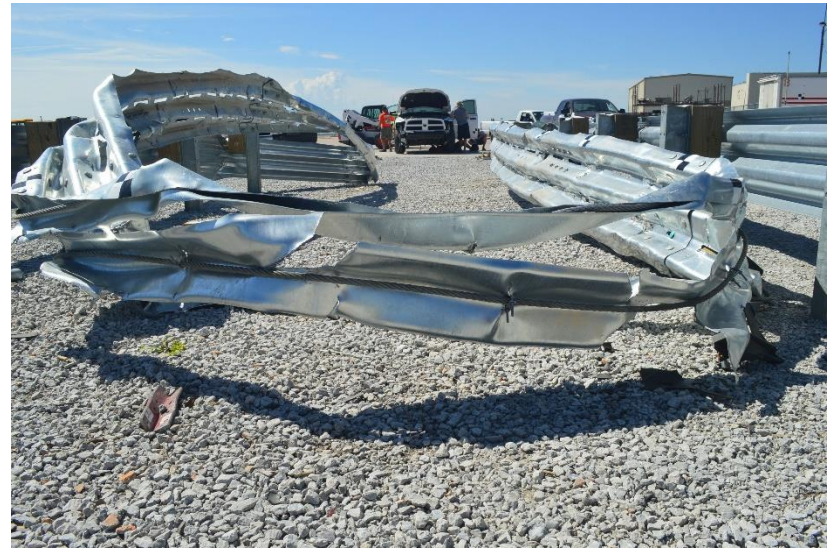
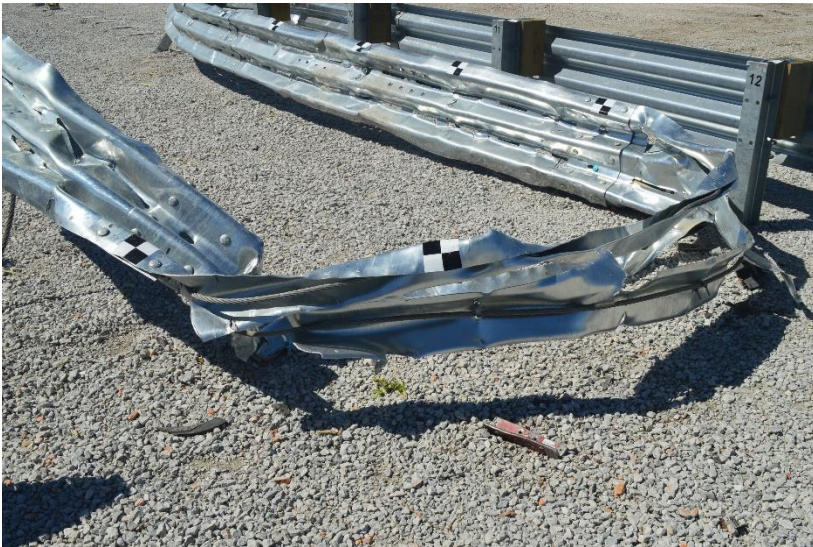
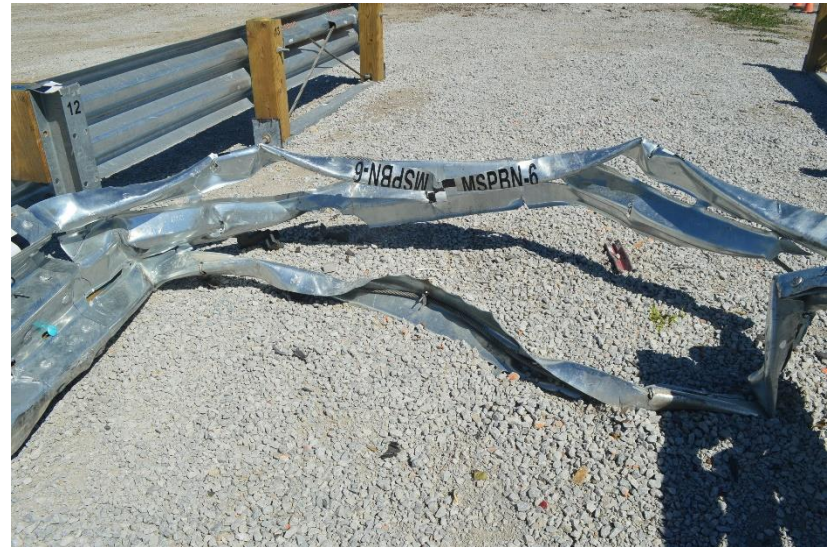
Figure 144. Overview of System Damage with Vehicle Removed, Test No. MSPBN-6.

Damage to the barrier was extensive, as shown in Figures 143 through 154. Barrier damage primarily consisted of contact marks, deformation, bending, and tearing of the thrie-beam rail segments and disengagement of the breakaway posts. Damage occurred to both sides A and B of the barrier and was contained from the nose section of bullnose downstream to posts nos. A9 and B9 on each side of the system. Post nos. A1 through A8 and B1 through B8 were fractured or disengaged from their bases.

The maximum longitudinal permanent set of the barrier system was 55 ft — 7 $\frac{7}{8}$ in. (17.0 m) at the centerline of the rail in the nose, as measured in the field. The maximum lateral permanent set of the barrier was interior to the system and was not reported. The maximum longitudinal dynamic barrier deflection was 55 ft — 11 in. (17.0 m) at the centerline of the barrier, as determined from high-speed digital video analysis. The maximum lateral dynamic barrier deflection was interior to the system and was not reported. The longitudinal working width of the system was found to be 56 ft — 5 in. (17.2 m), and the lateral working width was found to be 15 ft — 9 in. (4.8 m), as determined from high-speed digital video analysis. A schematic of the working width for test no, MSPBN-6 is shown in Figure 155.

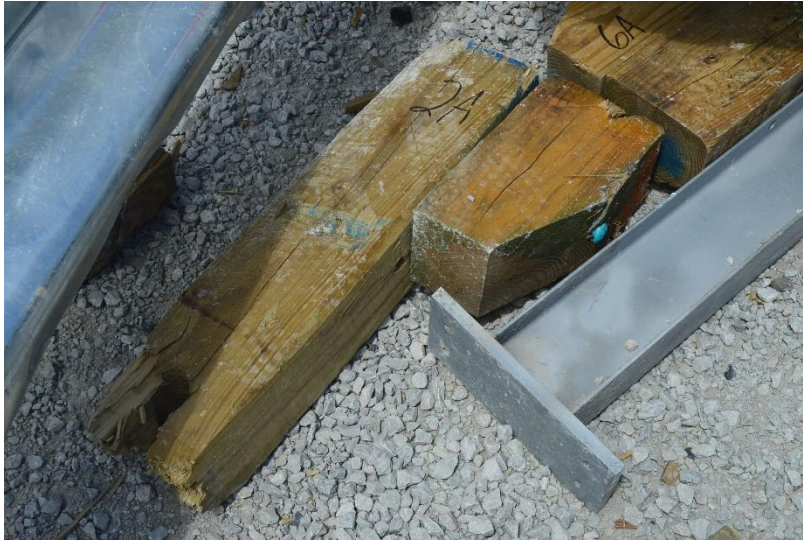
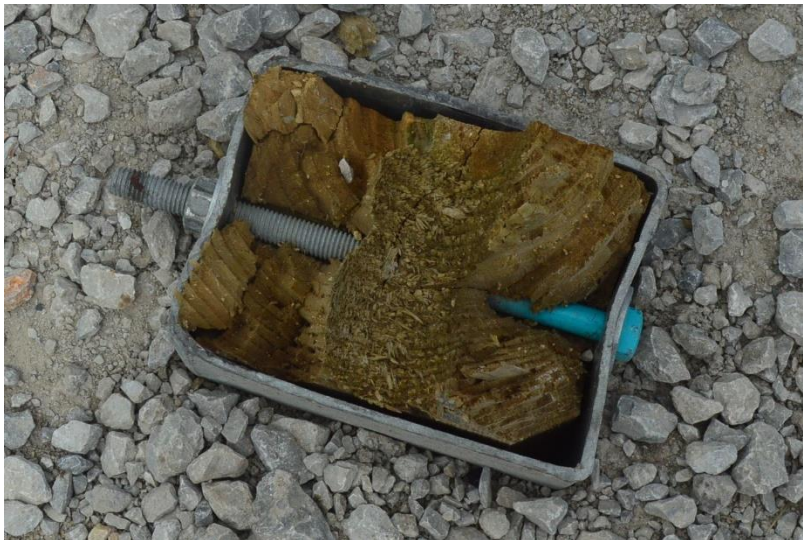
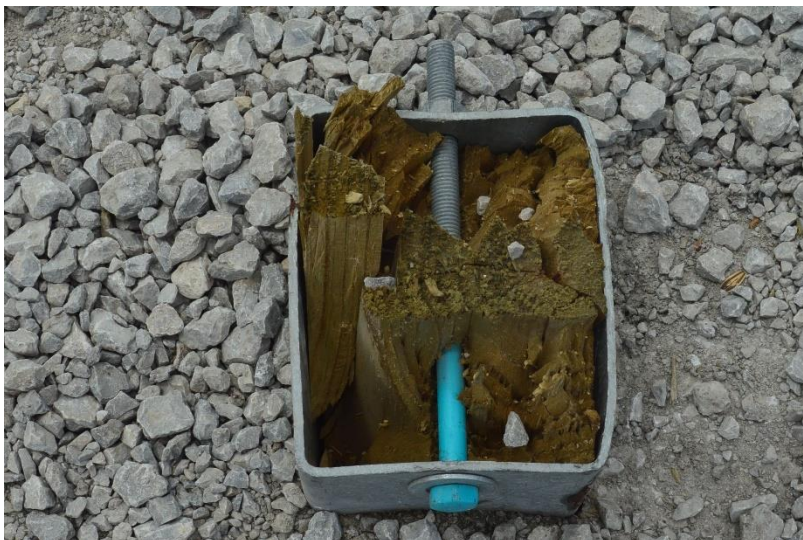
Figure 145. Damage to Impact Location, Test No. MSPBN-6

The thrie-beam nose section of the barrier and the adjacent rail sections on Side A and Side B were deformed backward and into the interior of the barrier as the vehicle entered the system. Rail tearing occurred at several locations in the nose of the system. The slot tabs on the bottom valley of the nose section were fractured, except for the two 2-in. (51-mm) wide slot tabs adjacent to post no. B1 and the first 2-in. (51-mm) wide slot tab adjacent to post no. A1. The 1-in. (25-mm) wide slot tab on the top valley of the nose section 60¼ in. (1,530 mm) upstream of post no. B1 was fractured as well. The middle corrugation of the nose-section thrie beam was completely fractured approximately 9 in. (229 mm) upstream from post no. A1. Several additional partial rail tears were noted on the nose section of the bullnose system. The nose cables were all intact following the impact event.

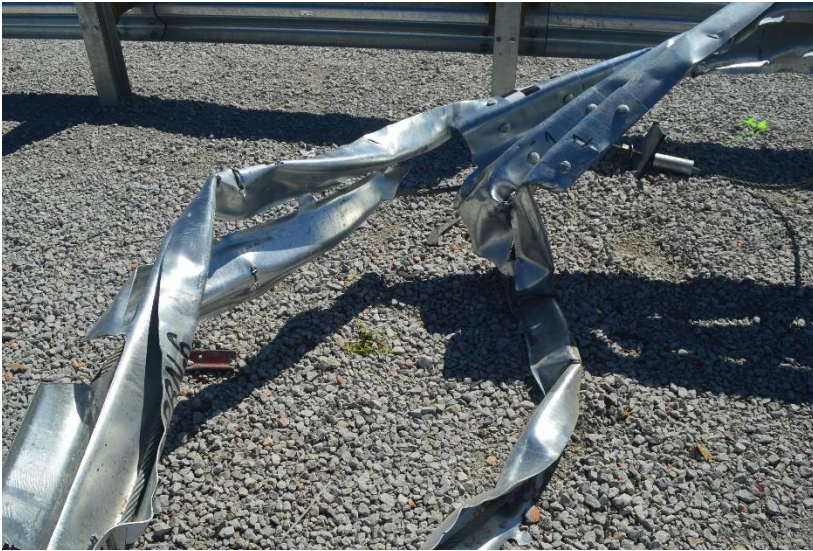
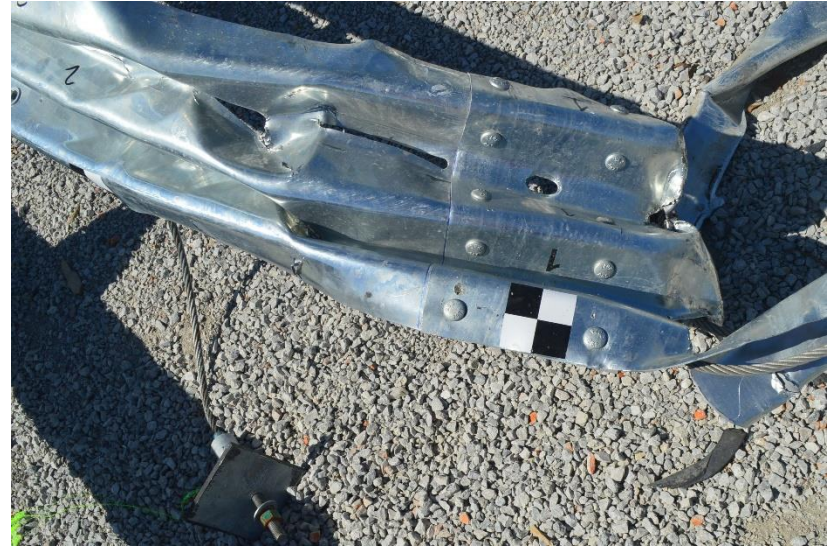
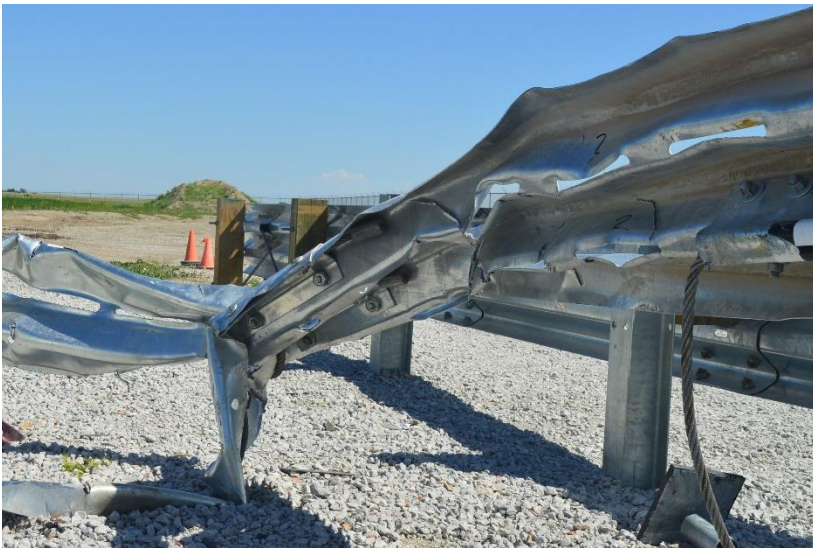
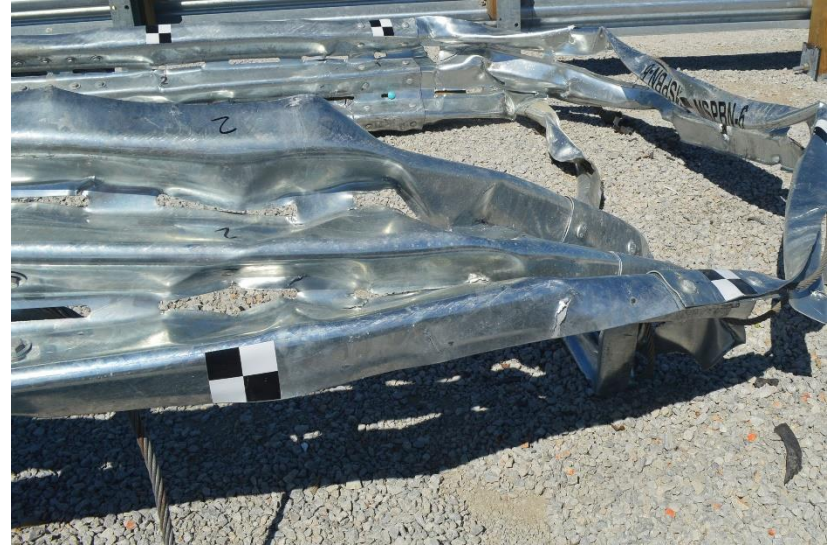
Figure 146. Damage to Post Nos. A1 (middle) and A2 (bottom), Test No. MSPBN-6
183

All four of the BCT posts adjacent to the nose of the system were fractured and disengaged. All twelve UBSP posts were disengaged from their bases, six on each side of the system, due to fracture of the base plate connection bolts. Post nos. A1 and A2 were fractured at the ground and were disengaged from the rail. Post nos. A3 through A8 were all disconnected from their respective bases with all four base plate bolts being fractured, and each post was disconnected from the railing. Post no. A9 was disengaged from the rail, and a ¼-in. (3-mm) soil gap was observed in front of the post. Post nos. A10 through A15 received no visible damage.

Review of the disengaged UBSP posts revealed some damage to the upper sections of the posts. No permanent deformation was noted to the base plates on either the upper or lower section

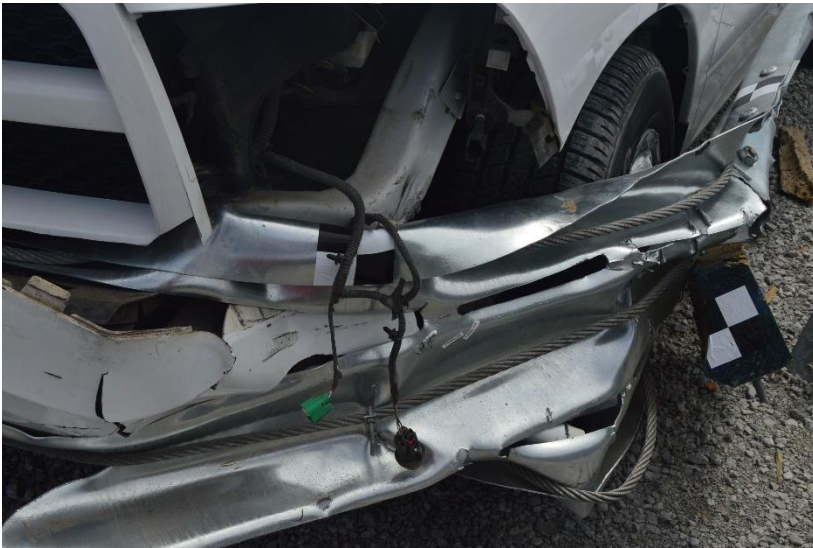
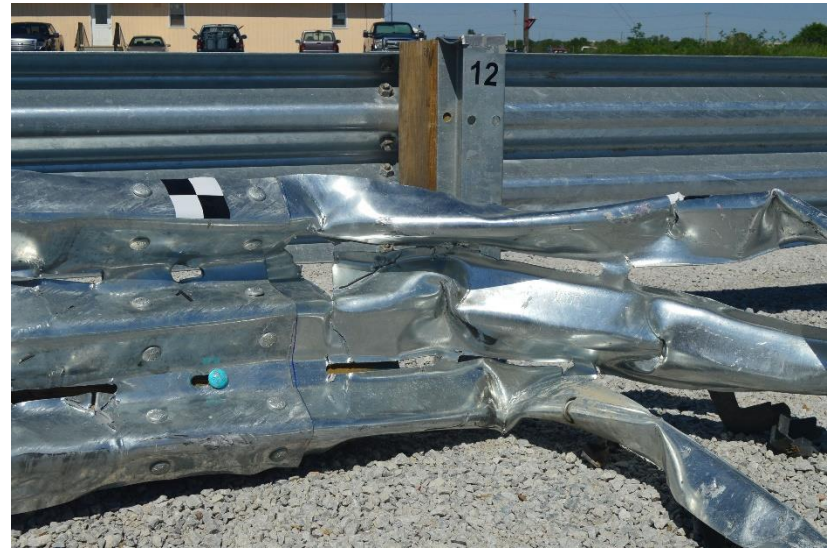
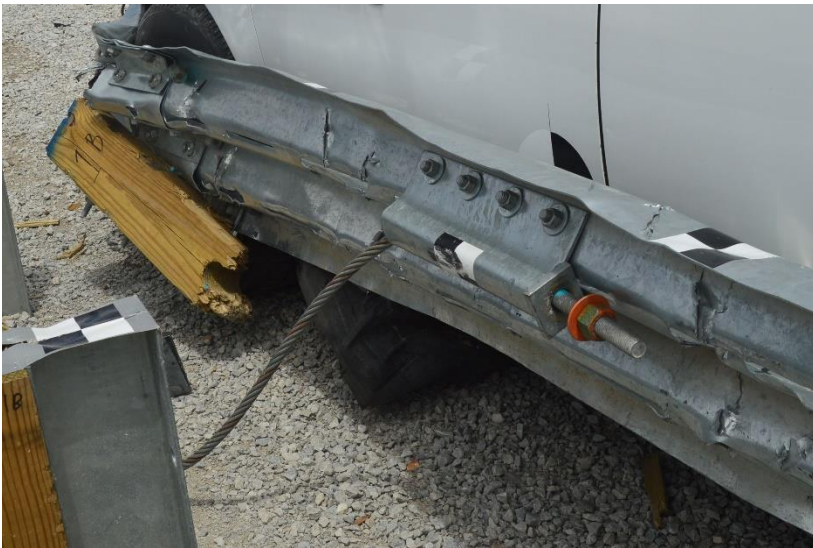
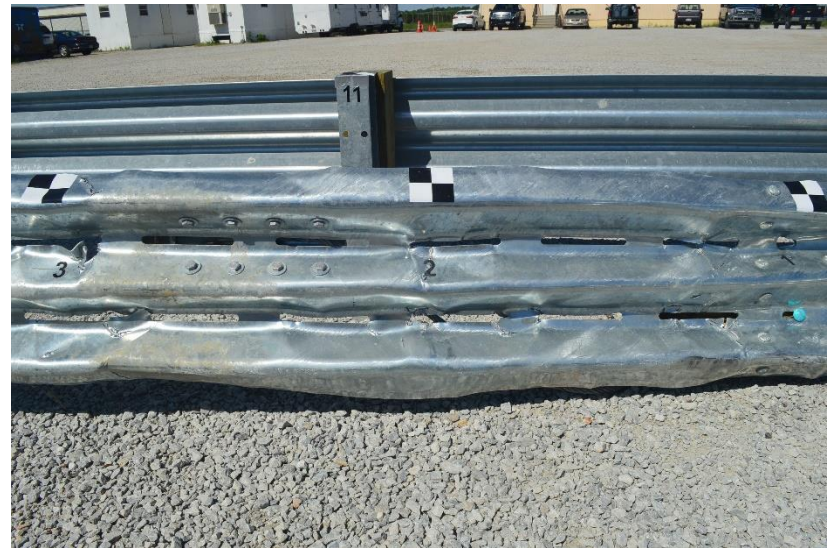
Figure 150. Damage to Post Nos. B1 and B2, Test No. MSPBN-6

Post nos. B1 and B2 were fractured at the ground. Post no. B1 remained attached to the rail, while post no. B2 was disengaged from the rail. Post nos. B3 through B8 were all disconnected from their respective bases with all four base plate bolts being fractured. Only post no. B8 remaining attached to the thrie beam. Post no. B9 was twisted about its vertical axis, and a ¼-in. (3-mm) soil gap was observed behind the post. Post nos. B10 through B14 received no visible damage.

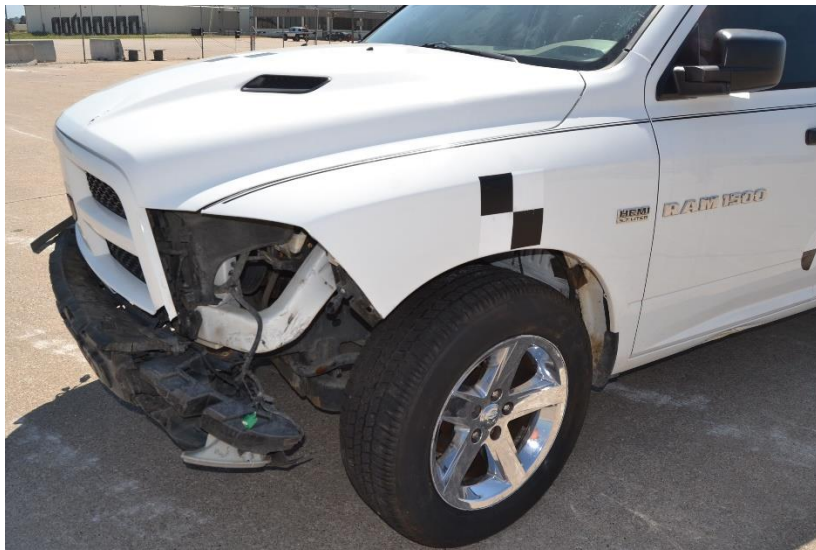
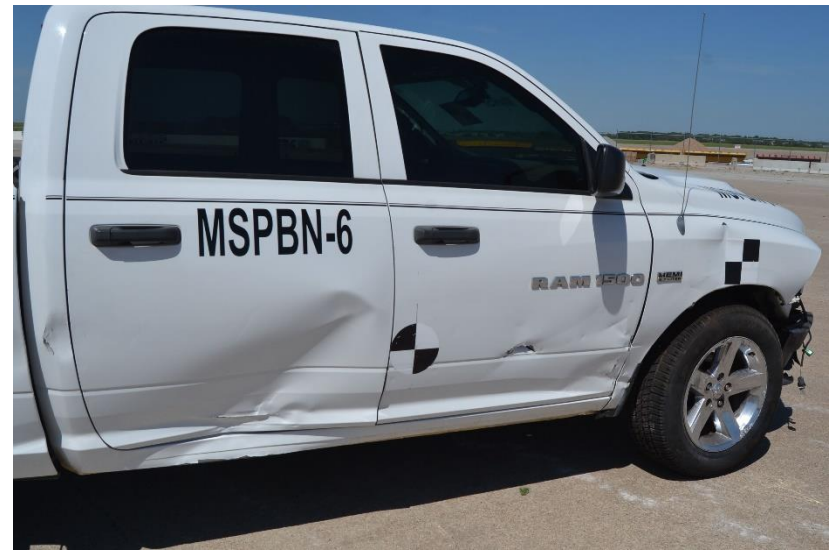
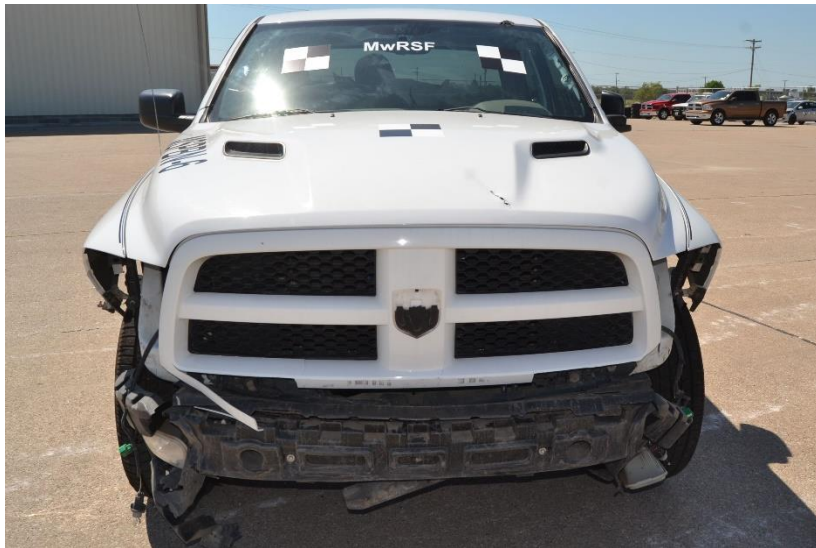
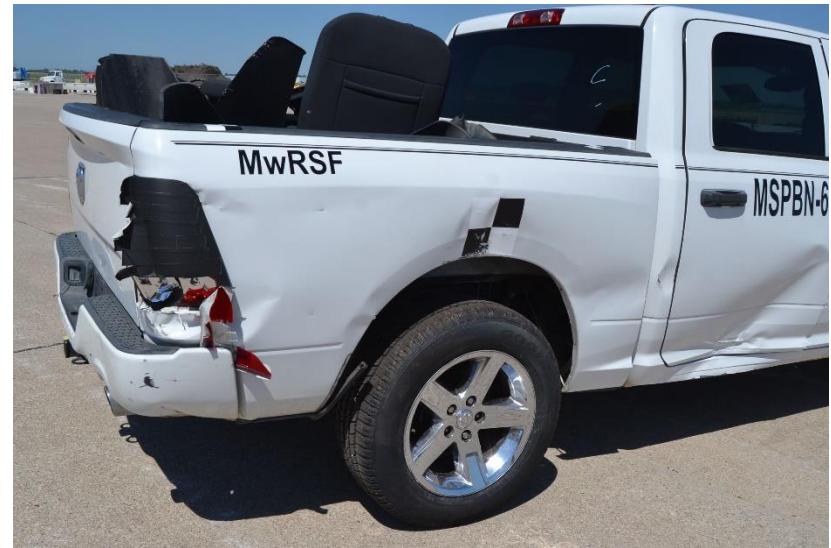
Figure 157. Vehicle Damage, Test No. MSPBN-6

The damage to the vehicle was minimal, as shown in Figures 156 through 159. The maximum occupant compartment deformations are listed in Table 17 along with the deformation limits established in MASH 2016 for various areas of the occupant compartment. Note that none of the established MASH 2016 deformation limits were violated. Complete occupant compartment and vehicle deformations and the corresponding locations are provided in Appendix D.

The damage mainly occurred to the front and right side of the vehicle. The front bumper disengaged from the vehicle. An 8-in. (212-mm) long tear in the hood was observed. A 16-in. (406-mm) long by 5-in. (127-mm) deep dent was found in the right-front fender. The right-front door had a tear 6 in. (152 mm) long by 2¼ in. (57 mm) wide. A large dent 15 in. (381 mm) long by 11½ in. (292 mm) wide occurred on the right-front door. The right-rear door received a dent 38 in. (965 mm) long by 23 in. (584 mm) wide. Dents were also observed under the right-rear door and along the right side of the bed body. Damage to the suspension included a bent right-rear sway bar and damage due to rubbing of the front-right upper control arm. No damage was observed to the drivetrain or undercarriage. The windshield and side windows also remained undamaged.

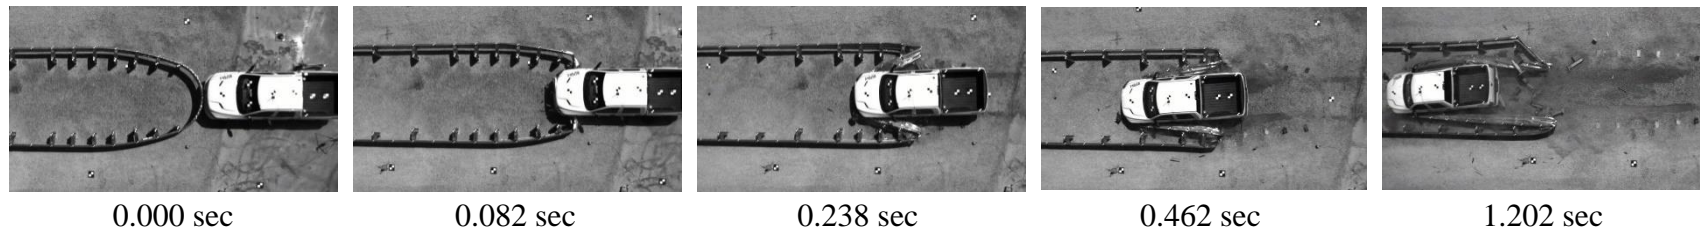
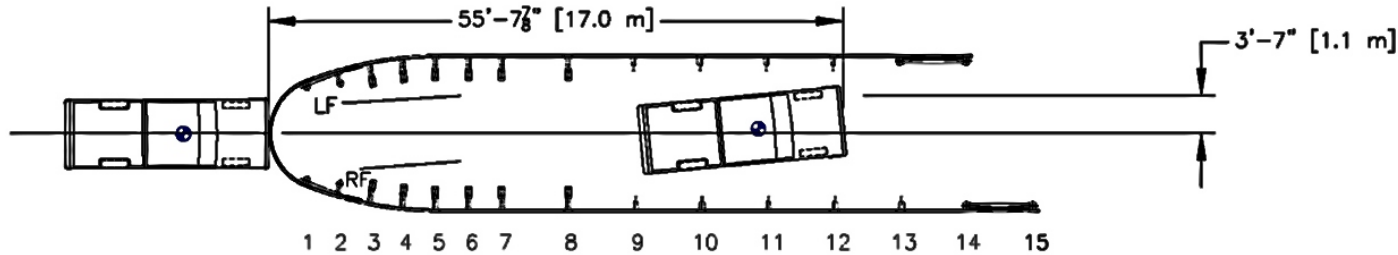
Figure 160. Summary of Test Results and Sequential Photographs, Test No. MSPBN-6

The analysis of the results for test no. MSPBN-6 showed that the system adequately contained and decelerated the 2270P vehicle to a controlled stop within the system. A summary of the test results is shown in Figure 160. Detached elements, fragments, or other debris from the test article did not penetrate or show potential for penetrating the occupant compartment, or present an undue hazard to other traffic, pedestrians, or work-zone personnel. Deformations of, or intrusions into, the occupant compartment that could have caused serious injury did not occur. The test vehicle did not penetrate nor ride over the barrier and remained upright during and after the collision. Vehicle roll, pitch, and yaw angular displacements, as shown in Appendix G, were deemed acceptable, because they did not adversely influence occupant risk nor cause rollover. Therefore, test no. MSPBN-6 was determined to be acceptable according to the MASH 2016 safety performance criteria for test designation no. 3-31.

- Vehicle Damage Minimal
 - VDS [20] 12-FD-1
 - CDC [21]..... 12-FDMW-1
 - Maximum Interior Deformation 0.5 in. (13 mm)
- Test Article Damage..... Extensive
- Maximum Test Article Deflections
 - Permanent Set 55 ft – 7½ in. (17.0 m) longitudinal
 - Dynamic 55 ft – 11 in. (17.0 m) longitudinal
 - Working Width 56 ft – 5 in. (17.2 m) longitudinal, 15 ft – 9 in. (4.8 m) lateral
- Transducer Data

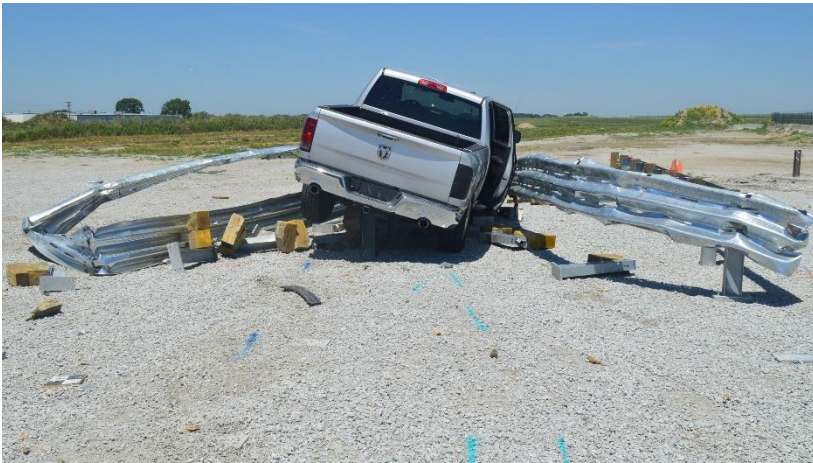
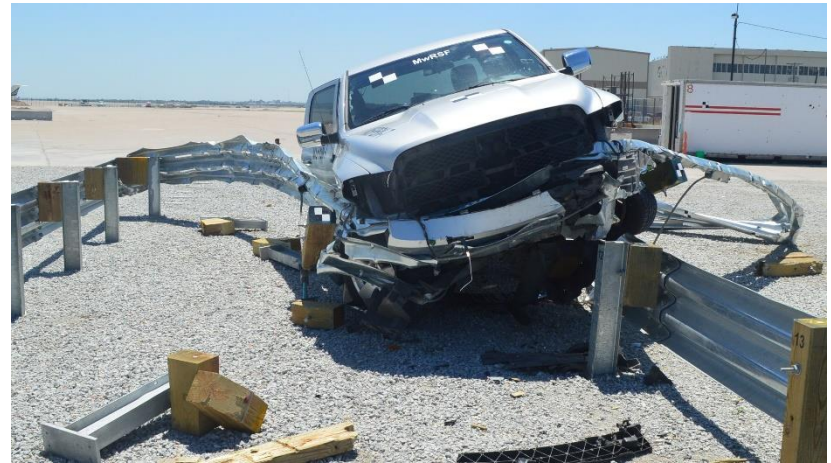
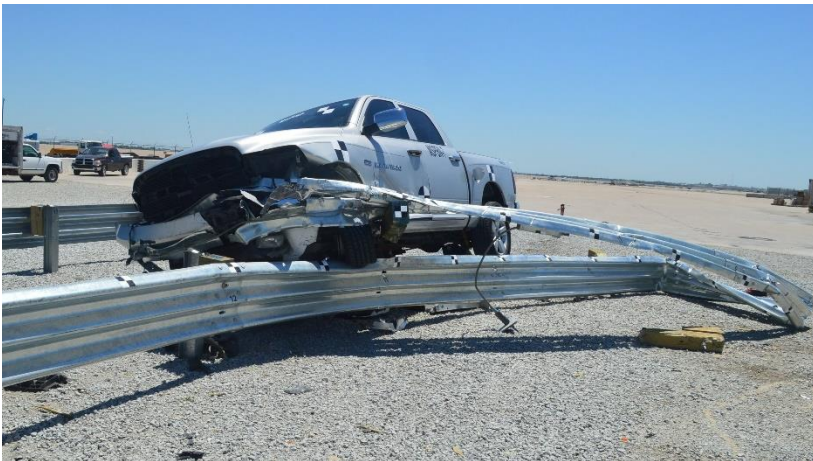
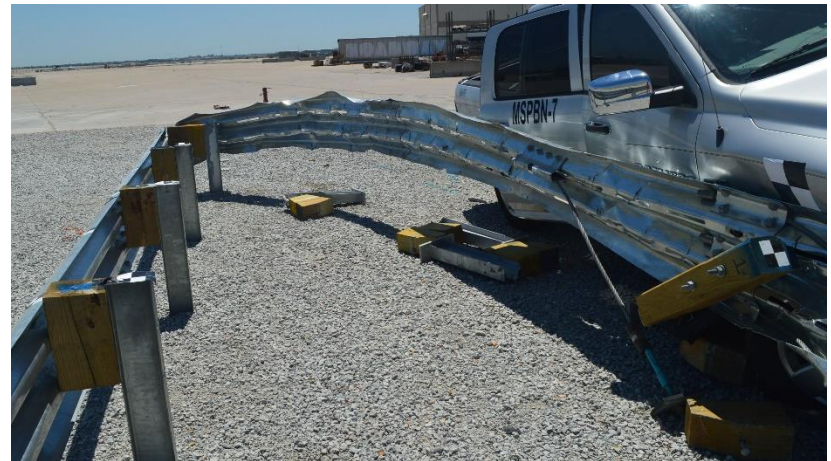
Figure 167. Overview of System Damage with Vehicle Present, Test No. MSPBN-7

Damage to the barrier was extensive, as shown in Figures 167 through 178. Barrier damage primarily consisted of contact marks, deformation, bending, and tearing of the thrie-beam rail segments, disengagement of the breakaway posts, and deformation and displacement standard line posts. Damage occurred to both sides A and B of the barrier and was contained from the nose section of bullnose system downstream from posts nos. A8 and B12 on each side of the system. Post nos. A1 through A7 and B1 through B8 were fractured or disengaged from their bases.

The thrie-beam nose section of the barrier and the adjacent rail sections on Side A and Side B were deformed backward and into the interior of the barrier as the vehicle entered the system. Rail tearing occurred at several locations in the nose of the system. Rail tearing occurred at several locations in the nose of the system. The slot tabs on the bottom valley of the nose section were fractured, except for the first 2-in. (51-mm) wide slot tab adjacent to post no. A1. On the top valley of the nose section, all of the slot tabs in the rail were torn, except for the two, 2-in. (51-mm) wide slot tabs adjacent to post nos. A1 and B1. The top and middle corrugations of the nose section thrie beam was completely fractured approximately 55 in. (1,397 mm) upstream of post no. B1. The middle corrugation of the nose section thrie beam was completely fractured approximately 9 in. (229 mm) upstream of post no. A1. Several additional partial rail tears were noted on the all three corrugations of the nose section thrie beam. The nose cables were all intact following the impact.

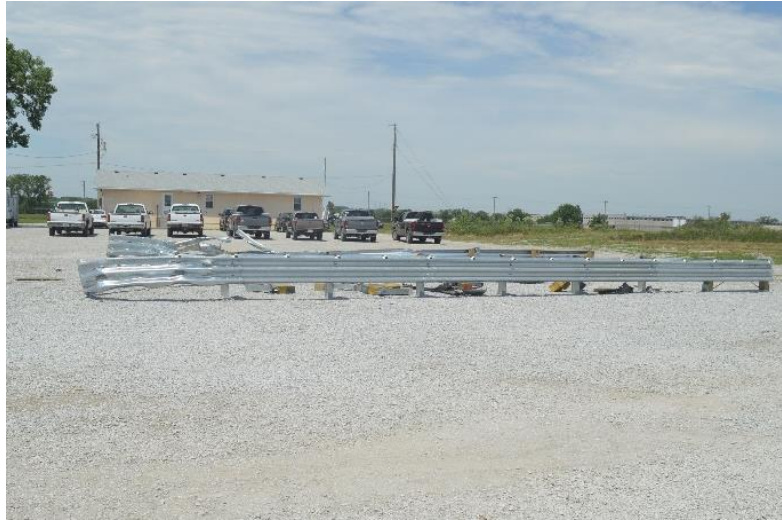
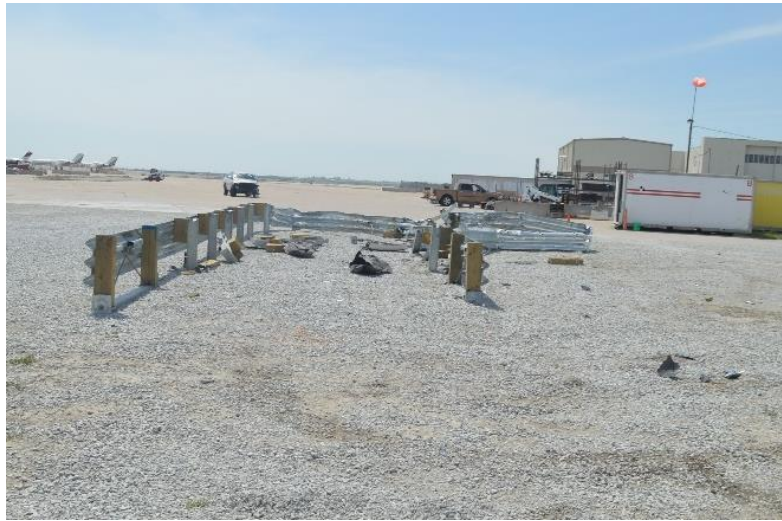
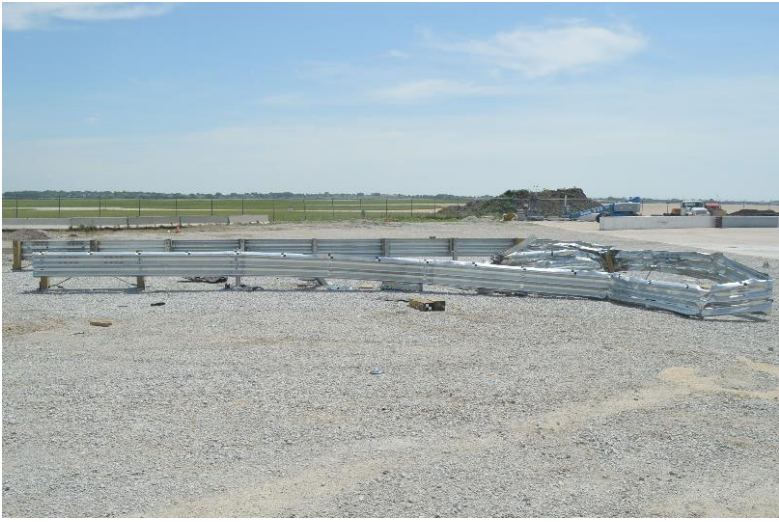
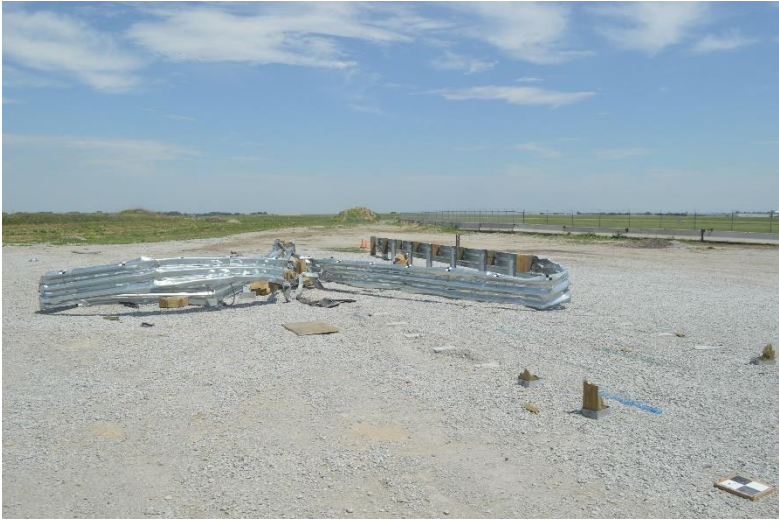
Figure 168. Overview of System Damage without Vehicle Present, Test No. MSPBN-7

The maximum longitudinal permanent set of the barrier system was 52 ft – 1 in. (15.9 m) at the centerline of the bullnose, as measured in the field. The maximum lateral permanent set of the barrier was 12 ft – 1½ in (3.7 m) on the rail at post no. B6, as measured in the field. The maximum longitudinal dynamic deflection was 52 ft – 9 in. (16.1 m) on the rail near the center of the nose section, as determined from high-speed video analysis and post-test measurements. The maximum lateral dynamic barrier deflection was 14 ft – 6 in. (4.4 m) on the rail between post nos. B5 and B6, as determined from high-speed digital video analysis. The working width of the system was found to be 29 ft – 2 in. (8.9 m), also determined from high-speed digital video analysis. A schematic of the working width is shown in Figure 179.

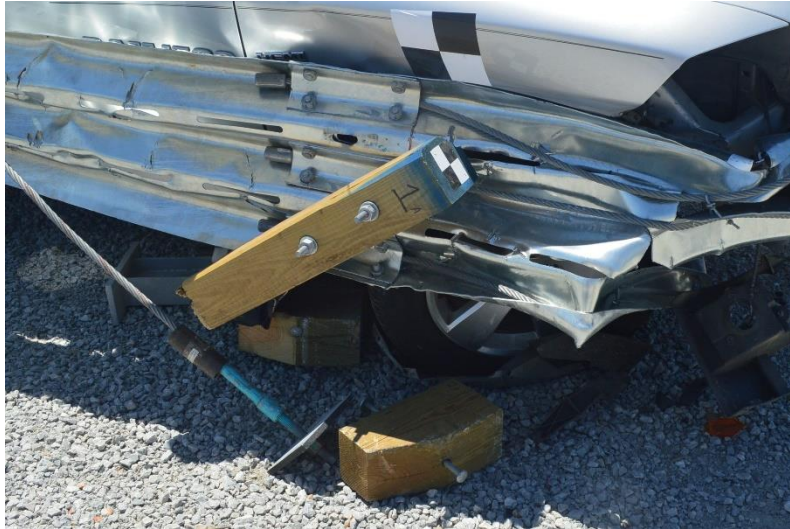
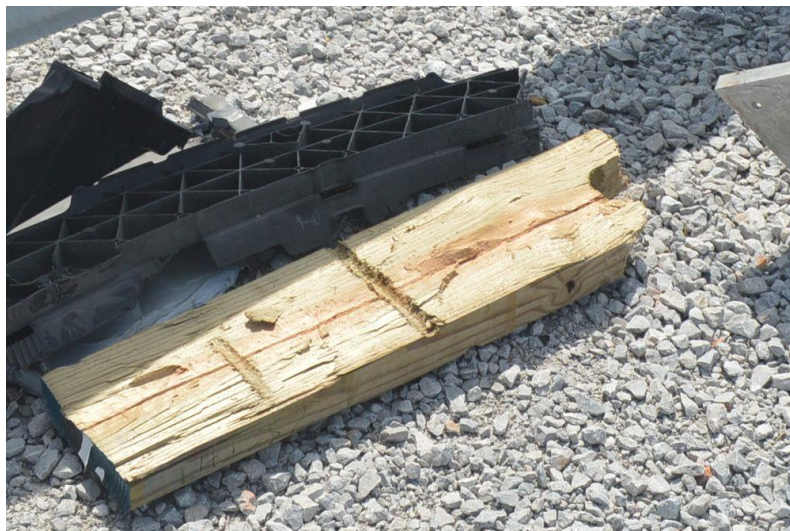
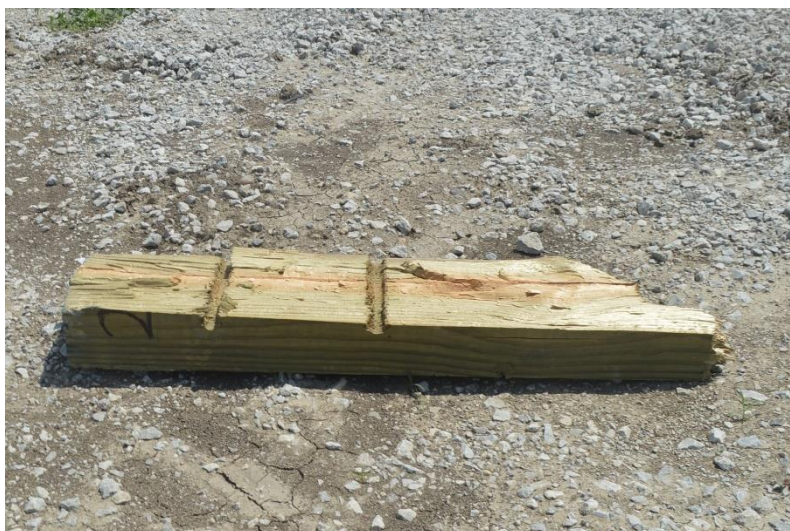
Figure 170. Damage to Post Nos. A1 and A2, Test No. MSPBN-7

All four of the BCT posts adjacent to the nose of the system were fractured and disengaged. Eleven UBSP posts were disengaged from their bases, five on Side A and six on Side B of the system, due to fracture of the base plate connection bolts. Post nos. A1 and A2 were fractured at the ground and were disengaged from the rail. Post nos. A3 through A7 were all disconnected from their respective bases with all four base plate bolts being fractured, and each post was disconnected from the railing. No visible damage was observed in post nos. A9 through A15.

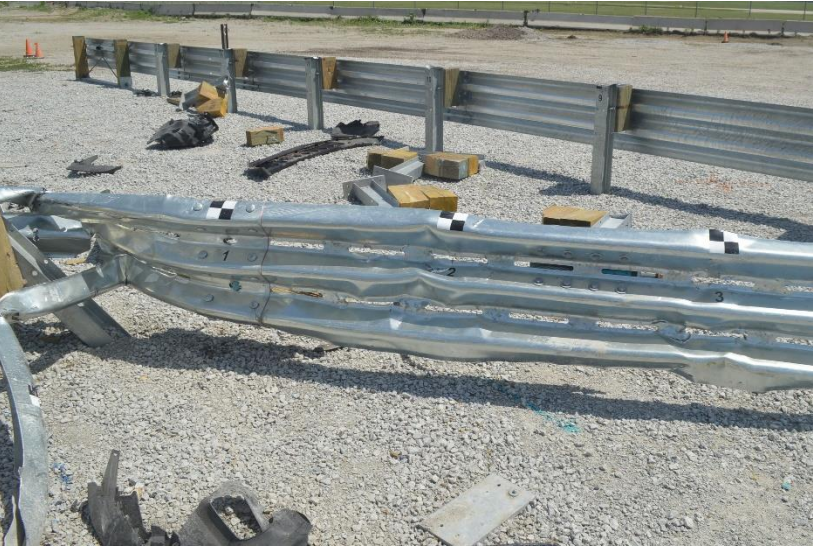
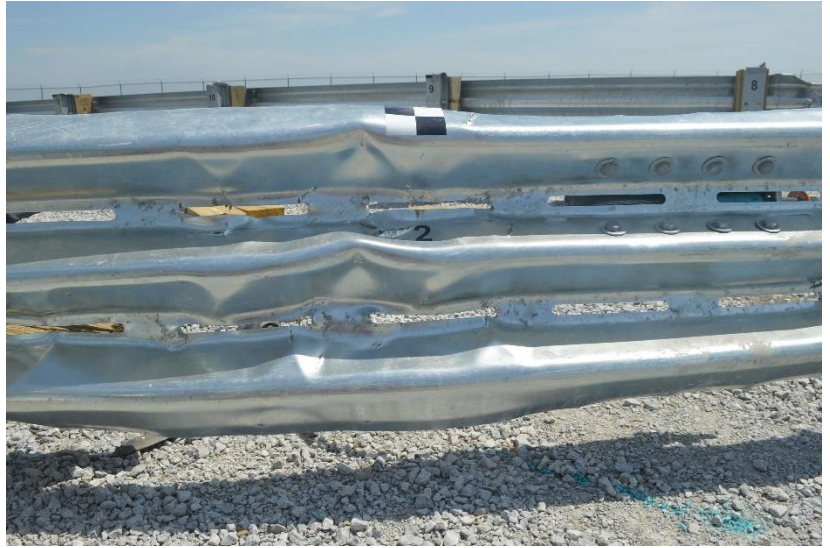
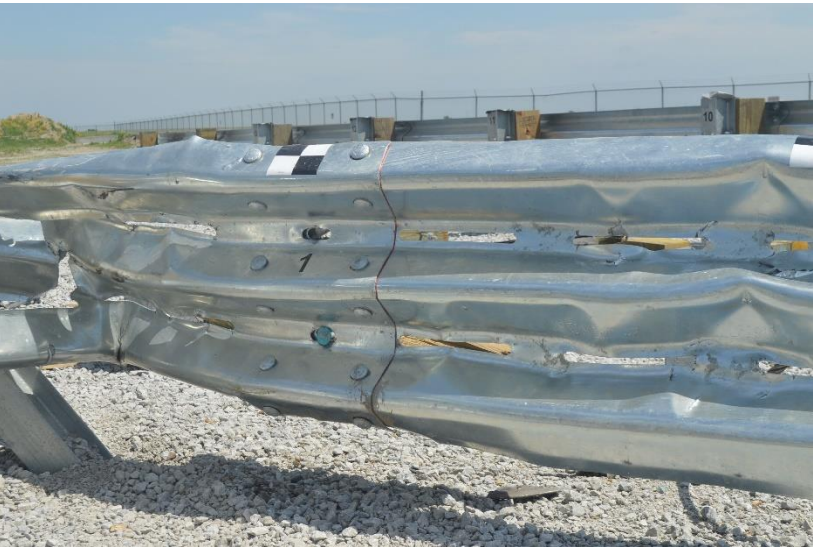
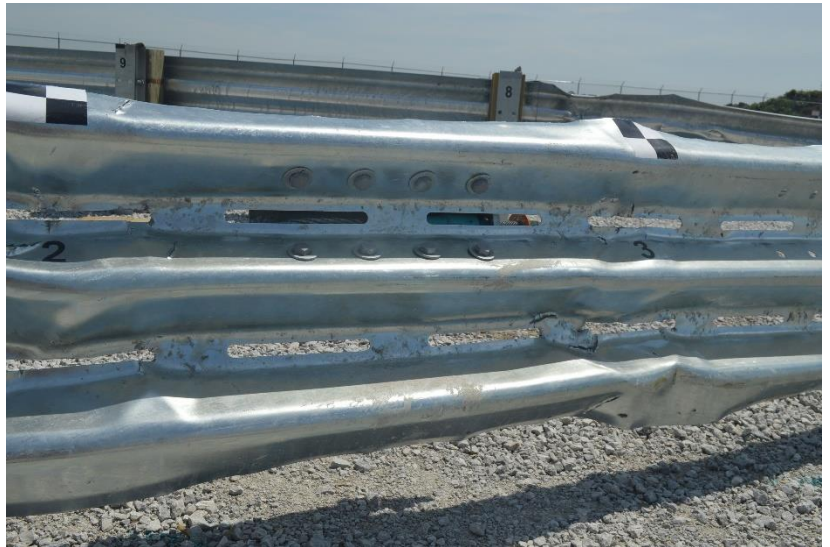
Figure 171. Damage to Rail at Post Nos. A1 through A3, Test No. MSPBN-7

Rail section nos. 2 through 3 on Side A of the system were kinked, deformed, and bent inward toward the interior of the system just upstream of post no A8. The railing was kinked and hinged at 34½ in. (876 mm) upstream from post no. A8. The rail was bent also kinked and hinged inward 2 in. (51 mm) downstream from post no. A6 and 9 in. (229 mm) upstream from post no. A7. A 3-in. (76-mm) long tear was observed on the bottom corrugation approximately 6 in. (406 mm) downstream from post no. A4.

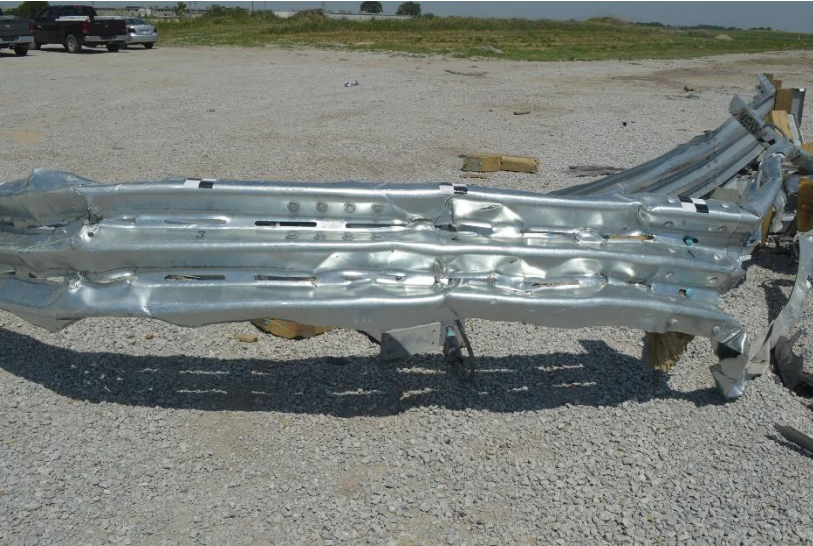
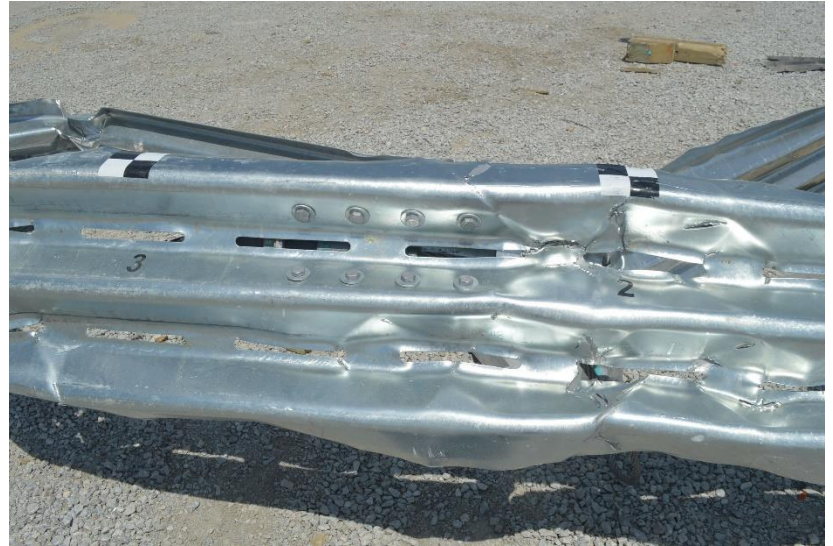
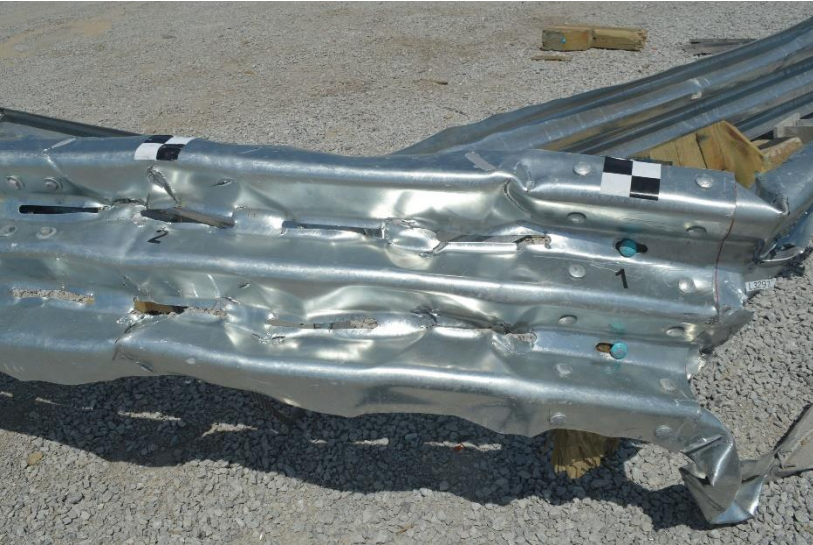
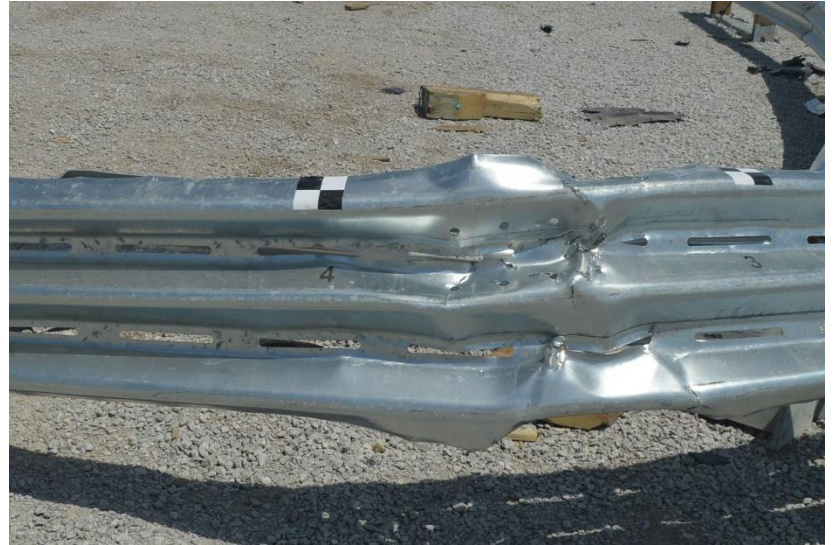
Figure 175. Damage to Rail at Post Nos. B1 through B4, Test No. MSPBN-7

Post nos. B1 and B2 were fractured at the ground. Post no. B1 remained attached to the rail, while post no. B2 was disengaged from the rail. Post nos. B3 through B8 were all disconnected from their respective bases with all four base plate bolts being fractured, and all of the posts were detached from the rail. Post nos. B9 through B11 were bent and rotated downstream and were detached from the rail as the vehicle overrode them. Post no. B12 was rotated forward and twisted counterclockwise, while the railing remained attached to the post. No visible damage was observed in post nos. B13 through A14.

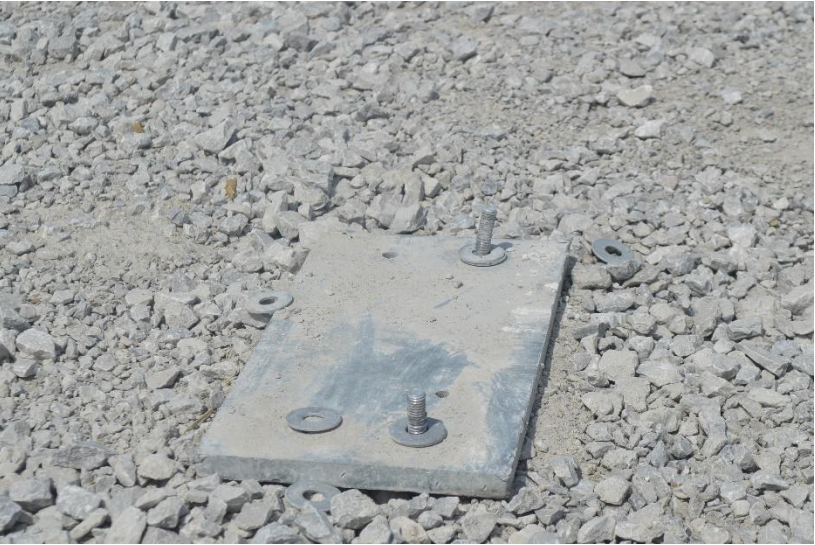
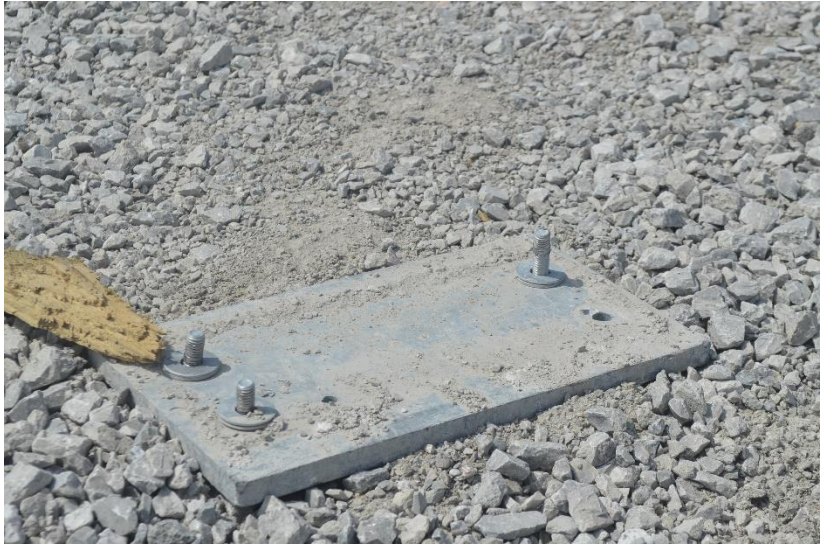
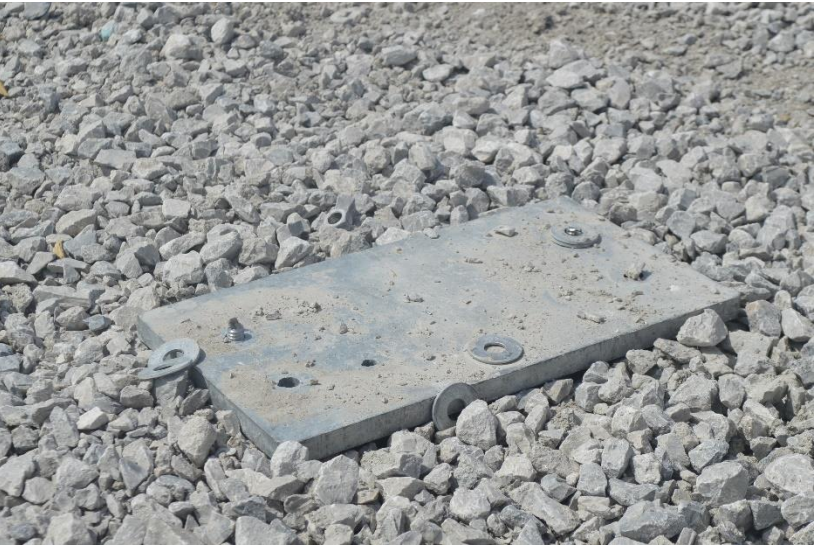
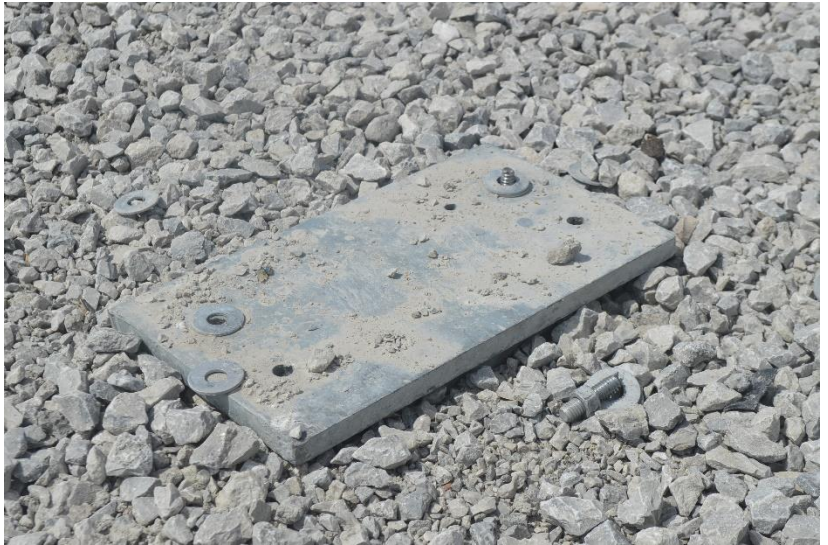
Figure 178. UBSP Post Bases, Test No. MSPBN-7

Review of the disengaged UBSP posts revealed some damage to the upper sections of the posts. No permanent deformation was noted to the base plates on either the upper or lower section of the UBSP post, and displacement of the base of the post was minimal for all of the disengaged UBSP posts.
