*Midwest Pooled Fund Research Program
Fiscal Years 2017-2020 (Year 28)
Research Project Number TPF-5(193) Supplement #123
NDOT Sponsoring Agency Code RFP-18-BULLNOSE*

MASH TESTING OF BULLNOSE WITH BREAKAWAY STEEL POSTS (TEST NOS. MSPBN-4 THROUGH MSPBN-8)

MwRSF Research Report No. TRP-03-418-20

September 1, 2020

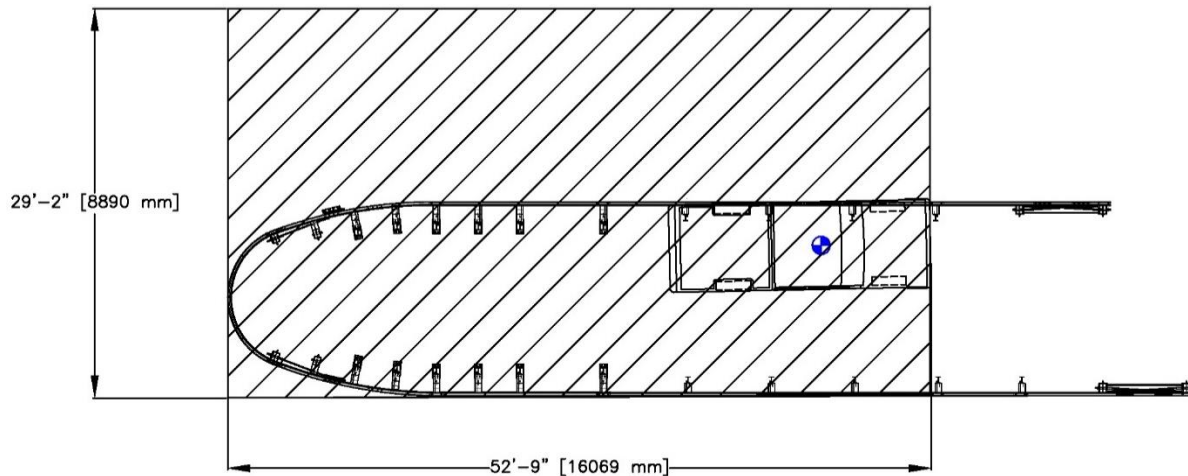
Figure 179. Working Width, Test No. MSPBN-7

The maximum longitudinal permanent set of the barrier system was 52 ft – 1 in. (15.9 m) at the centerline of the bullnose, as measured in the field. The maximum lateral permanent set of the barrier was 12 ft – 1½ in (3.7 m) on the rail at post no. B6, as measured in the field. The maximum longitudinal dynamic deflection was 52 ft – 9 in. (16.1 m) on the rail near the center of the nose section, as determined from high-speed video analysis and post-test measurements. The maximum lateral dynamic barrier deflection was 14 ft – 6 in. (4.4 m) on the rail between post nos. B5 and B6, as determined from high-speed digital video analysis. The working width of the system was found to be 29 ft – 2 in. (8.9 m), also determined from high-speed digital video analysis. A schematic of the working width is shown in Figure 179.

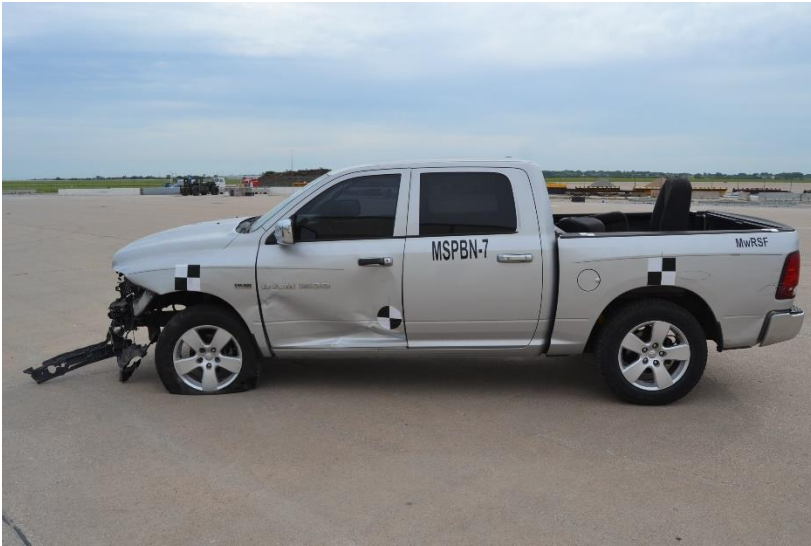
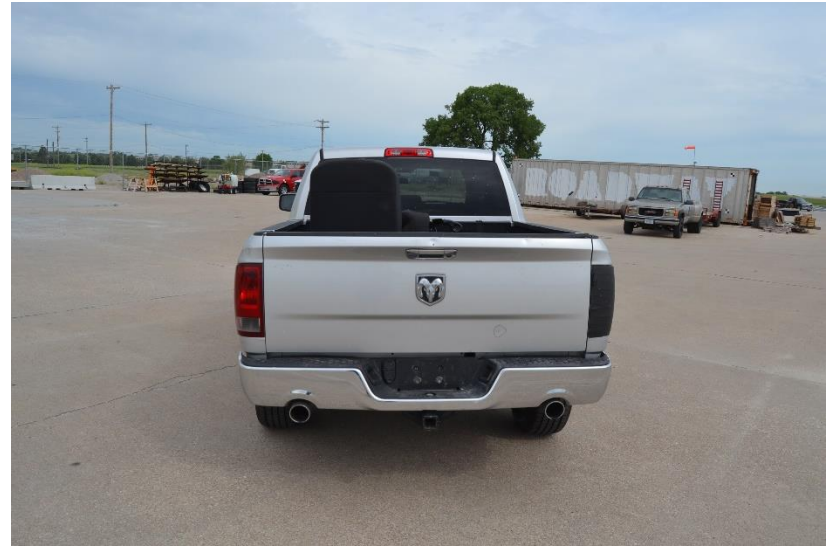
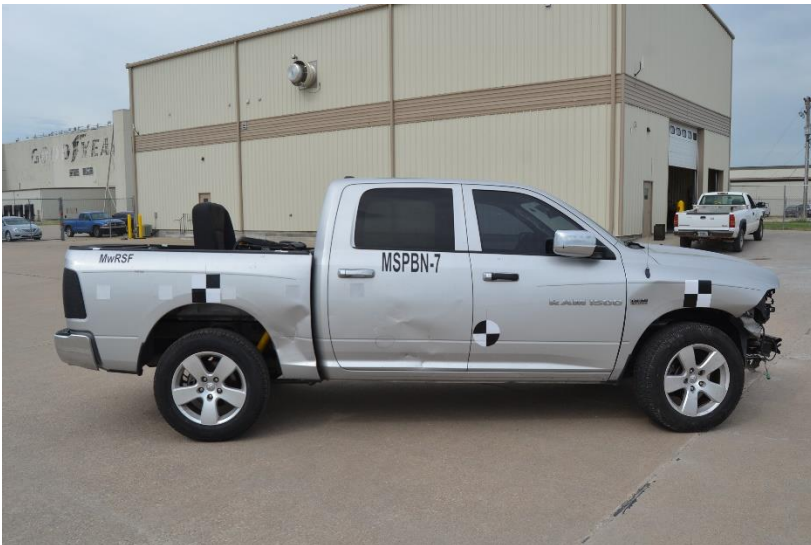
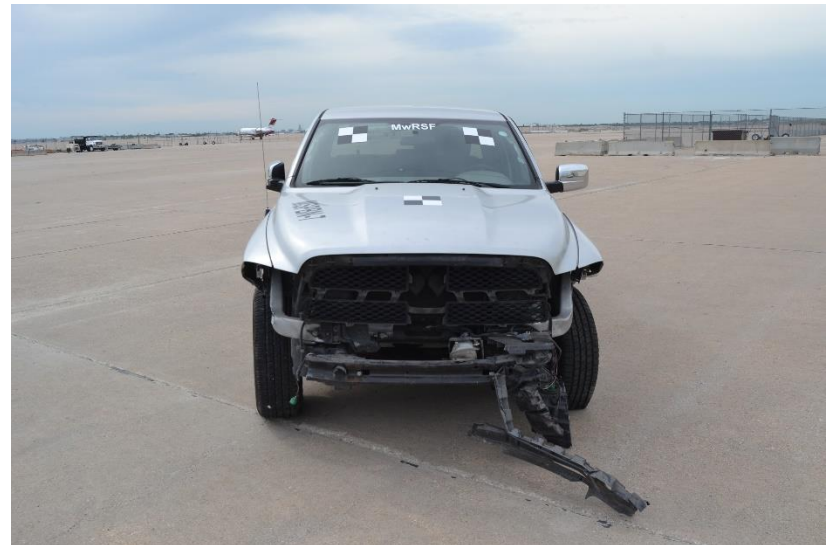
Figure 180. Vehicle Damage, Test No. MSPBN-7

The damage to the vehicle was minimal, as shown in Figure 180 through Figure 183. The maximum occupant compartment deformations are listed in Table 22 along with the deformation limits established in MASH 2016 for various areas of the occupant compartment. Note that none of the established MASH 2016 deformation limits were violated. Complete occupant compartment and vehicle deformations and the corresponding locations are provided in Appendix D.

The majority of the damage was concentrated on the front of the vehicle. The front bumper, headlight, and grille were all disengaged. The left-front quarter panel in front of the tire was folded inward. The left-front door was crushed inward below the door handle over an area $43\frac{1}{2}$ in. (1,105 mm) wide by $23\frac{1}{2}$ in. (597 mm) high. The right-front quarter panel was folded inward in front of the tire and had a dent 9 in. (229 mm) long by $8\frac{1}{4}$ in. (210 mm) wide behind the tire. The right-rear door had a 7-in. (178-mm) long by 5-in. (127-mm) wide dent at the bottom and an 11-in. (279-mm) long gouge in the center. A 12-in. (305-mm) by 18-in. (457-mm) dent and a $6\frac{1}{4}$ -in. (159-mm) long gouge were observed in the right-rear quarter panel in front of the rear tire. The side windows and windshield remained undamaged.

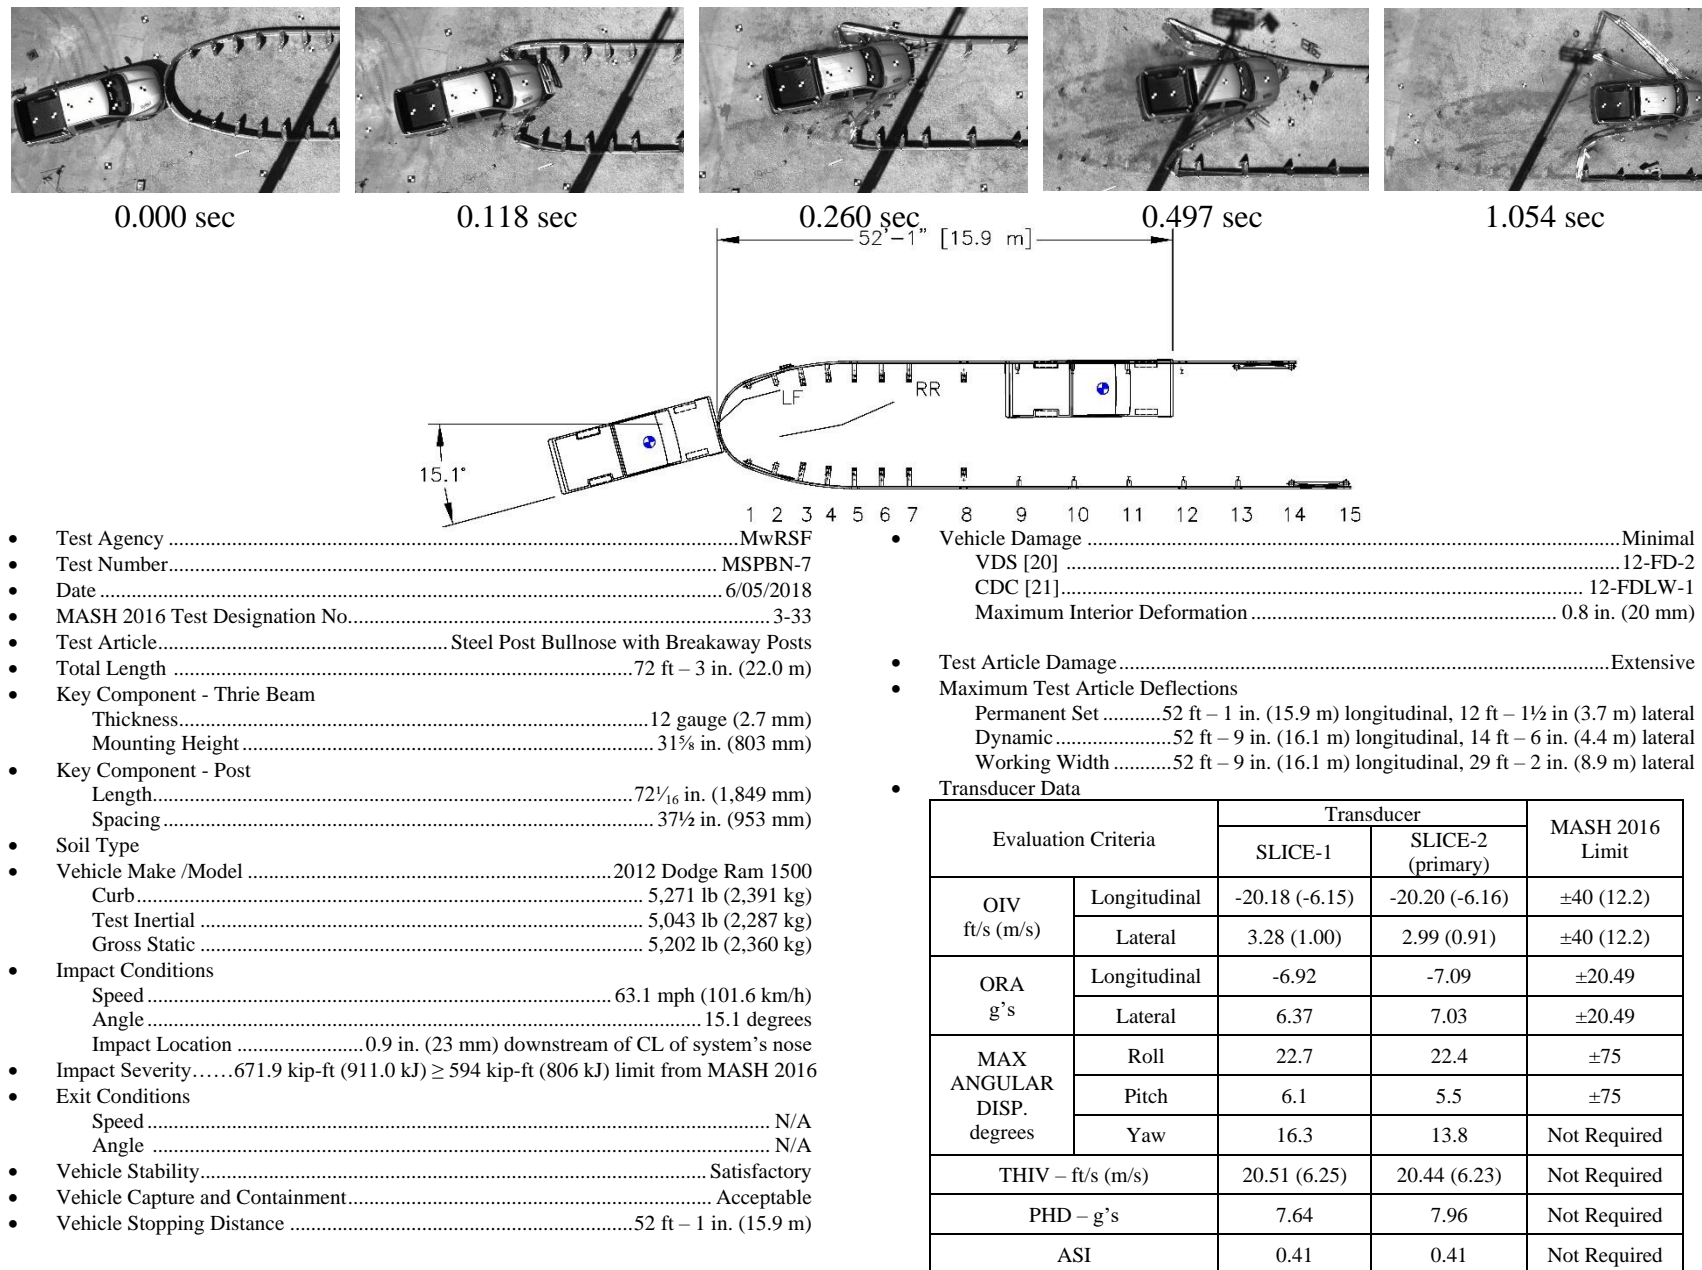
Figure 184. Summary of Test Results and Sequential Photographs, Test No. MSPBN-7

The analysis of the results for test no. MSPBN-7 showed that the system adequately contained and decelerated the 2270P vehicle to a controlled stop within the system. A summary of the test results is shown in Figure 184. Detached elements, fragments, or other debris from the test article did not penetrate or show potential for penetrating the occupant compartment, or present an undue hazard to other traffic, pedestrians, or work-zone personnel. Deformations of, or intrusions into, the occupant compartment that could have caused serious injury did not occur. The test vehicle did not penetrate nor ride over the barrier and remained upright during and after the collision. It should be noted that the impacting vehicle did ride up some of the debris in the system and climbed onto Side B of the system late in the event. The vehicle remained securely captured by the thrie beam at the front of the vehicle and did not contact the ground outside of the bullnose system. Additionally, it was noted that the vehicle climb did not adversely affect vehicle stability, and there was no damage observed to the to the occupant compartment due to override of the posts. Vehicle roll, pitch, and yaw angular displacements, as shown in Appendix H, were deemed acceptable, because they did not adversely influence occupant risk nor cause rollover. Therefore, test no. MSPBN-7 was determined to be acceptable according to the MASH 2016 safety performance criteria for test designation no. 3-33.

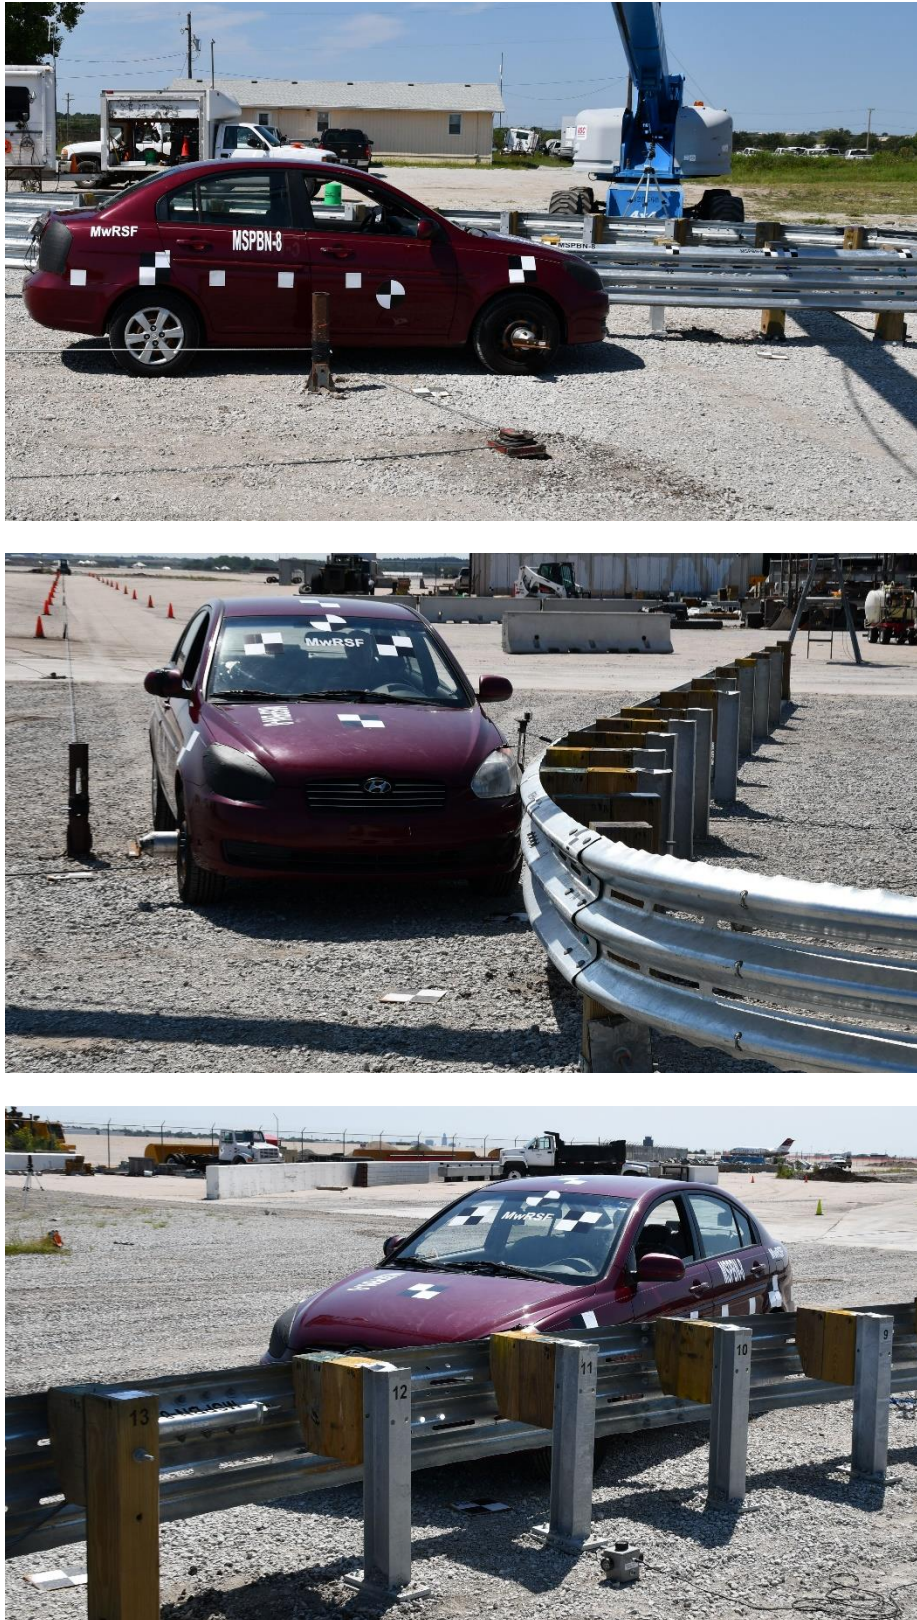
Figure 215. Impact Location, Test No. MSPBN-8

Test no. MSPBN-8 was conducted under the MASH 2016 TL-3 guidelines for test designation no. 3-37b. Test designation no. 3-37b is an impact of the 1100C vehicle at 62 mph (100 km/h) and 25 degrees on the system in the reverse direction. The critical impact point for this test was selected to maximize the potential for vehicle interaction and snag on the cable anchorage near the upstream end of the bullnose system. Initial vehicle impact was to occur at the centerline of post no. A11, as shown in Figure 215. The 2,394-lb (1,086-kg) small car impacted the bullnose with breakaway posts at a speed of 63.2 mph (101.8 km/h) and at an angle of 25.0 degrees. The actual point of impact was 0.8 in. (20 mm) downstream from the target location at the centerline of post no. A11. The vehicle was captured and redirected by the thrie beam on the side of the bullnose system. During the redirection of the vehicle, deflection of the UBSP and BCT posts was noted, but none of the posts fractured. Additionally, the vehicle's left-front wheel clipped the final BCT post and disengaged a small piece of the post near the base. However, vehicle interaction with the cable anchorage was not observed, and the anchorage remained intact. Vehicle capture and stability of the vehicle were acceptable during redirection and while exiting the barrier system. After exiting the bullnose system, the small car impacted protective portable concrete barriers at the MwRSF test site and rolled onto its side. The stability and trajectory of the vehicle prior to the secondary impact were acceptable, and the roll experienced during the secondary impact was not

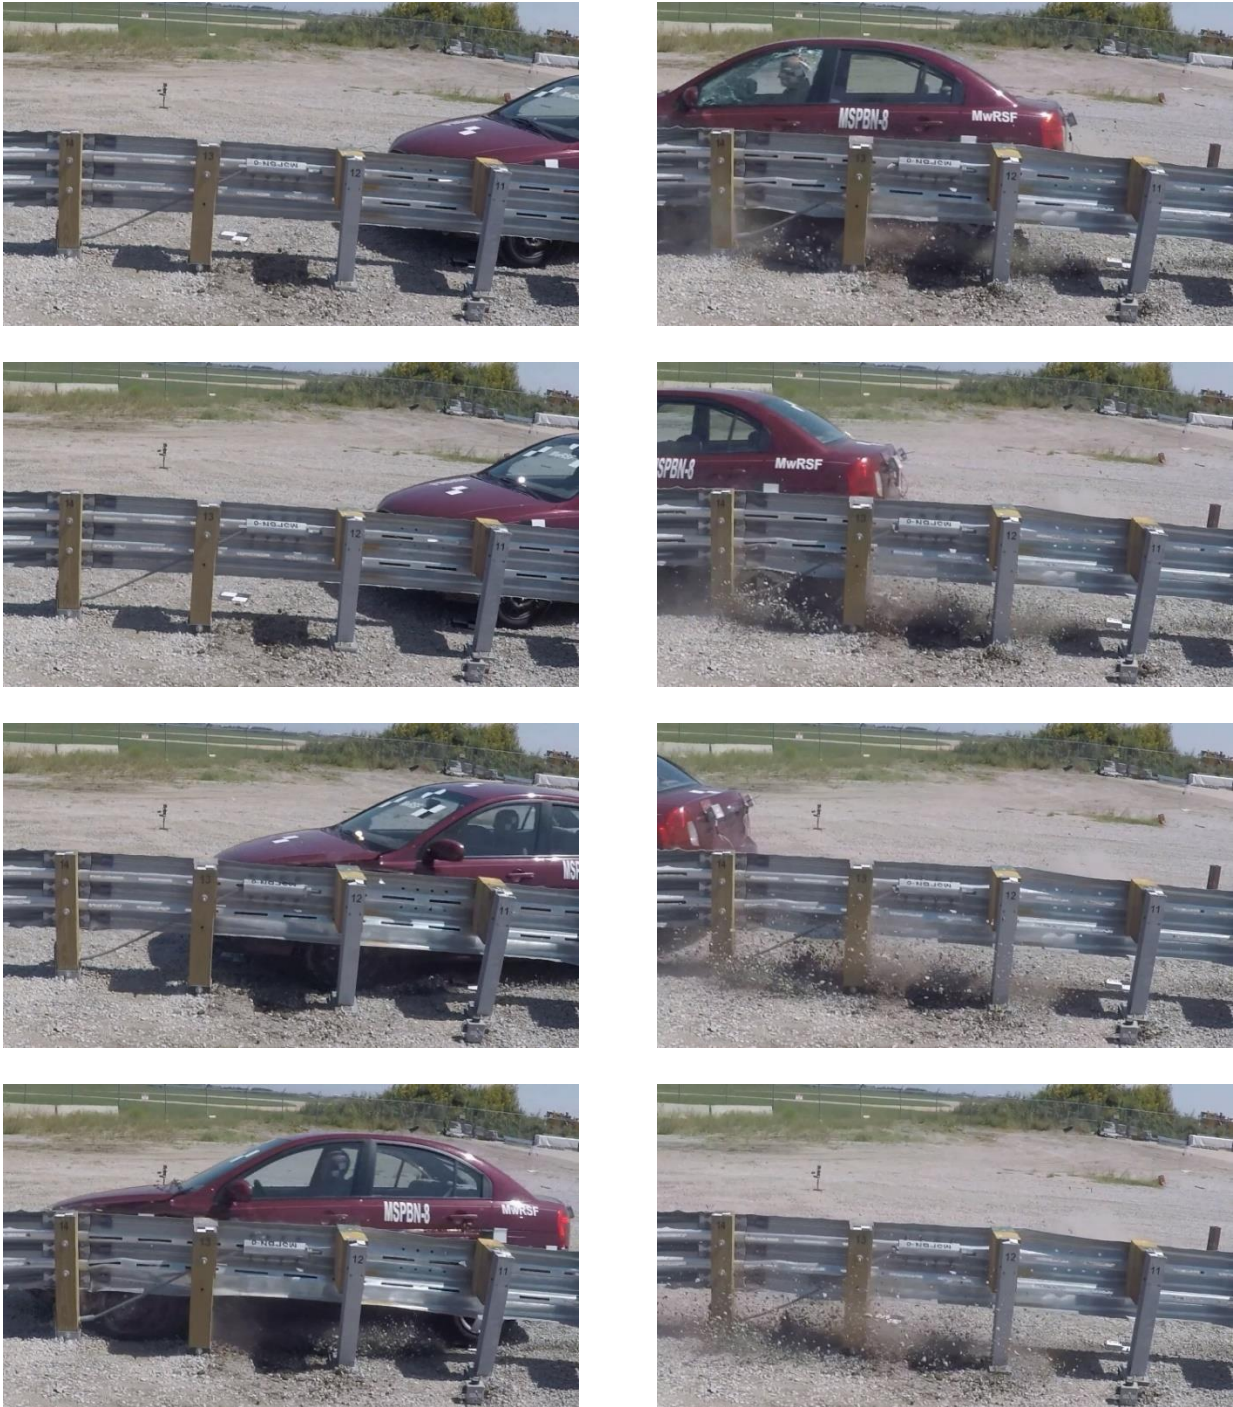
Figure 218. Documentary Photographs, Test No. MSPBN-8

a concern with respect to the system's safety performance evaluation. The vehicle came to rest 156 ft — 6 in. (47.7 m) downstream from the impact location.

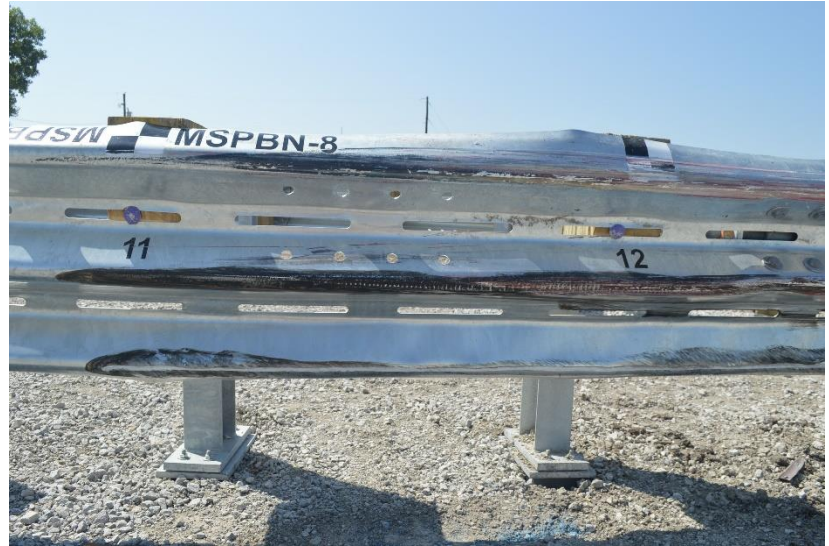
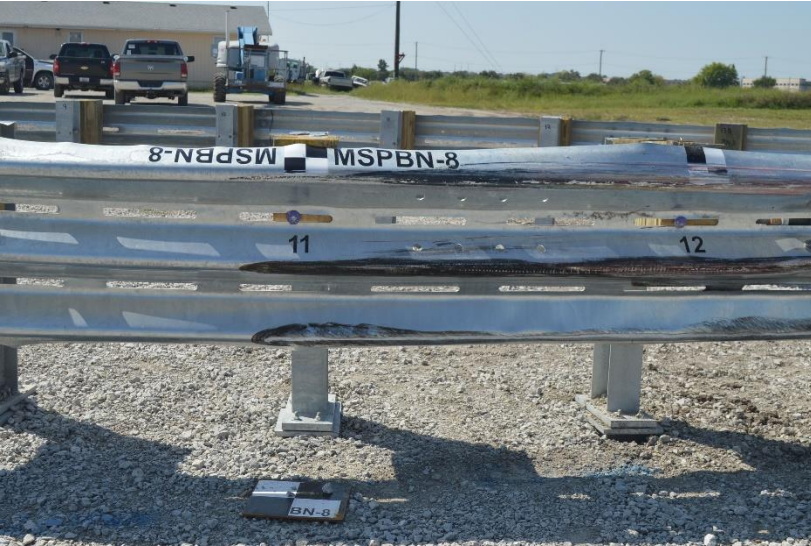
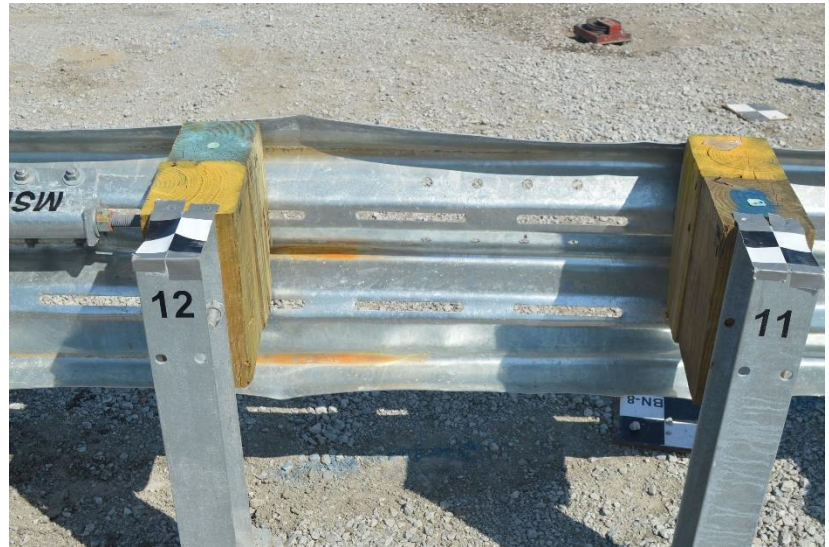
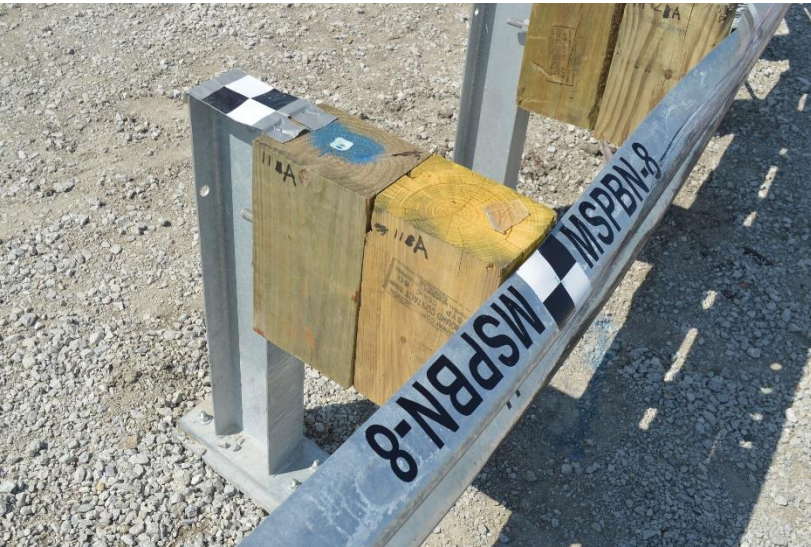
Figure 223. Damage to System at Post Nos. A11 and A12, Test No. MSPBN-8

Rail damage was limited to rail section no. 2 on Side A where the impact had occurred. Contact marks were observed along all three of the rail corrugations. The overall length of these marks was 9 ft – 3¾ in. (2.8 m) and they were observed starting 32¾ in. (832 mm) downstream from post no. A10 and continued downstream. Two small kinks in the thrie-beam rail were observed 40 in. (1,016 mm) and 71½ in. (1,816 mm) downstream from post no. A10 along the top and bottom edges, respectively. A 2½-in. (64-mm) long by ¾-in. (19-mm) wide kink occurred 35 in. (889 mm) downstream from post no. A11 along the bottom corrugation. A 3½-in. (89-mm) long by ½-in. (13 mm) wide dent occurred in the thrie-beam rail 13 in. (330 mm) downstream from post no. A12 on the middle corrugation. A 7½-in. (191-mm) long kink occurred along the bottom edge of the thrie-beam rail 6 in. (152 mm) upstream from post no. A14. Deformation of the lower portion of the bottom corrugation of the thrie beam was observed from approximately midway between post nos. 11 and 12 to post no. 14.

None of the UBSP posts or the BCT posts in the impact region were disengaged. Post nos. A11 through A13 were deflected in the soil, but they did not display damage or deformation. Post no. A14 was rotated both backward and downstream. The upstream front corner of post no. A14, just above the post sleeve had a 2½-in. (64-mm) tall by 2-in. (51-mm) long by ½-in. (13-mm) deep gouge caused by wheel contact with the post. The cable anchorage did not show any signs of vehicle contact, and the anchorage remained intact following the impact.

The maximum lateral permanent set of the barrier system was 2¾ in. (70 mm), which occurred at post no. A12, as measured in the field. The maximum lateral dynamic barrier deflection was 5.2 in. (132 mm) on the rail at post no. A12 as determined from high-speed digital video analysis. The working width of the system was found to be 177¼ in. (4,502 mm). A schematic of the initial and final positions is shown in Figure 225.

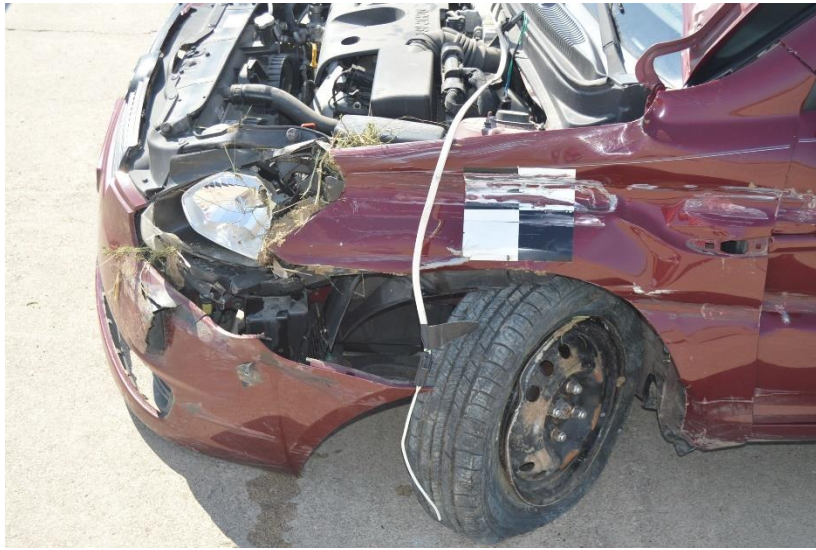
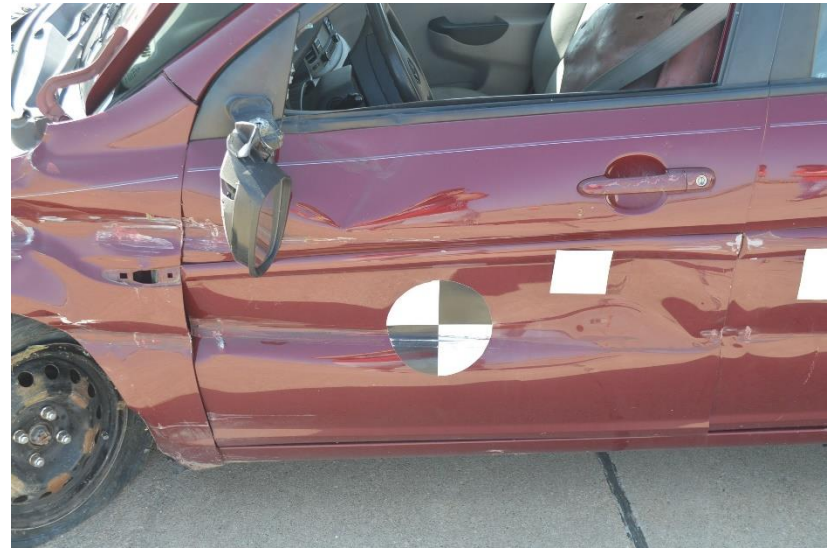
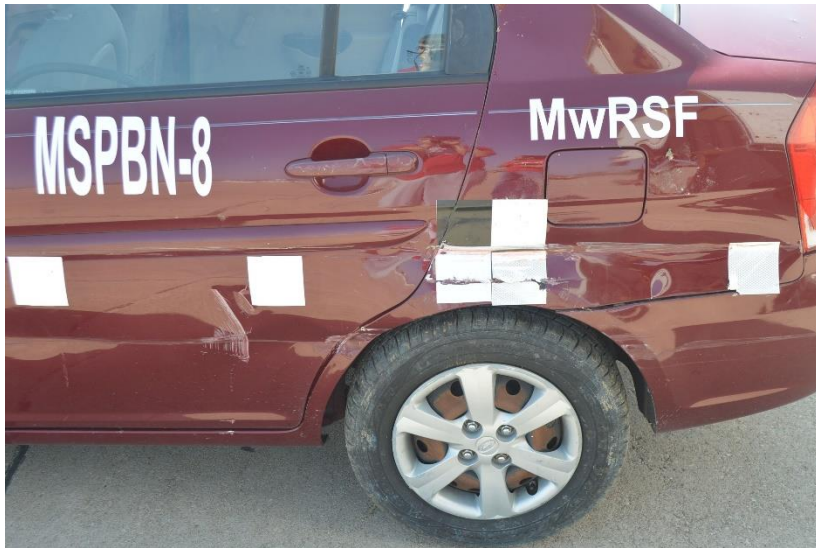
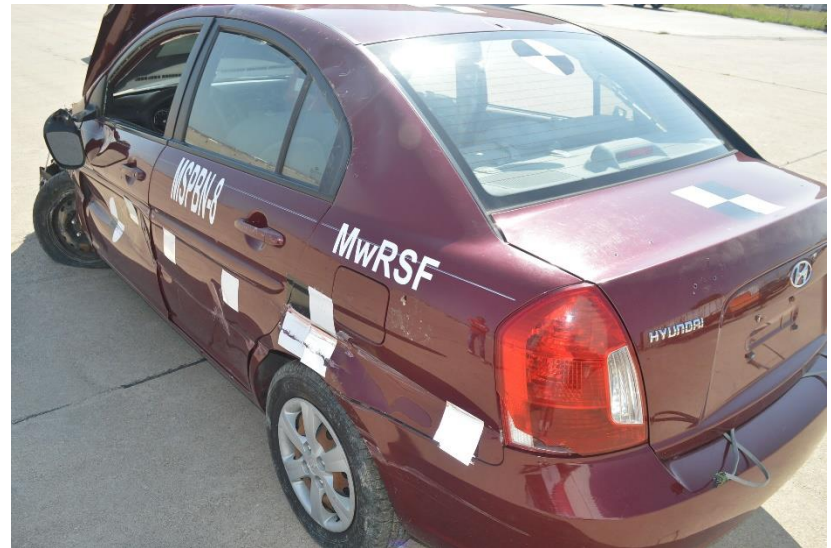
Figure 227. Vehicle Damage, Test No. MSPBN-8

Vehicle damage was minimal due to the primary impact and consisted mainly of crushing of the left-front vehicle structure and deformed sheet metal. Secondary impact damage was more extensive due to the impact with the concrete barrier and the subsequent roll onto the vehicle side. The damage to the vehicle is shown in Figure 226 through Figure 228. The maximum occupant compartment deformations are listed in Table 26 along with the deformation limits established in MASH 2016 for various areas of the occupant compartment. Note that none of the established MASH 2016 deformation limits were violated. Complete occupant compartment and vehicle deformations and the corresponding locations are provided in Appendix D.

The majority of the vehicle damage was caused by impact with the test article, which was concentrated on the left-front corner of the vehicle where impact had occurred. The front bumper was crushed inward toward the engine bay. The left-front quarter panel was crushed inward, dented, and was scraped along its length. The left-front door was crushed inward along its length. Scrapes and dents were also observed along the length of the door. The left-side mirror was partially disengaged but remained attached with wires. The left-rear door was also scraped and dented along its middle length. A dent was observed along the top frame above the left-rear door. The left-rear quarter panel was dented along its length and scraped in several places. The rear bumper was scraped along its left side where it contacted the system.

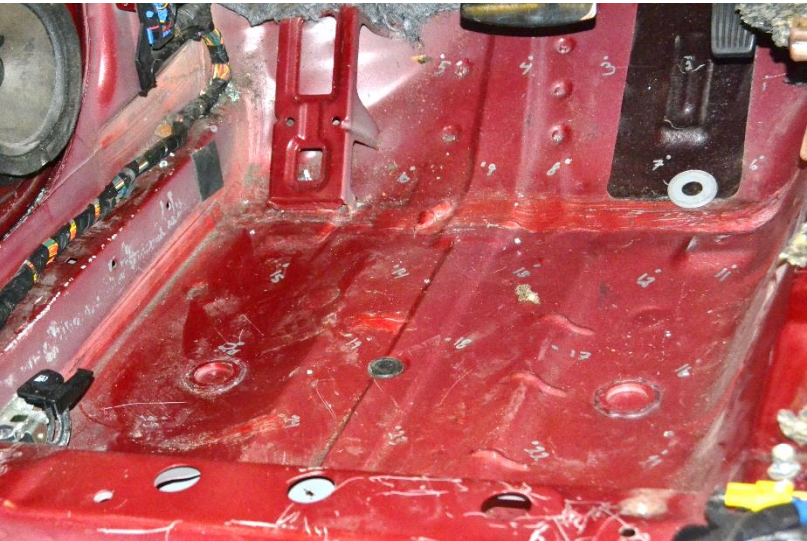
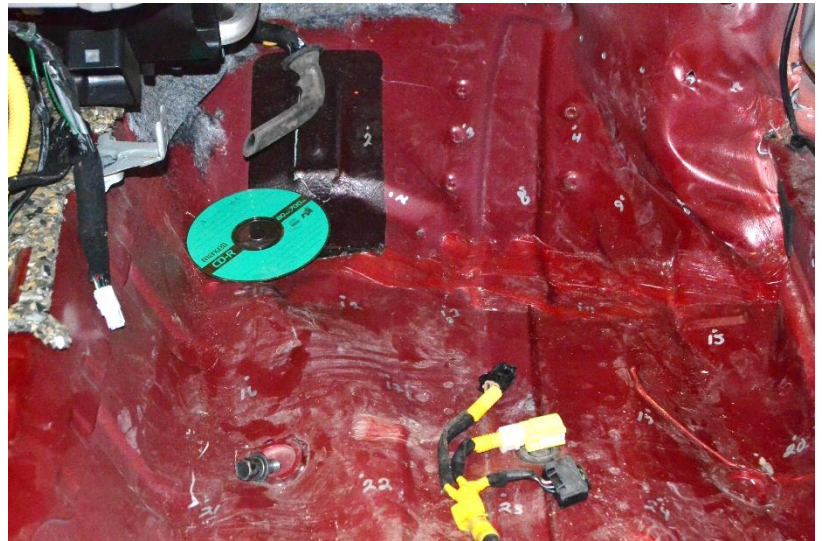
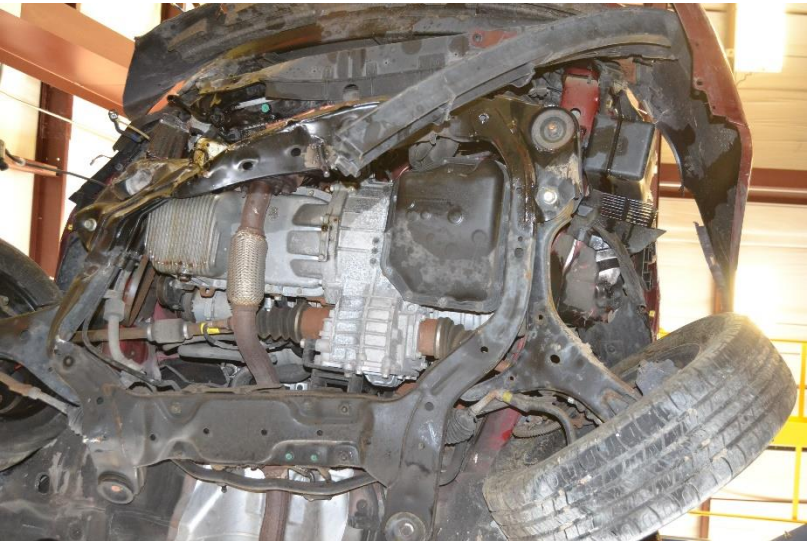
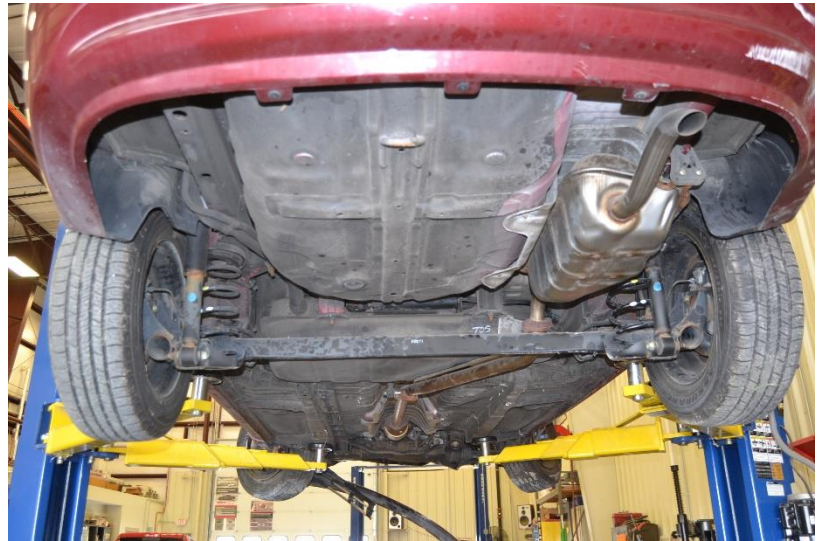
Figure 228. Occupant Compartment and Undercarriage Damage, Test No. MSPBN-8

The left-front window fractured due to contact with the simulated occupant's head during the initial impact and shattered when the vehicle was brought to a stop downstream from the test article. Damage that occurred to the right side of the vehicle was due to secondary impact with portable concrete barriers located downstream from the test article. The vehicle's engine hood was opened during the secondary impact event.

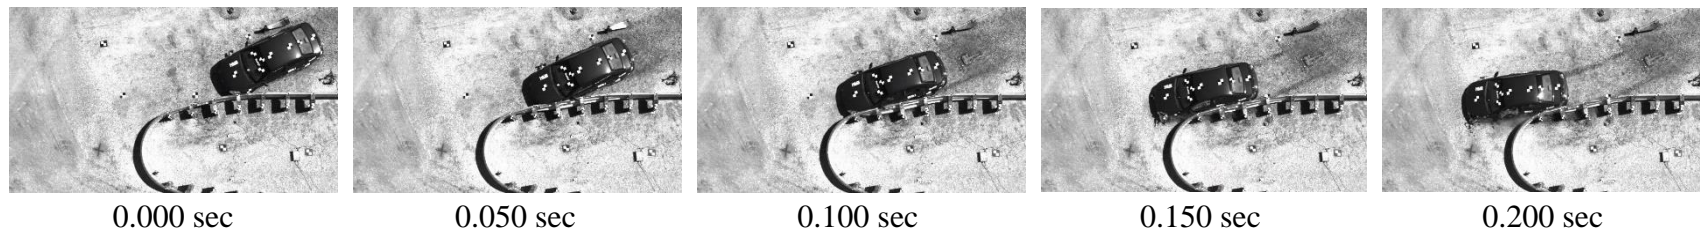
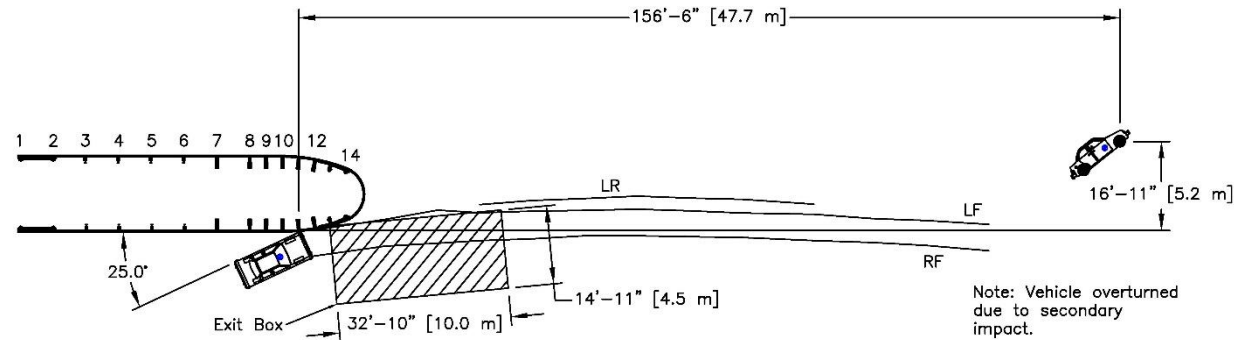
Figure 229. Summary of Test Results and Sequential Photographs, Test No. MSPBN-8

The analysis of the results for test no. MSPBN-8 showed that the system adequately contained and redirected the 1100C vehicle with controlled lateral displacements of the barrier. A summary of the test results is shown in Figure 229. Detached elements, fragments, or other debris from the test article did not penetrate or show potential for penetrating the occupant compartment, or present an undue hazard to other traffic, pedestrians, or work-zone personnel. Deformations of, or intrusions into, the occupant compartment that could have caused serious injury did not occur. The test vehicle did not penetrate nor ride over the barrier and remained upright during and after the collision. Vehicle roll, pitch, and yaw angular displacements, as shown in Appendix I, were deemed acceptable, because they did not adversely influence occupant risk nor cause rollover. After impact, the vehicle exited the barrier at an angle of 8.4 degrees, and its trajectory did not violate the bounds of the exit box. Therefore, test no. MSPBN-8 was determined to be acceptable according to the MASH 2016 safety performance criteria for test designation no. 3-37b.
