MGS WITH CURB AND OMITTED POST: EVALUATION TO MASH 2016 TEST NO. 3-11

MIDWEST ROADSIDE SAFETY FACILITY

MwRSF Research Report No. TRP-03-433-21

November 11, 2021

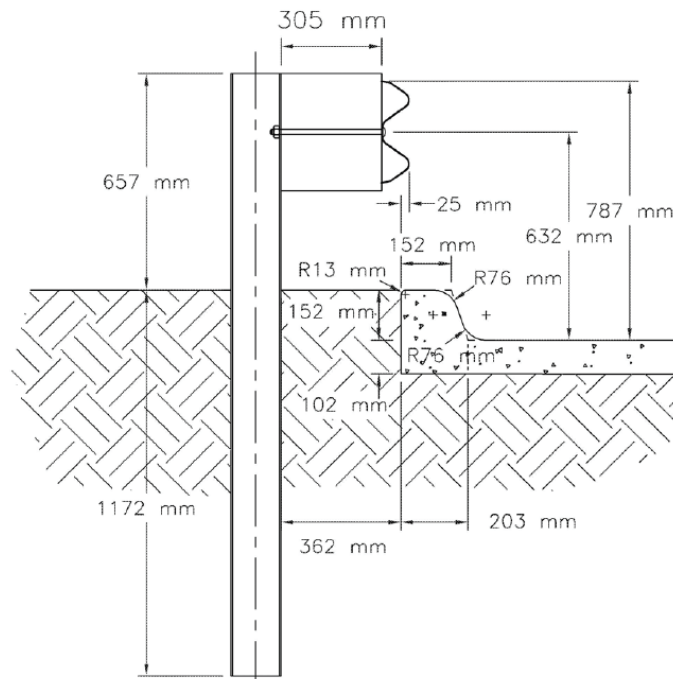
Figure 1. MGS Offset 6 in. from 6-in. AASHTO Type B Curb [1-3]

In early development, the MGS was crash tested in combination with a 6-in. tall, AASHTO Type B curb offset 6 in. from the front face of the guardrail, as shown in Figure 1 [1-3]. The test met the criteria of National Cooperative Highway Research Program (NCHRP) Report 350 test designation no. 3-11[4].

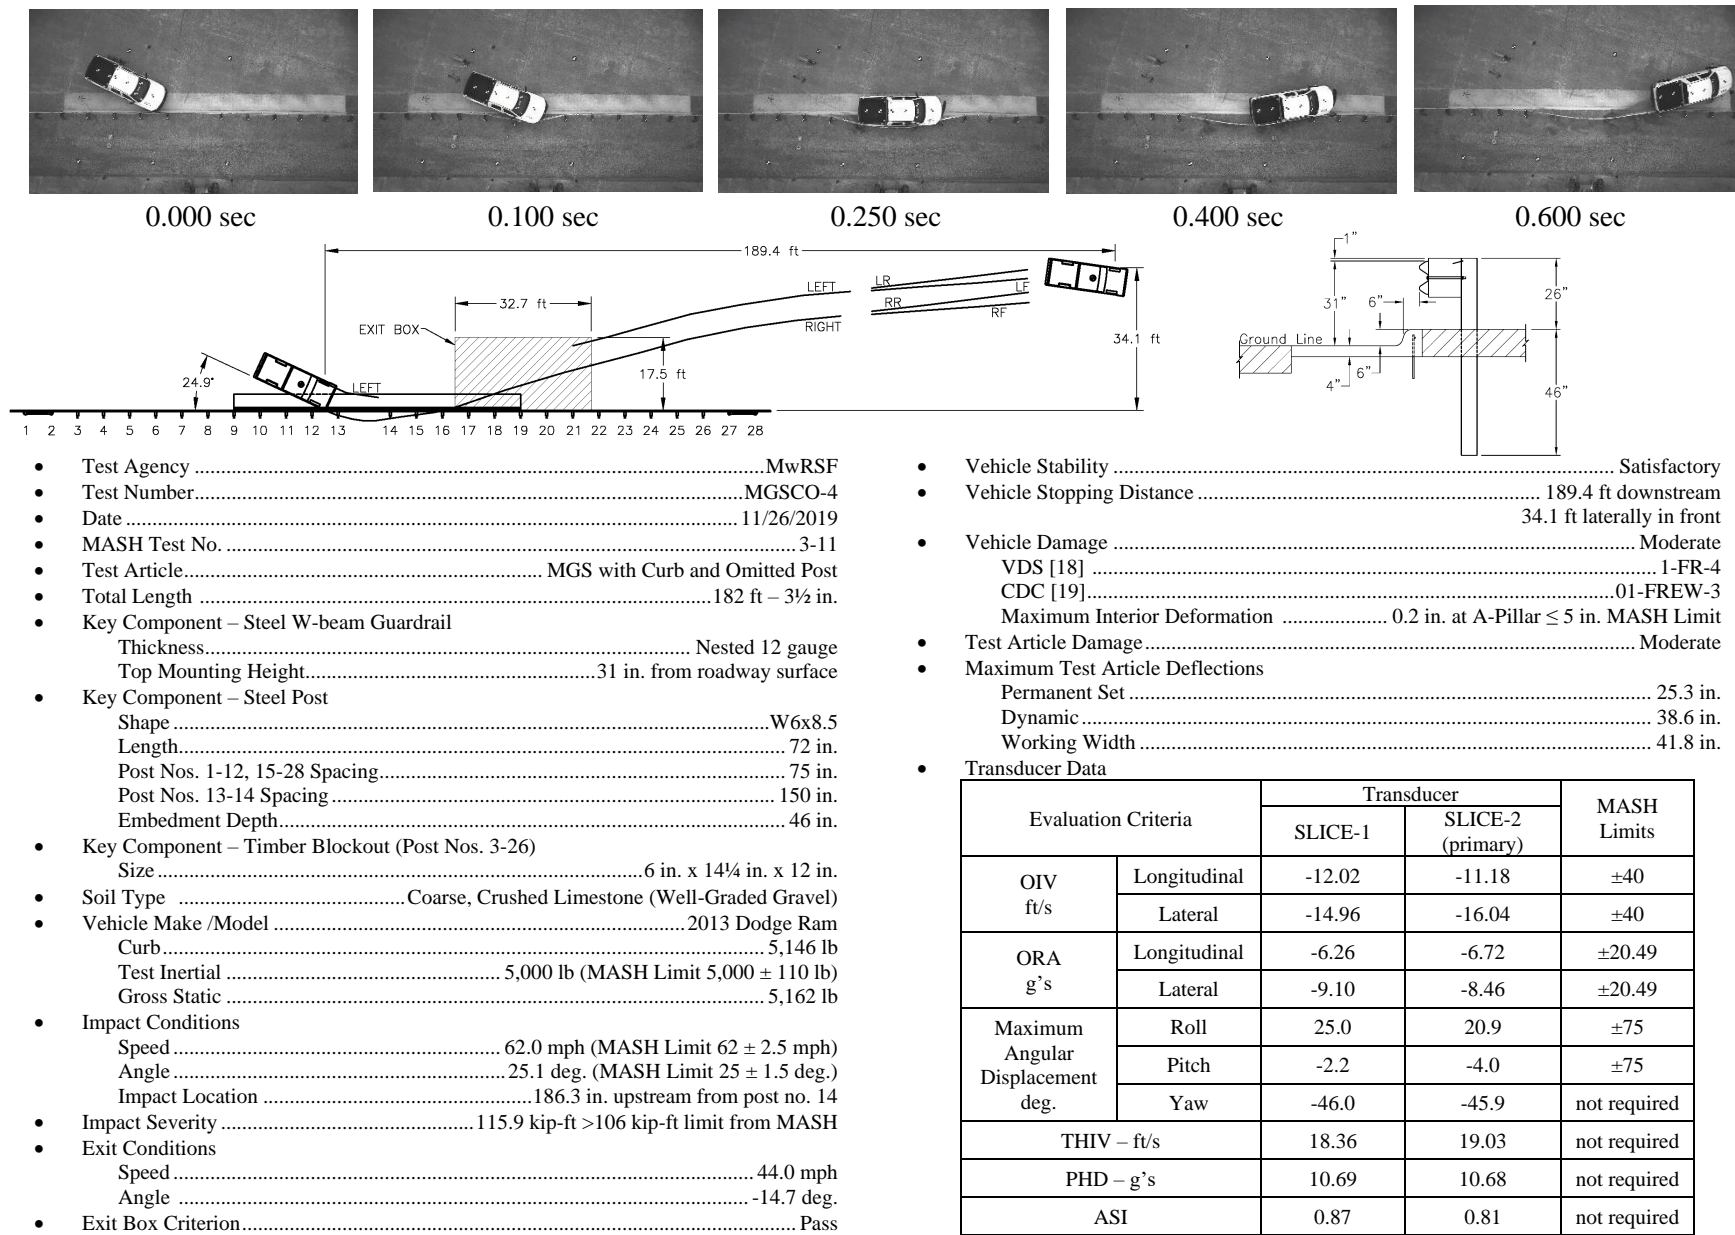
Figure 38. Summary of Test Results and Sequential Photographs, Test No. MGSCO-4

The analysis of the test results for test no. MGSCO-4 showed that the system adequately contained and redirected the 2270P vehicle with controlled lateral displacements of the barrier. Sequential photographs and a summary of the test results are shown in Figure 38. Detached elements, fragments, or other debris from the test article did not penetrate or show potential for penetrating the occupant compartment, or present an undue hazard to other traffic, pedestrians, or work-zone personnel. Deformations of, or intrusions into, the occupant compartment that could have caused serious injury did not occur. The test vehicle did not penetrate nor ride over the barrier and remained upright during and after the collision. Vehicle roll, pitch, and yaw angular displacements, as shown in Appendix E, were deemed acceptable because they did not adversely influence occupant risk nor cause rollover. After impact, the vehicle exited the barrier at an angle of -14.7 degrees, and its trajectory did not violate the bounds of the exit box. Therefore, test no. MGSCO-4 was determined to be acceptable according to the MASH safety performance criteria for test designation no. 3-11.
