## **DYNAMIC TESTING AND EVALUATION OF CULVERT-MOUNTED, STRONG-POST MGS TO TL-3 GUIDELINES OF MASH 2016**

### **MIDWEST ROADSIDE SAFETY FACILITY**

MwRSF Research Report No. TRP-03-383-20-R1

November 2, 2020

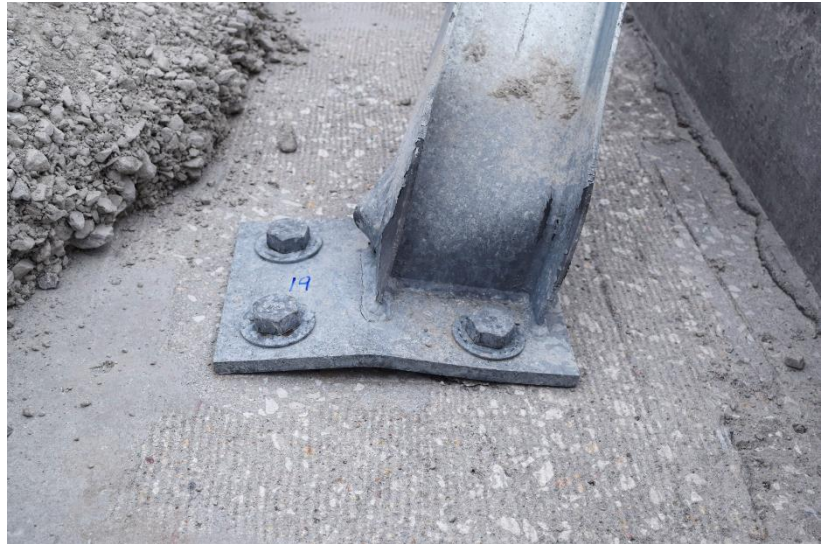
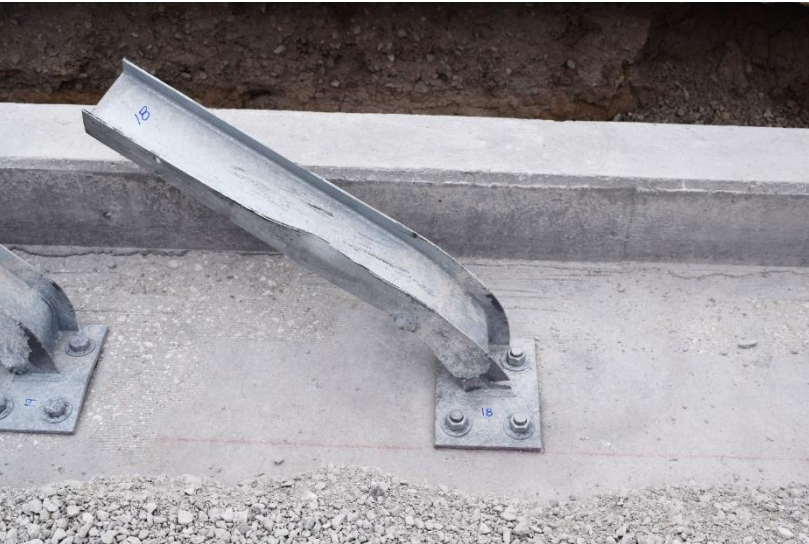
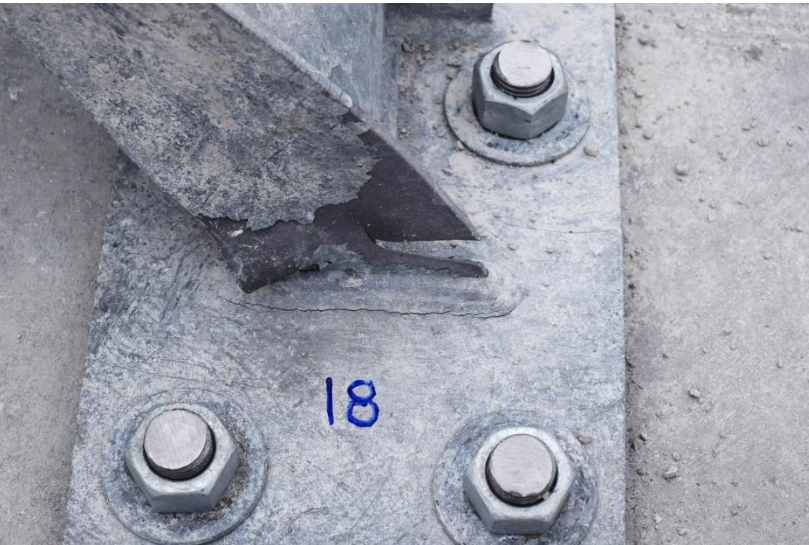
Figure 63. Damage to Post and Base Plate Nos. 18 and 19, Test No. CMGS-1

Post no. 17 slightly deflected backward. Post nos. 18 and 19 were bent longitudinally toward the ground in the downstream direction. Post no. 20 was bent slightly longitudinally downstream. Contact marks were found on the front face of post nos. 18 and 19. No significant post damage occurred to post nos. 1 through 16 nor 21 through 41. The upstream and downstream anchorage systems remained unmoved and the posts in both anchorage systems were not damaged. The wooden blockout at post nos. 18, 19, and 21 disengaged from the system. The blockout at post no. 20 rotated but did not disengage. The blockouts at post nos. 3 through 17 and 22 through 39 were undamaged.

Following the test, the soil on top of the culvert headwall was removed for inspection of the damage to the posts and base plates as well as to review any potential damage to the culvert. Deformation of the post base plates was observed on post nos. 17 through 21. Minor cracking was observed on the weld at the front flange of the base plate of post no. 17. The upstream side of the front flange of post no. 18 was torn up to the web near the base plate weld. All anchorage bolts and epoxied threaded rods were intact and remained secure, although some minor deformation of the bolts and rods was observed. No damage was observed to the concrete culvert slab or the headwall.

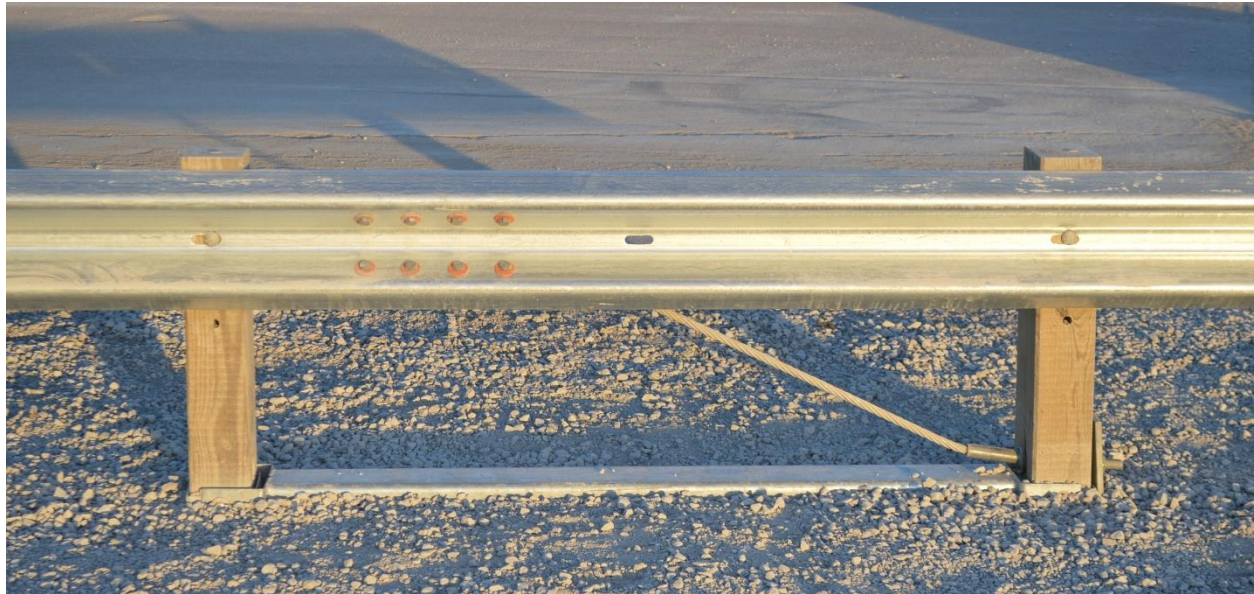
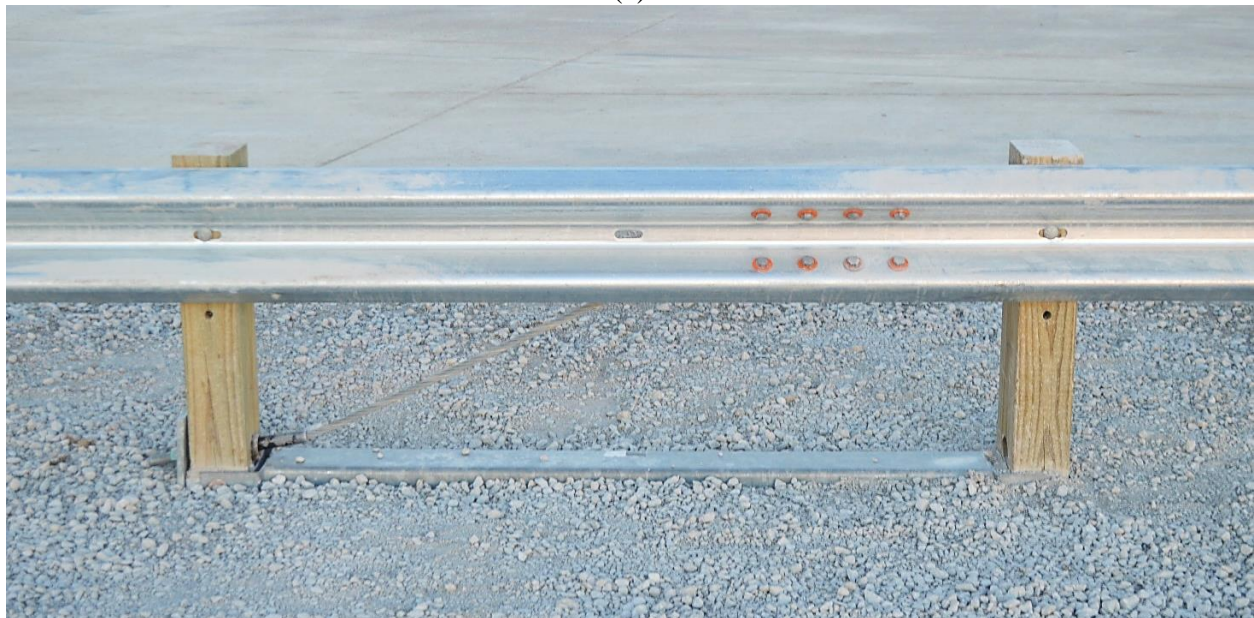
Figure 66. (a) Upstream Anchorage System After Test, and (b) Downstream Anchorage System After Test, Test No. CMGS-1

Damage to the barrier was moderate, as shown in Figures 60 through 66. Barrier damage consisted mostly of deformed W-beam, contact marks on the guardrail sections, and deformed posts. The length of vehicle contact along the barrier was approximately 16 ft which spanned from 12 $\frac{5}{8}$  in. (321 mm) downstream from post no. 16 to 15 $\frac{1}{2}$  in. (394 mm) downstream from post no. 21.

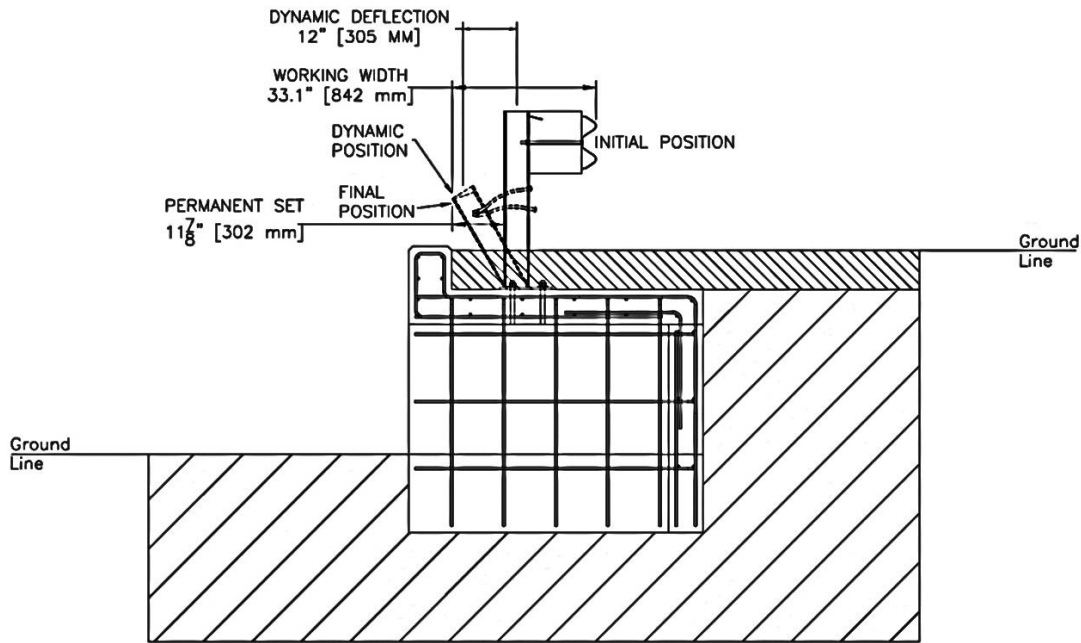
Figure 67. Permanent Set Deflection, Dynamic Deflection, and Working Width, Test No. CMGS-1

The maximum lateral permanent set of the barrier system was 11 $\frac{7}{8}$  in. (302 mm), which occurred at the back of post no. 18, as measured in the field. The maximum lateral dynamic deflection was 12 in. (305 mm) at post no. 18, as determined from high-speed digital video analysis. The working width of the system was 33.1 in. (842 mm) at post no. 18, also determined from high-speed digital video analysis. A schematic of the permanent set, dynamic deflection, and working width is shown in Figure 67.

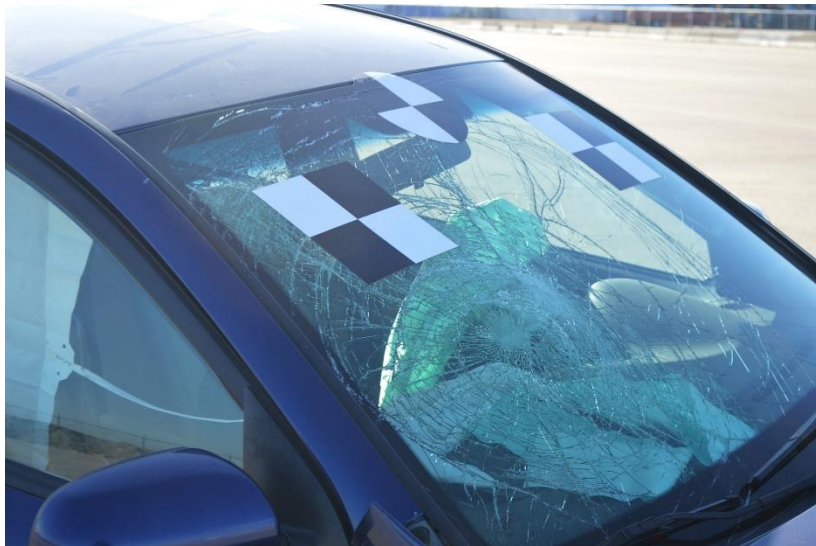
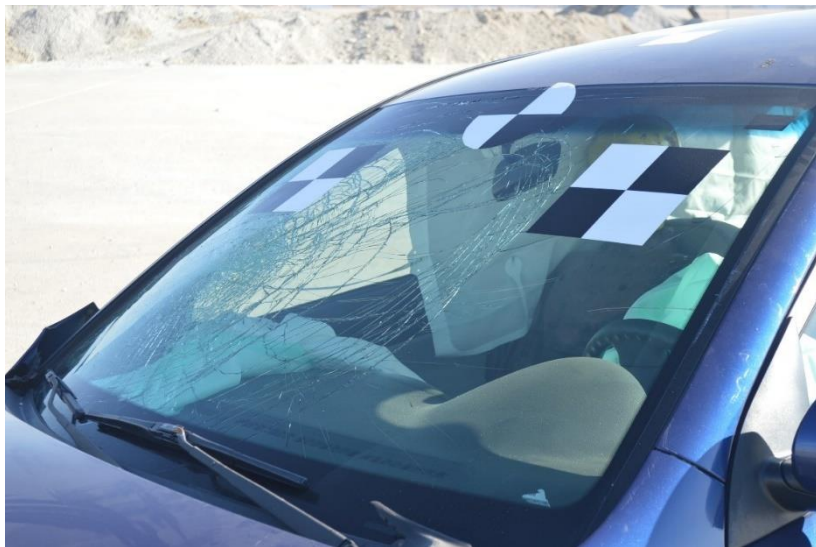
Figure 70. Vehicle Windshield Damage, (a) on Test Site on Test Day, (b) in Vehicle Shop Prior to Measurement, Test No. CMGS-1

<sup>2</sup> – Deformation was not present on test day but occurred after snow and ice on windshield caused deformation prior to measurement

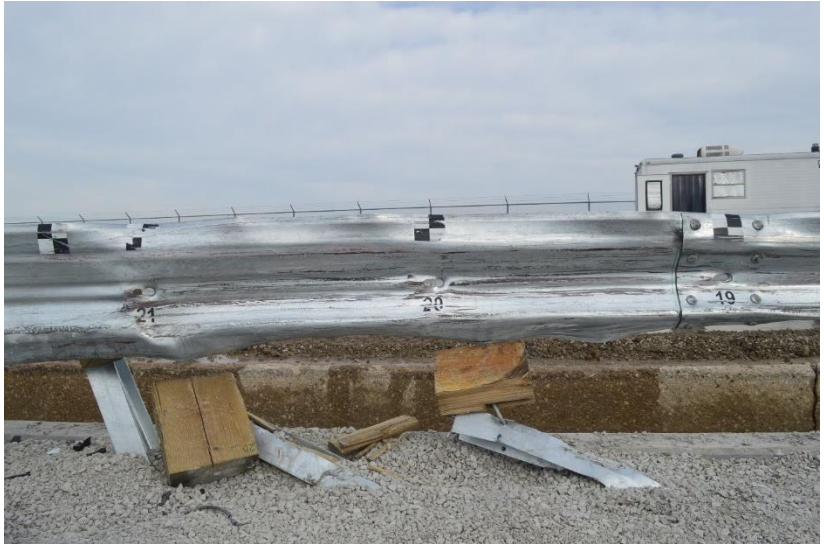
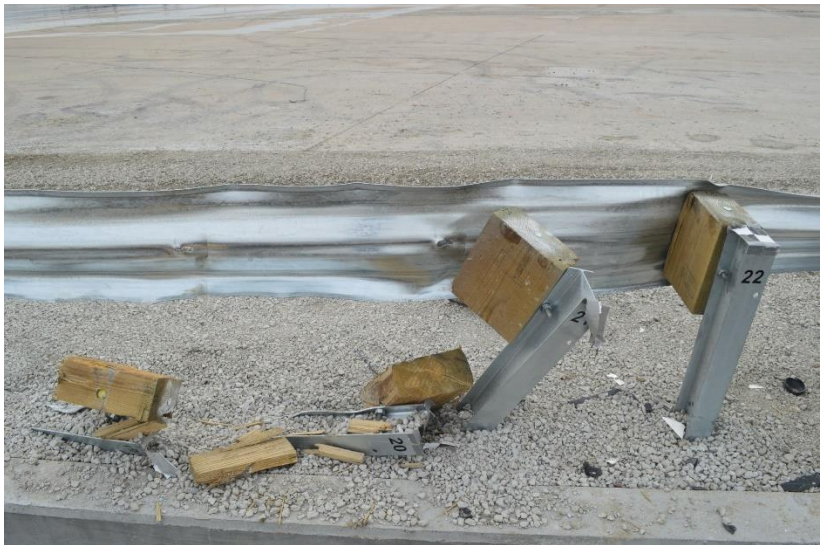
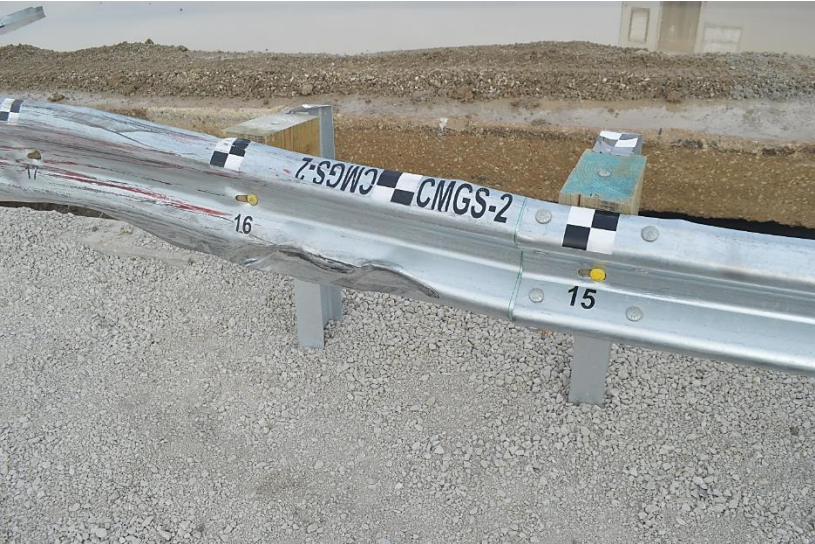
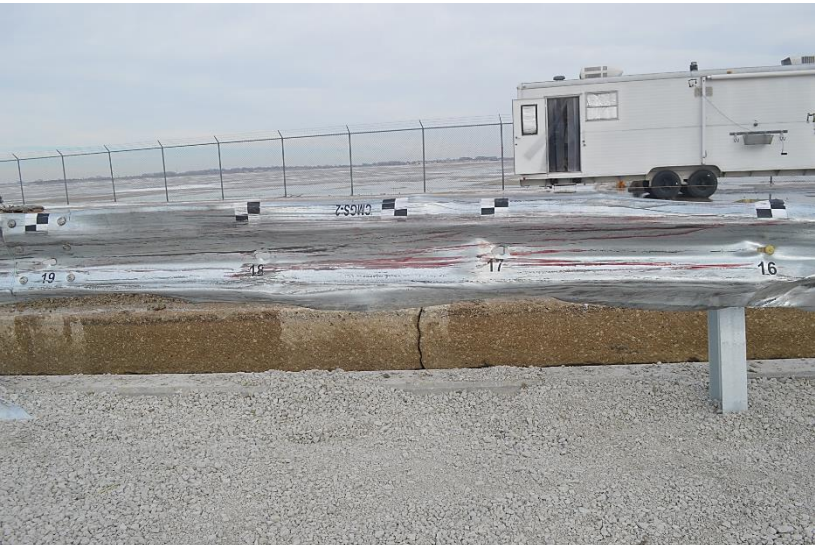
Figure 81. Damage to Post Nos. 15 through 21, Test No. CMGS-2

Post nos. 15 and 16 slightly deflected backward. Post nos. 17 and 18 broke away from the base plate and were pulled out of the soil. However, this did not adversely affect the system's performance, and the disengaged posts did not pose secondary hazard to traffic. Post nos. 19 through 21 also deflected longitudinally toward the ground in the downstream direction but remained attached to the culvert. Contact marks were found on the front face of post nos. 18 and 19. No significant post damage occurred to post nos. 1 through 15 or 24 through 41. The upstream anchorage system was displaced nearly 1 in. (25 mm) and the downstream anchorage system remained unmoved. The posts in both the upstream and downstream anchorage systems were not damaged. The wooden blockouts at post nos. 17 through 20 disengaged from the system. The blockout at post no. 21 rotated but did not disengage from the rail. The blockouts at post nos. 3 through 16 and 22 through 39 remained undamaged.

Following the test, the soil on top of the culvert headwall was removed for inspection of the damage to the posts and base plates as well as to review any potential damage to the culvert. Deformation of the post base plates was observed on post nos. 16 through 22. Post nos. 17 and 18 fractured at the base of the post above the weld line at the front flange and web of the post and through the weld at the back flange of the post. The upstream side of the front flange of post nos. 20 and 21 was torn up to the web near the base plate weld. All anchorage bolts and epoxied threaded rods were intact and remained secure, although some minor deformation of the bolts and rods was observed. No damage was observed to the concrete culvert slab or the headwall.

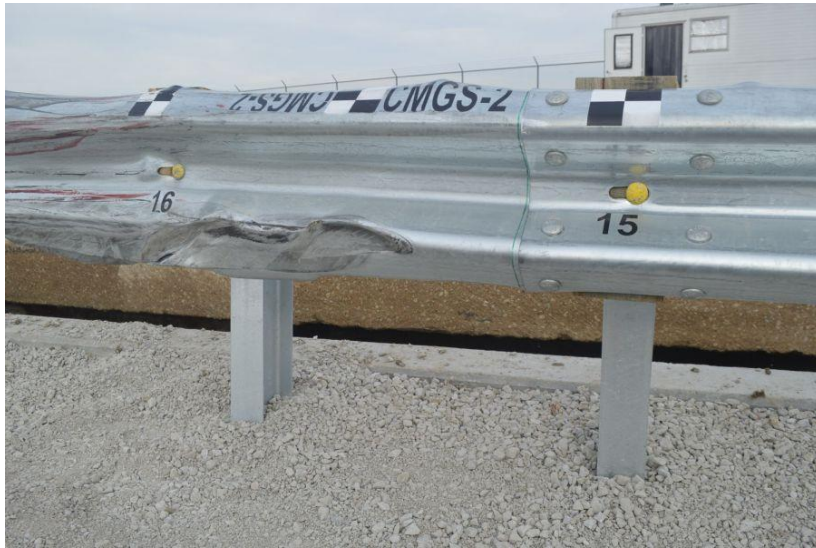
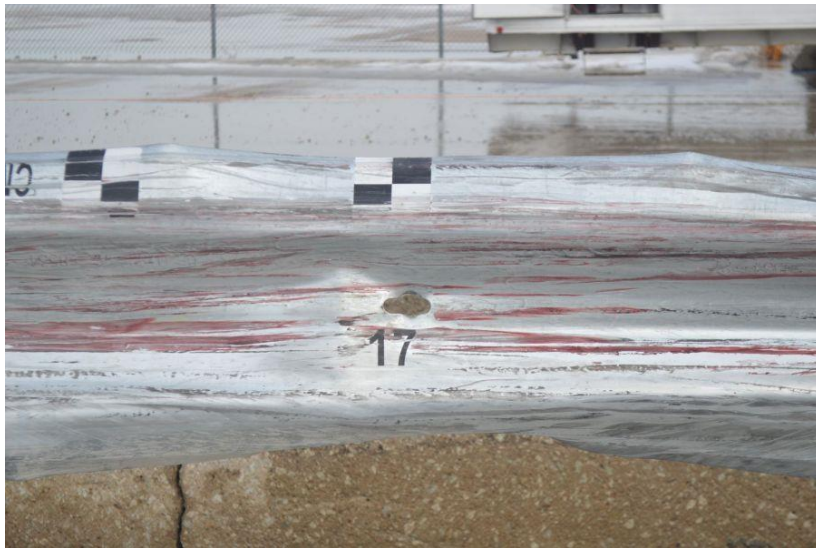
Figure 82. Guardrail Damage, Post Nos. 15 through 19, Test No. CMGS-2

The guardrail damage consisted moderate deformation and flattening of the impacted section of the W-beam between post nos. 15 and 23. The W-beam disengaged from post nos. 17 through 21. Contact marks were found on the guardrail between post nos. 15 through 23. Small horizontal rail tearing was observed at and upstream from post no. 16, as shown in Figure 84. No significant guardrail damage occurred upstream from post no. 15 nor downstream from post no. 23.

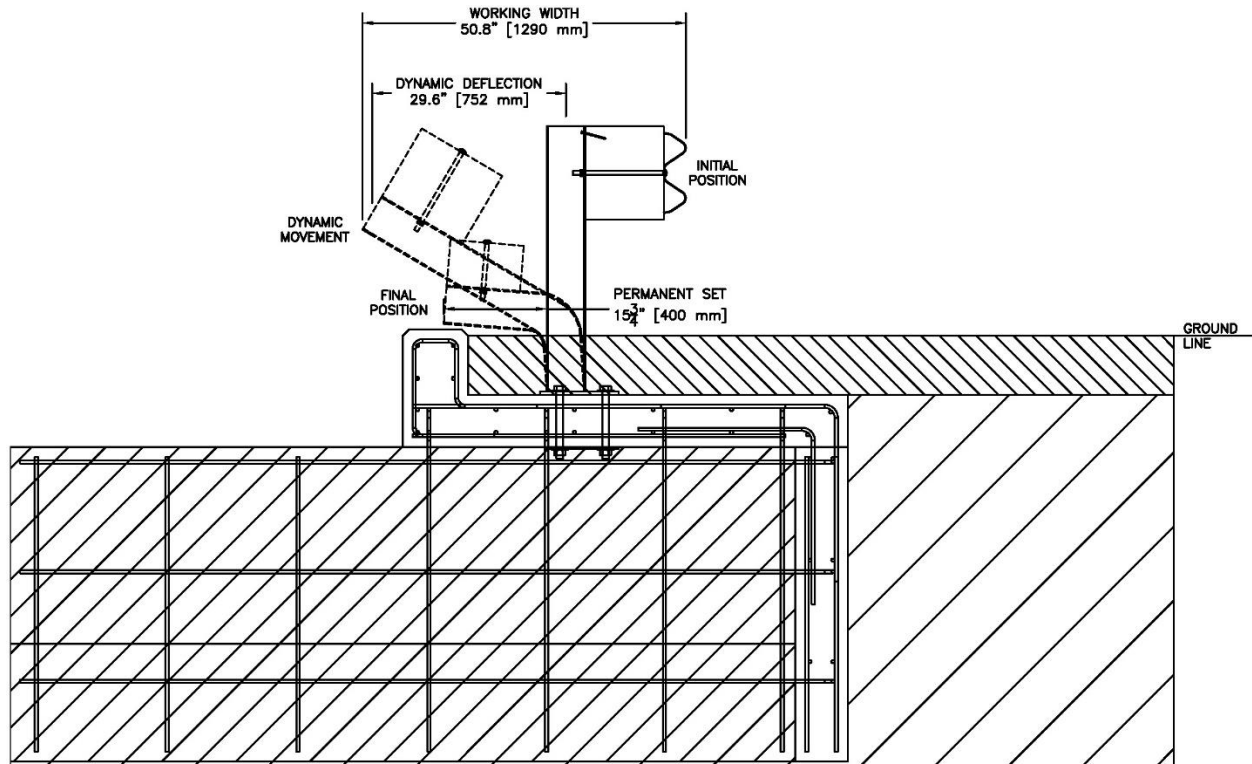
Figure 90. Permanent Set Deflection, Dynamic Deflection, and Working Width, Test No. CMGS-2

The maximum lateral permanent set of the barrier system was 15¾ in. (400 mm) which occurred at the back of rail at post no. 19, as measured in the field. The maximum dynamic barrier deflection was 29.6 in. (752 mm) at post no. 17. The working width of the system was 50.8 in. (1,290 mm) at post no. 17, also determined from high-speed digital video analysis. A schematic of the permanent set deflection, dynamic deflection, and working width is shown in Figure 90.

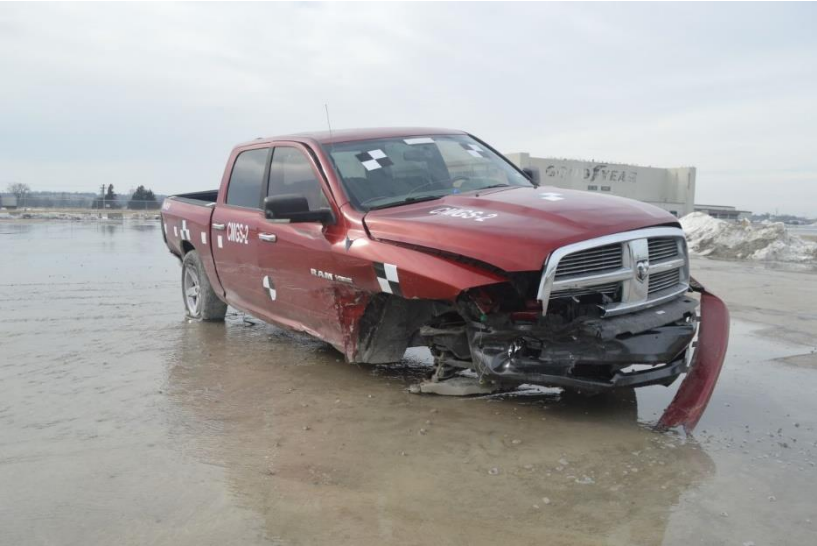
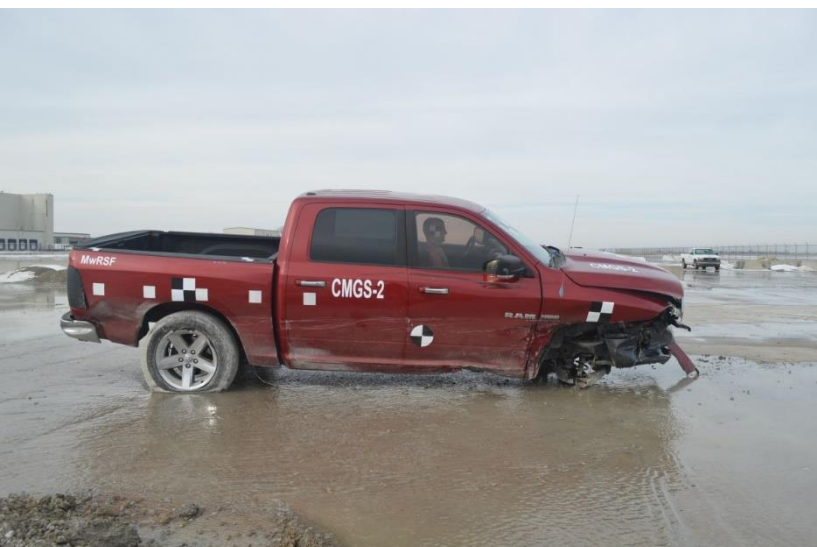
Figure 91. Vehicle Damage, Test No. CMGS-2

The majority of the vehicle damage was concentrated on the right-front corner, where primary impact occurred. The vehicle's front bumper was crushed inward. The lower passenger side grille was broken. The front bumper cover was torn off except for the two bolts on the driver side. The vehicle right-front wheel was disengaged, and right-rear tire was deflated. The airbags did not deploy during the impact. The right corner of the rear bumper on the passenger side buckled inward and the rear corner of the right-rear fender was deformed from the impact with the barrier.

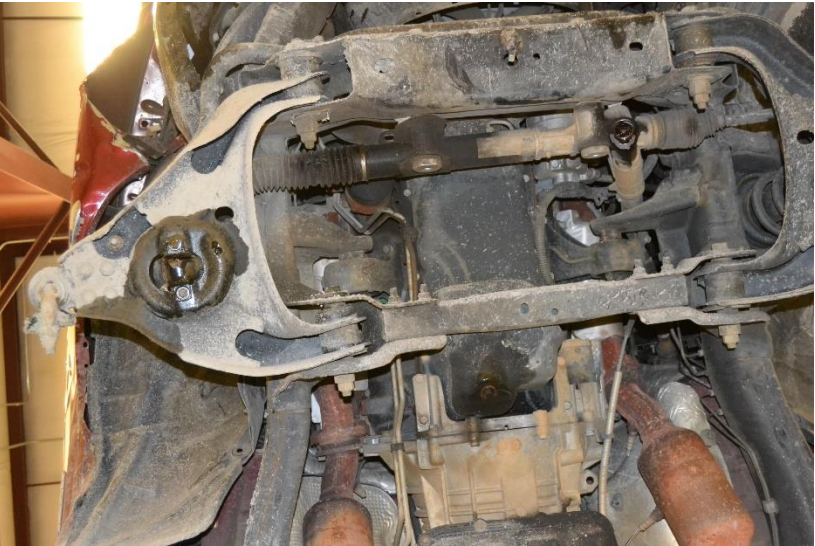
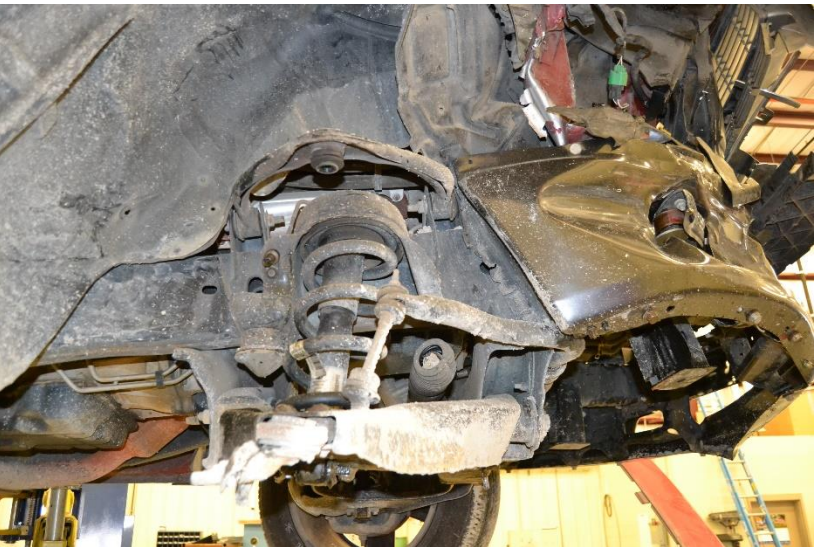
Figure 95. Vehicle Undercarriage Damage, Test No. CMGS-2

The roof, the hood, and the left side remained undamaged. The left-side and rear window glass also remained undamaged. The airbags did not deploy during the impact. The overall undercarriage damage included a 2-in. (51 mm) bend in the lower control arm, and the steering knuckle broke along with the steering arm on the passenger side. The front passenger-side brake line was disconnected. Interior occupant compartment deformations were moderate with a maximum of 1½ in. (29 mm), which did not violate the limits established in MASH 2016.
