# **INVESTIGATING THE USE OF A NEW UNIVERSAL BREAKAWAY STEEL POST – PHASE 3**

## **MIDWEST ROADSIDE SAFETY FACILITY**

MwRSF Research Report No. TRP-03-244-10

December 16, 2010

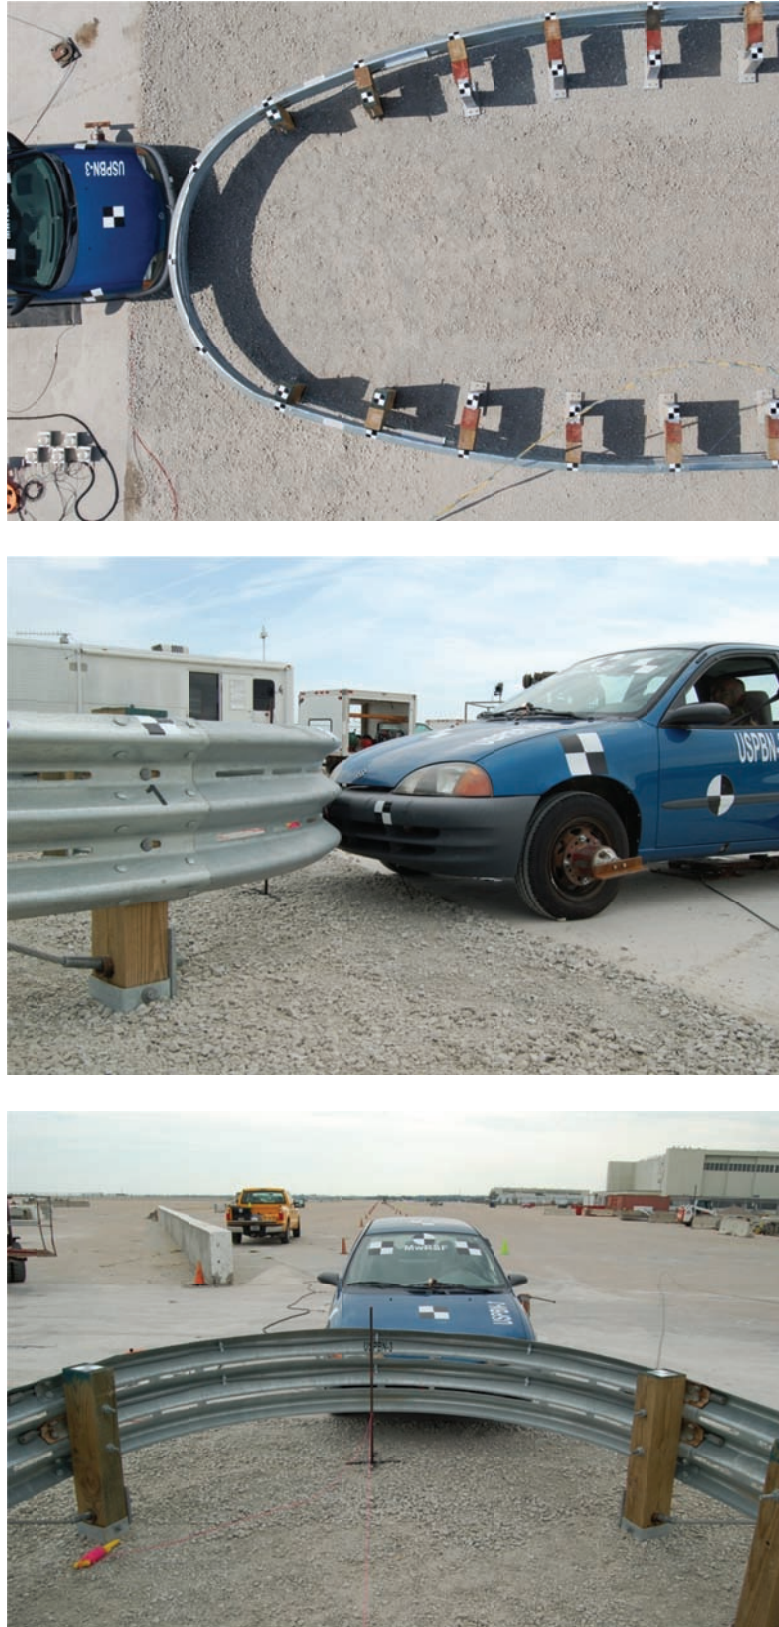
Figure 37. Documentary Photographs, Test No. USPBN-3

The 2,024-lb (918-kg) passenger car with a simulated occupant in the driver's seat impacted the bullnose median barrier at a speed of 63.3 mph (101.9 km/h) and at an angle of 0 degrees. A summary of the test results and sequential photographs are shown in Figure 34. Additional sequential photographs are shown in Figures 35 and 36. Documentary photographs of the crash test are shown in Figure 37.

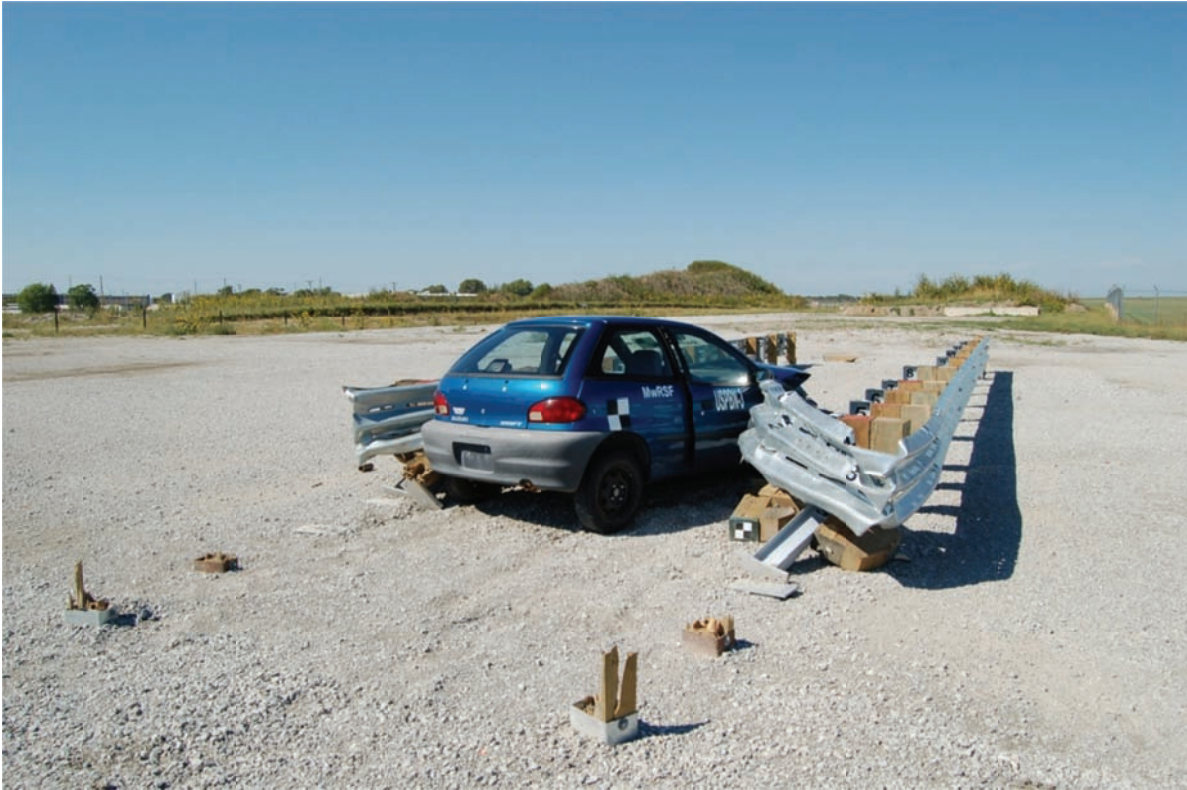
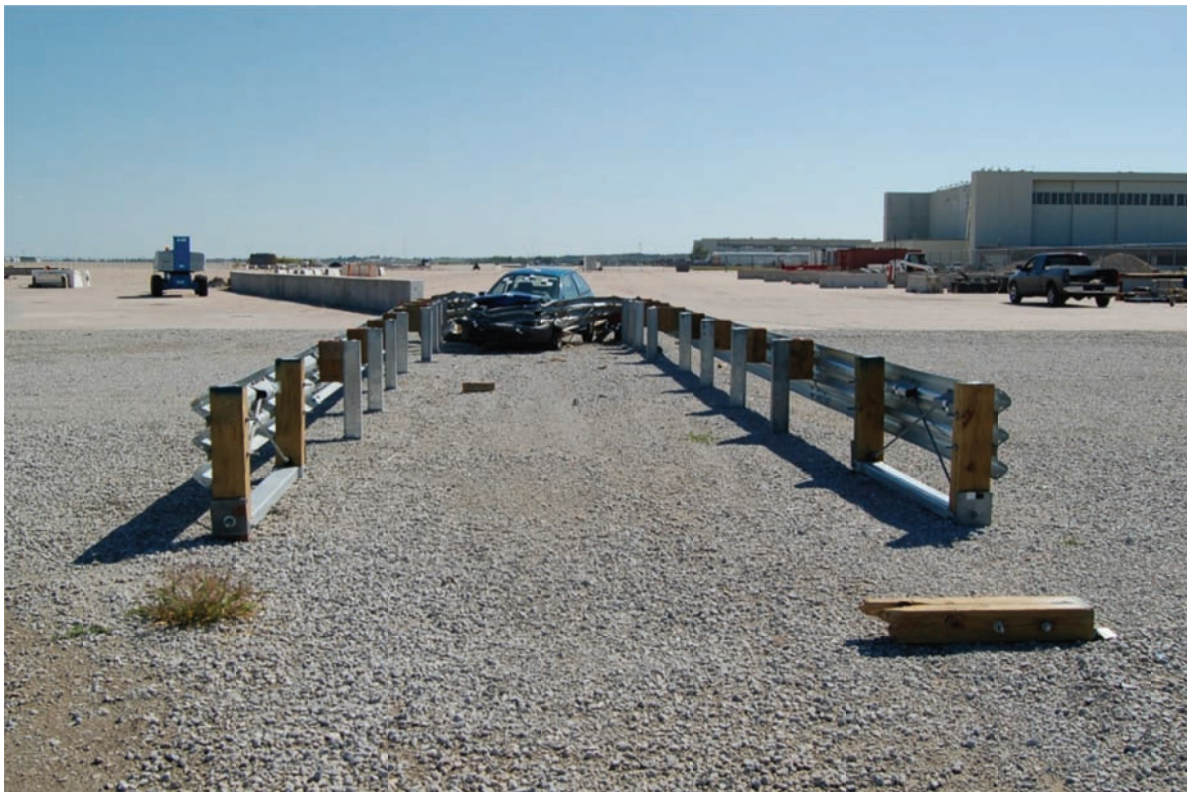
Figure 38. Impact Location, Test No. USPBN-3

Initial vehicle impact was to occur with the passenger's side quarter point of the vehicle at the center of the bullnose, as shown in Figure 38. The actual point of impact was at the quarter point. A sequential description of the impact events is contained in Table 4. The vehicle came to rest 20 ft – 11 in. (6.4 m ) downstream and 9 in. (0.2 m) to the left of the center of the bullnose. The vehicle trajectory and final position are shown in Figures 34 and 39.

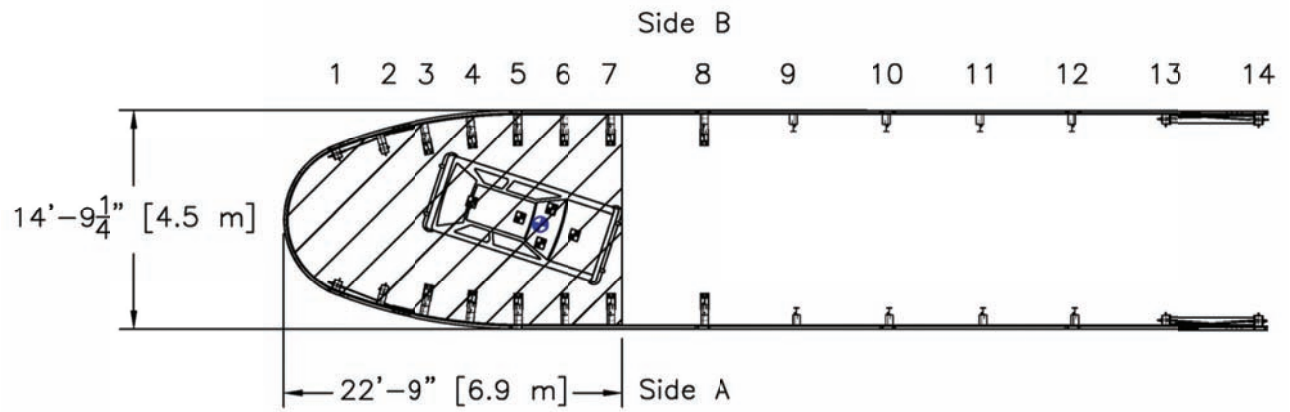
Figure 43. System Damage, Test No. USPN-3

The working width envelope of the system was found to be 22 ft – 9 in. (6.9 m) longitudinally and 14 ft – 9¼ in. (4.5 m) laterally and is shown in Figure 44.

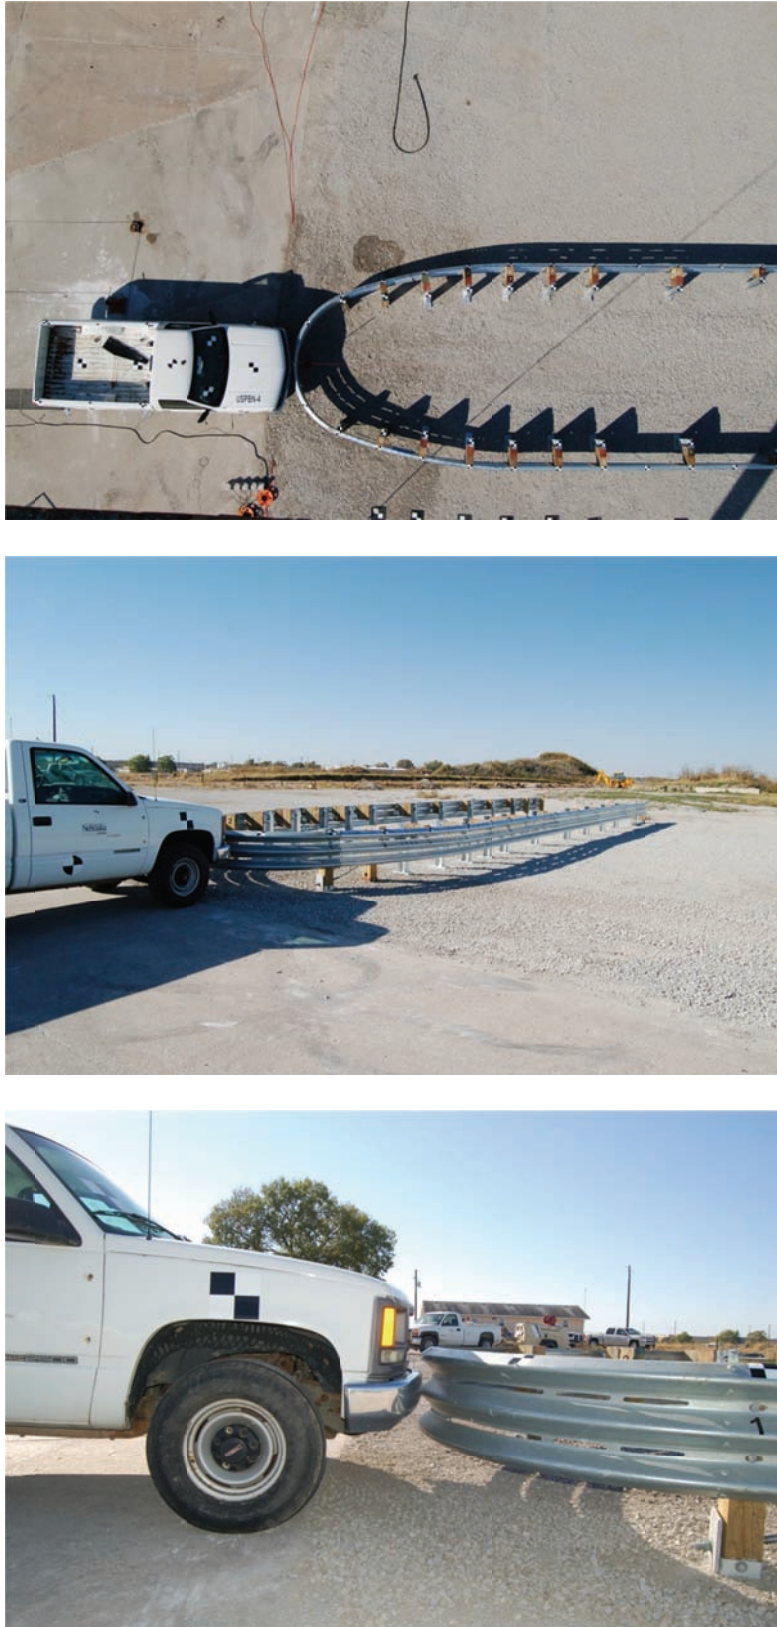
Figure 49. Impact Location, Test No. USPN-4

Initial vehicle impact was to occur at the centerline of the system, as shown in Figure 38. The actual point of impact was at the centerline of the system. A sequential description of the impact events is contained in Table 7. The vehicle came to rest 50 ft – 10 in. (15.5 m) downstream and 2 ft – 7 in. (0.8 m) to the left of the initial impact. The vehicle trajectory and final position are shown in Figures 46 and 50.

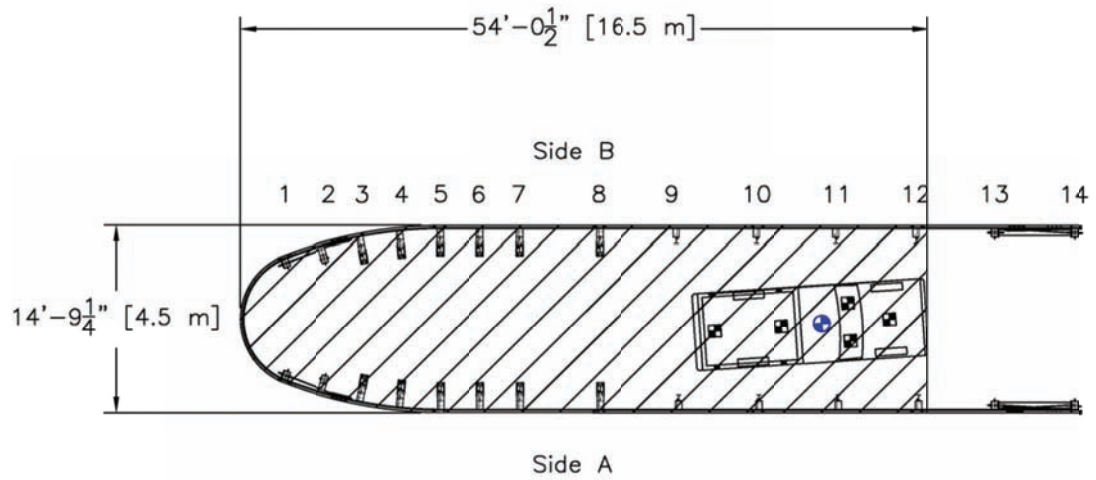
Figure 54. Working Width Envelope, Test No. USPBN-4

The working width envelope of the system was found to be 54 ft – ½ in. (16.5 m) longitudinally and 14 ft – 9¼ in. (4.5 m) laterally and is shown in Figure 54.
