CRASH TESTING AND EVALUATION OF HDOT'S THRIE-BEAM APPROACH GUARDRAIL TRANSITION ATTACHED TO 42-IN. TALL, SOLID CONCRETE BRIDGE RAIL WITH AESTHETIC, RECESSED, ROUNDED PANELS AND 6-FT WIDE SIDEWALK: MASH TEST NOS. 3-20 AND 3-21

MwRSF Research Report No. TRP-03-472-22

December 13, 2022

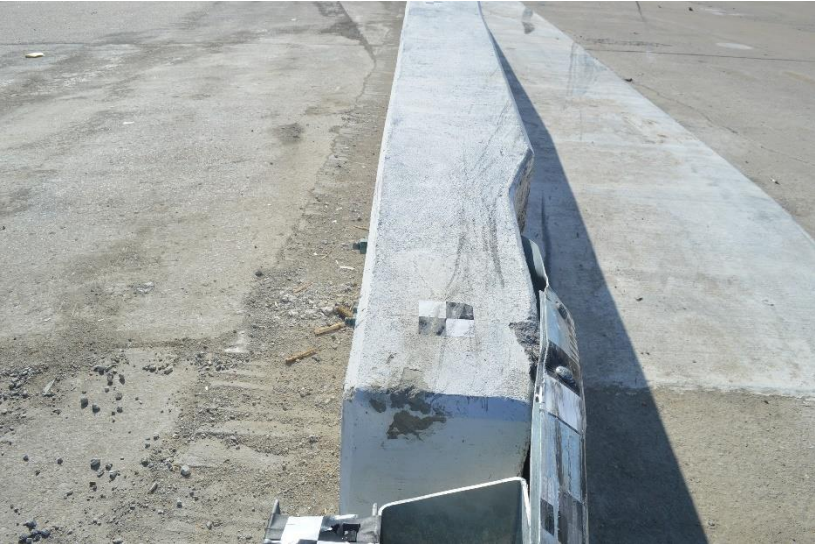
Figure 66. Buttress Damage, Test No. H42ST-1

The concrete curb had tire marks on the front and top face, starting 13 in. downstream from post no. 16 and extending onto the front and top face of the curb and front and top of the concrete buttress. The tire mark on the curb was 12 ft – 4 in long and 8 in. wide. A 6 ft – 10 in. long contact mark was found at the upstream end of the top face of the concrete buttress and extended across the entire width. Concrete spalling was found on the top-front edge of the concrete buttress behind the nested thrie beam, as depicted in Figure 66. Minor concrete spalling also occurred at the joint between the curb and the concrete buttress. Concrete cracking was observed on the back face of the curb (i.e., 3 in. from the top of the curb), starting 1 in. from the upstream face of the concrete buttress.

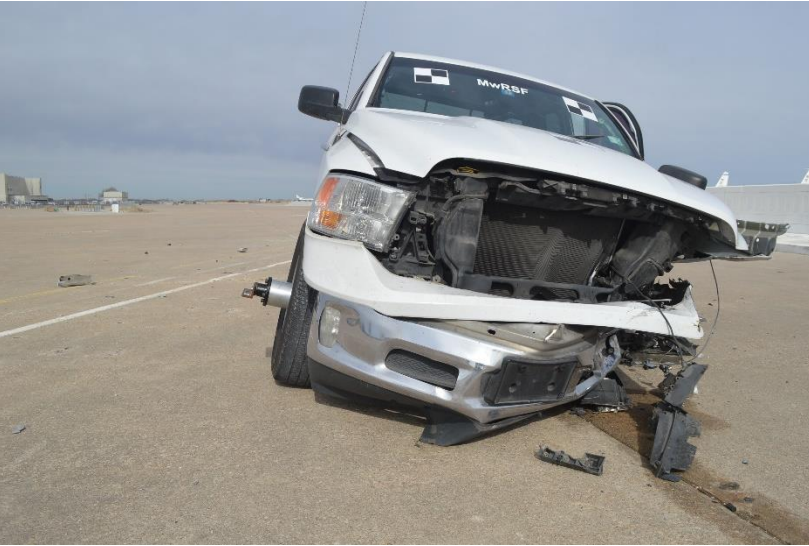
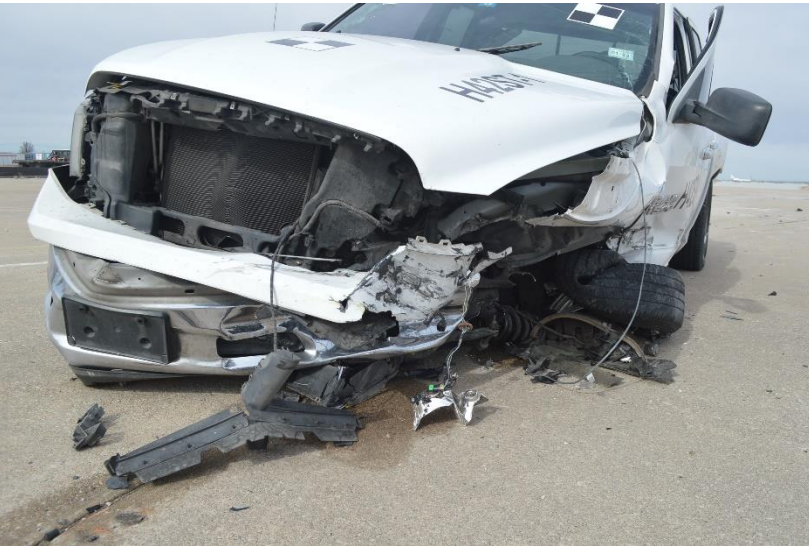
Figure 69. Vehicle Damage, Test No. H42ST-1

The majority of the damage was concentrated on the left-front corner and left side of the vehicle where the impact had occurred. The grille disengaged from the vehicle, and the front

bumper was crushed inward. The left headlight was disengaged from the vehicle, while the hood remained intact. Significant damage was imparted to the left-front fender, including being crushed inward and folded at the bottom of the panel. The region by the lower A-pillar was severely crushed and dented by the wheel opening. The left-front door was scraped and crushed inward along its entire length, causing the door to bow outward in its center with the window frame severely bent; nonetheless, the glass remained intact. The left-rear door and fender remained intact. The left side of the windshield was cracked. The left box side was dented and scraped along its entire length, with the dent starting in the vertical center of the panel and ending at the lower edge of the panel behind the rear wheel opening.

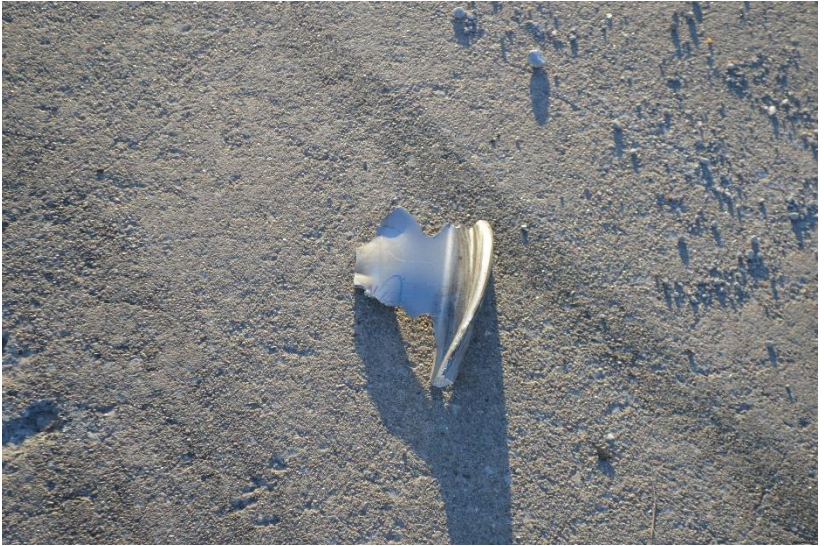
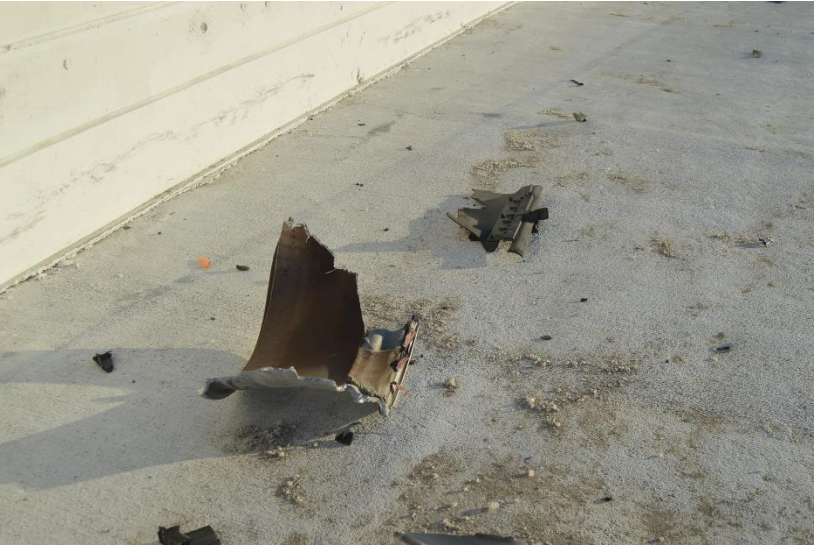
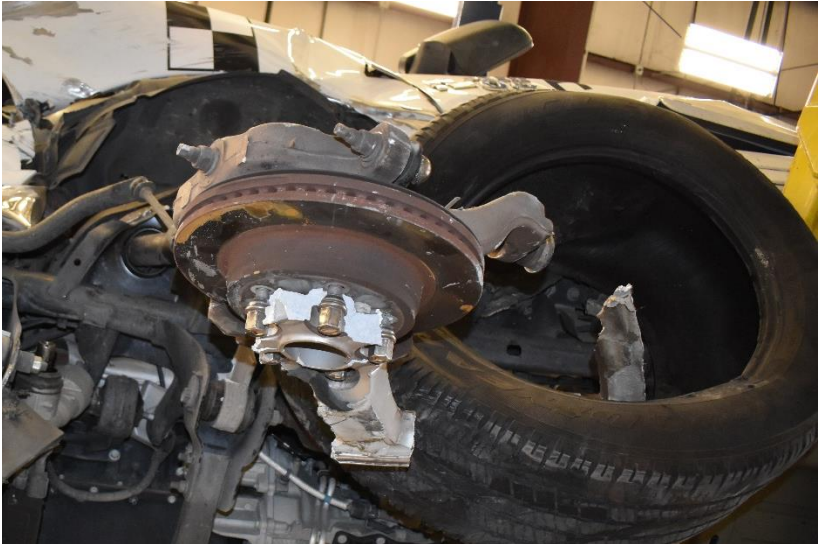
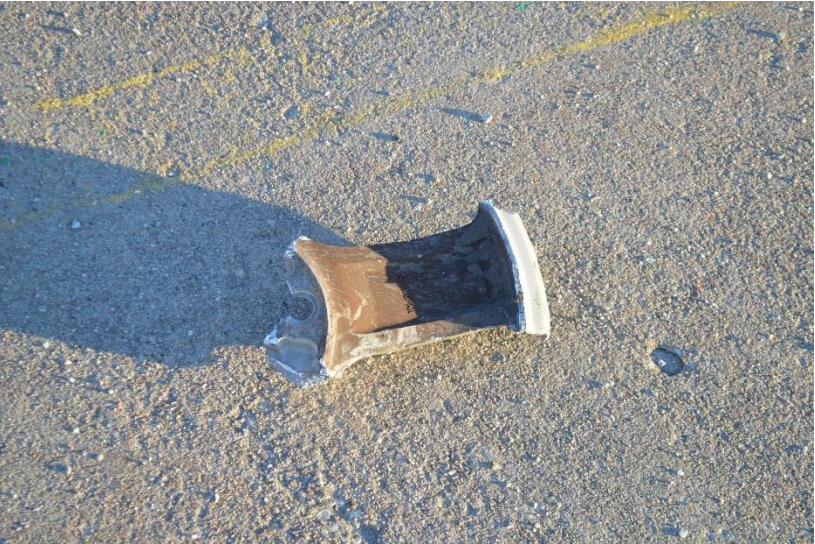
Figure 71. Vehicle's Left-Front Rim Damage and Debris, Test No. H42ST-1

During test no. H42ST-1, the left-front wheel contacted the thrie-beam rail and produced a more aggressive interaction between the elements than was observed in test no. HWTT-2 [2]. It should be noted that the 2270P test vehicle for test no. H42ST-1 had an aluminum rim, while a steel rim was used in test no. HWTT-2. A snag event occurred at the middle corrugation of the middle of the 37.5-in. long span nearest to the concrete buttress, resulting in some vehicle pocketing near the concrete buttress as well as rim gouging and/or snagging on the middle and lower rail humps. Again, these noted behaviors did not occur in test no. HWTT-2 as that thrie-beam rail appears to be smoother as compared to the test no. H42ST-1 observations. In test no. H42ST-1, this snagging behavior did not violate MASH 2016 evaluation criteria. Further details regarding test no. HWTT-2 can be found in the MwRSF report [2].

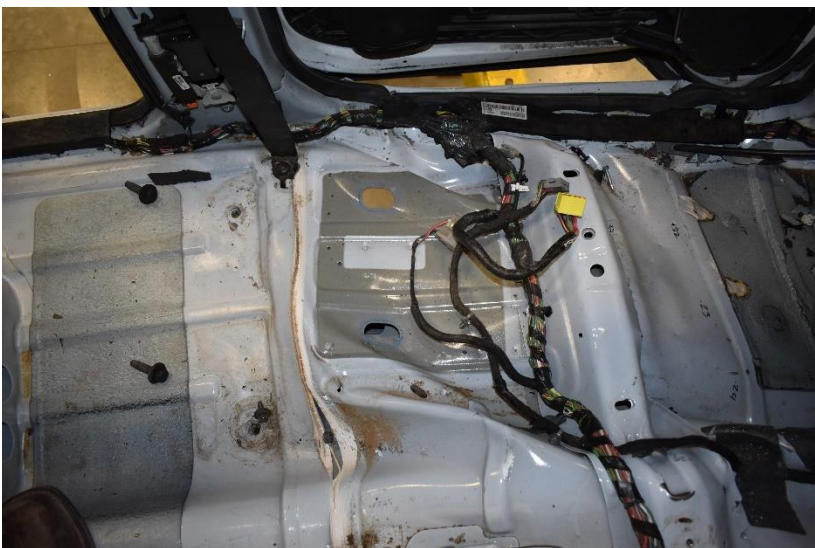
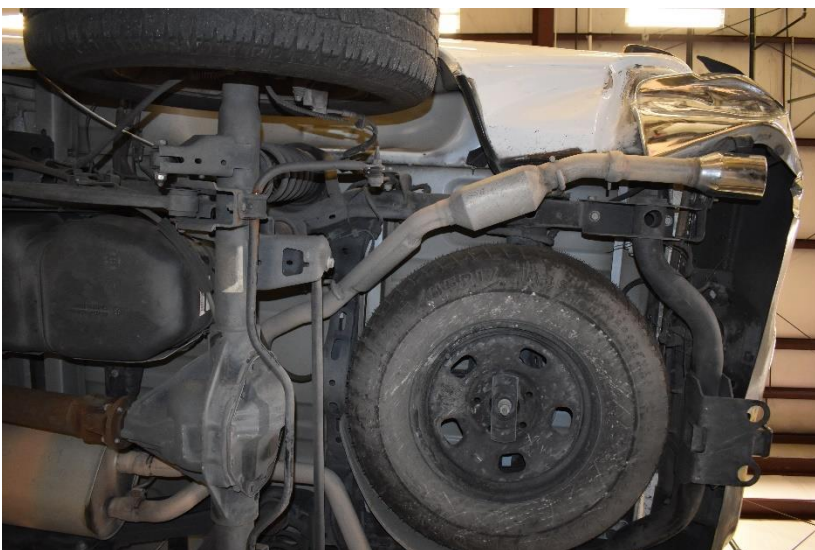
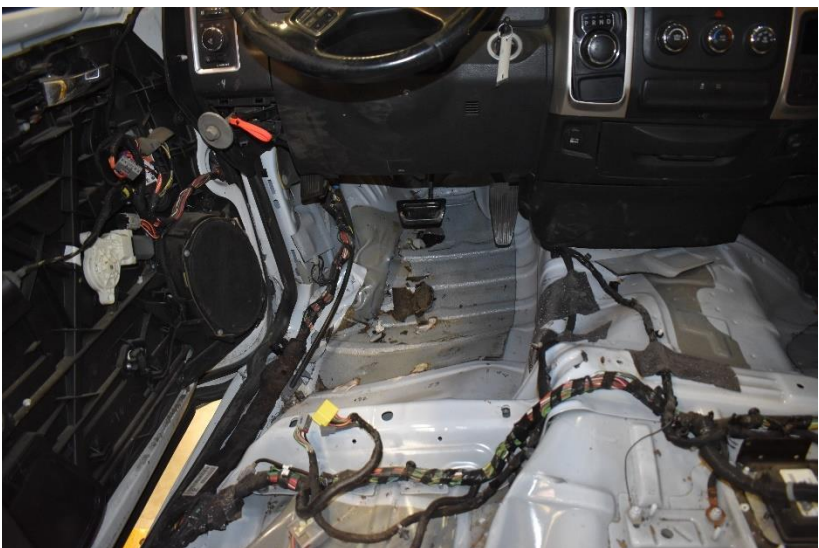
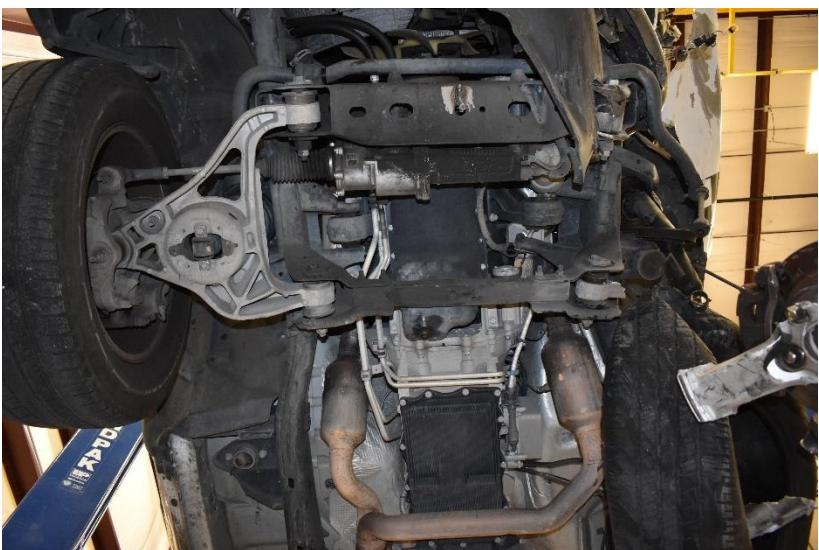
Figure 72. Vehicle Floorboard and Undercarriage Damage, Test No. H42ST-1

The damage to the vehicle was moderate to severe, as shown in Figures 68 through 72. The maximum occupant compartment intrusions are listed in Table 5, along with the intrusion limits established in MASH 2016 for various areas of the occupant compartment. Complete occupant compartment and vehicle deformations and the corresponding locations are provided in Appendix D. MASH 2016 defines intrusion or deformation as the occupant compartment being deformed and reduced in size with no observed penetration. There were no penetrations into the occupant compartment, and none of the established MASH 2016 deformation limits were violated. Outward deformations, which are denoted as negative numbers in Appendix D, are not considered crush toward the occupant, and are not evaluated by MASH 2016 criteria.

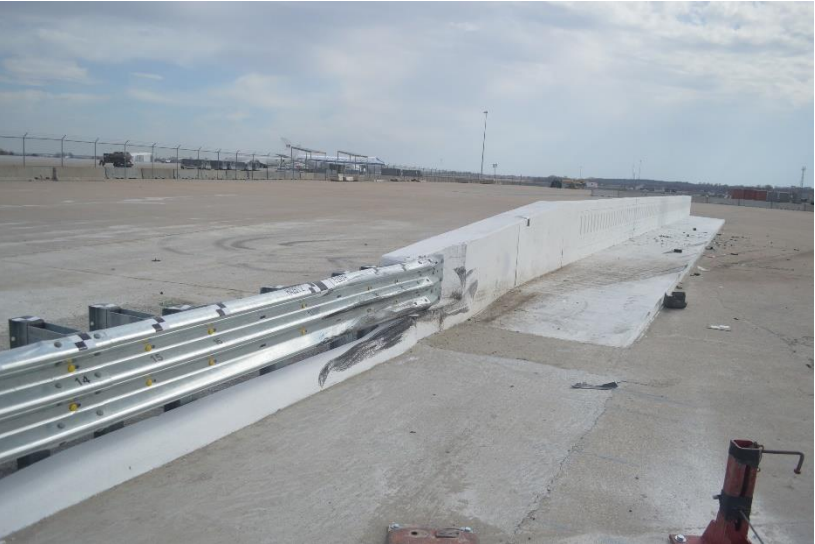
Figure 82. System Damage, Test No. H42ST-2

Damage to the barrier was minimal, as shown in Figure 82 through 84. Barrier damage consisted of contact marks and kinking of the thrie-beam sections, contact marks on the front face of the concrete buttress, and gouging of the concrete. The length of vehicle contact along the barrier was approximately 10 ft – 9 in., which began 2 in. downstream from the center of post no. 17 and extended onto the concrete parapet.

Contact marks on the thrie beam began 2 in. downstream from the centerline of post no. 17 and extended to the downstream end of thrie beam and onto the anchor plate for a total length of 6 ft – 9½ in. A contact mark was found on the upstream face of the concrete parapet with a length of 5 ft – 3 in. and extended to the downstream end of the curb. The bottom corrugation sustained various degrees of flattening damage beginning 9 in. downstream from the center of post no. 17. Multiple kinks were found on the top and bottom of the thrie beam around post nos. 13, 14, 17, and 19. Post nos. 18 and 19 slightly rotated counterclockwise, but there was no damage to the posts.

A contact mark was found on the concrete curb starting 2½ in. downstream from the centerline of post no. 17 and extending to the downstream edge of the concrete parapet. The length of this contact mark was approximately 5 ft – 4 in. The top and front edge of the curb was gouged beginning 9½ in. downstream from the centerline of post no. 19 and continued downstream onto the upstream edge of the concrete parapet. The most significant gouging occurred 21 in. downstream from the upstream edge of the concrete parapet. A ¼-in. soil gap was observed behind the back of the curb starting 15 in. upstream from the centerline of post no. 17 and extending to the upstream face of the concrete parapet.

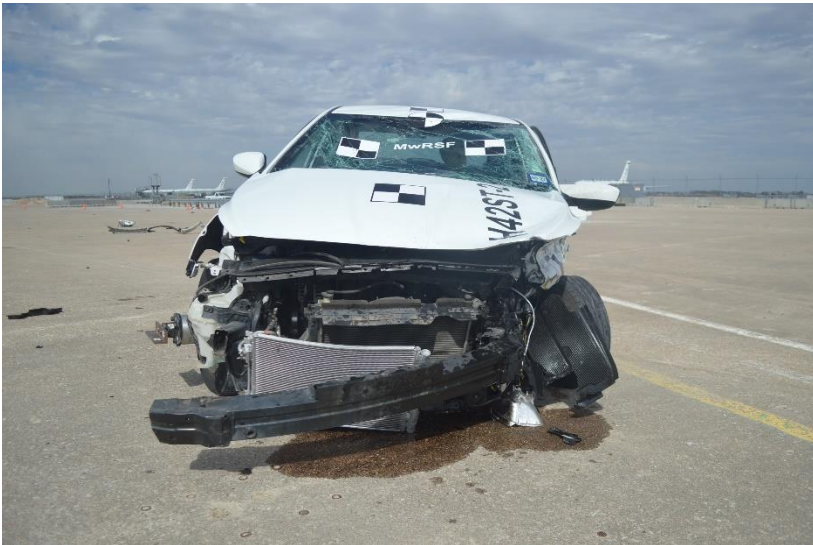
Figure 86. Vehicle Damage, Test No. H42ST-2

The damage to the vehicle was moderate, as shown in Figures 86 through 89. The maximum occupant compartment intrusions are listed in Table 9, along with the intrusion limits established in MASH 2016 for various areas of the occupant compartment. Complete occupant compartment and vehicle deformations and the corresponding locations are provided in Appendix D. MASH 2016 defines intrusion or deformation as the occupant compartment being deformed and reduced in size with no observed penetration. Outward deformations, which are denoted as negative numbers in Appendix D, are not considered crush toward the occupant, and are not evaluated by MASH 2016 criteria.

The majority of the damage was concentrated on the left-front corner and left side of the vehicle where the impact occurred. The left side of the vehicle hood was bent and slightly scraped.

The windshield was cracked across its entire width and was deformed inward 3.5 in., which exceeded the MASH 2016 limit of 3 in. However, the deformation was due to the translation of the base of the bottom-left A-pillar and did not occur due to direct contact with the test article, nor pose a penetration hazard to the vehicle occupant. Thus, this damage was not a violation of MASH 2016 criteria. Similar windshield damage and deformation had been observed in other recent MASH 1100C tests into rigid barriers, including full-scale crash testing of the Hawaii 34-in. tall (i.e., test no. H34BR-1) and 42-in. (i.e., test no. H42BR-1) tall concrete bridge rails [3, 17] as well as full-scale crash testing of the North Carolina two-bar metal bridge rail (i.e., test no. NCBR-1) [18]. Windshield damage in the form of tearing and deformations have been allowed for these other systems/tests when the barrier does not make direct contact with the windshield, as seen in the FHWA eligibility letters provided for each system [19-21].

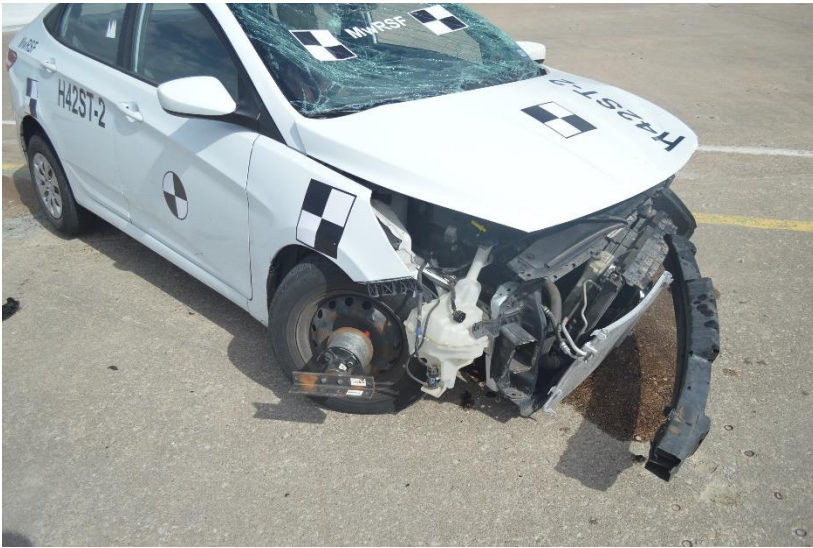
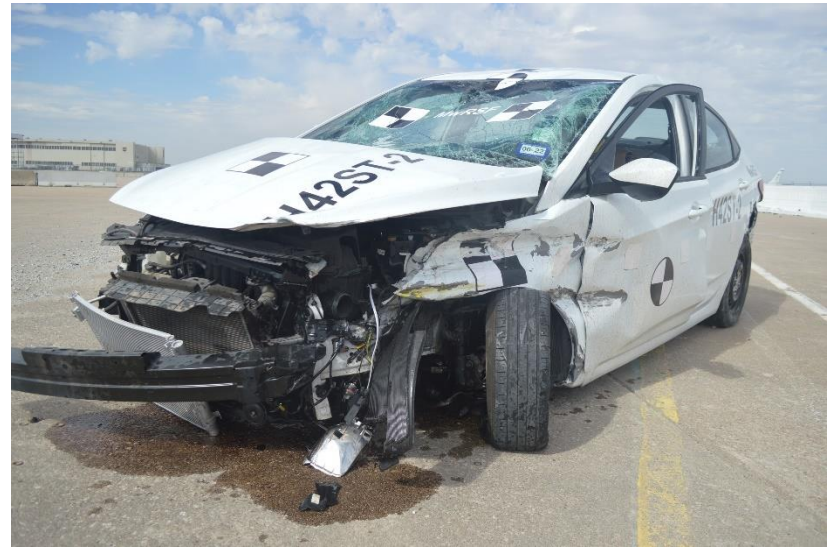
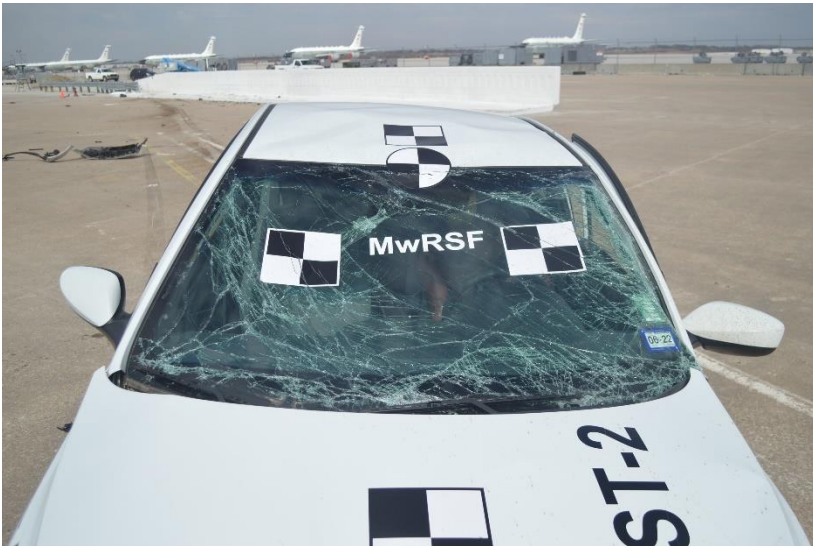
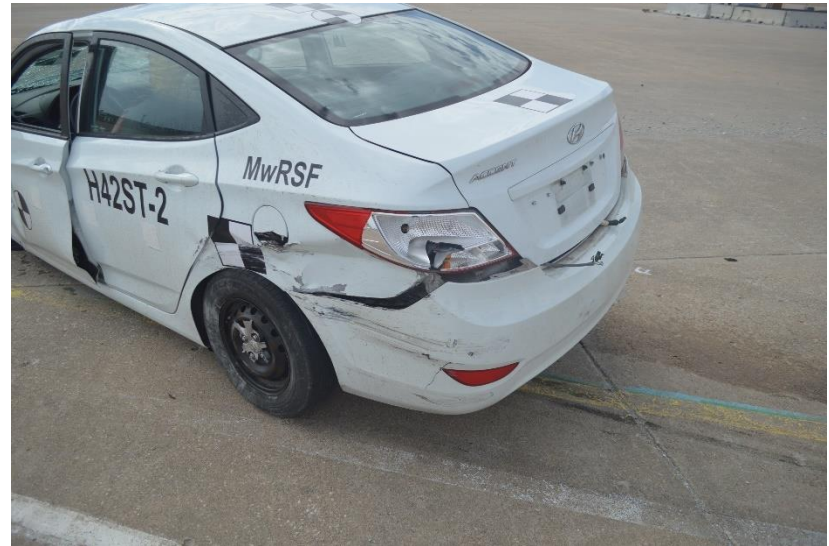
Figure 87. Vehicle Damage, Test No. H42ST-2

Undercarriage damage was moderate. No damage occurred to the left-front shock and springs, including the bump stops. The front-left side link of the sway and anti-roll bar were bent, and there was no damage to the rear side. The left-front steering knuckle was fractured at the strut mount. The left control arm was bent and slightly twisted with scraping along the trailing edge of the arm in the center of the test vehicle. The left outer tie rod of the steering control arm was significantly bent. The transmission case was cracked on the very left end. There was no damage to the oil pan, engine, or transmission mounts. The front engine cross member was bent and twisted, with the majority of the damage on the left side. The right side of the frame horn was slightly bent outward, while the left side was slightly bent inward.

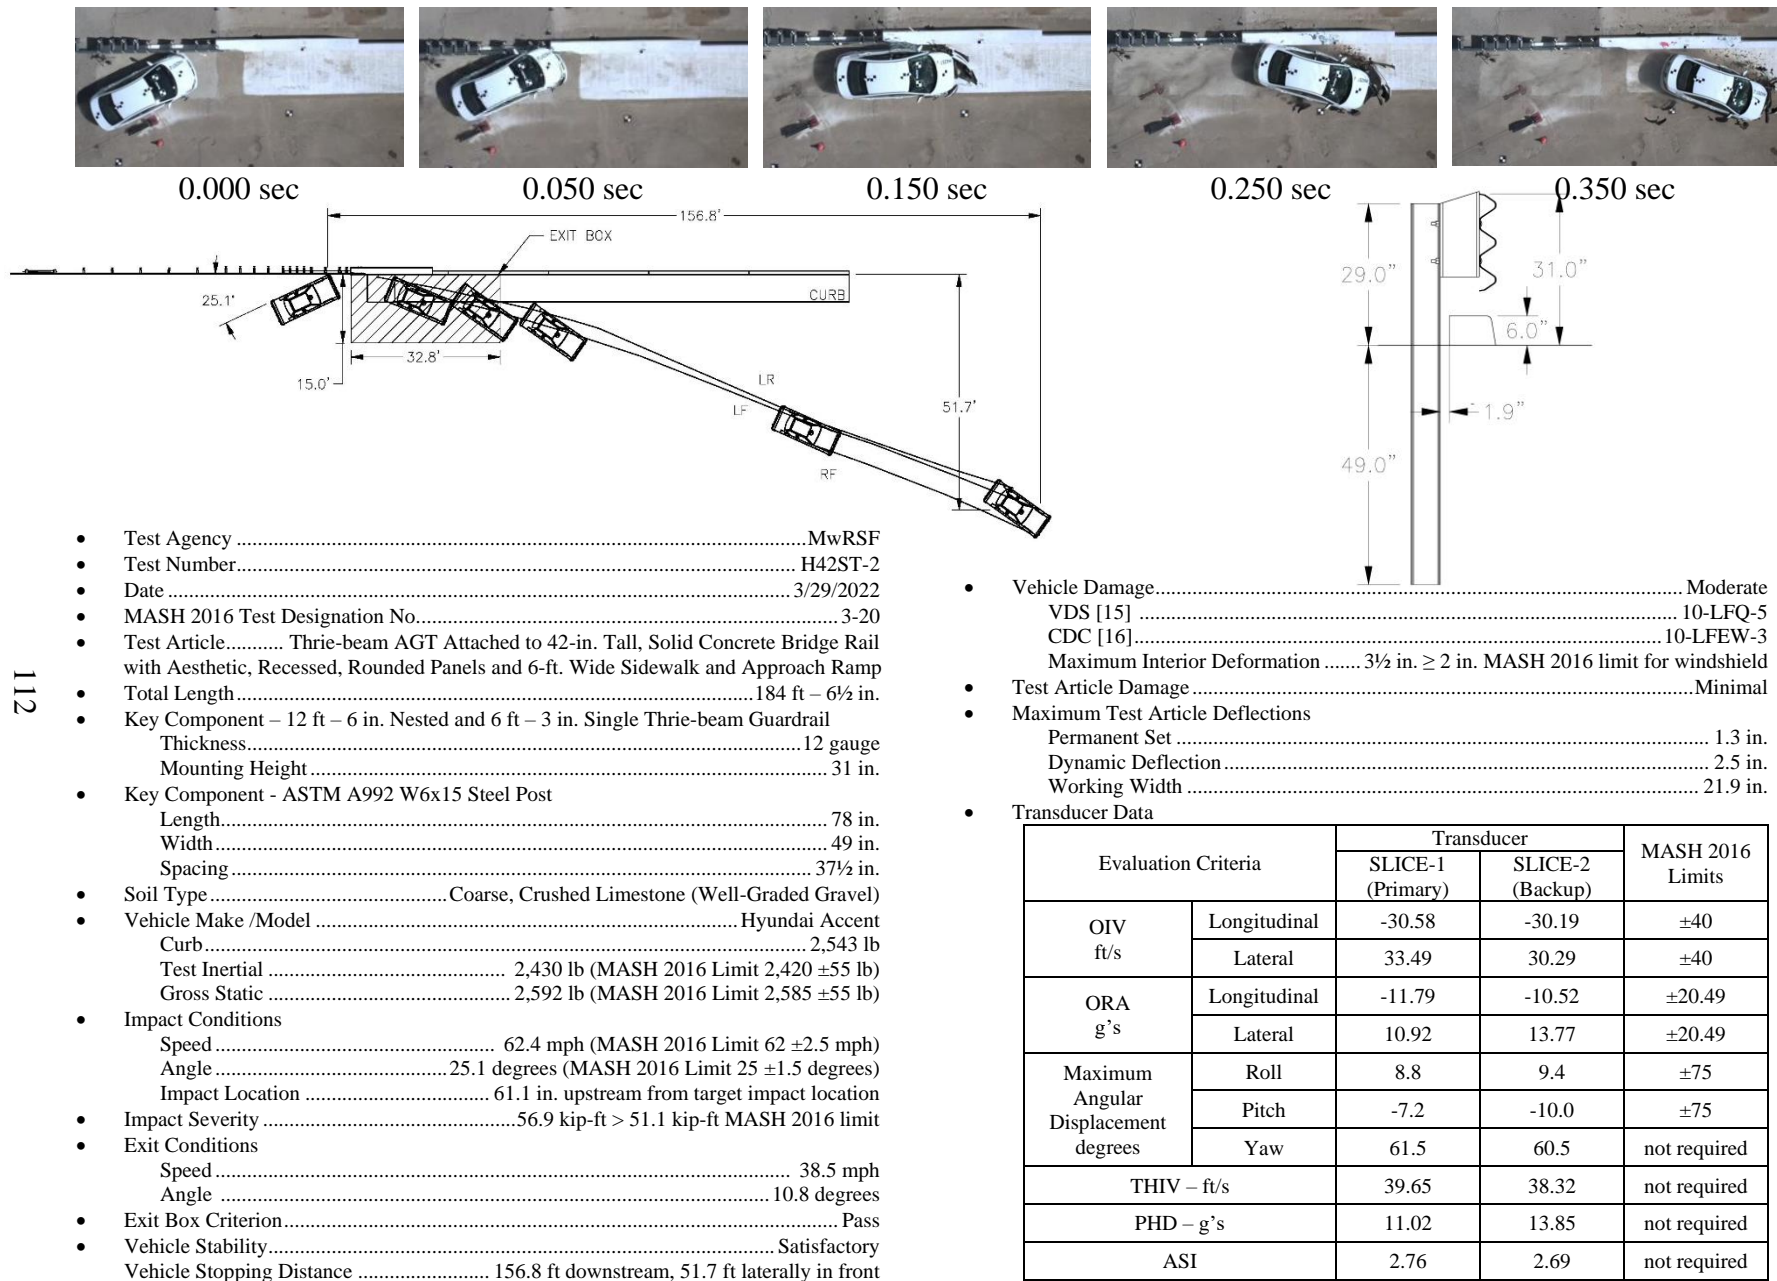
Figure 90. Summary of Test Results and Sequential Photographs, Test No. H42ST-2

The analysis of the test results of test no. H42ST-2 showed that the system adequately contained and redirected the 1100C vehicle with controlled lateral displacements of the barrier. A summary of test results and sequential photographs are shown in Figure 85. Detached elements, fragments, or other debris from the test article did not penetrate or show potential for penetrating the occupant compartment, or present an undue hazard to other traffic, pedestrians, or work-zone personnel. Deformations of, or intrusion into, the occupant compartment that could have caused severe injury did not occur. The simulated occupant's head extended out the side window but did not contact any barrier components. Deformation of the windshield measuring 3.5 in. exceeded the MASH 2016 limit of 3 in. However, the deformation was due to the translation of the base of the bottom-left A-pillar and did not occur due to direct contact with the test article, nor pose a penetration hazard to the vehicle occupant. Thus, this damage was not a violation of MASH 2016 criteria. The test vehicle did not penetrate nor override the barrier and remained upright during and after the collision. Vehicle roll, pitch, and yaw angular displacements, as shown in Appendix F, were deemed acceptable as they did not adversely influence occupant risk nor caused rollover. After impact, the vehicle exited the barrier at angle of 10.8 degrees, and its trajectory did not violate the bounds of the exit box. Thus, test no. H42ST-2 was determined to be acceptable according to the MASH 2016 safety performance criteria for test designation no. 3-20.
