*Midwest Pooled Fund Research Program
Fiscal Year 2019 (Year 29)
TPF-5(193) Supplement #138
NDOT Sponsoring Agency Code RPFP-19-CABLE-1*

**MASH TEST DESIGNATION NOS. 3-11 & 3-17 OF A NON-
PROPRIETARY, HIGH-TENSION CABLE MEDIAN BARRIER
WITH CLOSED-SECTION POSTS**

MwRSF Research Report No. TRP-03-431-22

December 1, 2022

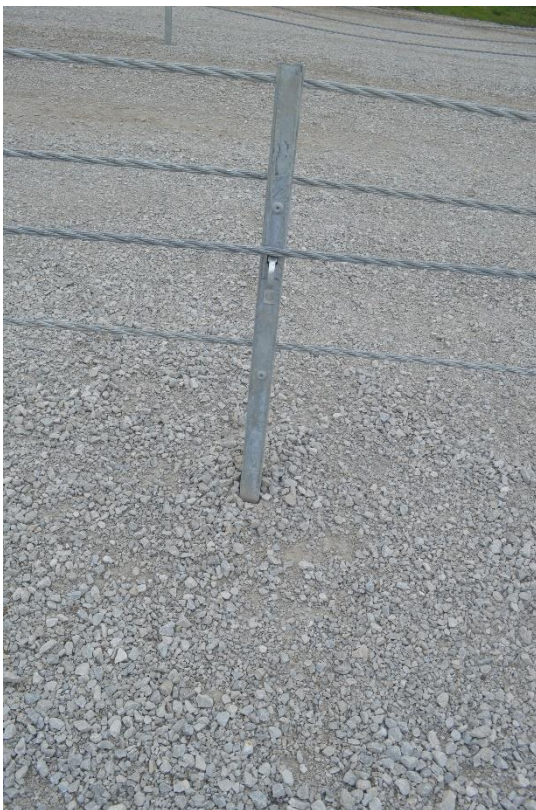
Figure 52. Post Nos. 25 (Left) and 26 (Right) Damage, Test No. MTP-1

Damage consisted primarily of bracket and brass rod deformation, cable release, soil gap formation, and minor post rotation between post nos. 18 and 25. Significant ground line post bending began at post no. 26, which bent backward. Combined backward bending and non-impact side wall buckling behavior occurred at post nos. 27 and 29 through 31. Partial section fracture occurred at post no. 28, with the upstream, downstream, and impact side walls of the post separating entirely from the post base along a plane through the two ground line holes. The non-impact side wall of post no. 28 remained intact. Post no. 32 twisted significantly but a small section of material remained between the two ground line holes on the downstream side wall. Post nos. 33 through 37 and 39 bent backward and downstream and experienced partial section fracture. Post no. 38 did not fracture, but bent backward and downstream. Complete section fracture through the ground line holes occurred at post no. 40. Post nos. 41 through 45 and 48 through 58 sustained a combination of partial section fracture and downstream bending. Post nos. 46 and 47 fractured completely. Only minor damage including bracket deformation, minor soil gap formation, and brass rod damage occurred between post no. 59 and 76. A summary of disengaged cables, bracket damage, and brass rod damage is shown in Table 7.
