*Hawaii Department of Transportation  
Research Contract No. 68212  
Research Project No. STP-1500(092) – Phase II*

## **CRASH TESTING AND EVALUATION OF THE HDOT 42-IN. TALL, SOLID CONCRETE BRIDGE RAIL WITH AESTHETIC RECESSED ROUNDED PANELS AND 6-IN. TALL SIDEWALK: MASH TEST DESIGNATION NOS. 3- 10 AND 3-11**

MwRSF Research Report No. TRP-03-455-22

December 15, 2022

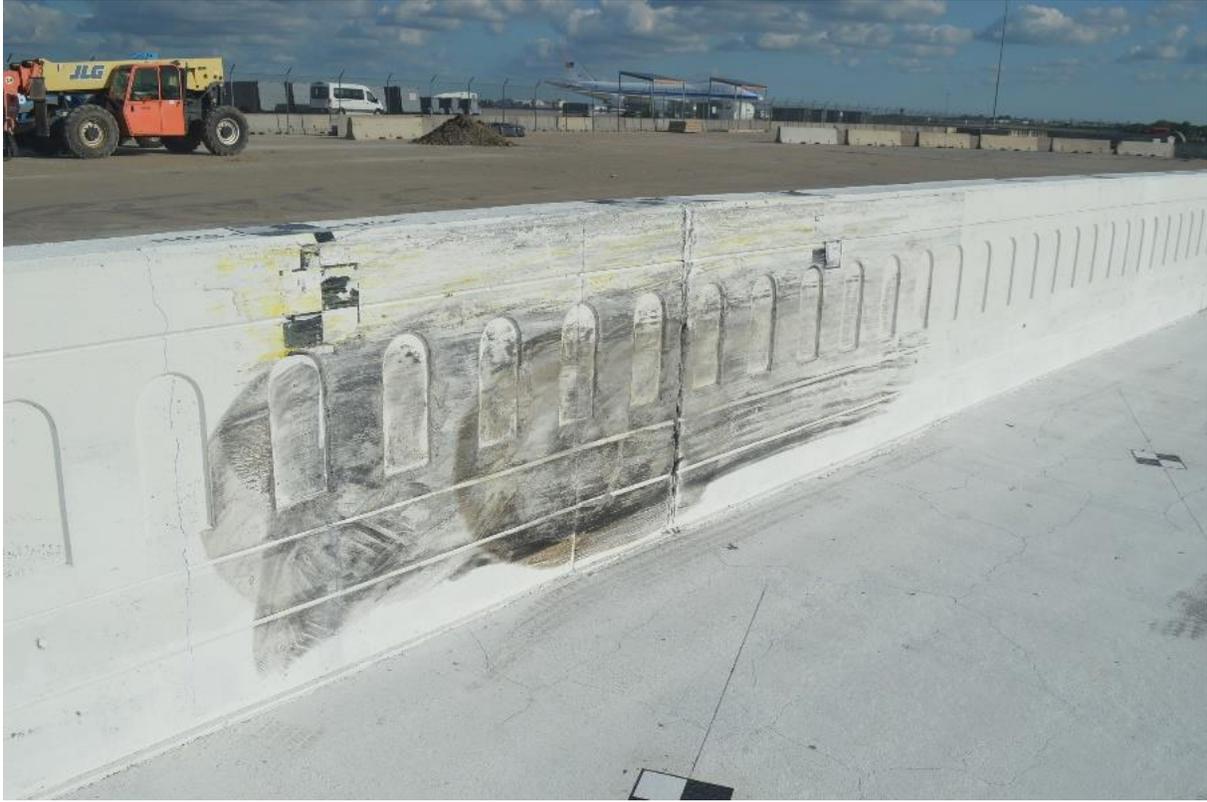
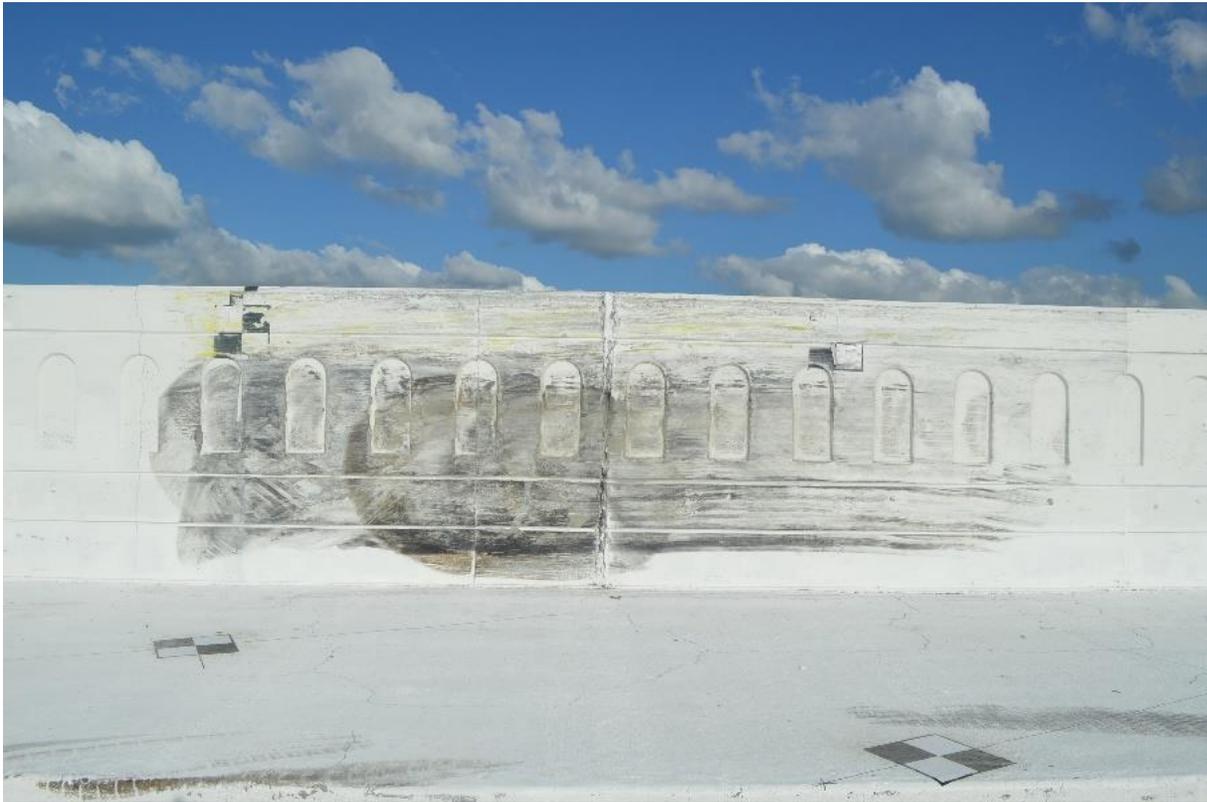
Figure 49. System Damage, Test No. H42S-1

Damage to the barrier was minimal, as shown in Figures 47 through 53. Barrier damage consisted of contact marks on the front and top faces of the concrete segments and concrete gouging. Note that some cracking visible in the system photographs was documented beforehand and did not occur due to the test no. H42S-1 impact. The length of vehicle contact along the barrier was approximately 13½ in., which spanned from 1 ft – 1½ in. upstream from the impact point.

Contact marks were visible on the front and top faces of the barrier. A 143-in. long by 42-in. tall contact mark began upstream from impact at the mid-height of the barrier. An 88-in long by 6-in. wide contact mark was found on the top face of the barrier, beginning 5½ in. downstream from impact.

The barrier sustained minor gouging, beginning 7 in. downstream from the impact point and extending 52¼ in. downstream from expansion joint no. 1, starting from the base of the barrier to 28 in. above the sidewalk. Minor gouging was observed on the downstream, upstream, and bottom edges of the five panels upstream from expansion joint no. 1 and the three panels downstream from the expansion joint. Most gouging occurred on the downstream edges of the four panels upstream from expansion joint no. 1, as shown in Figure 50. Panel gouging is summarized in Table 5. In addition to the recess panel gouging, minor gouging from vehicle wheel contact occurred along the lower half of the barrier upstream from the expansion joint, as shown in Figures 51 and 52. The expansion joint was gouged on the edges with small amounts of joint fill material removed by the vehicle, as shown in Figure 53.

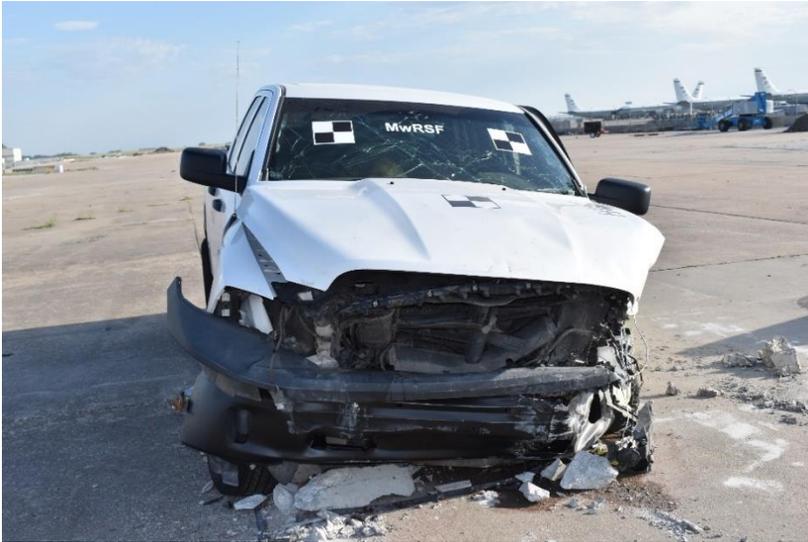
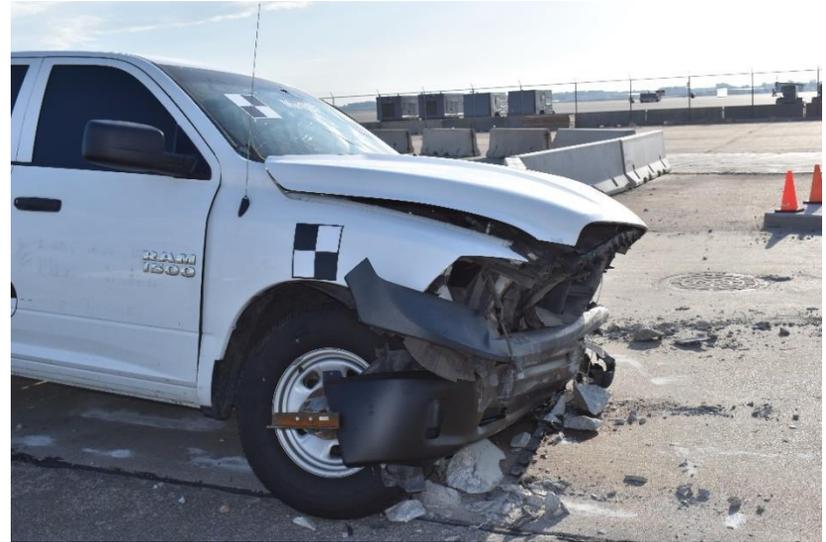
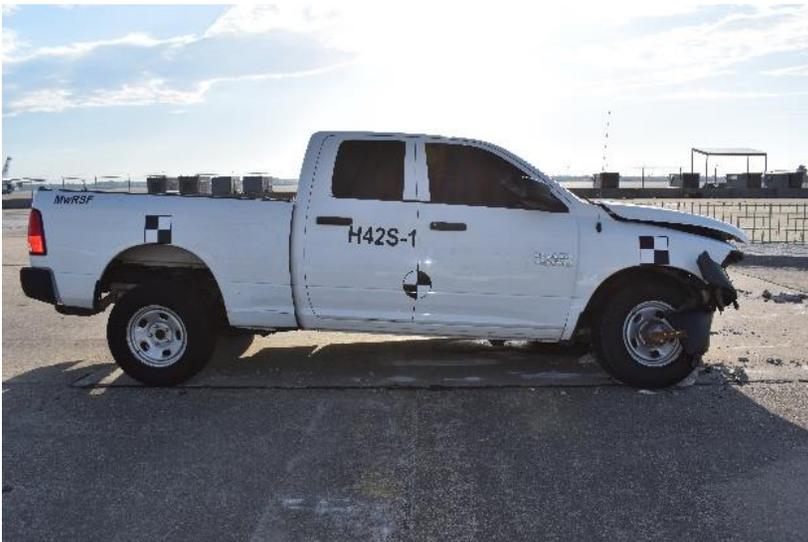
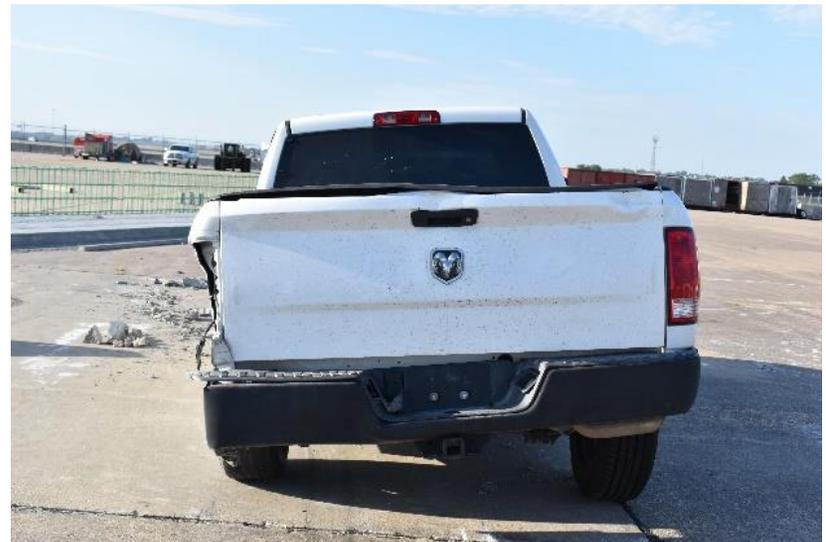
Figure 55. Vehicle Damage, Test No. H42S-1

The damage to the vehicle was moderate, as shown in Figures 55 through 58. The majority of the damage was concentrated on the left-front corner and left side of the vehicle where the impact had occurred. The left side of the front bumper and the left-front fender were crushed inward and bent. The left-front tire was partially disengaged from the rim, and the left-front rim was deformed. The front headlights and grille were disengaged from the vehicle. The hood was crushed inward on its left edge. The left-front door was crushed in the middle, pinching the latch. The entire left side of the vehicle was scraped. The left side of the bed was crushed inward along its entire length. The left-rear taillight was disengaged from the vehicle. The left side of the rear bumper was crushed inward. The windshield had cracking across its entire length. The vehicle sustained significant damage due to a second impact with the temporary concrete barriers shielding other areas of the test site when coming to rest outside of the system.

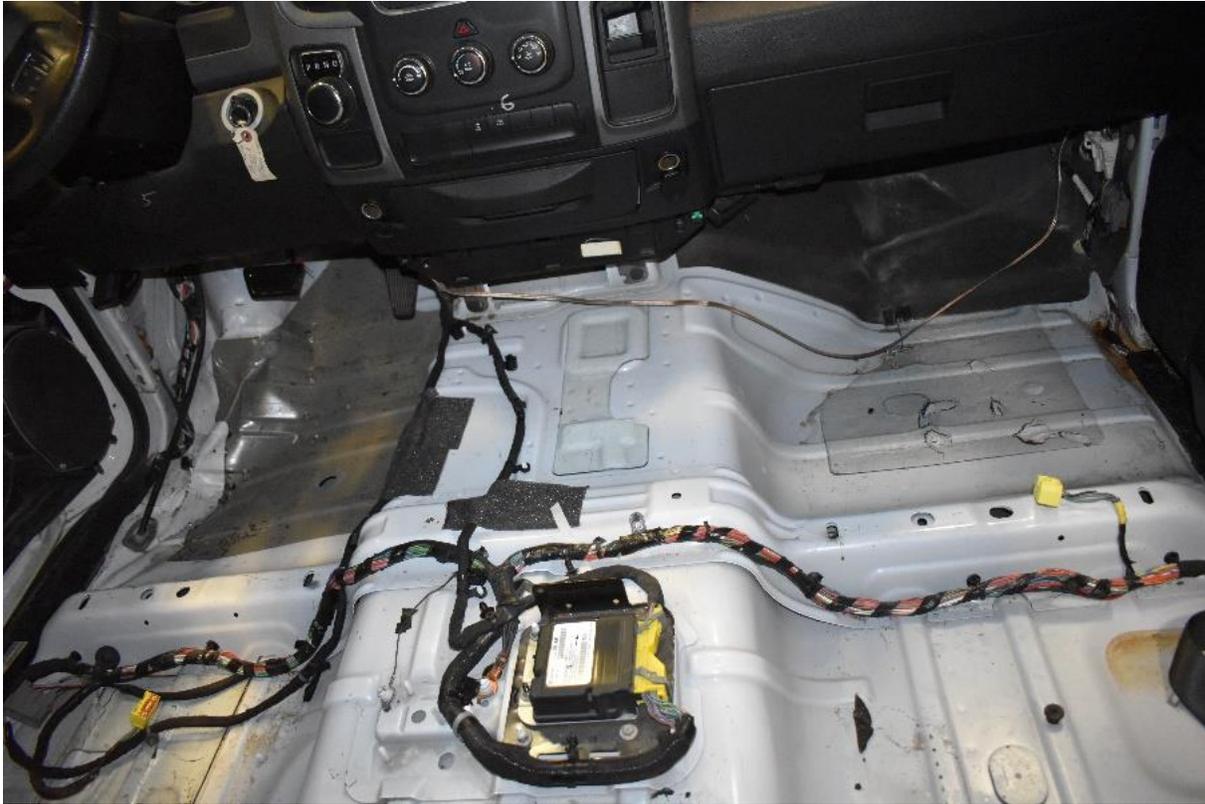
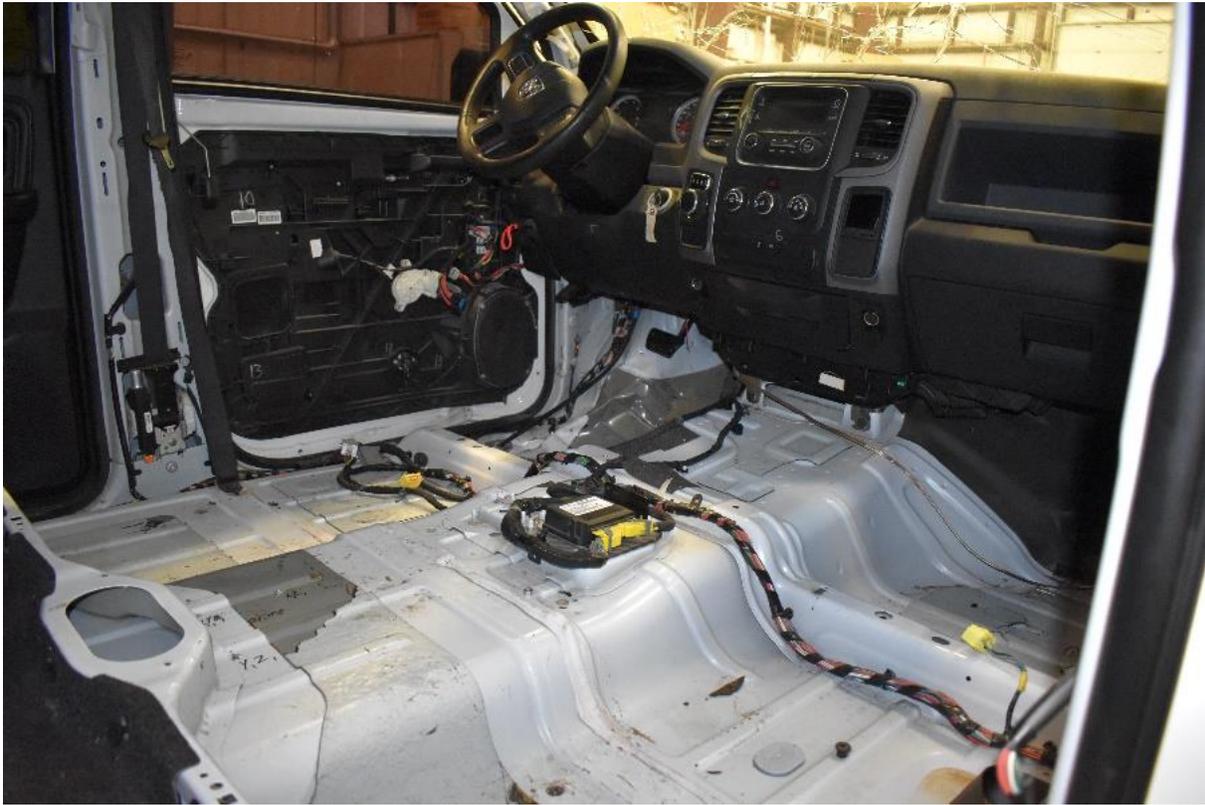
Figure 57. Vehicle Interior Damage, Test No. H42S-1

The maximum occupant compartment intrusions are listed in Table 6, along with the intrusion limits established in MASH 2016 for various areas of the occupant compartment. Complete occupant compartment and vehicle deformations and the corresponding locations are provided in Appendix C. MASH 2016 defines intrusion or deformation as the occupant compartment being deformed and reduced in size with no observed penetration. There were no penetrations into the occupant compartment, and none of the established MASH 2016 deformation limits were violated. Outward deformations, which are denoted as negative numbers in Appendix C, are not considered crush toward the occupant, and are not evaluated by MASH 2016 criteria.

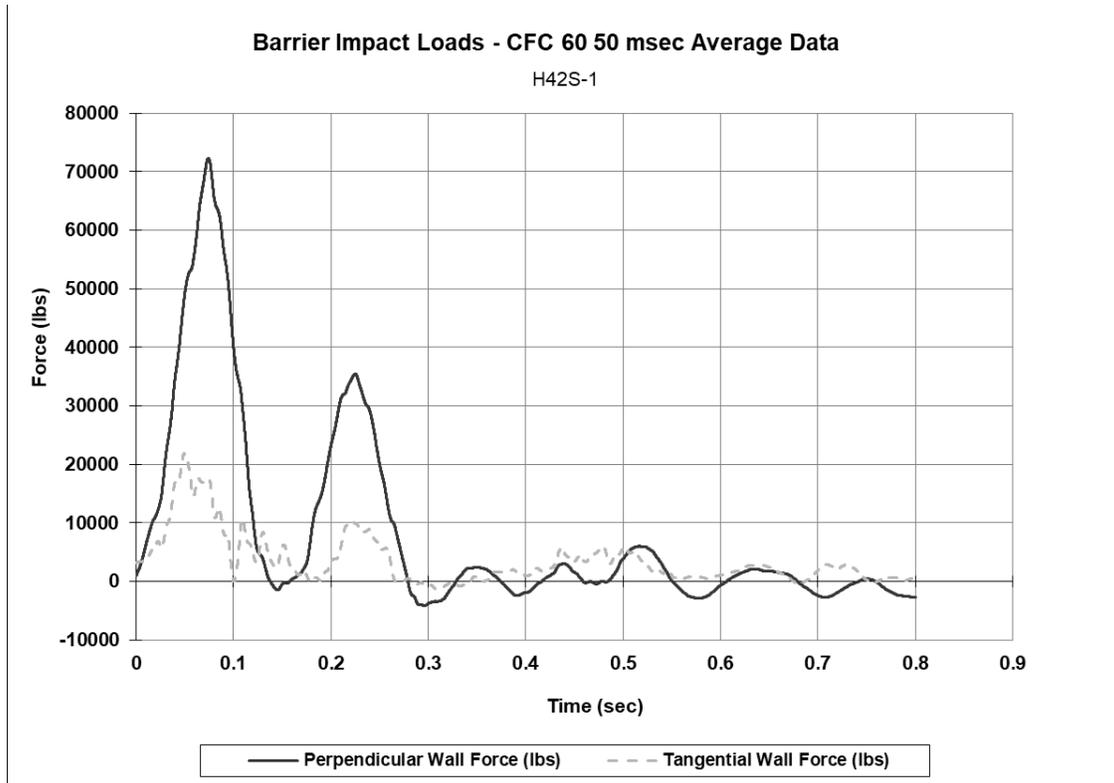
Figure 59. Perpendicular and Tangential Forces Imparted to the Barrier System (SLICE-2), Test No. H42S-1

average vehicle accelerations were then combined with the uncoupled yaw angle versus time data in order to estimate the vehicular loading applied to the barrier system. From the data analysis, the perpendicular impact forces were determined for the bridge rail, as shown in Figure 59. The maximum perpendicular (i.e., lateral) load imparted to the barrier was 72.0 kips, as determined by the SLICE-2 (primary) unit.

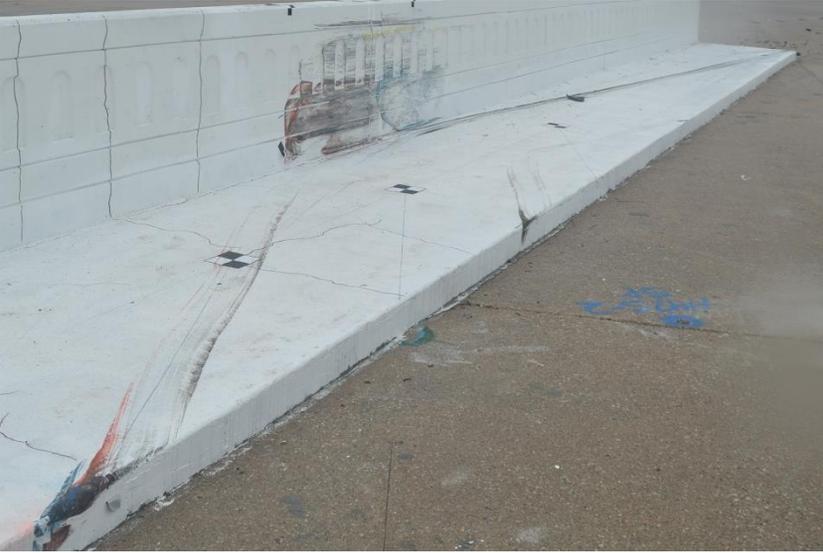
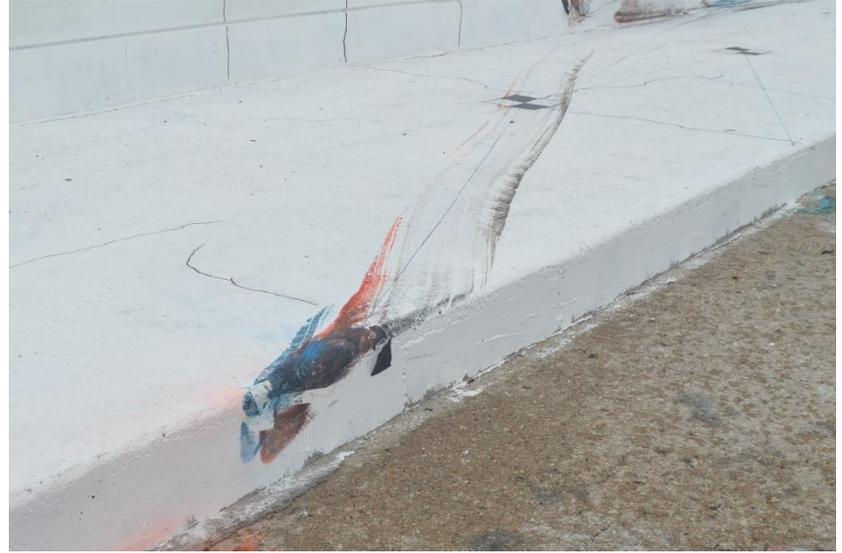
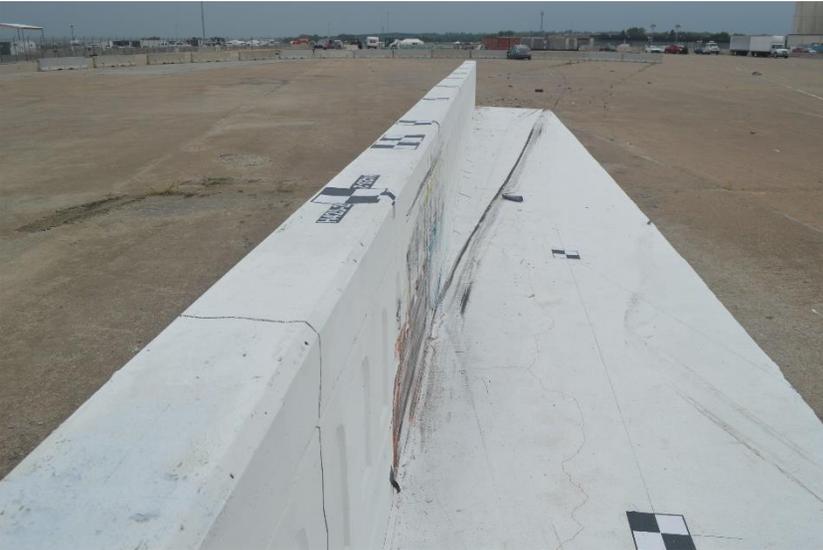
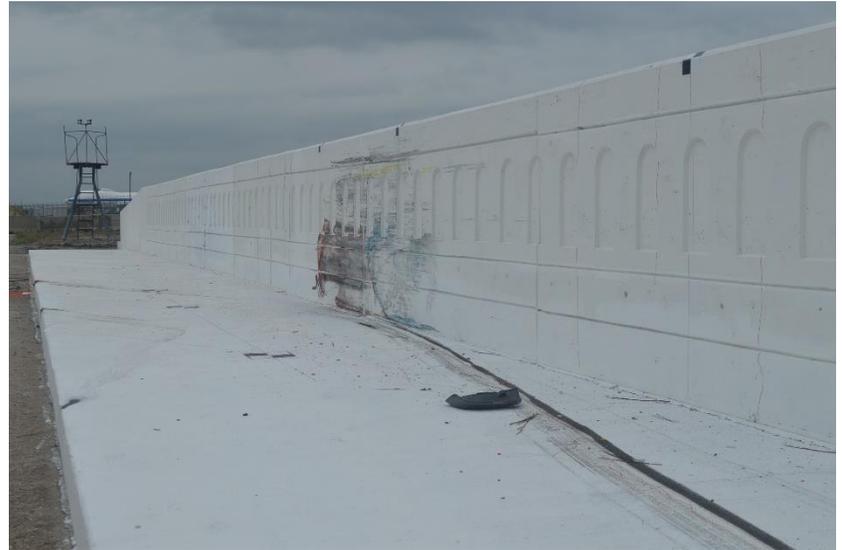
Figure 67. System Damage, Sidewalk, Test No. H42S-2

Damage to the barrier was minimal, as shown in Figures 66 through 72. Barrier damage consisted of contact marks on the front of the concrete segments and concrete gouging. Note that some cracking visible in the system photographs was documented beforehand and did not occur as a result due to the test no. H42S-2 impact. The length of vehicle contact along the barrier was approximately 10 ft – 5 in., which spanned from 4 ft – 2 in. upstream from expansion joint no. 2 to 6 ft – 2½ in. downstream from expansion joint no. 2.

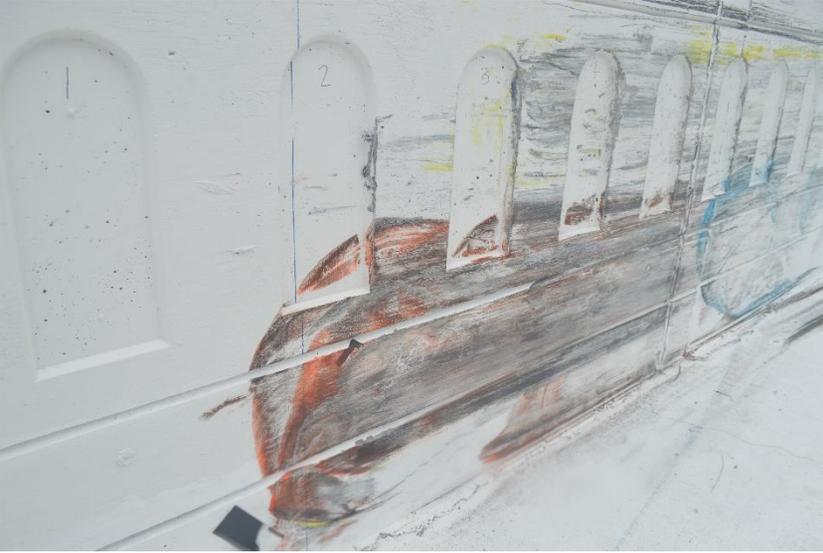
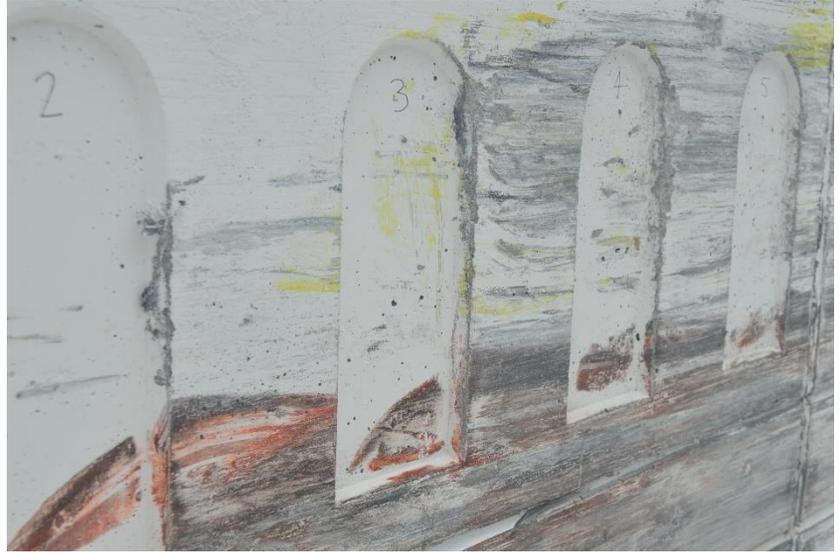
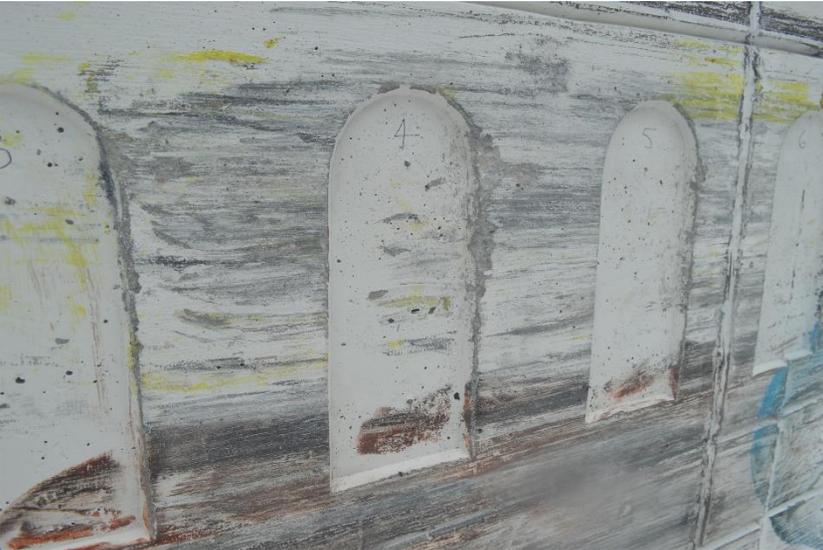
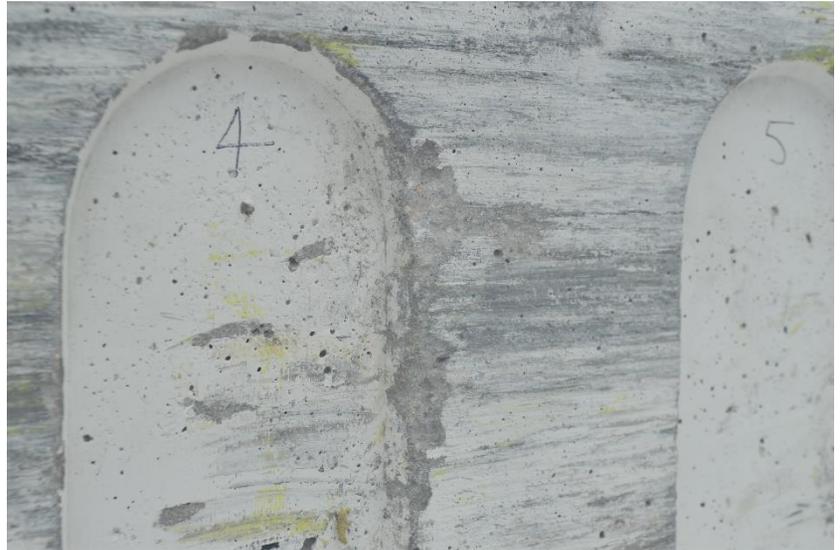
Figure 68. System Damage, Test No. H42S-2

Contact marks were visible on the front face of the barrier. A 125-in. long by 39¼ -in. tall contact mark began 50½ in. upstream from the impact point at the mid-height of the barrier. The barrier sustained minor gouging, beginning 5 in. downstream from the impact point and extending to the downstream edge of recess panel no. 9. Gouging was sustained from the lowest horizontal recess to 27¾ in. above the surface of the sidewalk. Majority of gouging occurred along the edges of the aesthetic recess panels, with the most significant gouging occurring on the downstream edges of the four panels upstream from the expansion joint, as shown in Figures 69 and 70. Minor gouging was also sustained on the upstream and downstream edges of the four panels upstream from the expansion joint and the four panels downstream from the expansion joint. Panel gouging is detailed in Figures 69 and 70 and summarized in Table 11. In addition to recess panel gouging, minor gouging from vehicle wheel contact occurred along the lower half of the downstream face of the expansion joint, as shown in Figure 71. The expansion joint sustained minimal gouging at the edges, as shown in Figure 72.

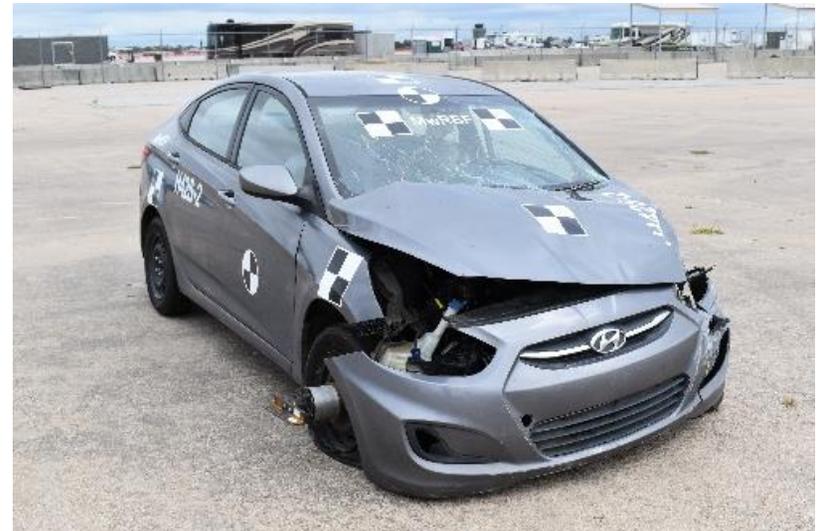
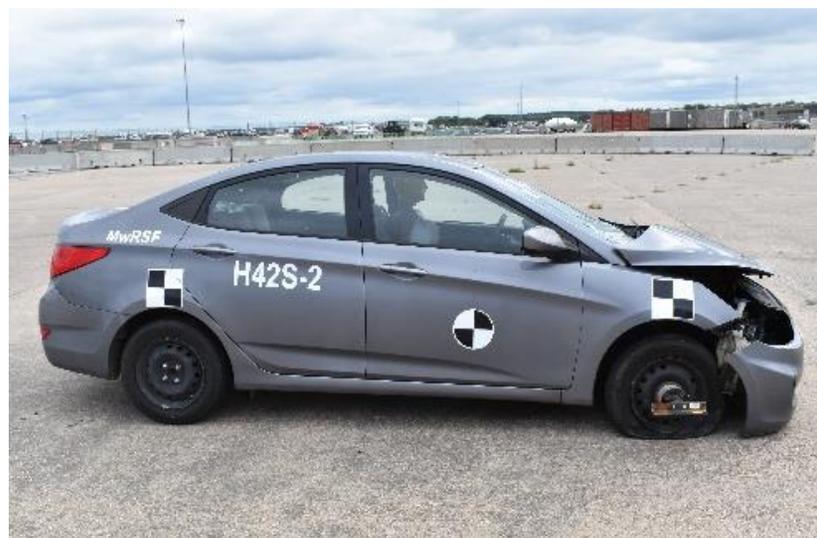
Figure 74. Vehicle Damage, Test No. H42S-2

The damage to the vehicle was moderate, as shown in Figures 74 through 77. Most damage was concentrated on the left-front corner and left side of the vehicle where the impact had occurred. The left side of the front bumper and the left-front fender were crushed inward, and the bumper was bent across its entire width. The left-front tire was partially disengaged from the steel rim, and the left-front steel rim was deformed. The front headlights were disengaged from the vehicle. The hood was crushed inward on its left edge and partially disengaged across the length of the front bumper. The left-front door was crushed in the front region, causing the door to partially open. The front and back corners of the vehicle were scraped. The left-rear bumper was crushed inward and partially disengaged from the vehicle. The windshield had severe cracking across its entire length. The vehicle sustained mild damage due to a second impact with the temporary concrete barriers shielding other areas of the test site, when coming to rest outside of the system.

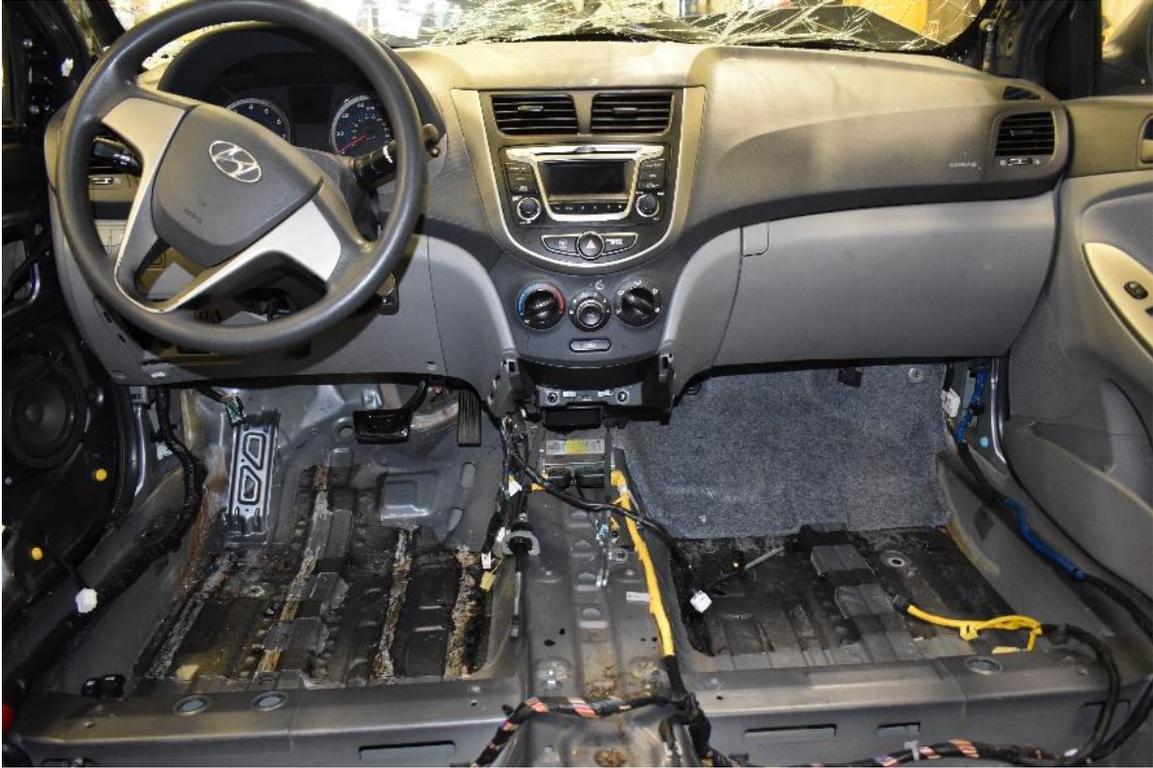
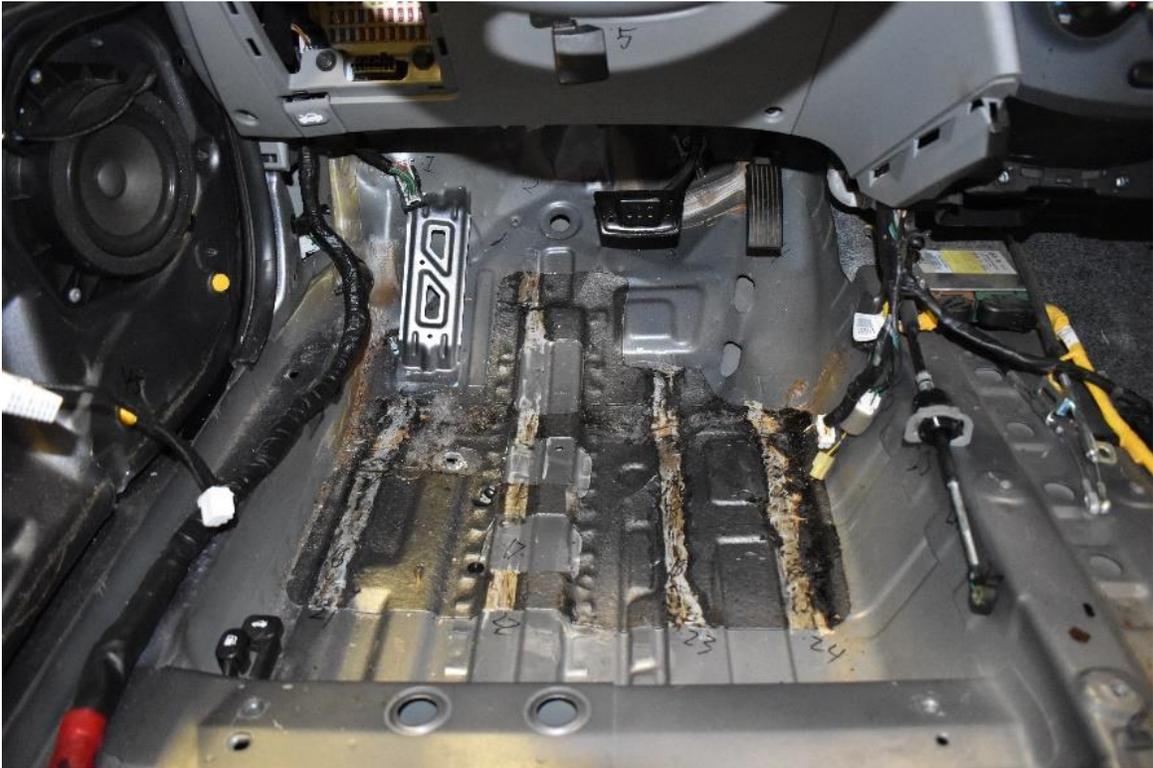
Figure 76. Vehicle Interior Damage, Test No. H42S-2

The maximum occupant compartment intrusions are listed in Table 12, along with the intrusion limits established in MASH 2016 for various areas of the occupant compartment. Complete occupant compartment and vehicle deformations and the corresponding locations are provided in Appendix C. MASH 2016 defines intrusion or deformation as the occupant compartment being deformed and reduced in size with no observed penetration. There were no penetrations into the occupant compartment, and none of the established MASH 2016 deformation limits were violated. Outward deformations, which are denoted as negative numbers in Appendix C, are not considered crush toward the occupant, and are not evaluated by MASH 2016 criteria.
