CRASH TESTING AND EVALUATION OF AN OPEN CONCRETE BRIDGE RAILING

MIDWEST ROADSIDE SAFETY FACILITY
Nebraska Transportation Center
University of Nebraska-Lincoln

MwRSF Research Report No. TRP-03-406b-24

February 29, 2024

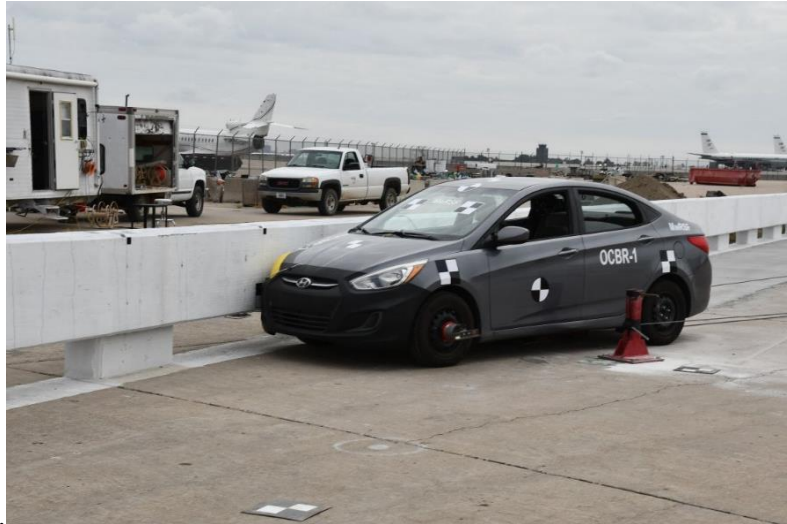
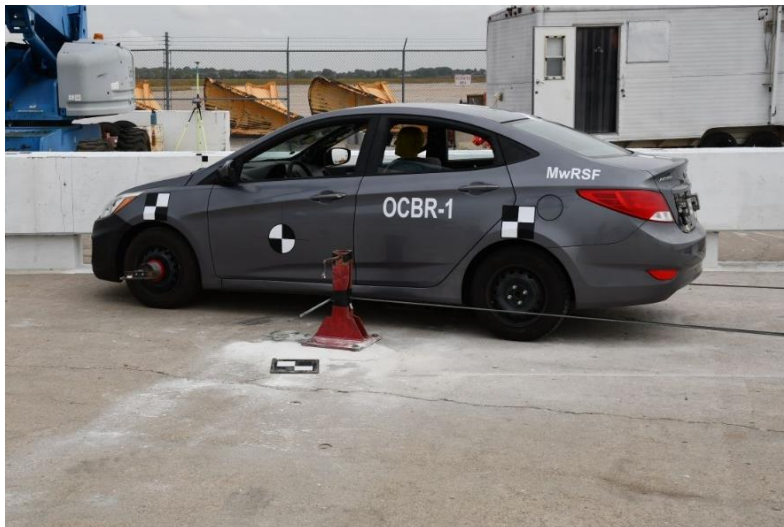
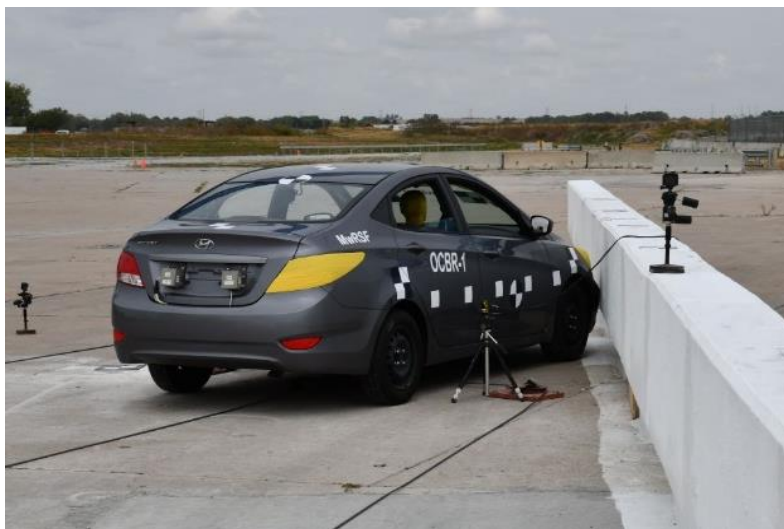
Figure 46. Target Impact Location, Test No. OCBR-1

Initial vehicle impact was to occur 43³/₁₆ in. upstream from the upstream edge of post no. 11, as shown in Figure 46, which was selected using Table 2.7 of MASH 2016. The 2,431-lb small car impacted the open concrete bridge rail at a speed of 64.2 mph and at an angle of 25.2 degrees. The actual point of impact was 45.3 in. upstream from the upstream edge of post no. 11, which was 2.1 in. upstream from the targeted impact location. The right-front wheel of the vehicle extended beneath the rail and impacted post no. 11 of the system. Wheel and tire overlap at post no. 11 was approximately 5¼ in. from the face of the post. As the vehicle was redirected, loading of the right-front fender, right-front door, and the bottom of the A-pillar caused fracture of the driver-side window and deformation and cracking of the windshield. This damage to the vehicle glass was not due to the windshield or side window contacting the barrier but was attributed to the loading and deformation of the vehicle body. It was also noted that the simulated occupant’s head extended out of the window, but did not contact the test article. The vehicle exited the barrier and continued downstream in a stable manner until brakes were applied. After brakes were applied, the vehicle came to rest 186.2 ft downstream of the impact target and 16.5 ft laterally in front of the system, facing downstream and toward the non-traffic side of the barrier.

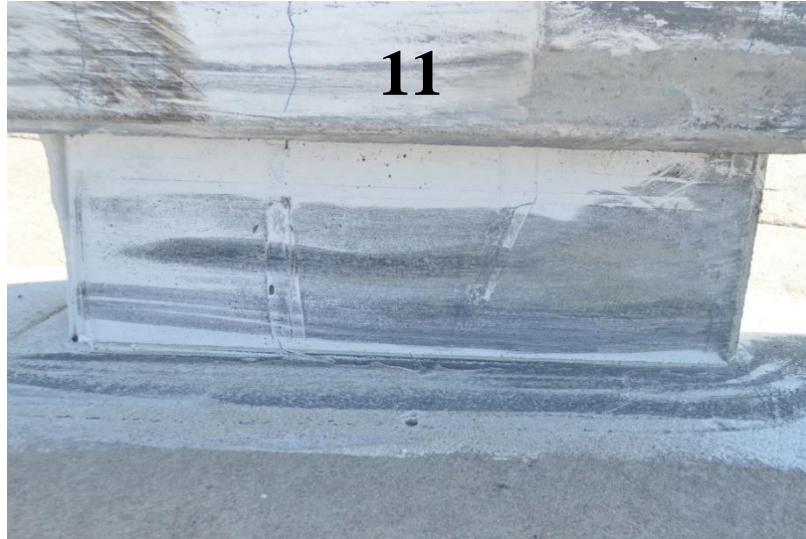
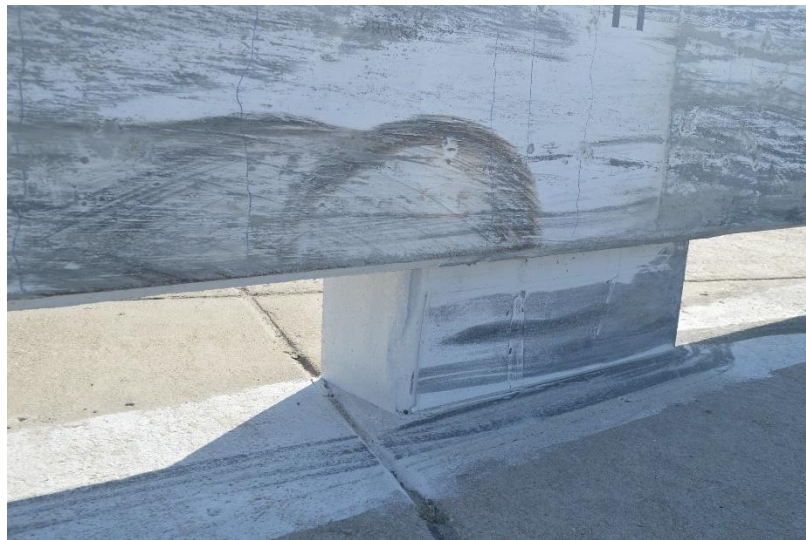
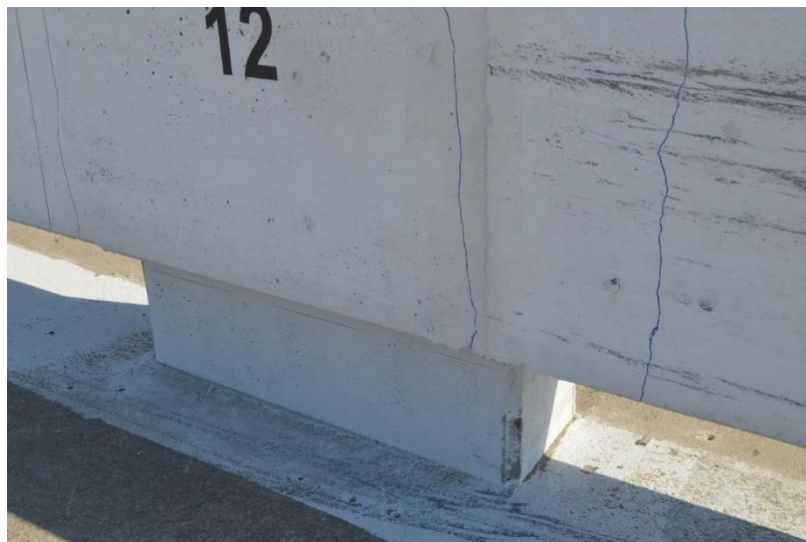
Figure 54. Concrete Post Damage, Post Nos. 11 and 12, Test No. OCBR-1

Minor spalling with lengths between 2 in. and 3¼ in. were present between 1½ in. and 19¼ in. from the impact point. Minor gouging was present between 33¼ in. and 44½ in. from the impact point. Gouges of lengths between 20¼ in. and 34 in. were present between the centerline of the impact point and 57¼ in. from the impact point. Major gouges of over 100 ft in length were present between 22½ ft downstream and 55½ ft downstream from the impact point. Post nos. 11 and 12 had gouges on their upstream faces. No cracking or structural damage to the bridge rail beam or posts was noted.

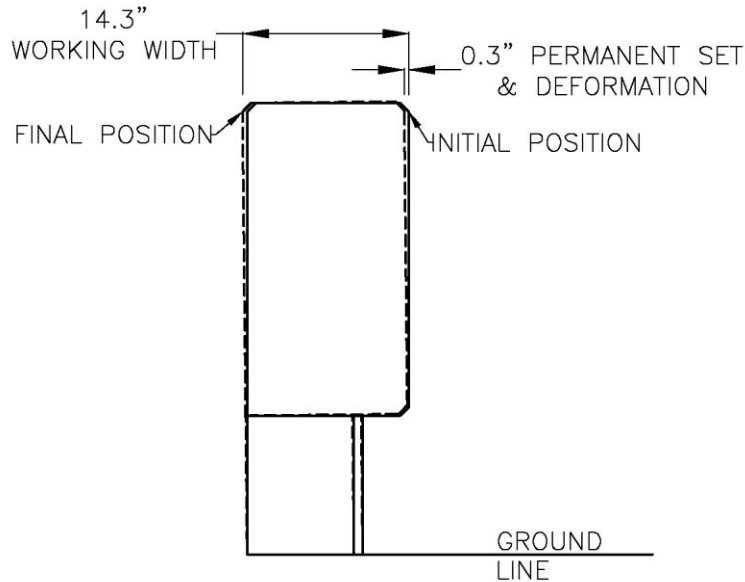
Figure 55. Permanent Set, Dynamic Deflection, and Working Width, Test No. OCBR-1

The maximum lateral permanent set of the barrier system was 0.3 in., as measured in the field. The maximum lateral dynamic barrier deflection was 0.3 in., as determined from high-speed digital video analysis. The working width of the system was found to be 14.3 in., also determined from high-speed digital video analysis. A schematic of the permanent set deflection, dynamic deflection, and working width is shown in Figure 55.

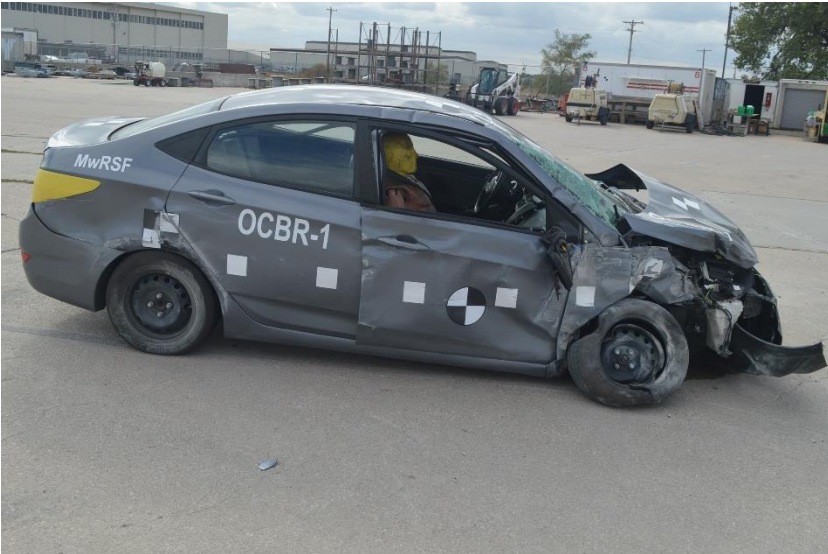
Figure 57. Vehicle Damage, Test No. OCBR-1

Majority of the damage was concentrated on the right-front corner and right side of the vehicle where the impact had occurred. The bumper cover detached from the impact side of the vehicle. The bumper was crushed inward on the right side of the vehicle. The left side of the radiator detached from the frame. As for the hood, the right side was crushed inward due to impact and significant dents were found across the right half of the hood and the rooftop. The left fender was bent inward toward the left side of the vehicle. Deformation of the fender, bumper, A-pillar, and door areas was observed. Additionally, the loading of the body structure caused deformation of the windshield and tearing of the windshield liner. The windshield deformation and windshield tearing were not an issue with respect to the MASH occupant criteria as the deformation and tearing was not caused by direct loading of the glass by the test article.

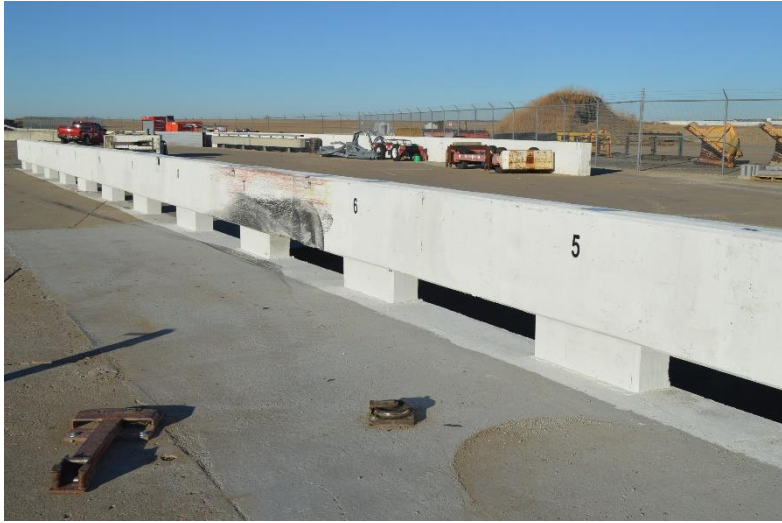
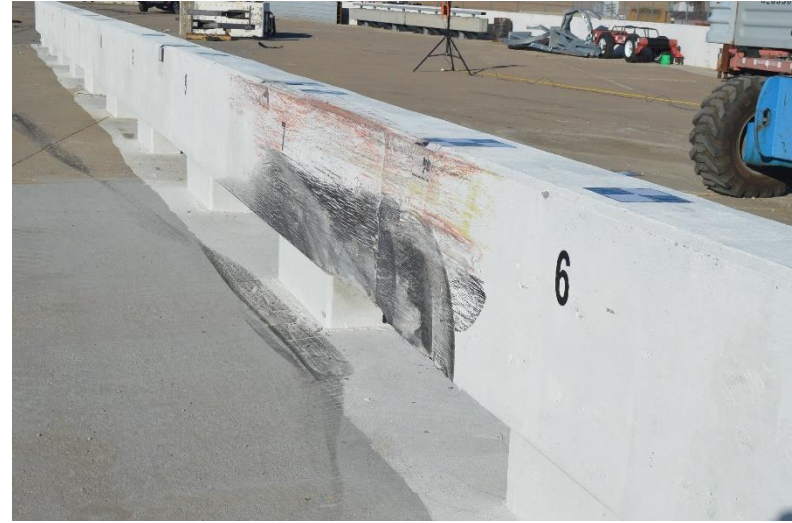
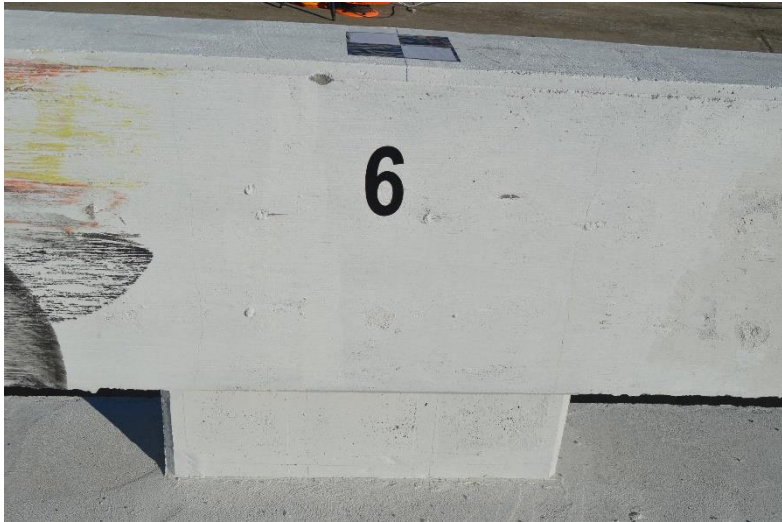
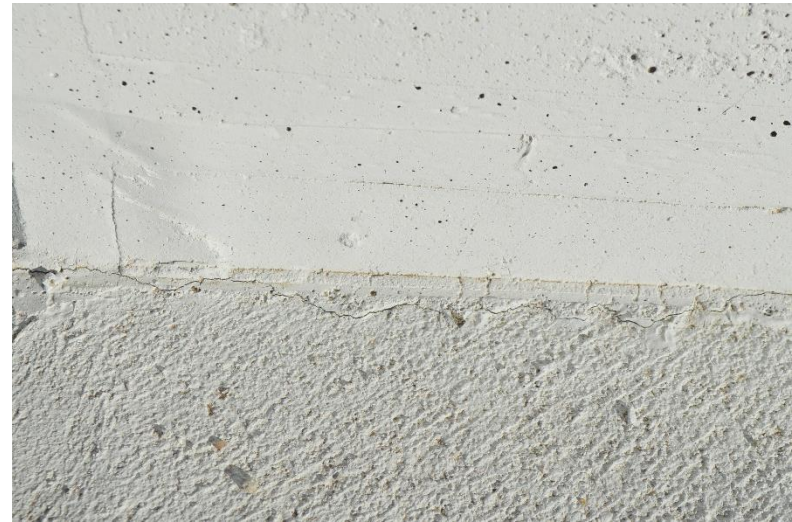
Figure 66. Overall System and Post No. 6 Damage, Test No. OCBR-2

Damage to the barrier was minimal, as shown in Figures 66 and 67. Barrier damage consisted of contact marks on the front face of the concrete segments and cracking. The length of vehicle contact along the barrier was approximately 12 ft – 3 in. which started 14¾ in. downstream from the centerline of post no. 6.

A contact mark was found on the top face of the barrier beginning 28½ in. downstream from the centerline of post no. 6 and extending 120 in. Various gouges were observed along the bottom edge of the beam between post nos. 6 and 7 where vehicle impact occurred, the most severe beginning 49 in. downstream of the centerline of post no. 6 and extending 34 in. downstream at a maximum depth of 2 in. Cracking of the bridge rail beam was observed 6 in. upstream from the centerline of post no. 6 and 49 in. upstream from post no. 8, with the cracks measuring 7 in. and 13 in. in length, respectively. The top of the bridge deck cracked at the upstream corner of post no. 7 and the downstream corner of post no. 6, but the cracks did not extend through to the bottom face of the deck. Cracks were also found at the post-to-deck interface areas at the edge of post nos. 6 and 7. Finally, post no. 6 was cracked at its base by the downstream corner and post no. 7 was cracked at its base by the upstream corner.

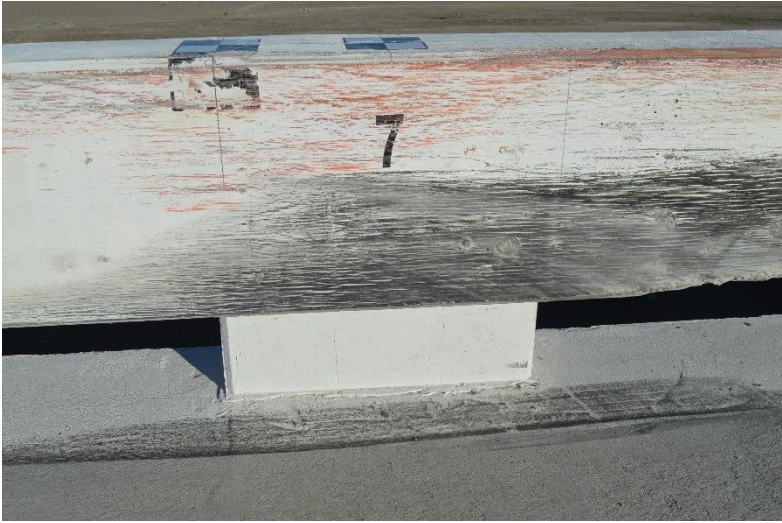
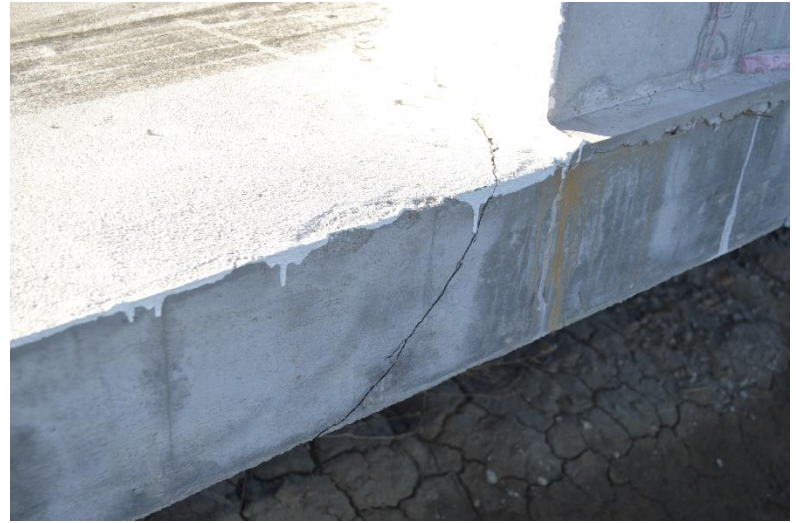
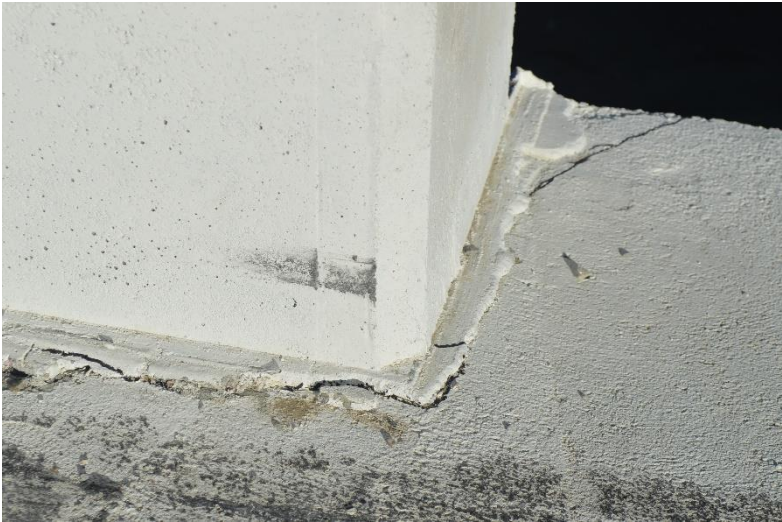
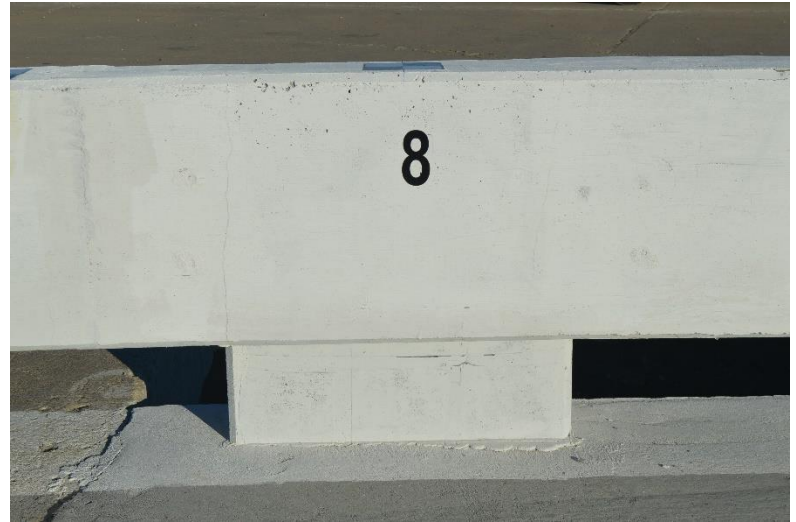
Figure 67. Post Nos. 7 and 8 Damage, Test No. OCBR-2

The maximum lateral permanent set of the barrier system was 0.3 in. at the rail at post no. 7, as measured in the field. The maximum lateral dynamic barrier deflection was 1.3 in. at the rail at post no. 7, as determined from high-speed digital video analysis. The working width of the system was found to be 15.3 in. at the rail at post no. 7, also determined from high-speed digital video analysis. A schematic of the permanent set deflection, dynamic deflection, and working width is shown in Figure 68.

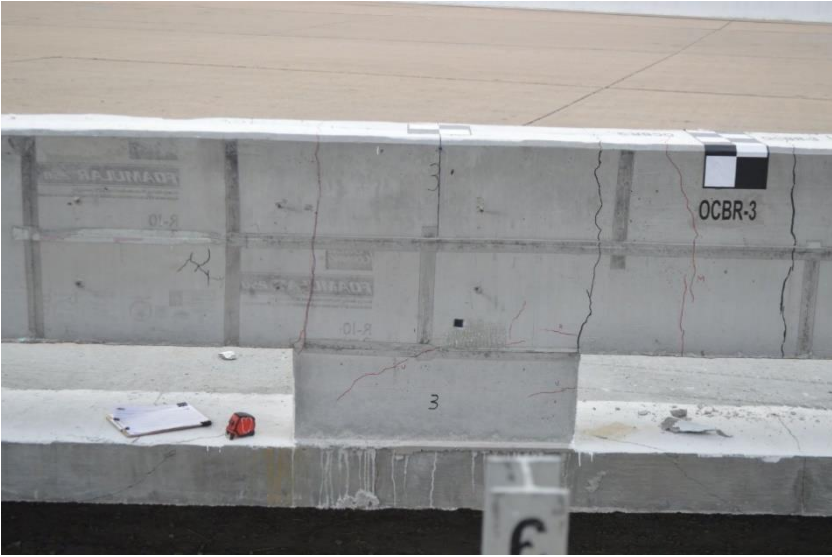
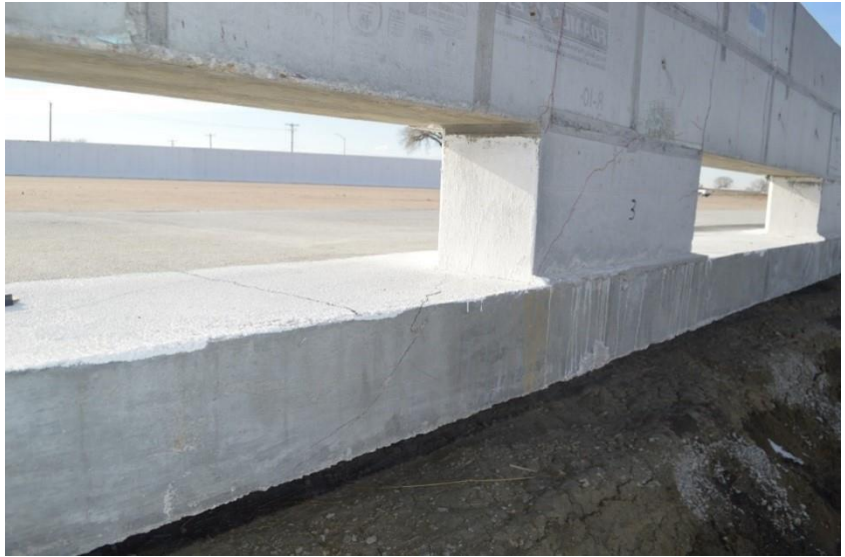
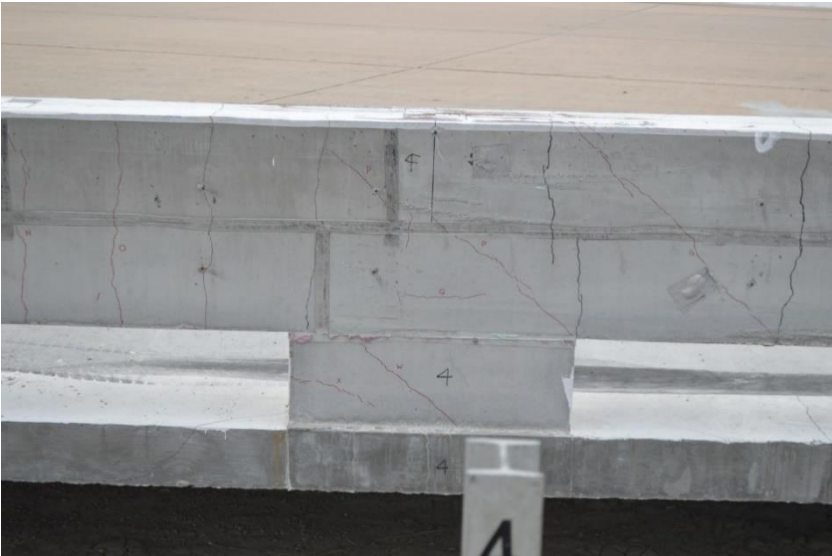
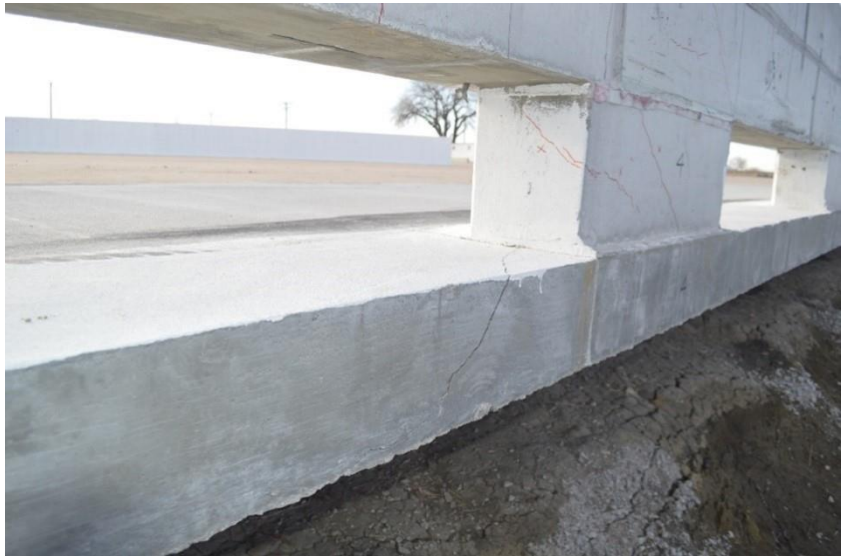
Figure 79. Concrete Beam and Post Damage, Post Nos. 3 and 4, Test No. OCBR-3

Damage to the barrier was moderate, as shown in Figures 77 through 80. Barrier damage consisted of contact marks, spalling, cracking, and gouging of the bridge rail beam and concrete cracking on deck. The length of vehicle contact along the barrier was approximately 64 ft – 10½ in., starting 3 ft – 10½ in. downstream from post no. 2.

Multiple contact marks of various heights and lengths were present on the front and top face of the bridge rail beam. Two contact marks measuring over 300 in. in length were present on the front face of the bridge rail beam starting 2 in. downstream from post nos. 3 and 18 in. downstream from post no. 11. Another contact mark was found on the top face of the bridge rail beam with a length of 62 ft starting 27 in. upstream from post no. 3. Additional contact marks were present between post no. 3 and the downstream end of the bridge rail beam.

Spalling and gouging were noted on the face of the bridge rail beam due to interaction of the wheel lugs with the face of the beam. A total of seven gouges on the top face and front edge of the bridge rail beam with lengths between 4 and 111 in. were found between post nos. 2 through 5. Another set of gouges with lengths between 9½ in. and 70½ in. spanned from post no. 11 to the downstream end of the bridge rail beam. Spalling was observed 38½ in. upstream from post no. 14 spanning 20 in. downstream.

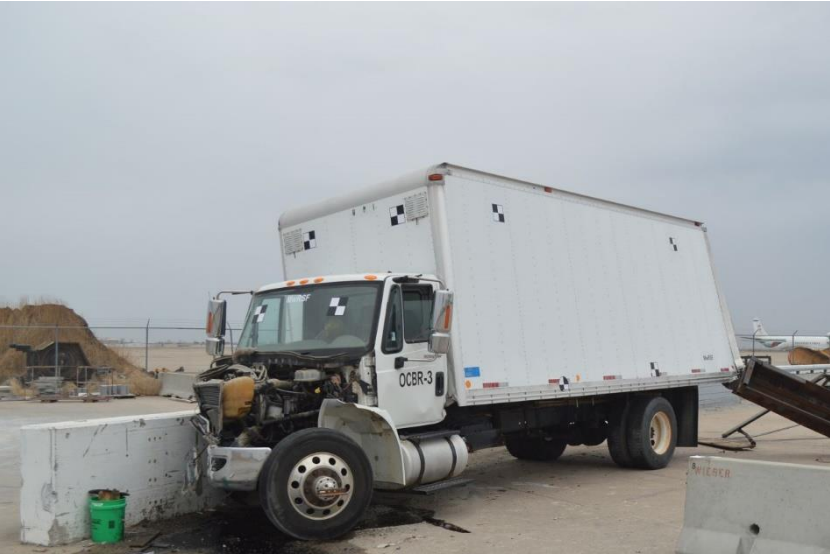
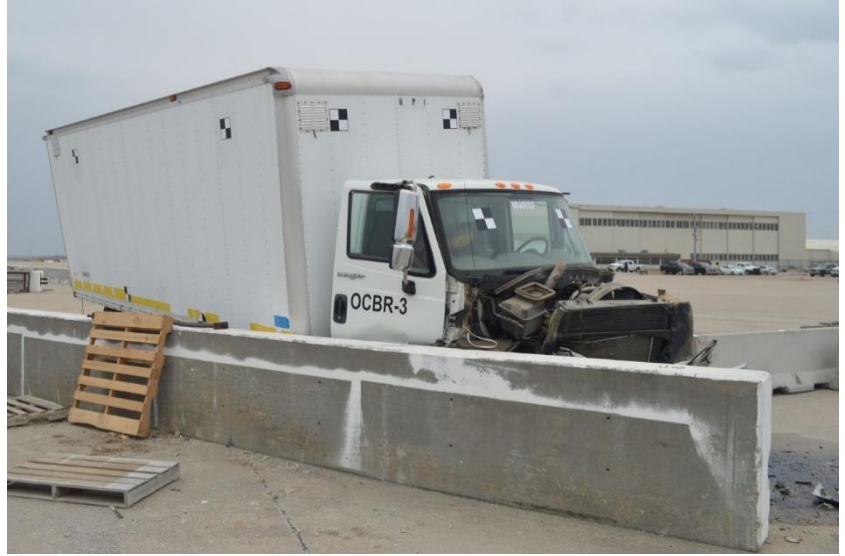
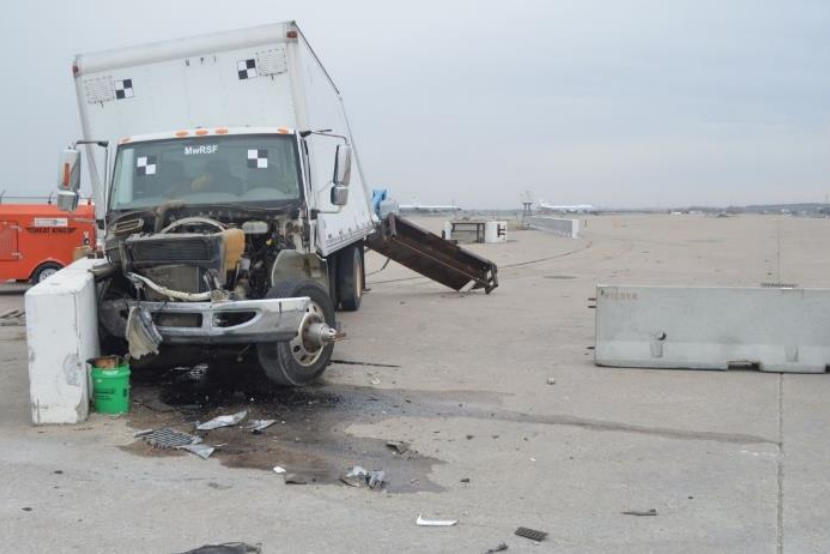
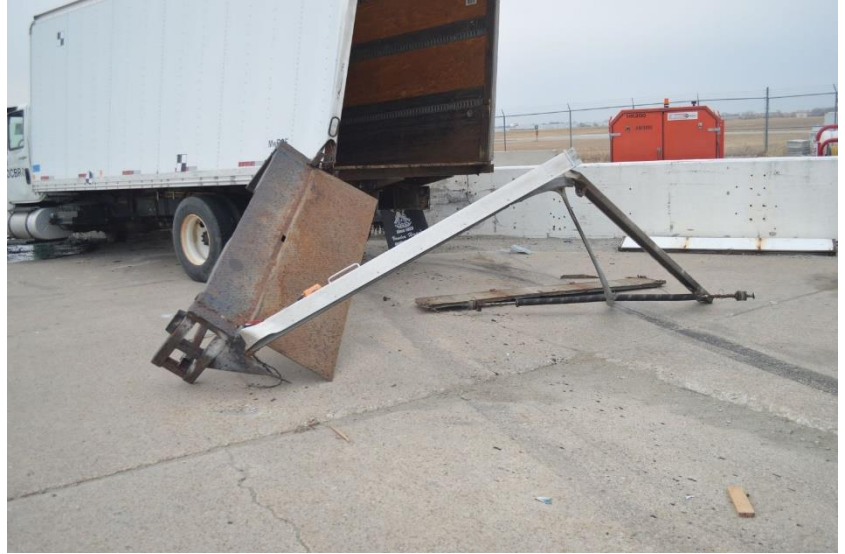
Figure 83. Vehicle Damage, Test No. OCBR-3

The damage to the vehicle was moderate, as shown in Figures 83 and 84. The maximum occupant compartment intrusions are listed in Table 13 along with the intrusion limits established in MASH for various areas of the occupant compartment. Note that the reference sets for occupant compartment intrusion were compromised so the standard occupant compartment measurements were not taken. However, comparisons were made to an exemplar vehicle with the same cab and interior configuration. Measurements were taken at the maximum area of deformation of the interior occupant compartment. The occupant compartment deformation was within MASH limits.

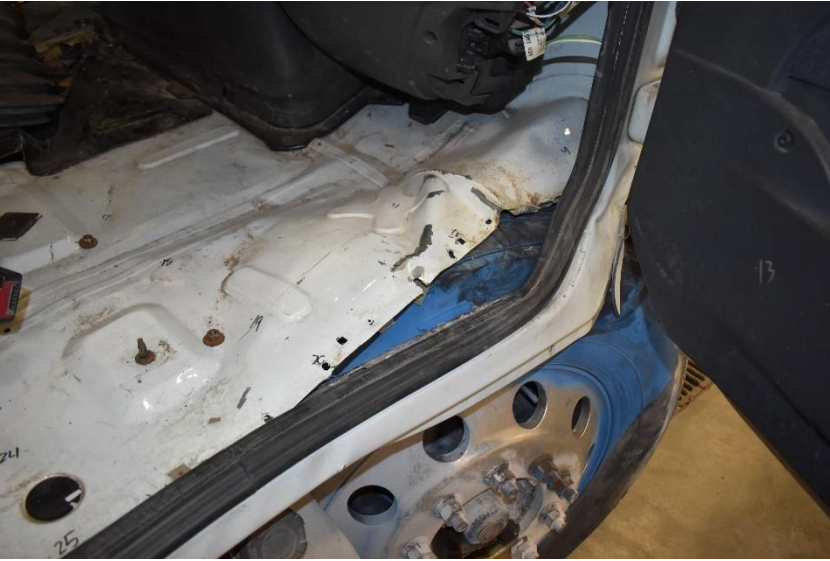
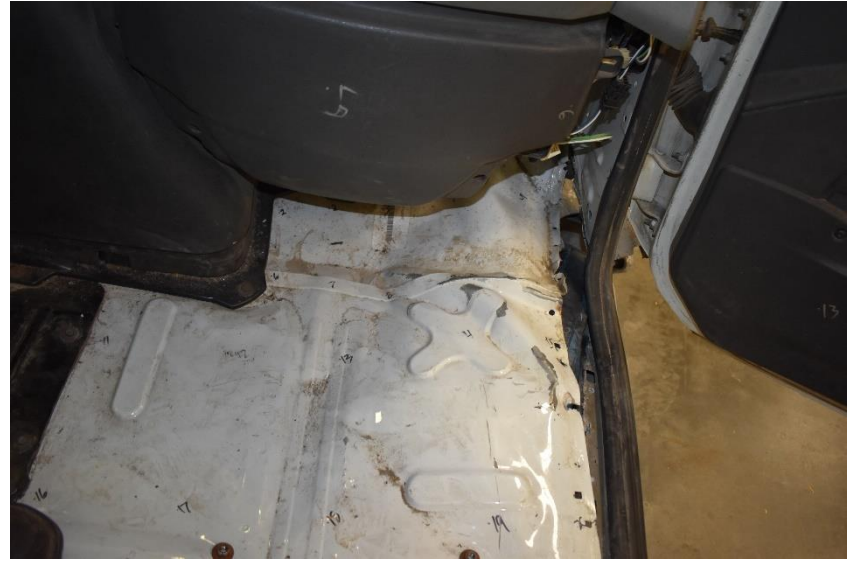
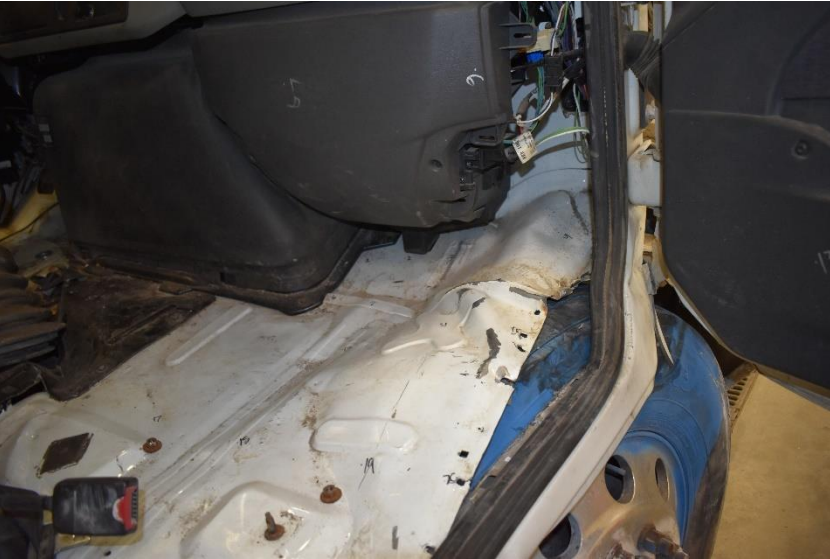
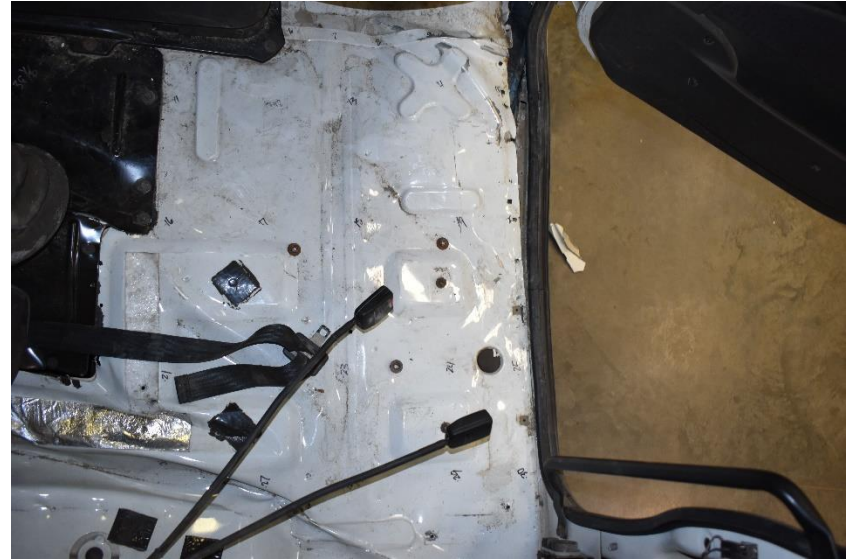
Figure 84. Vehicle Damage, Test No. OCBR-3

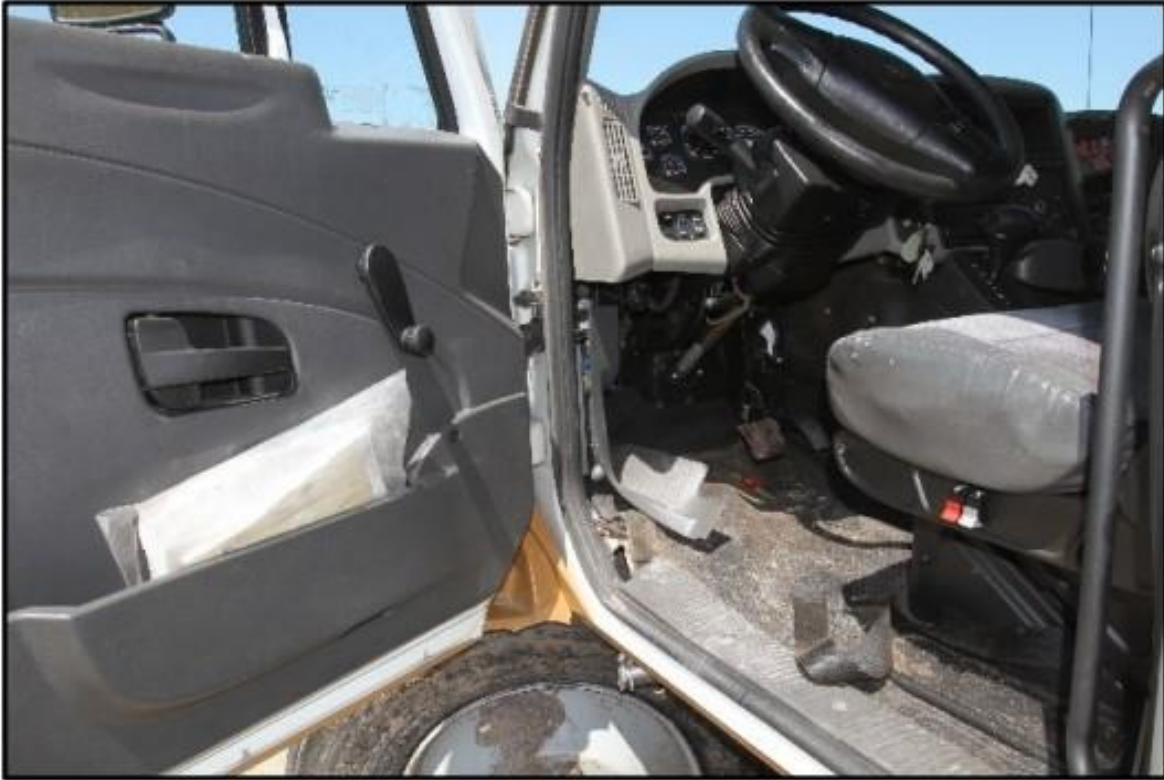
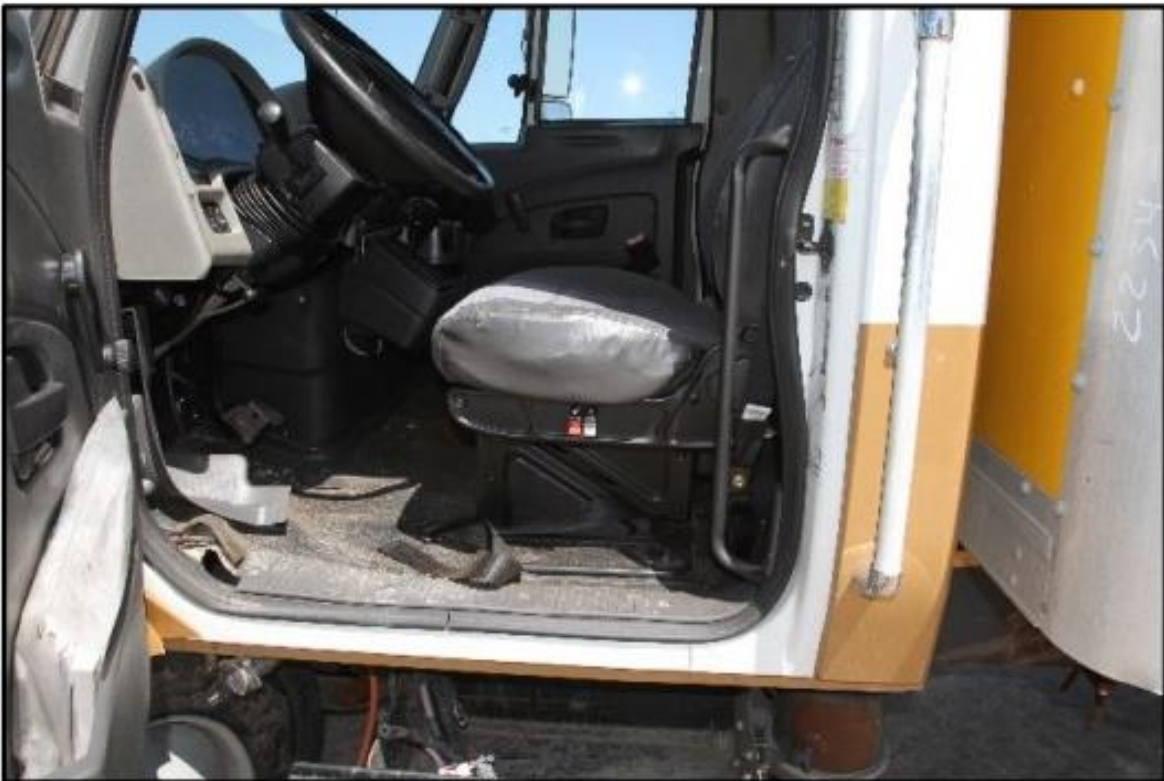
4. Review of previous MASH TL-4 bridge rail testing identified very similar levels of deformation and side seam deformations in existing full-scale crash tests. These tests were all deemed acceptable under MASH. Examples of these deformations and the relevant full-scale crash testing are provided in Figures 86 through 91.

Figure 87. Vehicle Floor Pan Separation, C1W Bridge Rail, Test No. 469469-1 [19]

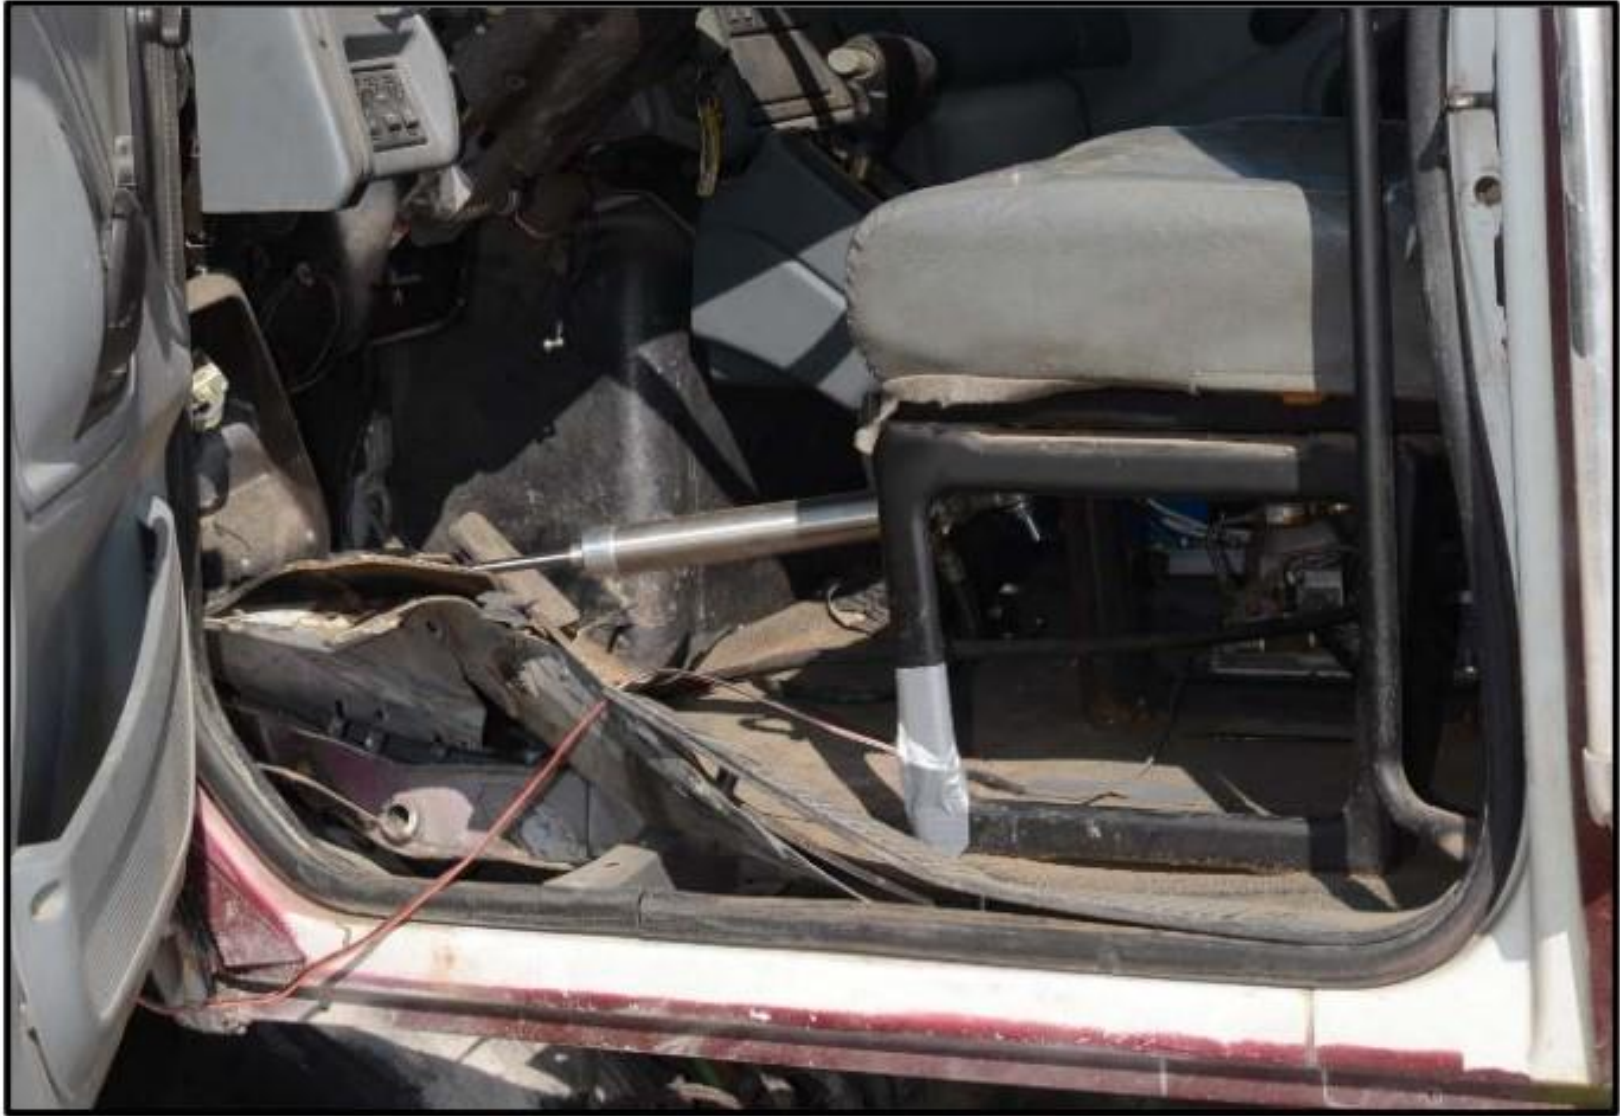
Figure 88. Vehicle Floor Pan Separation, TL-4 Barrier on Rubber Posts, Test No. 468958-3 [20]

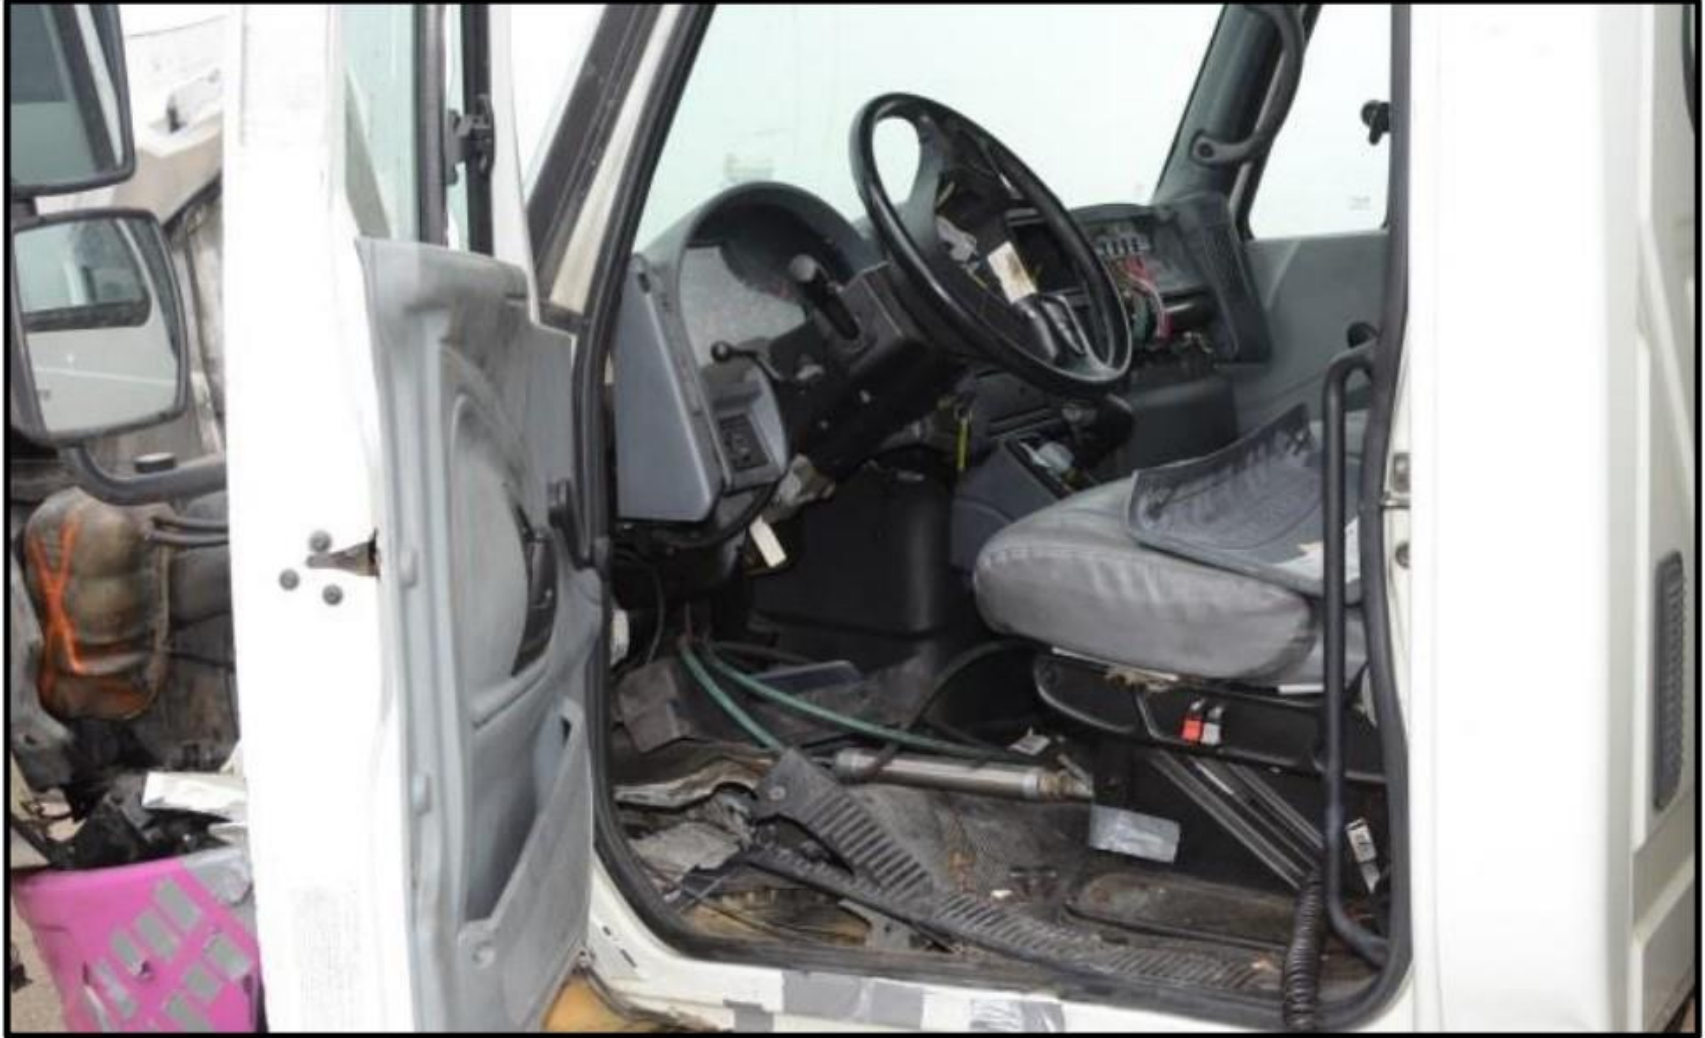
Figure 89. Vehicle Floor Pan Separation, 42-in. Tall Single Slope Barrier, Test No. 469467-1 [21]

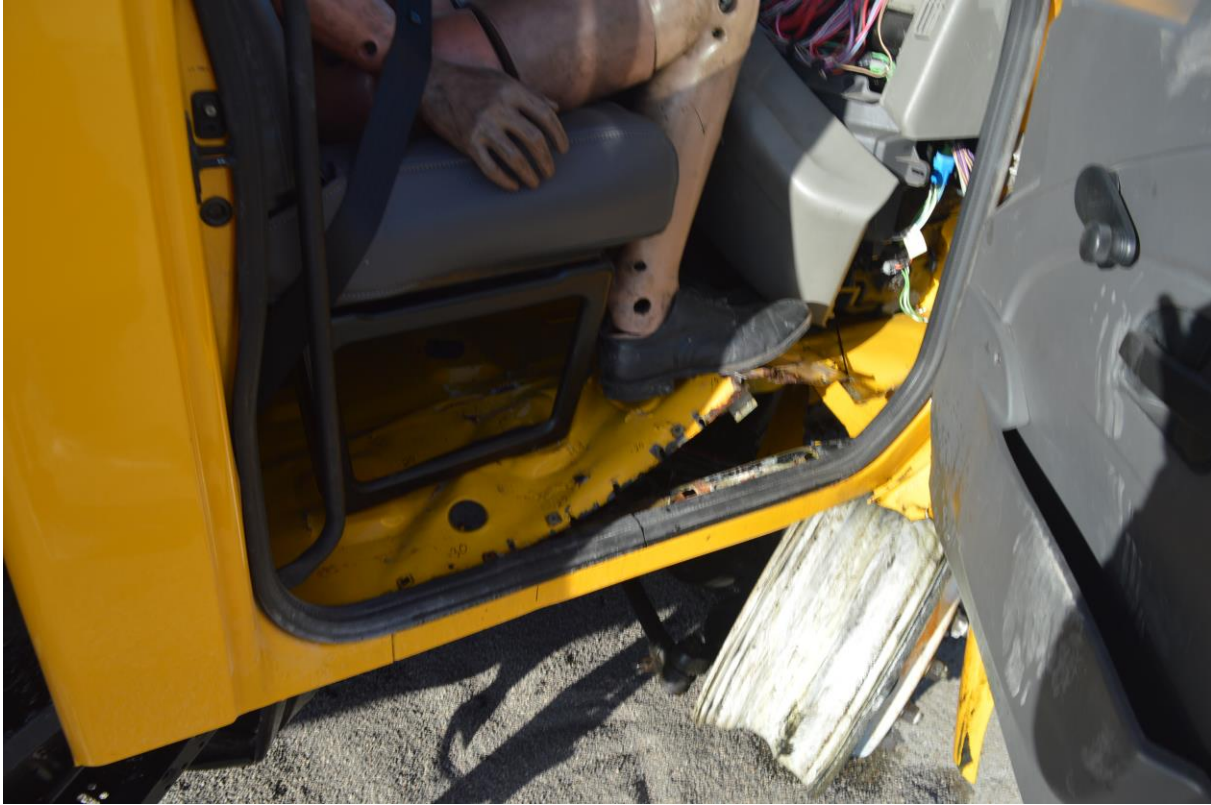
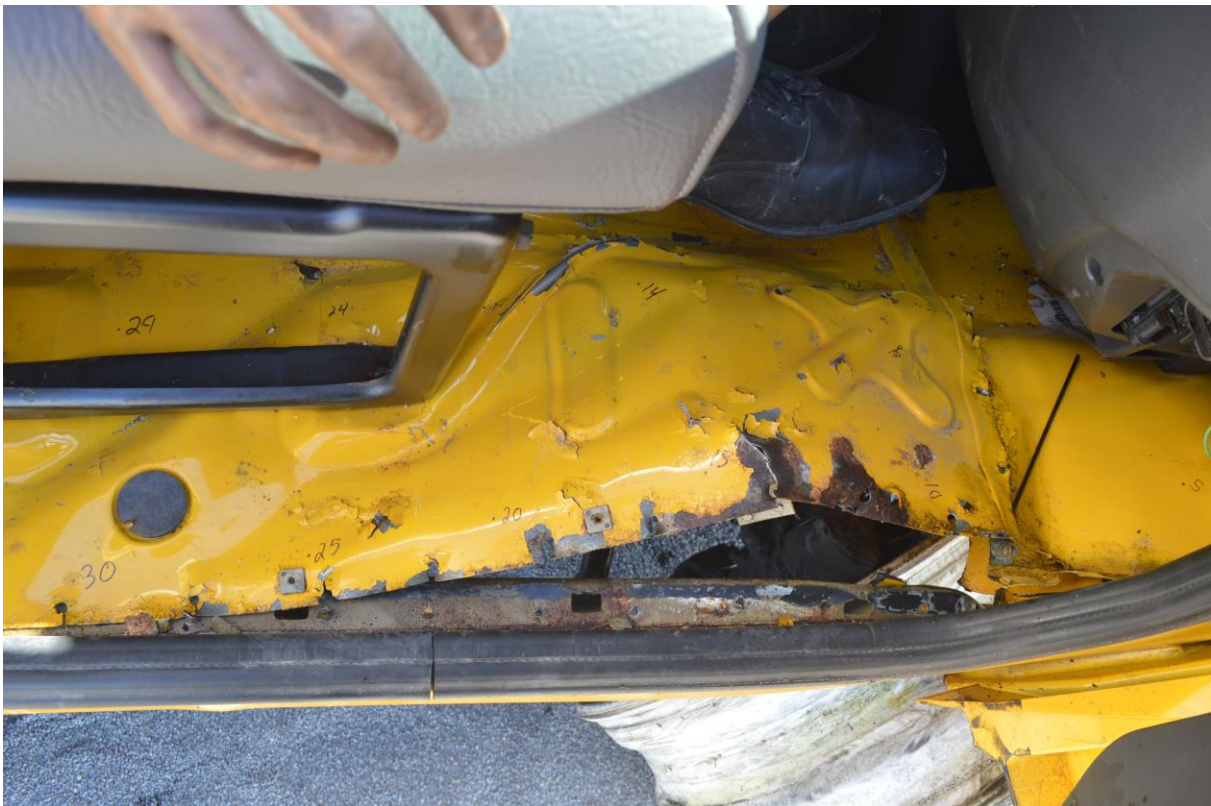
Figure 90. Vehicle Floor Pan Separation, Minnesota Combination Bridge Rail, Test No. MNCBR-1 [22]
