CRASH TESTING AND EVALUATION OF AN OPEN CONCRETE BRIDGE RAILING

MIDWEST ROADSIDE SAFETY FACILITY
Nebraska Transportation Center
University of Nebraska-Lincoln

MwRSF Research Report No. TRP-03-406b-24

February 29, 2024

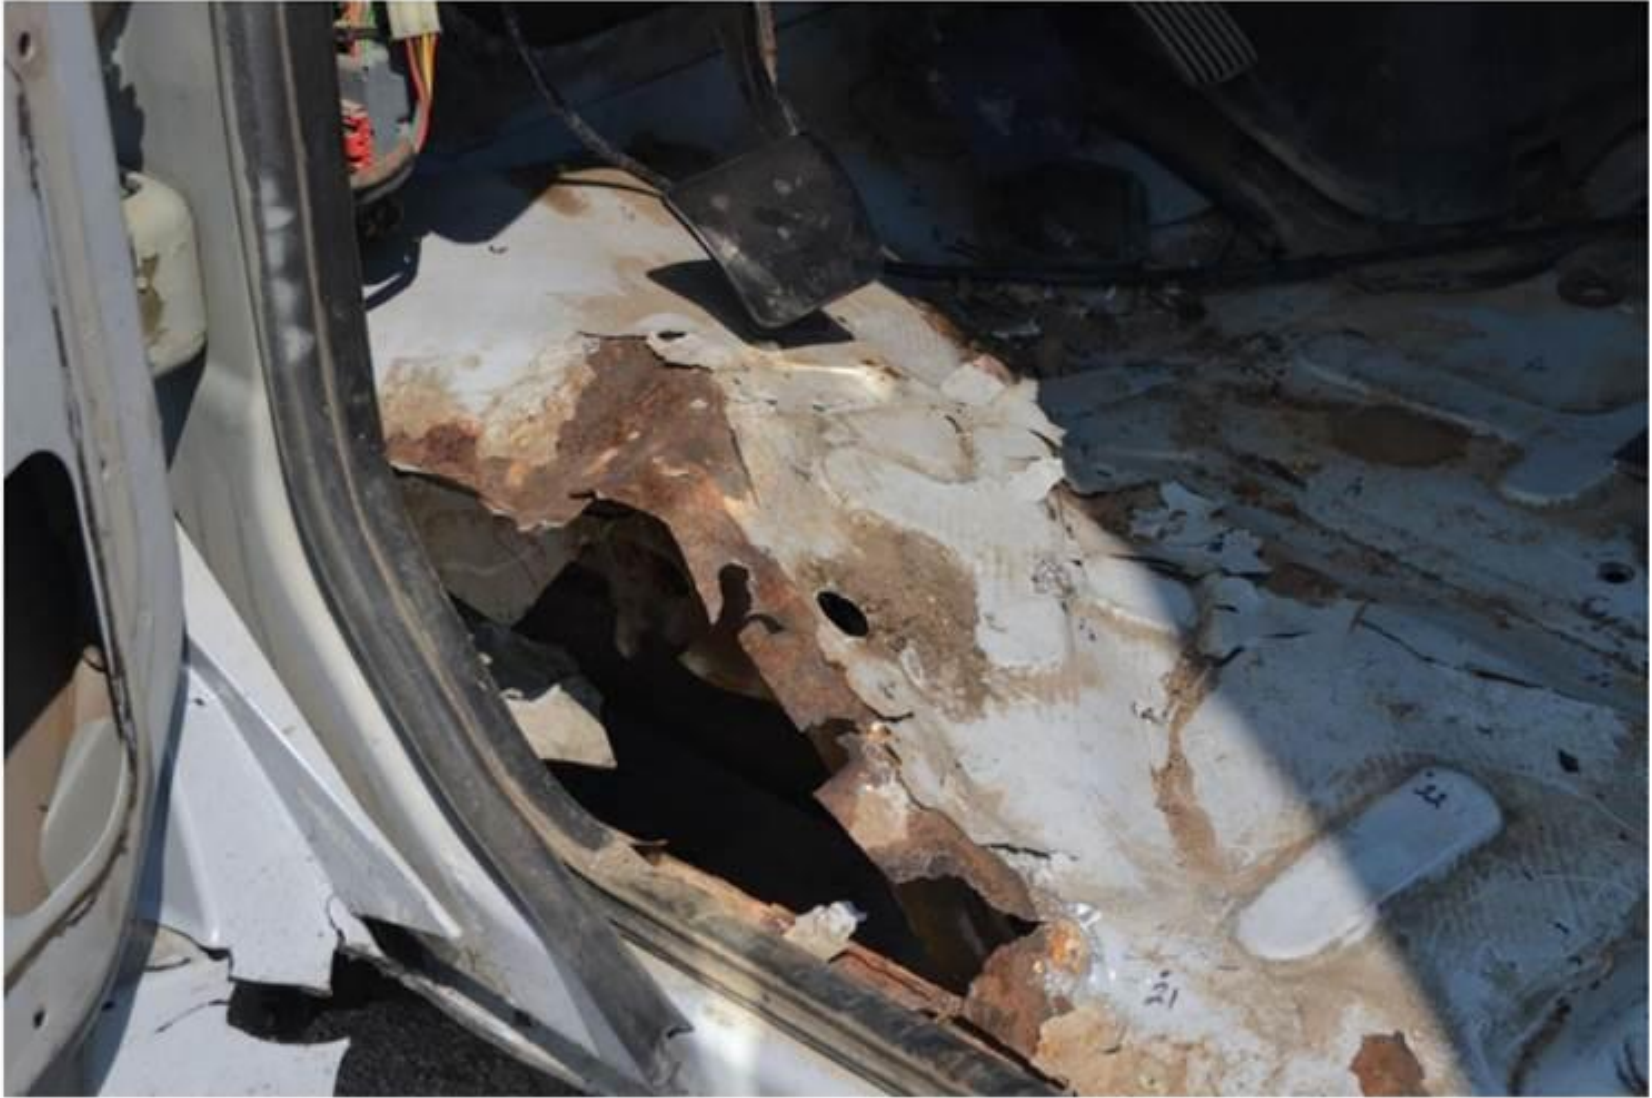
4. Review of previous MASH TL-4 bridge rail testing identified very similar levels of deformation and side seam deformations in existing full-scale crash tests. These tests were all deemed acceptable under MASH. Examples of these deformations and the relevant full-scale crash testing are provided in Figures 86 through 91.

Figure 91. Vehicle Floor Pan Separation, Optimized TL-4 Concrete Bridge Rail, Test No. 4CBR-1 [23]

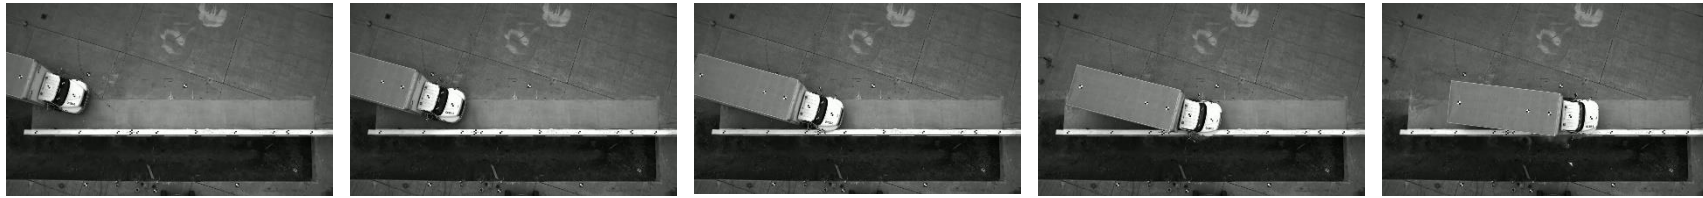
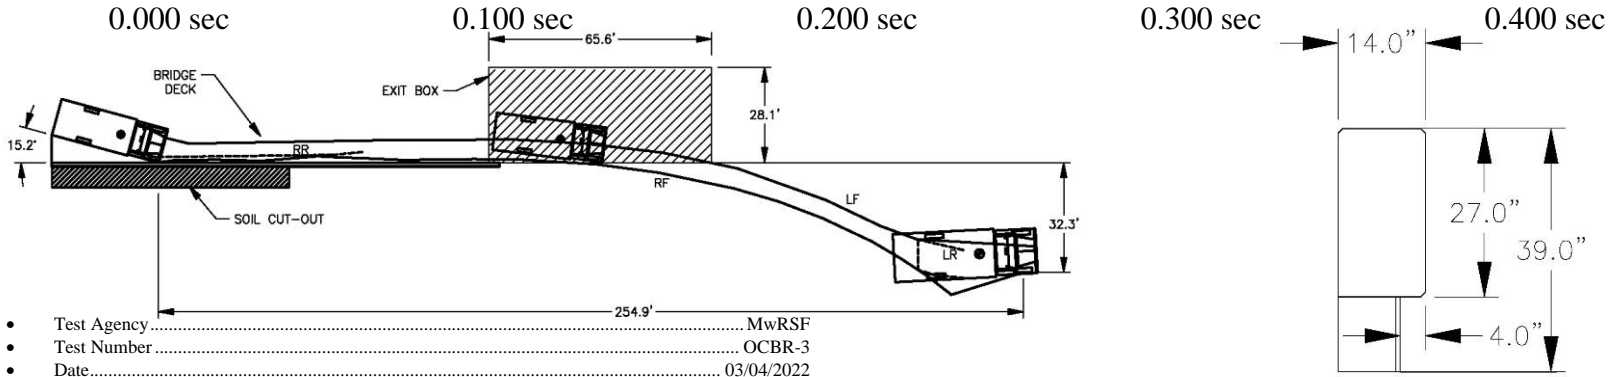
Figure 94. Summary of Test Results and Sequential Photographs, Test No. OCBR-3

The analysis of the test results for test no. OCBR-3 showed that the system adequately contained and redirected the 10000S vehicle with controlled lateral displacements of the barrier. A summary of the test results and sequential photographs are shown in Figure 94. Detached elements, fragments, or other debris from the test article did not penetrate or show potential for penetrating the occupant compartment, or present an undue hazard to other traffic, pedestrians, or work-zone personnel. Deformations of, or intrusions into, the occupant compartment that could have caused serious injury did not occur. The test vehicle did not penetrate nor ride over the barrier and remained upright during and after the collision. Vehicle roll, pitch, and yaw angular displacements, as shown in Appendix F, were deemed acceptable because they did not adversely influence occupant risk nor cause rollover. After impact, the vehicle exited the barrier and its trajectory did not violate the bounds of the exit box. Therefore, test no. OCBR-3 was determined to be acceptable according to the MASH safety performance criteria for test designation no. 4-12.

- Exit Conditions
 - Speed approximately 40.2 mph
 - Angle N/A
- Exit Box Criterion Pass
- Vehicle Stability Satisfactory
- Vehicle Stopping Distance 254.9 ft downstream, 32.3 ft in front

- Vehicle Damage Moderate
 - VDS [16] 1-RFQ-5
 - CDC [17] 01RFAW4

- Test Article Damage Moderate
- Maximum Test Article Deflections
 - Permanent Set 0.9 in.
 - Dynamic 1.5 in.
 - Working Width 50.8 in.
- Transducer Data
