Research Project Number TPF-5(430) – Supplement #10

EVALUATION OF THE MGS WITH HALF POST SPACING AND 7-FT POSTS ADJACENT TO SLOPE

MIDWEST ROADSIDE SAFETY FACILITY

MwRSF Research Report No. TRP-03-452-24

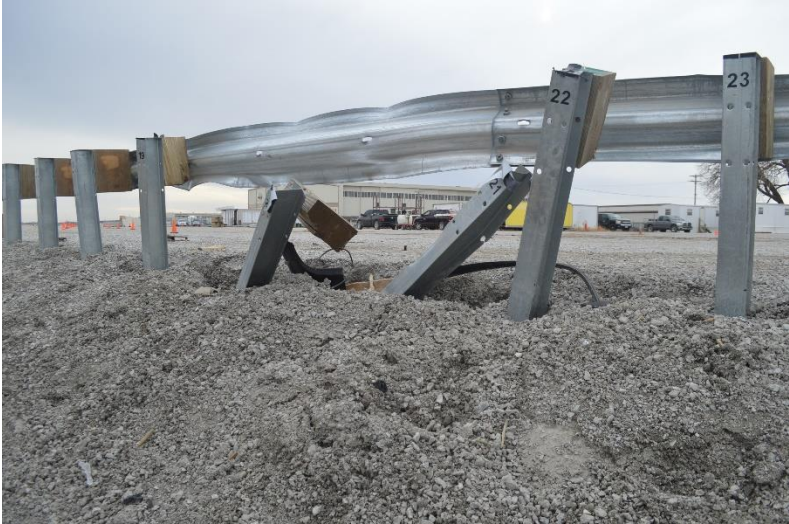
Figure 36. System Damage, Test No. MGS7S-1

Damage to the barrier was moderate, as shown in Figures 35 through 41. Barrier damage consisted of contact marks on the guardrail sections and posts, guardrail and post deformations, and post damage. The primary length of vehicle contact along the barrier was approximately 19 ft – 1 in. which spanned 14¼ in. downstream from post no. 17 to approximately 18¼ in. downstream from post no. 23. Contact marks were located on post nos. 17 through 23, spanning different lengths.

The W-beam guardrail configuration experienced rail kinking between post nos. 16 and 26. Minor rail flattening also occurred at post no. 18. Intermittent soil heaving was observed spanning from post nos. 19 through 23 which led to displacement of a portion of the 2H:1V slope behind the system.

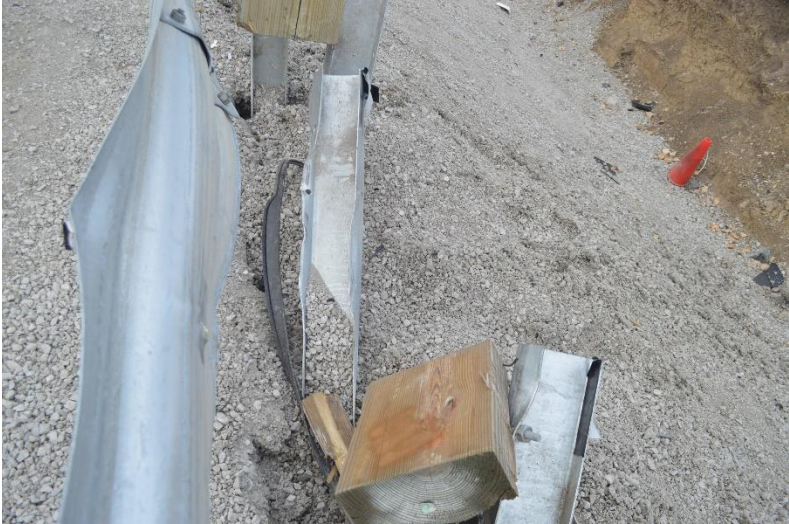
Figure 39. Post and Flange Damage, Test No. MGS7S-1

The guardrail was detached from the post at post nos. 20 through 22. Post no. 19 experienced breakout fracture on the downstream half of the breakout and buckling occurred on the back side of the flange. Post no. 20 experienced breakout fracture on the downstream half of the breakout, and a bent bolt at the post flange. The post was no longer in contact with the rail due to the post bolt releasing from the guardrail. Post no. 21 was also disengaged from the rail resulting from bolt shear at the nut on the backside of the flange. At post nos. 20 through 22, the upstream front flange was bent twice, on the top half of the post. The block at post no. 21 was detached from the post and the block at post no. 22 was dented, both following impact with the vehicle. The bolt bent at mid length on post no. 21, while the bolt on post no. 22 was bent at the flange hole. As result of the damage experienced by post nos. 20 through 22, the bolt holes became warped. Post no. 21's flange curled backward at the upper downstream corner. The back flange was then bent forward at the upstream edge. The web of the post was bent on the front half. The front flange tore on the lower bolt hole of the downstream side.

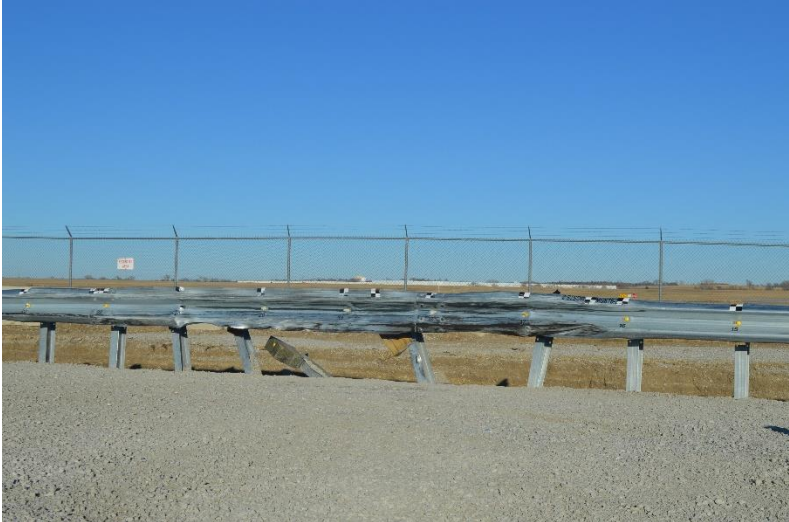
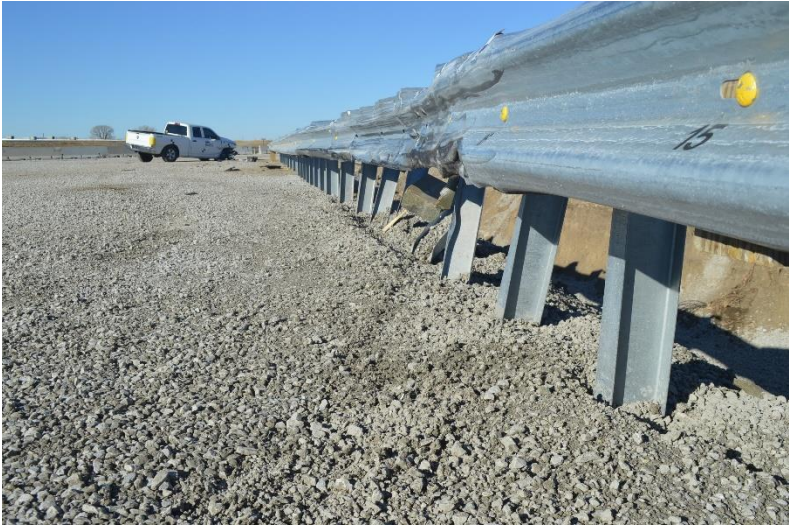
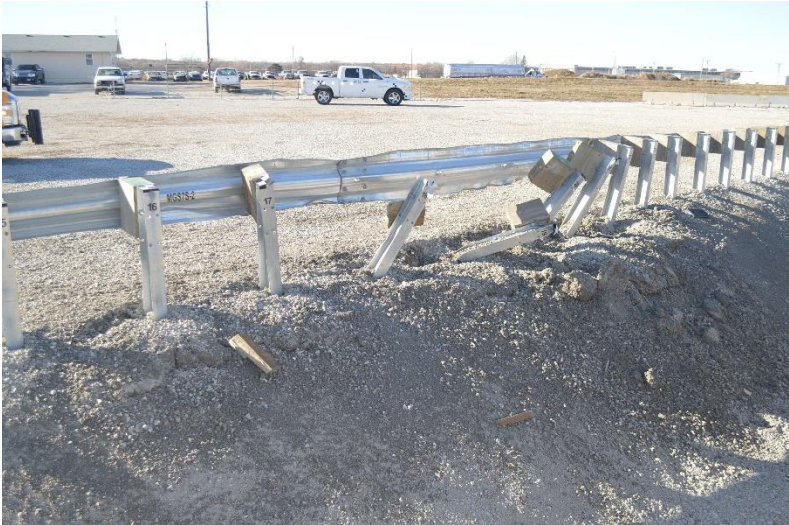
Figure 52. System Damage, Test No. MGS7S-2

Damage to the barrier was moderate, as shown in Figures 52 through 57. Barrier damage consisted of contact marks on the guardrail sections and posts, guardrail and post deformation, and post damage. The length of vehicle contact along the barrier was approximately 25 ft – 8 in. which spanned from 10½ in. upstream from the center of post no. 16 to approximately 2½ in. upstream of post no. 24. Additional contact marks were located on post nos. 18 through 23 and the blockouts of post nos. 17, 19, 22, and 23.

The majority of post deformation was concentrated on post nos. 17 through 22. The posts deflected backward upon impact. Post nos. 18 to 22 also experienced deflection in the downstream direction. Post nos. 18 to 21 were bent due to the deflection. In addition, post nos. 17 through 19 rotated clockwise while post nos. 20 through 22 rotated counter-clockwise. Torsional deformation occurred at these posts due to the specified rotation. Less critical damage was observed at post nos. 13 through 16, 23, and 24. Post nos. 15, 16, 23, and 24 deflected laterally backwards at lower levels. Post nos. 13 through 16 underwent clockwise rotation while post no. 24 experienced counter-clockwise rotation. Post nos. 18 and 19 displayed contact marks and flange deformation indicative of tire and wheel snag on the upstream flange of the posts.

The bolt hole was deformed on post nos. 17 through 24. The blockout at post no. 18 was fractured and disengaged. Post nos. 18 through 21 were no longer connected to the rail due to the post bolt releasing through the guardrail slot. Soil fissures occurred from post no. 18 to post no. 22. Large segments of soil were pushed backwards behind the posts in the impact region which disengaged sections of the 2H:1V slope behind the system and formed a line of soil disengagement in front of post nos. 16 through 23.

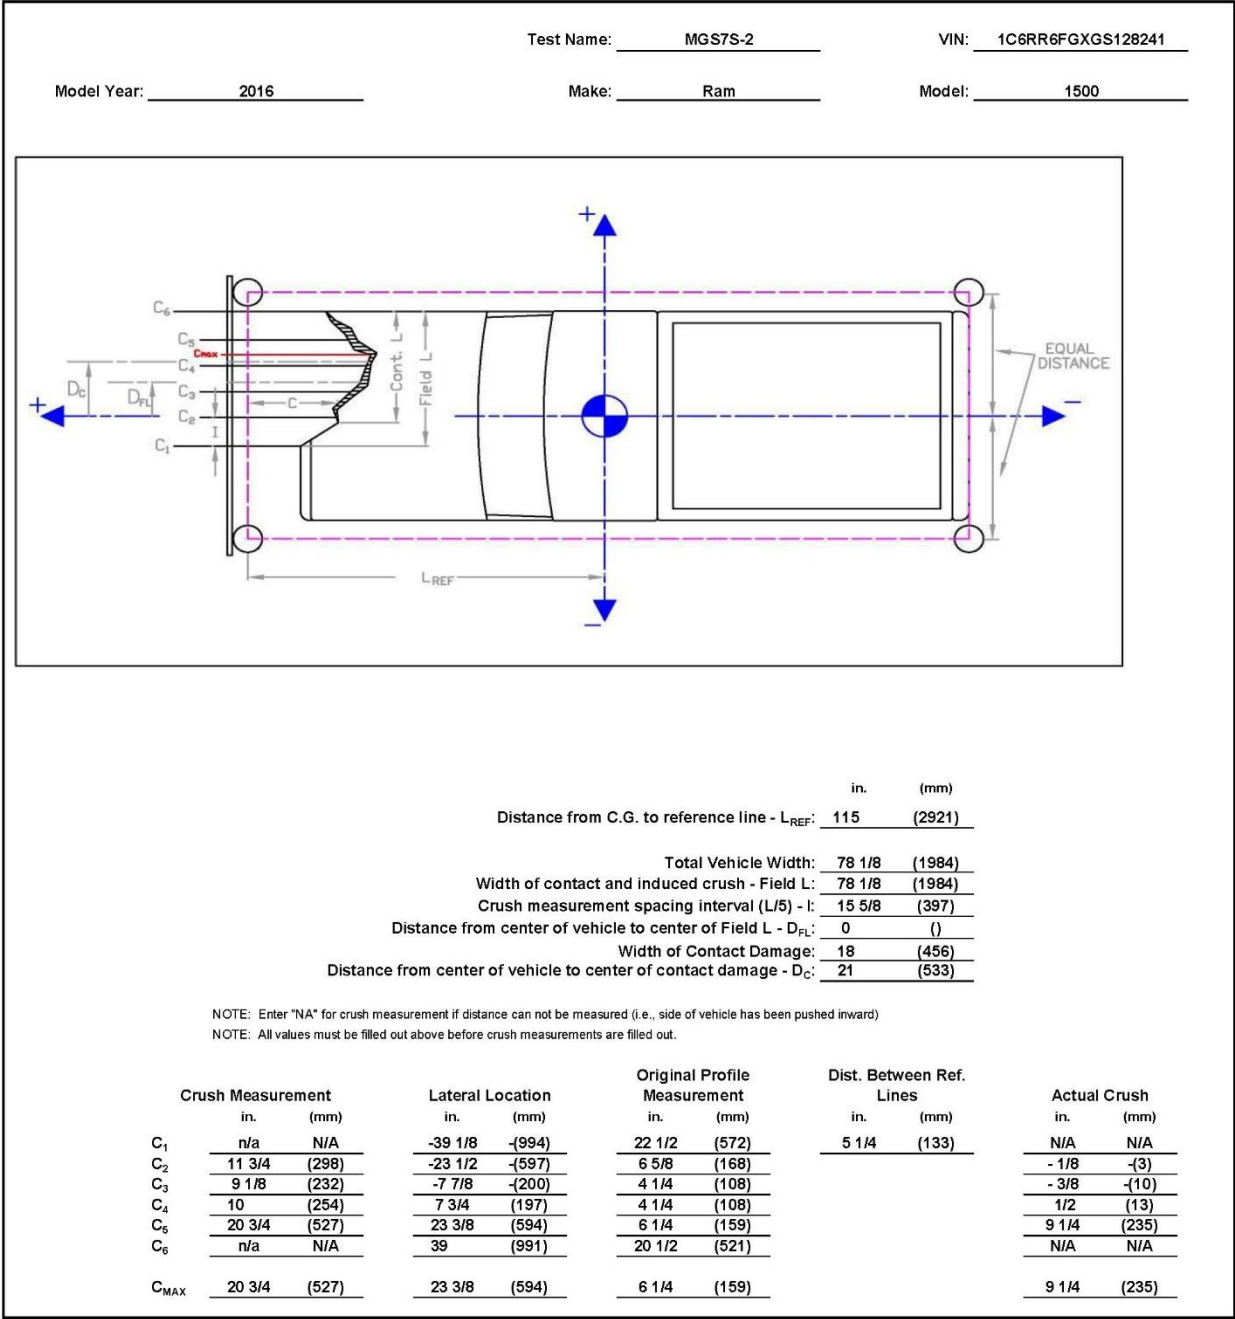
Figure D-13. Exterior Vehicle Crush (NASS) – Front, Test No. MGS7S-2

The majority of vehicle damage was concentrated on the right-front corner and right side of the vehicle. Both headlights and the grille were disengaged from the vehicle. The bumper was bent inward and slightly crushed on the right side of the bumper. The right-front fender was dented and scraped along the entire length. The right-front door was scraped and dented along the entire length. Damage to the door was concentrated upon the leading edge and lower half of the panel. The right rear door was slightly dented and scraped located around the vertical center of the panel. The right side of the truck box was dented and scraped along the entire length with the majority of the damage at the back end near the taillight. Damage was also located around the vertical center of the panel. The right end of the rear bumper was dented and scraped.
